**Cell 1 Regional Coastal Monitoring Programme
Update Report 6: 'Partial Measures' Survey 2014**

**Scarborough Council
Final Report**

July 2014

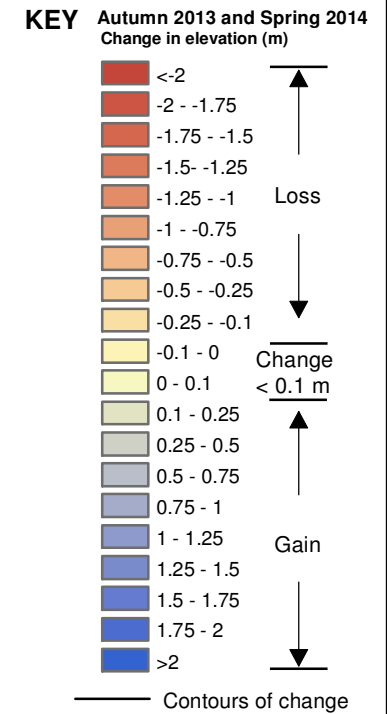
Appendix B- Map 4b
Short-term
Elevation Change
Scarborough South
Scarborough
Borough Council

Elevation difference
is between bespoke
Pre-Sediment
Recycling Survey
06 May 2014 and
bespoke Post-Sediment
Recycling Survey
20/05/2014

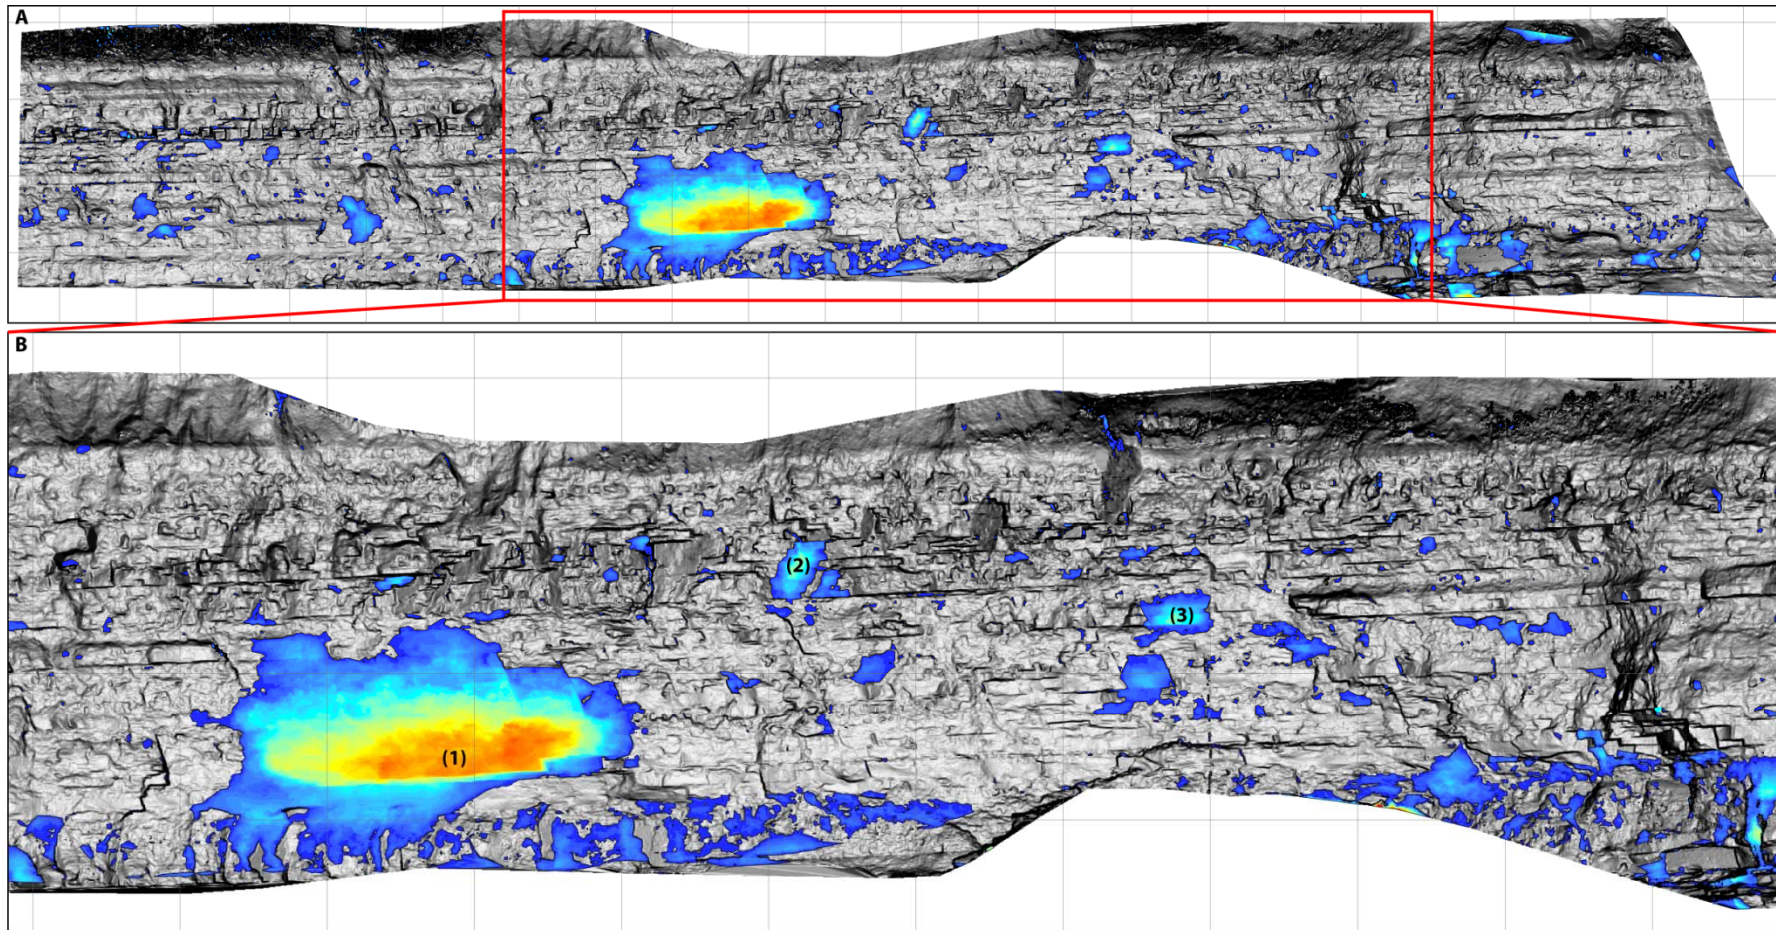
- We highlight key features of the erosion observed between March 2013 and March 2014 in Figure 1, numbered (1) to (3), and discussed below:
- We observe several areas indicative of the continued development (failure) of rockfall scars that have previously experienced collapse (e.g. Figure 1 (1 – 3)). These are normally vertically and horizontally extensive (> 1 m), but in general shallow in depth relative to the cliff face (< 0.15 m), often associated with release along face-parallel joints or stress relief features.

- Several areas which underwent larger scale ($> 1 \text{ m}^3$) failure in Years 1 & 2 continue to show quiescence, with minimal change on the now-exposed intact failure scar rock (e.g. area up and right of (1) in Figure 1). Whilst the fresh face of such areas remains unchanged, such features commonly are seen to extend laterally across the cliff (vertically and horizontally) albeit to a limited extent, as shown in the month by month expansion of rockfall scars (Figure 3).

- Some change is observed in isolated patches on the surface of the glacial till cap at the top of the cliff. On the Eastern section of the monitored section (Figure 1 - left), much of this change is associated with vegetation growth, rather than mass movements.

Figure 1. Monitoring erosion at Cowbar Nab between March 2013 and March 2014. **(A)** shows an elevation view of the rock cliff at Cowbar, displayed as if viewed from a point 100 m seaward from the cliff toe on the foreshore. The greyscale image is the slope of the cliff face, to provide indicative topography (hillshade), and the colours show erosion depth normal to the cliff face. Cold colours (blues) show erosion ≥ 0.1 m (the lower threshold of the change detection), and warm colours (orange to red) show erosion up to 3.5 m relative to the cliff face. The grid interval is 10 m in both horizontal and vertical axis. The red square delimits the extent of the area shown in B. **(B)** shows a close up view of the cliff directly beneath Cowbar Lane. The numerical labels are referred to in the body of the text.

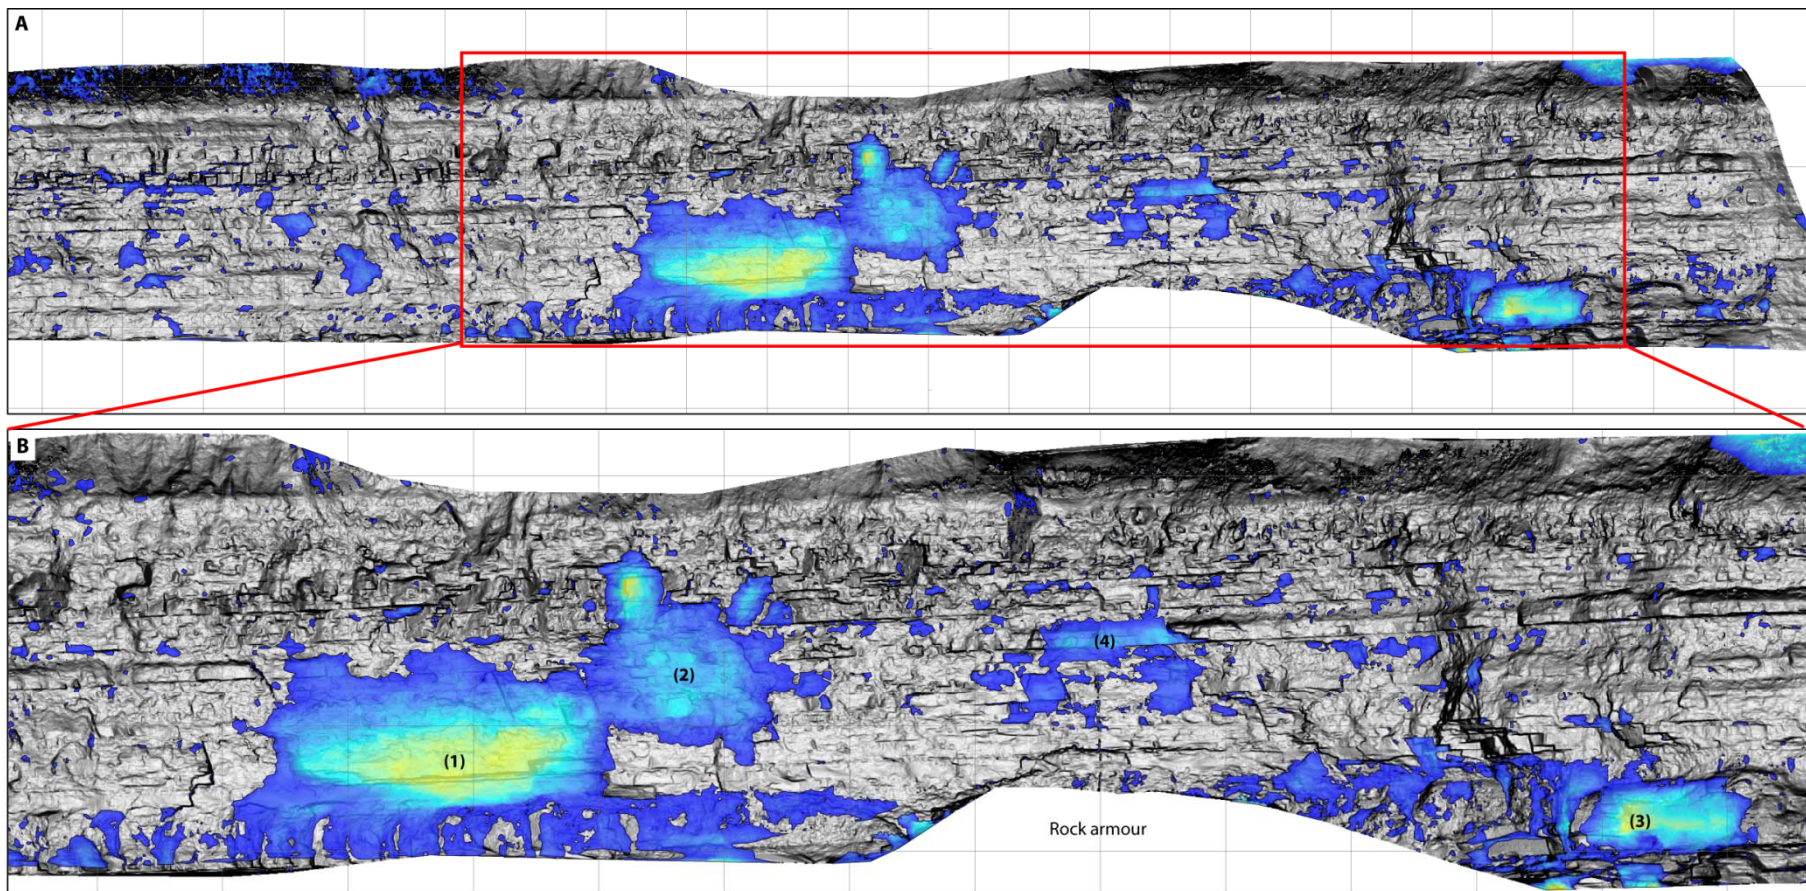
Figure 2. Monitoring erosion at Cowbar Nab between January 2011 and March 2014. **(A)** shows an elevation view of the rock cliff at Cowbar, displayed as if viewed from a point 100 m seaward from the cliff toe on the foreshore. The greyscale image is the slope of the cliff face, to provide indicative topography (hillshade), and the colours show erosion depth normal to the cliff face. Cold colours (blues) show erosion ≥ 0.1 m (the lower threshold of the change detection), and warm colours (orange to red) show erosion up to 3.5 m relative to the cliff face. The grid interval is 10 m in both horizontal and vertical axis. The red square delimits the extent of the area shown in B. **(B)** shows a close up view of the cliff directly beneath Cowbar Lane. The numerical labels are referred to in the body of the text.

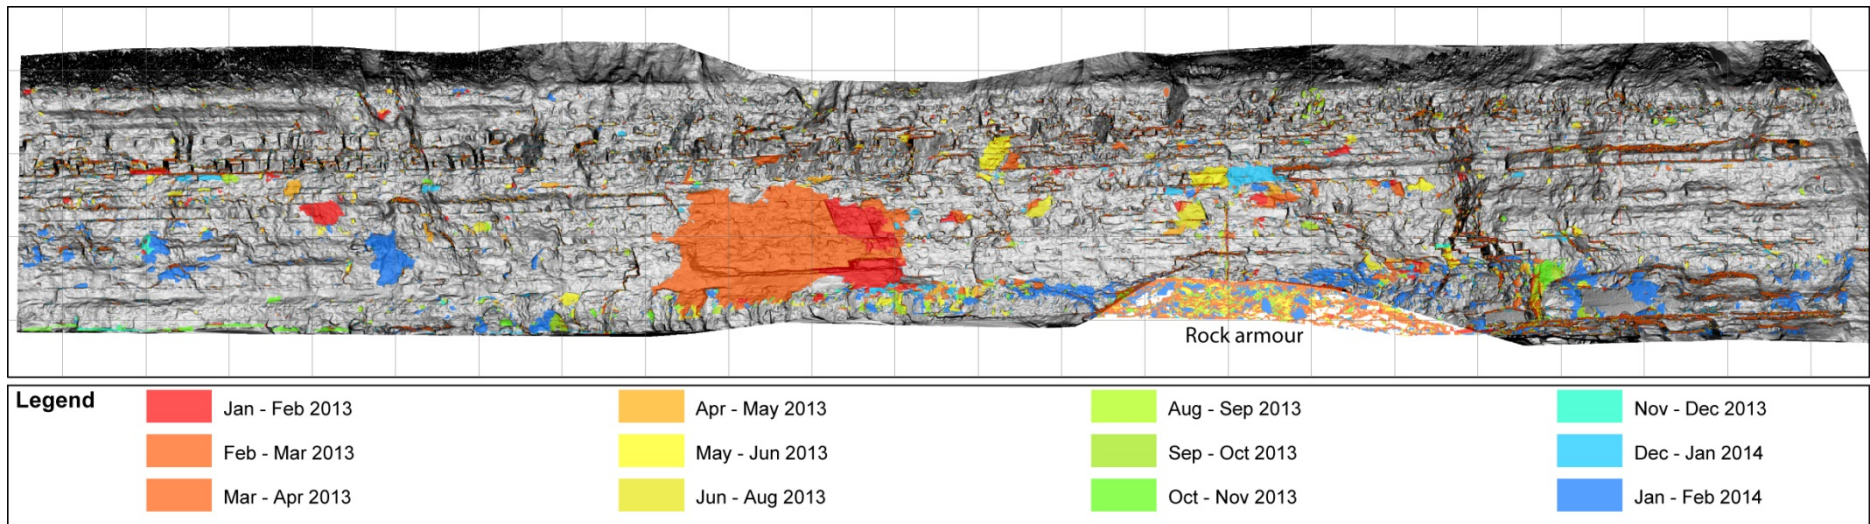
Figure 3. Monitoring erosion at Cowbar Nab between January 2013 and March 2014. The plot shows the the extent of recorded rockfalls for each month between January 2013 and the end of February 2014, each month with a unique colour. The grid interval is 10 m in both horizontal and vertical axis.

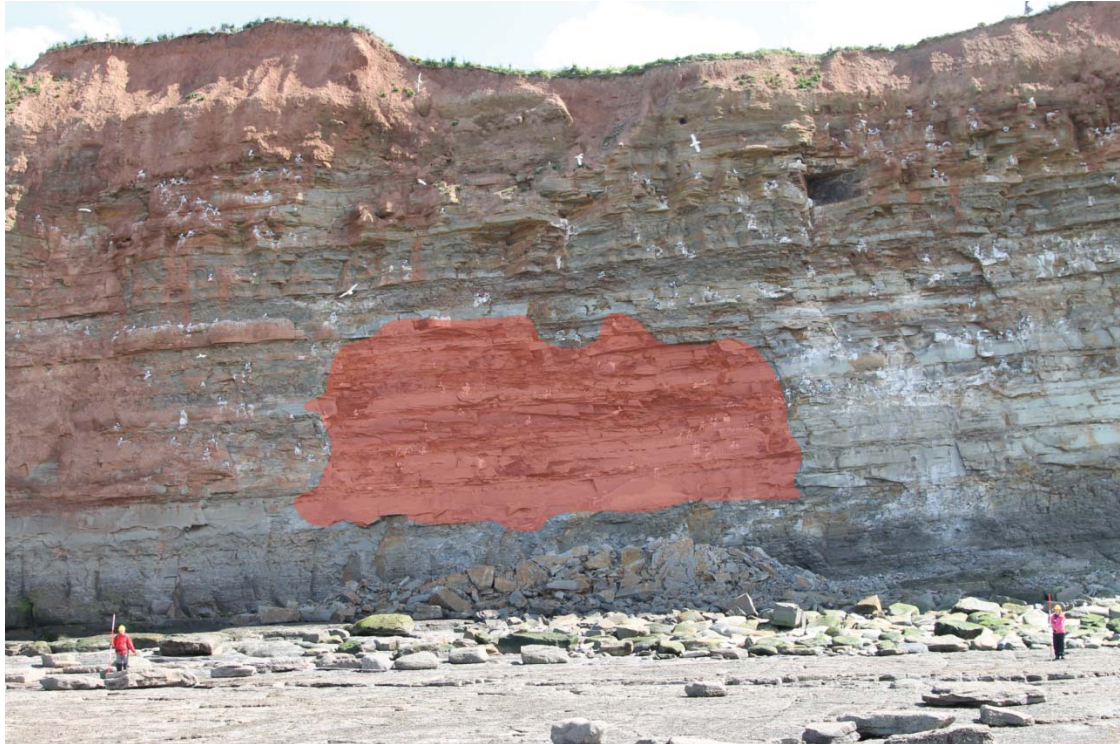
- ii. The rockfall occurred directly above an area which has been previously been observed to have experience marine undercutting, and was identified above as a potential location for future loss of material. The position of the rockfall relative to the location of Cowbar Lane is provided in Figure 7 for context.

- iv. The initial volume of material lost during as a result of this rockfall was identified as 687.1 m³. Further subsequent analysis revealed that this event multiple failures which span the 2012 – 2013 and this monitoring period as shown in Figure 3 and 6 which describe the evolution of this failure. The failure reported here was 325.5 m³.
- v. The period since this event has been quiet, with fewer rockfalls than have been observed in previous months. As a result the monitored erosion rate for years 1 – 3 is reduced as compared to that for years 1 – 2. The modelled rate is more stable as this accounts for the possibility of larger events such as this.

Figure 4: Photograph (14/04/13) showing the location and extent of the rockfall observed between 14th March and 14th April, with debris pile below. Note people for scale.

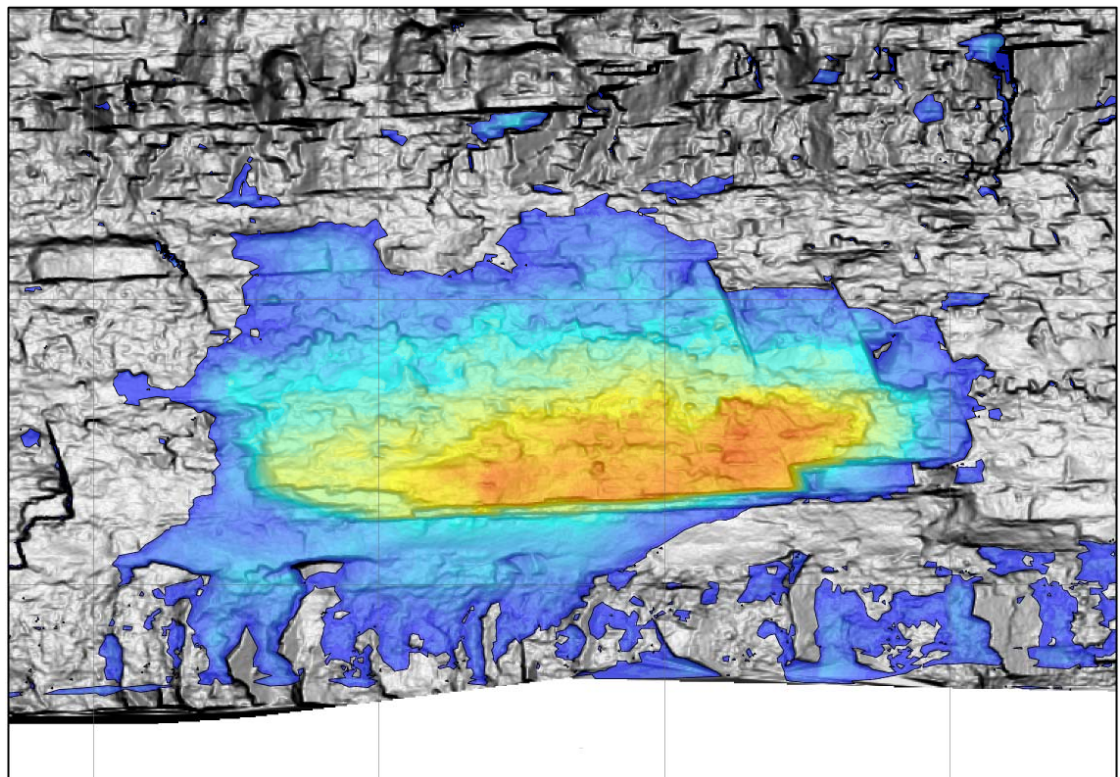
Figure 5: Close up view of rockfall scar recorded between March and April 2013. Image in greyscale shows hillshade for context of the slope topography. The warm colours show a greater depth of erosion, here up to 2.8 m, and cold colours (blues), show erosion greater than or equal to 0.1 m. Grid is 10 m interval in the horizontal and vertical axis.

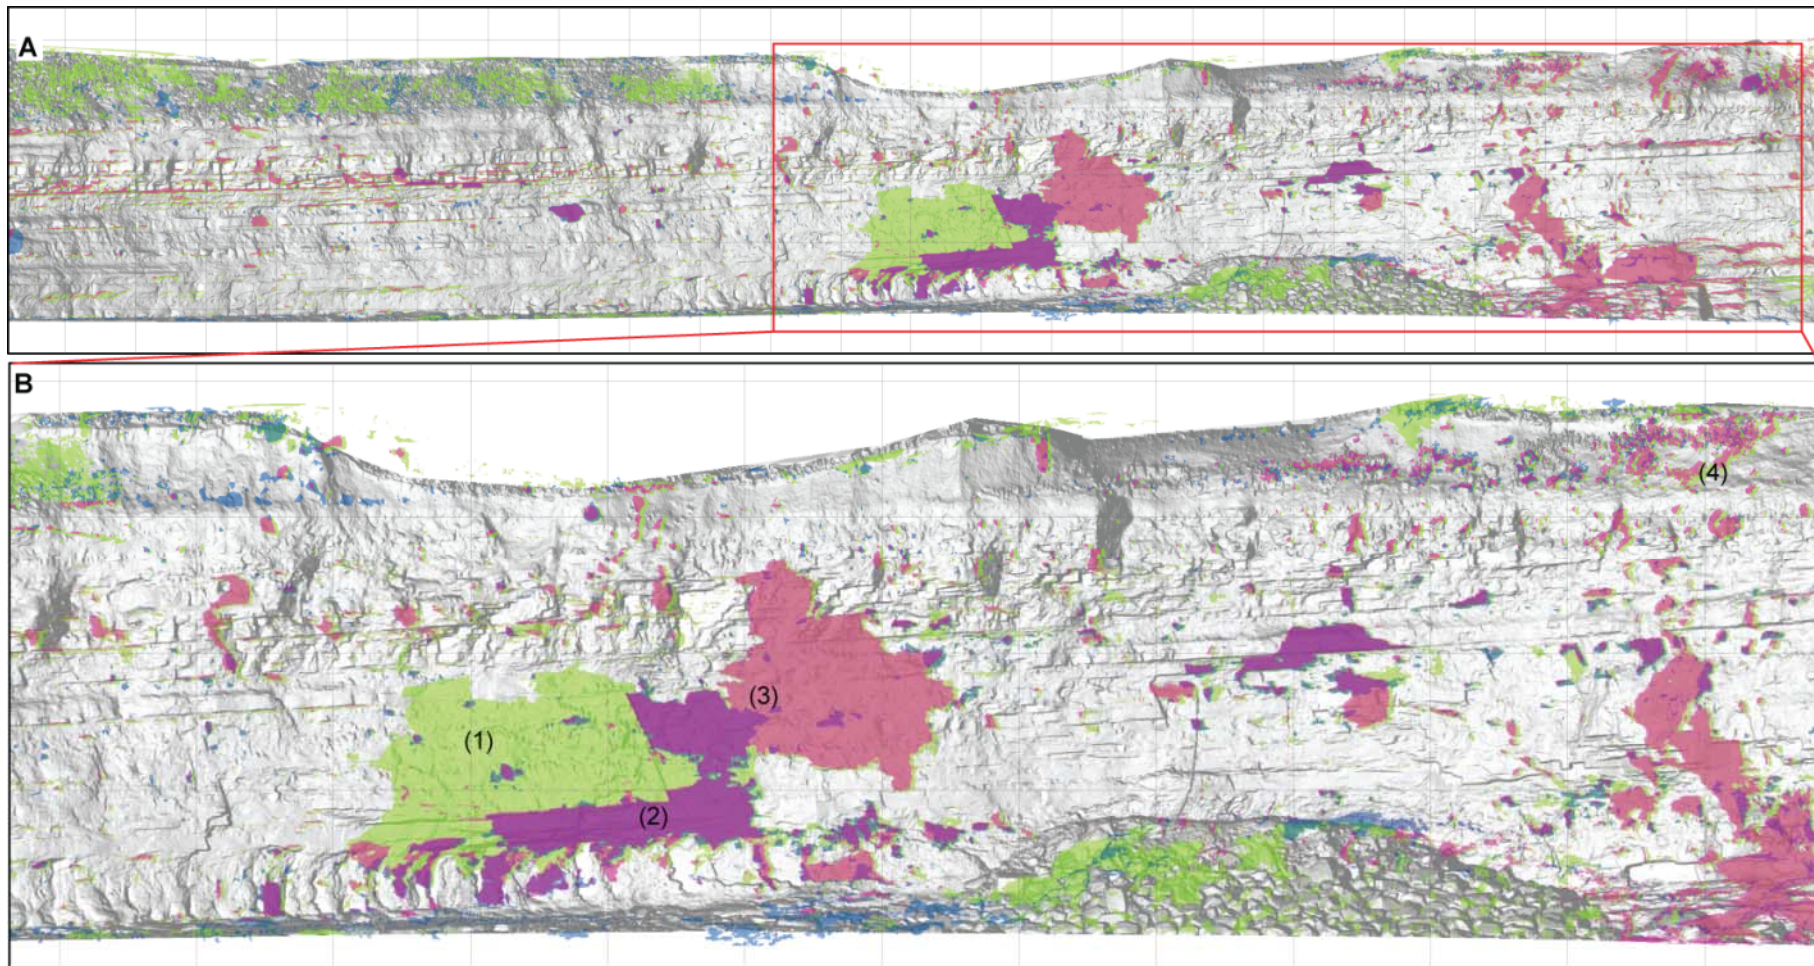
Figure 6. Areas of erosion > 0.1 m normal to the cliff face during YEAR 1 (14th January 2011 and 26th March 2012) (BLUE), and during YEAR 2 (26th March 2012 and 12th March 2013) (RED), and during April 2013 (12th March to 25th April 2013) (GREEN). PURPLE areas change sections of the cliff face which changes in both Years 1 and 2. **(A)** shows elevation view of the rock cliff at Cowbar, as seen from a point 100 m seaward from the cliff toe on the foreshore. The grey-scale image gives indicative cliff face topography (hillshade). The grid interval is 10 m in both horizontal and vertical axis. The red square delimits the extent of the section displayed in **(B)**. **(B)** shows a close up view of the section of cliff directly beneath Cowbar Lane. Figure 7 gives the position of the rockfall shown above relative to Cowbar Lane.

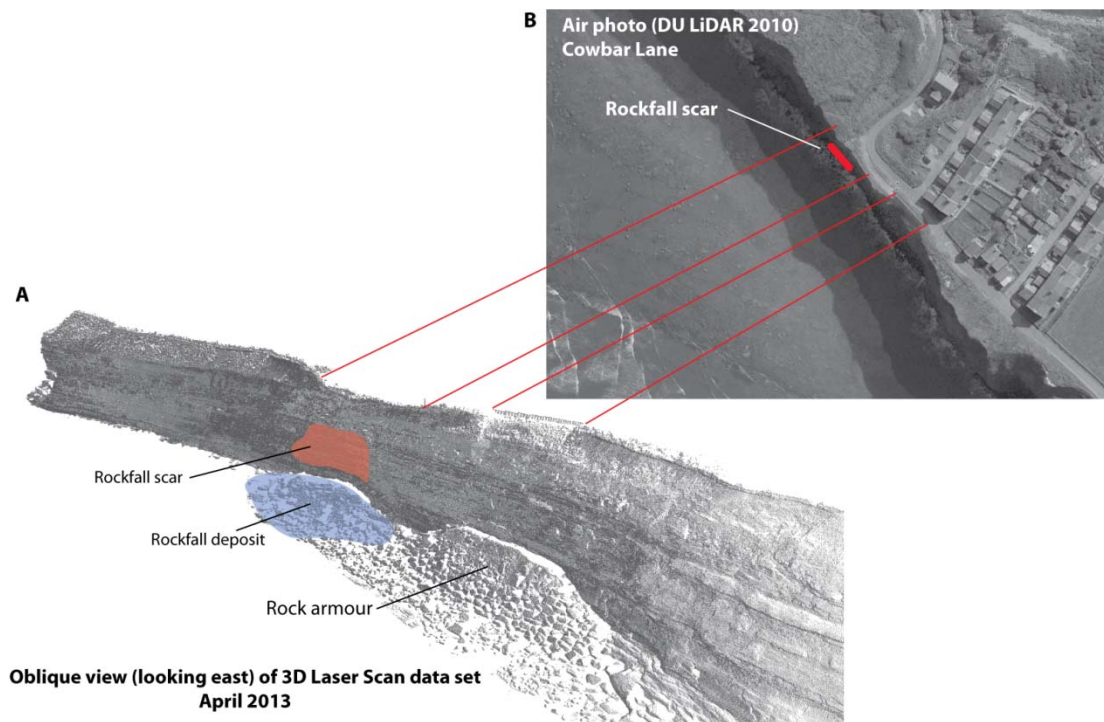
- iii. The rockfall did not result in the loss of the cliff top at this location, although it is likely that this area will continue to fail, and rockfall scars will coalesce, in the future. The cliff is now undercut and retains a steeper angle and should be continued to be monitoring on a regular monthly basis. There is no visible evidence of a deterioration in the stability of the cliff above the location of this rockfall. Events (1) and (2) in Figure 2 have removed lateral and basal support for the rock mass above, which may in time increase the probability of failure of this section of the cliff. Failure depths to date have been up to 2.8 m, and it is likely that this magnitude of failure depth with continue.

Figure 7. Location of the rockfall relative to Cowbar Lane. **(A)** shows a 3D point cloud collected from the terrestrial laser scanner, viewed obliquely. **(B)** Shows an air photo collected during a LiDAR survey in 2010.
