Cell 1 Regional Coastal Monitoring Programme Walkover Inspection Surveys 2022

North Tyneside Council

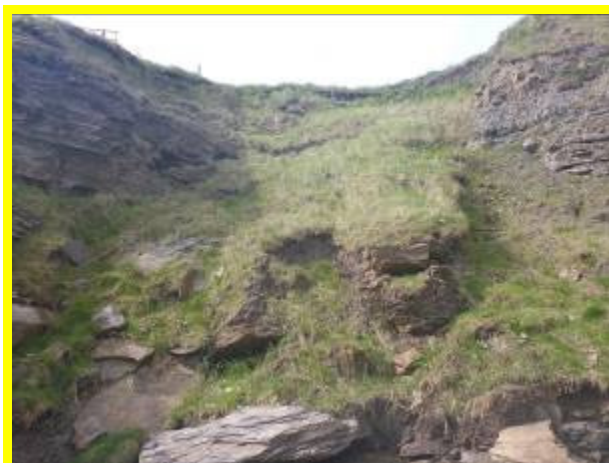
Remnants of 2009 slippage in soft material adjacent to Hartley Cove access steps (/4401C22)

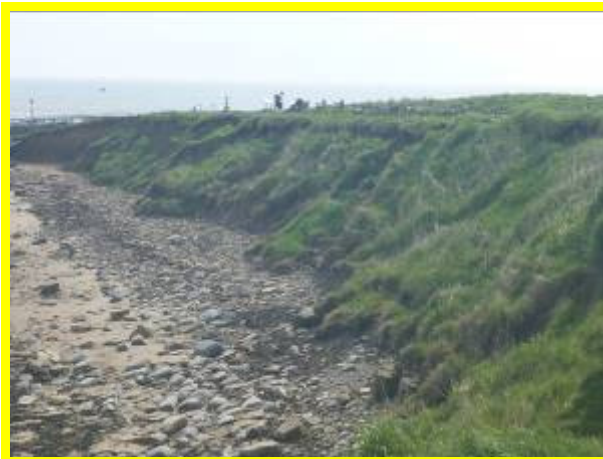
Erosion of soft earth slopes (/4401C25)

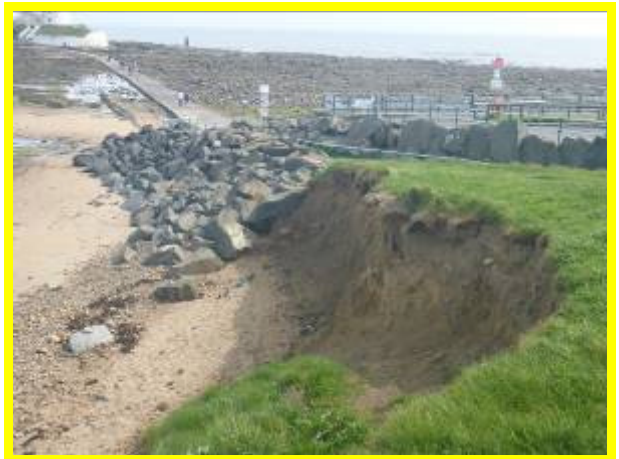
Erosion adjacent to rock revetment by St Mary's Island causeway (/4401C25)

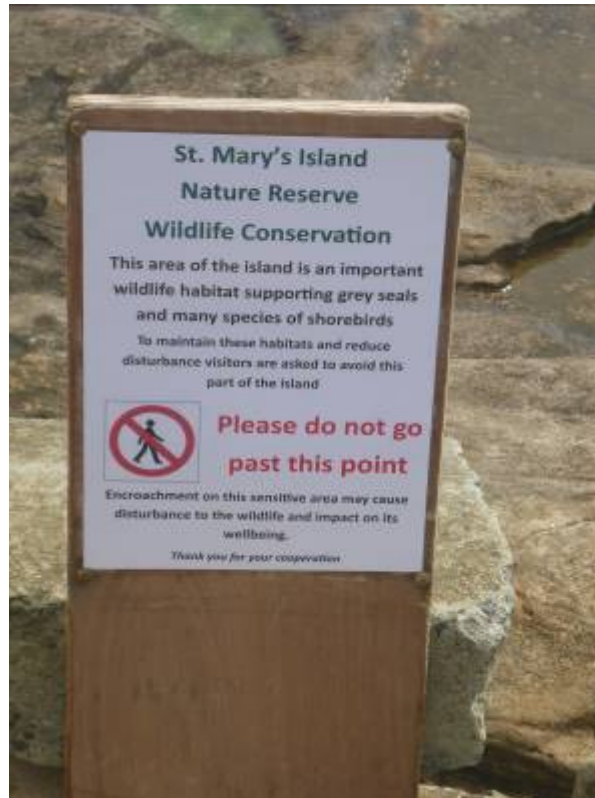
The causeway remains in poor condition, with concrete cracking, abrasion and loss of past repairs. Also, some sections of edge protection have broken loose. It is known from that improvements to the causeway are planned as part of the final phase of the Whitley Bay Seafrost Master Plan.

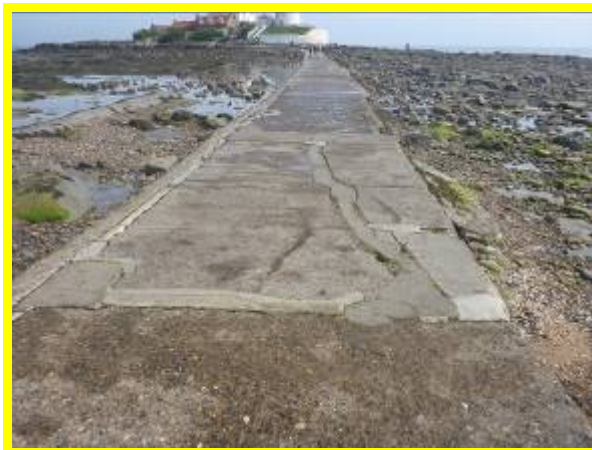
Partial loss of previous repairs to the causeway (/4401C25)

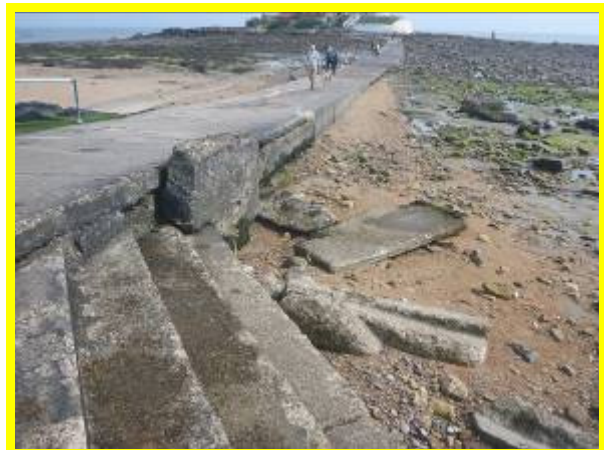
Concrete breaking-away from causeway edge (/4401C25)

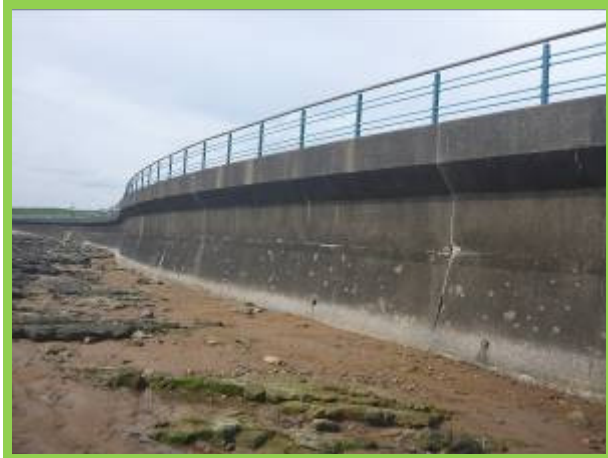
Trinity Road seawall in good overall condition, but with some minor maintenance required on an ongoing basis (/4501C04)

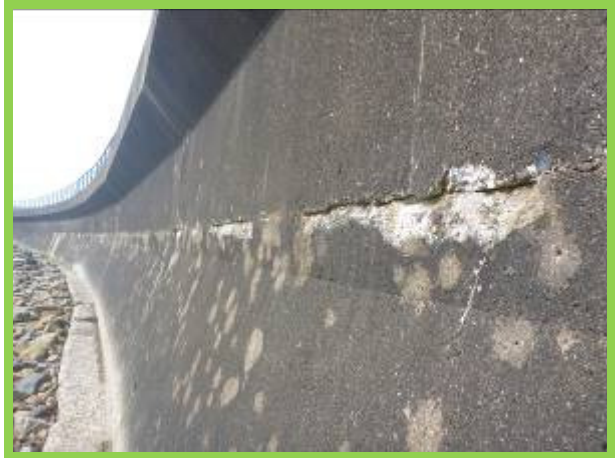
Trinity Road seawall in good overall condition but with some minor maintenance required on an ongoing basis (/4501C4)

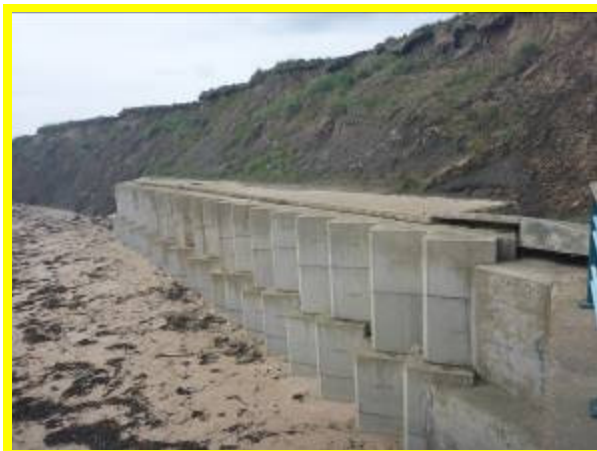
Uplifted deck above end of T-Block units at northern end (/4501C10)

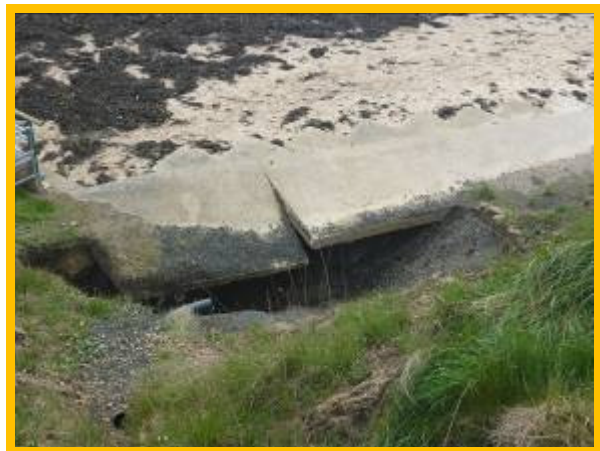
Voiding behind T-Block units at northern end (/4501C10)

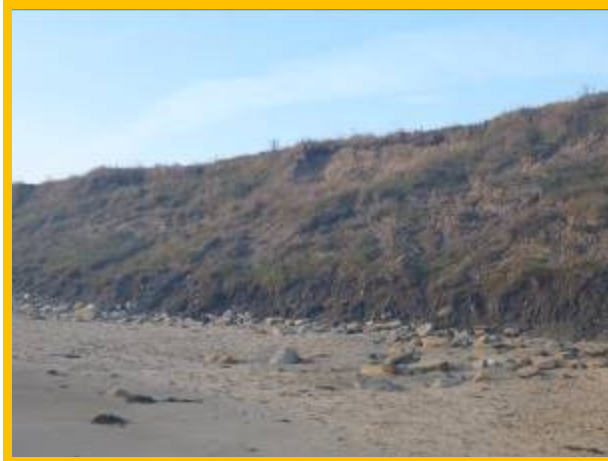
Slumping undefended cliffs (/4501C05)

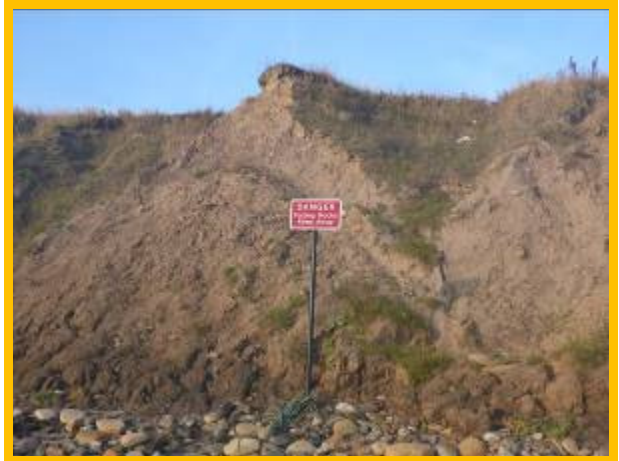
Public safety warning signs (/4501C05)

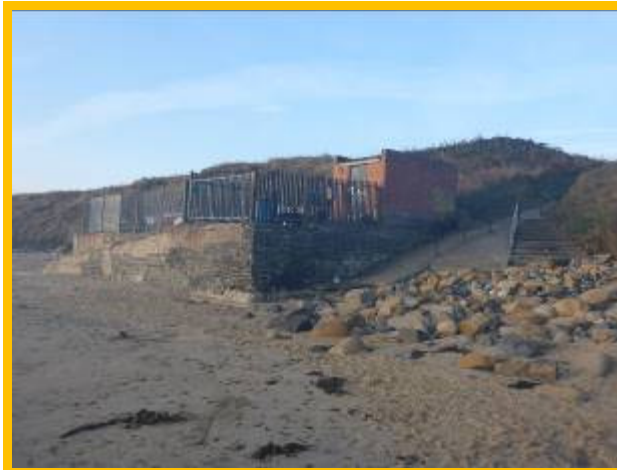
Wall at boatyard (/4501C05)

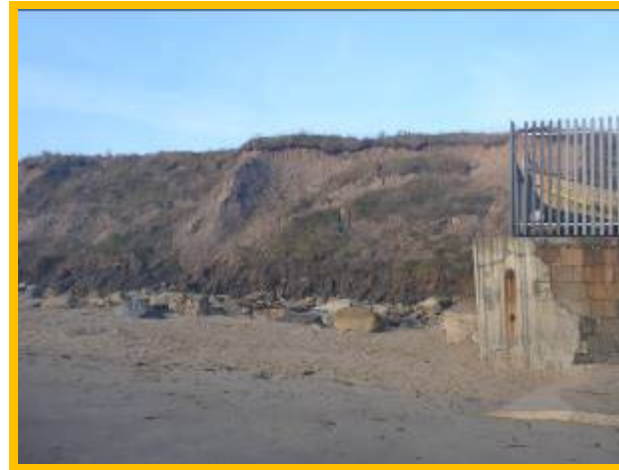
Slumping in cliffs to south of wall at boatyard (/4501C05)

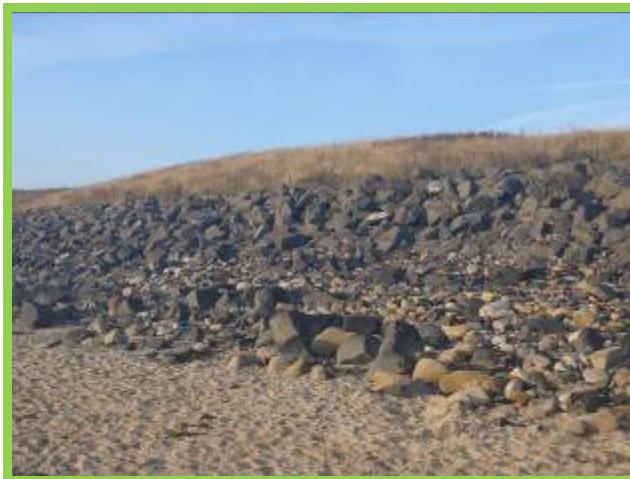
Rock revetment near Briardene Burn (/4501C06)

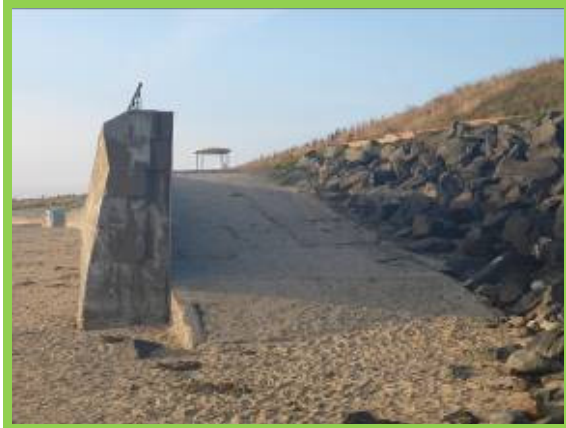
Northern access ramp (/4501C07)

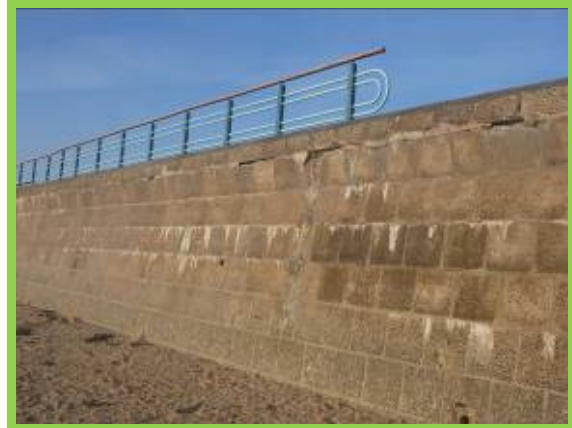
Previous repairs and local gaps in joints which would benefit from maintenance (/4501C07)

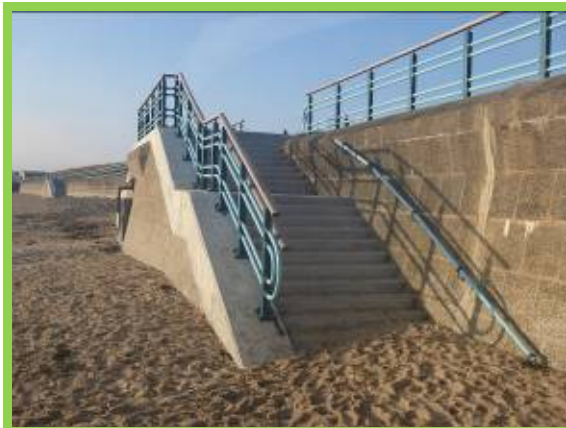
Recently refurbished access steps in very good condition (/4501C07)

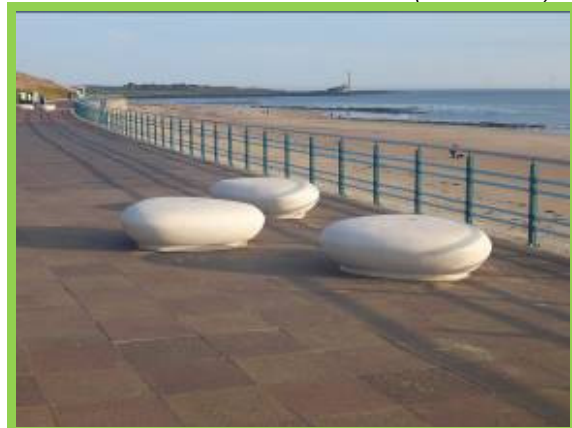
Improved promenade deck and open seating (/4501C07)

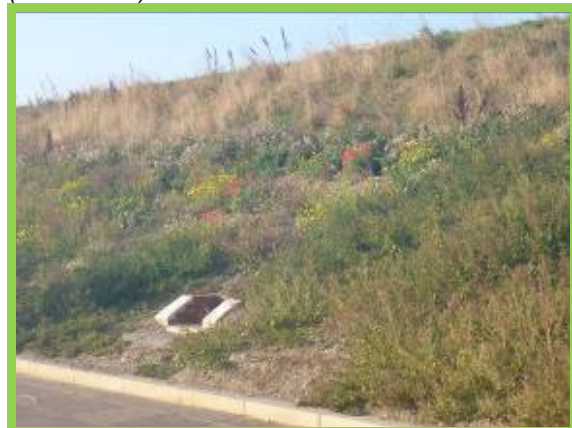
Wildflowers on backing slopes (/4501C07)

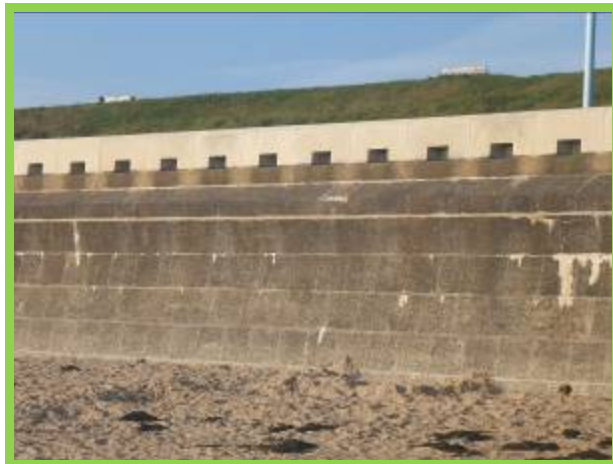
New coping on blockwork seawall (/4501C08)

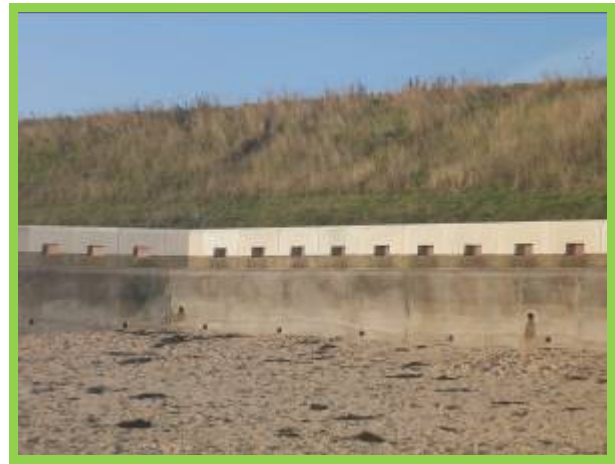
New coping on concrete recurved seawall (/4501C08)

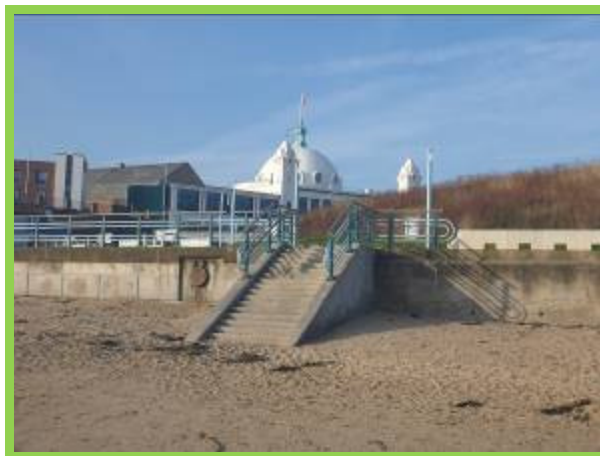
Transition between 4501C08 and 4501C09 at beach access steps

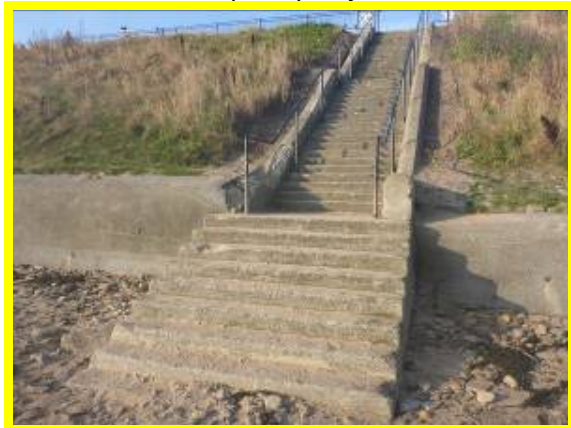
Abrasion damage at side-wall of beach access ramp (/4601C01)

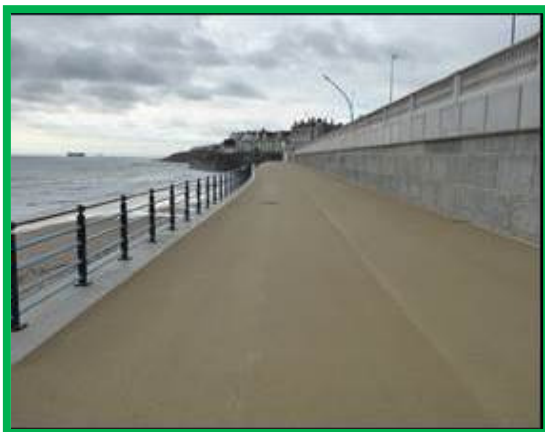
Refurbished promenade (typical of /4601C02 and /4601C03)

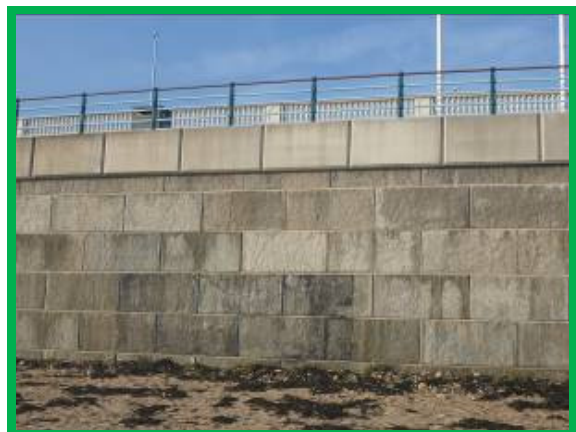
Refurbished sea wall (typical of /4601C02 and /4601C03)

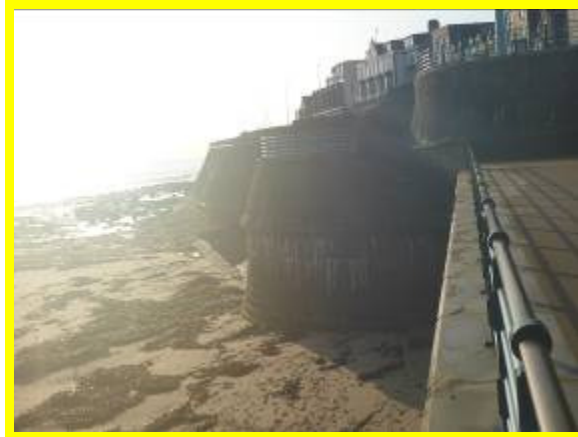
Blockwork sea wall at first 'bullnose' (/4601C04)

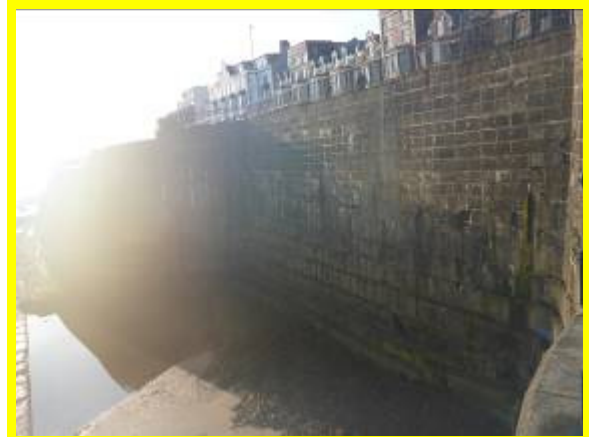
High blockwork sea wall (/4601C04)

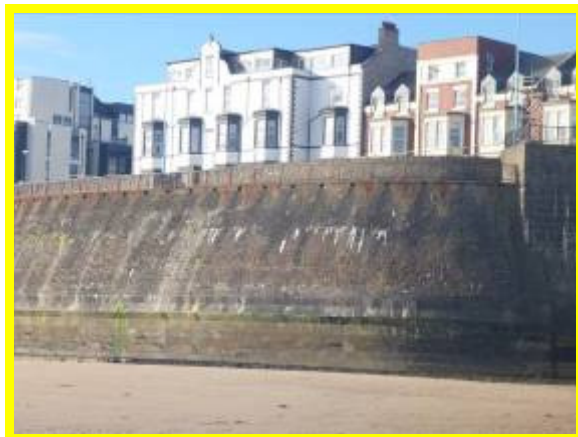
High blockwork sea wall (/4601C05) – from 2020 inspection

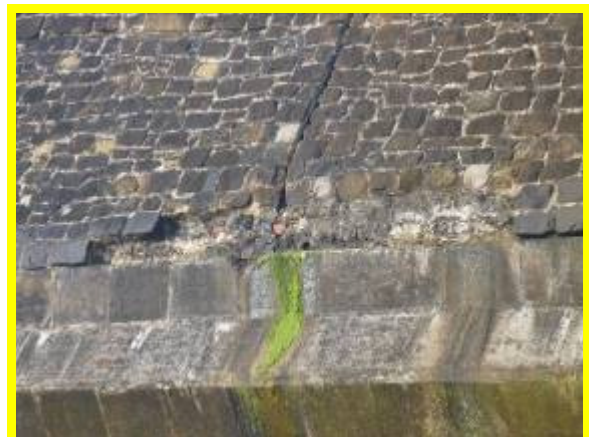
Missing brickwork (/4601C05) – from 2020 inspection

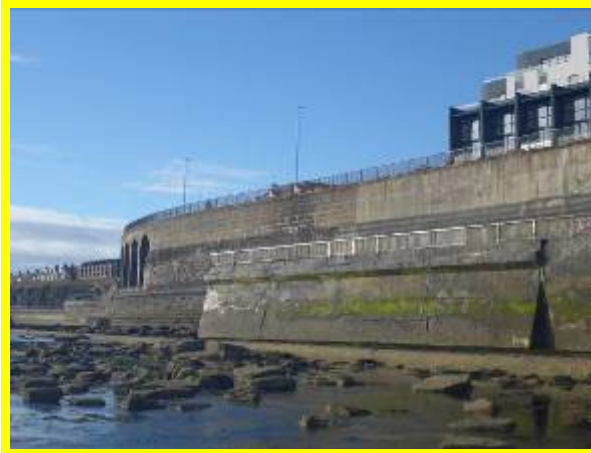
Intermediate sea wall between Central and Southern Promenades (/4601C06) – from 2020 inspection

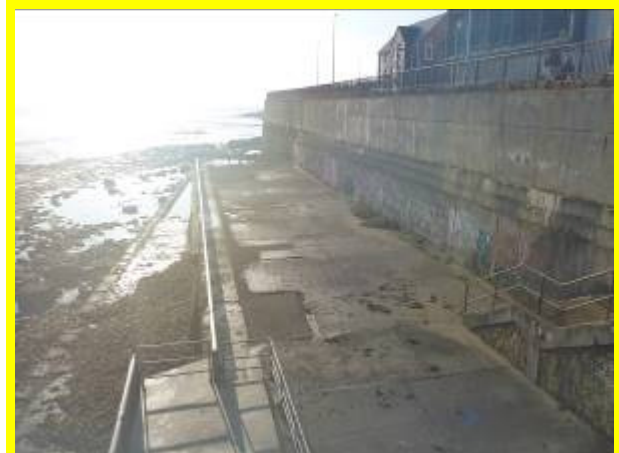
Repairs to intermediate sea wall between Central and Southern Promenades (/4601C06)

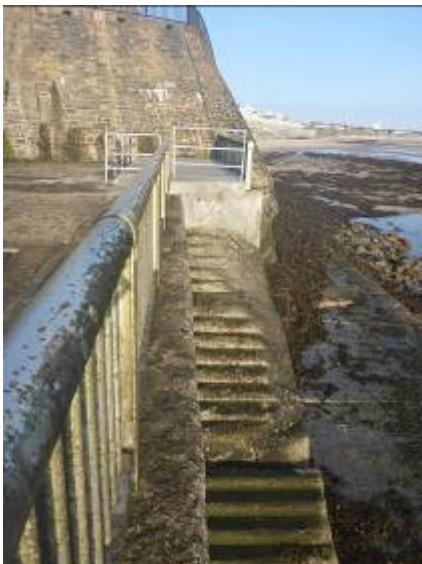
Closure of unsafe access steps along intermediate sea wall between Central and Southern Promenades (/4601C06)

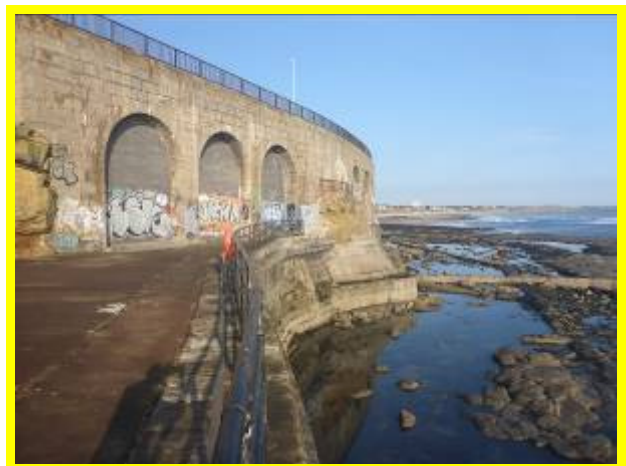
High masonry blockwork wall with infilled arches (/4601C07)

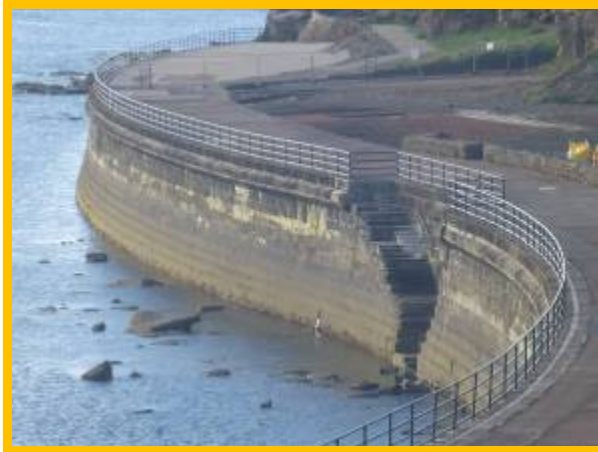
Stairwell which was infilled as part of the Southern Promenade Seawall Strengthening Scheme in 2020 (/4601C08) – photo from 2020 inspections

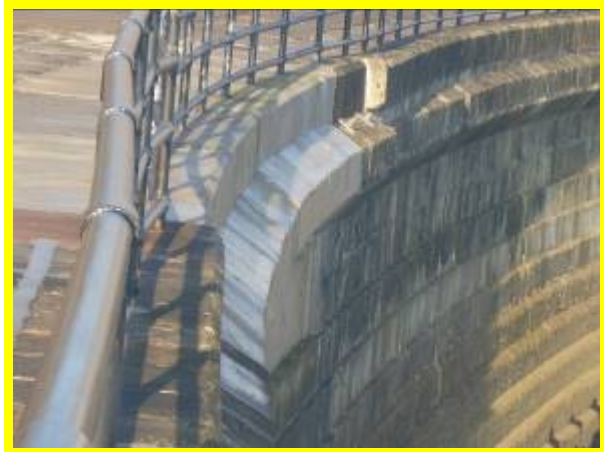
Repairs to wall as part of Southern Promenade Seawall Strengthening Scheme (/4601C08)

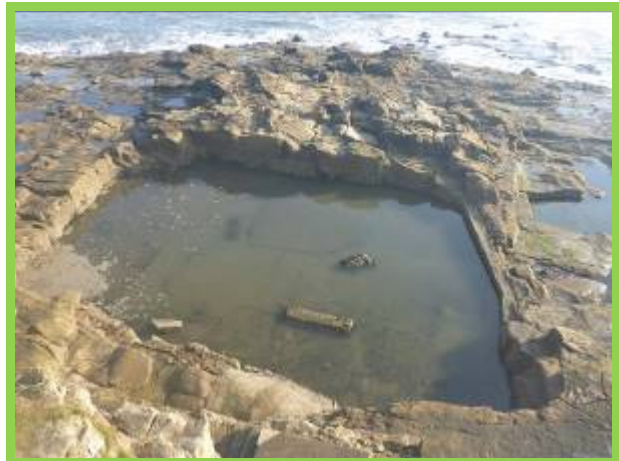
Tidal pool (/4601C09)

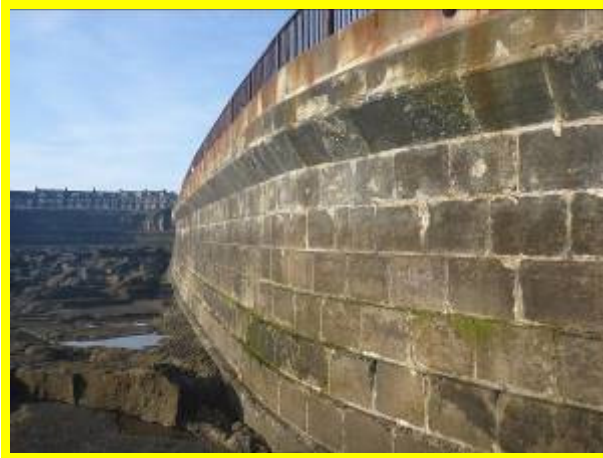
Brown's Bay northern sea wall in generally fair condition (/4601C10)

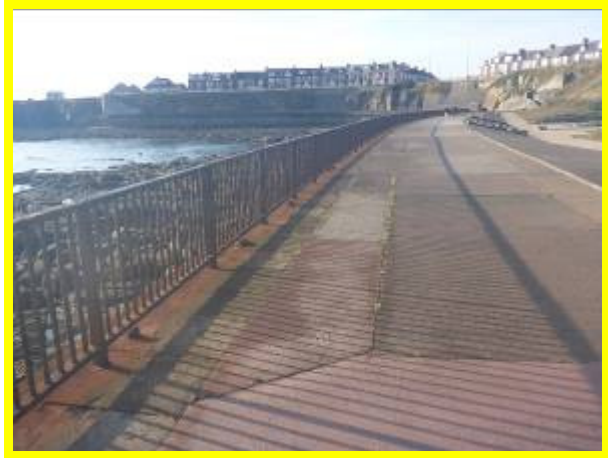
Minor surface cracks in promenade deck at northern end (/4601C10)

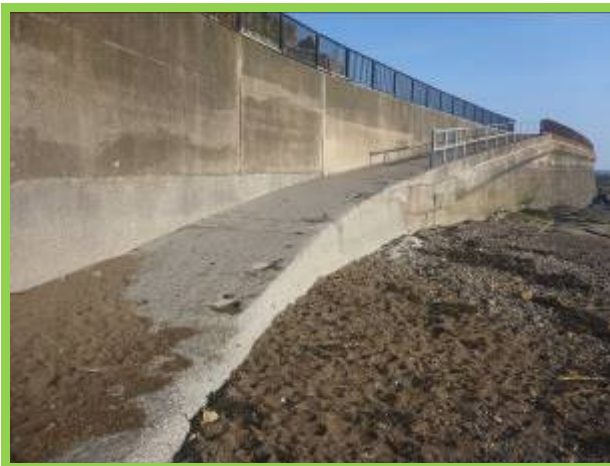
Brown's Bay access ramp with re-cast lower section (/4601C10)

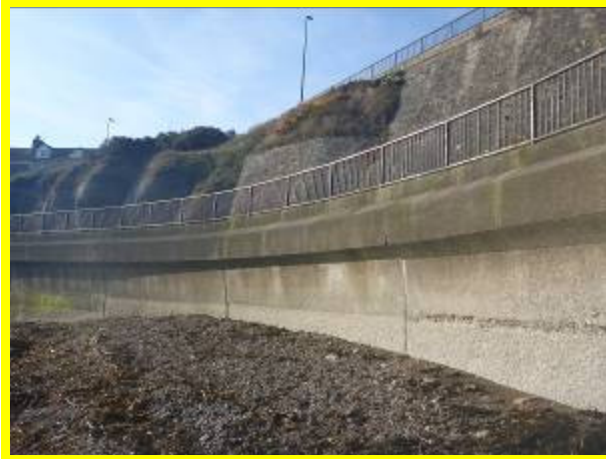
Brown's Bay southern sea wall in generally fair condition (/4701C01)

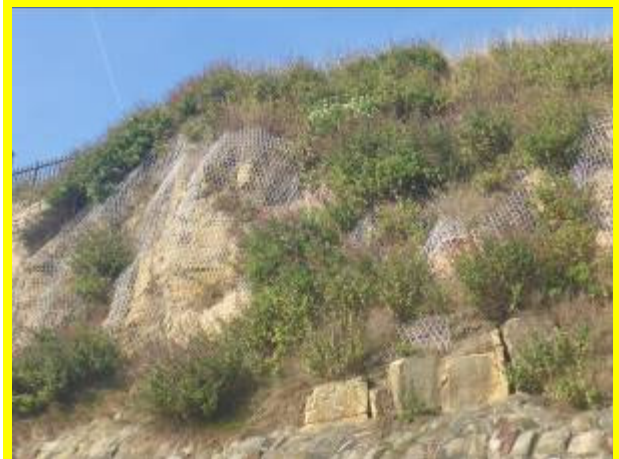
Rock bolts and netting on slopes to rear of promenade (/4701C01)

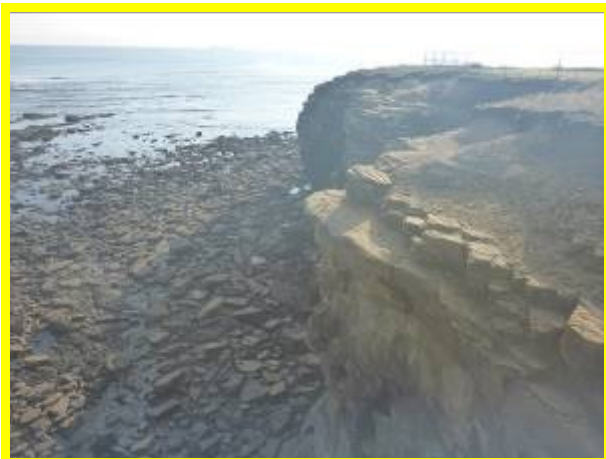
High rock cliffs with thin capping of till on northern side of Brown's Point (/4701C02)

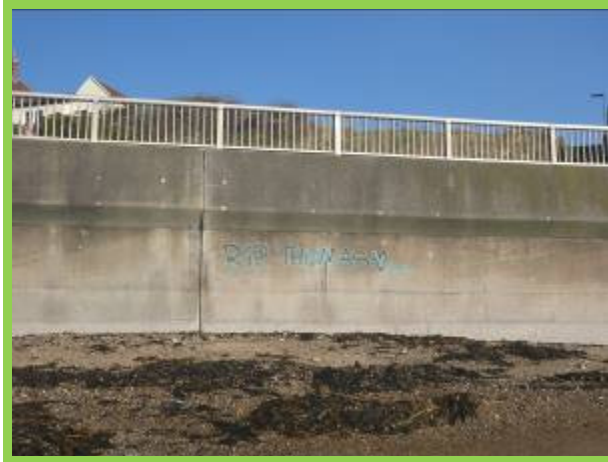
First section of sea wall in generally good condition (/4701C04)

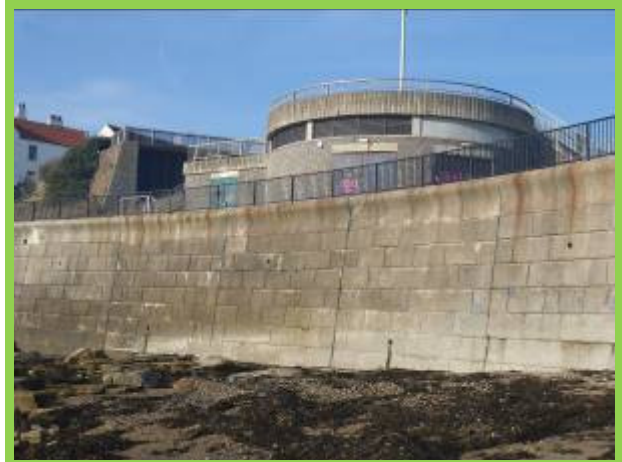
Middle section of sea wall in generally good condition but with face abrasion (/4701C05)

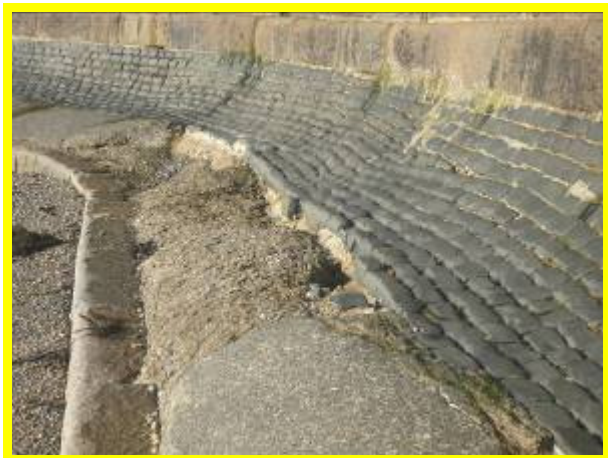
Final section of sea wall in generally fair condition (/4701C06)

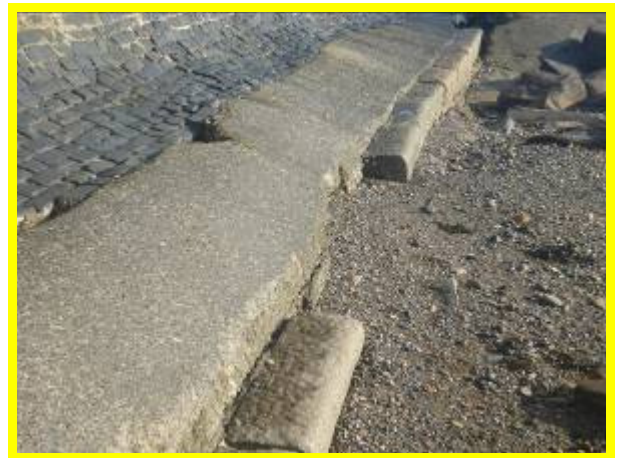
Some defects at the toe apron (/4701C06)

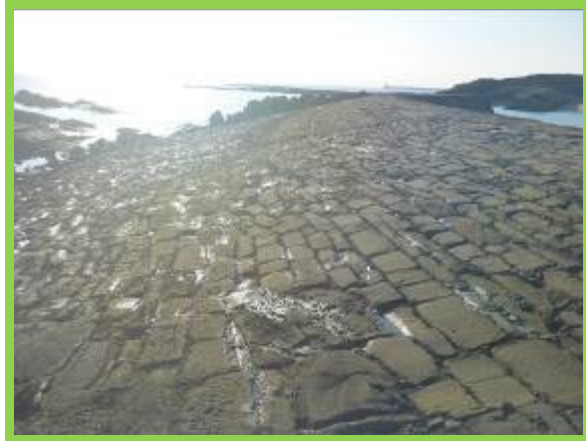
Cullercoates North Pier – sloping seaward face (4701C07)

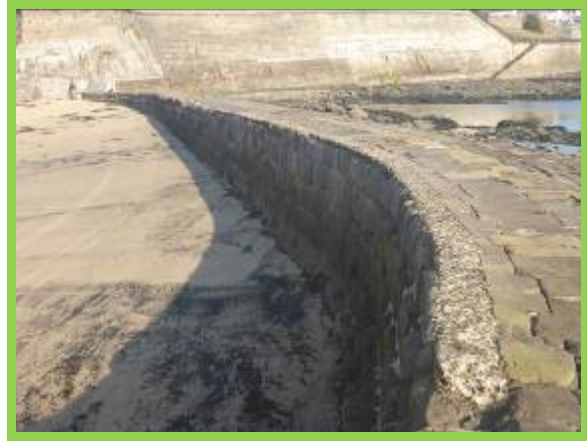
Cullercoates North Pier – deck and vertical landward face (4701C07)

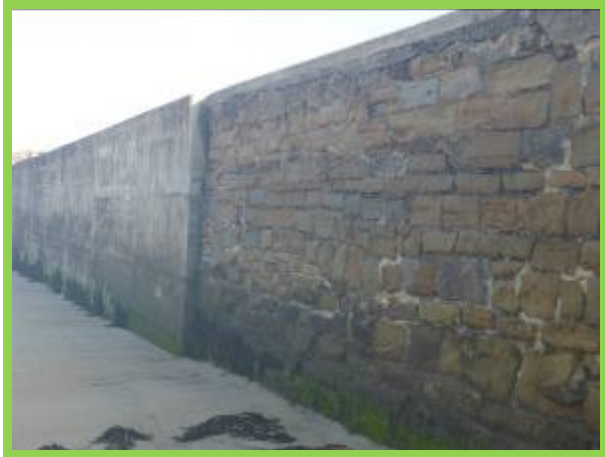
Cullercoates South Pier – vertical landward face showing original and encased sections (/4701C15)

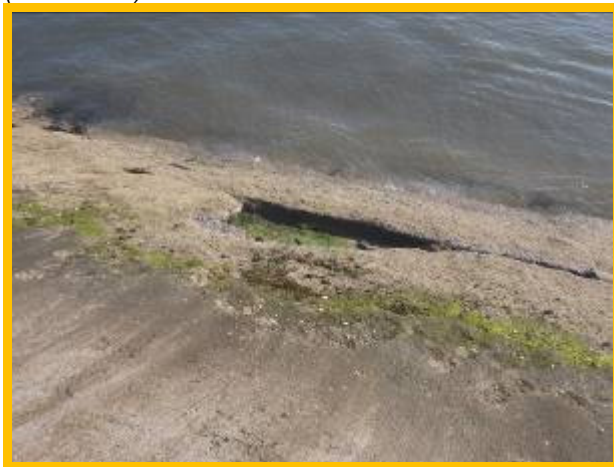
Cullercoates South Pier – locally poor defect on seaward sloping face (/4701C15)

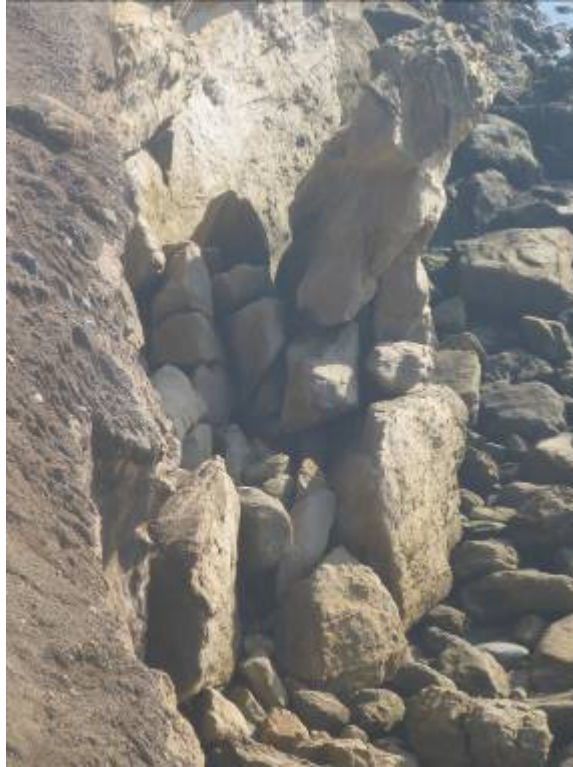
Fragmenting rock stack near Tynemouth North Point that has the potential to topple (/4701C16)

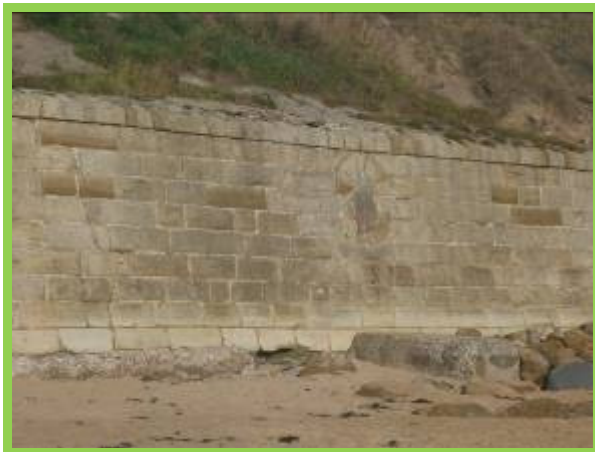
Undercutting and abrasion at toe of masonry tie-in wall (/4701C18)

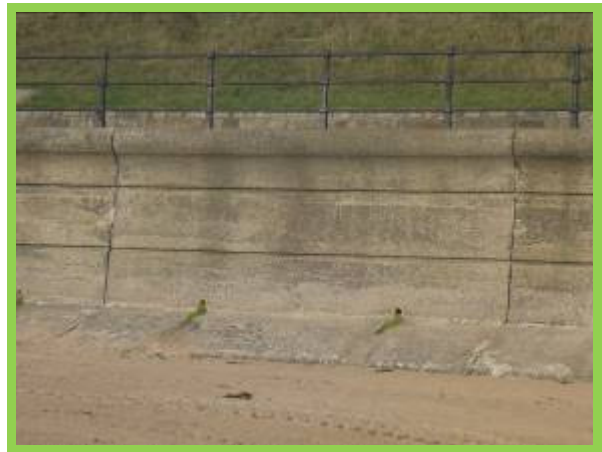
Abrasion at toe of vertical seawall (/4701C18) (/4701C18)

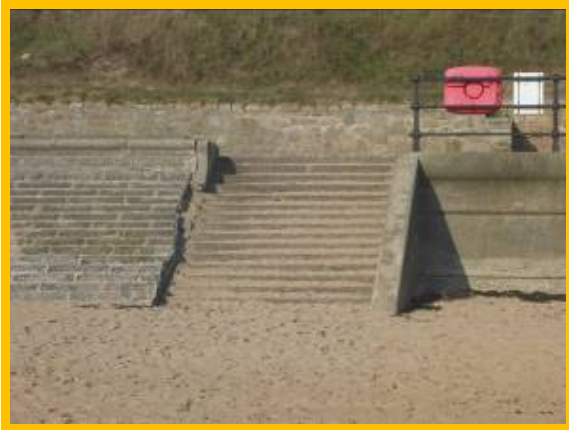
Damage at wing-wall of access steps (between /4701C18 and /4701C19) – locally poor

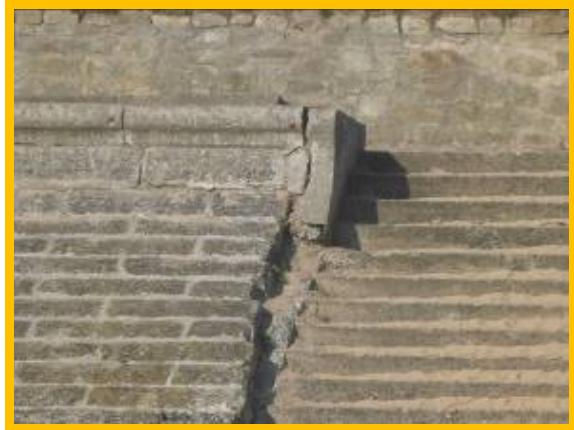
Damage at wing-wall of access steps (between /4701C18 and /4701C19) – locally poor

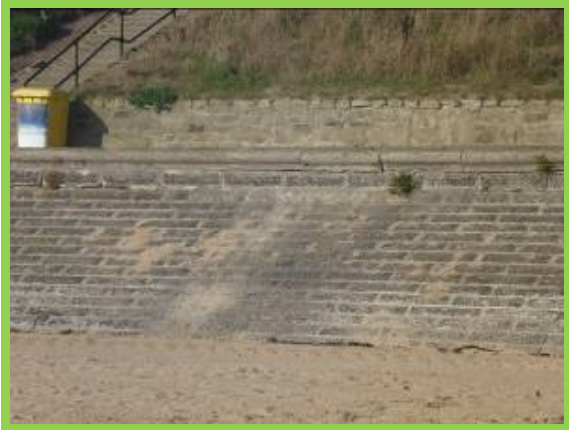
Sloping blockwork revetment (/4701C19)

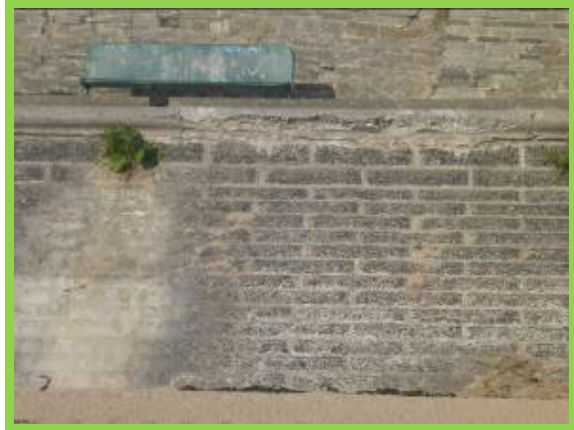
Abrasion to the revetment crest (/4701C19)

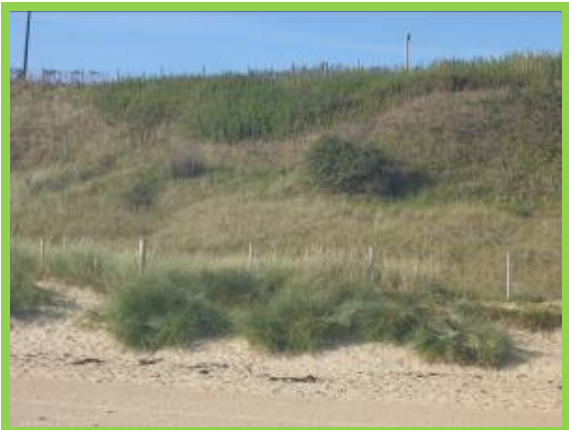
Stable and well vegetated dunes along Long Sands (/4701C21)

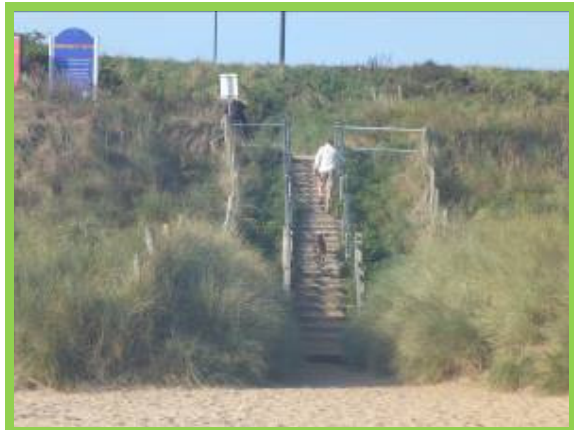
Formalised access routes through the dunes (/4701C21)

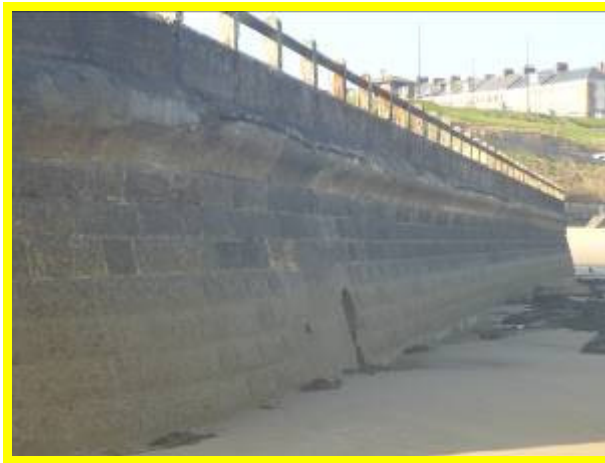
Wall abrasion at the Outdoor Pool (/4701C24)

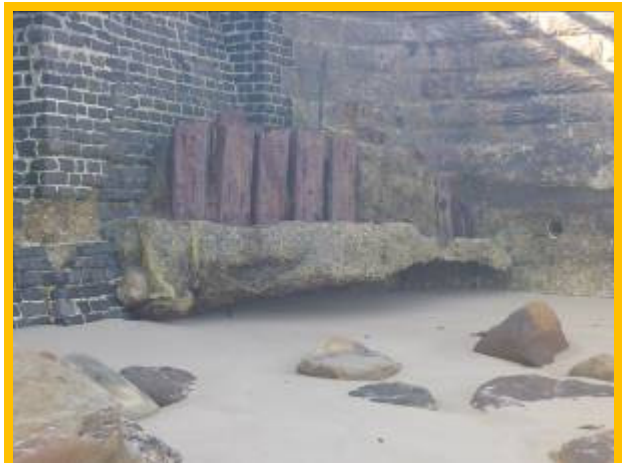
Tie-in wall between Outdoor Pool and undefended rock cliffs (/4701C25)

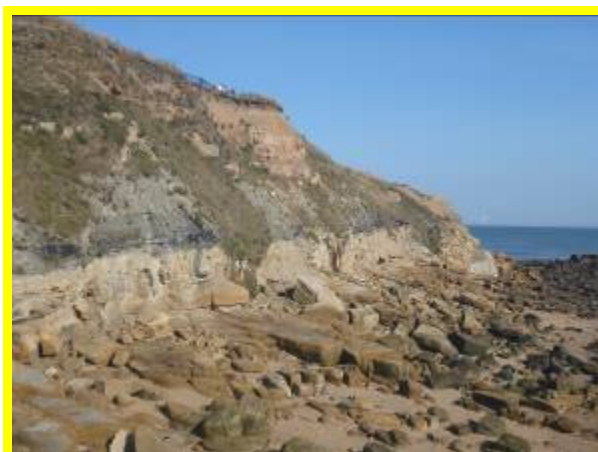
Cliffs around Sharpness Point (/4701C26)

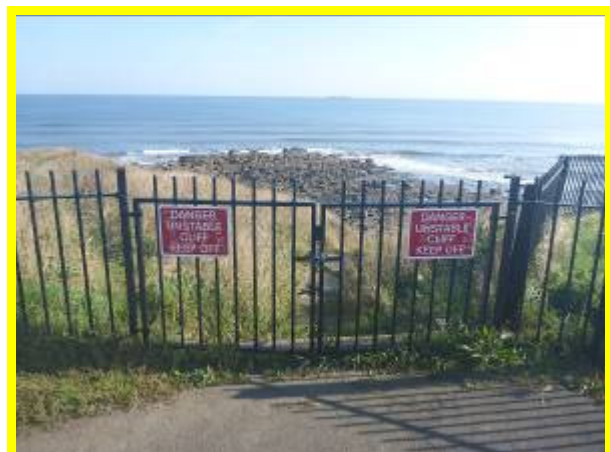
Unsafe access steps now closed-off (/4701C26)

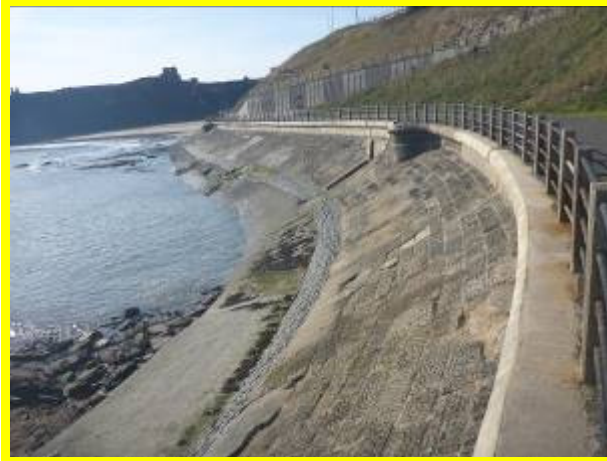
Sea wall in fair condition with damage and abrasion of the apron (/4701C27)

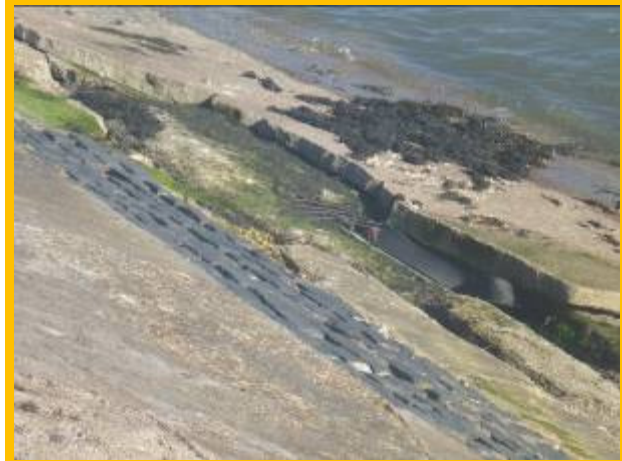
Damaged apron (/4701C27) – locally poor

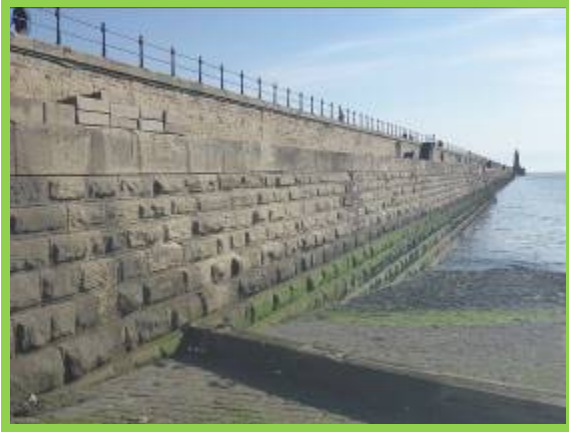
North Pier appears in good overall condition and is well maintained (/4801C01)

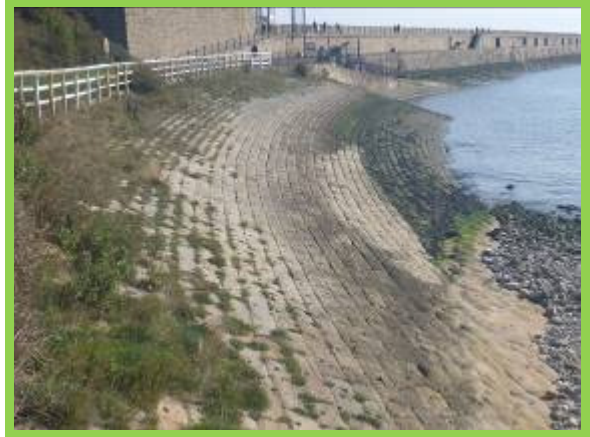
Masonry revetment (/4801C02)

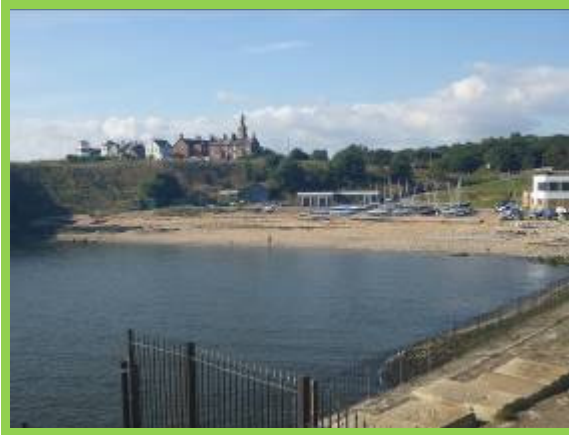
Prior's Haven (/4801C03)

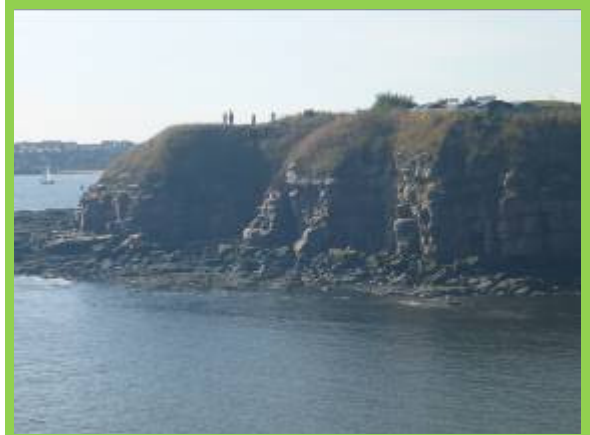
Rock headland at Freestone Point (/4801C11)

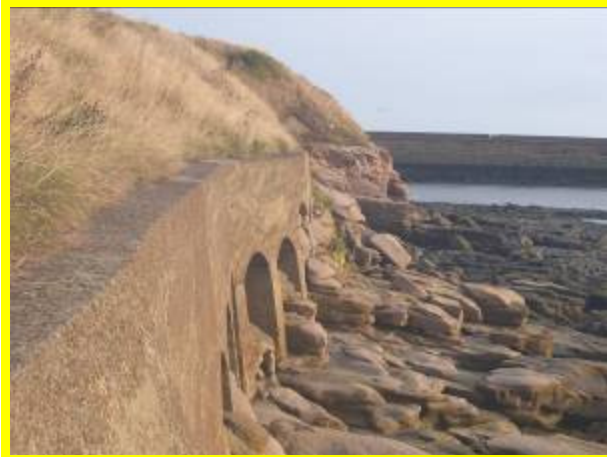
Masonry and concrete arched seawall (/4801C04)

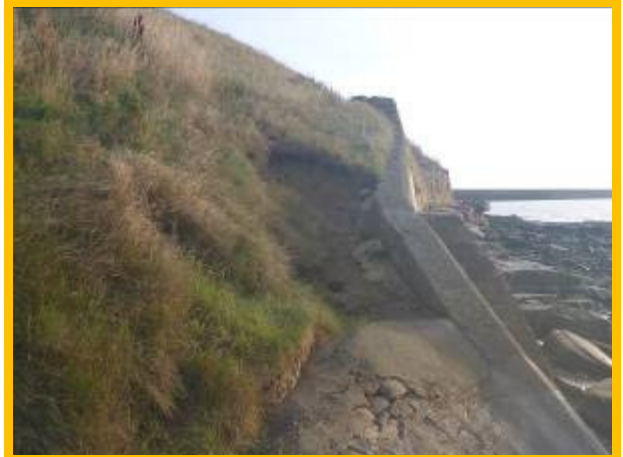
Erosion above wall (/4801C06)

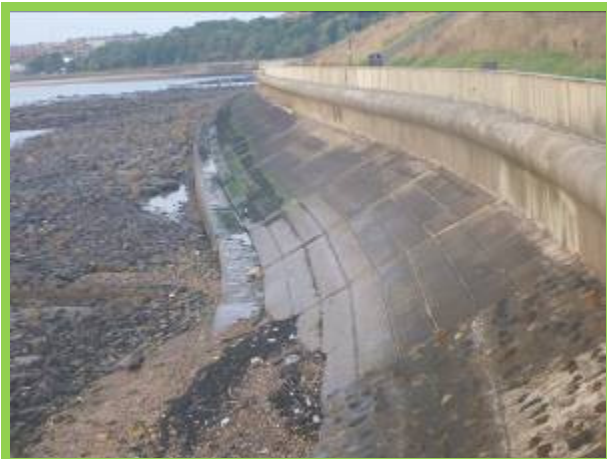
Concrete panel sloping revetment and short concrete toe wall (/4801C07)

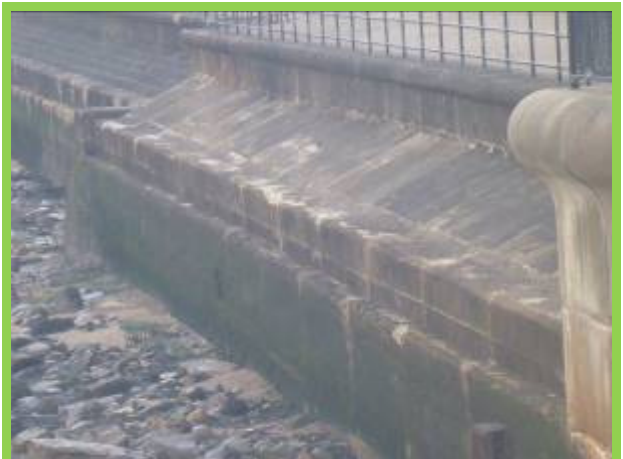
Concrete panel sloping revetment and high concrete toe wall (/4801C08)

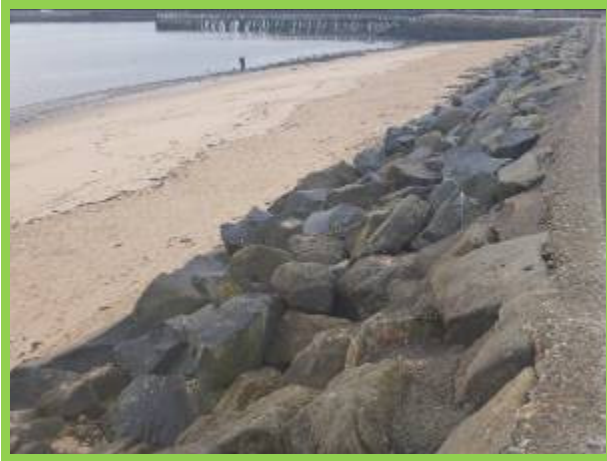
Rock revetment (/4801C09)

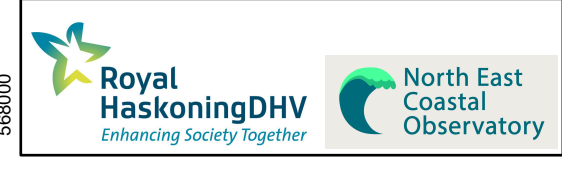
Appendix B Asset Condition & Recommendations
