**Cell 1 Regional Coastal Monitoring Programme
Coastal Walkover Inspections 2010**

South Tyneside Council

**South Tyneside Council
Final Report**

June 2010

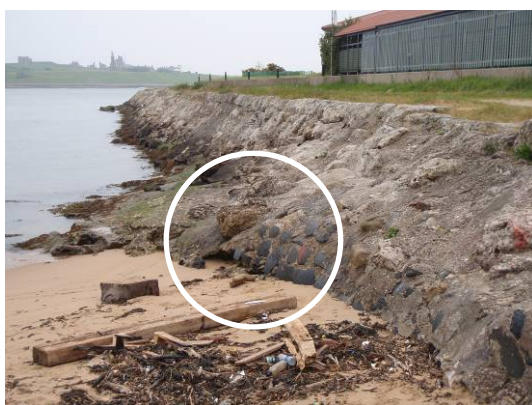
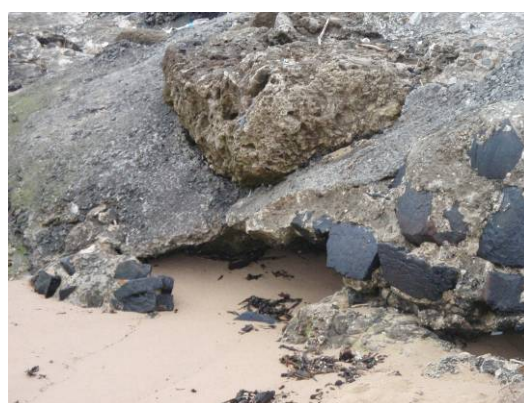
The grouted masonry revetment starts at the boat slipway and extends along the eastern side of the wave basin (below left) to join the landward root of the South Groyne. It is the responsibility of the Port of Tyne. The revetment was in fair condition although voids were observed at the toe due to erosion of mortar and missing masonry blocks (below right). Local repairs to infill the voids recommended in 2008 do not appear to have been carried out, but the voids have only marginally worsened. However, small holes were observed in the ground at the top of the revetment behind the upper layer of stonework. This may be indicative of wash-out of core material and it therefore remains recommended that void filling, especially at the toe, is undertaken. This should be accompanied by the general replacement or in-filling of missing masonry blocks and filling of cracked mortar where this occurs throughout the structure.

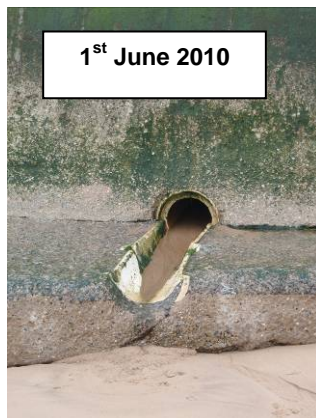
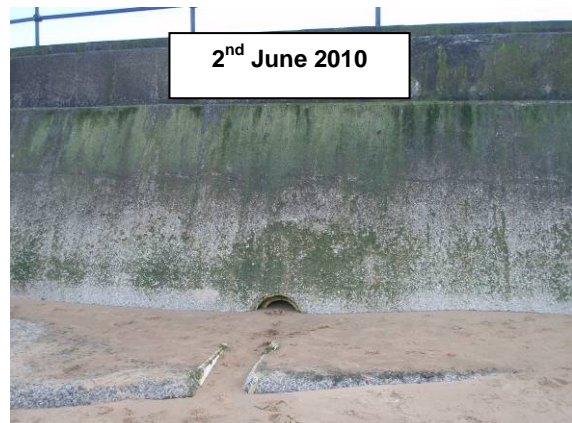
The section of sea wall between its protruding 'nose' and the dunes is in a very poor condition and at real risk of imminent failure. Here beach levels can typically vary by in excess of 1m between successive events. Even between the inspection on 1st June 2010 and the following day, sedimentation had resulted in a drainage outfall through the wall being blocked (below).

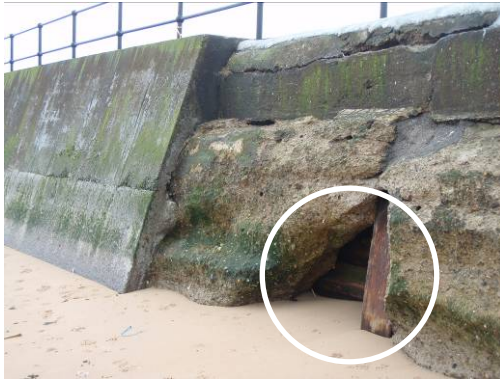
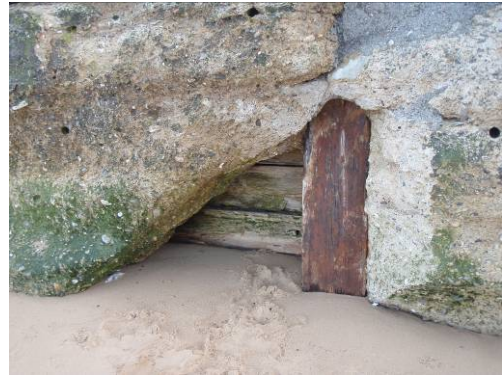
The worst affected length is at the protruding nose, where a large section of concrete has recently (April 2010) failed (below left), exposing an extensive area of the timber piles behind (below right). In addition, there are a total of 22 other (smaller) areas along this section of the wall where the timber piling is exposed through concrete damage and degradation.

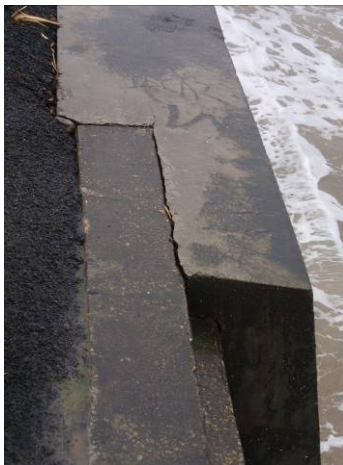
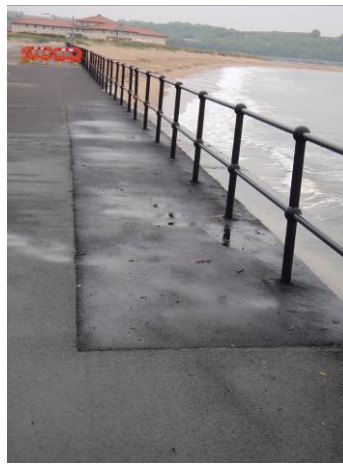
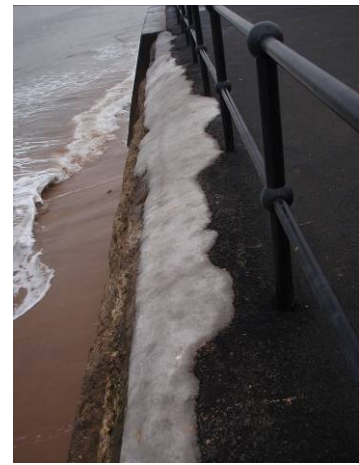
One section of wall at the nose was rendered with a new concrete facing as a purely cosmetic activity when the Tall Ships Race visited the River Tyne in 2005. The concrete render is now coming away from the wall, and a gap at the joint is clearly visible (below left). In this section, repairs have been made to the damaged hand railing and asphalt (below centre) and concrete coping (below right), although there remain numerous areas where coping stones are missing, concrete voids are present and the asphalt is at risk of unravelling.

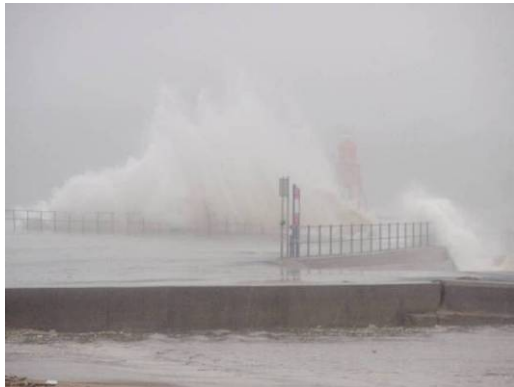
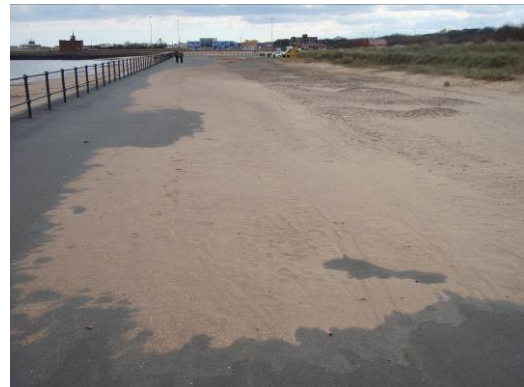
Along this frontage, overtopping can be violent. The overtopping associated with the high tides of the spring equinox in 2010 (below left) caused significant flooding of the land behind the wall and also deposited a lot of beach sediment across the promenade and car park (below right).

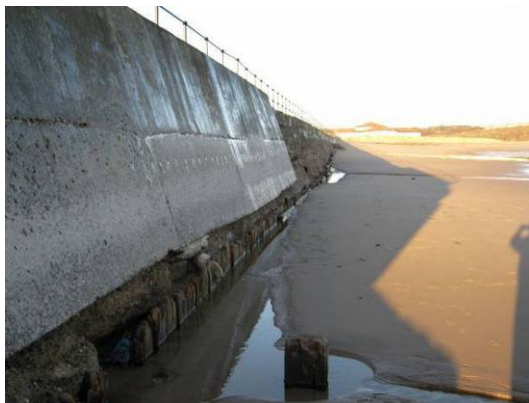
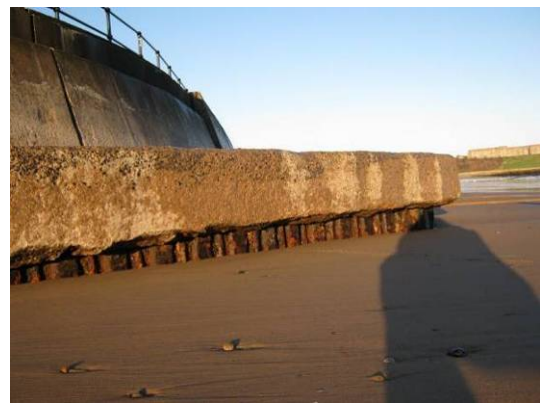
This overtopping was particularly severe in late spring 2010 because the high spring tides also coincided with low beach levels, during which timber foundations of the sea wall were exposed at its toe (below left) and concrete sheet piling was exposed at the toe of the apron (below right). During the inspections, beach levels had recovered to cover the toe foundations, but the wet-splashed promenade showed signs that overtopping had occurred earlier that day, and some occasional light spray was observed coming over the wall even several hours after high tide.

The ongoing deterioration of this section of sea wall is a real and immediate concern and with a potential capital scheme not achieving a suitable national scoring of priority, an intermediary plan and action needs to be put in place in the event that the wall were to fail.

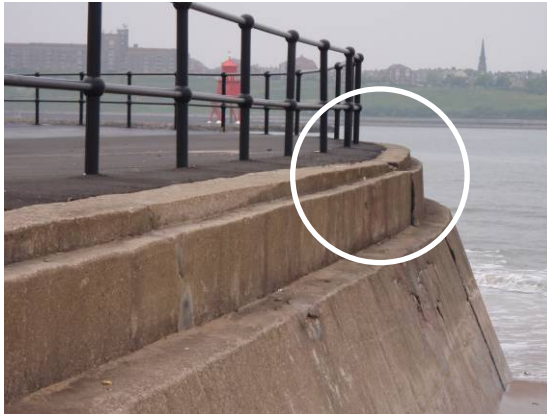
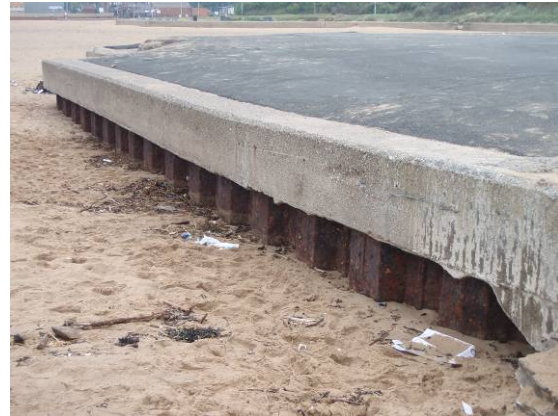
Between the protruding section of sea wall and the South Pier, the alignment follows a 'return section' and then a section running along the back of the beach. In the return section, the concrete is badly abraded and cracked in places and there appears to be evidence of some local settlement (below left). The construction joints remain well filled. Part way along the return section is a former crane derrick. Here the exposed sheet piles are extremely badly corroded (below right) and there is clear evidence of settlement and the breaking up of the structure.

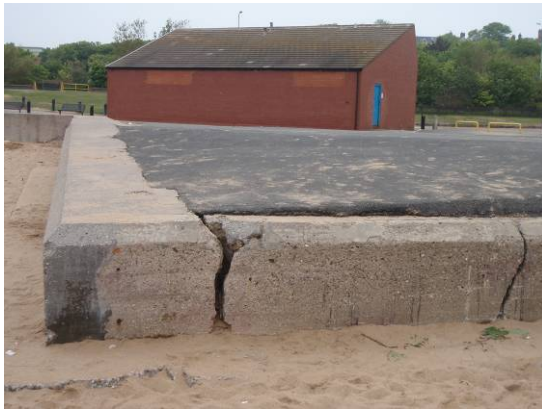
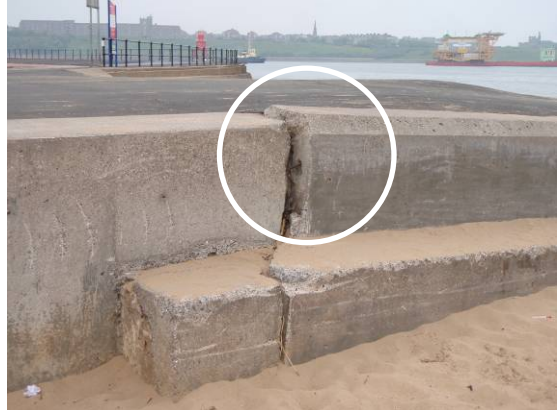
The present state of this section represents an ongoing deterioration in condition from the 2008 survey, with sections of wall visibly failing (below left) and reinforcement bars becoming exposed (below right). Despite some recent repairs to the asphalt, this section remains in poor condition, especially around the derrick base.

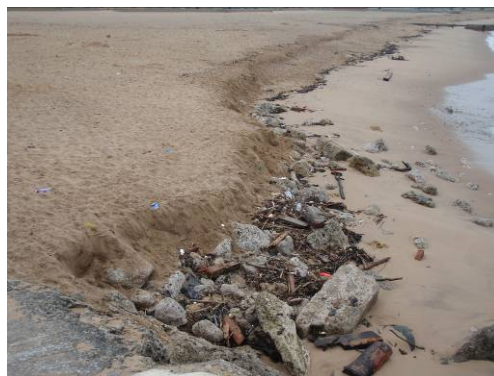
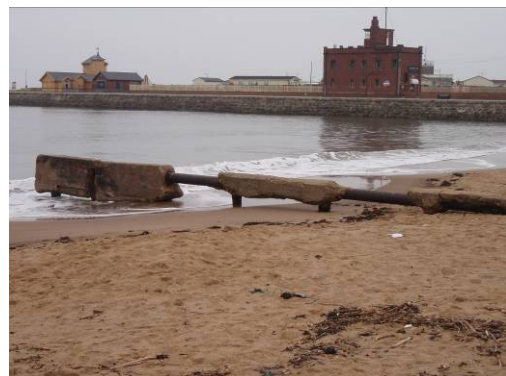
The section running parallel with the shore along the back of the beach is fronted by a wide beach. At one location there is a pedestrian access gap in the wall, which reduces its effectiveness as a sea defence to the backing promenade. Some wind-blown sand was observed along the promenade near the root of the South Pier and immediately behind the wall. Along the sea wall, the concrete was showing signs of spalling on the crest and a previous render was coming away from the crest. One large vertical crack was observed, along with other smaller vertical and diagonal cracks. Some of these have previously been filled but ten remain open. The toe of the wall was covered by beach sand and therefore not inspected. There was localised cliffing in the wide beach immediately adjacent to the South Pier (below left). The (obsolete) outfall along the beach is in a very poor condition (below right).

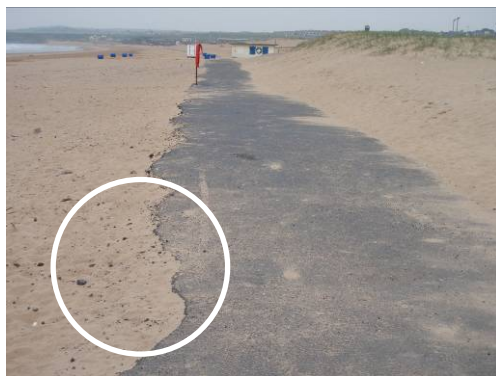
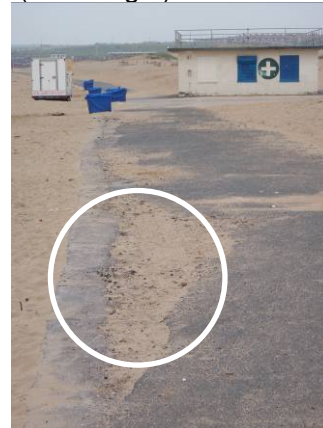
The northern section of Sandhaven, between South Pier and the children's play area, has a cobble berm in front of the dunes at its northern end, which narrows and thins with progression south. A 'donkey track' extends from the South Pier, initially behind the dunes and then switching to seaward of the dunes, to meet the Lifeguard Station. There are no signs of erosion at any point in the dunes along this frontage, but the donkey track starts to show signs of distress as soon as it switches in front of the dunes (below left). Near the Lifeguard Station the donkey track has relatively substantial coping on its seaward edge but this is showing signs of abrasion. Some previous asphalt repairs are identified in the donkey track and there are several areas where asphalt unravelling behind the coping has been in-filled naturally with sand (below right).

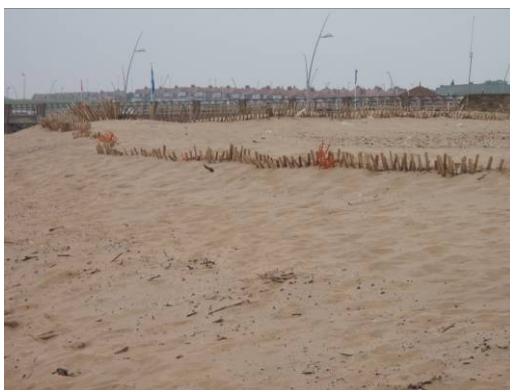
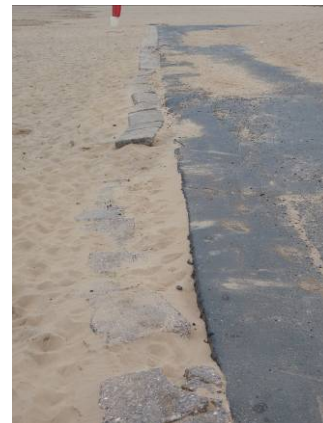
South of the Lifeguard Station, the dunes are barren of vegetation and have become 'hollowed' by intensive recreational activity, but still provide a good buffer in front of the promenade and the backing amenity assets. Efforts are being made to enhance sedimentation rates in the dunes through brushwood fencing (below left) and plans are being considered for zoning of public access to assist recovery further. At the very southern end of the dunes the damage to the donkey track is notable, with displaced coping and unravelling tarmac.

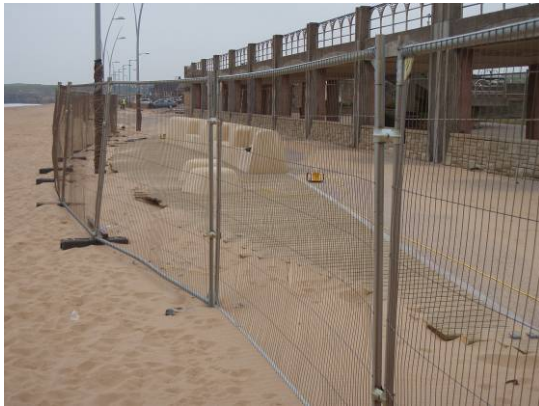
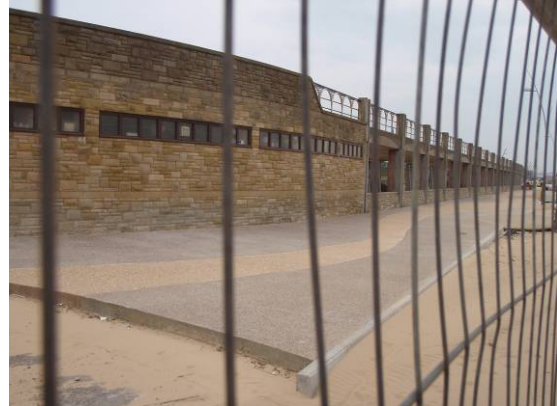
In front of the amphitheatre, construction works were also taking place, with the Sea Change project enabling the placement of new promenade furniture (below left) on timber bases protruding seaward from the promenade in three areas, and new patterned promenade paving (below right). Beach levels were flush with the promenade, covering the sea wall.

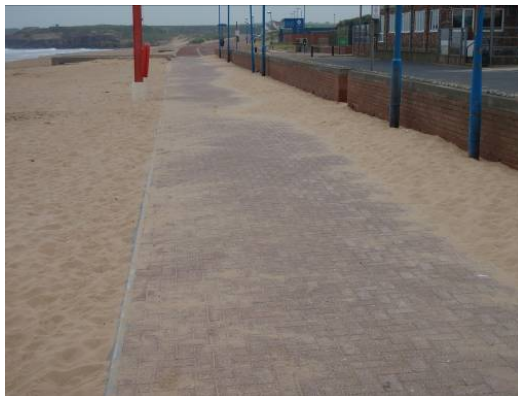
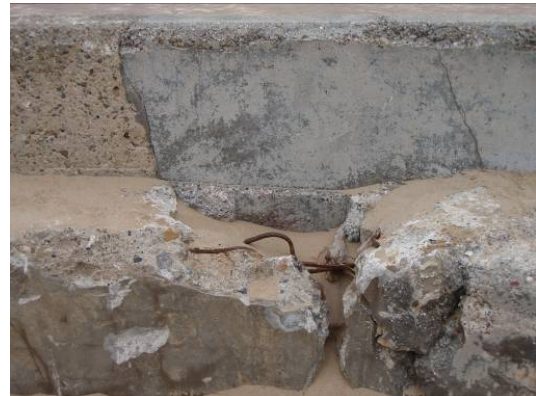
Further south of the construction works, the sea wall fronting the originally-paved promenade was covered by high beach levels, with much wind-blown sand deposited on the promenade in front of the car park (below left). The small protruding base areas with seating remains in a very poor condition, with recent failure of the coping resulting in concrete debris strewn across the beach. Previous render repairs have been made, but extensive cracking, spalling and abrasion remains evident. Reinforcement bars are exposed and corroding (below right)

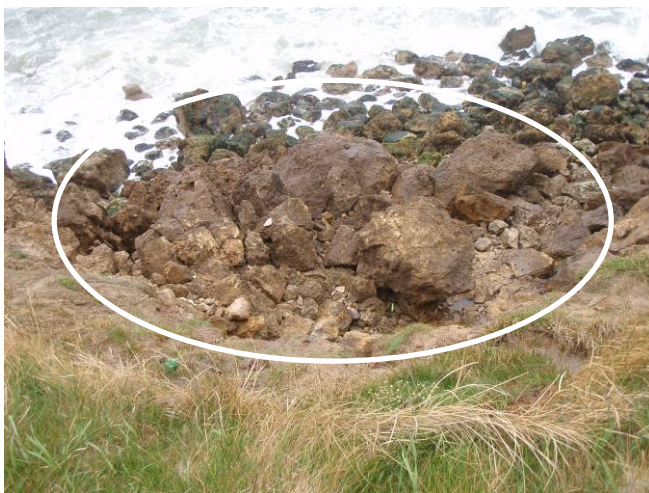
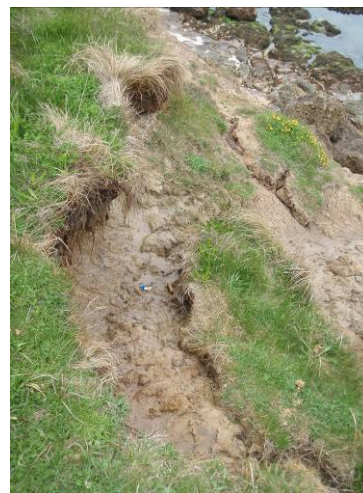
After virtually no change over recent years, the large headland at Trow Point has suffered some local rock falls (below left) within the harder rock and local slumps in the overlying softer material (below right) over the severe winter of 2009/2010. This particularly occurred along the seaward-facing front of the headland. Despite this, the headland remains as a competent mass controlling evolution of the bay to its south, Graham's Sand. Some areas of softer material remain in an over-steep condition and therefore further local slumps should be expected. Several rabbit holes were identified across the headland and vermin control may be warranted.

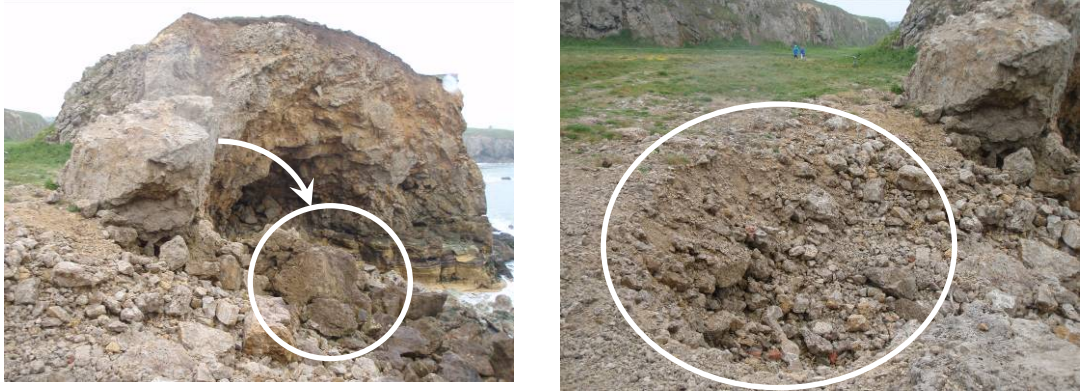
This headland has always been the most vulnerable of the three headlands at Trow Quarry due to its partly fragmented state, with undercutting at lower levels and, in at least one location, a cave formed at the base. Over the severe winter of 2009/2010, a fresh rockfall has occurred (below left) in the small rock stack that lies between the two larger, more competent rock masses at Target Rock headland. In addition, the material in between the rock masses has started to become eroded, with rock debris and brickwork evident on the foreshore (below right).

At present, there is sufficient residual rock headland not to cause a concern relating to potential outflanking of the defences in Graham's Sand and Southern Bay, but this situation should be closely monitored. In the previous *Trow Quarry Coastal Defence Scheme Monitoring Plan – Year 0 (Baseline)* a recommendation was made for Council staff to visit Target Rock quarterly and take notes and fixed aspect photographic records. This recommendation remains valid in light of the recent changes.

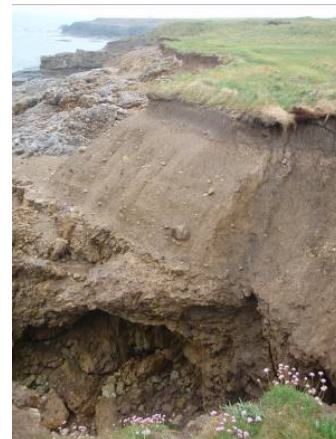
Further south of the collapsed cliff, there remain other precarious locations within Frenchman's Bay and between here and Man Haven, with arches and caves formed at the cliff toe, over-hanging rocks (right) and recent slumps in the overlying softer material, including several locations where the footpath and fencing is close presently to the cliff edge. Further local falls and slumps are expected in these locations over time.

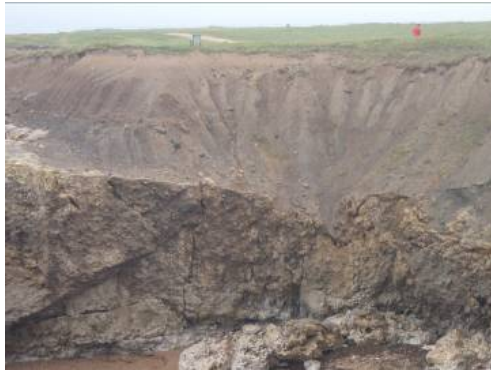
Within Man Haven Bay, and within the northern most of the three mini-bays between here and Camel Island, there appears to be evidence of debris flow (below left). This may have occurred over the harsh winter of 2009/2010 when snow melt may have mobilised some of the sediments within the softer overlying cliff material and washed it away down the cliff face. At Man Haven, one section of rock cliff underlying the debris flow also has a large vertical crack. Elsewhere between Man Haven and Camel Island, the frontage is heavily affected by cave and arch formation at the toe of the cliffs (below right).

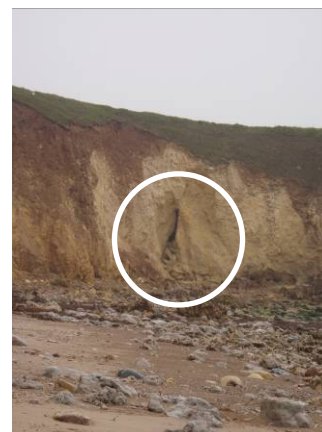
In other places the rock structure has become fractured (below left) and one area of cliff in particular has cracked (below right) with a failure due to this likely to occur.

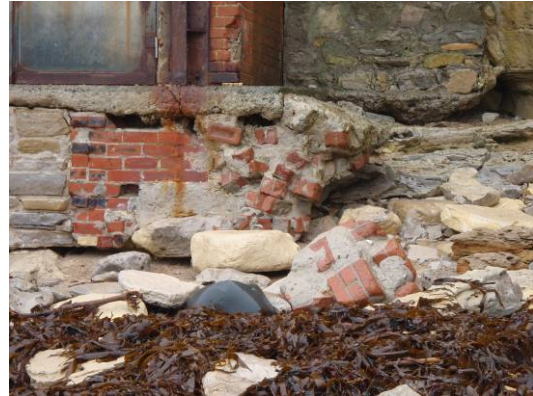
Also within the northern end of Marsden Bay there are three structures; all of which are in very poor condition. Along the access ramp to the northern end of Marsden Bay (by Camel Island) there is a concrete bunker located high up the cliff. This is perilously perched on the cliff face with previous cliff failures leaving a corner section of the bunker overhanging. There is also a stone-faced wall at the base of the disused Lifeboat Station which is now undermined and failing at its northern corner (below right). It appears that previous damage to the (former) stone-facing at this section has previously been repaired by brickwork, but this patch-up is now failing. Along the stone-faced section of this wall, there are numerous notable gaps between the stone-work and the coping.

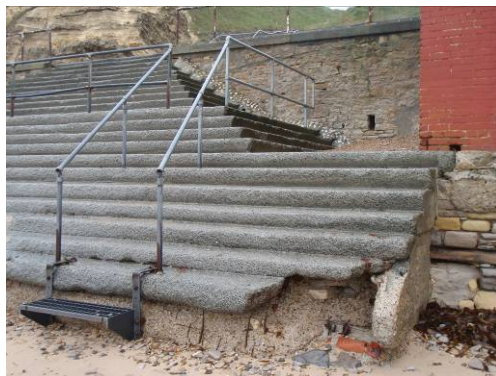
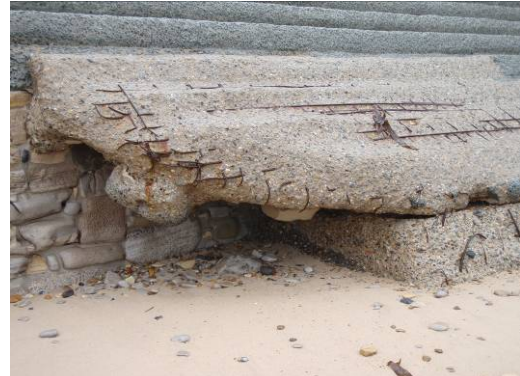
The buttress to the Redwell Steps is badly damaged along its length. The National Trust has guided access down the steps along specified routes using hand-railing in order to ensure the public avoids the worst affected areas and has bolted a temporary metal step at the base of the concrete steps to ease access to the beach (below left). In many places along the toe, the buttress is undermined, badly abraded and the reinforcement bars are exposed (below right), including in some areas of previous repairs. Several sections of the buttress are actively failing and the debris remains on the beach.

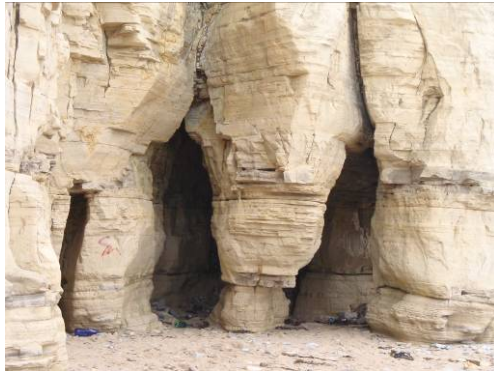
Between the Redwell Steps and the Grotto Public House, the cliffs have small arches and caves along their base in places (below left) and there is one cracked rock near Lot's Wife which is likely to fail due to toppling (below right).

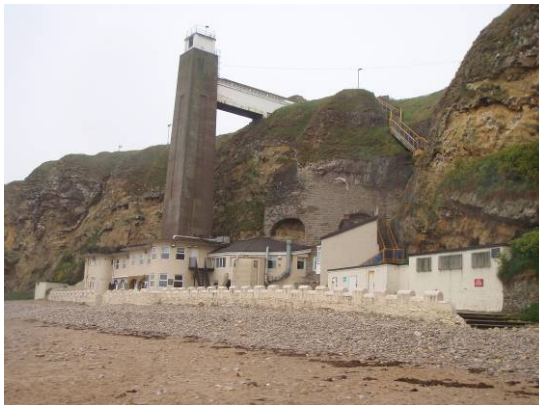
At Marsden Grotto, the masonry wall is well protected by a cobble berm on the upper beach and the rock netting constructed in 2007 remains in very good condition.

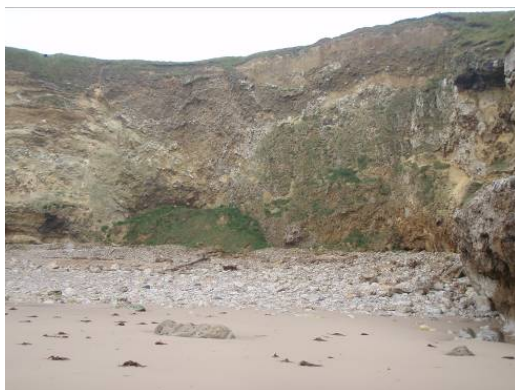
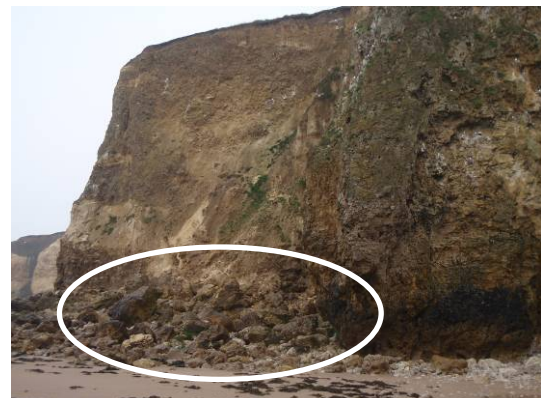
Between the Grotto and the access road to Lizard Point car park, the cliffs generally appear somewhat more stable than those in the north of the bay and in places are fronted by small cobble berms (below left). However, occasional rock falls (below right) and numerous caves and arches at the base of the cliffs are still evident.

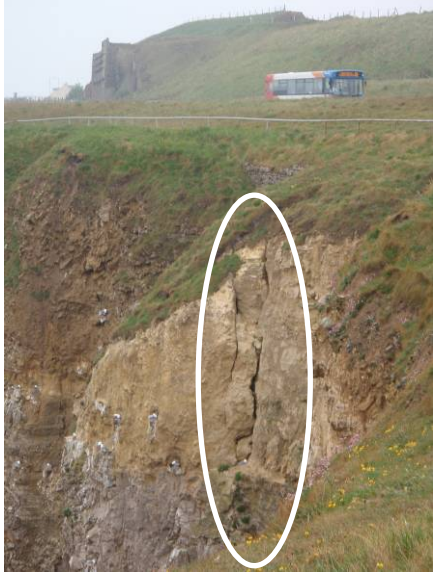
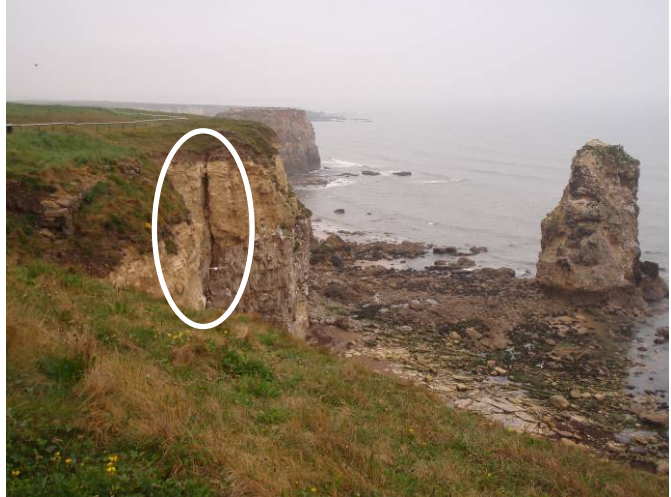
There are two locations, just south of Pompey's Pillar where the cliff-line 'pinches' close to the road, where there are large vertical cracks in the cliff (as shown below). These cracks were evident in a previous survey in August 2009 and have not worsened since, but rock falls in these locations will occur at some time. Nesting fulmar in the cliff face suggest that the cliffs remain relatively stable at the present time, since fulmar are known to have avoided nesting in areas that have subsequently failed soon after.

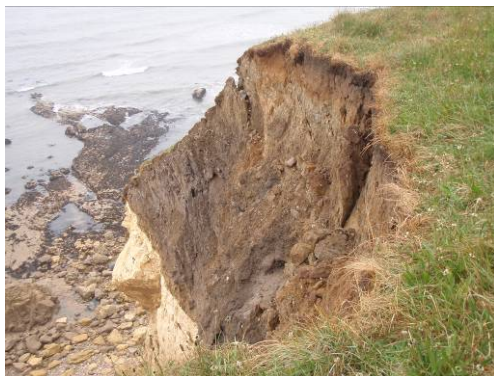
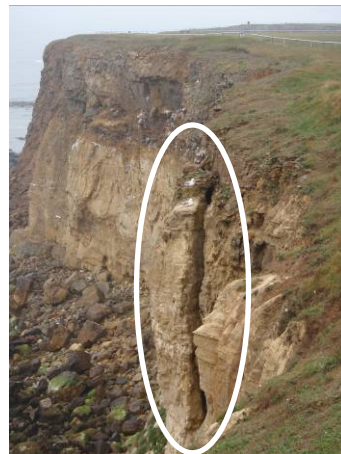
Elsewhere along this southern section of Marsden Bay, there are several other areas where small and localised toppling or slumping has occurred in the softer material that overlays the harder rock structure, including several areas where further local slumping is imminent (below left). Additionally, there is a further large vertical crack in the cliff face (below right).

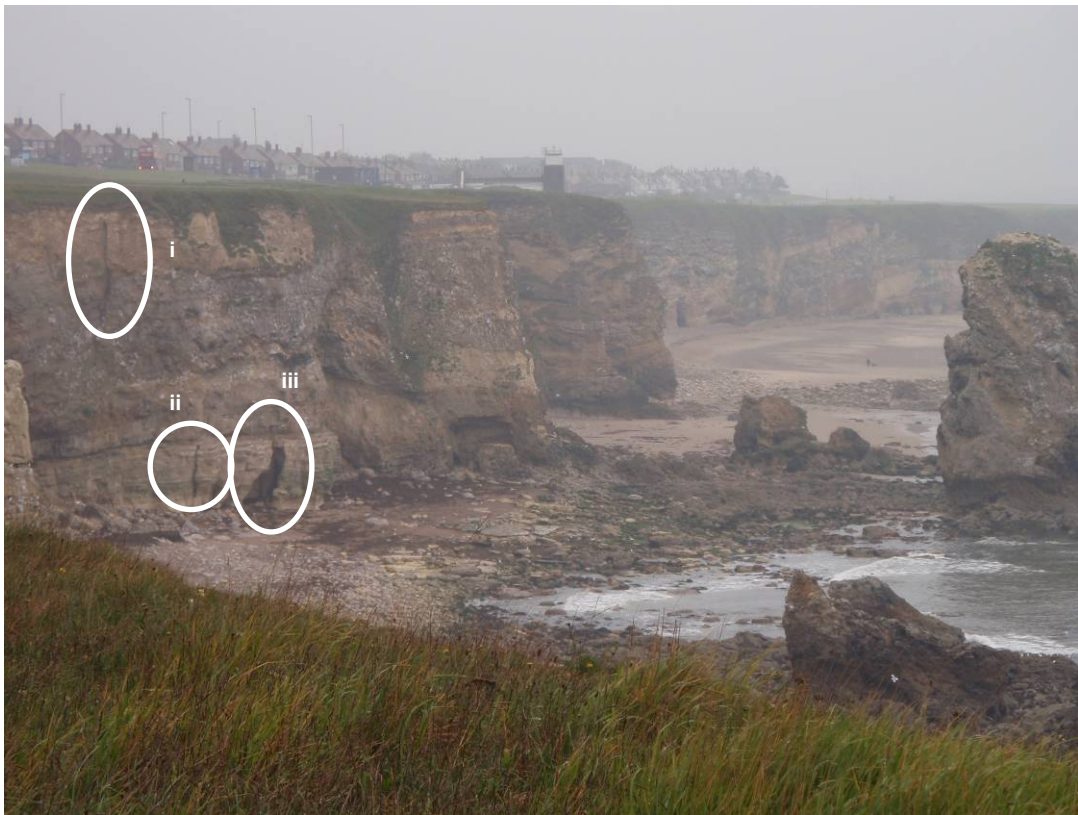
One of the fractured sections of rock face (below) has: (i) a large vertical crack in the cliff top; (ii) a large vertical crack in the cliff base; (iii) a cave formed at the base. It is highly likely that this section of cliff will fail in the future due to these weaknesses in cliff structure.

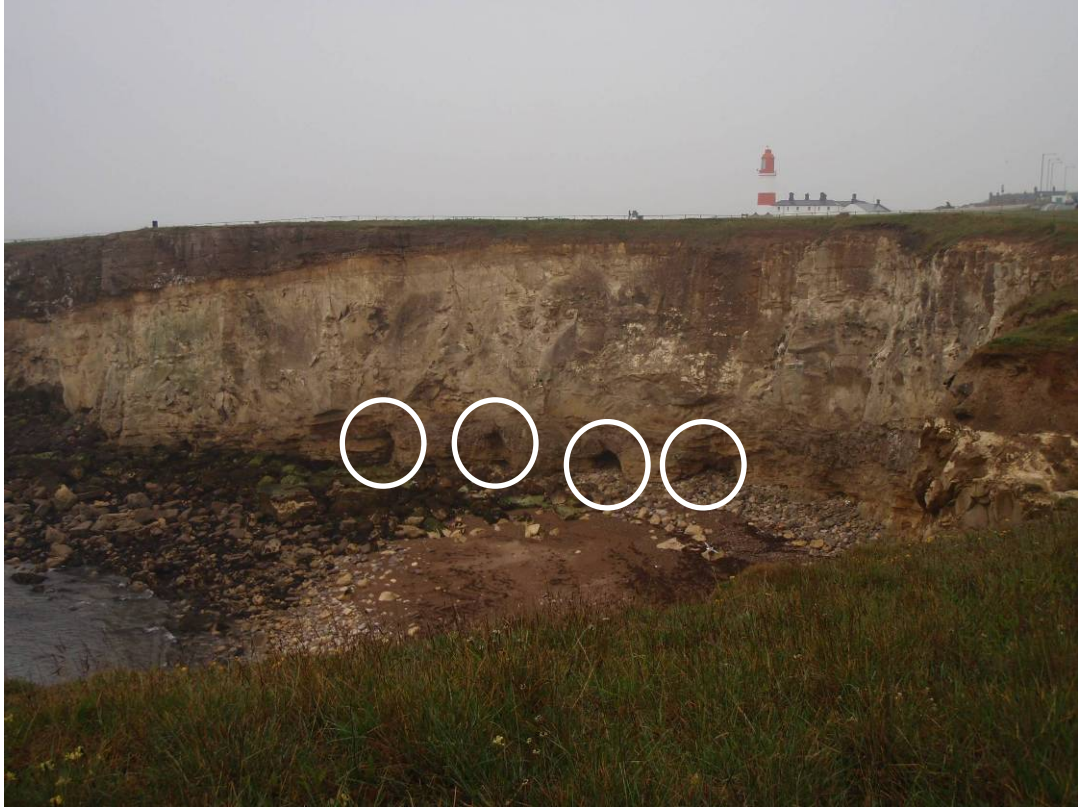
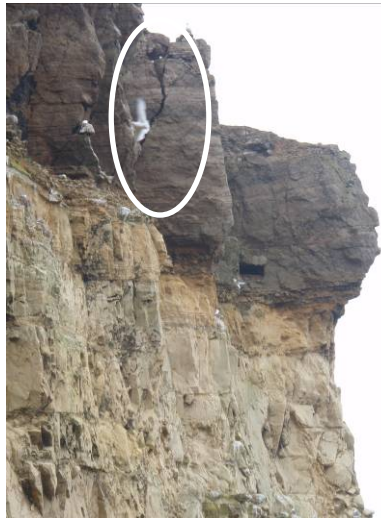
The section of cliff that extends along the access road to Lizard Point car park currently appears generally stable along most of its length, but does have four caves formed along its base (below).

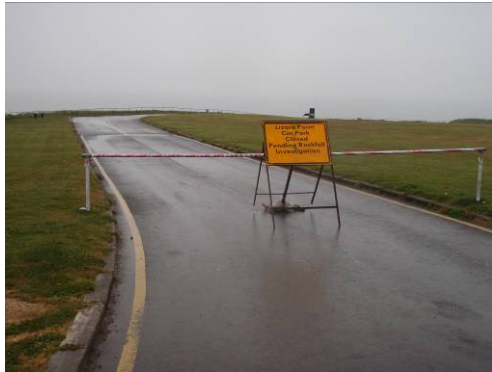
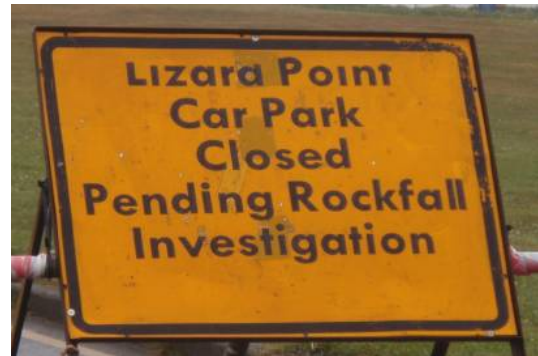
Further around the headland, along the section immediately fronting Lizard Point car park, there have been significant recent cliff failures. In response to this The National Trust has closed the car park (below) since March 2010.

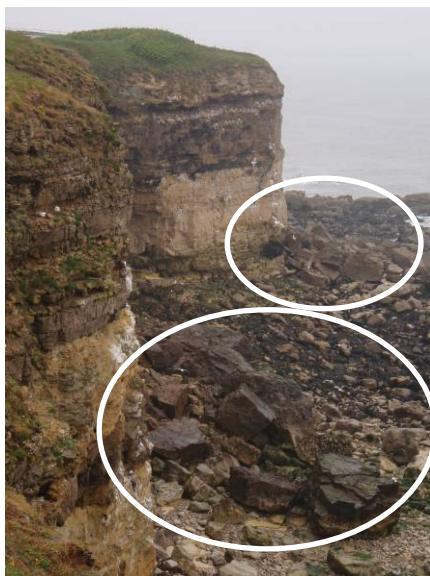
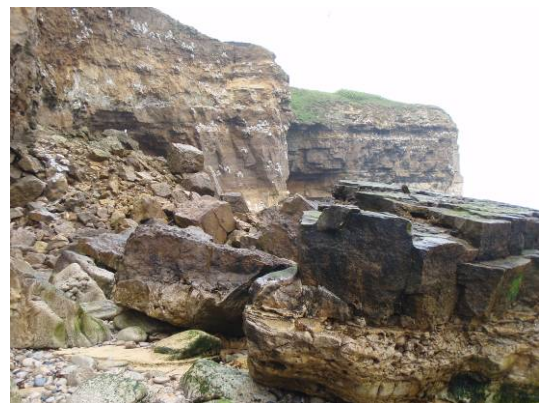
The condition of the cliff in the section fronting the car park, extending along to Concrete Pillar, is highly unstable. The worst affected section is in the lee of Jack Rock (the area immediately in front of the south east corner of the car park) where two recent rock falls have occurred (below).

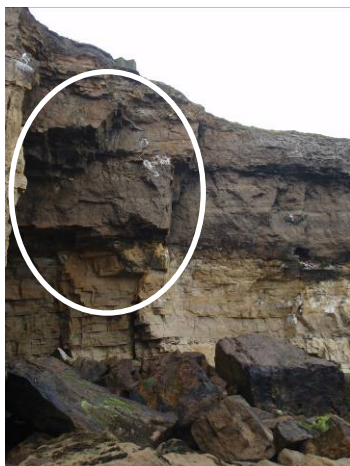
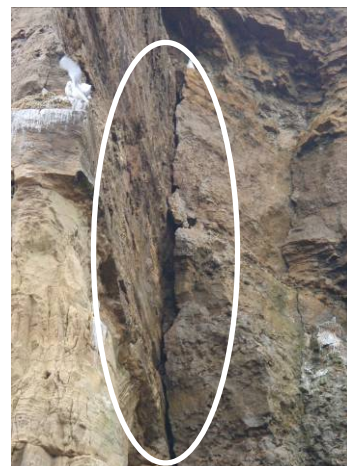
The rock falls have left extensive sections of cliff as sheer overhangs (below left) or in a highly fissured state (below right) and this section of cliff will experience further failures. The timescale of this is uncertain and depends largely on storm conditions acting at the toe of the cliff as well as general meteorological conditions.

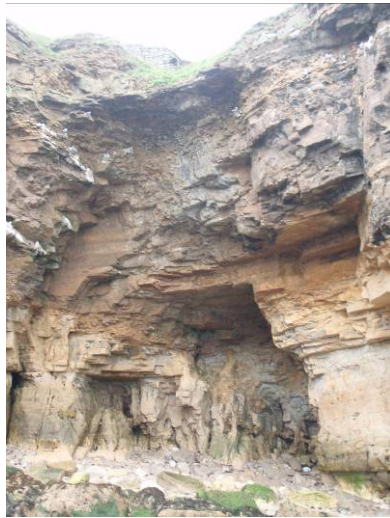
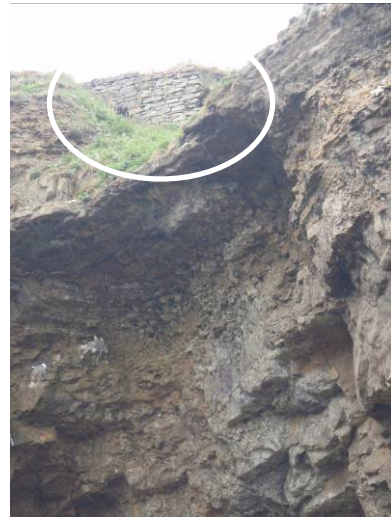
In between the area of the two rock falls a wide but shallow cave has formed, with overhanging rock (below left). Immediately above the roof of this cave, an old stone wall sits precariously on an overhang near the cliff top.

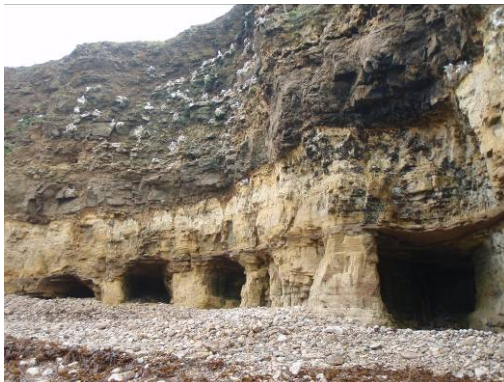
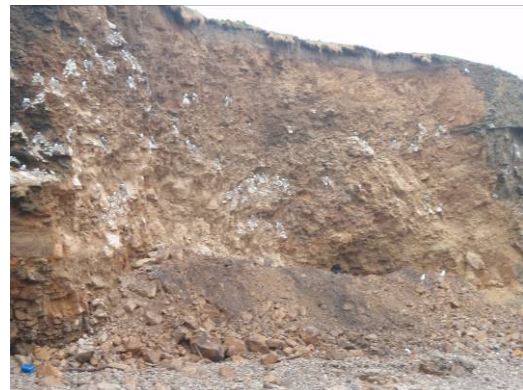
Further south of Jack Rock, extending to Concrete Pillar, the cliff remains active, but on a lesser scale. There are areas where caves have formed at the base of the cliffs (below left) and other areas where there have been recent cliff failures of a more local nature (below right).

This whole section of cliff between Lizard Point car park and Concrete Pillar remains highly unstable and further failures are expected due to the overhangs, caves and extensive fissures in the rock structure.

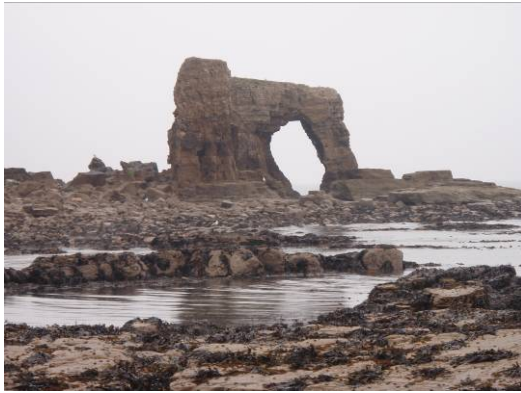
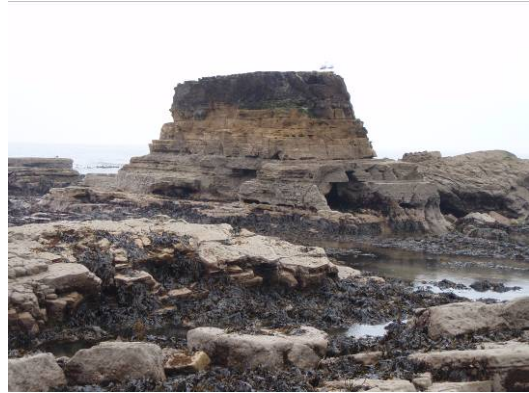
South of Lizard Point itself to the southern end of Potter's Hole, the frontage is typically characterised by the formation of caves, arches (below left) and sea stacks (below right) caused by erosion of the cliffs.

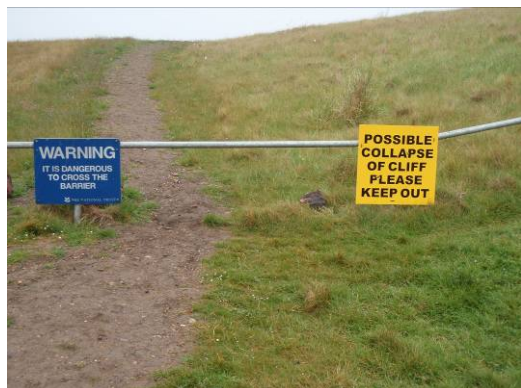
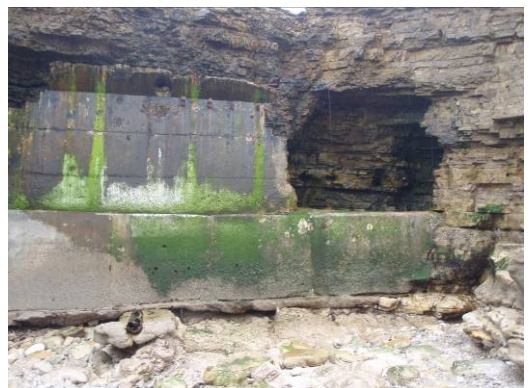
The National Trust has now fenced off this area, placed warning signs and diverted the public footpath and a scheme development remains ongoing. Since a previous scheme-specific survey in August 2009 the cave formation does not appear to have increased and the adjacent caves still have not yet breached through the limestone ridge. The existing concrete defences, previously used to 'plug' two of the nearby caves at this headland, are continuing to become undermined.

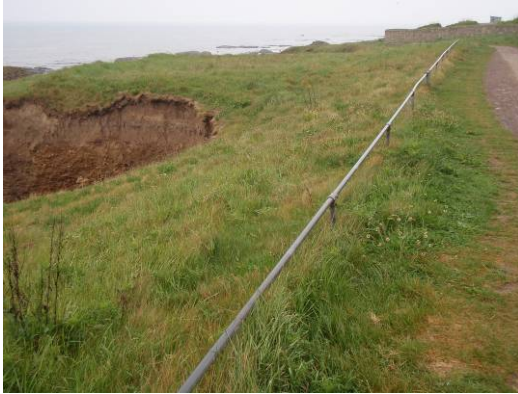
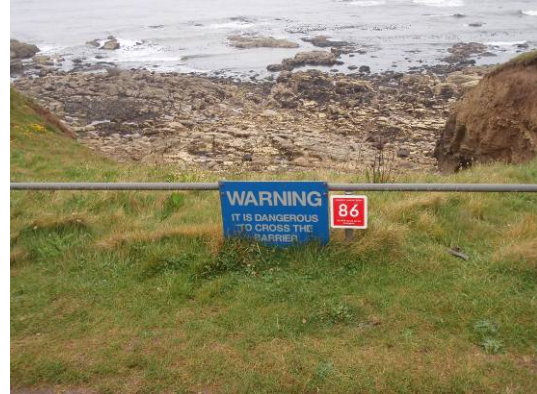
Along the Whitburn Nature Research, erosion has in a small number of locations caused the cliff top to come in close proximity to the public footpath (example below left). Low-level fencing and warning signs (below right) have been placed by The National Trust in these areas. Elsewhere the cliffs remain stable.

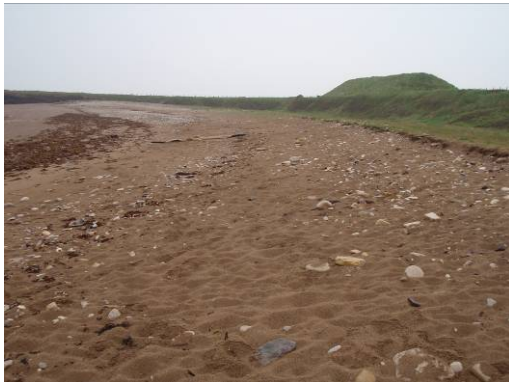
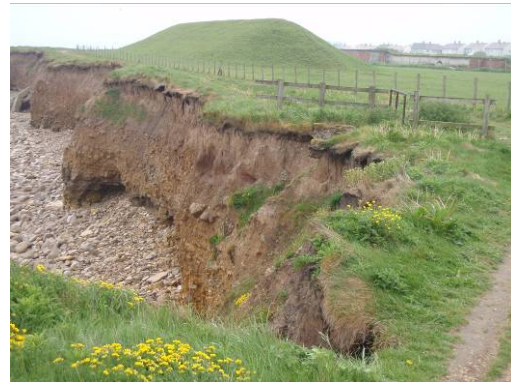
The southern section of the rifle ranges is actively experiencing small and localised slumps, a few of which are becoming close to the public footpath (below right), but nothing of major concern. In one area, close to the mound and military building, concrete blocks appear to have been dumped at the toe of the cliffs to slow their recession.

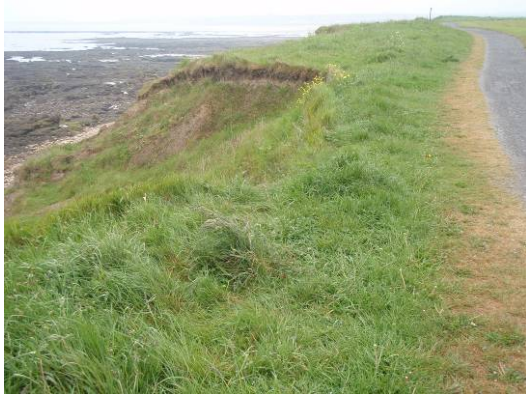
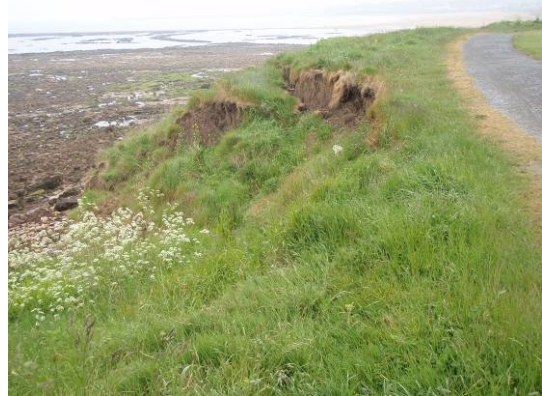
South of the rifle ranges to the outfall at the southern end of Whitburn, the cliffs are locally active, with some slumping observed, but again there are no issues of major concern.

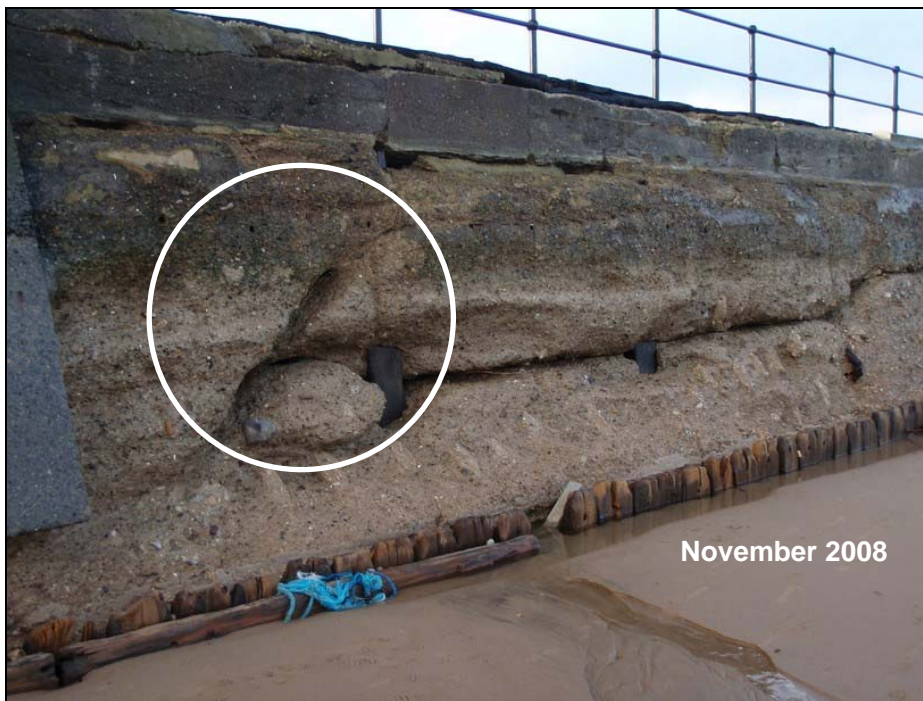
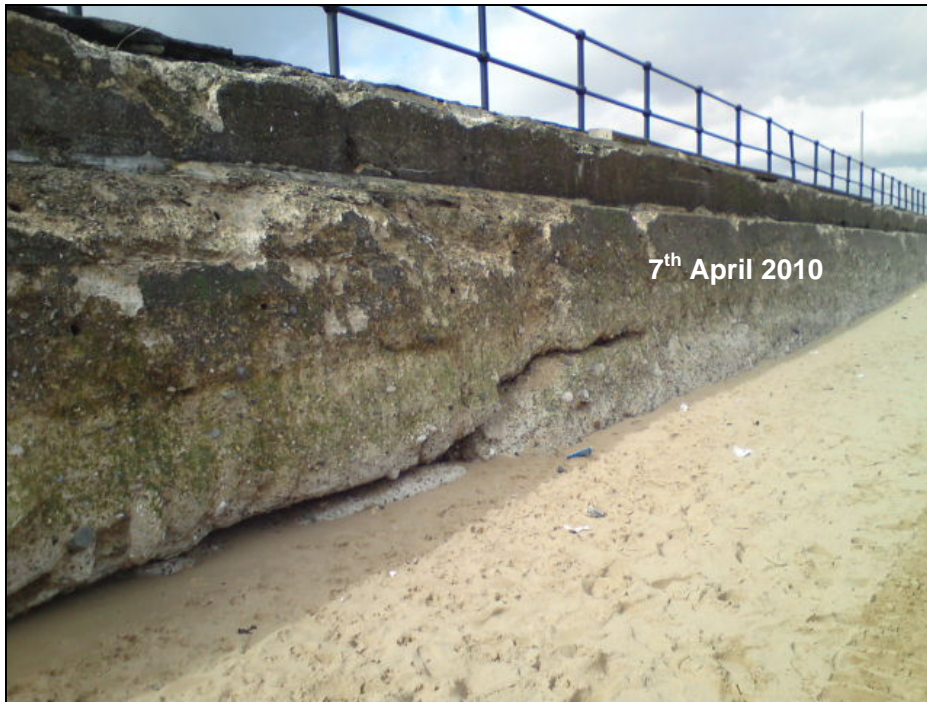
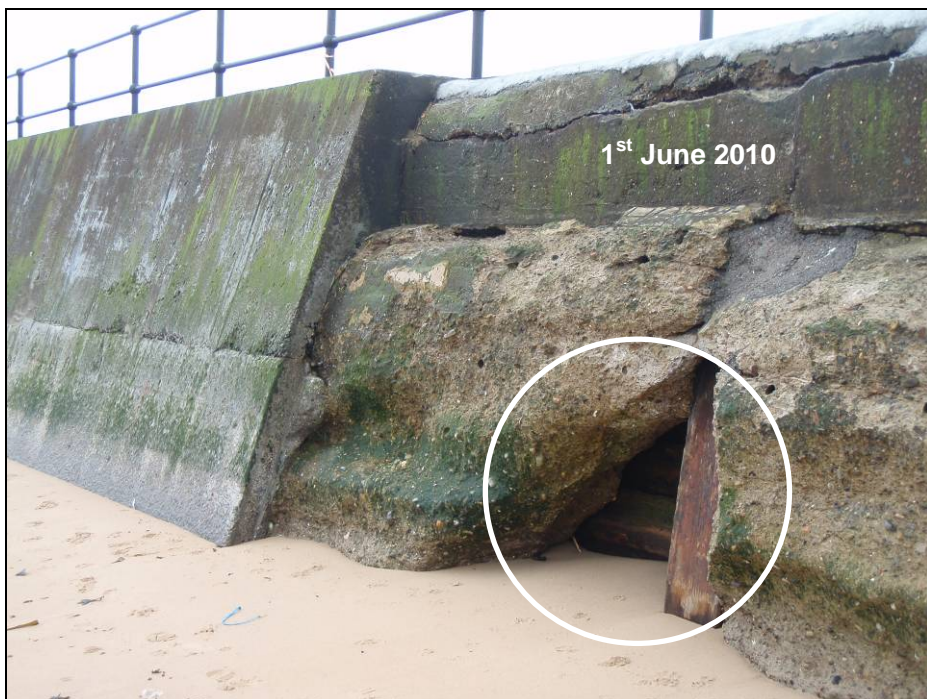
The most major changes since then exist at Littlehaven Sea Wall, where in early April 2010 a section of the wall collapsed following the heavy storms that coincided with the high spring equinox tides. The November 2008 inspections occurred at a time of relatively low beach levels, which exposed the timber foundations at the toe of the wall and revealed a diagonal crack in the wall (circled below) and a more extensive horizontal crack. The failed section of wall (from the circled area) was easily identified during the June 2010 inspection, but the relatively high beach levels at the time masked the more extensive horizontal crack and could, if unaware of the results from the previous inspections, have given rise to a lesser sense of urgency. The fluctuations in beach levels mean that at times that horizontal crack is exposed (as was the case during an intermediate visit on 7th April 2010).

Comparison with previous inspections therefore reveals that not only is the Littlehaven Sea Wall in a **very poor condition**, but it is **actively failing** and the existing patch repairs are unlikely to prevent a larger failure from occurring.

<p>There is an urgent need for capital investment in the Littlehaven Sea Wall in advance of its collapse. The plan to realign the wall may be placed on hold due to funding issues, but an intermediary contingency plan needs to be developed to provide a course of action should the wall fail.</p>
--
