**Cell 1 Regional Coastal Monitoring Programme:
Walkover Visual Inspections of Assets**

**South Tyneside Council
Final Report**

September 2012

Walkover Visual Inspection of Assets

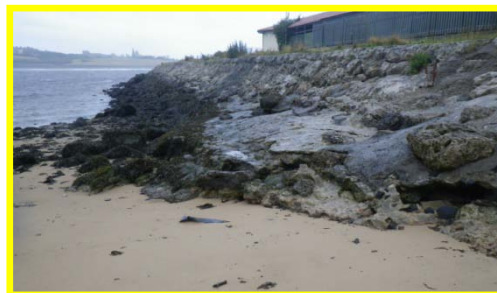
Erosion of mortar and loss of blocks at the toe of the wave basin revetment.

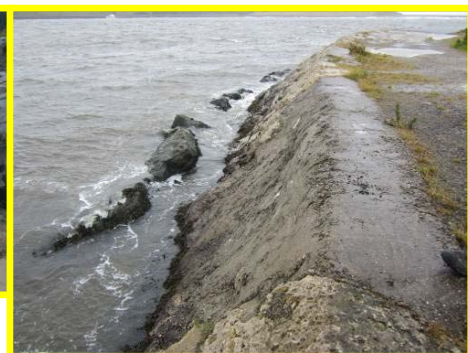
Concrete repair to face of revetment at north end.

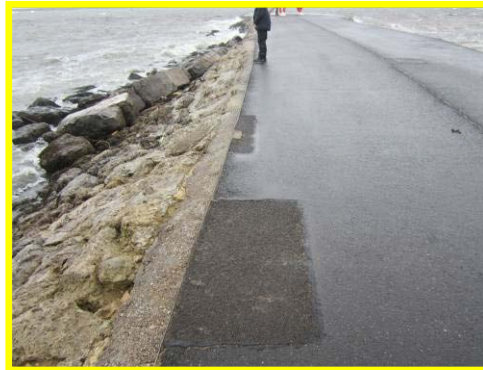
Repairs in asphalt surfacing to River Tyne South Groyne in good condition.

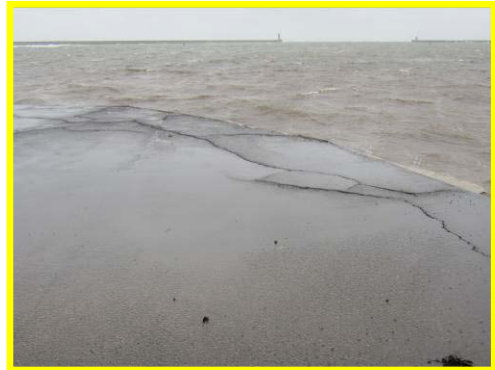
No significant change in cracks at seaward end since 2008.

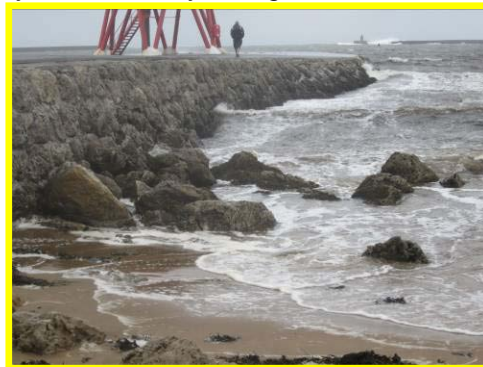
Movement of loosely placed rock armour along south face.

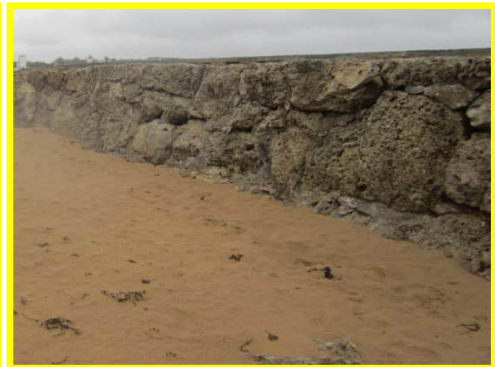
Void in concrete and some gaps between blocks along the south face.

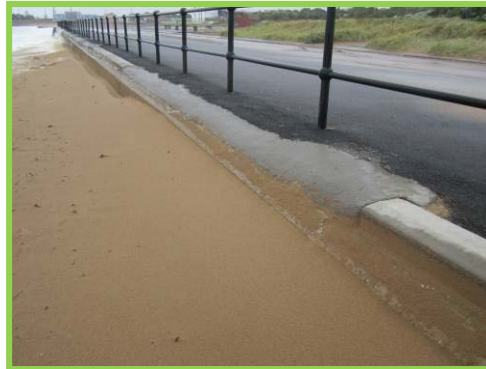
Repairs to missing coping stones remains in good condition.

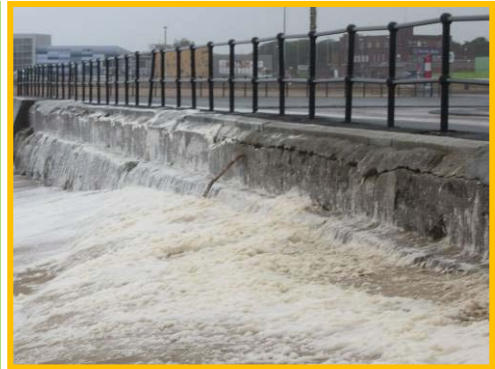
Cracks along concrete repairs at back of kerbing along the crest.

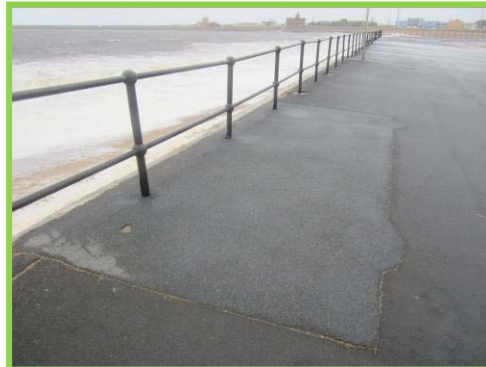
Repairs to surfacing due to overtopping damage still in good condition.

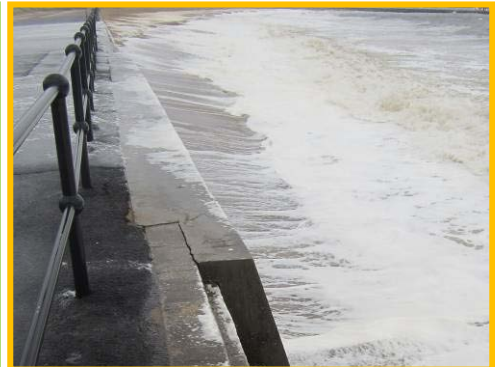
Gaps behind concrete facing at south end.

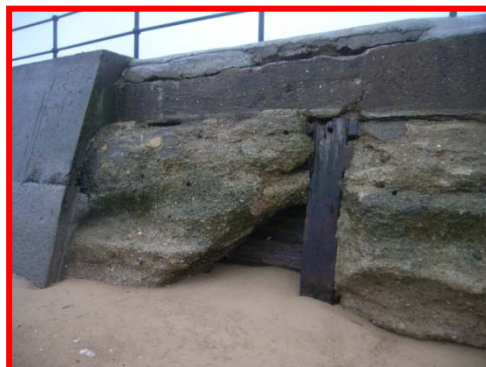
The Littlehaven Seawall is generally in a poor condition with signs of undermining and overtopping damage at the south end where it is very poor. At the north end high beach levels are burying the structure and no inspection was possible. Where coping stones are missing midway along the wall the previous concrete repair remains in fair condition. However, where this repair extends south there is a notable gap between the wall and the concrete kerbing. At the south end of the

Failed front wall facing taken prior to storm on 24/09/12.

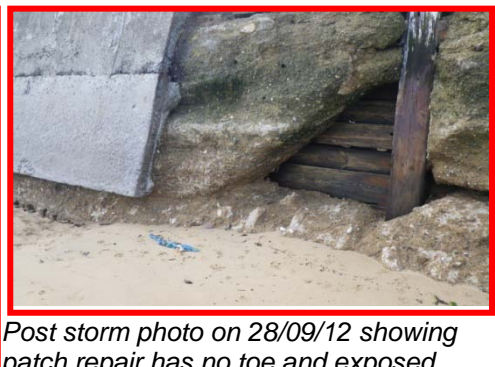
structure beach levels are very low exposing the old timber piles as identified during the 2010 inspection. Many of the other location of exposed piles identified in 2010 were not observed, possibly due to high beach levels. The section of concrete facing constructed in 2005 is showing signs of movement with a gap opening up behind although this does not appear to have worsened since 2010. Repairs to the hand railing and surfacing in this location remain in fair condition. The ongoing deterioration of this section of seawall remains a real and immediate concern. It is understood that a capital works scheme has been designed for this location and there are plans to start construction early in 2013.

Post storm photo on 28/09/12 showing patch repair has no toe and exposed timber toe piles.

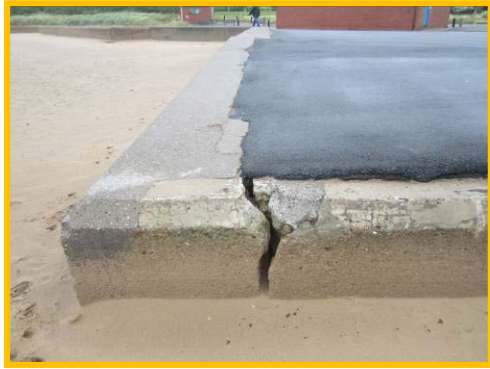
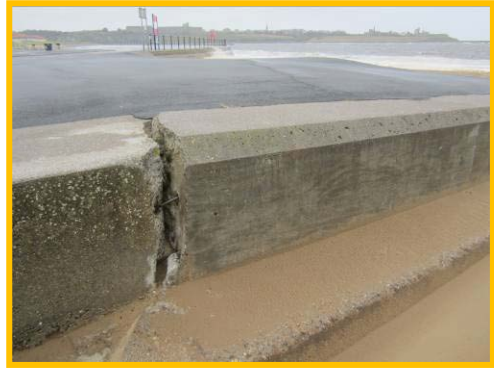
Settlement of the promontory area and wide cracks in the reinforced capping beam.

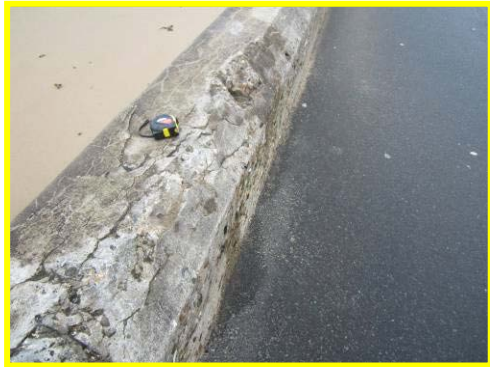
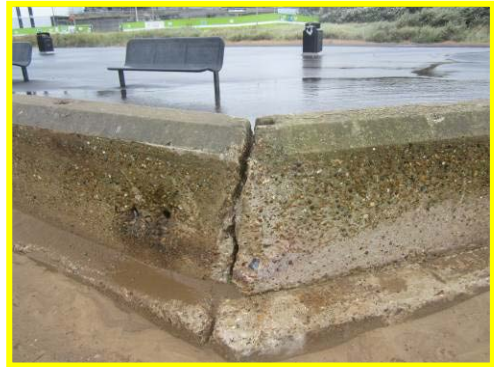
Cracks and spalling in low concrete capping wall.

The assumed obsolete outfall that is seaward of the beach at this location is still in very poor condition and in need of removal, below right.

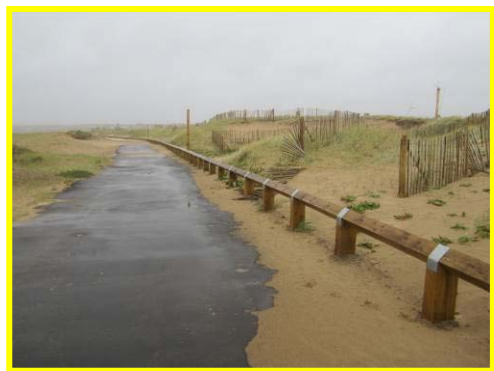
Dune fencing in good condition but 'donkey track' showing signs of distress.

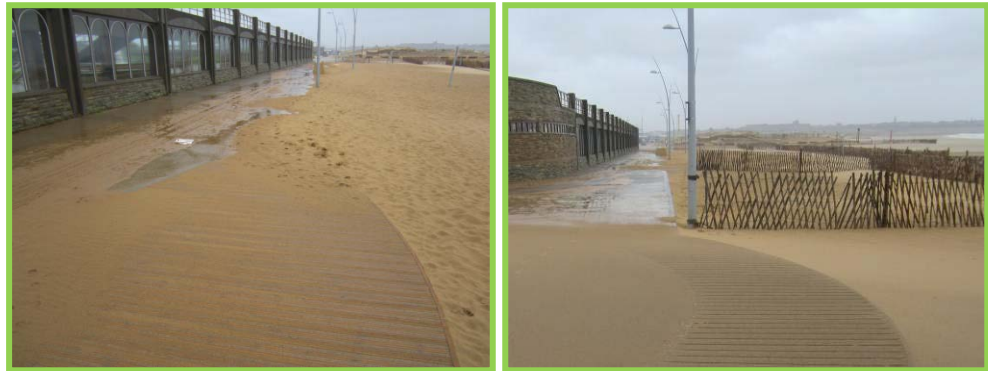
Windblown sand on the new promenade at the Amphitheatre. Dune fencing along the back of beach at the Amphitheatre

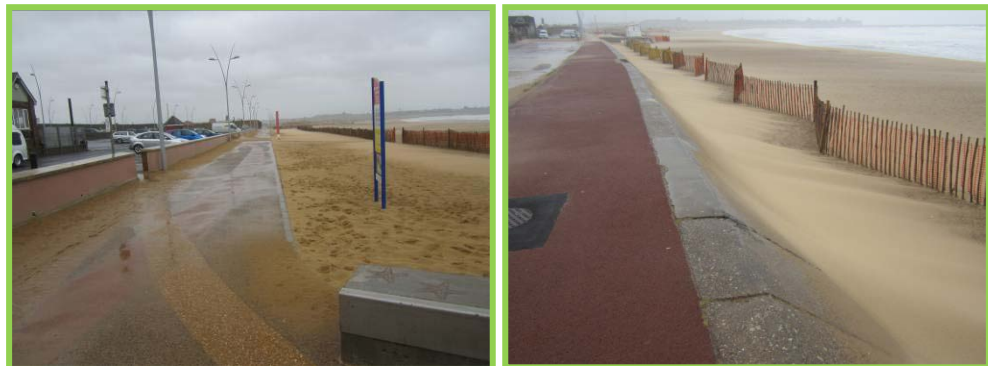
High beach levels, windblown sand on promenade adjacent to Public House. Spalling and abrasion along the sloping concrete revetment.

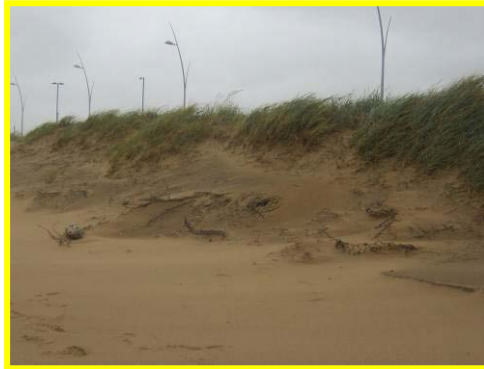
Some erosion along the toe of the dunes at the south end of Sandhaven

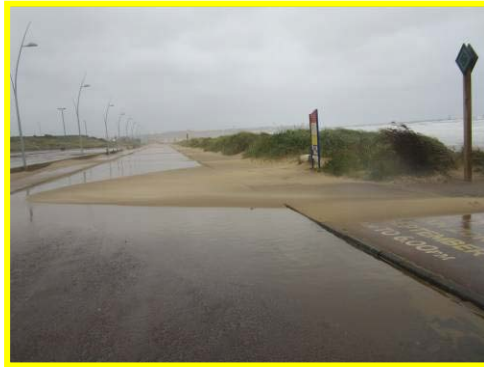
Windblown sand on the promenade at the access ramp and blowouts.

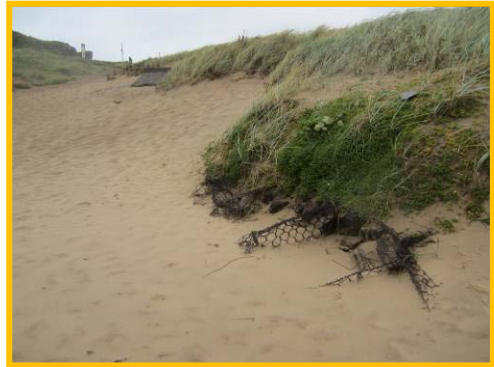
Exposed gabions at south (and north) end in poor condition.

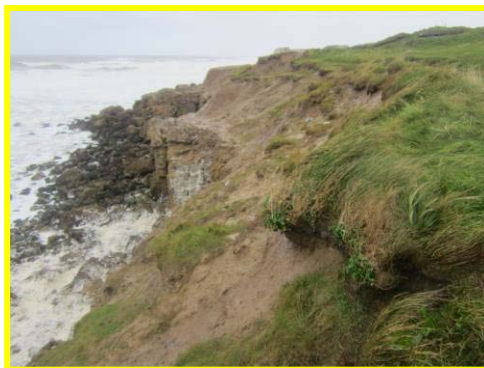
Slumps in the upper soft material at Trow Point.

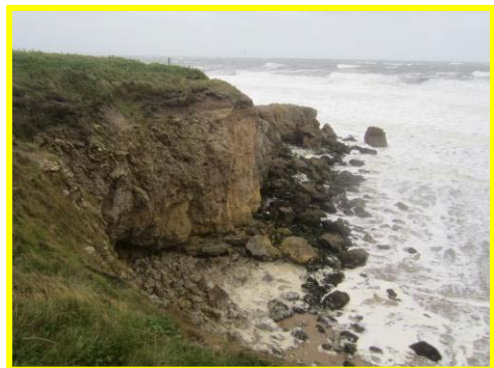
Rockfalls along the south face of Trow Point.

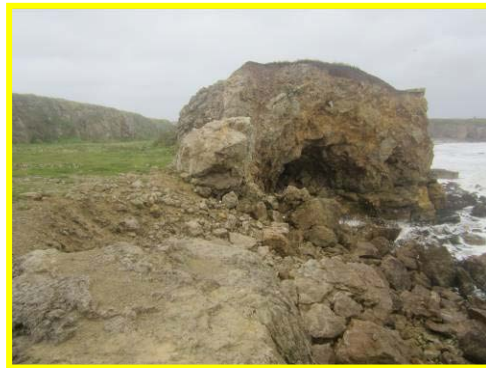
Cave forming in base of the headland at the south end of Graham's Bay.

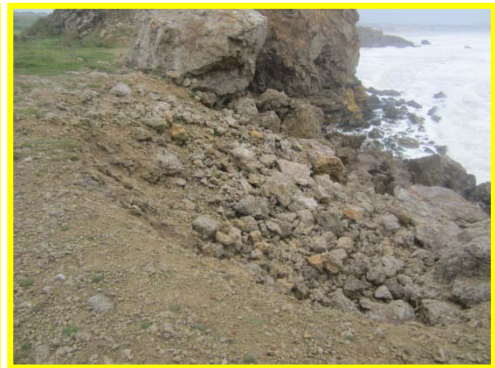
Ongoing erosion of loose rock slopes south of headland.

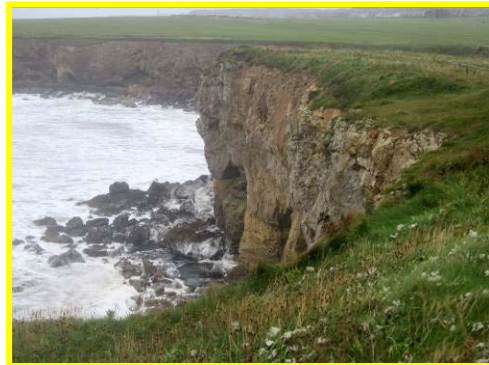
Arches formed at the toe of high rock cliffs at the south of Frenchman's Bay.

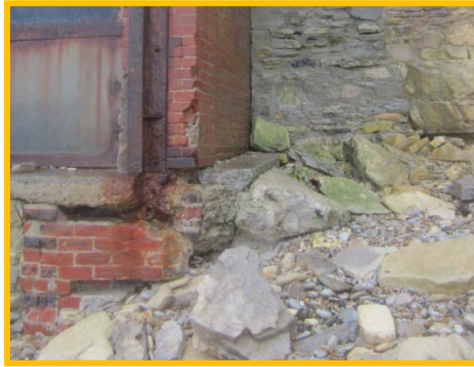
Undermining and loss of brickwork at north end of Redwell Land Lifeboat Stn.

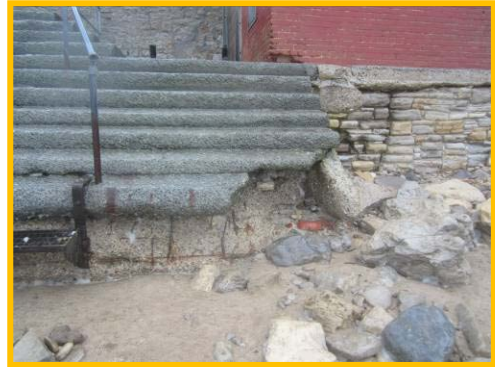
Undermining of stepped revetment and temporary metal access step.

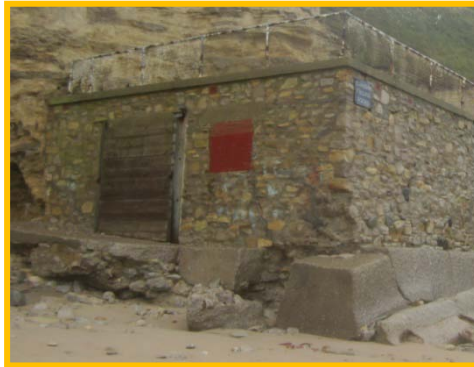
Undermining and displacement of toe beam and cracking in masonry wall.

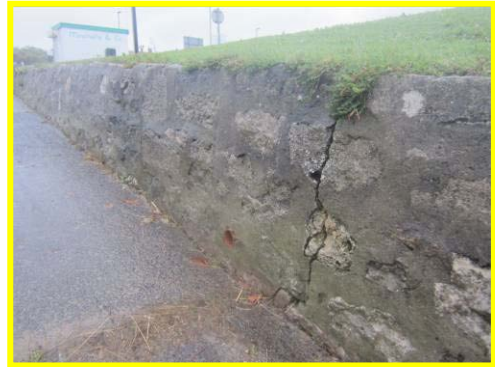
Vertical cracks in the retaining wall along the cliff top access steps.

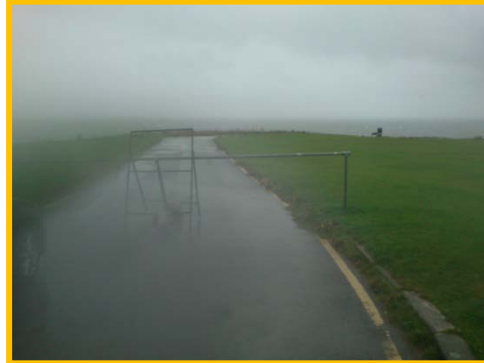
Closed track to Lizard Point car park, with sign missing on 24/09/2012.

- The cliffs near Lizard Point remain unstable and the National Trust car park remains closed with a temporary barrier, although the sign was missing on the day of the inspection. It is suggested that if the car park is to remain closed a more permanent barrier should be provided.

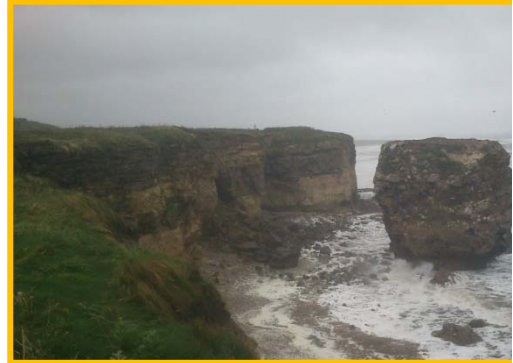
Rockfall, caves and extensive fissuring of cliff face

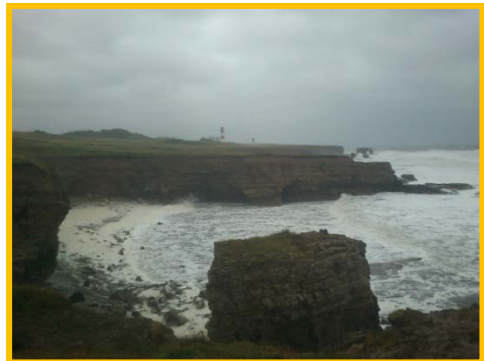
Caves forming in cliff base in Whitburn Park cliffs

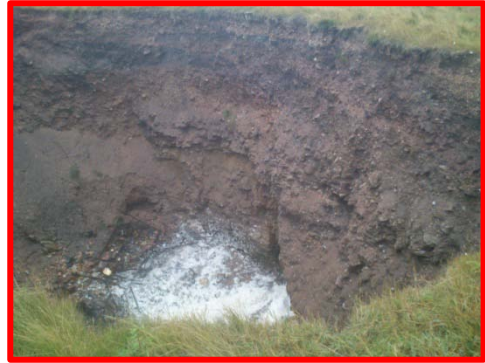
Fencing relocated at sink hole (on right mid field) View into sink hole 24.09.2012

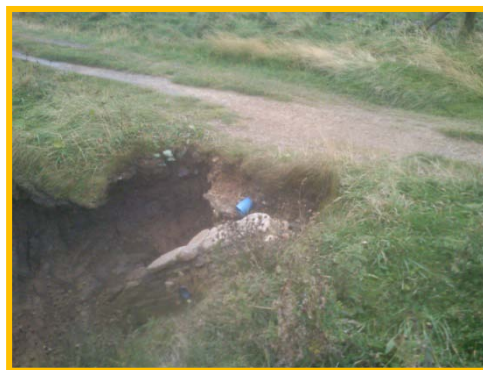
Localised erosion by land drainage outfall impinging on footpath.

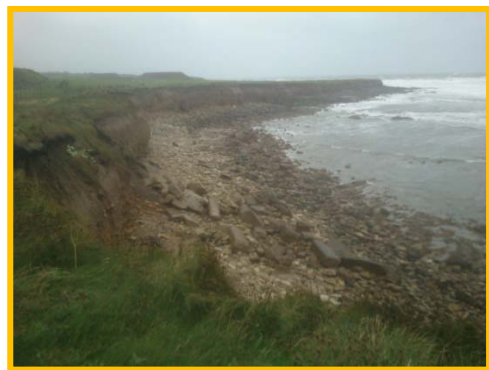
Concrete blocks dumped to protect cliff toe.

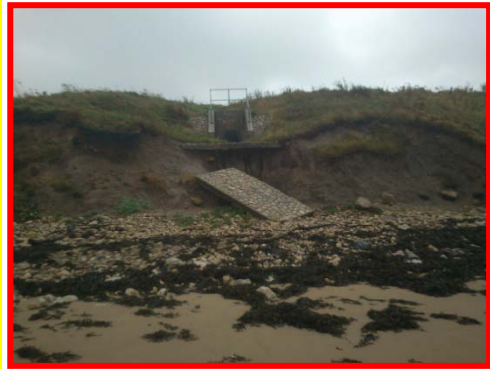
Towards the south of the unit there is a storm outfall that has suffered failure of the scour protection due to erosion of the cliff toe, below right. This should be repaired to avoid the outfall discharge further exacerbating the erosion.

Failed scour apron at storm outfall in need of repair.
