**Cell 1 Regional Coastal Monitoring Programme:  
Walkover Visual Inspections of Assets**

**South Tyneside Council  
Final Report**

**August 2014**

## Walkover Visual Inspection of Assets

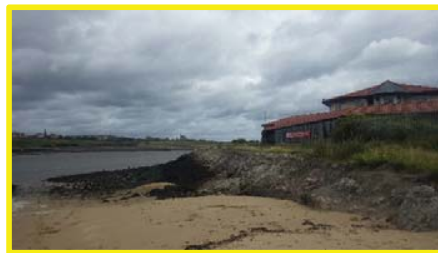
The grouted masonry revetment starts at the boat slipway and extends along the eastern side of the wave basin to join the landward root of the South Groyne. It is the responsibility of the Port of Tyne. The revetment was in fair condition, although voids were observed at the toe due to erosion of mortar and missing masonry blocks. Local repairs to infill voids previously recommended do not appear to have been carried out, but the voids have only marginally worsened. However, small holes were observed in the ground at the top of the revetment behind the upper layer of stonework. This may be indicative of wash-out of core material and as previously recommended void filling, especially at the toe, needs to be undertaken. This should be accompanied by the general replacement of missing masonry blocks and filling of cracked mortar where this occurs throughout structure.

*Grouted masonry revetment on south side of wave basin.*

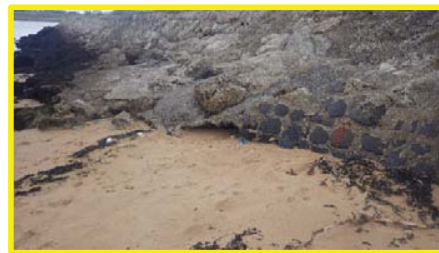
*Voids along toe of revetment.*

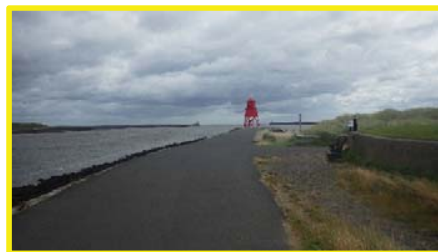
*Resurfacing of the bitmac deck of the South Groyne.*

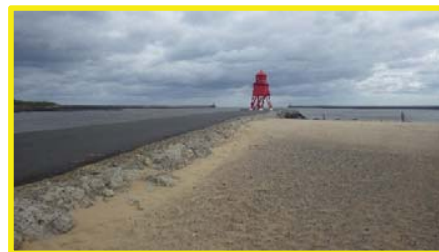
Along the northern (river-facing) side of the South Groyne there has been resurfacing of the bitmac deck. Elsewhere along the river-facing side there is occasional missing stonework and a small area of armour stone placed on the river bed in front of the structure has been displaced. The southern side of the South Groyne faces into Littlehaven and is generally less exposed and in better condition than river-facing side. Near the landward root there is evidence of cracking and the onset of voiding in the concrete.

*Cracking and onset of voiding in concrete on south facing side.*

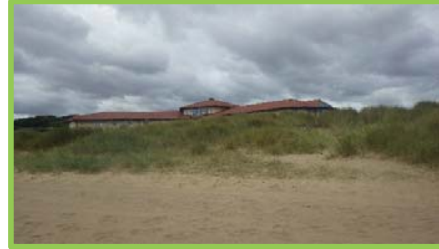
*No evidence of dune erosion.*

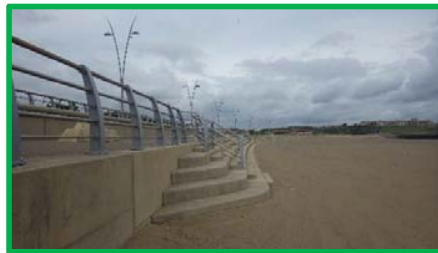
*Northern section of new seawall at Littlehaven.*

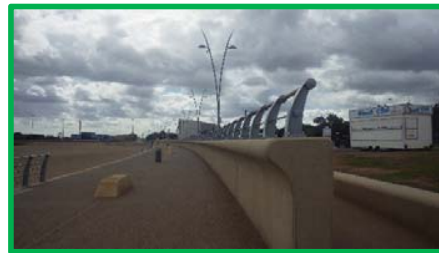
*Setback crest wall along northern section of new seawall.*

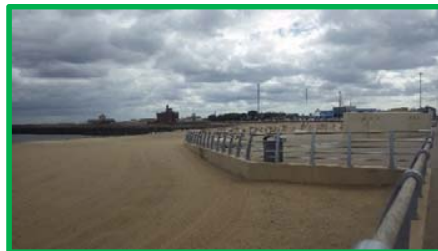
*Southern section of new seawall promontory.*

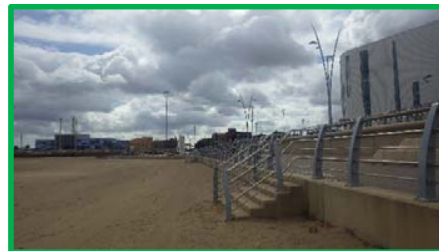
*Southern section of new seawall.*

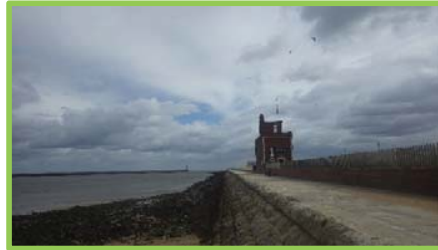
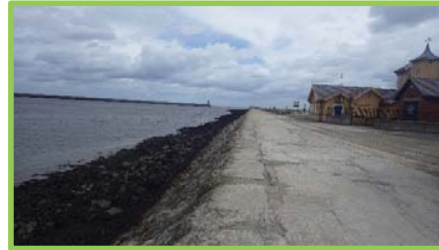
As in the previous inspection, access to the South Pier was restricted. The landward end of South Pier remains in good condition with minor re-pointing and repairs having been carried out. The structure is privately owned and maintained by the Port of Tyne.

*Minor re-pointing and repairs to South Pier.*

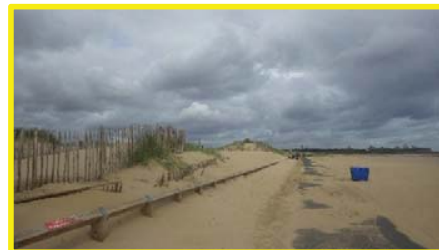
*Donkey-track covered with sand, in places.*

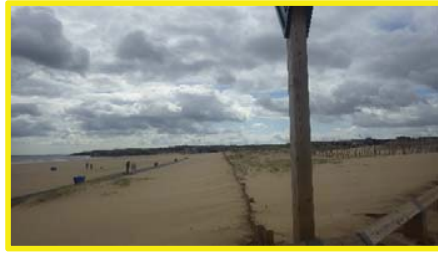
South of the Lifeguard Station the situation is similar. The dunes are healthy for levels of sand but are also barren of vegetation and have become 'hollowed' by intensive recreational activity. This area would also benefit from a replanting programme. At the time of inspection the new boardwalks and access routes were substantially covered in sand.

*Dunes healthy but barren of vegetation and 'hollowed'.*

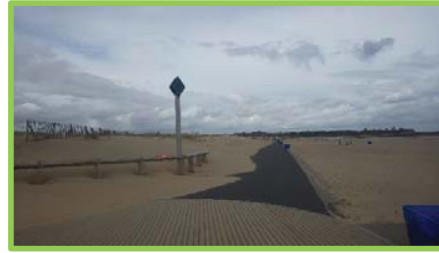
*Boardwalks and access routes substantially covering in sand.*

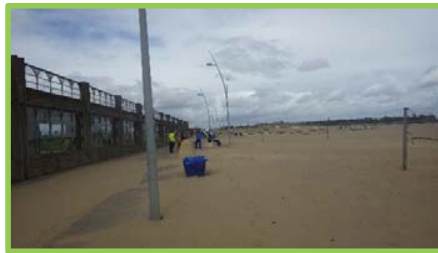
*Local Authority staff clearing sand from promenade.*

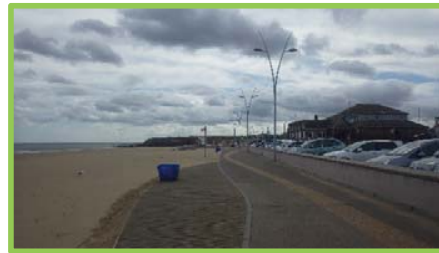
*Beach crest level with promenade.*

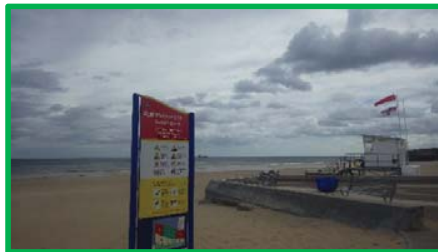
*New concrete wall at the lifeguard station.*

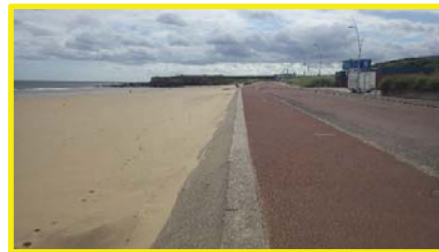
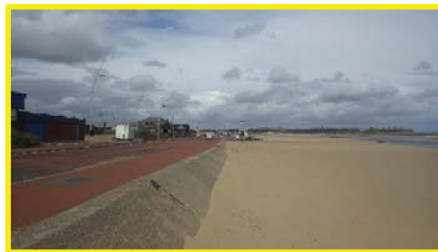
The sloping concrete revetment that extends further south is in fair condition with minor spalling and abrasion. The Lifeguard Station area has new concrete walls and beach levels are good. The last section of revetment, south of Lifeguard Station shows some signs of minor settlement due to discontinuity in slope form, but no cracks have opened.

*Minor spalling and abrasion to sloping concrete south of lifeguard station.*

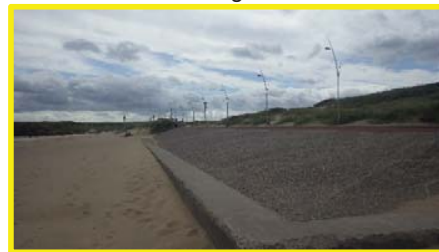
*Minor settlement to revetment but no cracking visible.*

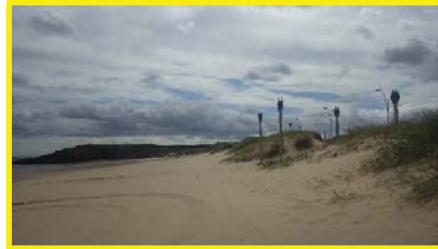
*Narrow dunes burying gabions at southern end of Sandhaven.*

by pedestrian activity (especially to Mangos Public House) and along dune crest. In two areas there is poured concrete and rubble underlying the sand and rabbit holes were observed suggesting that some vermin control would be appropriate. The concrete ramp at the south end of the bay is in poor condition with extensive cracking and sections of concrete missing. It is undermined and the gabion baskets adjacent to the ramp have been badly damaged. Remedial work is required on the ramp and a possible alternative to the gabion baskets should be investigated.

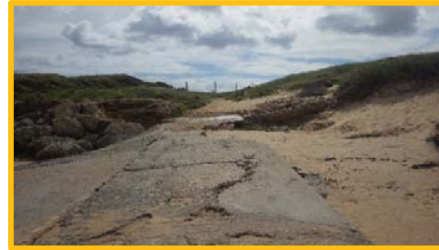
*Breaking up of ramp at south end of dunes.*

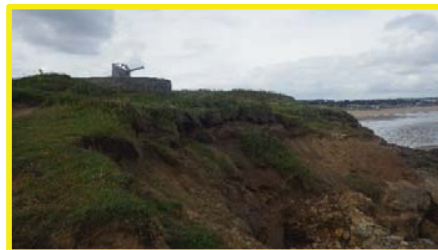
Since the previous inspection further local rock falls within the harder rock at Trow Quarry and local slumps in the overlying material have occurred. Despite this, the headland remains as a competent mass controlling evolution of the bay to its south, Grahams Sand. Some areas of softer material remain in an over-steep condition and therefore local slumps should be expected. This area should be monitored at regular intervals. Vermin continues to be a problem in this area.

*Local slumps in the overlying material at Trow Point.*

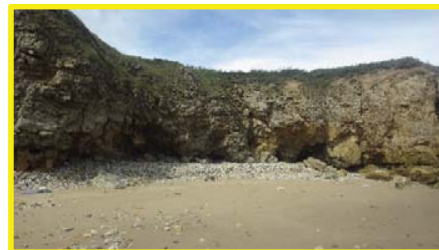
*Further rockfalls within the harder rock cliff.*

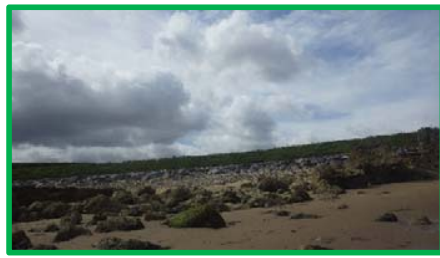
The rock revetment and re-graded slope at Graham Sand was in a very good condition. Some very large (natural) rocks were noted on the foreshore adjacent to the permanent rocky outcrop within the bay, similar to the situation at the previous inspection. There were signs that rabbits were still active in the area. Vermin control

*Rock revetment in very good condition.*

should be implemented to avoid them burrowing in the re-graded slope and destabilising it.

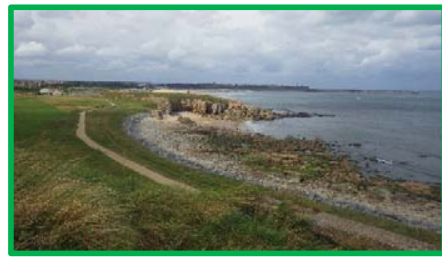
*Graded slope in very good condition*

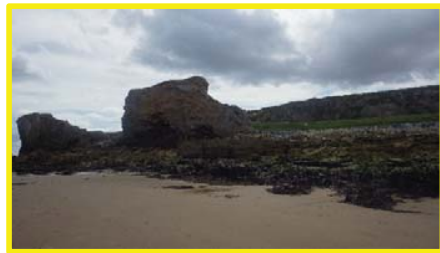
The headland at Target Rock has always been the most vulnerable of the three headlands at Trow Quarry due to its partly fragmented state, with undercutting at lower levels and caves forming at the base. The material between the rock masses continues to erode, with rock debris and brickwork evident on the foreshore. As in previous inspections, there is sufficient residual rock headland not to cause a concern relating to the potential outflanking of the defences in Grahams Sand and Southern Bay. However, this situation should be closely monitored. In the previous Trow Quarry Coastal Defence Scheme Monitoring Plan – Year 0 (Baseline) a recommendation was made for Local Authority staff to visit Target Rock quarterly and take notes and fixed aspect photographic records. This recommendation continues to remain valid in light of ongoing changes.

*Target Rock partially fragmented.*

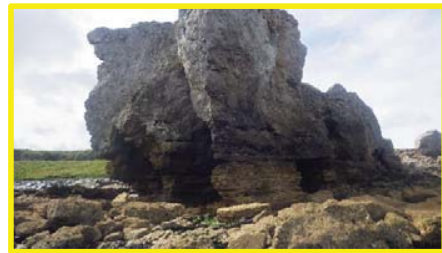
*Undercutting of lower levels and caves forming at the base of Target Rock.*

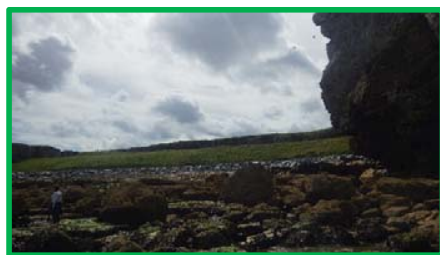
The rock revetment and re-graded slope at Southern Bay was in very good condition.

*Rock revetment and re-graded slope at Southern Bay in very good condition.*

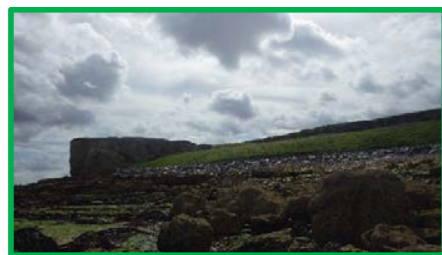
*Rock revetment and re-graded slope in very good condition.*

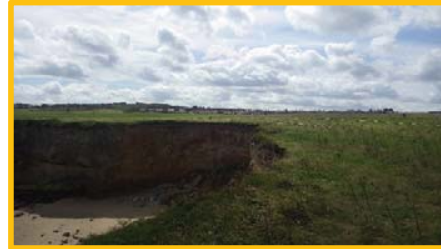
Cliff face moving close to coastal path.

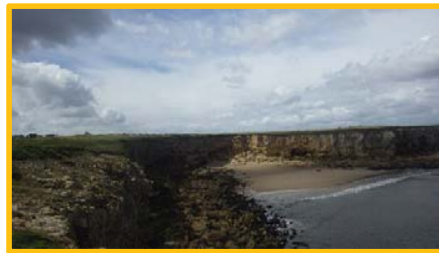
Further south of the collapsed cliff there are many very precarious locations within Frenchman's Bay and between here and Man Haven. Arches and caves have formed at the cliff toe with overhanging rocks and recent slumps in the overlying softer material, including several locations where the footpath and fencing is close to the cliff edge. Further local falls and slumps are expected on a regular basis.

Rock falls and cave formations between Frenchmans Bay and Manhaven.

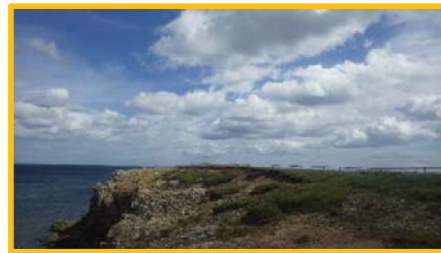
Recent slumps in overlying soft material.

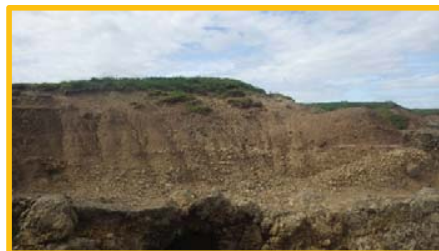
Within Man Haven Bay and within the northern most of the three mini-bays between here and Camel Island, there appears to be evidence of debris flow. This was also observed during the last inspection.

Slippage of soft material.

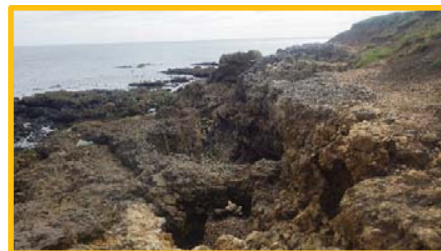
Voids in cliff face.

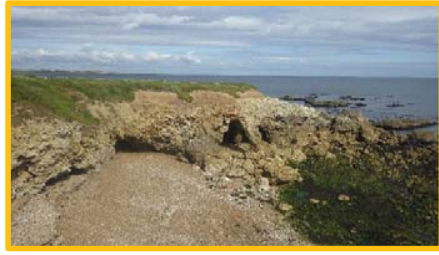
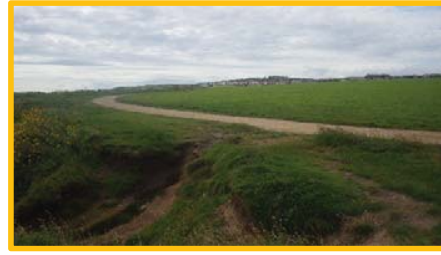
Between Man Haven and Camel Island the frontage is heavily affected by cave and arch formation at the toe of the cliffs in places. The cliff face is within a few metres of the coastal path. These sections should be monitored closely and signage enhanced where required.

Erosion and voids in base of cliff at Man Haven Slippage close to footpath.

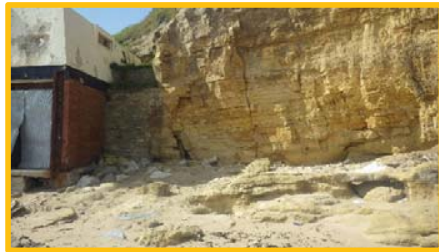
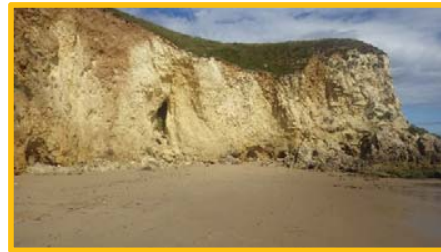
In other places the rock structure has become fractured and one area of cliff, identified in previous inspection, has cracked with failure due to this likely to occur.

Cracking of cliff face and undermining of structure at north end of Marsden Bay. Voids in cliff face.

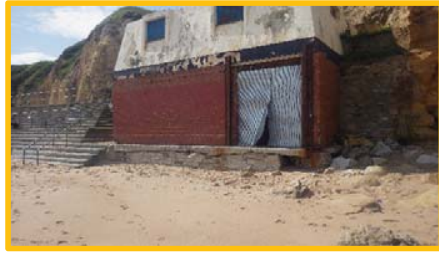
The stone-faced wall at the base of the disused Lifeboat Station is undermined and the brickwork identified in the previous inspection has been washed away. Along the stone-faced section of the wall there are numerous notable gaps between the stonework and coping. The buttress to the Redwell Steps is badly damaged along its length. The National Trust has guided access down the steps along specified routes, using hand railing in order to ensure the public avoids the worst affected areas. They have also bolted a temporary metal step at the base of the concrete steps to ease access to the beach (buried at this inspection due to beach level). In many places along the toe, the buttress is undermined and badly abraded. At this inspection the sand levels covered some of these problems. The structure south of the Redwell Steps is damaged at the corner and shows signs of cracking and gaps in the stonework. The building is being undermined and in danger of collapse. The building should be monitored at regular intervals.

Undermining of structure at disused lifeboat station.

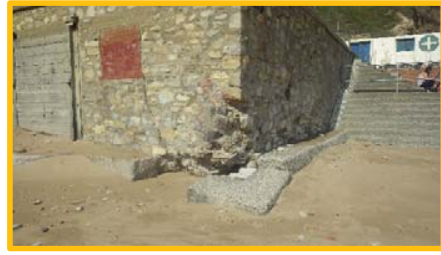
Damage to corner of stone building, vertical cracking.

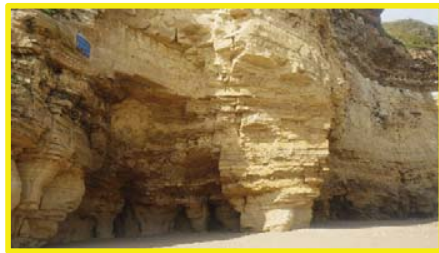
Between the Redwell Steps and the Grotto Public House, the cliffs have small arches and caves along their base in places. There is cracked rock near Lot's Wife which is likely to fall due to toppling. There is also evidence of vertical cracking in Lot's Wife stack which requires monitoring.

Cave formation in cliffs south of Redwell Steps.

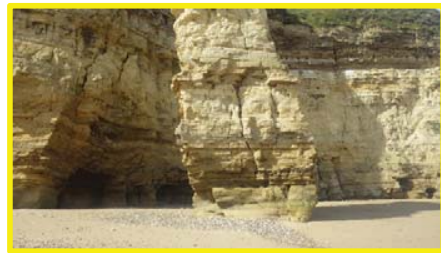
Cave formation and vertical cracking in Lot's Wife stack.

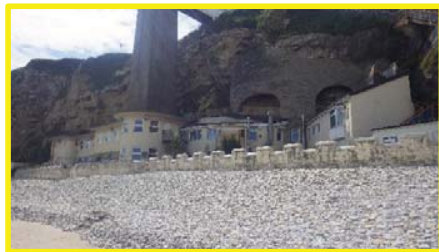
At Marsden Grotto, the masonry wall is well protected by a cobble berm on the upper beach and the rock netting constructed in 2007 remains in very good condition. Marsden Rock remains stable with cave formations at its base.

Marsden Grotto protected by cobble beach.

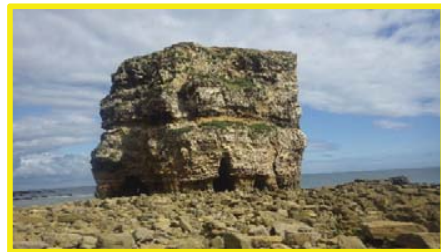
Caves at base of Marsden Rock,

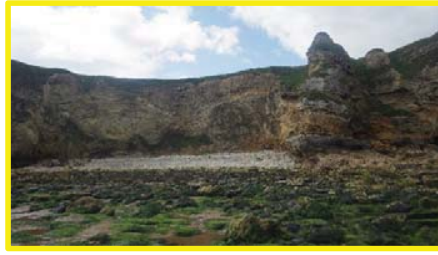
Between the Grotto and the access road to Lizard Point car park the cliffs generally appear more stable than those in the north of the bay and in places are fronted by small cobble berms. However, occasional rock falls and numerous caves and arches at the base of the cliffs are still evident. Elsewhere along this southern section of Marsden Bay there are several other areas where small and localised toppling or slumping has occurred in the softer material that overlays the harder rock structure, including several areas where further local slumping is imminent. Additionally there is evidence of vertical cracking in the cliff face.

Cliffs at south end of Marsden Bay fronted by small cobble berms

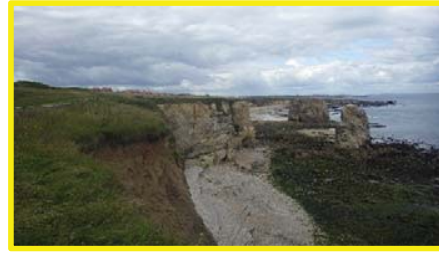
Slippage of soft material and further slumping imminent.

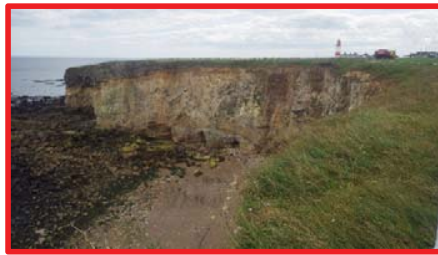
The section of cliff that extends along the access road to Lizard Point Car Park currently appears generally stable along most of its length, but does have caves formed along its base. There is evidence of recent rock falls. However, along the section immediately fronting Lizard Point Car Park, there continues to be cliff failures. The condition of the cliff in the section fronting the car park, extending along to concrete pillar, is still highly unstable. The worst affected section is in the lee of Jack Rock (the area immediately in front of the south east corner of the car park) where rock falls were identified at the previous inspection. The rock falls have left extensive sections of cliff as shear overhands or in a high fissured state and this section will continue to experience failures. The timescale of this is uncertain and depends largely on storm conditions acting at the toe of the cliff as well as general meteorological conditions. In between the area of the rock falls caves have formed, with overhanging rock.

Cliff failure in cliffs fronting Lizard point Car Park.

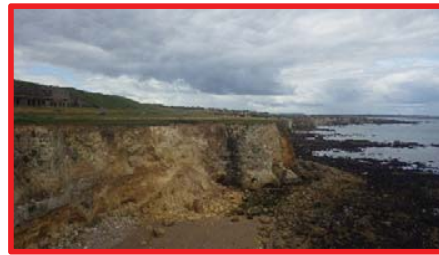
Recent rock falls in cliffs at Lizard Point Carpark.

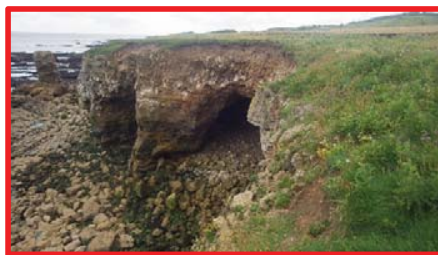
Further south of Jack Rock the cliff remains active. There are areas where there have been recent cliff failures of a more local nature. The whole section south of Lizard Point remains highly unstable and further failures are expected due to overhangs, caves and extensive fissures in the rock structure.

Cave formations at Lizard Point

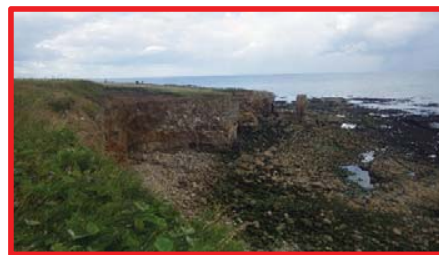
Rock falls and voids at base of cliff south of Lizard Point.

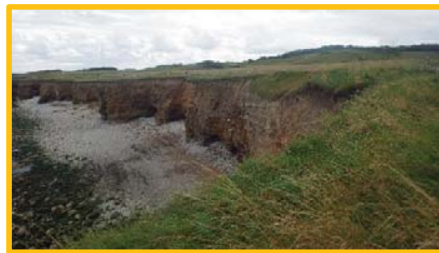
South of Lizard Point itself to the southern end of Potters Hole, the frontage is typically characterised by the formation of caves, arches and sea stacks caused by erosion of the cliffs. Whitburn Coastal Park covers the area of the former Old Harbour Quarry, which has subsequently been filled with waste material. The headland separating Byer's Hole from Potter's Hole cave formation has breached the limestone ridge that was left at the seaward edge of the former quarry, causing the wash out of fill material and in one location creating a sink hole. The National Trust fenced off this area, but at the time of inspection this was being ignored by the public. The National Trust have placed warning signs and diverted the public coastal footpath. The cave formation identified in previous inspections does not appear to have increased and the adjacent caves still have not breached through limestone ridge. The existing concrete defences, previously used to 'plug' two nearby caves at this headland, are continuing to be undermined, possibly contributing to the wash out.

Caves at base of cliffs between Lizard Point and Potters Hole.

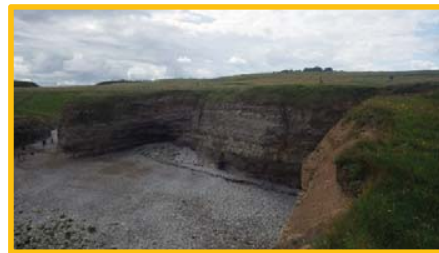
Slippage of soft material at Potters Hole.

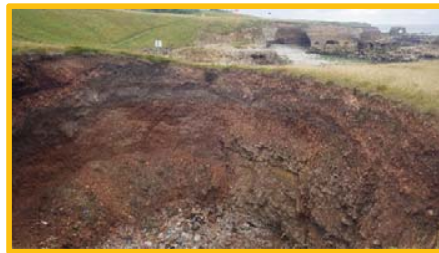
Collapsed ground between cliff face and coastal path

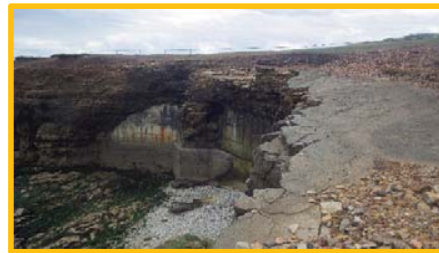
Undermining of concrete defences used to 'plug' caves.

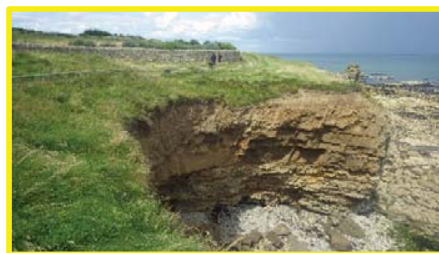
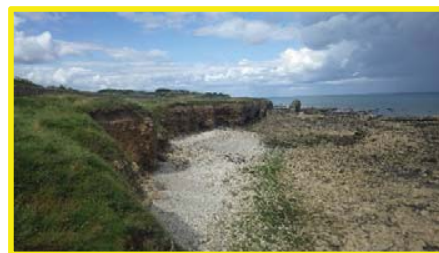
Along the Whitburn Nature Reserve, erosion has in a small number of locations caused the cliff top to come in close proximity to the public footpath. Low level fencing and warning signs have been erected by the National Trust in these areas. Elsewhere the cliffs remain stable.

Rock fall bringing cliff face close to coastal path.

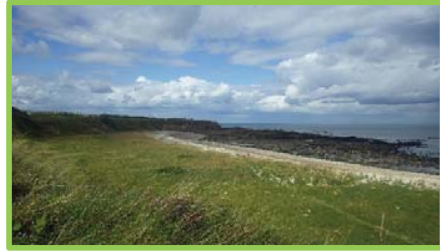
Coastal slopes not exposed to marine action at north end of rifle ranges.

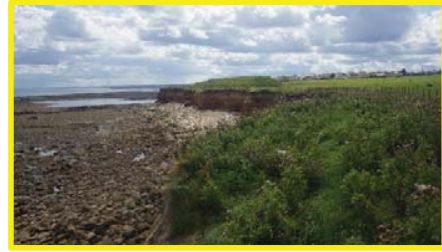
The southern section of the Rifle Ranges is actively experiencing small and localised slumps, a few of which are becoming close to the public coastal footpath, but still nothing of major concern. In one area, close to the mound and military building, concrete blocks appear to have been dumped at the toe of the cliffs to slow recession.

Small localised slumps at southern section of rifle ranges.

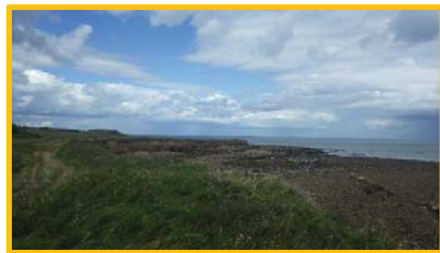
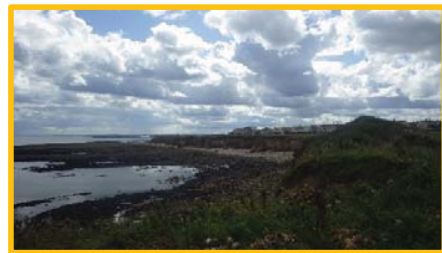
South of the Rifle Ranges to the outfall at the southern end of Whitburn, the cliffs are locally active, with some slumping observed, but again there are no issues of major concern.

Some slumps in cliffs south of Rifle Ranges.

Some slumps in cliffs south of Rifle Ranges

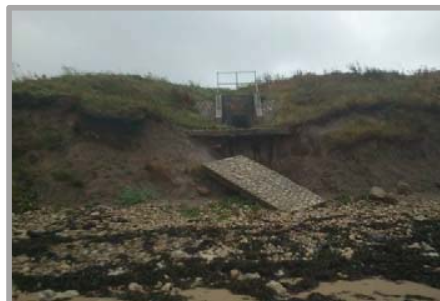
The storm outfall structure located close to the local authority boundary with Sunderland that was noted to have failed scour protection in the 2012 report has been reconstructed on a slightly different alignment, see photographs below.

Photo from 2012 report showing failed outfall scour protection south end of frontage.

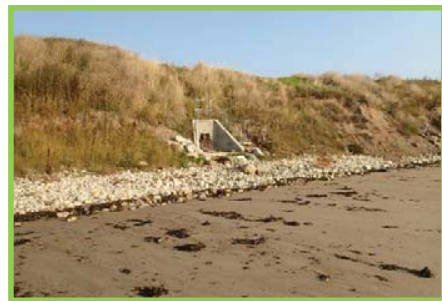
Outfall has been reconstructed at south end of frontage.
