Cell 1 Regional Coastal Monitoring Programme Walkover Inspection Surveys 2022

South Tyneside Council

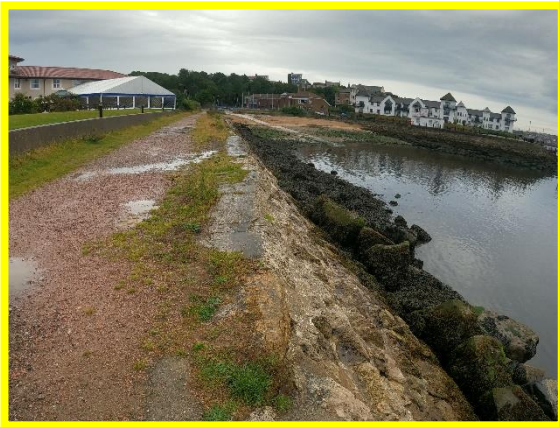
Grouted masonry revetment in fair condition (/0101C01)

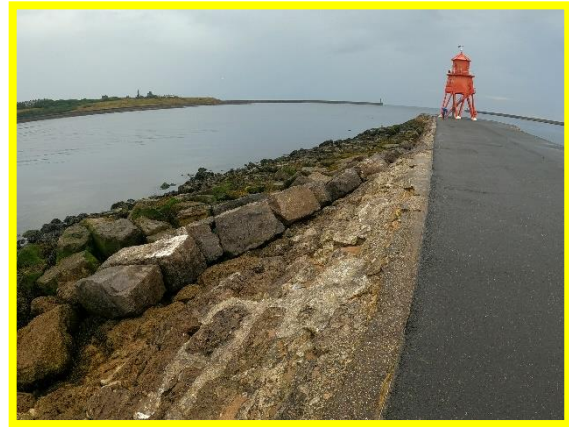
Additional armour stones placed on river-facing side of South Groyne (/0101C02)

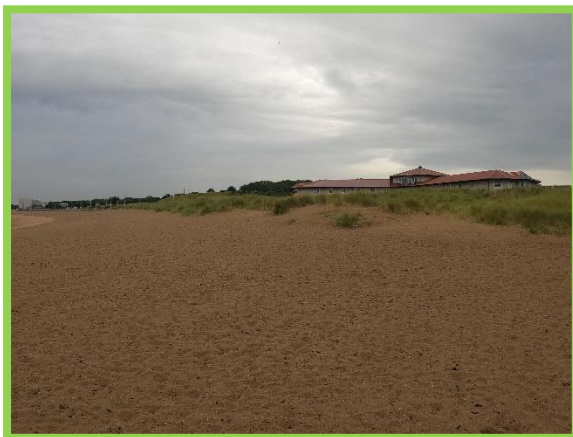
Stable dunes fronting Little Haven Hotel (/0102C01)

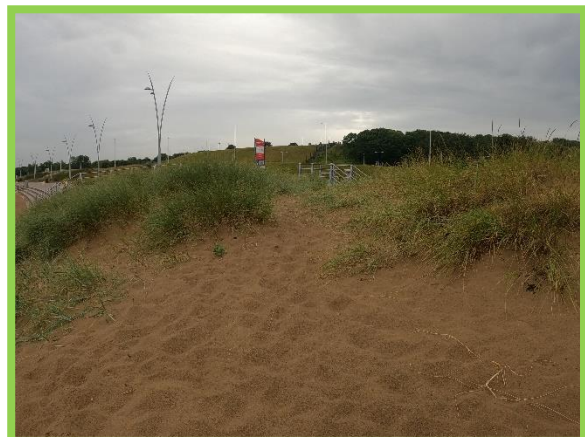
Local trampling of the dunes (/0102C01)

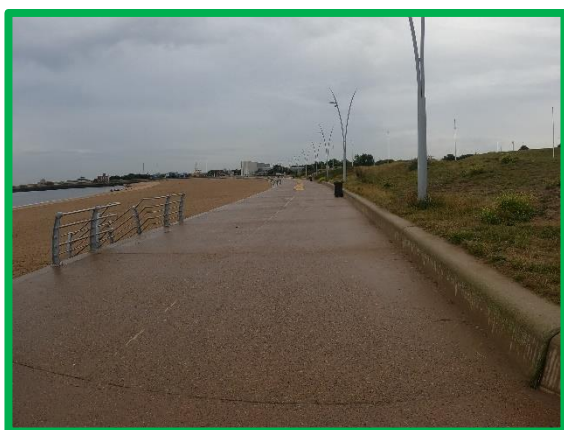
Littlehaven promenade and seawall in very good condition (/0102C02)

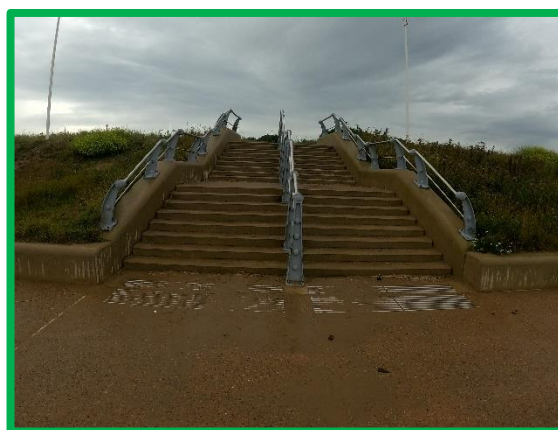
Littlehaven promenade and seawall in very good condition (/0102C02)

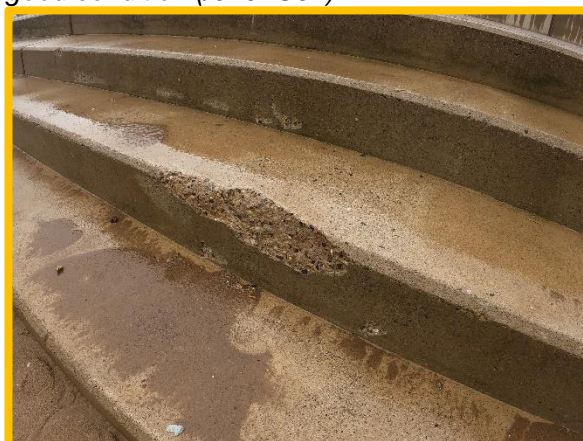
Damaged stepped edge and scrapes marks caused by maintenance activities (/0102C04)

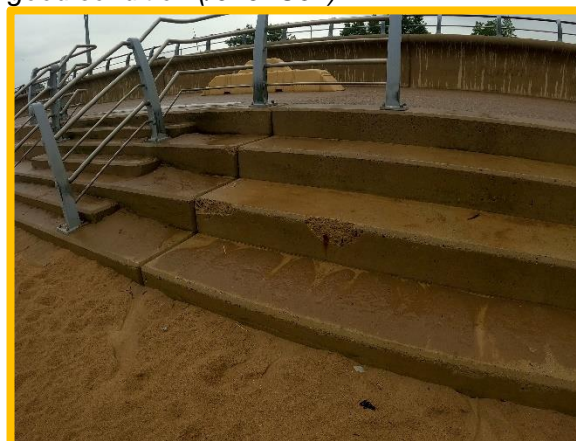
Damaged stepped edge exposing reinforcement (/0102C04)

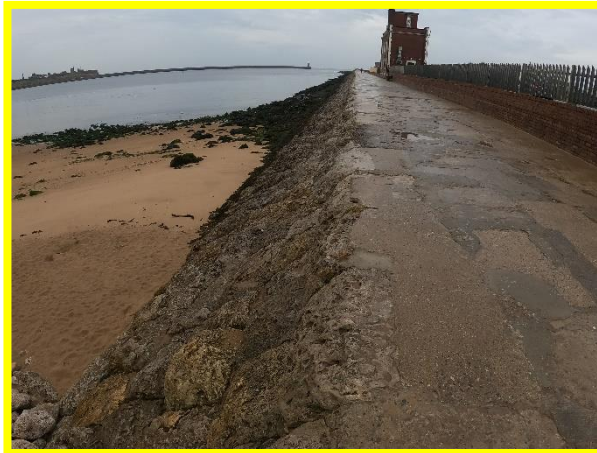
South Pier in overall fair condition along northern face, landward end (/0103C01)

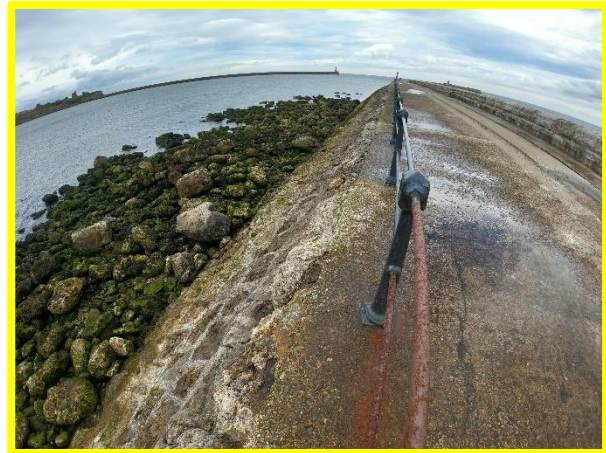
Heavily corroded section of handrail seaward of the access gate (/0103C01)

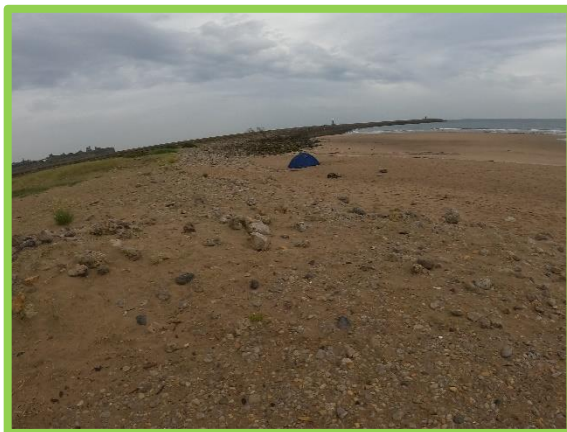
Cobble berm fronting dune system (/0201C01)

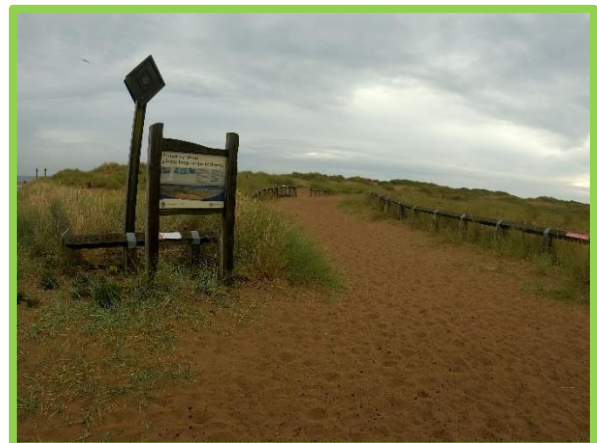
Dune system (/0201C01)

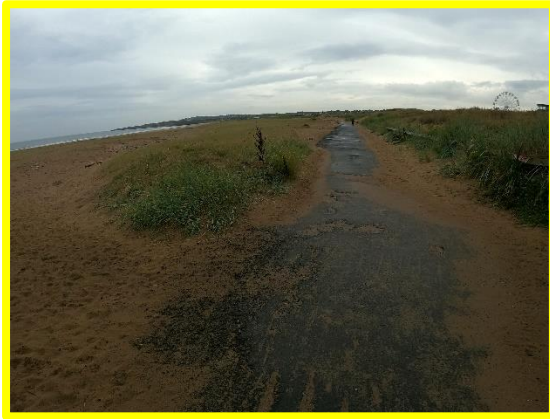
Southern section of the 'donkey track' showing surface deterioration (/0201C01)

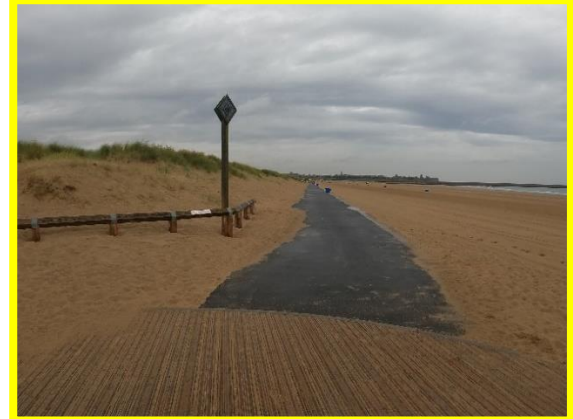
The 'donkey track' looking north towards South Pier (/0201C02)

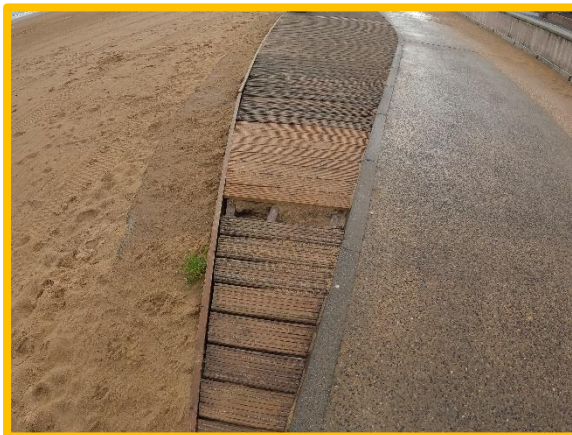
Damaged timber boardwalk near the Sand Dancer public house (/0201C03)

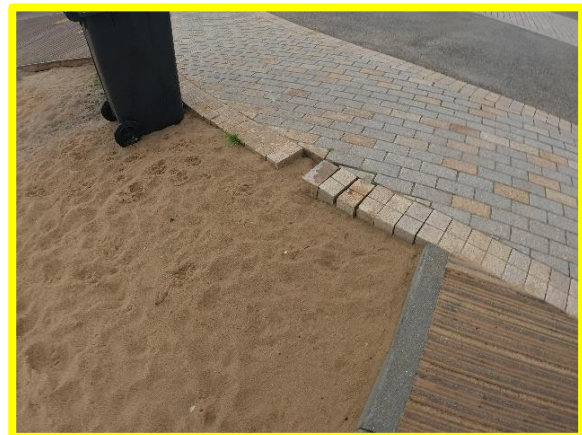
Disused lifeguard station platform next to reconstructed wall promontory (/0201C04)

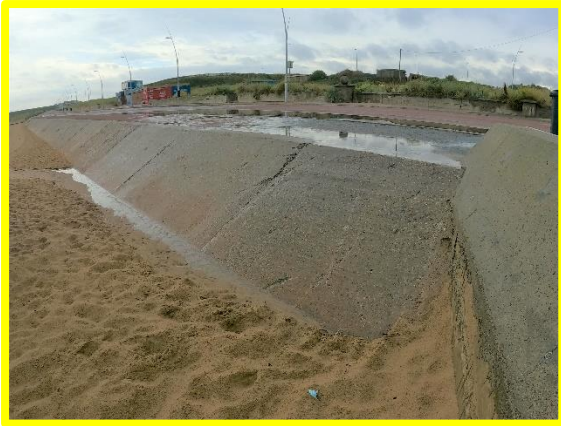
Healthy beach levels in vicinity of lifeguard station and surf school (/0201C05)

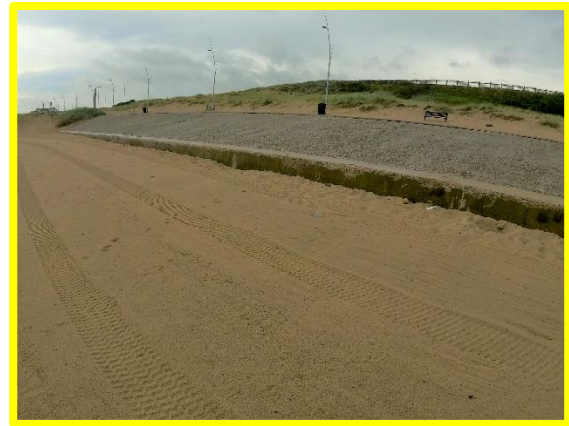
Cracking to render on wall at rear of promenade (/0202C06)

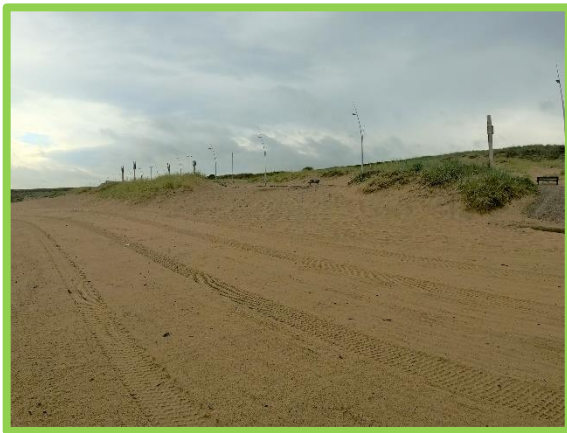
Stable but narrow dunes at south end of Herd Sands (/0202C01)

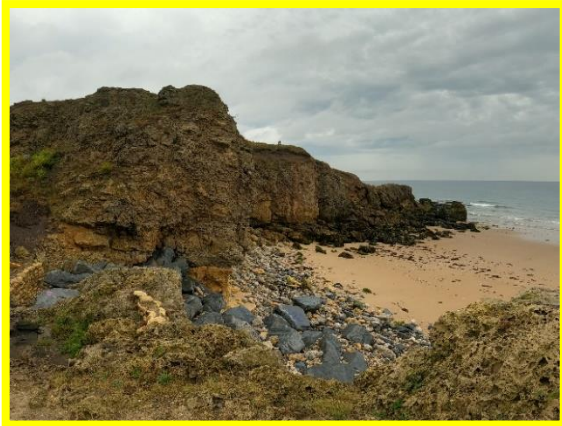
Southern aspect of Trow Point (/0302C01)

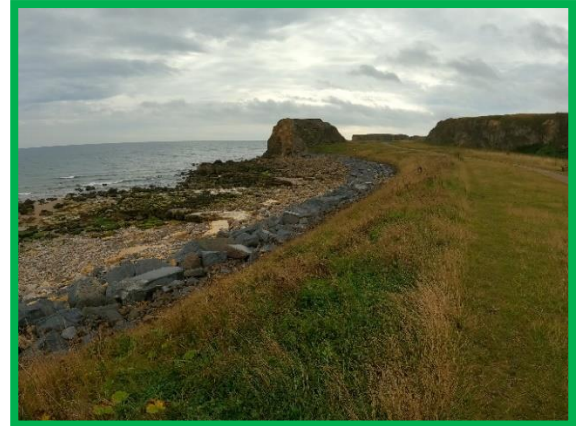
Rock revetment and re-graded slope at Graham's Sand (/0302C02)

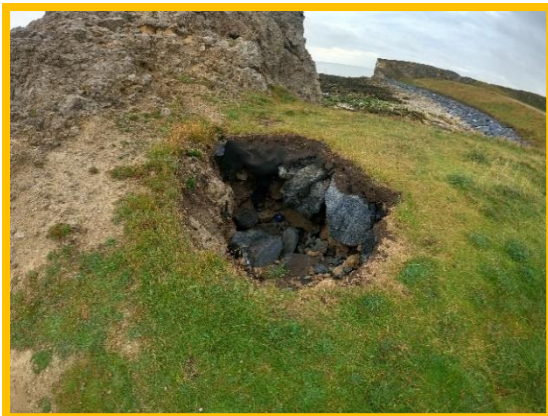
Reopened sinkhole landward of Target Rock (/0302C03)

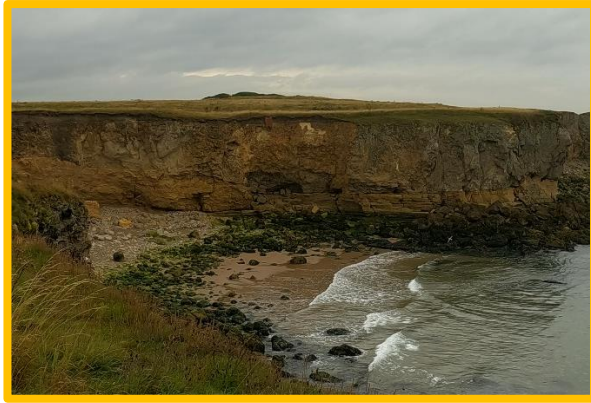
Undercutting at base of cliffs at Frenchman's Point (/0401C04)

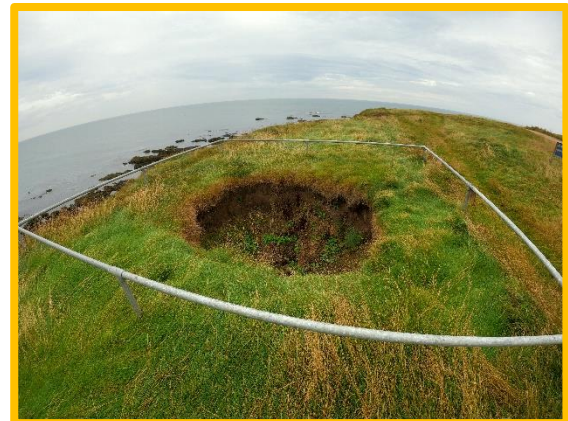
Sink hole just south of Man Haven Bay (/0401C04)

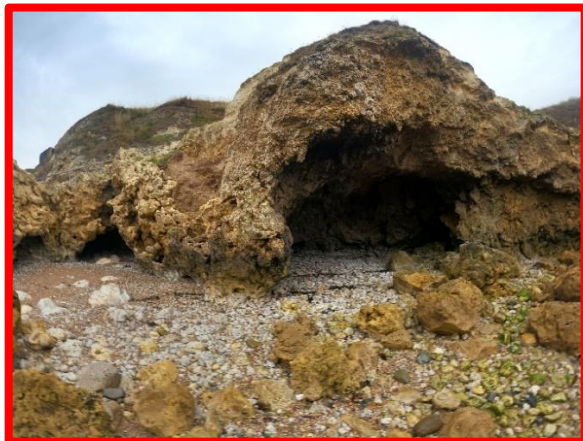
Two large caves undermining access point adjacent to Camel Island (/0401C04)

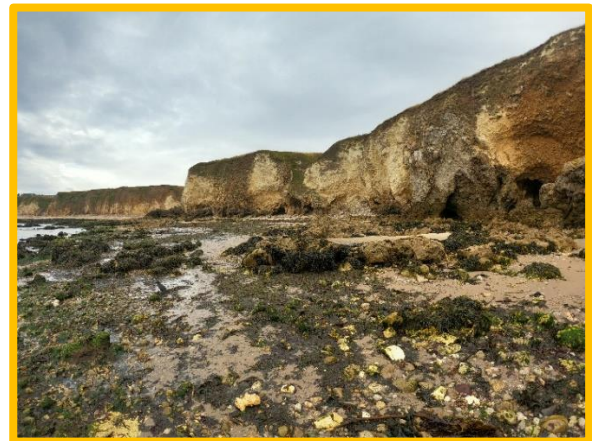
Rockfall at northern end of Marsden Bay (/0401C04)

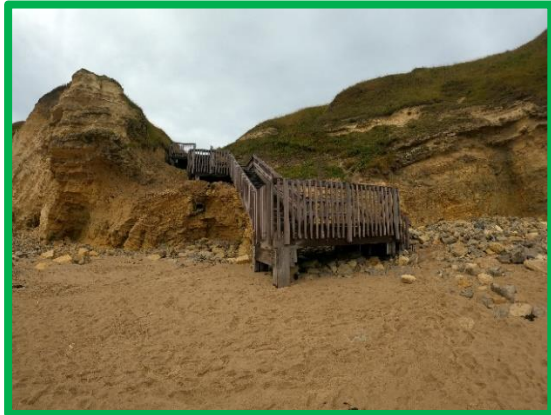
Disused lifeguard station and the Redwell Steps access (/0401C01)

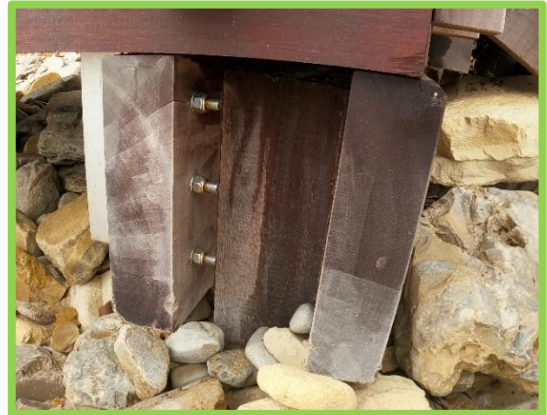
Minor damage to structural timbers (/0401C01)

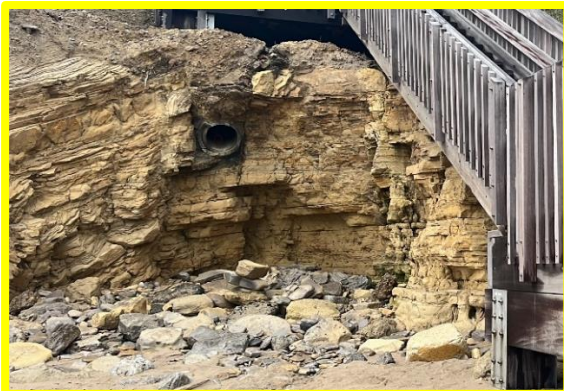
Retreating cliff line adjacent to landing two (/0401C01)

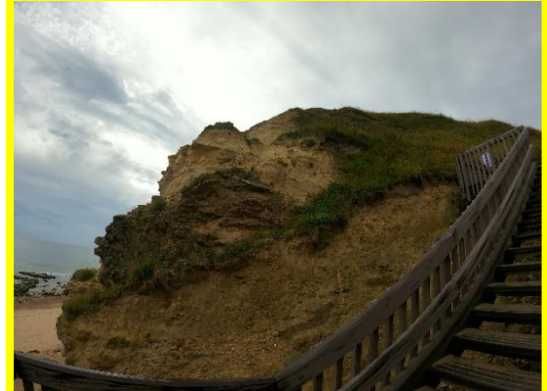
Cracking through the rock overhang adjacent to structure (/0401C01)

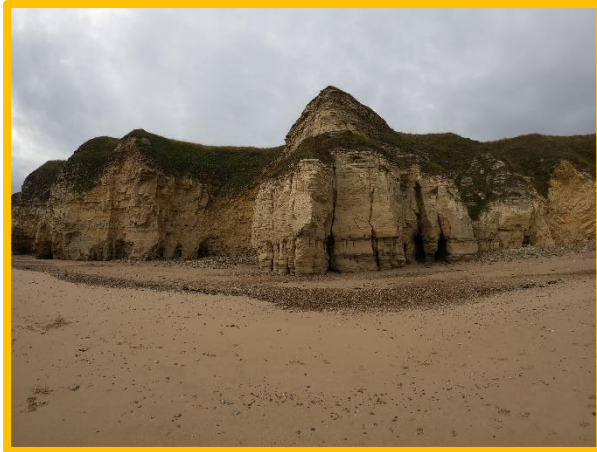
Caves and arches along toe of cliffs in Marsden Bay (/0401C03)

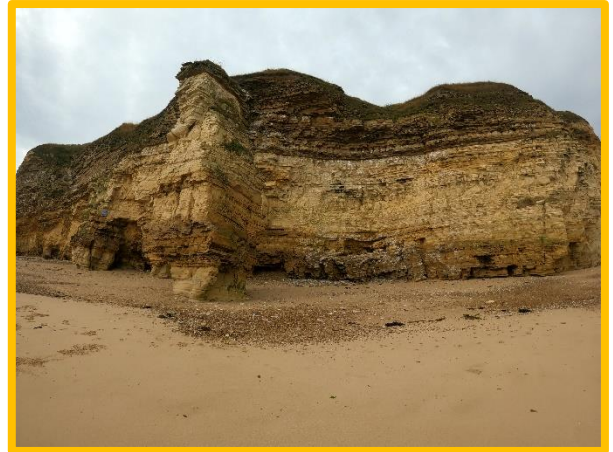
Caves and arches along toe of cliffs adjacent to Wife Lot (/0401C03)

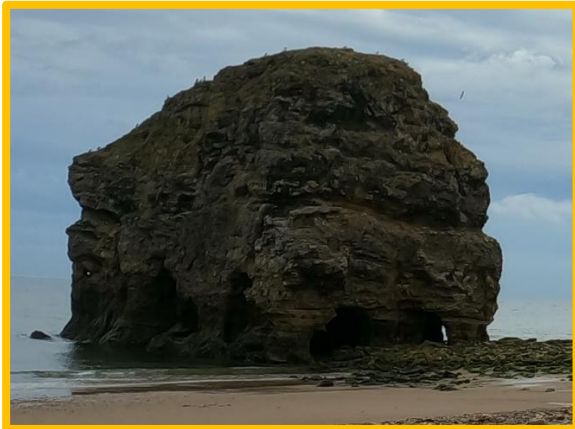
Caves and arches in Marsden Rock (/0401C03)

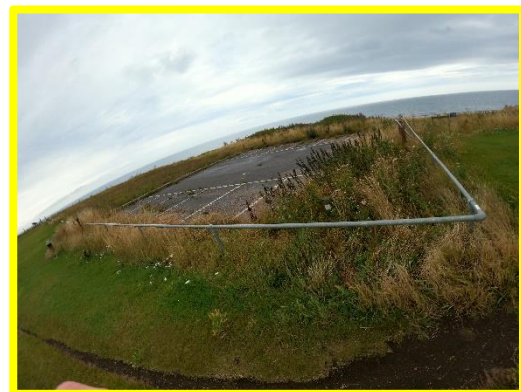
Closed car park due to large cliff failure (/0402C01)

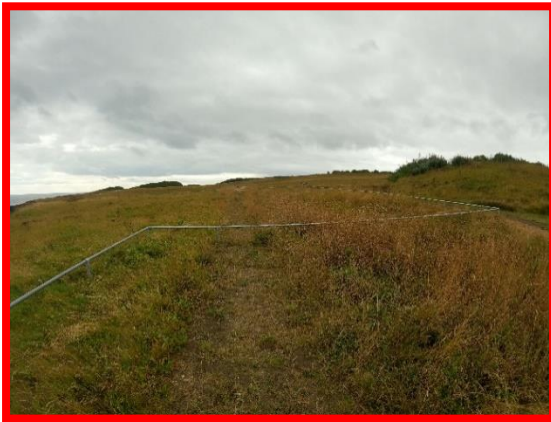
Fencing to divert the public around a new sink hole at Whitburn Coastal Park (/0501C01)

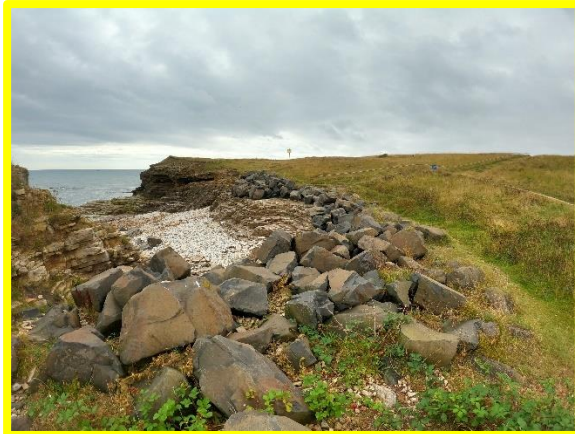
Southern section of rock armour on (/0501C01)

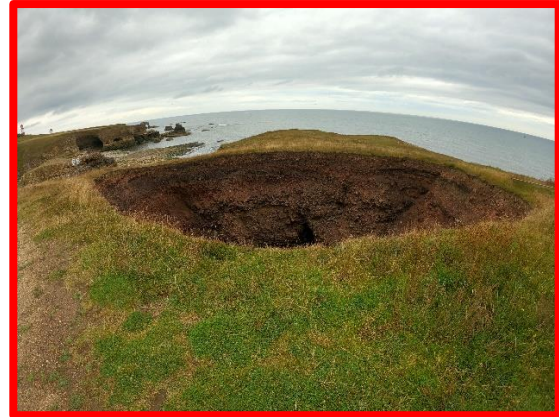
Enlarged sink hole at the former Old Harbour Quarry (/0501C01)

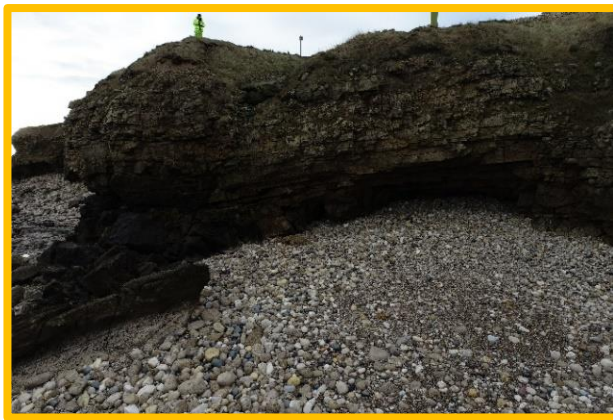
Large cave at Whitburn Nature Reserve (/0502C01)
