**NECAG Coast Protection Assets
and Coastal Slope Condition Analysis**

**Sunderland City Council
Final Report**

April 2009

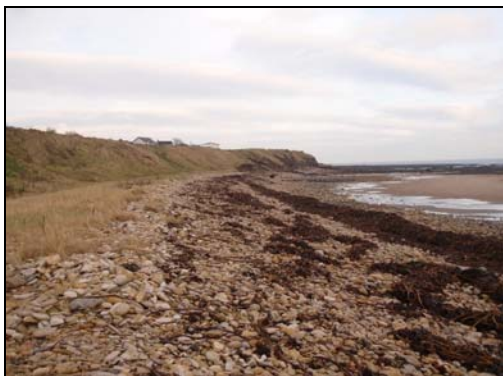
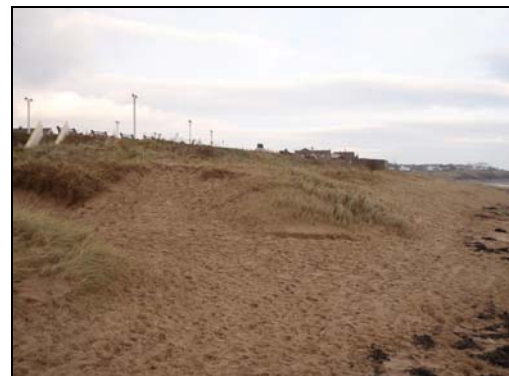
The frontage is undefended landward of the Whitburn Steel outcrop. Here shingle has accreted on the upper beach (pictured, below left). The steep coastal slopes to the north gradually reduce in level to the south, where a grassed embankment fronted by vegetated sand and shingle dunes is present (pictured, below right).

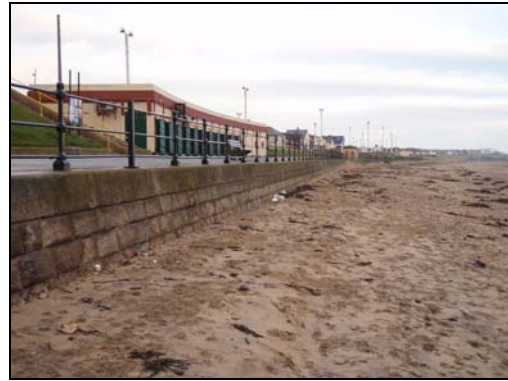
From South Bents to Seaburn the sea defence consists of a concrete seawall and a masonry seawall with a concrete crest fronting the promenade (pictured, right). The promenade is backed by concrete and masonry walls and a grass embankment leading up to the main coastal road. The concrete wall is in fair condition with several longitudinal cracks and vertical cracks which extend for the full height of the wall. The larger cracks have vegetation growth which should be removed before infilling the cracks.

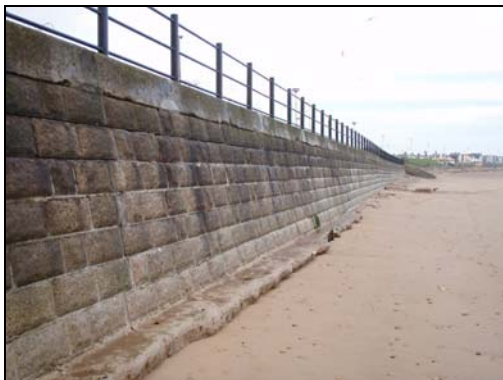
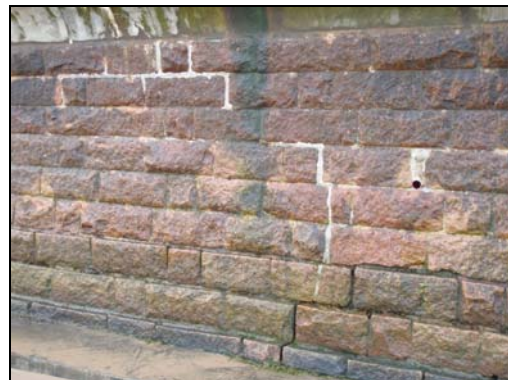
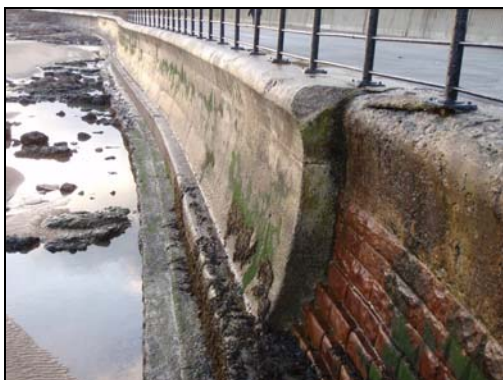
The beach level reduces to the south. The sea wall requires minor repointing, specifically at the joint between the masonry and the concrete crest which appeared to have widened slightly along a significant length of the wall. There was evidence of repairs to several large settlement cracks although these cracks appeared to have extended beyond the previous repairs and were in need of further remedial work. Timber piles and a concrete apron were exposed at the toe where the beach level was lower towards the southern end of the wall (pictured, below left). Water storage at the toe of the wall prevented detailed inspection of the toe along the southern section of the wall. The seawall past Seaburn includes a concrete crest wall in which previous cracks had been infilled.

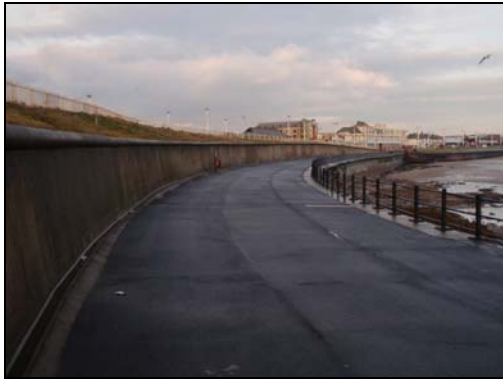
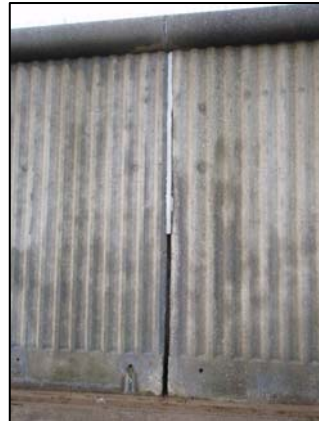
Most of the construction joints in the concrete splash wall to the rear of the promenade are missing sealant (pictured, below). This should be replaced to prevent water egress into the structure. The concrete units are in good condition with only minor cracking evident at the crest and slight surface deterioration around drainage outlets.

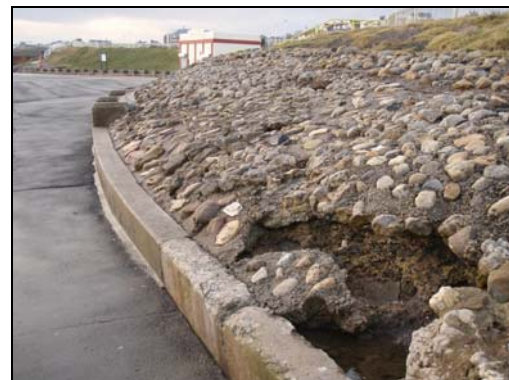
There is some local damage to the grouted stone revetment to the rear of the promenade (pictured, right). Voids are opening up, with water collecting inside the revetment. These voids should be infilled to prevent the voids widening and erosion of the fill material, which could compromise the stability of the revetment and embankment above. The low concrete wall in front of the revetment is cracked with evidence of significant spalling. These sections of wall should be replaced/repared.

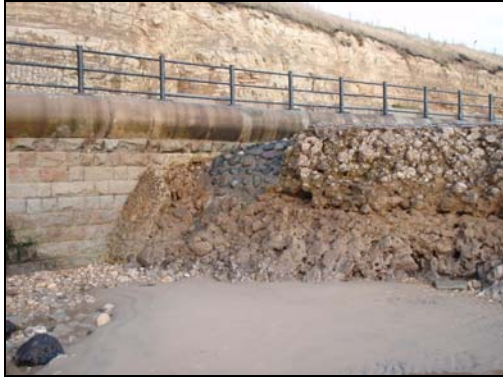
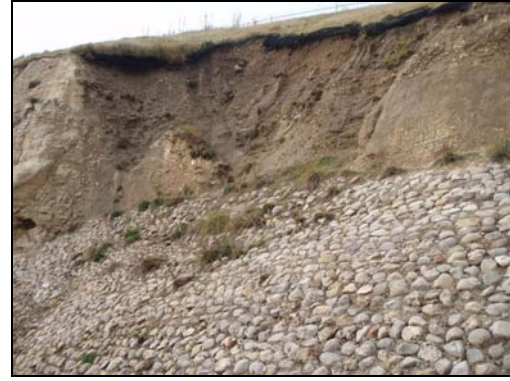
The masonry wall is built over the rock outcrop at Parson's Rock (pictured, below left). The wall ties in with the rock and there have been several repairs made with grouted rubble to fill voids which had opened up between the wall and the rock. To the rear of the promenade is a concrete wall incorporating benches which was cracked and rust-stained. Above this wall are cliffs. Local erosion and minor slope failure had taken place exposing geotextile material below the topsoil/vegetation at the crest. In places the cliffs are fronted by a grouted stone revetment at the toe which was in good condition (pictured, below right).

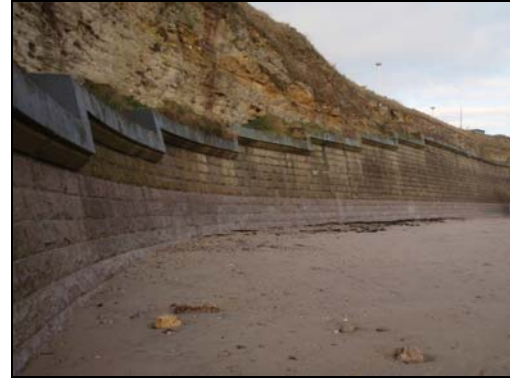
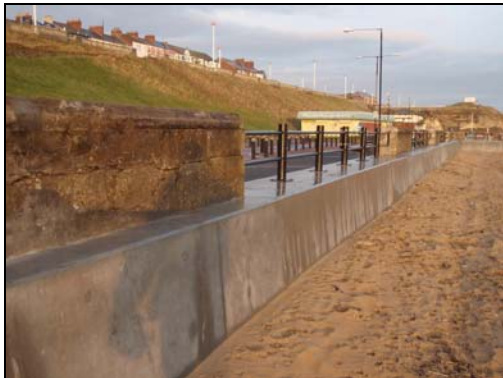
South of Parson's Rocks the defence is a masonry seawall with a concrete block crest (pictured, right). The crest level of the structure varies. The masonry is generally in good condition although several blocks are cracked and in need of repair. Repointing should be carried out to replace missing mortar which is particularly evident in the lower, intertidal section of the wall.

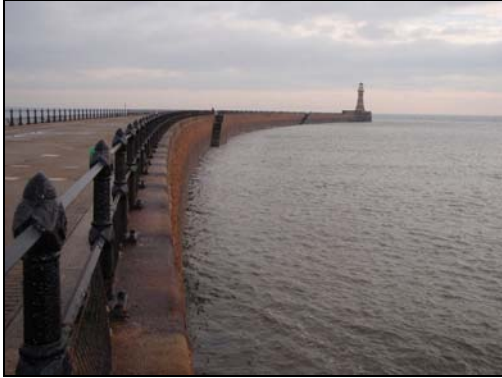
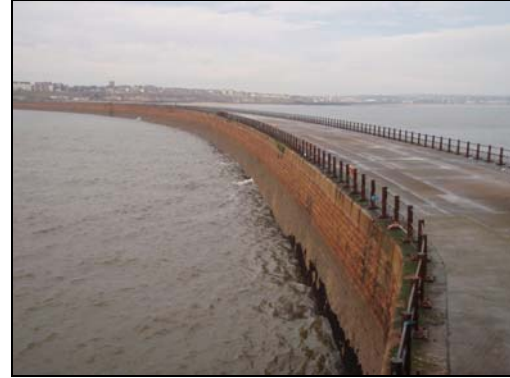
The pier is constructed from masonry and concrete and appeared in good condition above the waterline (pictured, below). More recent repointing works were evident and appeared to be working well.

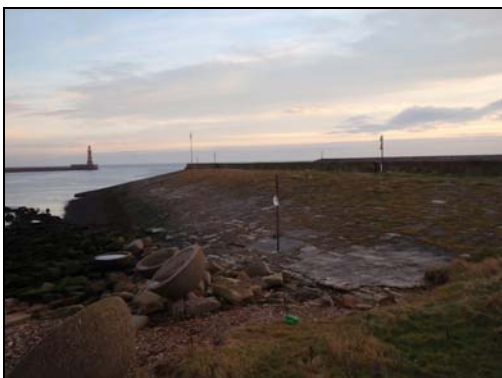
The northern face of the structure is formed by a grouted stone revetment (pictured, left). Several masonry blocks were missing, with concrete patch repairs to the surface which were showing signs of erosion.

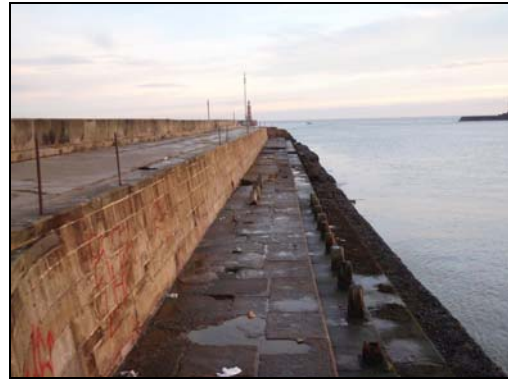
The southern face of the structure is constructed from masonry, with timber piles also visible (pictured, right). The masonry at the landward end appeared to be in fair condition with the need for some repointing and replacement of missing blocks.

A concrete crest wall runs along the centre of the structure and appeared in good condition. A detailed survey of the pier is recommended to determine the full extent of the structural problems and to establish an appropriate level of remedial work or possible replacement.

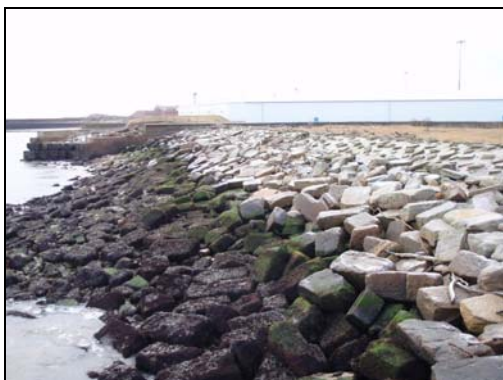
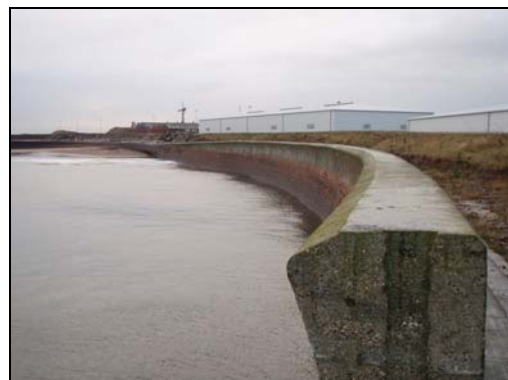
The most northern defence is a grouted stone revetment fronted by a rock armour toe which is in good condition (pictured, below left). The revetment ties in to a masonry seawall with a concrete crest wall (pictured, below right). The wall is also in good condition, with minor cracking and spalling of the surface.

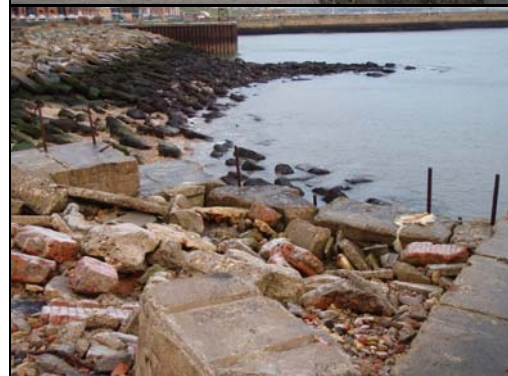
The tie-in between the two defences is in poor condition as there is no crest wall (pictured, right). Here the infill behind the wall is exposed and appears to be becoming washed out from the structure. Loss of fill material may leave the structure more vulnerable as water from overtopping waves will penetrate the rear of the seawall.

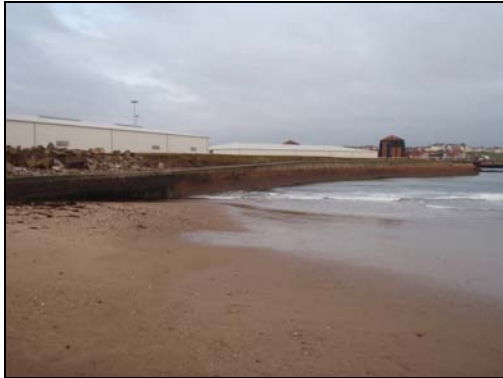
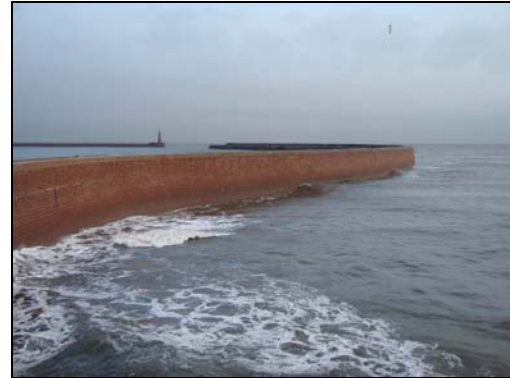
There was an area of sand and shingle foreshore between the seawall and the New South Pier (pictured, below left). The New South Pier (pictured, below right) appeared to be in good condition with minor mortar loss between masonry blocks and minor cracking to concrete elements. The pier provides important shelter to the harbour entrance and therefore should be regularly monitored and maintained.

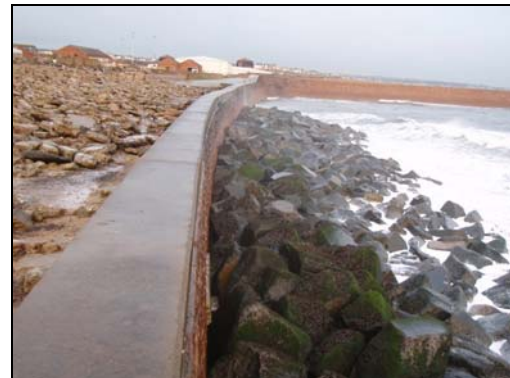
The masonry wall with concrete crest of the pier continues to the south with the crest level falling to create a seawall (pictured, right). The seawall is fronted by rock armour. The 1998 inspection reported the wall to be undermined and in poor condition. Works have been carried out to repair/replace sections of the wall in the interim although it was not possible to inspect the toe due to the presence of the rock armour and the high water level. However, the visible section of the wall showed no evidence of any undermining of the toe. The rock armour appeared in good condition, with appropriate voids between armour units and no significant movement or loss of material.

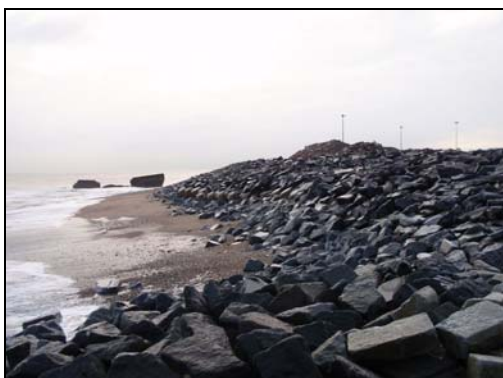
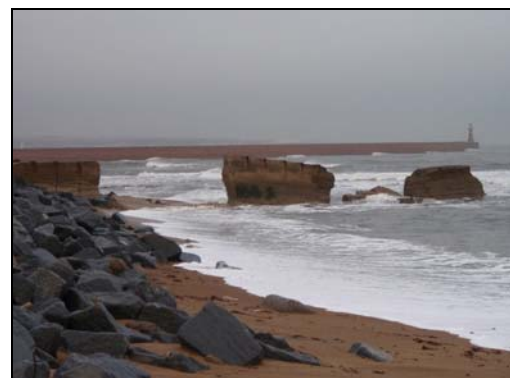
South of this length of seawall, the sea defence consists of a rock revetment (pictured, below left). The rock revetment was in fair condition, with some displacement of material and a slumping of the crest. Halfway along the revetment is a former concrete groyne which has now collapsed (pictured, below right). The remains of the structure will have a negligible effect on wave energy or sediment transport and may act to increase scour at the toe of the rock revetment. The structure will provide limited protection to the frontage.

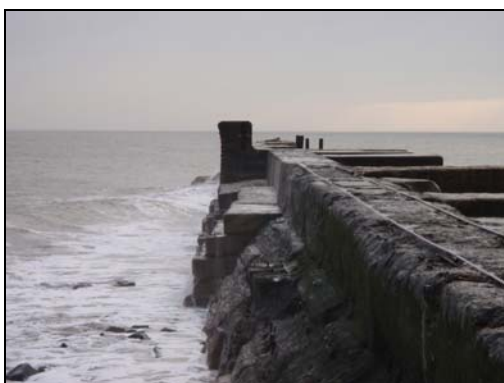
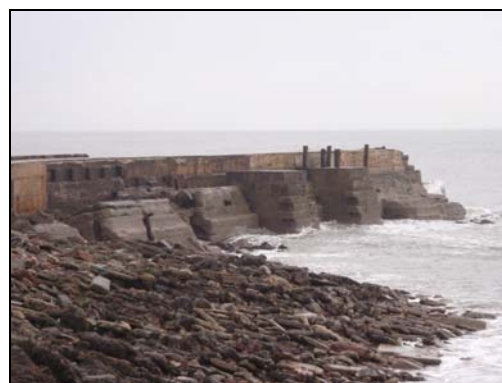
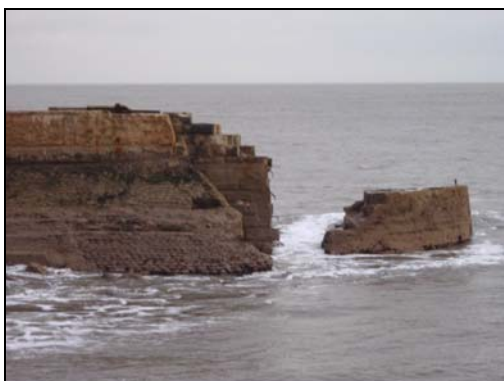
The South Outlet is formed between the North East Pier and the South West Breakwater and the bay is defended on all sides by rubble revetments. The rear of the bay is defended by sheet piles with rubble backfill. The North East Pier (pictured, below) was in poor to very poor condition. The structure was deemed unsafe to access due to the poor condition and the high water level.

Significant erosion had taken place to the seaward face of the structure, with displacement of large concrete blocks and steel piles exposed and badly rusted. Although the toe was not visible due to the water level, the visible section of the wall was displaced in a manner which suggested undercutting of the toe of the pier was occurring.

The landward face of the structure was in marginally better condition, although loss of material and displacement of concrete blocks was evident. The roundhead of the pier had failed (pictured, left) and the seaward end of the structure was vulnerable to wave attack. There had been significant loss of material from the seaward end of the structure.

The South West Breakwater requires extensive remedial work and the North East Pier requires major refurbishment or possible replacement, although the importance of maintaining the South Outlet may not be significant enough to justify the capital expenditure. The structures do, however, provide important coastal defence to the area of old dock land forming a barrier between the sea and the Hudson Dock.

A detailed survey of the structures should be conducted in order to establish the condition and performance of the structures which will aid the development of a strategy for the coastal defences around the South Outlet. The strategy would need to be integrated with the development plans of the port.

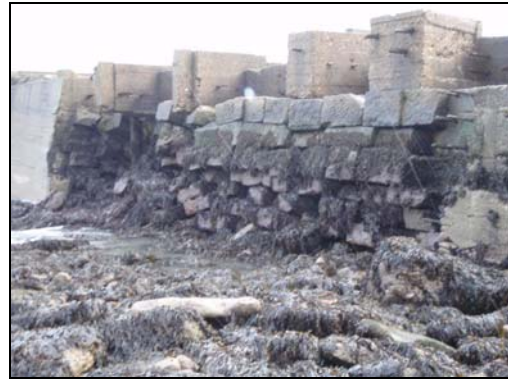
The South West Breakwater is generally in fair condition although there was an area of significant damage on the northern face around an area of displaced concrete blocks (pictured, right). There was evidence of undercutting and excavation of material below the blocks. The roundhead appeared to be in good condition although the concrete deck was almost completely absent. The southern face was in good condition although the upper section was badly eroded with exposed reinforcement.

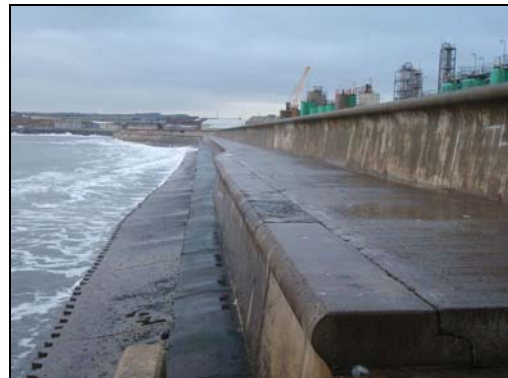
Two concrete seawalls with concrete aprons and sheet piles along the toe form the sea defences running down the outer South West Breakwater (pictured, right). The structure is in good condition with minor surface deterioration including rust-staining and small cracks. There is a large longitudinal crack running across the full width of a concrete slab on the lower apron. This should be infilled to prevent the loss of a section of the slab.

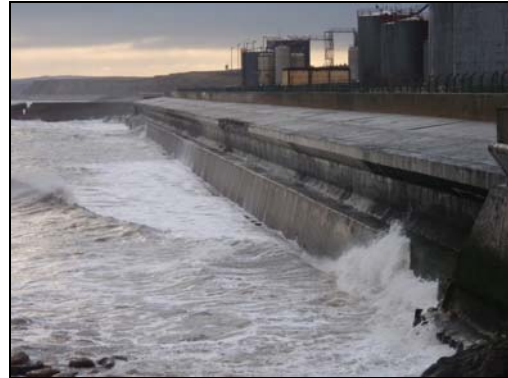
A large precast concrete crest unit is missing from the Hendon Banks Barrier seawall (pictured, right), in front of the sewage works and should be replaced or the gap infilled to prevent loss of further units and damage to the material behind.

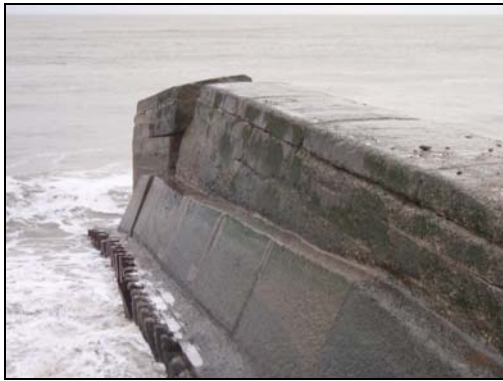
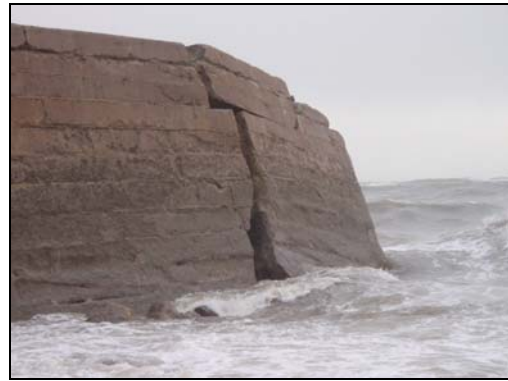
The breakwater marking the southern extent of the Port of Sunderland frontage has failed at the seaward end (pictured, below). A detailed survey of the breakwater is necessary to establish an appropriate course of action. It is likely that the seaward end of the structure is beyond repair so it may be necessary to remove the damaged section and make good the remaining structure.

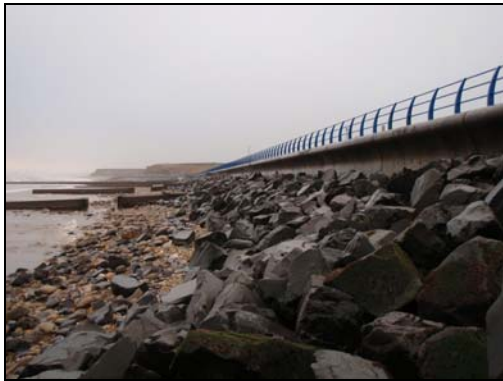
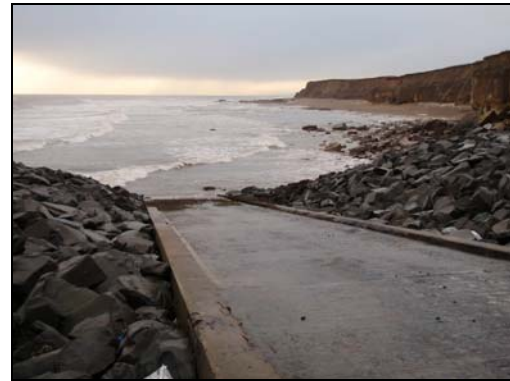
South of the port boundary the coastal defence consists of rock armour backed by a concrete seawall (pictured, below left). There is an access ramp to the foreshore at the southern extent of the defence which passes through the rock armour revetment (pictured, below right).

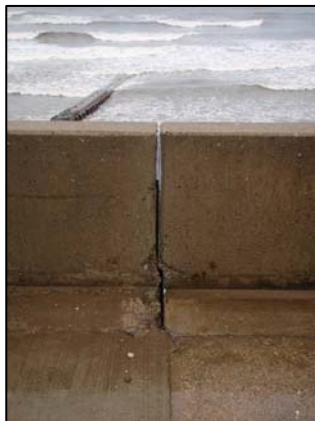
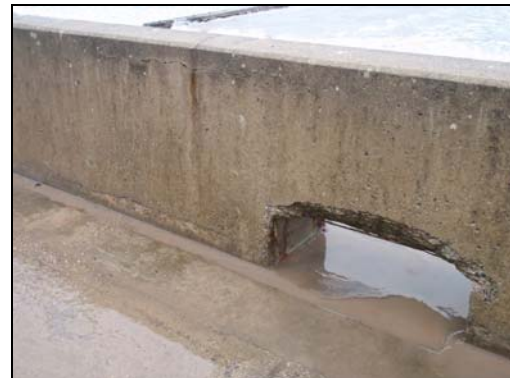
Towards the south there is a concrete crest wall which is in fair condition. Construction joints were missing sealant and scour damage around the drainage holes had exposed reinforcement (pictured, below).

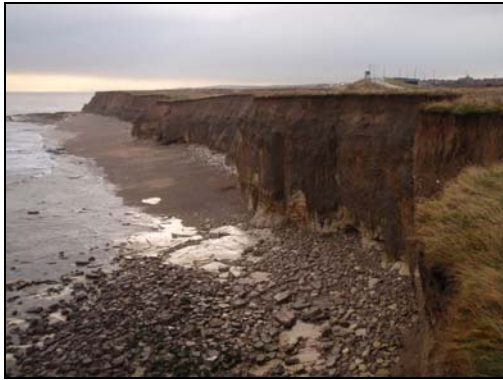
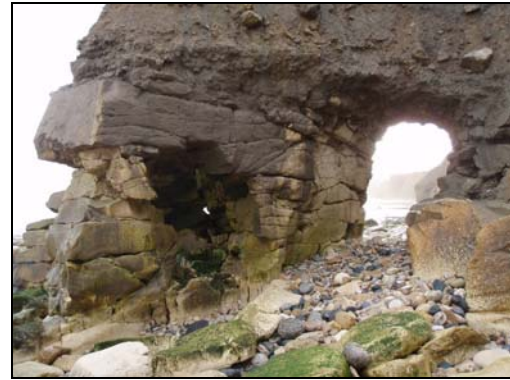
South of the Hendon Sewall, the frontage is characterised by natural cliff exposures of Magnesian Limestone overlain with glacial till (picture, below left). The level of the boundary between the relatively harder limestones and the till varies quite considerably resulting in different depths and exposure conditions to the till. The frontage is punctuated by two principal headlands, at Salterfen and Pincushion, but also by more local hard points, as different strengths in the limestone are exposed. The cliff line between Hendon and Salterfen was eroding, with little vegetation. To the south, between Salterfen and Pincushion, there was a greater punctuation of the coast with narrow sections of harder material and outcrops such as Maiden's Flat and Jane Jiverson's Rock locally resisting erosion. The variation and scale of these local hard points was evidenced by the small arches and stacks; particularly around Pincushion (pictured, below right).

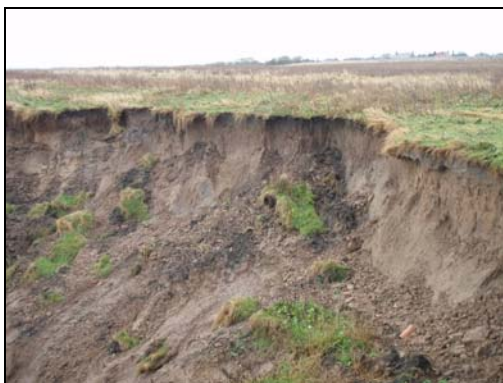
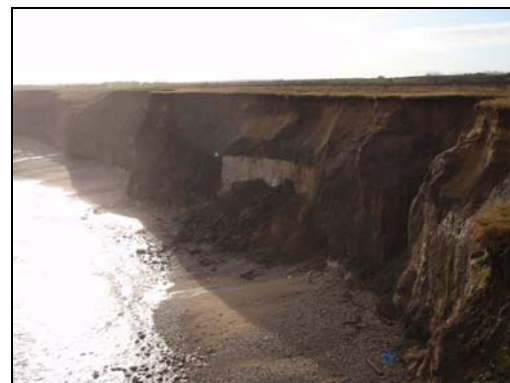
Evidence of recent minor slope failure towards the crest was visible along most of the frontage, most notably at Halliwell Banks (pictured, below left). Evidence of a more significant slope failure was present between the Pincushion and Ryhope Dene (pictured, below right).

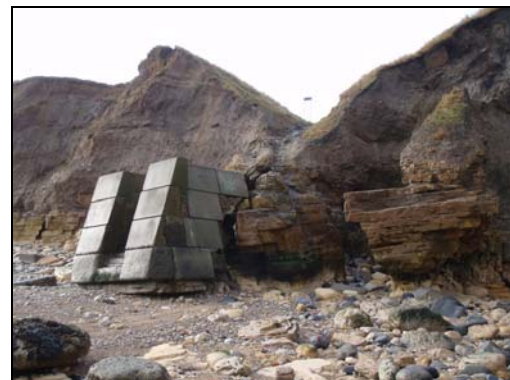
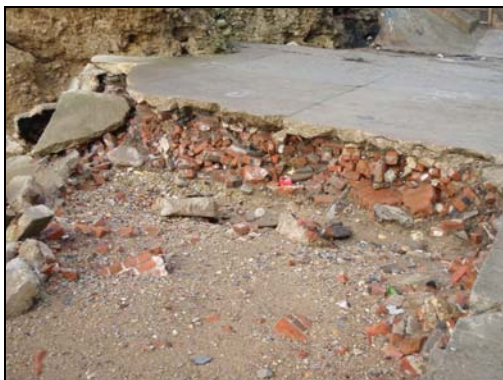
There are two failed structures within the undefended length of frontage. A set of concrete steps providing access to the foreshore from Salterfen Lane, south east of Grangeown has been outflanked and cut off from the cliff behind (pictured, right). The steps have been displaced and now appear to be acting to exacerbate scour to the natural cliffs to either side. Signs at the top of the access inform members of the public that the structure is not to be used.

The second failed structure is at the landward end of an outfall to the east of Ryhope Beach Road (pictured, left). Concrete slabs have failed and washed away to expose rubble infill material. The masonry and concrete walls have been outflanked and infill material was being washed out from the structure. Cabinet approval has been obtained to remove the two failed structures in order to close the access at Salterfen and construct a new access at Ryhope Beach Road.
