**Cell 1 Regional Coastal Monitoring Programme
Walk-over Visual Inspections of Assets**

**Sunderland City Council
Final Report**

May 2013

Walk-over Visual Inspections of Assets

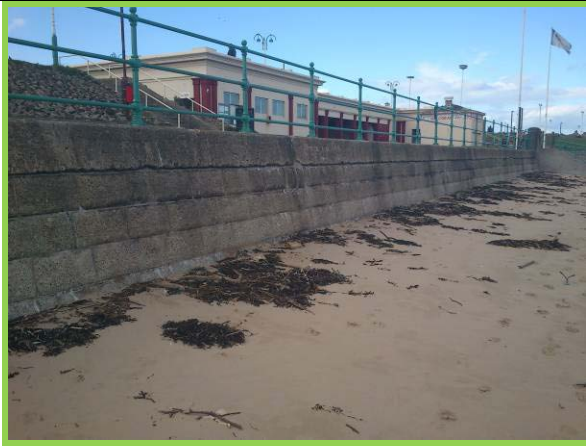
North end of seawall adjacent to Dykelands Road
(Asset ref. No. 121AB901B0603C02)

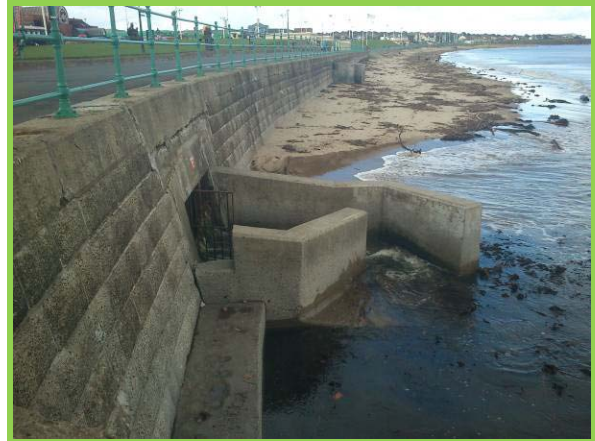
Outfall structures with cracks adjacent to wall.
(Asset ref. No. 121AB901B0603C02)

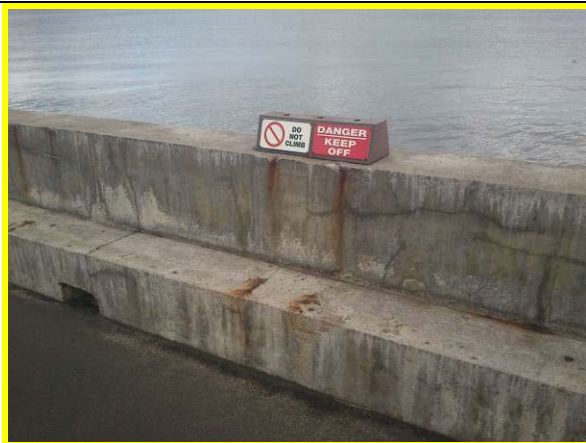
Crest wall with rust staining at fixings from previous seats and cracks
(Asset ref. No. 121AB901B0603C03)

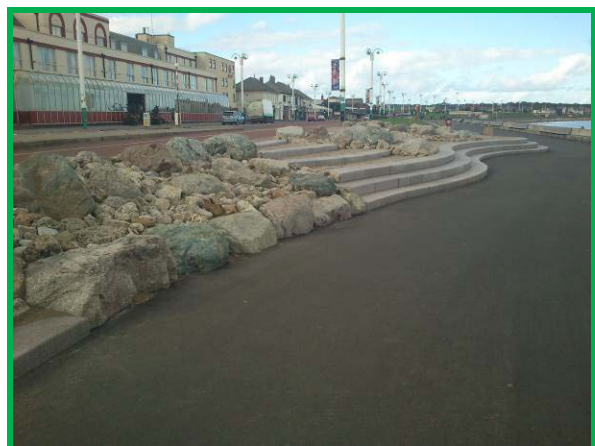
New promenade surfacing and rear revetment structures
(Asset ref. No. 121AB901B0603C03)

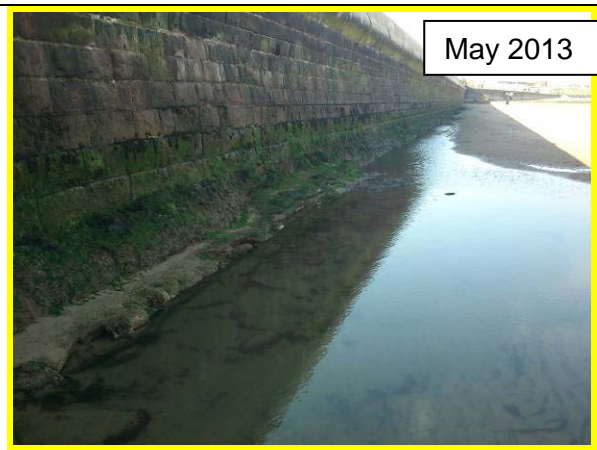
- **Seaburn** – Low beach levels in May 2013 were exposing the toe of the wall at the south end of the beach (Asset ref. no. 121AB901B0603C03), which is locally undercut. Cracks between the seawall and concrete outfall structures noted in 2010 still need attention.

Low beach level in May 2013 exposing seawall toe which is undercut in places and previous concrete bagwork repairs
(Asset ref. No. 121AB901B0603C03)

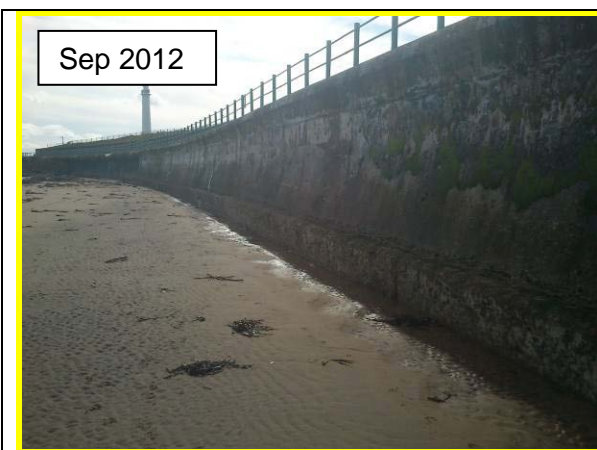
Sep 2012

Seawall adjacent to Seaburn Park, showing chloride staining on surface of concrete encasement (Asset ref. No. 121AB901B0604C01)

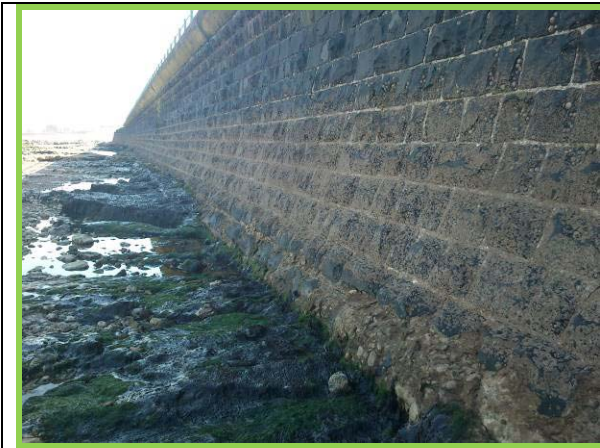
Masonry wall at Parsons Rocks
(Asset ref. No. 121AB901B0604C02)

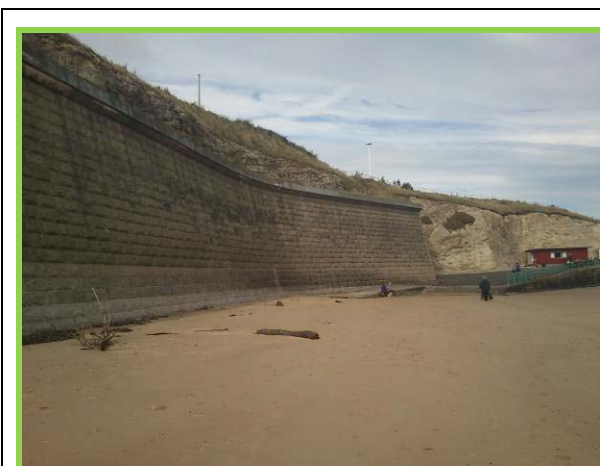
High masonry wall in good overall condition
(Asset ref. No. 121AB901B0605C01)

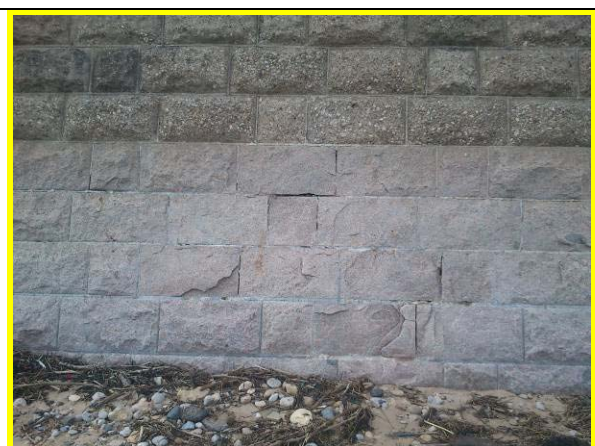
Localised abrasion / impact damage at toe of
high masonry wall
(Asset ref. No. 121AB901B0605C01)

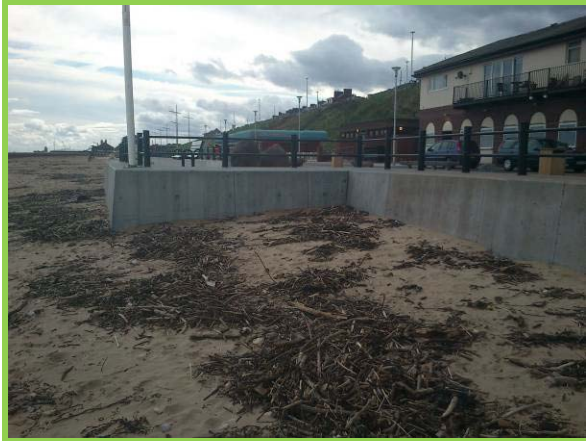
Low concrete encased wall at Marine Walk in good overall condition
(Asset ref. No. 121AB901B0605C02)

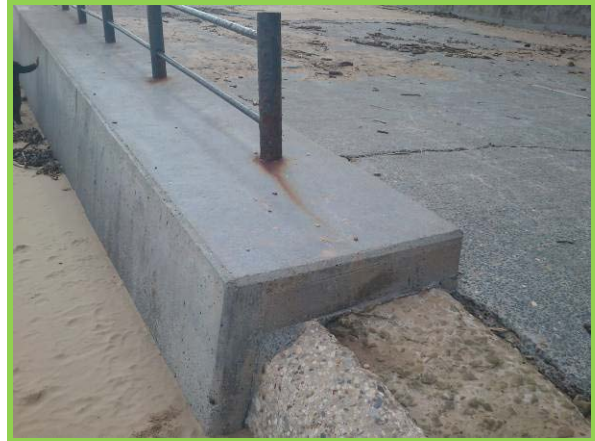
Corroded handrails adjacent to ramp at north which has cracks as reported in 2010.
(Asset ref. No. 121AB901B0605C02)

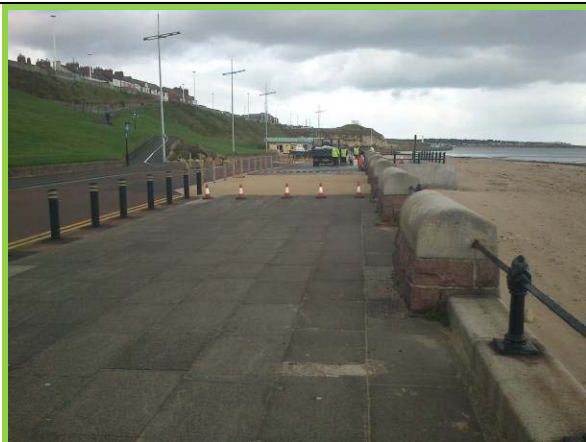
Resurfacing of section of promenade underway
(Asset ref. No. 121AB901B0605C02)

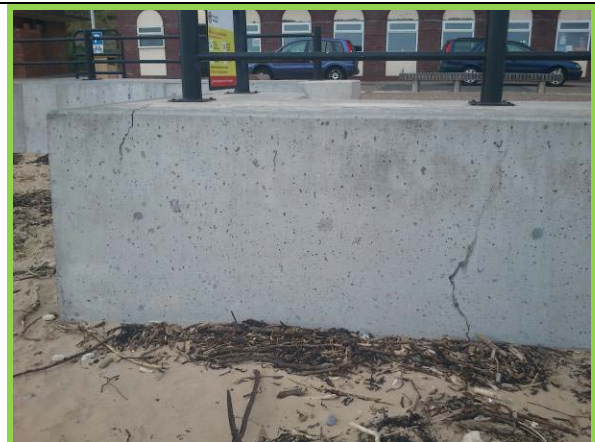
Minor vertical cracking in low concrete wall.
(Asset ref. No. 121AB901B0605C02)

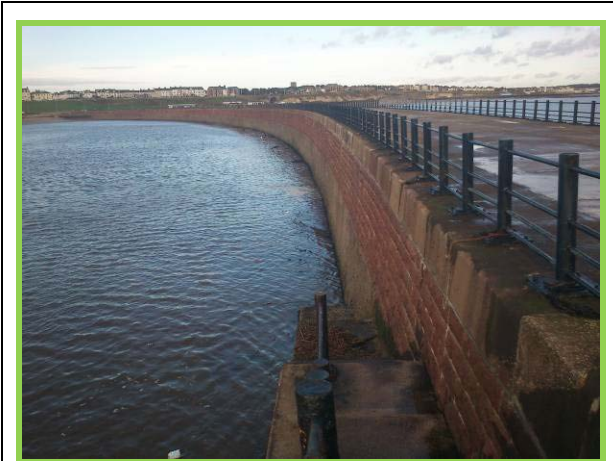
Inside face of Roker Pier appears in good condition (Asset ref. No. 121AB901B0702C04)

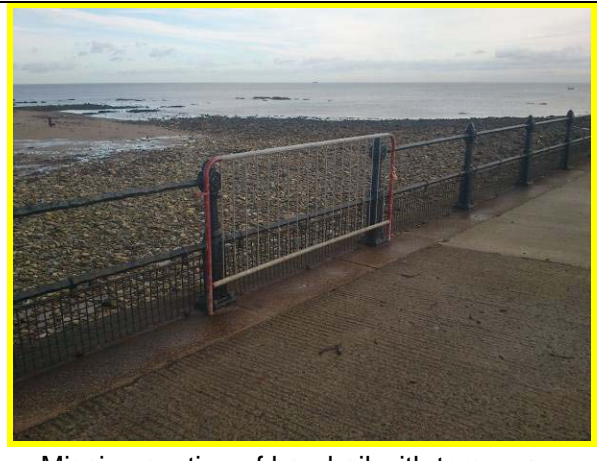
Missing section of handrail with temporary fence in place on north side of Roker Pier (Asset ref. No. 121AB901B0702C04)

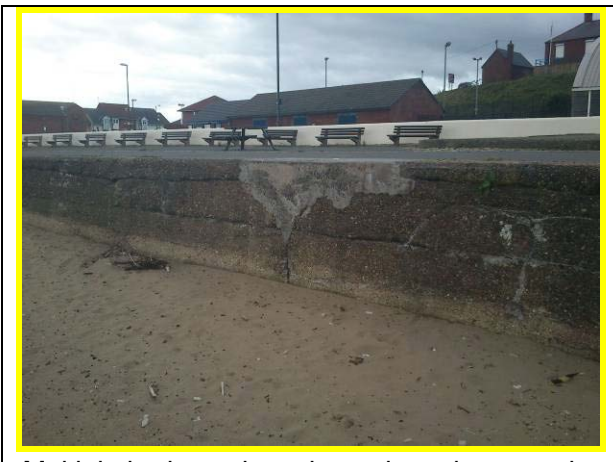
Multiple horizontal cracks and previous repairs in concrete wall (Asset ref. No. 121AB901B0702C01)

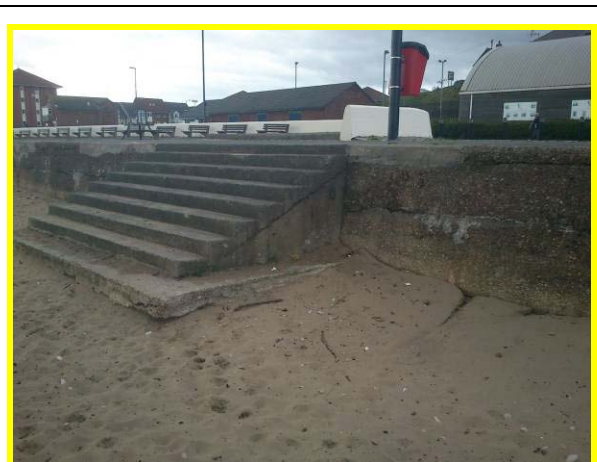
Undercutting at steps to Roker beach (Asset ref. No. 121AB901B0702C01)

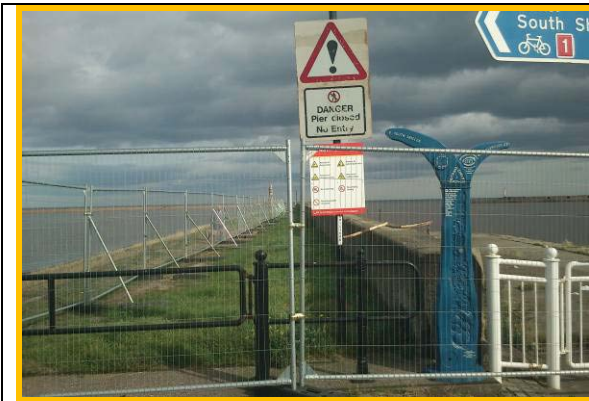
Old North Pier closed to public due to unsafe condition. (Asset ref. No. 121AB901B0702C03)

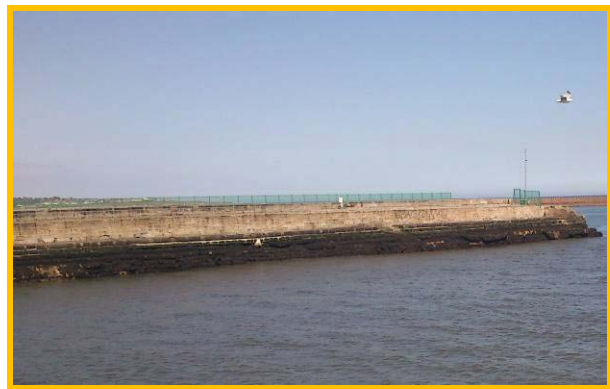
Voids in apron and undercutting of Old North Pier (Asset ref. No. 121AB901B0702C03)

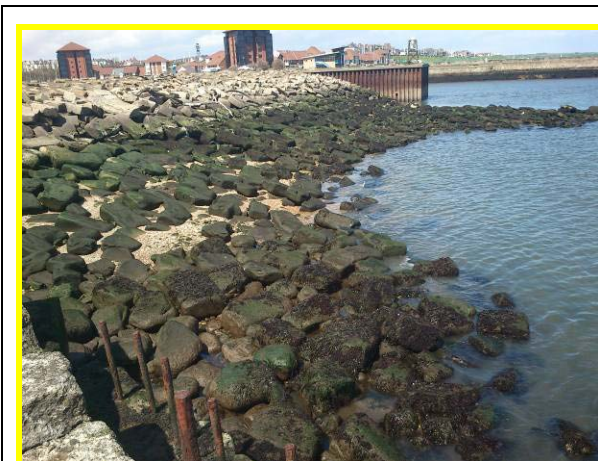
Rock revetment with loosely placed armour. (Asset ref. No. 121AB901B0703C03)

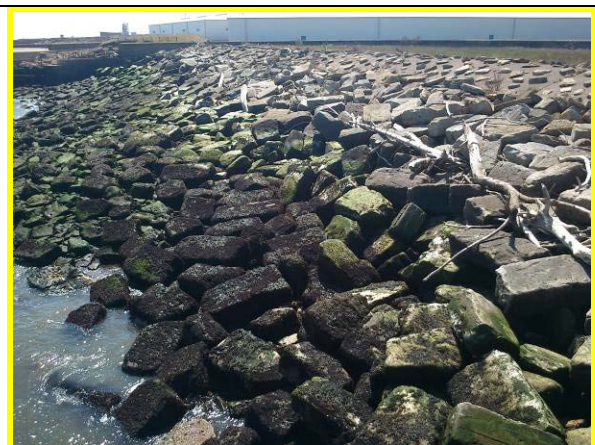
View of revetment from north, showing grouted concrete crest and secondary wall set back to rear. (Asset ref. No. 121AB901B0703C03)

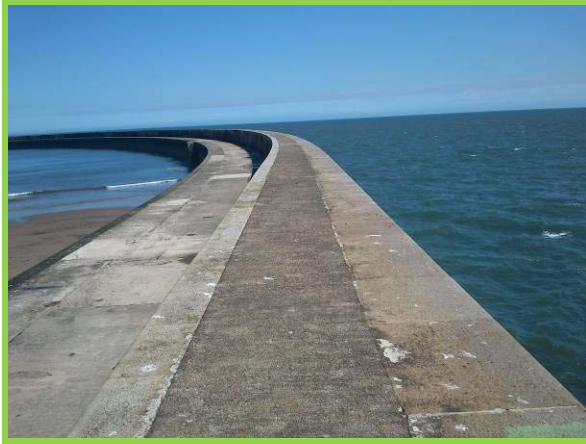
New South Pier in good overall condition. Deck slabs repaired since 2010
(Asset ref. No. 121AB901B0703C01)

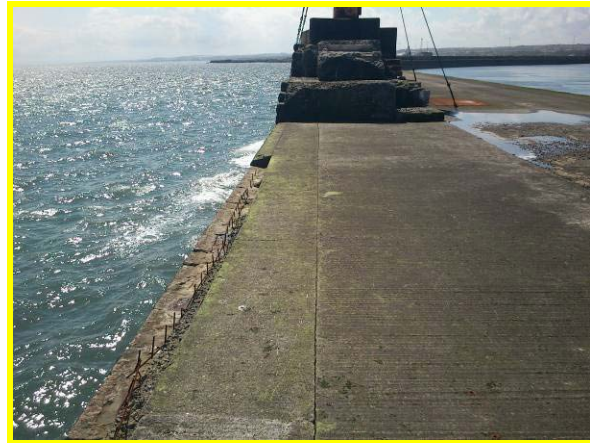
Repairs that were underway in 2010 to the pier deck with insitu concrete slabs have been completed. There was noted to be minor damage to the edge of one of the slabs about midway along the pier. Some coping sections had been lost over the winter and were in the process of being repaired, see below right. There were also some fairly recently replaced / reset coping stones on the inner face of the upper crest wall.

Missing section of coping near seaward end
(Asset ref. No. 121AB901B0703C01)

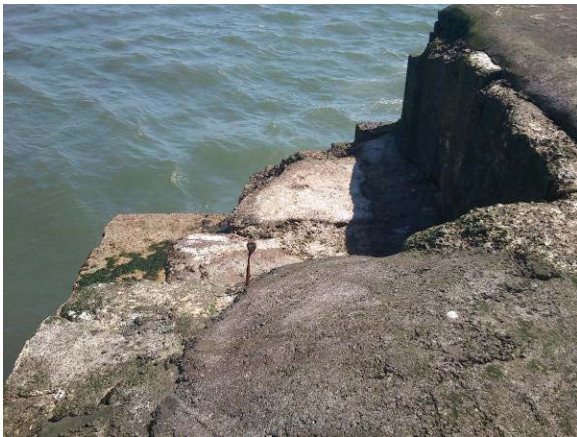
There are a number of large blocks missing at the seaward end of the pier, although photos from previous reports shows that this is not new damage. It is however advised that the end of the pier is made good in order to prevent the area of damage spreading.

Missing section at head of New South Pier
(Asset ref. No. 121AB901B0703C01)

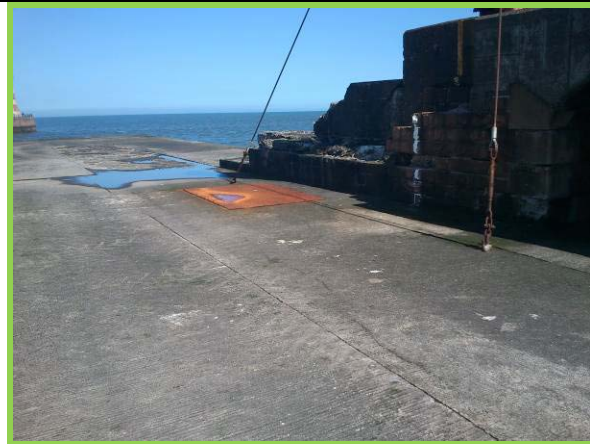
Internal access chamber cover has been repaired since 2010.
(Asset ref. No. 121AB901B0703C01)

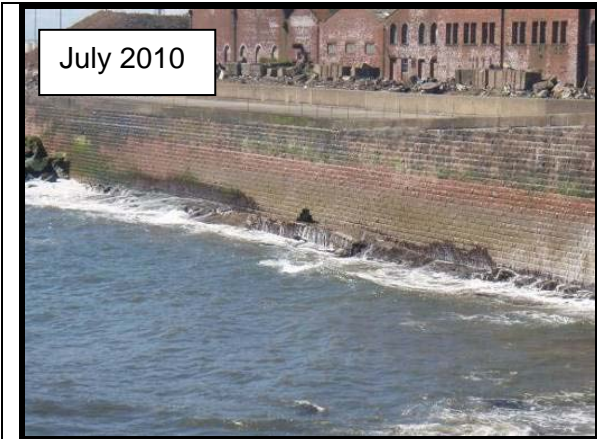
Void in base of wall – Photo from 2010 report
(Asset ref. No. 121AB901B0801C03)

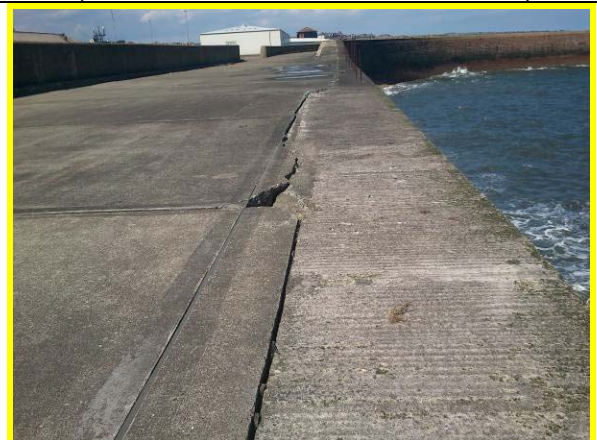
Slight lifting of deck slab
(Asset ref. No. 121AB901B0801C03)

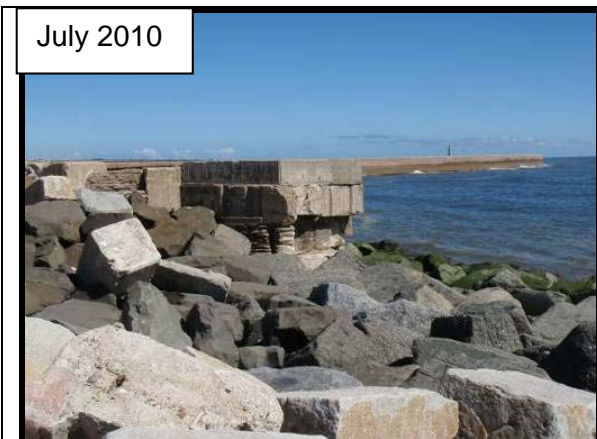
South end of wall protected by rock armour –
photo from July 2010
(Asset ref. No. 121AB901B0801C03)

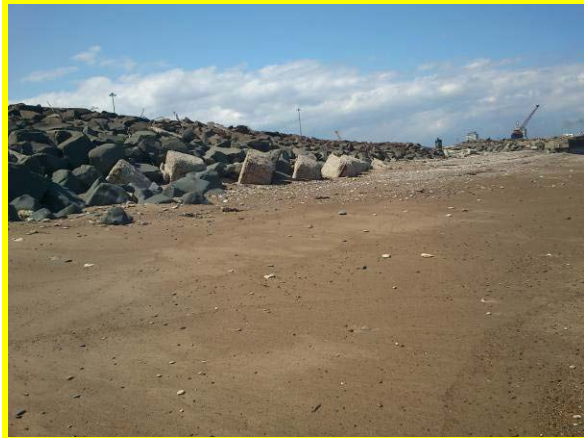
Northern section of rock armour
(Asset ref. No. 121AB901B0801C02)

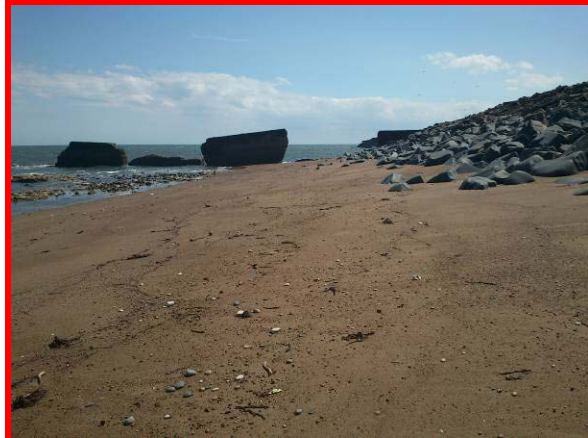
Remains of derelict concrete groyne from north
(Asset ref. No. 121AB901B0801C01)

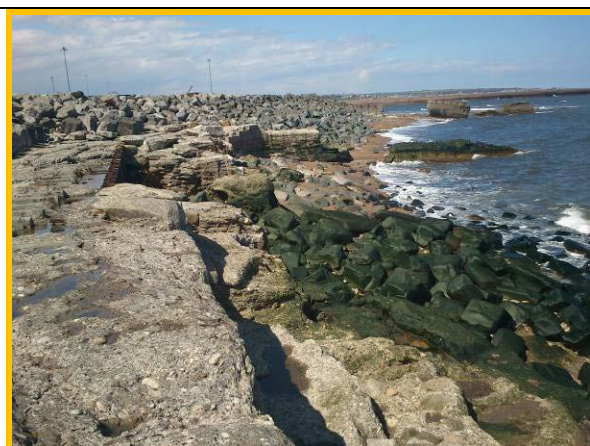
Derelict former defence structures with limited rock and concrete armour
(Asset ref. No. 121AB901B0801C05)

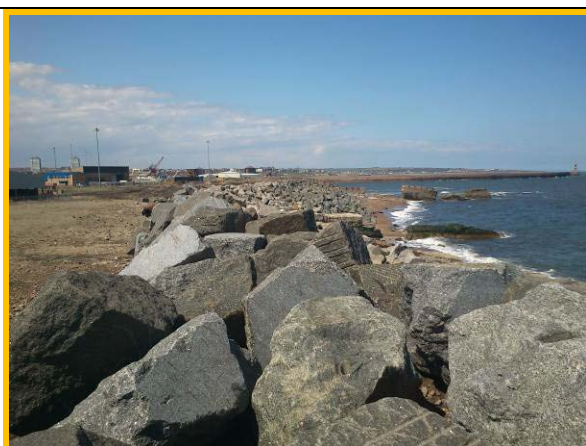
Stacked bund of rock armour at crest. (Asset ref. No. 121AB901B0801C05)

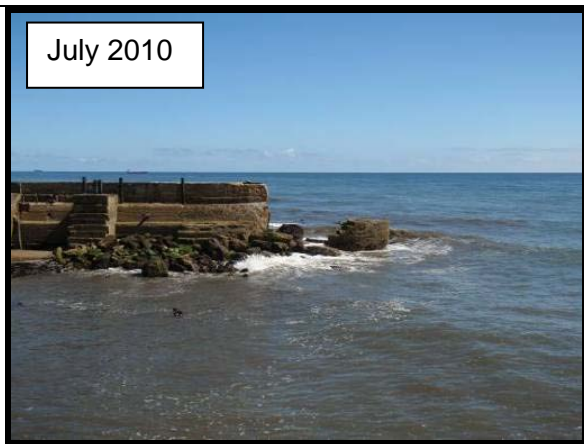
North East Pier failed roundhead July 2010
(Asset ref. No. 121AB901B0801C04)

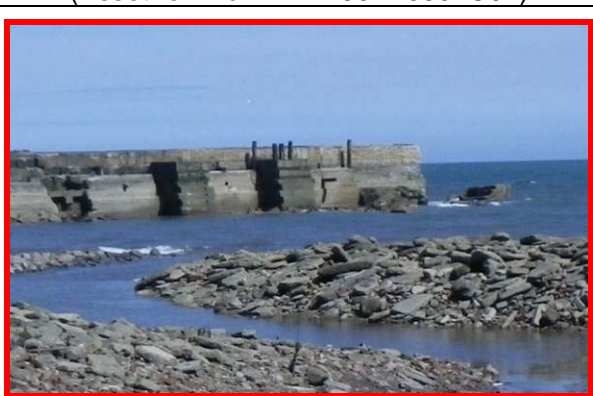
North East Pier roundhead has lost further material since 2010, photo 16.05.2013
(Asset ref. No. 121AB901B0801C04)

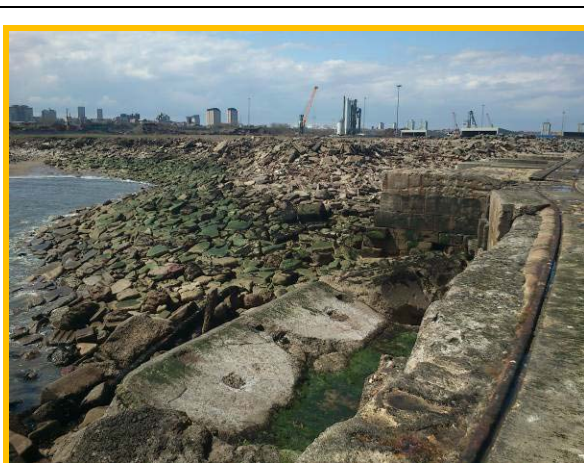
Inner face of landward end of North East Pier
(Asset ref. No. 121AB901B0801C07)

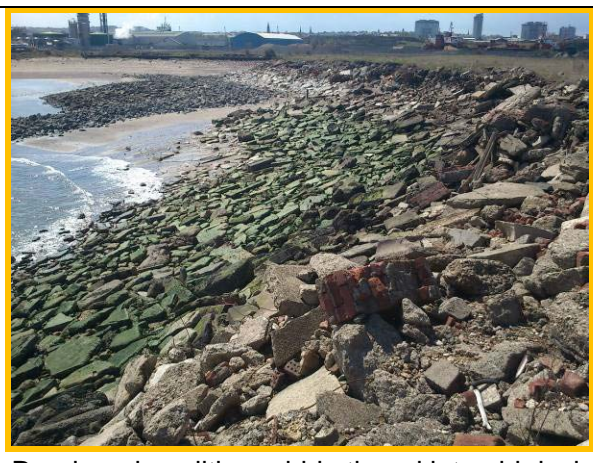
Random demolition rubble tipped into old dock to fill in front of buried quay
(Asset ref. No. 121AB901B0801C08)

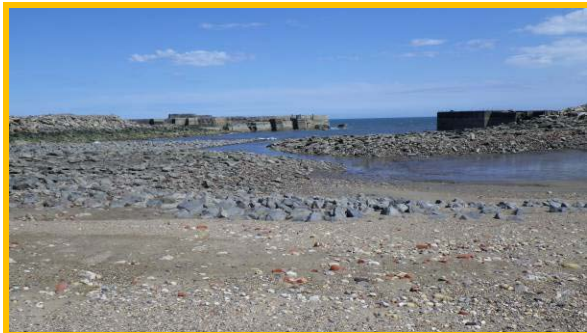
Looking seawards from South Outlet
(Asset ref. No. 121AB901B0801C07)

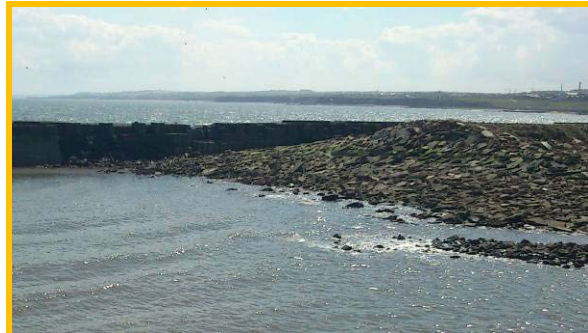
Random demolition rubble tipped into old dock
to rear of South West breakwater
(Asset ref. No. 121AB901B0802C06)

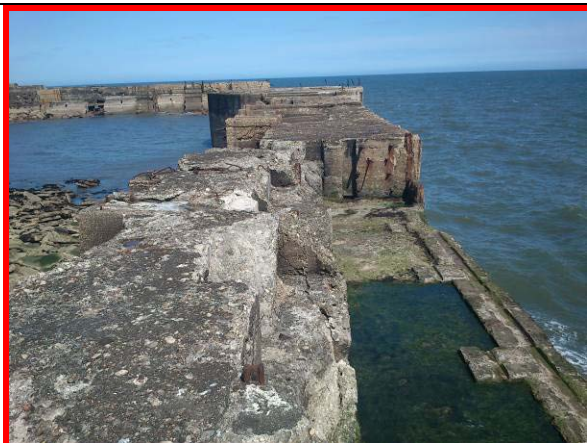
South West Breakwater – missing sections of
deck (Asset ref. No. 121AB901B0801C07)

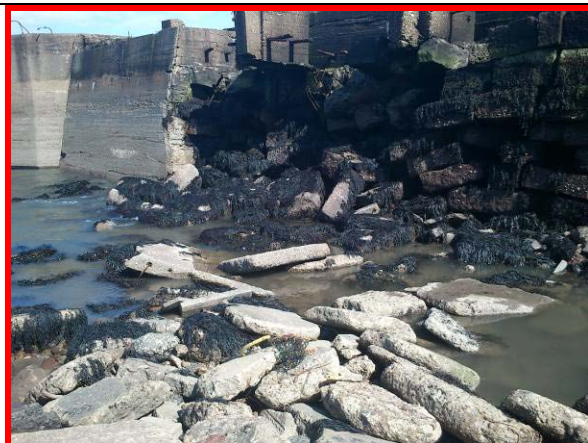
Loss of core to northern face of South West
Breakwater
(Asset ref. No. 121AB901B0802C06)

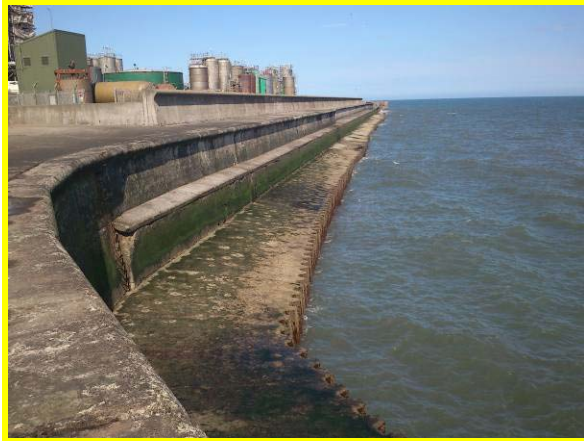
Spur barrier wall
(Asset ref. No. 121AB901B0802C04)

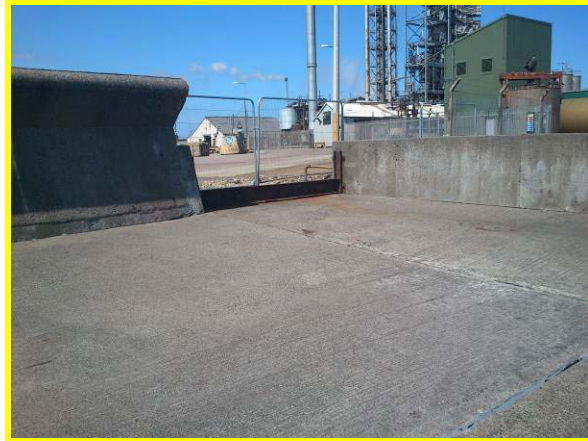
Gap in crest wall with missing flood boards
(Asset ref. No. 121AB901B0802C04)

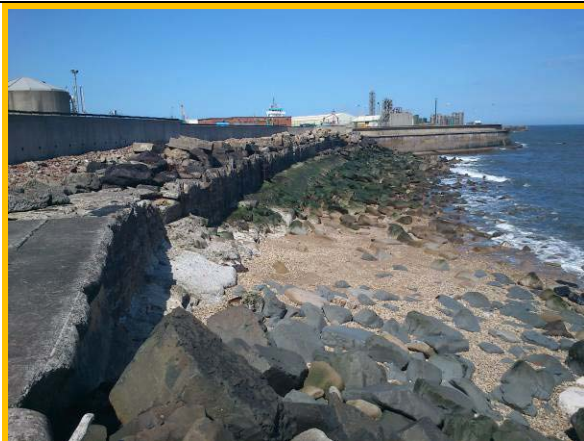
Loosely stacked rock armour on crest and at toe provides limited protection
(Asset ref. No. 121AB901B0802C03)

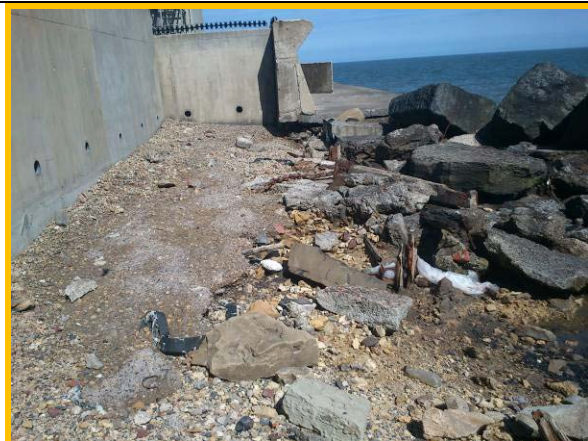
Eroded crest from wave overtopping at intersection with defence to north.
(Asset ref. No. 121AB901B0802C03)

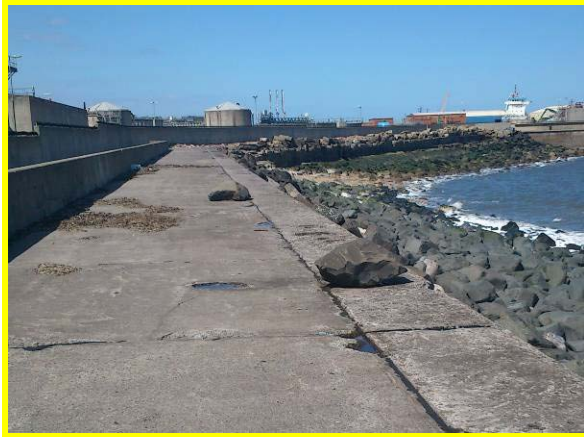
Small rock armour units washed onto crest slab by storm damage.
(Asset ref. No. 121AB901B0802C02)

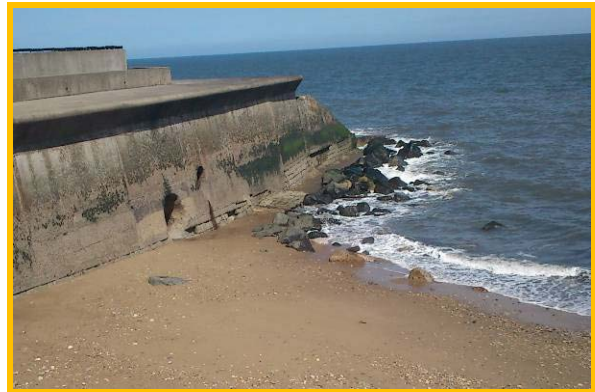
Damaged masonry and sheet piles require attention. (Asset ref. No. 121AB901B0802C01)

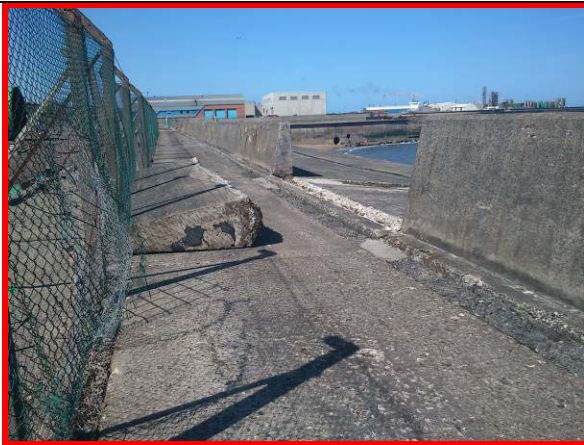
Failed section of crest wall.
(Asset ref. No. 121AB901B0802C01)

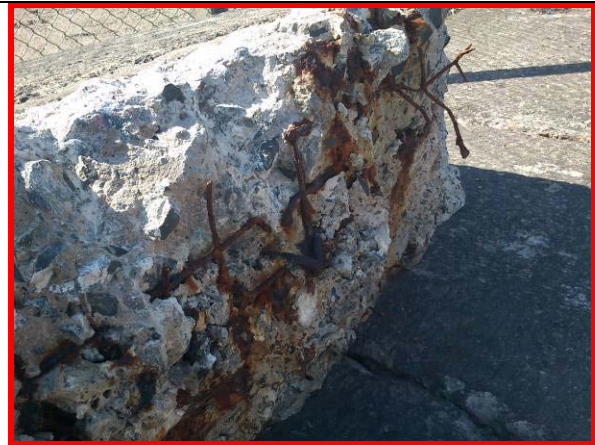
Close up of base of failed section of crest wall.
attention. (Asset ref. No. 121AB901B0802C01)

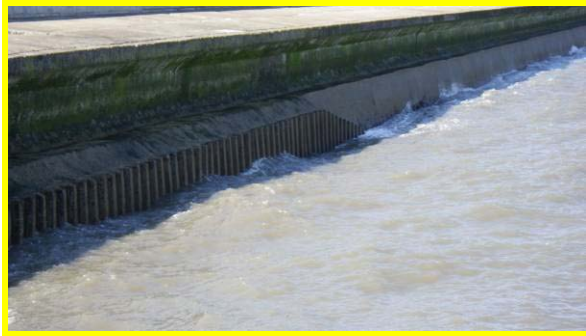
Toe piling to southern section crest wall.
(Asset ref. No. 121AB901B0802C01)

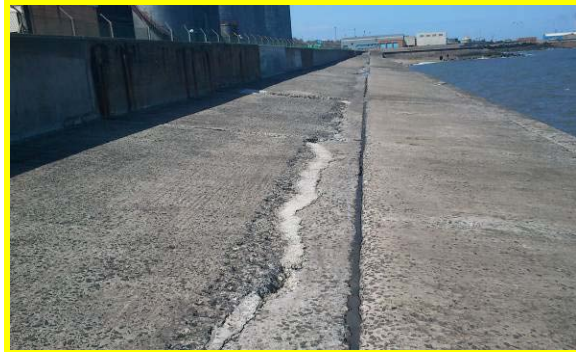
Cracking to crest slab with previous repairs and previously replaced sections of rear wall.
(Asset ref. No. 121AB901B0802C01)

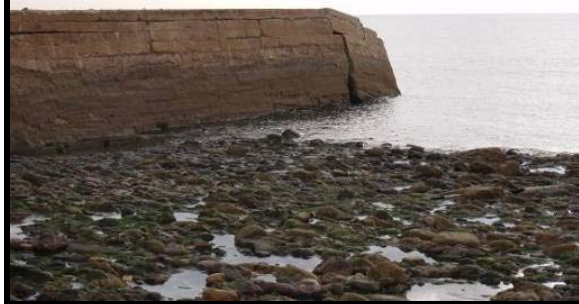
Aug 2010

Failed seaward end of breakwater at south of port area. Photo from 2010 report.
(Asset ref. No. 121AB901B0803C02)

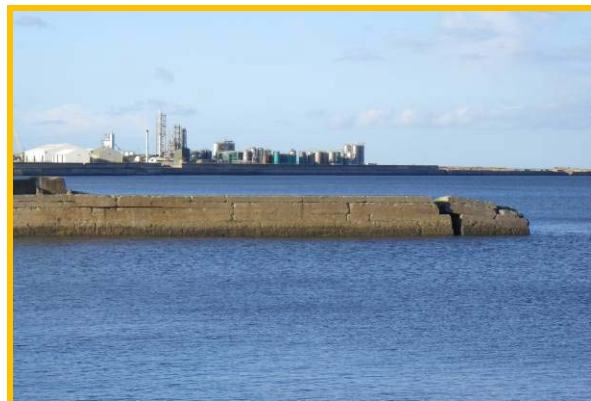
Breakwater at south boundary of port area.
Photo taken 28.09.2012
(Asset ref. No. 121AB901B0803C02)

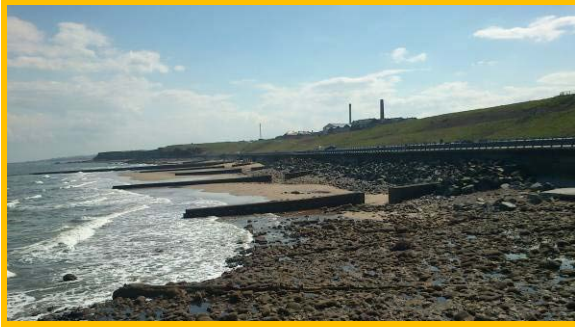
Concrete groynes on foreshore at Hendon
(Asset ref. No. 121AB901B0803C02)

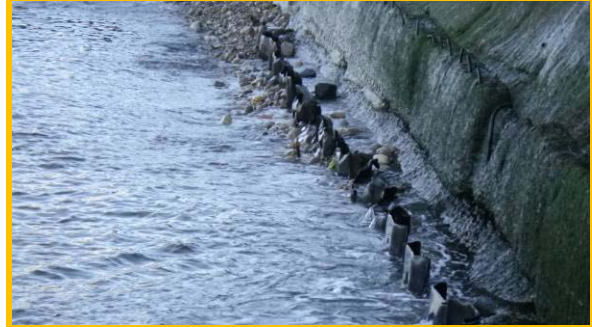
Highly abraded and corroded toe piling
(Asset ref. No. 121AB901B0803C02)

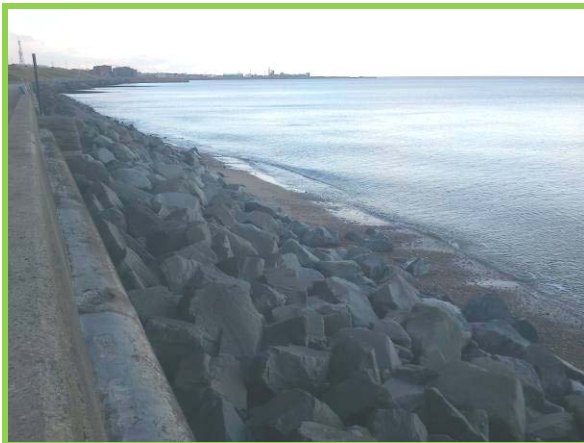
Rock armour in good condition
(Asset ref. No. 121AB901B0803C02)

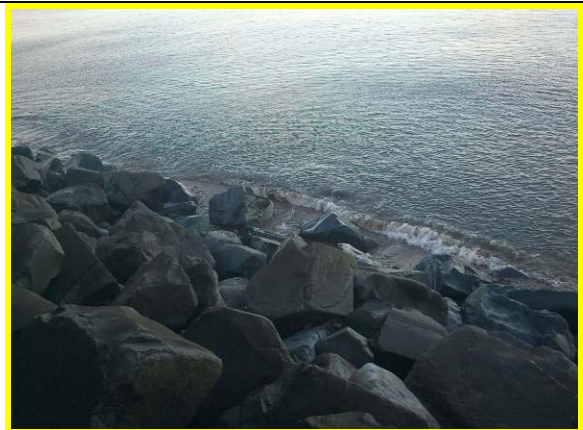
Localised displacement of rock armour at toe.

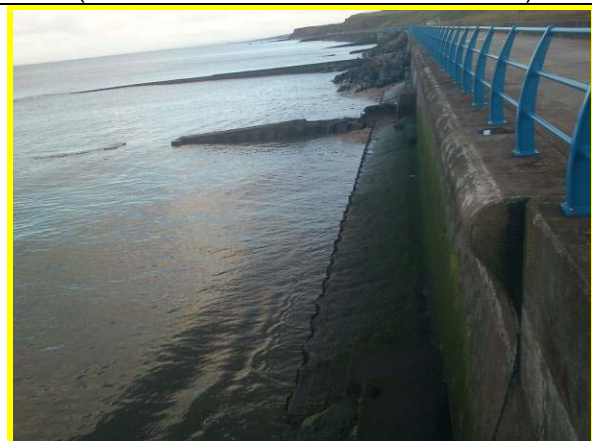
Wall and handrails in good condition, apart
from corroded toe piles; northern section of
defence. (Asset ref. No. 121AB901B0803C02)

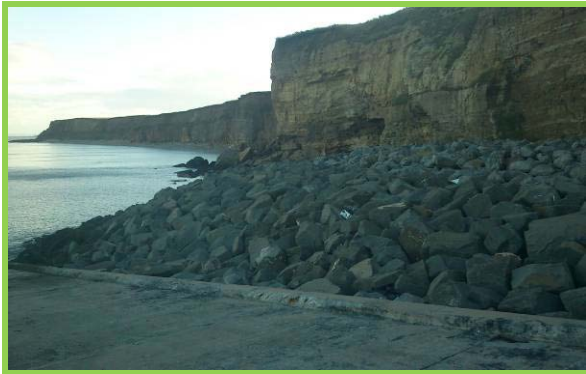
Rock armour at south end of Hendon Seawall with inactive cliffs in background.
(Asset ref. No. 121AB901B0803C01)

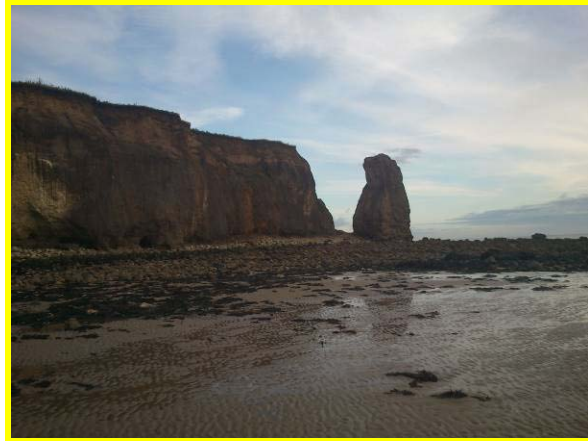
Formation of stacks at Pincushion (Locally Active)
(Asset ref. No. 121AB901B0804C02)
