**Cell 1 Regional Coastal Monitoring Programme
Walk-over Visual Inspections of Assets**

**Sunderland City Council
Final Report**

September 2014

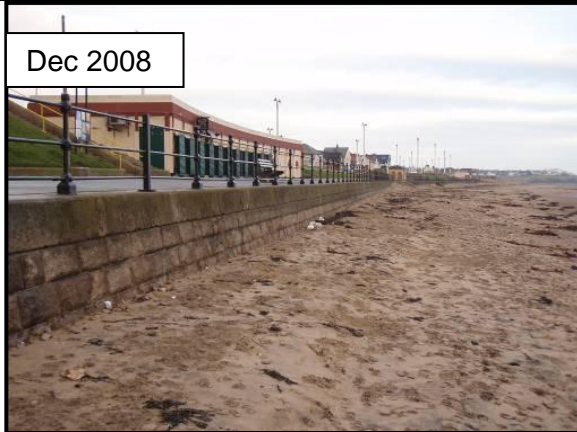
<p>Dec 2008</p> <p>Sandy upper beach surface during first inspection under programme in 2008. (Asset Ref. No. 121AB901B0603C01)</p>

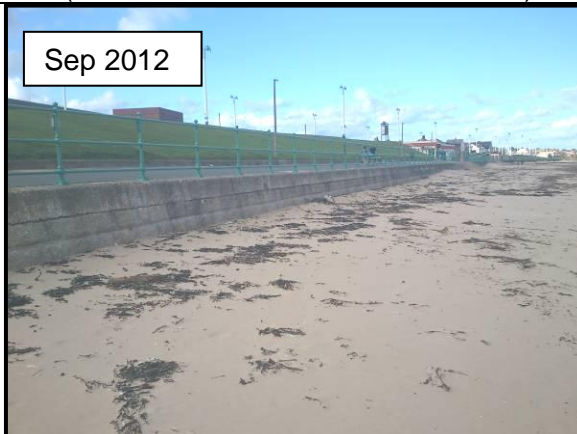
<p>Sep 2012</p> <p>Beach in similar condition to 2008 inspection. (Asset Ref. No. 121AB901B0603C01)</p>

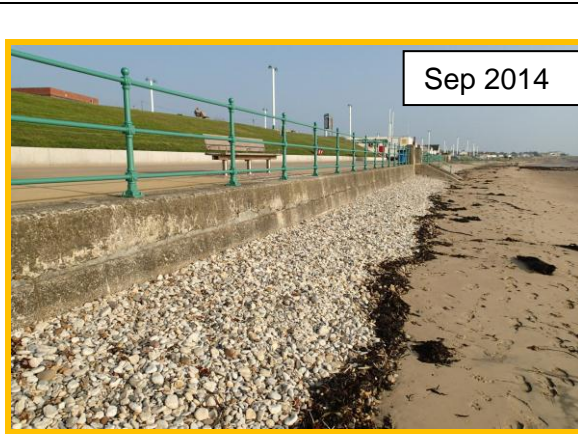
<p>Sep 2014</p> <p>Sand beach lower, exposing shingle as in 2010. (Asset Ref. No. 121AB901B0603C01)</p>

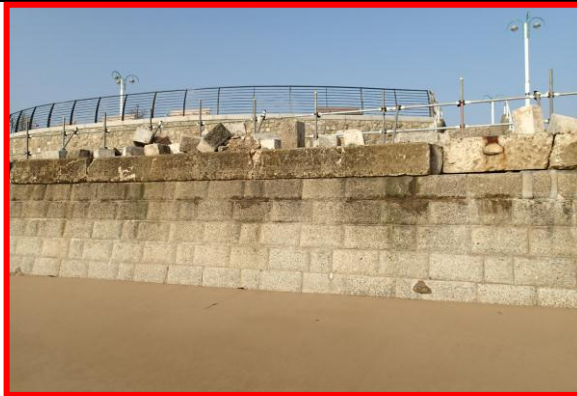
the asset has suffered from storm damage over the southern length, with the handrails and coping blocks removed by wave action and parts of the promenade damaged, see lower photos below. The area was fenced off awaiting repair.

<p>Loss of coping blocks and hand rails due to storm damage. (Asset Ref. No. 121AB901B0603C01)</p>

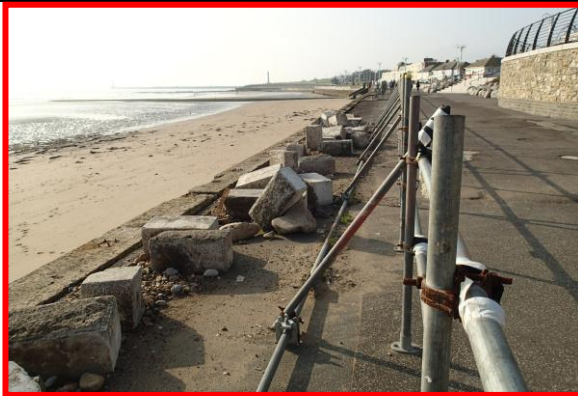
<p>Storm damage to promenade at south end of asset. (Asset Ref. No. 121AB901B0603C01)</p>

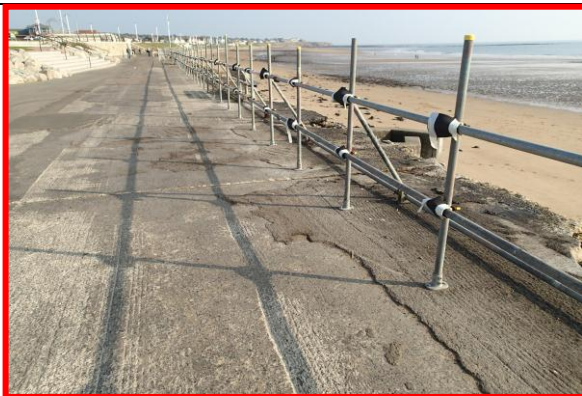
121AB901B0603C02). The storm damage noted in the unit to the north was continuous across this defence, with the coping blocks having been displaced or removed, handrails lost and the promenade torn up, see photos below top left and right. The area is fenced off, presumably until a repair can be implemented.

Storm damage to promenade.
(Asset Ref. No. 121AB901B0603C02)

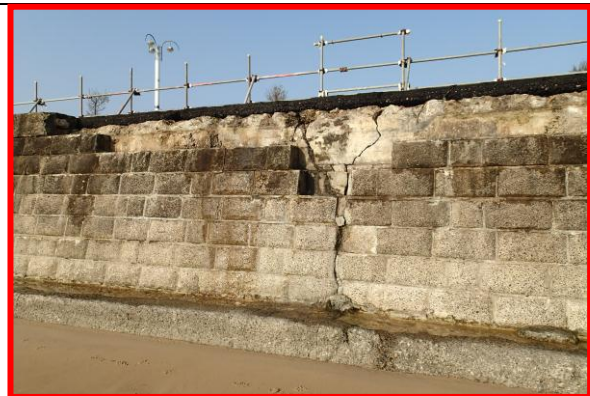
Storm damage to seawall at Seaburn.
(Asset Ref. No. 121AB901B0603C02)

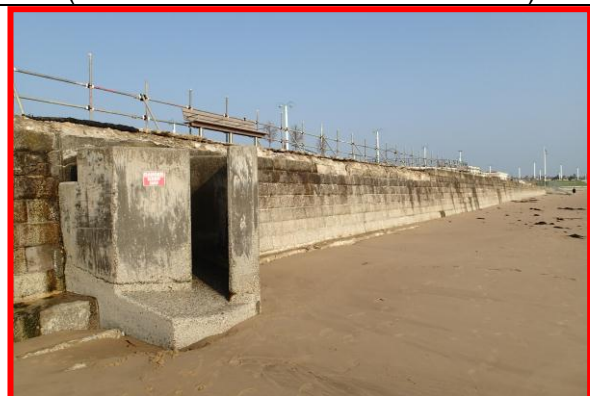
Failed coping adjacent to northern outfall.
(Asset Ref. No. 121AB901B0603C02)

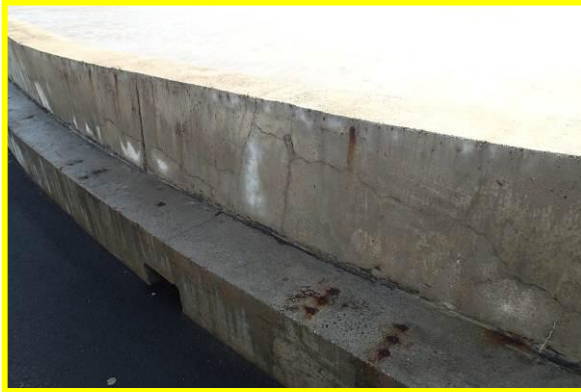
Crest wall cracks and rust staining at fixings from previous seats.
(Asset Ref. No. 121AB901B0603C03)

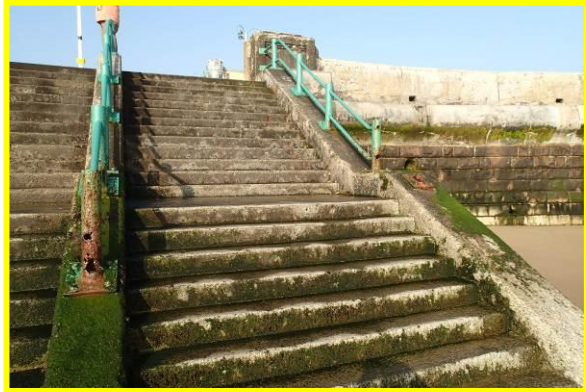
Heavily corroded hand rails to south steps at traffic roundabout, with seaward section missing.
(Asset Ref. No. 121AB901B0603C03/C02)

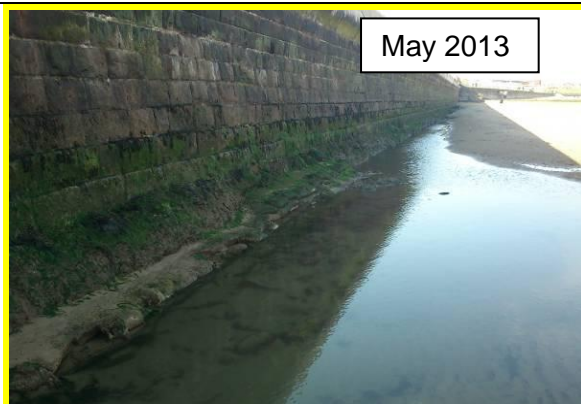
Low beach level in May 2013 exposing seawall toe which is undercut in places and previous concrete bagwork repairs.
(Asset Ref. No. 121AB901B0603C03)

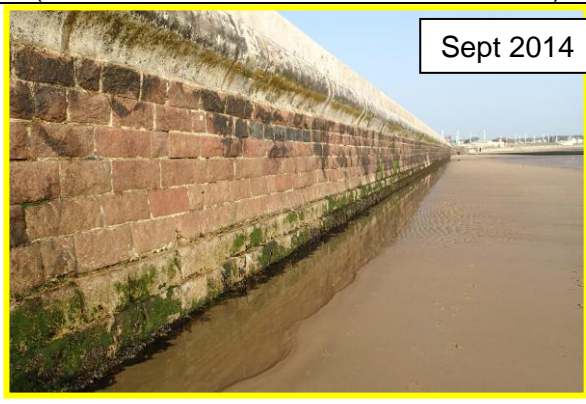
Higher beach level covering toe. Missing mortar / open joints between blocks.
(Asset Ref. No. 121AB901B0603C03)

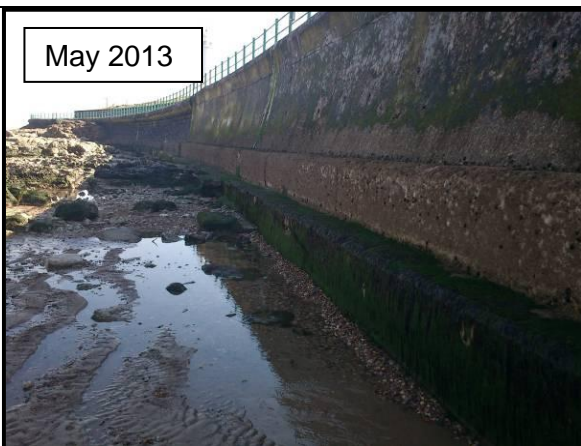
Low beach levels exposing lower section of wall in May 2013. (Asset Ref. No. 121AB901B0604C01)

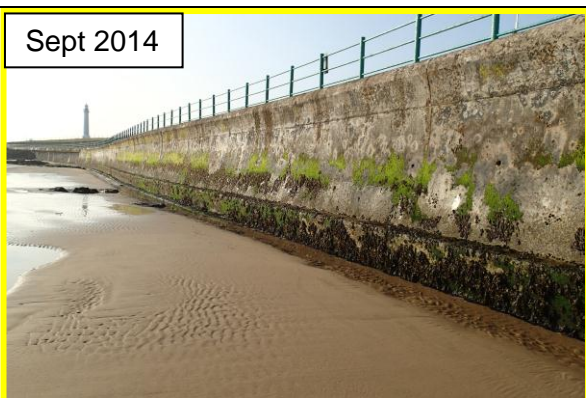
Seawall adjacent to Seaburn Park, showing chloride staining on surface of concrete encasement. Beach levels higher than in May 2013. (Asset Ref. No. 121AB901B0604C01)

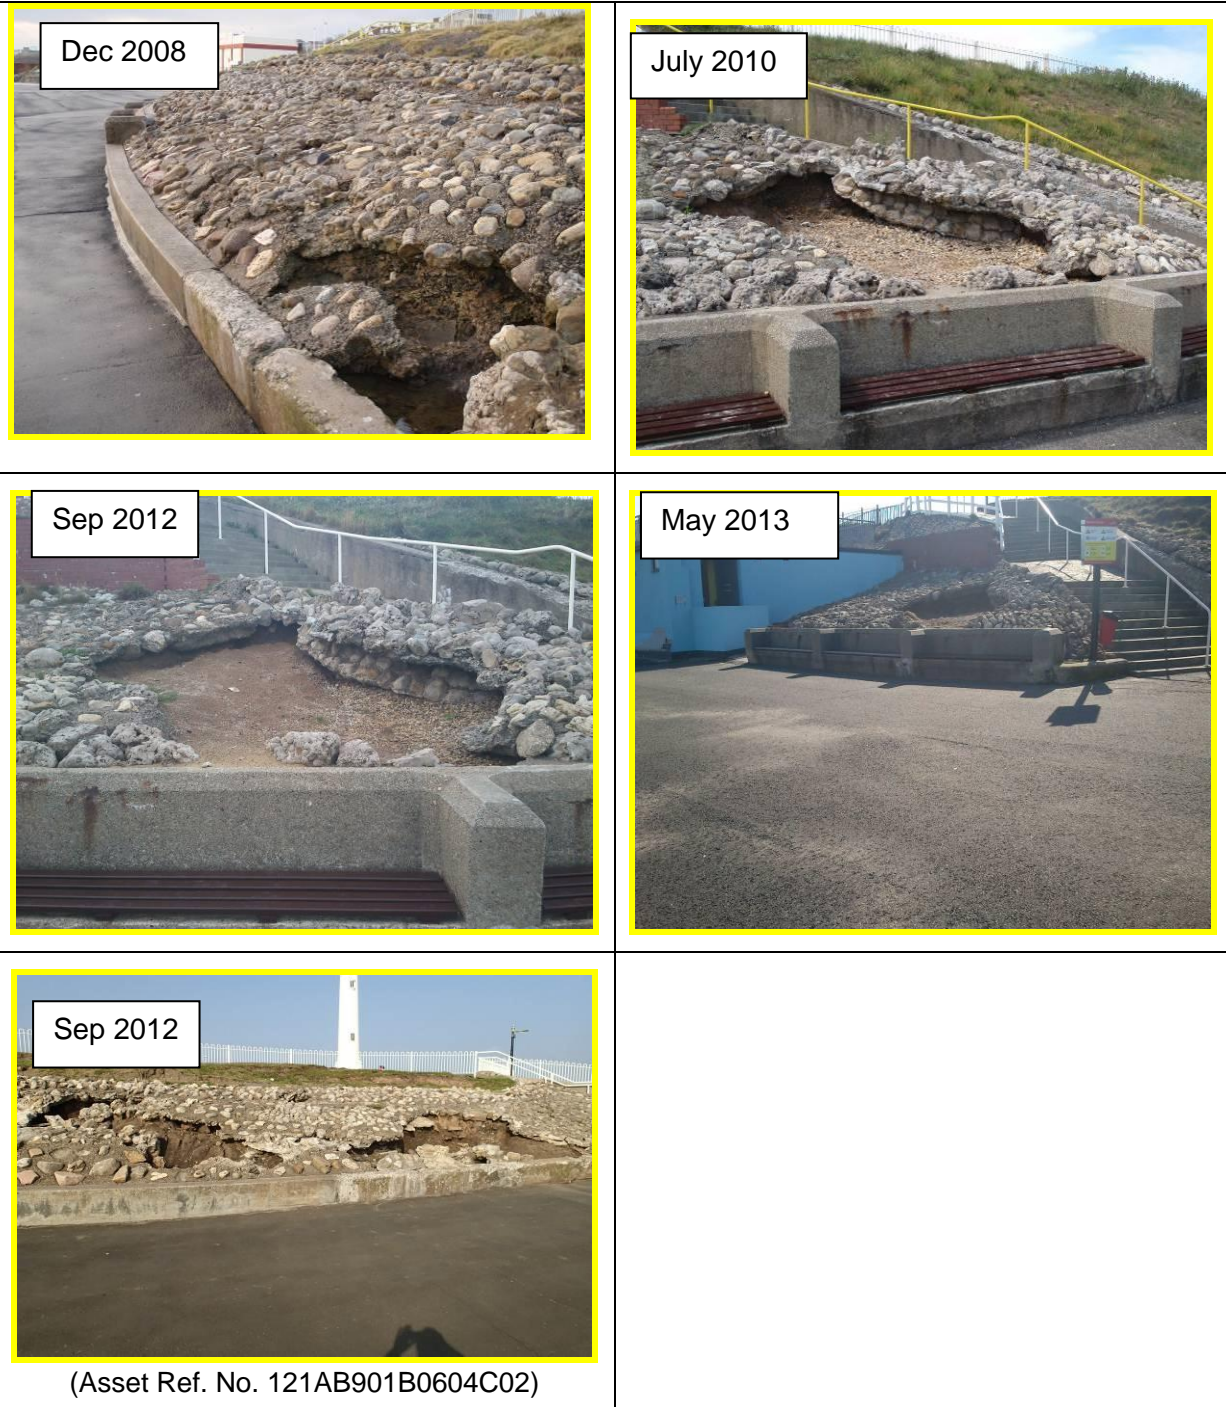
The grouted stone revetment landward of the promenade around Roker Cliff Park has had voids and damage identified in all inspections since 2008 (below). This appears to be at least partly related to storm wave overtopping damage and there appeared to have been significant expansion of damage over the winter 2013/14. As noted in previous reports, it would be prudent to infill the voids to minimise the risk of further expansion and the potential reduction in stability of the embankment above.

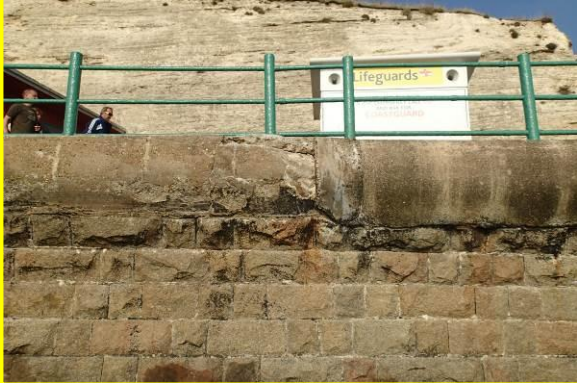
<p>Example of damage to coping. (Asset Ref. No. 121AB901B0604C02)</p>

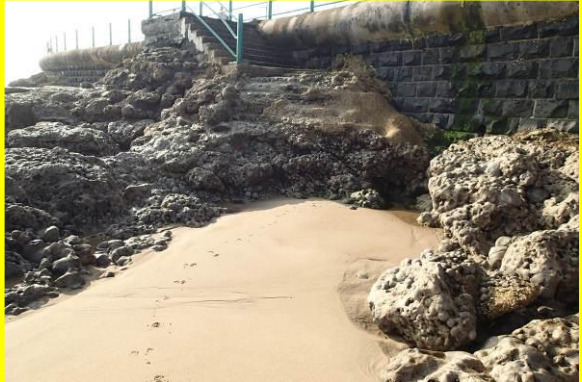
flank where there is a void starting to extent below the promenade, see photo below lower right, and maintenance repairs are recommended to prevent the damage escalating. The condition of the coping deteriorates towards the south end of the wall with cracking and missing mortar in some joints in the masonry blocks.

<p>Eroded natural / grouted rock at access steps to Parsons Rocks. (Asset Ref. No. 121AB901B0604C02)</p>

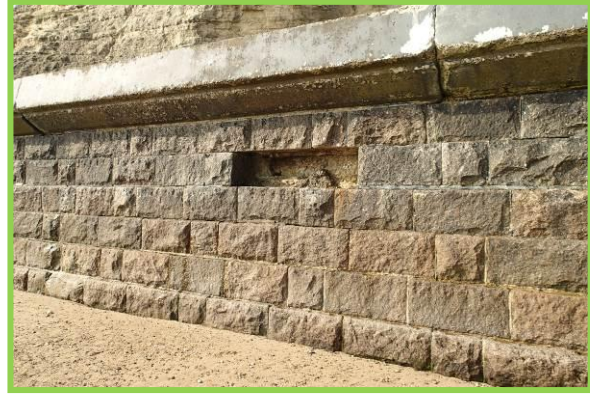
South of Parson's Rocks, the high masonry wall around the headland extending south to the ravine at Roker Park (Asset Ref. No. 121AB901B0605C01) was in generally good condition (below left) with local minor loss of mortar and spalling noted in a few places. The natural cliff above appeared to be relatively stable. At the most exposed section where the wall is most seaward, before the return to Roker Park, there was a single facing block missing from the wall, see photograph below right. This should be repaired before the damages spreads.

Missing block on most exposed seaward extent
of the wall.
(Asset Ref. No. 121AB901B0605C01)

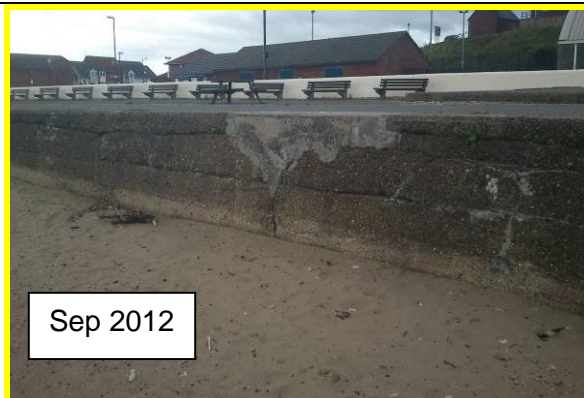
Multiple horizontal cracks and previous repairs in concrete wall. (Asset Ref. No. 121AB901B0702C01)

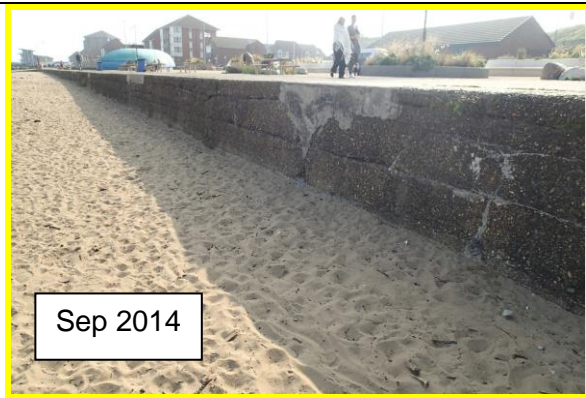
No change to cracks in wall, but beach level slightly higher.
(Asset Ref. No. 121AB901B0702C01)

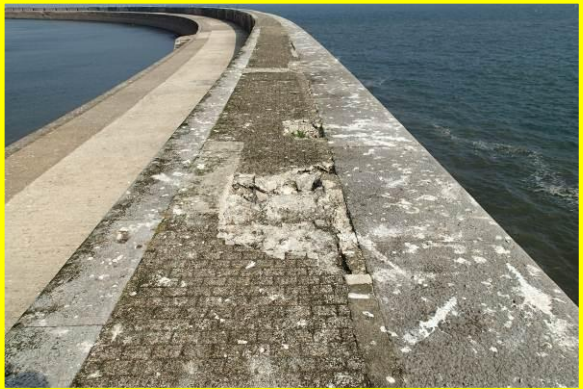
<p>Damaged area of upper deck to New South Pier. (Asset Ref. No. 121AB901B0703C01)</p>

As noted in previous reports there are a number of large blocks missing at the seaward end of the pier, although this is not new damage. It is however advised that the end of the pier is made good in order to prevent the area of damage spreading.

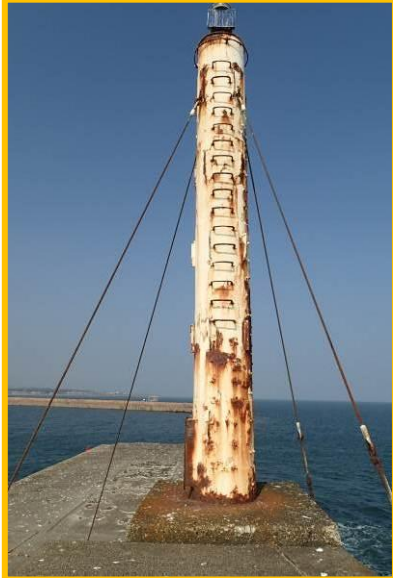
It was noted that the navigation light support and cable stays near the seaward end are highly corroded and in need of replacement, see photo below lower right.

<p>Navigation light support column and cable stays highly corroded and in poor condition. (Asset Ref. No. 121AB901B0703C01)</p>

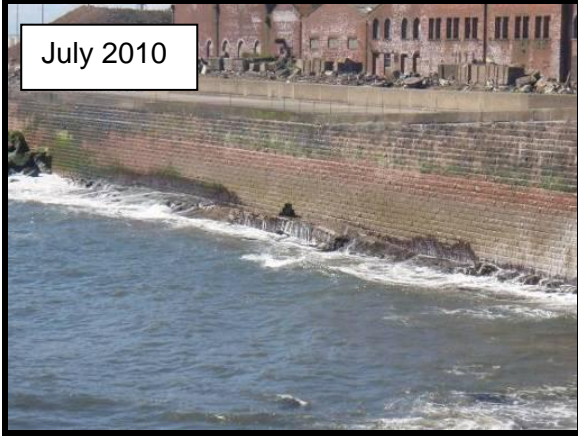
The seawall to the south of New South Pier (Asset Ref. No. 121AB901B0801C03) is a masonry wall continuous with the southern face of New South Pier. In the 2010 inspection a void was visible at the base of the wall, with approximately eight masonry blocks missing from the seaward face (below left). The void was not visible in 2013 or 2014, and there appeared to be a small area of additional rock in front of the location. Above the location of the void the concrete deck slabs had been repaired previously, and cracking between the slabs and the wall was noted in 2010.

<p>July 2010</p> <p>Void in base of wall – Photo from 2010 report. (Asset Ref. No. 121AB901B0801C03)</p>

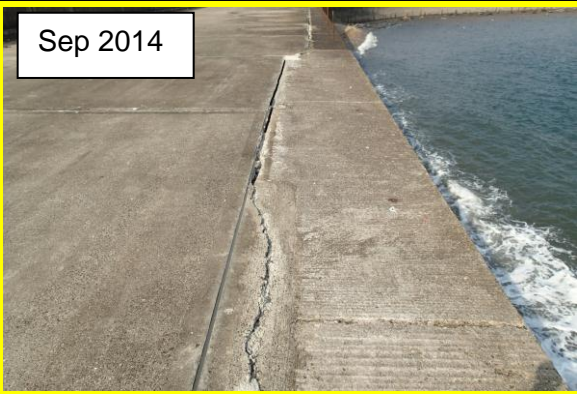
There was little change observed in 2014, although slight lifting of the slab was apparent, which may relate to wave uplift pressures within voids in the wall. It is recommended that consideration is given to extending the rock armour further north to cover the area of damage.

<p>Sep 2014</p> <p>Slight lifting of deck slab. (Asset Ref. No. 121AB901B0801C03)</p>

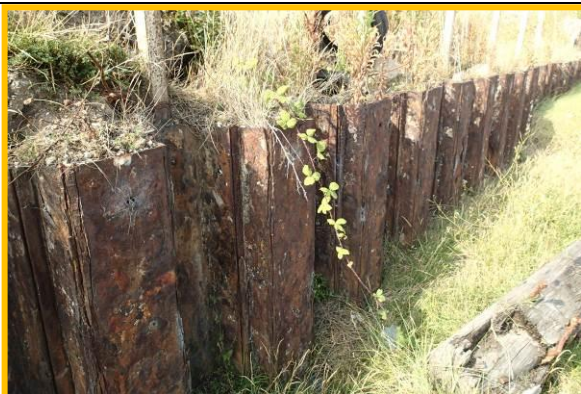
Badly corroded sheet pile defence at south west side of former South Outlet basin.
(Asset Ref. No. 121AB901B0802C07)

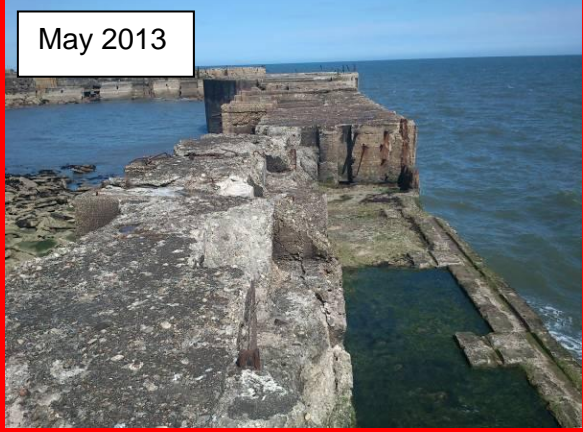
<p>May 2013</p> <p>South West Breakwater – missing sections of deck. (Asset Ref. No. 121AB901B0801C07)</p>

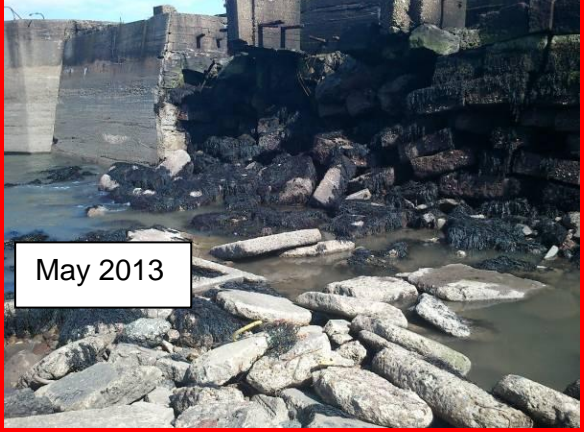
<p>May 2013</p> <p>Loss of core to northern face of South West Breakwater. (Asset Ref. No. 121AB901B0802C06)</p>

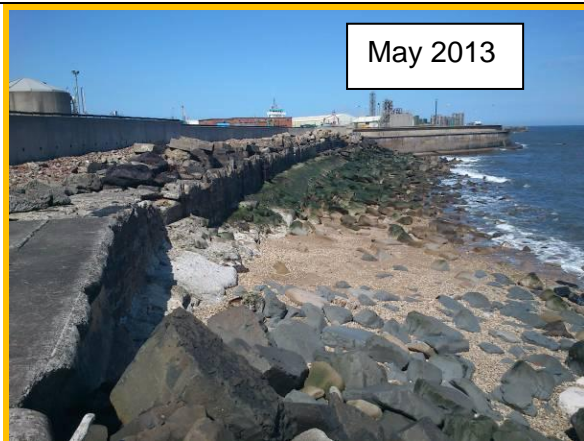
Loosely stacked rock armour on crest and at toe provides limited protection.
(Asset Ref. No. 121AB901B0802C03)

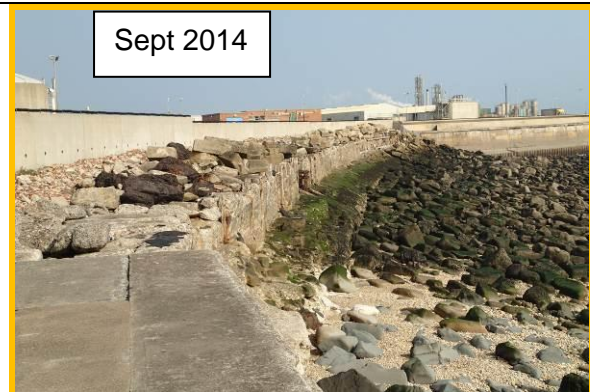
Defence rock armour in similar or slightly worse condition than in 2013.
(Asset Ref. No. 121AB901B0802C03)

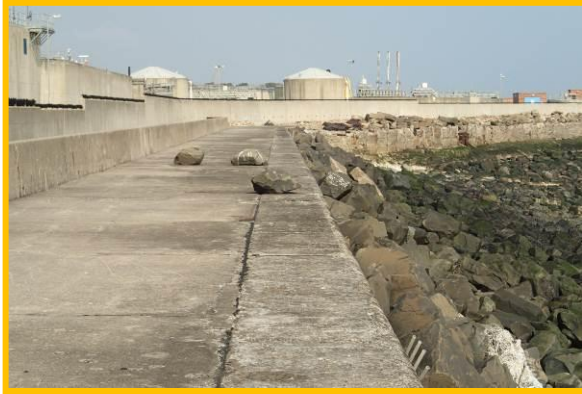
Small rock armour units washed onto crest slab causing storm damage.
(Asset Ref. No. 121AB901B0802C02)

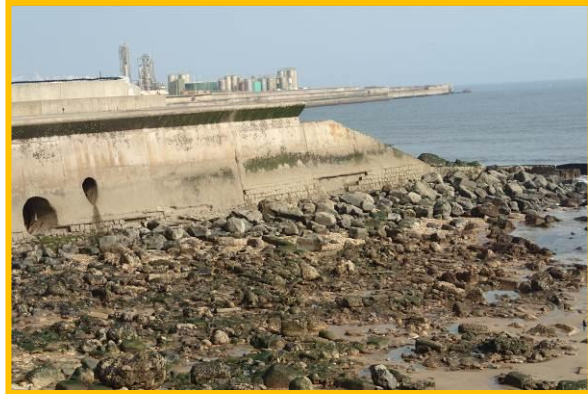
Missing facing masonry requires attention.
(Asset Ref. No. 121AB901B0802C01)

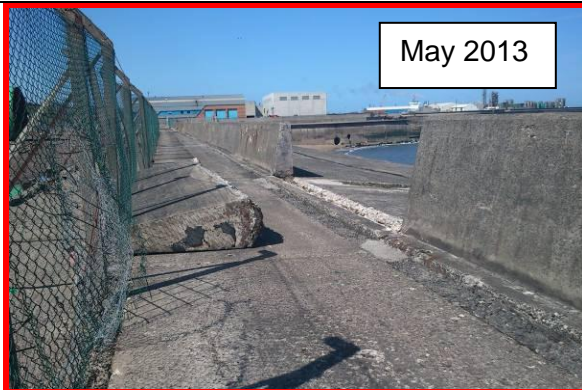
Failed section of crest wall.
(Asset Ref. No. 121AB901B0802C01)

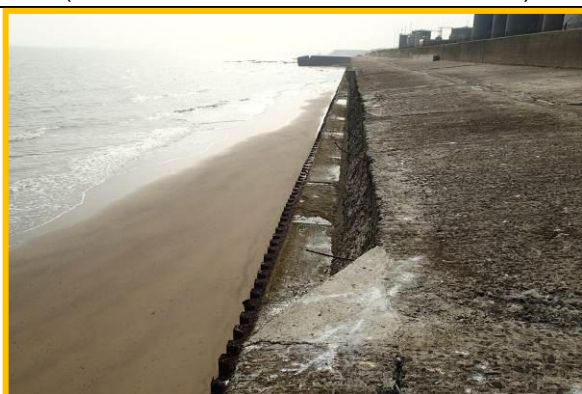
Missing section of coping at seaward edge of crest slab.
(Asset Ref. No. 121AB901B0802C01)

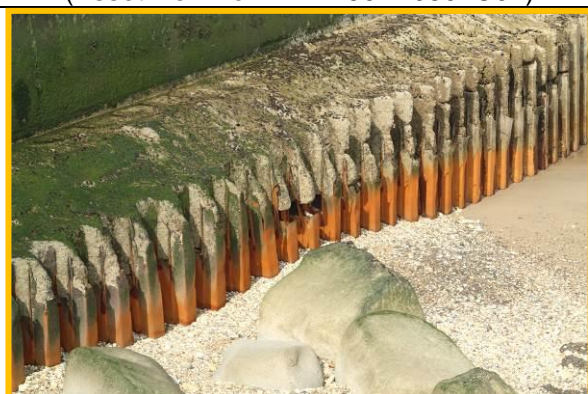
Badly abraded toe piles near south end of defence showing holes through to voids in wall.
(Asset Ref. No. 121AB901B0802C01)

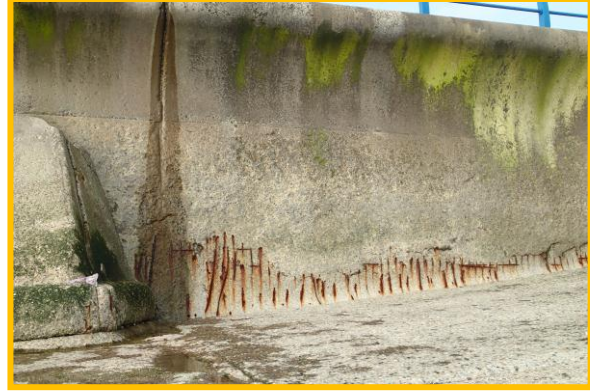
Abrasion of wall exposing reinforcement.
(Asset Ref. No. 121AB901B0803C02)

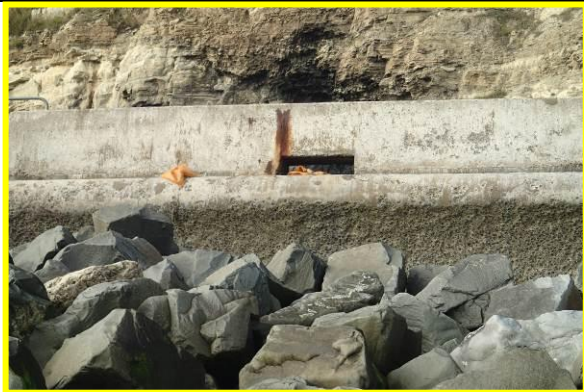
Crest wall with corrosion around enlarged drainage holes towards southern end of defence.
(Asset Ref. No. 121AB901B0803C02)

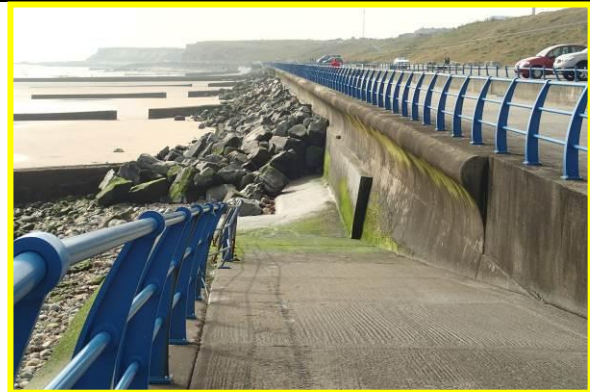
Wall and handrails and rock armour in good condition but defence has badly corroded toe piles; northern section of defence. (Asset Ref. No. 121AB901B0803C02)

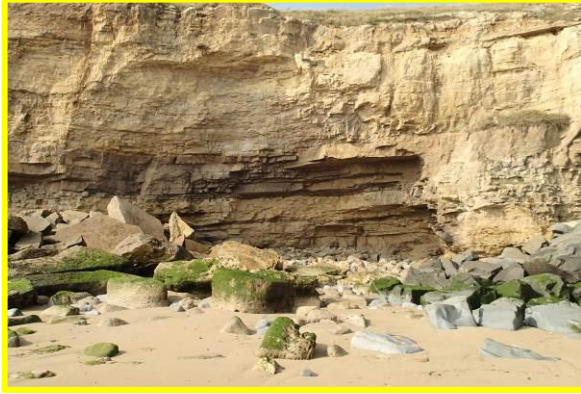
Caves forming in cliff toe at southern end rock armour to the south end of Hendon Seawall.
(Asset Ref. No. 121AB901B0803C01)

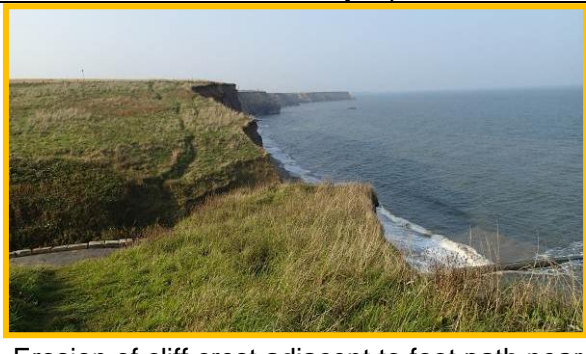
Erosion of cliff crest adjacent to foot path near Ryhope dene
(Asset Ref. No. 121AB901B0804C02)
