**Cell 1 Regional Coastal Monitoring Programme
Coastal Walkover Inspections 2010**

**Durham County Council
Final Report**

September 2010

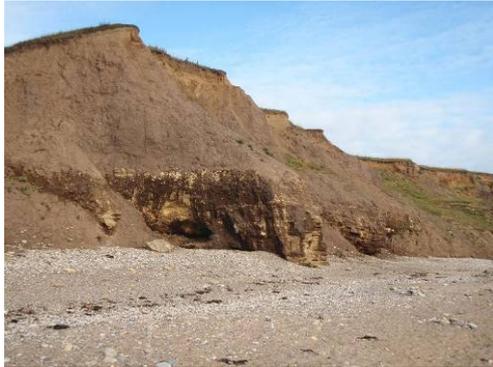
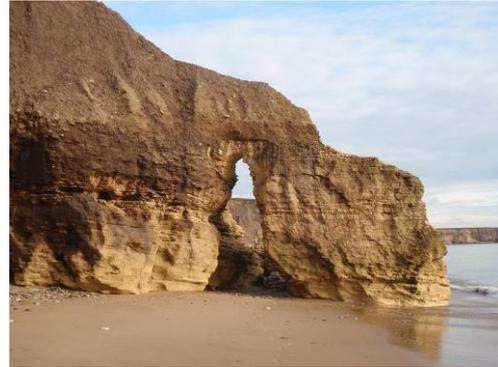
The northern section of Durham County Council's jurisdiction extends along undefended sea cliffs from Ryhope Dene to the picnic site located to the north of Seaham Dene. The cliffs comprise a Magnesian Limestone base with overlying glacial till (below left). There remains ongoing active slumping in the till along the whole undefended length, but of a local nature. There are frequent caves and arches formed in the harder rock at the base of the cliffs caused by differential erosion by waves (below right).

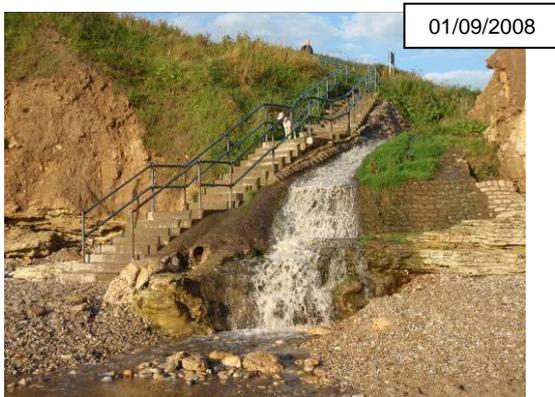
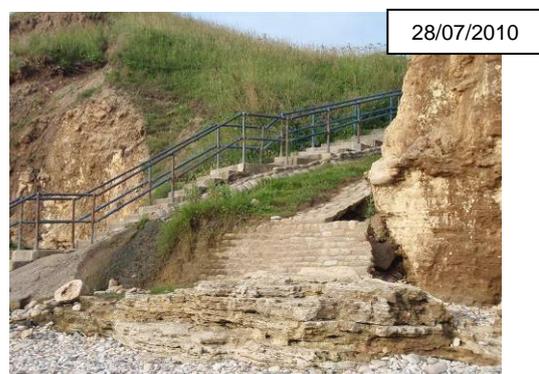
Immediately adjacent to the access steps from the picnic site car park is a stream that discharges to the foreshore. In 2008 this stream was in spate due to the heavy rainfall that preceded the survey (below left). During the 2010 inspections, there was very little flow (below right). The short length of blockwork wall immediately to the north of the stream, however, was suffering outflanking where it ties-in to the undefended cliffs.

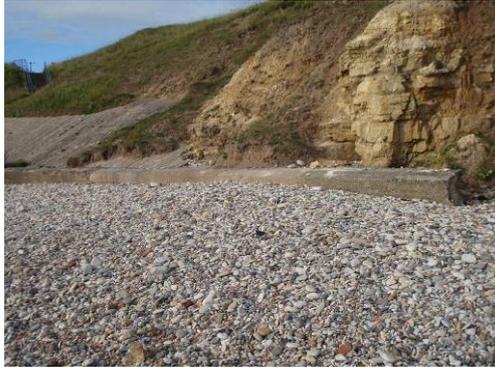
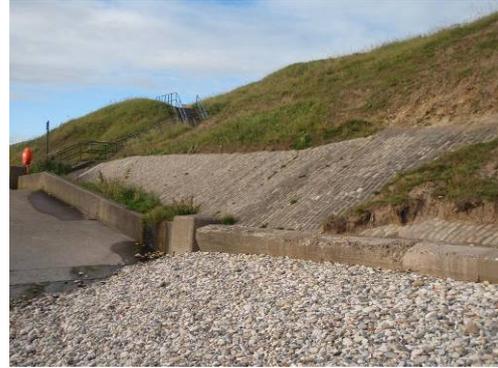
Immediately south of the car park access steps is a short undefended length of cliff, followed by a short (approximately 10m) length of low-level wall which is moderately abraded and slightly outflanked at its northern end (below left). This situation has not worsened since the 2008 inspections and during the recent visit the beach levels at the wall were quite high, offering protection to the structure (below right). Backing the southern end of this low-level wall, and continuing behind the very northern end of the Seaham sea wall is a blockwork revetment on the backing slope which remains in fair condition.

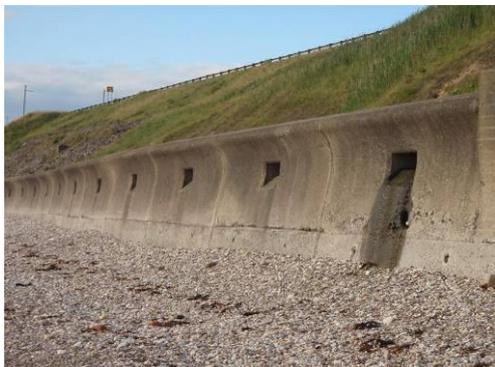
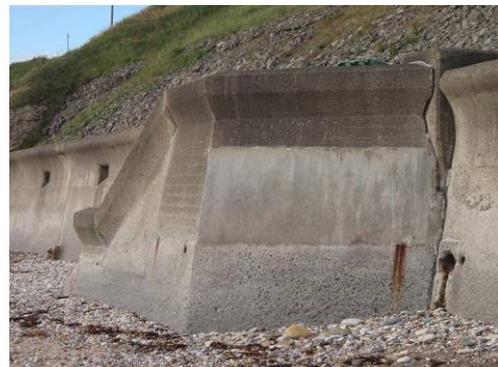
The visible sections of the main Seaham sea wall and promenade are in fair condition (below left), with most construction joints adequately sealed, but some minor gaps starting to become apparent at occasional joints. There are cracks at the joints between all three sets of access steps and their intersections with the main wall (below right), but there is relatively little abrasion damage and no obvious signs of cracking or settlement along the main wall itself.

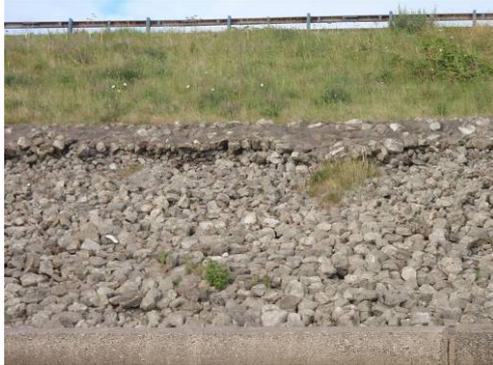
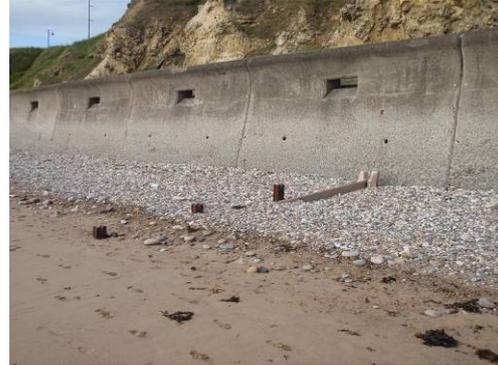
- There has been a slippage along a short section of the blockwork revetment that protects the coastal slope behind the Seaham promenade. This would benefit from maintenance to prevent further unravelling.

Along part of the frontage there is a blockwork revetment protecting part of the coastal slope behind the sea wall and promenade. This appears to have suffered some slippage since the last inspection and could usefully be maintained to improve stability of the surrounding slope (below left). There are also the remnants of three timber groynes (one shown below right) and two concrete outfalls, all supported on corroded steel piles. Due to the high beach levels little of these structures could be visually inspected.

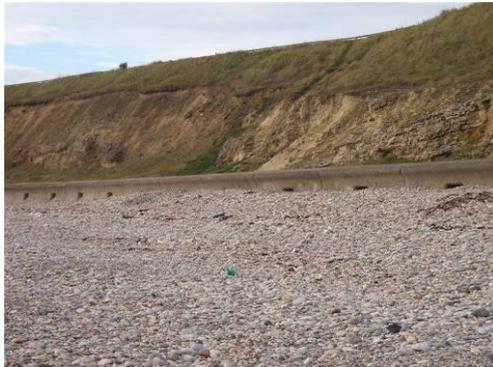
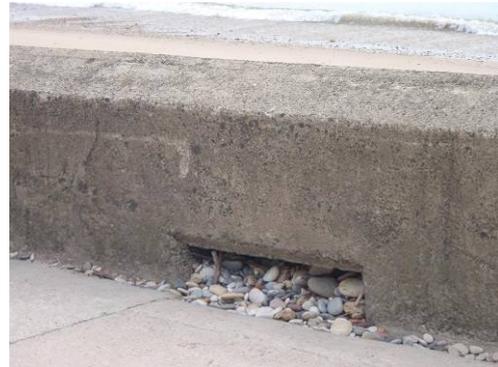
The beach levels at the time of the inspection were high, with a cobble berm overlaying the sandy foreshore and covering parts of the face of the wall to varying levels along the frontage (below left). This meant that the lower sections and toe of the sea wall could not visually be inspected. At the southern end of the frontage, towards Featherbed Rocks, the beach levels were highest and in one place shingle and cobble is blocking the drainage holes in the crest wall (below right).

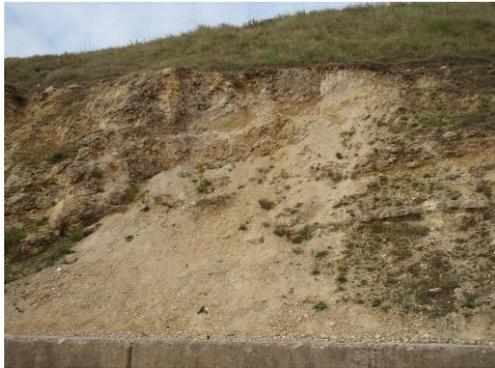
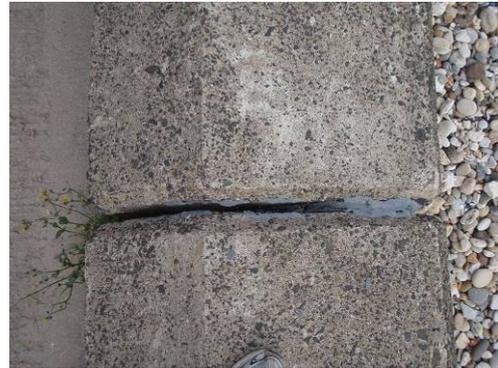
The effect of the high beach levels has been to protect the sea wall from direct wave action, but also to create a 'ramp' up which waves can run and overtop the sea wall, causing local erosion of the backing slopes. This process appears to have occurred recently directly behind the areas with highest foreshore levels due to the presence of cliff debris at the wall at the rear of the promenade (below left). Incidences of local abrasion damage, occasional cracking and missing gap sealant (below right) in the sea wall increase with progression towards its southern end.

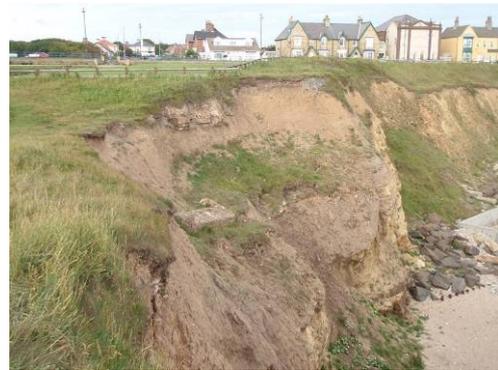
Around Featherbed Rocks, a rock revetment has been constructed extending around the headland and further south (below left). Where this structure stands proud of the toe of the cliff, some rockfalls and slumps in the softer material remain ongoing (slumps shown below right). In places this is releasing rubble down the cliff face.

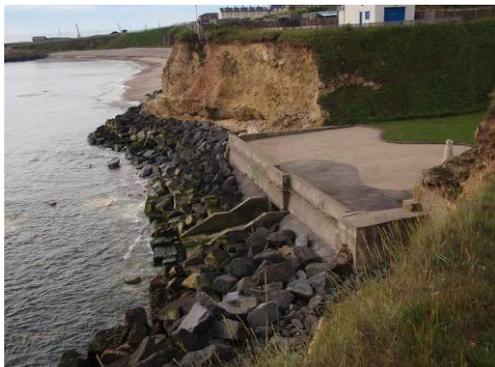
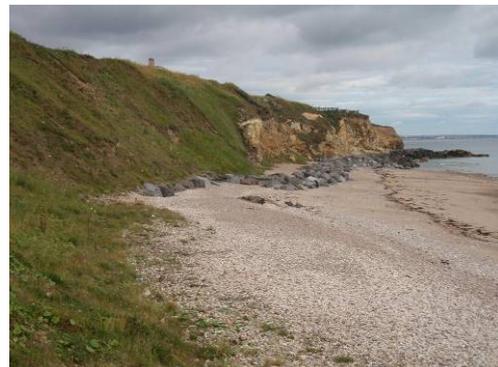
South of the headland, the rock armour protects a concrete platform (below left) and cliff top properties. There is slight outflanking at the tie-in between the platform and the cliffs which should continue to be monitored for signs of worsening. The rock revetment then starts to taper out with progression south (below right).

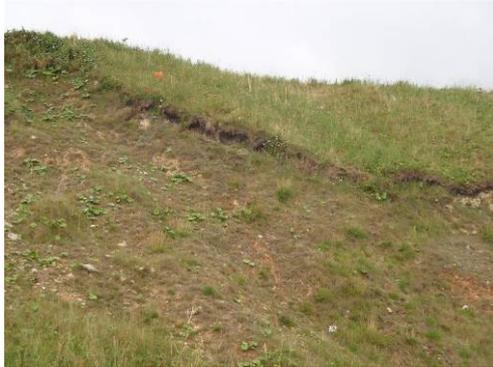
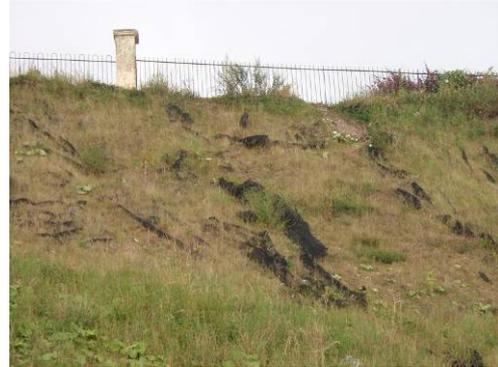
Along the lightly defended or undefended cliffs south of the formal revetment, there is evidence of ongoing slumping in the cliffs (below left), revealing soil netting in places near the access steps (below right).

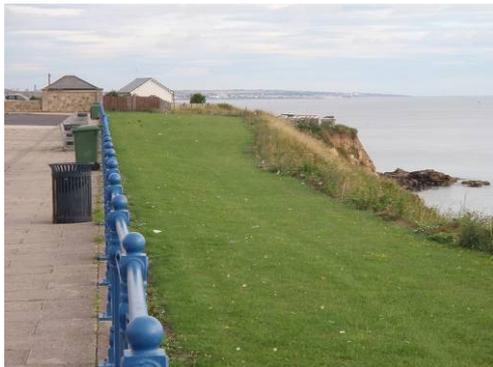
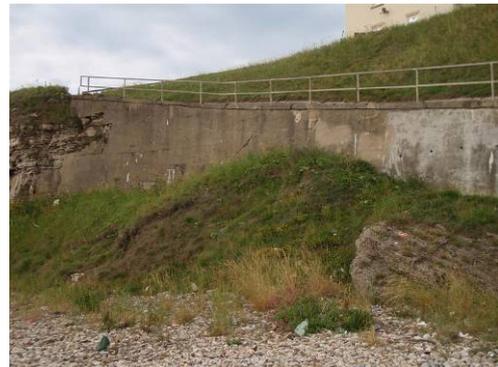
Due to this ongoing process, direct access to the cliff top from the car park has been prevented using robust fencing (below left). Access to the foreshore is made via a ramp which is protected by a vertical wall showing some cracking. Below the wall, the cliffs have experienced some slumping (below right) which should be monitored into the future.

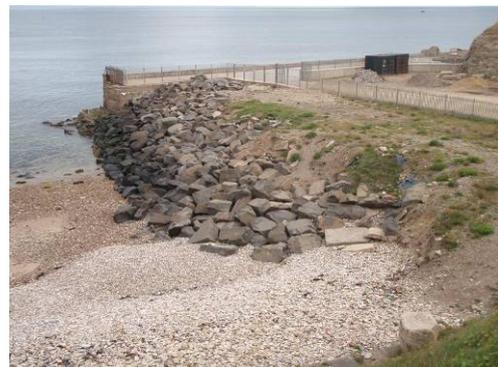
The cliffs in the small bay south of the access steps are well protected by high beach levels and are currently stable (below left). The landward end of North Pier, at Red Acre Point, has been reinforced with rock armour and although there appears to be some erosion to the landward end of this (below right), it is not worse than was recorded in 2008.

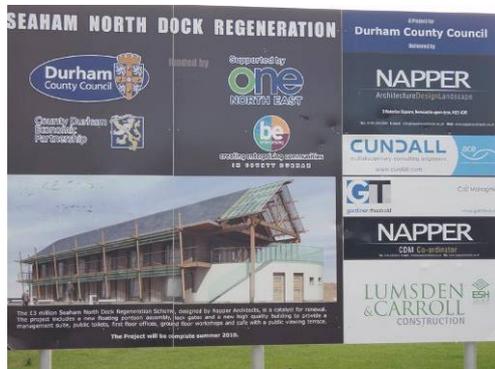
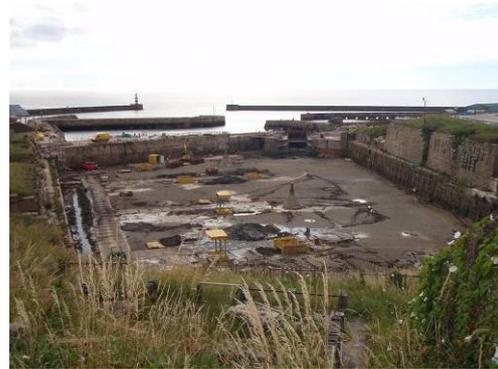
Seaham Harbour is privately-owned by the Seaham Harbour Dock Company, with most areas not being publicly-accessible. During the 2010 inspections, construction work was ongoing as part of the Council-supported £3M North Dock Regeneration Project, which will include a new floating pontoon, lock gates and dock-side facilities (below).

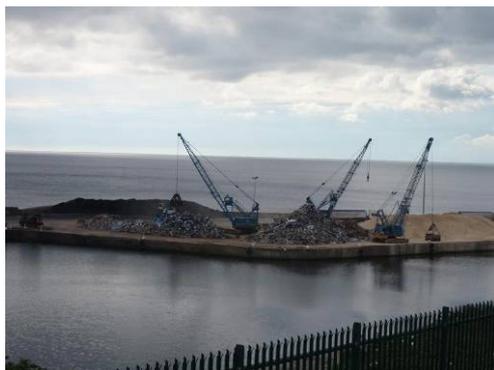
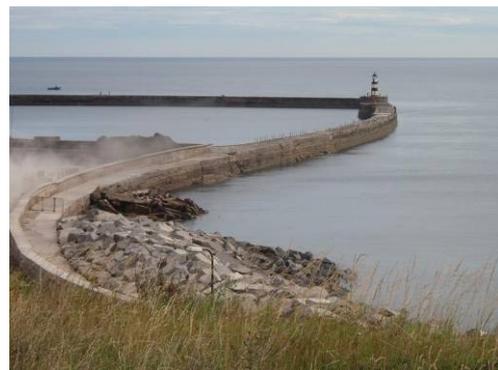
Along South Dock, considerable dock-related activity was ongoing (below left) so the structures at the root of the South Pier were only inspected from a distance. Rubble has been tipped along the seaward face of South Pier in one area fronting South Dock, with rock revetment then continuing to provide a more formal defence further south (below left).

Vessel-based inspections of Seaham Harbour by the Dock Company at appropriate intervals following construction of the regeneration project are recommended.

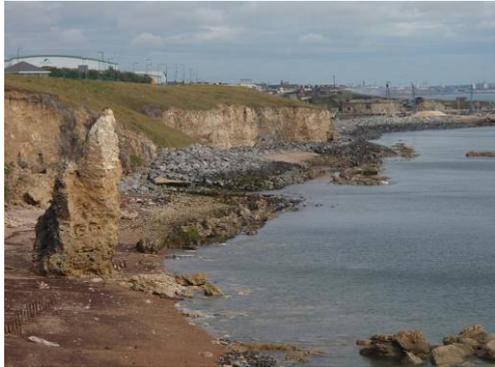
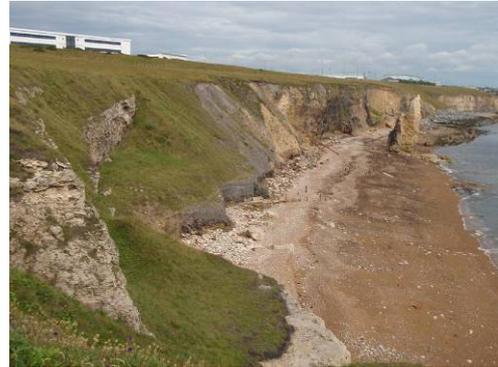
The frontage between Seaham Harbour South Pier and Seaham Fleet Rock is protected by a continuation of the rock armour revetment extending southwards from the South Pier (below left). This has stabilised the previously eroding cliffs. South of the revetment to Nose's Point, the cliffs are fronted by a colliery spoil slope which is actively cliffing at its seaward edge with occasional slumps in the upper spoil slope face (below right).

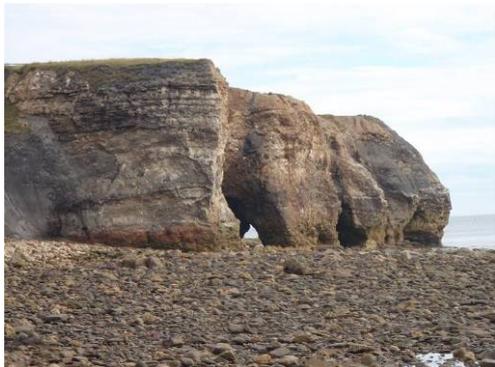
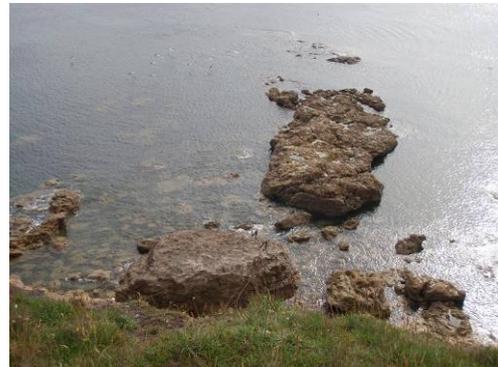
At Nose's Point headland, the cliffs characteristically have caves and arches formed at their base (below left), with rocky outcrops on the foreshore (below right). The headland appears relatively stable and exerts a control on both the Dawdon frontage to its north and Blast Beach to the south.

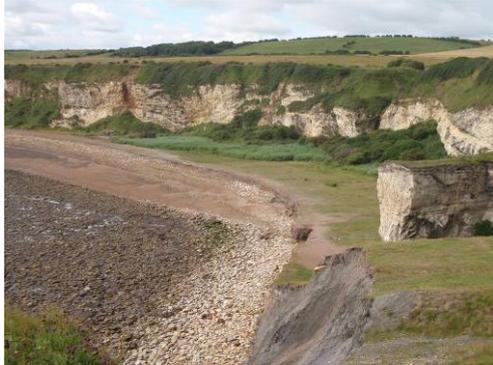
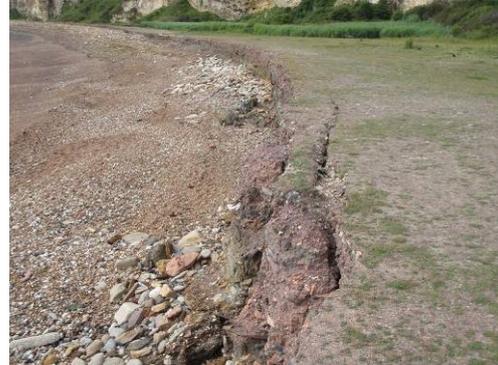
Between Nose's Point and Chourdon Point, the (now relict) cliffline is protected by a relatively wide colliery spoil beach (below left). In places there is cracking in the spoil clifflet (below right), indicating that clumps will continue to fail.

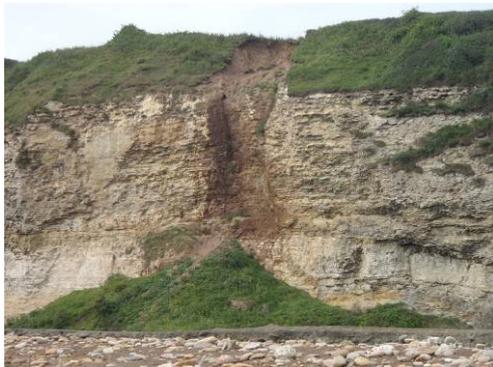
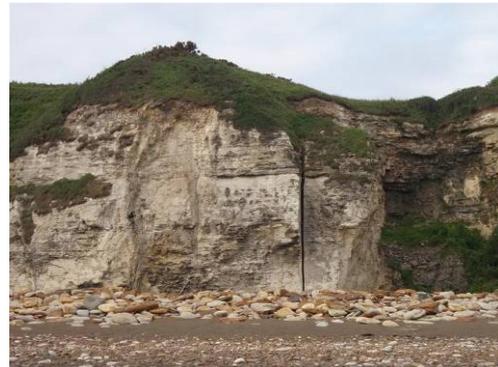
In general, the backing cliffs are stable and well vegetated, but there are areas of occasional slumps (below left) and cracks (below right).

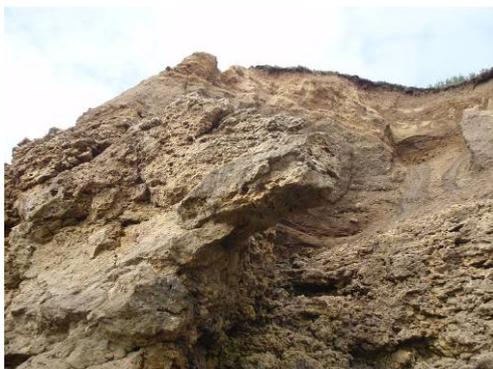
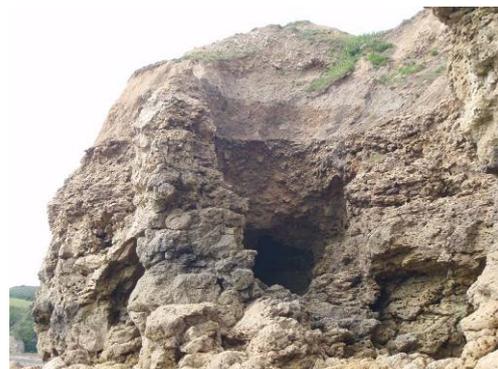
At Chourdon Point there is more evidence of fracturing in the harder rock structure, leading to caves at the base. There is more frequent slumping in the overlying till. There is a particularly vulnerable section at the 'point' of the headland, where rockfalls have left overhangs (below left) and a large cave has excavated through the rock structure to link up with an arch feature (below right). It is highly likely that the roof of this arch will collapse, leaving pillars standing.

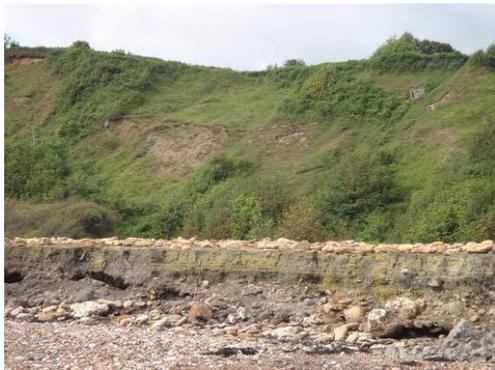
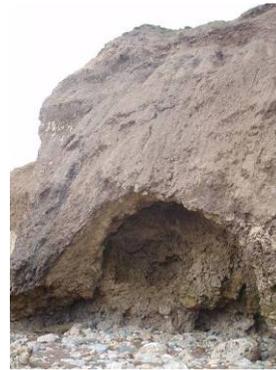
The colliery spoil beach at the base of the cliffs in Hawthorne Hive is in places cliffing, showing signs of ongoing erosion. The waste beach becomes wider and higher in the centre of the bay, where the backing cliffs become much more stable as a consequence (below left). The cliffs at Hive Point become a little more fractured in structure with caves forming at the base (below right) and south to Beacon Point there is yet more activity, with local rockfalls and large rock stacks and smaller pillars on the foreshore. There are some areas where slumps of the softer material have occurred and one wide but shallow cave has formed at the base of the cliffs just north of Beacon Point.

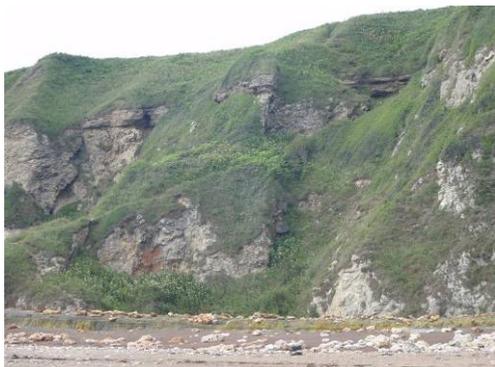
The colliery spoil beach at Shippersea Bay again provides protection to the backing cliffs (below left). There is a clear distinction (below right) at the northern end of the bay, just south of Beacon Point, between where colliery spoil protects the cliff and where the cliffs are unprotected.

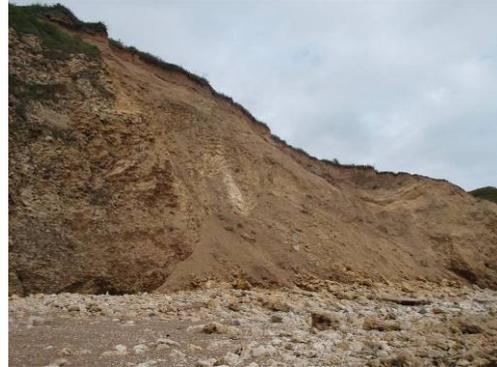
Around Shippersea Point the cliffs are subject to cave and arch formation at their base, with local rockfalls occasionally occurring (below left). The cliffs around Shot Rock and Loom are particularly active with rockfalls and there has been one large collapse from the upper cliff section (below right), resulting in fencing being erected near this susceptible cliff edge to locally divert walkers away from the cliff-top footpath.

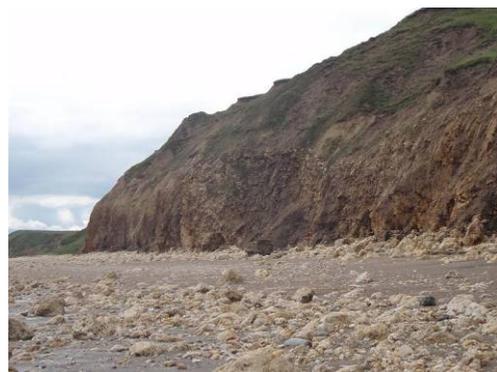
Between Loom and Fox Holes colliery waste again provides a protective beach (below left) but south from the outfall at Fox Hole Dene to Horden Point, the cliffs again are eroding through occasional slumps (below right).

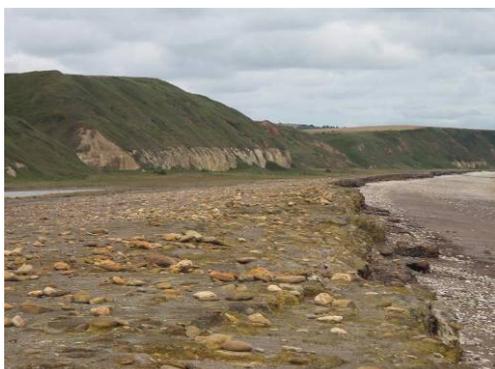
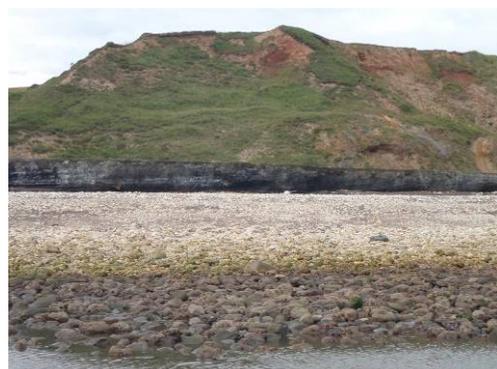
Between Horden Point and Blackhall Rocks there is the greatest uninterrupted length of colliery spoil beach (below left). This protects the backing cliffs from marine action, enabling them to become stable and vegetated (below right).

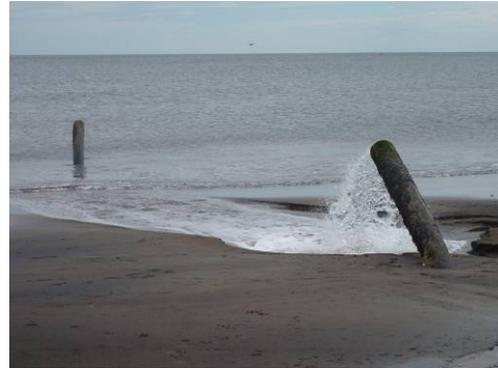
Several lagoons are also formed at the rear of the spoil beach, where levels are sufficiently high to prevent regular marine action (below left). There is one location where some outfall pipes are present on the lower foreshore, one of which is still discharging (below right), as well as some debris from a concrete structure.

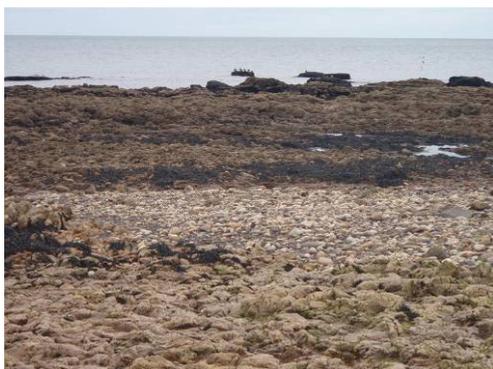
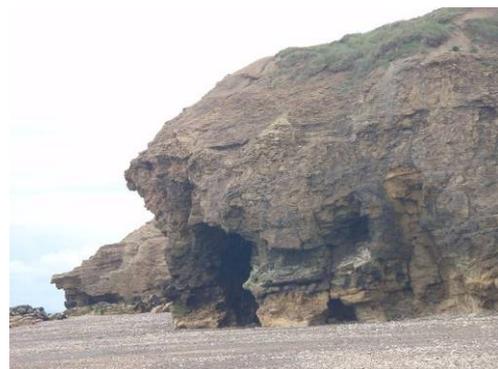
At Blackhall Rocks there is an extensive rocky outcrop on the foreshore (below left), and the backing cliffs around Gin Cave have cave formation at their base (below right).

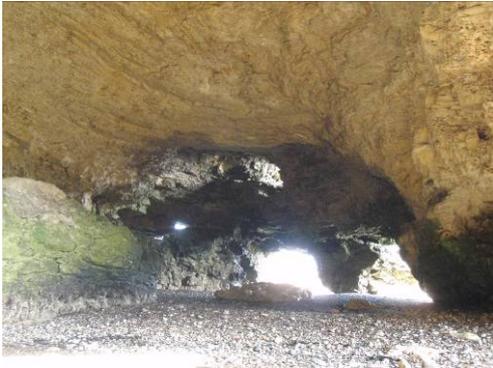
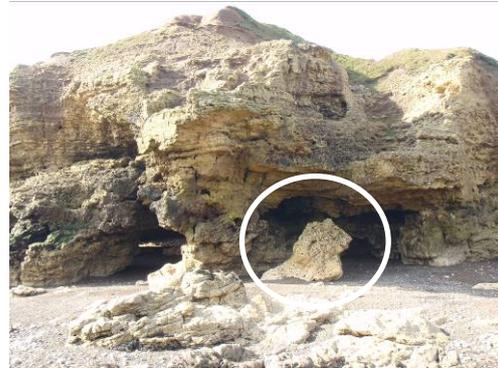
Gin Cave is an extensive cave with multiple openings (below left). The cave roof and walls appear relatively stable although there is evidence of historic failure as a large piece of rock has fallen from the roof above the northern entrance and now stands on the foreshore (below right).

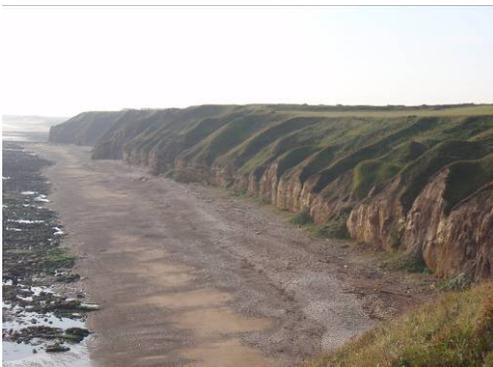
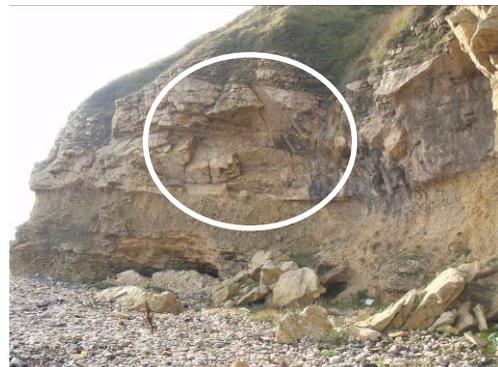
The frontage south of Blackhall Rocks is protected by the rock scars of the foreshore. The cliffs are formed from softer material overlying a near vertical hard rock base (below left). The softer material is slumping throughout although the extensive vegetation coverage indicates a relatively slow rate of erosion. Where material has fallen onto the foreshore, vegetation is present, suggesting a relatively stable environment. Rock falls from oversteepened/overhanging sections are evident locally as material is present on the foreshore (below right). Fractures are visible in the rock indicating potential failure locations in the future.

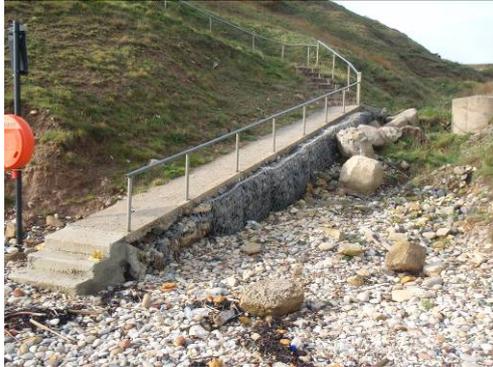
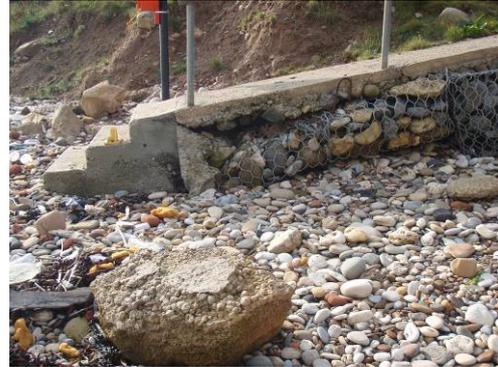
Timber access steps lead to a concrete access ramp to the south of Limekiln Gill (below left). The ramp is supported on rock filled gabion baskets which are generally in good condition. Erosion at the bottom of the ramp has led to the loss of a section of concrete, resulting in a local reduction in support to the slab (below right). At present there is no significant movement or distress to the structure although the situation should continue to be monitored.

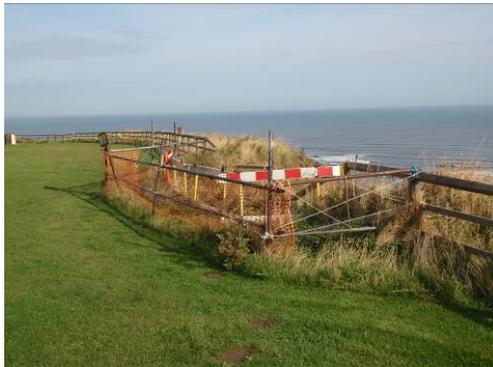
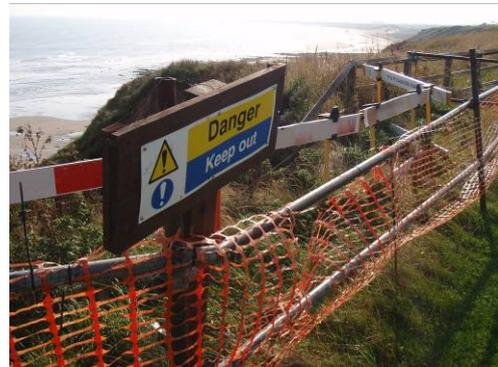
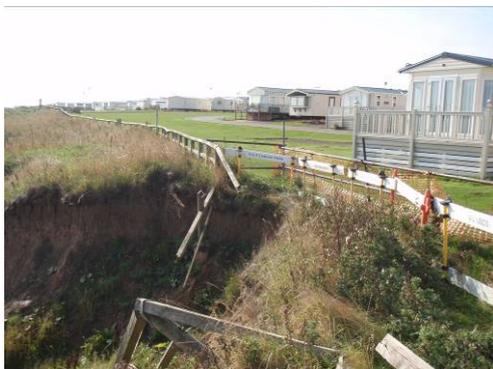
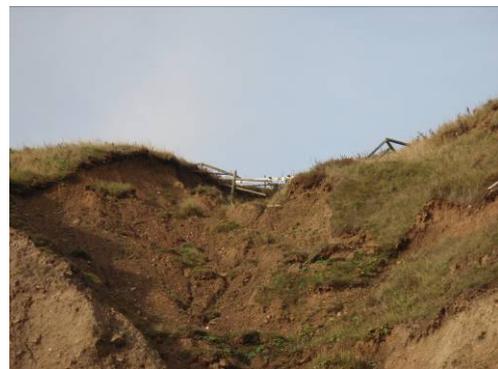
- A local slope failure has occurred within Crimdon Park Caravan Site and a temporary barrier has been erected from steel tubing and plastic fencing with warning signs erected to warn members of the public.

A local slope failure has occurred within Crimdon Park Caravan Site. Approximately 100m north of the Crimdon Park access steps, the timber fencing has been lost over a length of approximately 10m. A temporary barrier has been erected from steel tubing and plastic fencing with warning signs erected to warn members of the public (below).

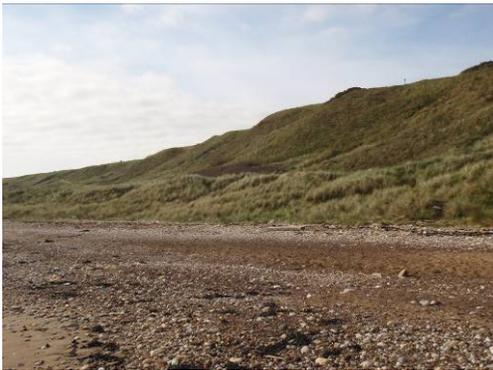
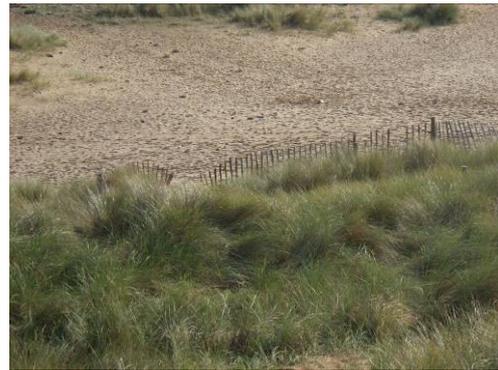
Between the southern extent of Crimdon Park Caravan Site and Crimdon Beck, the frontage comprises of extensive dunes (below left). This length of frontage is not sheltered by protective scars, however a wide sandy beach is present.

Chesnut fencing (below right) is in place to aid with sand accretion and control pedestrian access around the access steps from the car park, where minor erosion is evident.

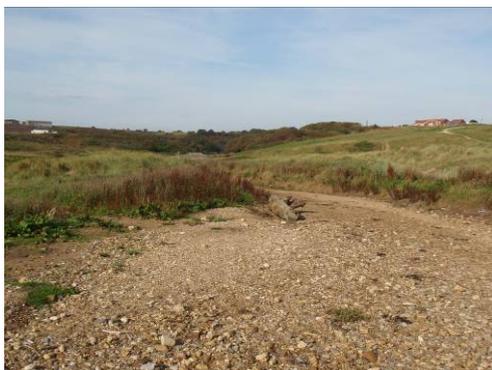
A network of informal footpaths crosses the dunes in addition to the more formal boardwalks and aggregate footpaths. This has led to loss of vegetation and minor lowering of the dunes in proximity to these routes.
