Walk-over Visual Inspections of Assets

**Hartlepool Borough Council
Final Report**

October 2012

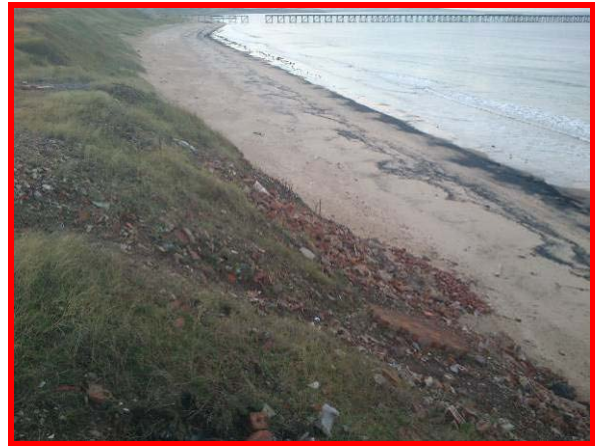
Eroding embankment / cliff previously protected by brick filled gabions.
(Asset ref. No. 1221C901C0302C02)

The slag embankment previously had a short, around 100m near vertical section (Asset ref. No. 1221C901C0302C02) protecting the cliff adjacent to a former large industrial building, that was protected by brick filled wire gabions, see photos from 2008 and 2010 below. Many of the failing gabion baskets were removed on health and safety grounds prior to the 2010 inspections and the asset now consists of a brick / waste rubble slope/revetment rather than the vertical structure observed in 2008 (above right).

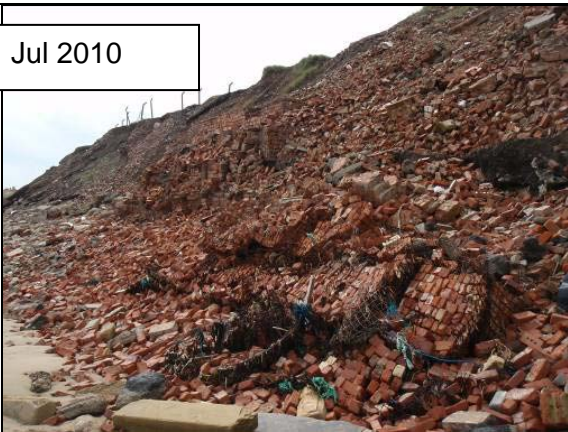
Jul 2010

(Asset ref. No. 1221C901C0302C02)

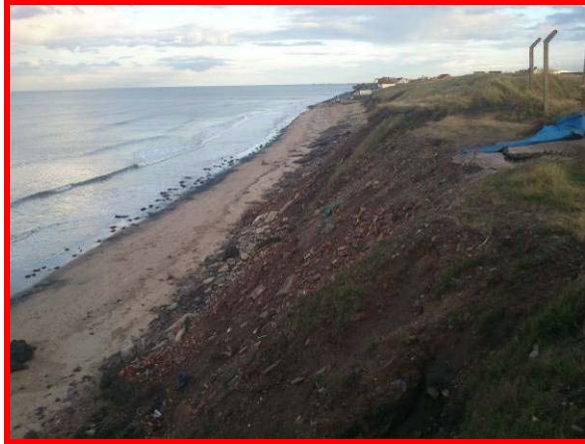
Eroding embankment cliff, previously protected by brick filled gabions which have failed.
(Asset ref. No. 1221C901C0302C02)

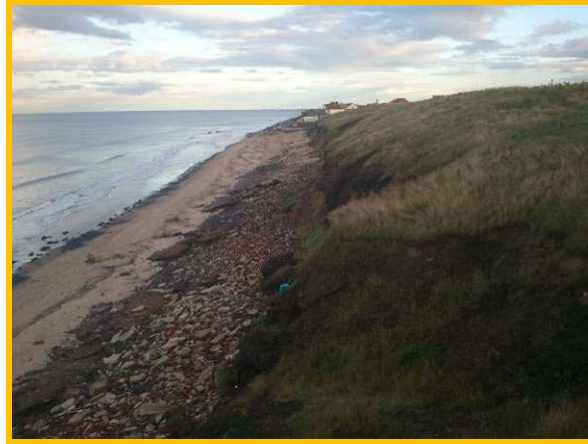
Eroding slag embankment to north west of Marine Drive.
(Asset ref. No. 1221C901C0302C03)

The slag and rubble embankment to the north of Marine Drive (Asset ref. No. 1221C901C0302C03) has deteriorated further since the 2010 inspections, with greater erosion of the steeper vegetated embankment to the rear (above right), leading to areas of undercutting and overhangs. The former protective chemical slag apron has largely broken up, and the underlying cobble / rubble slope appeared lower than in previous years, although it may just be that beach sand levels were high. The short section of rock armour at the interface between the slag bank and Marine Drive seawall was in fair condition, partly covered with sand, although this may have been at least partly related to works underway on the adjacent seawall.

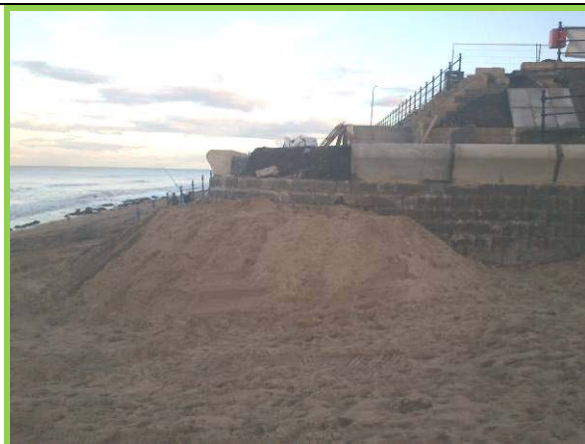
Works underway to replace sections of seawall at return end (Asset ref. No. 1221C901C0303C01)

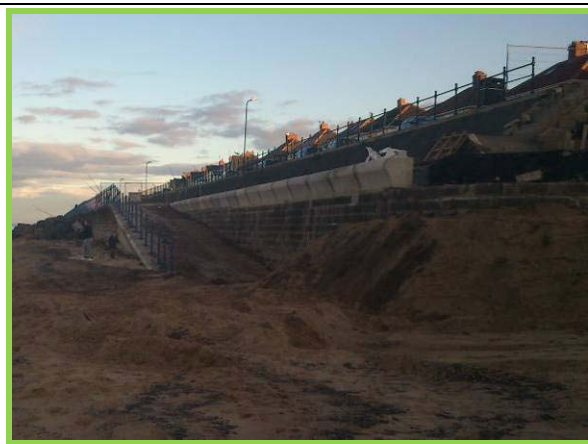
Works underway to replace sections of seawall at return end (Asset ref. No. 1221C901C0303C01)

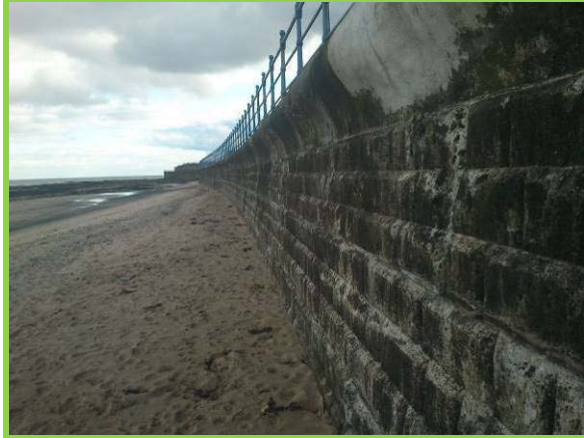
View of blockwork wall with repairs to cope.
(Asset ref. No. 1221C901C0303C01)

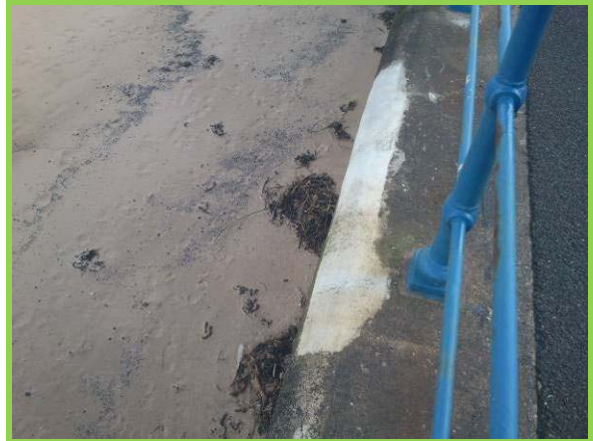
Patch repairs to coping on Marine Drive
holding well.
(Asset ref. No. 1221C901C0303C01)

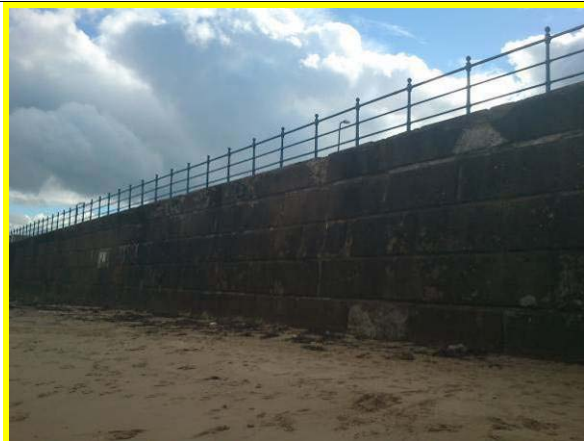
Blockwork wall at Sea View terrace.
(Asset ref. No. 1221C901C0303C02)

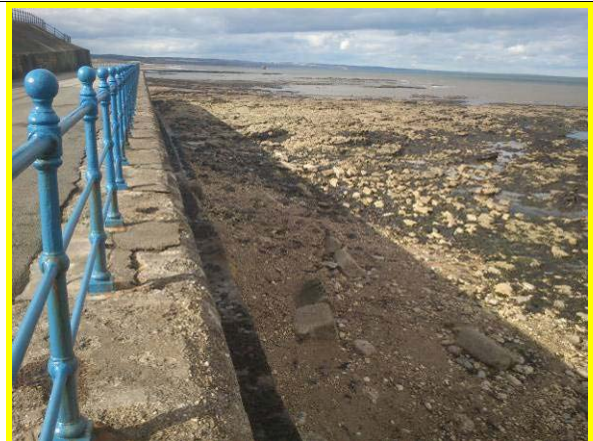
Damage to concrete coping units increases
towards south. (Asset ref. No.
1221C901C0303C02)

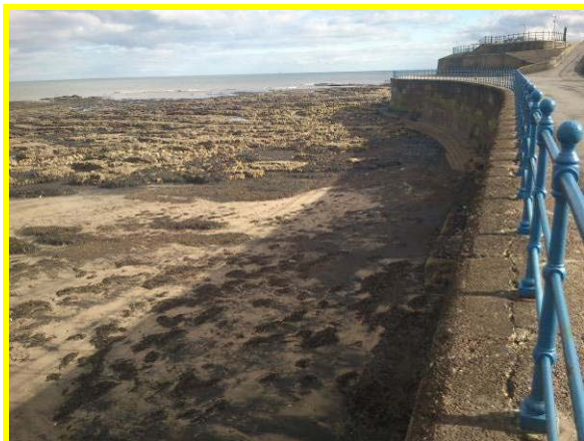
View of wall in fair overall condition, looking
south (Asset ref. No. 1221C901C0303C02)

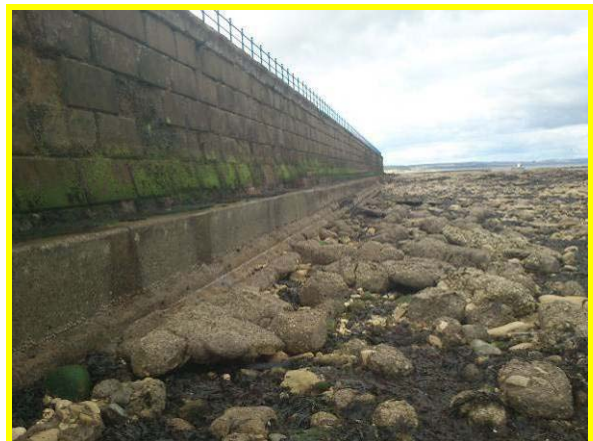
Scour and abrasion at wall toe (Asset ref. No.
1221C901C0303C02)

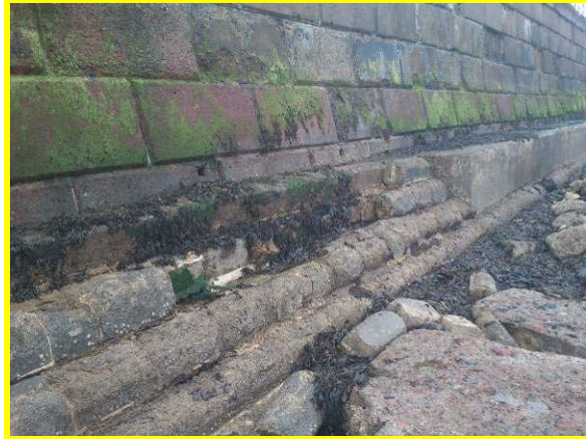
Damage to concrete toe (Asset ref. No. 1221C901C0303C02)

The concrete toe was visible along the majority of the length of seawall, with a sand beach only present at the northern end, near Sea View Terrace. The toe consists of a variety of constructions from older stepped concrete profiles to more recent massive precast concrete blocks and insitu fill and was in fair to good condition throughout. In some locations the most recently placed sections were in very good condition. However, in several other locations where new concrete units were not present at the toe, the older sections of toe had been undercut locally as the soft rock on which the wall is founded gets abraded and worn down (above right) and toe units had been displaced, requiring repair.

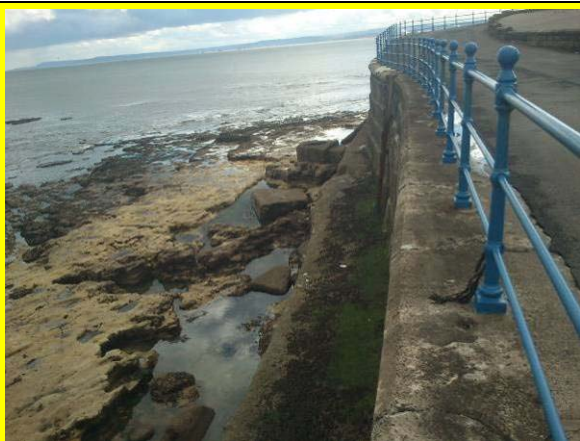
Stepped wall at apex of Headland, showing previous failed units placed in voids on foreshore.(Asset ref. No. 1221C901C0303C03)

The short length of wall at the apex of the headland (Asset ref No. 1221C901C0303C03) near the Coastguard building, above left, has a slightly stepped profile to the concrete blocks. Previous repairs to the capping beam are showing further damage. There have been extensive previous repairs and as the area around here is the most exposed section of defence there is a need for regular ongoing maintenance. There was evidence of fairly recent repairs to grout voids under the toe apron and a number of previously failed blocks are present scattered on the foreshore.

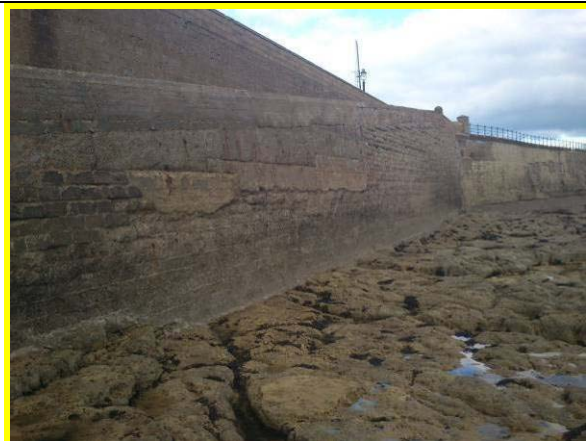
Surface abrasion damage to wall adjacent to ramp showing multiple previous repairs. (Asset ref. No. 1221C901C0303C04)

The smaller blockwork wall with rendered sections (Asset ref No. 1221C901C0303C04) immediately south of the apex of the headland was in fair to locally poor condition; see above right and below left. There are some missing blocks, extensive abrasion damage, pitting of block surfaces, parts of the wall are bulging and there is extensive cracking in the buttress sections. There are numerous previous patch repairs with some requiring further attention.

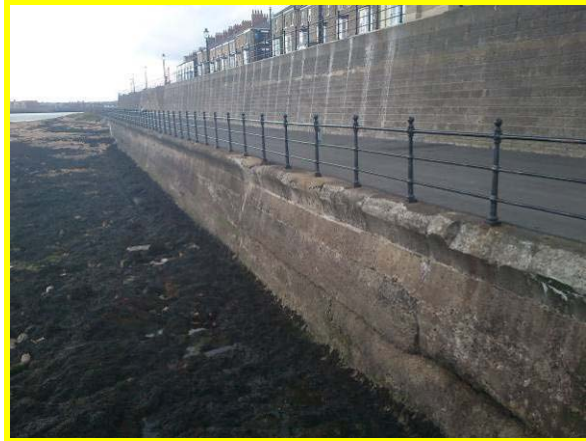
Spalling and damage to coping of front wall
(Asset ref. No. 1221C901C0401C05)

Spalling was evident to the curved coping of the adjoining concrete seawall (above right) (Asset ref. No. 1221C901C0401C05) that links between Block Sands wall and the Old Pier. The damage was worst at both ends, where foreshore levels are lowest although there have been repairs near the Old Pier, see below right.

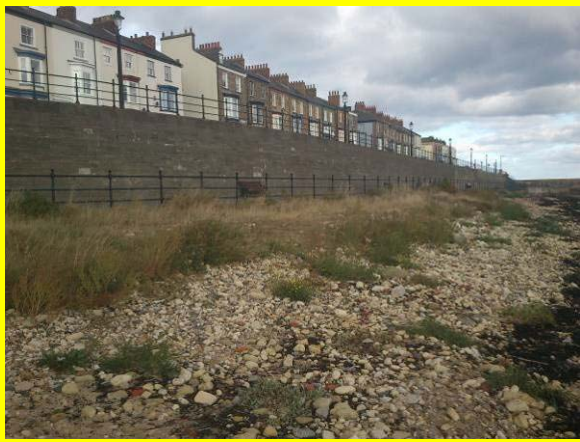
High cobble beach at mid-length of wall
(Asset ref. No. 1221C901C0401C05)

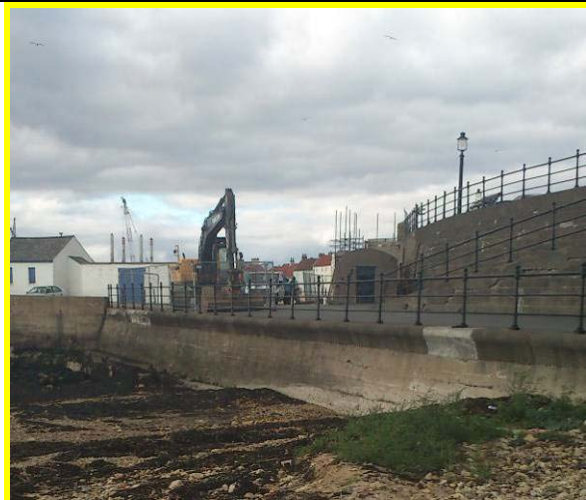
Repaired section of coping in foreground,
further damage in distance
(Asset ref. No. 1221C901C0401C05)

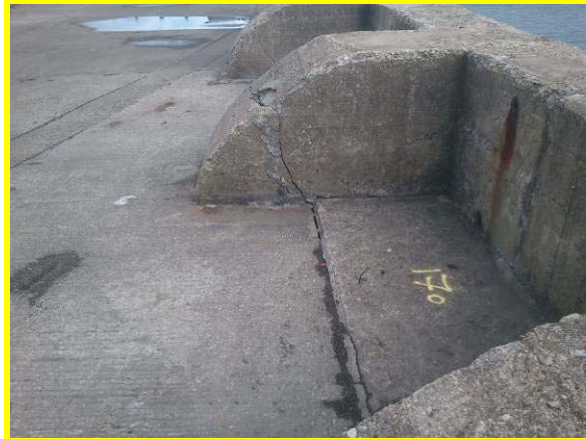
Cracks through deck and crest wall.
(Asset ref. No. 1221C901C0401C34)

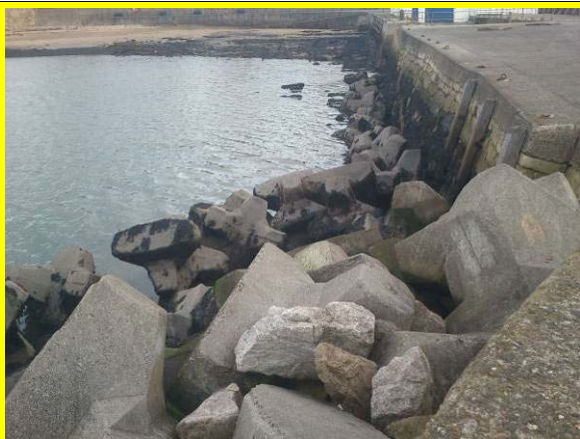
Settlement was also apparent in the inner face of the Old Quay, see below left, although this appeared to be historical movement. Works were underway to rebuild a set of access steps and adjacent buttress wall in the rear retaining wall behind the root of the Old Pier (below right).

Landward side of Old Pier showing settlement
in the (original?) masonry blockwork.
(Asset ref. No. 1221C901C0401C06)

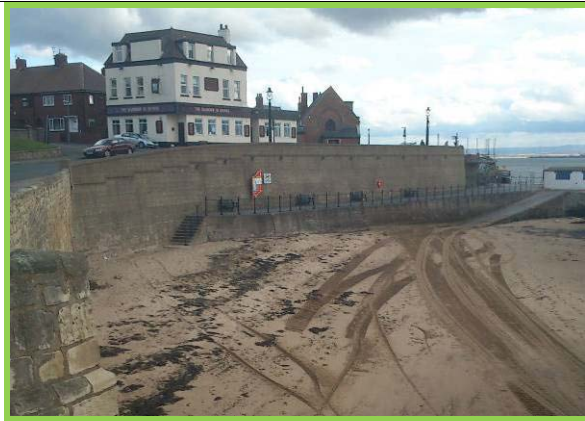
Masonry wall at south east end of Town Wall.
(Asset ref. No. 1221C901C0401C35)

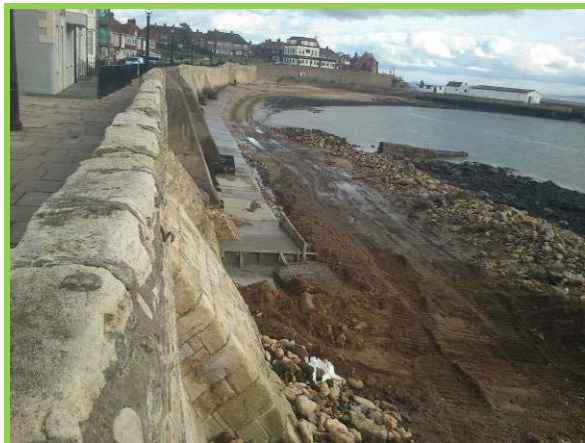
Toe protection apron works underway at Town Wall, (Asset ref. No. 1221C901C0401C35)

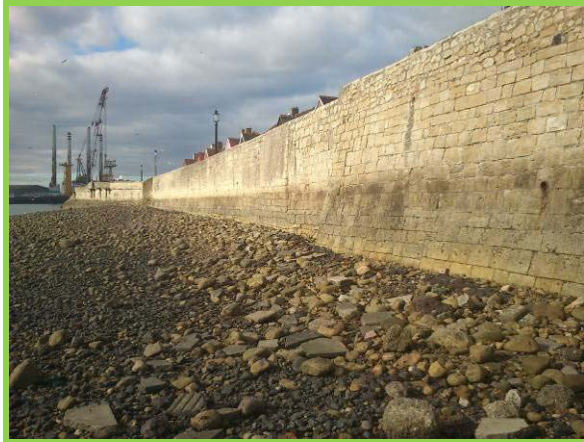
steps at the old ferry terminus are in poor to fair condition with significant corrosion to the steps and spalling to the wing walls with missing masonry. However, the condition of this part of the structure is not a significant concern since the area is barriered off to the public.

Western section of Town Wall showing low beach levels,
(Asset ref. No. 1221C901C0401C35)

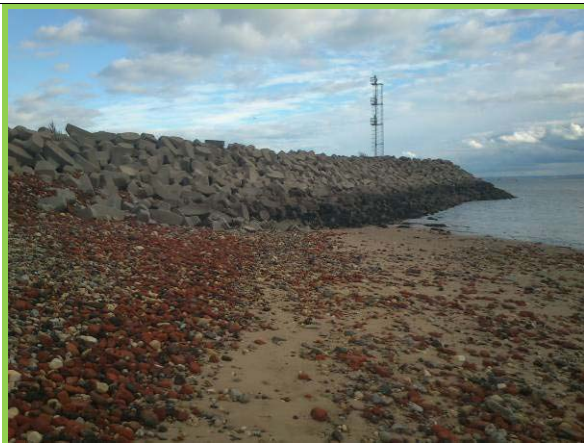
Middleton Jetty in good condition. Retains sand and rubble beach to south
(Asset ref. No. 1221C901C0401C16)

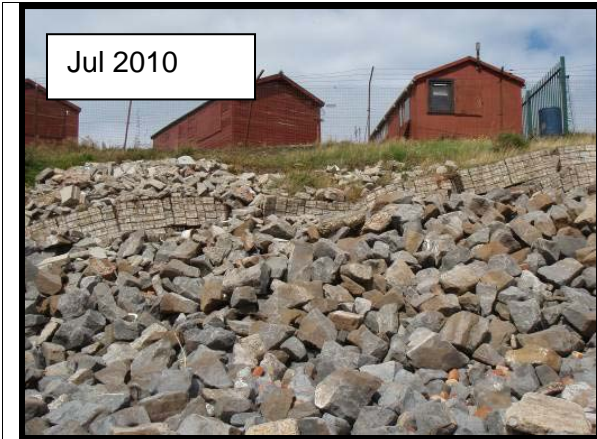
Adjacent to Middleton Jetty to the south is a gabion basket wall with a stepped profile, (Asset Ref. No. 1221C901C0401C17). The Gabion baskets (below left and right) are fronted by low sand dunes in the north and rock armour in the south. Rock armour units increased in size towards the south and appear to be performing well. The gabion baskets were reported to have settled locally in 2010 inspections and the situation appeared very similar in 2012, see photos below. The baskets were still largely intact although should be monitored as the wall could unravel rapidly should baskets fail. Consideration should be given to adding more rock armour, and reprofiling the rock in front of the failing gabions.

View of Gabion baskets with rock armour.
 Photo from 2010 report.
 (Asset ref. No. 1221C901C0401C17)

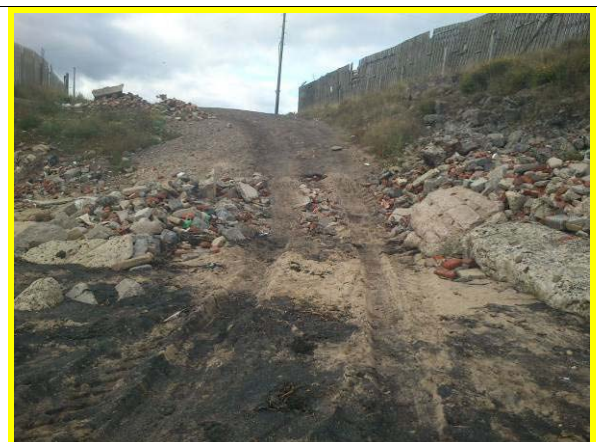
Informal beach access ramp with tipped
 demolition waste.
 (Asset ref. No. 1221C901C0401C18)

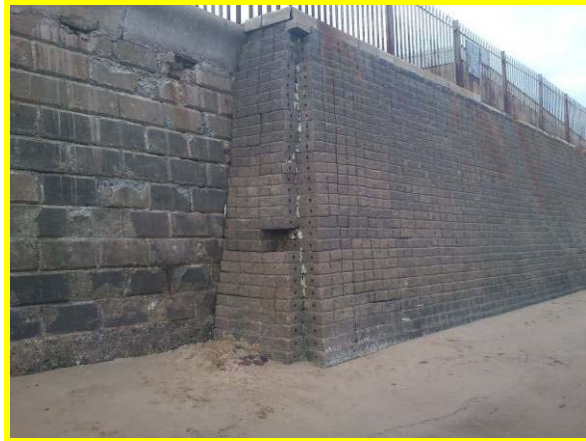
Missing blocks at interface between two sections of wall
(Asset ref. No. 1221C901C0401C19)

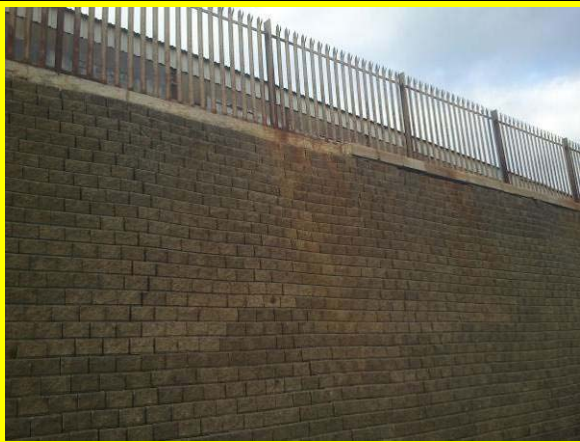
Missing coping stones and bulging of the wall.
(Asset ref. No. 1221C901C0401C19)

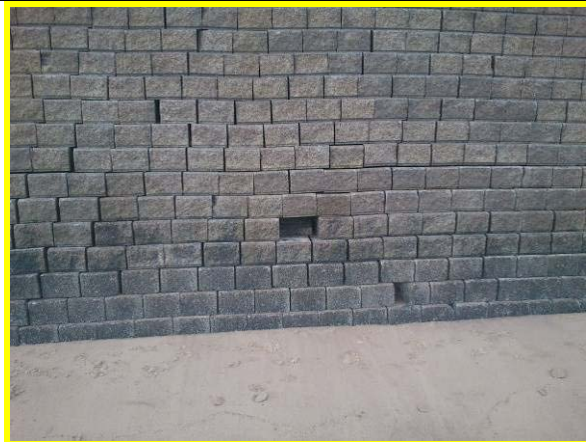
Missing blocks and opening joints
(Asset ref. No. 1221C901C0401C19)

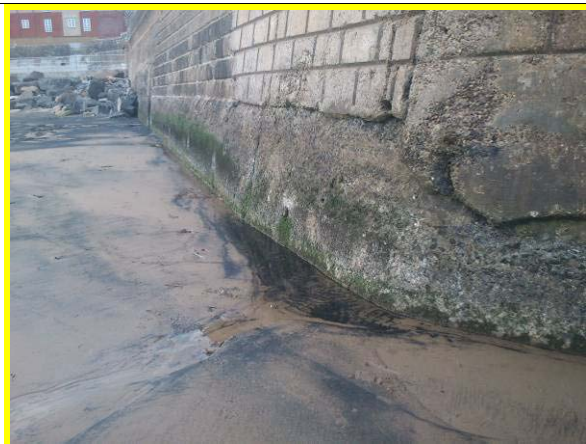
The concrete block wall to the south has extensive abrasion damage to the faces of the blockwork (below left), particularly at lower levels, see below left and right. Cracking of the concrete coping was also observed and there are a previous repairs to damage to the facing of the south facing section of wall that appears to be holding well.

Toe scour and abrasion damage at corner of wall (Asset ref. No. 1221C901C0401C19/20)

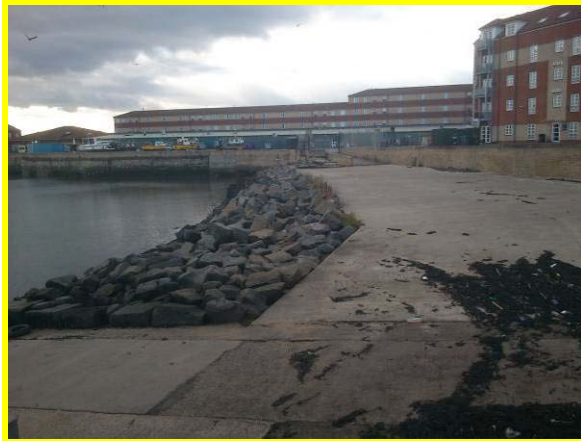
The rock armour revetment overlaying the former stone stepped revetment at the north end of West Harbour (Asset ref. No. 1221C901C0401C23) appeared to be in fair condition, below left. The mass quay wall structure at the rear of the harbour, to the north side of the lock (Asset ref.

Revetment at north end of West harbour.
(Asset ref. No. 1221C901C0401C23)

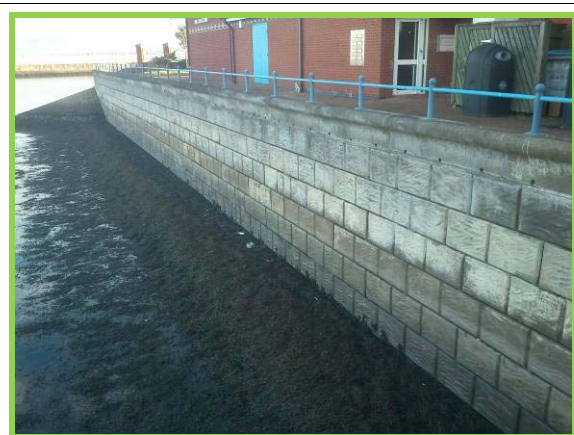
Wall to south side of lock entrance, toe apron covered in seaweed.
(Asset ref. No. 1221C901C0401C25)

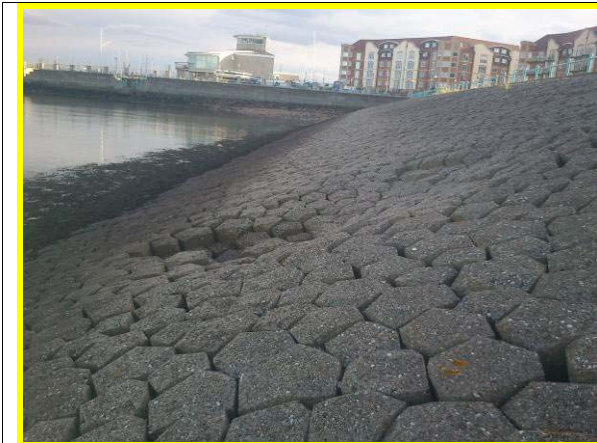
The concrete block set revetment (Asset ref. No. 1221C901C0401C25) fronting Slake Terrace was in good condition, apart from an area of settlement with a diameter of about 2m. This defect has been noted on the inspections since 2008 and does not appear to have changed significantly. As noted previously, the settlement is indicative of a local loss of fill material below the concrete blocks and should continue to be monitored as further loss could reduce the integrity of the asset.

Area of settlement in block revetment
(Asset ref. No. 1221C901C0401C25)

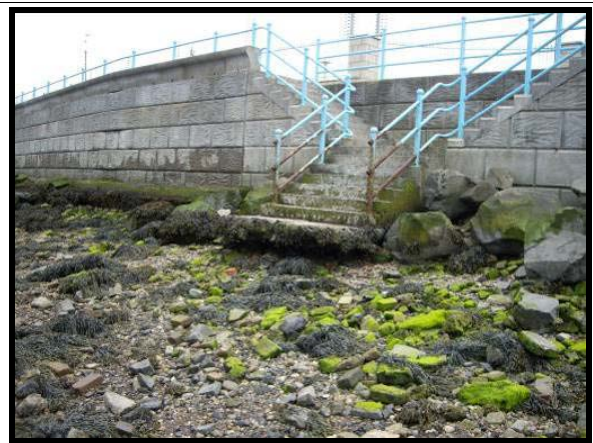
Photo from 2010 report
(Asset ref. No. 1221C901C0401C27)

The vertical quay wall landward of Middle Pier, to the north of the Yacht Club was noted to have problems with undercutting at the steps and slipway from the yacht club in the 2010 inspections, see photo above right. The situation was similar in October 2012, with undercutting at the slipway, the steps and also at the wall between the steps and the slipway. The voids under the apron should be repaired and additional protective rock armour placed to reduce wave reflections and help avoid further scour damage.

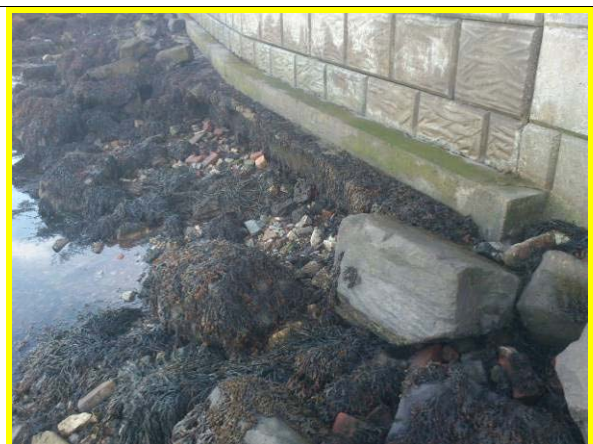
Exposure of wall toe at gaps in toe armour
(Asset ref. No. 1221C901C0401C27)

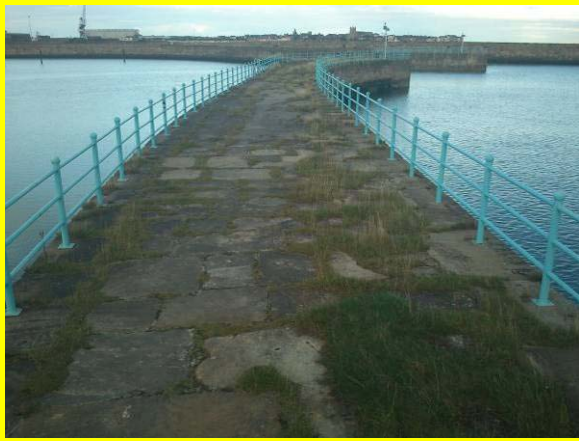
Middle Pier appeared to be in fair condition, although there was significant growth of vegetation in gaps in the masonry slabs in the deck, which should be removed and the gaps repointed, see below left. The lower parts of the structure were heavily obscured by seaweed, but where visible appeared in fair condition with some loss of mortar to joints.

Vegetation growing in between masonry slabs and patch repairs in deck of Middle Pier (Asset ref. No. 1221C901C0401C28)

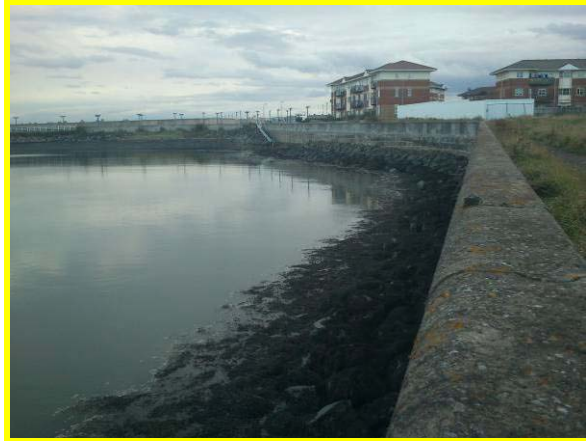
Rear flood wall at south part of West Harbour in fair condition. (Asset ref. No. 1221C901C0401C29)

The old masonry wall with newer concrete parapet flood wall along the rear of the southern part of the harbour, above right was in fair condition. There was again heavy coverage with seaweed obscuring the defence, but some open joints requiring repointing were visible in places.

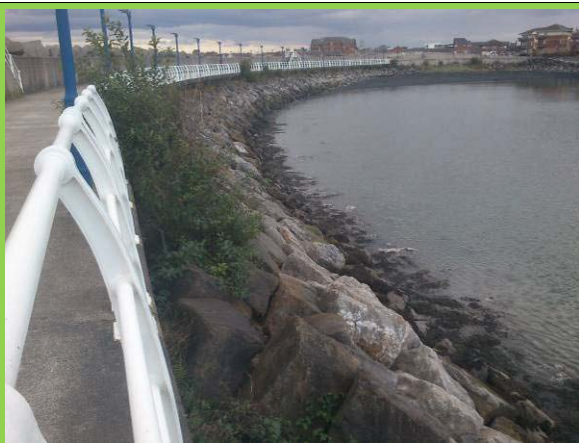
South Pier rock armour on inner face, with vegetation that should be removed. (Asset ref. No. 1221C901C0401C32)

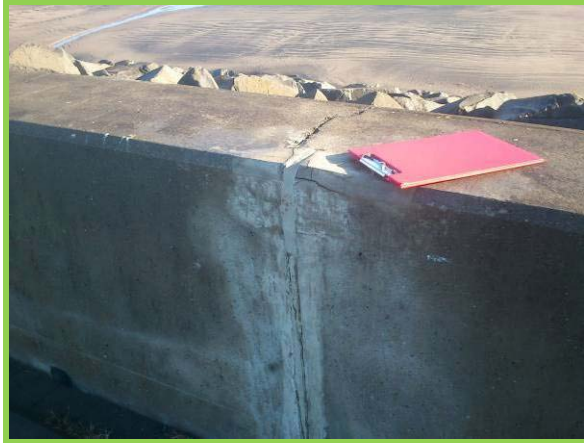
Construction joint in crest wall with failed previous repairs south of Newburn Bridge
(Asset ref. No. 1221C901C0401C33)

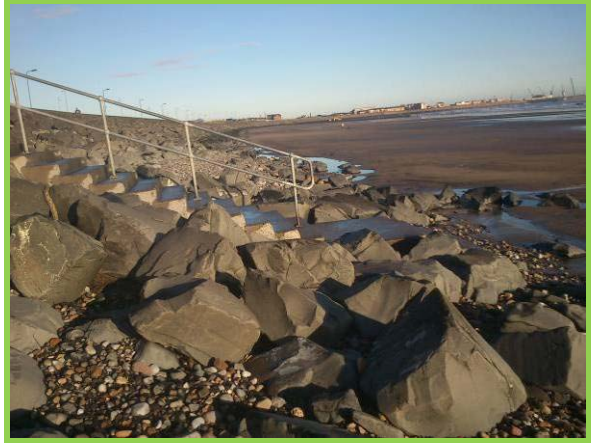
Displacement of rock armour near steps south of Newburn bridge
(Asset ref. No. 1221C901C0401C33)

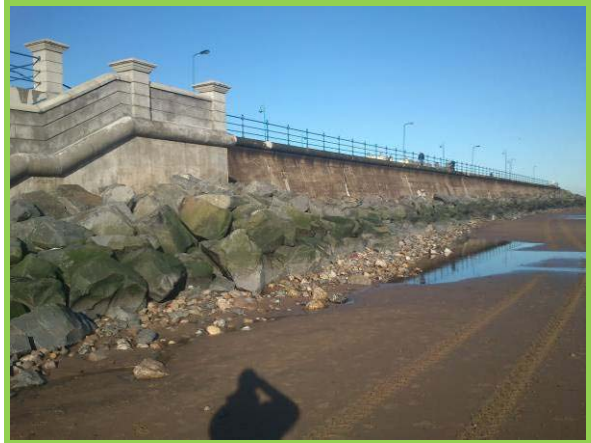
Northern set of steps has been substantially repaired / rebuilt since 2010 (Asset Ref. No. 1221C901C0501C05)

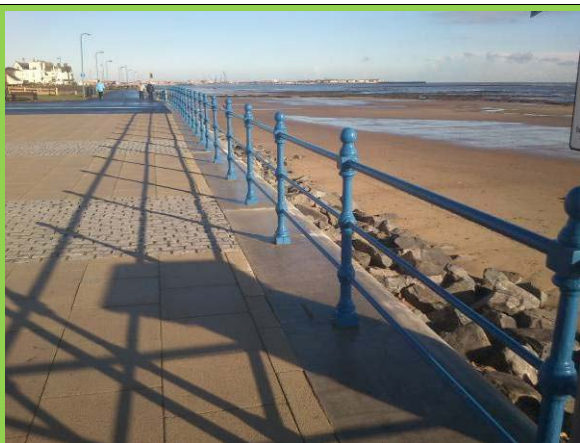
Repaired coping and promenade (Asset Ref. No. 1221C901C0501C05)

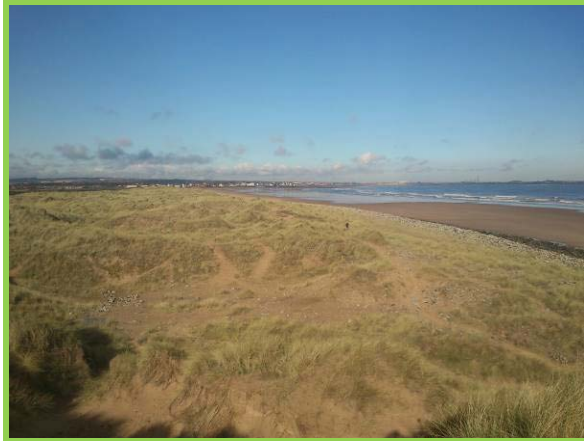
View of dunes at Seaton Sands from near North Gare Breakwater, showing informal paths through dunes causing local erosion.
(Asset ref. No. 1221C901C0502C01)

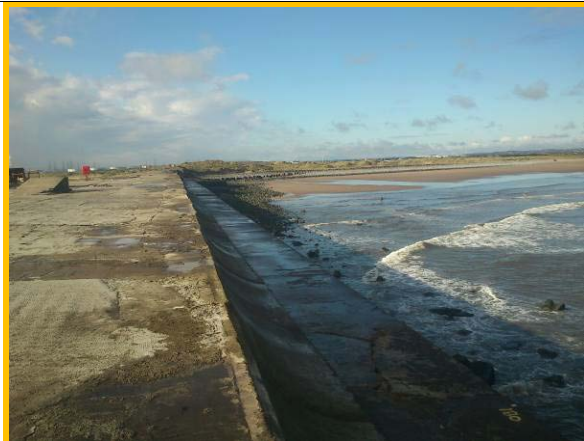
View of upper deck level showing patch repairs and northern side of breakwater from near fence.
(Asset ref. No. 1221C901C0502C01)

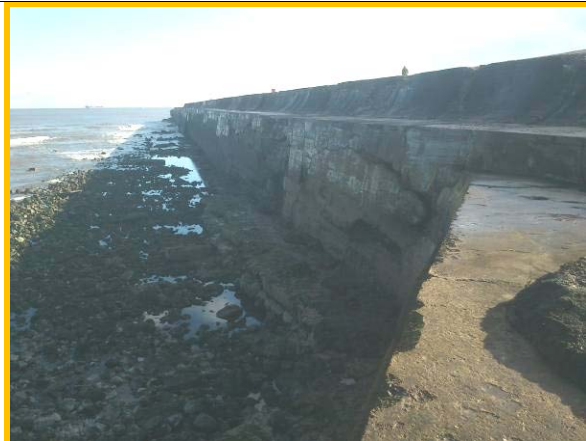
Northern side of breakwater, with extensive cracking and voids.
(Asset ref. No. 1221C901C0502C01)
