## Walk-over Visual Inspections of Assets

**Hartlepool Borough Council  
Final Report**

**July 2014**

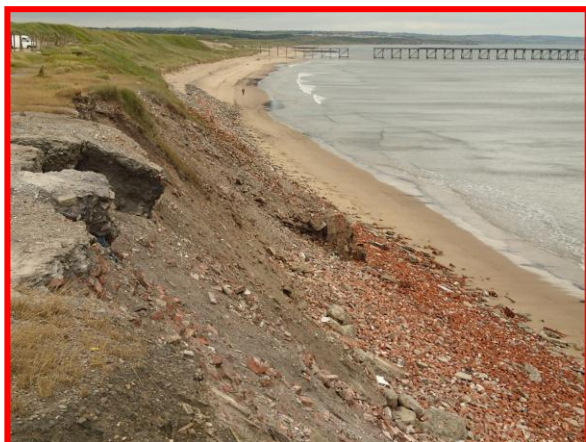
Eroding embankment / cliff previously protected by brick filled gabions.  
(Asset ref. No. 1221C901C0302C02)

The slag embankment previously had a short, around 100m near vertical section (Asset ref. No. 1221C901C0302C02) protecting the cliff adjacent to a former large industrial building, that was protected by brick filled wire gabions, see photos from 2008 and 2010 below. Many of the failing gabion baskets were removed on health and safety grounds prior to the 2010 inspections and the asset now consists of an eroding brick / waste rubble slope (above right) rather than the vertical structure observed in 2008.

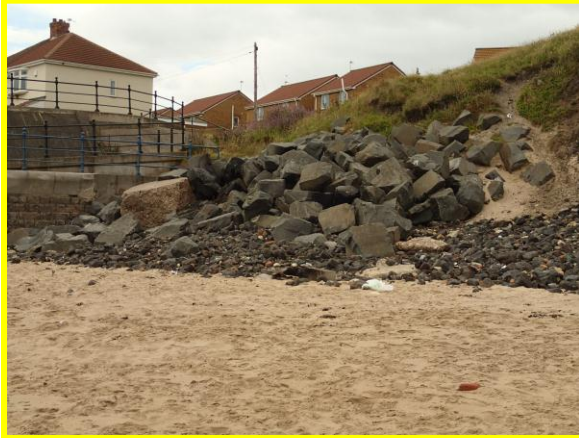
Rock armour at intersection of Marine Drive and slag bank (Asset ref. Nos. 1221C901C0303C01 / 302C03)

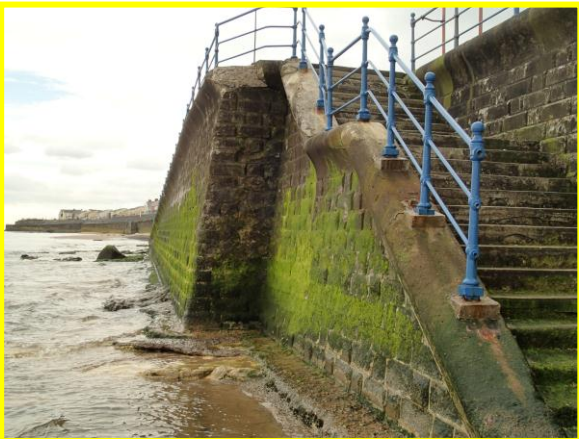
View of blockwork wall with damaged cope and cracking (Asset ref. No. 1221C901C0303C01)

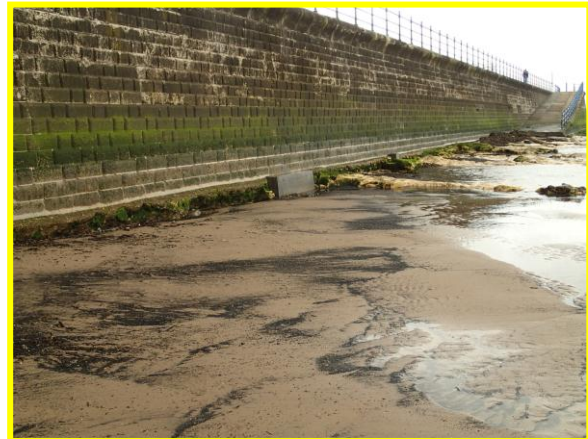
Local repairs to toe have been undertaken but further work is needed to toe and damaged coping. (Asset ref. No. 1221C901C0303C01)

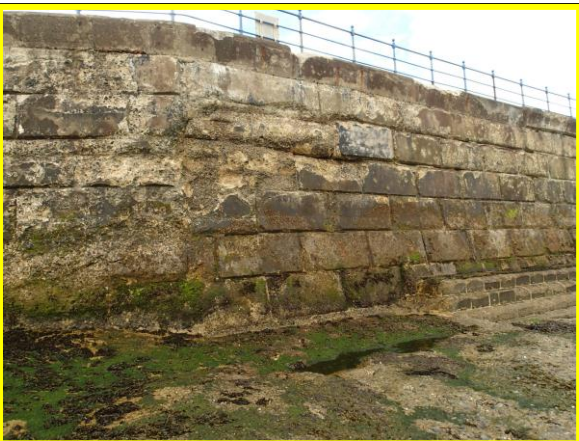
Abraded blockwork wall near Broad Field rd. (Asset ref. No. 1221C901C0303C02)

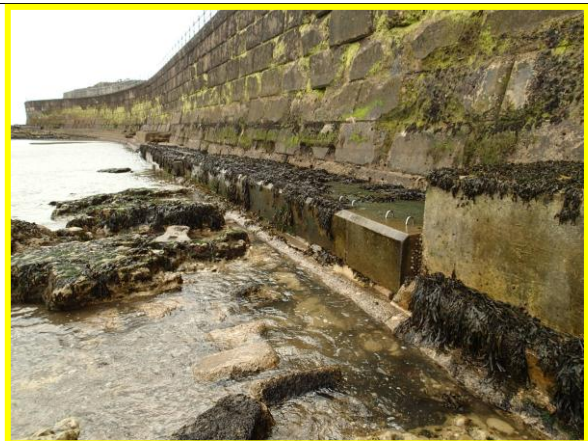
Previous repairs to toe near Sea View Terrace (Asset ref. No. 1221C901C0303C02)

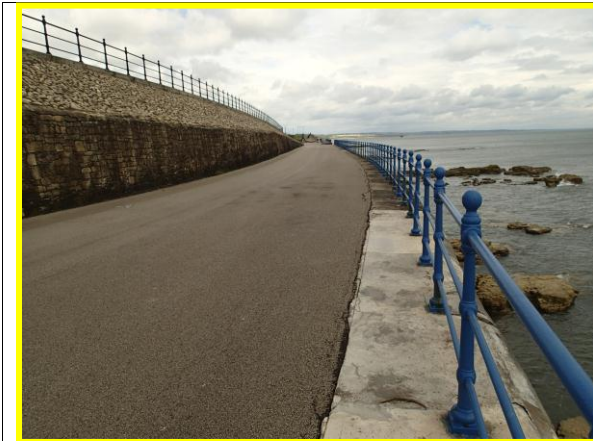
View of promenade and repairs to coping, showing crack adjacent to coping (Asset ref. No. 1221C901C0303C02)

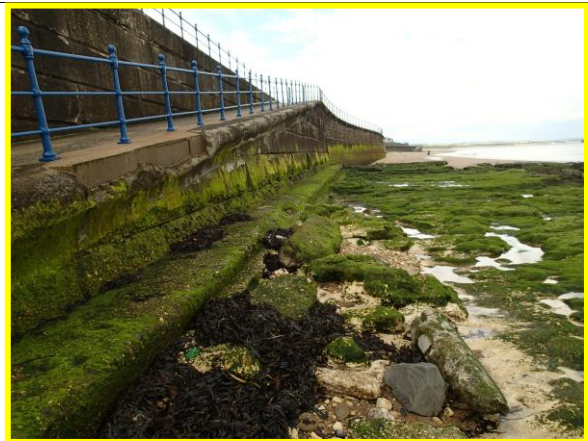
Scour and abrasion at wall toe (Asset ref. No. 1221C901C0303C02)

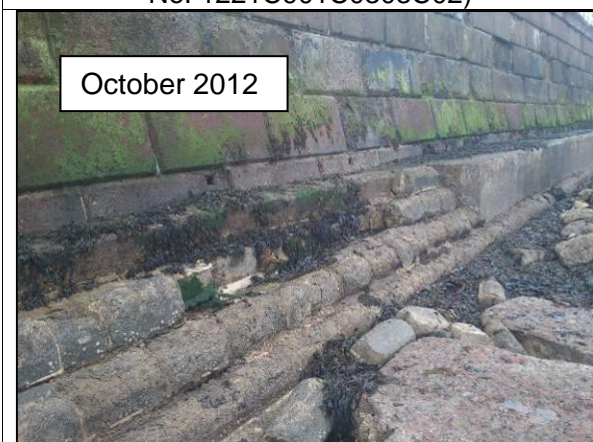
Damage to concrete toe (Asset ref. No. 1221C901C0303C02)

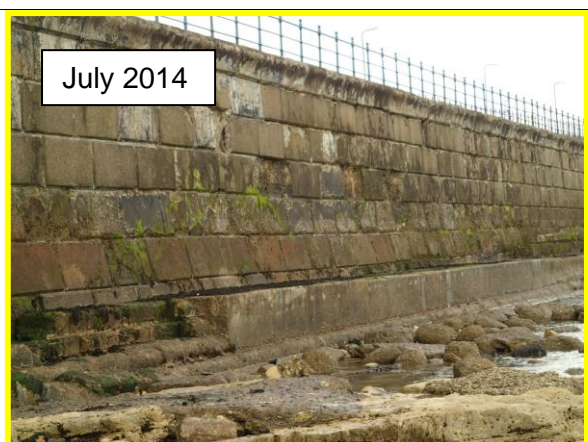
Damage to concrete toe similar to 2012 inspection (Asset ref. No. 1221C901C0303C02)

The concrete toe was visible along the length of seawall. Beach levels were lower than in 2012, when there had been a sand beach present at the northern end, near Sea View Terrace. The toe consists of a variety of constructions from older stepped concrete profiles to more recent massive precast concrete blocks and insitu fill and was mostly in fair to good condition. In some locations the most recently placed sections were in very good condition. However, in several other locations where new concrete units were not present at the toe, the older sections of toe had been undercut locally as the soft rock on which the wall is founded gets abraded and worn down (above left and right) and toe units had been displaced, requiring repair.

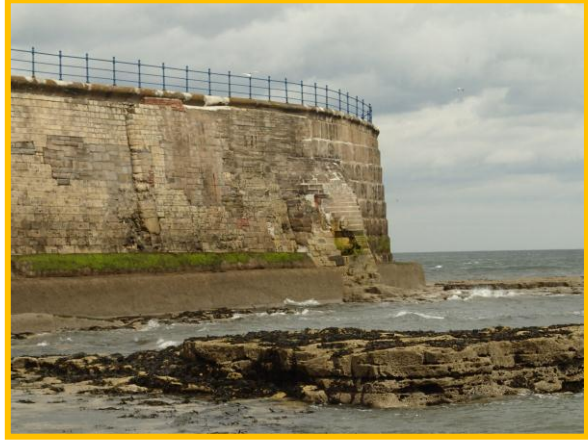
Damage and missing blocks at south of headland (Asset ref. Nos. 1221C901C0303C04 & 1221C901C0303C04)

The wall with smaller blockwork and rendered sections (Asset ref No. 1221C901C0303C04) immediately south of the apex of the headland was in poor condition; see above right and below left. There are some missing blocks, extensive abrasion damage, pitting of block surfaces, parts of the wall are bulging and there is extensive cracking and loss of blocks in the buttress sections. There are numerous previous patch repairs and further attention is required.

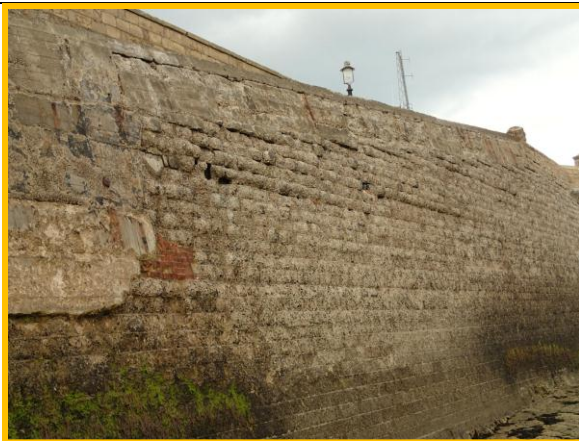
Surface abrasion damage to wall adjacent to ramp showing multiple previous repairs and voids. (Asset ref. No. 1221C901C0303C04)

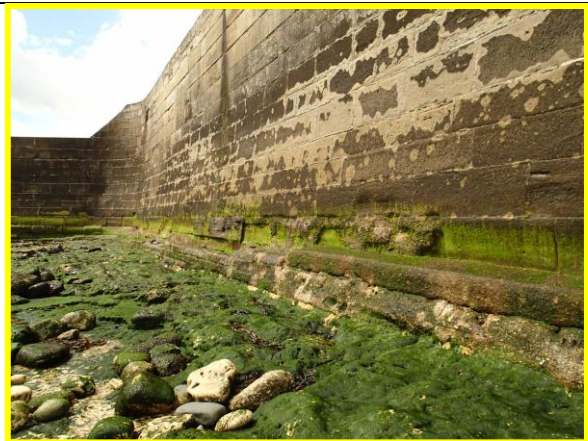
The dressed masonry wall (Asset ref. No. 1221C901C0401C02) between the ramp and the Heugh Breakwater (below right) was in a similar condition to the 2012 inspection, with some missing pointing, evidence of previous repairs and extensive abrasion damage to the lower courses of blocks. The marine growth indicates that the abrasion is not recent.

Dressed masonry wall adjacent to Heugh breakwater, showing abrasion to lower wall (Asset ref. No. 1221C901C0401C02)

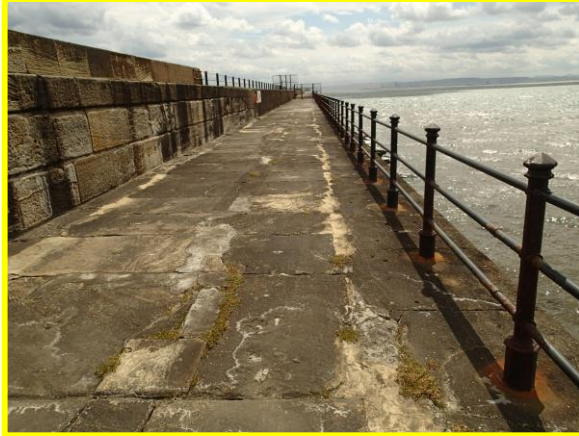
Heugh breakwater promenade, with repairs to gaps between slabs (Asset ref. No. 1221C901C0401C01)

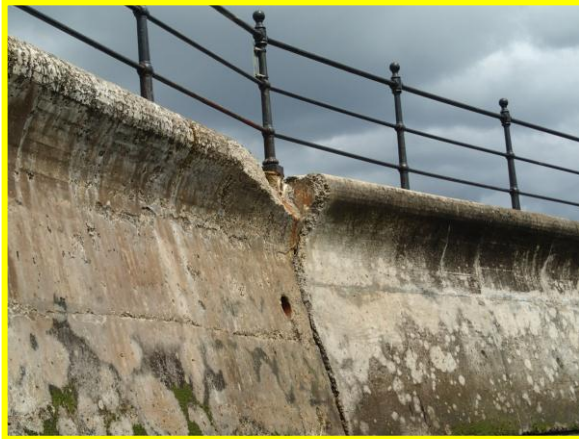
Damage to coping on Block Sands seawall  
(Asset ref. No. 1221C901C0401C04)

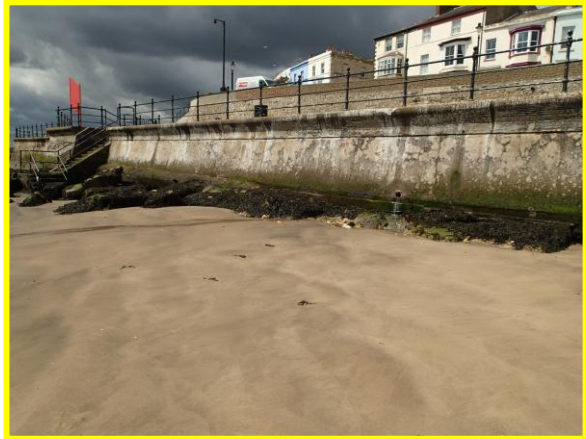
Low beach levels exposing toe at Block Sands wall.  
(Asset ref. No. 1221C901C0401C04)

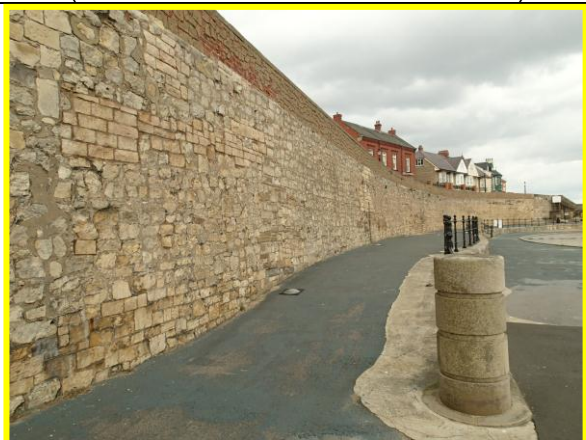
Rear retaining wall at Block Sands with missing mortar in joints and damage to blocks (Asset ref. No. 1221C901C0401C04)

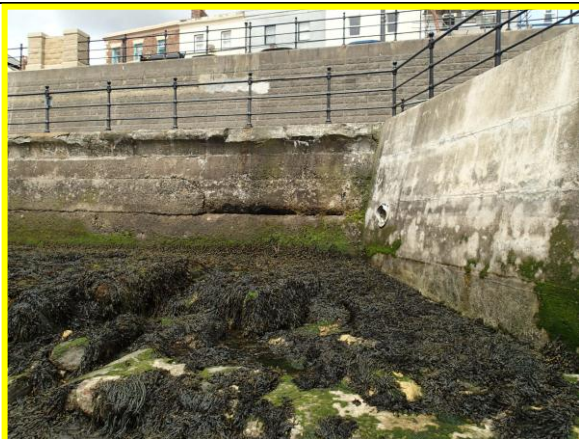
Damage to wall adjacent to west end of Block Sands seawall.  
(Asset ref. No. 1221C901C0401C05)

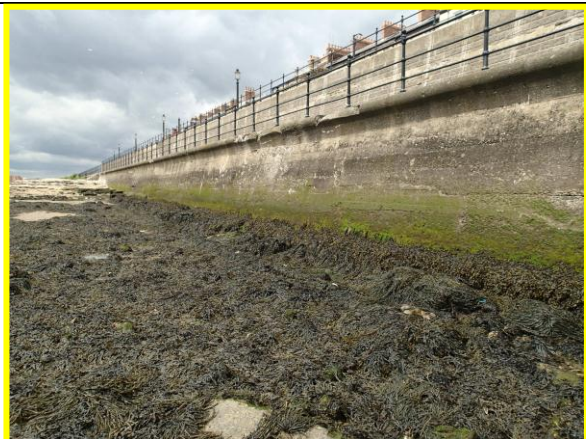
Damaged coping at exposed eastern section  
(Asset ref. No. 1221C901C0401C05)

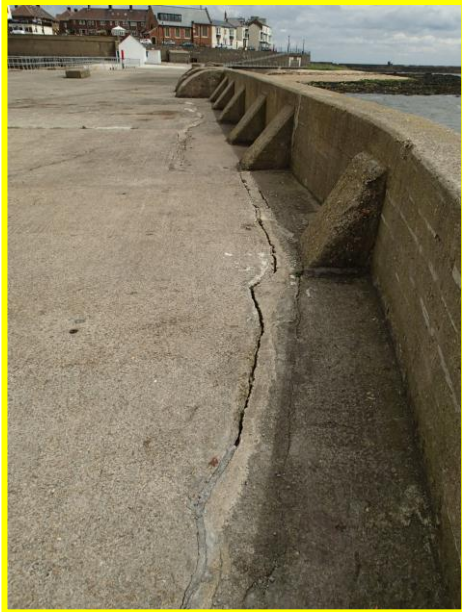
Cracking alongside crest wall  
(Asset ref. No. 1221C901C0401C34)

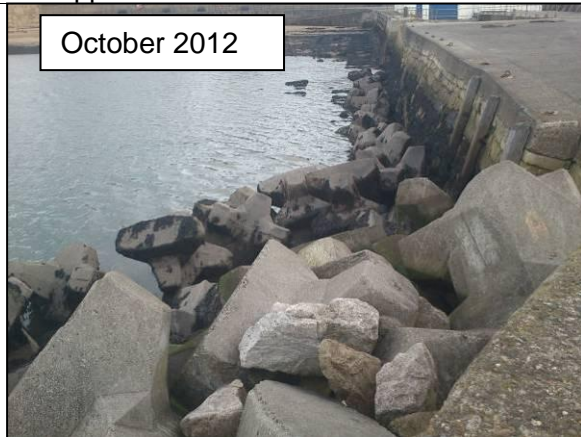
Landward side of Old Pier showing settlement in the (original?) masonry blockwork.  
(Asset ref. No. 1221C901C0401C06)

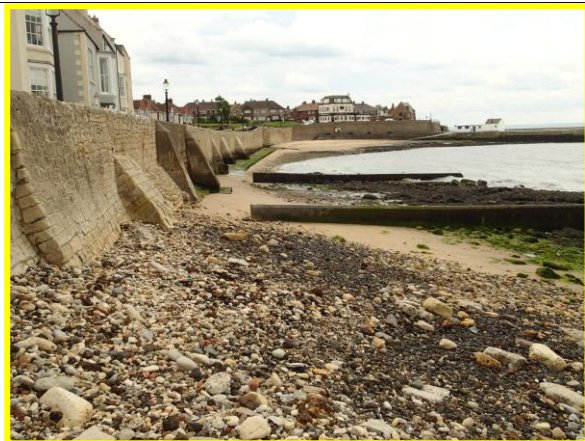
View east along main part of Town Wall. The section in midfield has historically been rebuilt with concrete blocks anchored with steel tie bars which are corroding.  
(Asset ref. No. 1221C901C0401C35)

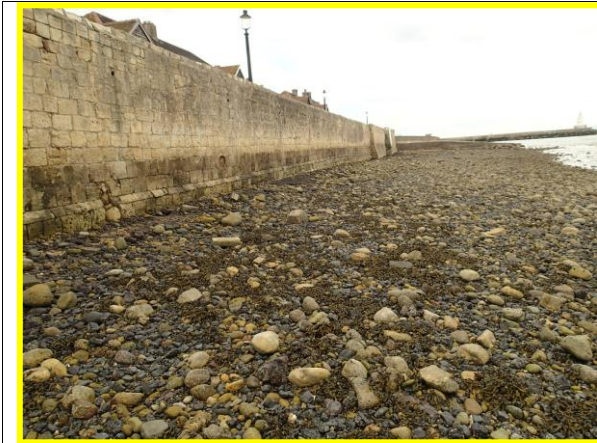
Western section of Town Wall showing low beach levels,  
(Asset ref. No. 1221C901C0401C35)

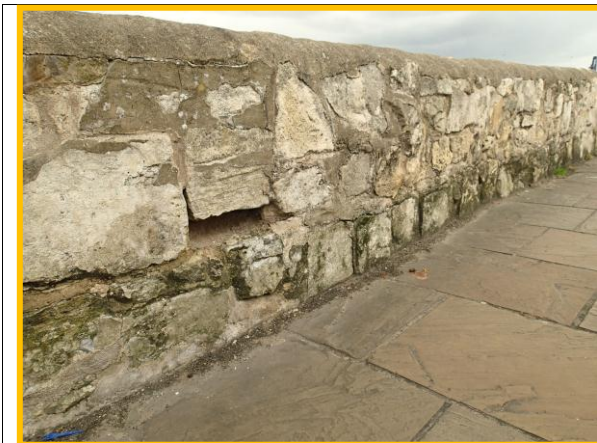
Eastern part of parapet wall to Town Wall showing missing stones and mortar,  
(Asset ref. No. 1221C901C0401C35)

The Town Wall requires regular maintenance as it is a Scheduled Monument and the materials that can be used in repair are not very durable. It is assumed that the pointing would have been repaired when the major works to stabilise the wall were undertaken in 2012. However, the inner face of the crest wall is now in a poor condition and requires urgent repairs to replace missing stones and mortar in various isolated locations, see photos below left and right.

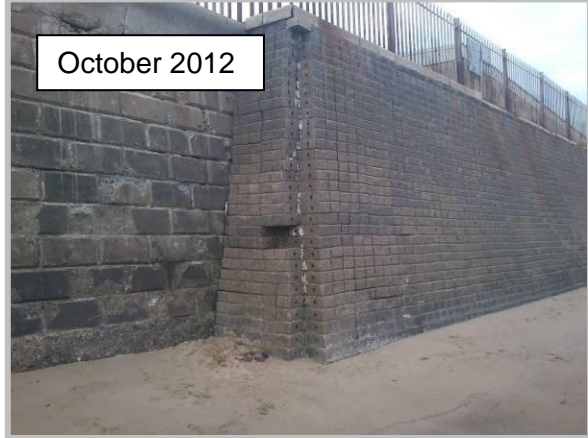
Missing blocks at interface between two sections of wall. Photo from previous report.  
(Asset ref. No. 1221C901C0401C19)

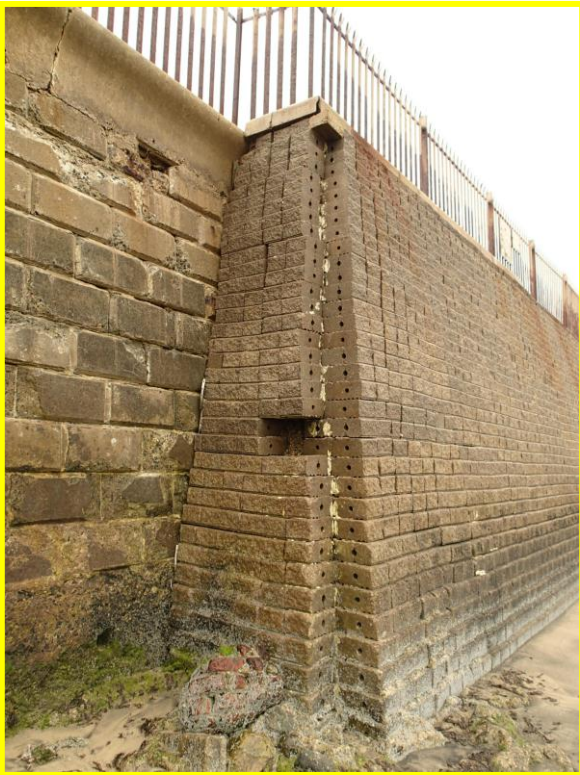
Missing blocks at interface between two sections of wall.  
(Asset ref. No. 1221C901C0401C19)

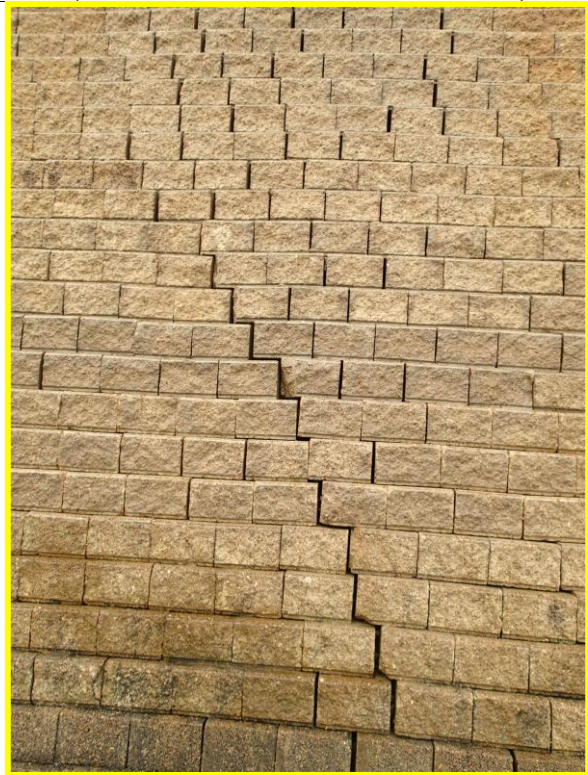
Cracks and opening joints due to movement  
(Asset ref. No. 1221C901C0401C19)

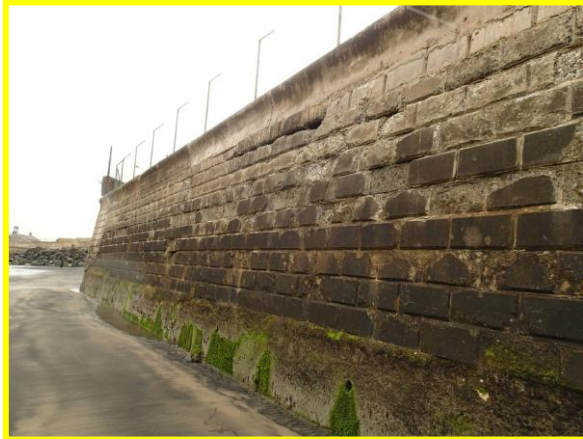
Older concrete block wall has damaged blocks with missing facing.  
(Asset ref. No. 1221C901C0401C19)

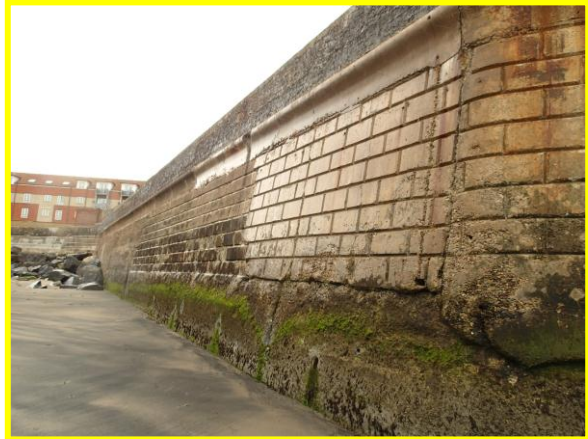
Toe scour and abrasion damage at corner of wall (Asset ref. No. 1221C901C0401C20)

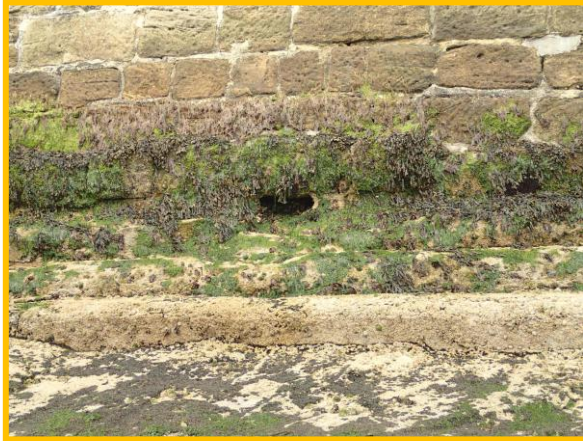
Damaged toe apron exposing void under wall on Middleton Beach side of North Pier (Asset ref. No. 1221C901C0401C22)

The outside face of North Pier appeared in generally fair condition from the landward, Middleton Beach end. However, as in 2012 the low beach levels had exposed the timber piles at the edge of the toe apron and the apron has areas of damage and voiding, see below right. There was evidence of patch previous defects in the apron, but there was a void under the face of the wall at the edge of the apron, below lower left. This and other similar defects should be repaired before the structure becomes destabilised.

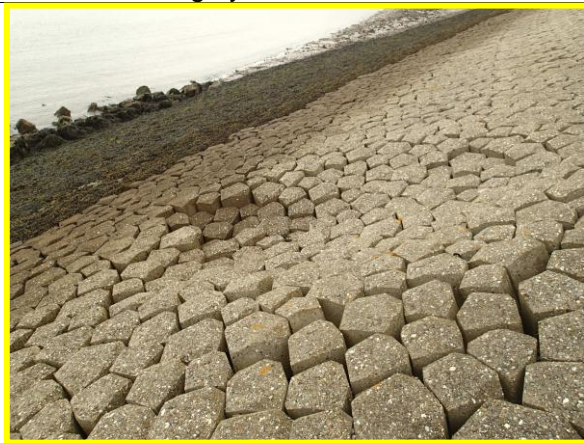
Area of settlement in block revetment  
(Asset ref. No. 1221C901C0401C25)

The concrete block set revetment (Asset ref. No. 1221C901C0401C25) fronting Slake Terrace was in good condition, apart from an area of settlement with a diameter of about 2m, see below left. This defect has been noted on the inspections since 2008 and does not appear to have changed significantly. As noted previously, the settlement is indicative of a local loss of fill material below the concrete blocks and should continue to be monitored as further loss could reduce the integrity of the asset.

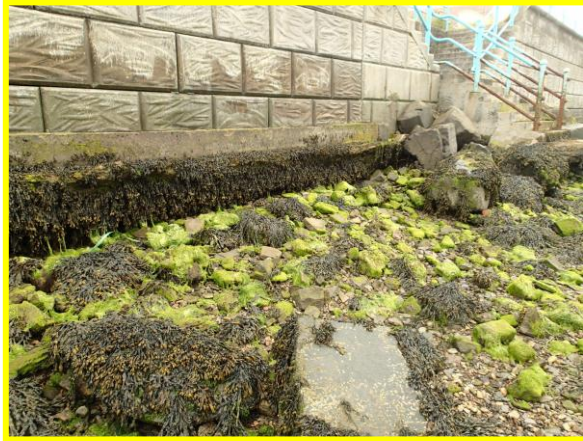
Undermining of toe of wall looking west from slipway (Asset ref. No. 1221C901C0401C27)

The undercutting at the steps, slipway and walls to the vertical wall north of the Yacht Club first noted to have problems in the 2010 inspections, was similar or slightly worse in October 2012 and appeared more extensive in the July 2014 inspection, see photo above right and below left and right, with undercutting at the slipway, the steps and also at the wall between the steps and the slipway. As previously recommended the voids under the apron should be repaired and additional protective rock armour placed to reduce wave reflections and help avoid further scour damage.

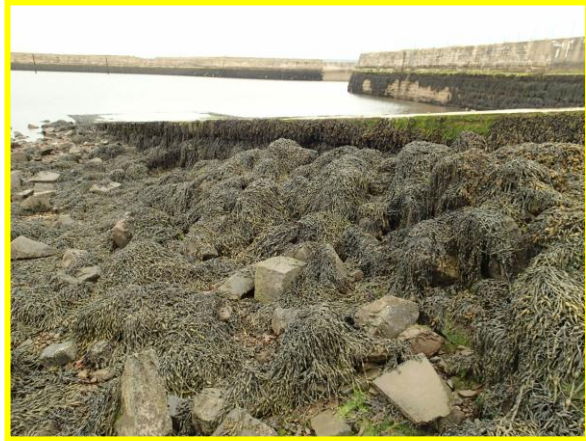
Undercutting of slipway (Asset ref. No. 1221C901C0401C27)

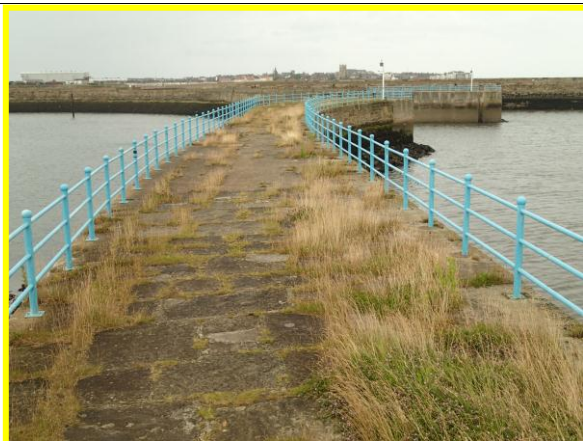
Vegetation growing in between masonry slabs and patch repairs in deck of Middle Pier (Asset ref. No. 1221C901C0401C28)

Middle Pier appeared to be in fair condition, although there was significant growth of vegetation in gaps in the masonry slabs in the deck, which should be removed and the gaps repointed, see below left. The condition was very similar to that seen in 2012. The lower parts of the structure were heavily obscured by seaweed, but where visible appeared in fair condition with some loss of mortar to joints.

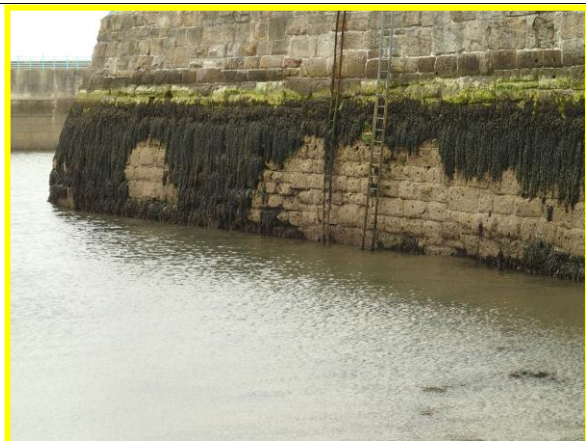
Inner face of Middle Pier, showing mortar loss where gaps in seaweed (Asset ref. No. 1221C901C0401C28)

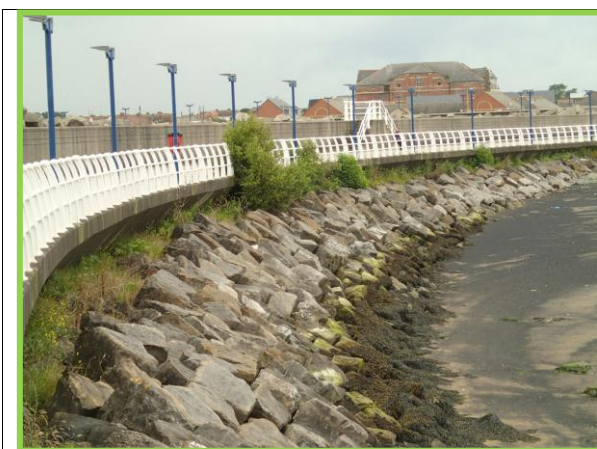
South Pier rock armour on inner face, with vegetation that should be removed. (Asset ref. No. 1221C901C0401C32)

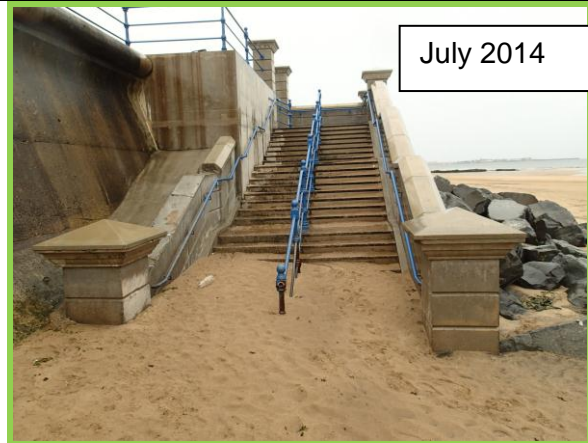
High sand levels at northern steps. Note missing coping stones on wall adjacent to steps  
(Asset Ref. No. 1221C901C0501C05)

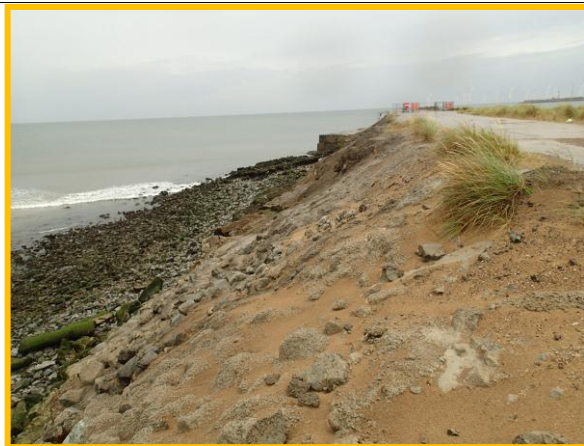
View of patch repairs to north side of breakwater  
(Asset ref. No. 1221C901C0502C01)
