**Cell 1 Regional Coastal Monitoring Programme
Walkover Inspection Surveys 2018**

Hartlepool Borough Council

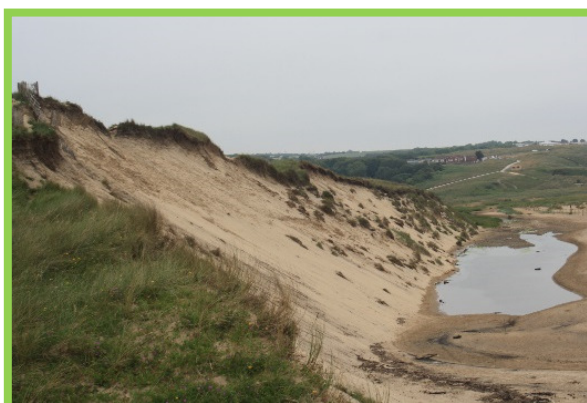
Looking north along dunes from Crimdon Dene (/C0301C01)

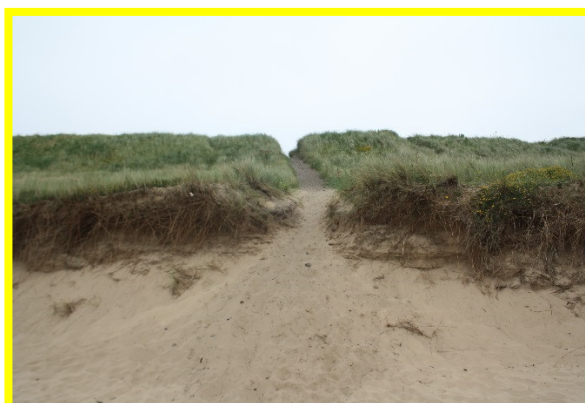
Informal access at Spion Kop cemetery (/C0302C01)

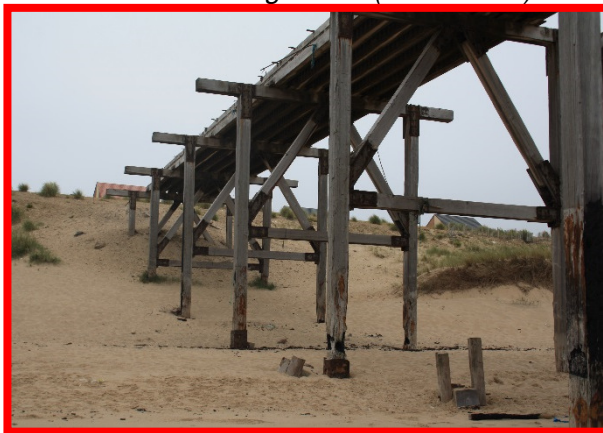
Loss of section to timber support columns of historic pier structure, likely due to fire damage (/C0302C01)

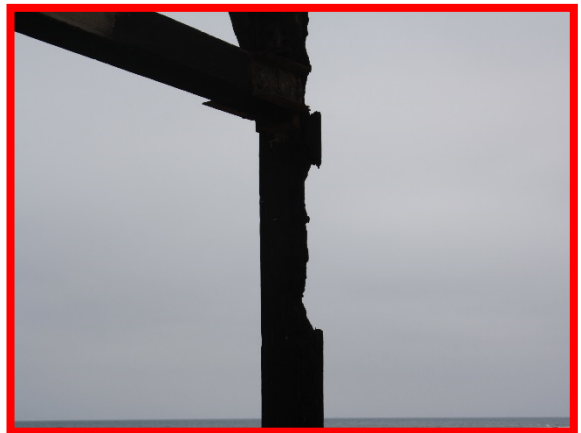
Loss of section to pier support columns, likely due to fire damage (/C0302C01)

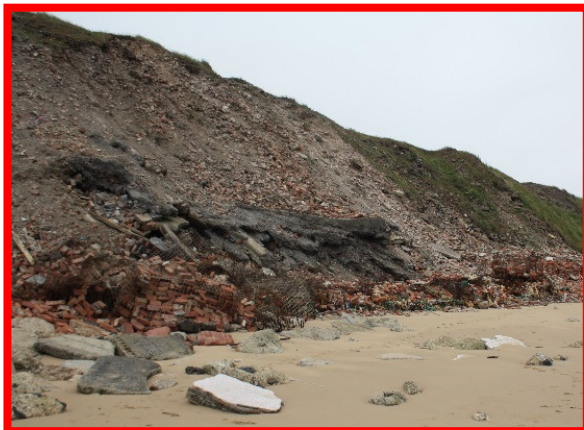
Collapsed former gabion structure (/C0302C02)

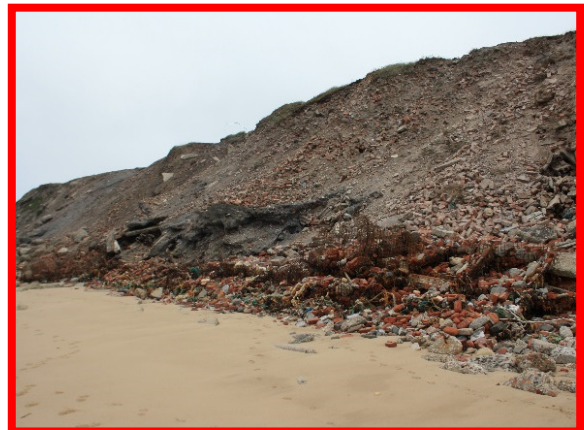
Erosion of made ground slope and collapsed former gabion structure (/C0302C02)

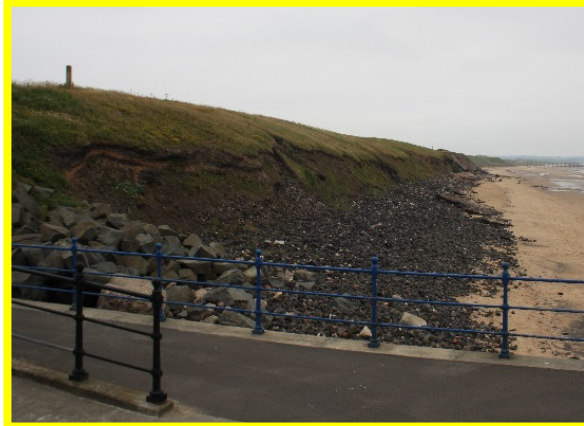
View looking north from Marine Drive (/C0302C03)

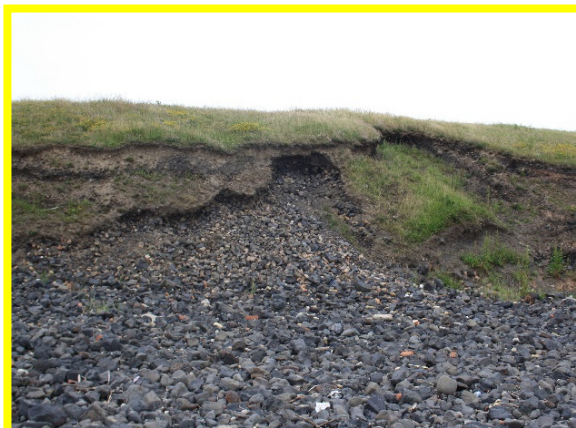
Local slope failure (/C0302C03)

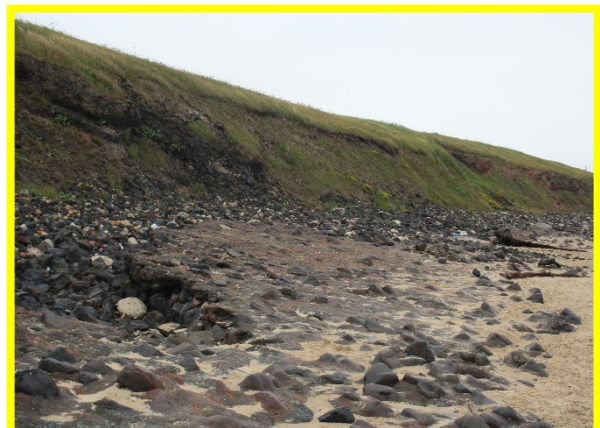
Oversteepened coastal slope, slag apron breaking up (/C0302C03)

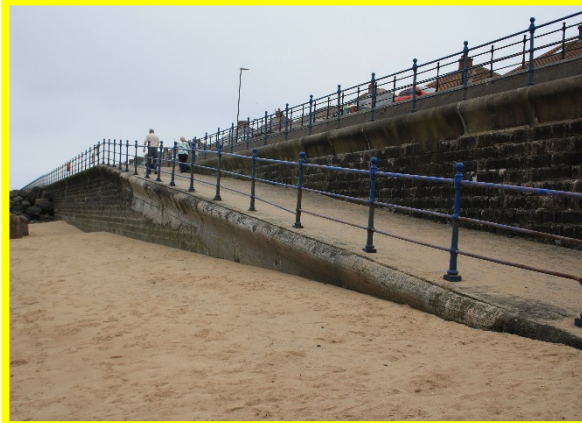
Repaired access ramp at northern end of Marine Drive (/C0303C01)

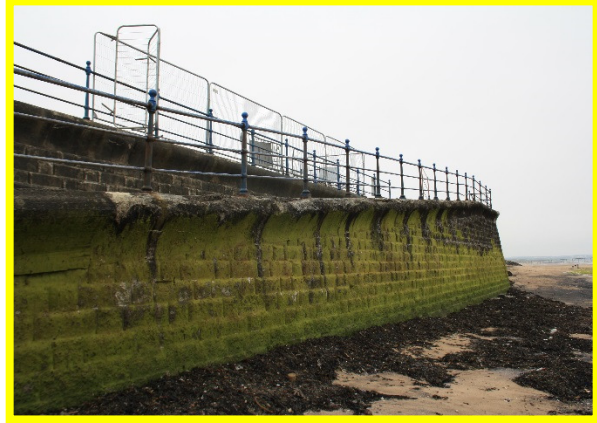
Local damage to coping/handrails at Arabella Street access ramp (/C0303C01)

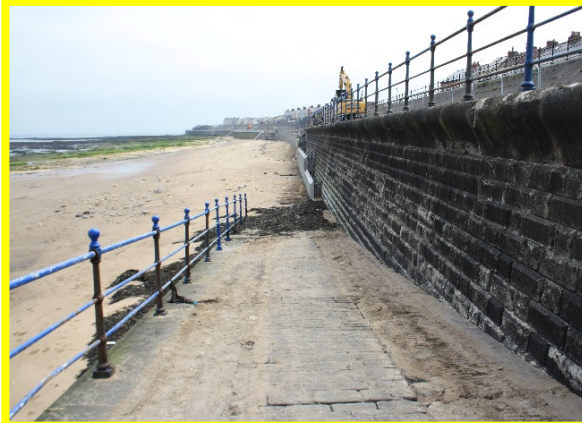
Access ramp at Arabella Street, previously undercut (/C0303C01)

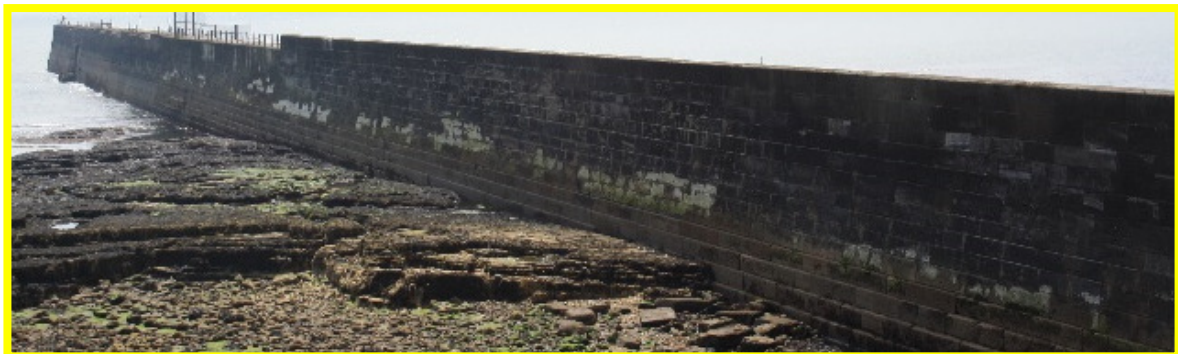
Heugh Breakwater - North aspect (/C0401C01)

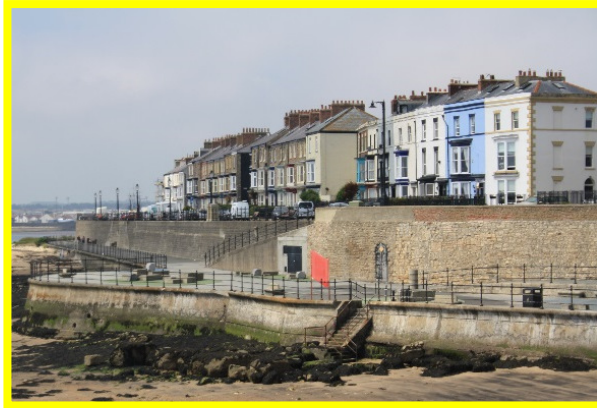
View looking south from Heugh Breakwater (/C0401C04)

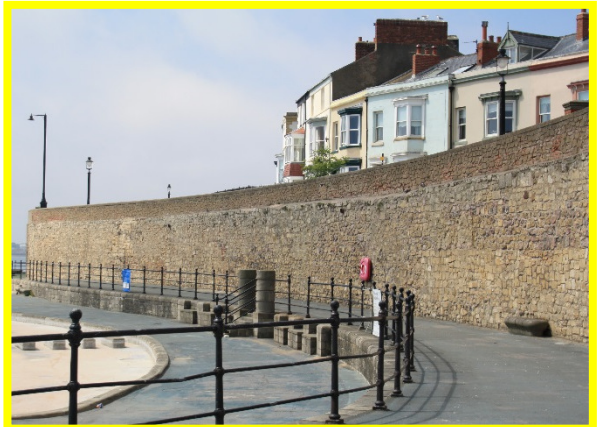
Rear masonry wall in fair condition (/C0401C04)

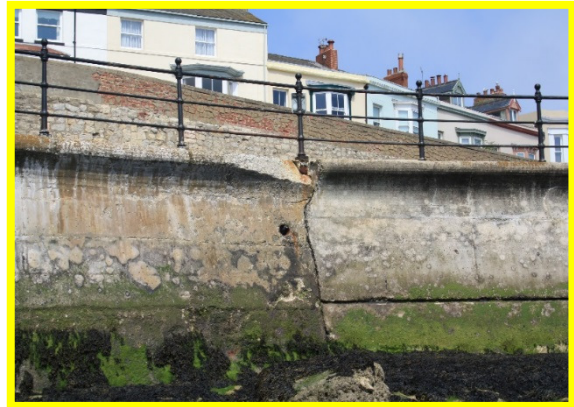
Damage to recurve concrete cope (/C0401C04)

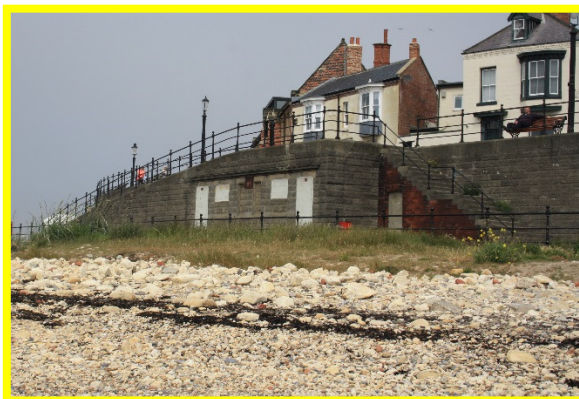
Former public conveniences. High beach with vegetation in foreground (/C0401C05)

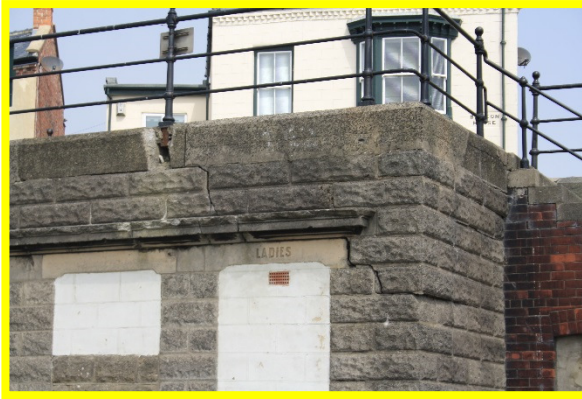
Cracking in former public convenience building (/C0401C05)

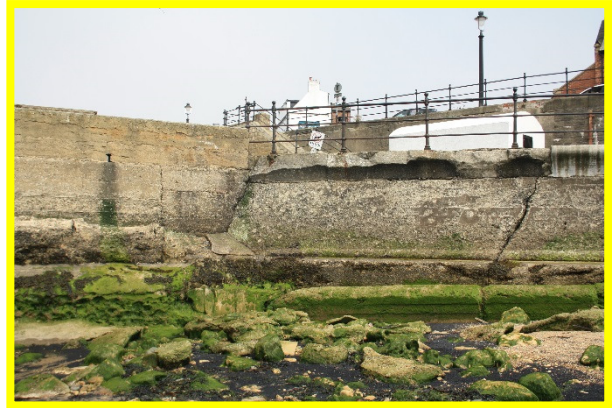
Spalling damage to recurve wall, significant crack suggesting settlement. Old Pier to left of image (/C0401C05)

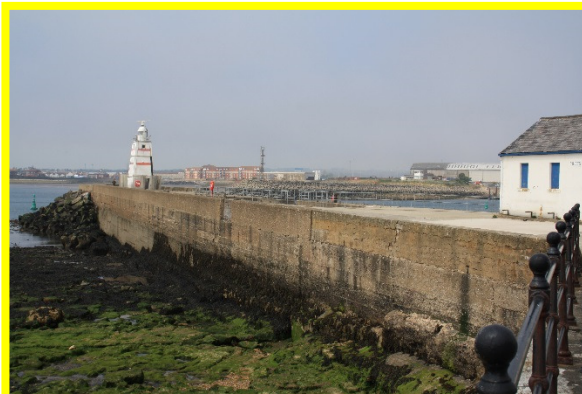
Outer face of North Pier (/C0401C34)

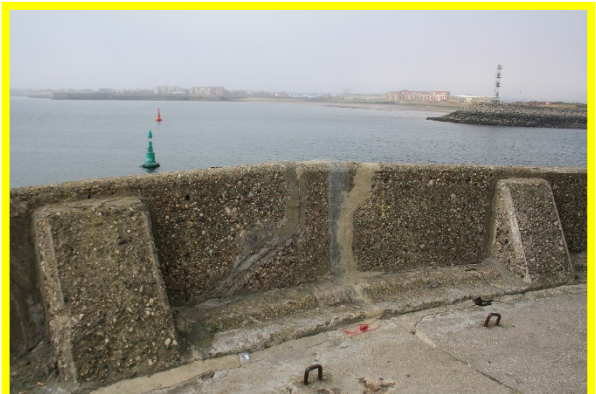
Cracks in concrete parapet wall and deck filled in with cement/grout (/C0401C34)

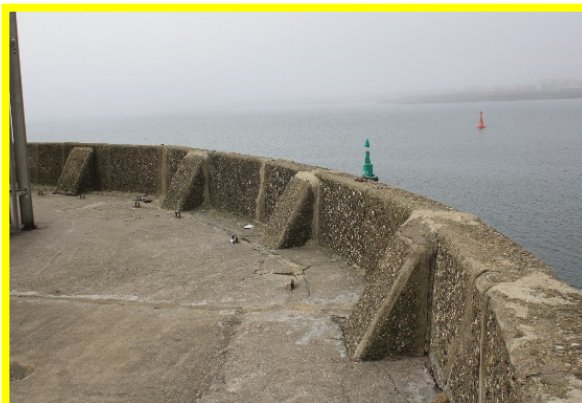
Cracking in parapet wall and deck, and gaps between 'buttresses' and wall filled in with cement/grout (/C0401C34)

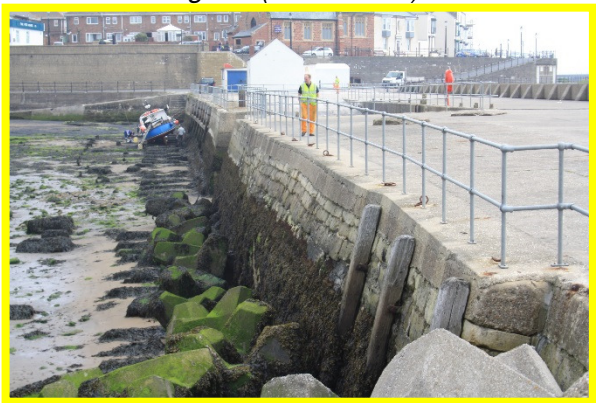
Inner face of North Pier – note potential settlement of masonry blocks (/C0401C06)

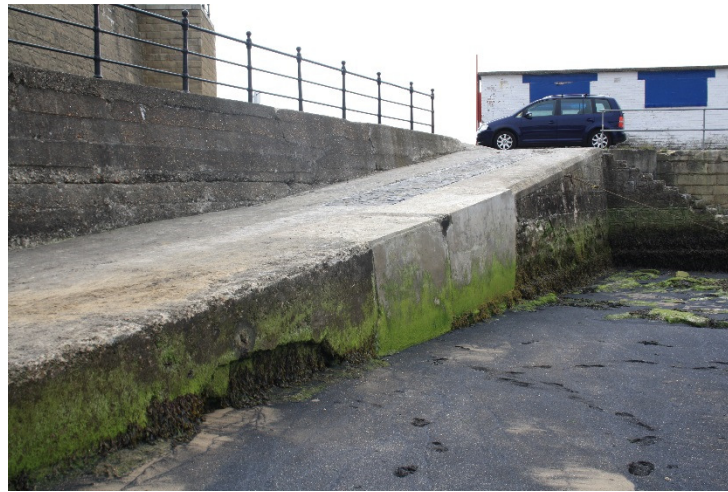
Recent concrete repair to slipway, voids/undercutting remains (/C0401C35)

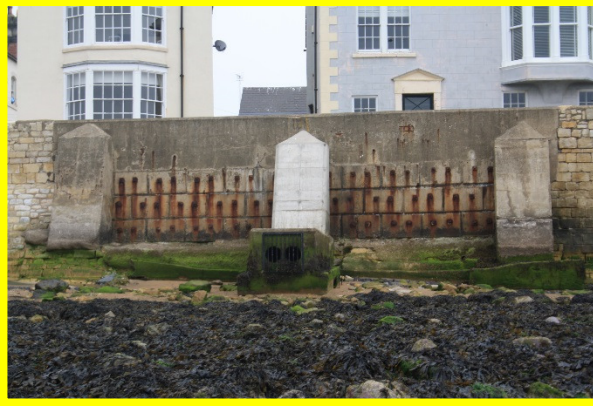
Recently constructed outfall and abutment. Significant corrosion/rust staining previously observed (/C0401C35)

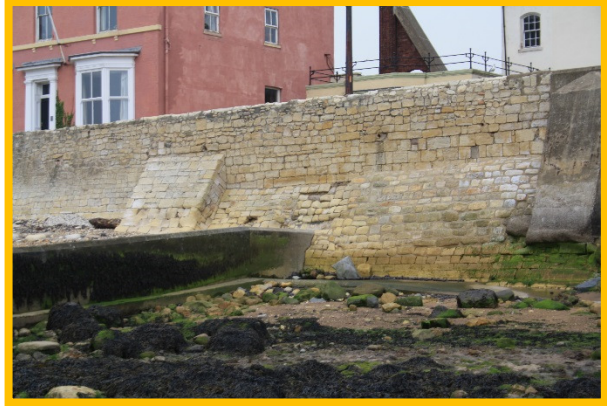
Open jointing in lower masonry courses. Local undermining of concrete buttress (/C0401C35)

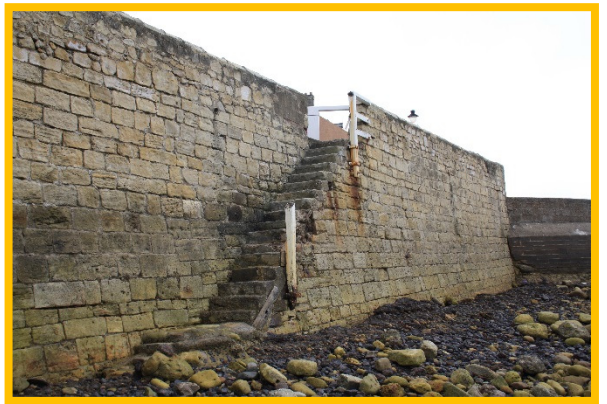
Several open joints in masonry (/C0401C35)

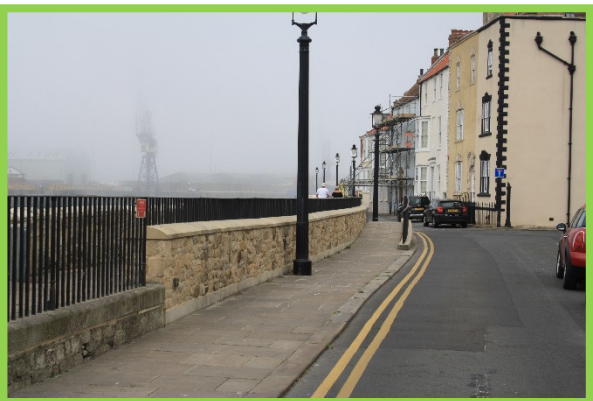
Recently completed masonry wall and walkway to rear of seawall along Northgate. (/C0401C35)

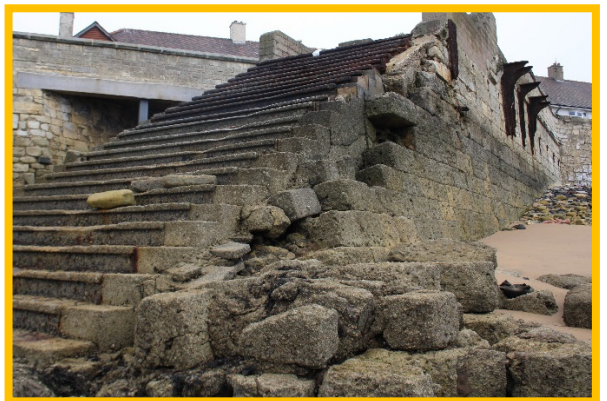
Damage to steps at former passenger ferry landing (/C0401C35)

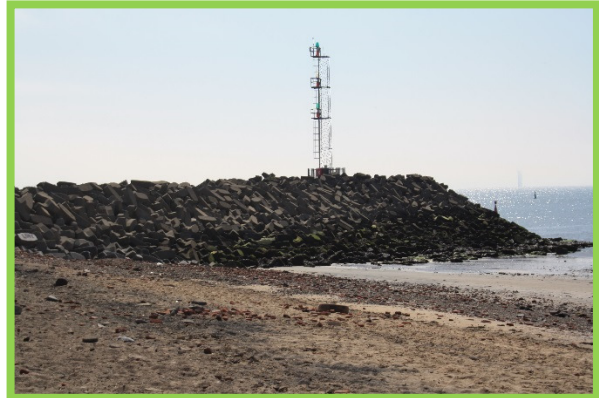
Middleton Jetty south aspect (/C0401C16)

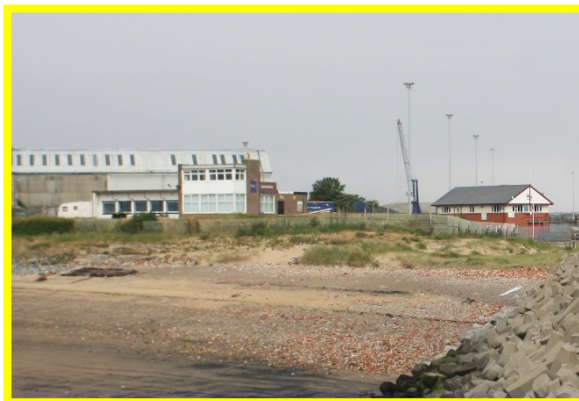
Gabion wall and embryo dunes from Middleton Jetty (/C0401C17)

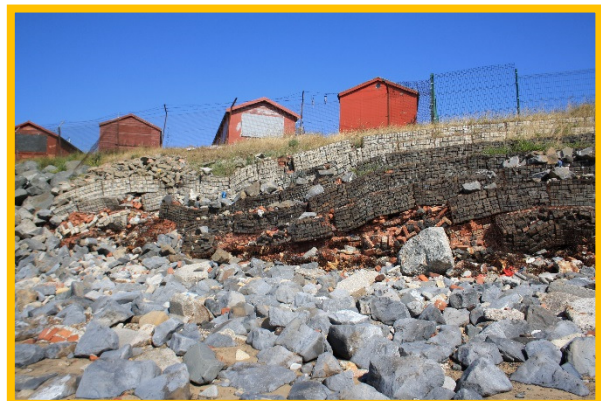
Settlement in stacked gabion wall (/C0401C17)

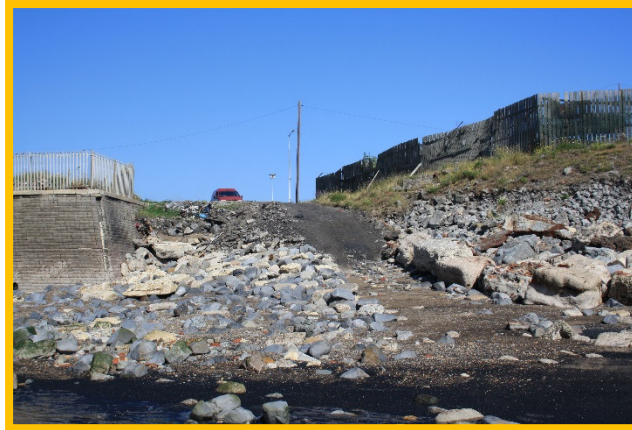
Informal access ramp (/C0401C18)

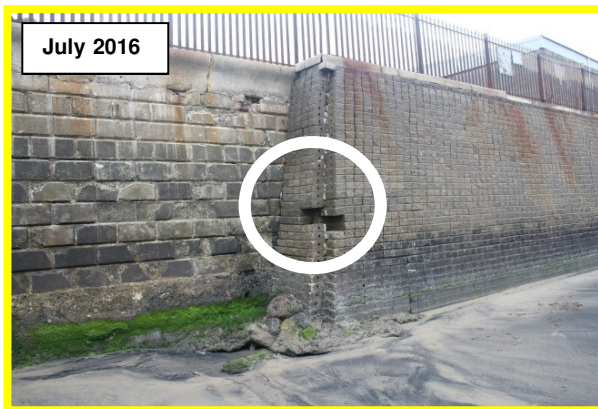
Missing blocks at interface between two walls. Local scour at toe (2016) (/C0401C19)

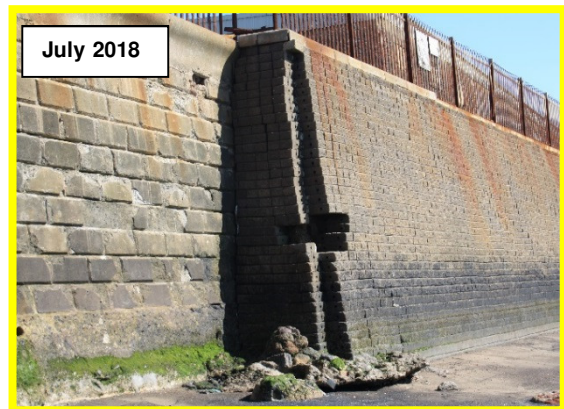
Progressive loss of blocks at interface between two walls. Local scour at toe (2018) (/C0401C19)

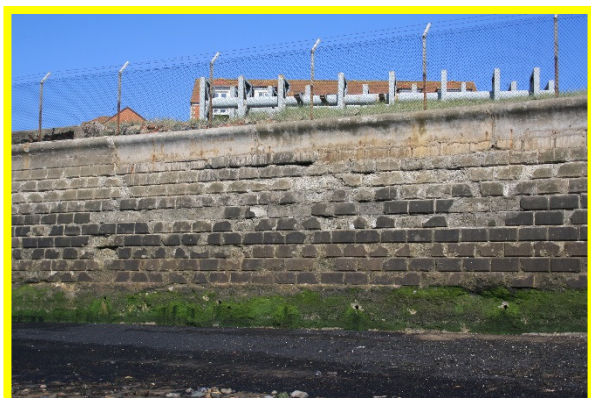
Spalling/abrasion of concrete blocks (/C0401C19)

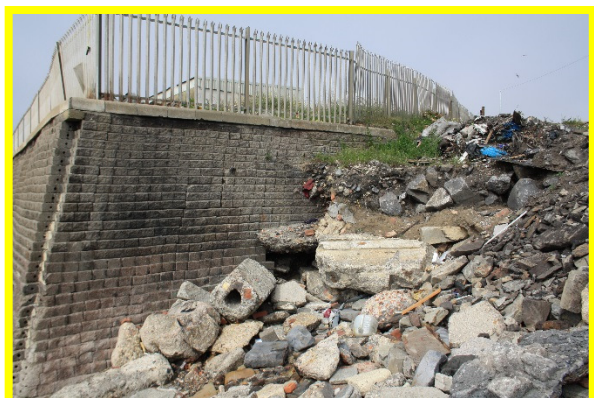
Scour hole and evidence of settlement visible at northern end of seawall (/C0401C19)

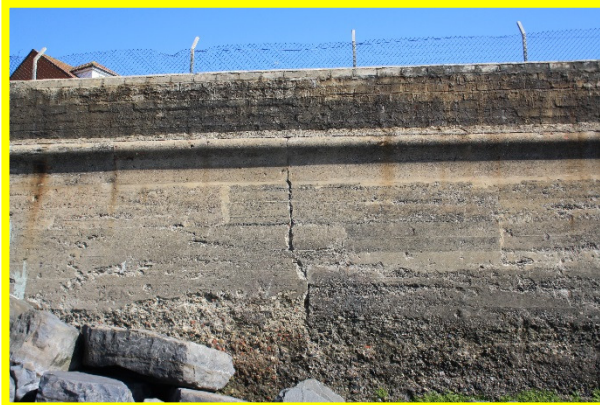
*Vertical crack through parapet and seawall
(/C0401C20)*

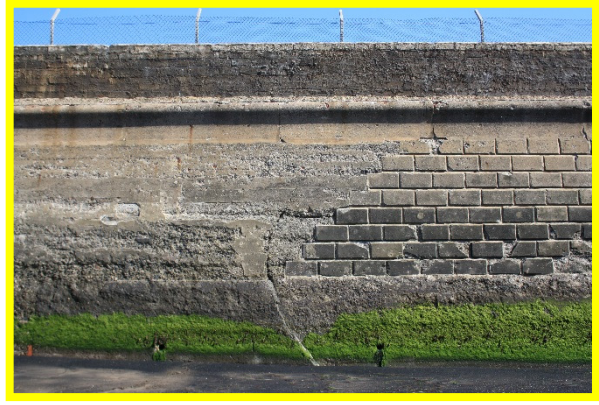
*Vertical crack through parapet and seawall
(/C0401C20)*

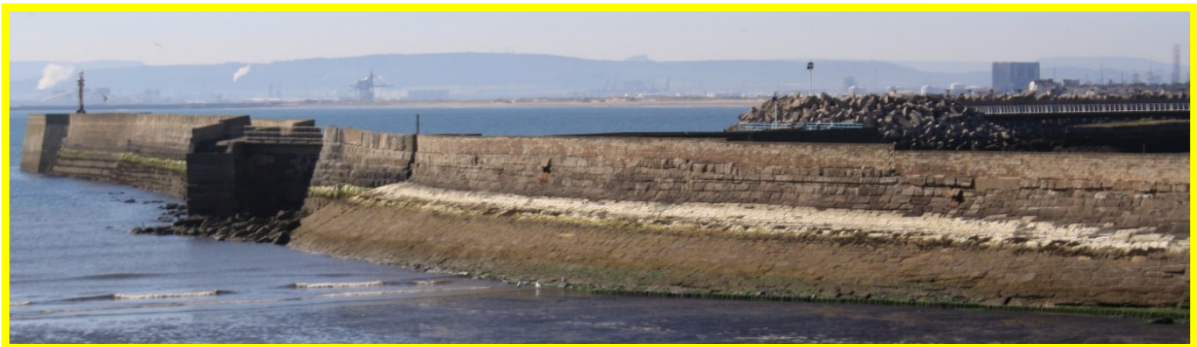
North face of North Pier (/C0401C22)

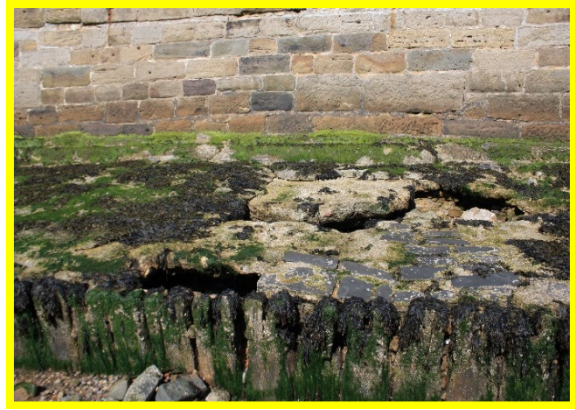
Voids in apron of North Pier, approx. 0.5m depth extending under concrete and through timber piles (/C0401C22)

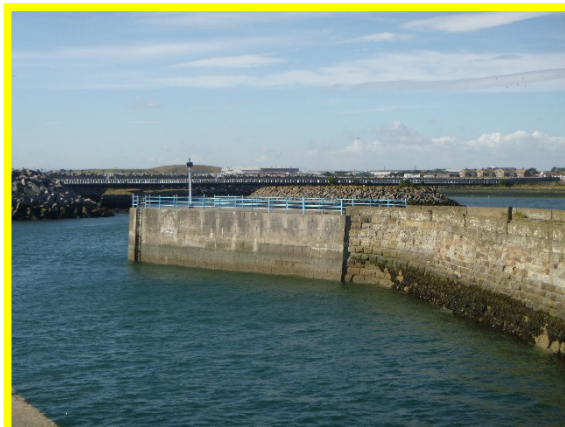
Head of inner arm of North Pier (/C0401C21)

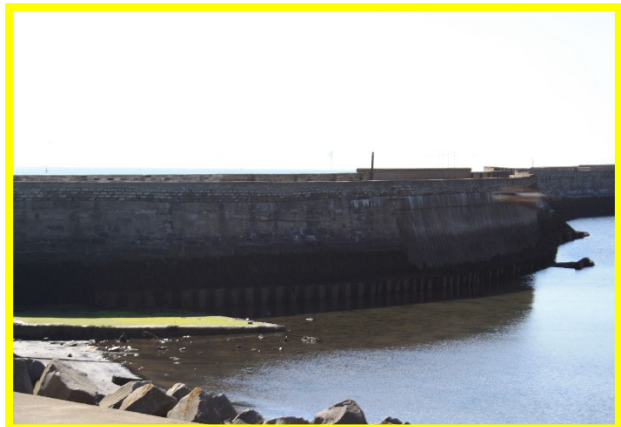
South face of North Pier (/C0401C22)

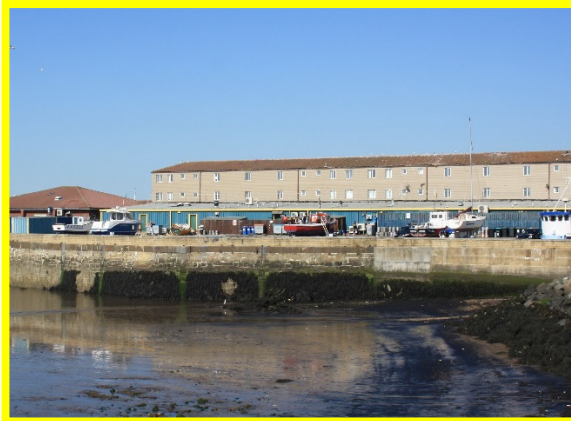
Masonry seawall to north of harbour entrance (/C0401C24)

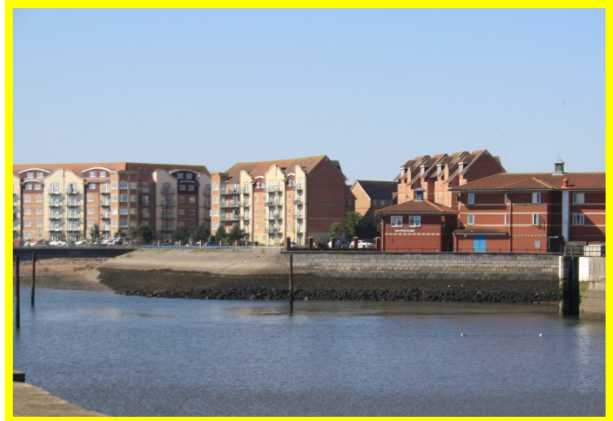
Concrete blockwork revetment obscured by vegetation (/C0401C25)

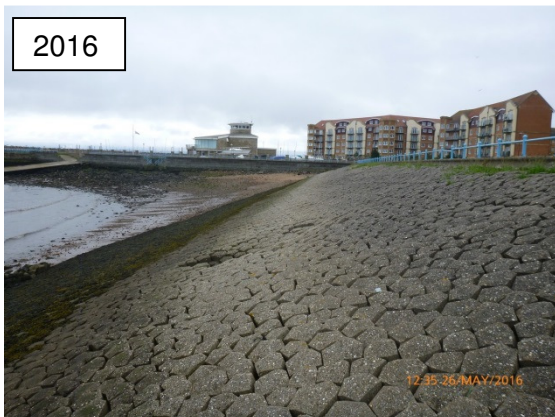
Local settlement of concrete blocks in 2016 (/C0401C26)

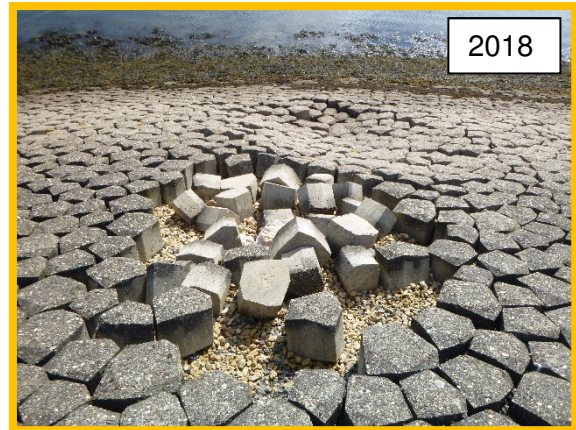
Local settlement of concrete blocks (/C0401C26)

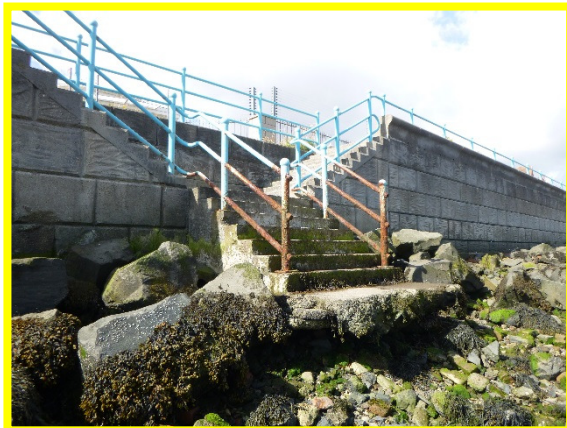
Undercutting of access steps (/C0401C27)

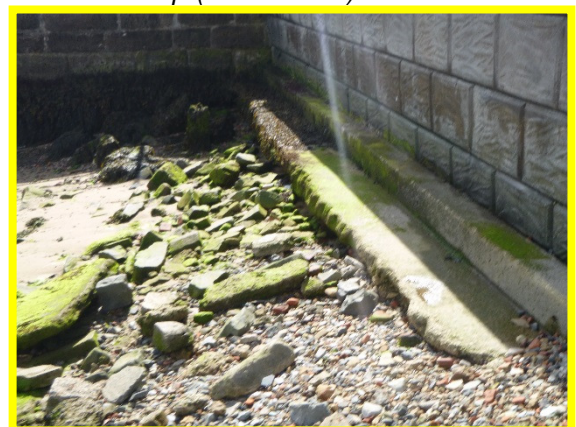
Low beach levels exposing undercutting of concrete toe (/C0401C27)

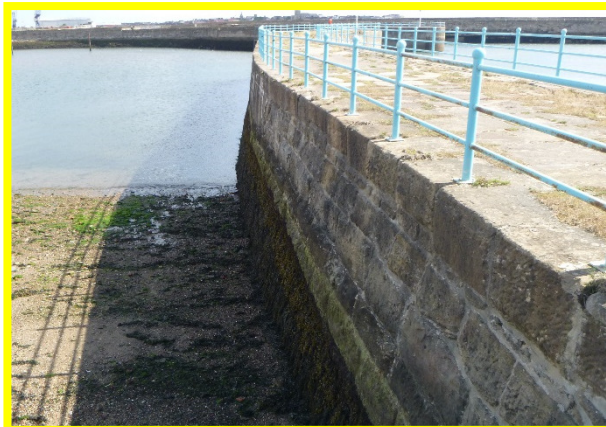
Eastern face of Middle Pier (/C0401C28)

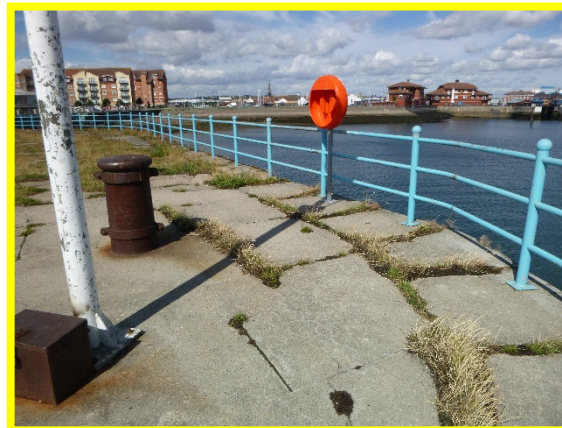
Extensive vegetation growth through joints in Middle Pier deck (/C0401C28)

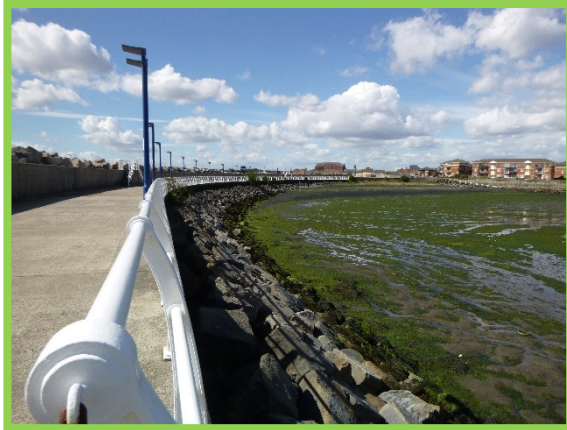
Inner face of South Pier (/C0401C32)

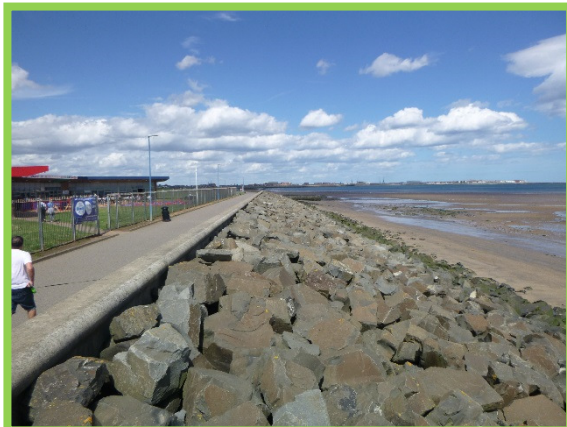
Rock armour revetment and concrete seawall (/C0401C33)

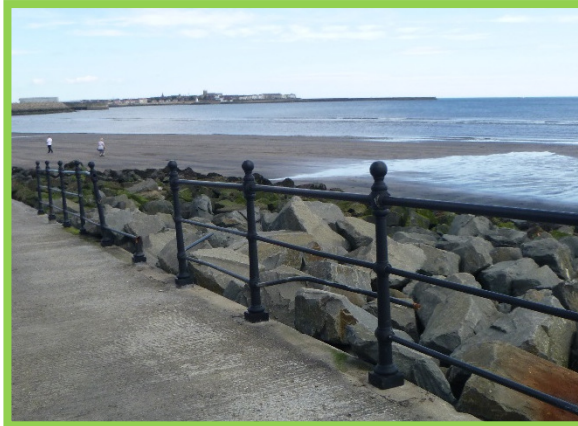
Displaced rock armour and damaged guardrail at northern access ramp (/C0401C33)

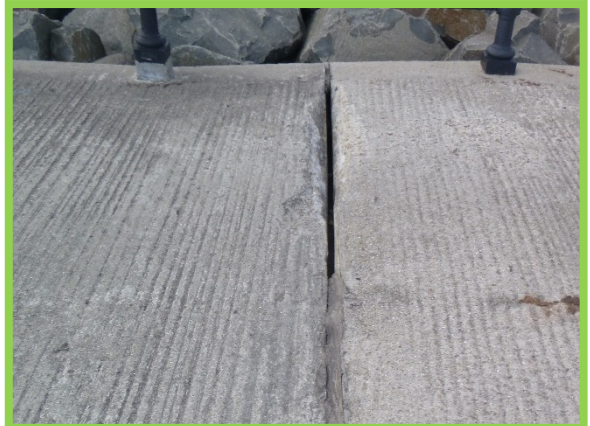
Loss of flexible joint sealant (/C0401C33)

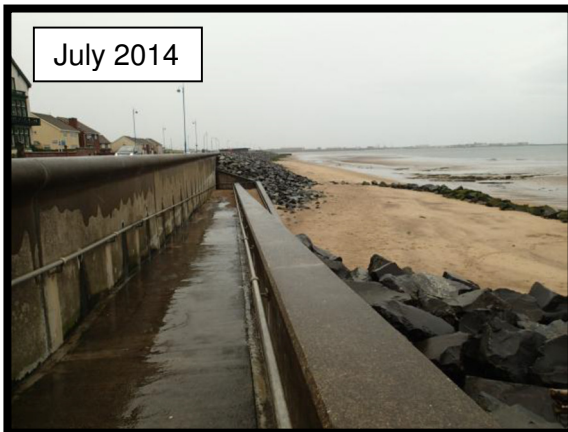
Exposed rock armour berm at Little Scar access ramp (/C0401C33)

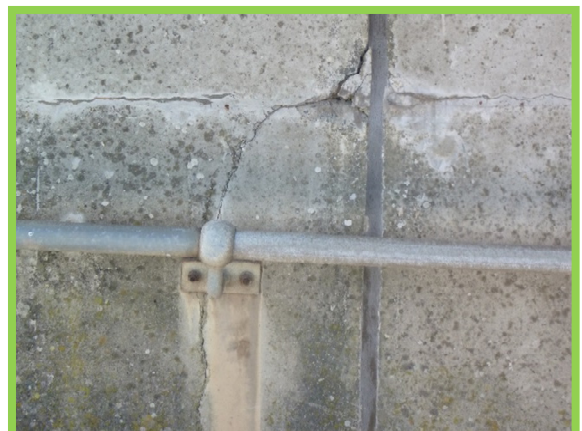
Cracks in concrete seawall at Little Scar access ramp (/C0401C33)

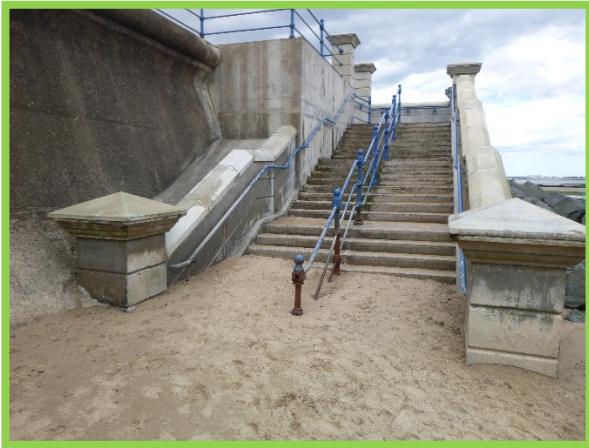
Northern access steps (/C0501C05)

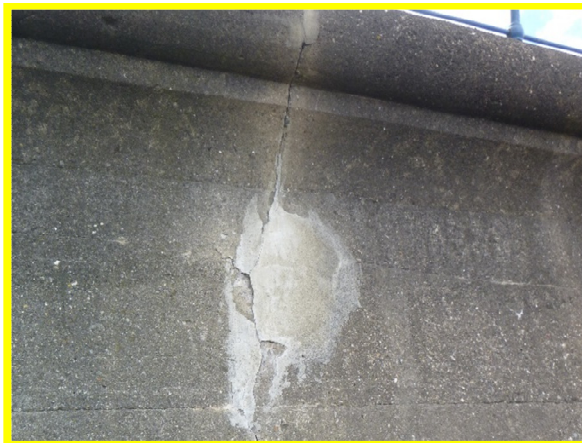
Local cracking and spalling of concrete (/C0501C05)

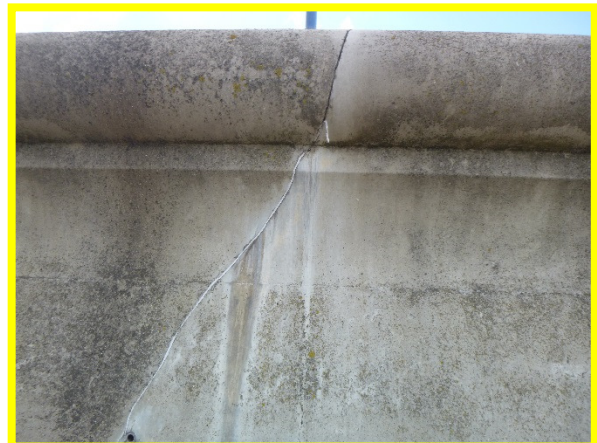
Crack in concrete cope. Note previous repair/fill now failing (/C0501C05)

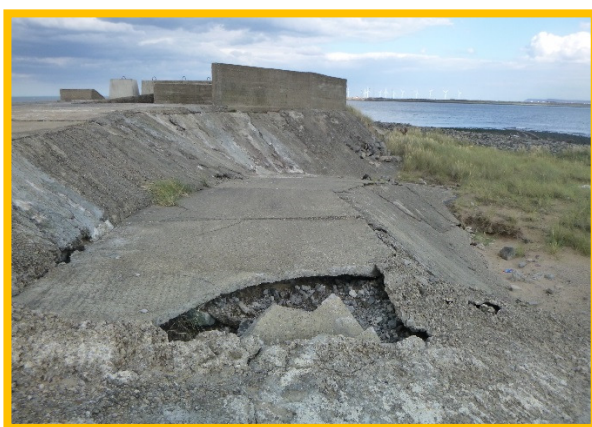
*Voiding along south face of North Gare Breakwater
(/C0503C01)*
