**Cell 1 Regional Coastal Monitoring Programme
Post Storm Walkover Inspection Surveys 2023
(Hartlepool Headland)**

Hartlepool Borough Council

Post Storm Walkover Inspection Surveys 2023

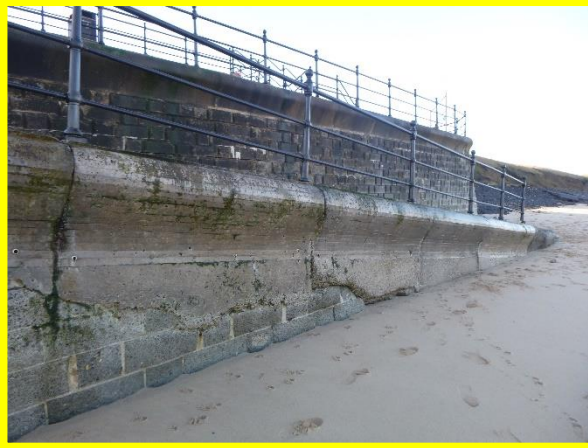
Historic repair to access ramp coping stone in fair condition (/C0303C01)

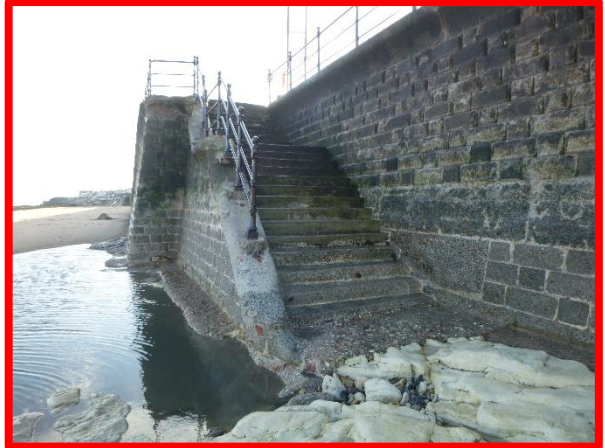
Local damage to coping/handrails at Thorpe Street access steps (/C0303C01)

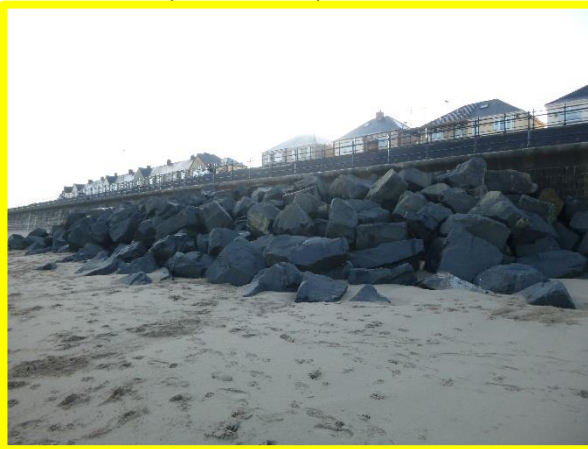
Rock armour in fair condition (/C0303C01)

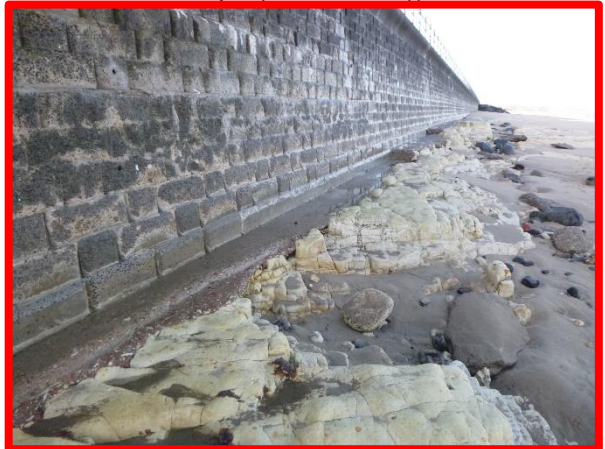
Evidence of abrasion to wall (/C0303C01)

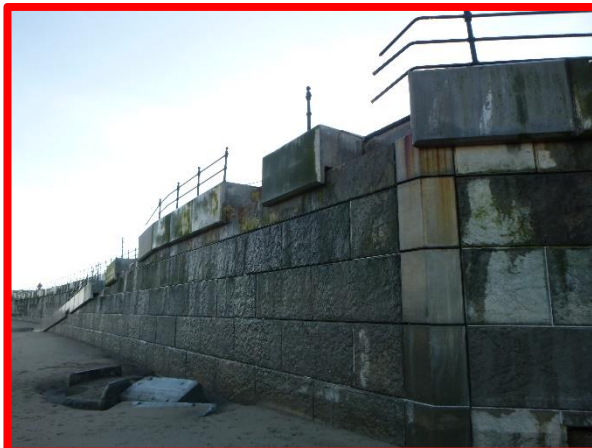
1. **missing coping stones:** there are approximately 11 coping stones which have been completely lost from the wall and slipways. It is believed these have been intentionally pulled from the wall to reduce the risk of them falling uncontrolled.

Missing coping stones (/C0303C01)

Due to the significance of the defects and the fact that there is evidence of them occurring along this full frontage, it is recommended that a thorough design review is undertaken. A strategy for addressing existing defects is urgently required, and this should also be extended to identify an approach for reducing the risk of future defects occurring, which may involve capital works. In particular this should focus on addressing issues with the coping stone connection detail.

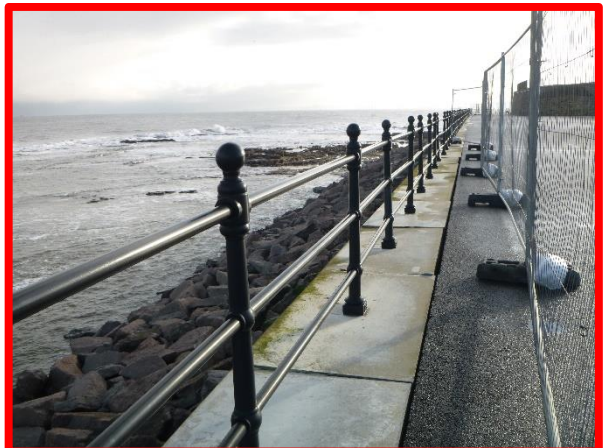
2. **evidence of movement in coping stones:** in addition to the missing coping stones, there is approximately 50m length of coping stones, spread across four sections, where there is significant lateral movement in the coping stones where there is a risk that these will fall. The amount of movement within the coping stones indicates that the ties which hold the stones in place are insufficient and have likely severed along some of this length.

Evidence of movement of coping stones (/C0303C02)

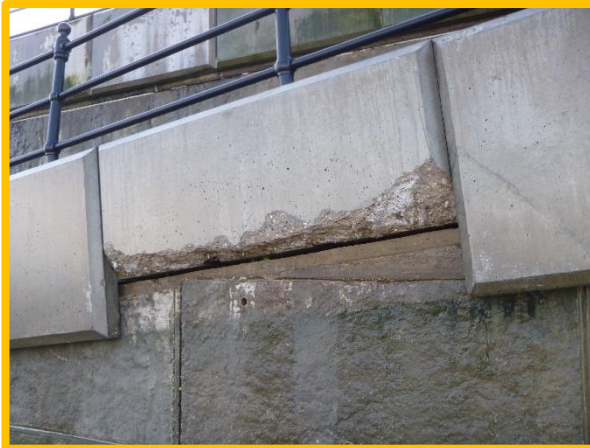
3. **Damage to coping stones:** there is localised evidence of damage to the face of the coping stone, notably the L-shaped lip, which hold the coping stone in place.

Damage to coping stones (/C0303C02)

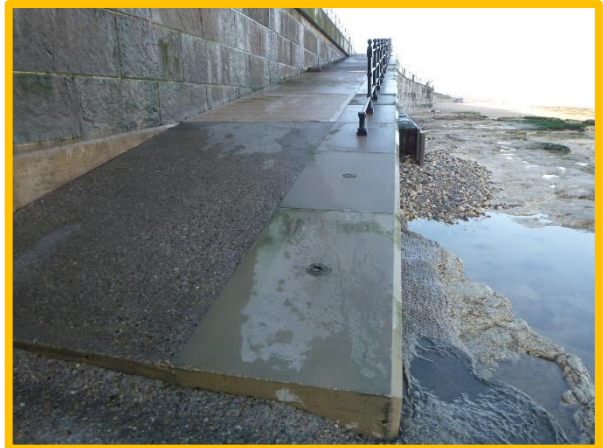
4. **missing sections of hand rail:** there are several sections of handrailing which is missing or damaged. This principally seems to be driven by loss or movement in the coping stones. However, there are some sections on the lower reaches of the slipways where the coping is not damaged and the handrail has been damaged due to wave impacts.

Missing section of handrail (/C0303C04)

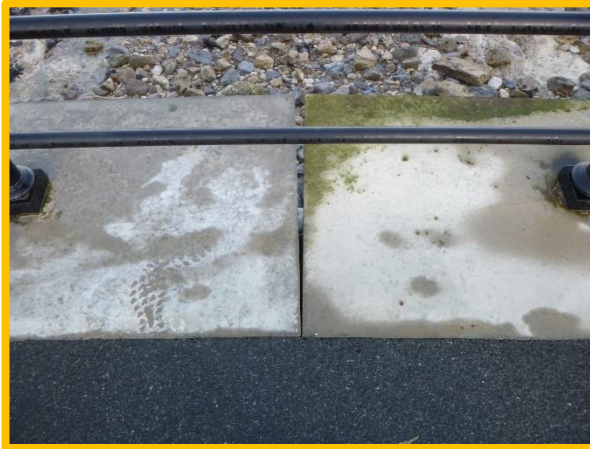
5. **missing flexible joint sealant:** as reported in the 2022 inspection report, it is estimated that approximately half of the flexible joint sealant is missing from the wall. Joint sealant was found to missing between facing panels and between coping stones. Most critically it was found to be missing between every single coping stone on the apex of the headland at Moor Parade. This is significant because the gap between each coping stone is splayed out in a seaward facing direction due to the curvature of the wall.

Missing flexible joint sealant (/C0303C02)

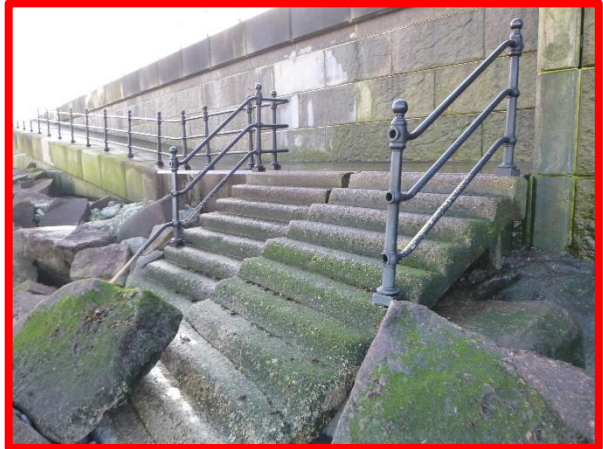
6. **damage to access steps:** a set of access steps located east of Town Moor have been badly damaged and have now failed, with one of the panels having been displaced.

Damage to access steps (/C0303C02)

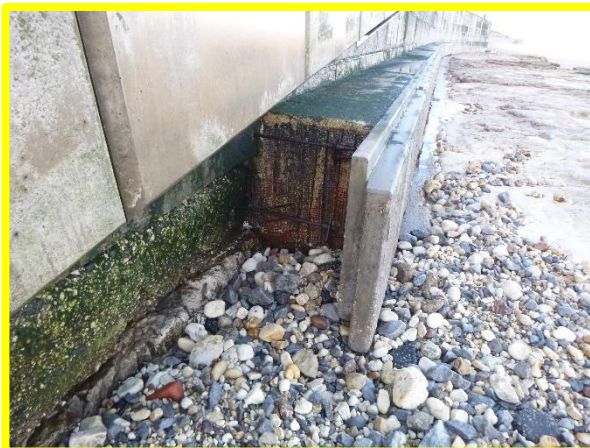
Outflanked toe feature (/C0303C01)

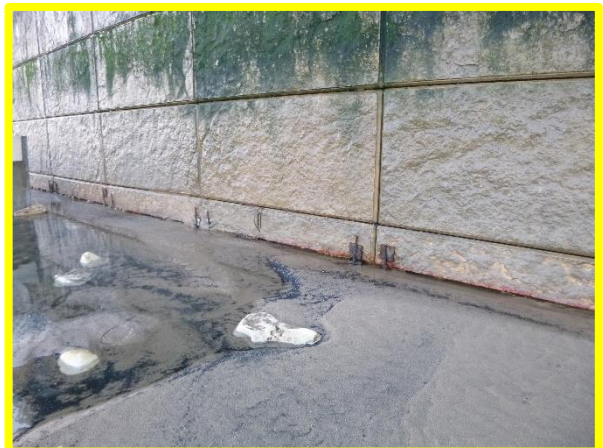
Exposed toe of wall (/C0303C01)

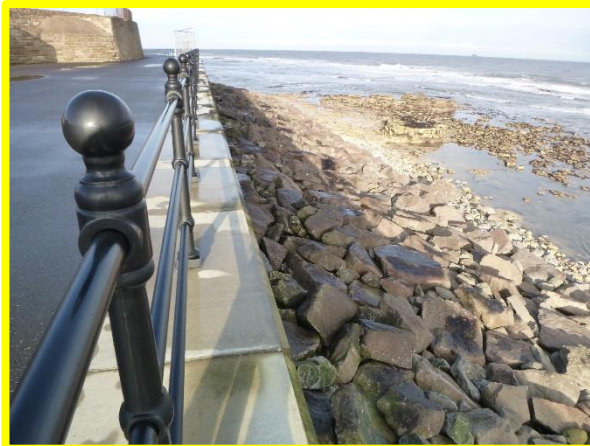
Shallow profile rock armour but shows good interlock (/C0303C02)

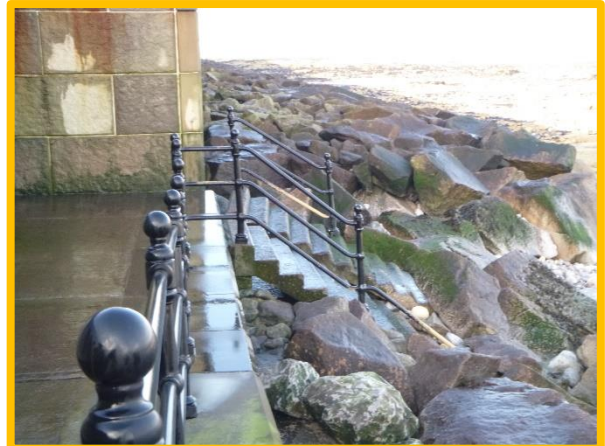
Extensive evidence of rock movement notably around failed access steps. (/C0303C04)

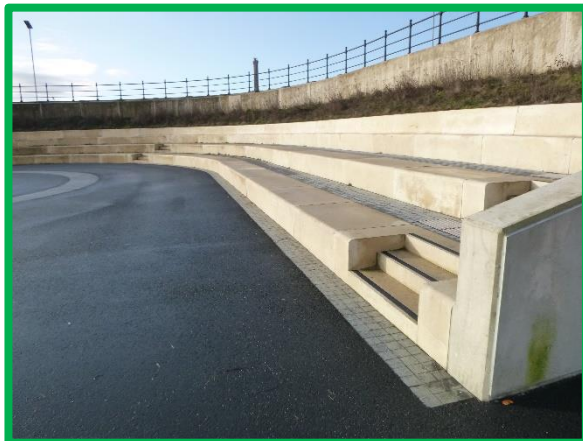
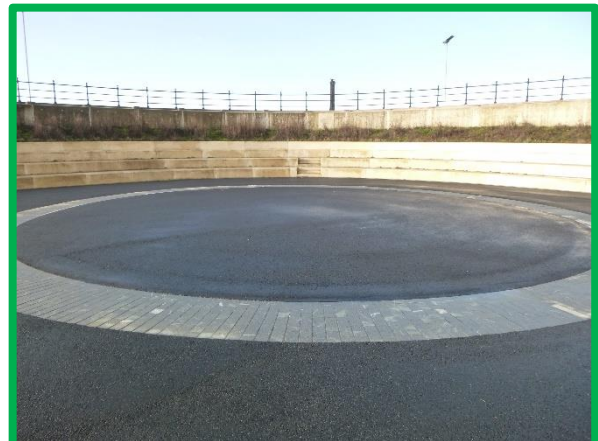
In 2021 a project to rejuvenate the Elephant Rock amphitheater, located on the lower promenade and forming a secondary defence, was complete. It remains in as built condition.

Elephant Rock – Outdoor Event Area (/C0303C02)

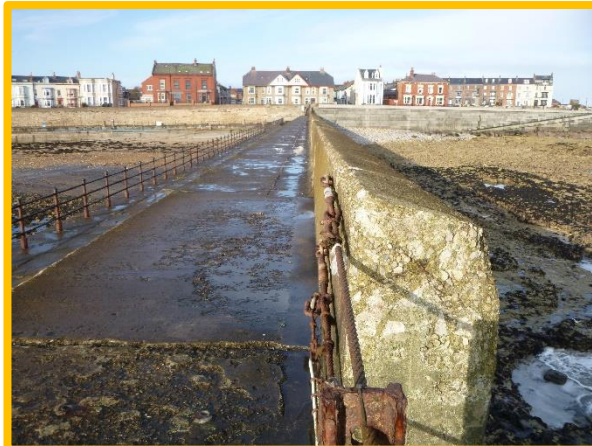
Spalling of concrete (/C0401C01)

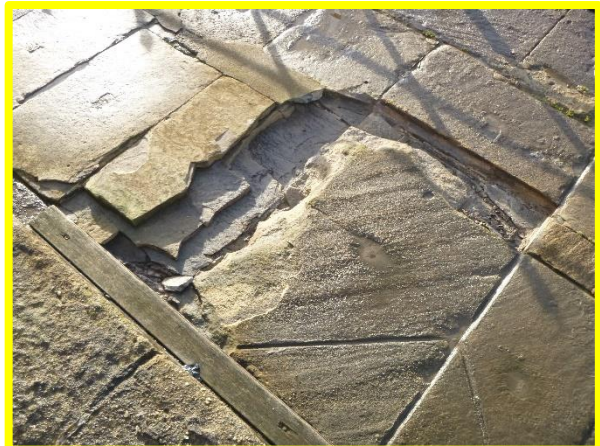
Cracking to the deck slab (/C0401C01)

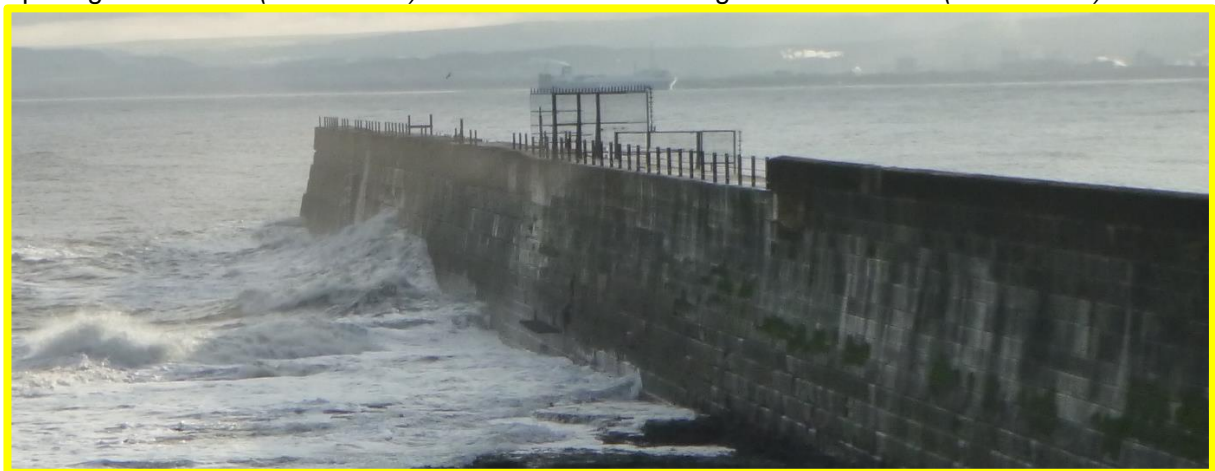
Northern aspect of the Heugh Breakwater (/C0401C01)

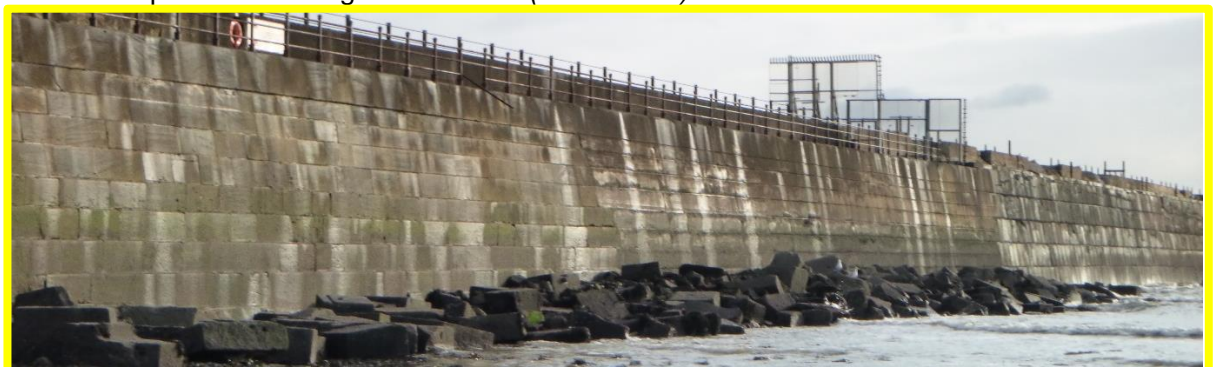
Southern aspect of the Heugh Breakwater (/C0401C01)

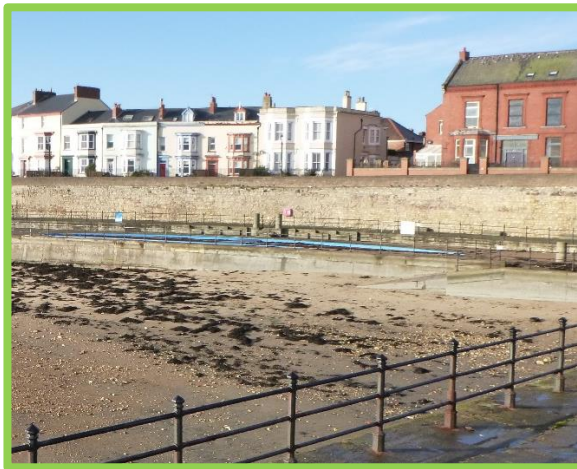
Healthy beach levels at Block Sands adjacent to Heugh Breakwater (/C0401C03)

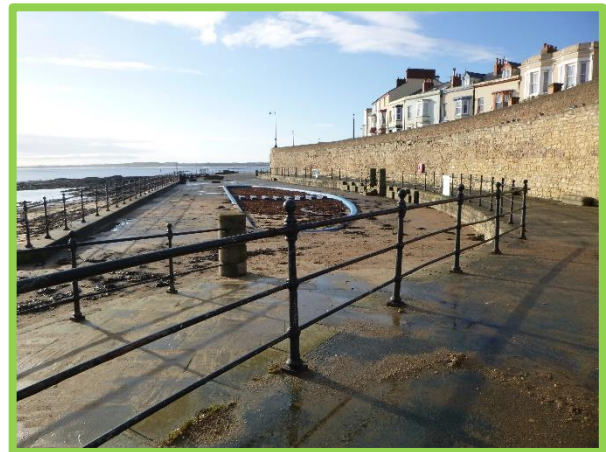
Rear masonry wall in fair to good condition (/C0401C03)

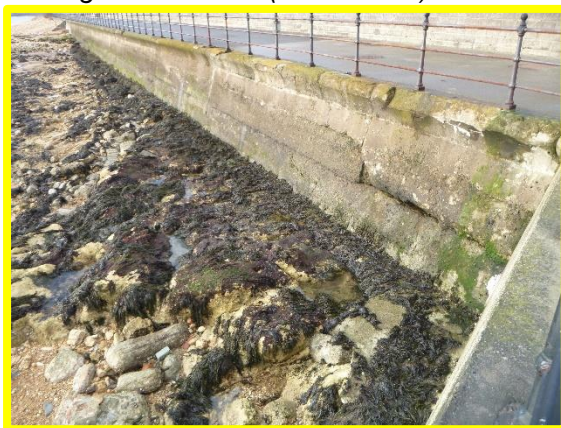
Damaged cope around handrailing fixing (/C0401C04)

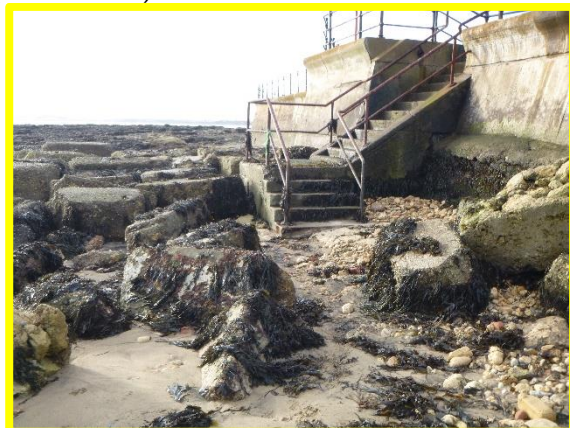
Access steps in fair condition (/C0401C04)

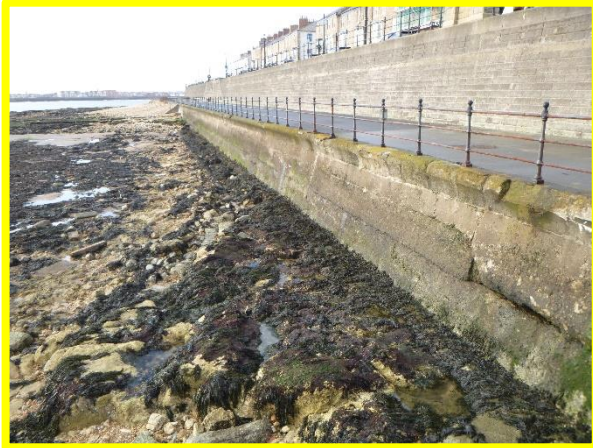
At the interface with the Old Pier the wall had sustained damage to the concrete recurve. A large crack extended the full height of the wall, potentially suggesting a global movement of the structure; however, no distress was evident in the promenade immediately above this section of wall. Undercutting was identified at the interface with Old Pier in 2016, however has not been visible since due to high beach levels. This location should be monitored with consideration given to infilling/repairing the existing undercutting/voids. There was no notable change to the condition of the wall during the autumn 2023 post-storm inspections/

Damaged recurve cope (/C0401C05)

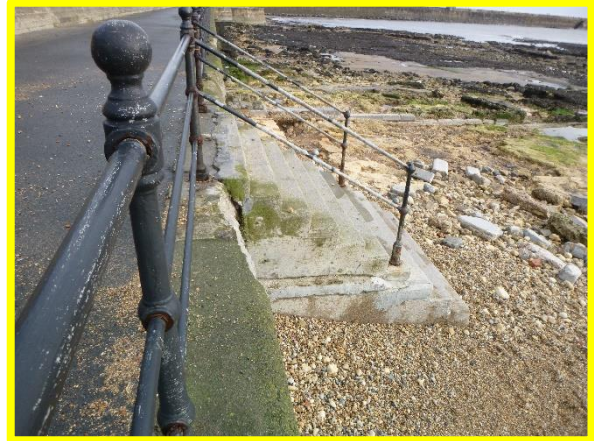
Steps in fair condition (/C0401C05)

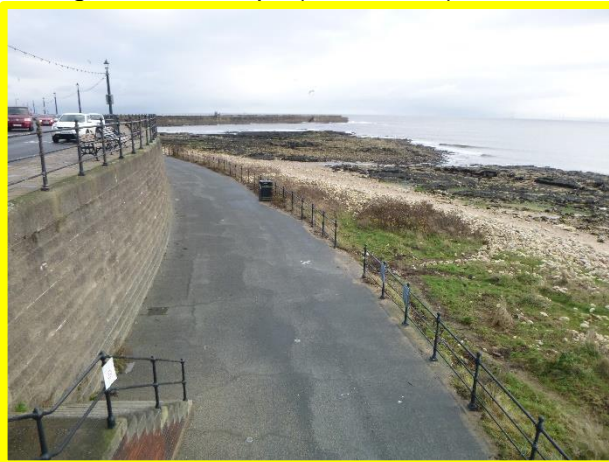
Steep pebble beach fronting vegetated area (/C0401C05)

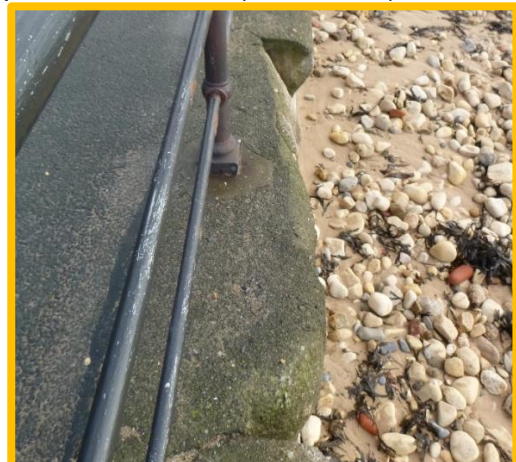
Historic damage to coping stone (/C0401C05)

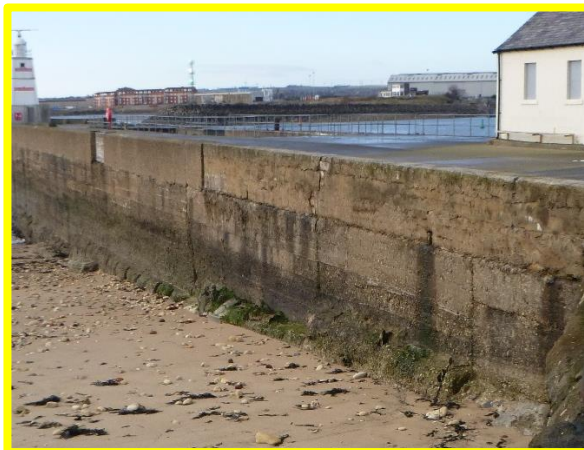
*Southern aspect of the Old Pier (Pilot Pier)
(/C0401C34)*

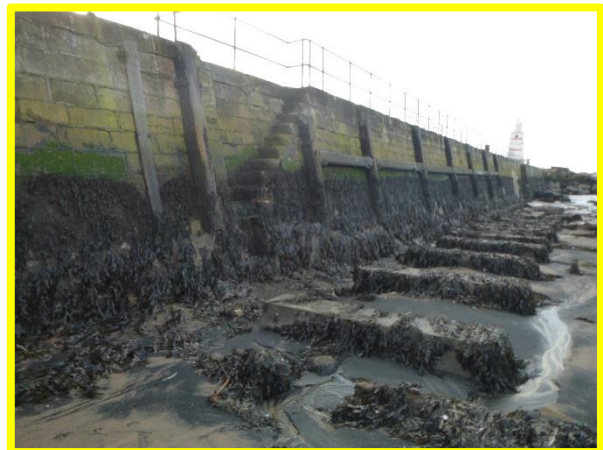
*Inner face of North Pier – uneven profile
suggesting potential settlement of masonry
blocks (/C0401C06)*

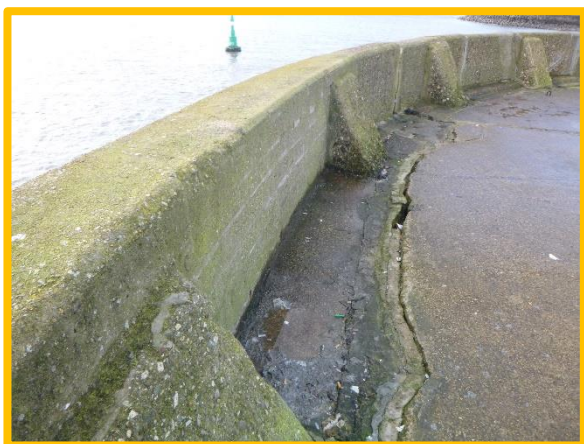
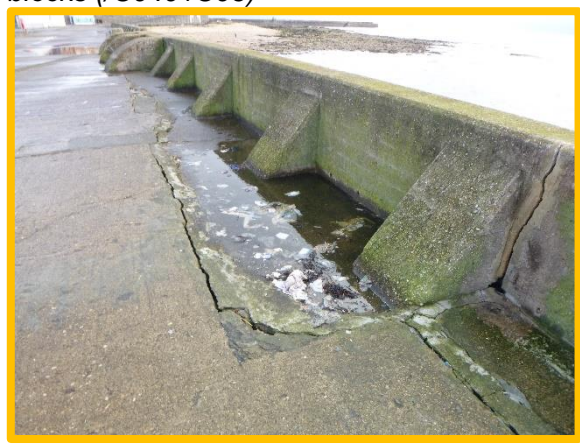
As recorded in previous inspections, an approximately 30m crack is present between the concrete parapet wall and main slab around the roundhead. This cracking may indicate settlement of the structure or seaward rotation of the parapet rather than local damage. These defects have been present since the 2014 survey, although appear to have worsened since the previous inspection. It was noted in the 2018 inspection that strain gauges were installed on the lighthouse structure which suggests monitoring of the structure is ongoing.

*Cracking in parapet wall and deck
(/C0401C34)*

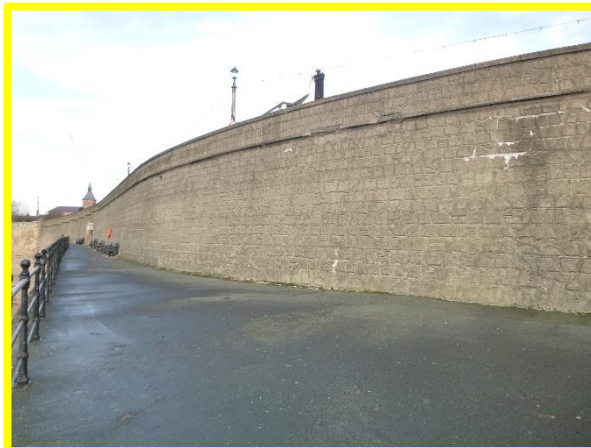
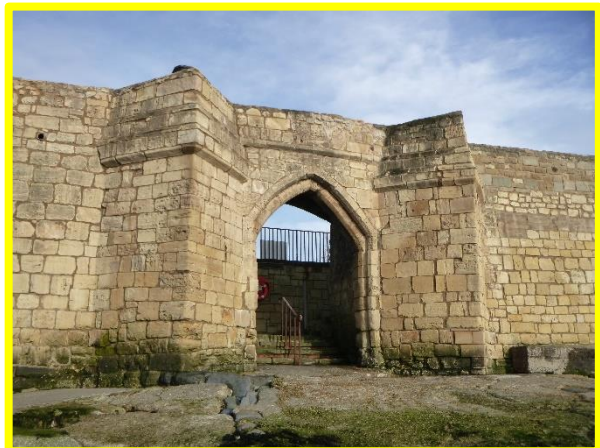
Town Wall benefiting from recent repointing works (/C0401C35)

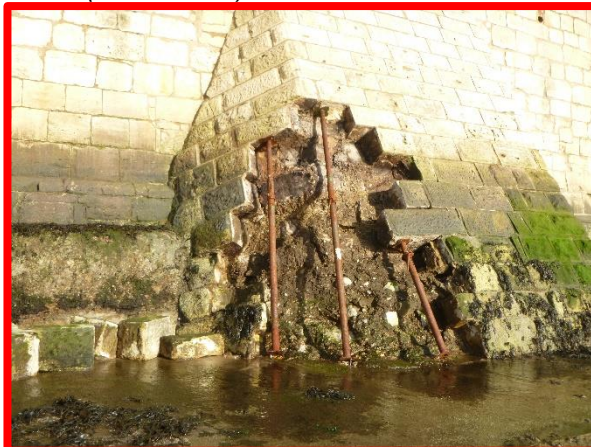
The masonry Town Wall, and supporting abutments, incorporate a multitude of historic *ad hoc* repairs but generally remains in fair condition. The wall has benefitted from recent local repointing works. During the 2022 inspection a significant defect was noted to the most easterly stone abutment where several blocks were missing. It was unclear whether this was a previous repair that had unraveled or whether the repair was in progress. It is recommended that this is addressed immediately to prevent further deterioration compromising the structure. A number of the other masonry abutments are heavily abraded and rounded at the toe. This defect appeared to have been rectified in the 2023 inspection, however another similar (but more significant) defect has occurred in the same abutment.

Significant defect to masonry abutment (/C0401C35)

- **Hartlepool Headland wall** – undertake detailed design review of asset following extensive damage. Produce strategy for addressing existing defects and to reduce risk of future defects occurring.
- **Town Wall** – Repair significant defect to most easterly masonry abutment.

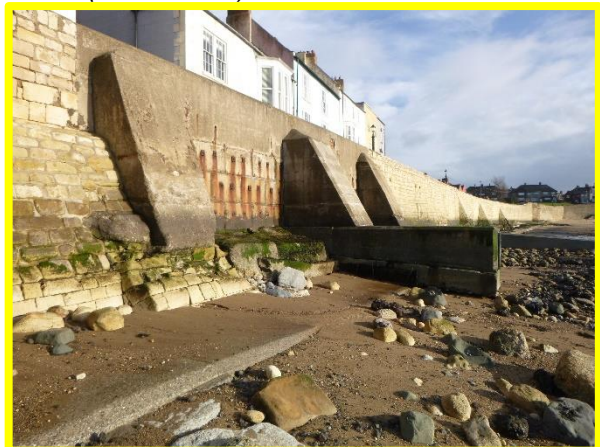
Recently constructed outfall and abutment. (/C0401C35)

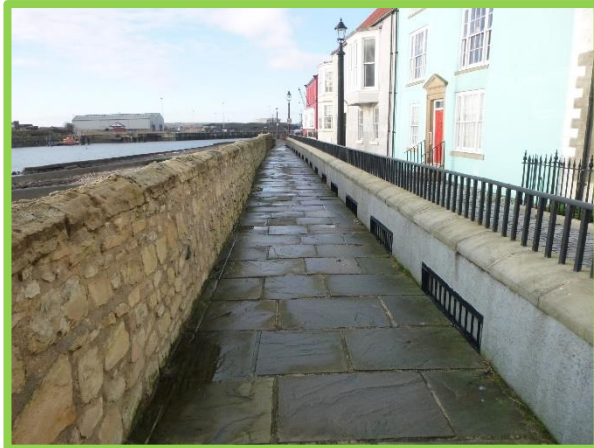
Repaired footpath and flood wall in good condition (/C0401C35)

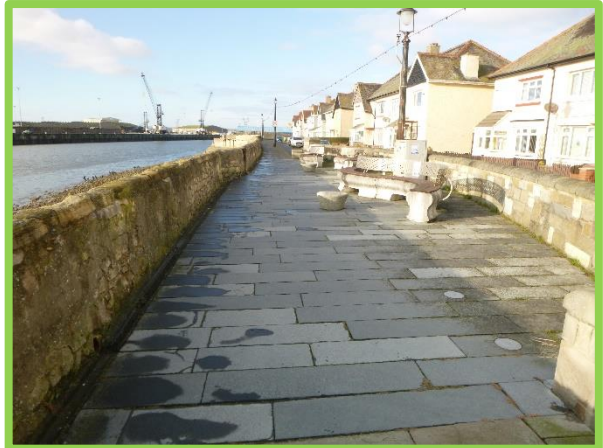
Promenade and rear wall in good condition (/C0401C35)

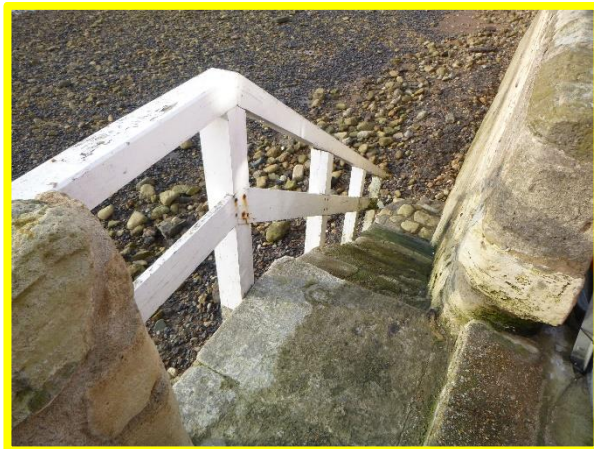
Beach access steps (/C0401C35)

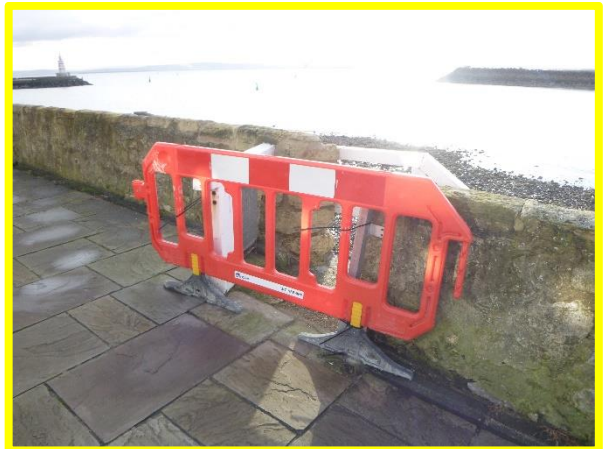
Beach access steps closed off (/C0401C35)

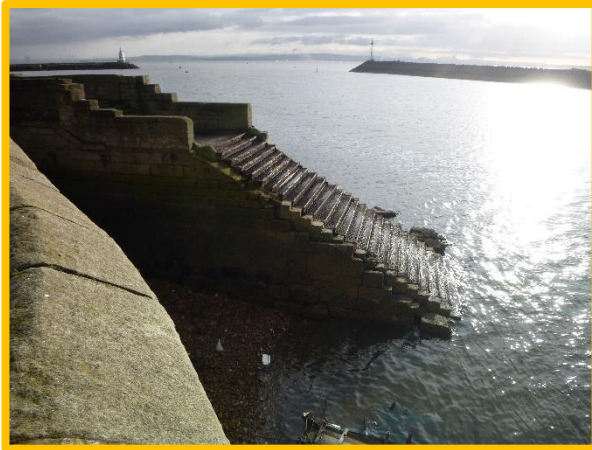
The steps at the former passenger ferry landing marking the southern extent of the asset remain in poor condition with loose and displaced masonry and heavily corroded steel ties. Public access to this structure, from the road, is prevented by a masonry wall and signage.

Damage to steps at former passenger ferry landing (/C0401C35)

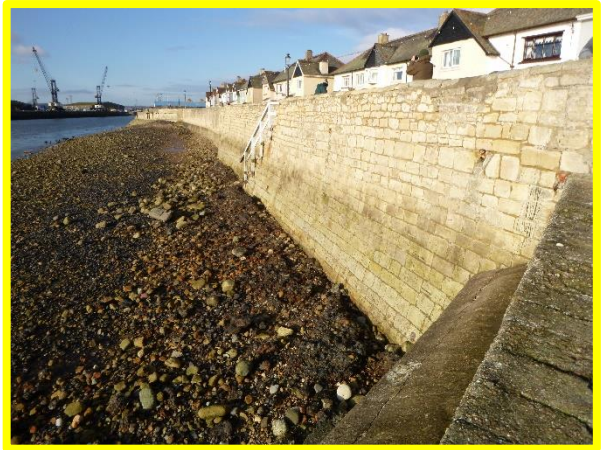
Wall generally in fair condition (/C0401C35)
