NECAG Coast Protection Assets and Coastal Slope Condition Analysis

**Redcar and Cleveland
Borough Council
Final Report**

April 2009

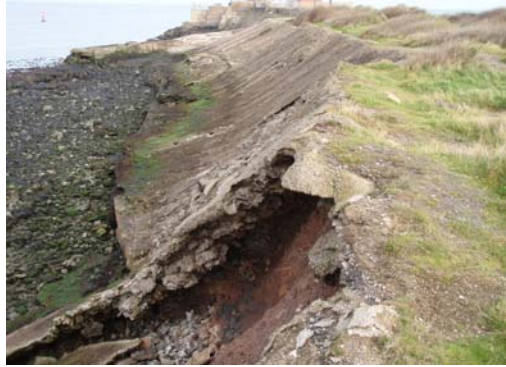
The northern extent of the frontage is marked by the South Gare Breakwater. The structure is generally in poor condition with significant cracking, spalling, loss of mortar and sealant to many of the concrete and masonry elements. Several pre-cast concrete seawall units are missing towards the seaward extent of the structure exposing cracked and rust stained concrete walls beneath. Wave action has removed several concrete slabs from the eastern side of the revetment, the broken remains of which are now visible on the foreshore below. Voids are opening up, allowing water/waves to penetrate and potentially weaken the structure. A large section of concrete render is missing from the western side of the breakwater, which has exposed the earth/rubble core of the structure and is beginning to undercut the crest road. Failure of a concrete toe and apron has exacerbated the damage, with evidence of washing out of infill material. This area requires urgent attention to limit further damage. A structural survey of the breakwater is recommended in order to establish the full extent of the damage and identify appropriate remedial works.

<p>Damaged render exposing fill material on west side (Asset Ref No 12221C901C0506C01)</p>

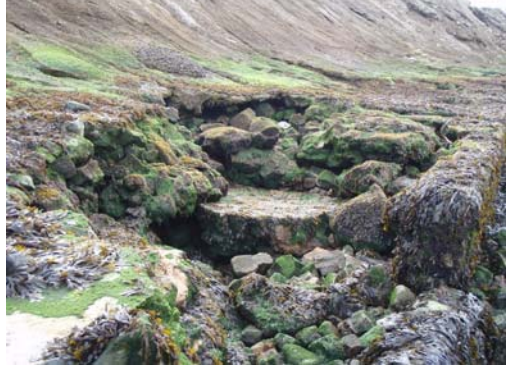
<p>Failure of concrete wall at embankment toe on west side (Asset Ref No 12221C901C0506C01)</p>

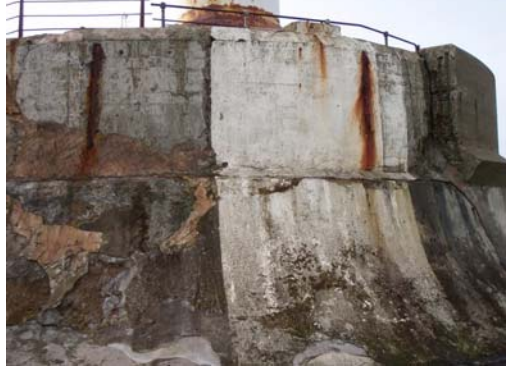
<p>Missing pre-cast concrete units at seaward extent (Asset Ref No 12221C901C0506C01)</p>

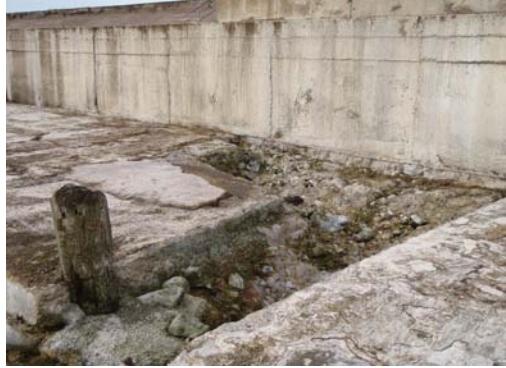
<p>Missing concrete slab on east side (Asset Ref No 12221C901C0506C01)</p>

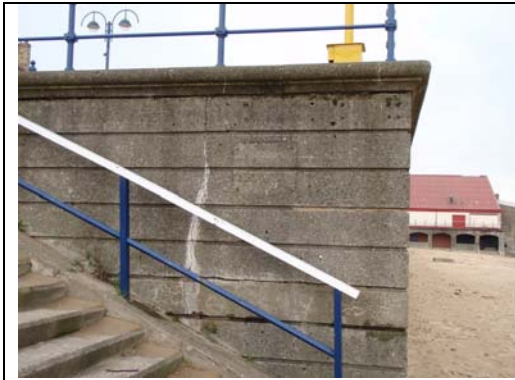
Settlement/movement of seawall (Asset Ref No 1221C901C0602C04)

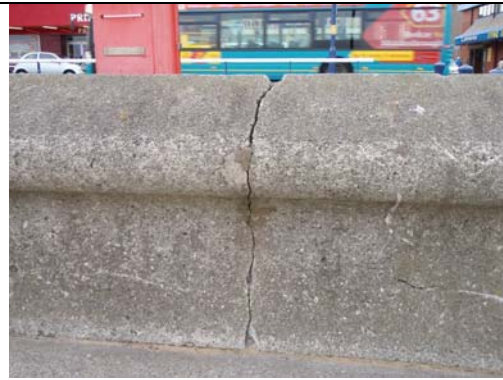
Crack propagating from construction joint (Asset Ref No 1221C901C0602C02)

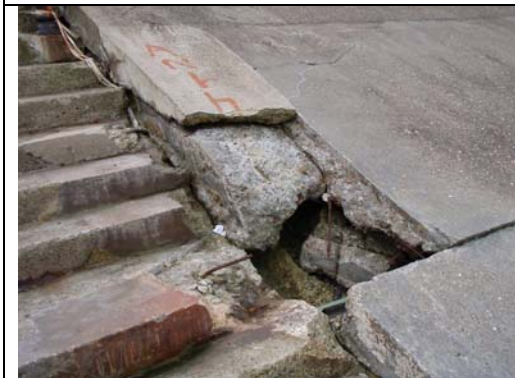
Failure of previous repair exposing reinforcement and infill material (Asset Ref No 1221C901C0602C01)

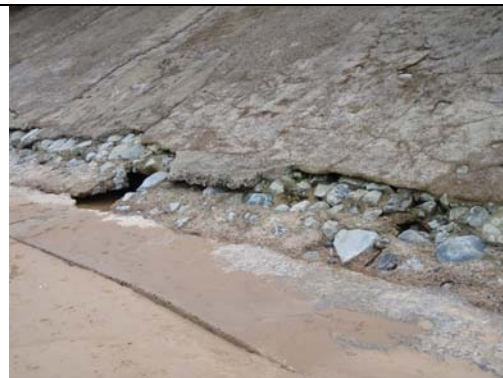
A concrete revetment protecting the Redcar frontage (Asset Ref No 1221C901C0602C01) is beginning to be undercut, with voids opening up at the toe. These voids should be infilled to prevent washout of fill material and further damage which may compromise the integrity of the structure. The timber groyne along Redcar Sands to the east of Redcar (Asset Ref No 1221C901C0603C01) are in poor condition with large numbers of planks missing and piles beginning to split.

Erosion at toe exposing masonry and forming voids (Asset Ref No 1221C901C0602C01)

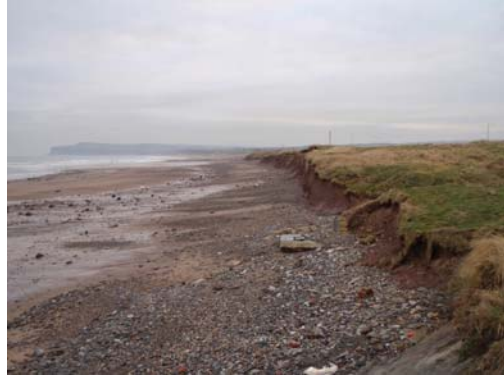
E52/10 Looking south from Mill Howle
(Locally Active)

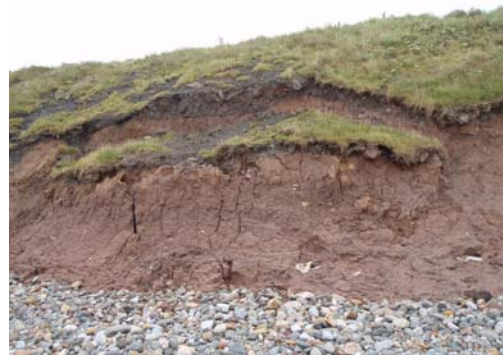
E52/10 Recent slope slip
(Locally Active)

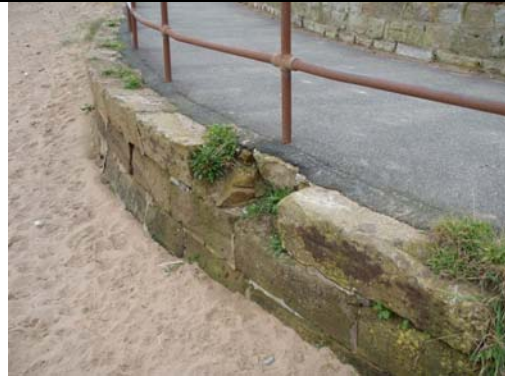
Missing masonry blocks and mortar with vegetation growth in gaps (Asset Ref No 12221C901C0702C02)

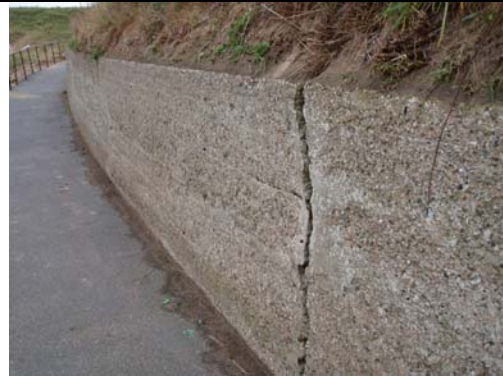
Crack in concrete wall below coastal slope (Asset Ref No 12221C901C0702C02)

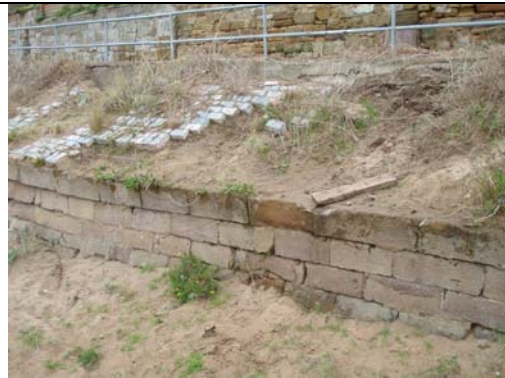
The masonry revetment (Asset Ref No 12221C901C0702C02) is in poor condition with extensive loss of blocks and erosion of the material below. The low beach level exposes the masonry wall below. This structure is missing several blocks which should be replaced and also needs repointing to replace missing mortar. To the southeast of the access at Marske, a coursed masonry wall (Asset Ref No 12221C901C0702C01) has a large settlement crack and missing bricks to the seaward end.

Missing masonry blocks with erosion and vegetation growth below (Asset Ref No 12221C901C0702C02)

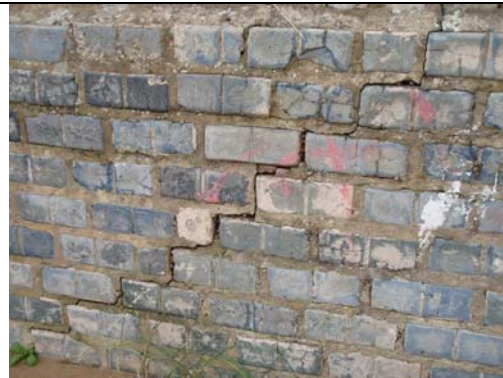
Settlement crack in masonry wall (Asset Ref No 12221C901C0702C01)

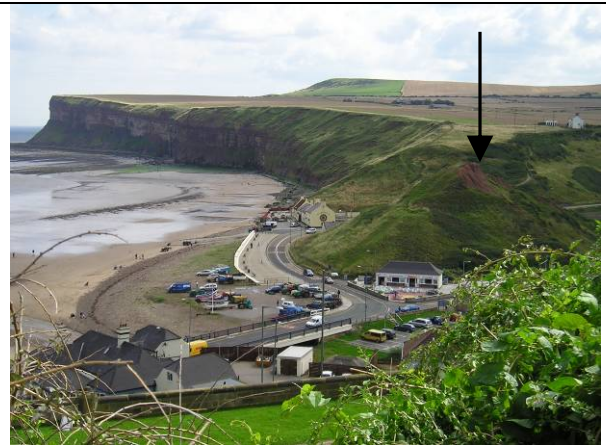
E52/1 looking eastwards at the mound like feature above the café (Locally Active)

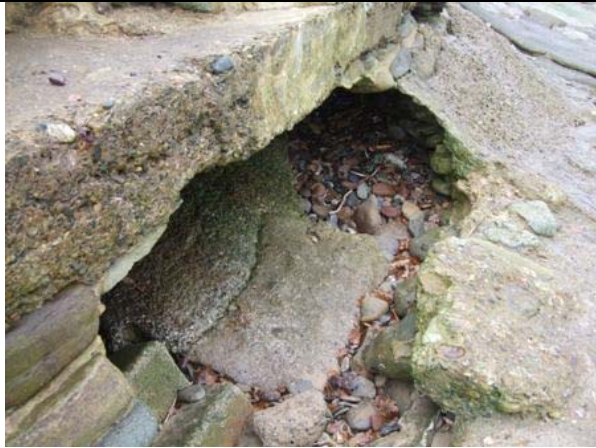
East of the Skelton Beck outfall is the southerly limit of the Saltburn defences. Here the coastal protection consists of heavily eroded sections of concrete defence, displaying large amounts of excavation, undercutting, major cracking and in some parts, total collapse (Asset Ref No. 1221C901C0704C05). A disused concrete sewer pipe is exposed due to erosion of the covering concrete. Urgent remedial work is required to prevent damage to adjacent property. The properties to the rear of this defence including the public house, museum and derelict property are privately owned and the defences are not maintained by Redcar and Cleveland Borough Council.

Undercutting and excavation of concrete defences (Asset Ref No. 1221C901C0704C05)

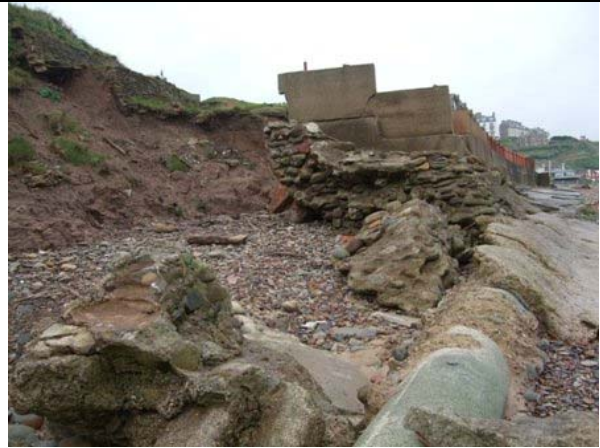
Total collapse of part of concrete defences and failure of unprotected cliffs (Asset Ref No. 1221C901C0704C05)

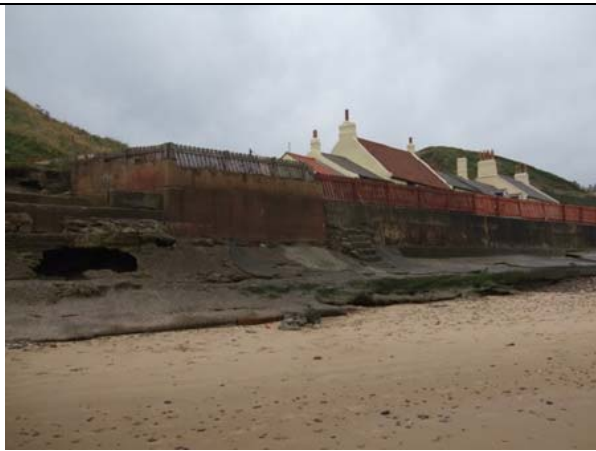
Property at risk behind eroded concrete defences (Asset Ref No. 1221C901C0704C05)

A masonry seawall protecting much of the frontage at Saltburn (Asset Ref No's 1221C901C0703C02 to 1221C901C0704C06) requires repointing and refilling of expansion joints in places. East of Skelton Beck there are heavily eroded sections of sea defences, displaying extensive excavation, undercutting, cracking and in parts, total collapse (Asset Ref No 1221C901C0704C05). Urgent remedial work is required to prevent damage to adjacent property.

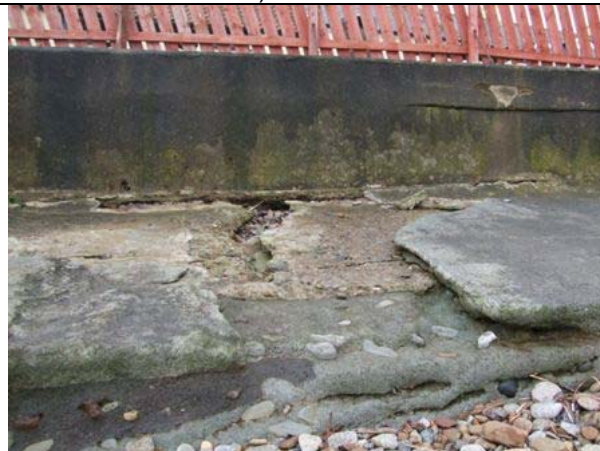
Cracking and erosion of concrete defences (Asset Ref No. 1221C901C0704C05)

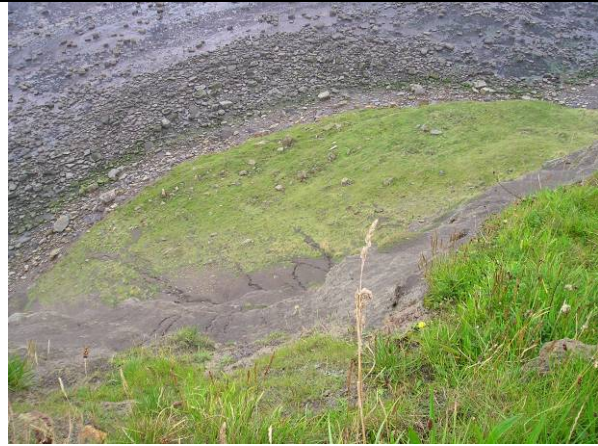
E54/3a vegetated debris flow lobe at cliff base, strewn with rock fall deposits (Partly Active)

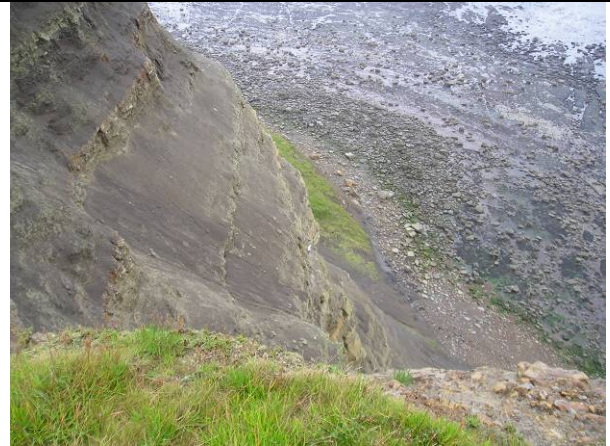
E54/2b erosion of lower cliff slopes (Totally Active)

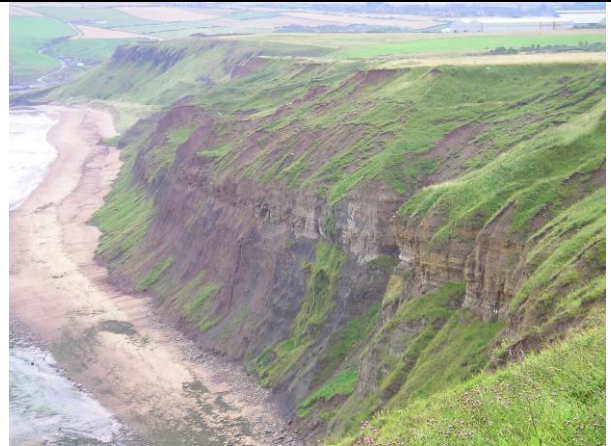
E55/2 looking southeast towards Skinningrove, steep, vegetated debris cones at cliff base (Partly Active)

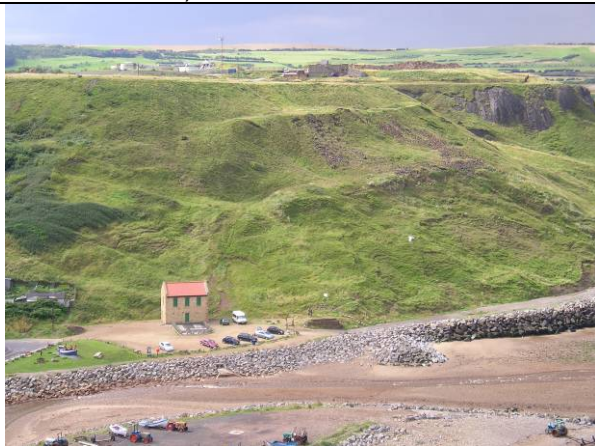
East of the jetty, the cliff unit adjacent to Skinningrove is Locally Active (E56/1). The well vegetated slopes have a stepped appearance with evidence of slumping and sliding mid-slope, despite the presence of rock armour at the toe.

E56/1 east of the jetty at Skinningrove (Locally Active)

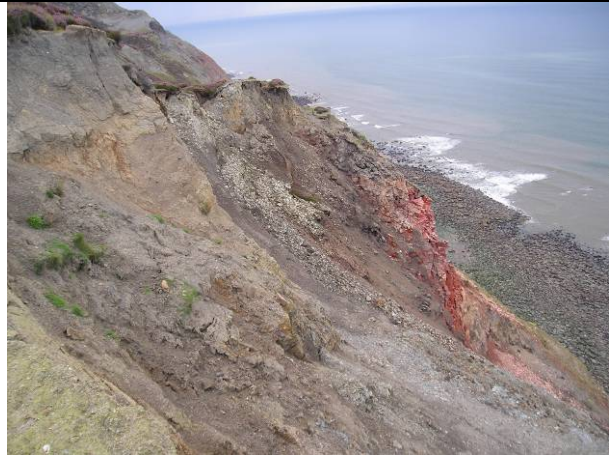
Below Rockhole Hill there is a single unit classified as Totally Active (E58/1c). Here the lower cliff face is undergoing mass failure. Active sliding was observed during the walkover survey and a large crack and associated displacement slump are present behind the active zone.

E58/1c looking across to the northwest (Totally Active)

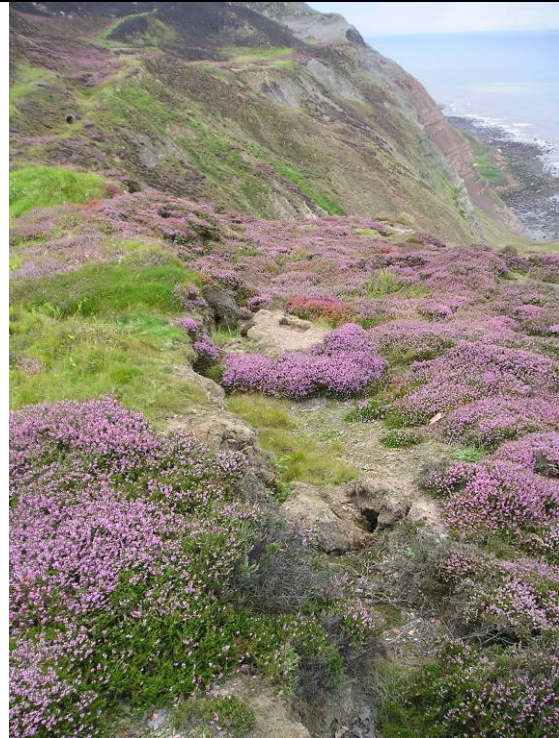
Behind unit E58/1c crack and displaced slump (Totally Active)

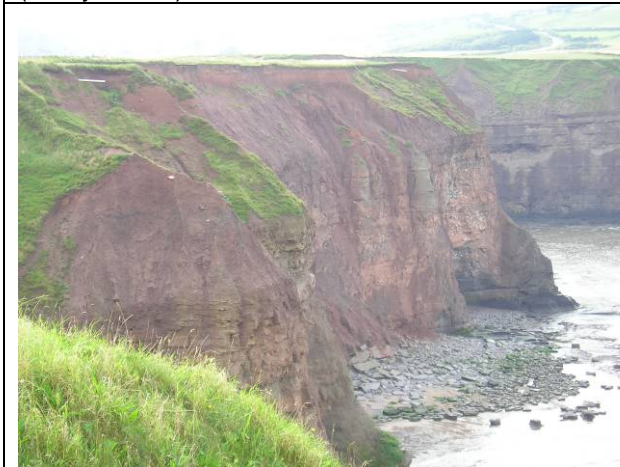
Along Cowbar Lane, there is one CBU where the upper till unit is undergoing particularly severe erosion and slumping onto the shoreline below (Totally Active- E59/3). This has led to the loss and redirection of parts of the lane. Near Cowbar attempts have been made to stabilise the till using a flexible mesh facing which to the date of the inspection appears to have been successful (Partly Active- E59/1).

E59/3 looking west from Cowbar (Totally Active)

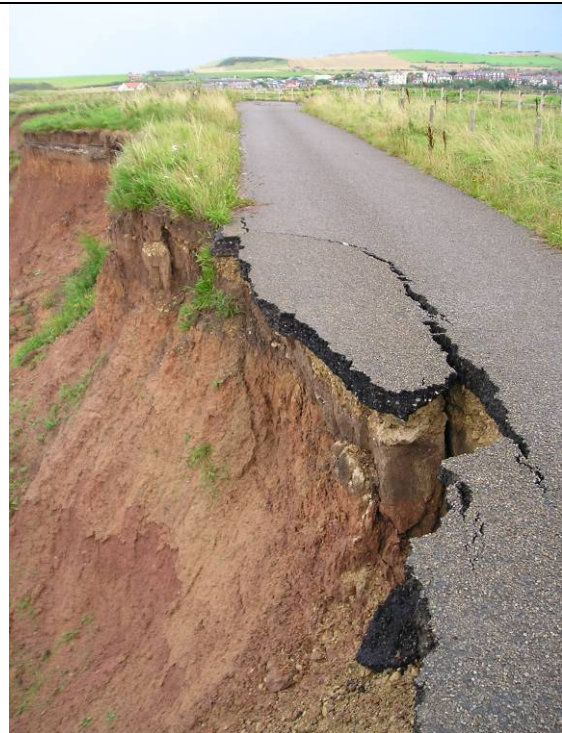
E59/3 loss of Cowbar Lane (Totally Active)

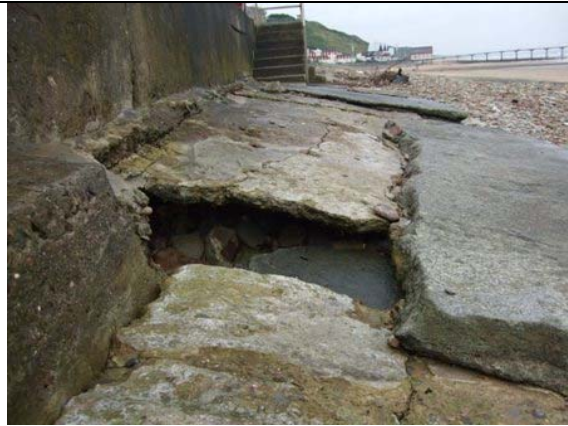
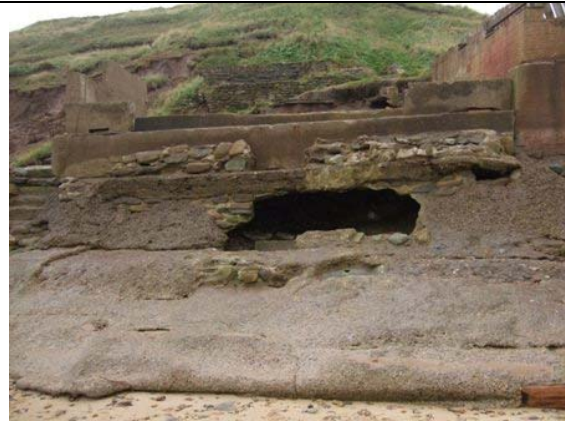
degradation of the condition of the asset with increased evidence of minor cracking and spalling, although this process may have been accelerated by changes in beach level and exposure of the toe of the defences. The rating drop for the mixed concrete and masonry defence shows more extensive defects including significant cracking, undercutting and joint failure. Large holes have appeared and the southern end has collapsed.

The mixed concrete and masonry defence (Asset Ref No. 1221C901C0704C05)

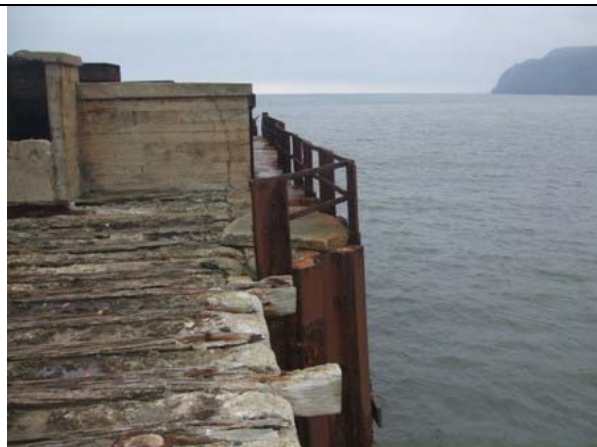
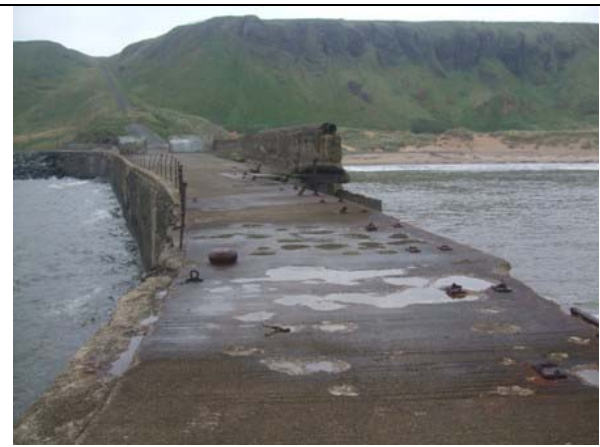
At Skinningrove, the jetty shows evidence of significant cracking, deformation and corrosion in places (Asset Ref No. 1221D901D0201C02). It is disused as a jetty, however, access is still possible and so consideration should be given to public health and safety.

Most assets in this area show little change in condition since 1998 when they were last inspected and recorded in the NFCDD. However, the condition of asset 1221D901D0201C02 has slipped from a fair to poor grading. This asset is the old jetty to the west of Skinninggrove which is disused, has large cracks in several places and shows signs of deformation.

The jetty west of Skinninggrove (Asset Ref No. 1221D901D0201C02)
