**Cell 1 Regional Coastal Monitoring Programme
Coastal Walkover Inspections 2010**

**Redcar and Cleveland
Borough Council
Final Report
December 2010**

This report documents the condition of the coastal cliffs and assets along Redcar and Cleveland Borough Council's frontage, which extends from the South Gare Breakwater in the north, to Cowbar Nab, Staithes in the south.

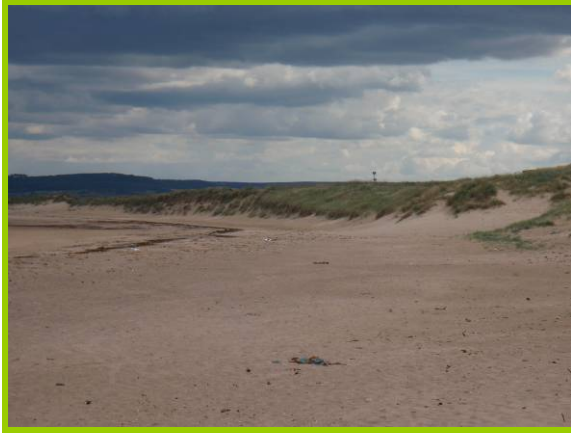
E52/11 View towards Redcar (Inactive)

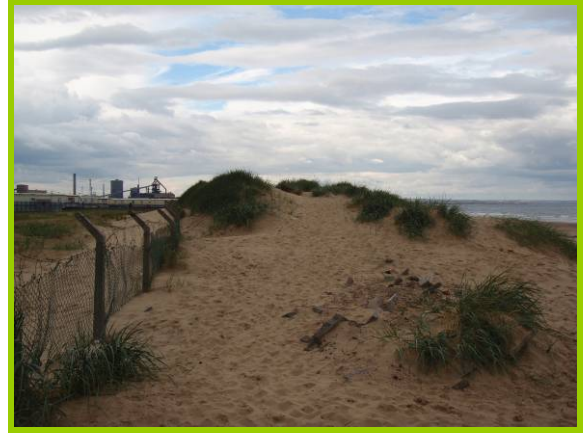
As reported in 2008, the sand dunes (E52/11) were generally stable with a good coverage of established vegetation. Minor erosion, loss of vegetation and lowering of dune crests was evident locally where members of the public access the beach most frequently (the northern and southern extents of the dunes). A healthy beach level was maintained throughout Coatham Sands.

E52/11 Local lowering of dunes and loss of vegetation due to pedestrian access (Inactive)

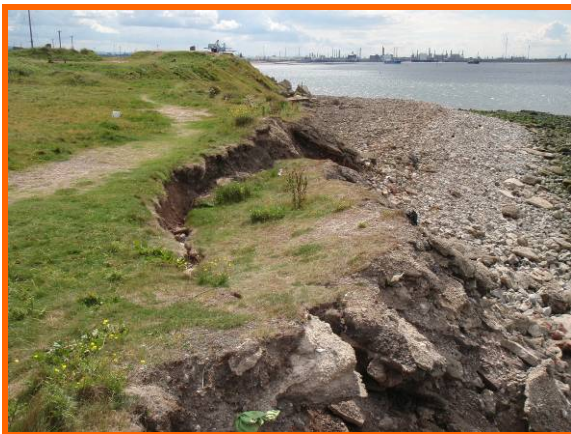
The western side of the breakwater appeared in worse condition than the eastern side due to the defects observed in the slag embankment section of the structure. Large sections of in-situ concrete render were missing from the western side of the breakwater, which had exposed the earth/rubble core of the structure and was beginning to undercut the crest road. Failure of a concrete toe and apron has exacerbated the damage, with evidence of washing out of significant amounts of infill material. These defects were identified locally in the 2008 inspection and appear to have become more extensive in the interim as undercutting and local slope failure was evident throughout the western side of the breakwater. This area requires urgent attention to limit further damage.

Extensive local slope failure on west side of structure (Asset Ref No 12221C901C0506C01)

A detailed survey of the structure was beyond the scope of the present inspection and a full structural survey of the breakwater is recommended in order to establish the full extent of the damage and identify appropriate remedial works.

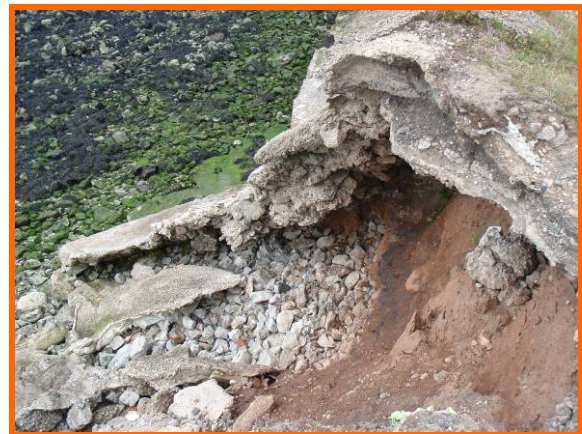
Undercutting of slag embankment on west side of structure (Asset Ref No 12221C901C0506C01)

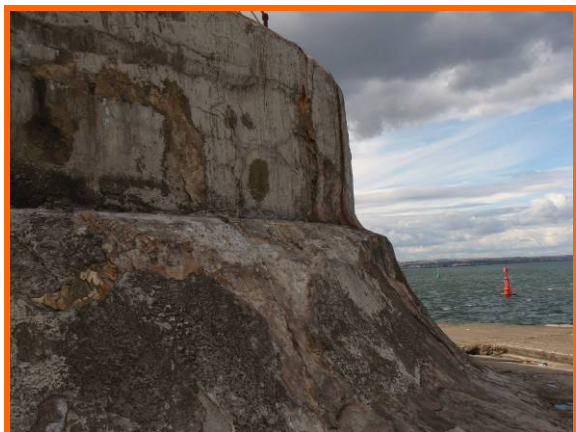
Several pre-cast concrete seawall units were missing towards the seaward extent of the structure exposing cracked and rust stained concrete walls beneath with extensive spalling of concrete.

Extensive spalling of concrete at head of breakwater (Asset Ref No 12221C901C0506C01)

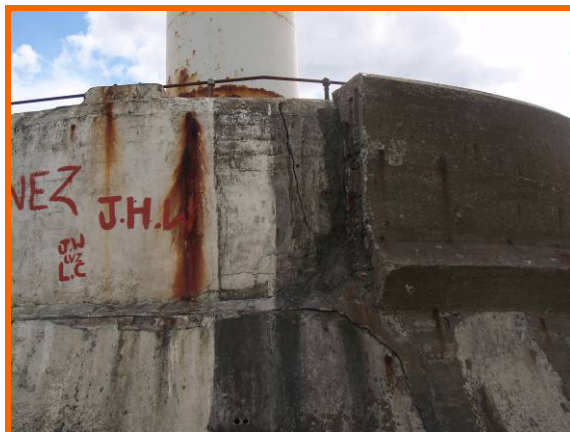
Missing pre-cast concrete units at head of breakwater (Asset Ref No 12221C901C0506C01)

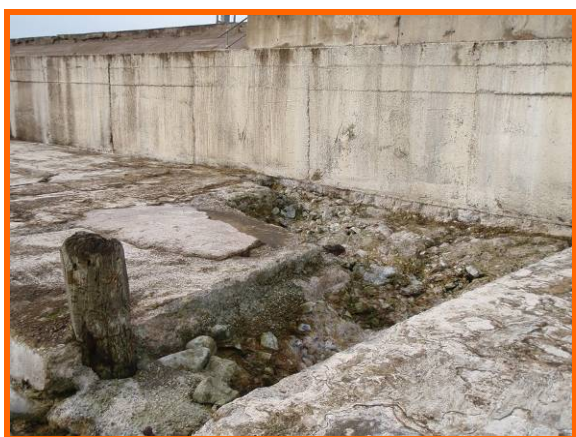
Voids present in deck - 2008 (Asset Ref No 12221C901C0506C01)

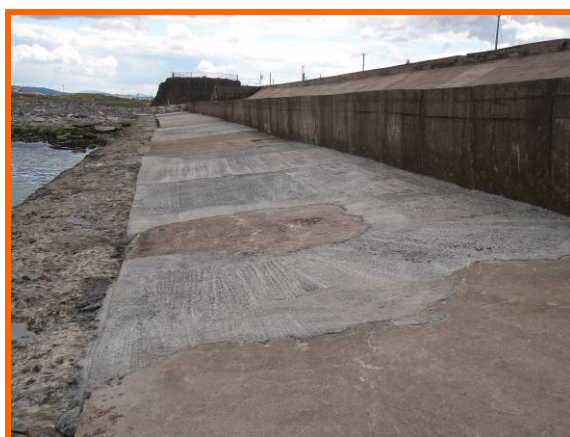
Local in situ concrete pours were evident to the eastern side of the structure, replacing the missing deck slabs and infilling/covering the voids identified in the 2008 inspection.

Slab repairs to deck on east side of structure – 2010 (Asset Ref No 12221C901C0506C01)

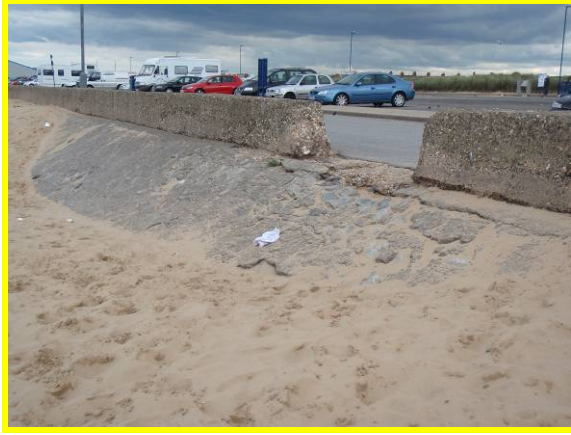
To the west of Redcar, the defences comprise a grouted stone revetment with a concrete wall along the crest. Beach levels were higher than during the 2008 inspections, obscuring most of the revetment element. The concrete wall was generally in good condition although missing a section towards its northern extent. This appeared to be used as an access point to the beach, resulting in a loss of beach material and exposure of the revetment. Beach levels were lower towards the south of the asset, exposing more of the revetment which appeared in fair condition with minor grout loss and vegetation growth.

Gap in concrete wall and exposed revetment
(Asset Ref No 12221C901C0601C01)

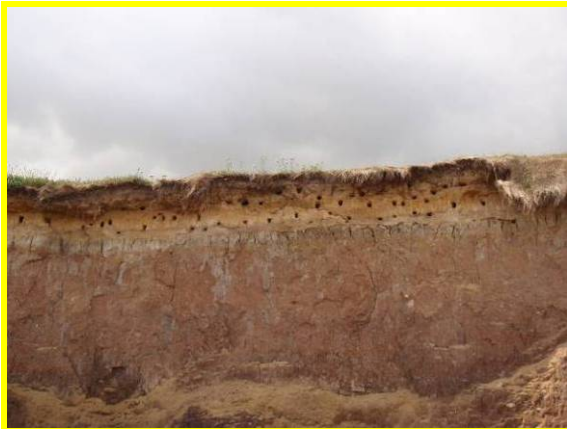
Extensive burrowing by Sand Martins was observed in the softer material towards the crest of the coastal slopes. This weakening of the material had exacerbated local headscarp failure. The coastline had receded notably surrounding a concrete outfall structure at Mill Howle.

E52/10 Sand Martin activity evident in upper slope face (Locally Active)

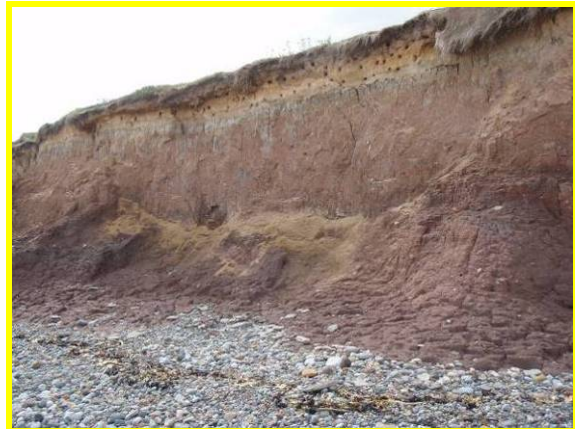
E52/10 Local headscarp failure (Locally Active)

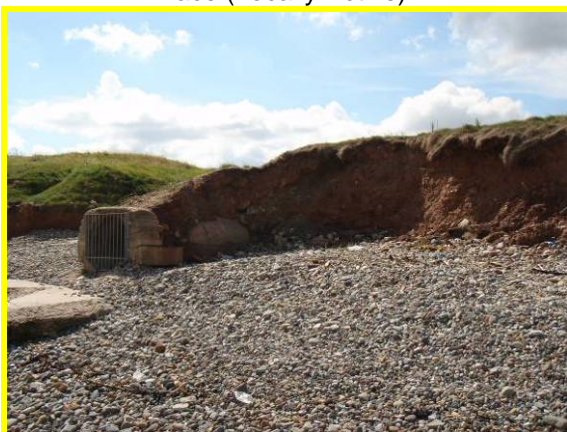
E52/10 Erosion of natural slopes surrounding outfall structure at Mill Howle (Locally Active)

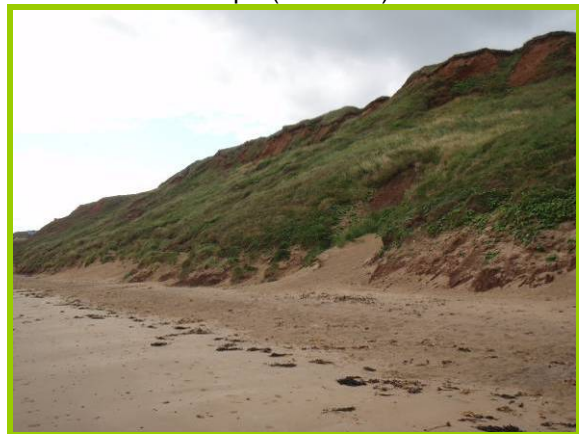
E52/4: Coastal slopes viewed looking south (Inactive)

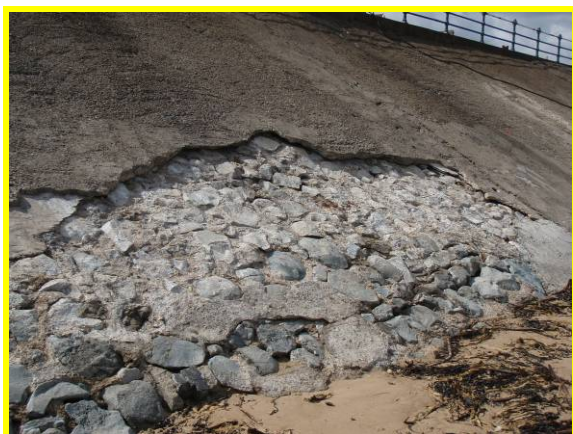
The defence assets to the east of Redcar comprise of a grouted stone revetment with an insitu concrete render. The concrete render was missing in places, exposing the grouted stone below which showed some minor loss of grout and stones. The 2008 inspection identified local undercutting and void formation at the toe of the structure although this was not observed in the 2010 inspection due to higher beach levels.

Loss of concrete render exposing grouted stone with minor voids (Asset Ref No 1221C901C0602C01)

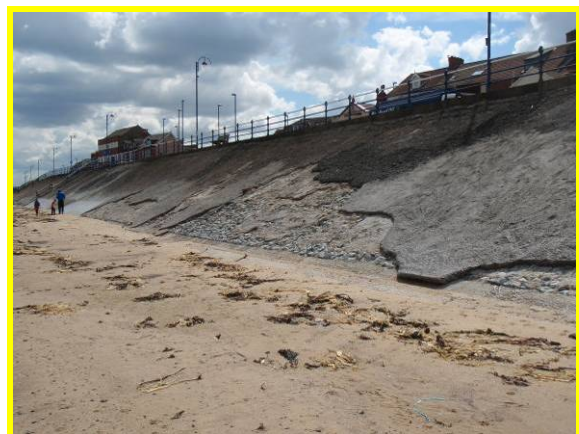
Loss of concrete render. Local infill repairs evident (Asset Ref No 1221C901C0602C01)

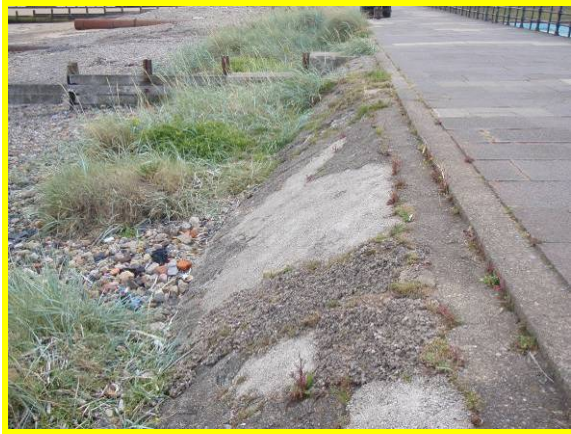
Missing concrete render – evidence of local patch repairs (Asset Ref No 1221C901C0701C01)

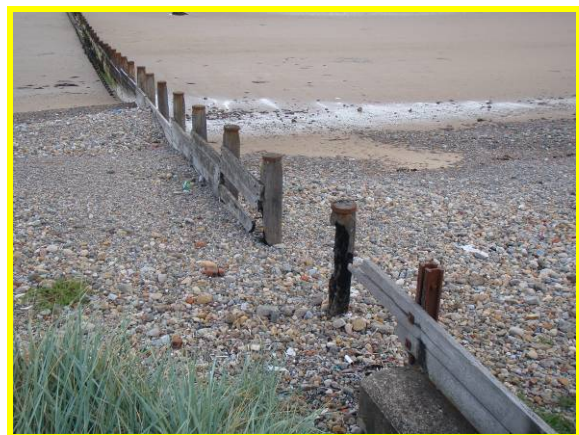
The timber groynes along Redcar Sands showed evidence of damage with both natural and human contributors – evidence of fire damage was observed at the landward end of several groynes. Broken and missing boards became more prevalent moving southwards along the groyne field. The groynes appeared to be operating effectively as the beach level was generally healthy throughout, with increasing levels moving southwards. Beach levels were higher than during the 2008 inspections as the sheet piles around the base of the piles were generally buried.

Fire damage and missing/broken timbers (Asset Ref No 1221C901C0701C01)

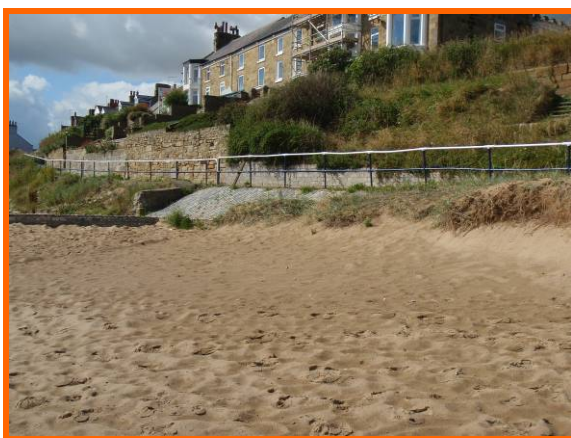
The masonry revetment (Asset Ref No 12221C901C0702C02) to the north west of the beach access at Marske was in poor condition with extensive loss of blocks and erosion of the material below. Vegetation growth within the voids obscured a large proportion of the structure. The low beach level exposed the masonry wall below the revetment which showed evidence of local settlement although this was of the same magnitude as observed in 2008 which suggests the structure is stable.

Missing masonry blocks with erosion and vegetation growth below (Asset Ref No 12221C901C0702C02)

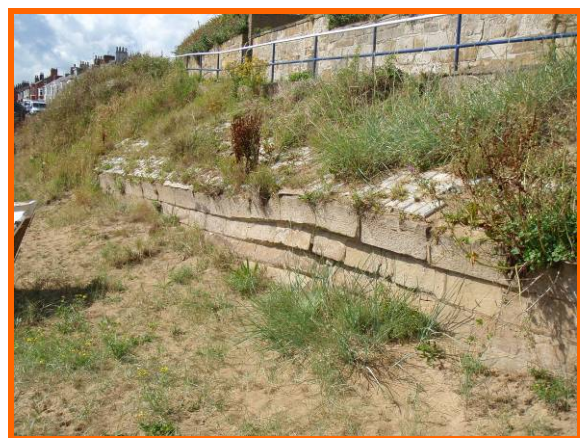
Local settlement of masonry structure (Asset Ref No 12221C901C0702C02)

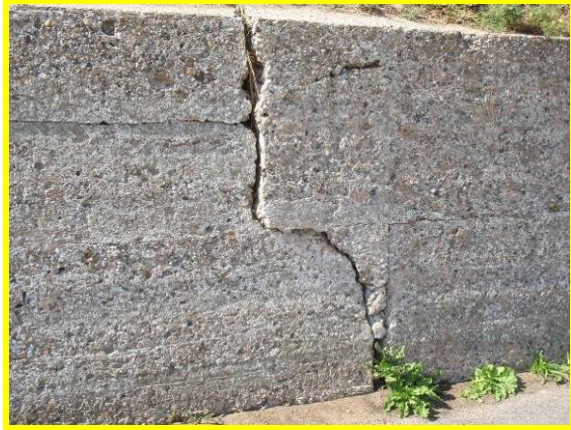
Crack in concrete wall below coastal slope (Asset Ref No 12221C901C0702C03)

The concrete wall (Asset Ref No 12221C901C0702C03) at the toe of the vegetated slope was cracked through its full height. This defect was reported in the 2008 inspections and appeared to be of the same width and extent. The slope above (CBU E52/7) showed no evidence of recent movement or any placement of excessive loading on the structure.

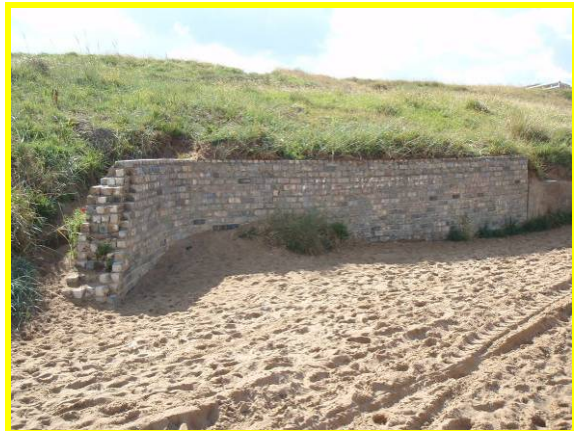
The masonry wall to the southeast of the beach access at Marske (Asset Ref No 12221C901C0702C01) has a large settlement crack and missing bricks to the seaward end and is in similar condition to that reported in 2008. Minor scour appeared to be occurring to the rear of the wall.

Masonry wall with cracks and missing masonry at seaward extent (Asset Ref No 12221C901C0702C01)

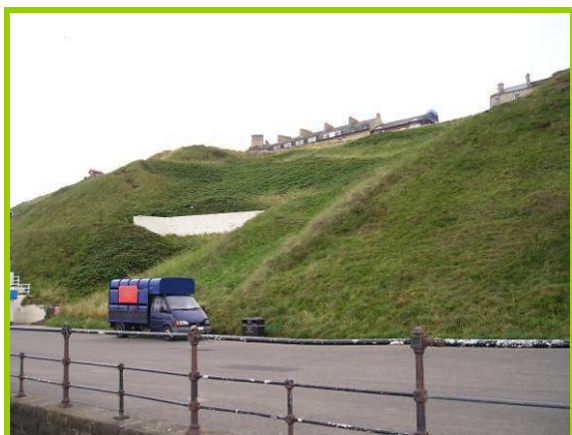
E52/3a looking up at well vegetated cliffs from Saltburn Sands (Inactive)

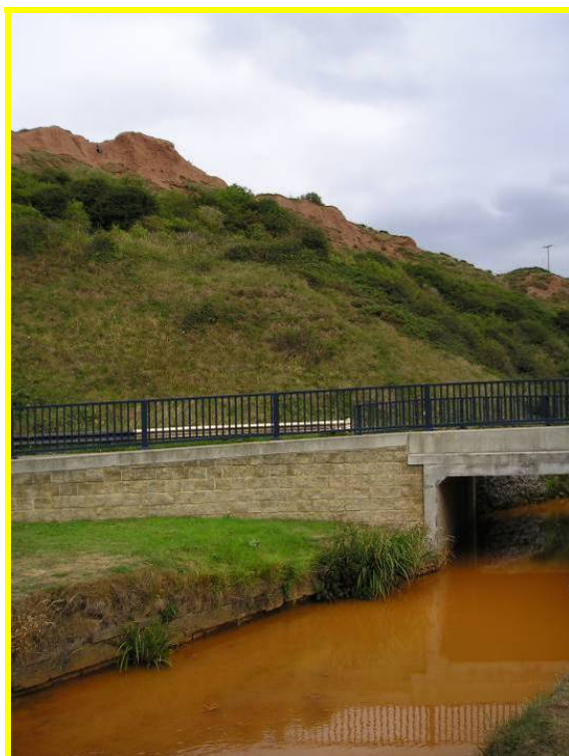
E52/1 erosion at the head of the mound just east of Saltburn Gill (Locally Active)

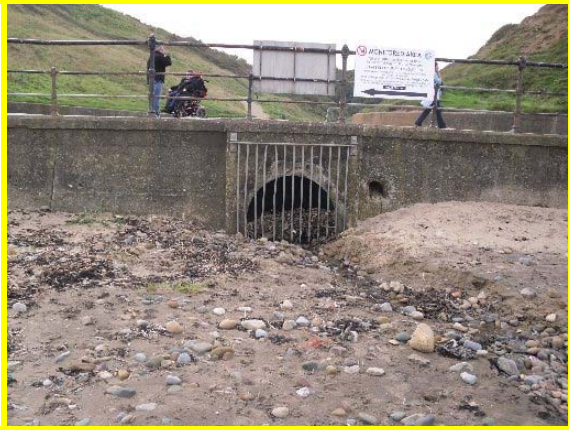
Partially blinded outfall exiting through sea wall at Hazel Grove Foot
(Asset Ref No 1221C901C0703C02)

There is an outfall which exits at Hazel Grove Foot and is protected by a trash screen. At the time of inspection the screen was partially blinded, therefore it is recommended that this be cleared. Other recommended actions include repointing of masonry blockwork and re-sealing the expansion joints between in-situ concrete promenade slabs. There are several other small defects which should be noted and repaired – a small section of a lower hand railing is missing and occasional coping stones are missing or have been repaired.

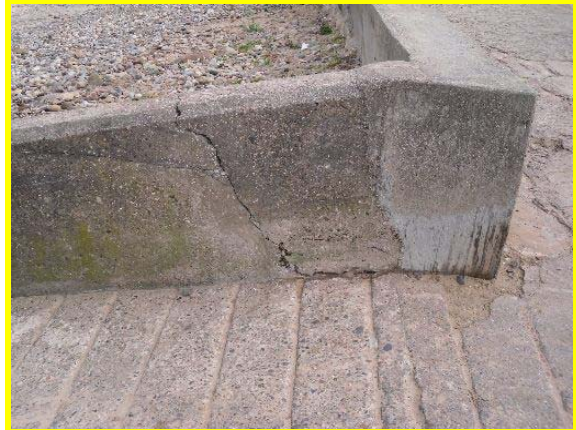
Cracked wing wall in slipway attached to sea wall at Hazel Grove Foot
(Asset Ref No 1221C901C0703C02)

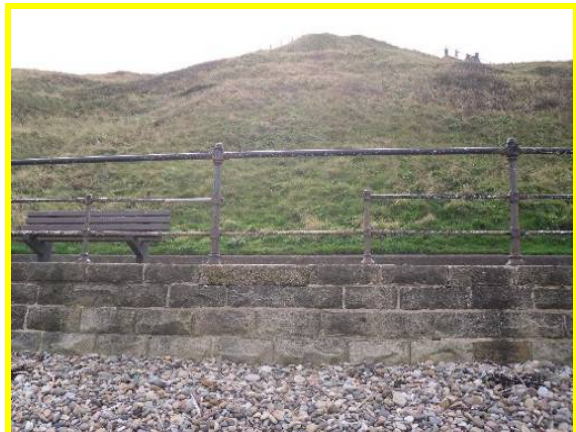
One section where a section of hand rail is missing
(Asset Ref No 1221C901C0704C04)

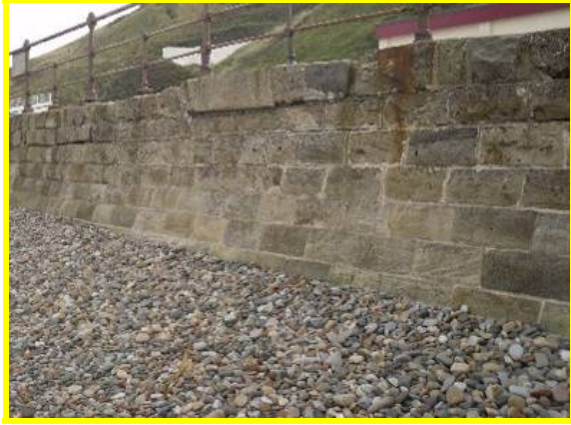
Example of coping repair
(Asset Ref No 1221C901C0704C04)

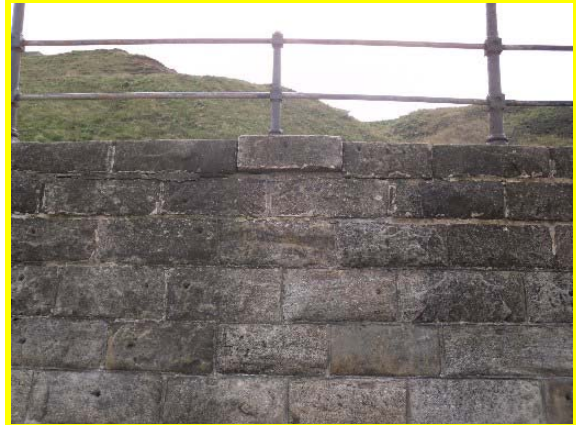
Example of area where coping is loose
(Asset Ref No 1221C901C0704C04)

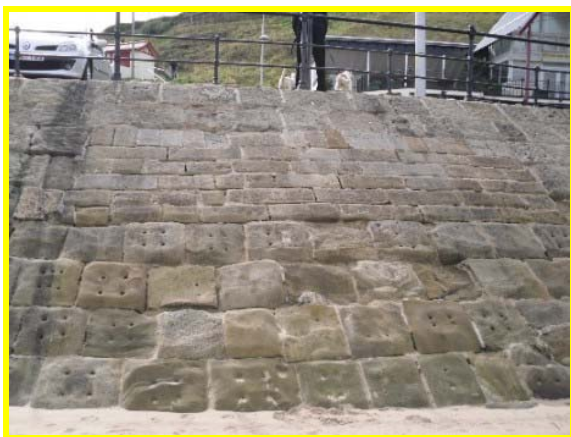
Area of repair, and potential area of deformation
(Asset Ref No 1221C901C0704C01)

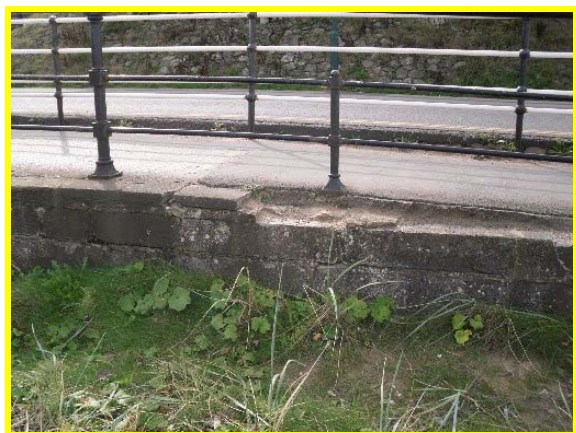
Example of area where coping is missing
(Asset Ref No 1221C901C0704C06)

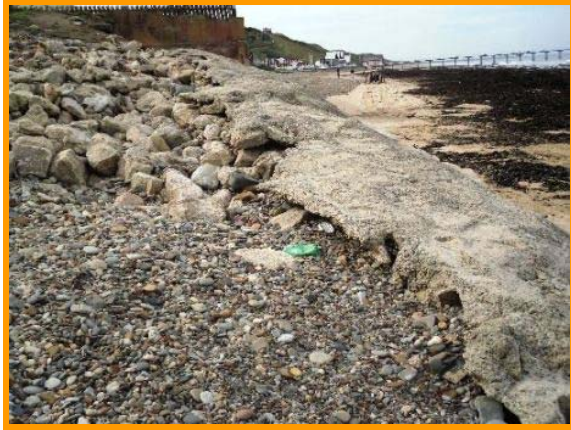
East of the Skelton Beck outfall is the limit of the Saltburn defences. Here, in 2008, the coastal protection consisted of heavily eroded sections of concrete defences, displaying large amounts of excavation, undercutting, major cracking and in some parts, total collapse (Asset Ref No. 1221C901C0704C05). Urgent remedial work was required to prevent damage to adjacent property. In 2010 it was observed that large scale works had been completed, but that these works did not appear to have been carried out by professional contractors. It is unknown whether official consent for the works was granted.

2010: View of repairs – mass concrete and rubble
(Asset Ref No. 1221C901C0704C05)

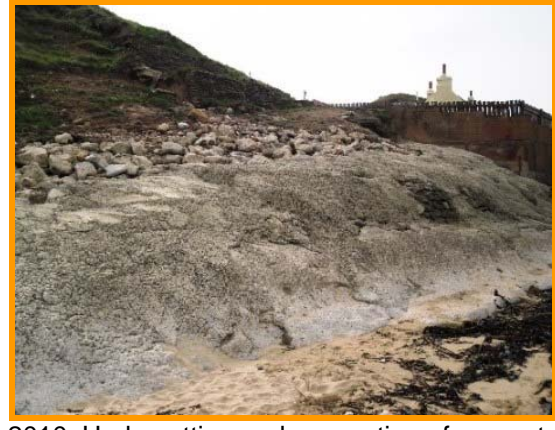
2010: Undercutting and excavation of concrete defences
(Asset Ref No. 1221C901C0704C05)

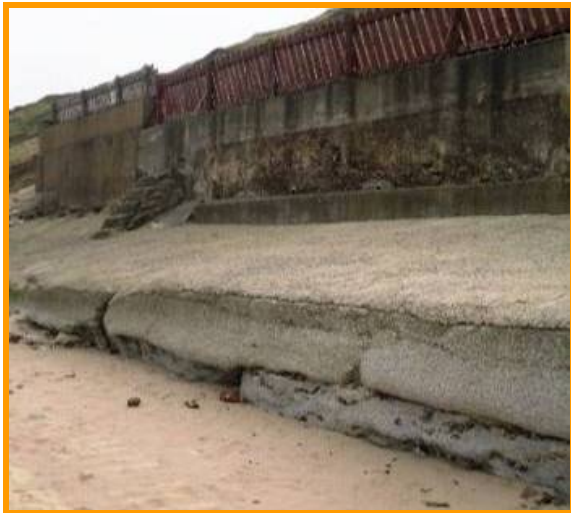
2010: Repairs visible, but defence still shows evidence of cracking and erosion
(Asset Ref No. 1221C901C0704C05)

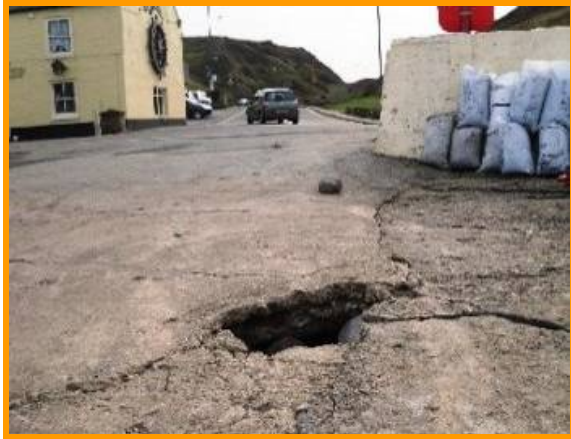
The slipway adjacent to the public house in the above photographs shows signs of erosion and washout. The photographs overleaf illustrate this.

Void and cracking slipway
(Asset Ref No. 1221C901C0704C05)

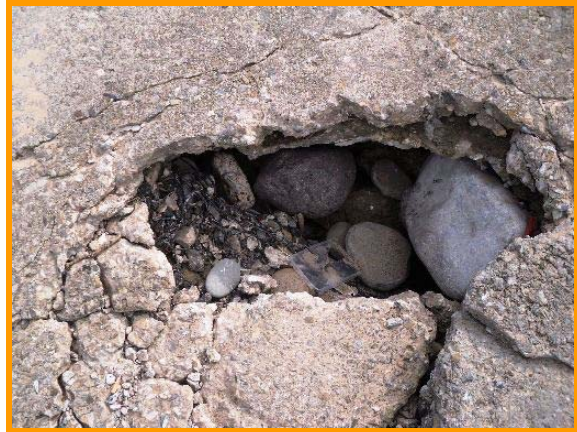
Void within slipway
(Asset Ref No. 1221C901C0704C05)

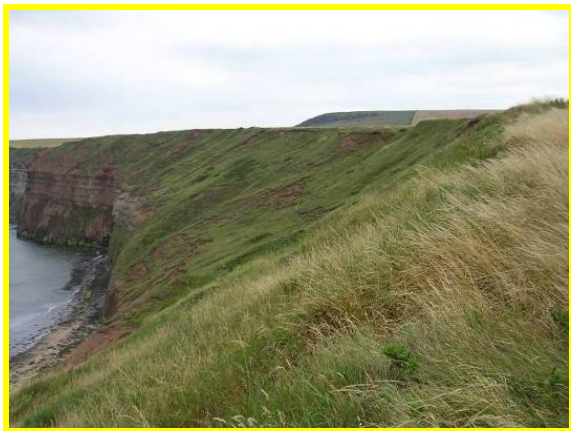
E53/4 Slumping in the till layer of the cliff
northeast of Saltburn (Locally Active)

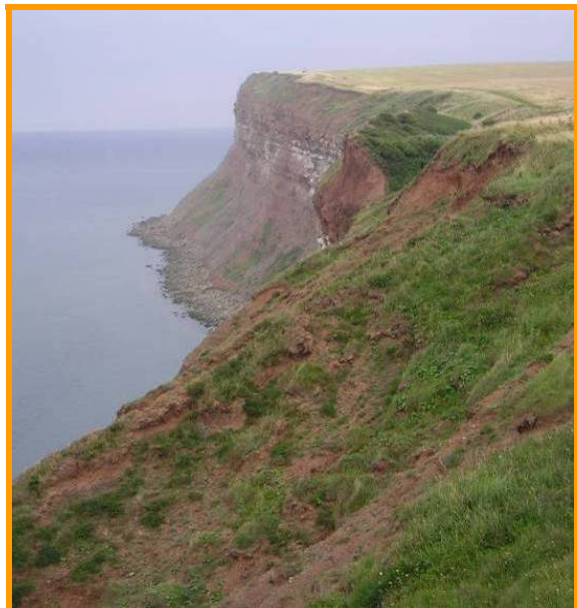
E53/2 Lower debris cones and staining of the cliff
in the distance (Partly Active)

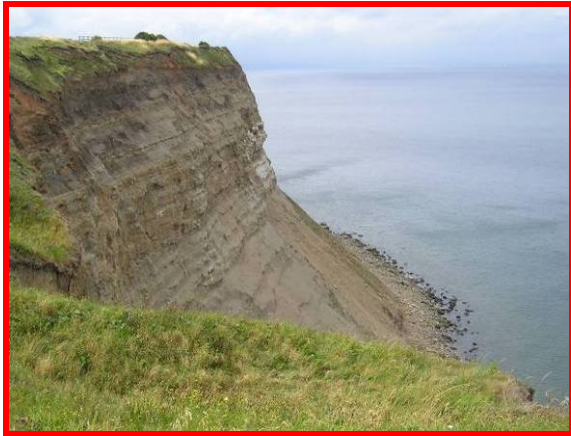
E54/4 looking northwest along Hunt Cliff (Totally Active)

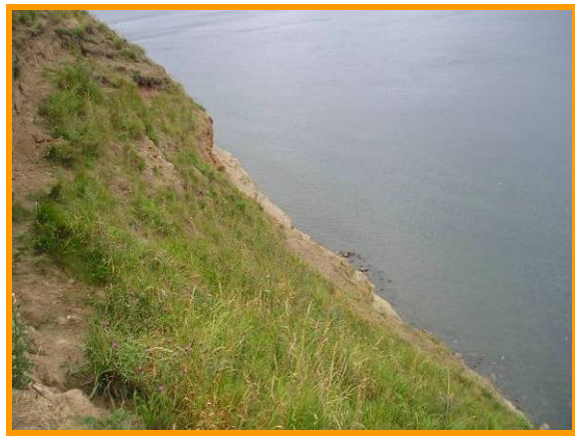
E54/2a some vegetation cover on the upper part of the cliff (Partly Active)

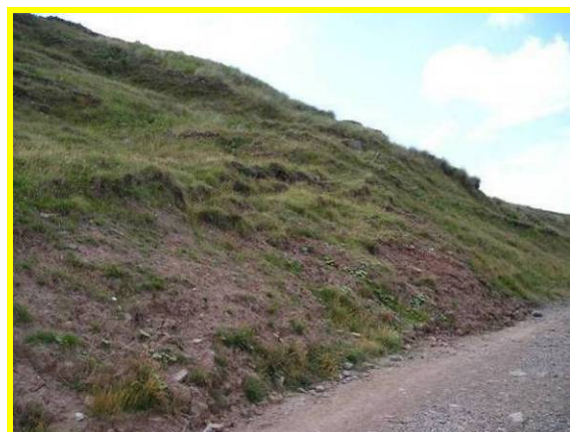
E56/1 recent activity at the cliff toe (Locally Active)

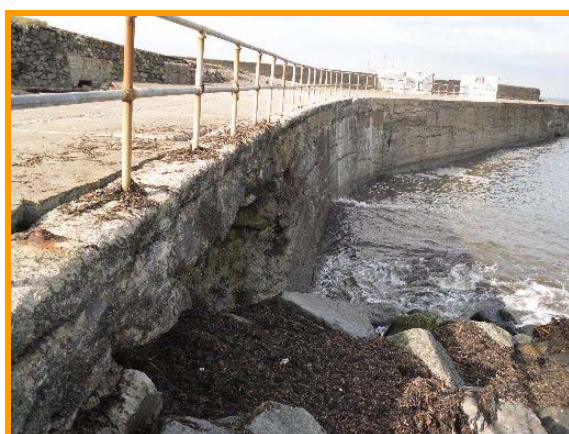
Within this area, coastal defences are present around Skinningrove village, but there are none west of the large jetty. The original mining breakwater (or 'jetty') is located 400m northwest of the village, although still present, it is redundant, and does not appear to be actively maintained. There are gates (currently broken open) which are in place to prevent access onto the jetty by the public. The jetty is constructed of concrete and sheet piles and shows evidence of significant cracking, deformation and corrosion in places (Asset Ref No. 1221D901D0201C02). It is recommended that this asset be confirmed as redundant, and that it is secured once again in order to prevent access by the public.

Looking seaward along the jetty, washout visible in foreground
(Asset Ref No. 1221D901D0201C02)

At Skinningrove, the jetty continues to show evidence of significant cracking, deformation and corrosion in places (Asset Ref No. 1221D901D0201C02). Although It is disused as a jetty, access is still possible and so consideration should be given to public health and safety. It is strongly recommended that the jetty is once again secured to prevent public access.

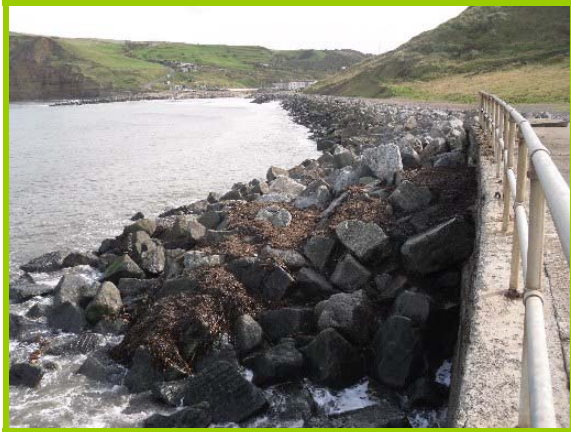
Tightly packed rock armour in good condition,
from jetty to village
(Asset Ref No. 1221D901D0202C01)

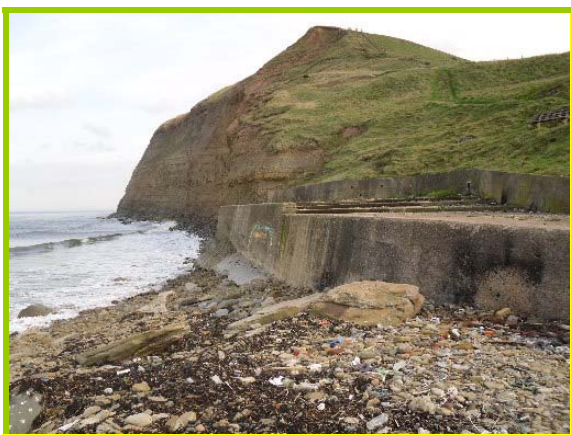
East of the breakwater there are two further assets, a shingle ridge (Asset Ref No. 1221D901D0202C04) and a concrete wall (Asset Ref No. 1221D901D0202C03). The inspection team was unable to inspect the toe of this wall, as beach levels were relatively high. The promenade was significantly cracked in places and there was a void, approximately 700mm deep. The retaining wall behind appeared to be sound at present.

Beach ridge with concrete wall beyond
(Asset Ref Nos. 1221D901D0202C04 and
1221D901D0202C03)

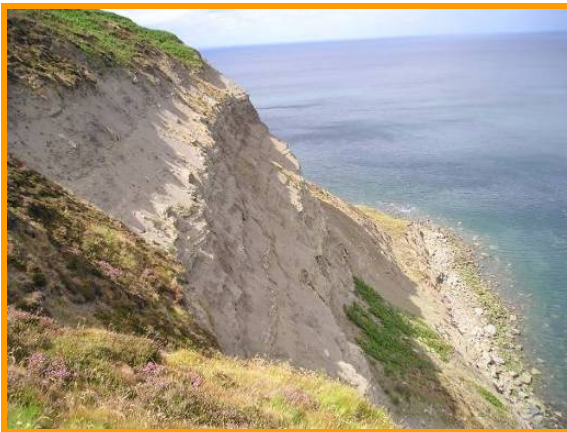
E58/1a expansive bare face with ongoing fresh activity (Partly Active)

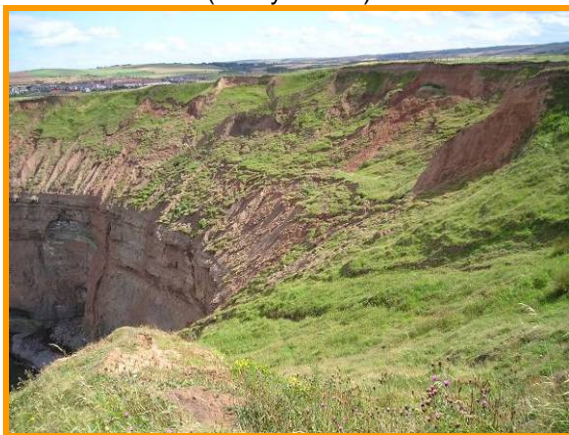
E59/5 failure and active headscarp recession within the upper till part of the cliff (Partly Active)

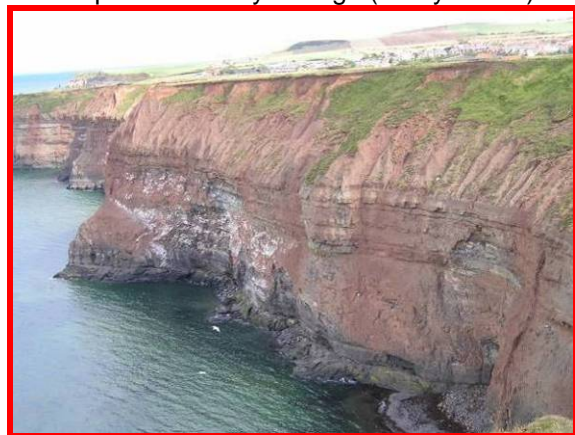
E59/4 fresh failures within the till and rockfall from lower cliff face (Totally Active) (Note: this unit was previously classified as Partly Active in 2008)

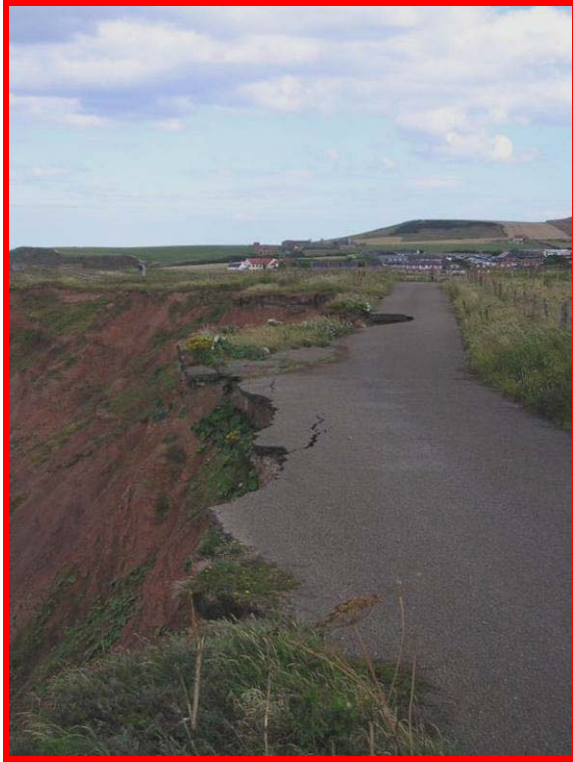
E59/3 ongoing loss of abandoned road at Cowbar
(Totally Active)

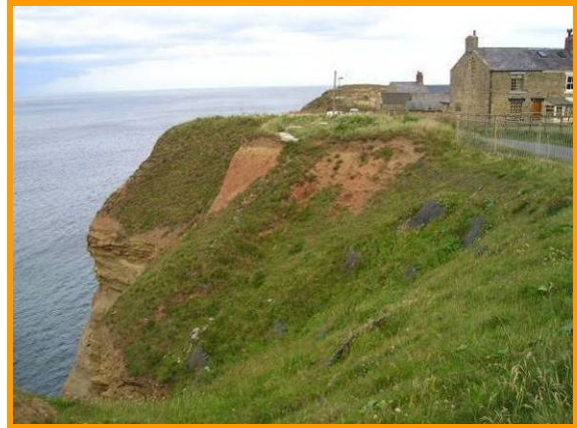
E59/1 and E60/1b cliff repairs in the till cap at
Cowbar (Partly Active)

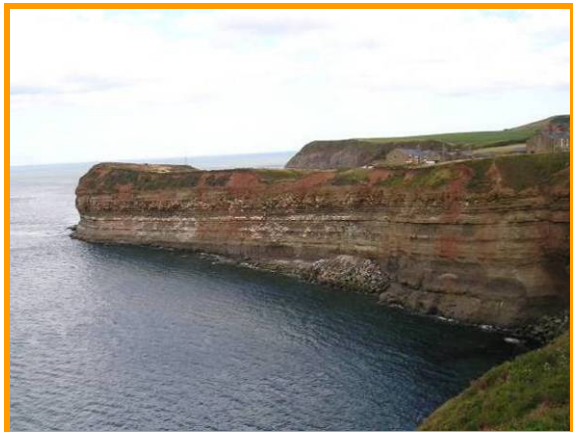
E60/1b ongoing till failure and rock toe defences
along Cowbar Nab (Partly Active)

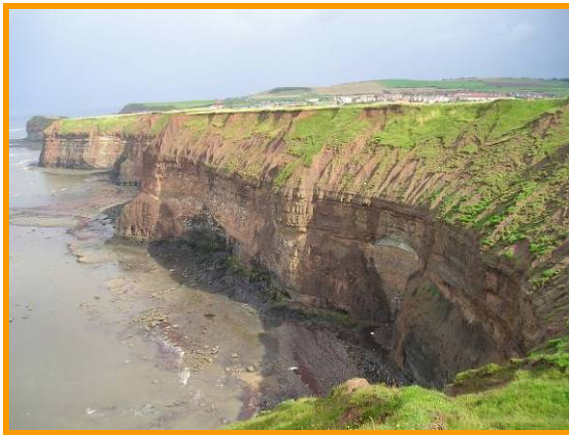
E59/4 Classified as Partly Active in 2008

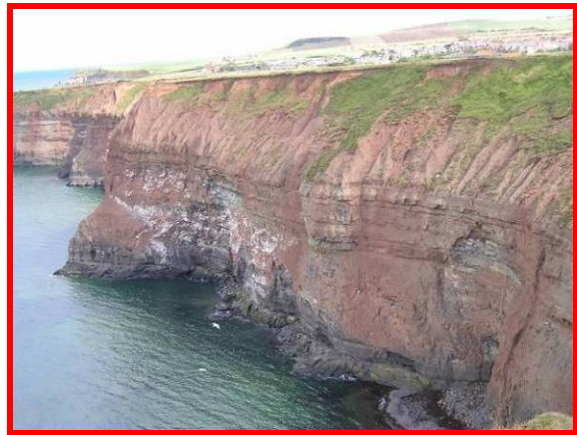
E59/4 Reduced vegetation cover and staining of cliffs – classified as Totally Active in 2010

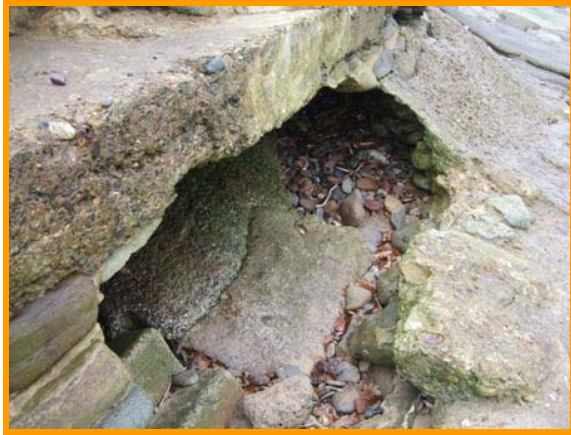
2008: Undercutting and excavation of concrete defences (Asset Ref No. 1221C901C0704C05)

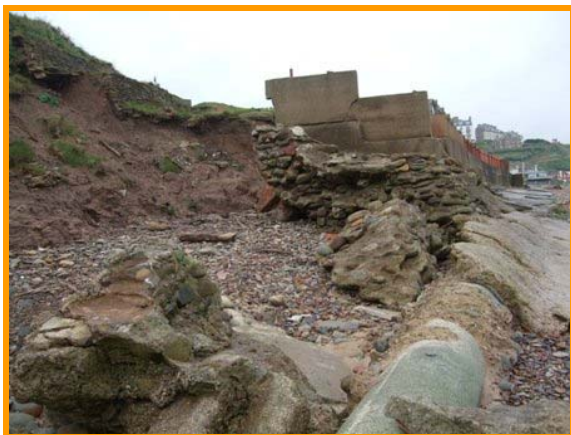
2008: Partial collapse of concrete defences and failure of unprotected cliffs above (Asset Ref No. 1221C901C0704C05)

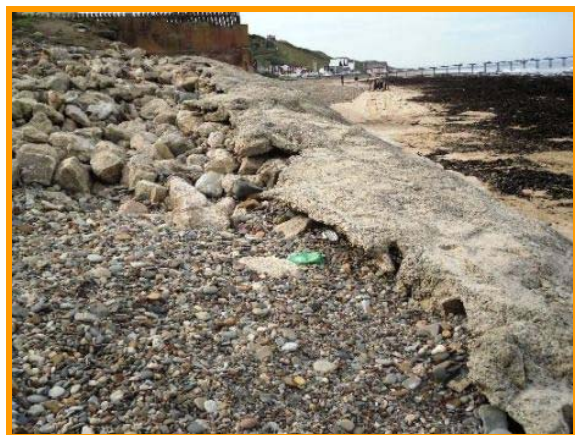
2010: Total collapse of part of concrete defences and failure of unprotected cliffs (Asset Ref No. 1221C901C0704C05)

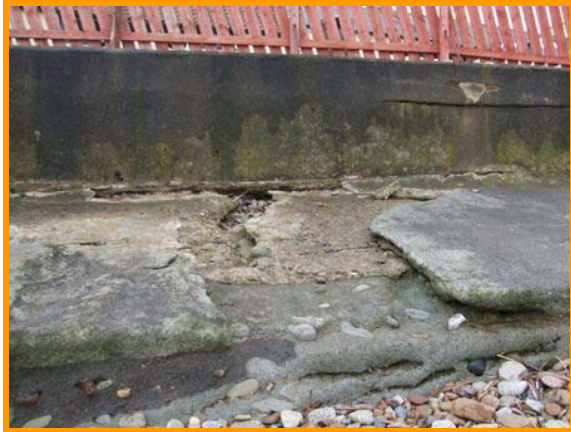
2008: Property at risk behind eroded concrete defences (Asset Ref No. 1221C901C0704C05)

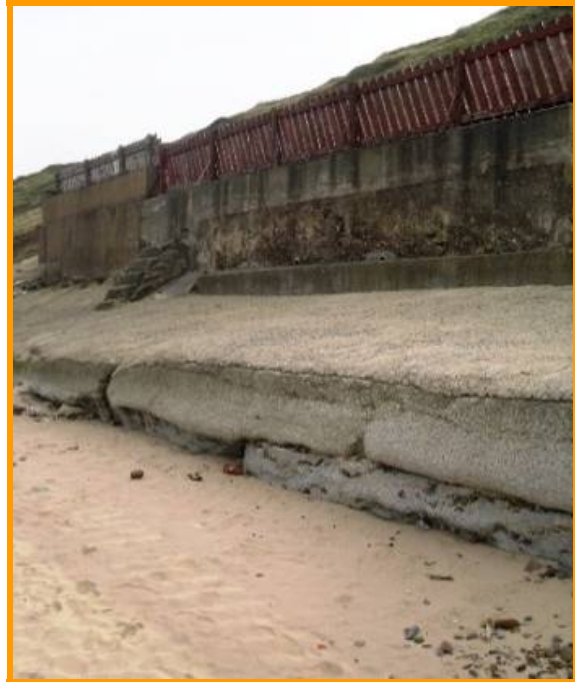
2010: Repairs visible, but defence still shows evidence of cracking and erosion (Asset Ref No. 1221C901C0704C05)

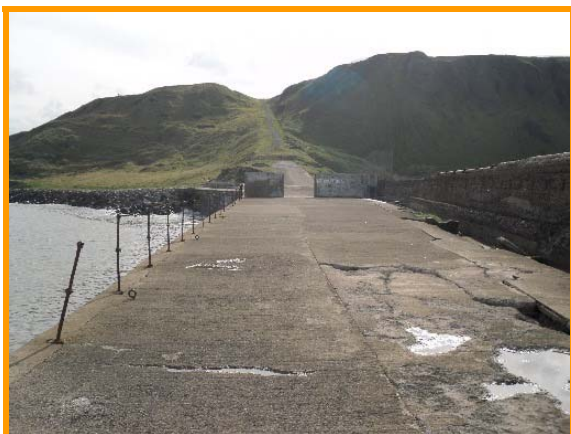
Looking landward along the jetty, showing open gates in background (Asset Ref No. 1221D901D0201C02)
