**Walk-over Visual Inspections of Assets  
including Coastal Slopes**

**Redcar and Cleveland  
Borough Council  
Final Report**

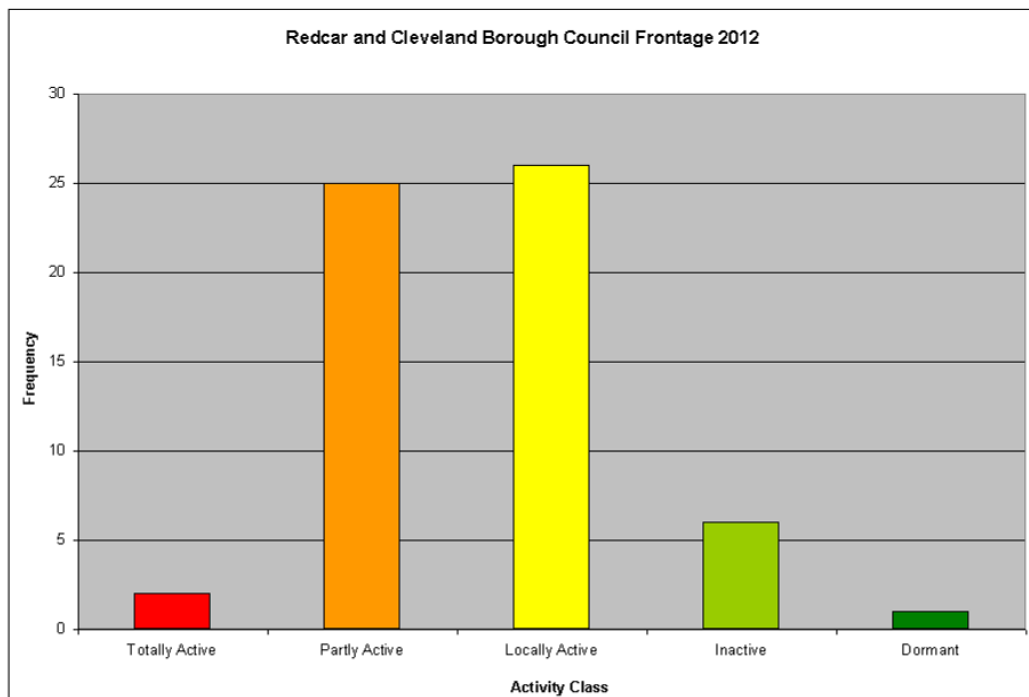
Figure 2-1. Frequency of cliff activity along the Redcar & Cleveland frontage in 2012

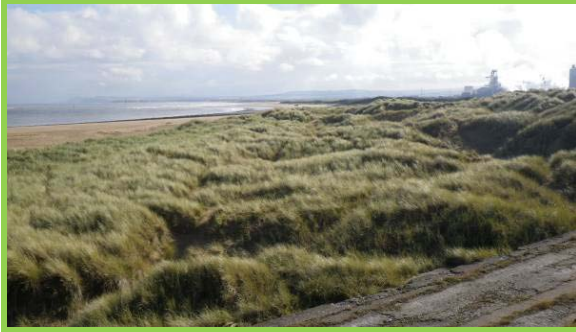
E52/11 View towards Redcar from South Gare.  
(Inactive)

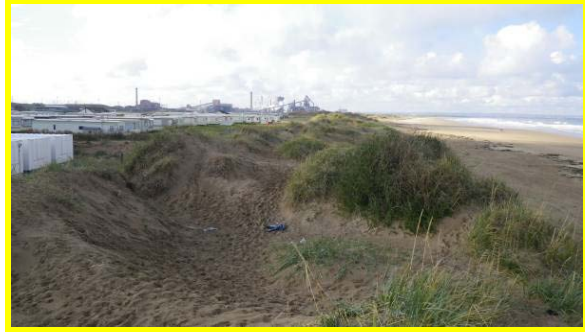
Localised pedestrian damage to dunes near  
caravan park

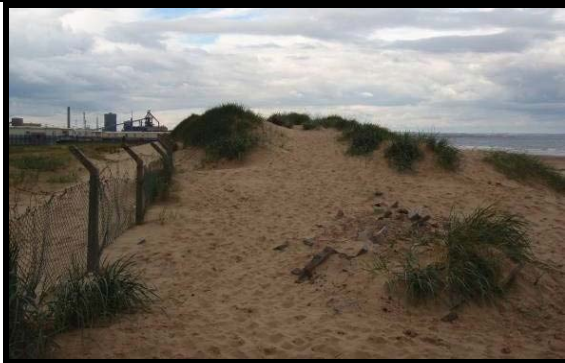
E52/11 view from south - Photo from 2010

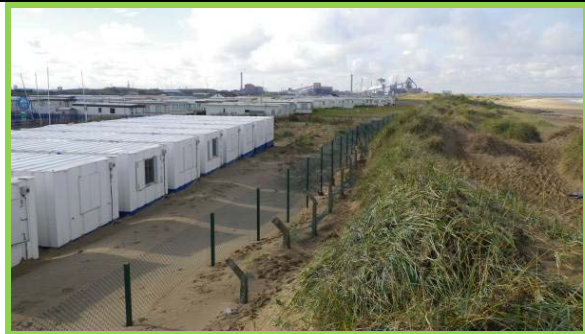
E52/11 Accretion of dunes at caravan park and  
next to site compound at Coatham (Inactive)  
Photo 15/10/2012

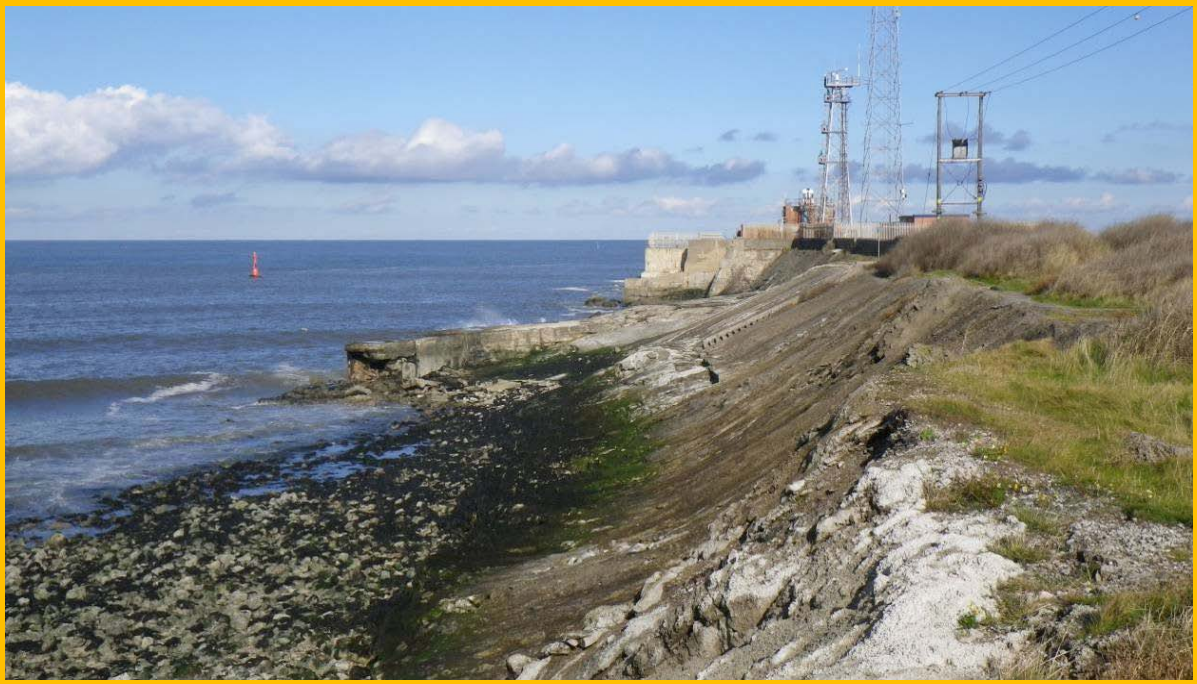
Patchwork of repairs on west side of South Gare Breakwater, recent repairs to concrete grouted revetment in foreground (Asset Ref No 12221C901C0506C01)

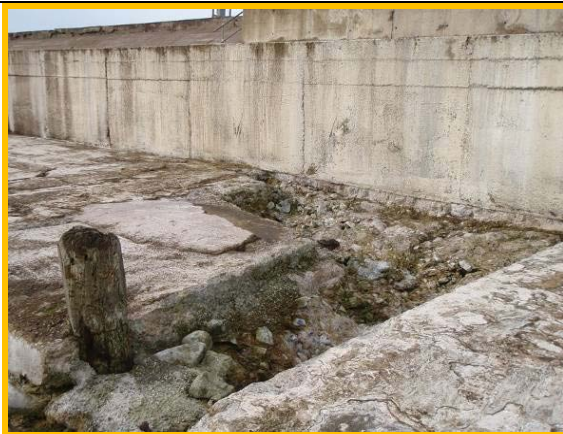
Voids present in deck - 2008  
(Asset Ref No 12221C901C0506C01)

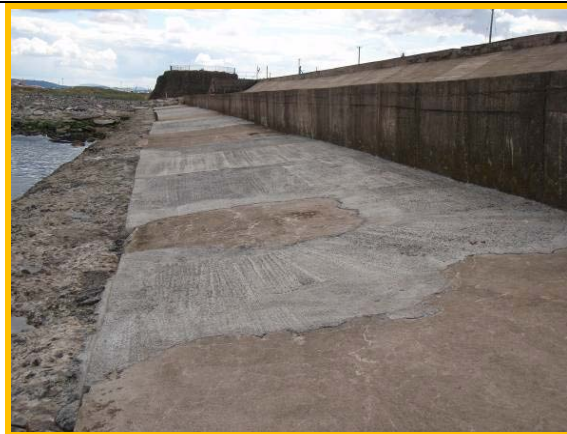
Slab repairs to deck on east side of structure –  
2010 (Asset Ref No 12221C901C0506C01)

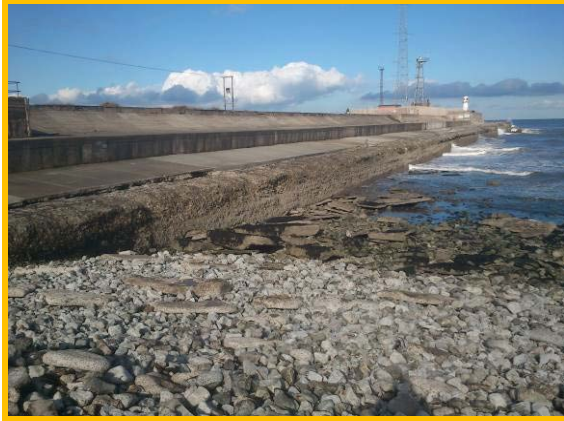
View of east side of South Gare breakwater, showing debris from failed deck slabs on beach. (Asset Ref No 12221C901C0506C01)

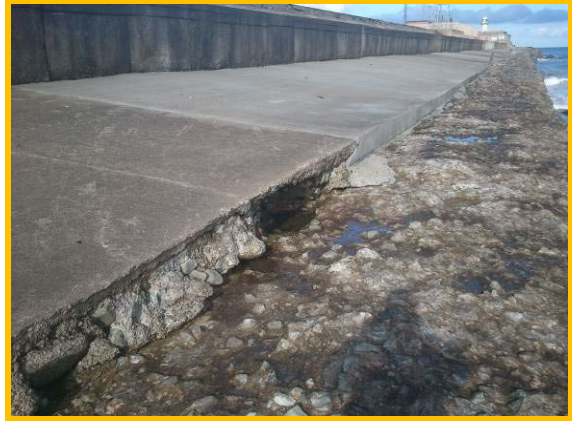
Repaired deck slabs over voids appear to be holding but facing to outer structure missing (Asset Ref No 12221C901C0506C01)

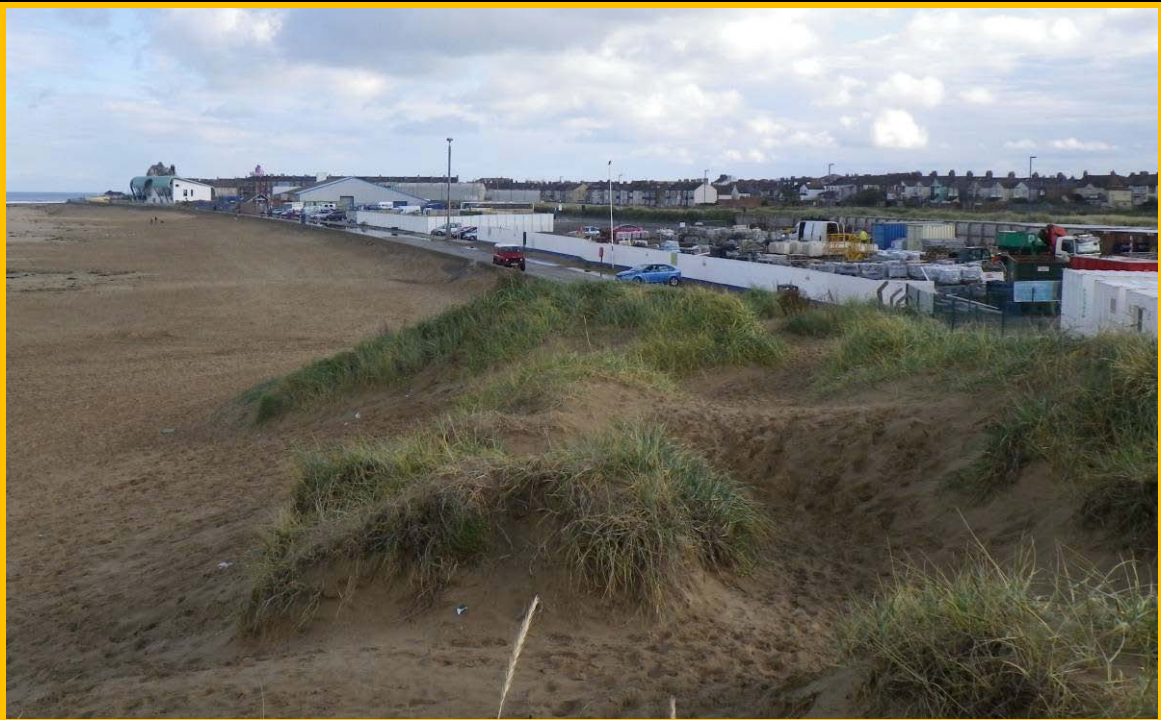
Overview of defences at west of Redcar from sand dunes adjacent to contractor's compound

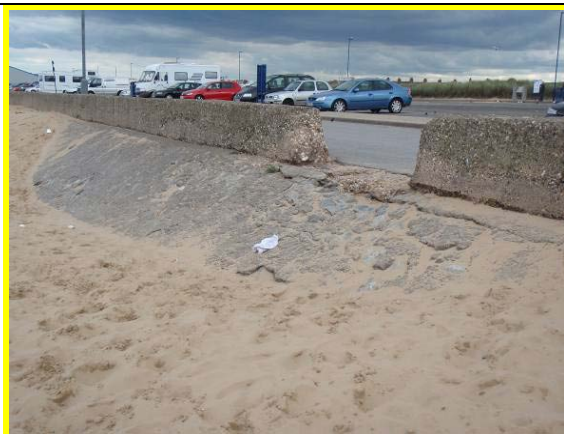
Gap in concrete wall and exposed revetment  
Photo from 2010

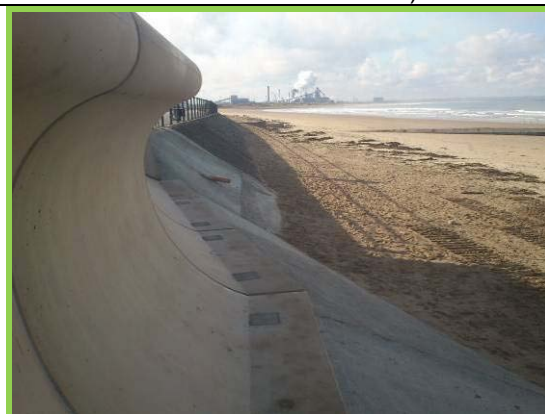
Interface with new seawall at the eastern end of  
Asset Ref No 12221C901C0601C01

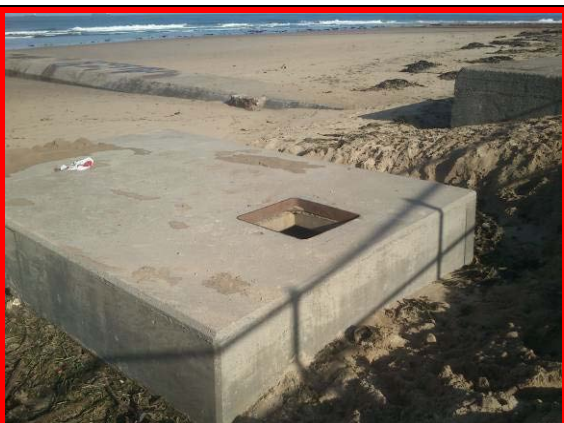
Open inspection chamber cover to west of outfall structure at Coatham beach leading to safety risk of falls into deep void / confined space.  
(Adjacent to asset Ref No 12221C901C0601C01)

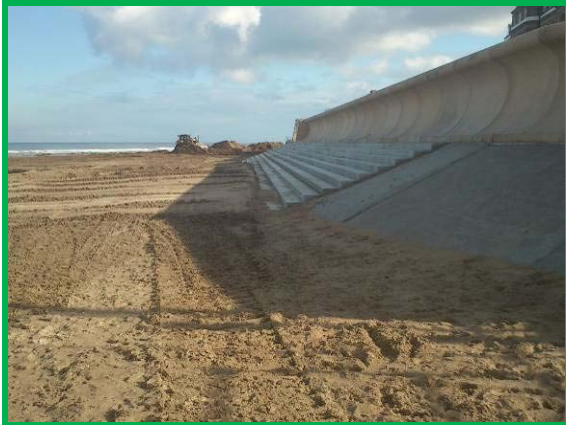
Works underway at west end of Redcar seawall, Asset ref. 1221C901C0602C06

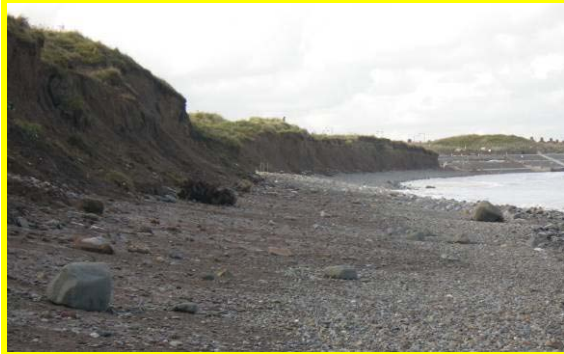
E52/10 Interface between new seawall and cliff at Mill Howle (Locally Active)

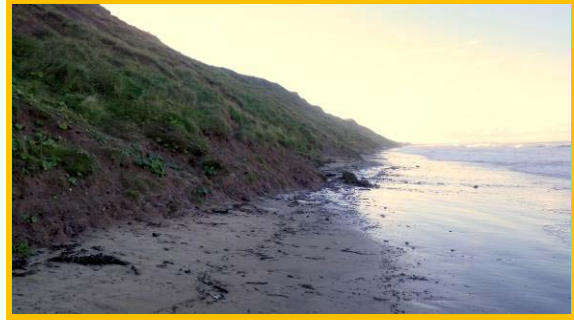
E52/4: Coastal slopes viewed looking north west from Saltburn (partly active)

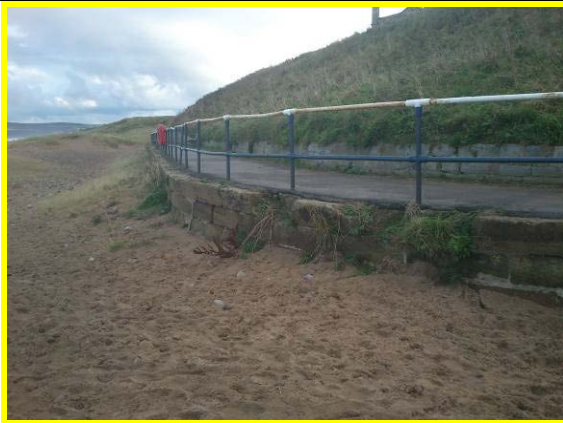
Missing coping blocks on wall below path.  
(Asset Ref No 12221C901C0702C03)

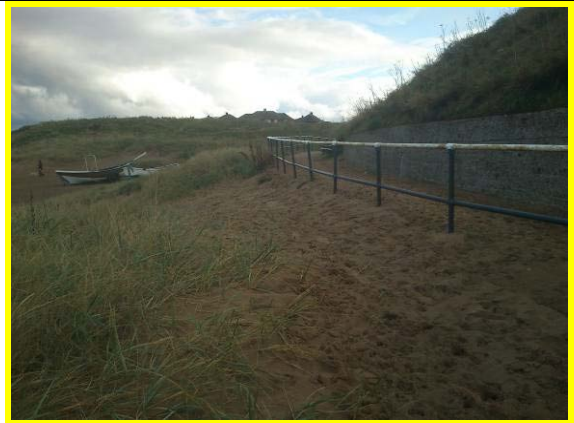
High beach levels covering wall and parts of path.  
(Asset Ref No 12221C901C0702C03)

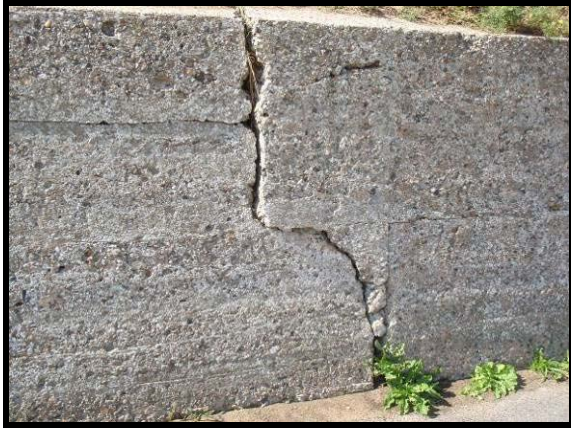
Crack in concrete wall below coastal slope (Asset Ref No 12221C901C0702C03)  
Photo from 2010 report.

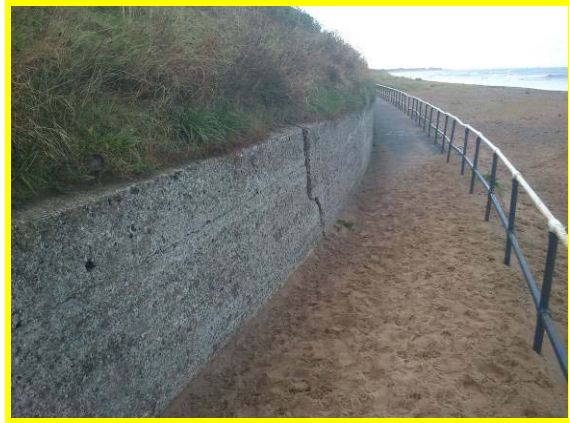
Crack in wall – photo from 15/10/2012.  
(Asset Ref No 12221C901C0702C03)

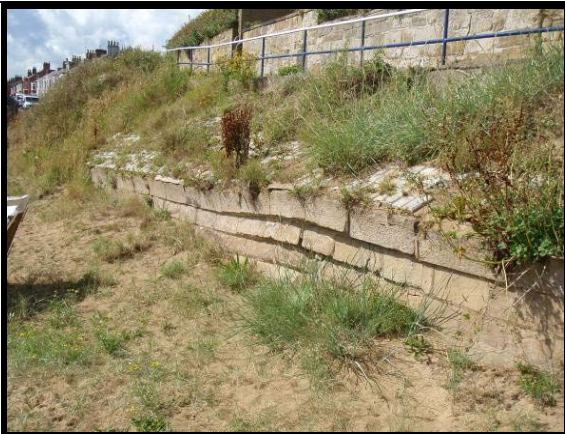
Local settlement of masonry structure  
(Asset Ref No 12221C901C0702C02)  
**Photo from 2010 Report**

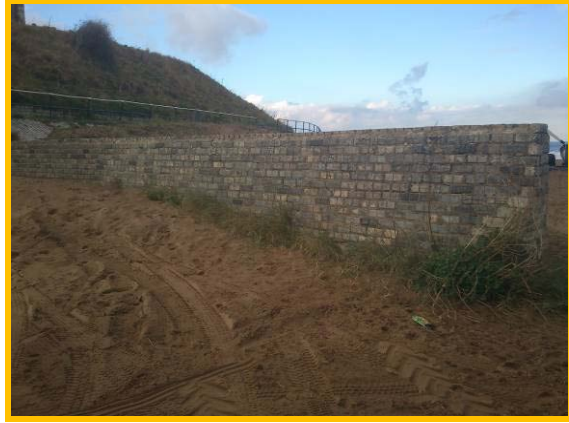
Wall enclosing fishing boat park (Asset Ref No 12221C901C0702C02)

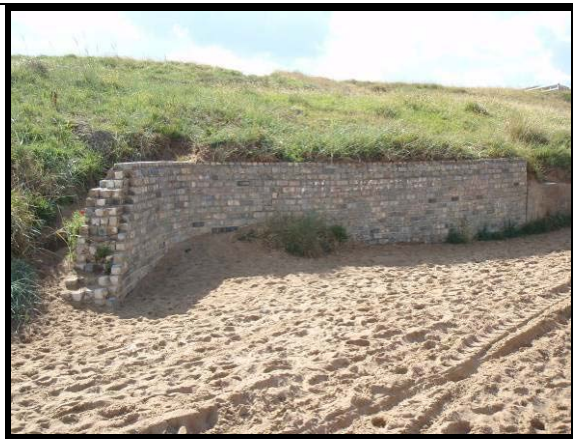
Photo from 2010 Report

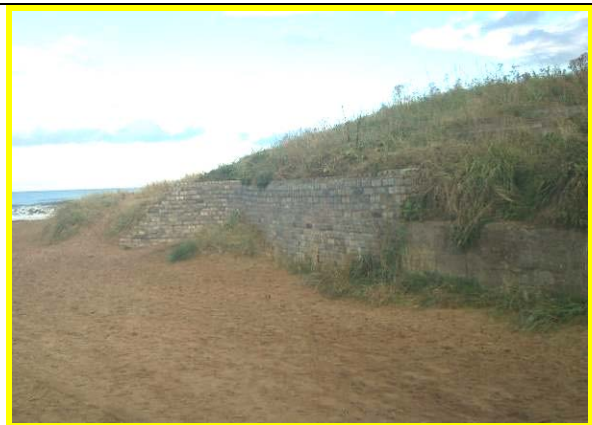
Missing masonry at seaward end of wall to southeast of beach access. (Asset Ref No 12221C901C0702C01)

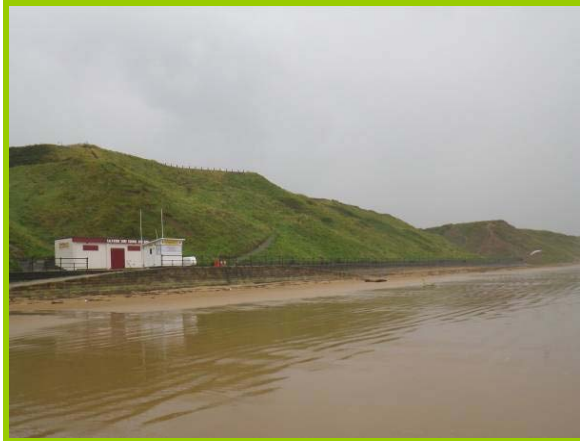
**E52/3b** from the stable and well vegetated cliffs above Saltburn Sands (Inactive)

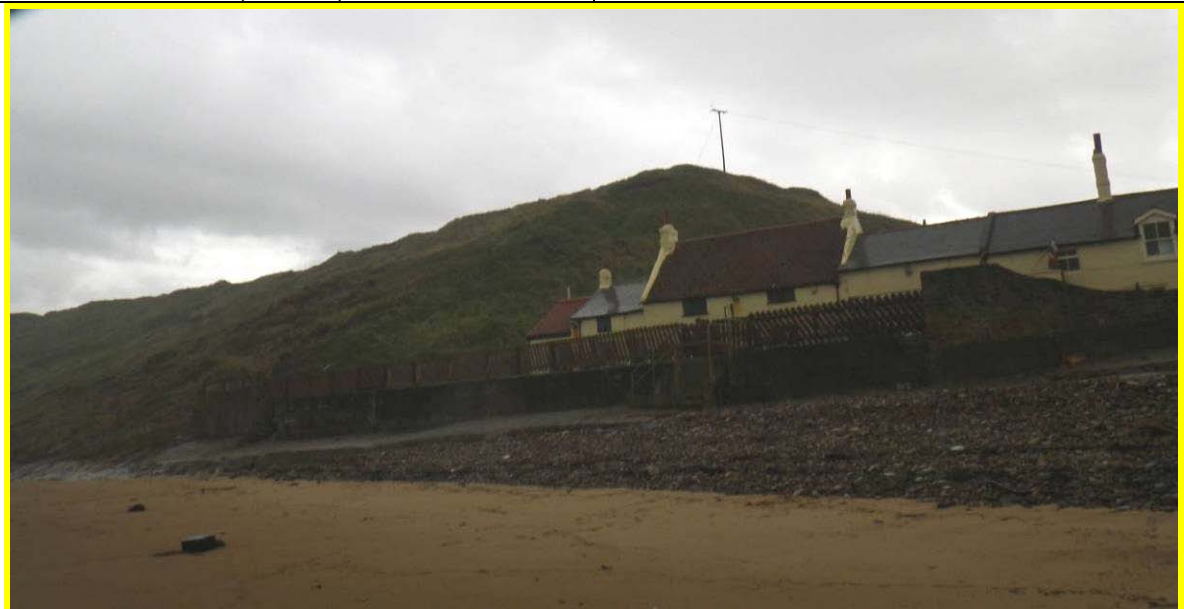
**E53/5** has slumped, leaving open cracks in the cliff face and resulting in instability classified as Locally Active.

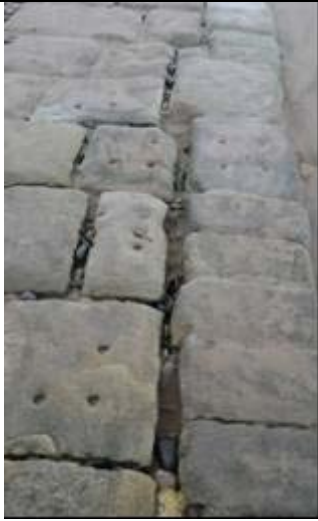
Example of area where repointing is needed to blockwork (Asset Ref No 1221C901C0704C04)

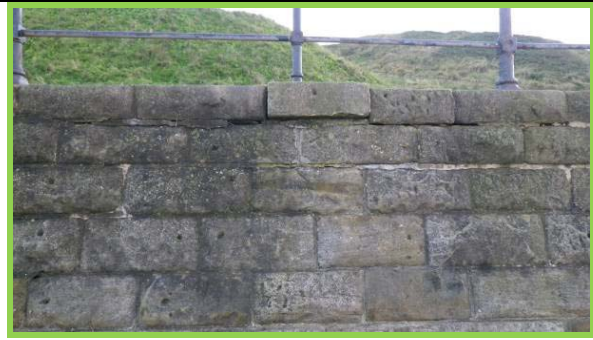
Damaged section of coping at handrail upstand (Asset Ref No 1221C901C0704C04)

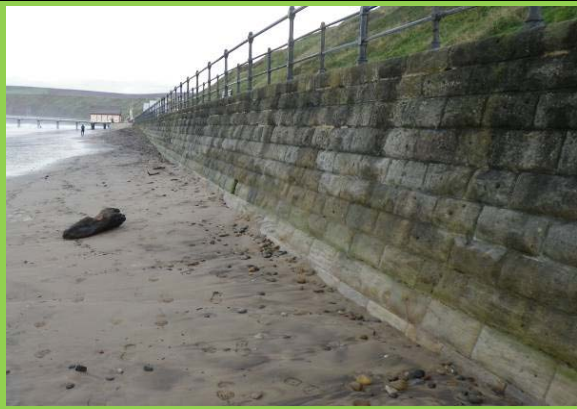
General view of wall looking south, showing abrasion near toe (Asset Ref No 1221C901C0704C04)

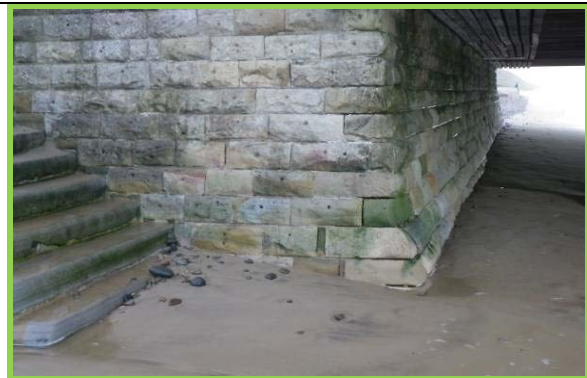
Open joints in pier abutment masonry requires repair. (Asset Ref No 1221C901C0704C04)

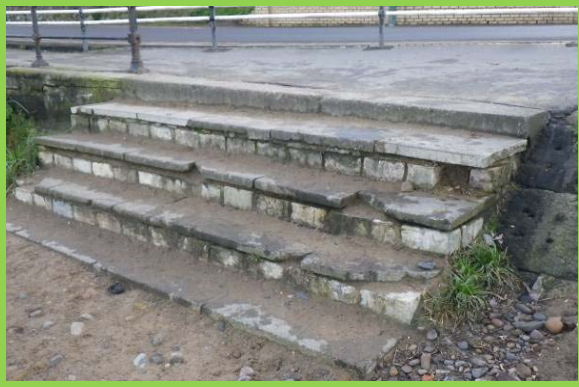
Damaged steps to beach  
(Asset Ref No 1221C901C0704C01)

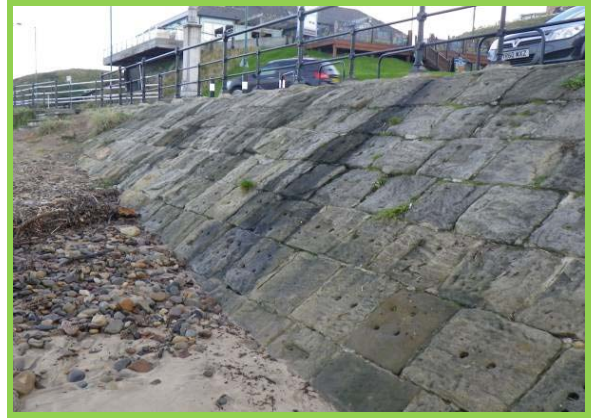
View of sloping masonry revetment at car park area. (Asset Ref No 1221C901C0704C01)

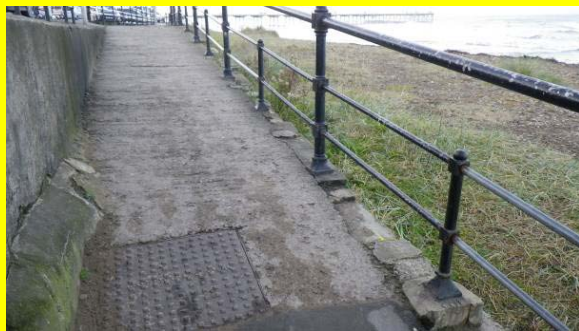
Missing coping stones to edge of path  
(Asset Ref No 1221C901C0704C06)

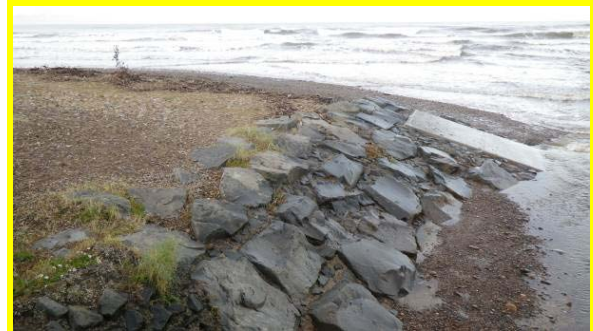
Armouring at edge of outfall from Skelton Beck  
(Asset Ref No 1221C901C0704C06)

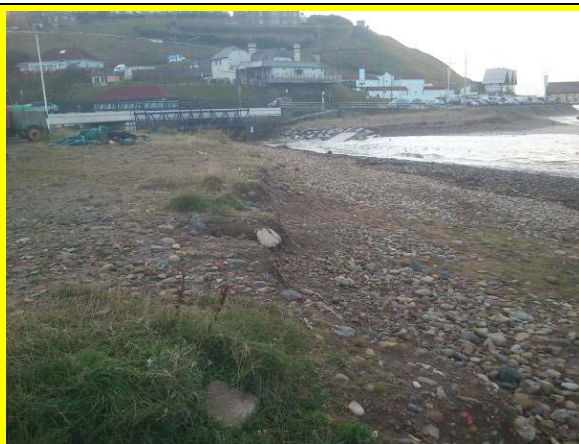
Evidence of previous storm damage to shingle bank at boat park (Asset Ref No 1221C901C0704C02)

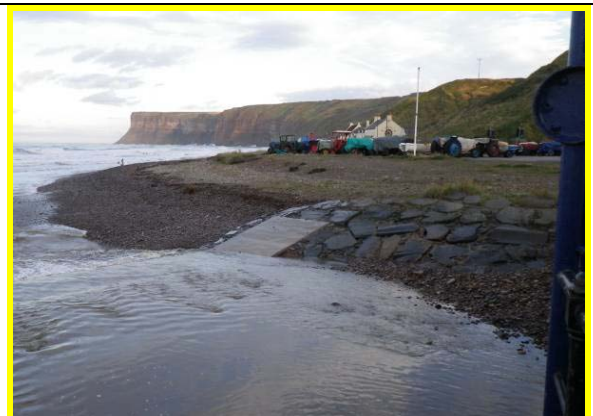
Armouring at edge of outfall from Skelton Beck adjacent to Asset Ref No 1221C901C0704C02

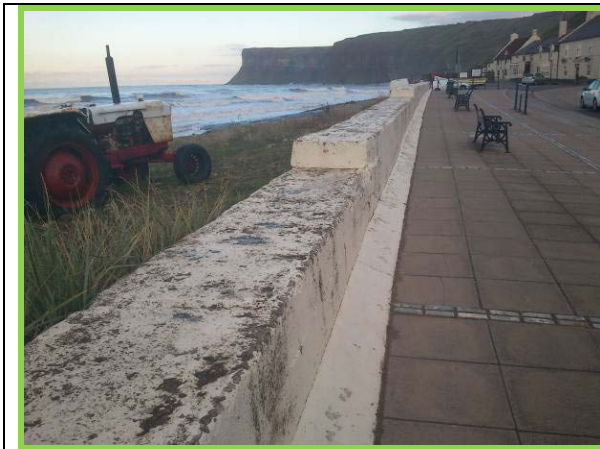
Set back rendered wall protected by shingle beach (Asset Ref No 1221C901C0704C03)

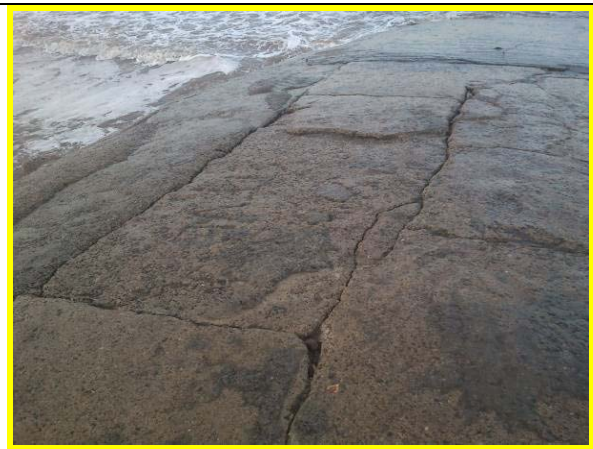
Damage to slipway at east end of Asset Ref No 1221C901C0704C03

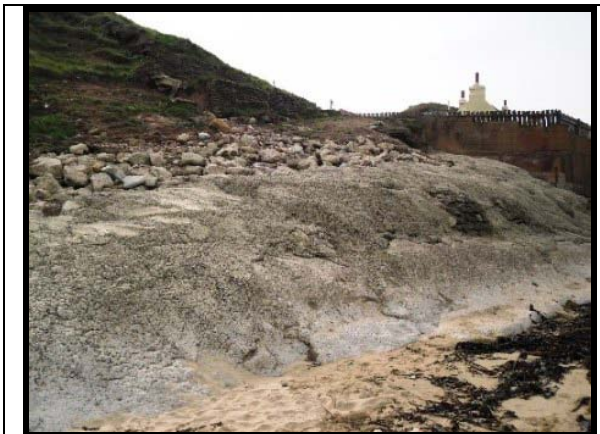
Undercutting and excavation of concrete defences (Asset Ref No. 1221C901C0704C05)  
**Photo from 2010**

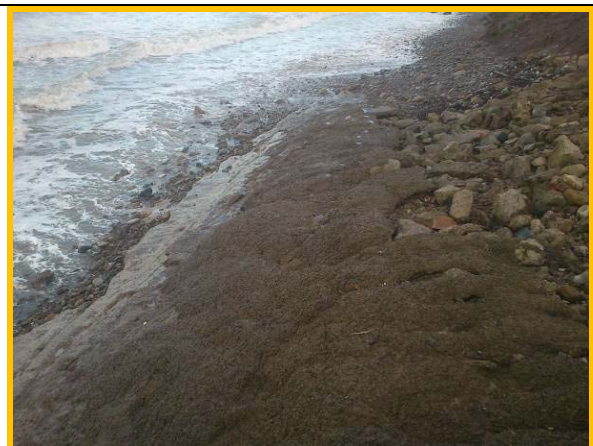
Damage to poured concrete over rubble defence. (Asset Ref No. 1221C901C0704C05)

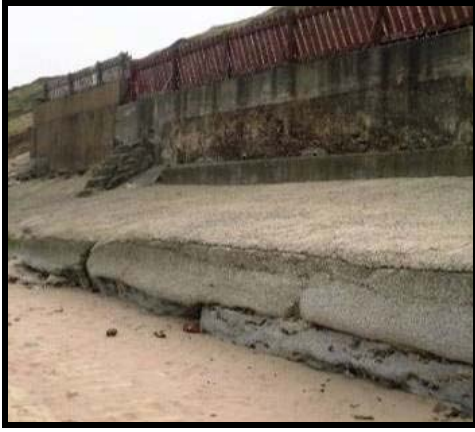
Repairs visible, but defence still shows evidence of cracking and erosion (Asset Ref No. 1221C901C0704C05)  
**Photo from 2010**

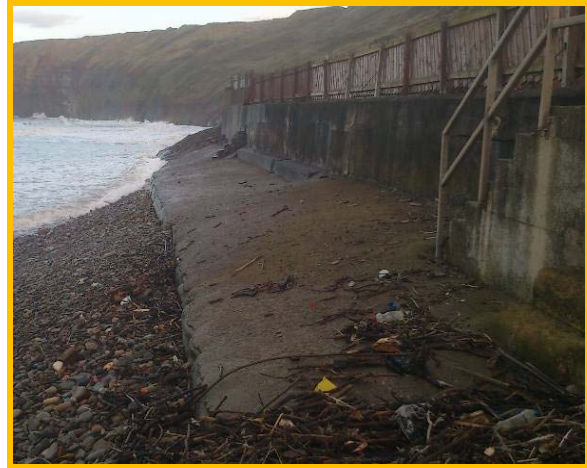
2012: Some accretion of cobbles, defence in similar condition to 2010 (Asset Ref No. 1221C901C0704C05)

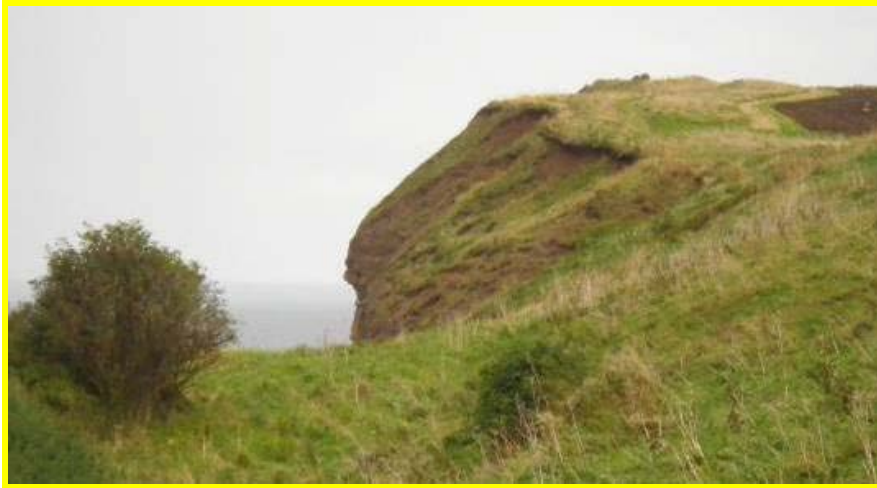
**E53/1** Instability in the upper till section of this unit (Locally Active).

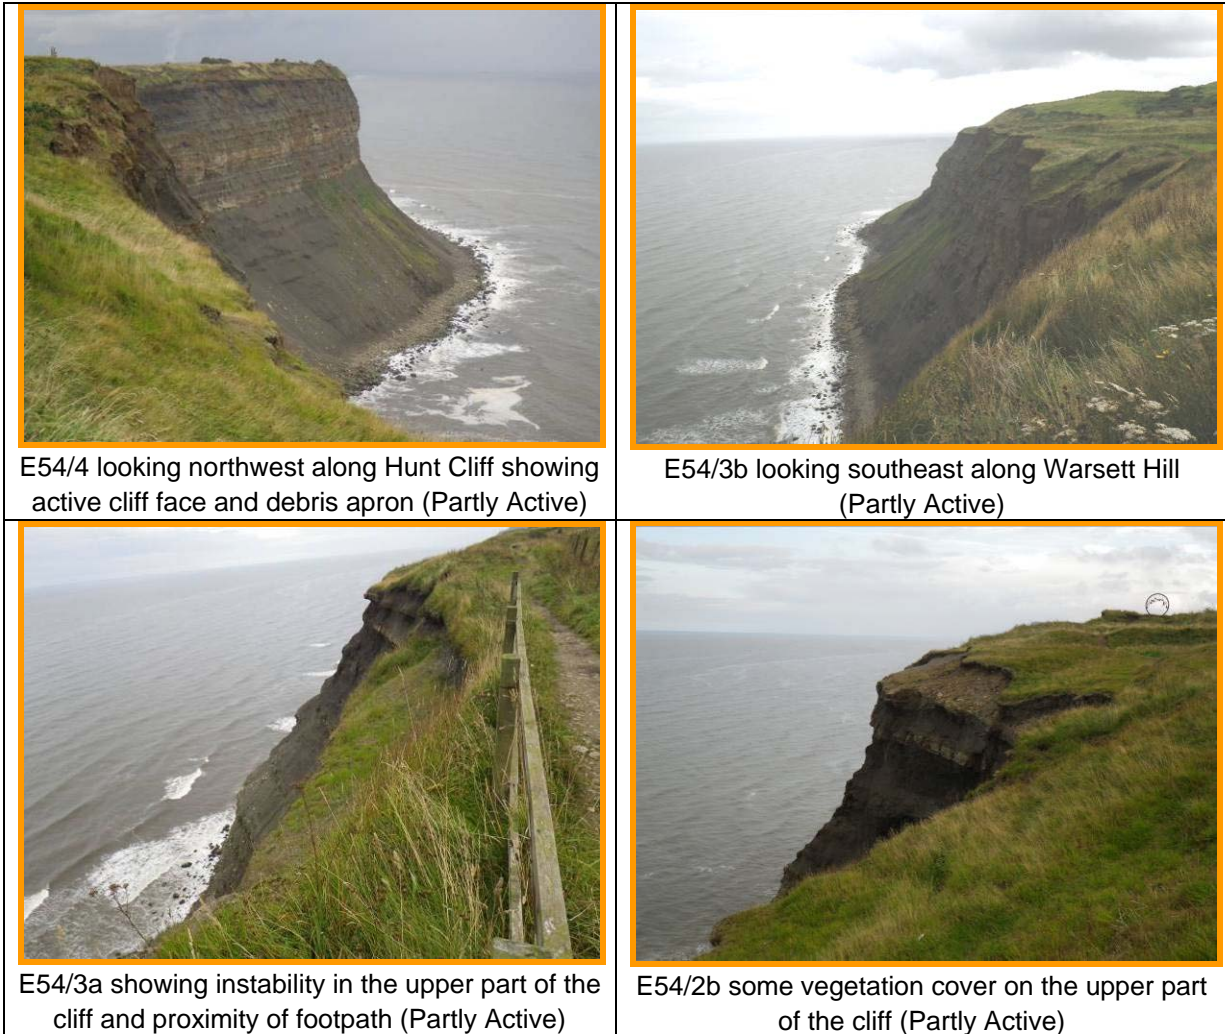
*Coast Protection Asset Condition Assessment*  
 There are no coastal assets within this area.

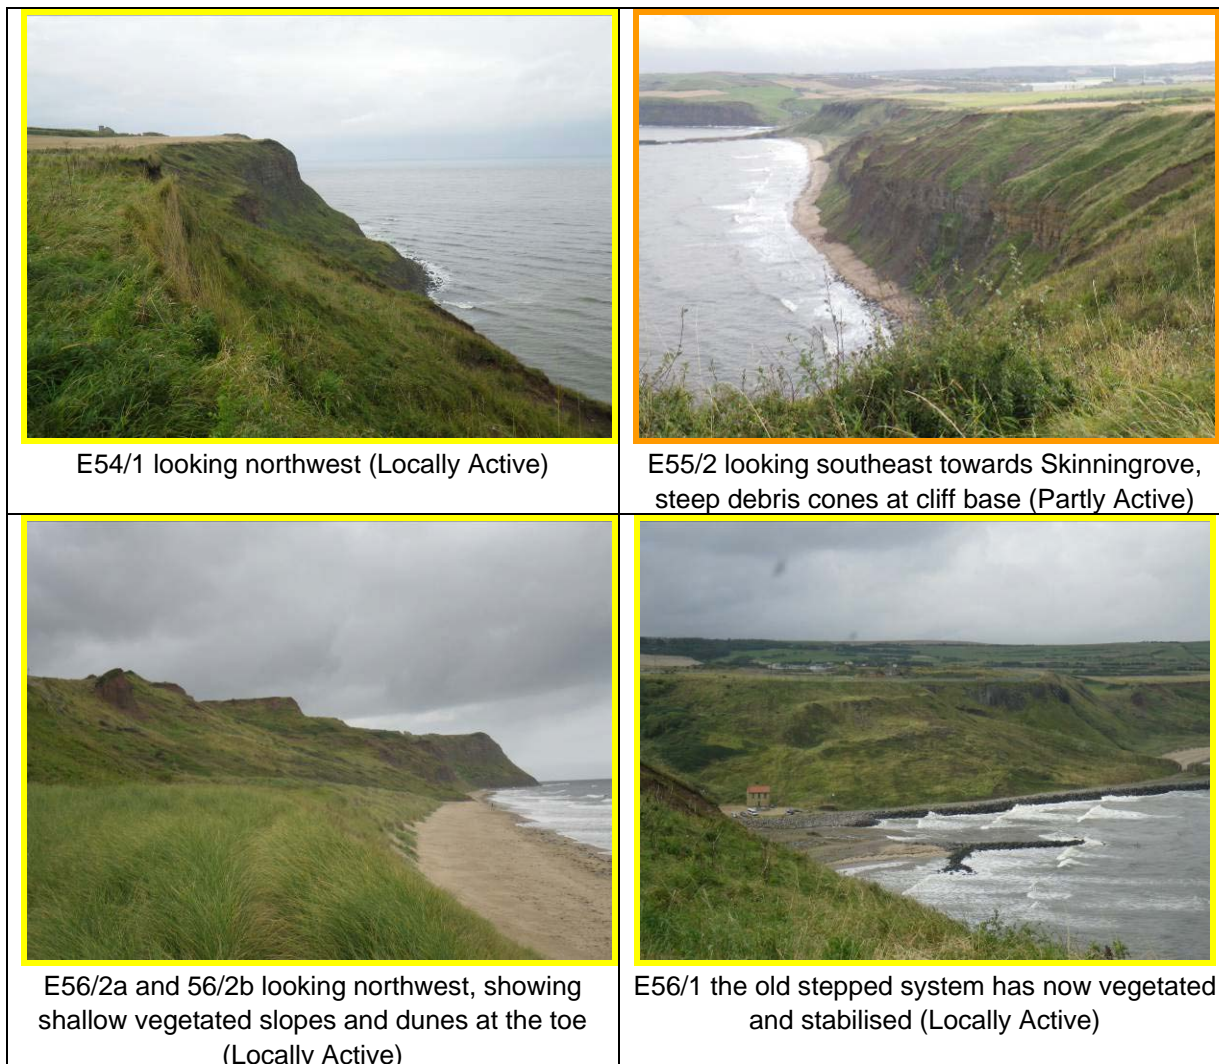
#### *Coast Protection Asset Condition Assessment*

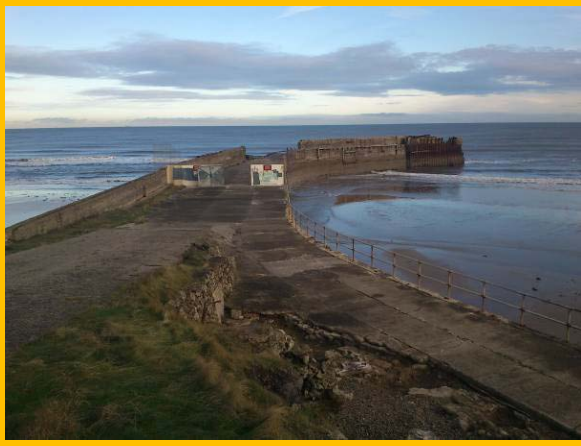
Jetty – view from south showing open gates  
(Asset Ref No. 1221D901D0201C02)

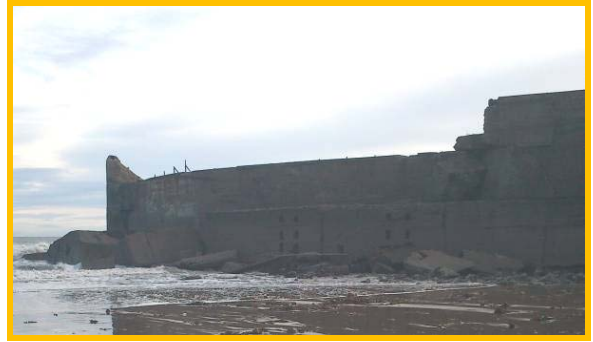
Seaward side of jetty showing failed sections and displaced slabs  
(Asset Ref No. 1221D901D0201C02)

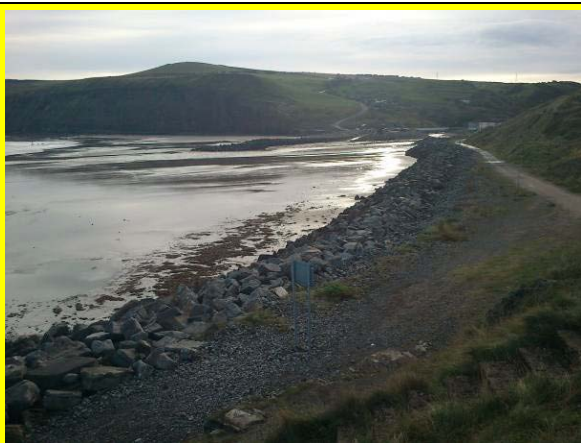
General view of rock armour revetment, from jetty to village (Asset Ref No. 1221D901D0202C01)

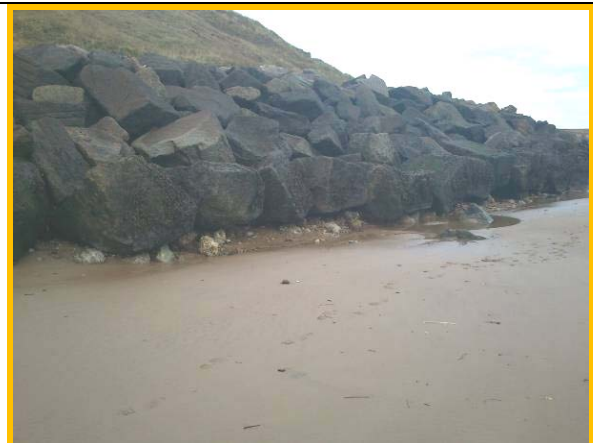
Low beach levels have exposed toe of rock armour to scour damage (Asset Ref No. 1221D901D0202C01)

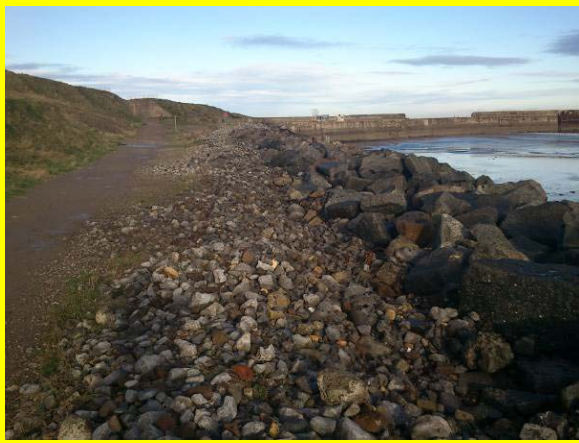
View of crest infill rubble adjacent to path has been scattered by wave overtopping (Asset Ref No. 1221D901D0202C01)

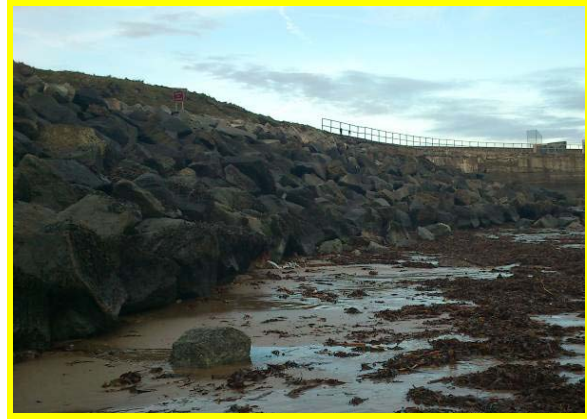
View of rock armour looking towards jetty (Asset Ref No. 1221D901D0202C01)

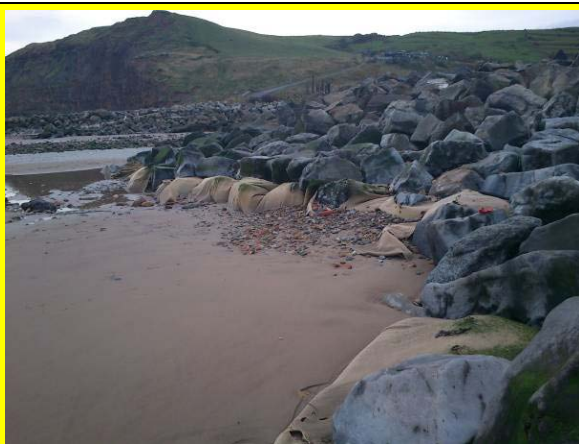
Exposed geotextile matting at rock armour toe. (Asset Ref No. 1221D901D0202C02)

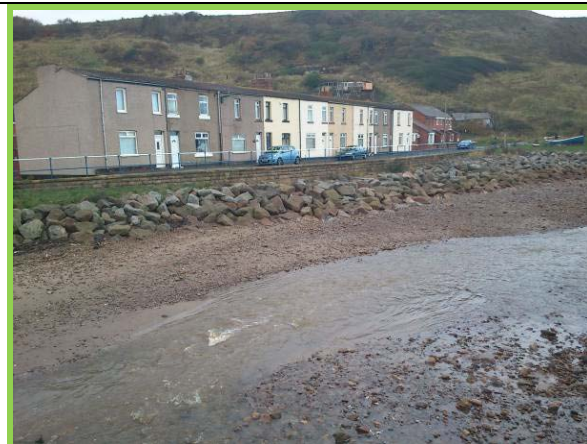
Rock armour along Kilton Beck with small wall behind in Skinninggrove village (Asset Ref No. 1221D901D0202C02)

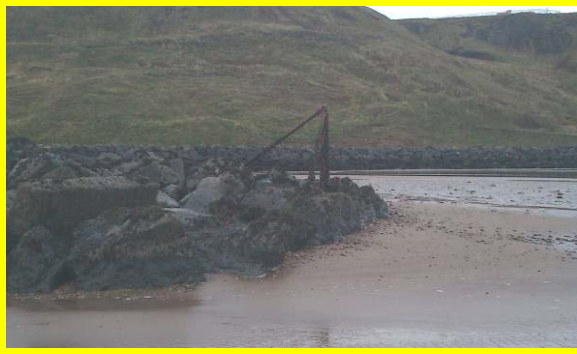
Seaward end of fishtail breakwater showing damaged navigation marker (Asset Ref No. 1221D901D0202C05)

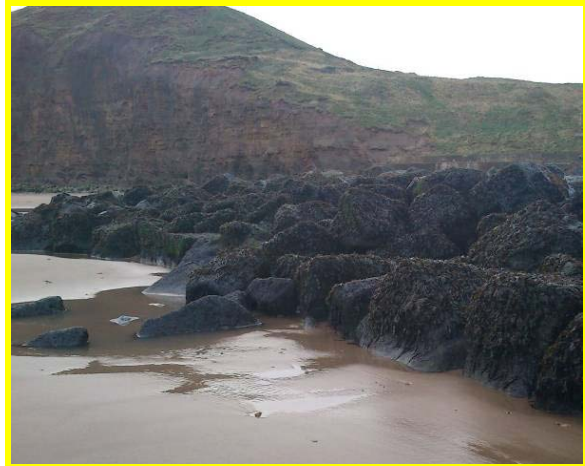
Area of displaced armour on seaward side of fishtail (Asset Ref No. 1221D901D0202C05)

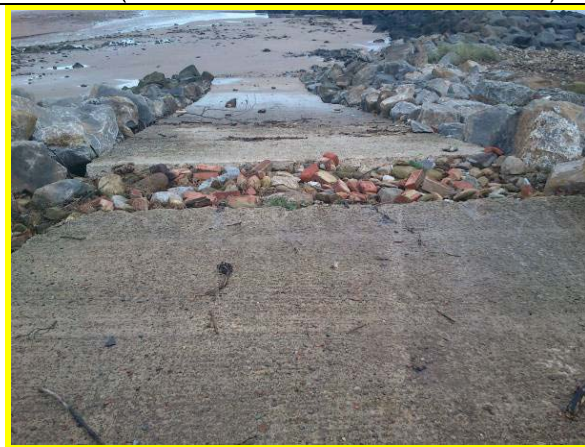
Slipway from boatpark on root of fishtail groyne showing missing section near crest filled with rubble. (Asset Ref No. 1221D901D0202C05)

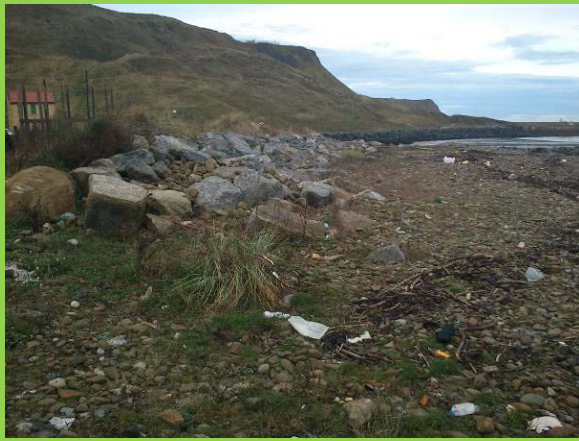
Shingle ridge with boulders to rear protecting boatpark. (Asset Ref. No 1221D901D0202C04)

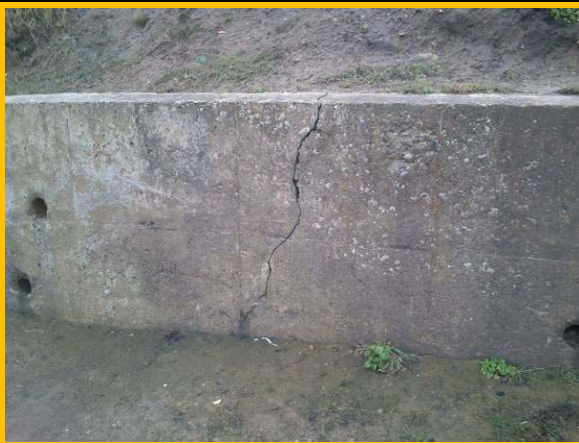
Crack in low rear retaining wall. (Asset Ref No. 1221D901D0202C03)

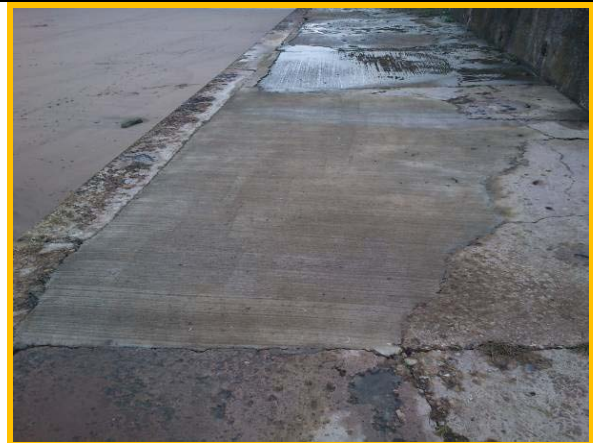
Patchwork repairs to promenade slabs. (Asset Ref No. 1221D901D0202C03)

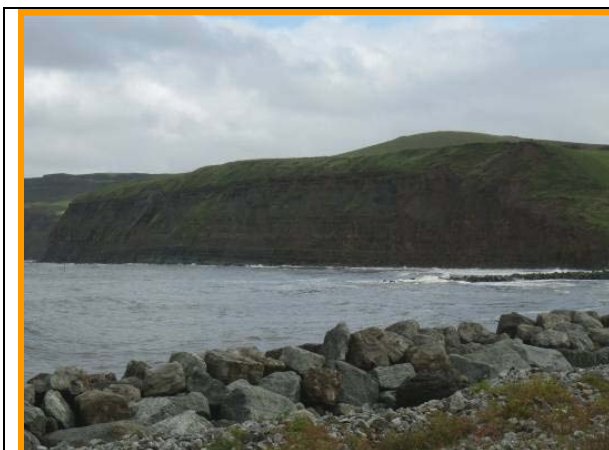
E57/7 looking southeast across the bay at Skinninggrove (Partly Active)

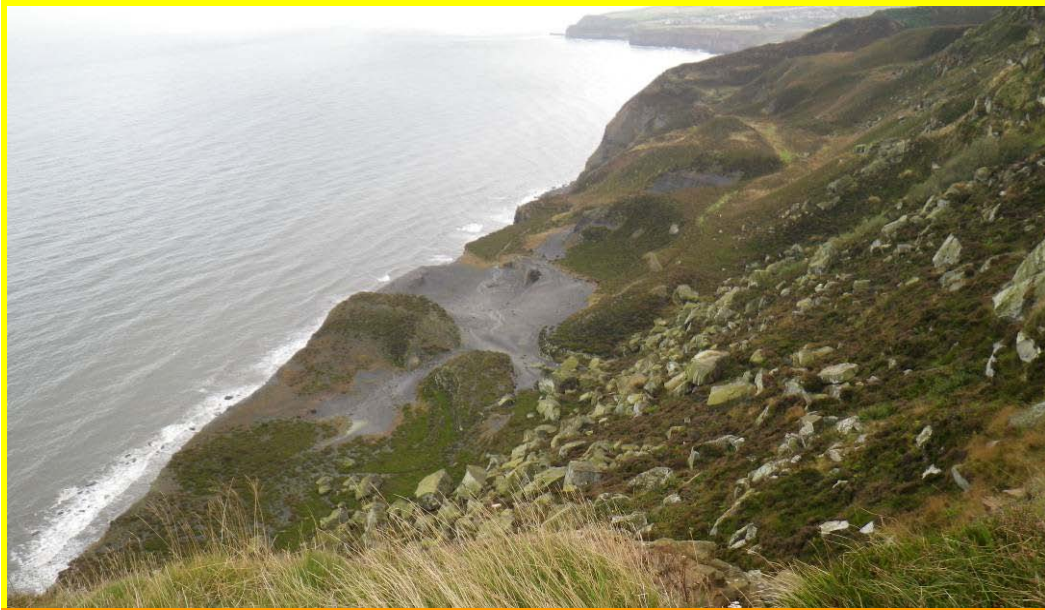
E58/3 Upper and Lower, Failed blocks litter the mid slope, which is vegetated. The lower slopes are more exposed. The Upper slopes are Locally Active and the lower slopes are Partly Active.

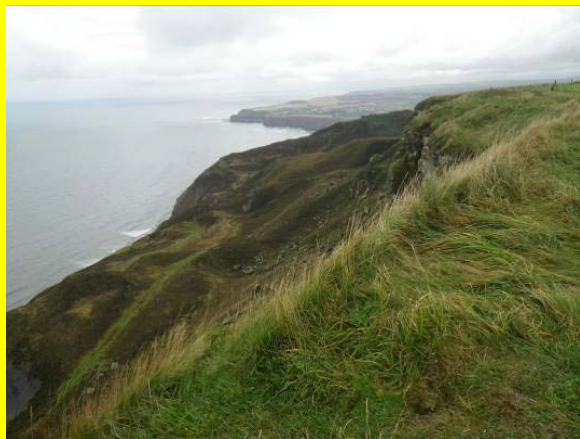
E58/2 upper the gentler sloping much more vegetated upper slopes are not as active as the slopes below (Locally Active)

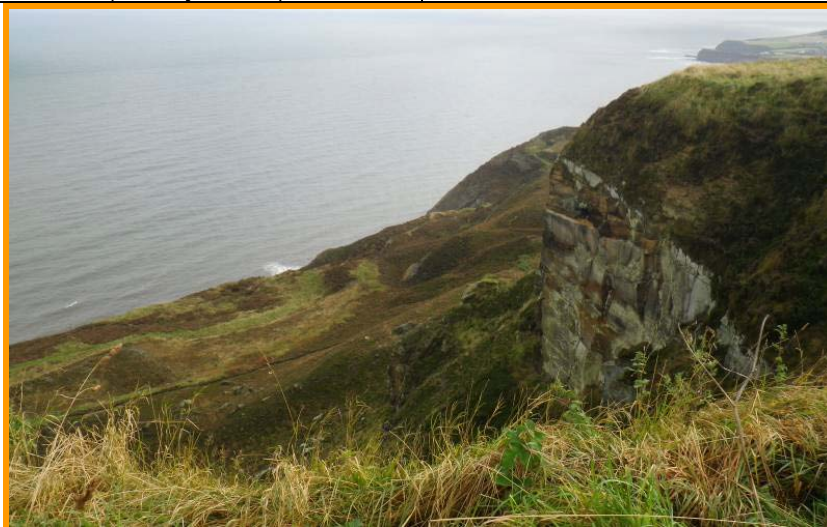
E58/1c the majority of the unit is vegetated and stable with the exception of the bare rock face on the upper slope and the zone of coastal erosion. (Partly Active)

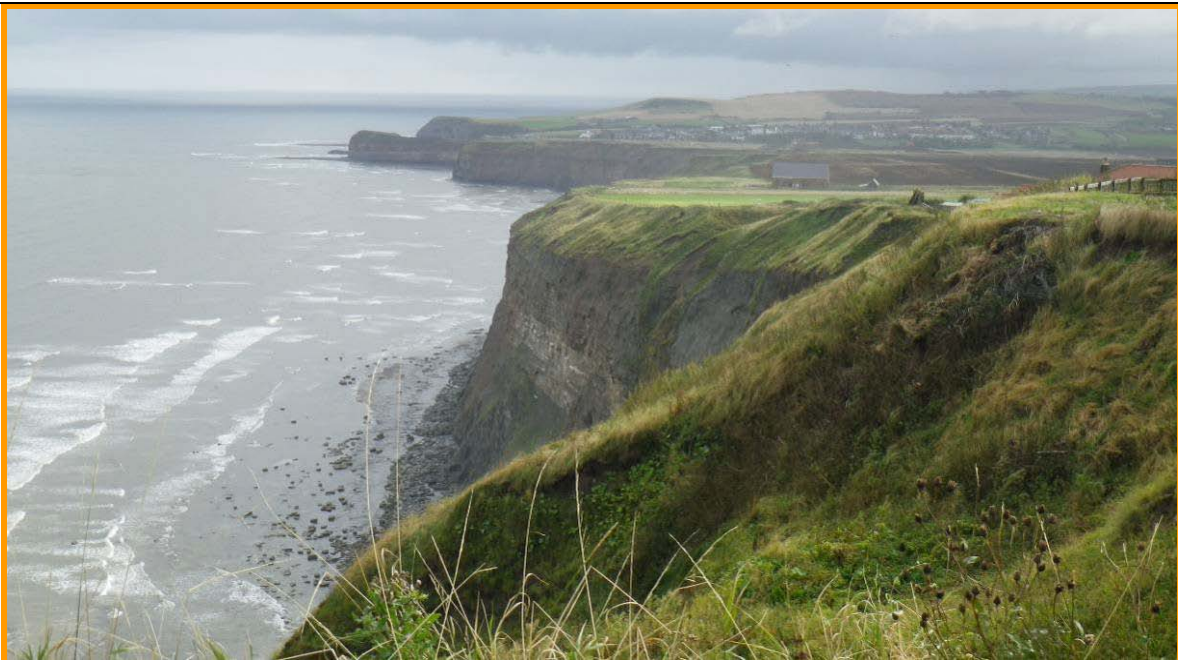
E59/8 looking towards Staithe from Boulby (Partly Active). Cowbar Nab in middle distance.

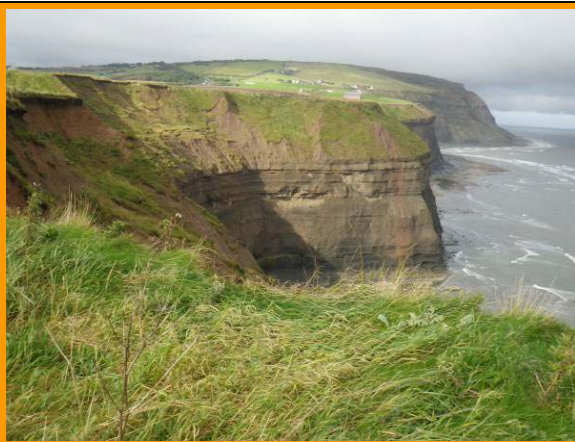
E59/5 failure and active headscarp recession within the upper till part of the cliff (Partly Active)
