**Walk-over Visual Inspections of Assets  
including Coastal Slopes**

**Redcar and Cleveland  
Borough Council  
Final Report**

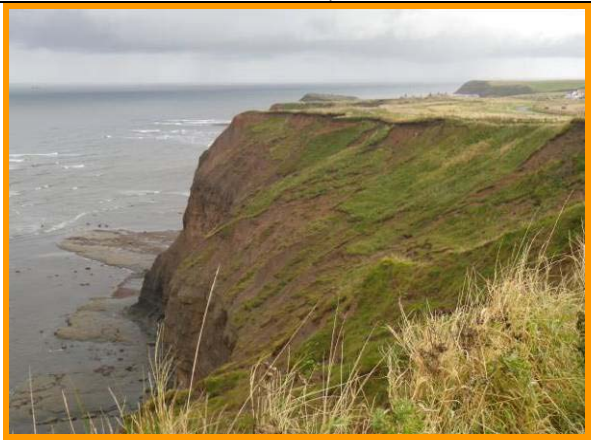
E59/4 fresh failures within the till and rockfall from lower cliff face (Partly Active)

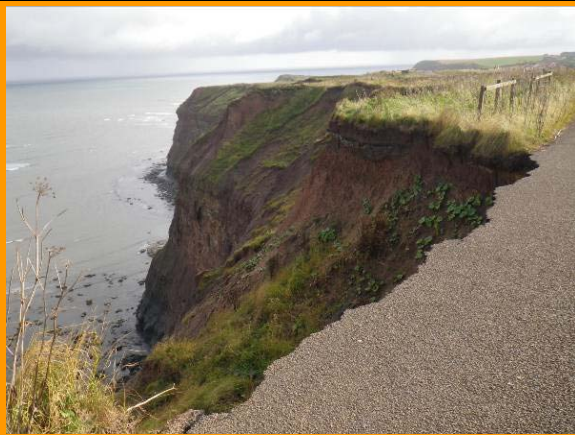
E59/3 ongoing loss of abandoned road at Cowbar (Partly Active)

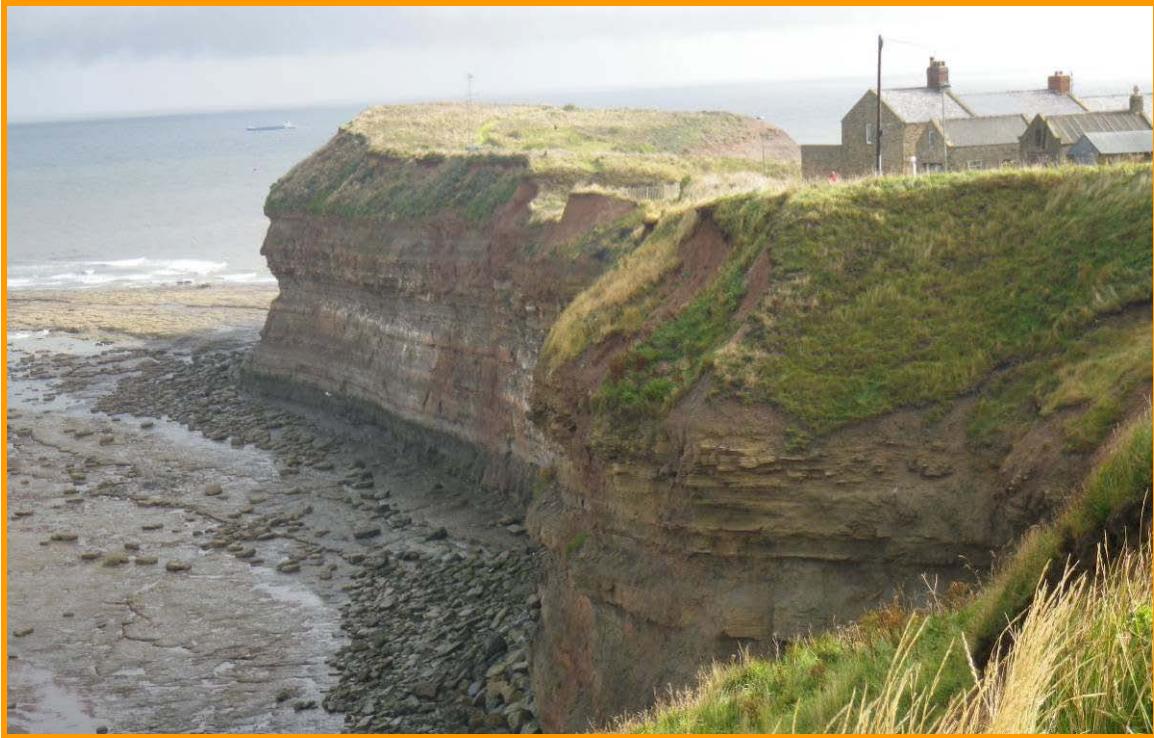
E60/1b continuing erosion on the seaward face of Cowbar (Partly Active)

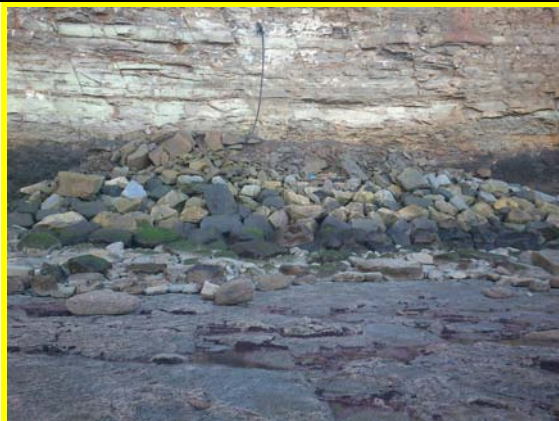
Eastern section of rock armour at cliff toe next to Cowbar lane  
(Asset Ref No. 1221D901D0401C01)

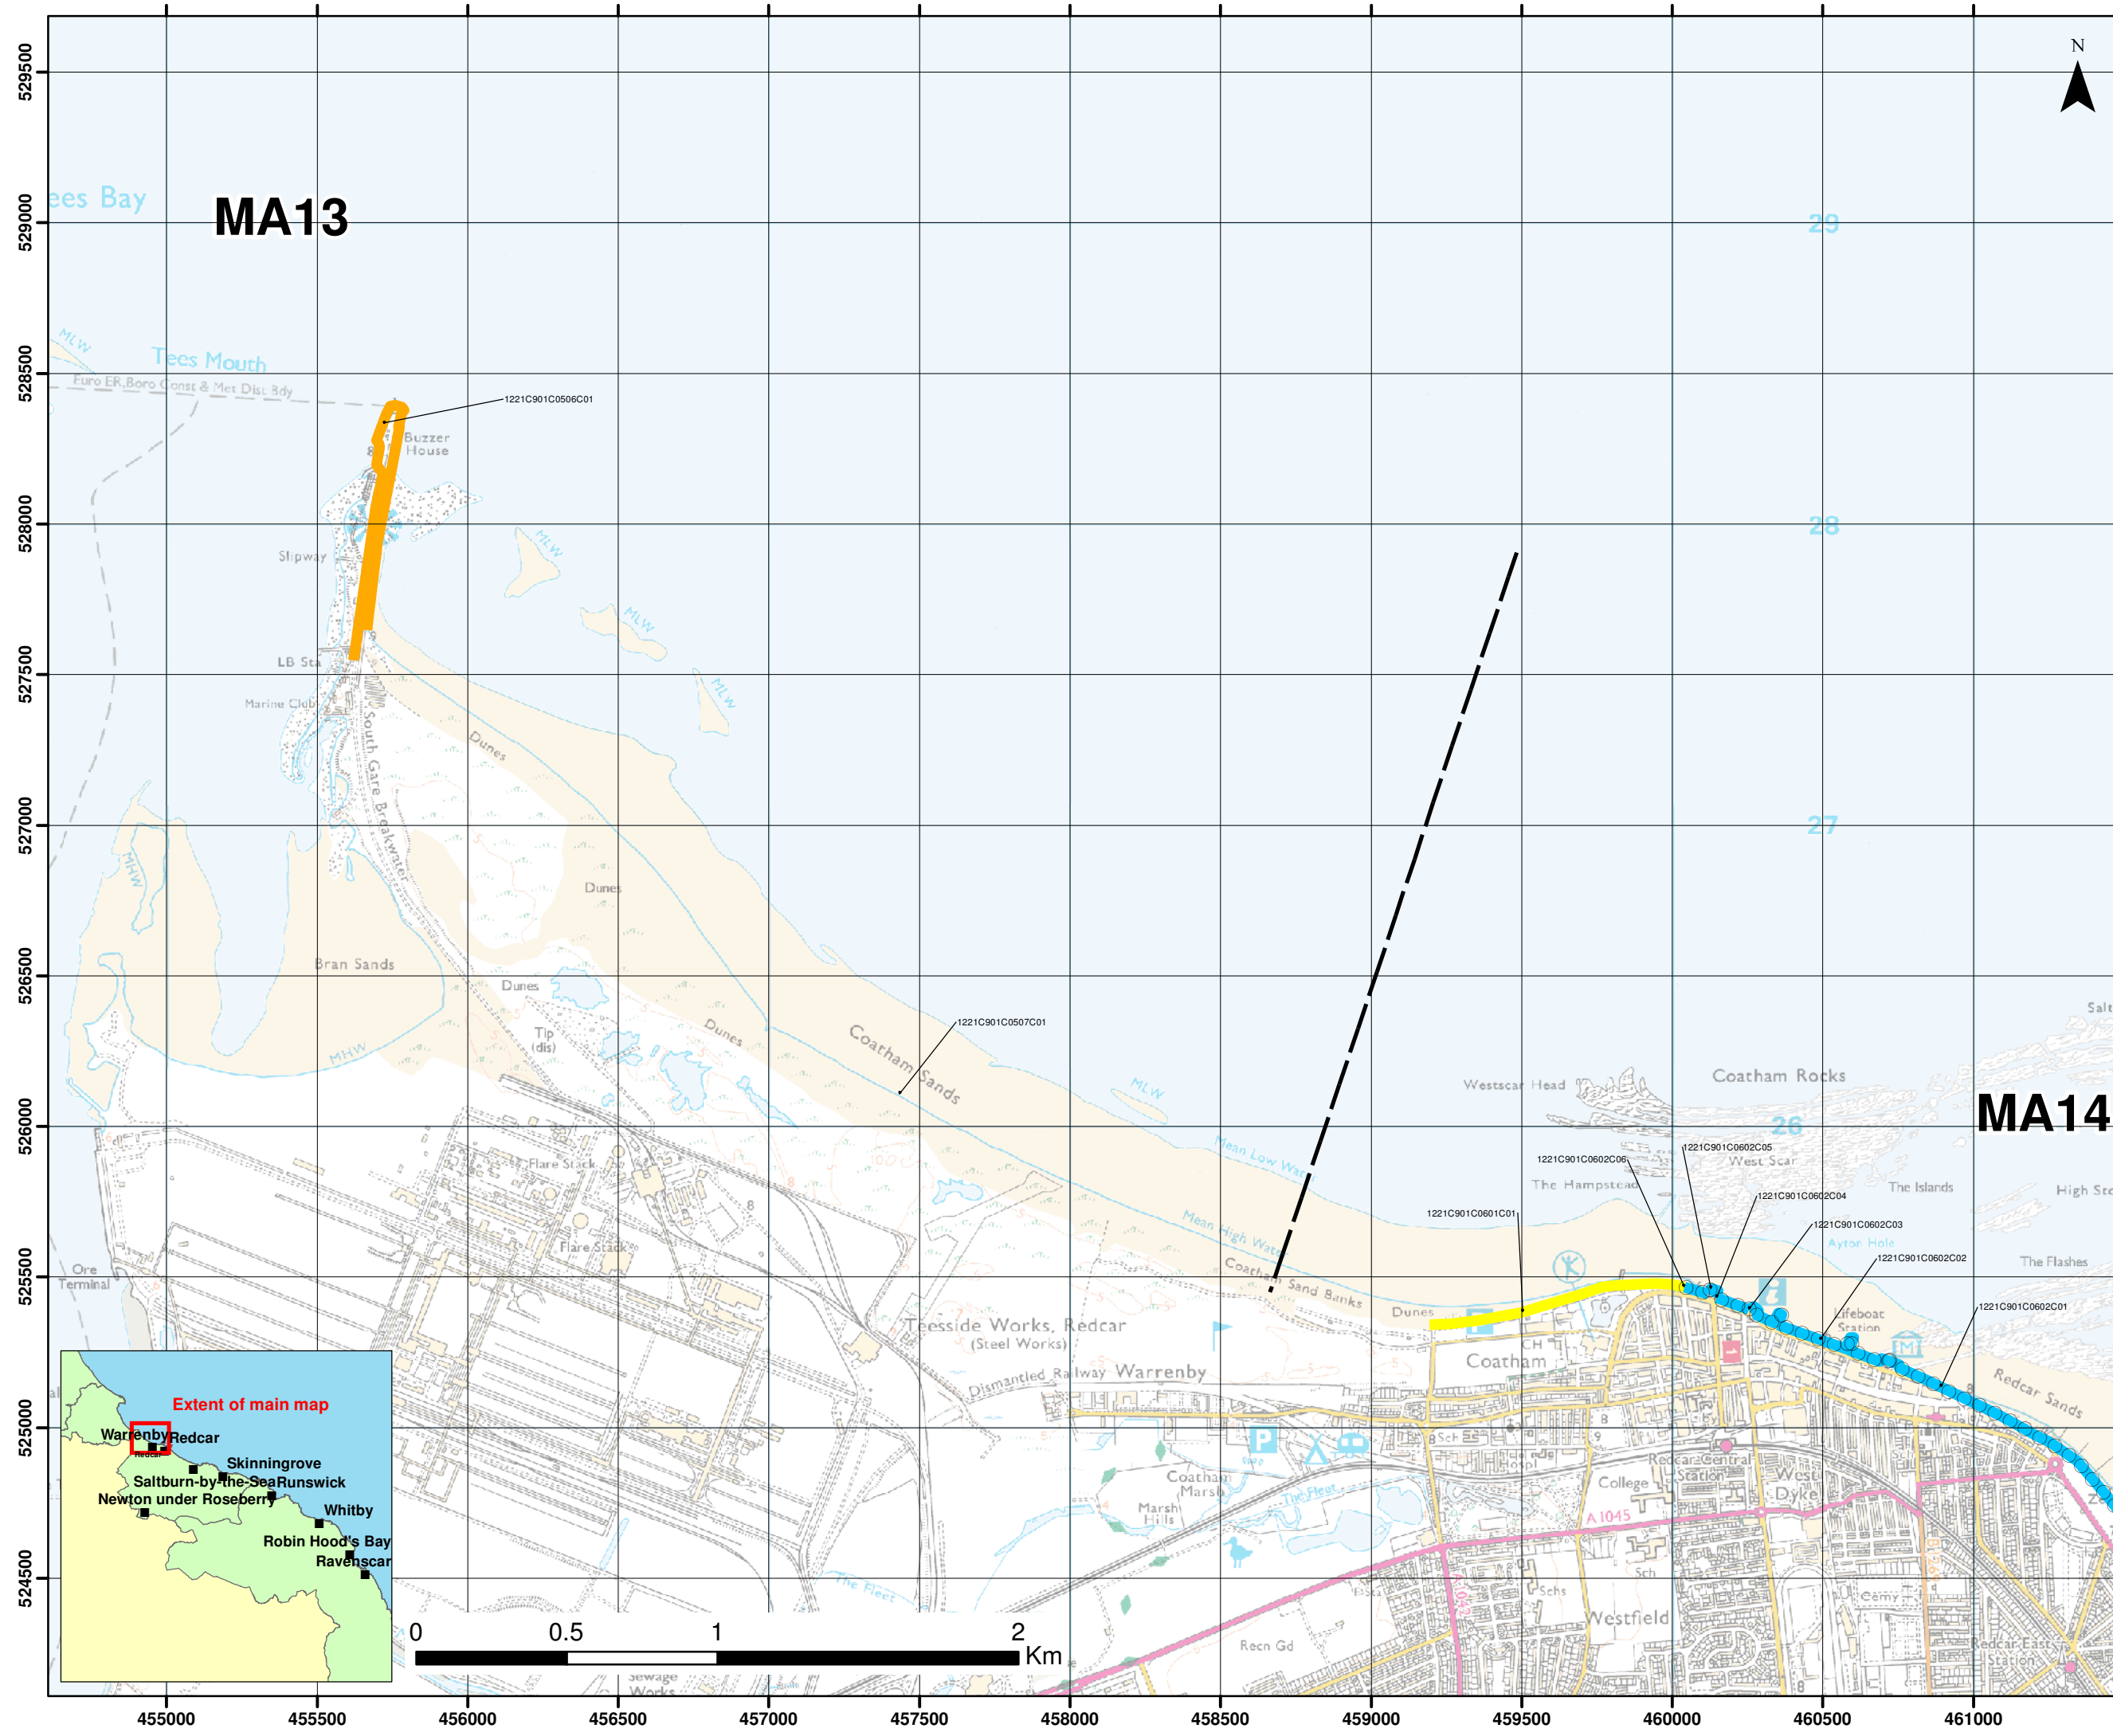
#### **Maps 1 to 4**

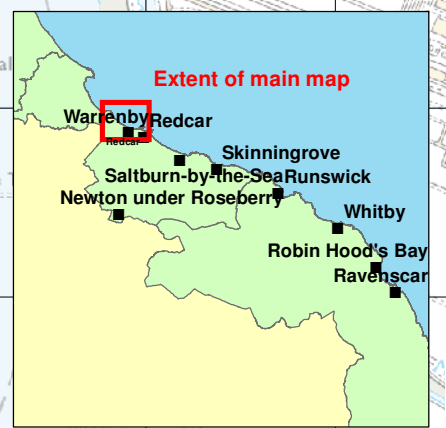
Client: North East Coastal Group

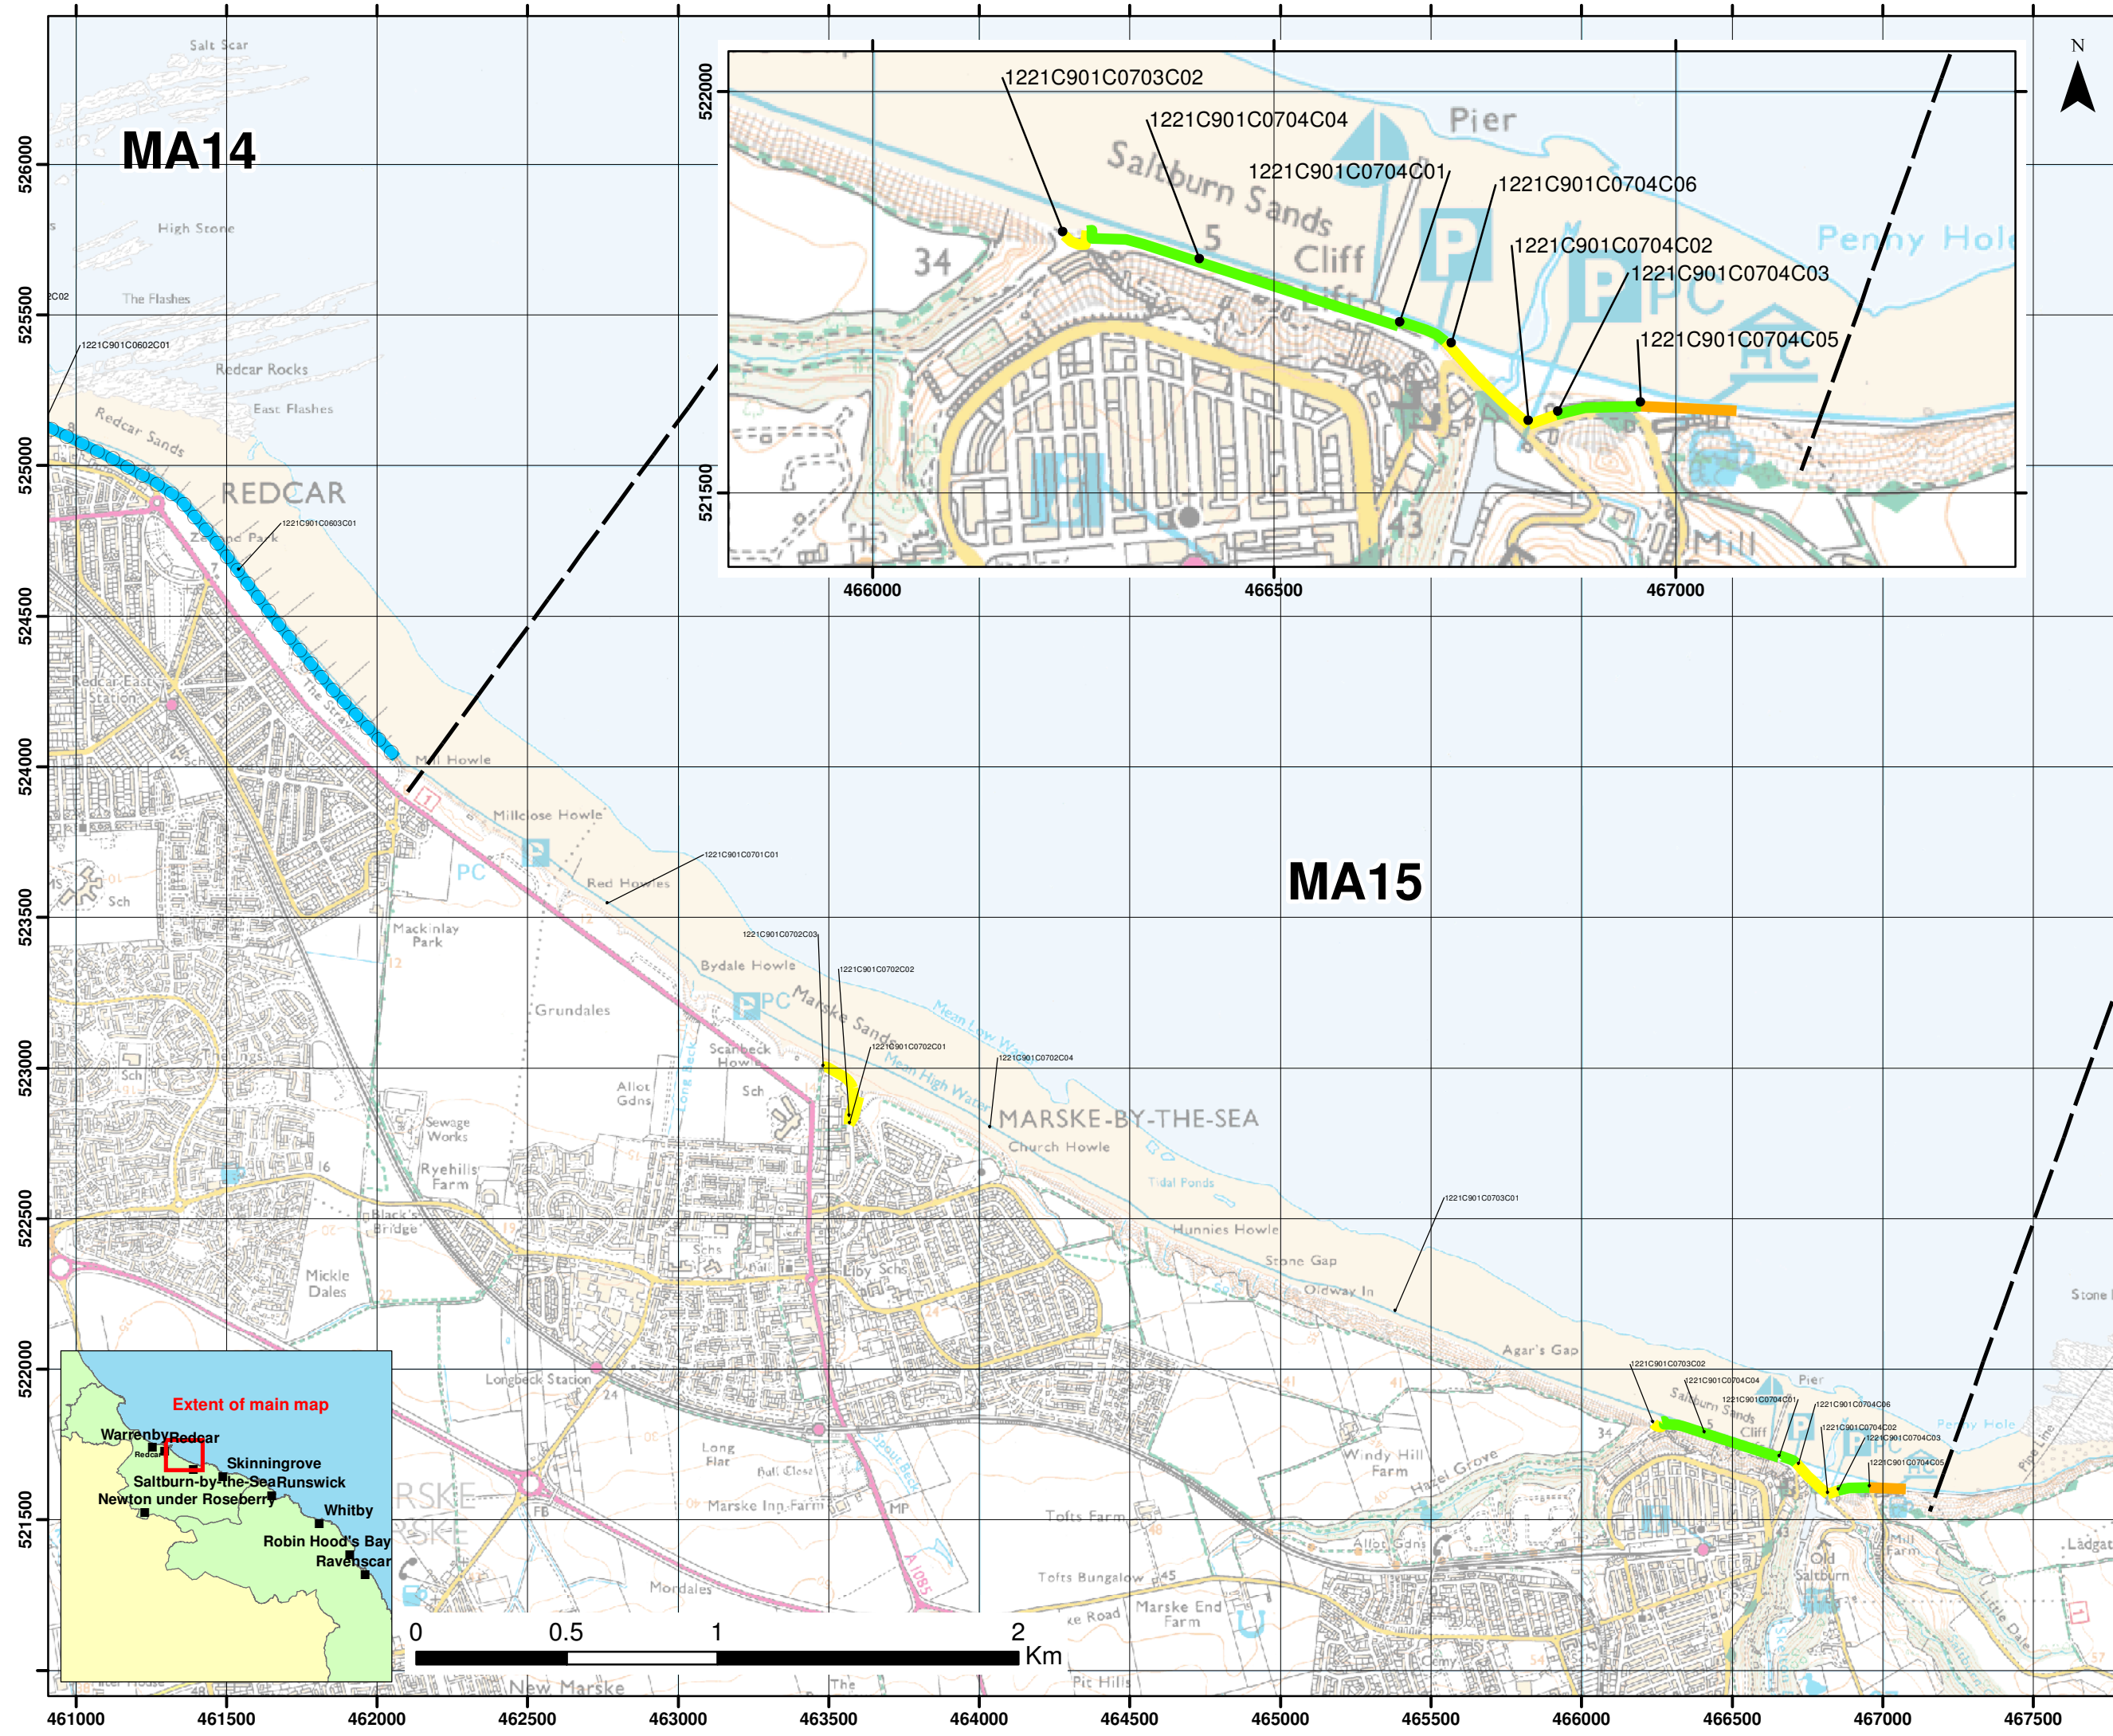
Reproduced from Ordnance Survey mapping with the permission of the Controller of Her Majesty's Stationery Office © Crown Copyright.  
Scarborough Borough Council Licence No. LA 079251

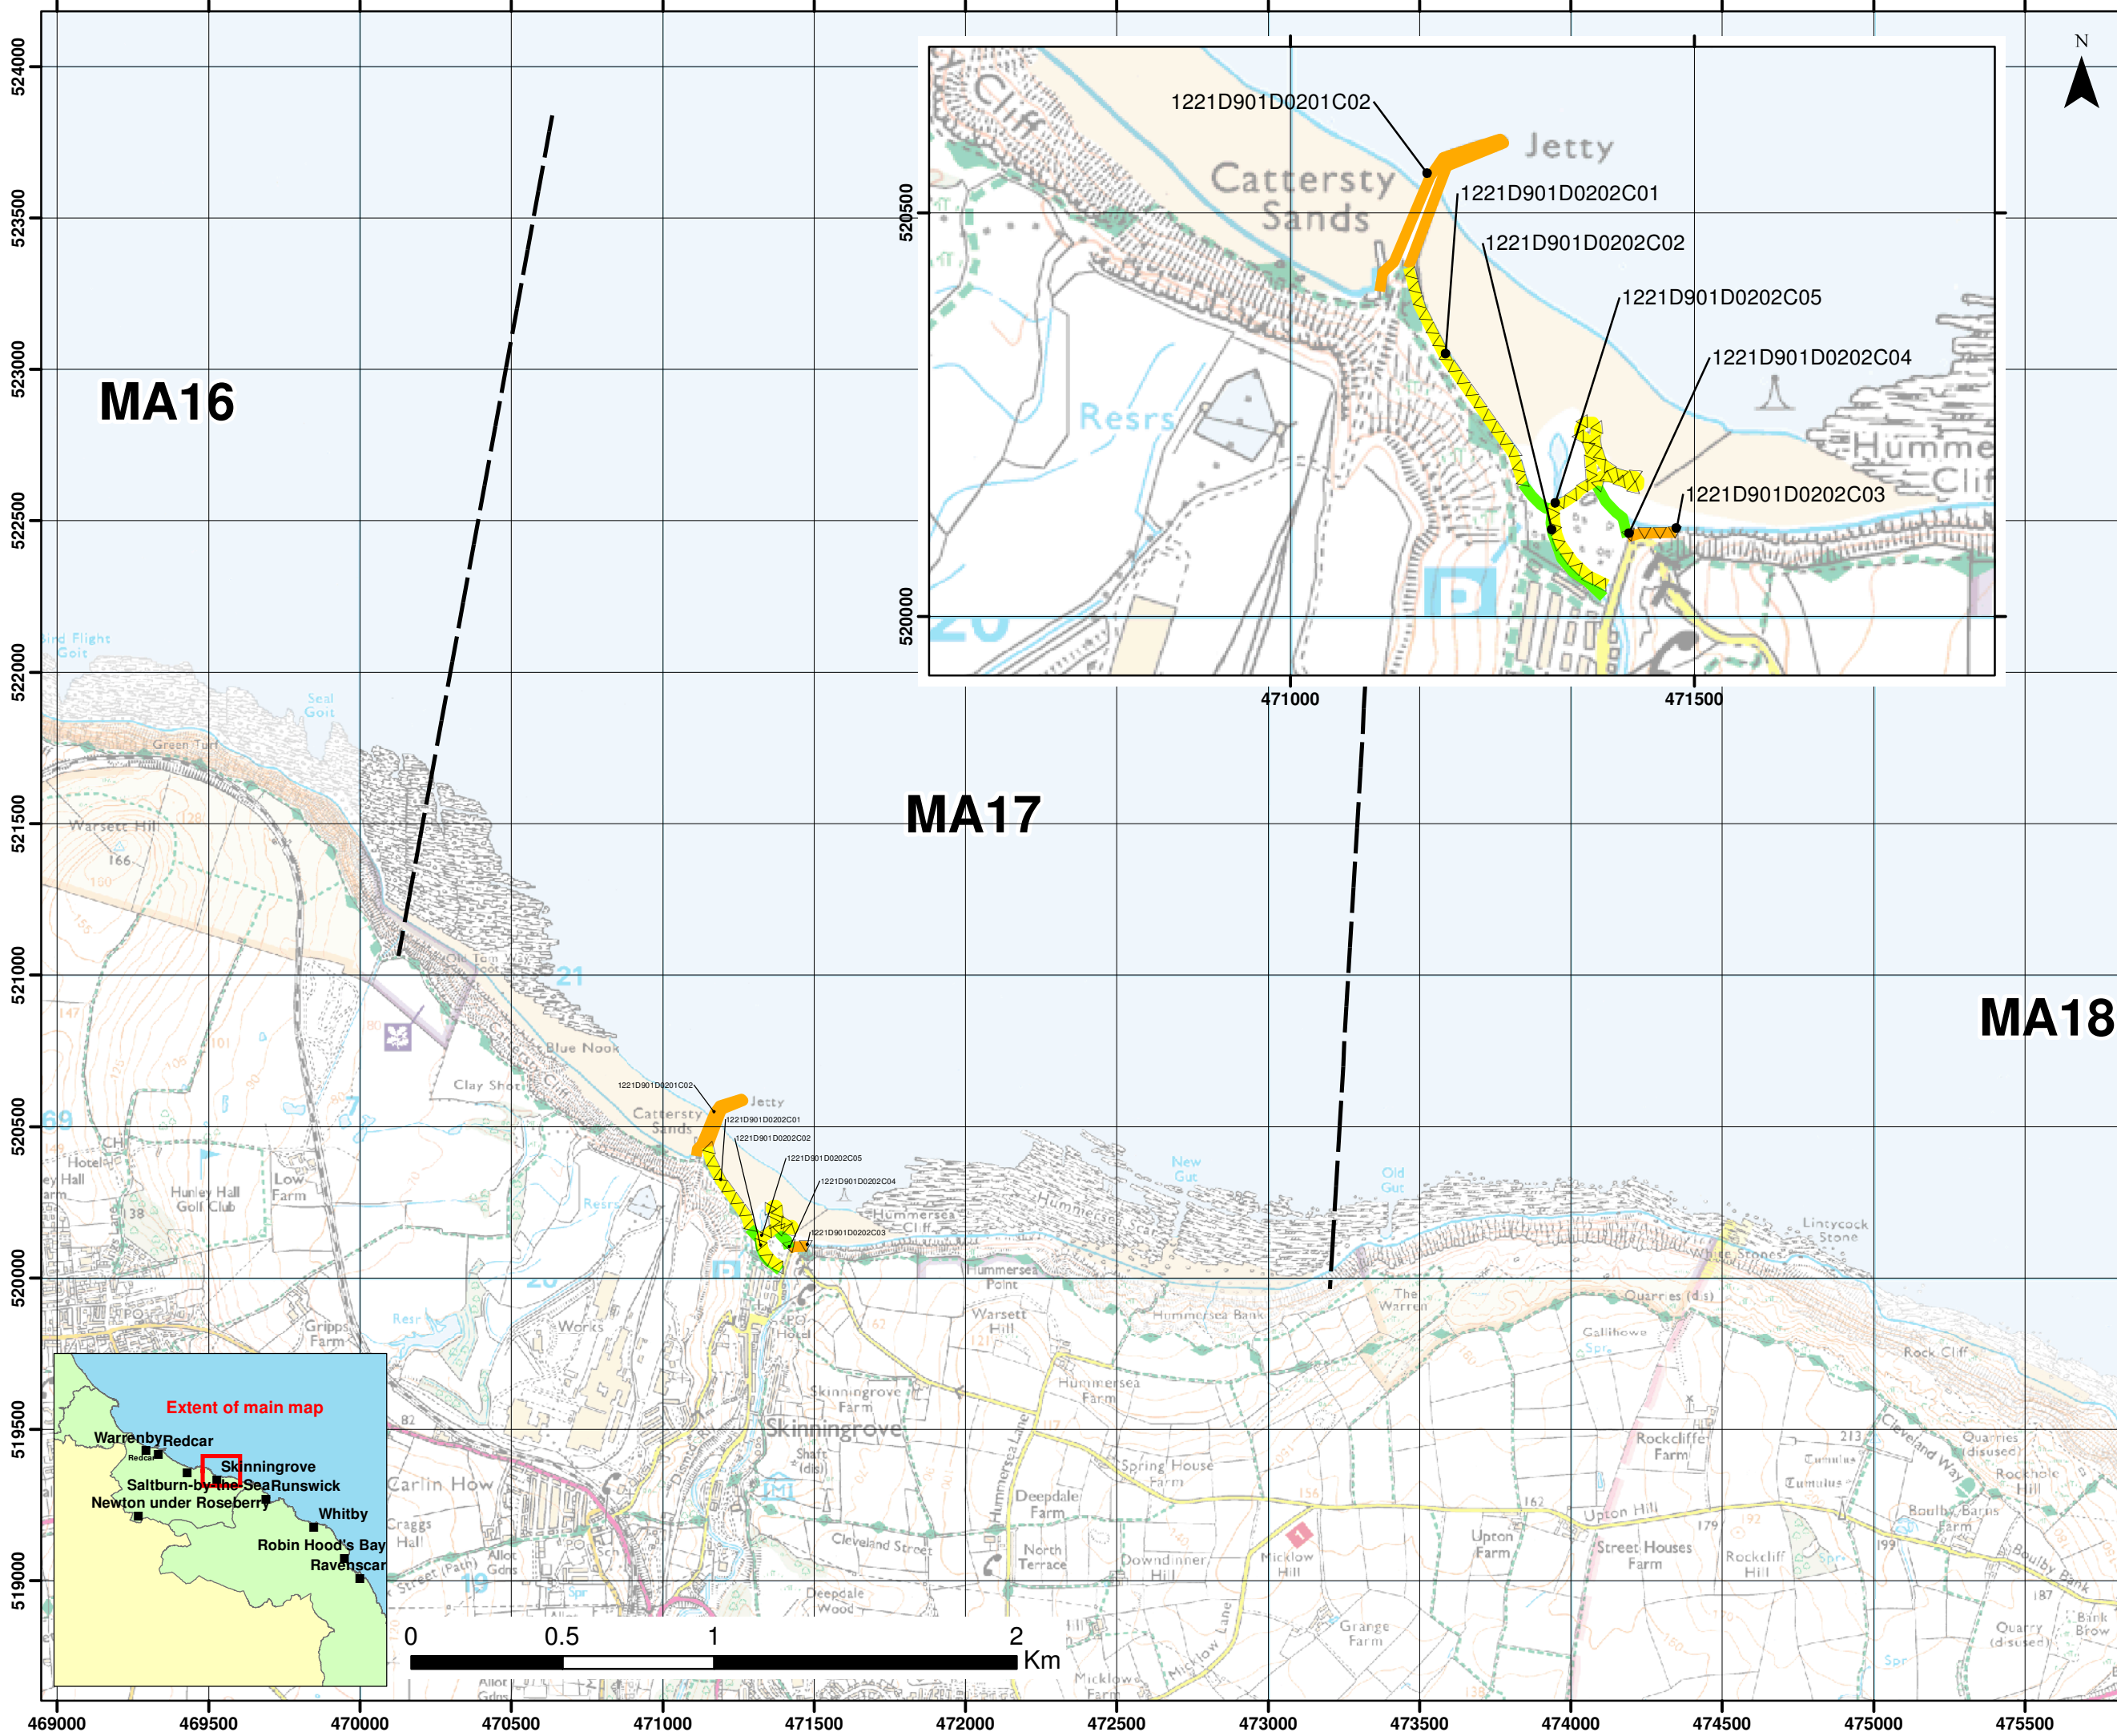
Reproduced from Ordnance Survey mapping with the permission of the Controller of Her Majesty's Stationery Office © Crown Copyright. Scarborough Borough Council Licence No. LA 079251

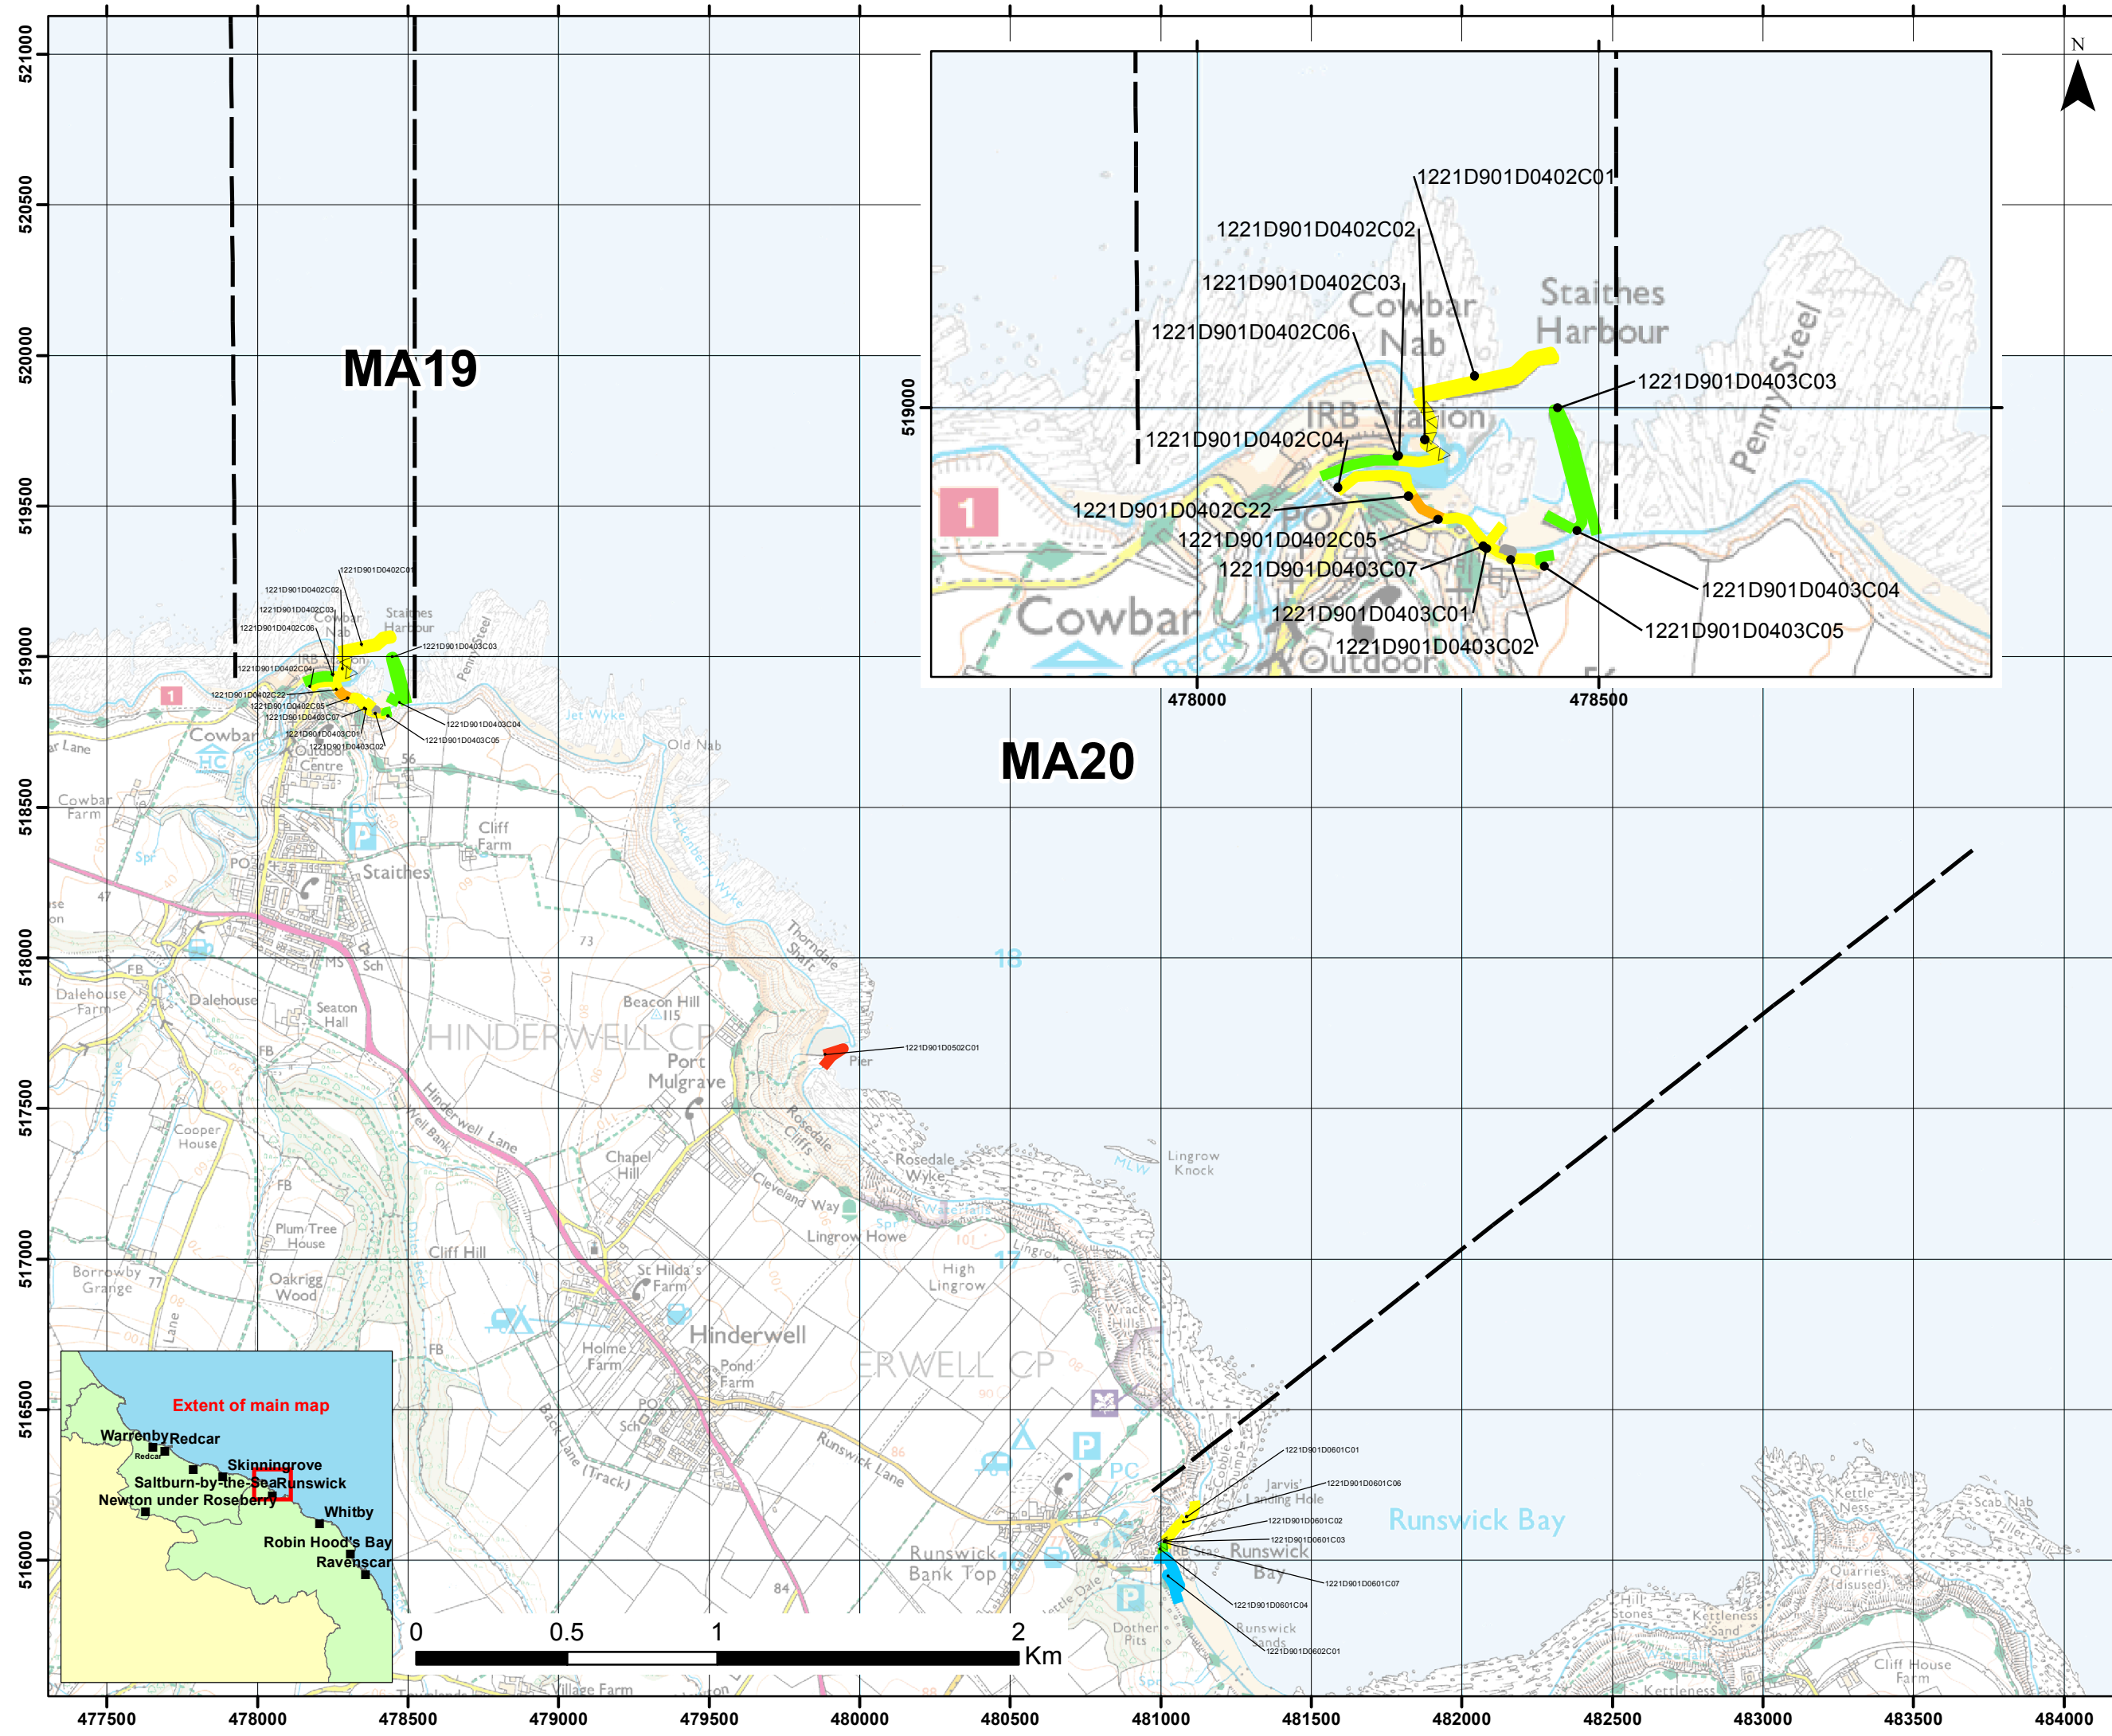
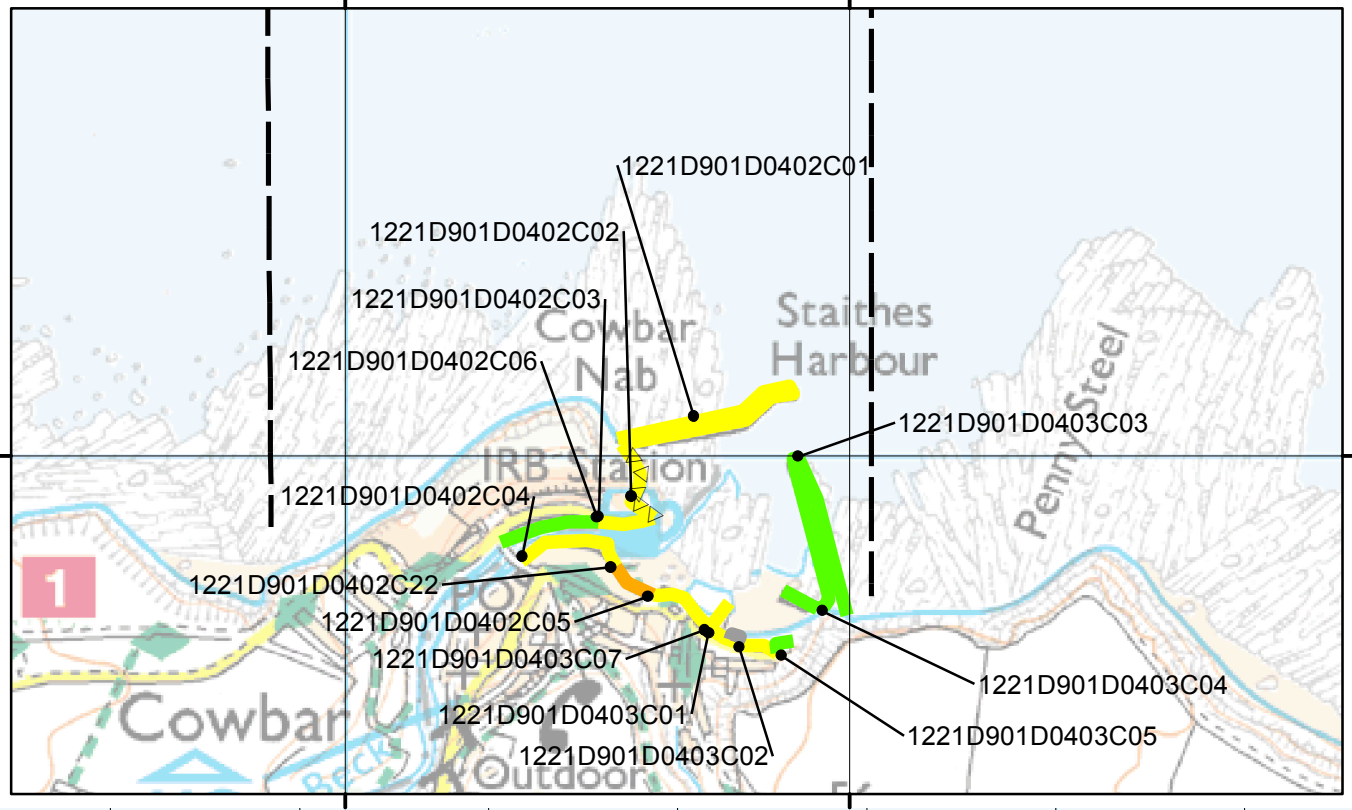
- KEY**
- Management Unit
  - Asset condition (2012)**
  - Very good
  - Good
  - Fair
  - Poor
  - Very poor
  - Not inspected
  - Asset condition change**
  - △△△ Worsened since 2009/10
  - Improved since 2009/10
