**Walk-over Visual Inspections of Assets
including Coastal Slopes**

**Redcar and Cleveland
Borough Council
Final Report**

July- August 2014

Cell One Coast Protection Assets and Coastal Slope Condition Analysis

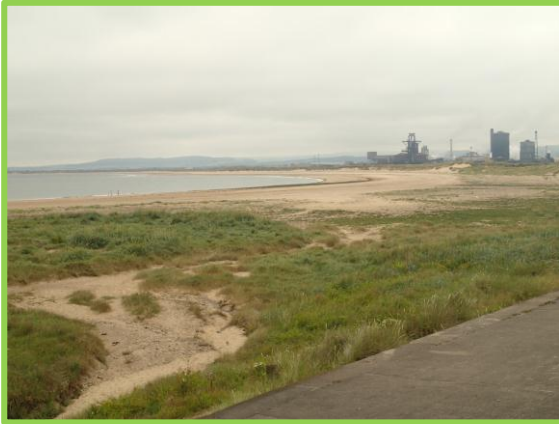
As reported in 2008, 2010 and 2012 inspections, the sand dunes (E52/11) were generally stable with a good coverage of established vegetation. Minor erosion, loss of vegetation and lowering of dune crests was evident locally where members of the public access the beach most frequently (the northern and southern extents of the dunes). A healthy beach level was maintained throughout Coatham Sands.

E52/11 View towards Redcar from South Gare.
(Inactive)

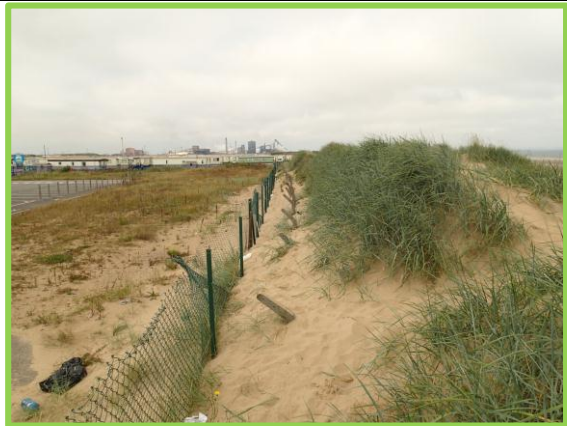
E52/11 Further accretion and roll back of dunes
next to former site compound at Coatham

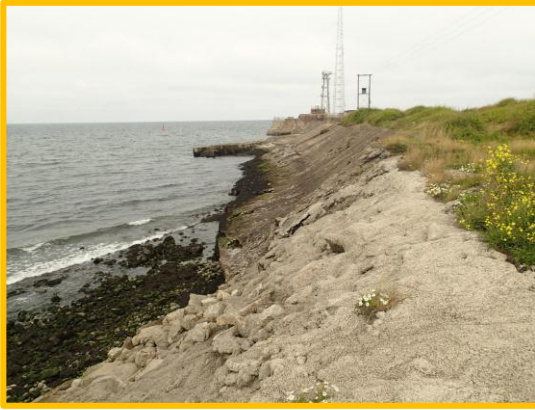
Although structure remains in poor overall condition, it continues to function in protection of the navigation channel and control of bay to south. There was evidence of recent repairs to grouted revetment on the west side and concrete deck slabs on south side.

Patchwork of repairs on west side of South Gare Breakwater, (Asset Ref No 12221C901C0506C01)

As noted in previous reports, a detailed survey of the structure is beyond the scope of the present inspections and a full structural survey of the breakwater is recommended in order to establish the full extent of the damage and identify appropriate remedial works.

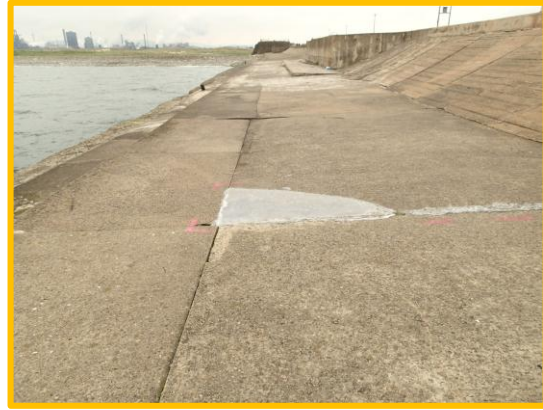
Patchwork of repairs on east side of South Gare Breakwater, appear to be holding but facing to outer structure missing (Asset Ref No 12221C901C0506C01)

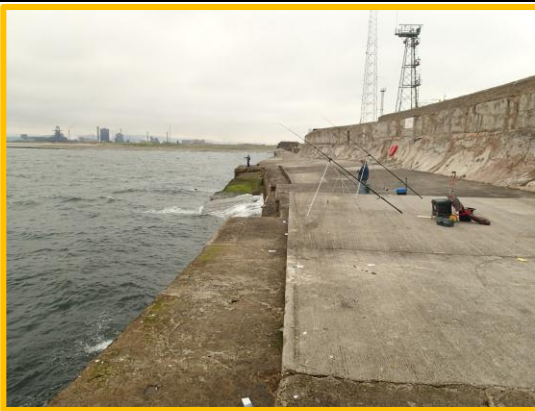
View of east side of South Gare breakwater. (Asset Ref No 12221C901C0506C01)

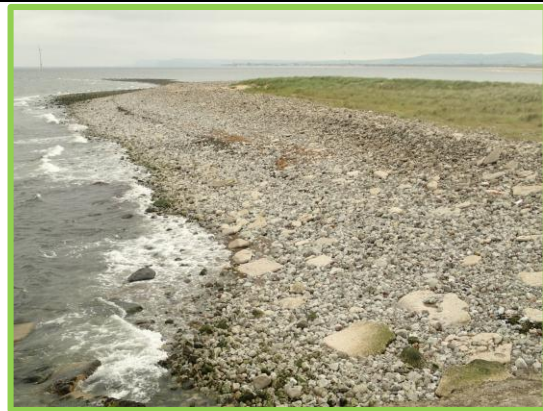
Slag bank running south east from South Gare with debris from failed sections of breakwater (Asset Ref No 12221C901C0506C01)

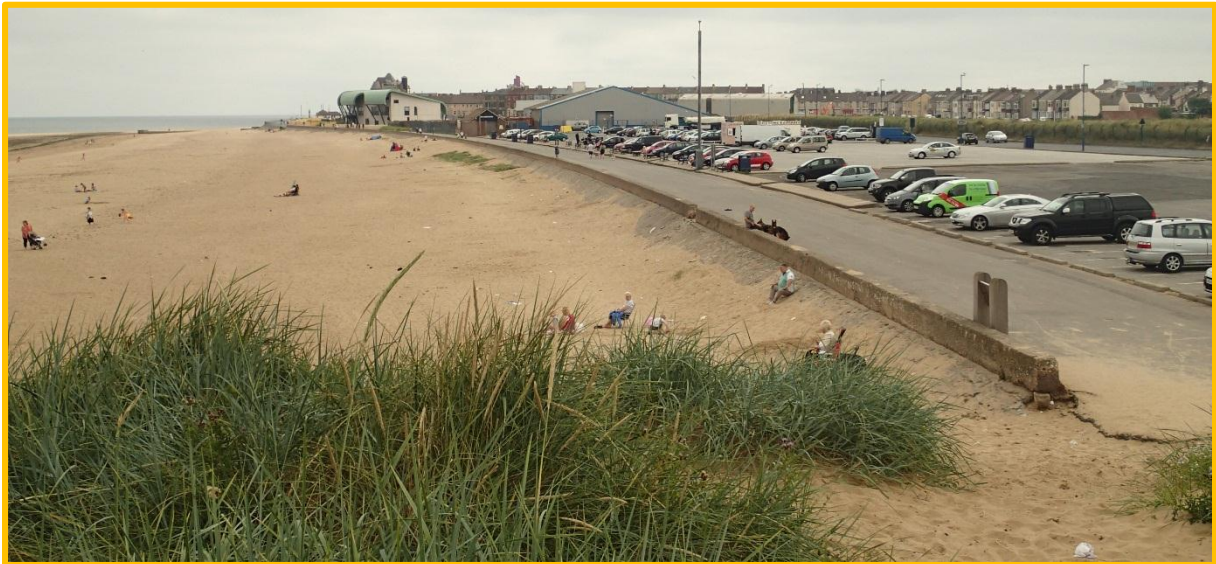
To the west of Redcar, a grouted stone revetment with a concrete wall along the crest tie into the dunes to the north of the Coatham Sands car park (see photo below). While there appears to have been accretion of the dunes and roll-back to cover sections of the fence at the former contractor's compound (see E52/11 above) there is extensive damage to the vegetation due to pedestrian trampling, which will be exacerbating wind blown sand problems.

Overview of defences at west of Redcar from east end of sand dunes.
(Asset Ref No 12221C901C0601C01)

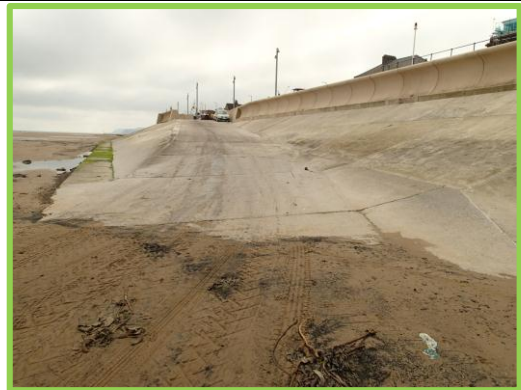
Low beach levels adjacent to boat park slipway
Asset ref No. 1221C901C0602C02

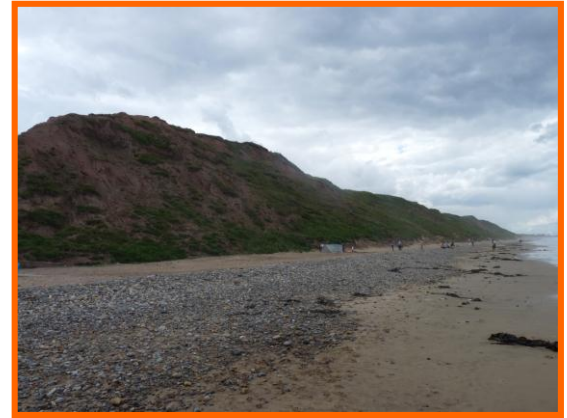
E52/4: Eastern end of unit - coastal slopes viewed
looking north west from Saltburn (Partly Active)
Photo August 2014

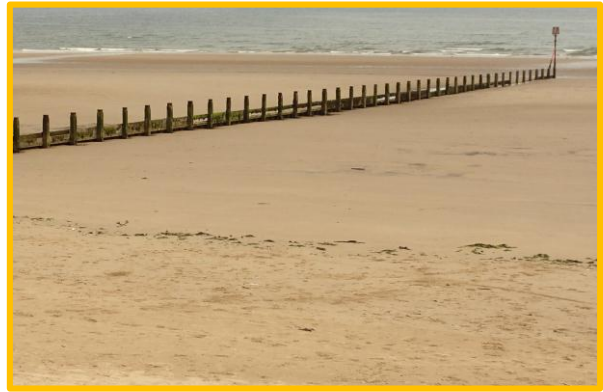
Many groynes refurbished in 2012 have missing planks. Asset ref No. 1221C901C0603C01

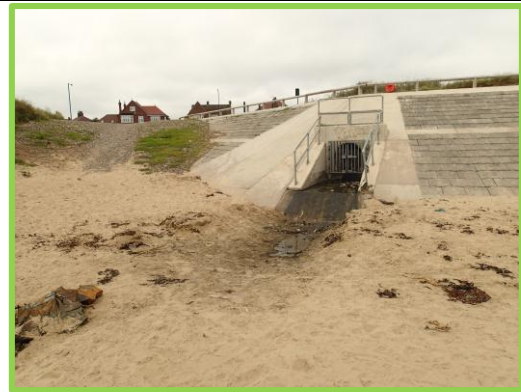
Partly blocked outfall at south east end of seawall Asset ref No. 1221C901C0603C01

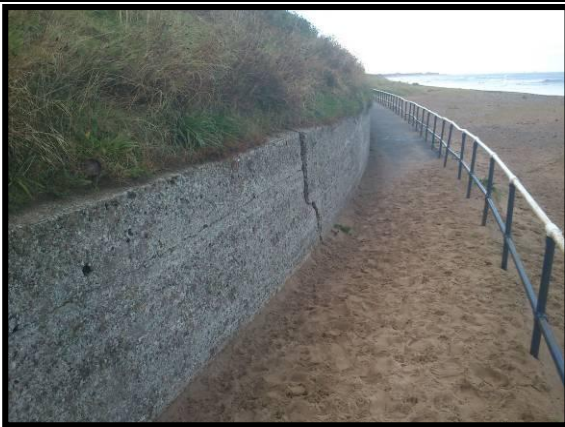
Crack in concrete wall below coastal slope (Asset Ref No 12221C901C0702C03)
Photo from 2010 report.

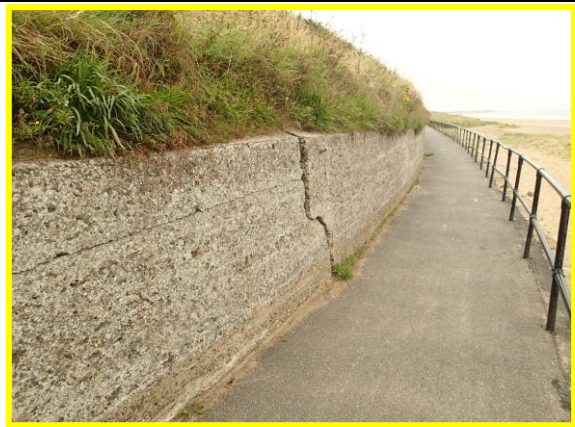
Crack in wall no change from 2010– photo from 24/07/2014. Note lower beach levels. (Asset Ref No 12221C901C0702C03)

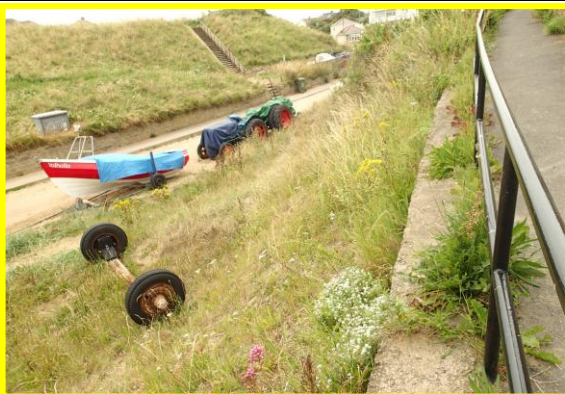
The masonry revetment (Asset Ref No 12221C901C0702C02) on the north west side of the beach access at Marske was reported in poor condition with extensive loss of blocks and erosion of the material below in the 2010 inspections. Vegetation growth has obscured a large proportion of the structure in 2012 and 2014. Where visible the wall appeared in fair condition and there appear to have been some localised repairs since 2012, so the overall condition assessment has been changed to fair. The masonry wall below the revetment shows evidence of local settlement although this was observed in 2008 and 2010, suggesting the structure is stable. There had been repairs to some of the inner sections.

Extensive vegetation growth on revetment; (Asset Ref No 12221C901C0702C02)

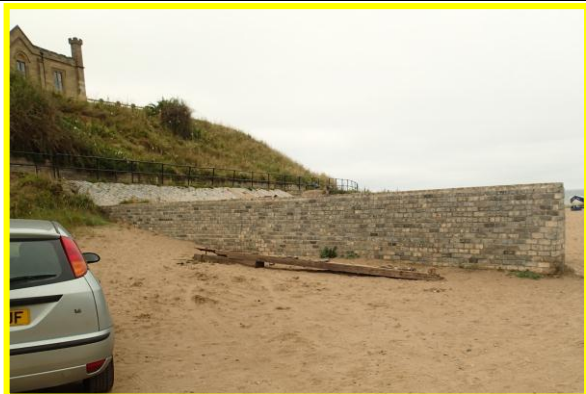
Wall enclosing fishing boat park (Asset Ref No 12221C901C0702C02)

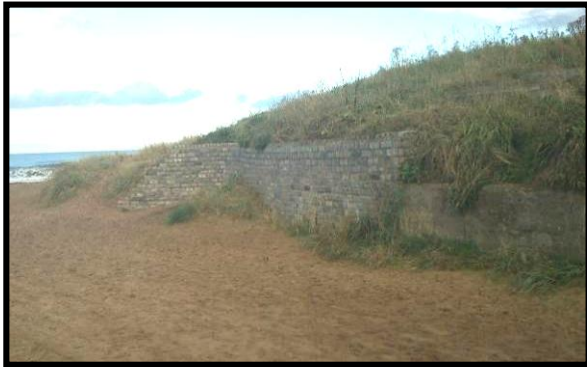
Photo from 2012 Report
(Asset Ref No 12221C901C0702C01)

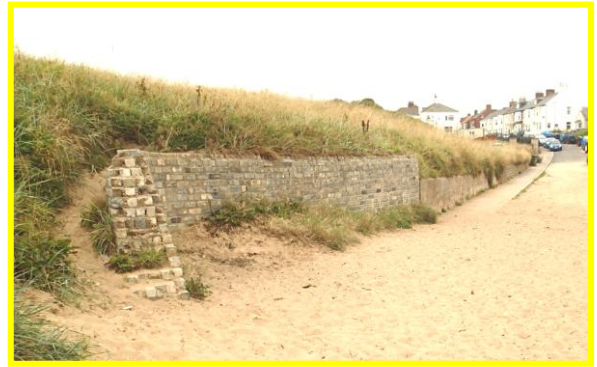
The masonry wall to the southeast of the beach access at Marske (Asset Ref No 12221C901C0702C01) has settlement cracks and missing bricks to the seaward end. However it is in very similar condition to that reported in 2008, 2010 and 2012.

Missing masonry at seaward end of wall to southeast of beach access. (Asset Ref No 12221C901C0702C01)

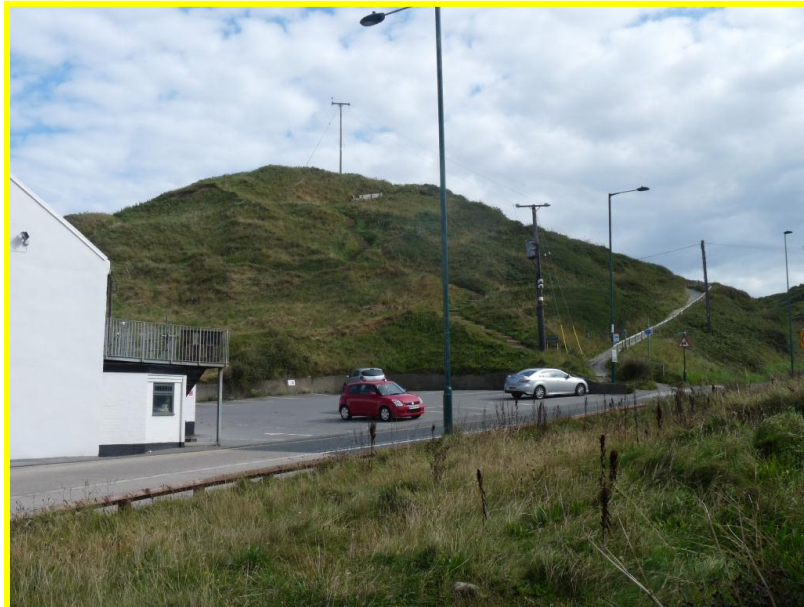
CBU **E53/5** was classified as Locally Active in 2012 due to shallow slumping which occurred on the cliff face and the unit was reclassified as Locally Active. The slumping has occurred despite the presence of toe protection and probably occurred in response to the wet weather experienced in the latter half of 2012. Evidence of activity still remains, so a status of Locally Active has been retained for this unit in 2014.

E53/5 slumped in 2012, leaving open cracks in the cliff face which are still visible. Locally Active. Photo August 2014

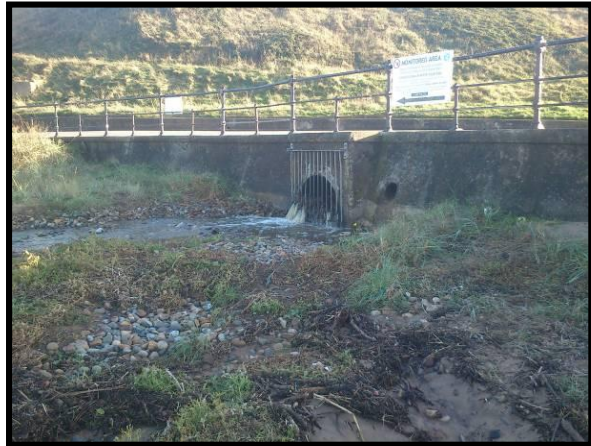
The outfall that exits at Hazel Grove Foot is protected by a trash screen, which was partially blocked at the time of the 2010 and 2012 inspections. It was clear at the time of the 24 July 2014 inspection, see below right and although the channel onto the beach from the outfall appeared lower, the immediately adjacent beach in the small bay was higher. The missing blocks and damage to the coping at the eastern beach access ramp noted in 2012 were not changed, but it is still recommended that this should be addressed to avoid the damage expanding.

Partially blocked outfall exiting through sea wall at Hazel Grove **Photo from 2012 report**
(Asset Ref No 1221C901C0703C02)

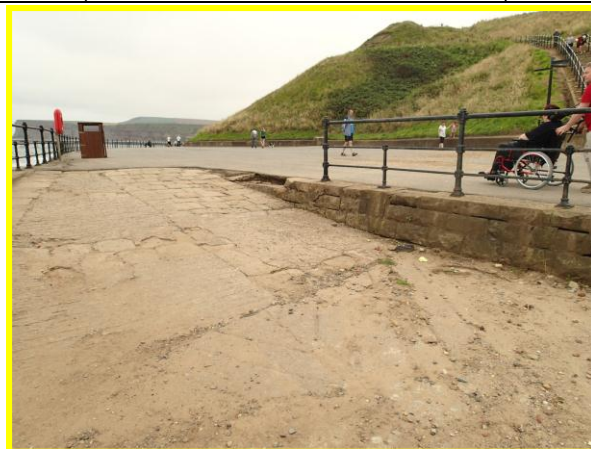
Missing coping stones at edge of ramp at Hazel Grove Foot (Asset Ref No 1221C901C0703C02)

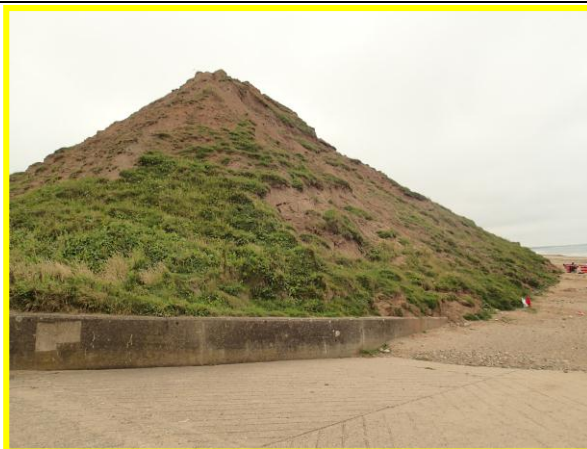
Eroding cliff (E52/4) adjacent to ramp at the north of Hazel Grove Foot, (Asset Ref No 1221C901C0703C02).

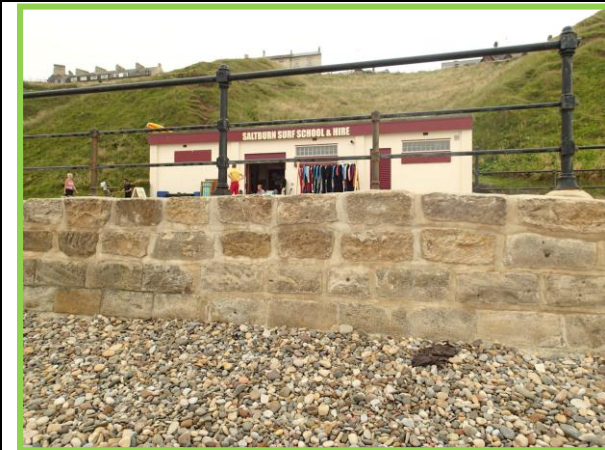
Example of area where blockwork has been recently repaired (Asset Ref No 1221C901C0704C04)

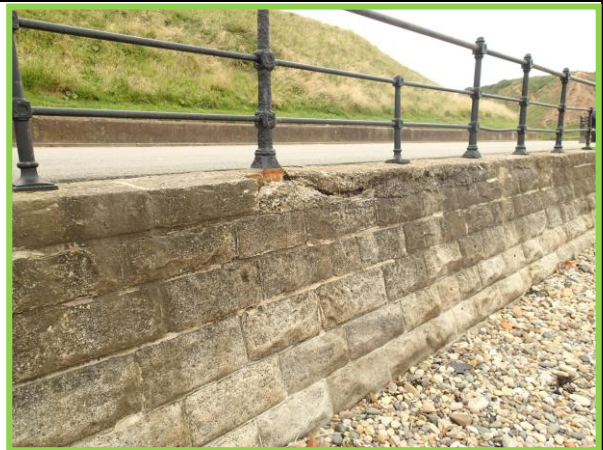
The main section of wall, (Asset Ref No 1221C901C0704C04) is in good overall condition, but has abrasion damage near the toe in places and requires repair to a number of minor defects. There have been a number of repairs undertaken to replace missing mortar in blockwork joints throughout and this is particularly notable at the beach ramps which are believed to have suffered damage during the December 2013 storm.

Damaged section of coping towards western end of wall (Asset Ref No 1221C901C0704C04)

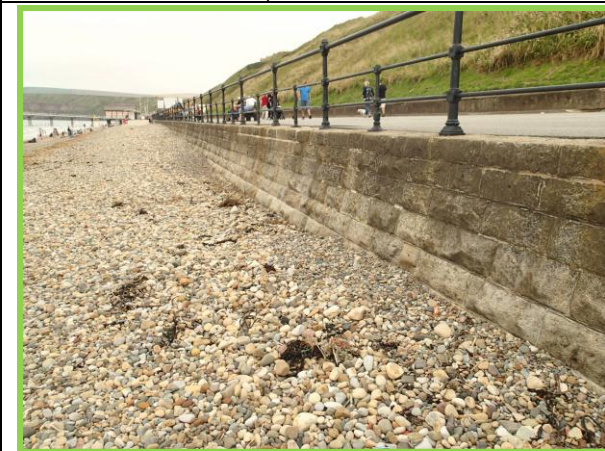
General view of wall looking south east (Asset Ref No 1221C901C0704C04)

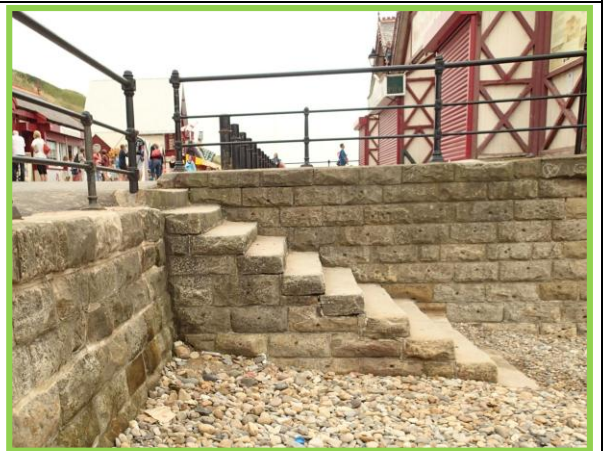
Loss of filler below steps requires re-pointing (Asset Ref No 1221C901C0704C04)

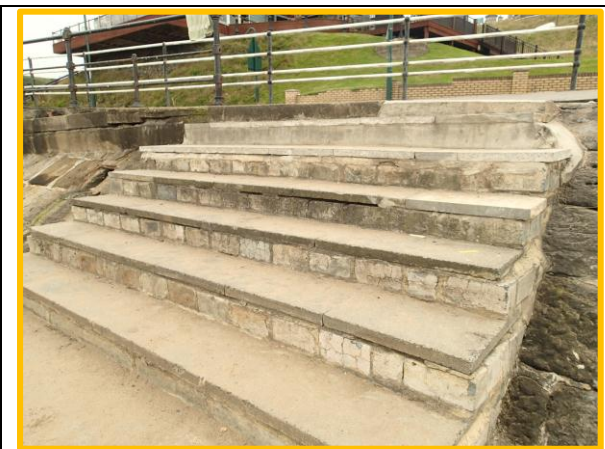
To the south east of the pier, asset Ref. No. 1221C901C0704C01 is a section of masonry blockwork revetment adjacent to the car park area. This is in overall good condition with no missing blocks. One large section has been repaired using smaller blocks. Most mortar joints were in good condition but there was some missing mortar in localised areas. The slipway joints noted to be poor in 2012 had been repaired. The steps to the beach area to at the south end noted to be in poor condition in 2012 had been repaired, but new cracks were opening up beneath the treads.

Repaired steps to beach have cracks beneath treads (Asset Ref No 1221C901C0704C01)

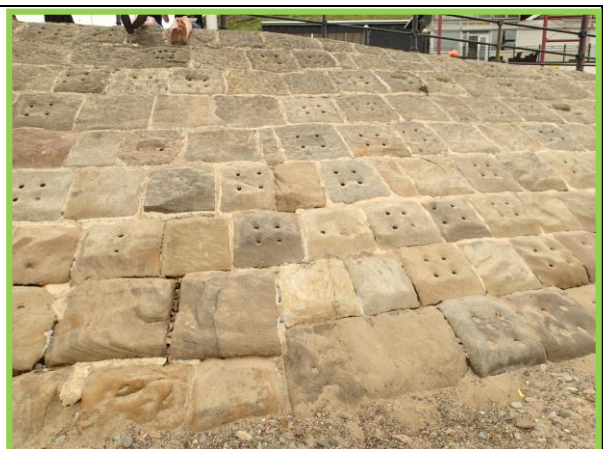
View of sloping masonry revetment at car park area. (Asset Ref No 1221C901C0704C01)

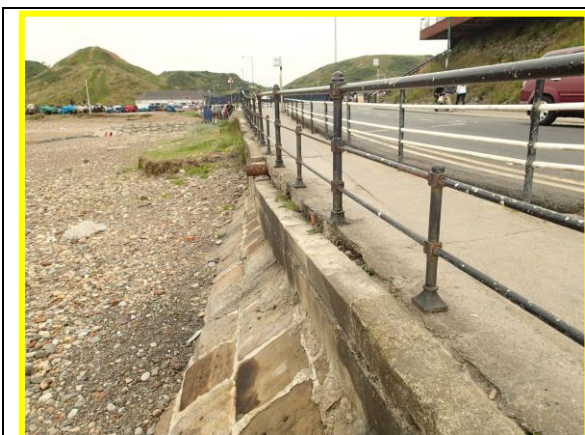
Asset 1221C901C0704C06 is the concrete blockwork seawall and associated elements immediately adjacent to both sides of Skelton Beck. This remains in fair overall condition with joint washout and cracking visible and a short section of coping stone missing, as in 2012. At the time of the inspection the wall was protected by the high beach level in this area.

Damage to coping stones to edge of path by road. (Asset Ref No 1221C901C0704C06)

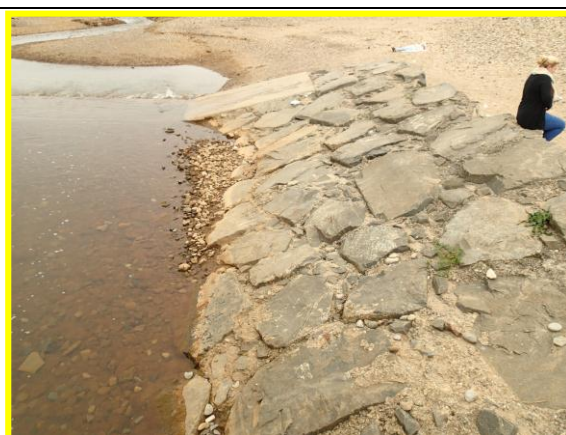
Lower beach levels to east side of beck had exposed the crest of the rock armouring (Asset Ref No 1221C901C0704C06)

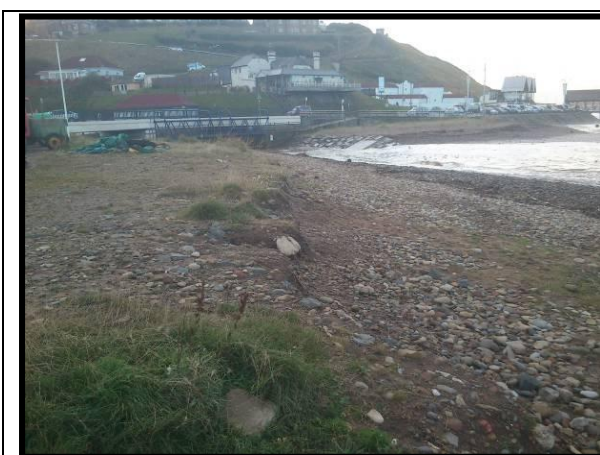
Evidence of previous storm damage to shingle bank at boat park Photo from 2012 report (Asset Ref No 1221C901C0704C02)

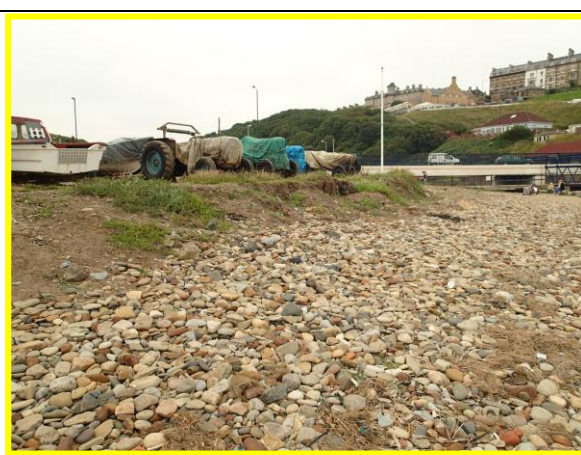
Asset ref. 1221C901C0704C02 is the frontage to the east of Skelton Beck at the boat park. This is classed as undefended in NFCDD, with protection relying on the shingle bank on top of which the boat park is located. The shingle bank was lower than in 2012, exposing the edge of the boat park surfacing.

Erosion of cobble bank adjacent to boat park. Asset Ref No 1221C901C0704C02

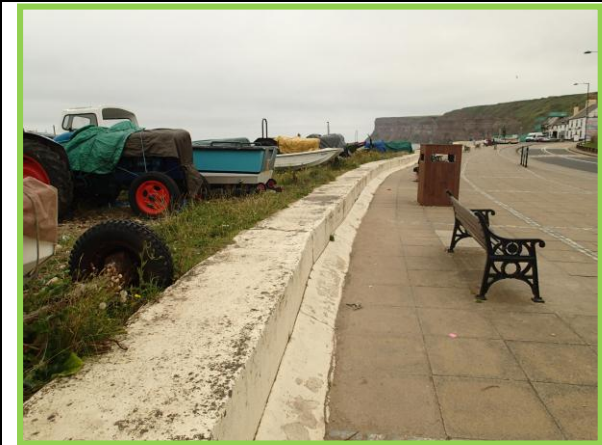
To the south of the boat park the defence asset 1221C901C0704C03 is a set back wall protected by a cobble beach. The set back wall in good overall condition, although there is some cracking and loss of render. The slipway at the east end which was noted as being undercut by erosion in 2012 has been fully repaired and was in good condition.

Set back rendered wall protected by shingle beach (Asset Ref No 1221C901C0704C03)

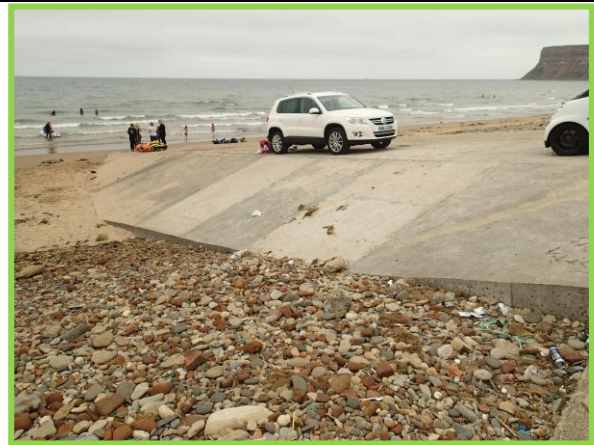
Repaired slipway at east end of Asset Ref No 1221C901C0704C03

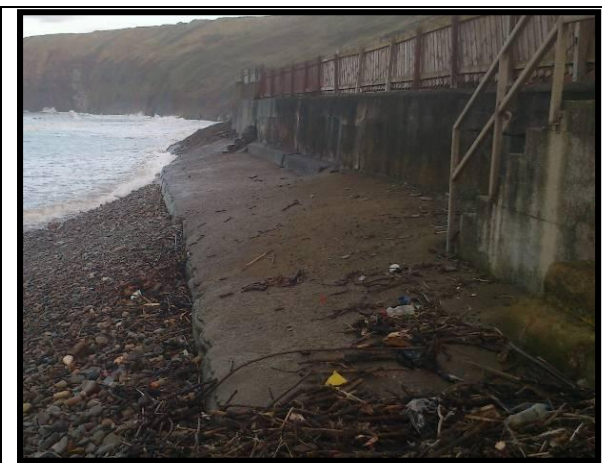
Photo from 2012: Some accretion of cobbles, defence in similar condition to 2010 (Asset Ref No. 1221C901C0704C05)

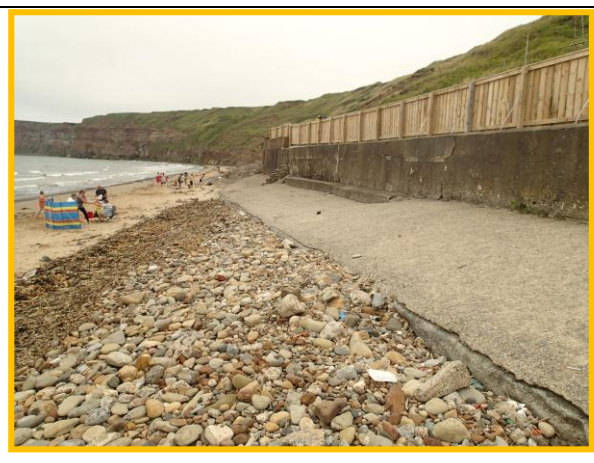
The most southerly section of coastal defences at Saltburn is Asset Ref. 1221C901C0704C05. This is a patchwork of informal defences protecting the public house and land to the east side of the slipway. Here, in 2008, the coastal protection consisted of heavily eroded sections of concrete defences, displaying large amounts of excavation, undercutting, major cracking and in some parts, total collapse (Asset Ref No. 1221C901C0704C05). In 2010 it was observed that large scale emergency repairs had been completed, but that these works did not appear to have been carried out by professional contractors and the condition rated as poor. The 2012 inspection found that the previous repairs were in a similar condition, with overall asset condition poor, see photos below. At the time of the July 2014 inspections it was observed that further repairs had been undertaken, although higher beach levels were covering the defence toe and probably concealing undermining that would be susceptible to damage during storms, so the overall condition rating was kept as poor.

Higher beach levels at time of 2014 inspection affording some protection to defence. (Asset Ref No. 1221C901C0704C05)

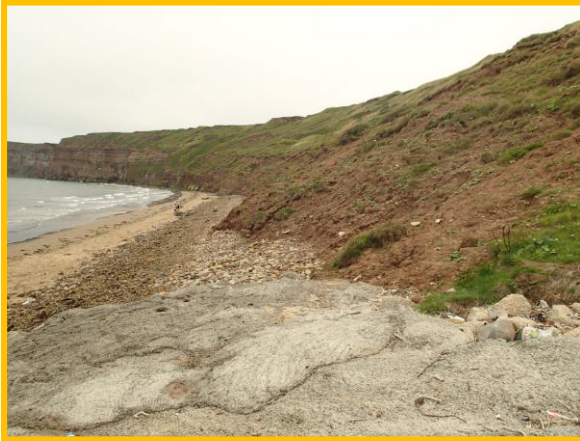
Poured concrete repairs at east end of defence adjacent to slumping cliffs
(Asset Ref No. 1221C901C0704C05)

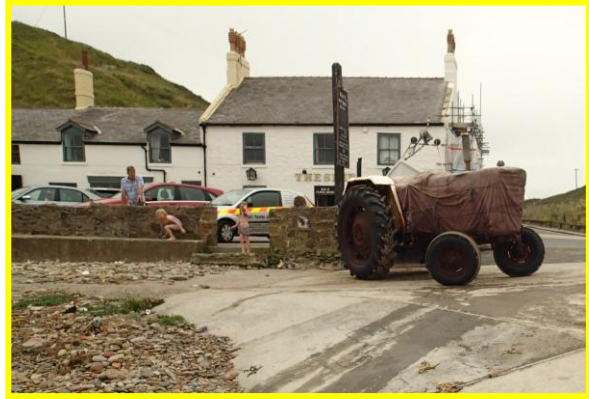
Low wall at edge of pub car park in fair condition
(Asset Ref No. 1221C901C0704C05)

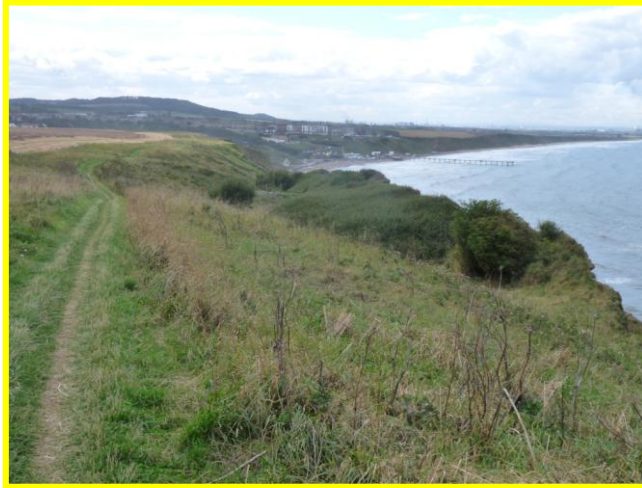
E53/2 Evidence of previous instability in the upper till section of this unit (Locally Active). Photo August 2014

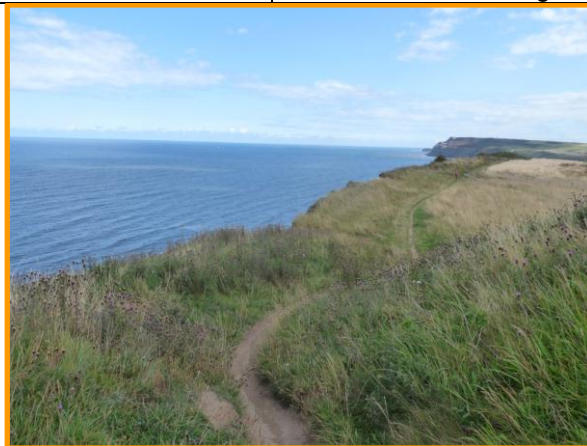
E54/2b and MU54/2a – looking east. Note very sharp, actively eroding cliff line (Partly Active)

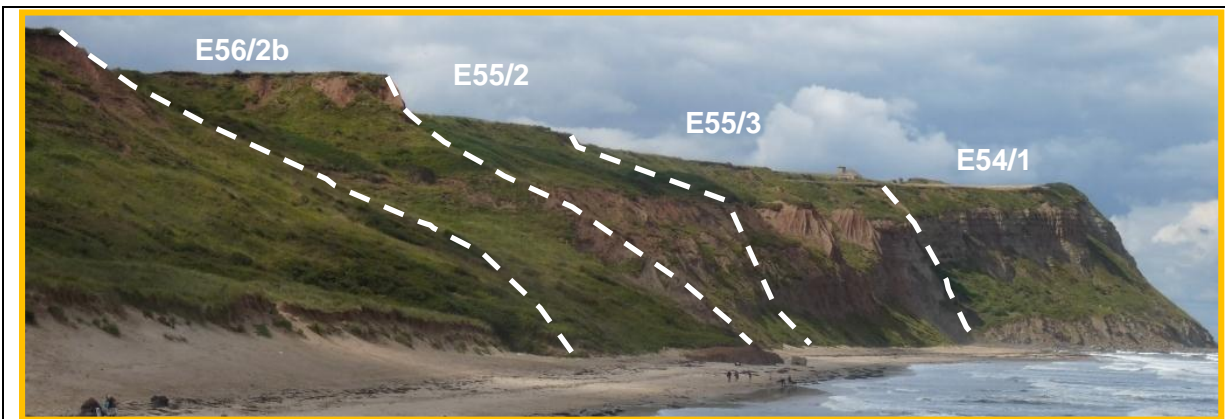
E54/1, E55/3 and E55/2 and E56/2b looking northwest (Locally Active)

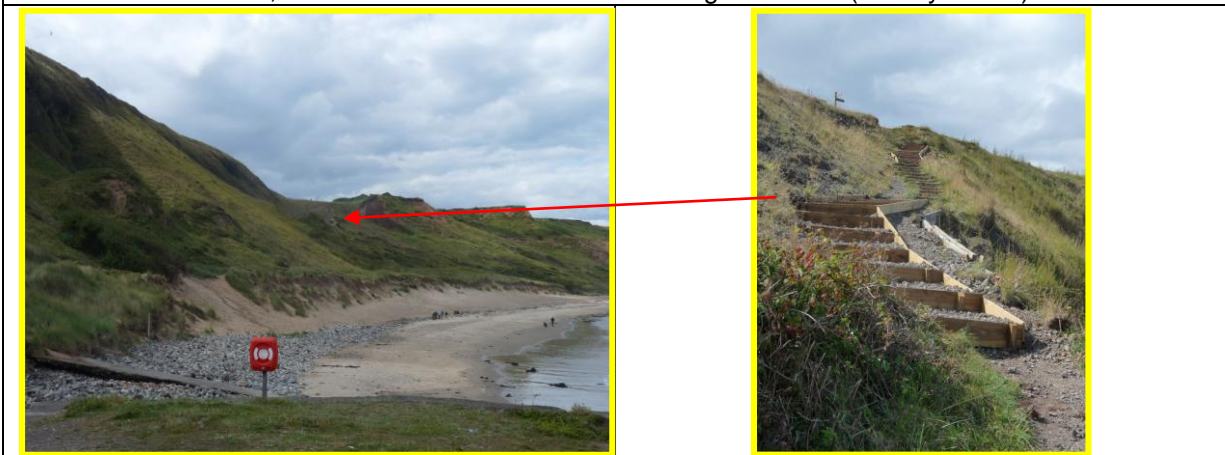
E56/2a (west) Well vegetated cliff but new steps in on Cleveland Way footpath have been put in to cross failure scarp (Locally Active)

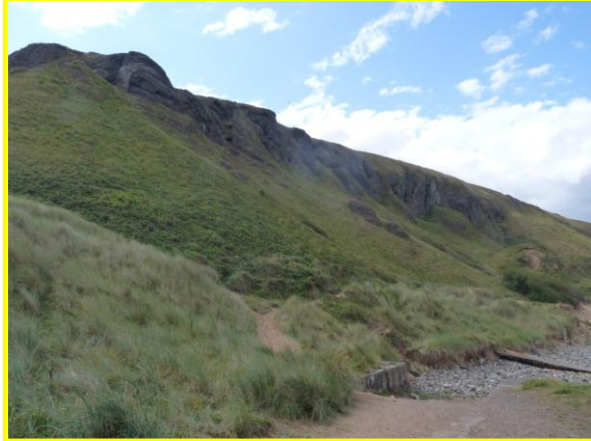
E56/2a (east) – Locally Active

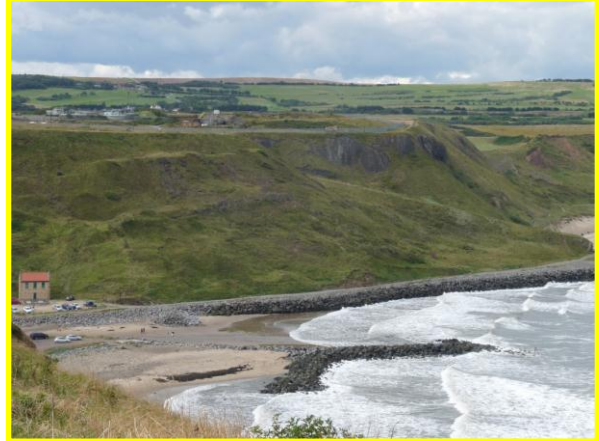
E56/1 – Numerous shallow failures visible. Locally Active

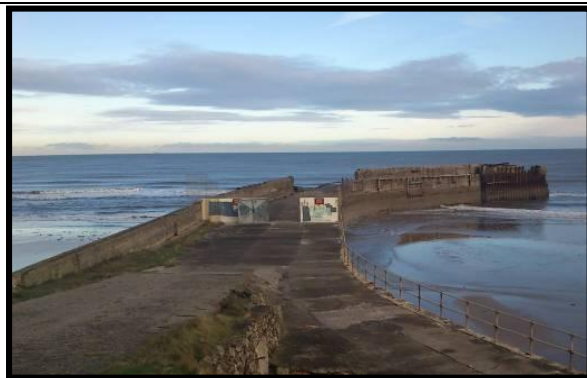
View of Jetty in 2012 (Asset Ref No. 1221D901D0201C02)

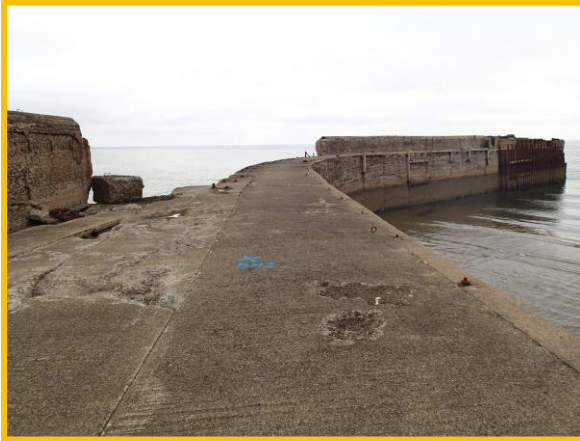
View of crest from access gate showing missing section of crest wall.
(Asset Ref No. 1221D901D0201C02)

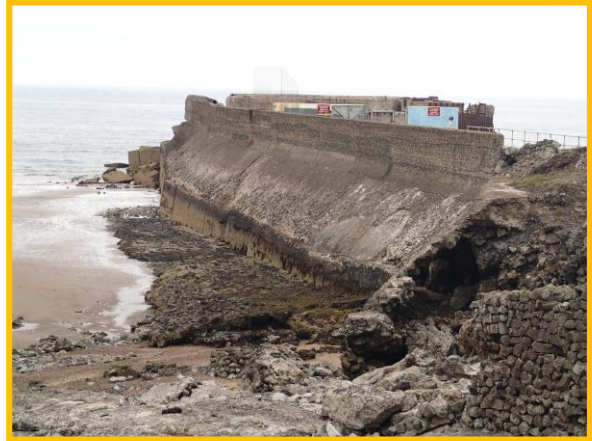
At Skinningrove, the jetty continues to deteriorate (Asset Ref No. 1221D901D0201C02). Although it is disused as a jetty, access is still possible and so consideration should be given to public health and safety and as previously recommended the jetty should be secured to prevent public access. The beach levels at Skinningrove were higher than during the 2012 inspection and the undermining seen in 2012 to some of the rock armour defences between the jetty and the village, (Asset Ref No. 1221D901D0202C01) was not visible. Although there was no notable movement in the armour, it had been undermined in places and so vulnerable to storm damage. At the eastern side of Kilton Beck the wall (Asset Ref No. 1221D901D0202C03) protecting the road where it turns inland remains in poor condition, despite repairs to the crest as the low beach levels were exposing the toe which is significantly undermined.

Voiding and collapse of west side of jetty structure (Asset Ref No. 1221D901D0201C02)

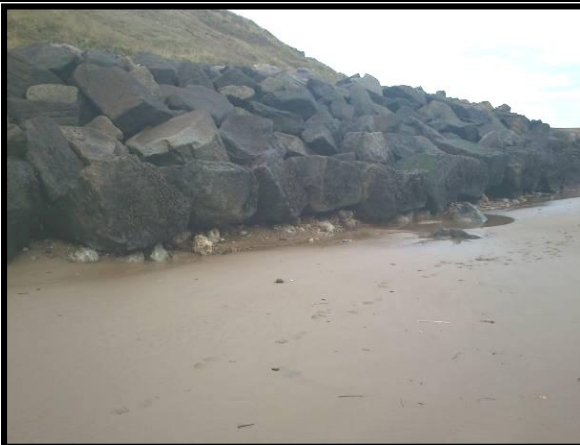
Photo from 2012 report showing low beach levels have exposing toe of rock armour to scour damage (Asset Ref No. 1221D901D0202C01)

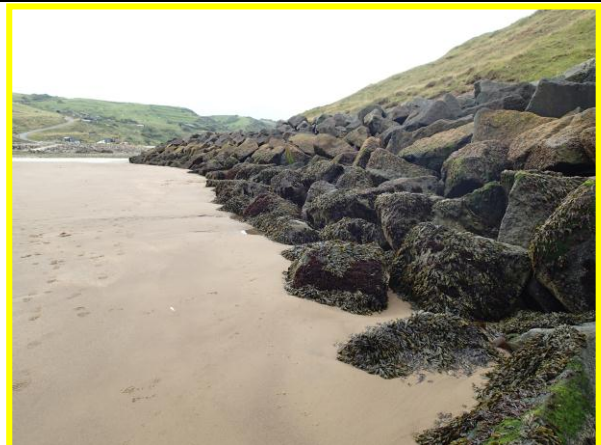
Rock armour in fair to good condition (Asset Ref No. 1221D901D0202C01)

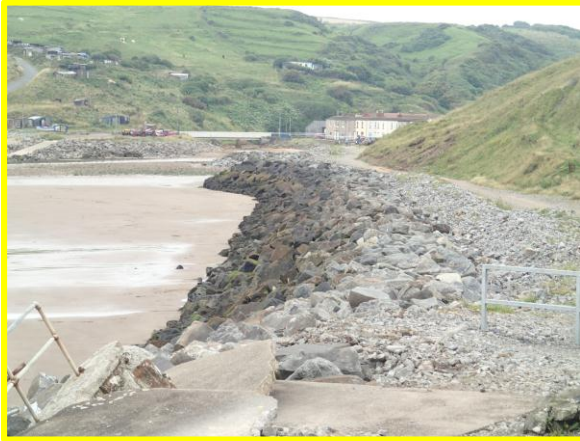
General view of revetment looking from Jetty towards village
(Asset Ref No. 1221D901D0202C01)

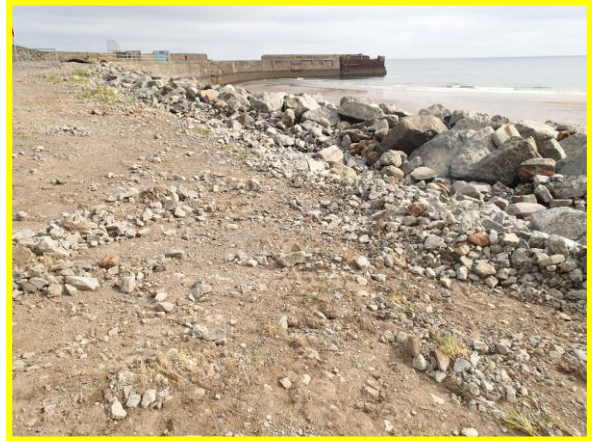
Rubble fill at crest has been reprofiled
(Asset Ref No. 1221D901D0202C01)

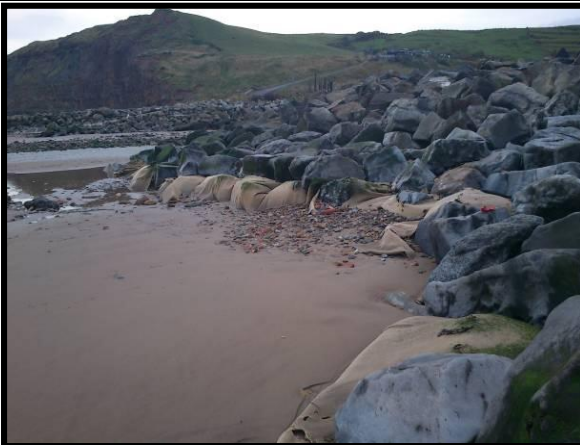
Photo from 2012: Exposed geotextile matting at rock armour toe. (Asset Ref No. 1221D901D0202C02)

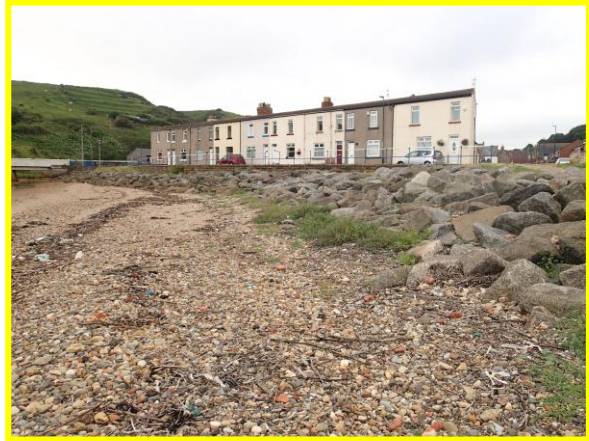
View of rock armour from near car park (Asset Ref No. 1221D901D0202C02)

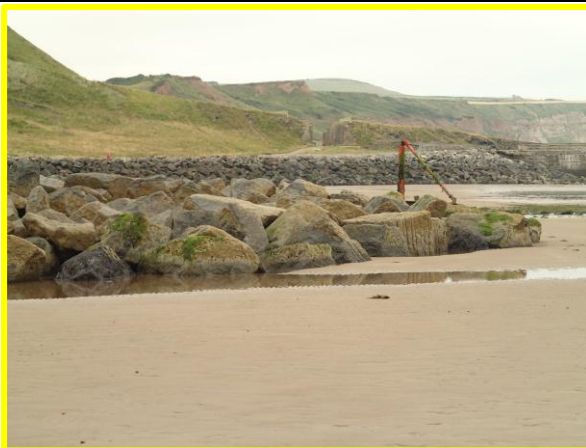
Seaward end of fishtail breakwater showing damaged navigation marker (Asset Ref No. 1221D901D0202C05)

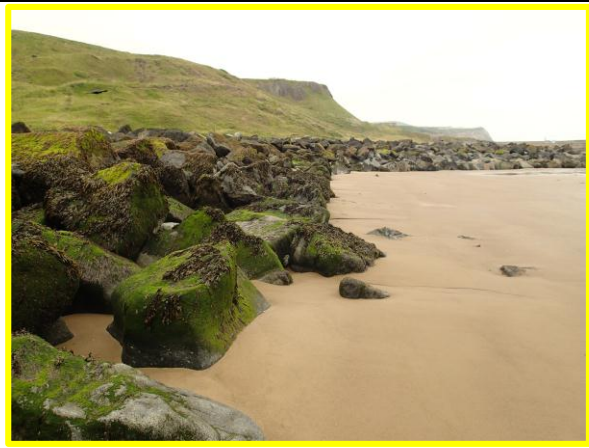
Area of displaced and loosely packed armour on seaward side of fishtail (Asset Ref No. 1221D901D0202C05)

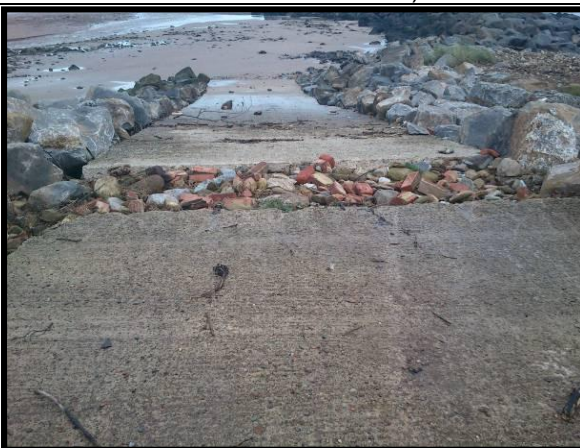
Slipway from boat park **Photo from 2012.** (Asset Ref No. 1221D901D0202C05)

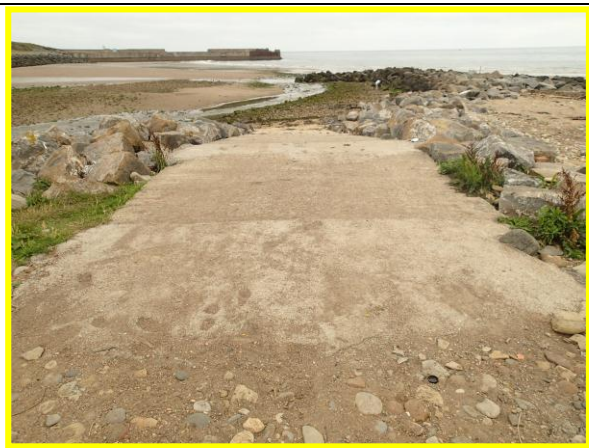
Slipway with repaired section near crest. (Asset Ref No. 1221D901D0202C05)

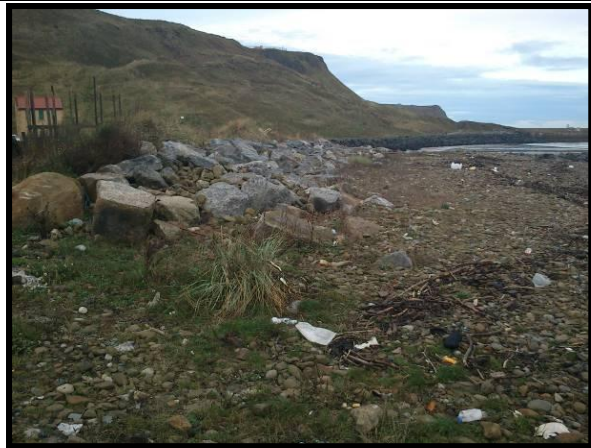
Photo from 2012: Shingle ridge with boulders to rear protecting boat park. (Asset Ref. No 1221D901D0202C04)

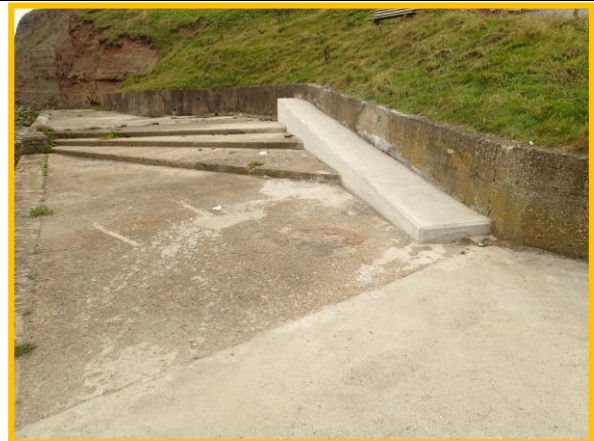
Wall crest showing repairs and eroding cliff to east in background. (Asset Ref. No 1221D901D0202C03)

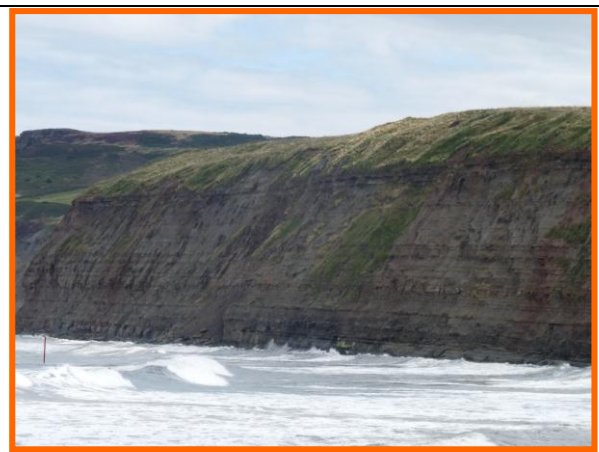
E57/6 This unit has been upgraded because the majority of the lower and mid-cliff is active and there is evidence of failure from upper cliff. (Partly Active)

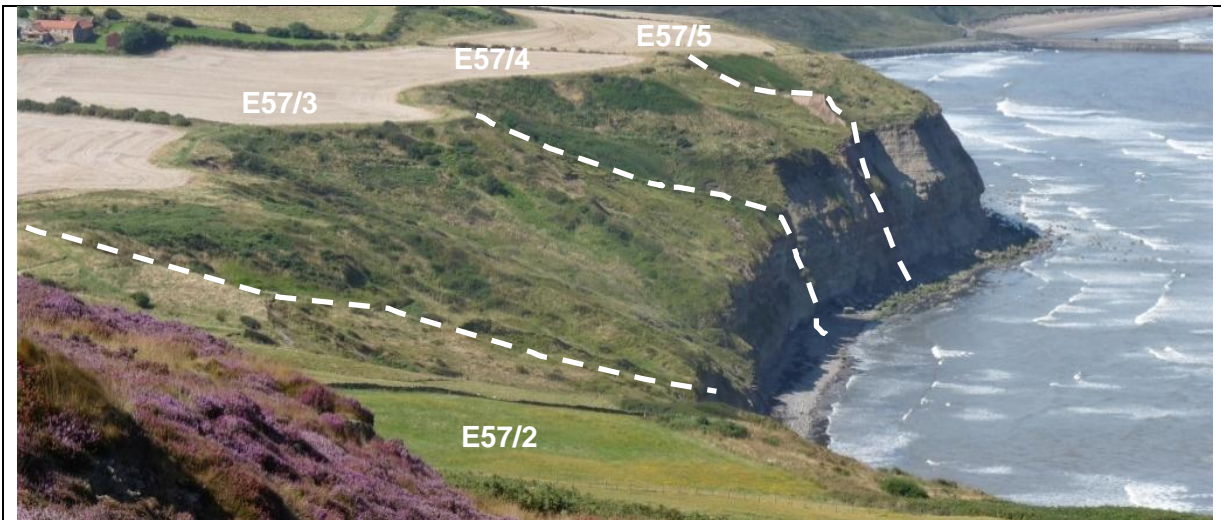
Units 57/5 to 57/3 are all locally active and characterised by mudslides developed in till overlying steep rock cliffs which are undergoing toe erosion.

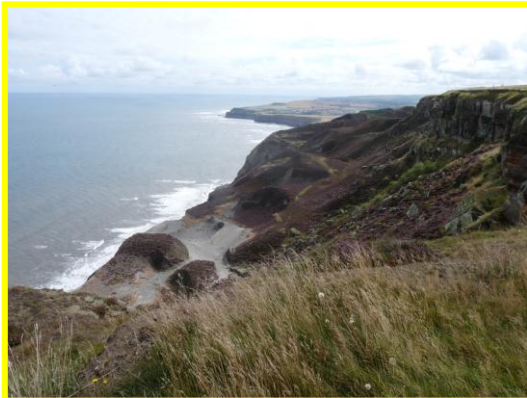
E58/2 Upper and Lower, Failed blocks litter the mid slope, which is vegetated. The lower slopes are more exposed. The Upper slopes are Locally Active and the lower slopes are Partly Active.

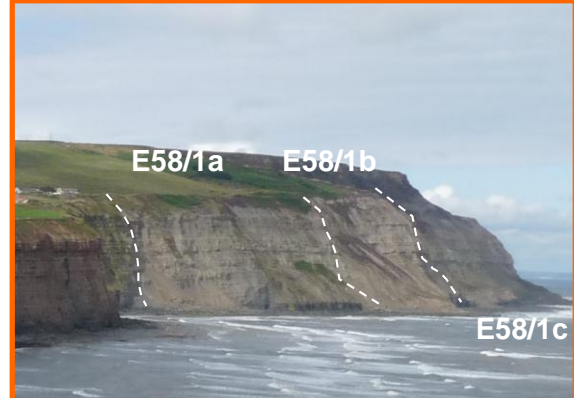
E58/1c – This unit has an active sea cliff (Partly Active). Also shows are E58/1b and 1c which have similar geology and morphology.

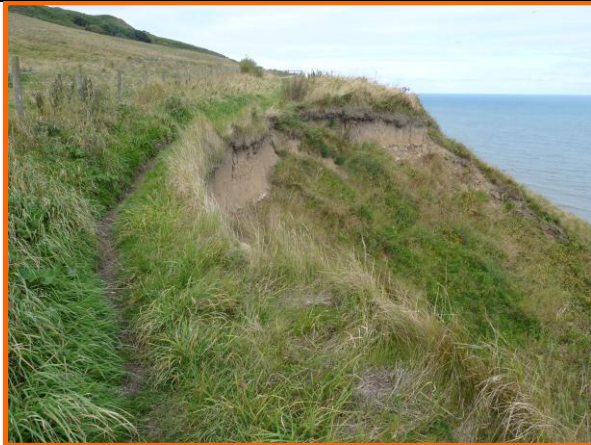
E58/1a – Example of headscarp recession encroaching onto Cleveland Way (Partly Active)

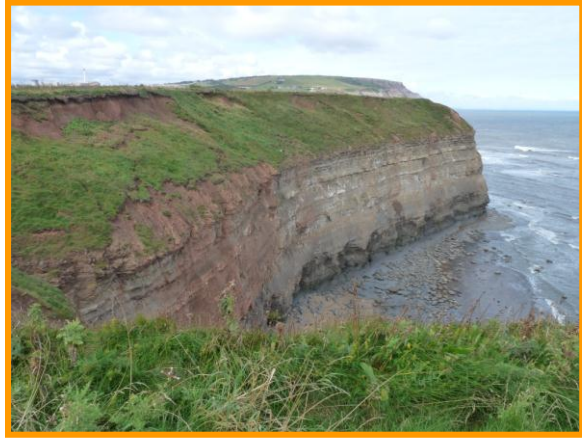
E59/2 fresh failures within the till (Partly Active)

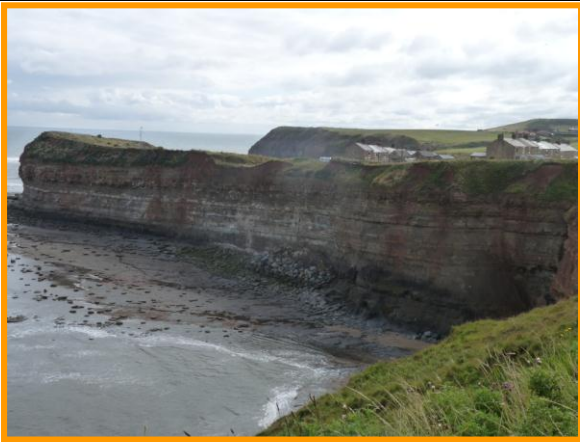
E60/1b ongoing rockfall from lower cliff and localised failures of overlying till (Partly Active)

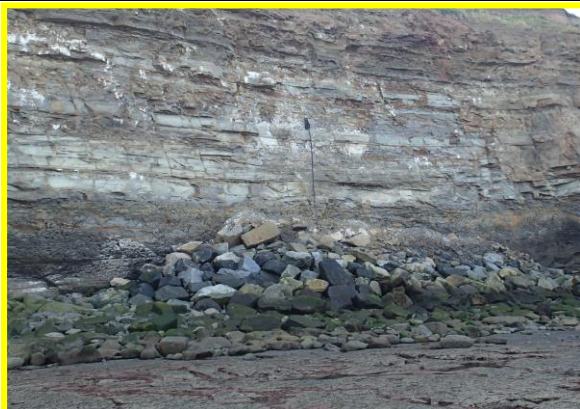
Eastern section of rock armour at cliff toe next to Cowbar lane Photo taken 12/09/2014 (Asset Ref No. 1221D901D0401C01)
