## **Cell 1 Regional Coastal Monitoring Programme Walkover Inspection Surveys 2016**

**Redcar & Cleveland  
Borough Council**

**September 2016**

## Walkover Inspection Surveys 2016

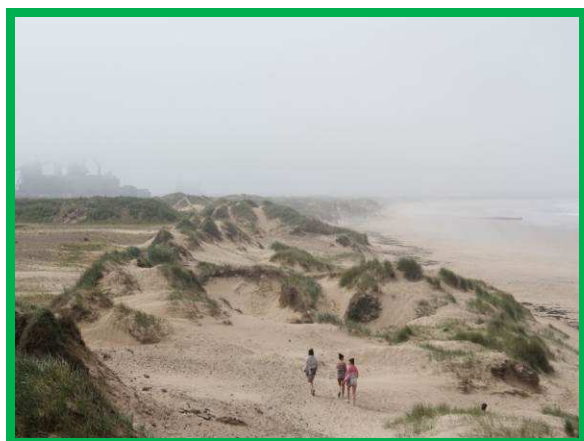
As reported in previous inspections from 2008 onwards, the sand dunes along Coatham Sands were generally stable with a good coverage of established vegetation. Minor erosion, loss of vegetation and lowering of dune crest was evident locally at more frequently used beach access points (the northern and southern extents of the dunes). Dunes appeared to continue to roll back into the caravan park and former site compound areas. A healthy beach level was maintained throughout Coatham Sands.

*View looking north west from caravan site (/C0506C01)*

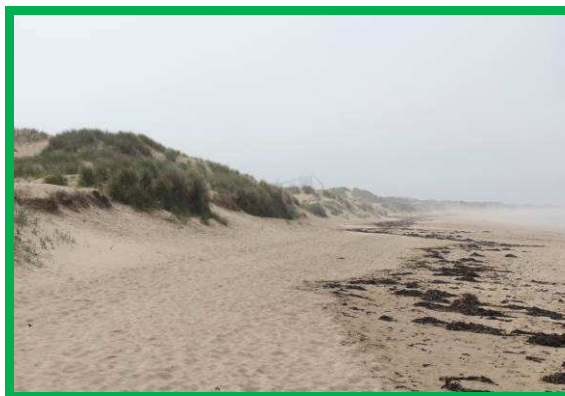
*View looking north west (/C0506C01)*

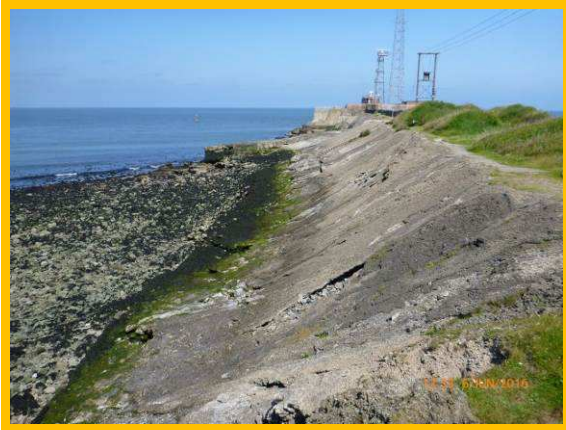
Western face (/C0506C01)

Observed defects to the structure included extensive cracking and spalling, exposure of reinforcing steel, missing mortar/open joints, damaged render, missing masonry, undercutting and void formation beneath slag embankments, failure/collapse of historic western pier arm structure, damaged concrete Accropode units and rock armour units and displacement of/poor interlock between armour units. Multiple patchwork and ad-hoc repairs were evident throughout. As noted in previous surveys, a detailed survey of the structure is beyond the scope of the present inspections and a full structural survey of the breakwater is recommended in order to establish the full extent of the damage and identify any remedial works.

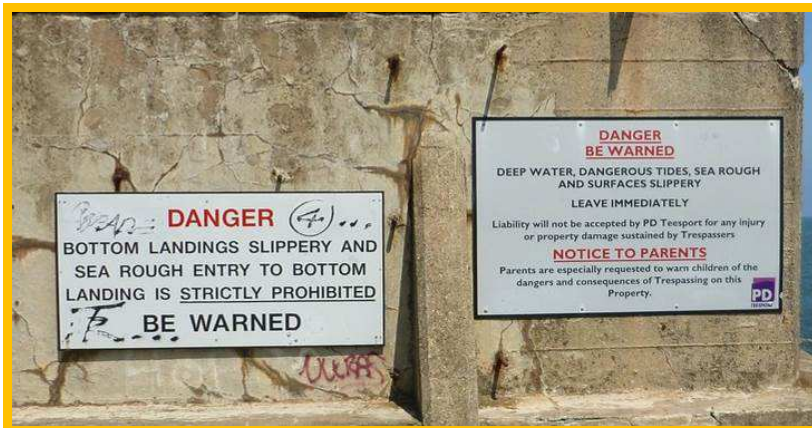
Warning signage (/C0506C01)

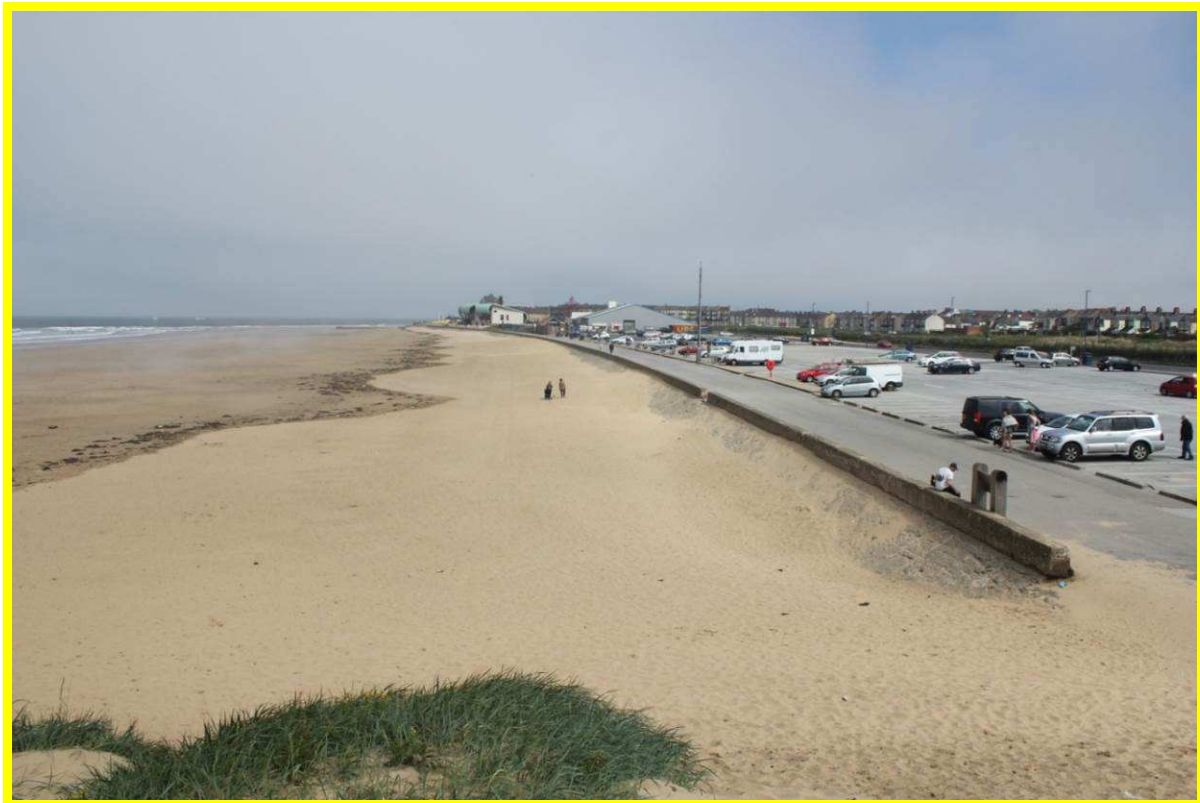
To the west of Redcar, defences comprise a concrete crest wall with grouted stone revetment fronting the promenade and car park. These remained in fair condition at the time of the inspections. Beach levels were slightly higher than in 2014 and may have obscured some of the defects previously identified, such as exposure/undermining of the northeastern extent of the wall and promenade, however local areas of damage and missing blocks were still visible. The concrete wall was generally in fair condition, with the approximately two metre gap towards the northeastern extent still present. Wind-blown sand was evident along much of the landward side of the crest wall.

*View looking south east (/C0601C01)*

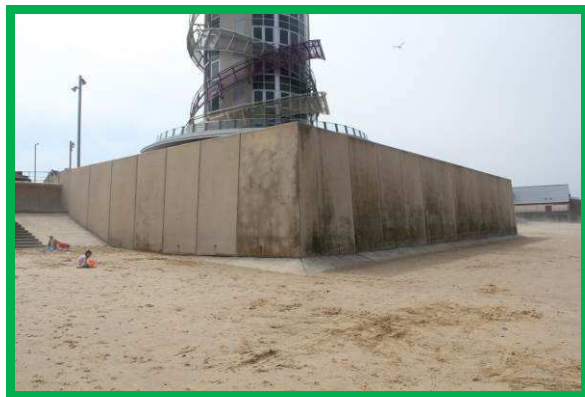
Concrete sea wall at Redcar Beacon  
(/C0602C03)

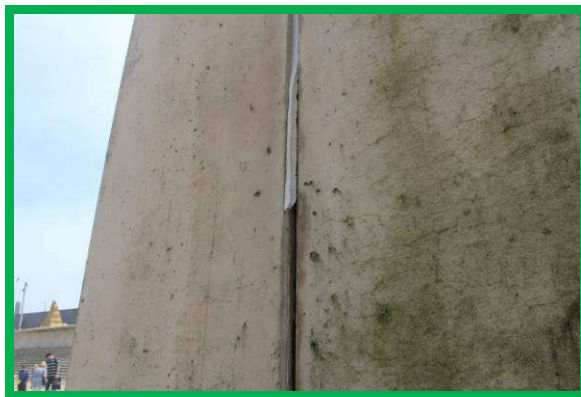
Loose and missing flexible joint sealant  
(/C0506C01)

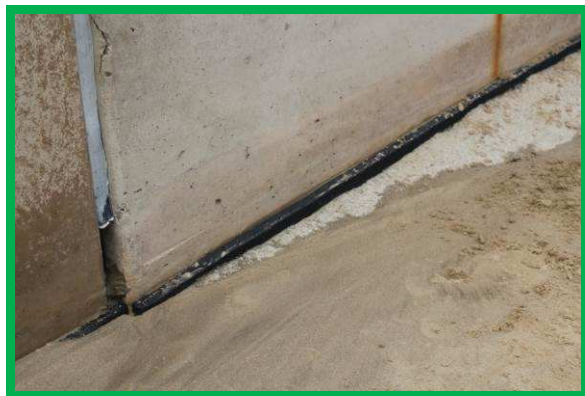
Missing flexible joint sealant in vertical joint. No sealant in horizontal joint – black filler board visible  
(/C0602C03)

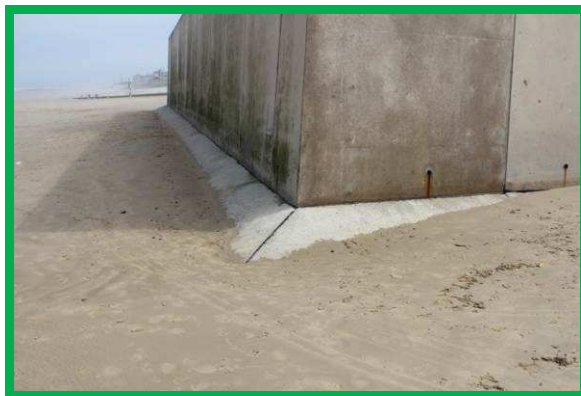
Exposed concrete apron – no sealant in joints – black filler board visible  
(/C0602C03)

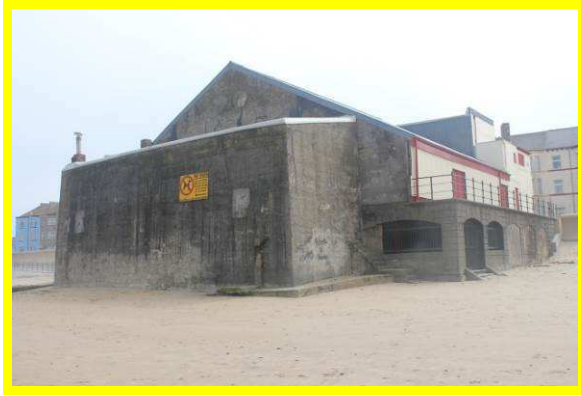
The seawall at the cinema was not upgraded as part of the Redcar scheme. Beach levels were higher than in 2014 and the undermining of the toe apron at the north west corner was obscured. The wall is generally in fair condition, with cracking locally and evidence of previous repairs. The interfaces with the more recently constructed defences adjacent on both sides remained in good condition.

*Cinema seawall (/C0602C05)*

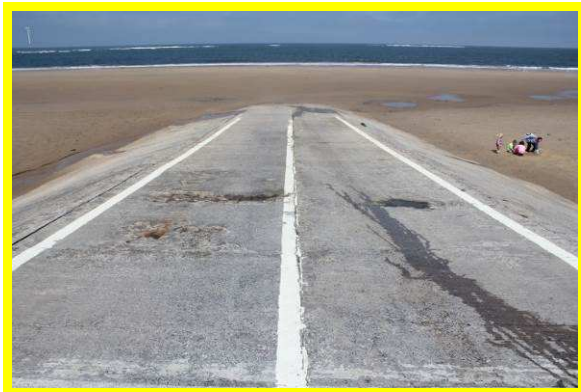
*Cracking and local damage to surface of RNLI slipway (/C0602C02)*

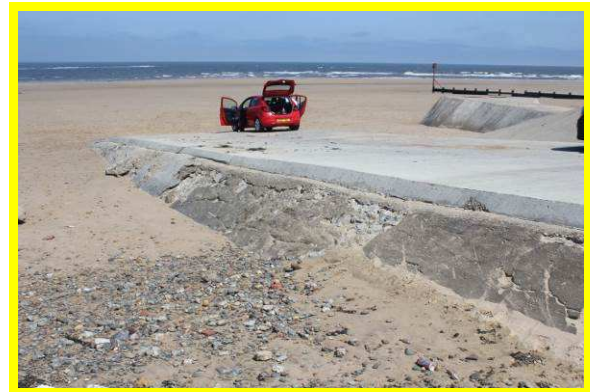
*South eastern access ramp. Loss of concrete render exposing grouted stone fill beneath concrete deck slab (/C0602C01)*

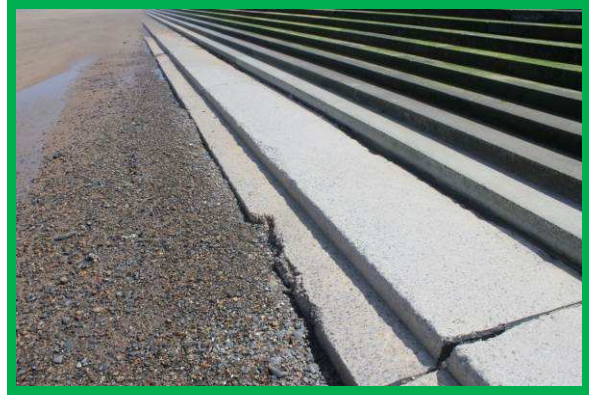
Local minor damage to lower in situ concrete toe section where exposed (/C0602C01)

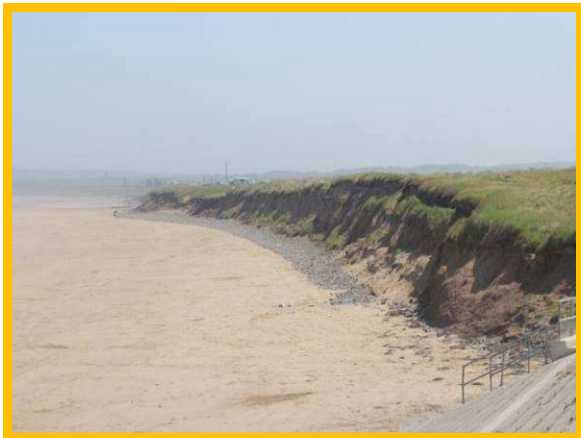
Unit **E52/10** was graded as Partly Active during the 2014 inspection as the whole unit was showing signs of erosion, particularly around the subtle headland approximately mid-length of the unit. This continues to be the case and the status of Partly Active has been retained. A concrete outfall structure is present within this unit and instability/scour was evident adjacent to the same. The gabion baskets fronting the outfall were failing and the concrete blockwork revetment showed signs of settlement. An informal access ramp was present at the interface with the hard defences at the south eastern extent of The Stray and the crest level is lower in this location. This should be monitored to ensure the condition does not deteriorate with consideration given to fencing/signage to marshal pedestrian access towards the formal access points.

View looking south east (/C0701C01) CBU E52/10

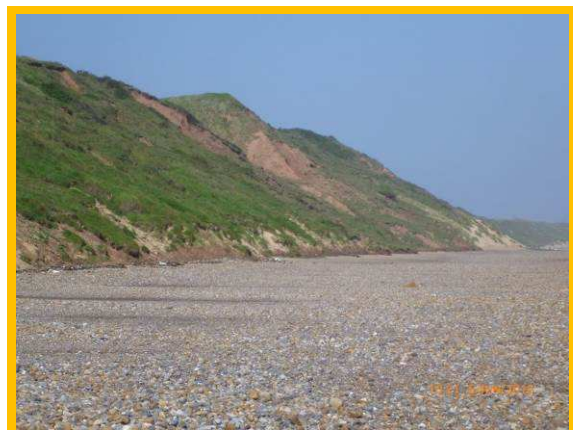
*View looking north west (CBU E52/4)*

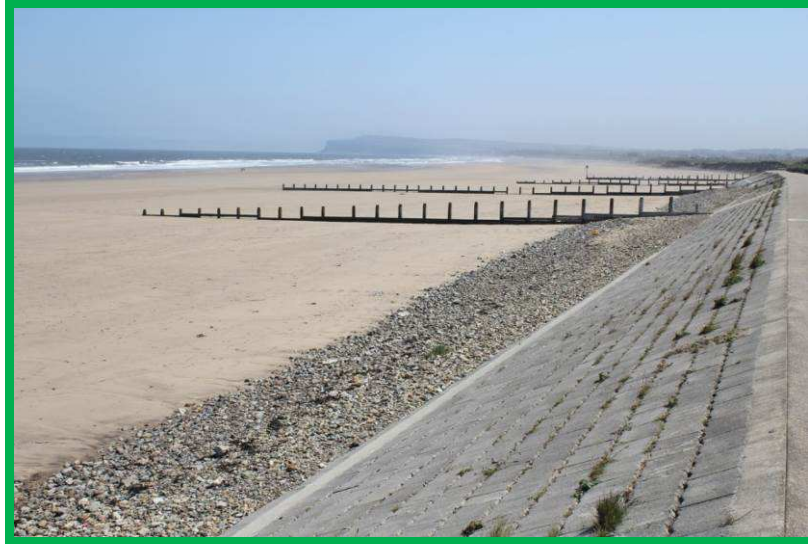
As observed in 2014, several timber elements were missing from the groynes, particularly towards the seaward ends. The groynes appeared to be performing satisfactorily, with beach levels maintained and cobble size material accumulating to the rear of the beach.

*View on The Stray frontage looking south east (C0603C01)*

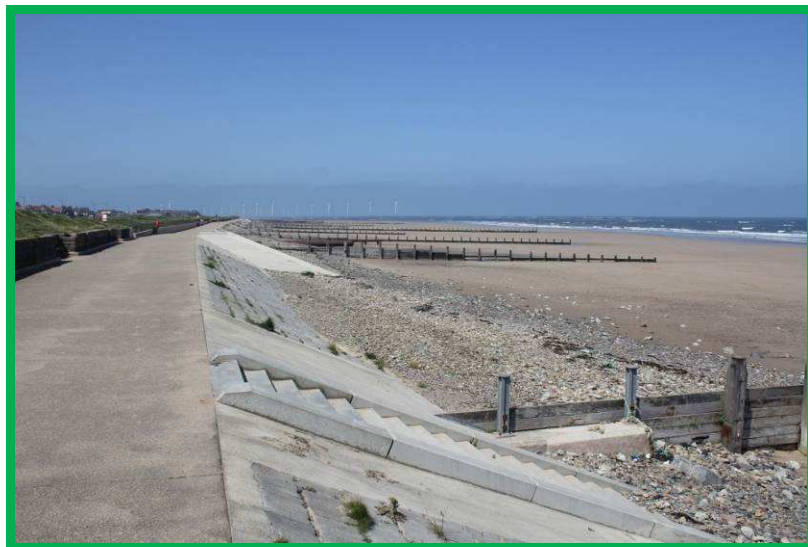
*View on The Stray frontage looking north west (C0603C01)*

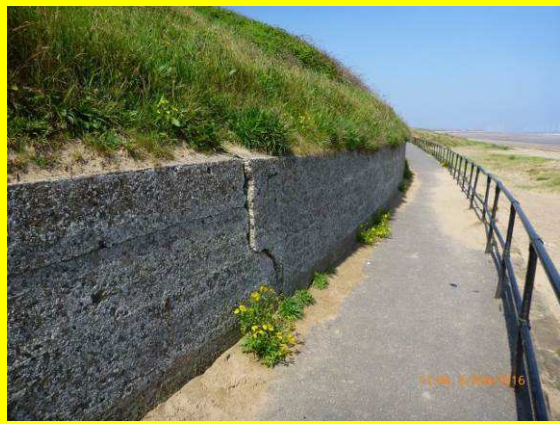
The concrete wall at the toe of the vegetated slope was reported as cracked through its full height in all inspections from 2008 onwards, however the defect appeared to be of the same width and extent in the present inspections. The slope above showed no evidence of recent movement or any placement of excessive loading on the structure.

*Crack in wall – no apparent change  
(/C0702C03)*

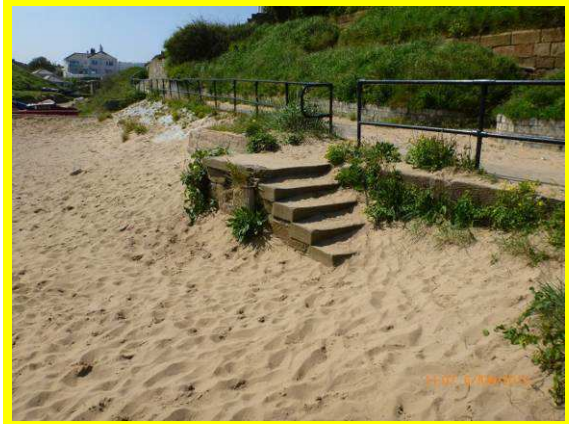
*High beach levels (/C0702C03)*

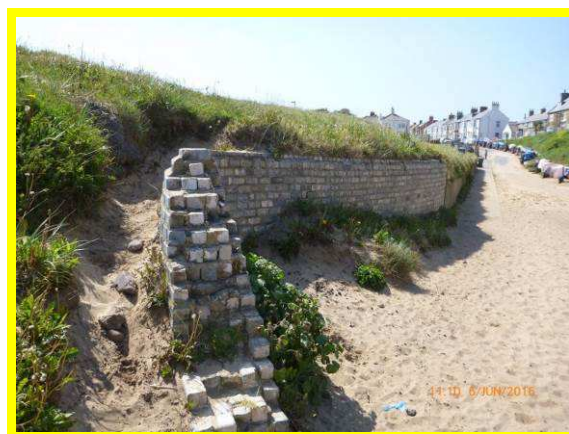
The masonry wall to the southeast of the beach access at Marske had settlement cracks through the full height and missing bricks at the seaward end, with scour evident to the rear of the structure. The landward, concrete wall was generally in fair condition, although as reported in previous surveys, displayed vertical cracks locally.

*Masonry wall south east of beach entrance (/C0702C01)*

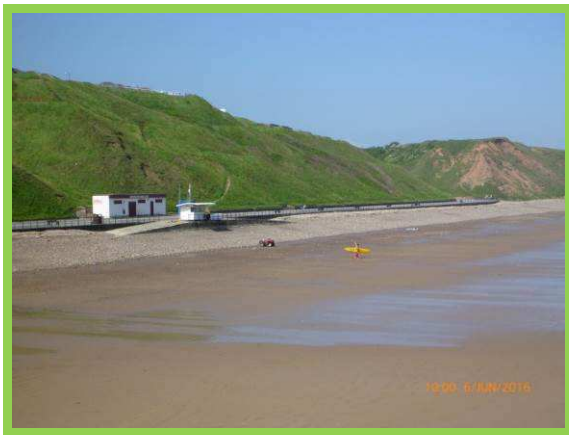
Units **E52/3b** and **E52/3a** above Saltburn Sands are again classified as Inactive as in 2014, these units are defended at the toe by a sea wall and are well vegetated. Several unvegetated areas where shallow failures had exposed underlying material were noted in December 2013, but these do not appear to have developed since and vegetation appears to be re-establishing.

*View looking north west (E52/3b)*

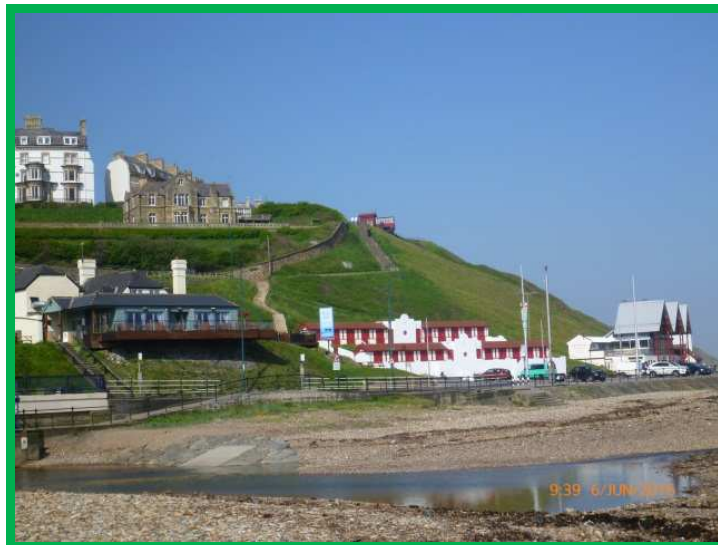
*View looking west (E52/3b)*

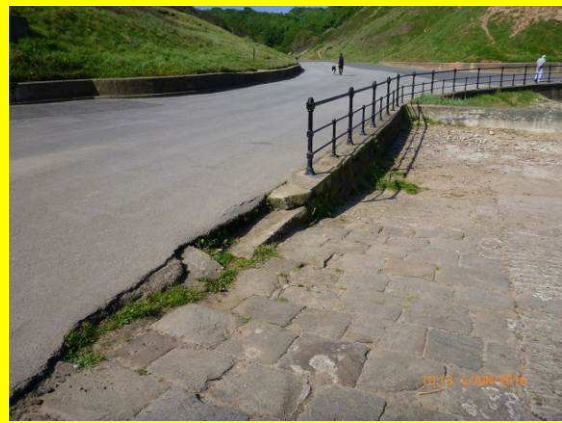
Hazel Grove Foot marks the north western extent of the hard defences which run along the Saltburn frontage. Missing coping stones and local damage (cracking and spalling) to the concrete wall and access ramp surface were present, as noted in 2014, and do not appear to have worsened resulting in a fair condition grading.

*Missing coping stone exposing fill beneath promenade surface (/C0703C02)*

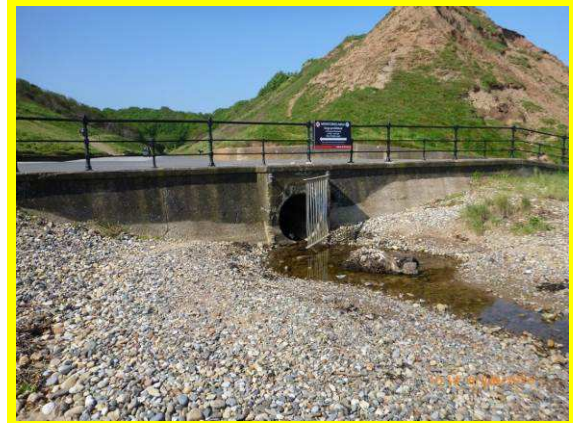
A health and safety issue was presented by the open security grille which allowed access to the culvert.

*Security grille open (/C0703C02)*

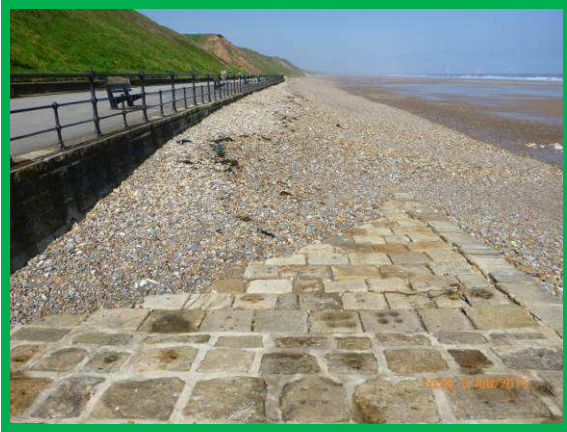
View looking northwest. High beach levels. Open joints to lower section of masonry access ramp (/C0702C04)

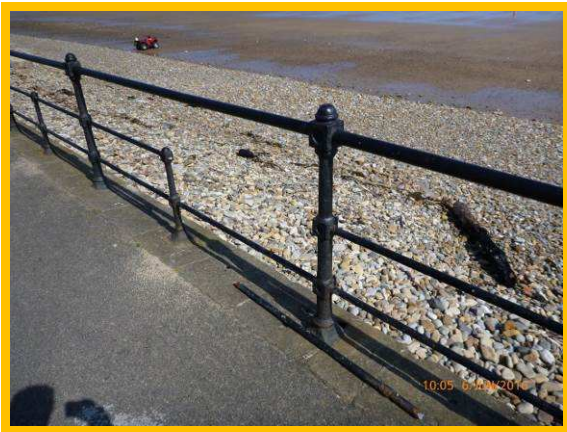
Local damage to pedestrian guardrail (/C0702C04)

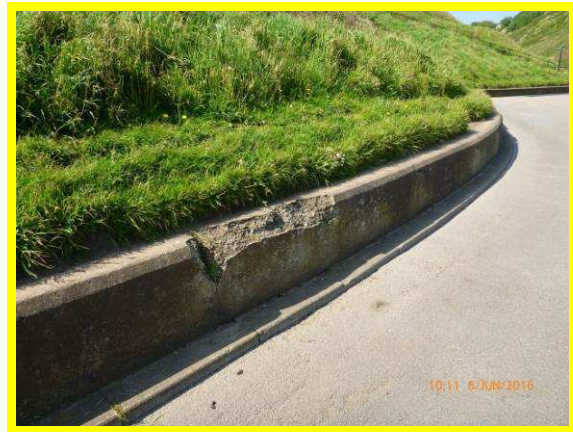
Local damage to concrete wall (/C0702C04)

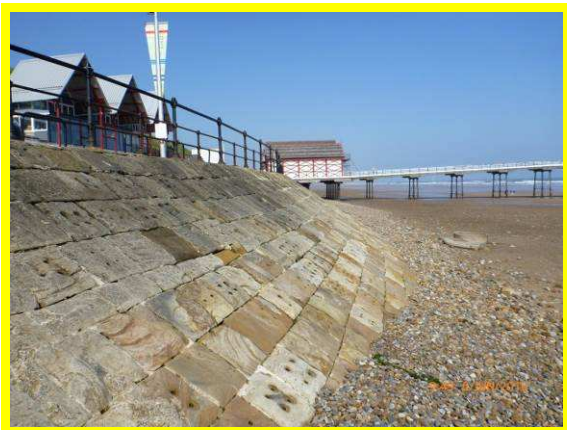
To the south east of the pier, the defences comprise a masonry blockwork revetment which is generally in good condition with some missing mortar observed locally. Cobble beach levels appeared lower at the 'apex' of the curve of the structure, with more of the blockwork exposed. The concrete blockwork wall to the west of Skelton Beck was generally in fair condition although a section was missing coping stones, leaving the footway fill material exposed. Grouted masonry apron and masonry abutments to pedestrian bridge appeared to be in fair condition.

View looking north west (/C0704C01)

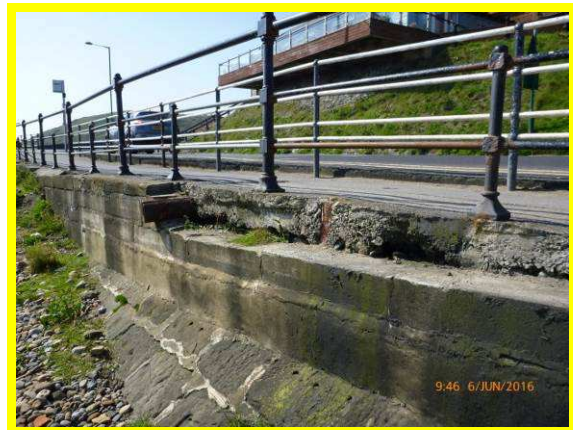
Missing coping blocks (/C0704C06)

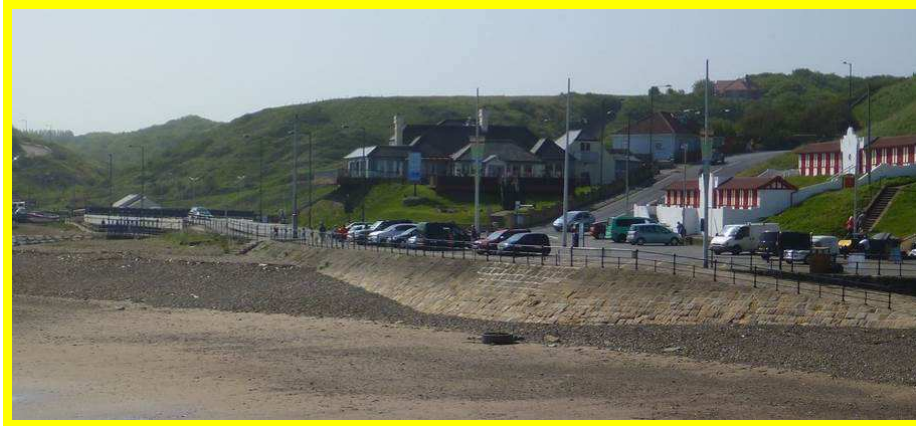
*View looking southeast from pier. Beach levels lower at 'apex' of headland (/C0704C01)*

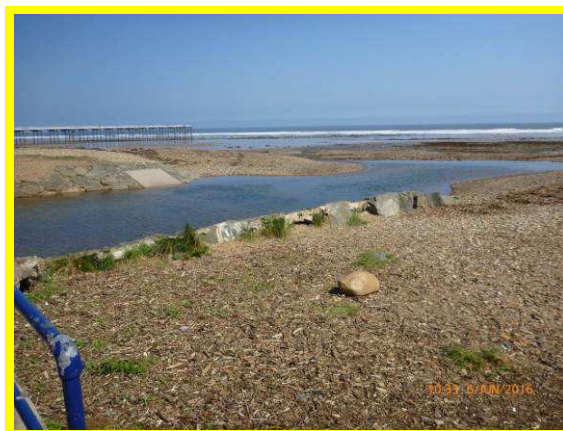
To the east of Skelton Beck, the frontage is undefended past the boat/car park .Erosion/lowering of the cobble beach was evident at the eastern extent. Vegetation had begun to establish toward the crest of the shingle although local erosion was apparent, potentially as a result of members of public accessing the beach from the car park. Possibly a general lowering of beach levels on the east bank of Skelton Beck indicated by the exposure of the crest of the grouted rock revetment (although no significant change from 2014).

*Exposed crest of grouted rock revetment (/C0704C06)*

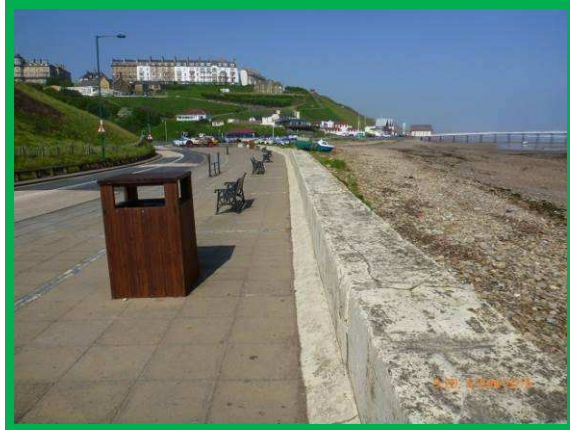
To the south of the boat park is a set back wall protected by a high cobble beach. The wall is in good condition with local defects such as minor cracking and loss of render. Vegetation had established the top of the material towards the east. The recently refurbished concrete slipway was generally in good condition, however flexible joint sealant was observed to be loose and missing locally. The vertical face of the slipway was visible on the western side of the structure and minor abrasion was evident (the southern face of the structure was obscured by the high cobble beach).

*View looking west (/C0704C03)*

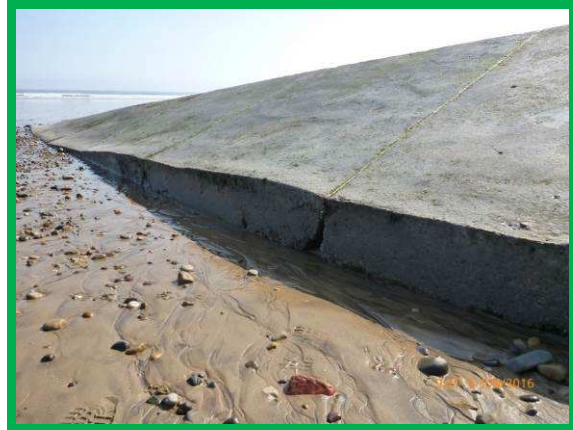
*Western face of concrete slipway (/C0704C03)*

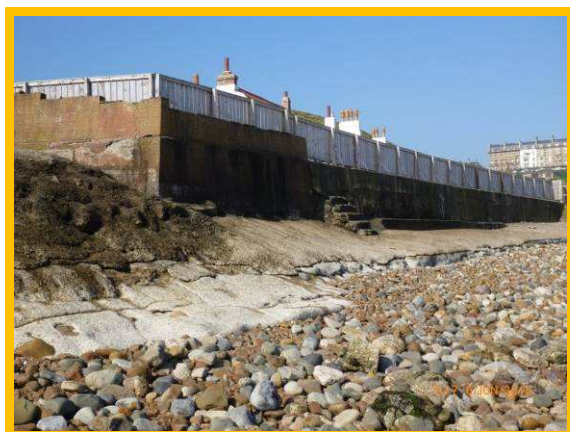
The most southerly section of coastal defences at Saltburn comprises the masonry and concrete seawalls and concrete aprons protecting the public house and land to the east of the slipway. Cracking and abrasion of concrete blocks to the east and missing mortar and masonry to the west was observed. Beach levels appeared similar to those of 2014 and therefore covering the toe of the structure and potentially obscuring undercutting and voiding as in 2010 and 2012 surveys. The overall condition grading remained as poor.

The concrete apron/revetment poured to east of the defence is undercut with voids forming. A series of masonry walls higher up the slope were also undercut.

*View looking west (/C0704C05)*

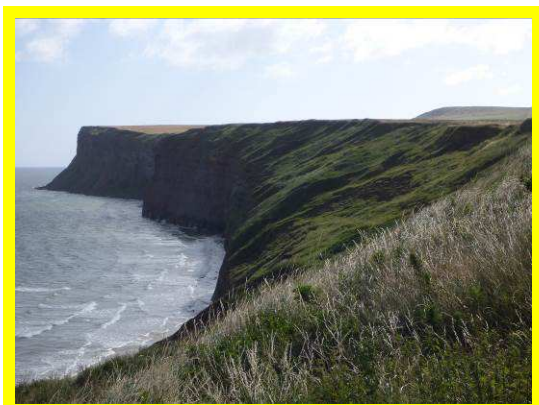
Whilst previous mudslides had been observed in Units **53/4** and **53/2** during the 2014 inspections, it is only in Unit **53/2** that mudslides appear more widespread in 2016. Therefore all units from **E53/5** to **E53/1** have been classed as Local Active except Unit **53/2** which remains as Partly Active in 2016.

**E53/3 to E53/1** Generally small scale slumping in the till layer of the cliff northeast of Saltburn (Locally Active except E53/2, right).

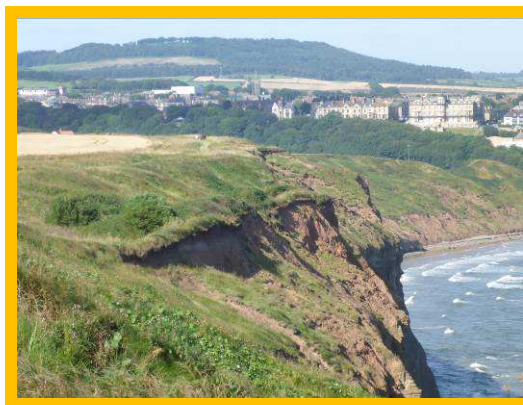
**E53/2** slumping in the till layer of the cliff northeast of Saltburn (Partly Active)

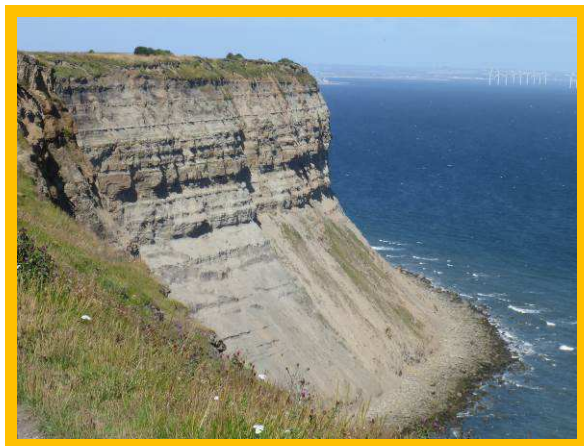
The cliffs are characterised a slope-over-wall form, comprising vertical rock cliffs capped by weaker till. There is evidence of localised and recent rock fall activity in the cliff and mudsliding. These high, steep cliffs were all classified as Partly Active during the 2016 walkover survey.

**E54/4** looking northwest along Hunt Cliff showing active cliff face and debris apron (Partly Active)

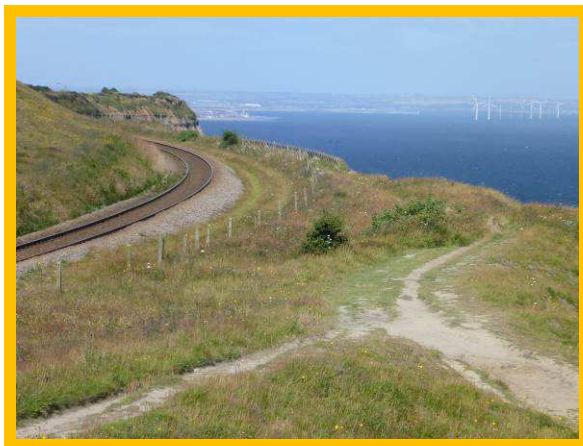
**E54/3a** proximity of footpath and railway line to actively eroding cliff top (Partly Active)

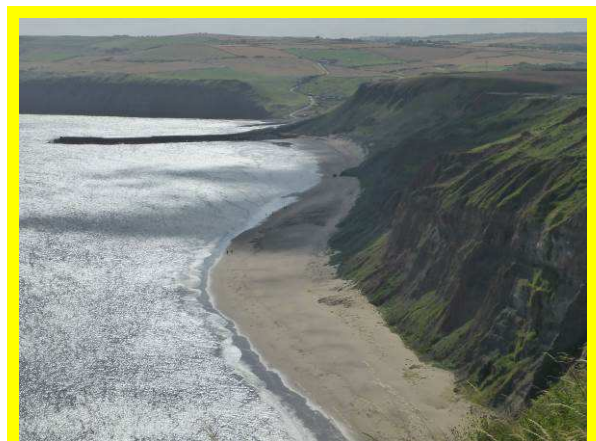
**E56/2a and 56/2b** Cliffs above Cattersty Sands, looking towards Skinningrove (Locally Active)

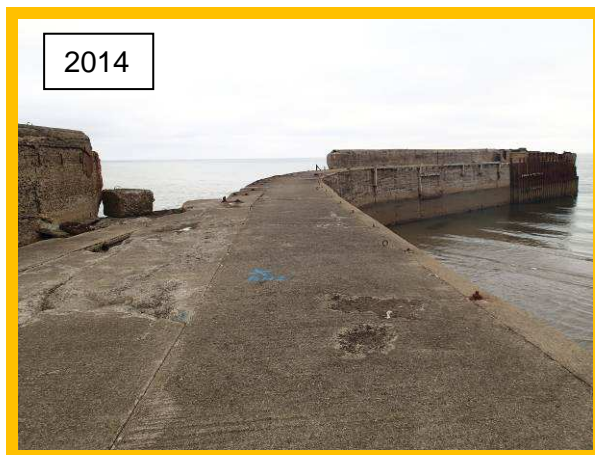
View of crest from access gate showing missing section of crest wall and damaged deck in 2014  
(Asset Ref No. 1221D901D0201C02)

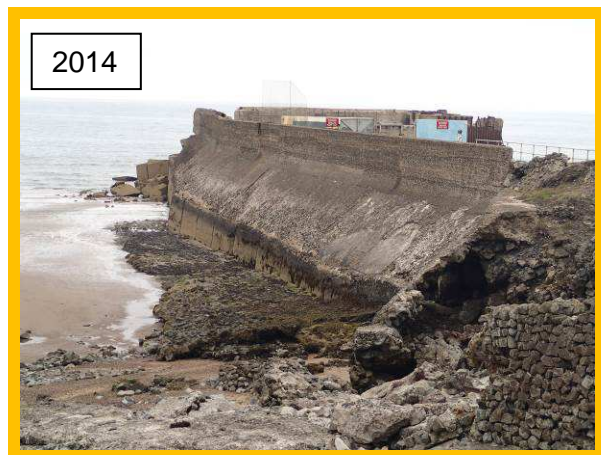
Voiding and collapse of west side of jetty structure in 2014  
(Asset Ref No. 1221D901D0201C02)

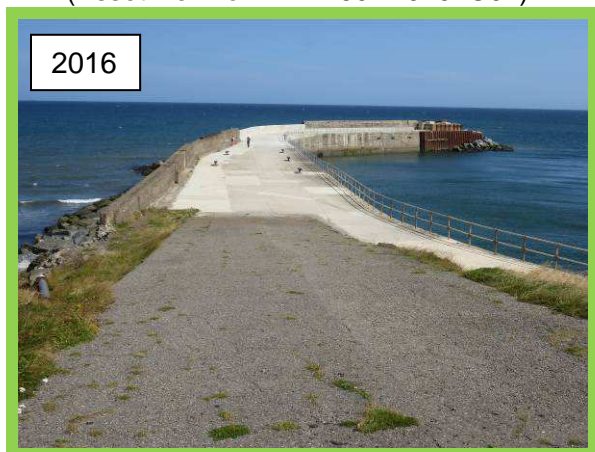
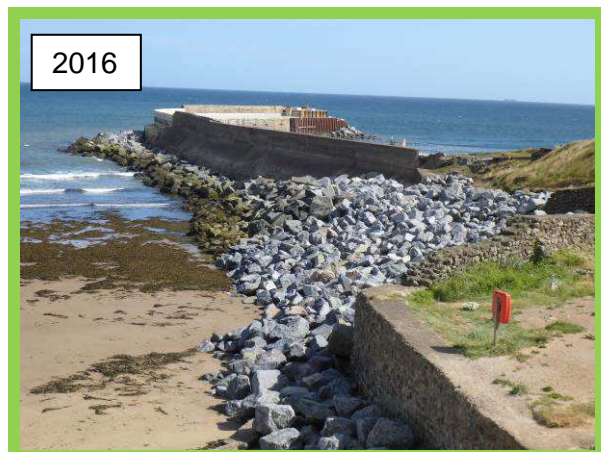
Although Skinningrove Jetty (Asset Ref No. 1221D901D0201C02) is redundant for its original purpose, the export of pig iron, and until recently has been in a failing state, the massive structure provides some coastal stabilisation, fixing the orientation of the adjacent bay to the east and giving some protection to Skinningrove village to the south east. It also helps hold the beach in front of the undefended cliffs to the west. Refurbishment works were undertaken in 2015 to repair a failed section of crest wall and damaged jetty decking, whilst placing additional rock armour protection on the collapsing seaward side. These works improved the condition of the jetty from poor to good. A number of small defects remain however, including corroded steel sheet piling, cracked and abraded concrete and some of the new works have poorly inserted sealant in construction joints and exposed reinforcement bars, which could lead to future maintenance problems.

Repaired and improved structure in 2016  
(Asset Ref No. 1221D901D0201C02)

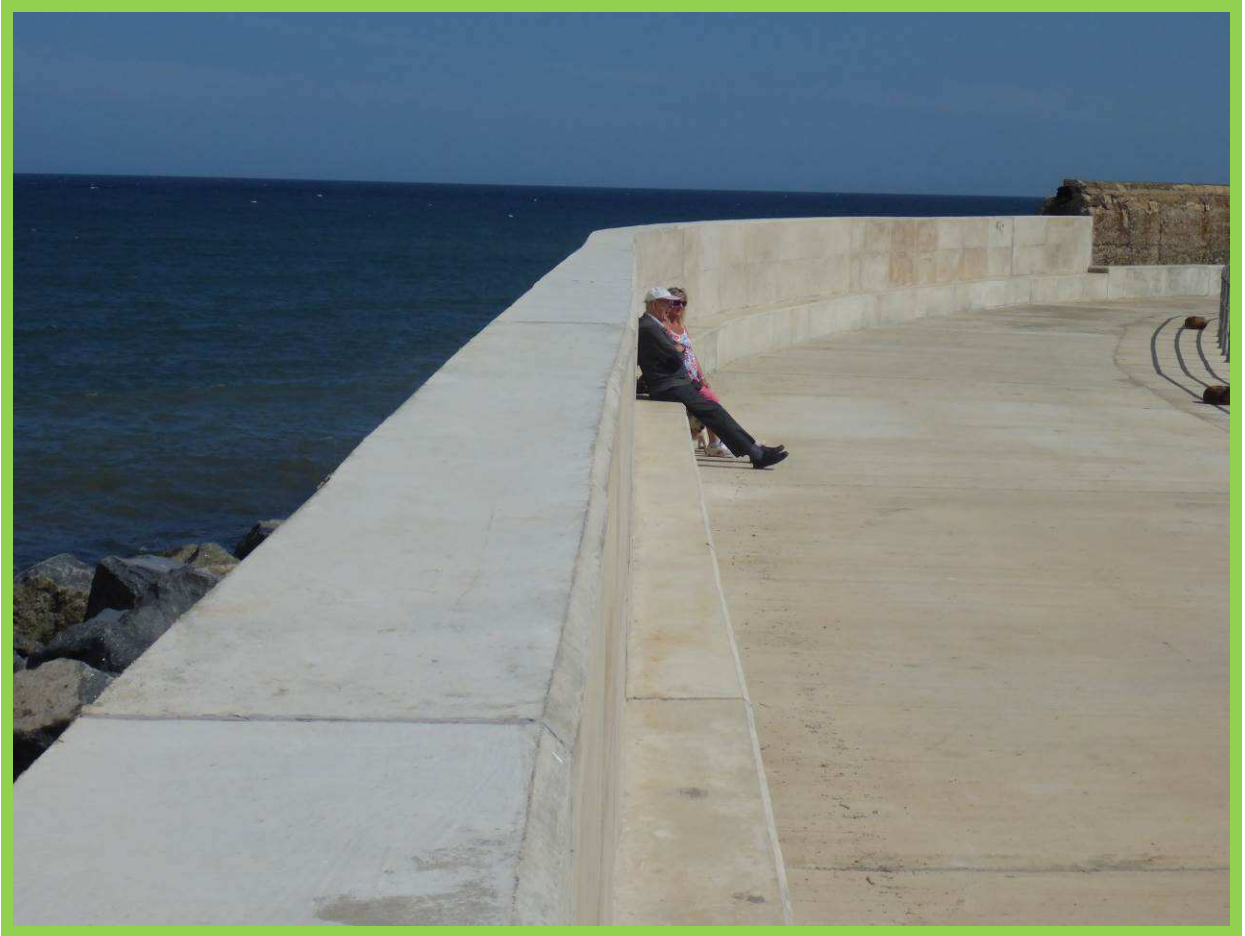
Rebuilt jetty wall (Asset Ref No. 1221D901D0201C02)

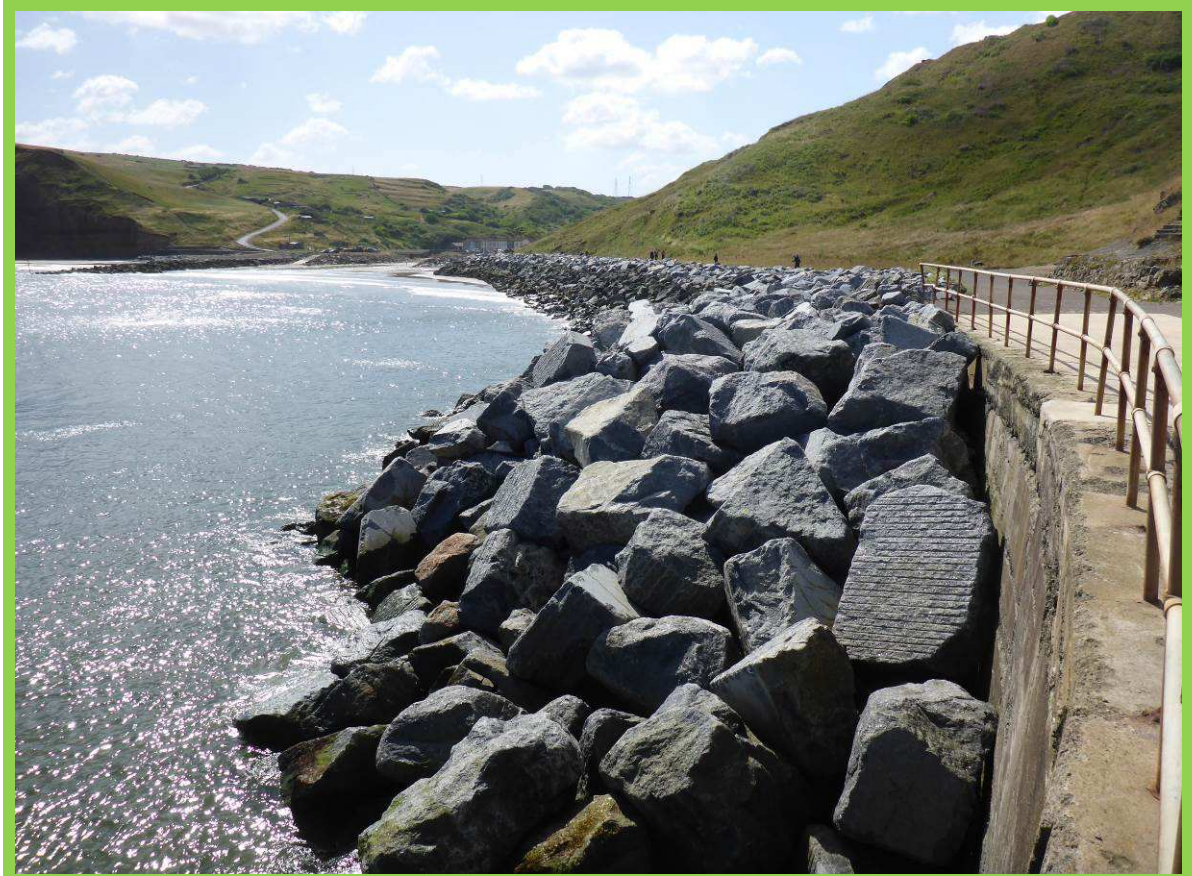
The rock armour defence between Cattersty Jetty and Skinningrove village, (Asset Ref No 1221D901D0202C01) was re-profiled as part of the recent Skinningrove coastal defence works, with an extension of the armour around the inner face of the jetty. This appears to offer good protection against overtopping as there was no evidence of slippage in the backing slopes. The crest of the berm has also been surfaced as part of those works.

Modified rock revetment protecting inner face of jetty (Asset Ref No. 1221D901D0202C01)

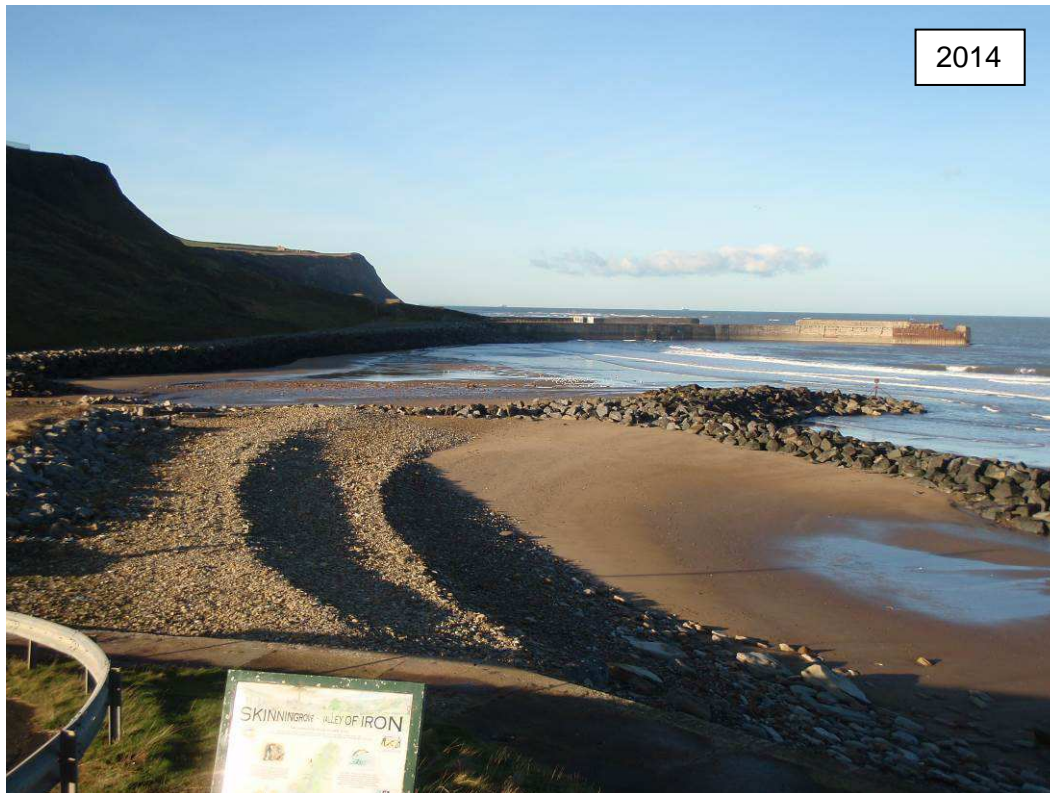
Original defences to the east of Kilton Beck, 2014

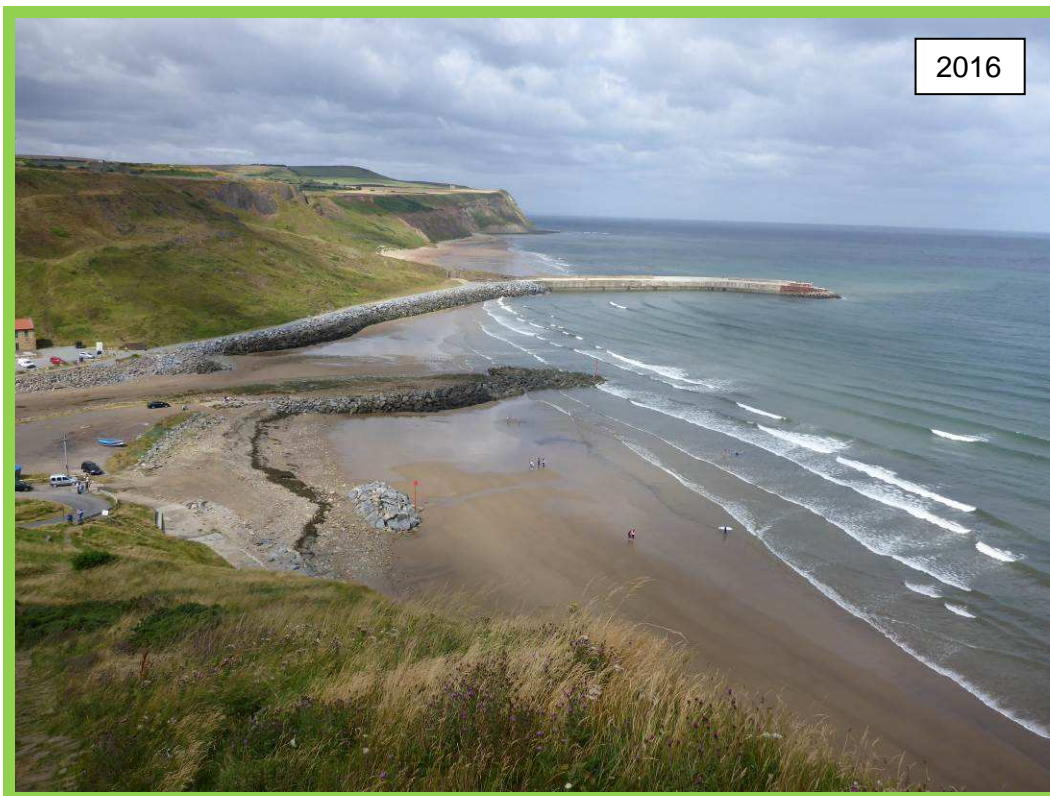
Defences to the east of Kilton Beck were also modified during the recent works, with the fishtail groyne being reduced in size and a small detached breakwater being constructed. Future monitoring and inspections should be used to determine the location and scale of beach changes that may result as a consequence of these modifications.

Modified defences to the east of Kilton Beck, 2016

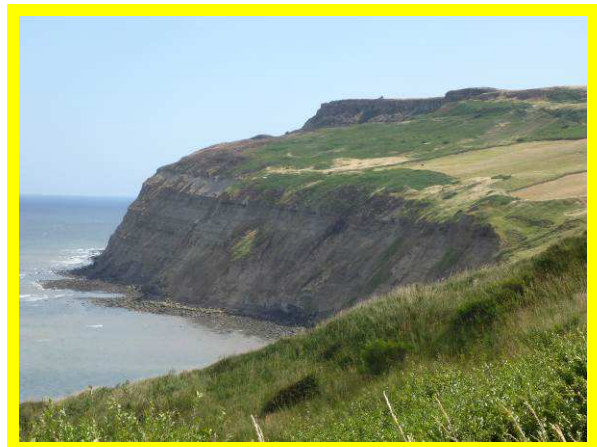
**E57/6** High rock cliff with till cap (Locally Active)

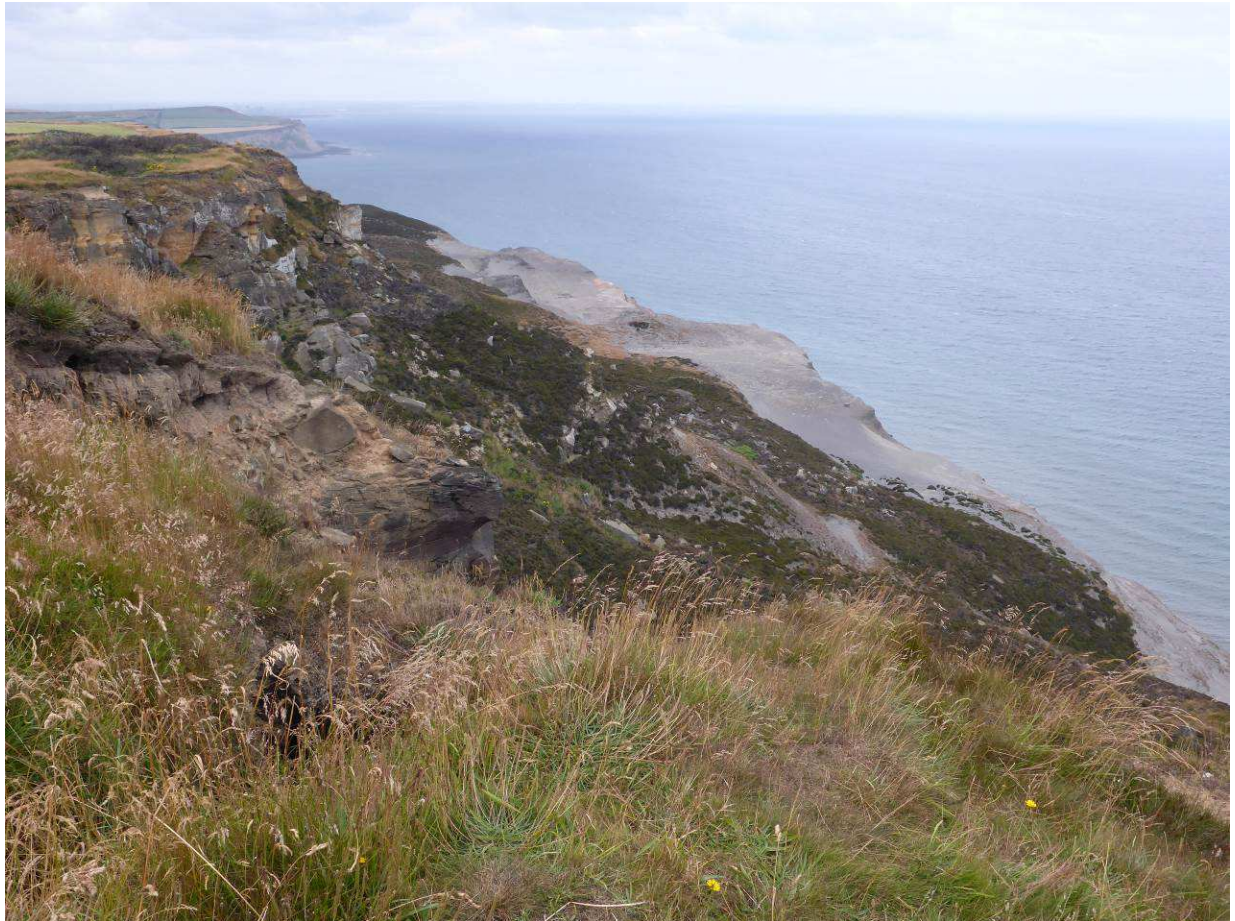
To the east of The Warren, the cliffs rise to become some of the highest in Britain. Here the cliff form owes its character to the large abandoned alum quarries which were operational in this area during the 19<sup>th</sup> Century. Units **E58/5 to E58/2** each has an upper and lower unit. The upper parts of the quarry units are backed by steep sandstone cliffs and feature heavily vegetated, undulating terrain, possibly the product of past rockfalls as a result it is classified as Locally Active in 2016, unchanged since 2012. The lower part of the cliff is exposed to marine attack, is steep and comprises exposed shales that are heavily weathered and prone to ongoing and intense erosion. Consequently these lower units are all classified as Partly Active in 2016, unchanged since 2012. Below Rockhole Hill there is a single unit (**E58/1c**) classified as Partly Active.

**E58/5 to E58/2** – Cliffs of the Loftus Alum Quarries  
(Locally Active upper sections and Partly Active lower sections)

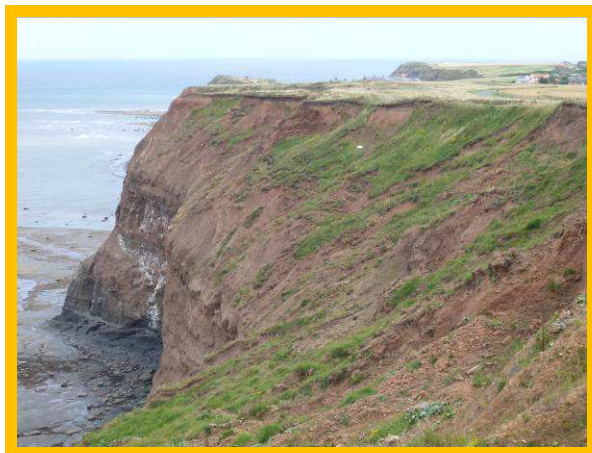
In the coastal section between Boulby and Cowbar Nab the cliffs are much lower than those adjacent to the west. The majority of CBUs within this area are classified as Partly Active. They are characterised by a soft upper till unit which supports a variable vegetation cover and is subject to landsliding and consequent headscarp recession. Lower down the cliff the harder rock unit is largely bare except where covered by debris cones, reflecting localised rockfall activity.

**E58/1 to E/59/6** Soft, slumping, upper till resting upon harder rock (Partly Active)

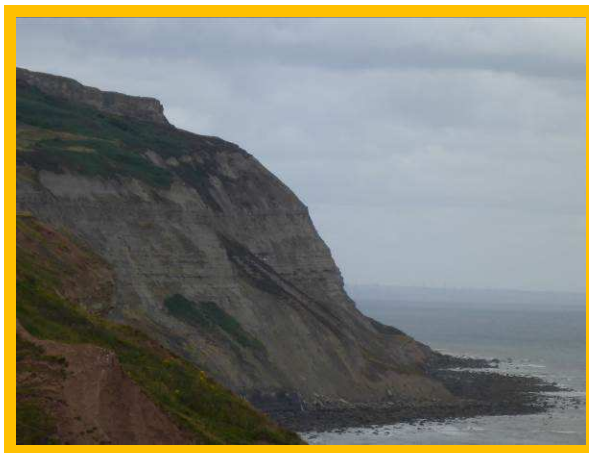
**E58/1 to E/59/6** Soft upper till resting upon harder rock subject to rock fall (Partly Active)
