## **Cell 1 Regional Coastal Monitoring Programme Walkover Inspection Surveys 2016**

**Redcar & Cleveland  
Borough Council**

**September 2016**

## Walkover Inspection Surveys 2016

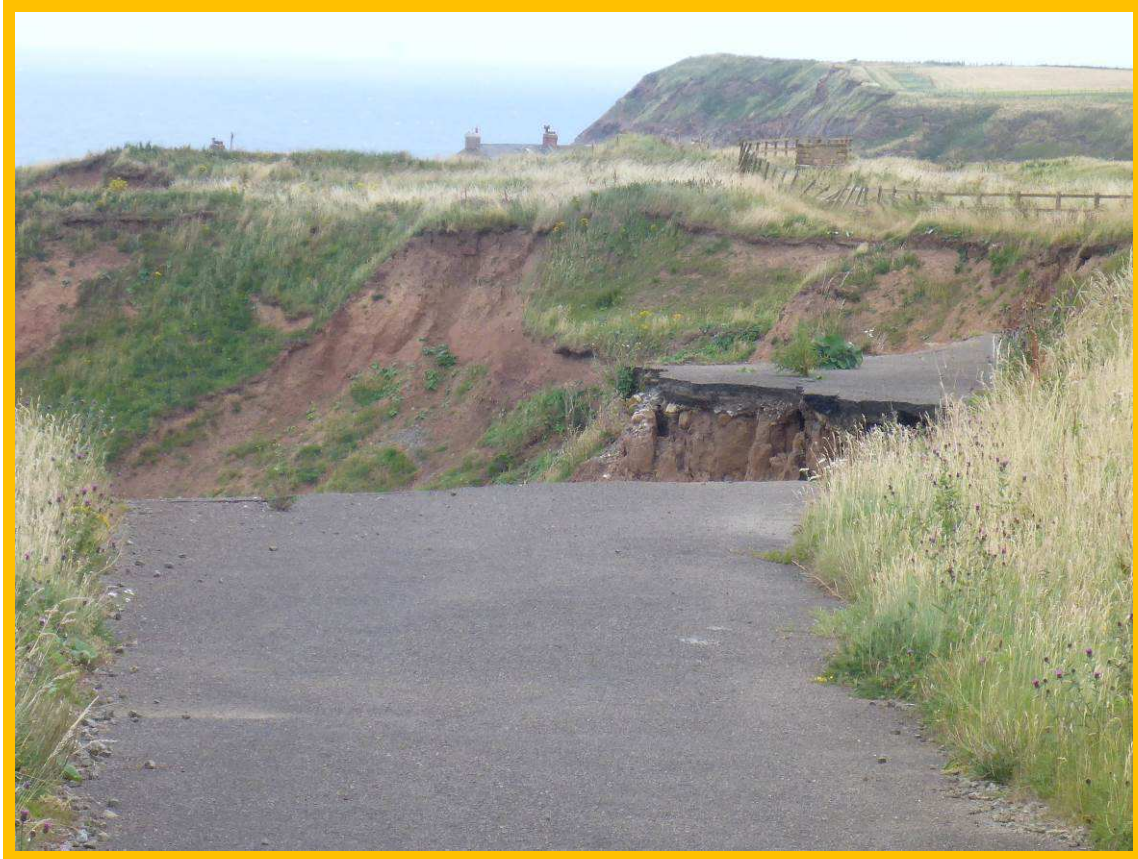
An area of particular and long standing concern along this stretch is adjacent to Cowbar Lane. Here units **E59/5** to **E59/1** are all classified as Partly Active in 2016, unchanged from 2012. They are characterised by an upper till unit which is undergoing severe erosion and there is evidence of recent rockfall from the lower part of the cliff. This is resulting in the loss of the now abandoned parts of Cowbar Lane. Rock armour is also locally present along the toe of unit **E60/1b**, which is acting to locally protect the base of the cliffs, but is not able to prevent failures in the till materials above. However, a fresh rockfall occurred in 2016 immediately adjacent to the rock armour, leading to further slippage in the till cliffs above and closure by The National Trust of public access to Cowbar Nab.

**E59/3 and E59/4** Loss of road due to ongoing erosion at Cowbar Lane

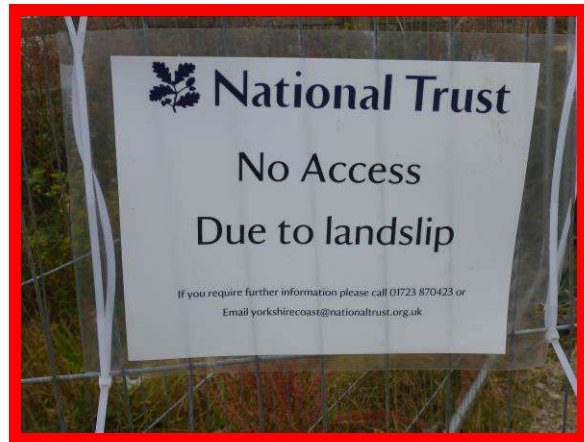
**E60/1** Closure of access to Cowbar Nab
