Cell 1 Regional Coastal Monitoring Programme Walkover Inspection Surveys 2018

**Redcar & Cleveland
Borough Council**

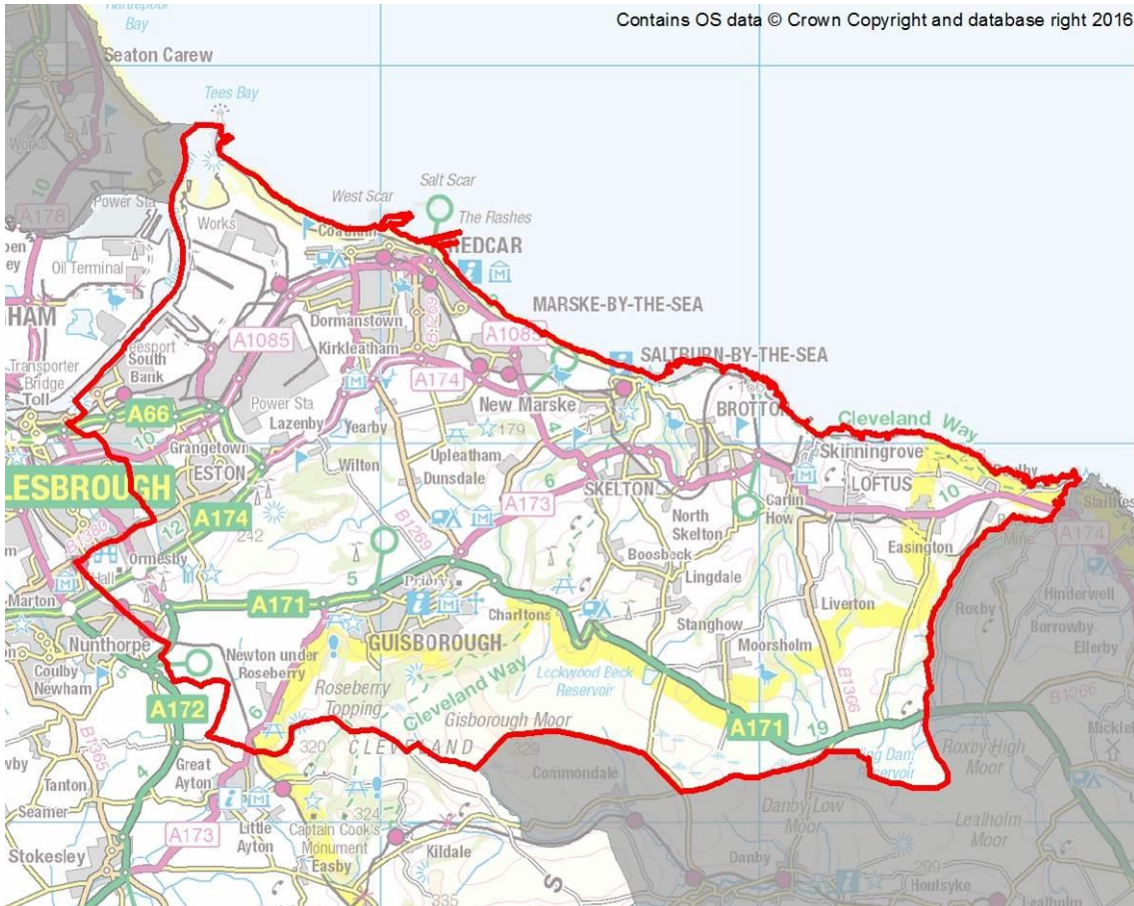
Figure 1-1: Redcar & Cleveland Borough Council study area

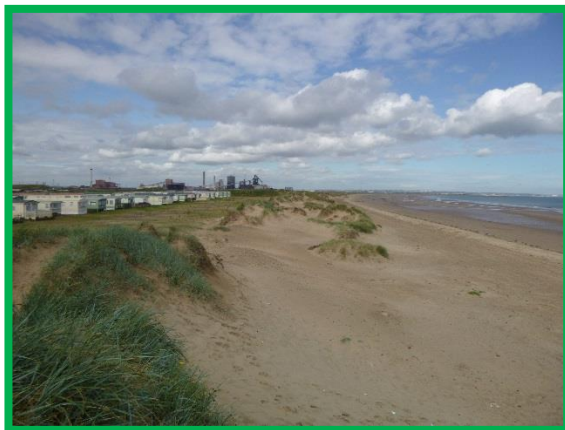
View looking north west from caravan site (/C0507C01)

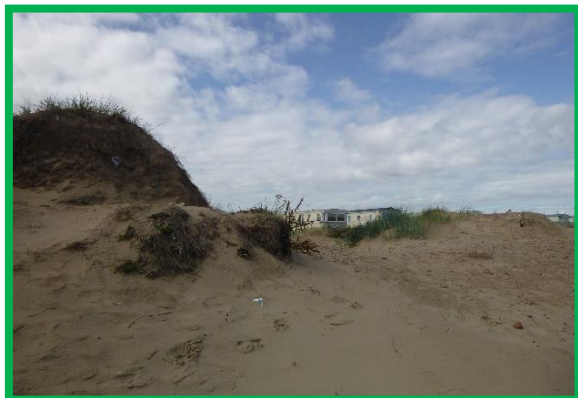
Loss of dune crest at access point (/C0507C01)

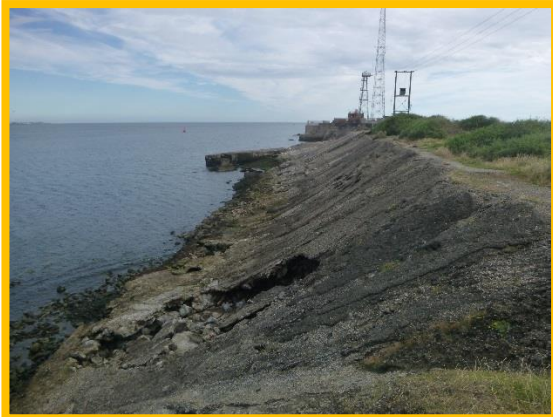
Large void in western face (/C0506C01)

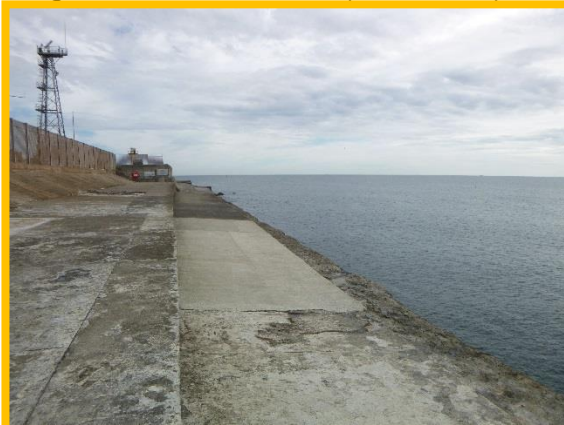
Historic repairs to deckslab along eastern face (/C0506C01)

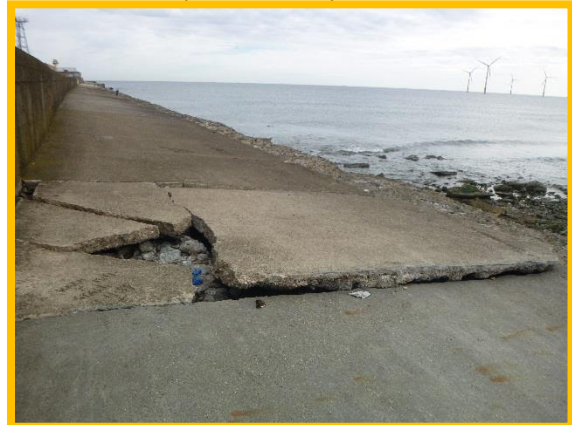
Damage to deckslab along eastern face (/C0506C01)

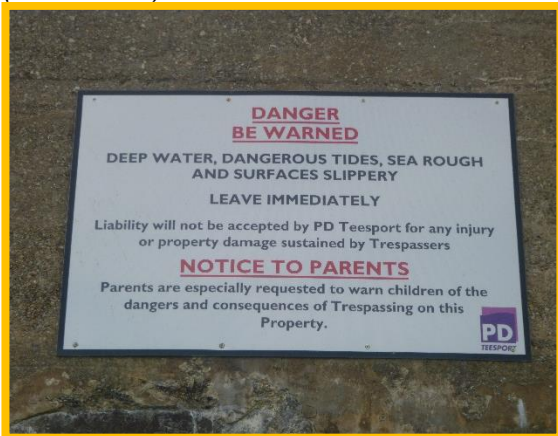
Warning signage (/C0506C01)

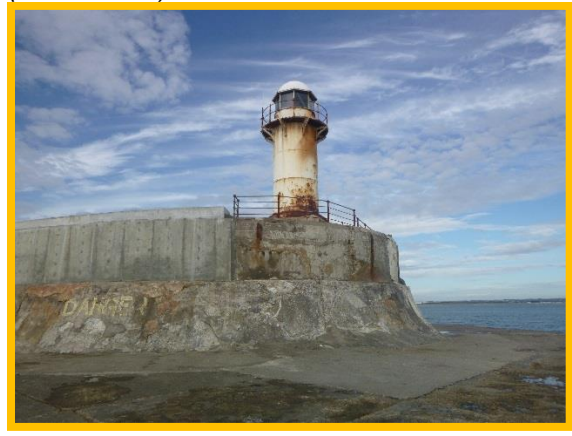
Northern extent of upper structure (/C0506C01)

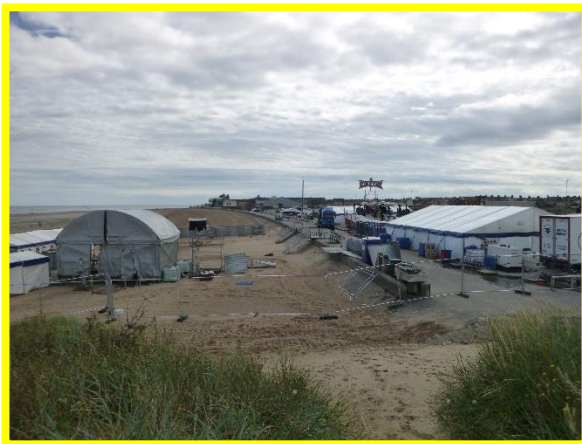
View looking east (/C0601C01)

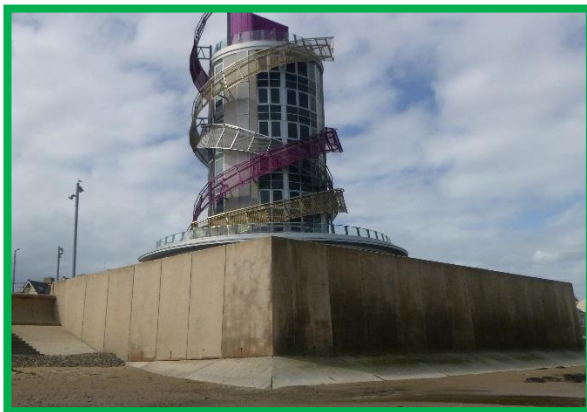
Concrete sea wall at Redcar Beacon
(/C0602C03)

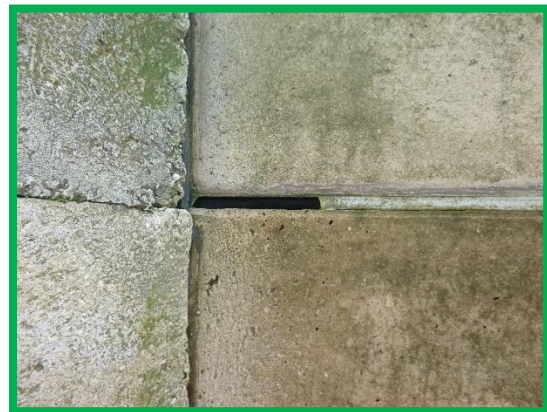
Loose and missing flexible joint sealant
(/C0506C01)

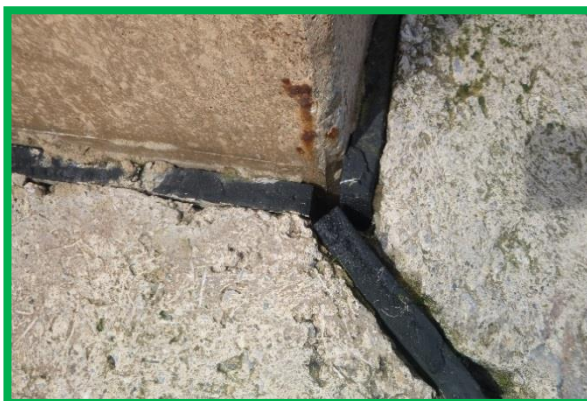
Missing flexible joint sealant in vertical joint. No sealant in horizontal joint – black filler board visible
(/C0602C03)

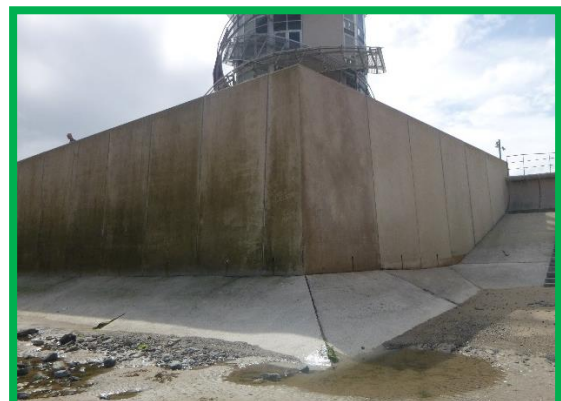
Exposed concrete apron – no sealant in joints – black filler board visible
(/C0602C03)

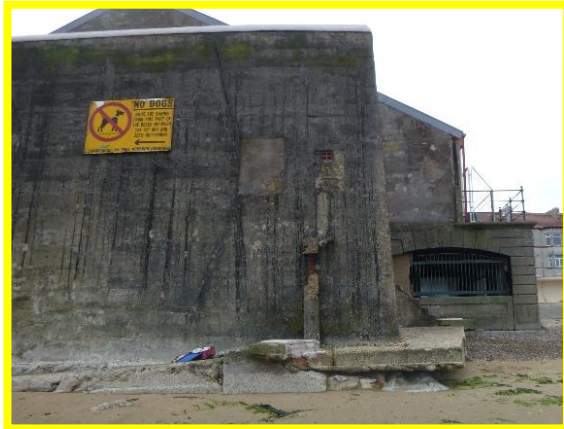
Cinema seawall (/C0602C05)

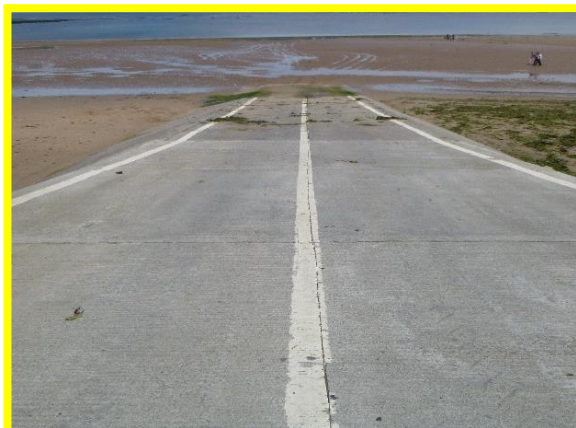
Cracking and local damage to surface of RNLI slipway (/C0602C02)

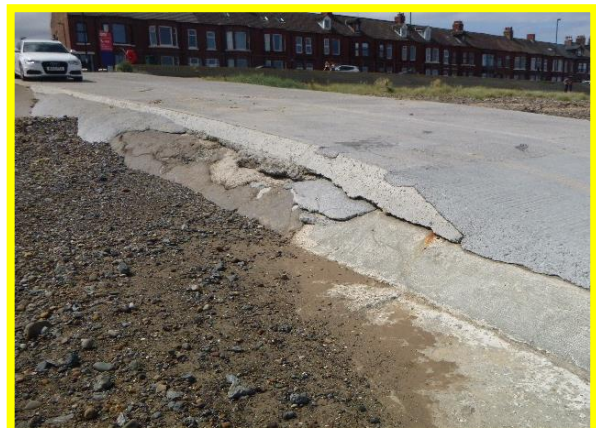
South eastern access ramp. Loss of concrete render exposing grouted stone fill beneath concrete deck slab (/C0602C01)

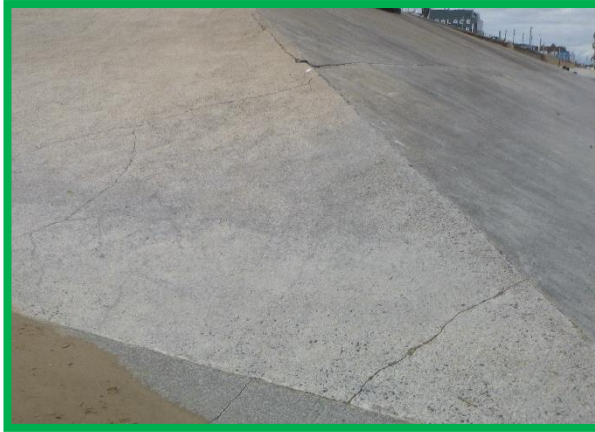
Cracking of precast slabs around access ramps (/C0602C01)

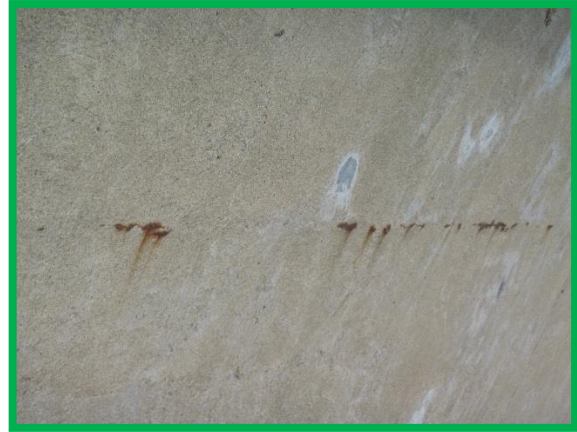
Corrosion staining in precast slabs sections around access ramps (/C0602C01)

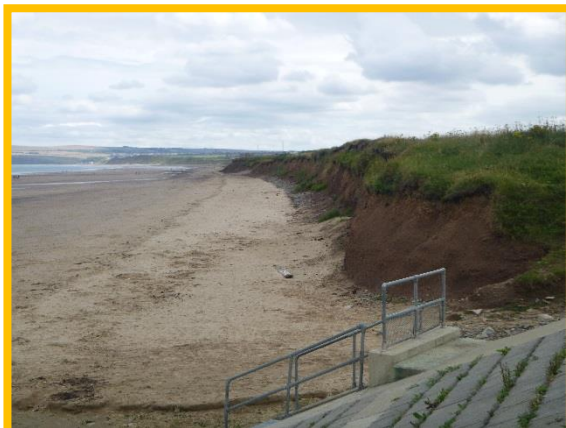
View looking south east (/C0701C01) CBU E52/10

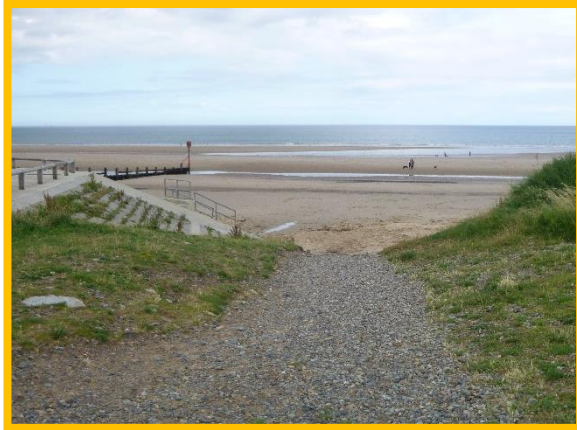
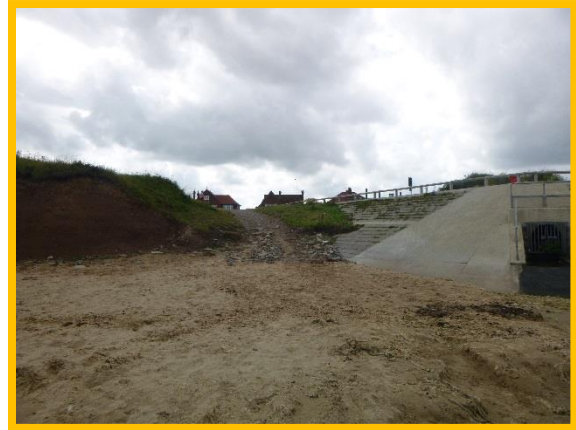
Informal access at interface with hard defences (/C0701C01) CBU E52/10

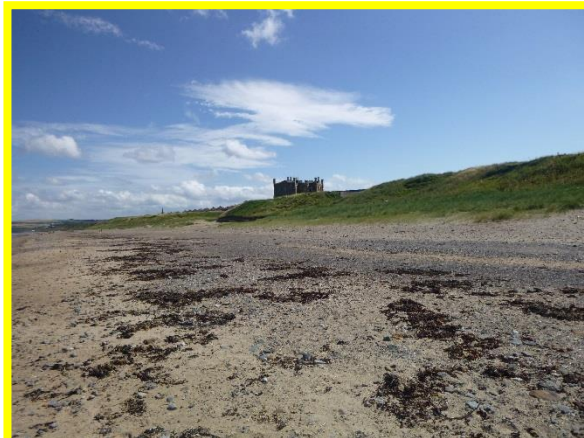
View looking south east (CBU E52/8)

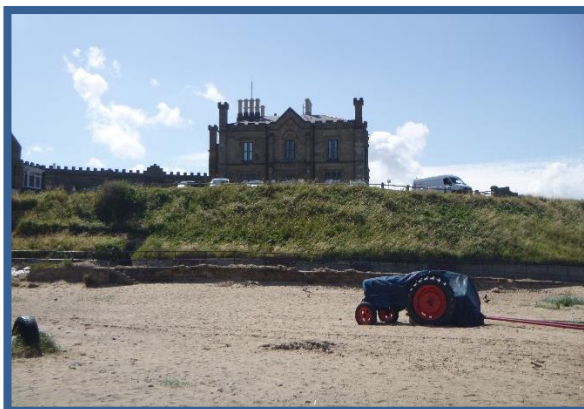
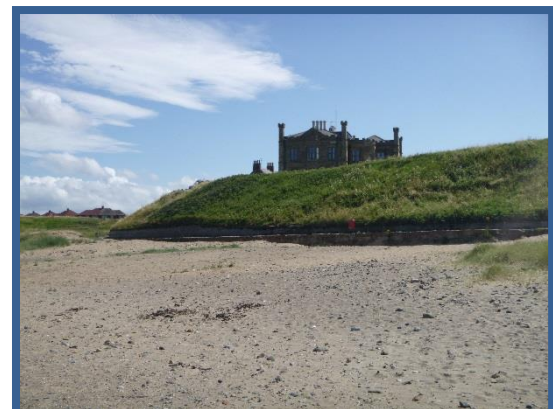
Vegetated slope above masonry wall CBU E52/7

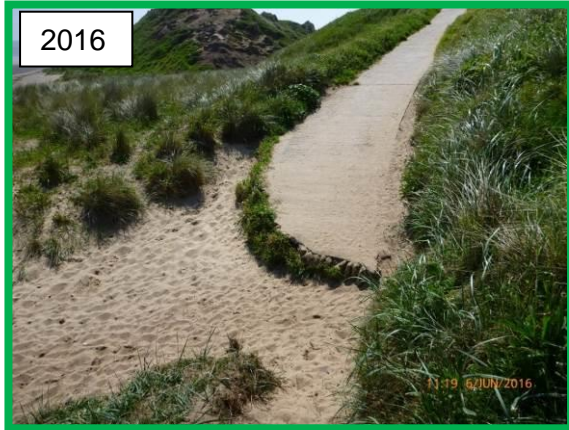
Exposure of timber piles at foot of concrete footpath (CBU E52/6)

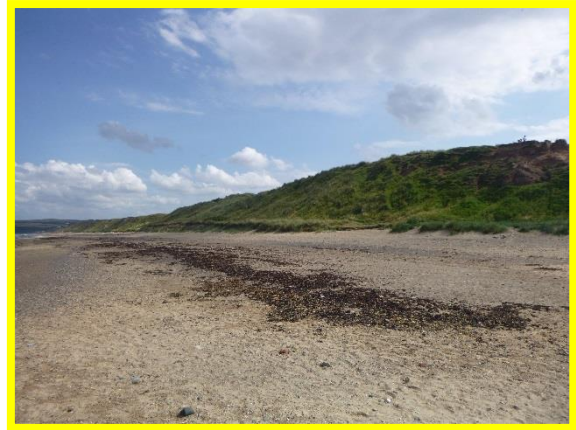
View looking south east (CBU E52/4)

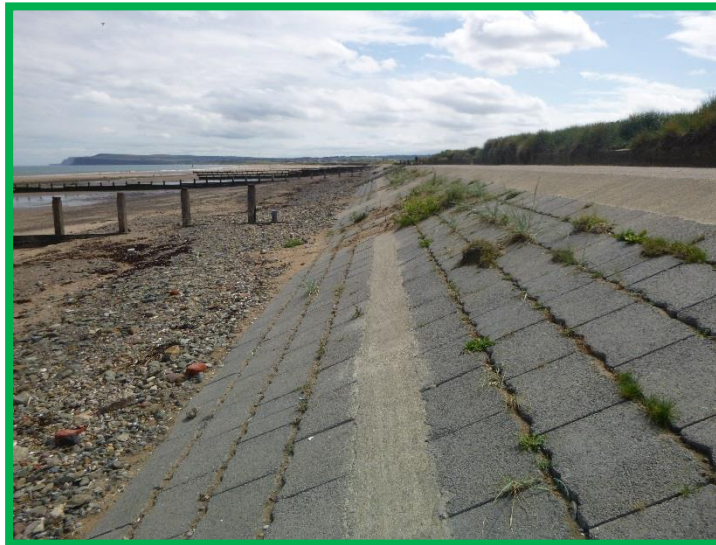
View on The Stray frontage looking south east (/C0603C01)

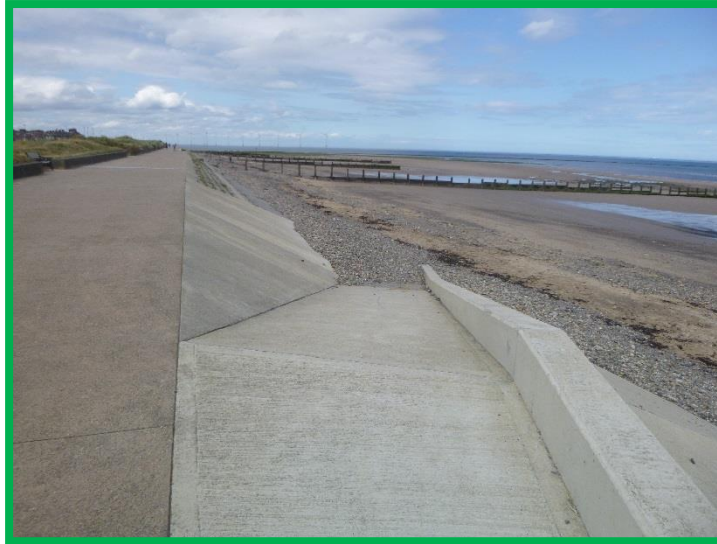
View on The Stray frontage looking north west (/C0603C01)

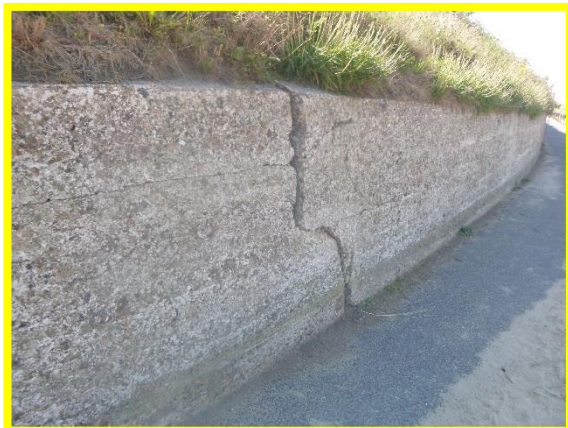
Crack in wall – no apparent change (/C0702C03)

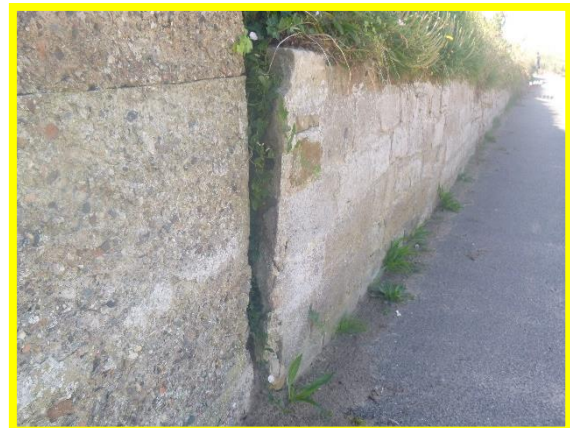
Masonry wall showing signs of lateral movement (/C0702C03)

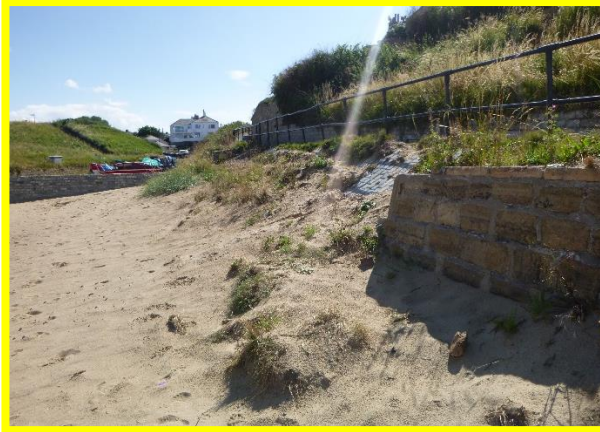
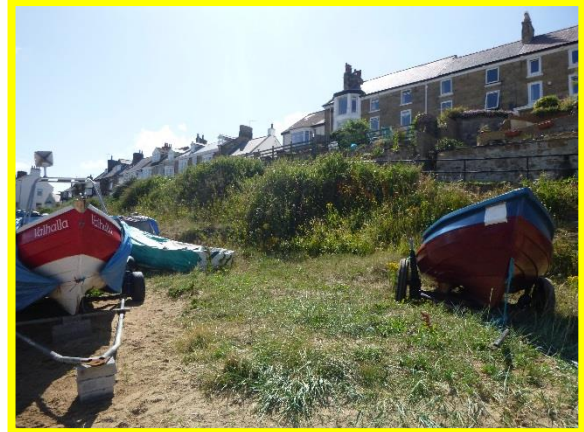
High beach levels and vegetation cover obscuring masonry wall and revetment north west of beach entrance (/C0702C01)

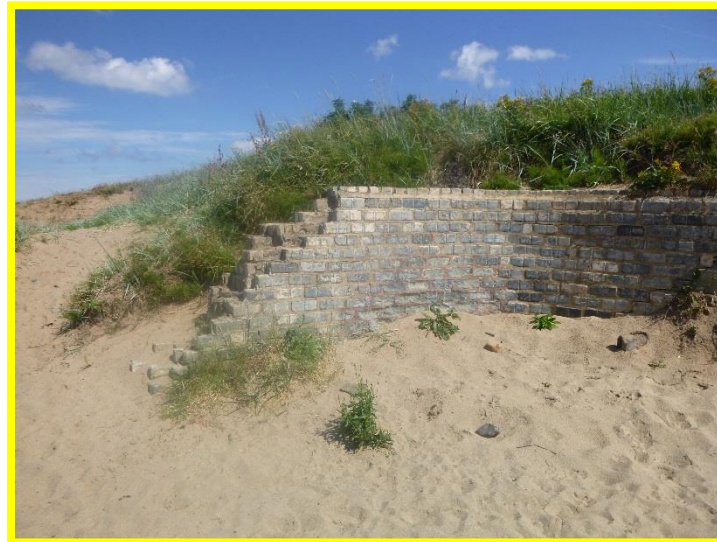
Masonry wall south east of beach entrance (/C0702C01)

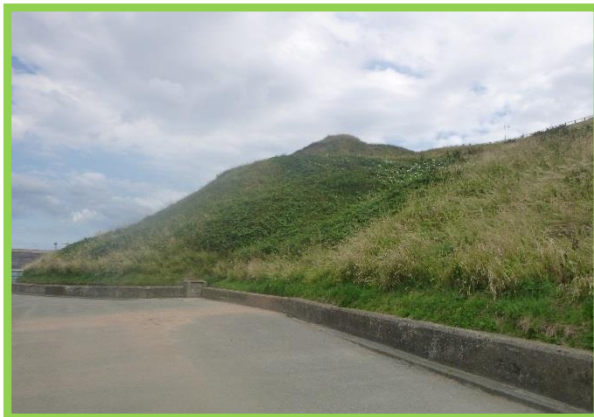
View looking east (E52/3b)

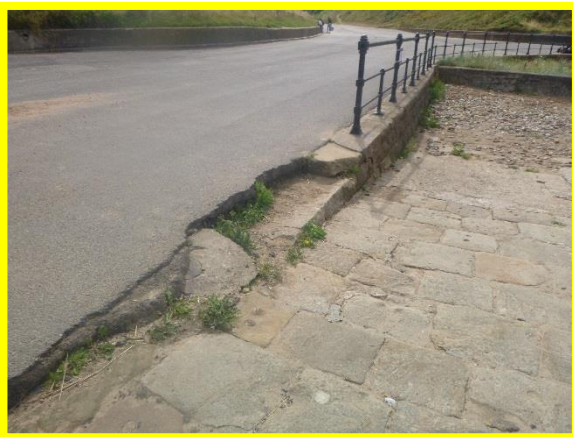
Missing coping stone exposing fill beneath promenade surface (/C0703C02)

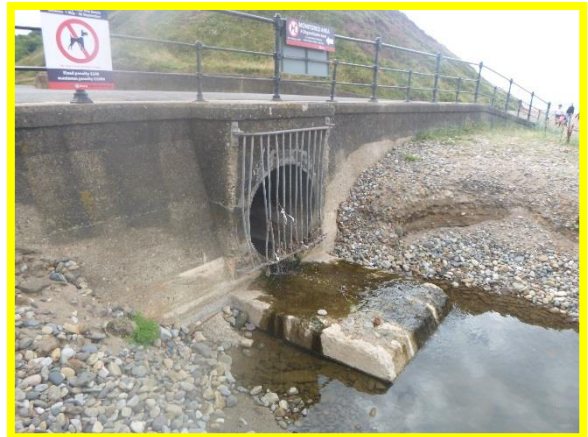
Security grille damaged (/C0703C02)

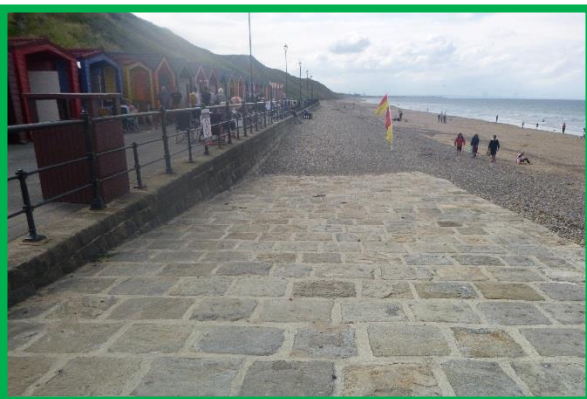
View looking northwest. Lower beach levels than 2016. (/C0702C04)

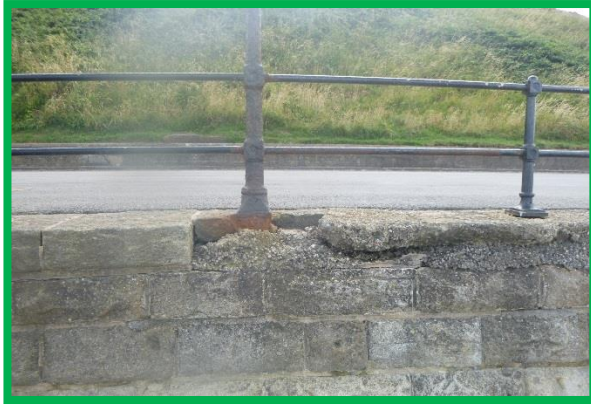
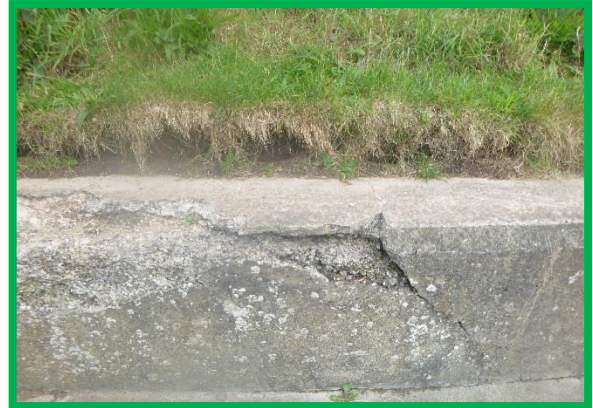
Local damage to pedestrian guardrail and coping stone (/C0702C04) Local damage to concrete wall (/C0702C04)

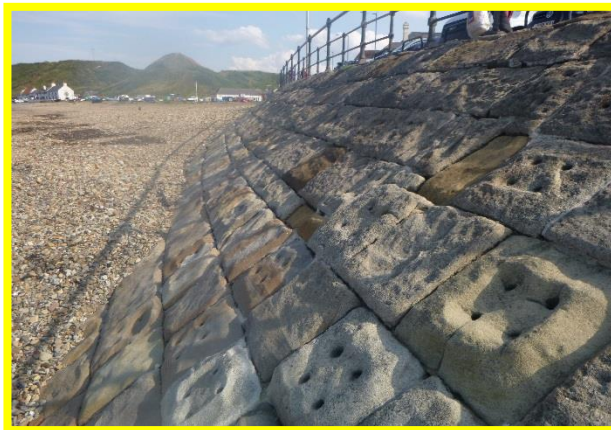
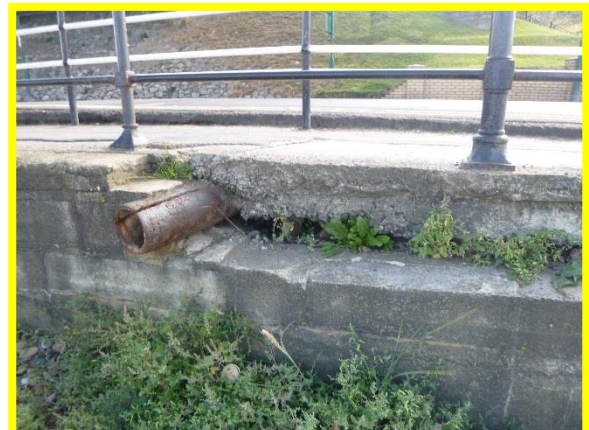
View looking north west (/C0704C01)

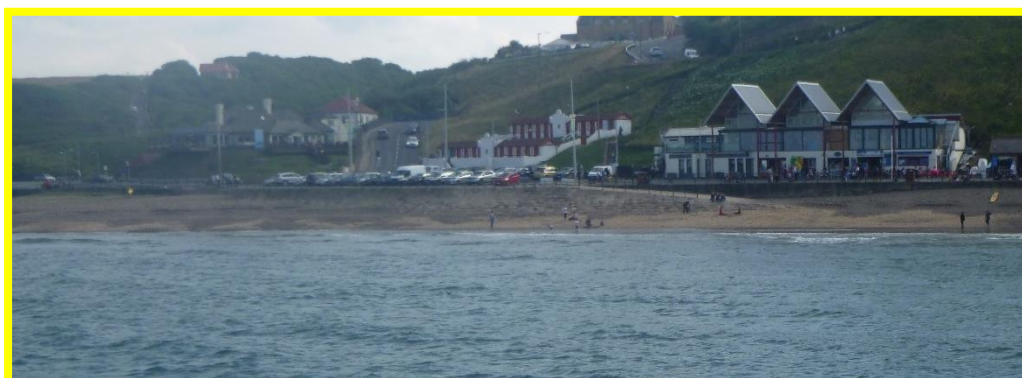
View looking southeast from pier. Beach levels lower at ‘apex’ of headland (/C0704C01)

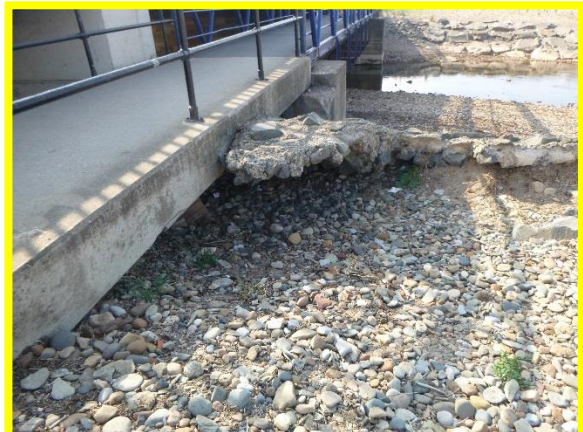
Undercutting of rock revetment apron (C0704C06)

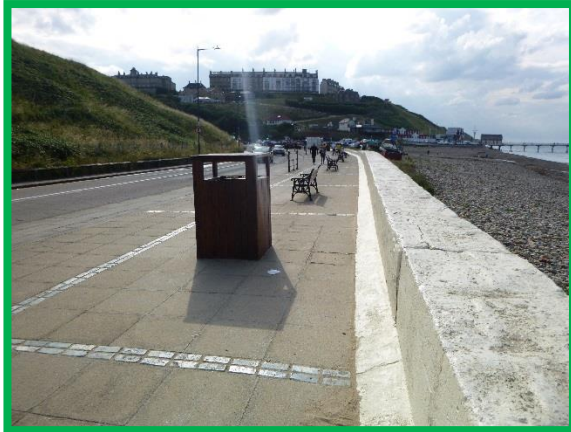
View looking west (/C0704C03)

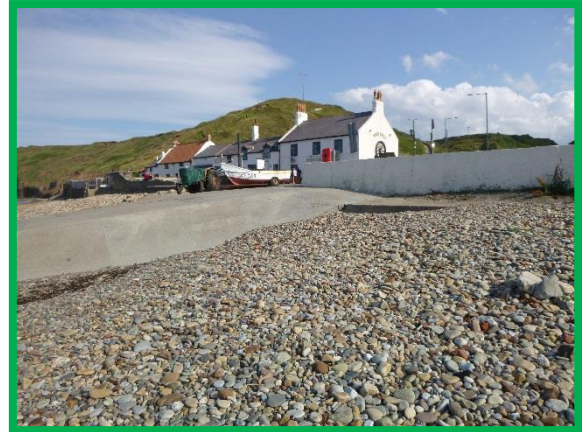
Western face of concrete slipway (/C0704C03)

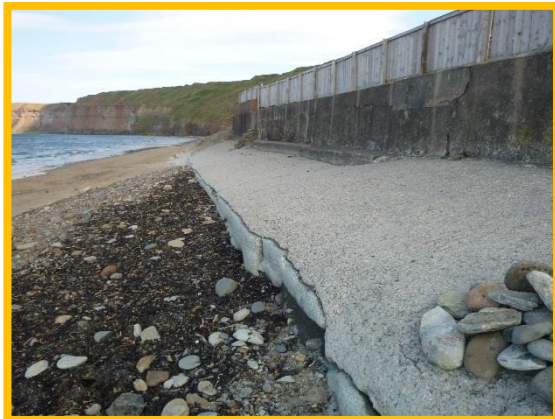
Low beach levels exposing undercutting of toe (/C0704C05)

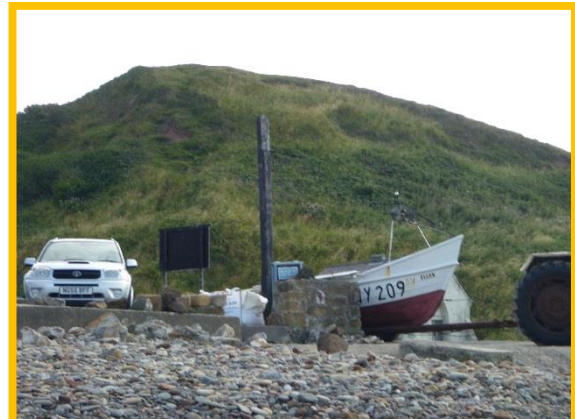
Damage to boundary wall fronting Public House (/C0704C05)

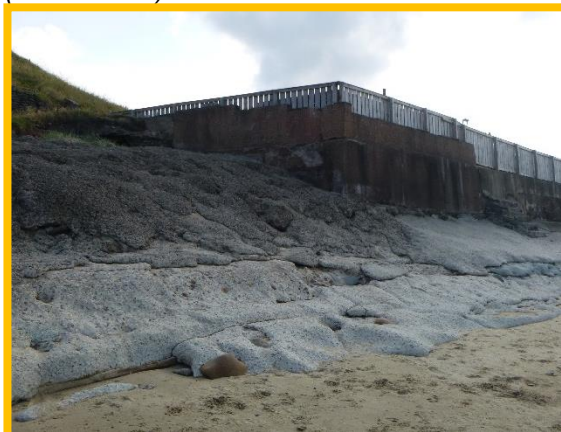
View looking west (/C0704C05)

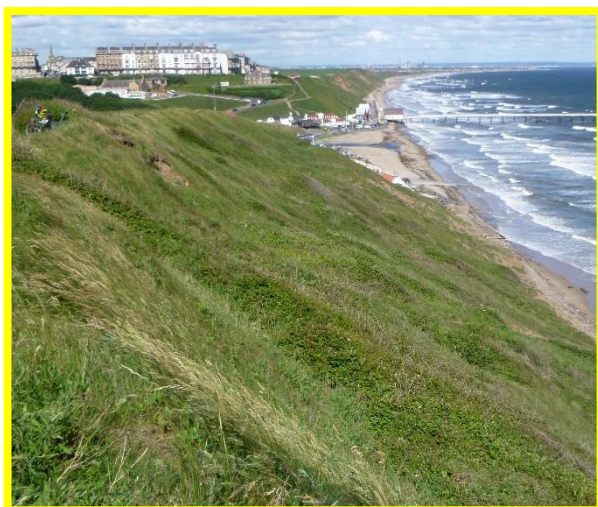
E53/3 to E53/1 Generally small-scale slumping in the till layer of the cliff northeast of Saltburn (Locally Active except E53/2, right).

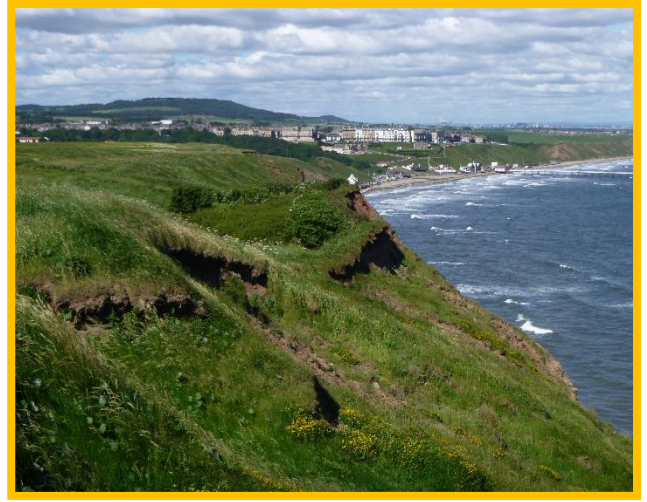
Suspected approximate location of rockfall **E53/2** (Partly Active).

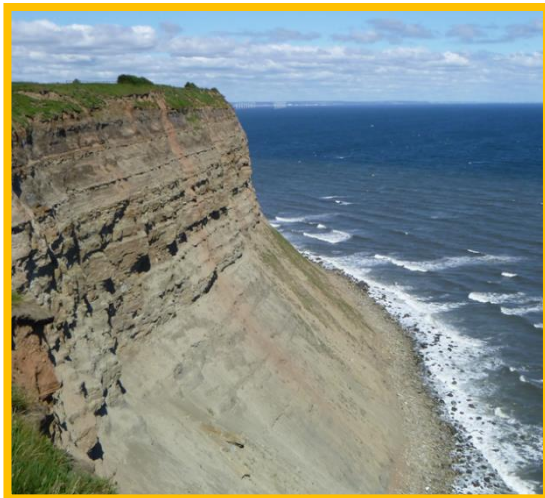
E54/4 looking northwest along Hunt Cliff showing active cliff face and debris apron (Partly Active)

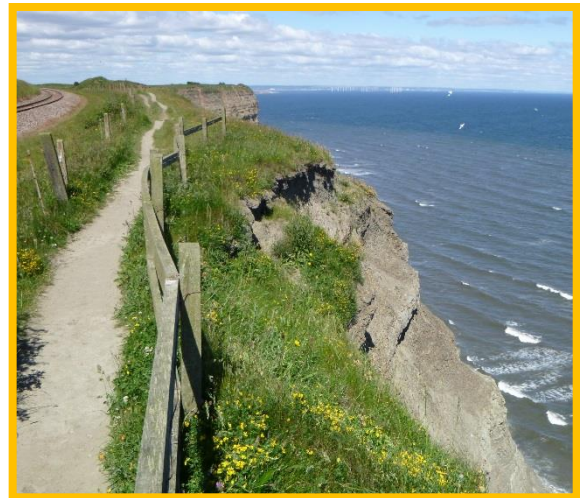
E54/3a proximity of footpath and railway line to actively eroding cliff top (Partly Active)

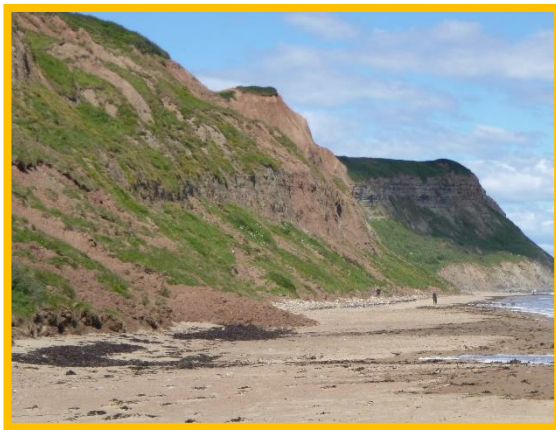
E55/2 – E54/1 Vegetated layer of till, which sits above the Lower Jurassic bedrock. Partly Active in foreground, Locally Active in background.

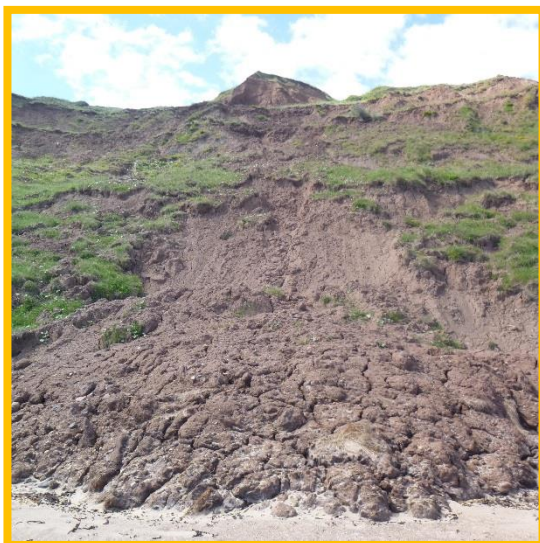
Characteristic mudslide along the toe of **E55/1**.

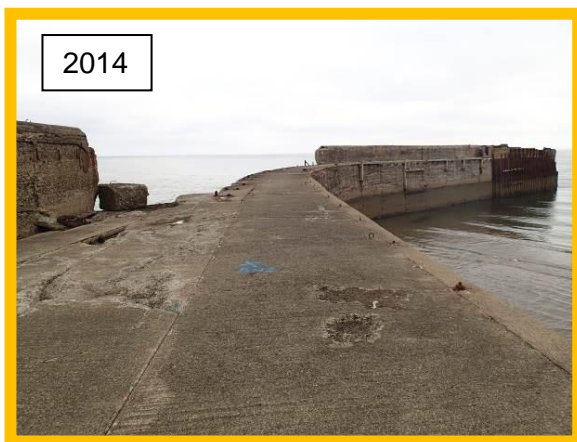
View of crest from access gate showing missing section of crest wall and damaged deck in 2014 (Asset Ref No. 1221D901D0201C02)

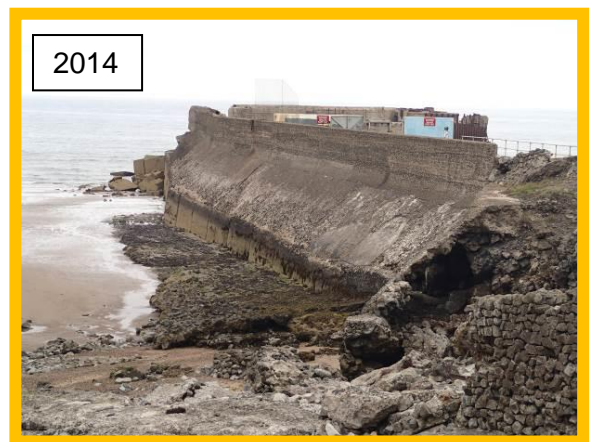
Voiding and collapse of west side of jetty structure in 2014 (Asset Ref No. 1221D901D0201C02)

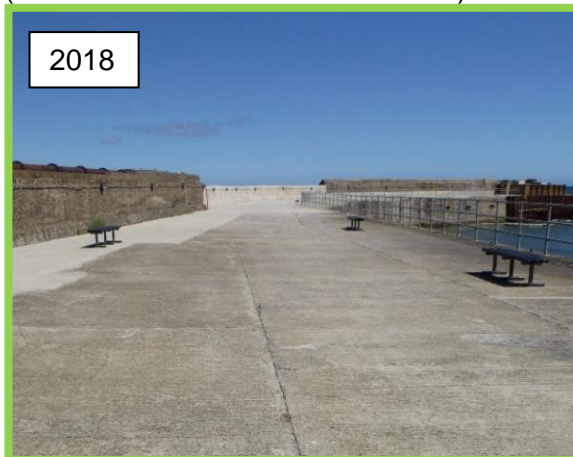
Repaired and improved structure in 2018 (Asset Ref No. 1221D901D0201C02)

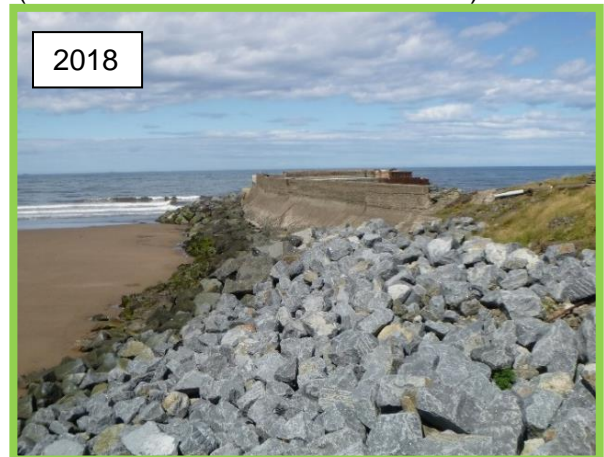
Repaired and improved rock armour (Asset Ref No. 1221D901D0201C02)

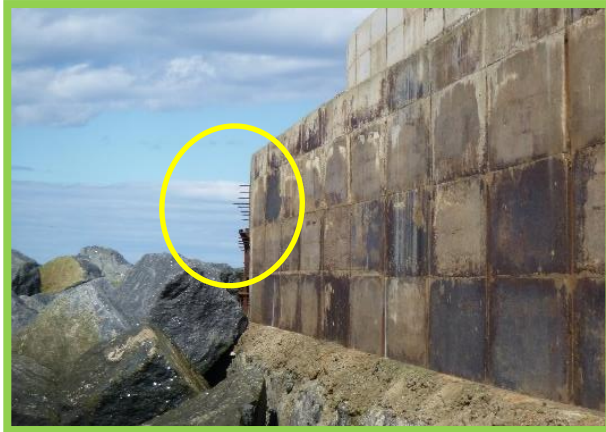
Seaward face of repair. Note exposed reinforcement.
(Asset Ref No. 1221D901D0201C02)

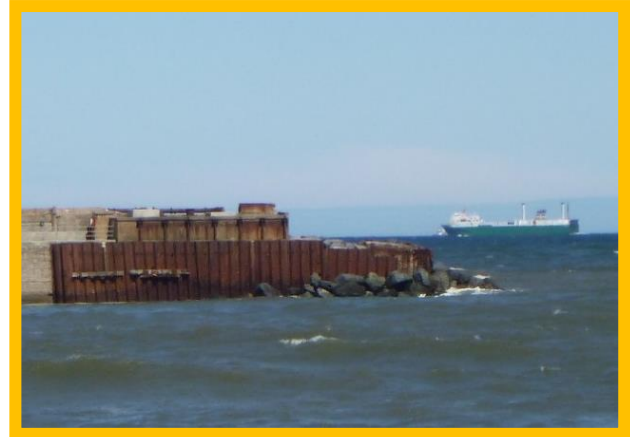
Heavily corroded sheet piles and rock armour around nose of original jetty structure.

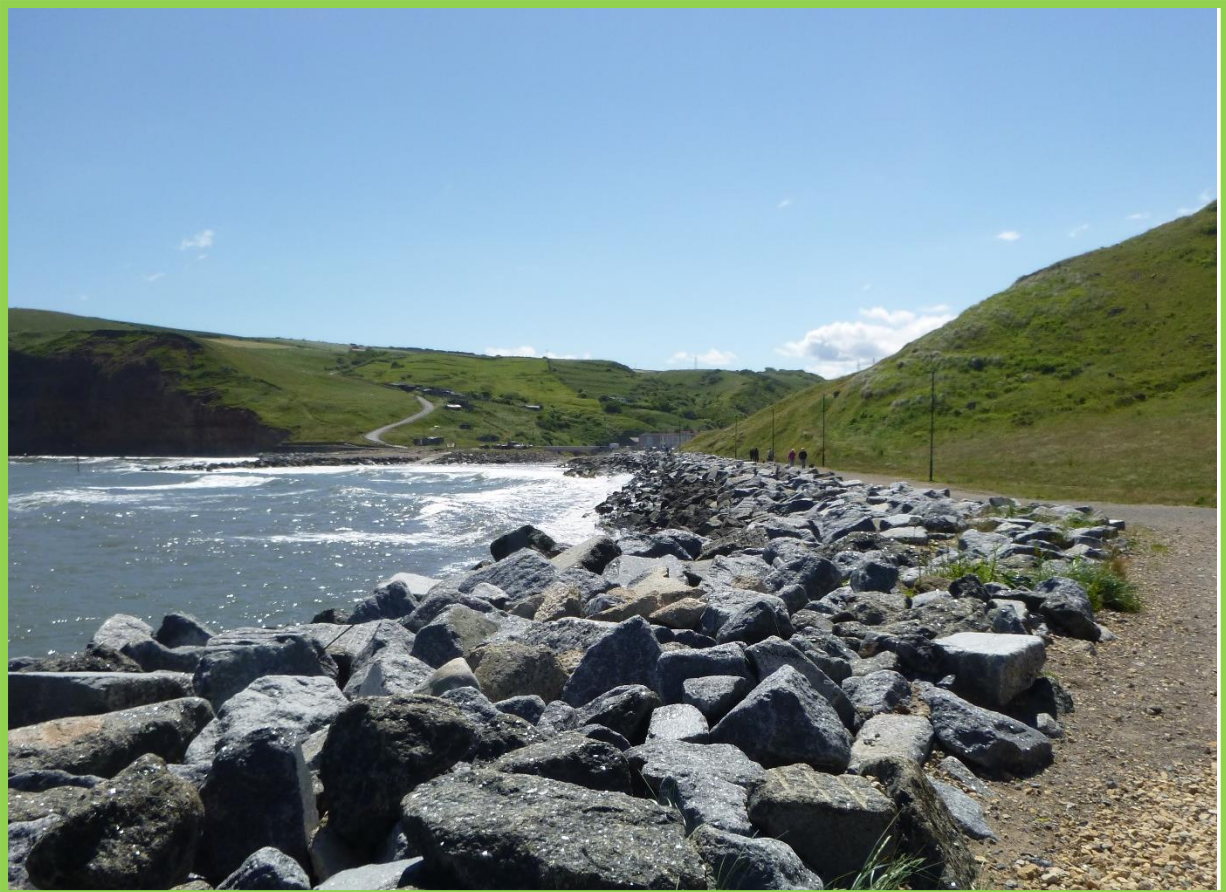
General view of modified revetment and surfaced path looking from Jetty towards village in 2018
(Asset Ref No. 1221D901D0202C01)

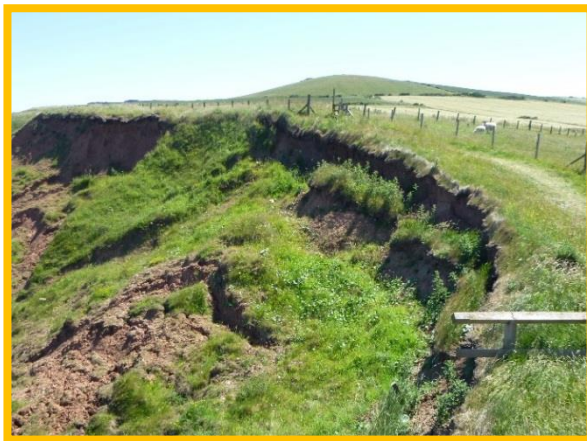
E57/7 Slumping cliffs (Partly Active)

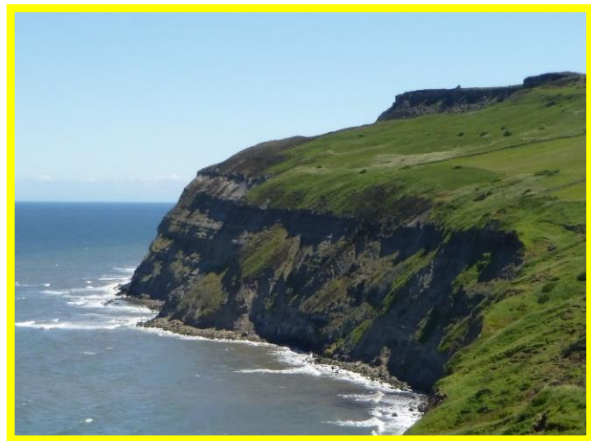
E57/6 High rock cliff with till cap (Locally Active)

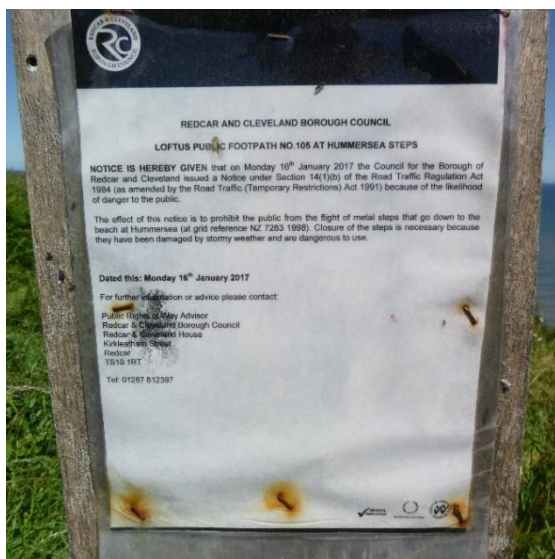
E57/3 Notice prohibiting Public Access to the beach at Hummersea.

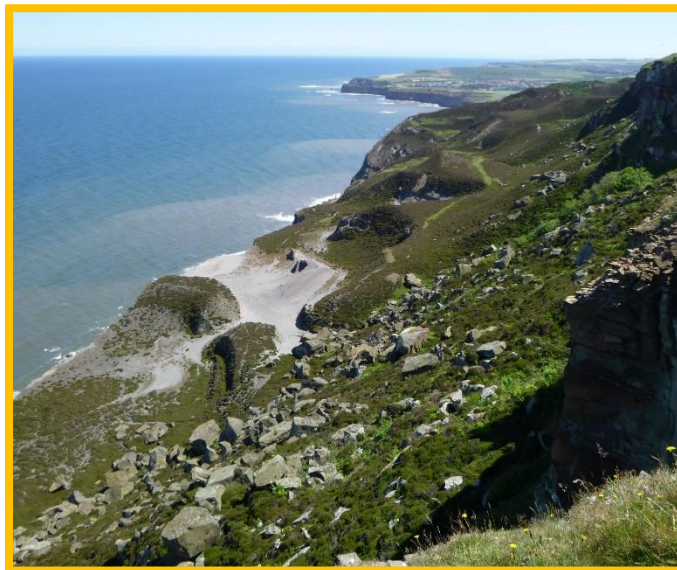
E58/5 to E58/2 – Cliffs of the Loftus Alum Quarries
(Locally Active upper sections and Partly Active lower sections)

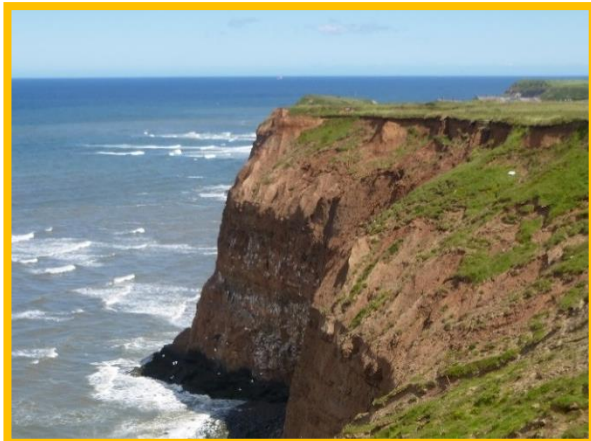
E58/1 to E59/6 Soft, slumping, upper till resting upon harder rock (Partly Active)

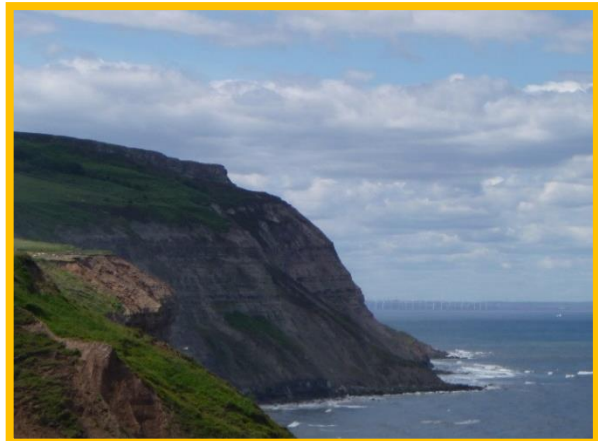
E58/1 to E59/6 Soft upper till resting upon harder rock subject to rock fall (Partly Active)

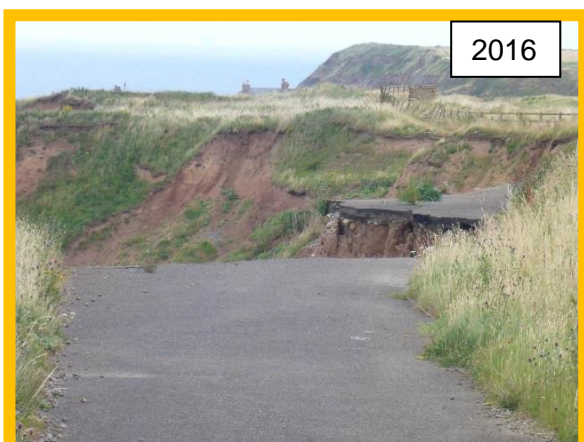
E59/3 and E59/4 Loss of road due to ongoing erosion at Cowbar Lane

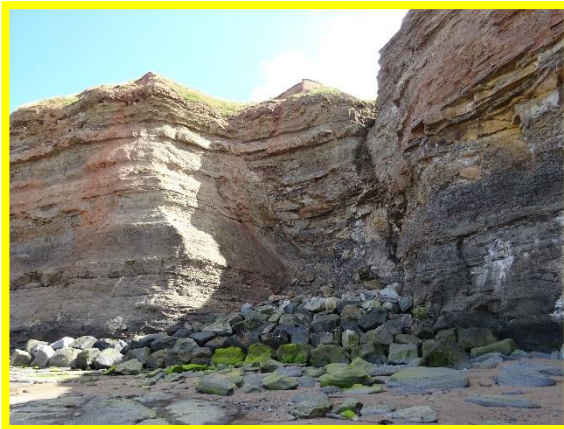
E59/1 Rock armour located at toe of cliff to the west of Cowbar Cottages
