## **Cell 1 Regional Coastal Monitoring Programme Walkover Inspection Surveys 2020**

**Redcar & Cleveland  
Borough Council**

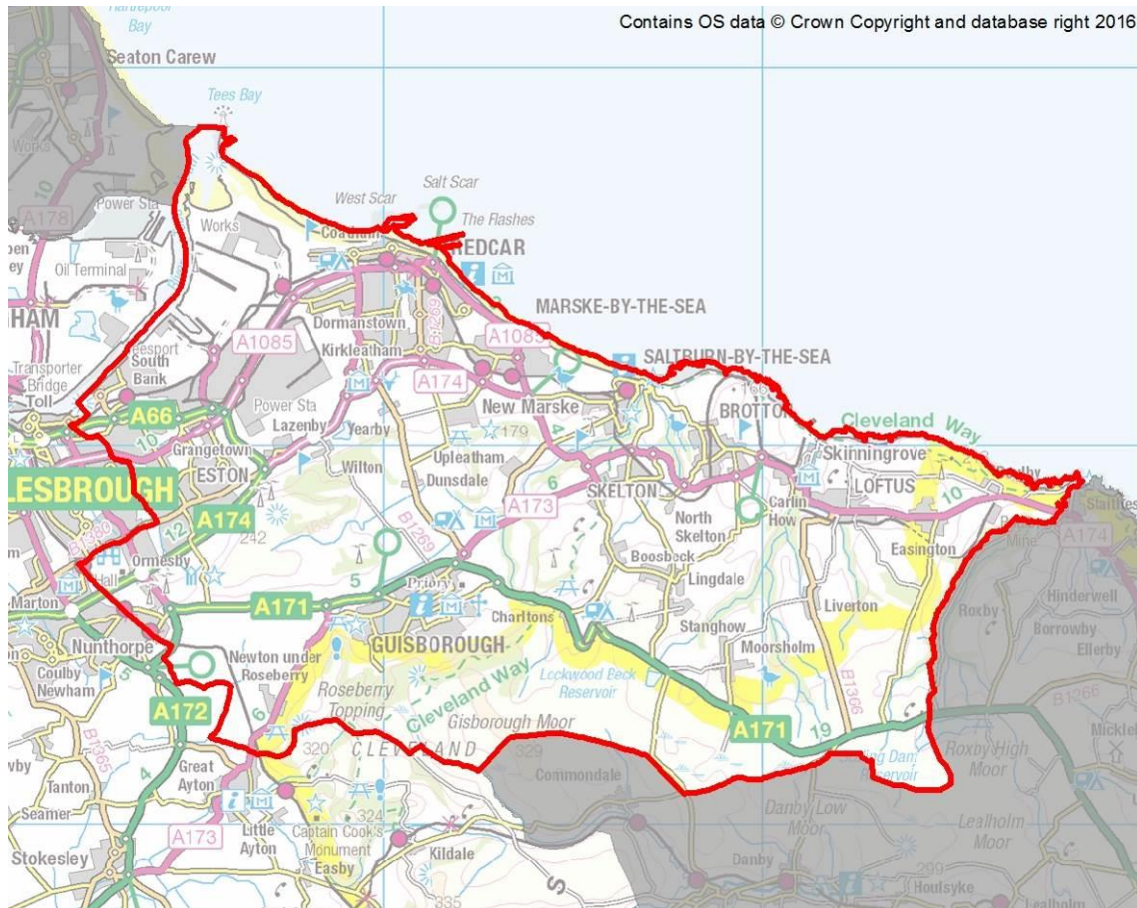
**Figure 1-1: Redcar & Cleveland Borough Council study area**

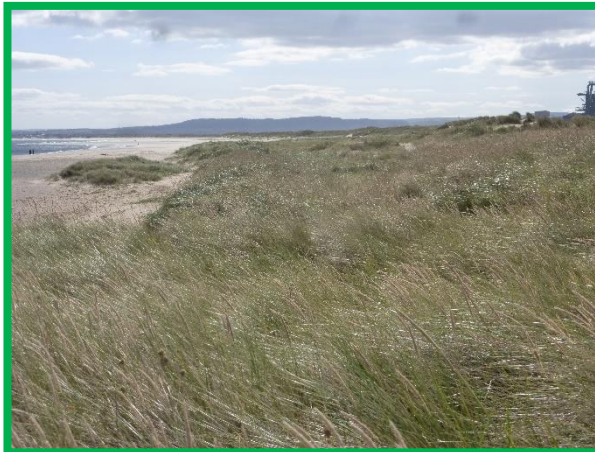
*Looking south east from South Gare breakwater across the dunes and Coatham Sands (/C0507C01)*

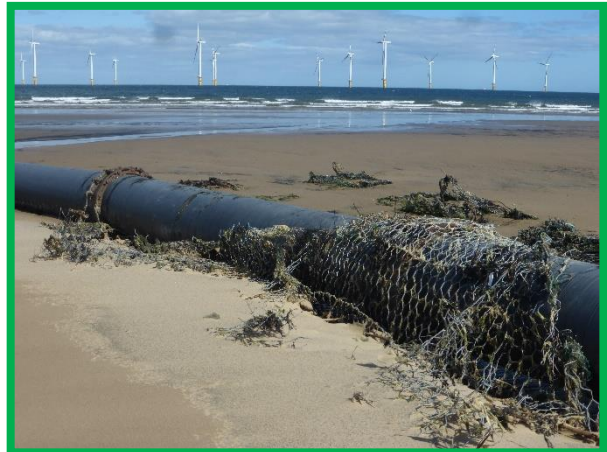
*Outfall on Coatham Sands in poor condition (/C0507C01)*

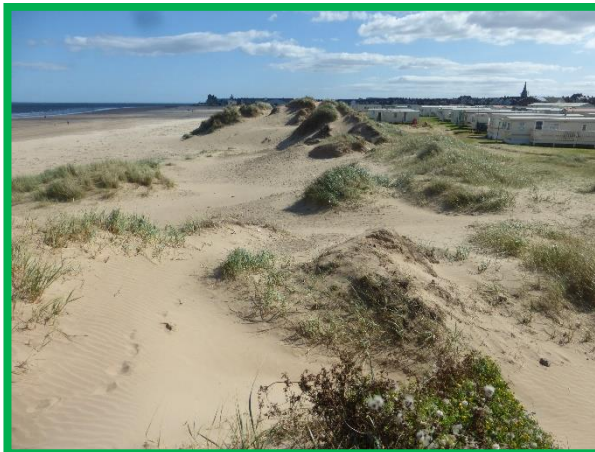
*View looking south west from caravan site (/C0507C01)*

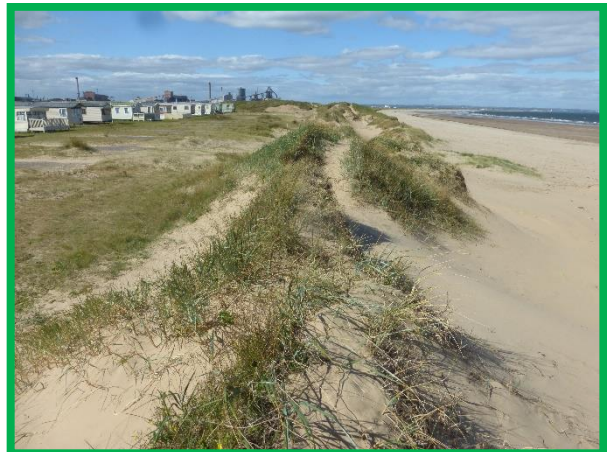
*View looking north west from caravan site (/C0507C01)*

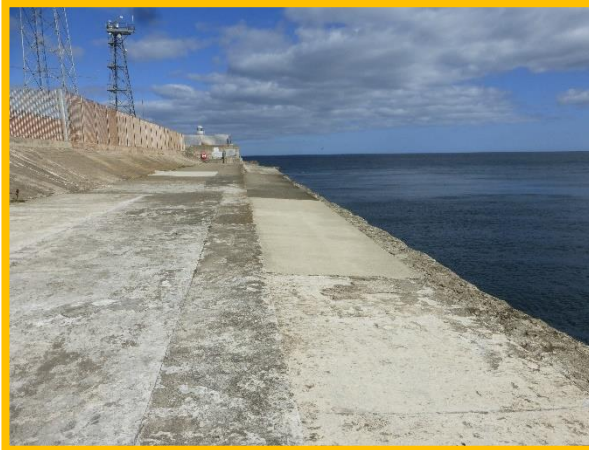
*Historic repairs to deck slab along eastern face (/C0506C01)*

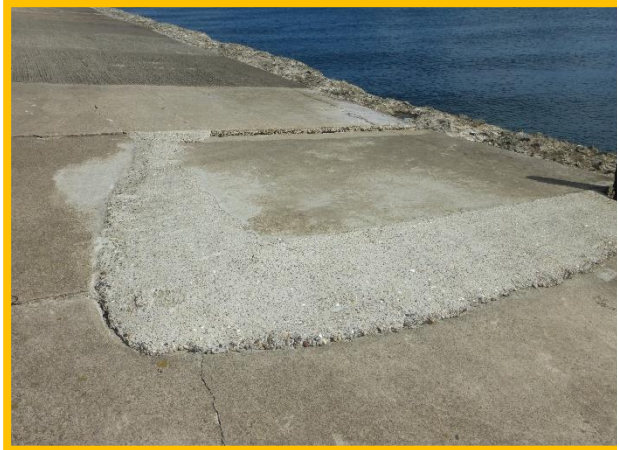
*Recent repair to deck slab along eastern face (/C0506C01)*

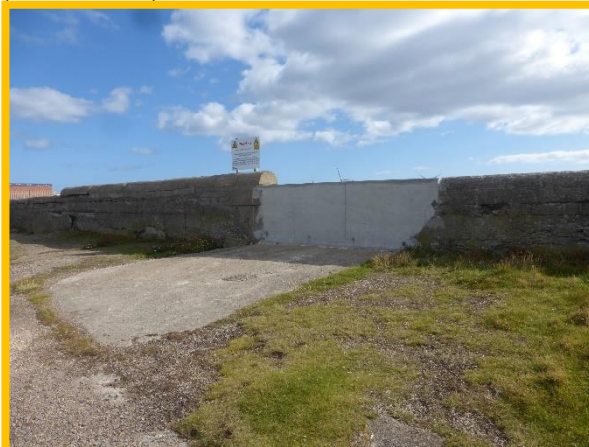
*Repairs to wall on breakwater crest (/C0506C01)*

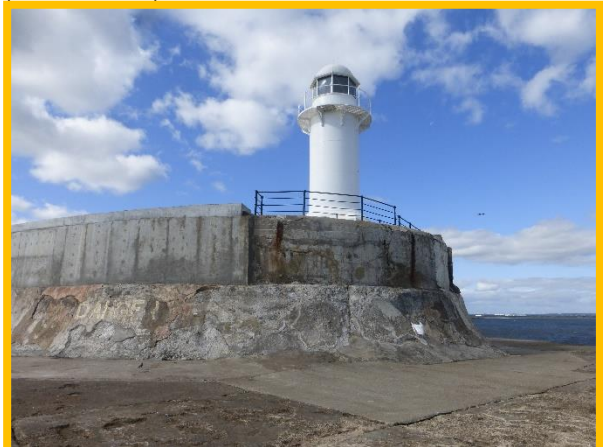
*Northern extent of upper structure (/C0506C01)*

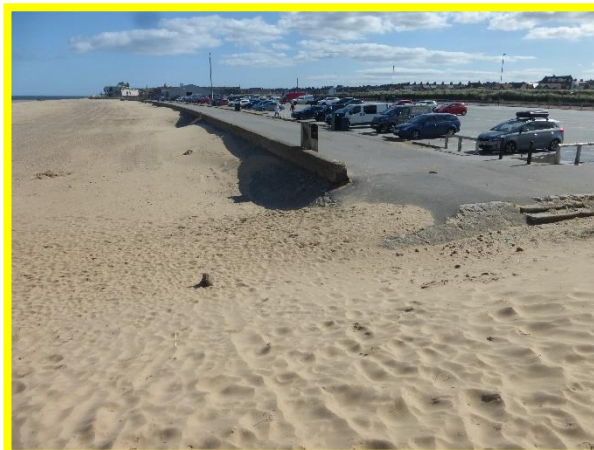
*View looking east, note high beach levels (/C0601C01)*

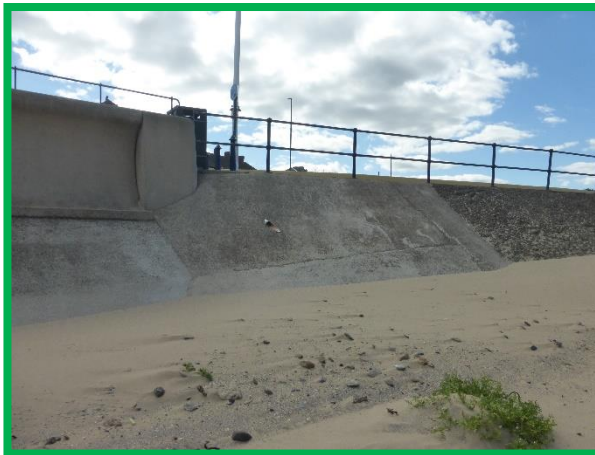
*Mass concrete transition in fair condition. Note; horizontal and vertical cracks and damaged drain outfall (/C0602C06)*

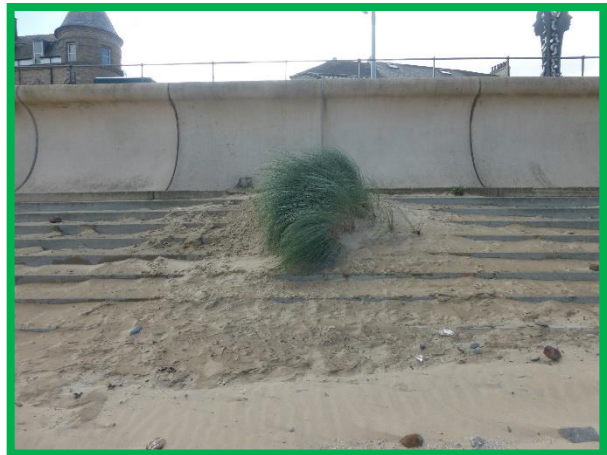
*Vegetation growth on stepped revetment. (/C0602C06)*

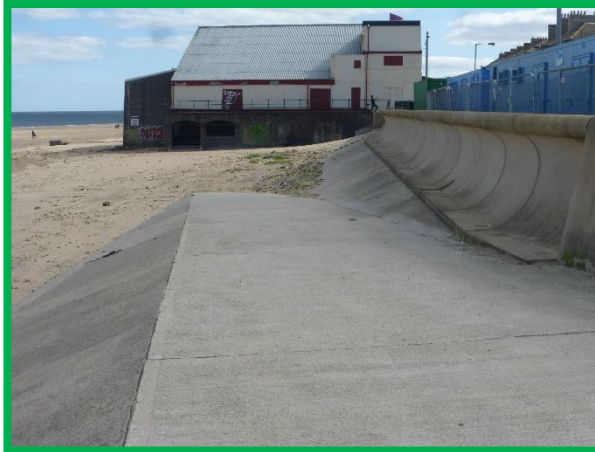
*Slipway in good condition (/C0602C06).*

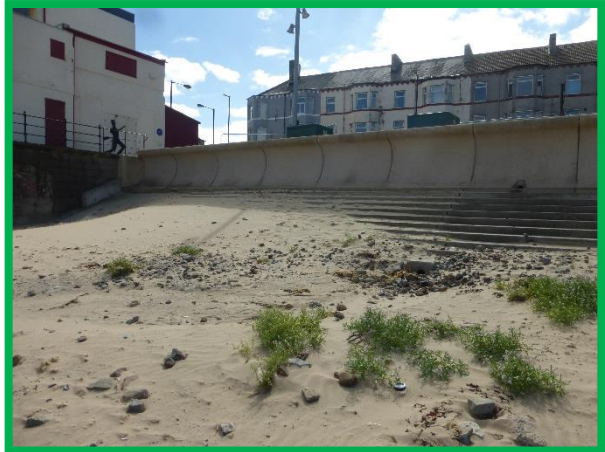
*Accumulation of beach material at transition with cinema wall (/C0602C06) & (/C0602C05)*

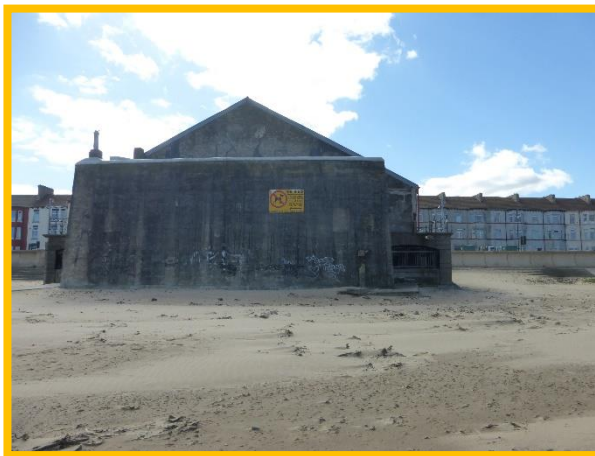
*Cinema seawall in poor condition high beach levels cover undercutting (/C0602C05)*

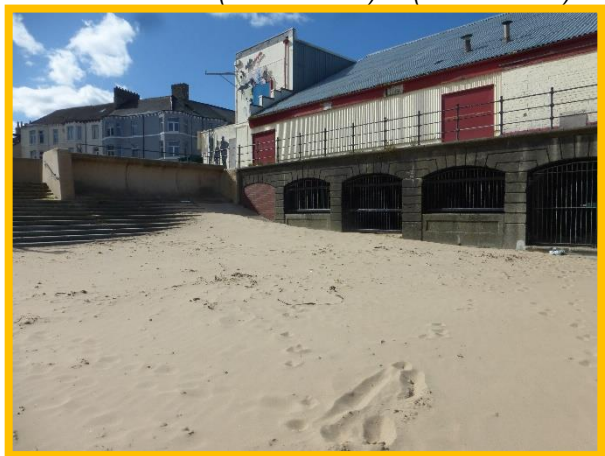
*Cinema seawall note accumulation of beach material (/C0602C05)*

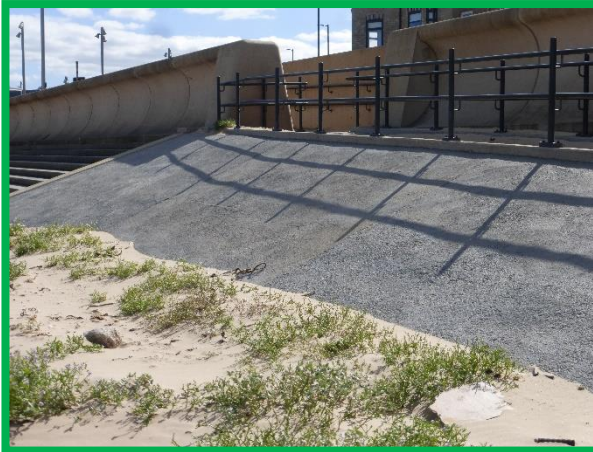
*Slipway on in very good condition (/C0602C04)*

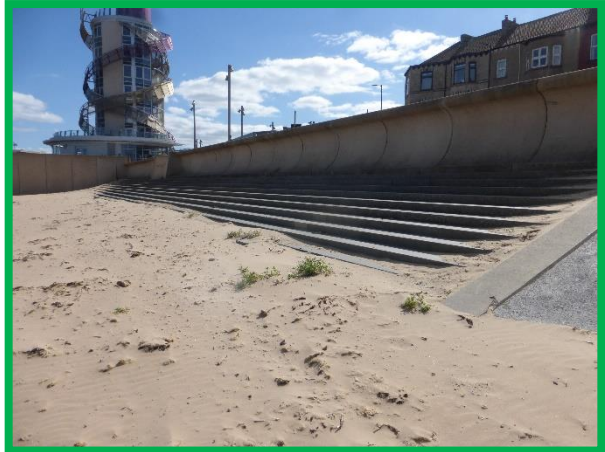
*Stepped concrete revetment with recurve wall in very good condition (/C0602C03)*

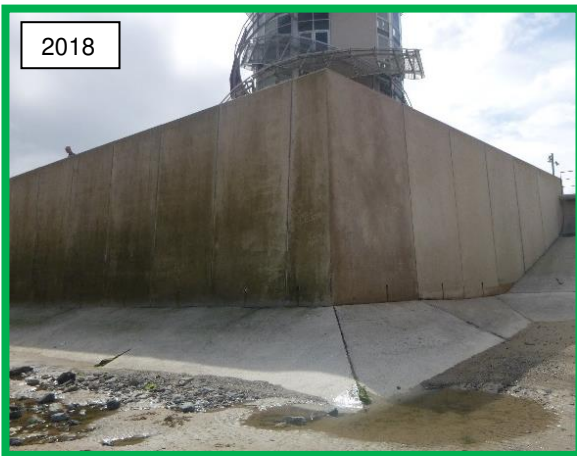
*Concrete sea wall at Redcar Beacon in 2018 (/C0602C03)*

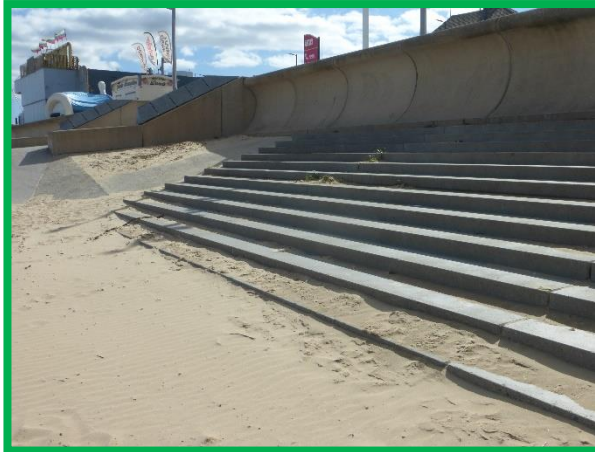
*Stepped concrete revetment and recurve wall in very good condition (/C0602C03)*

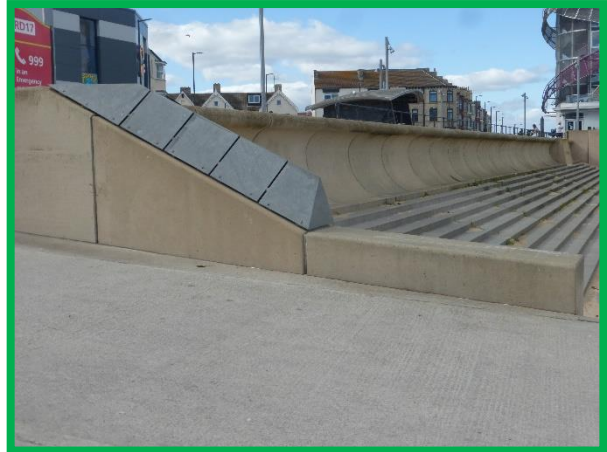
*Stepped concrete revetment and recurve wall in very good condition (/C0602C03)*

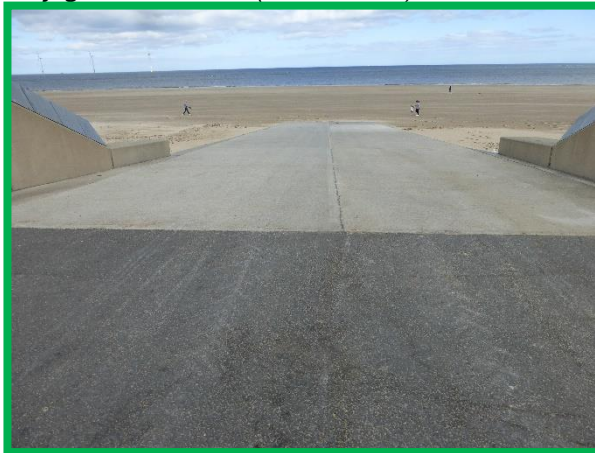
*Slipway in good very condition (/C0602C03)*

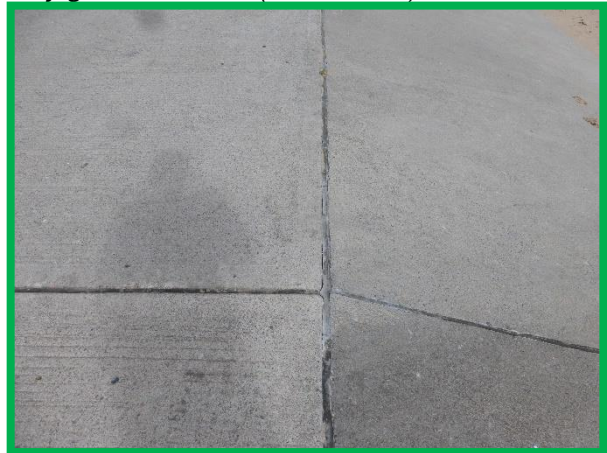
*Joint sealant on slipway remains in good condition (/C0602C03)*

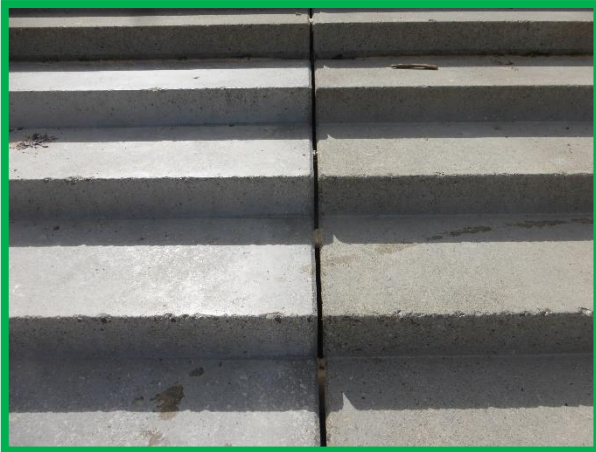
*Open joints in stepped concrete revetment. Overall condition remains as very good (/C0602C02)*

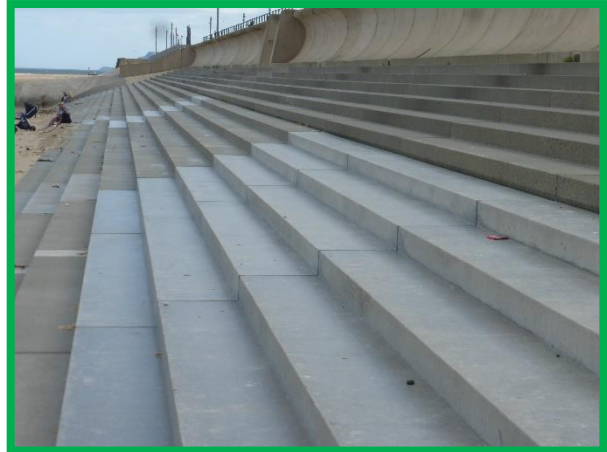
*Evidence of recent repairs to the stepped concrete revetment in very good condition (/C0602C02)*

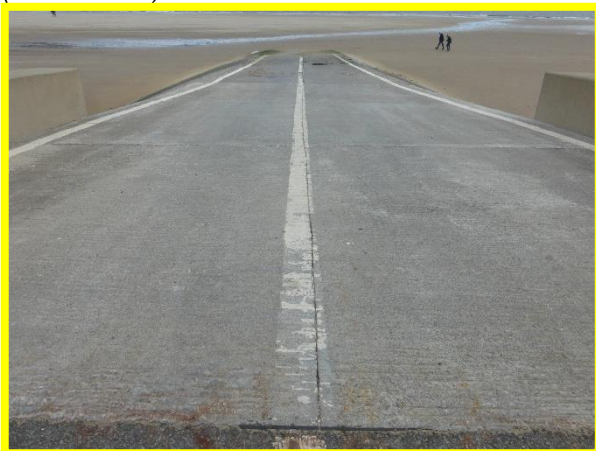
*Slipway in fair condition (/C0602C02)*

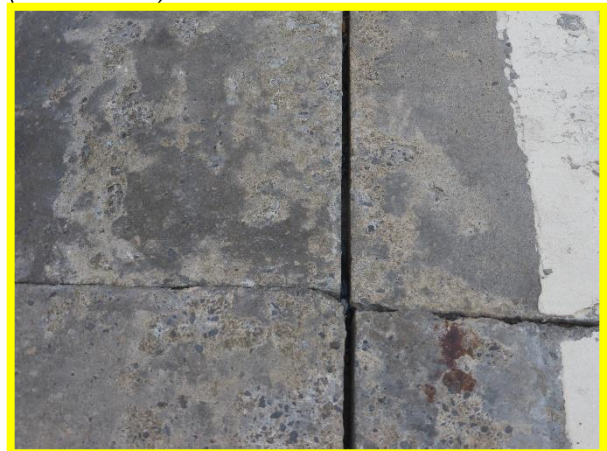
*Slipway in fair condition some minor spalling around joints (/C0602C02)*

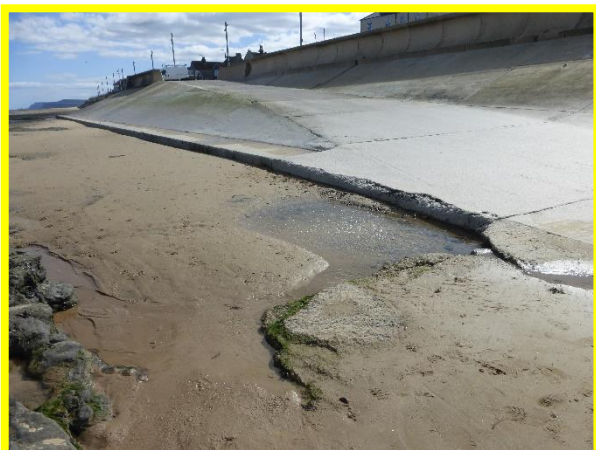
*South eastern access ramp. Loss of concrete render exposing grouted stone fill beneath concrete deck slab (/C0602C01).*

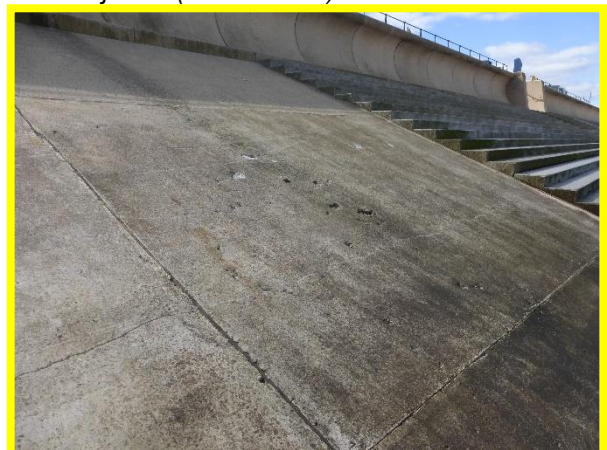
*Cracking to mass concrete slabs adjacent to slipway (/C0602C01).*

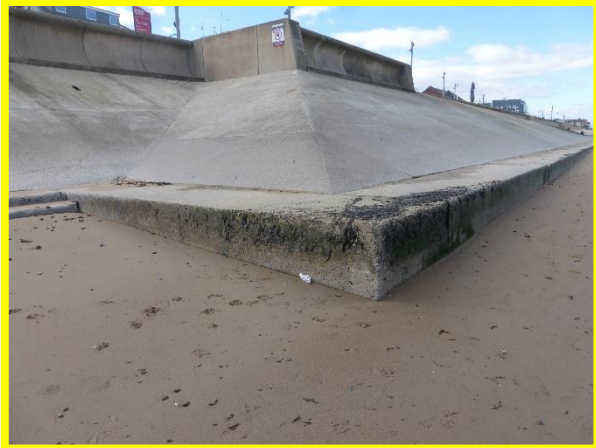
Concrete apron of slipway in good condition, despite being exposed. (/C0602C01).

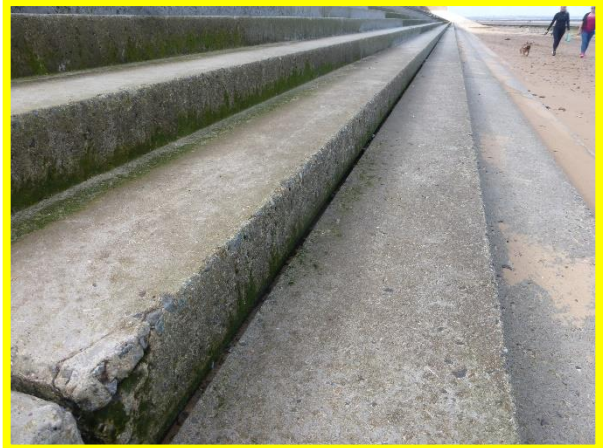
Localized cracking and damage to stepped revetment (/C0602C01).

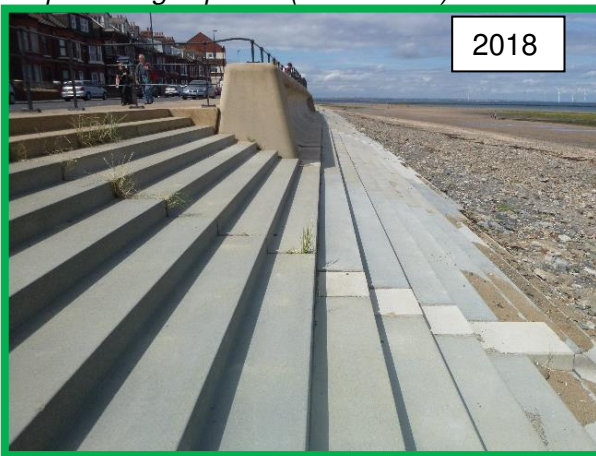
Sand accumulated in 2016 had been lost during the 2018 survey seen above (/C0602C01)

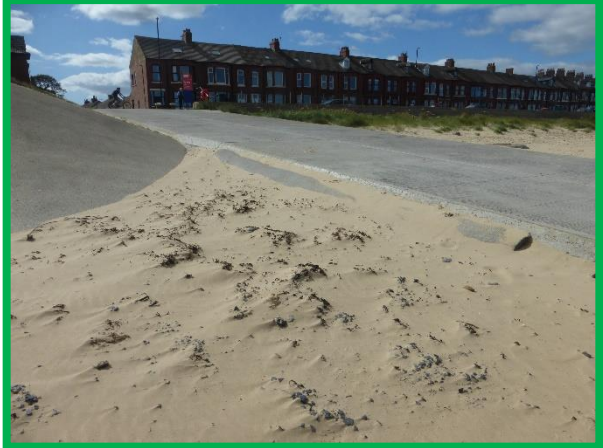
Accumulated sand covers previously noted defects in concrete slipway (/C0602C01)

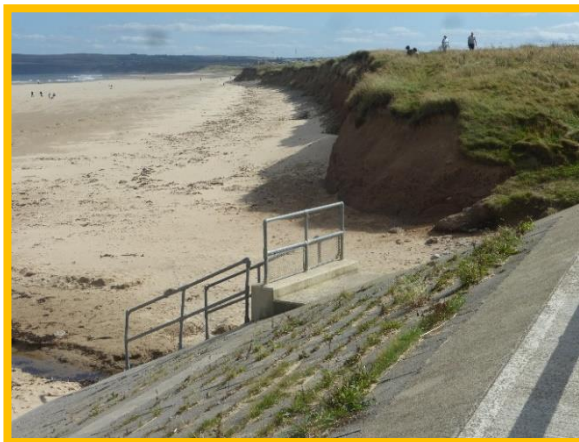
*View looking south east (/C0701C01) CBU E52/10*

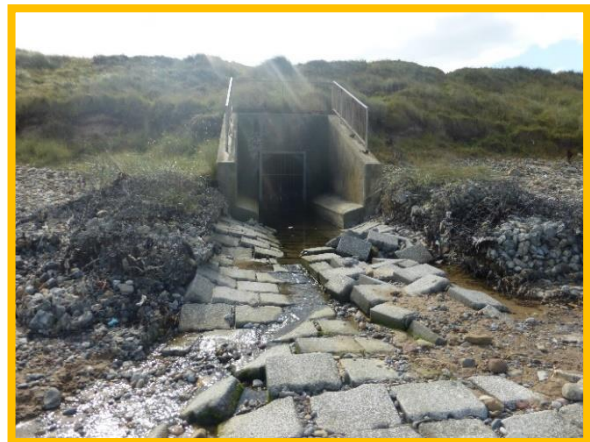
*Concrete outfall structure, note failed gabions and scour protection (/C0701C01) CBU E52/10*

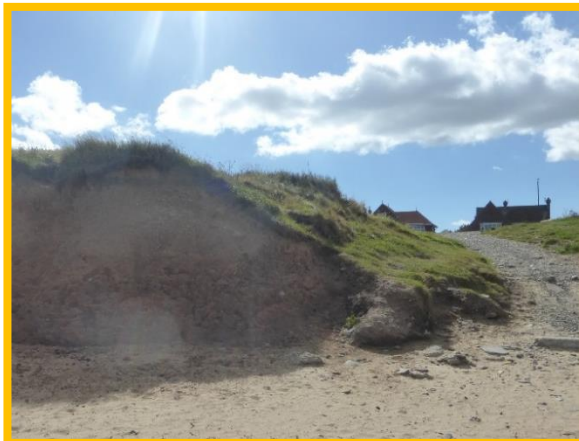
*CBU E52/10 (left) and informal access ramp (right)*

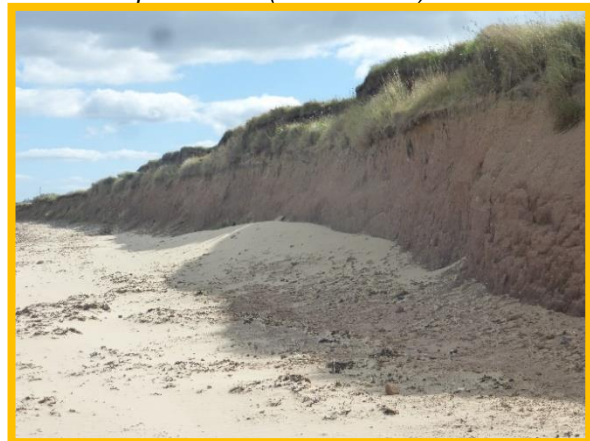
*Looking south east along CBU E52/10 Partly Active in 2020.*

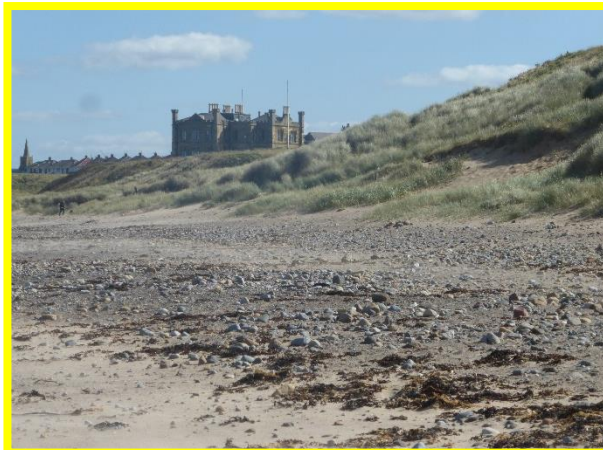
*View looking south east (CBU E52/8)*

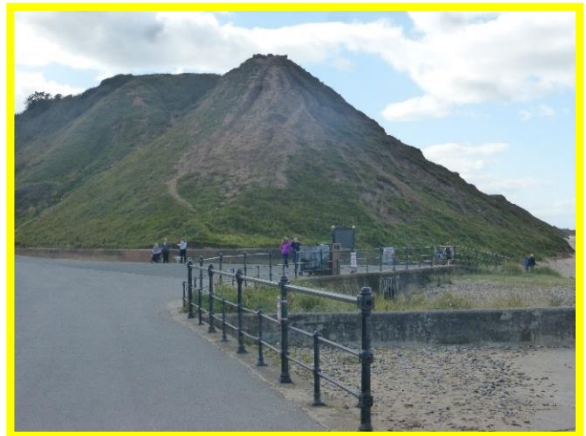
*Southern extent of CBU (CBU E52/4)*

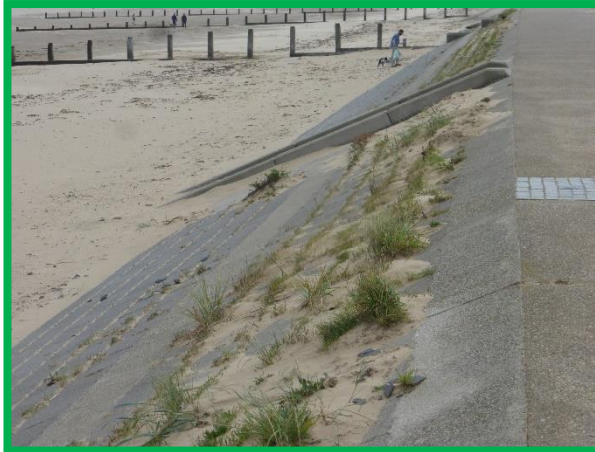
*View on The Stray frontage looking south east (/C0603C01)*

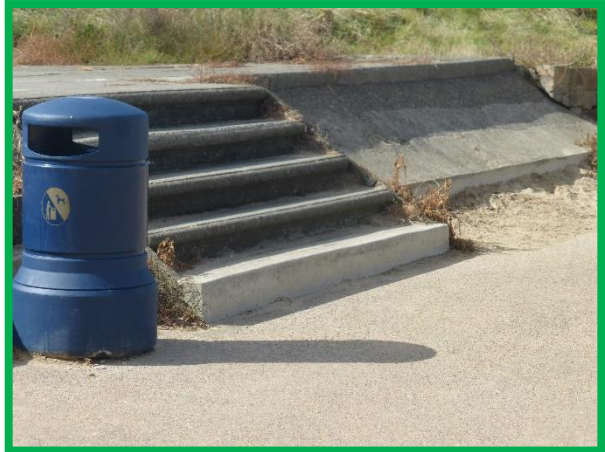
*Recently repaired step at The Stray (/C0603C01)*

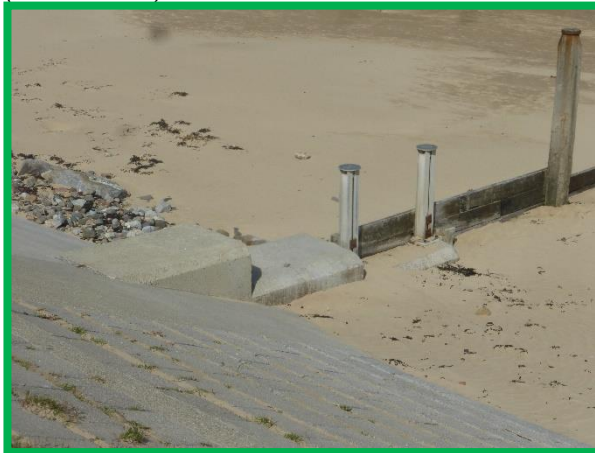
*Recently repaired groyne along The Stray (/C0603C01)*

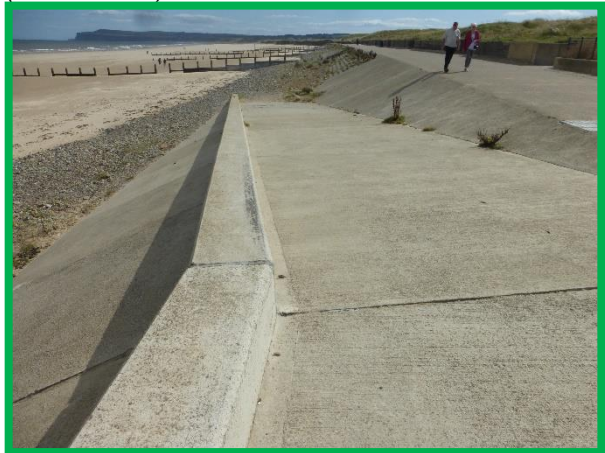
*Slipway in very good condition at The Stray (/C0603C01).*

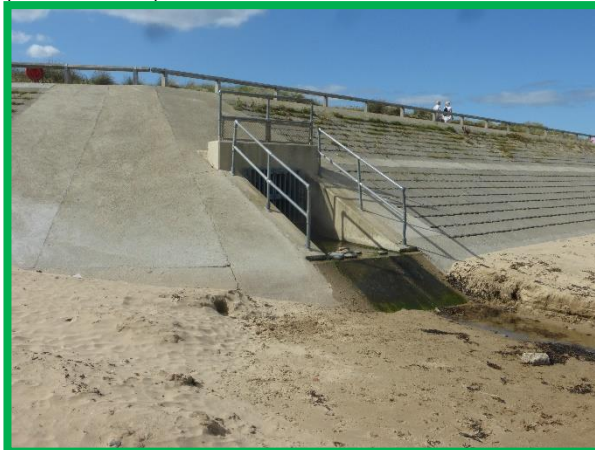
*Outfall at south eastern end of (/C0603C01)*

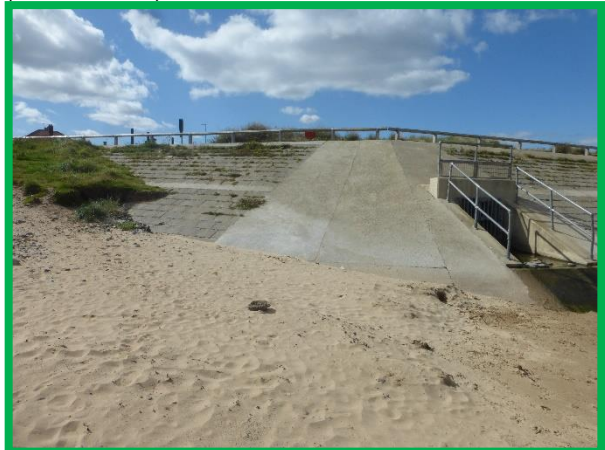
*Transition of revetment into natural defence (/C0603C01)*

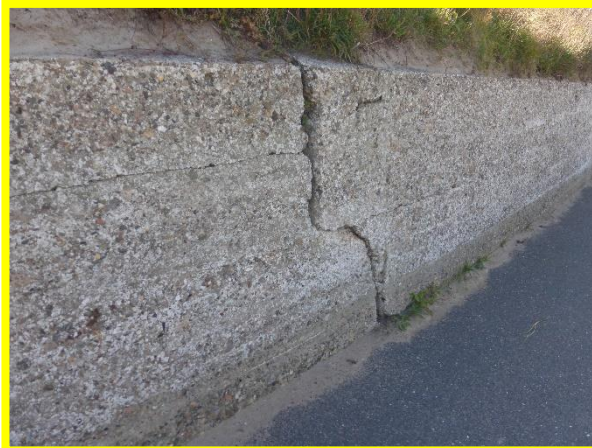
*Crack in wall – no apparent change (/C0702C03)*

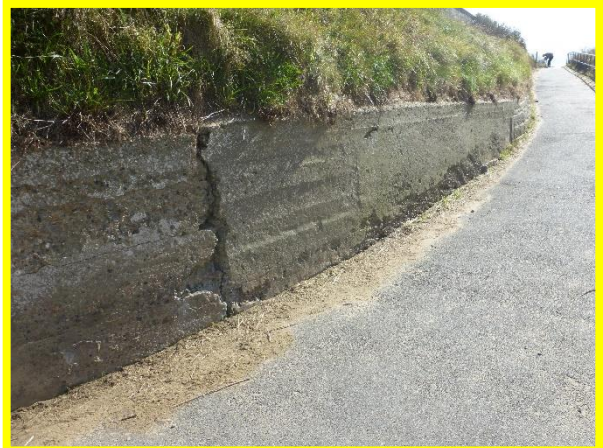
*Masonry wall showing signs of lateral movement (/C0702C03)*

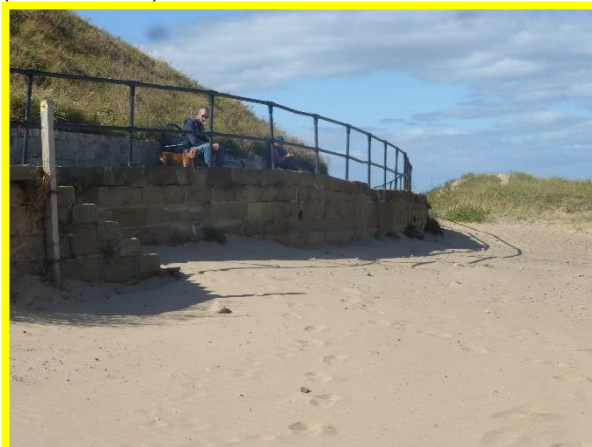
*Wall in fair condition some missing mortar and open joints (/C0702C03)*

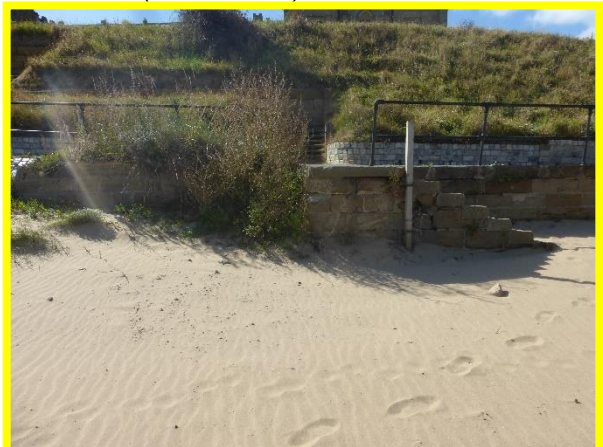
*Wall in fair condition some missing mortar and open joints (/C0702C03)*

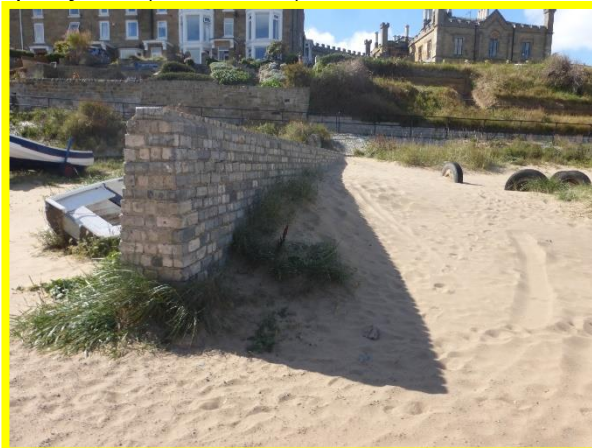
*High beach levels obscure masonry wall and north west of beach entrance (/C0702C01)*

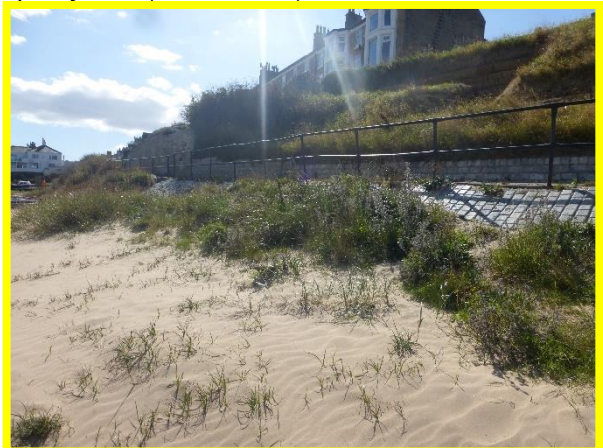
*High beach levels and vegetation revetment north west of beach entrance (/C0702C01)*

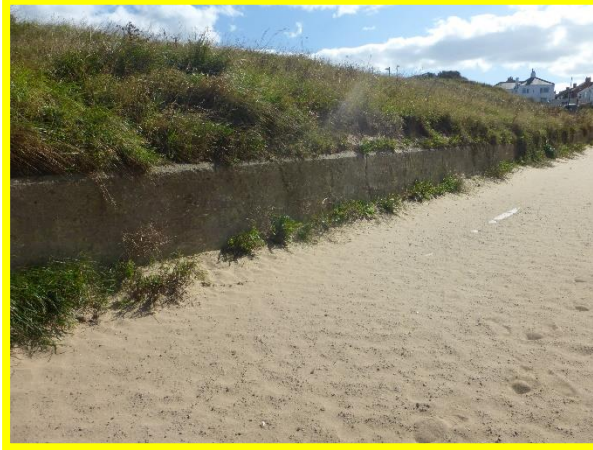
Masonry wall south east of beach entrance (/C0702C01)

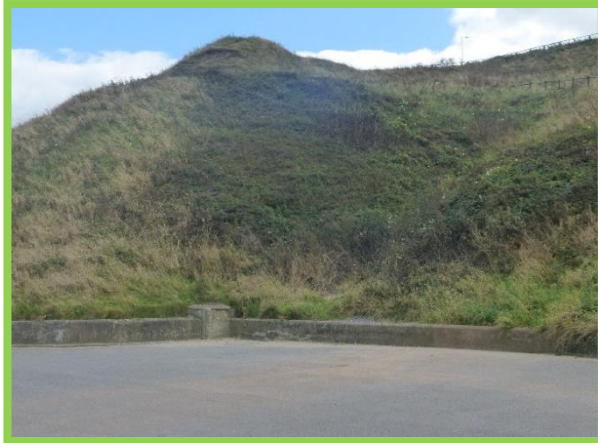
View looking east (E52/3b)

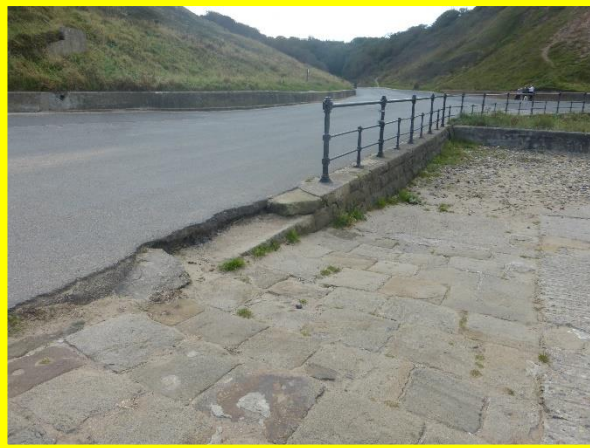
*Missing coping stone exposing fill beneath promenade surface (/C0703C02)*

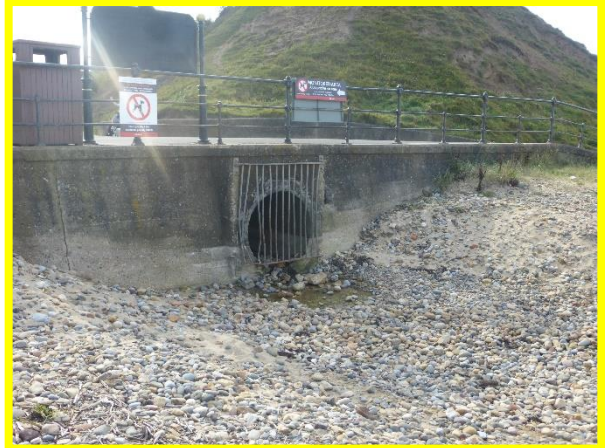
*Security grille damaged (/C0703C02). Note accumulation of beach sediment around base of outfall.*

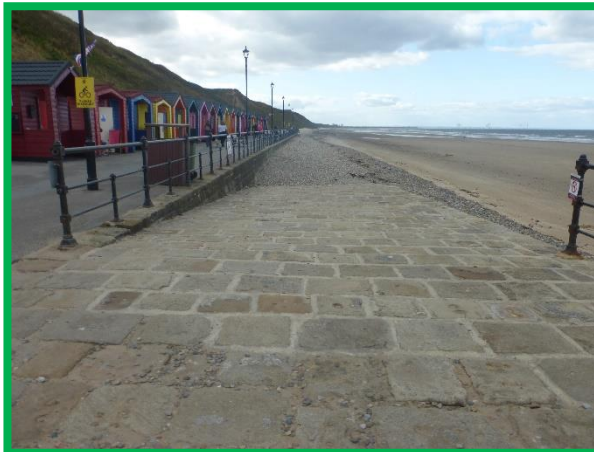
*View looking northwest. Lower beach higher than in 2018. (/C0702C04)*

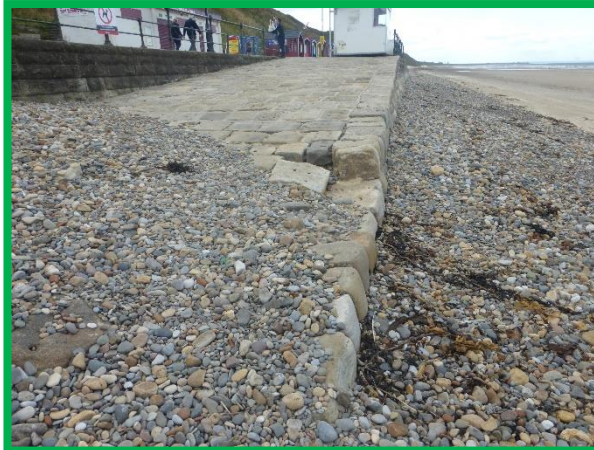
*Damage to slipway coping (/C0702C04)*

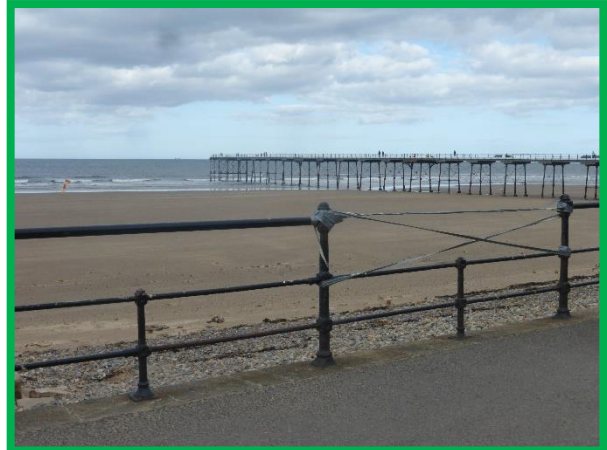
*Damage to handrailing along promenade (/C0702C04)*

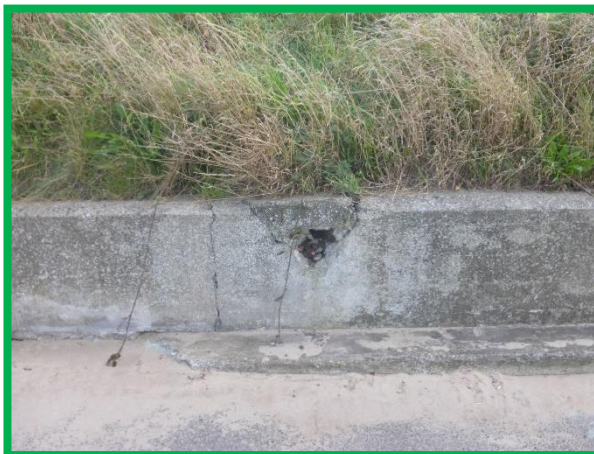
*Defects to shallow retaining wall at rear of promenade (/C0702C04)*

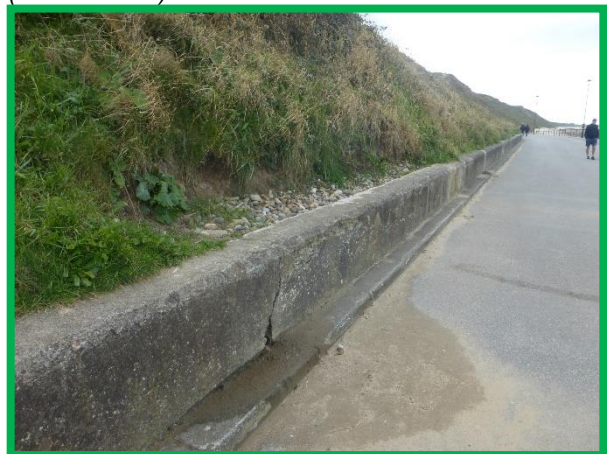
*Further damage to shallow retaining wall evidence of material lost from slope to rear (/C0702C04)*

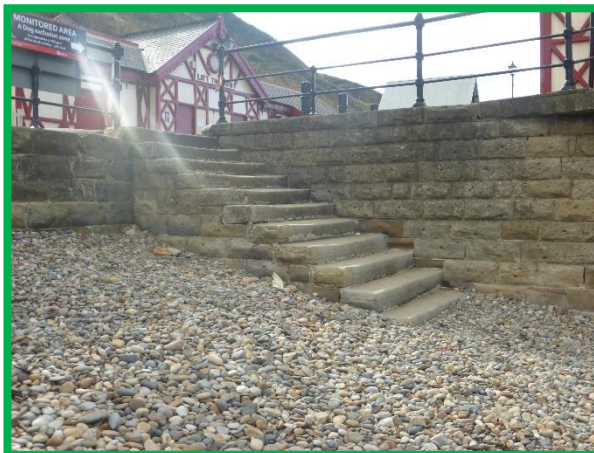
*Beach access steps adjacent Saltburn Pier (/C0702C04)*

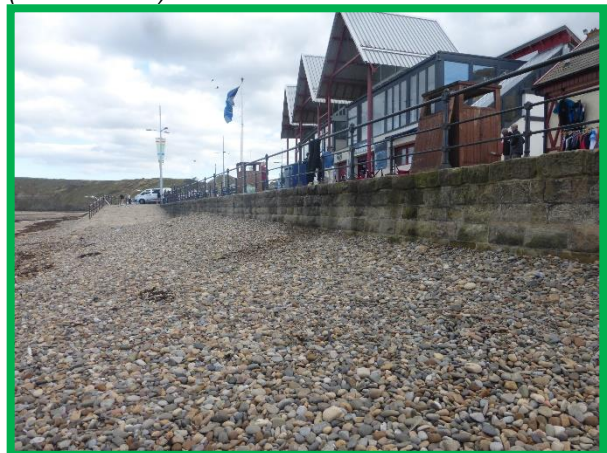
*Looking south east along masonry wall south of pier (/C0702C04).*

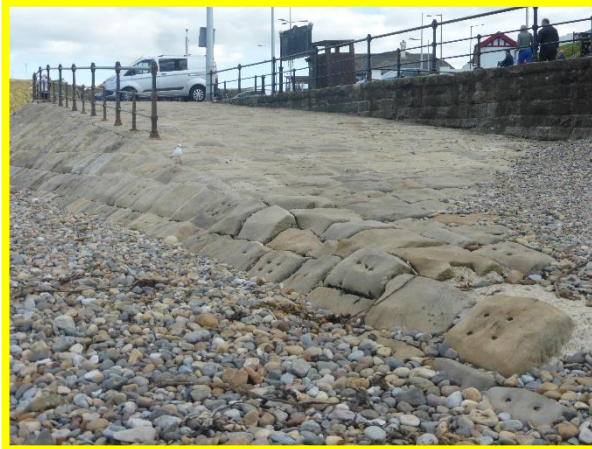
*Slipway south east of Saltburn Pier (/C0704C01)*

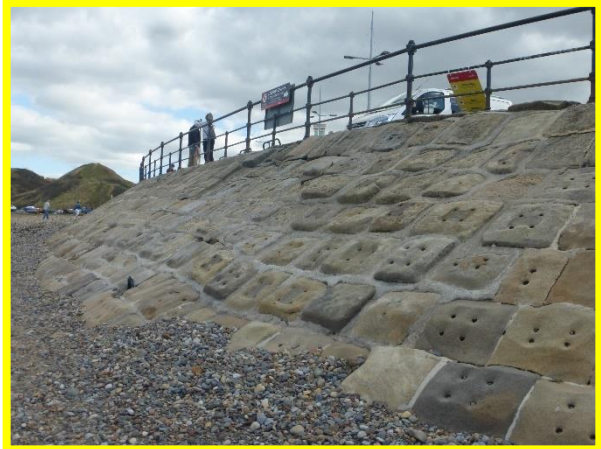
*Missing / damaged blocks at apex of structure (/C0704C01)*

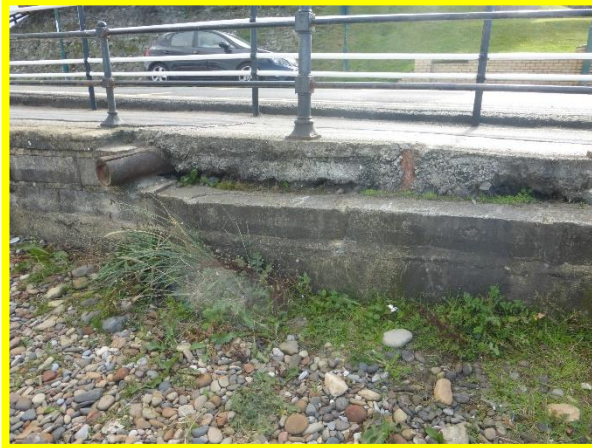
*Damage to coping stones along low blockwork wall (/C0704C06)*

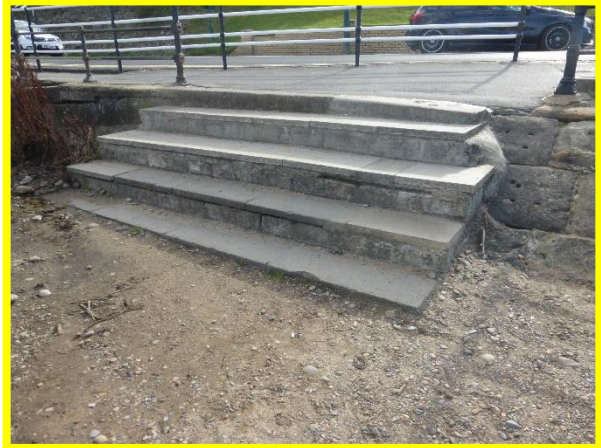
*Repairs to steps in fair condition (/C0704C06)*

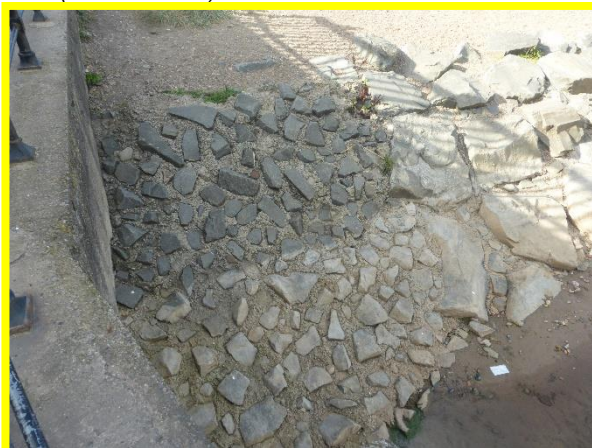
*Grouted rock revetment in fair condition (/C0704C06)*

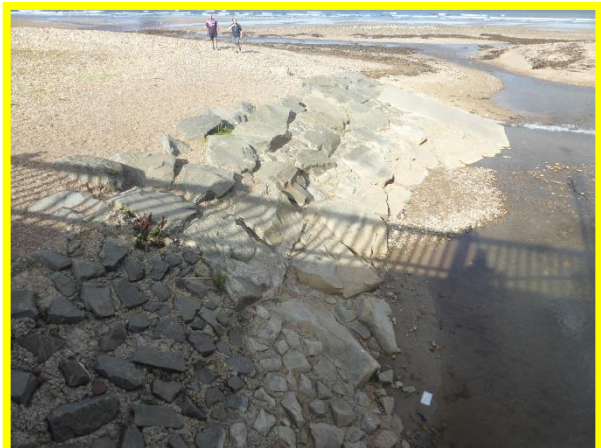
*Grouted rock revetment in fair condition (/C0704C06)*

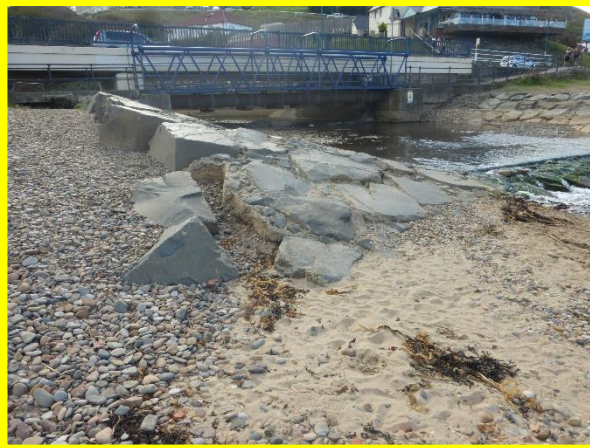
*Exposed crest of grouted rock revetment (/C0704C06)*

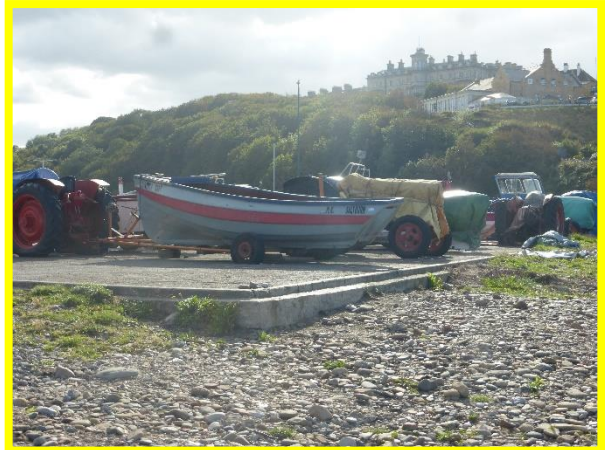
*Exposure of corner of car park (/C0704C02)*

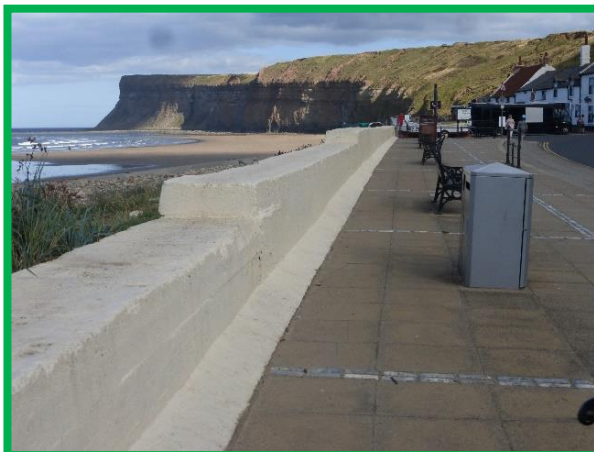
*View looking west (/C0704C03)*

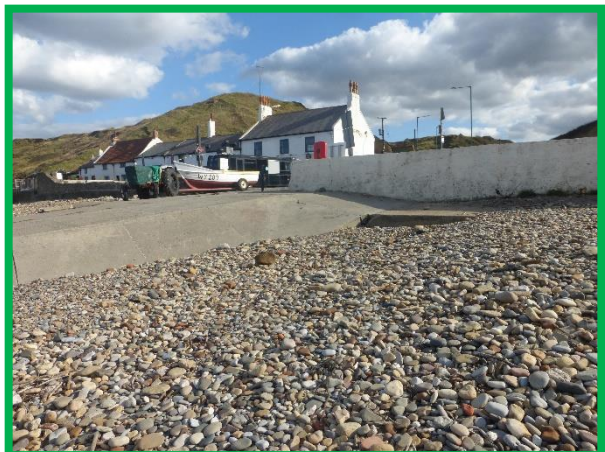
*Western face of concrete slipway (/C0704C03)*

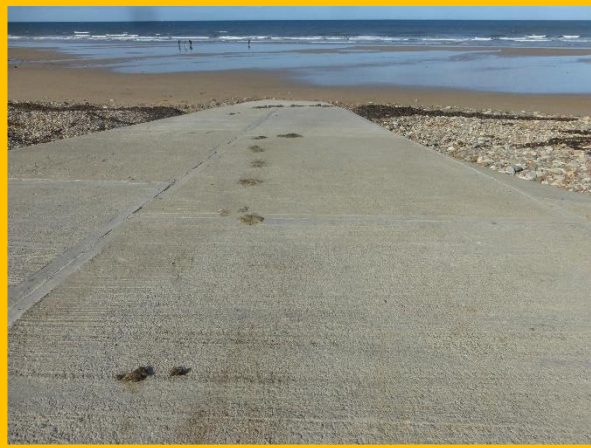
*Low beach levels exposing undercutting of toe (/C0704C05)*

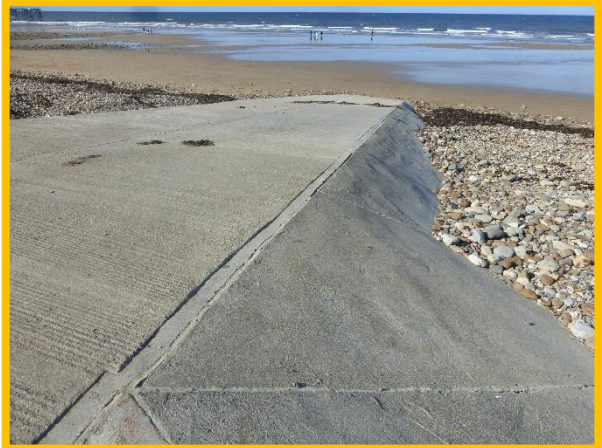
*Damage to boundary wall fronting Public House (/C0704C05)*

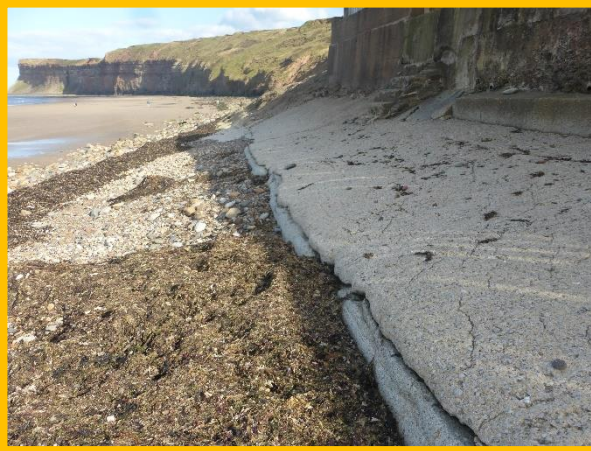
*Undercutting of concrete apron (/C0704C05)*

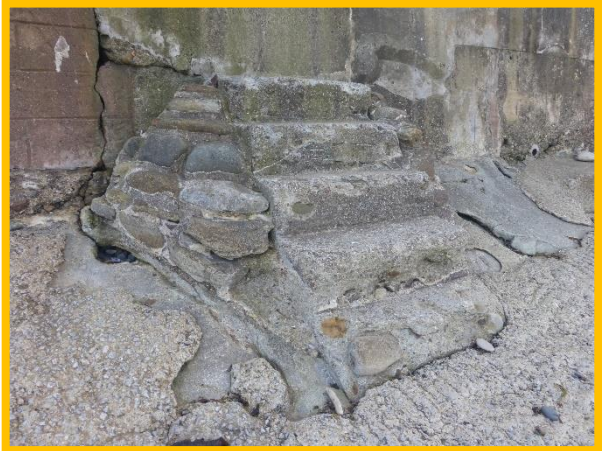
*Ad hoc repairs to seawall in poor condition (/C0704C05)*

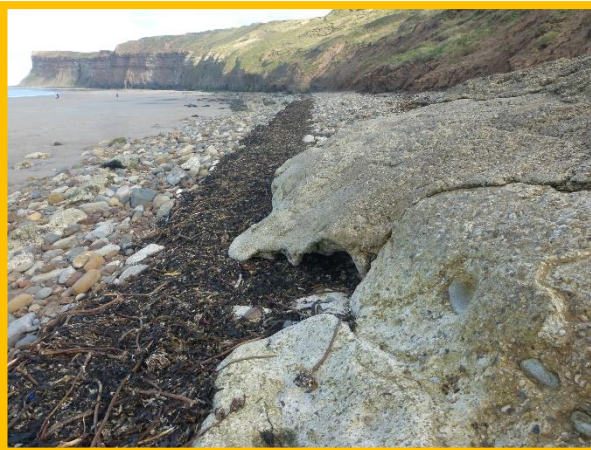
*Undercutting of mass concrete apron (/C0704C05)*

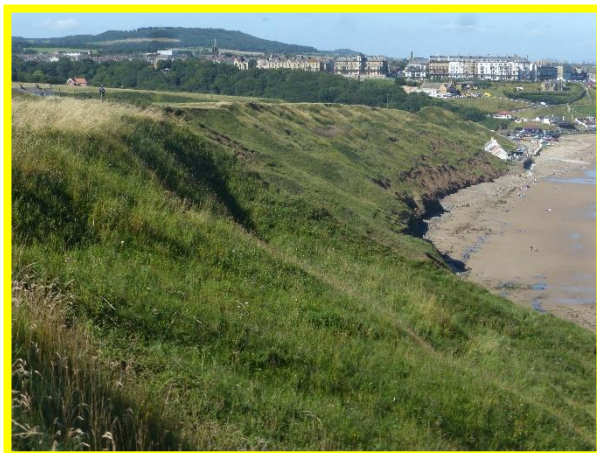
**E53/3 to E53/5** Generally small-scale slumping in the till layer of the cliff northeast of Saltburn (Locally Active in August 2020).
