## **Cell 1 Regional Coastal Monitoring Programme Walkover Inspection Surveys 2020**

**Redcar & Cleveland  
Borough Council**

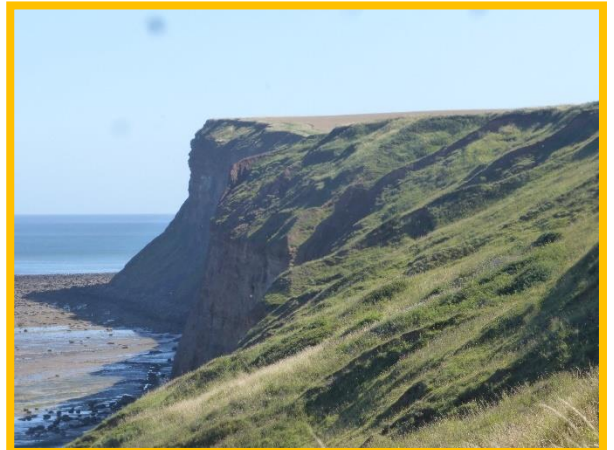
**E53/3** (foreground) Locally Active in 2020 **E53/2** is obscured by minor headland and **E53/1** (visible in background) Locally Active in 2020.

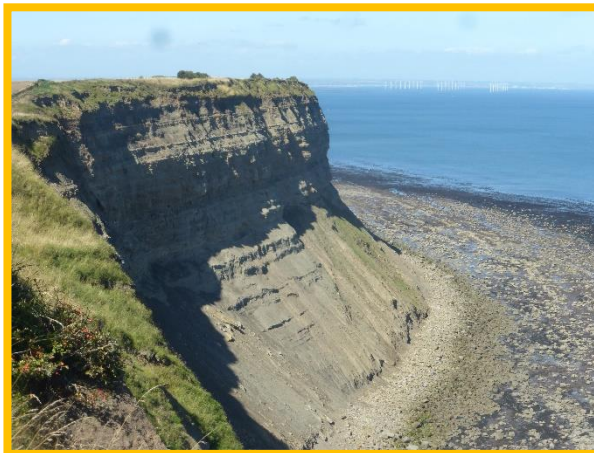
**E54/4** looking northwest along Hunt Cliff showing active cliff face and debris apron (Partly Active)

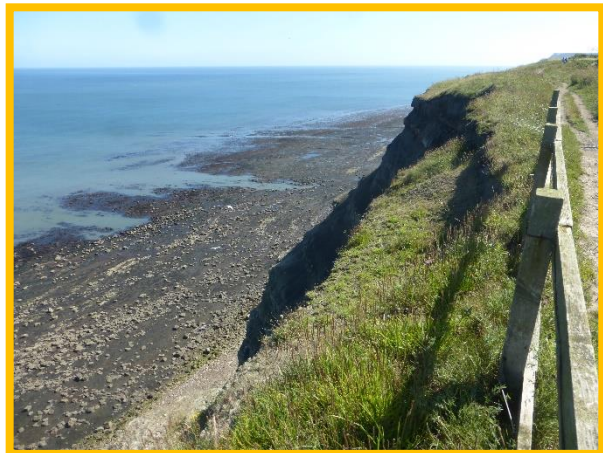
**E54/3a** proximity of footpath and railway line to actively eroding cliff top (Partly Active)

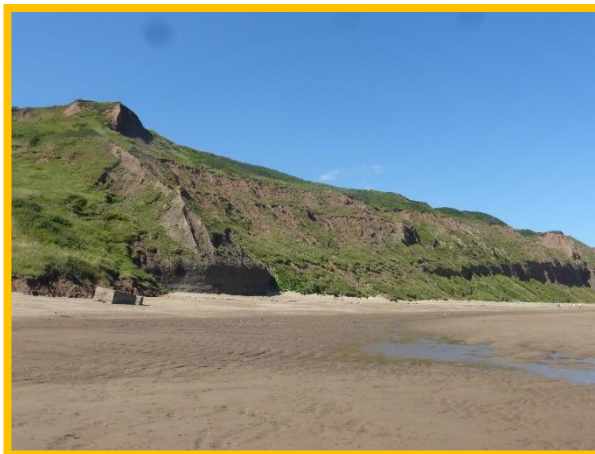
**E55/2** Vegetated layer of till, which sits above the Lower Jurassic bedrock. Partly Active. ]

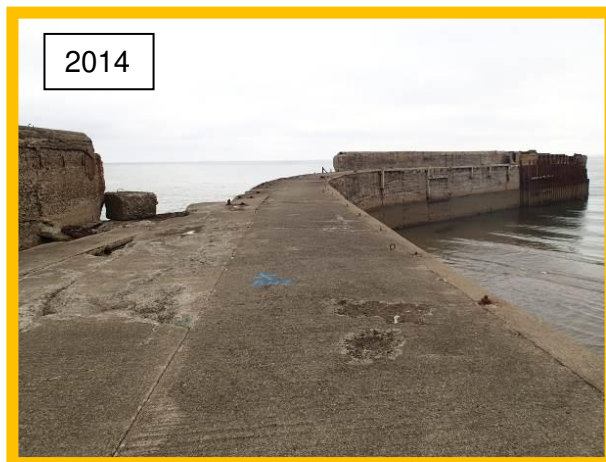
View of crest from access gate showing missing section of crest wall and damaged deck in 2014 (Asset Ref No. 1221D901D0201C02)

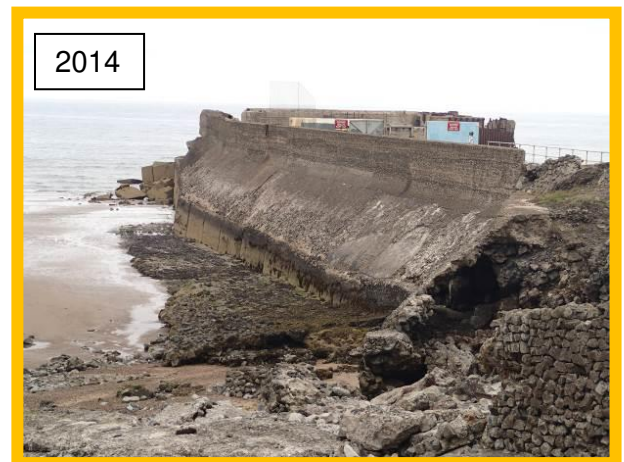
Voiding and collapse of west side of jetty structure in 2014 (Asset Ref No. 1221D901D0201C02)

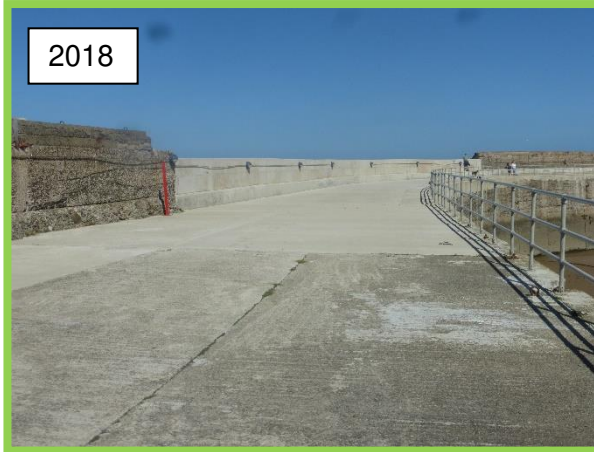
Repaired and improved structure in 2018  
(Asset Ref No. 1221D901D0201C02)

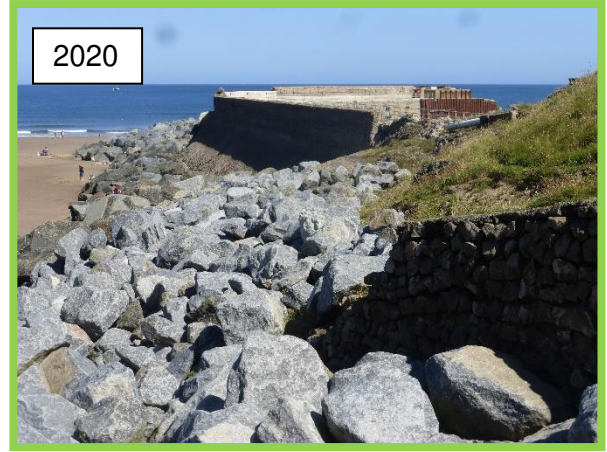
Repaired and improved rock armour  
(Asset Ref No. 1221D901D0201C02)

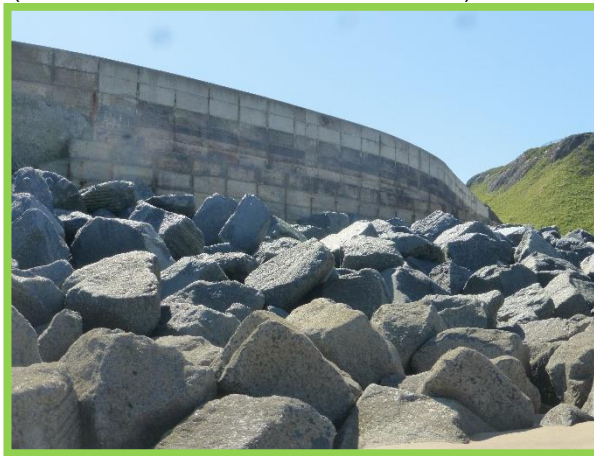
Seaward face of repair.  
(Asset Ref No. 1221D901D0201C02)

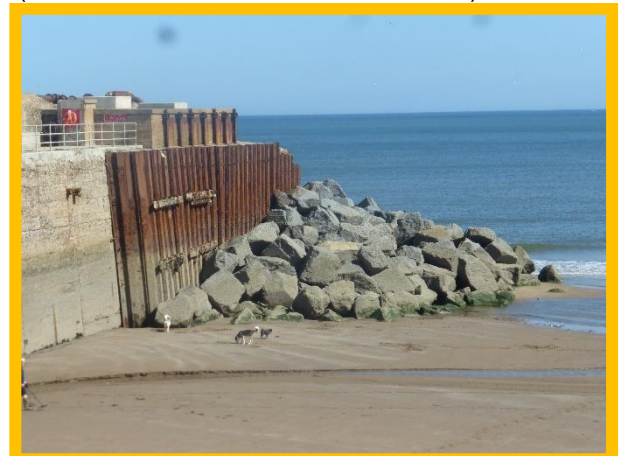
Heavily corroded sheet piles and rock armour  
around nose of original jetty structure.

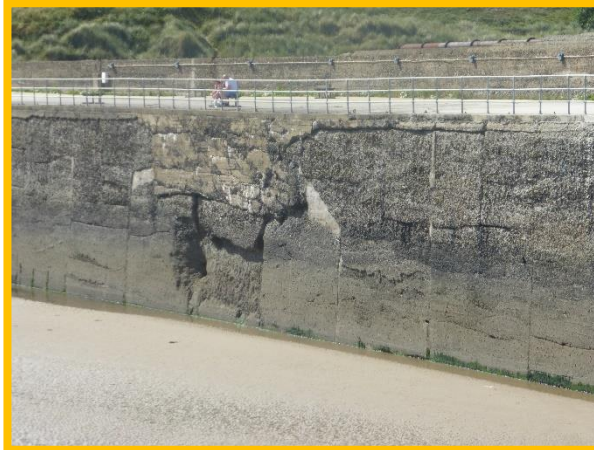
Void visible halfway along inner face of  
breakwater.  
(Asset Ref No. 1221D901D0201C02)

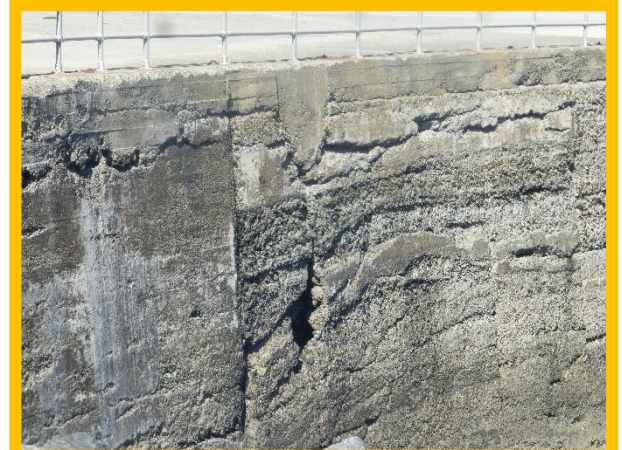
Void visible at root of breakwater.  
(Asset Ref No. 1221D901D0201C02)

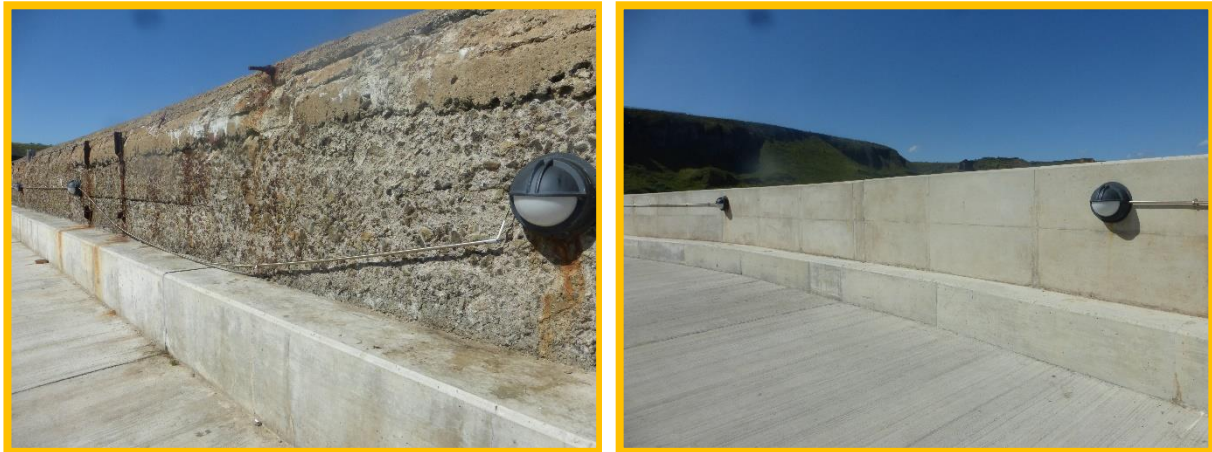
Damaged lighting conduit at head of breakwater. Severed conduit on breakwater.

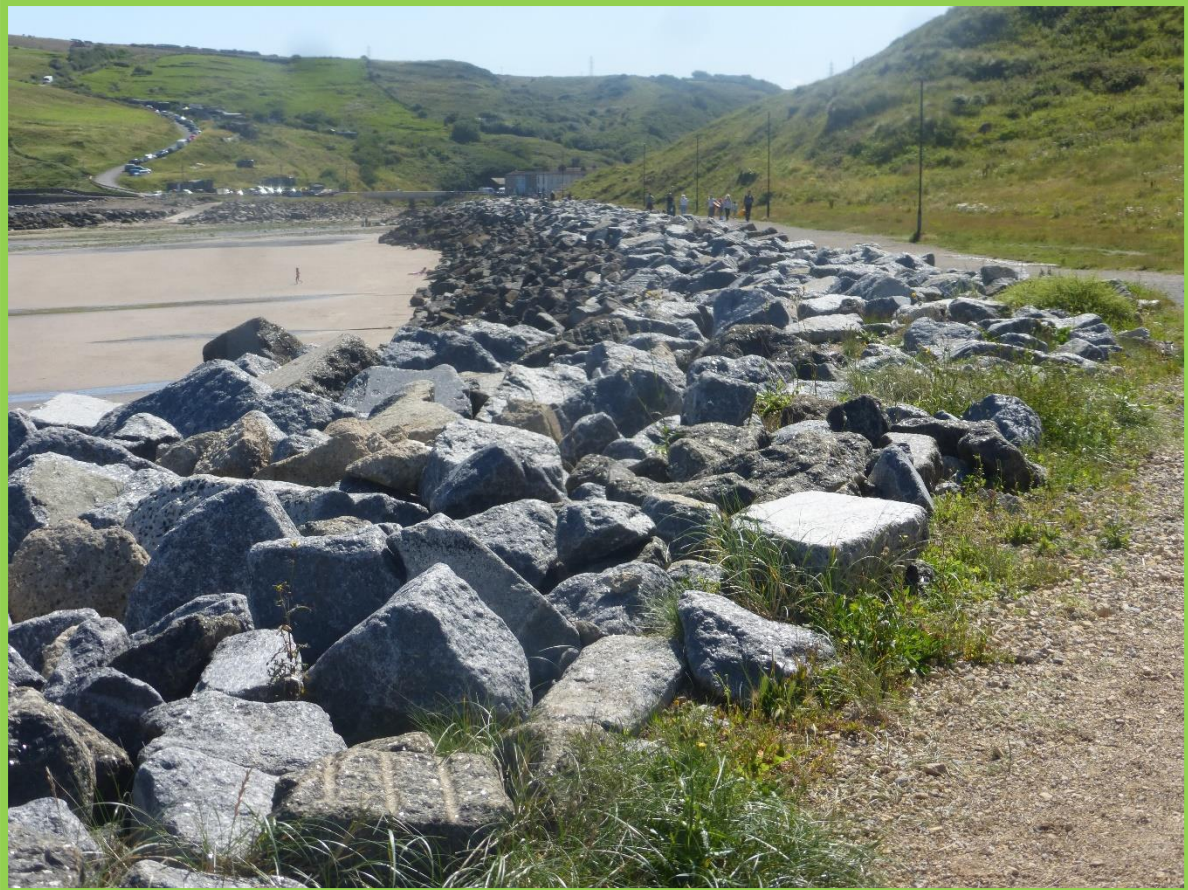
General view of modified revetment and surfaced path looking from Jetty towards village in 2020  
(Asset Ref No. 1221D901D0202C01)

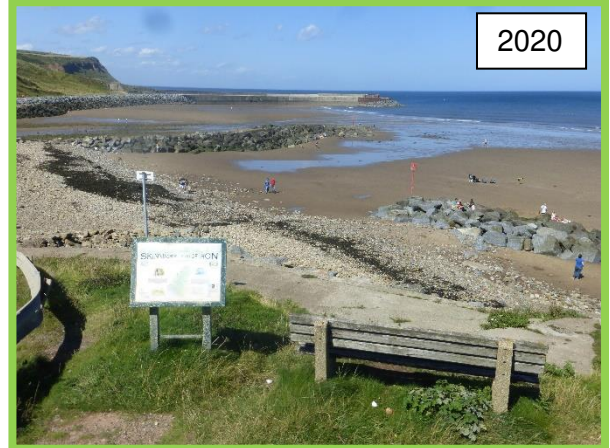
Original defences to the east of Kilton Beck, 2014

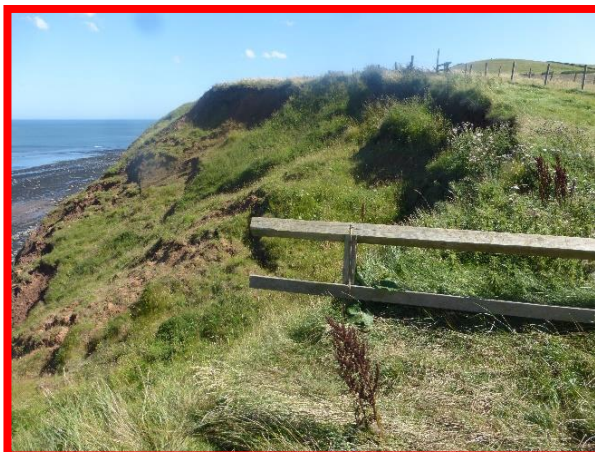
**E57/7** Slumping and recession along headscarp (Totally Active)

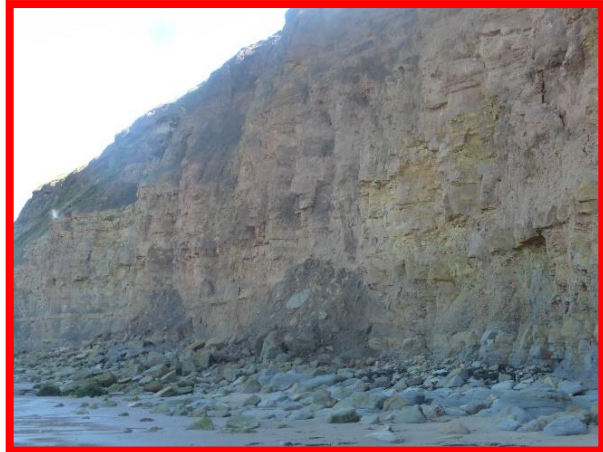
**E57/7** evidence of multiple significant rockfalls (Totally Active)

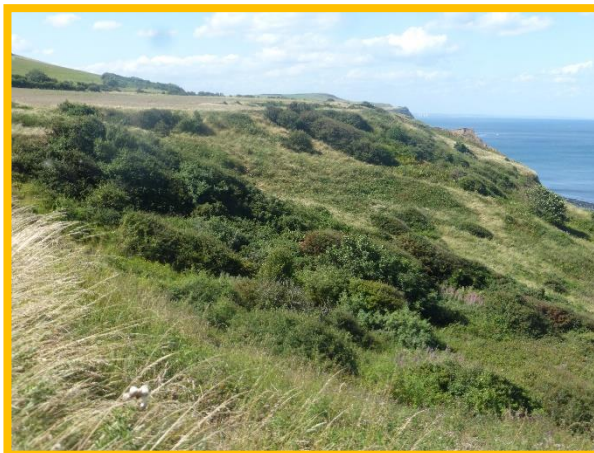
**E57/3** Hummersea Bank

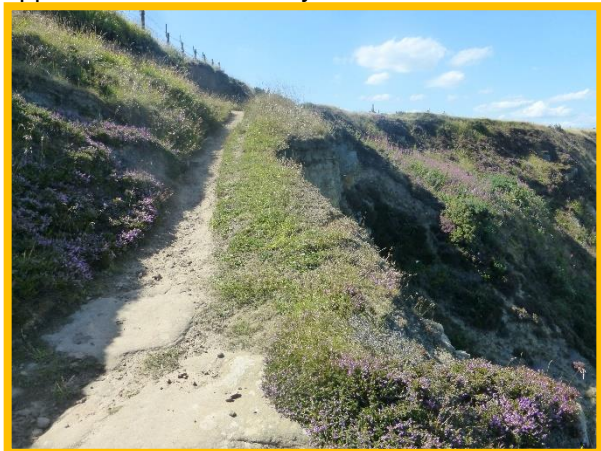
**E58/5** Upper further signs of headscarp recession presenting an imminent risk to footpath stability.

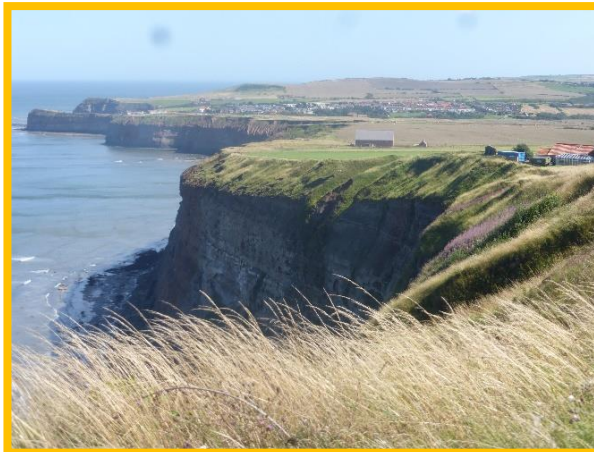
**E58/1 to E59/8** Soft, slumping, upper till resting upon harder rock (Partly Active). E59/9 (Locally Active) fronts the properties.

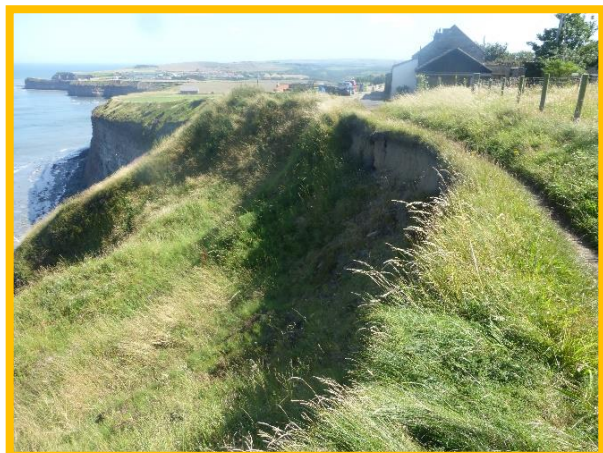
**E58/1a** headscarp recession encroaching on footpath.

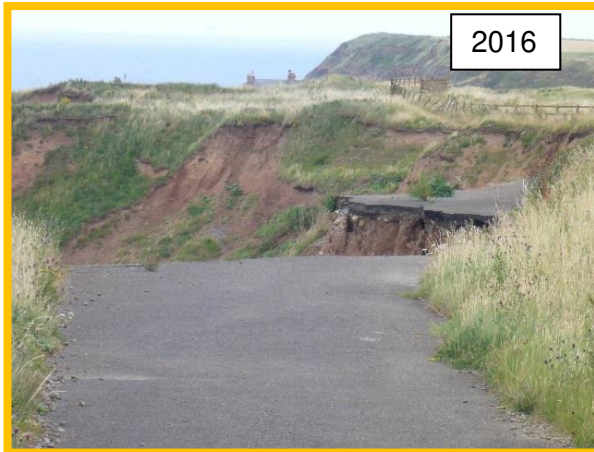
**E59/3 and E59/4** Loss of road due to ongoing erosion at Cowbar Lane

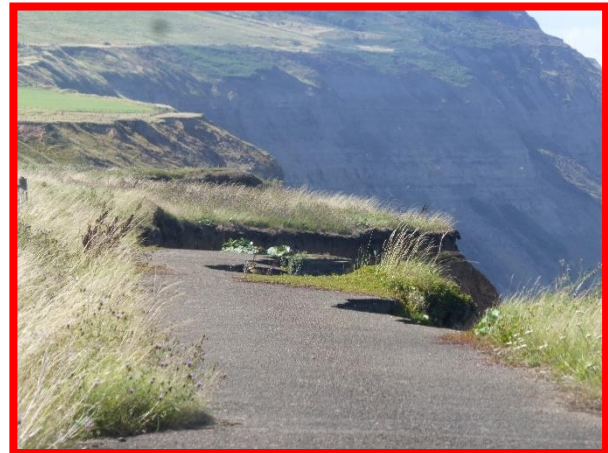
**E59/3** Ongoing erosion of soft till layer leading to collapse of road (Totally Active).

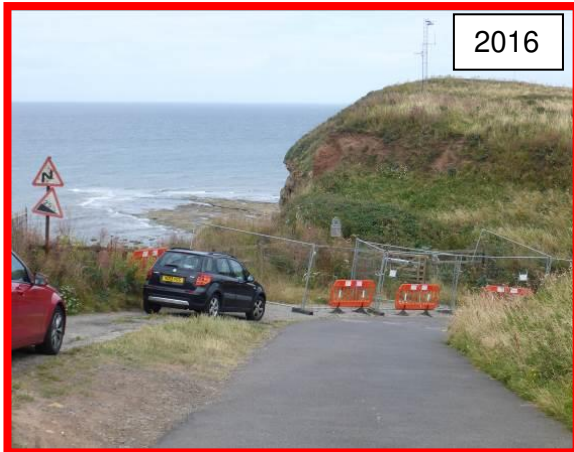
**E60/1** Closure of access to Cowbar Nab in 2016, in 2018 the access appeared in very similar state with the same Heras fencing and plastic barriers still in use.

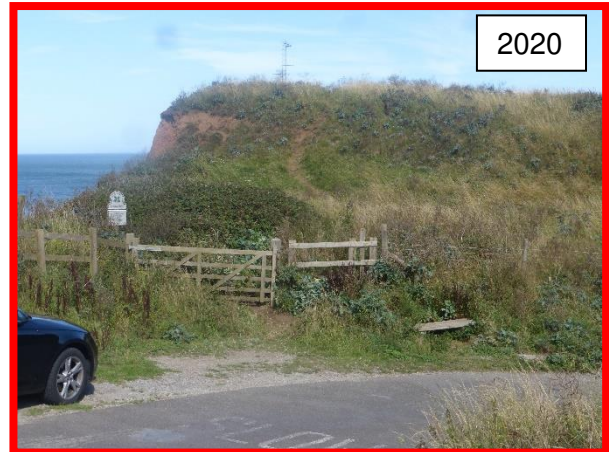
**E60/1** In 2020 the access is now no longer marked as closed although the path onto the Nab is overgrown.

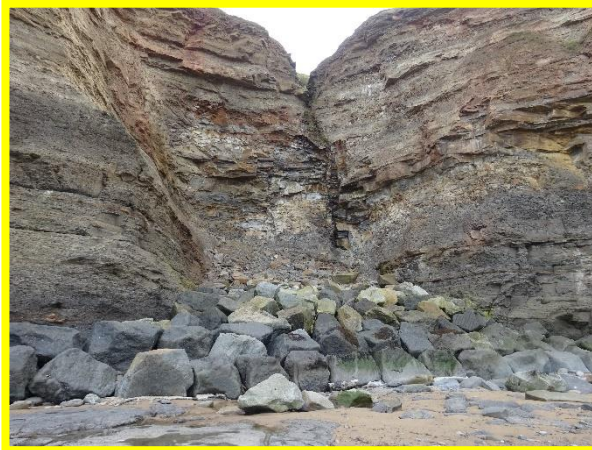
**E59/1** Rock armour located at toe of cliff to the west of Cowbar Cottages
