Cell 1 Regional Coastal Monitoring Programme Walkover Inspection Surveys 2022

**Redcar & Cleveland
Borough Council**

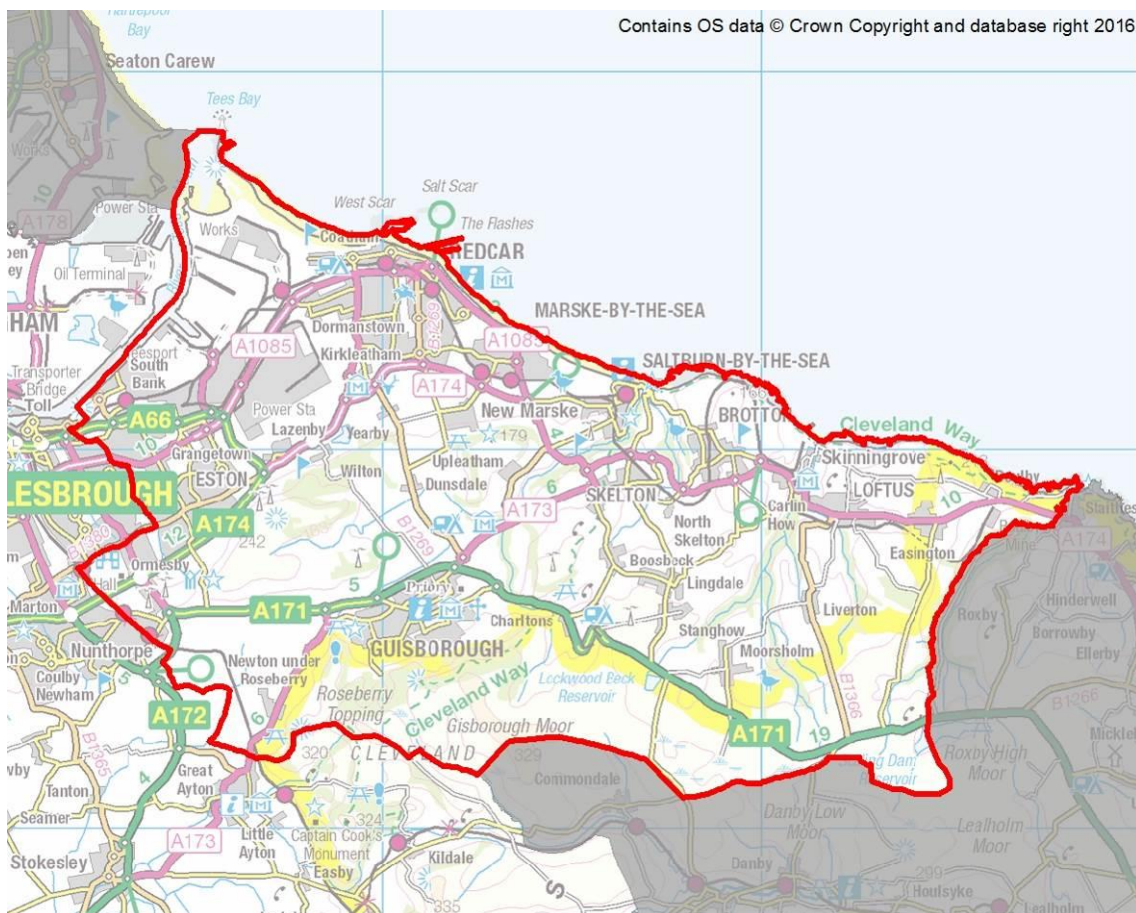
Figure 1-1: Redcar & Cleveland Borough Council study area

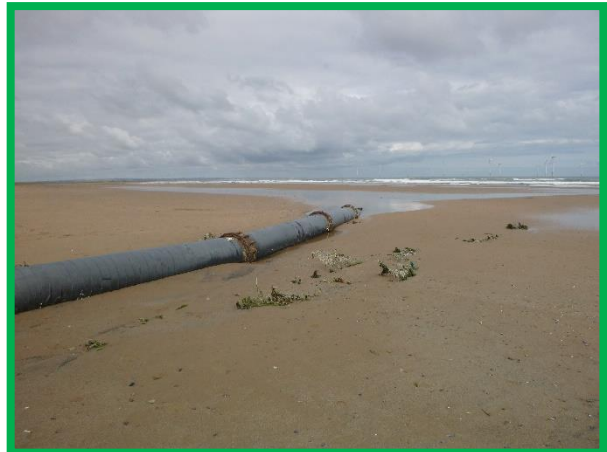
Outfall on Coatham Sands in poor condition, beach levels higher than 2020 (/C0507C01)

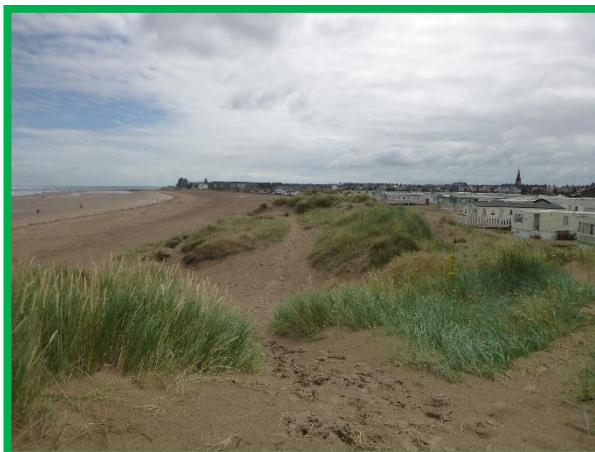
View looking south west from caravan site (/C0507C01)

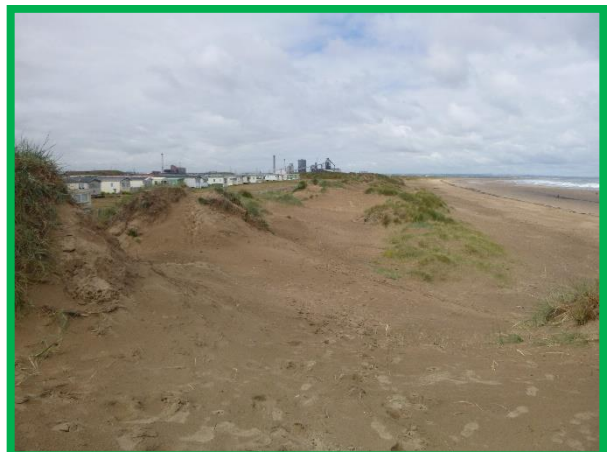
View looking north west from caravan site (/C0507C01)

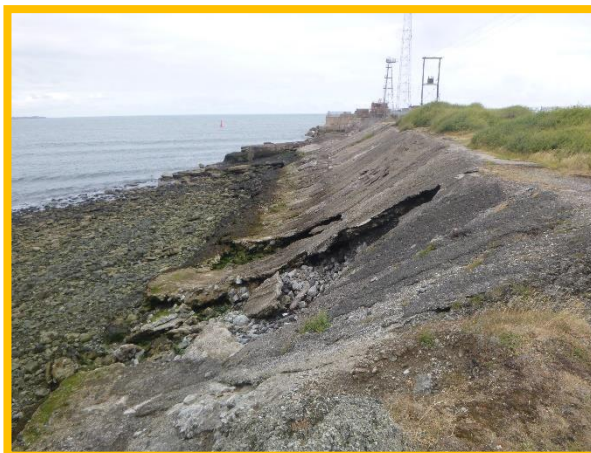
Large void in western face has worsened in 2022 (/C0506C01)

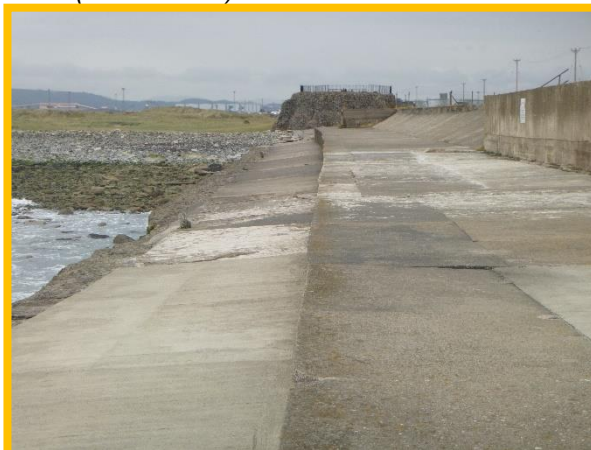
Historic repairs to deck slab along eastern face (/C0506C01)

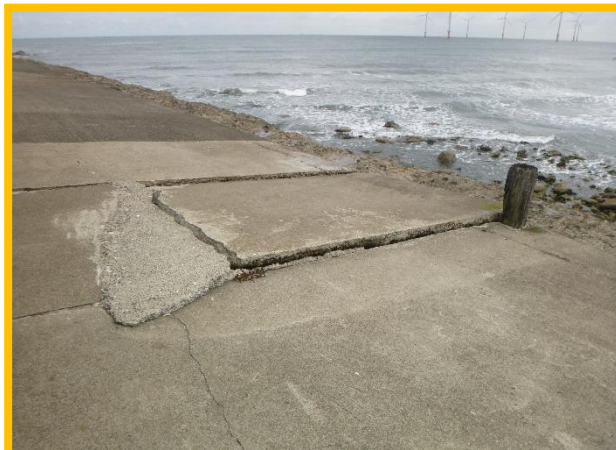
Repaired deck slab has now failed along eastern face (/C0506C01)

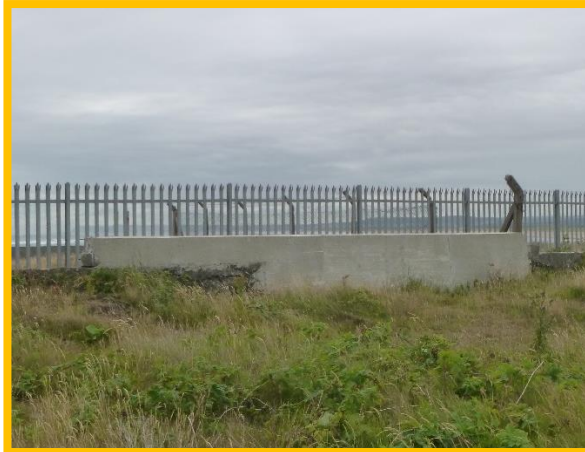
Repairs to wall on breakwater crest (/C0506C01)

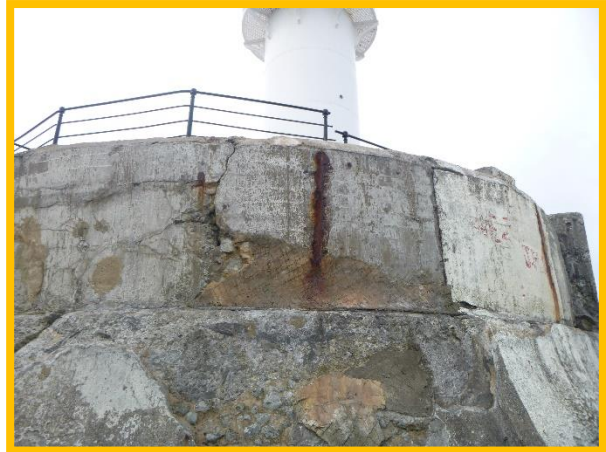
Northern extent of upper structure in poor condition (/C0506C01)

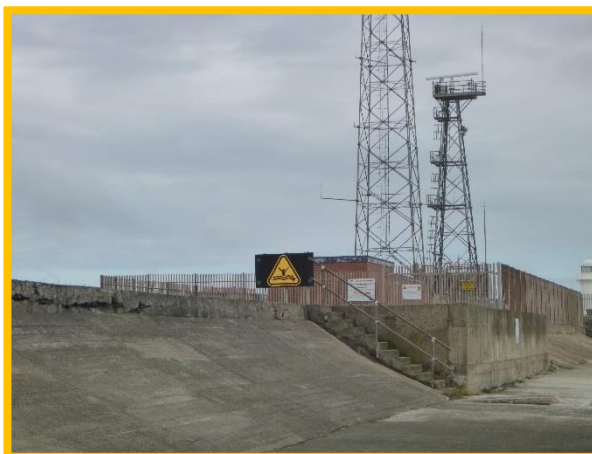
New LCD warning screen (/C0506C01)

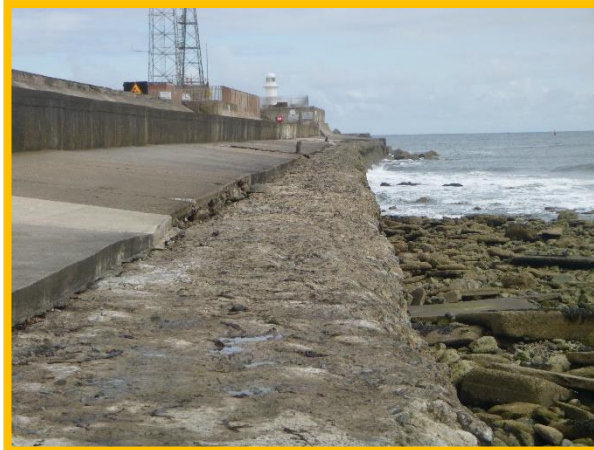
Failed coping slab along eastern face (/C0506C01)

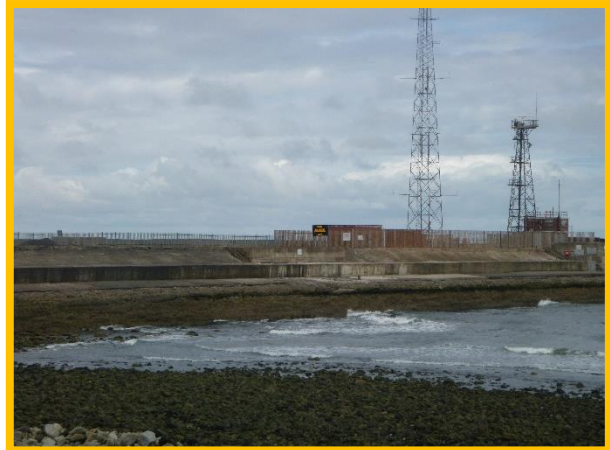
Potential voids visible beneath failed deck slab along eastern face (/C0506C01)

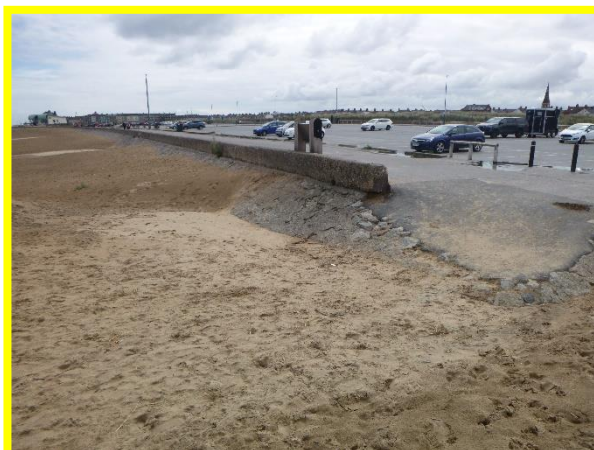
View looking east, note high beach levels (/C0601C01)

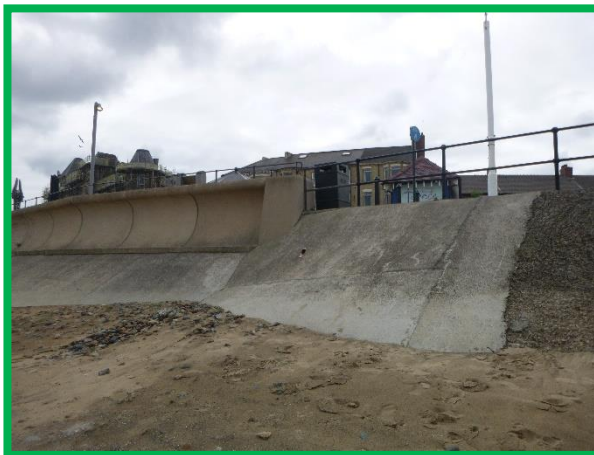
Mass concrete transition in fair condition. Note; horizontal and vertical cracks and damaged drain outfall (/C0602C06)

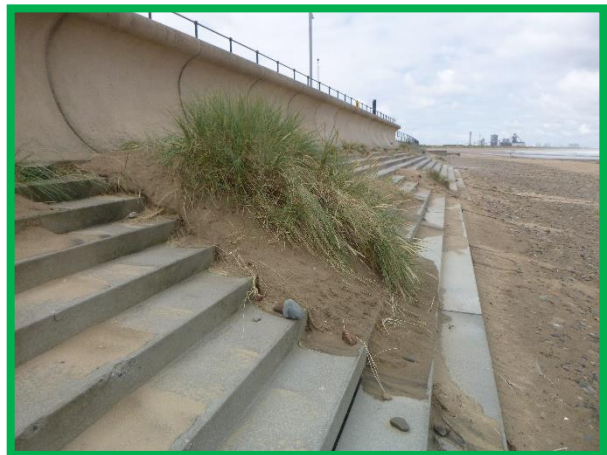
Vegetation growth on stepped revetment. (/C0602C06)

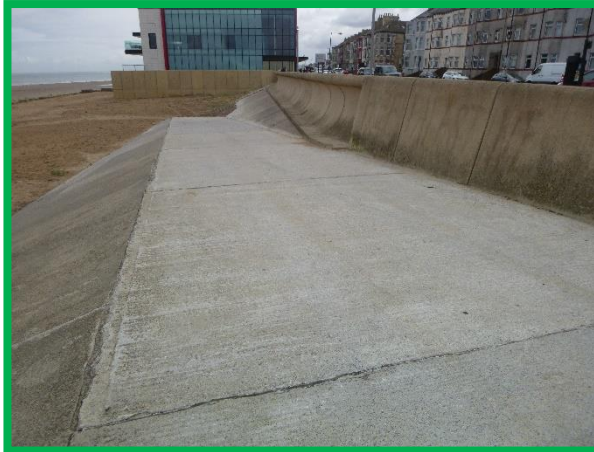
Slipway in good condition (/C0602C06).

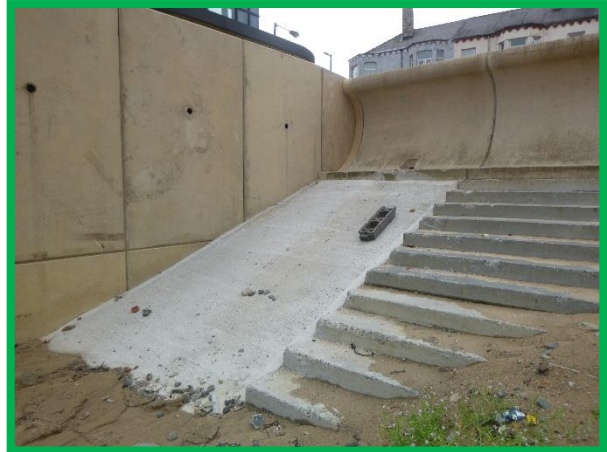
In-situ cast transition unit between stepped revetment and new cinema wall (/C0602C06) & (/C0602C05)

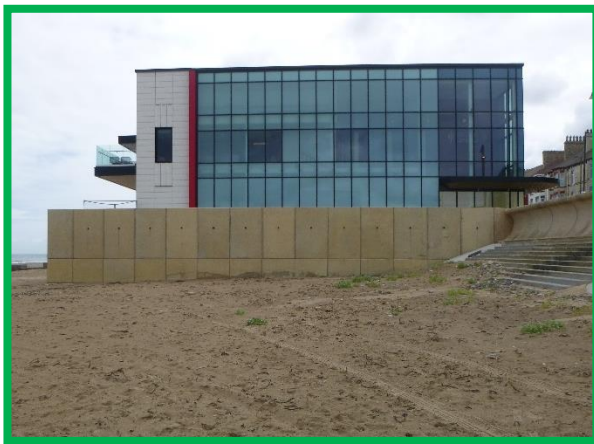
Cinema seawall in as-built condition (/C0602C05)

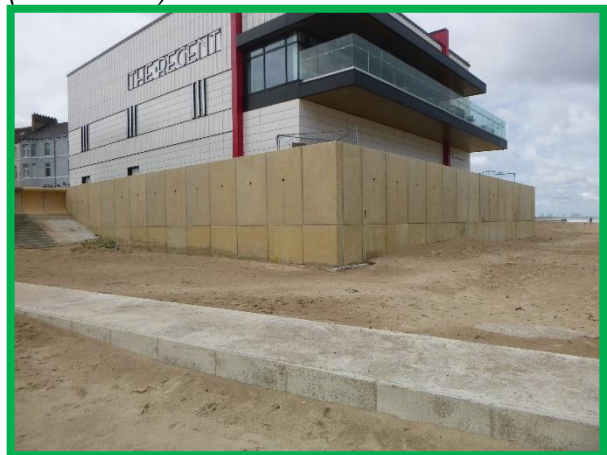
New Regent Cinema seawall (/C0602C05)

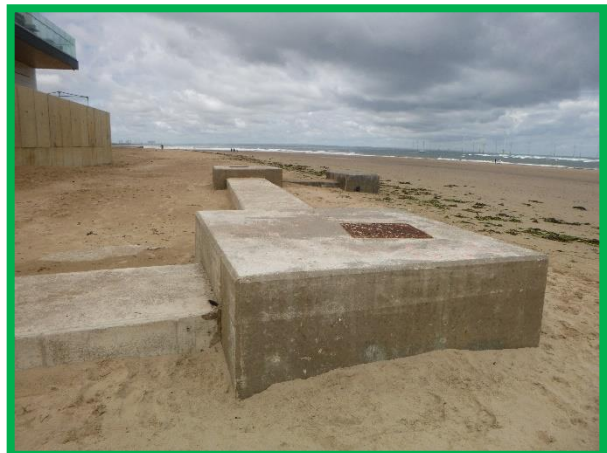
Outfall structure has been re-constructed and is in as-built condition (/C0602C05)

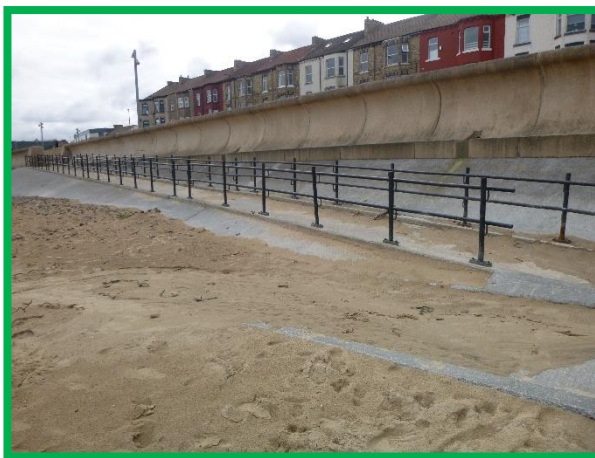
Slipway in very good condition (/C0602C04)

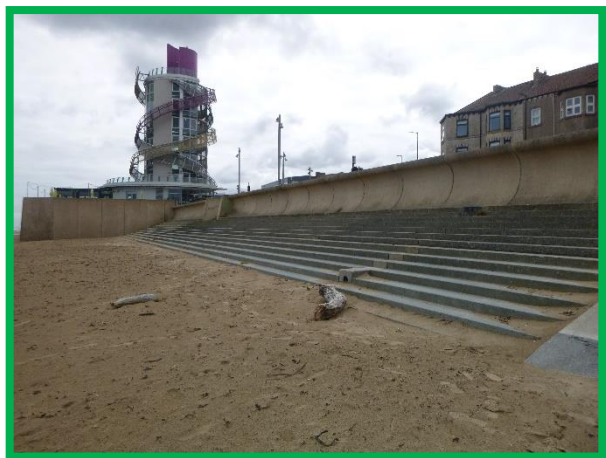
Stepped concrete revetment with recurve wall in very good condition (/C0602C03)

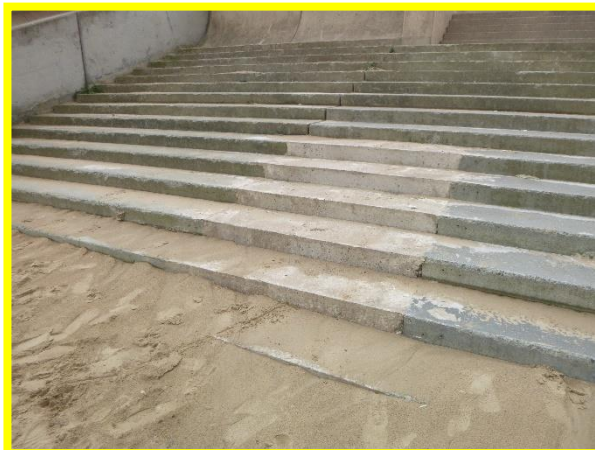
In situ concrete repair in fair condition (/C0602C04)

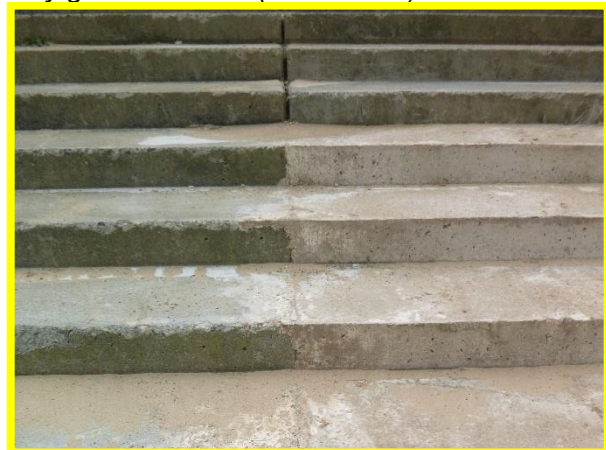
Close up of repair (/C0602C03)

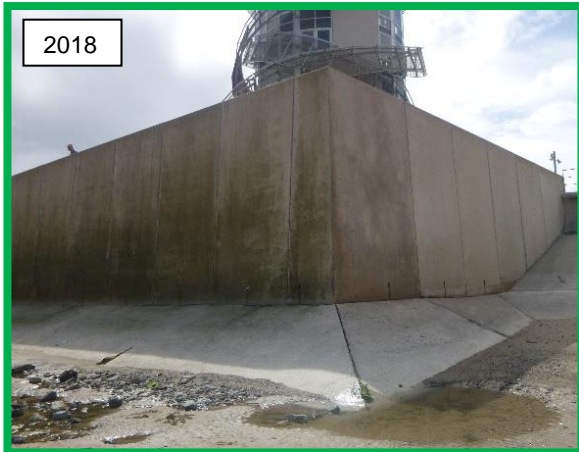
Concrete sea wall at Redcar Beacon in 2018 (/C0602C03)

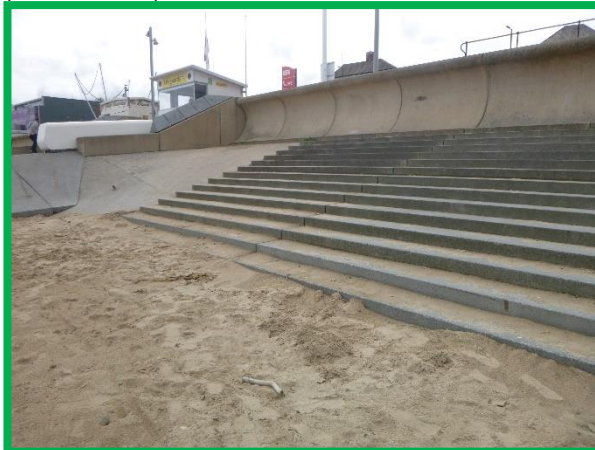
Stepped concrete revetment and recurve wall in very good condition (/C0602C03)

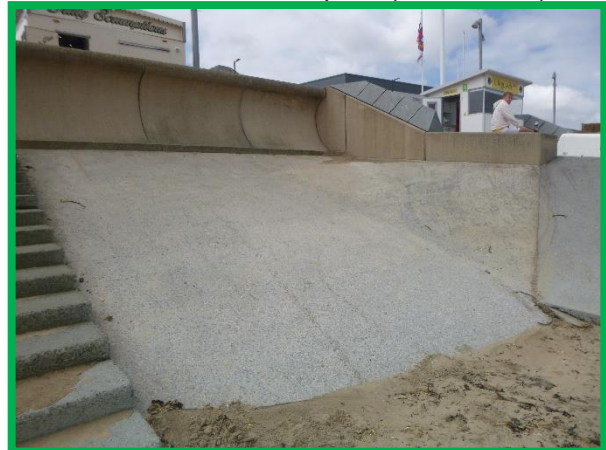
In-situ cast concrete transitions in good condition (/C0602C03)

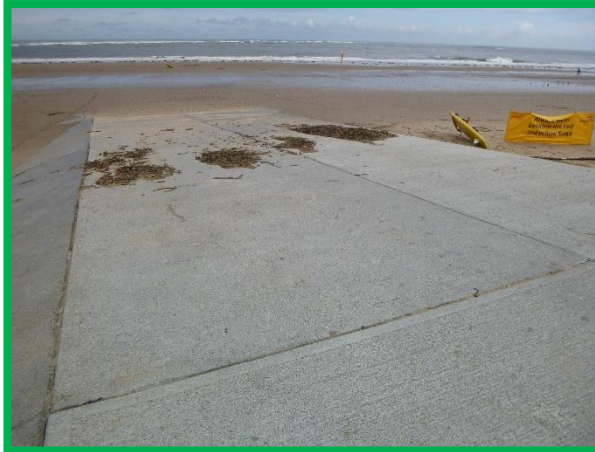
Slipway in good condition (/C0602C03)

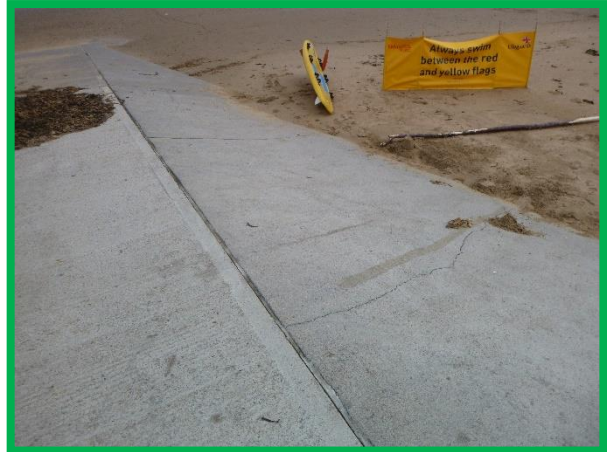
Joint sealant on slipway in fair condition (/C0602C03)

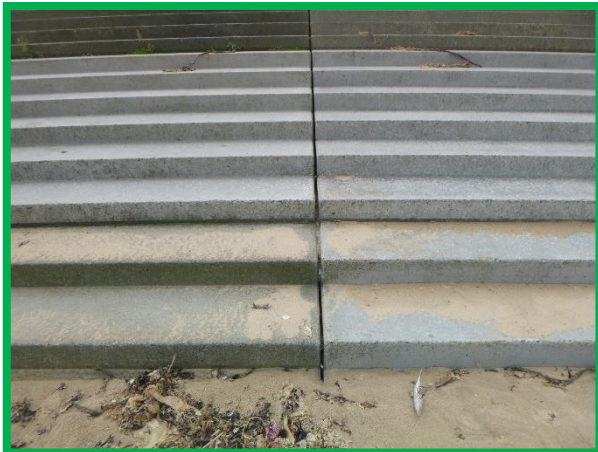
Open joints in stepped concrete revetment. Overall condition remains as very good (/C0602C02)

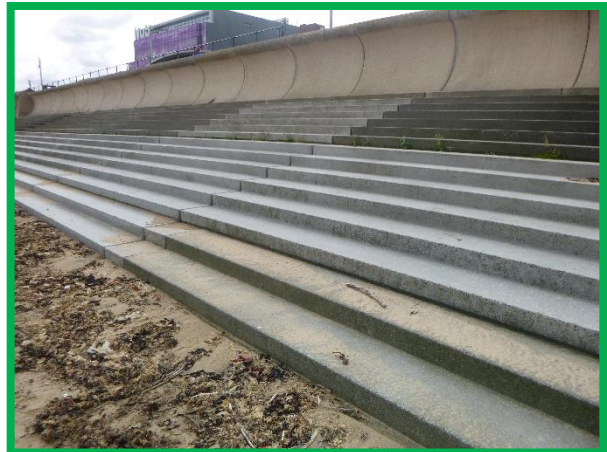
Evidence of repaired sections of the stepped concrete revetment in good condition (/C0602C02)

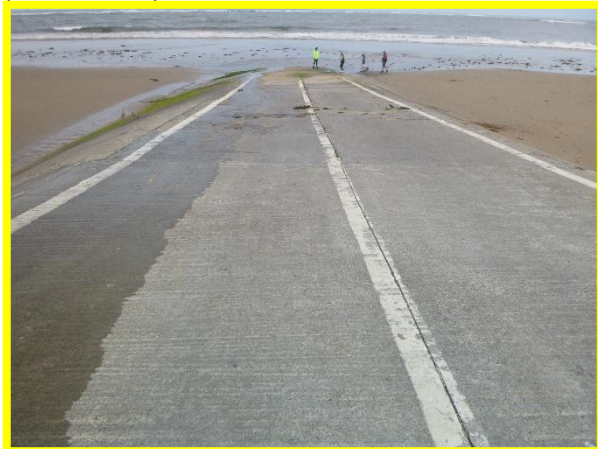
Slipway in fair condition (/C0602C02)

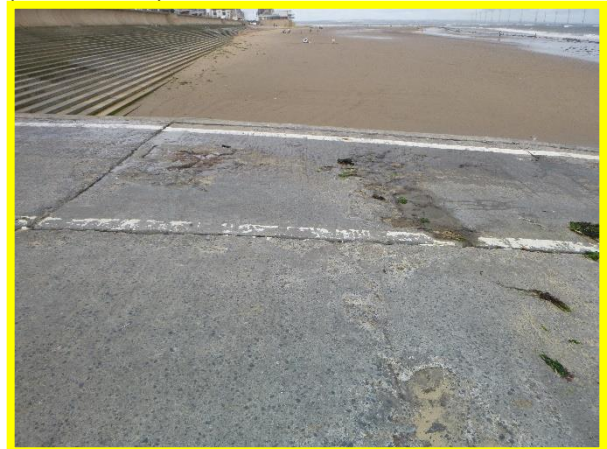
Slipway in fair condition with some spalling and abrasion damage (/C0602C02)

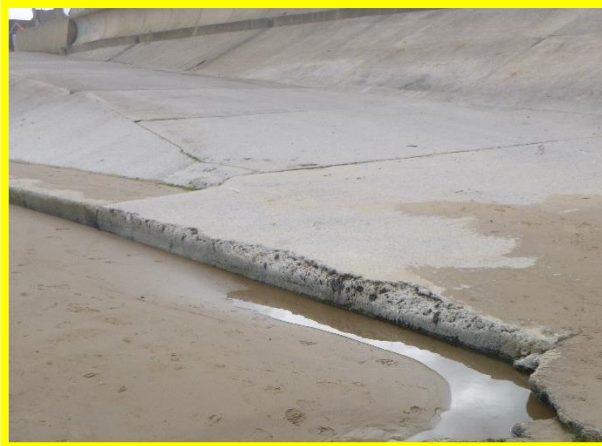
South eastern access ramp. Loss of concrete render exposing gouted stone fill beneath concrete deck slab (/C0602C01).

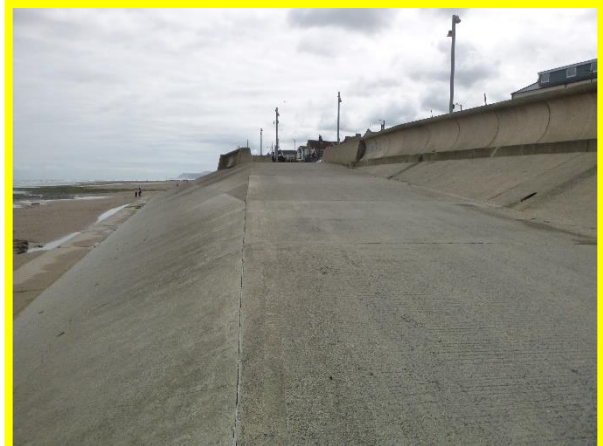
Slipway deck in fair condition (/C0602C01).

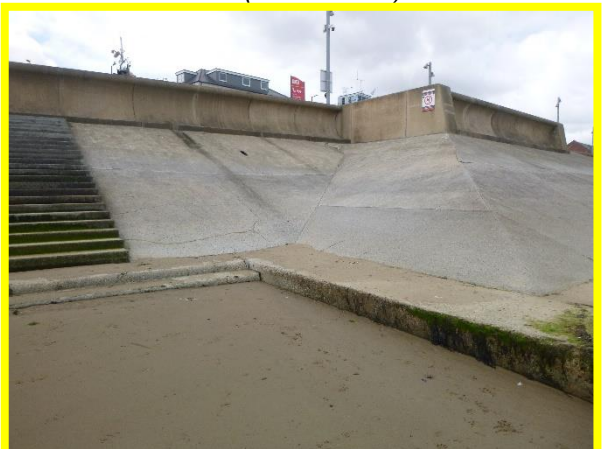
Concrete apron of slipway in good condition, despite being exposed.(/C0602C01).

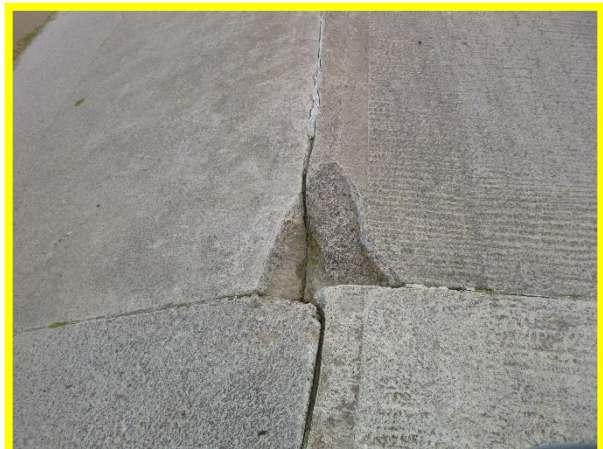
Cracking and damage to corner of slab on slipway (/C0602C01).

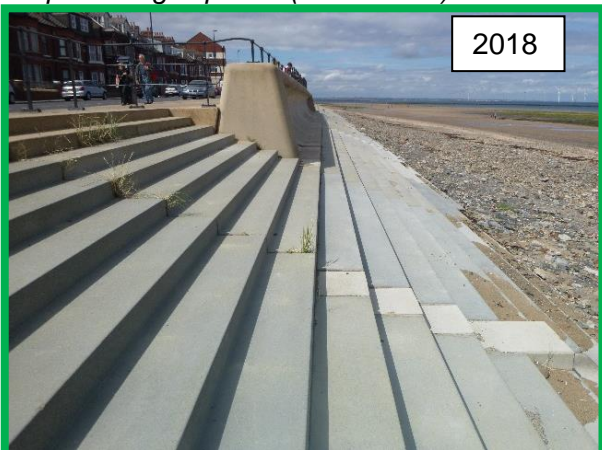
Sand accumulated in 2016 had been lost during the 2018 survey seen above (/C0602C01)

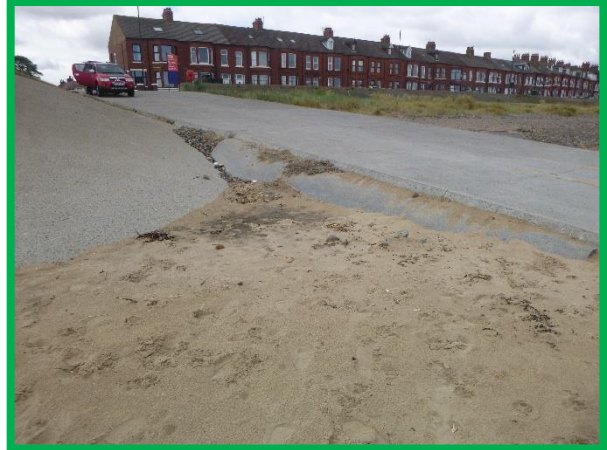
Concrete slipway in good condition (/C0602C01)

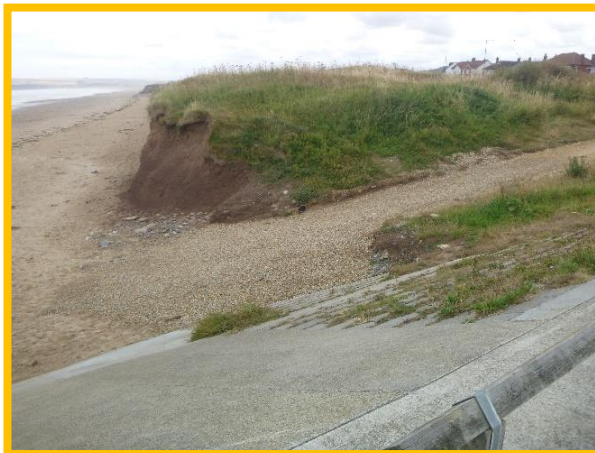
View looking south east (C0701C01) CBU E52/10

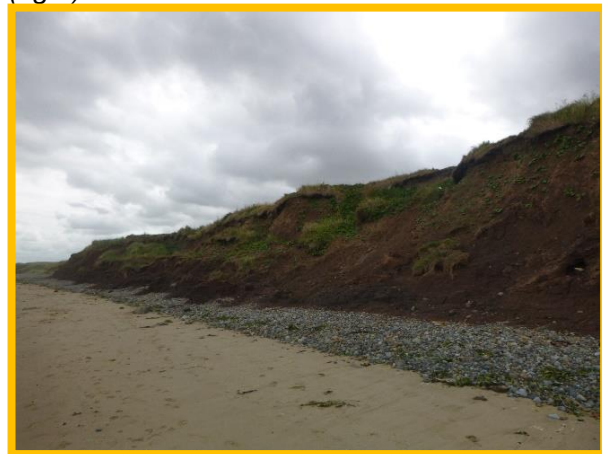
Looking south east along CBU E52/10 Partly Active in 2022.

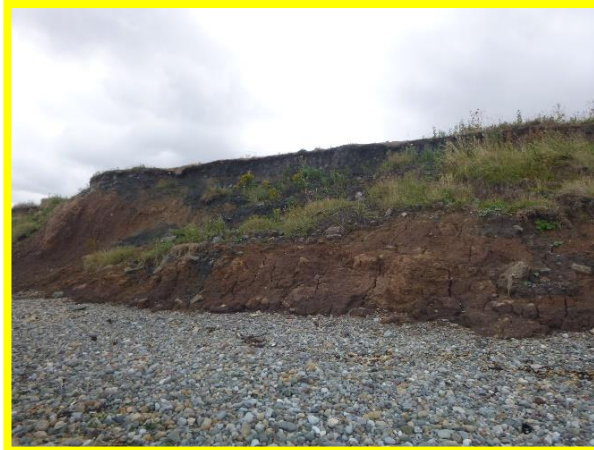
View looking north west (CBU E52/9)

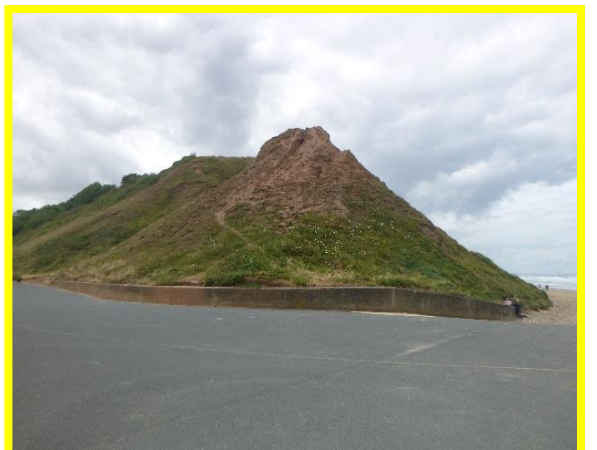
Southern extent of CBU (CBU E52/4)

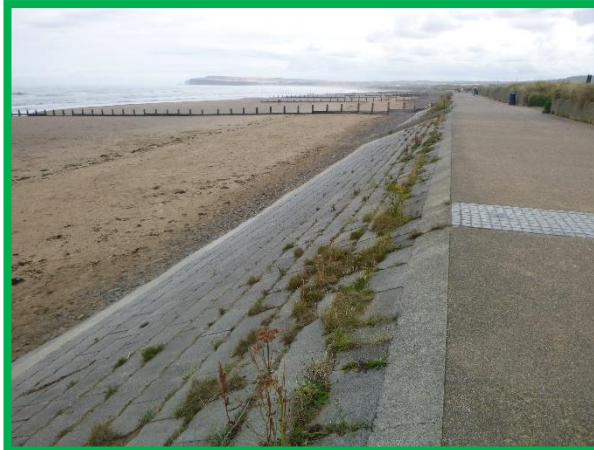
View on The Stray frontage looking south east (/C0603C01)

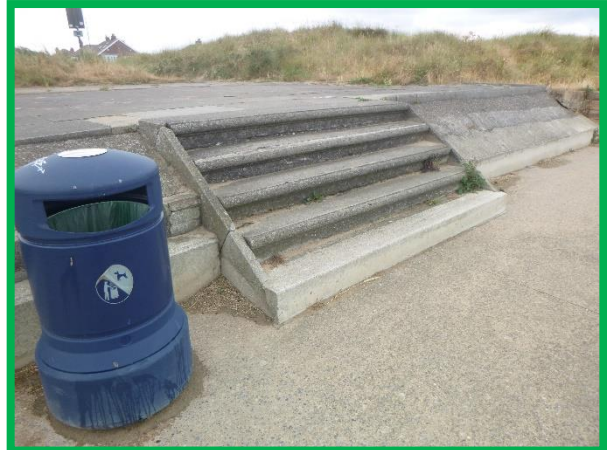
Recently repaired step at The Stray (/C0603C01)

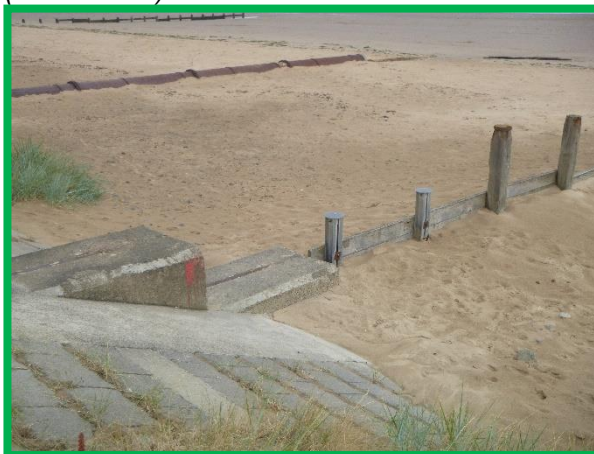
Recently repaired groyne along The Stray (/C0603C01)

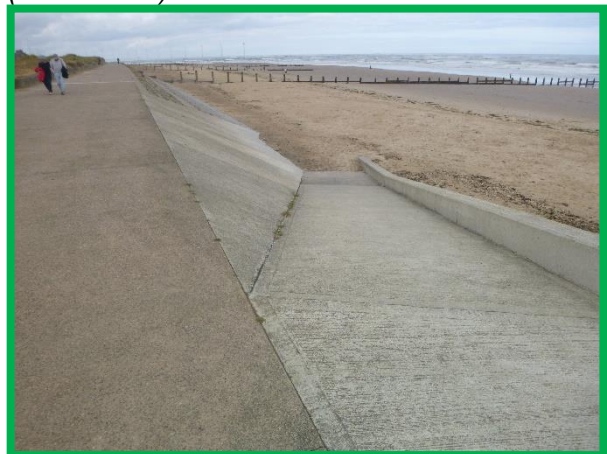
Slipway in very good condition at The Stray (/C0603C01).

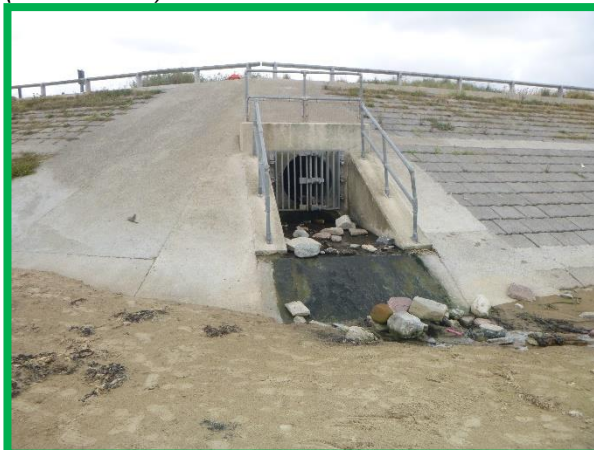
Outfall at south eastern end of (/C0603C01)

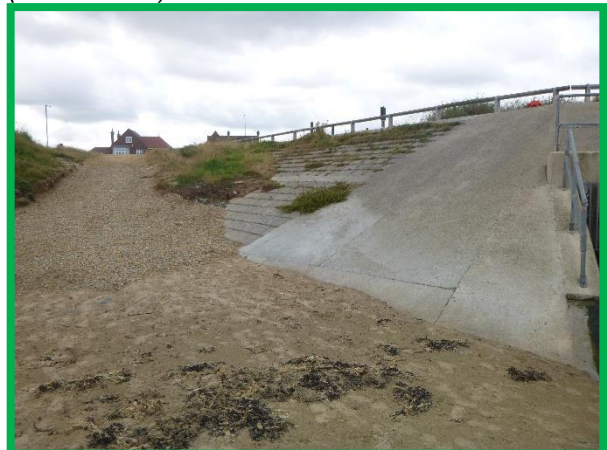
Transition of revetment into natural defence (/C0603C01)

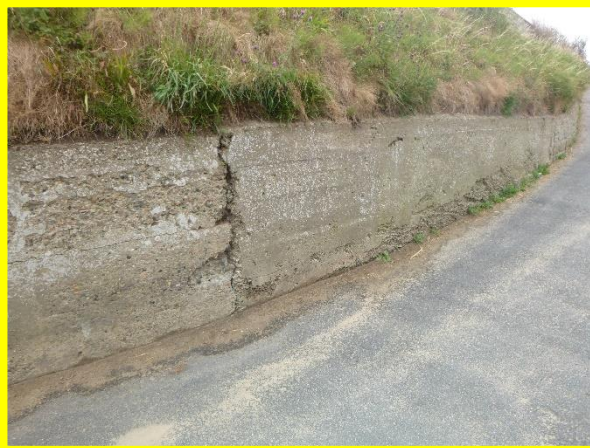
Crack in wall – no apparent change (/C0702C03)

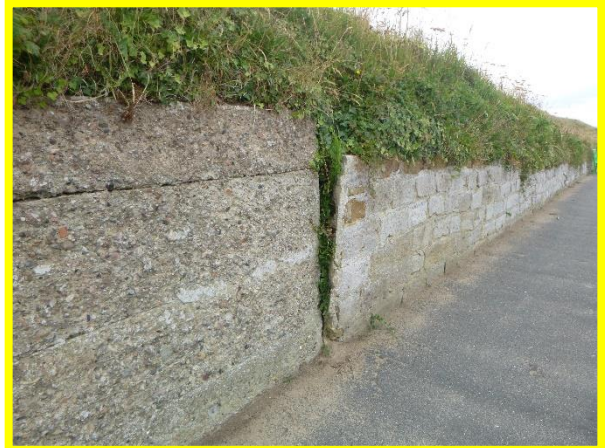
Masonry wall showing signs of lateral movement (/C0702C03)

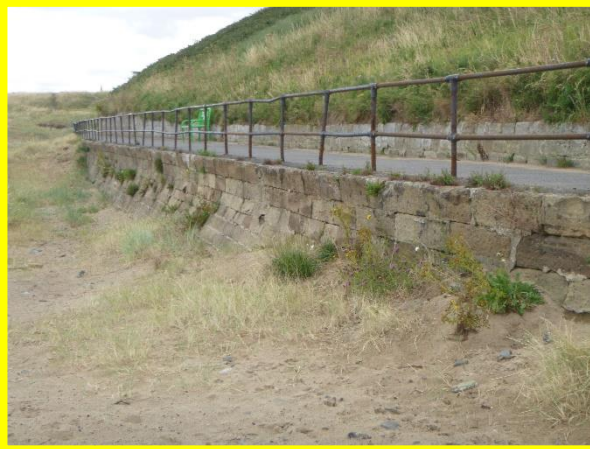
Wall in fair condition some missing mortar and open joints (/C0702C03)

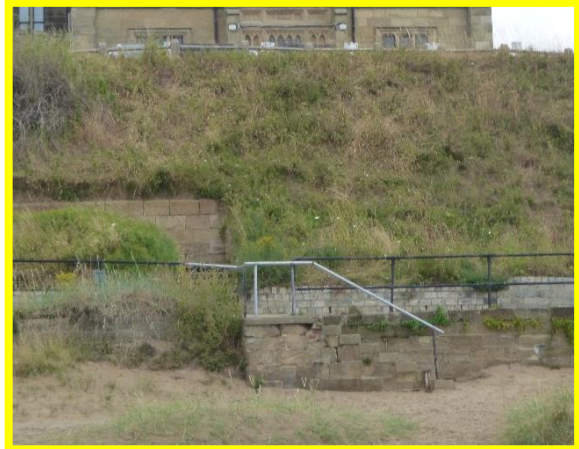
Steps in fair condition new handrail fitted since 2020 (/C0702C03)

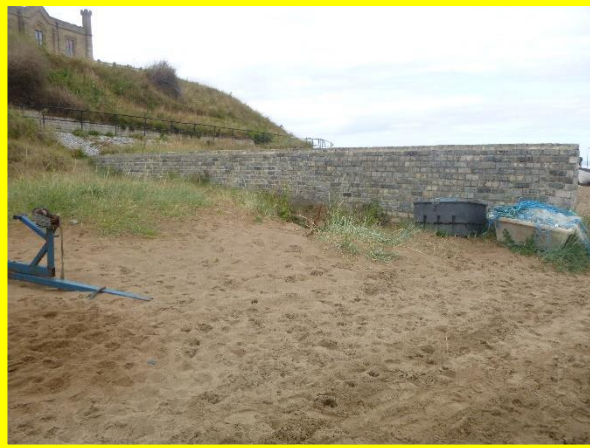
High beach levels obscure masonry wave wall and north west of beach entrance (/C0702C02)

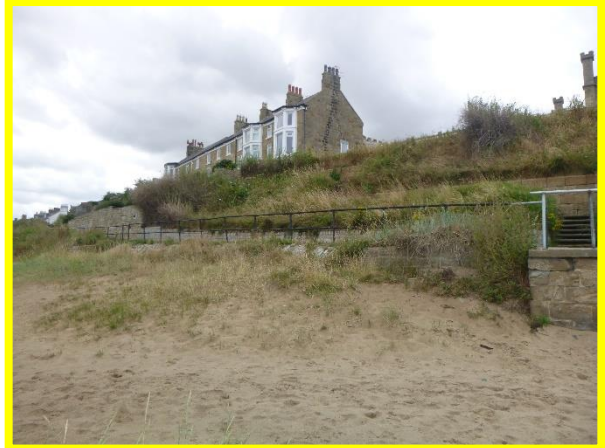
High beach levels and vegetation revetment north west of beach entrance (/C0702C02)

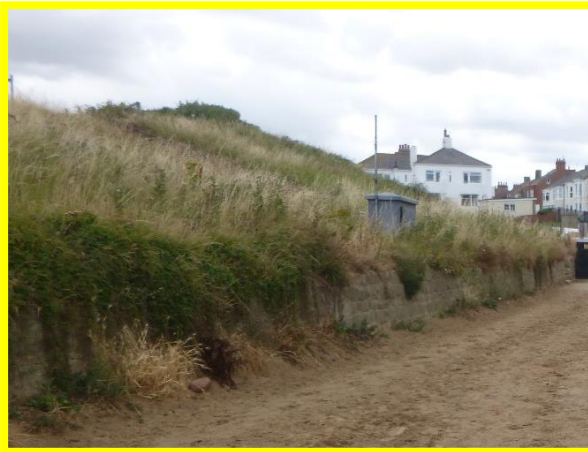
Masonry wall south east of beach entrance (/C0702C01)

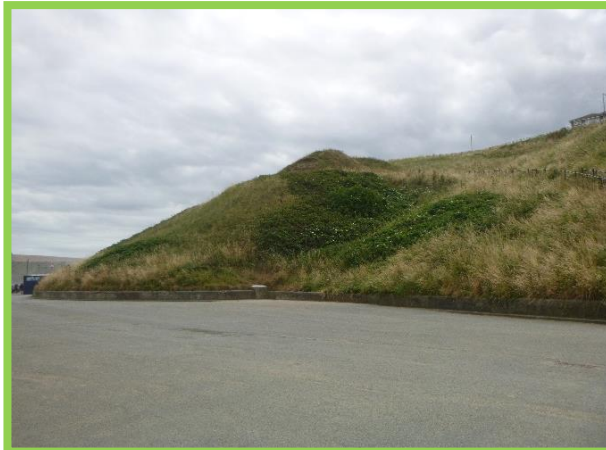
View looking east (E52/3b)

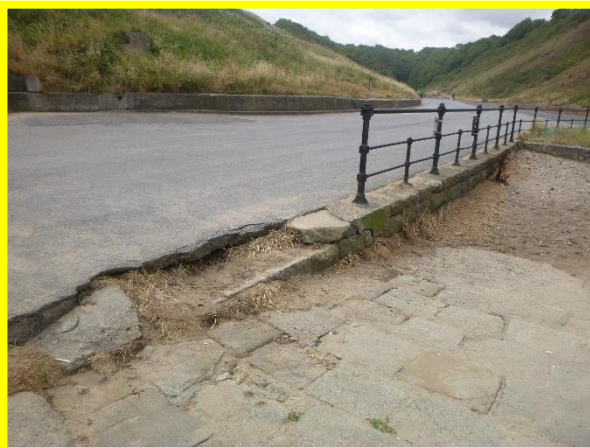
Missing coping stone exposing fill beneath promenade surface (/C0703C02)

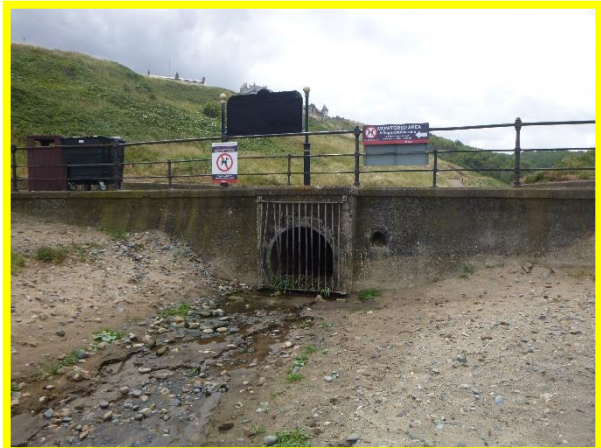
Security grille damaged (/C0703C02). Note accumulation of beach sediment around base of outfall.

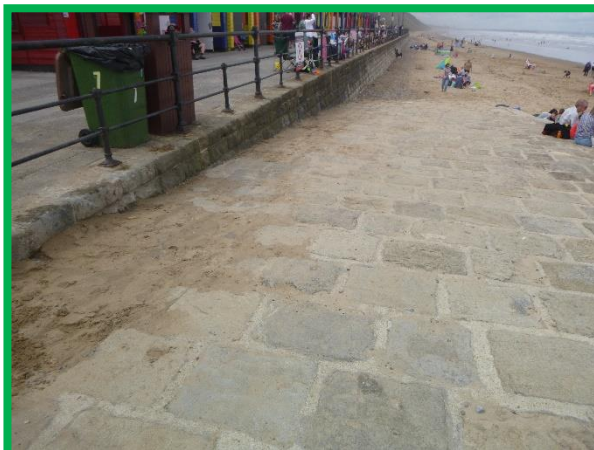
View looking northwest. Lower beach higher than in 2018. (/C0702C04)

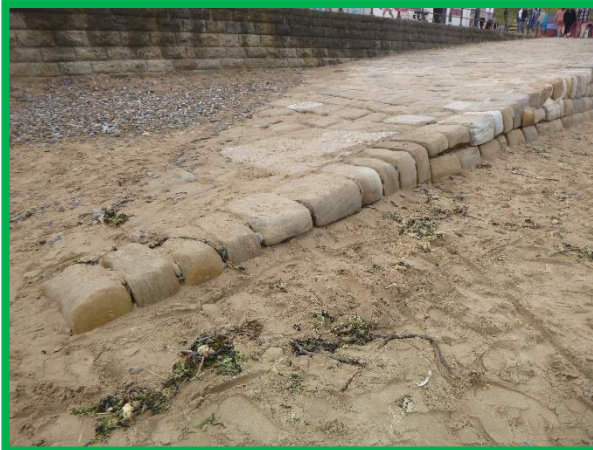
Repaired section of slipway coping (/C0702C04)

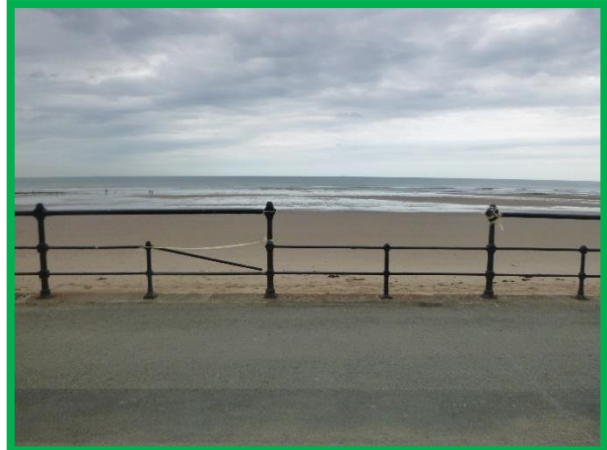
Damage to handrailing along promenade (/C0702C04)

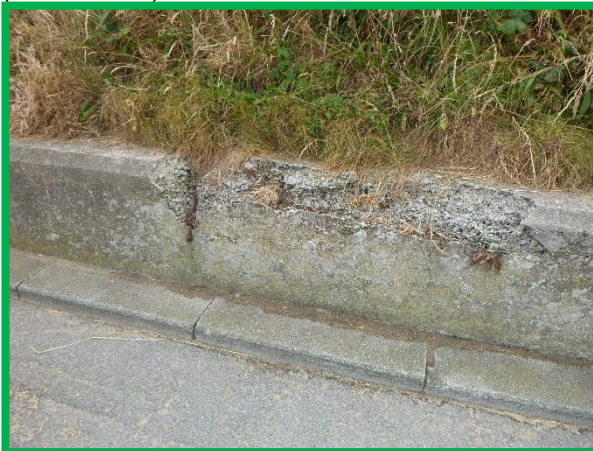
Defects to shallow retaining wall at rear of promenade (/C0702C04)

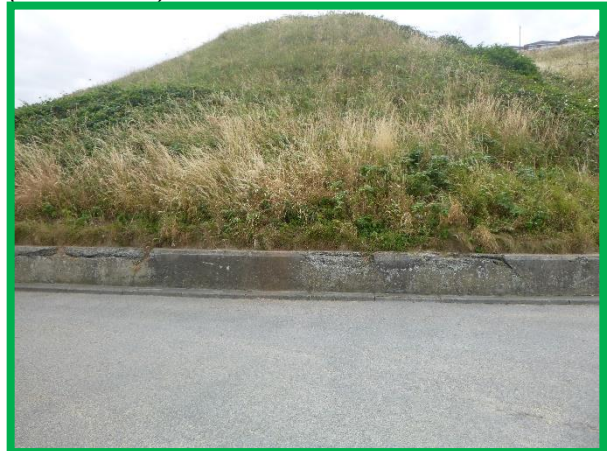
Further damage to shallow retaining wall (/C0702C04)

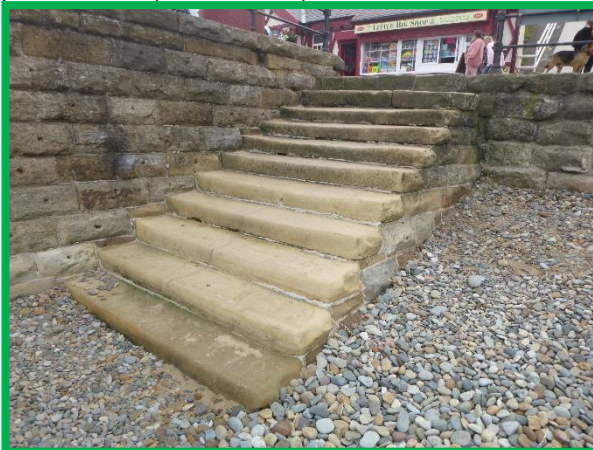
Beach access steps north of Saltburn Pier (/C0702C04)

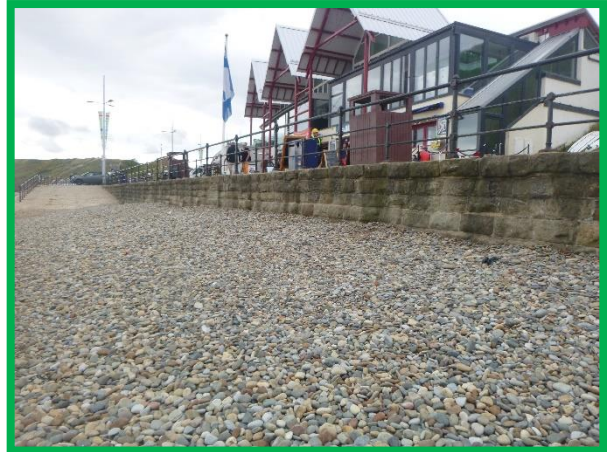
Looking south east along masonry wall south of pier (/C0702C04).

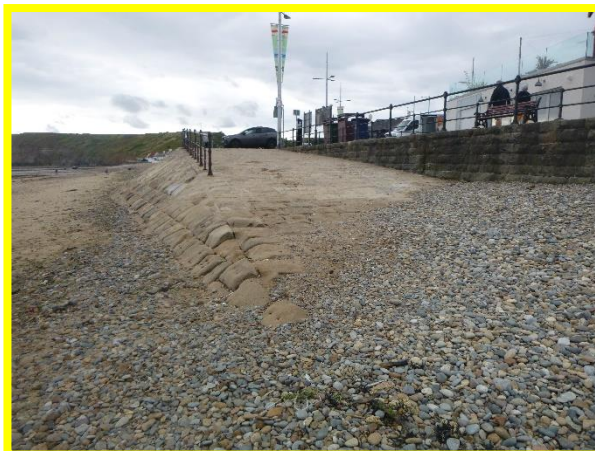
Slipway south east of Saltburn Pier (/C0704C01)

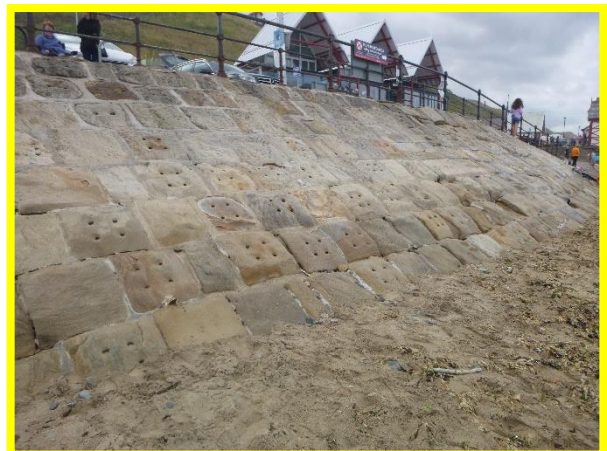
Missing / damaged blocks at apex of structure (/C0704C01)

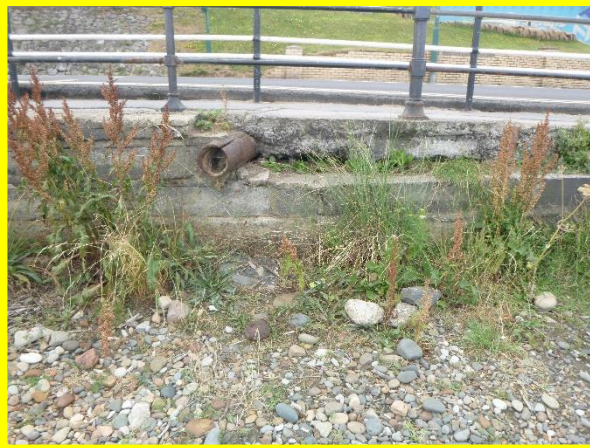
Damage to coping stones along low blockwork wall (/C0704C06)

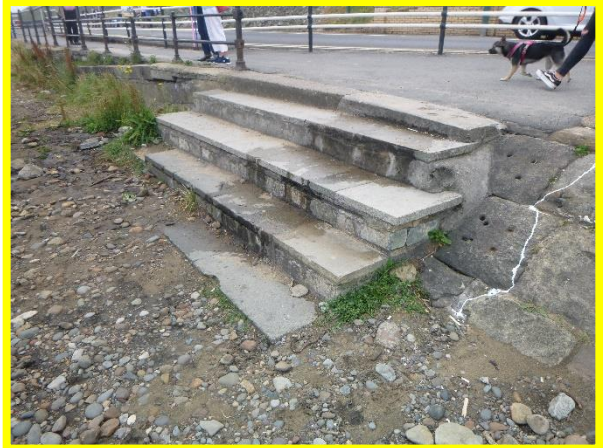
Repairs to steps in fair condition (/C0704C06)

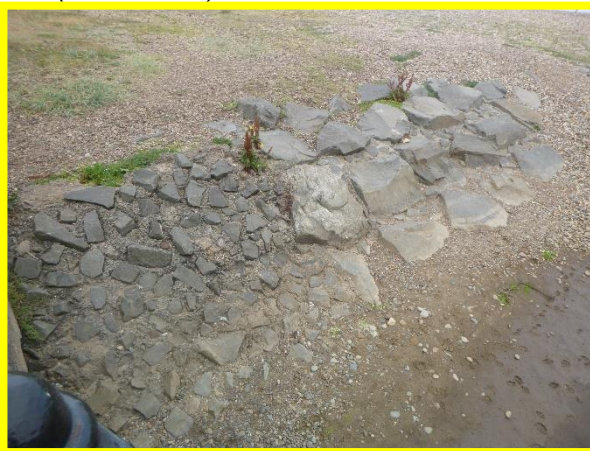
Grouted rock revetment to north of beck in fair condition (/C0704C06)

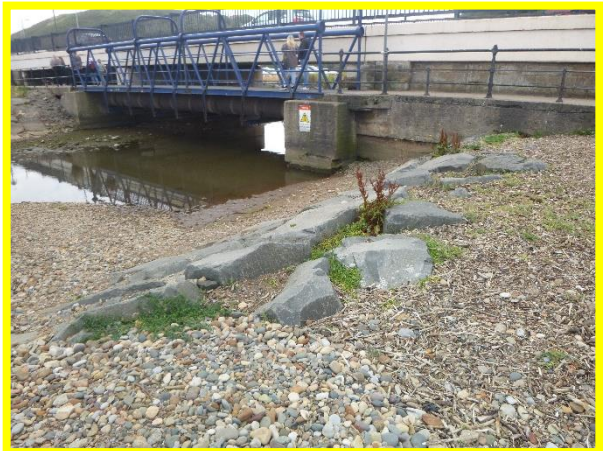
Grouted rock revetment to north of beck in fair condition (/C0704C06)

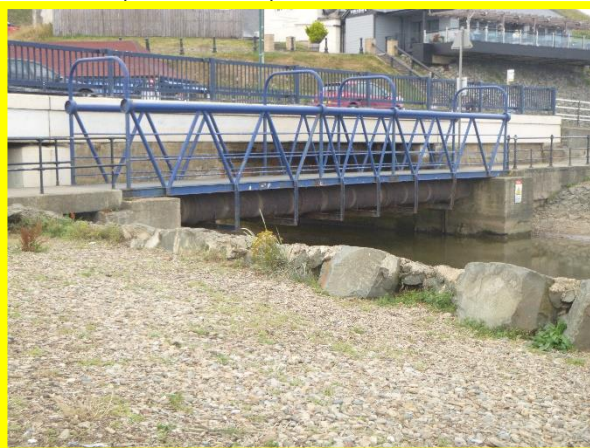
Exposed crest of grouted rock revetment to south of rock revetment (/C0704C06)

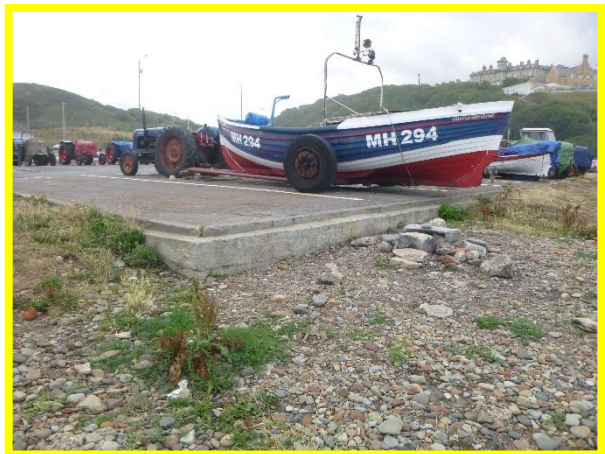
Exposure of corner of car park (C0704C02)

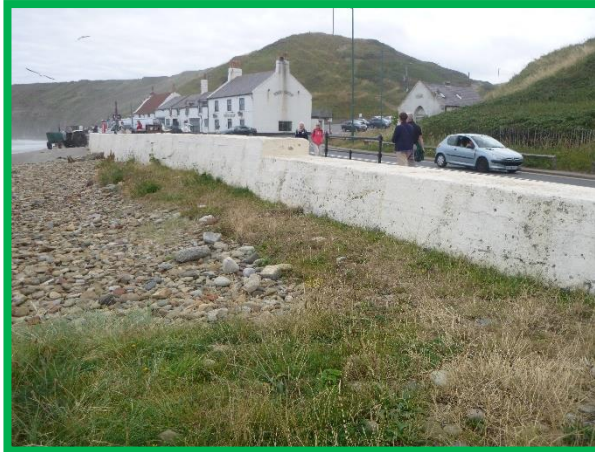
View looking west (/C0704C03)

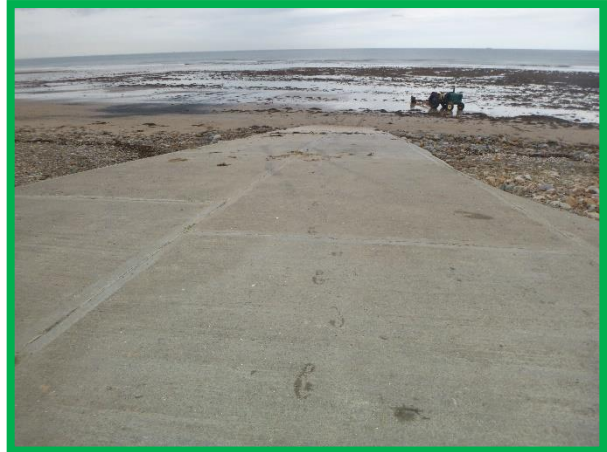
Concrete slipway adjacent Ship Inn car park (/C0704C03)

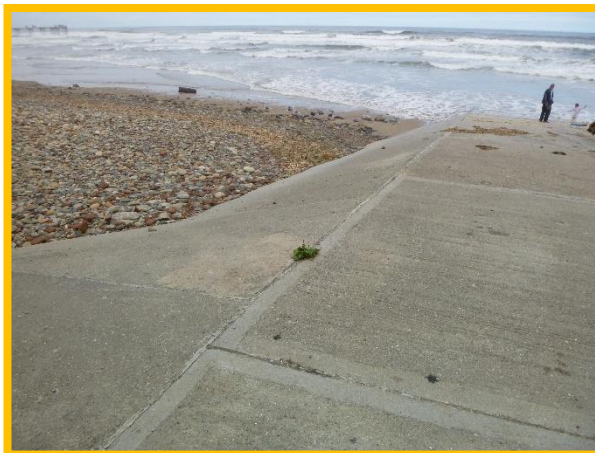
Slipway in fair condition higher beach levels cover previously reported undercutting (/C0704C05)

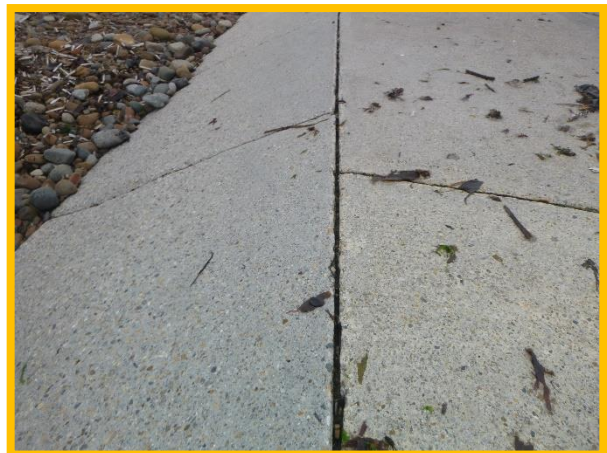
Open joints missing sealant (/C0704C05)
