Cell 1 Regional Coastal Monitoring Programme Walkover Inspection Surveys 2022

**Redcar & Cleveland
Borough Council**

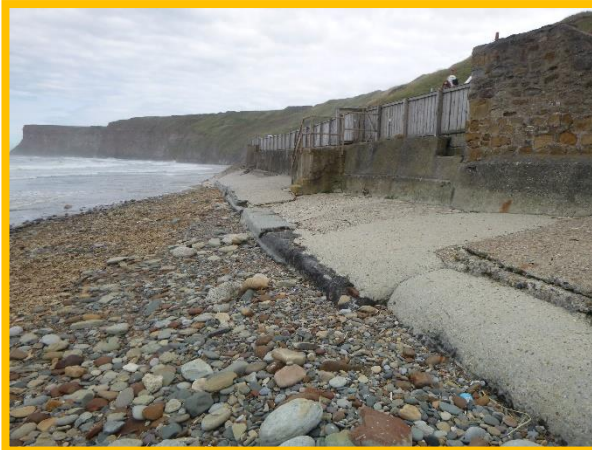
Undercutting of concrete apron (/C0704C05)

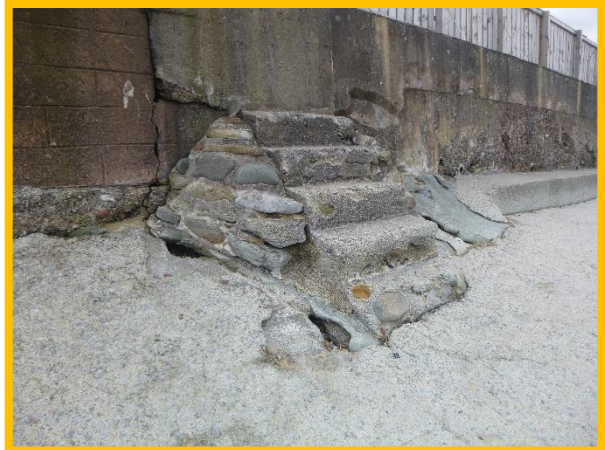
Ad hoc repairs to seawall in poor condition (/C0704C05)

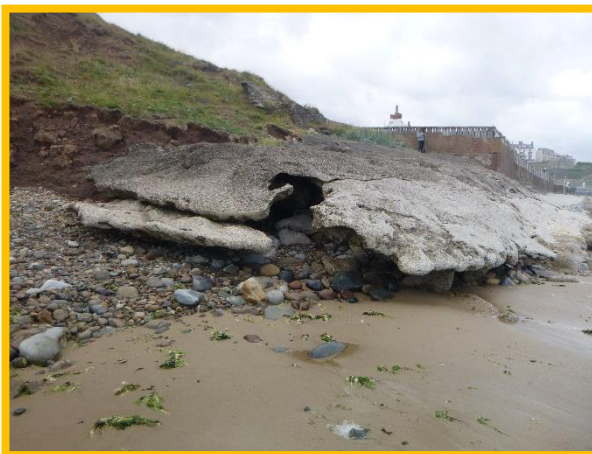
Undercutting of mass concrete apron (/C0704C05)

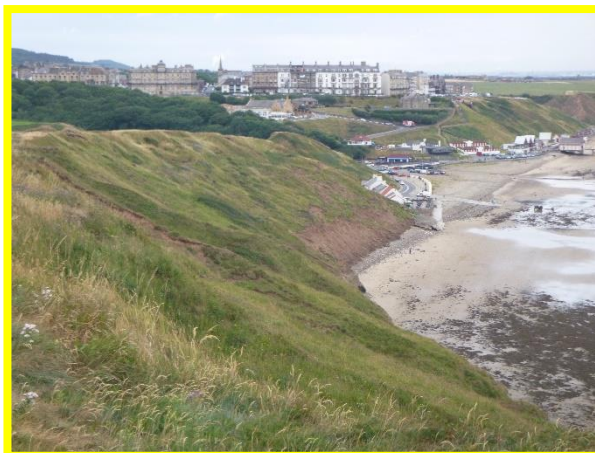
E53/3 to E53/5 Generally small-scale slumping in the till layer of the cliff northeast of Saltburn (Locally Active in August 2022).

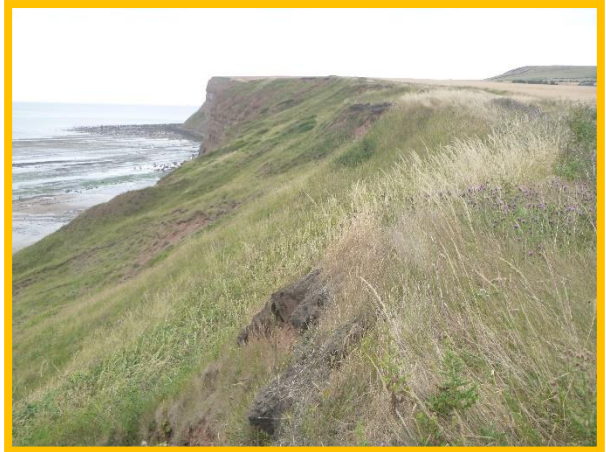
E53/2 (right) Partly Active in 2022 due to ongoing frequent headscarp recession and erosion of material at tow. **E53/3** (foreground) Locally Active in 2020 **E53/2** is obscured by minor headland and **E53/1** (visible in background) Locally Active in 2020.

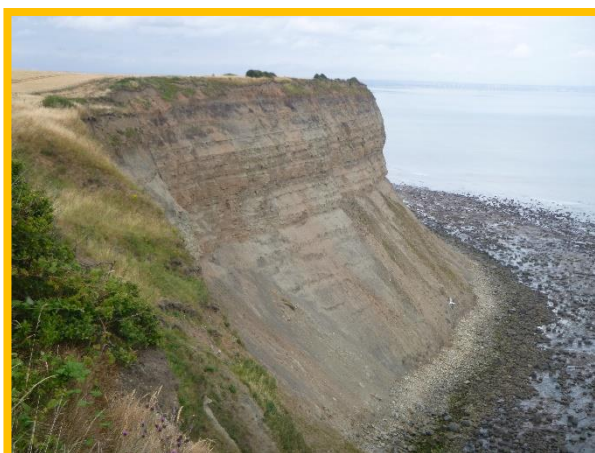
E54/4 looking northwest along Hunt Cliff showing active cliff face and debris apron (Partly Active)

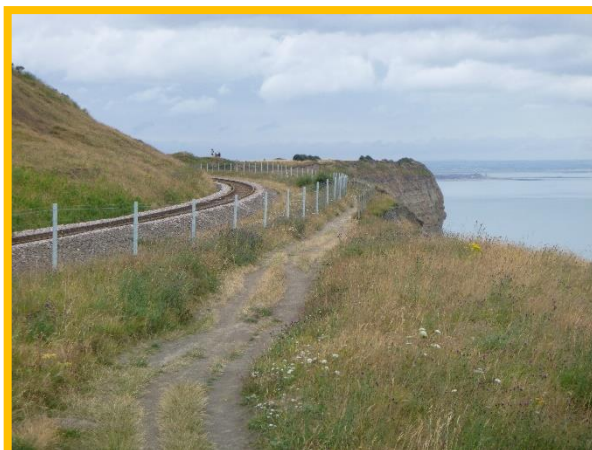
E54/2a proximity of footpath and railway line to actively eroding cliff top (Partly Active)

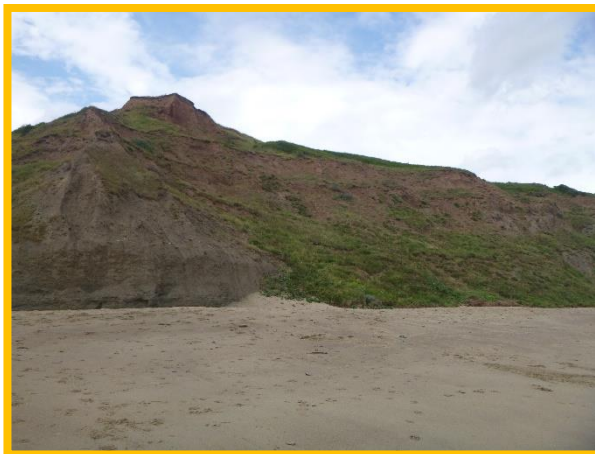
E55/2 Vegetated layer of till, which sits above the Lower Jurassic bedrock. Partly Active. .

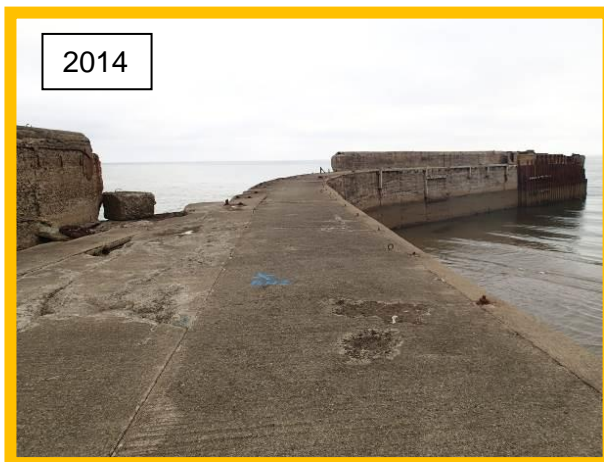
View of crest from access gate showing missing section of crest wall and damaged deck in 2014 (Asset Ref No. 1221D901D0201C02)

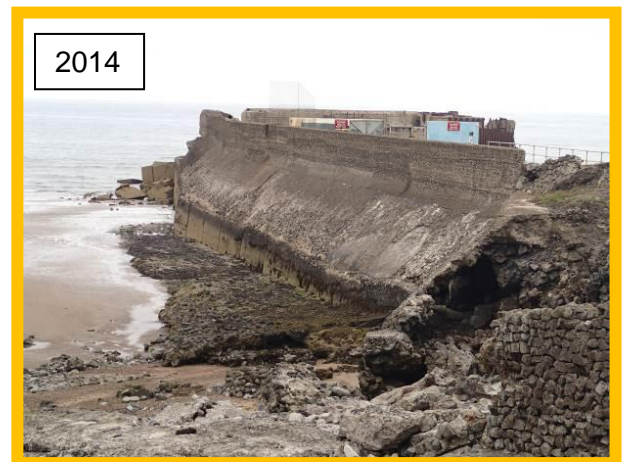
Voiding and collapse of west side of jetty structure in 2014 (Asset Ref No. 1221D901D0201C02)

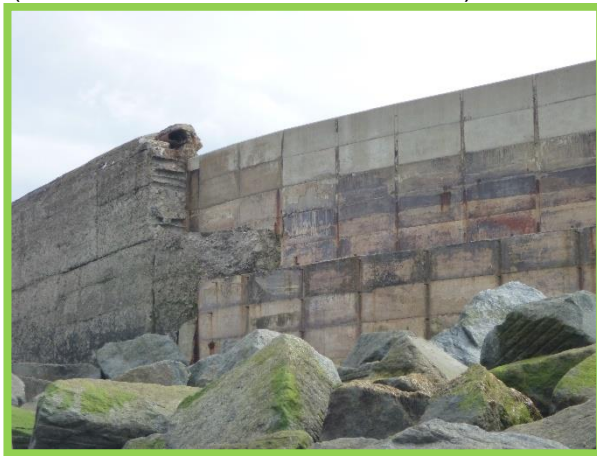
Seaward face of repair. Exposed re-bar and corrosion staining (Asset Ref No. 1221D901D0201C02)

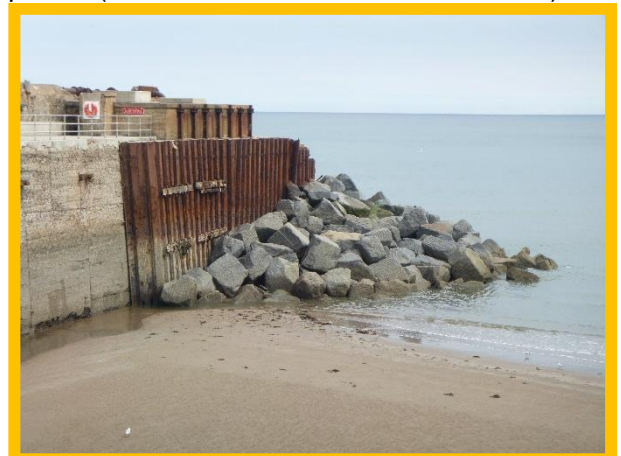
Heavily corroded sheet piles and rock armour around nose of original jetty structure.

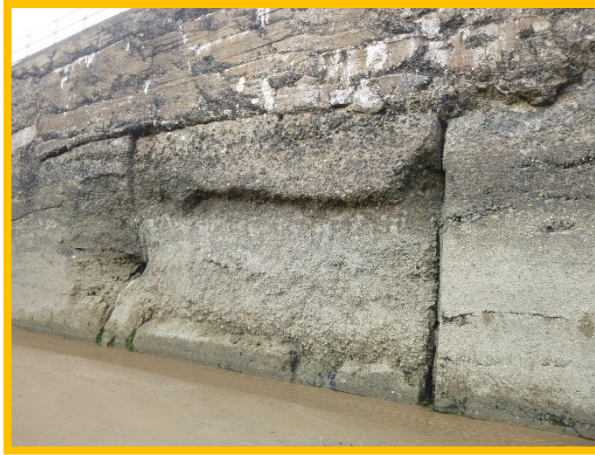
Large void visible halfway along inner face of breakwater. (Asset Ref No. 1221D901D0201C02)

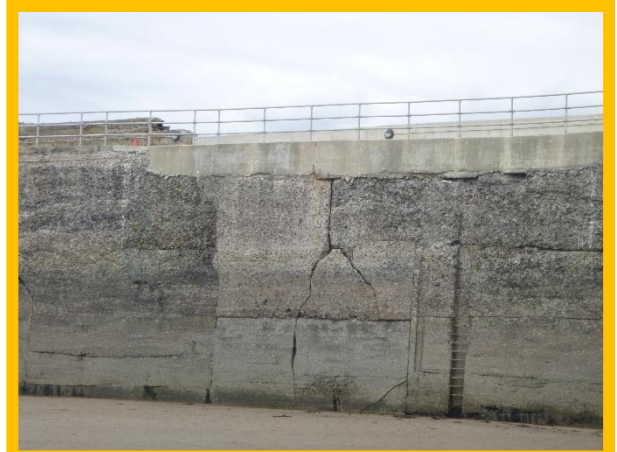
Large wishbone shaped crack on inner face of breakwater (Asset Ref No. 1221D901D0201C02)

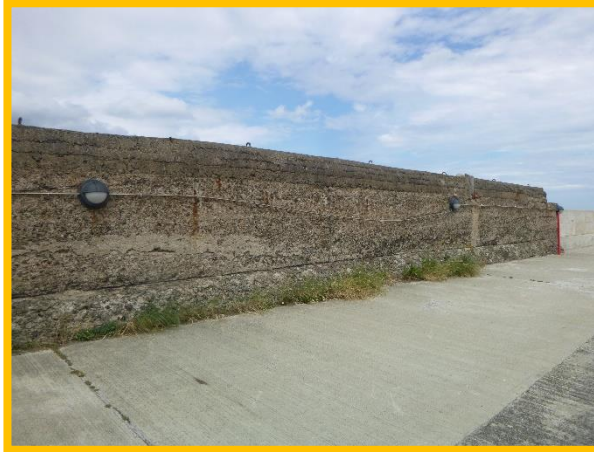
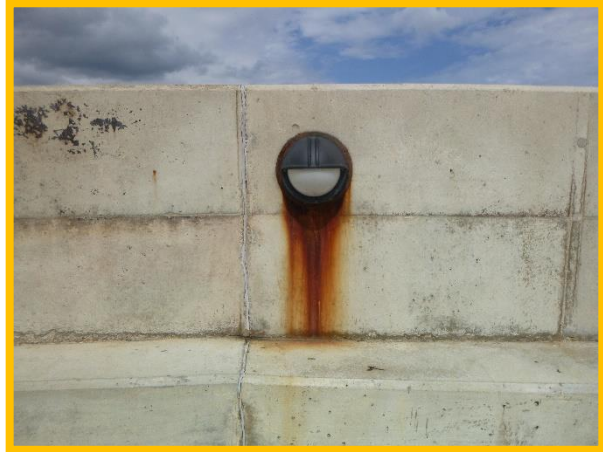
Damaged lighting conduit at head of breakwater. Severed conduit to light and rust staining

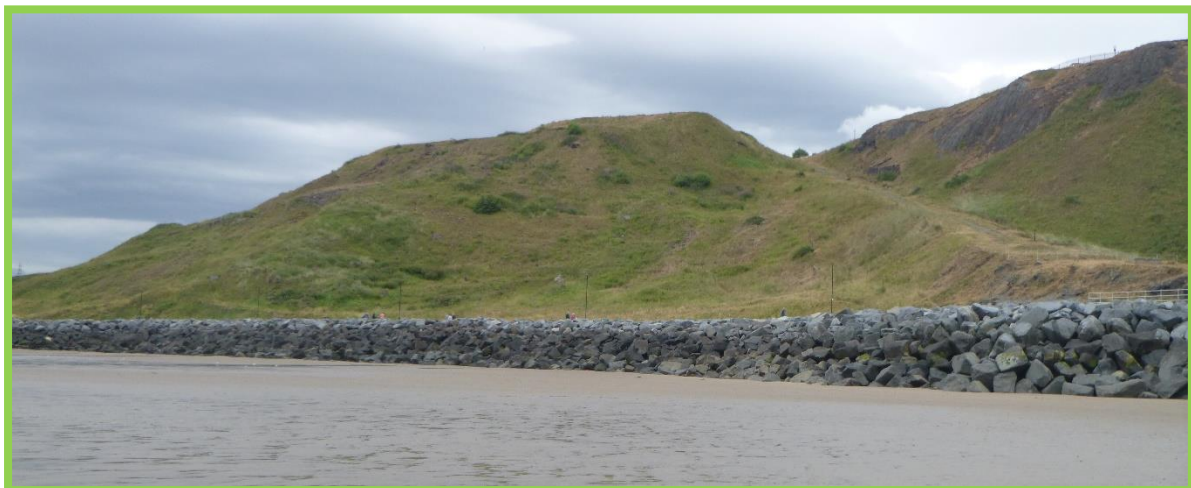
General view of rock armour revetment in 2022. Good profile and interlock. (Asset Ref No. 1221D901D0202C01)

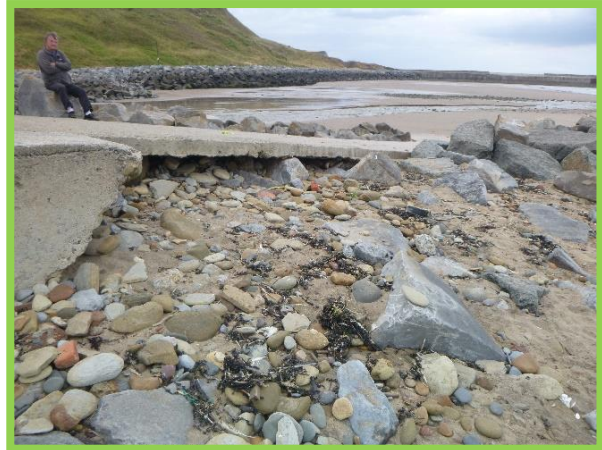
Undercutting of concrete slipway (Asset Ref No. 1221D901D0202C05)

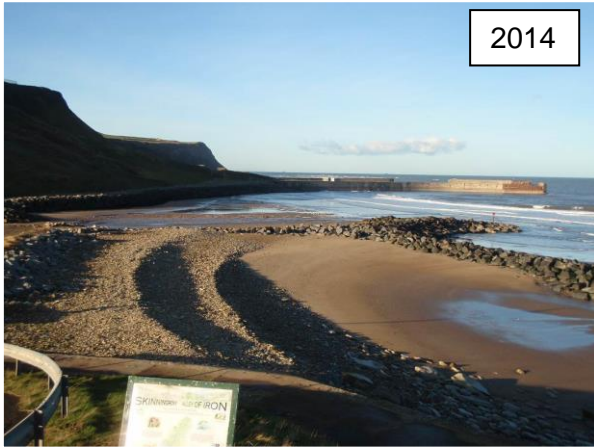
Original defences to the east of Kilton Beck, 2014

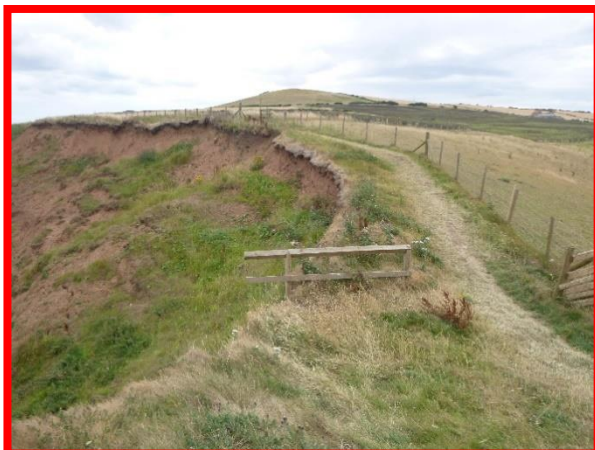
E57/7 Slumping and recession along headscarp (Totally Active)

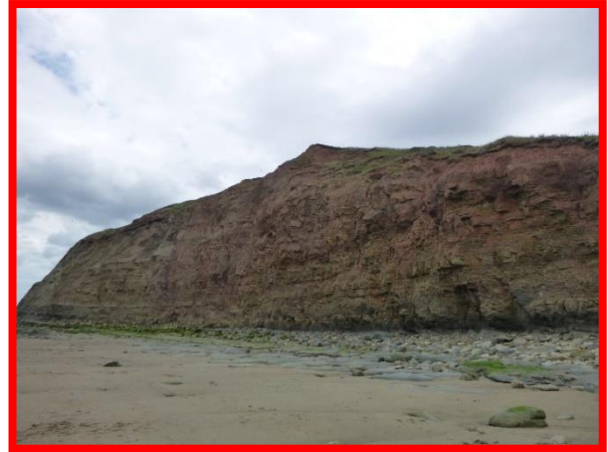
E57/7 evidence of multiple significant rockfalls (Totally Active)

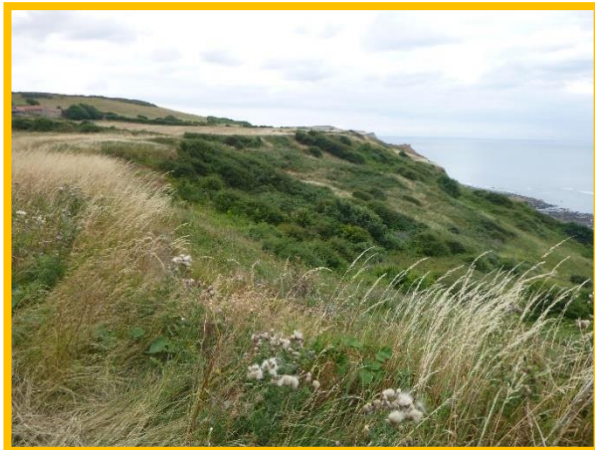
E57/3 Hummersea Bank

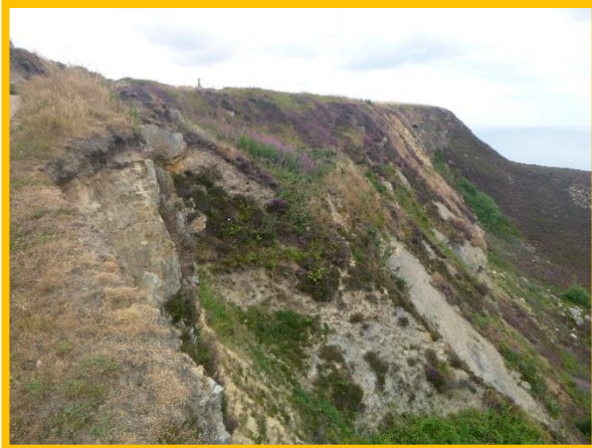
E58/2 Upper showing signs of ongoing headscarp recession.
Coast Protection Asset Condition Assessment

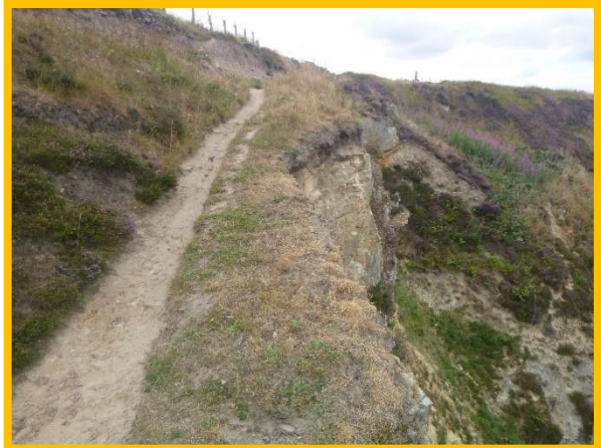
E58/5 Upper further signs of headscarp recession presenting an imminent risk to footpath stability.

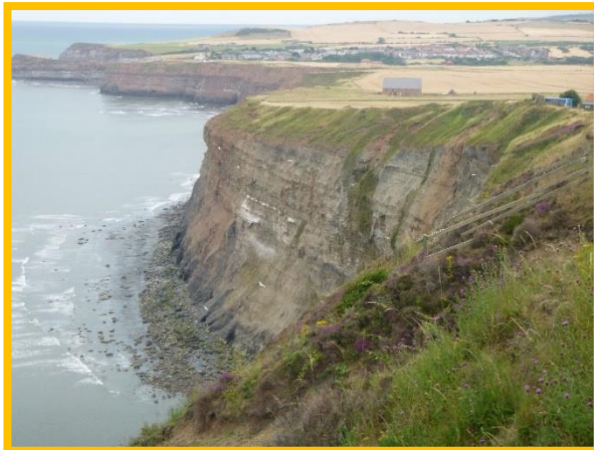
E58/1 to E59/8 Soft, slumping, upper till resting upon harder rock (Partly Active). E59/9 (Locally Active) fronts the properties.

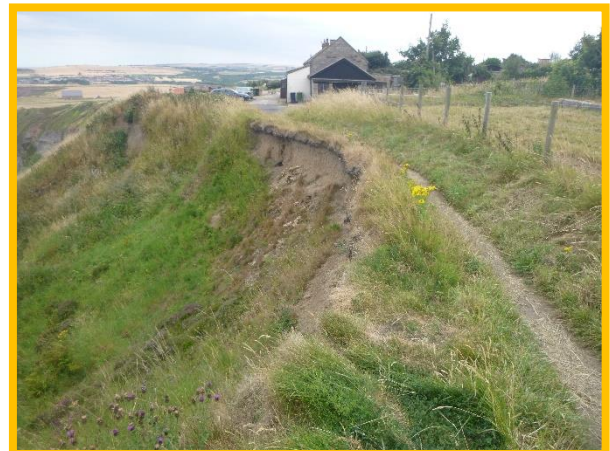
E58/1a headscarp recession encroaching on footpath.

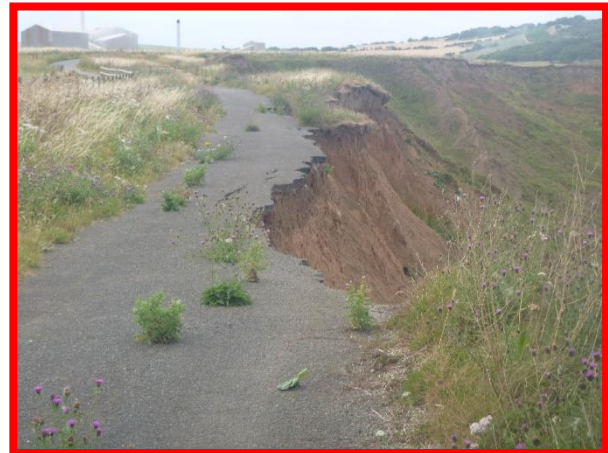
E59/3 Ongoing erosion of soft till layer leading to collapse of road (Totally Active).

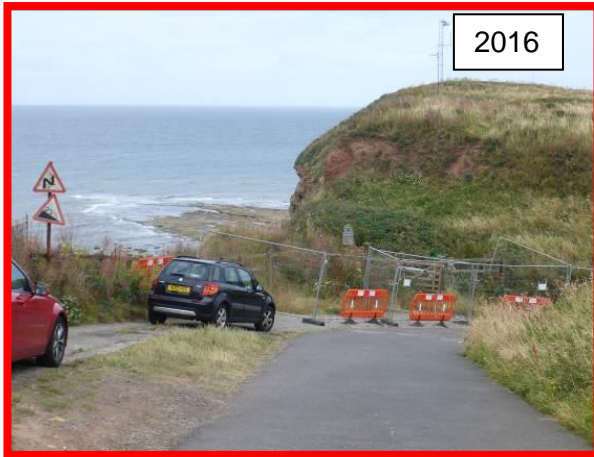
E60/1 Closure of access to Cowbar Nab in 2016, in 2018 the access appeared in very similar state with the same Heras fencing and plastic barriers still in use.

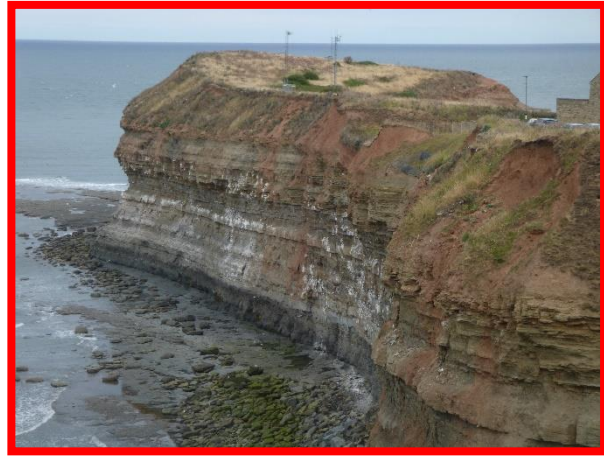
E60/1a and E60/1b Totally Active in 2022.

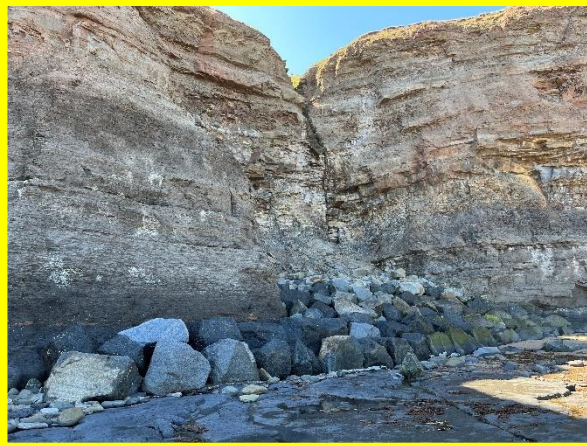
E59/1 Rock armour located at toe of cliff to the west of Cowbar Cottages
