**Walk-over Visual Inspections of Selected Assets  
following Storm Surge of  
5th December 2013**

**Redcar and Cleveland  
Borough Council  
Supplementary Report**

**December 2013**

## Cell One Coast Protection Assets Walk-over Visual Inspections of Selected Assets following Storm Surge of 5th December 2013

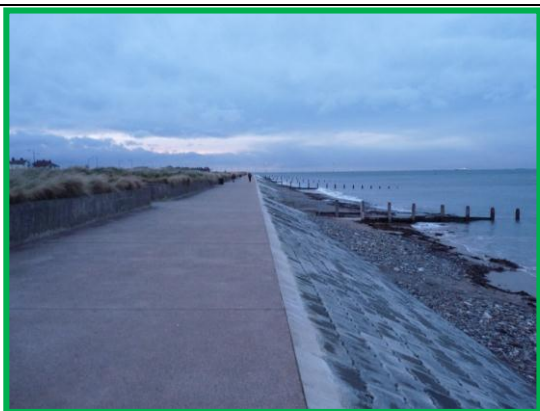
**Whilst not evaluated in 2012, unit E52/11 was identified for inspection following the storm surge in December 2013. The tide was high at the time of inspection making the beach difficult to inspect. However, principal observations were that substantial amounts of coarse material had accumulated against the defences several that pipes**

were exposed on the beach and exposures of fine material (substrate) indicated possible localised beach lowering. However, the new defences in this unit appeared to have experienced no damage and the small slope on the landward side of the defence only showed signs of very patchy erosion, which is possibly not related to the storm surge. As such this unit was downgraded from 'Inactive' to 'Dormant'.

**MU52/11 – Intact Defences. December 2013.**  
(Dormant)

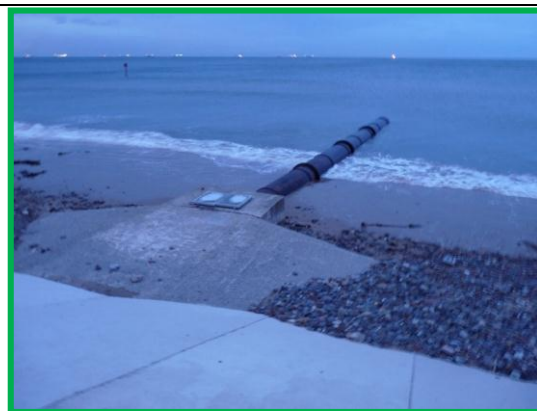
**MU52/11 – Exposed pipe (one of several).**  
Provides reference for beach level.(Dormant)

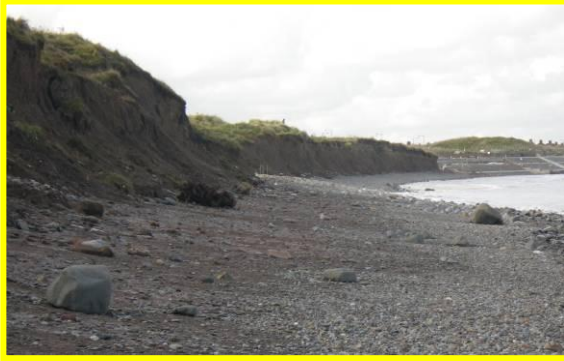
E52/10 Interface between new seawall and cliff at Mill Howle (Locally Active) October 2012

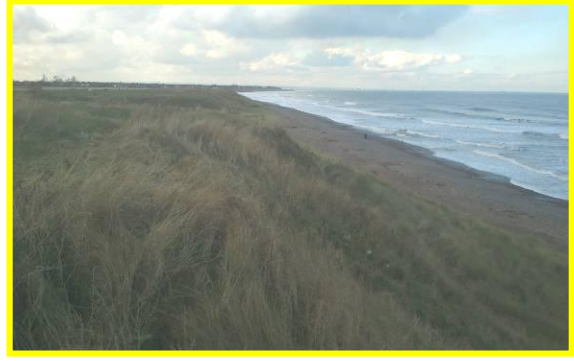
E52/9 Cobble beach gives some protection to Locally active cliff October 2012

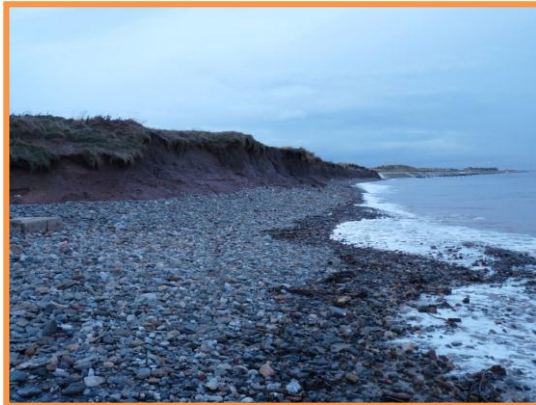
**Unit E52/10 is a low till cliff which is experiencing erosion throughout the whole unit. This unit gently protrudes relative to the rest of the coast and forms a very subtle headland. In some areas coarse material has accumulated significantly at the back of the beach but in many areas the till platform (concealed beneath the coarse material where present) was exposed. This unit has been elevated in status from 'Locally Active' to 'Partly Active' due to the whole unit showing signs of erosion.**

**E52/10 – Comprehensively eroding unit, with some coarse material at back of beach and less extensive exposures of till platform (see right). December 2013 (Partly Active).**

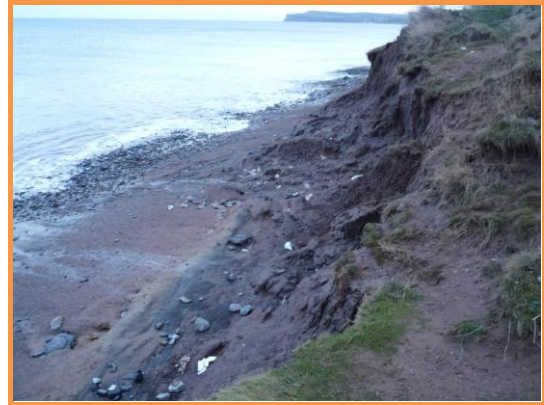
**E52/10 – More severe recent erosion and local exposure of till platform. December 2013 (Partly Active)**

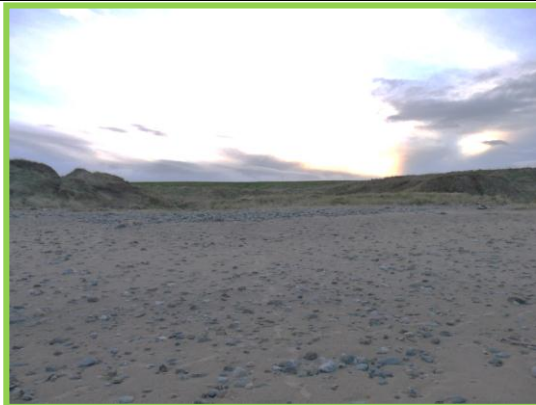
**E52/9 - December 2013. (Inactive)**

Unit E52/9 has been downgraded in activity status from 'Locally Active' to 'Inactive' due to the absence of significant erosion or failure.

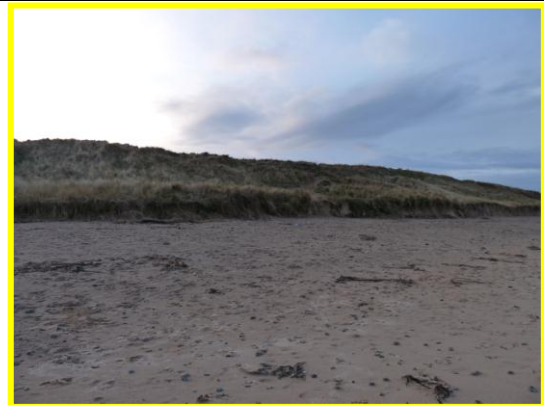
**E52/8 – Consistent toe erosion throughout unit but limited in its extent upslope. December 2013 (Locally Active)**

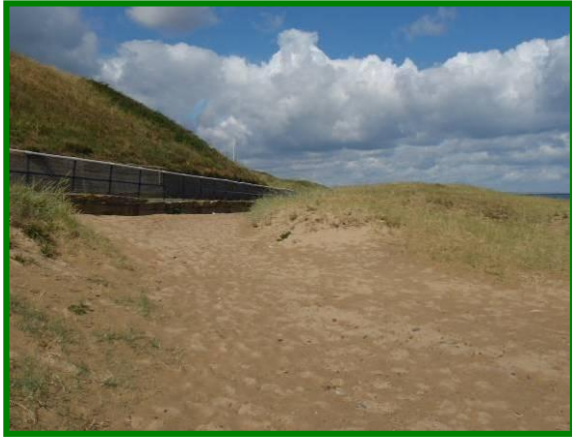
E52/7 Sand dunes and walls to toe of vegetated slope (Dormant) Photo from 2010

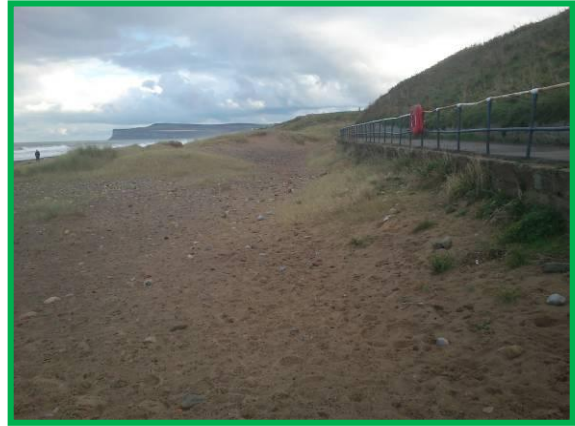
E52/7 Sand dunes and walls to toe of vegetated slope (Dormant) Photo October 2012

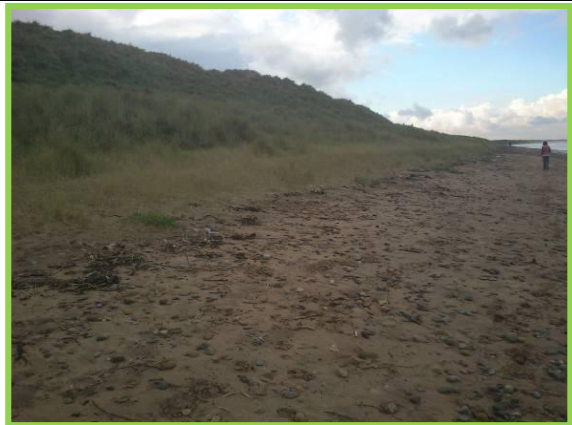
E52/6: Coastal slopes viewed looking north (Inactive) September 2012

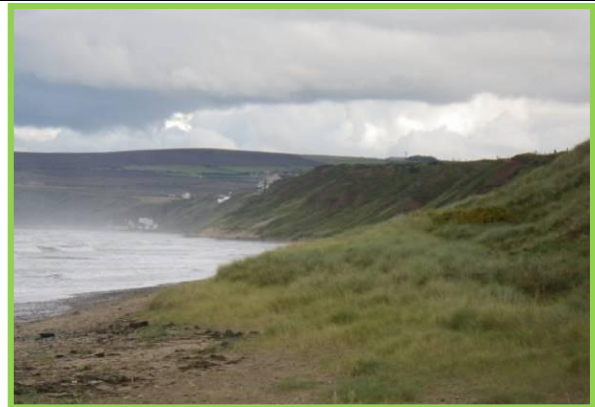
E52/5: Coastal slopes viewed looking south (Inactive) September 2012

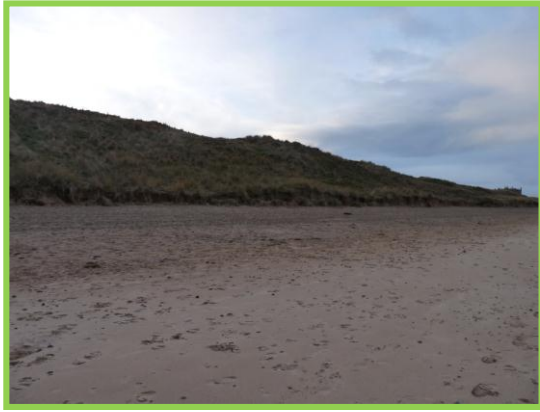
**E52/6 - Northern part of unit looking north. This unit was noted to have a steeper beach than units to the south with only limited, inconsistent erosion at its toe. December 2013**

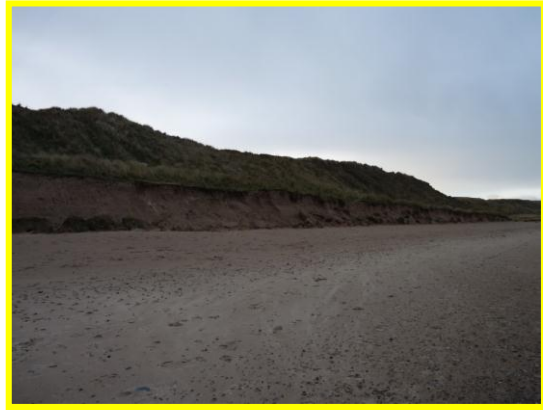
**E52/5 – Substantial and consistent toe erosion, but little evidence of instability in the upper cliff. This level of erosion was consistent throughout the unit. December 2013 (Locally Active).**

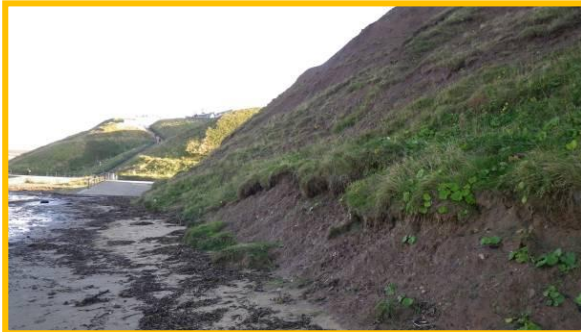
**E52/4: Coastal slopes viewed looking east to Saltburn (partly active) September 2012**

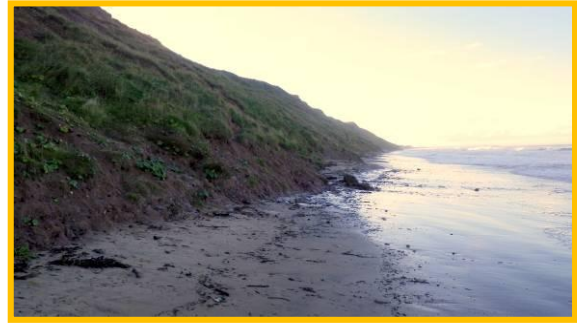
**E52/4: Coastal slopes viewed looking north west from Saltburn (partly active) September 2012**

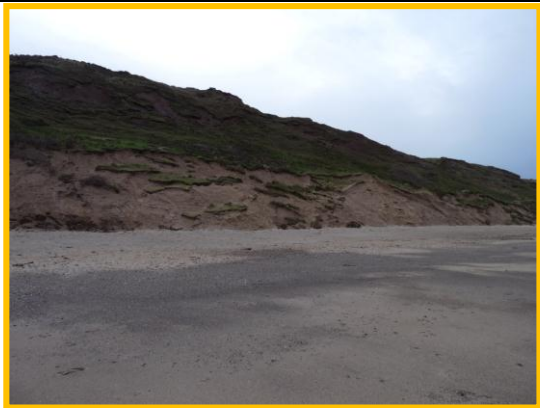
Unit E52/4 has retained its activity status of 'Partly Active' on the basis that the toe erosion has been very substantial, particularly where the lower cliff is comprised of sand (primarily the northern part of the unit). Where the cliff is formed of more cohesive materials (i.e. clay and silt, derived from glacial till), the upslope extent of toe erosion is less but this oversteepening of the toe appears to have a greater impact in terms of failures initiating in the from the mid and upper slopes. It is possible therefore that the unconsolidated more sandy material, being less cohesive, is more susceptible to toe erosion from marine action, but the more cohesive materials experience failure in the upper slope during wet weather, exacerbated by the removal of support at the toe, even though the upslope extent of this toe erosion is more limited.

**E52/4 – Significant toe erosion in sandy material and turf detachments above. Northern part of unit. December 2013. (Partly Active).**

Unit E52/4 retained its status of 'Partly Active' due to large parts of the cliffs still being well vegetated. However, toe erosion was substantial, extending in sandy materials to several metres in height, albeit in these areas the upper cliff continued to be well vegetated. In areas of more cohesive materials, toe erosion seemed to be less in terms of upslope extent, but the oversteepening through removal of the toe appeared to have initiated failures in the midslope.

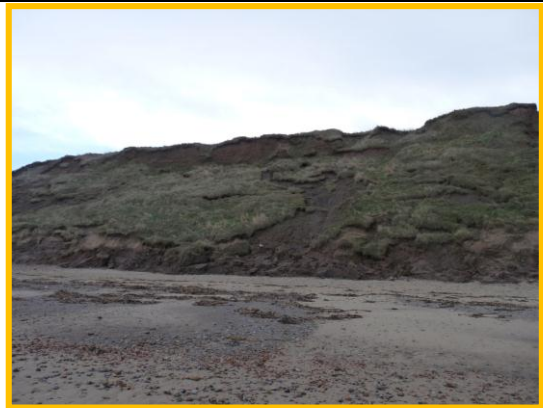
**E52/4 - Southern part of unit showing less toe erosion in more cohesive materials but shallow failures further up in the cliff. December 2013. (Partly Active).**

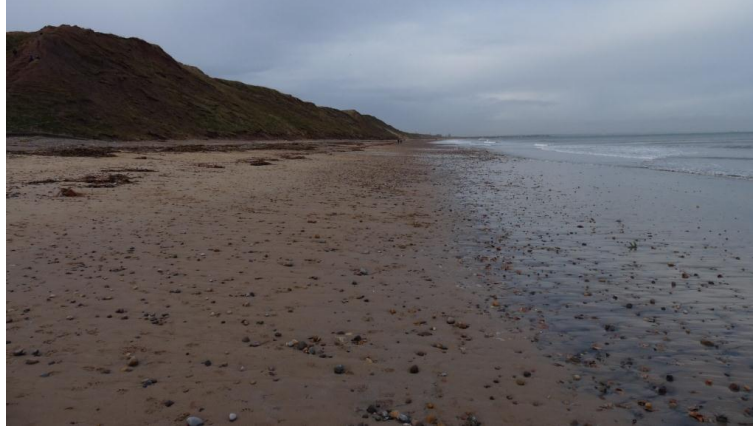
**E52/4 – View looking northwards from south end of unit to show beach condition. December 2013 (Partly Active)**

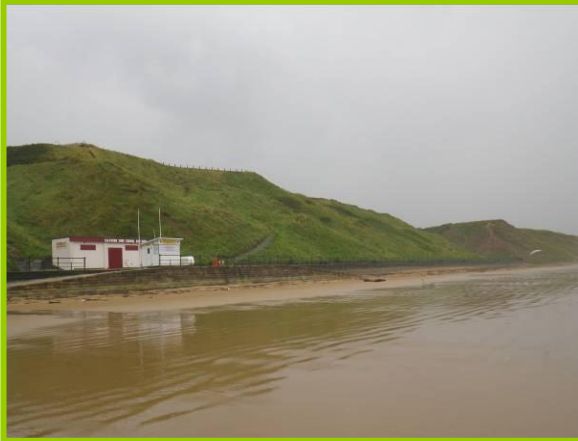
**E52/3b** from the stable and well vegetated cliffs above Saltburn Sands (Inactive) September 2013

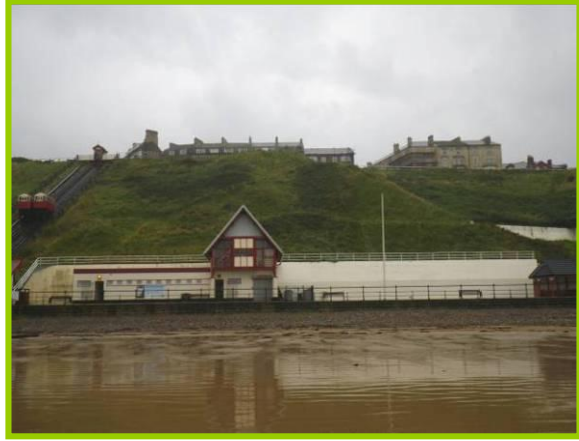
**E52/3a** the stabilised slopes close to the Cliff Lift (Inactive) September 2013

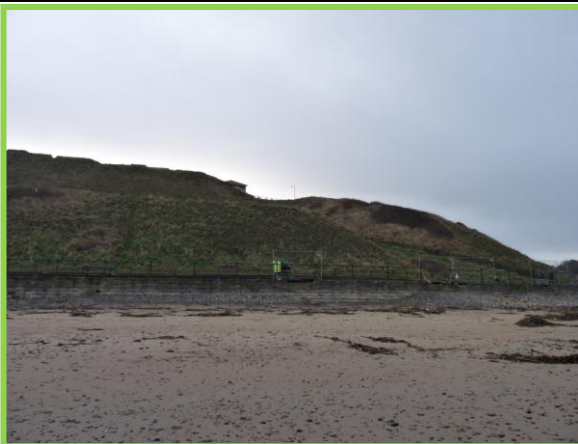
**E52/3b** – Stabilised slopes with no evidence of instability. However, damage to sea wall experienced during surge as indicated by ongoing repairs. December 2013. (Inactive)

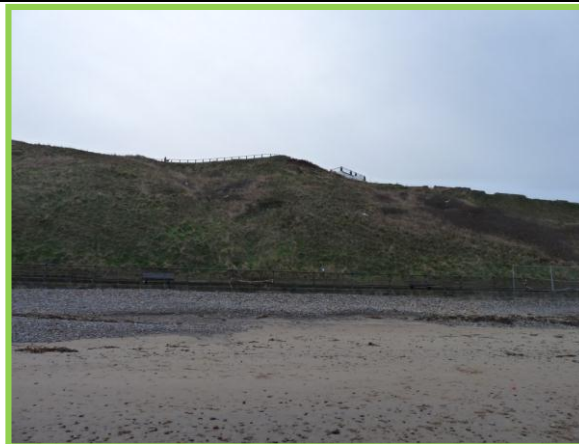
**E52/3b** – Stabilised, defended slopes. December 2013. (Inactive).

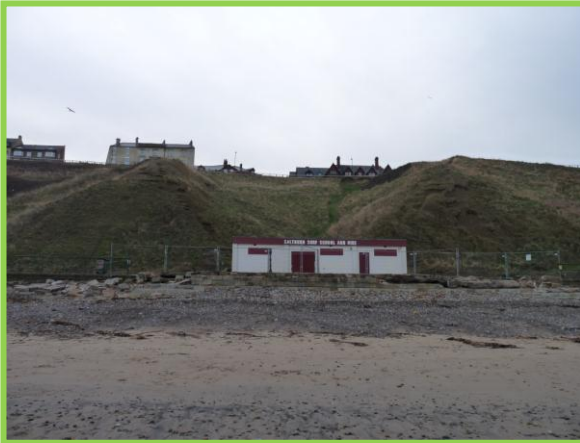
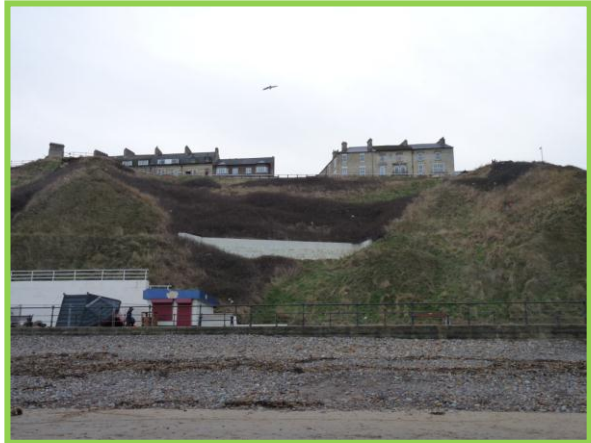
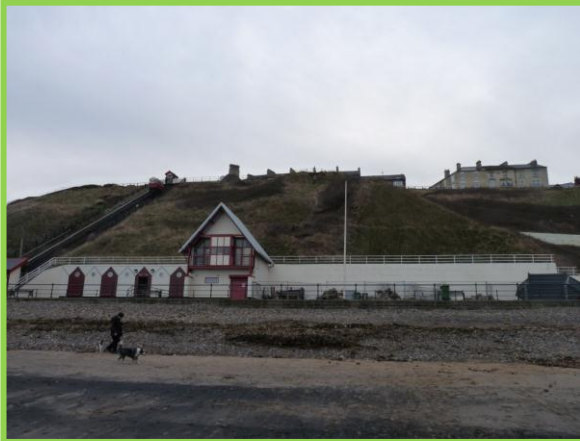
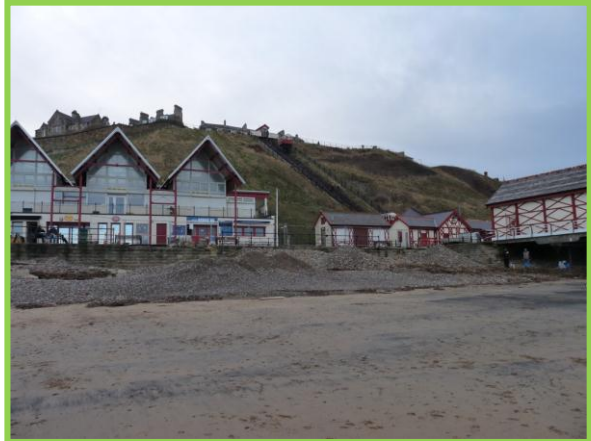
**MU52/3a – Views from North (top left) to south (bottom right). Slope is defended but minor shallow instability noticed at several places in units. Repairs ongoing adjacent to cliff lift. Note accumulation of large volumes of coarse material (in piles, bottom right photo). December 2013. (Inactive).**

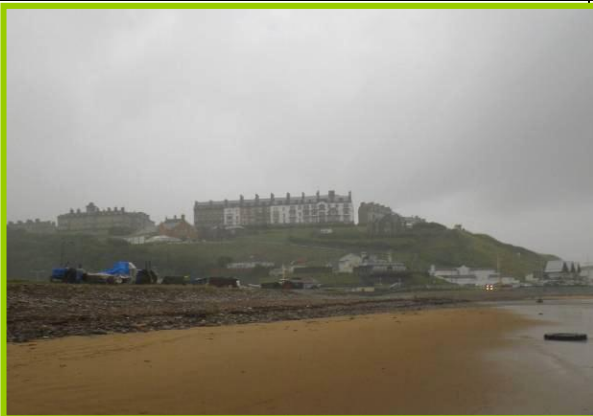
**E52/2** the stable cliffs above Saltburn Sands (Inactive) September 2013

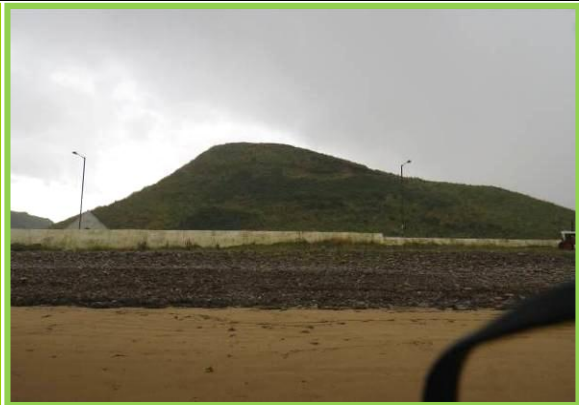
**E52/1** looking up at well vegetated cliffs from Saltburn Sands (Locally Active) September 2013

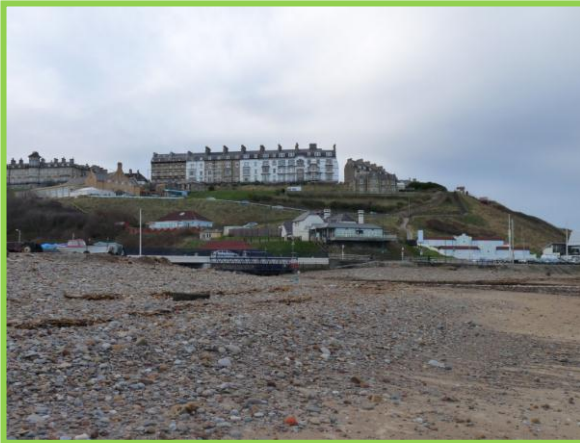
**E52/2 – Stable Cliffs. December 2013.  
(Inactive)**

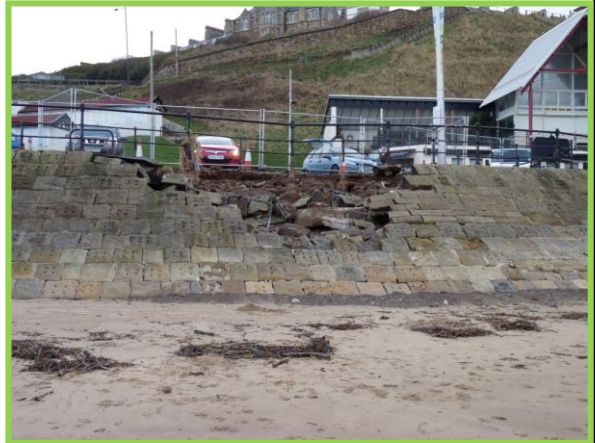
**E52/2 – Sea wall damaged during storm surge at toe of E52/2. December 2013.  
(Inactive)**

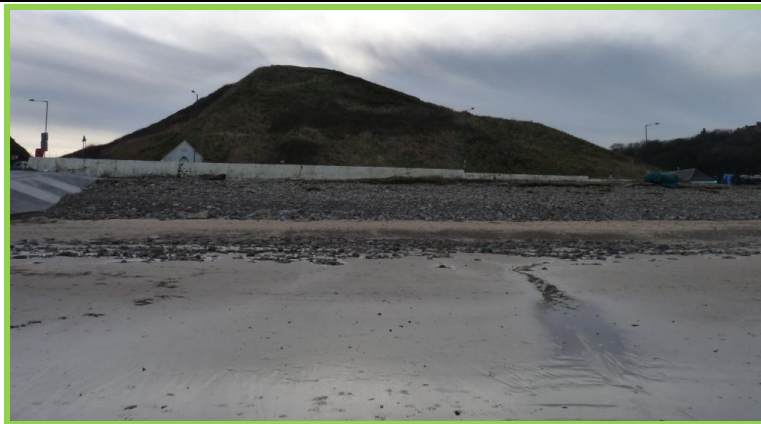
CBU **E52/1** showed more activity in 2012, with loose materials and localised erosion at the head of the large mound situated just east of Saltburn Gill and remained classified as Locally Active. **However, during the post-storm surge inspection in 2013, such activity was not noted and therefore the activity status of this unit has been downgraded to 'Inactive'.**

**E52/1 – Little evidence of activity at this point 'Inactive'. December 2013. (Inactive)**

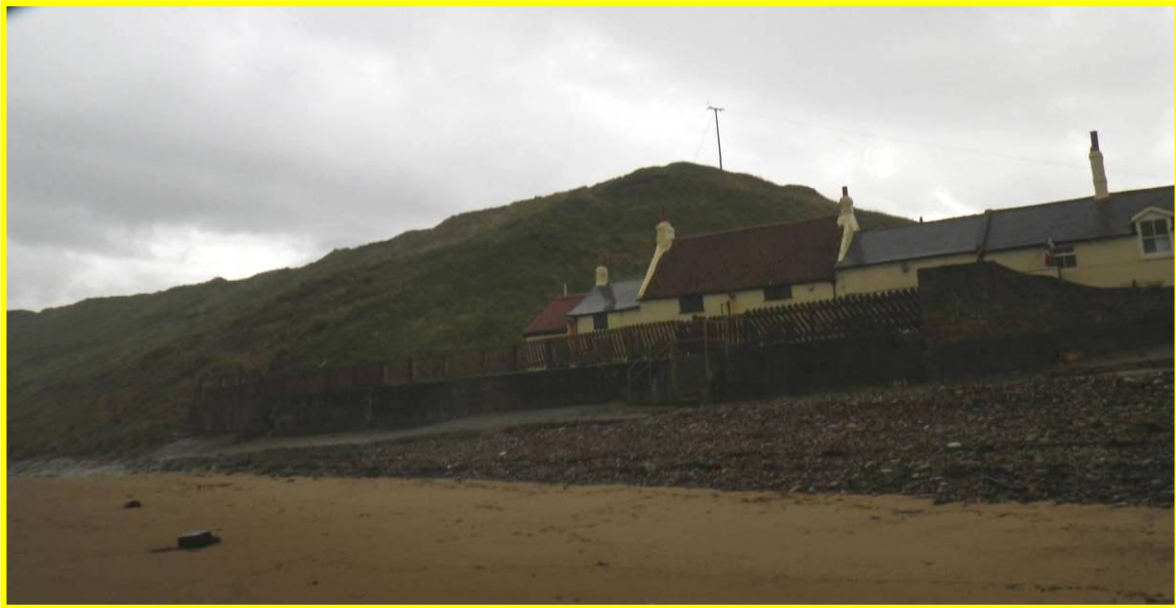
**E53/5** has slumped, leaving open cracks in the cliff face and resulting in instability classified as Locally Active. September 2012

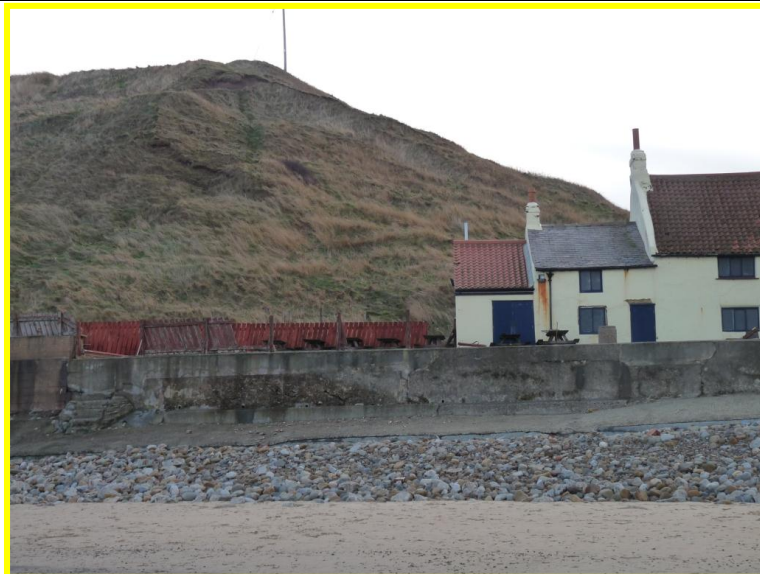
To the east, CBU **E53/5** was classified as Dormant in 2010. In 2012 there had been recent shallow slumping on the cliff face and the unit was reclassified as Locally Active. The slumping had occurred despite the presence of toe protection and probably occurred in response to the wet weather experienced in the latter half of 2012. **The slump scar had not completely revegetated by the time of the December 2013 inspection and therefore the status of 'Locally Active' has been retained.**

**E53/5** – Slump identified in previous survey not yet completely revegetated therefore ‘Locally Active’ Status has been retained. December 2013

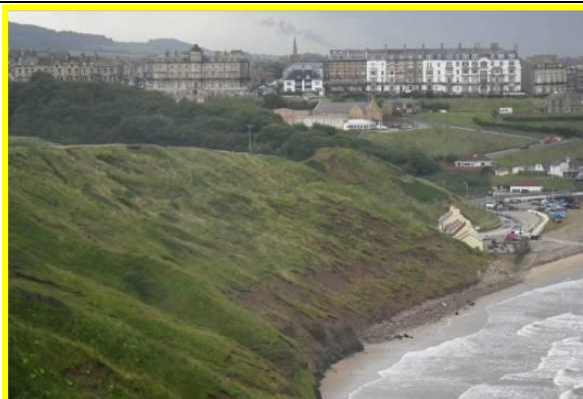
**E53/4** Slumping in the till layer of the cliff northeast of Saltburn (Locally Active).  
September 2012

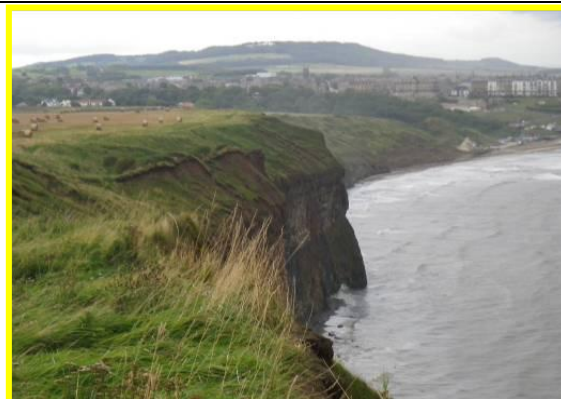
**E53/3 and E53/2** The rock part of the cliff is steep and exposed. The till part is much shallower and vegetated (Locally Active).  
September 2012

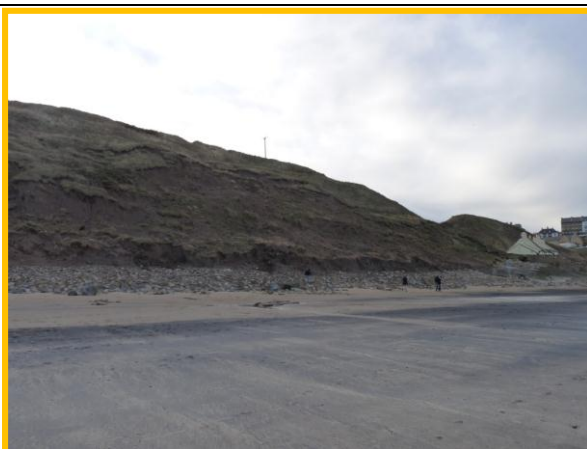
Unit **53/4** was noted in 2012 as having been subject to recent localised mudsliding in the till. The unit therefore remained classified as Locally Active until 2012. **However, widespread toe erosion was noted in this unit, along with failure of a substantial parts of the mid and**

**E53/4 – Continued slumping of the till cliffs (northern end of the unit). Toe erosion has been consistent throughout the unit and therefore the activity status has been elevated to Partly Active. December 2013.**

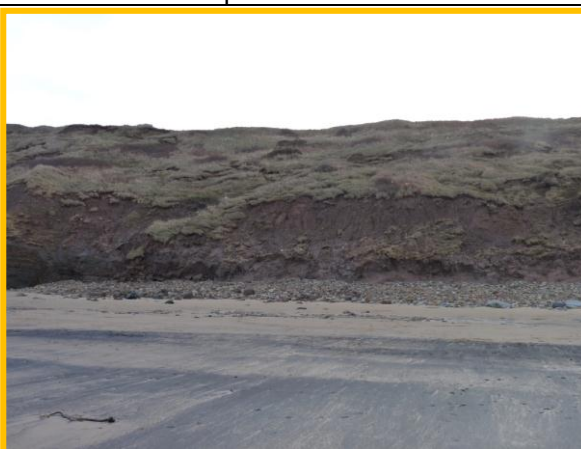
**E53/4 – Continued slumping of the till cliffs (southern end of the unit). Toe erosion has been consistent throughout the unit and therefore the activity status has been elevated to Partly Active. December 2013.**

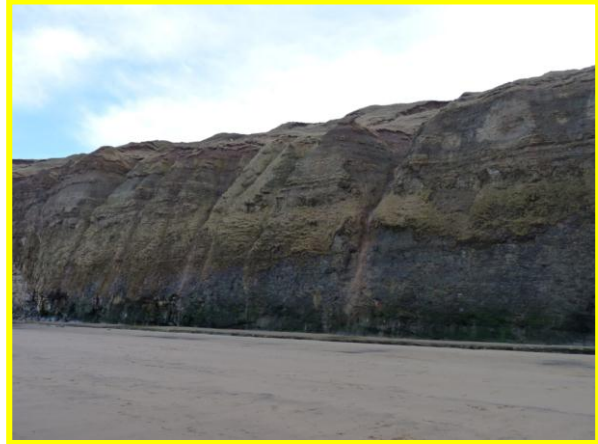
**E53/3 – Central part of unit. December 2013.  
Note streaking down cliff due to  
erosion/failure of till. (Locally Active).**

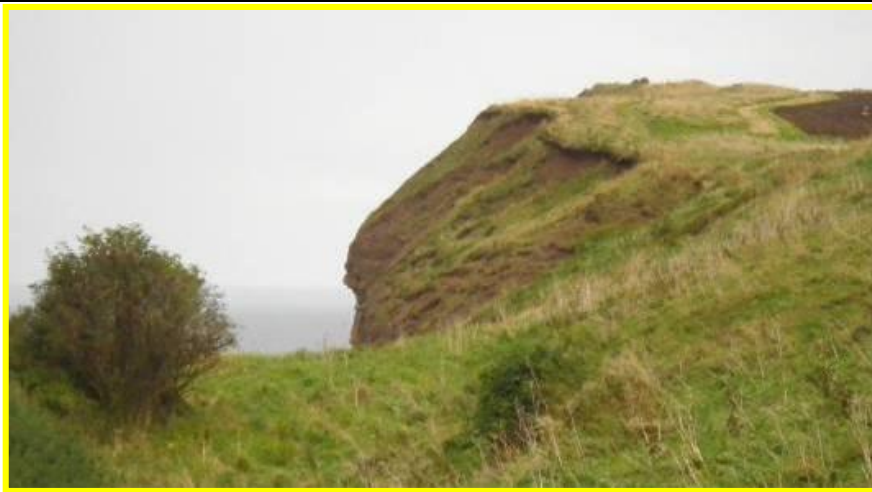
Unit 53/1 was showing signs of developing mudslides in the upper till section in 2012.

**E53/1 Instability in the upper till section of this unit (Locally Active).**

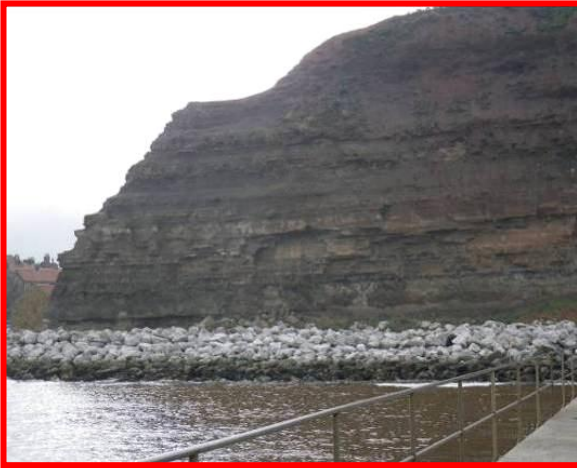
**MU4/1a** - Exposed and active end of Cowbar Nab, the southern half (Totally Active). Sept 2012

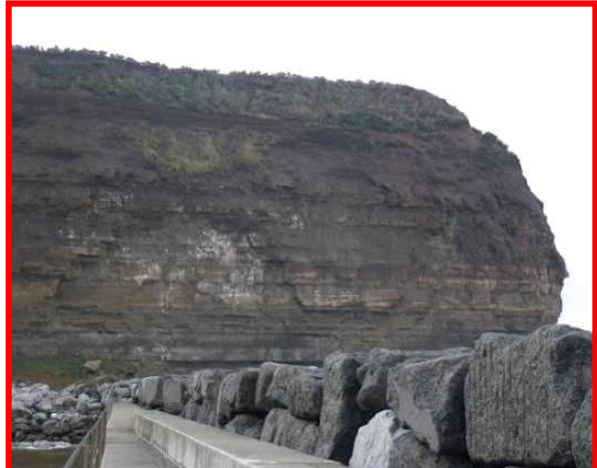
**E60/1a** - The northern half of Cowbar Nab. The cliff face is showing signs of erosion (Totally Active) Sept 2012

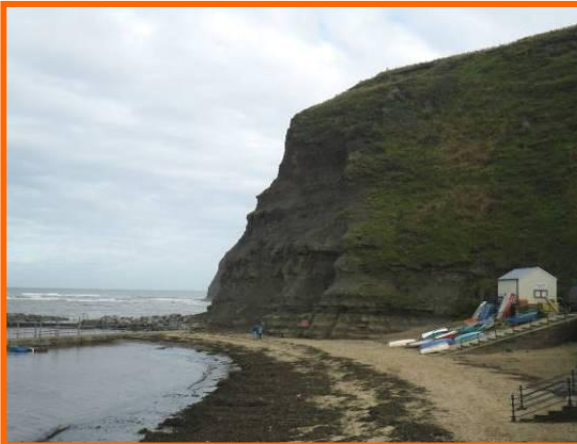
**MU4/2** –Vegetated cliff with localised erosion, behind Staithes harbour (Partly Active). Sept 2012

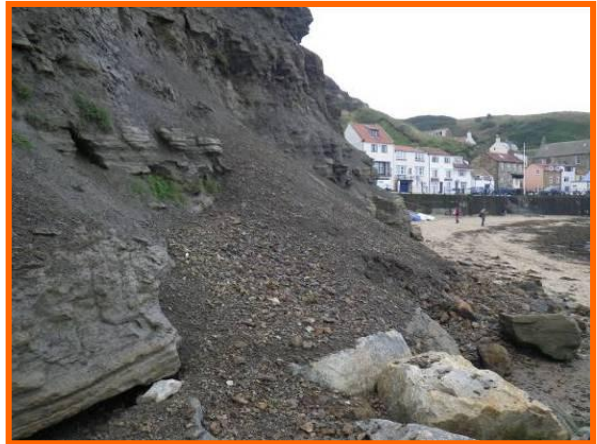
**MU4/2** – There have been a number of recent failures in this management unit, which is now classed as Partly Active. Sept 2012

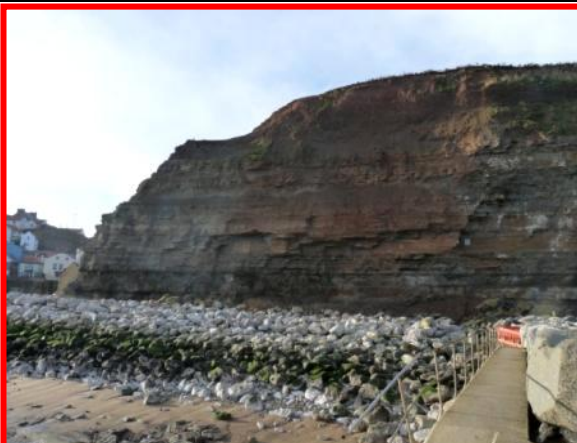
**MU4/1a** - The southern part of Cowbar Nab after the December 2013 surge – note fresh scarring in cliff face (Totally Active)

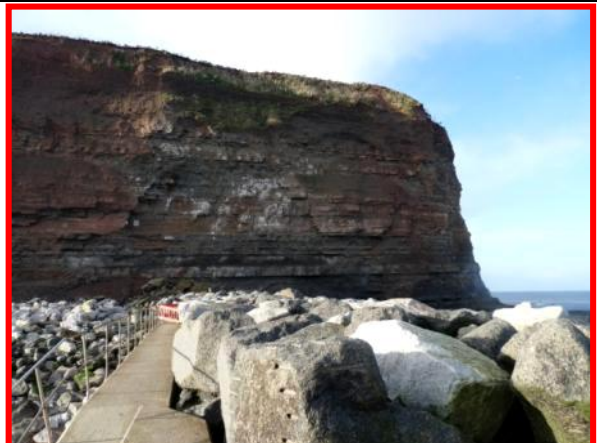
**E60/1a**- The northern part of Cowbar Nab after the December 2013 surge. Note relatively fresh scarring and talus accumulation on left of photo. (Totally Active)

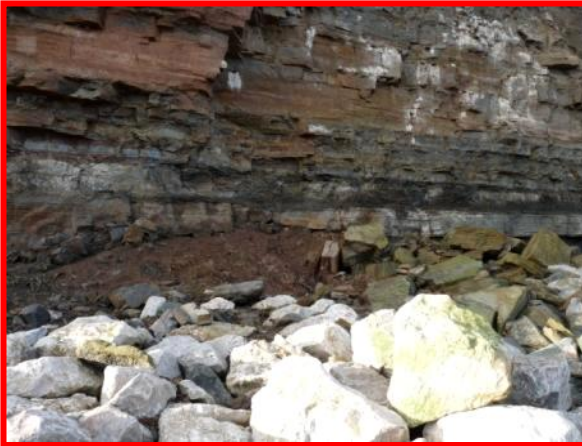
**MU4/1a - Close up photo of talus accumulation behind rock armour after the December 2013 surge. (Totally Active)**

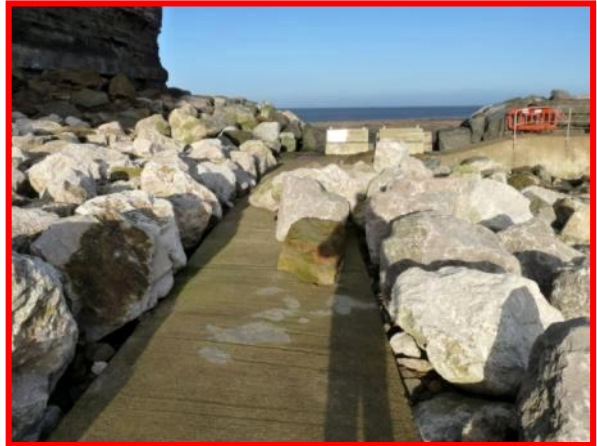
**During the post-surge inspection in December 2013, it was noted that in these units there had been relatively recent rockfalls and that there were significant talus deposits. Displaced rock armour and a rockfall block was noted on the path beneath these units, although it is not completely evident whether these blocks had been purposefully moved or had come to rest there. Given this high level of activity, the ‘Totally Active’ status for these units has been retained.**

**MU4/1a - Displaced rock armour and rockfall block on path after the December 2013 surge. (Totally Active)**

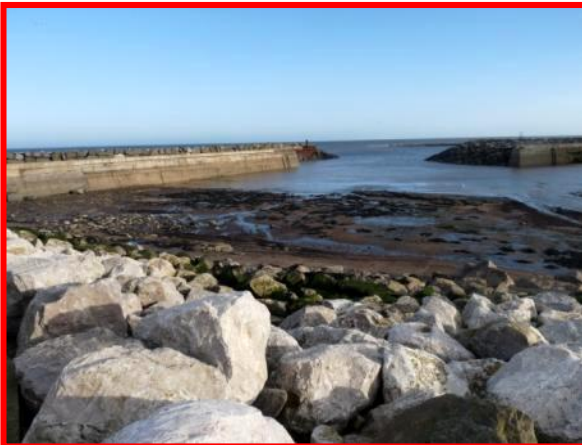
**MU4/1a - Beach condition after the December 2013 storm surge. (Totally Active)**

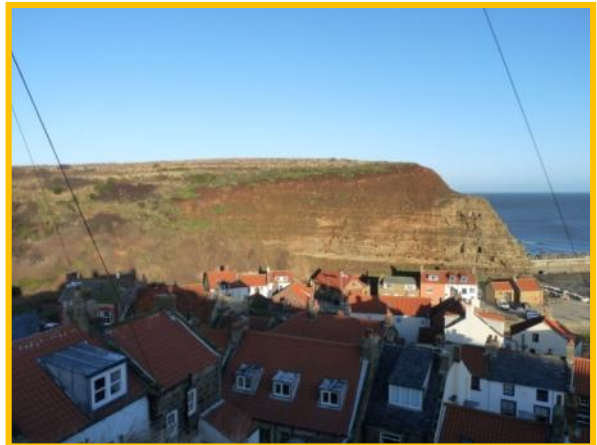
**Unit MU4/1b** is the south facing side of Cowbar Nab which runs adjacent to Staithes Beck. This unit is sheltered from the wave action because it is upstream of the harbour walls. The cliff does fail occasionally and has been given a classification of Partly Active. Further upstream from MU4/1b a rockfall has occurred on the steep slope adjacent to Staithes Beck. **No change in the level of activity following the December 2013 storm surge here was noted and therefore the ‘Partly Active’ status has been retained.**

**MU4/1b – No noticeable change in activity status following the surge. (Partly Active)**

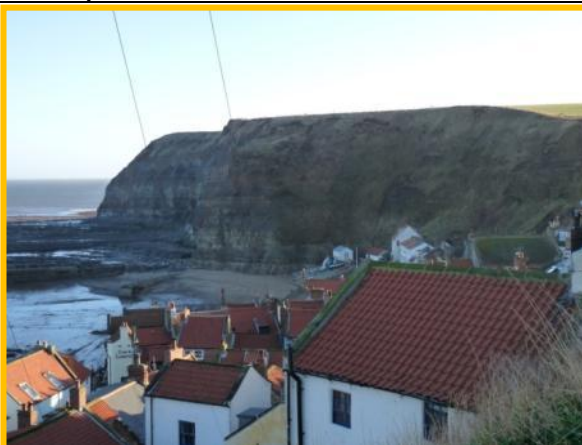
**Unit MU4/2** sits behind Staithes Harbour and is classified as Partly Active. This cliff is generally well vegetated with small localised patches of erosion. The eastern end of the unit is more exposed than the rest of the unit because of its position in the bay and is more prone to erosion. Failed material is evident in at the toe of the cliff and recent activity has been reported by residents of the eastern part of High St. The unit has been re classified from Locally Active to Partly Active to reflect this recent phase activity, which was likely to have been triggered by the exceptionally wet weather of 2012. **Following the December 2013 storm surge, this unit appeared to conform to the same description albeit with less evidence of talus at the toe which may have been removed during the surge.**

**MU4/2 – Cliff behind Staithes harbour. No notable change post December 2013 surge except lack of talus accumulation. (Partly Active)**

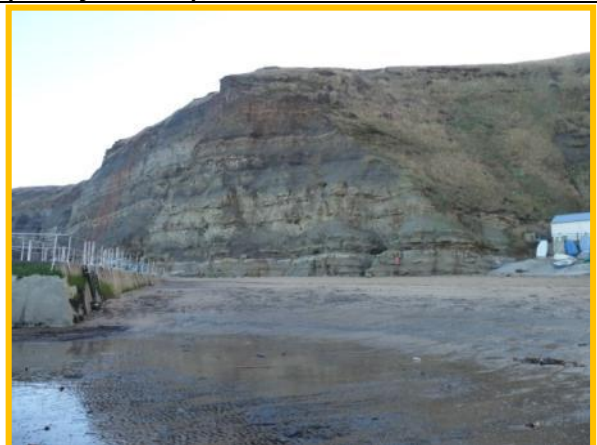
**MU4/2 - Beach condition post December 2013 storm surge. Note absence of talus at base of cliff. (Partly Active)**

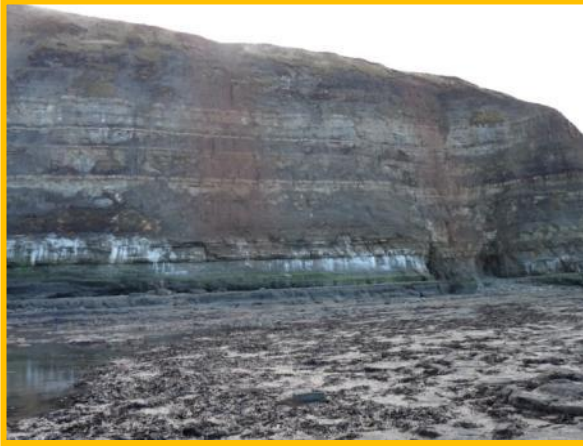
Further east, beyond the extent of Staithes harbour is unit **MU4/3**. The face of this unit is almost entirely exposed and showing signs of active erosion. Unlike any of the other cliffs within this Management Unit, this section is not protected at the toe and is therefore subject to marine erosion. This unit was classified as Partly Active in the 2009 and 2012 walkover surveys. **During the post December 2013 storm surge survey, evidence of rockfall accumulations at the base of the cliff were noted, along with evidence of recent failure in the overlying tills, indicated by exposed material at the top of the cliff and ‘streaking’ on the cliff face.**

**MU4/3 – undefended cliff east of Staithes Harbour. Note red-brown ‘streaking’ on cliffs from failures in till.**
