## **Cell 1 Regional Coastal Monitoring Programme Walkover Inspection Surveys 2016**

**Scarborough  
Borough Council**

**September 2016**

## Walkover Inspection Surveys 2016

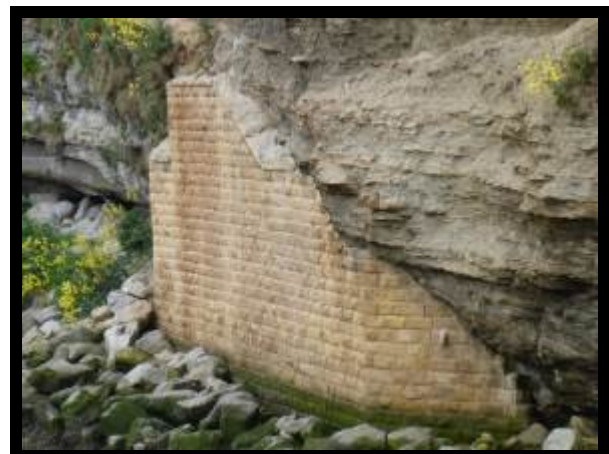
*Works completed upstream of bridge in 2013 to repair collapsed cliff (no asset ref)*

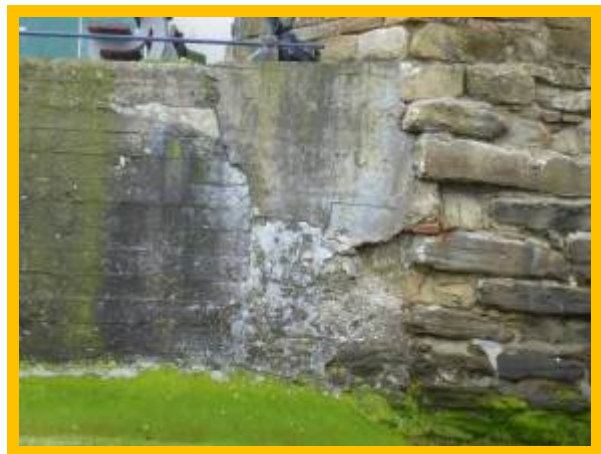
*Cracking, open joints and vegetation growth (/0402C22)*

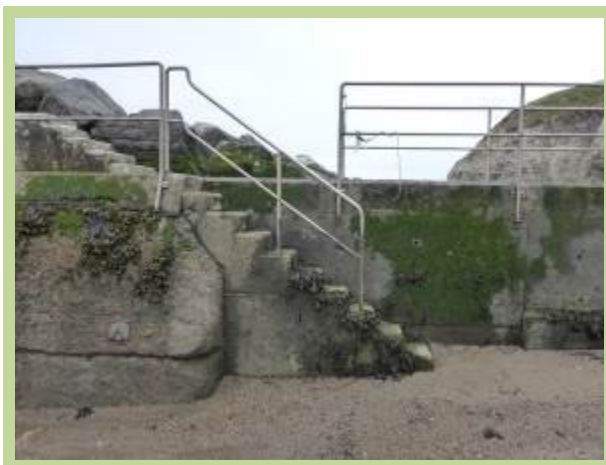
*Local abrasion, cracking and spalling, but otherwise good condition (/0403C03)*

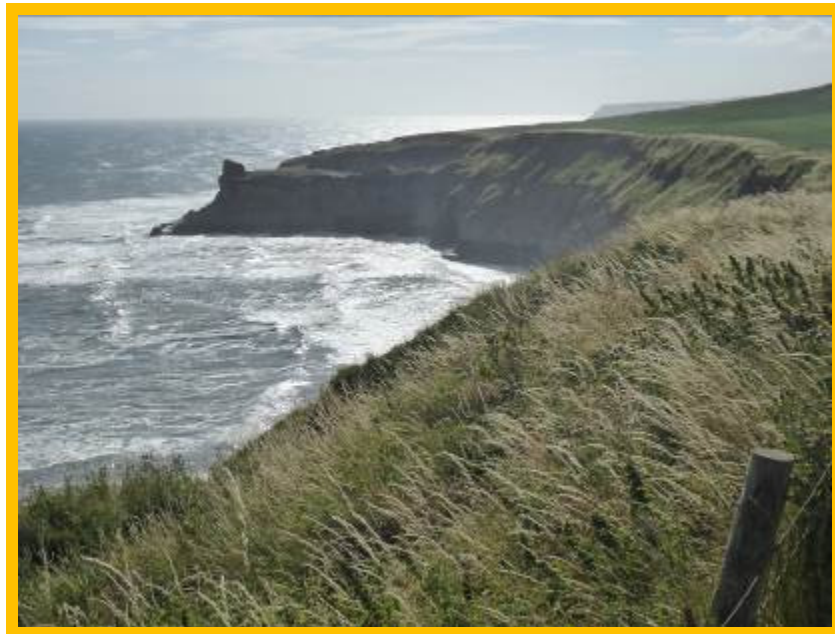
**MU5/1** – The including the highly weathered headland at Old Nab (Partly Active).

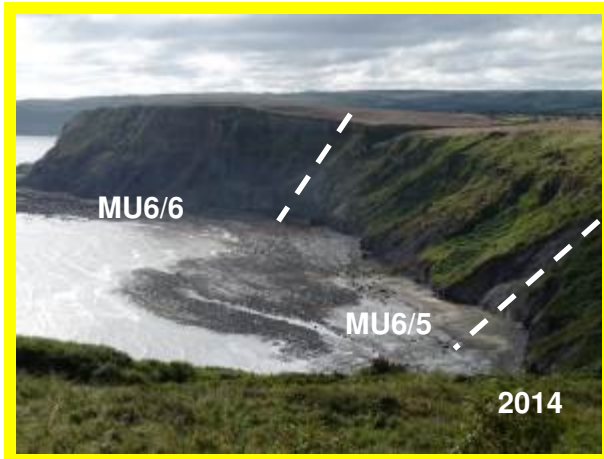
**MU6/5** – The unit was substantially vegetated in 2014 but active marine erosion and localised failures in the cliff are evident (Locally Active).

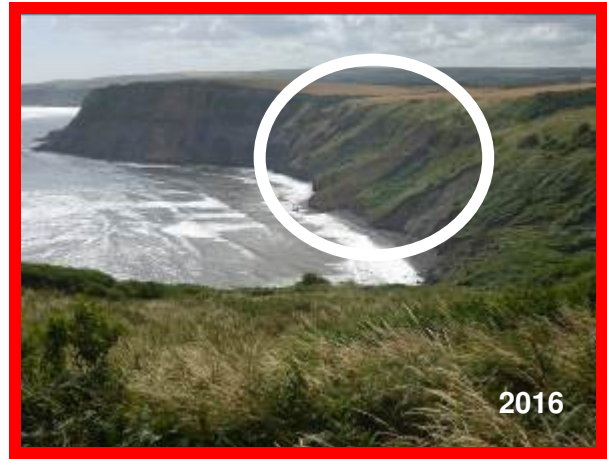
**MU6/5** – The unit was subject to a large landslip a few months prior to the inspections in August 2016 (Totally Active).

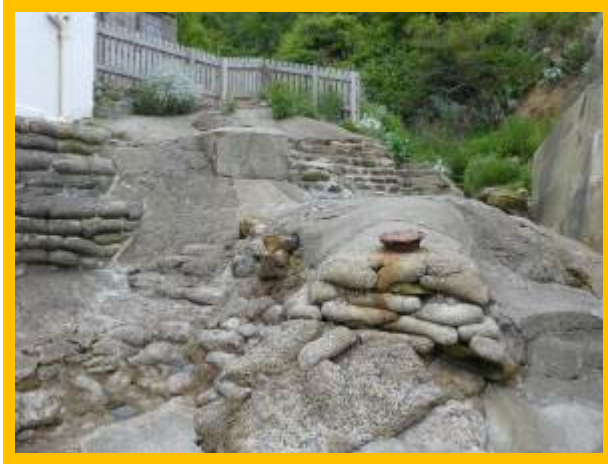
Moving south, the protruding section of wall (/0601C06) protecting the thatched cottage is in fair to poor condition. There are signs of repairs to the large vertical cracks in the wall and toe apron. However there are cracks remaining in the top of the concrete bagwork part of the wall. The concrete casing protecting the sewer pipe by the outfall of Runswick Beck is in undermined and failing condition, but the sewers are due to be relocated by Yorkshire Water as enabling works for the placement of the rock fillet in front of the sea wall.

*Bagwork wall in front of thatched cottage (/0601C06)*

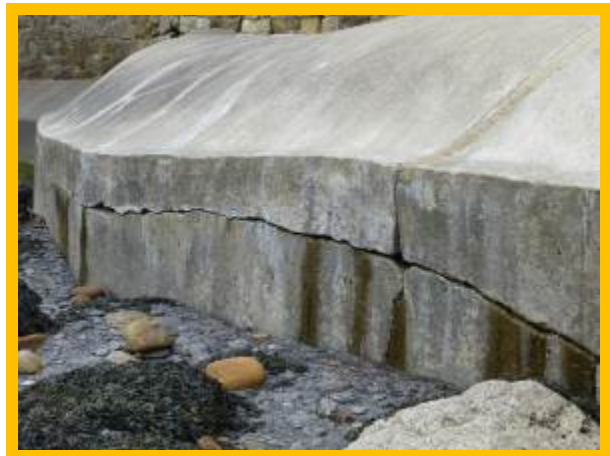
*Longitudinal cracking in concrete toe apron (/0601C06)*

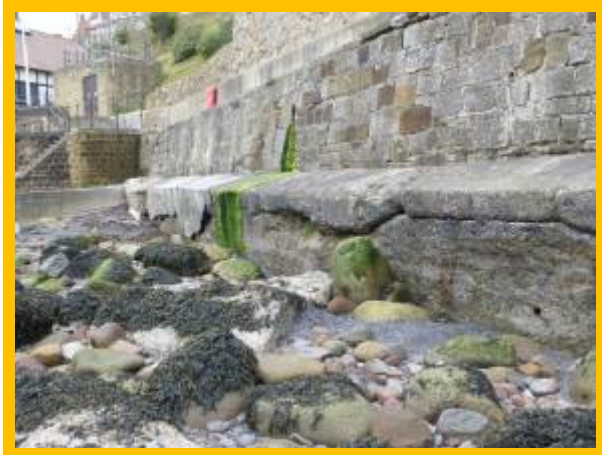
*Previous repairs to toe apron next to heavily abraded section (/0601C03)*

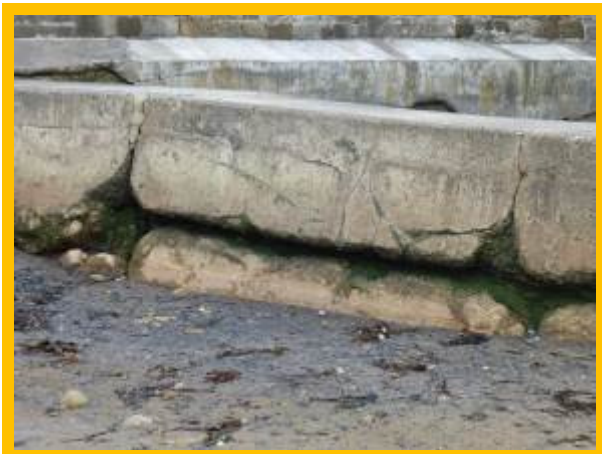
*Previous repairs to toe apron next to heavily abraded section (/0601C02)*

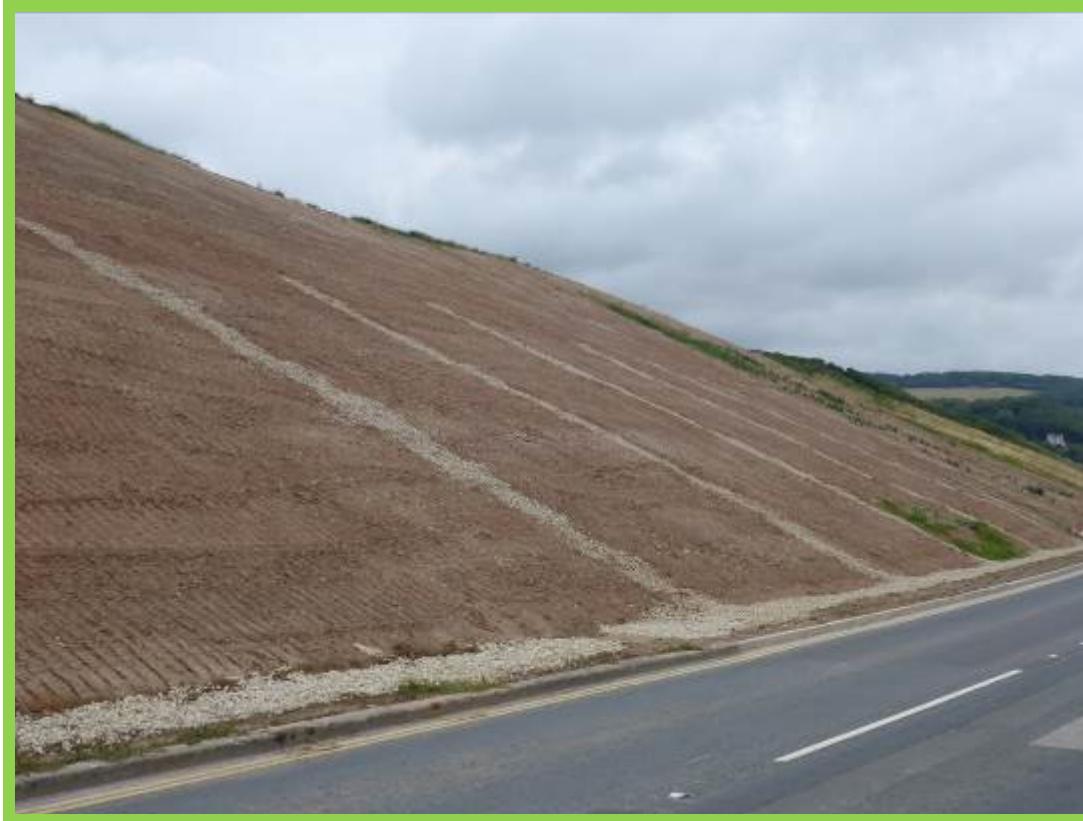
**MU9/3** Coastal slopes to rear of new sea defences in an inactive state following capital works involving re-grading, drainage and seeding as part of the Sandsend Road Coast Protection & Slope Stabilisation Scheme

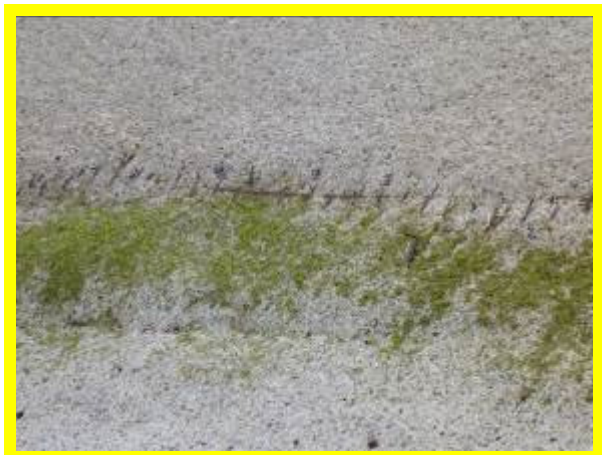
Exposed rebar (D0701C02)

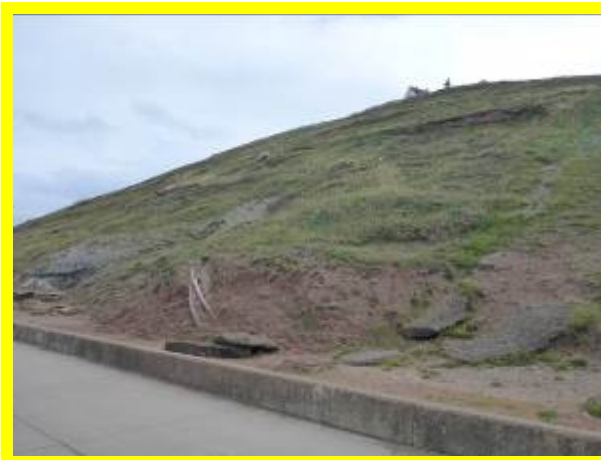
**MU11/1** Evidence of slumping in the lower coastal slopes (Locally Active)

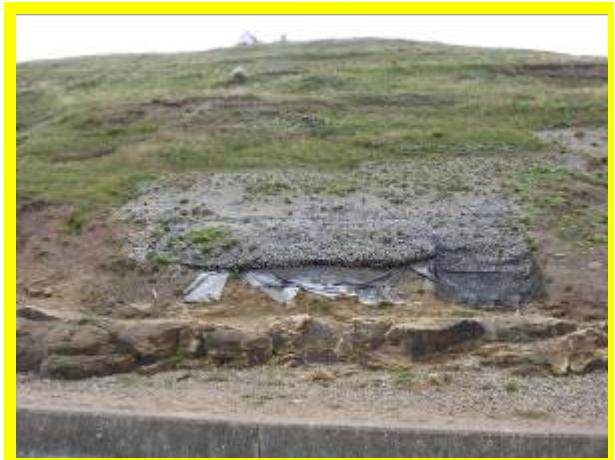
**MU11/1** Exposed previous repairs (Locally Active)

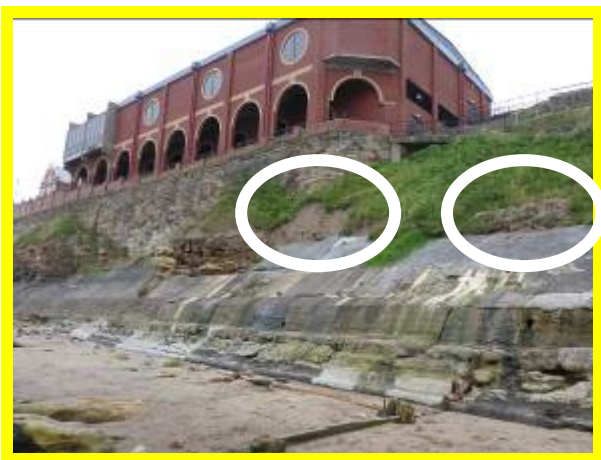
**MU11/3** Local slips in till above defences (Locally Active)

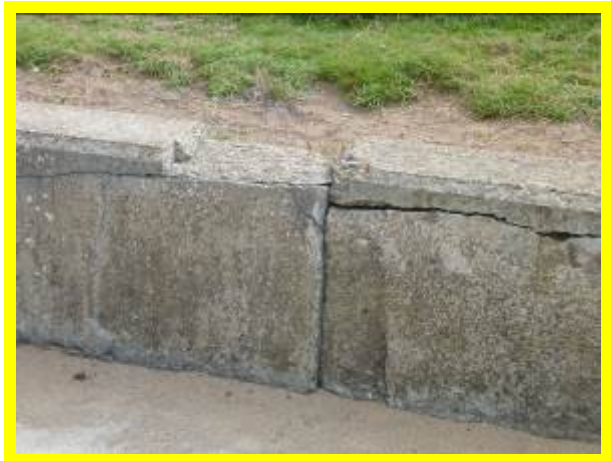
Damage to low wall at rear of promenade (D0801C01)

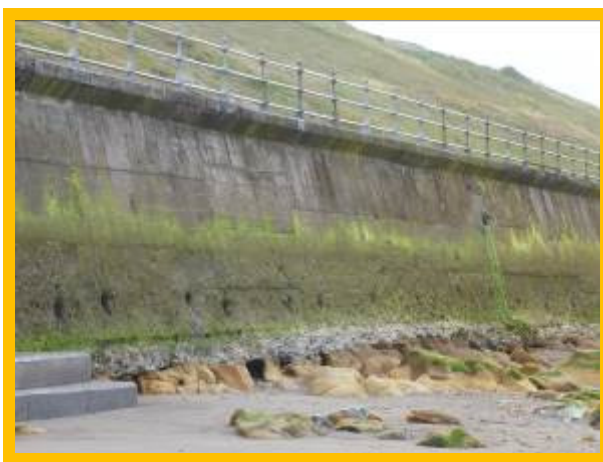
Junction between new concrete toe and original undercut toe (D0802C01)

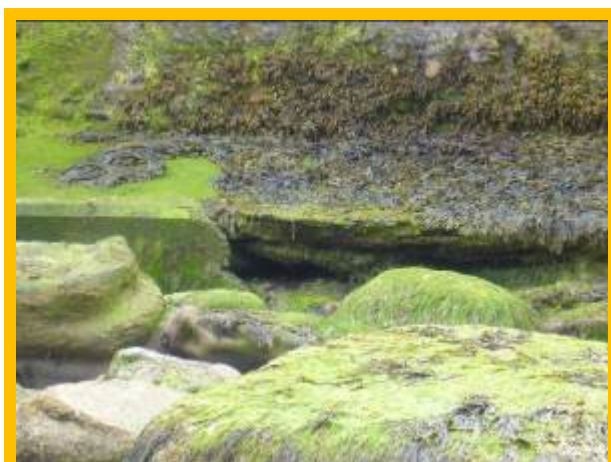
Junction between new concrete toe and original undercut toe (D0802C03)

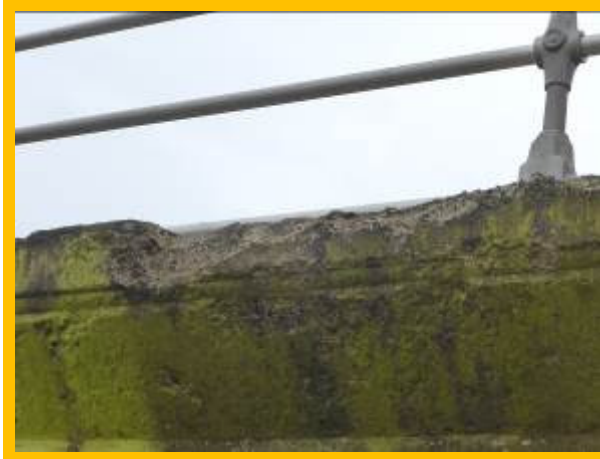
Damage to sea wall coping (D0802C03)

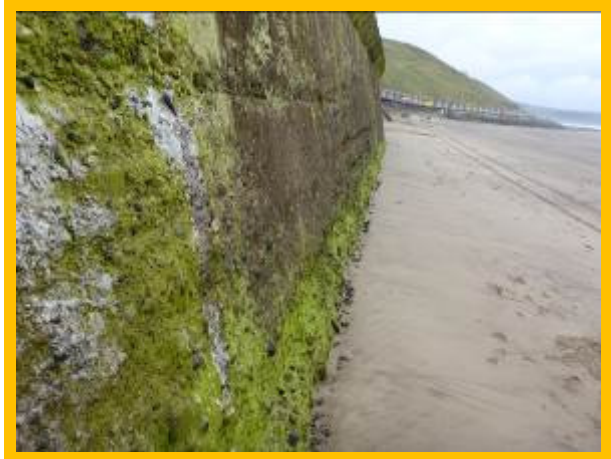
Abrasion damage to sea wall face (D0802C03)

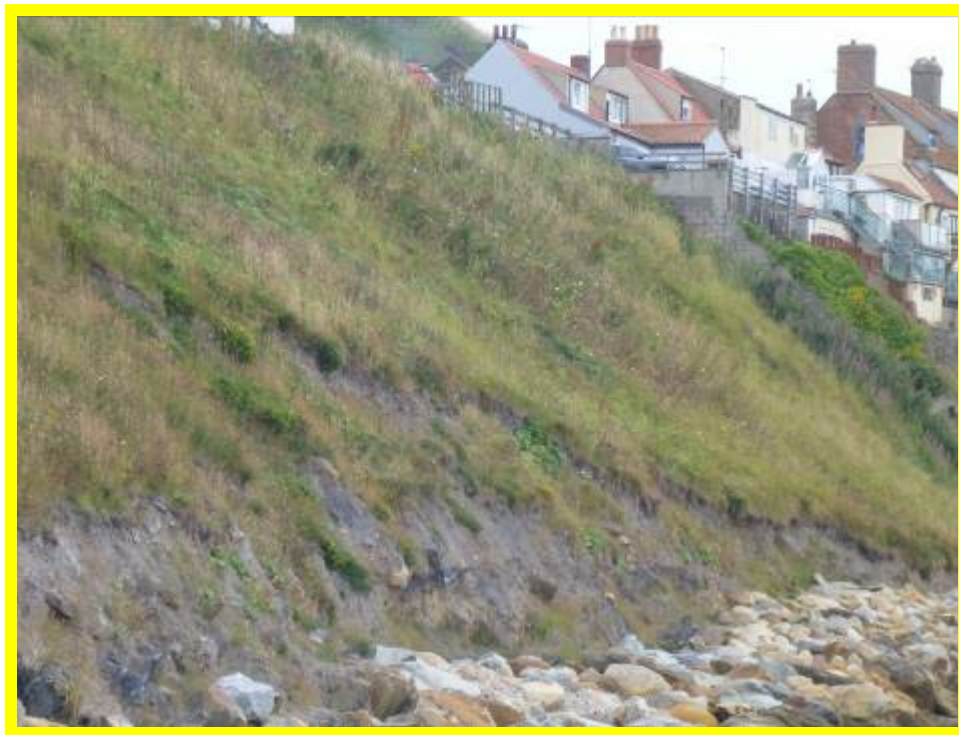
**MU12/1 Slumps in lower cliff (Locally Active)**

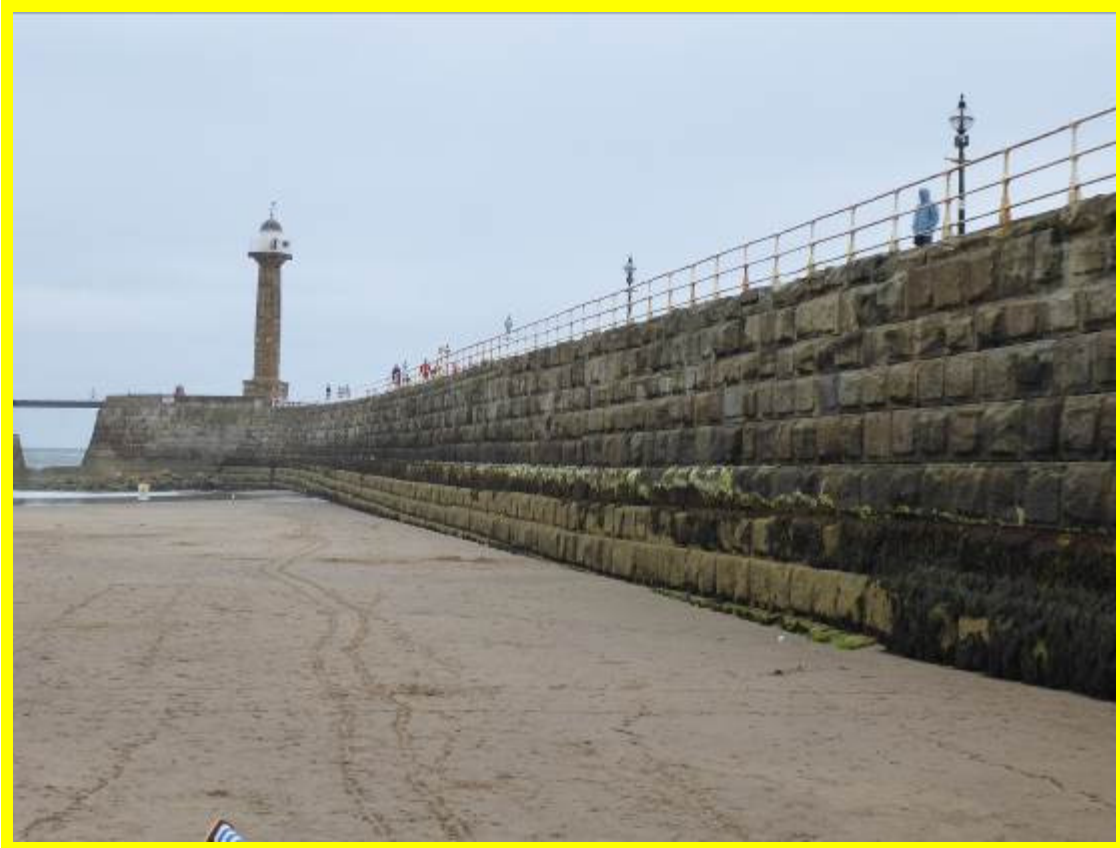
West Pier, generally in fair condition but locally poor (803C02)

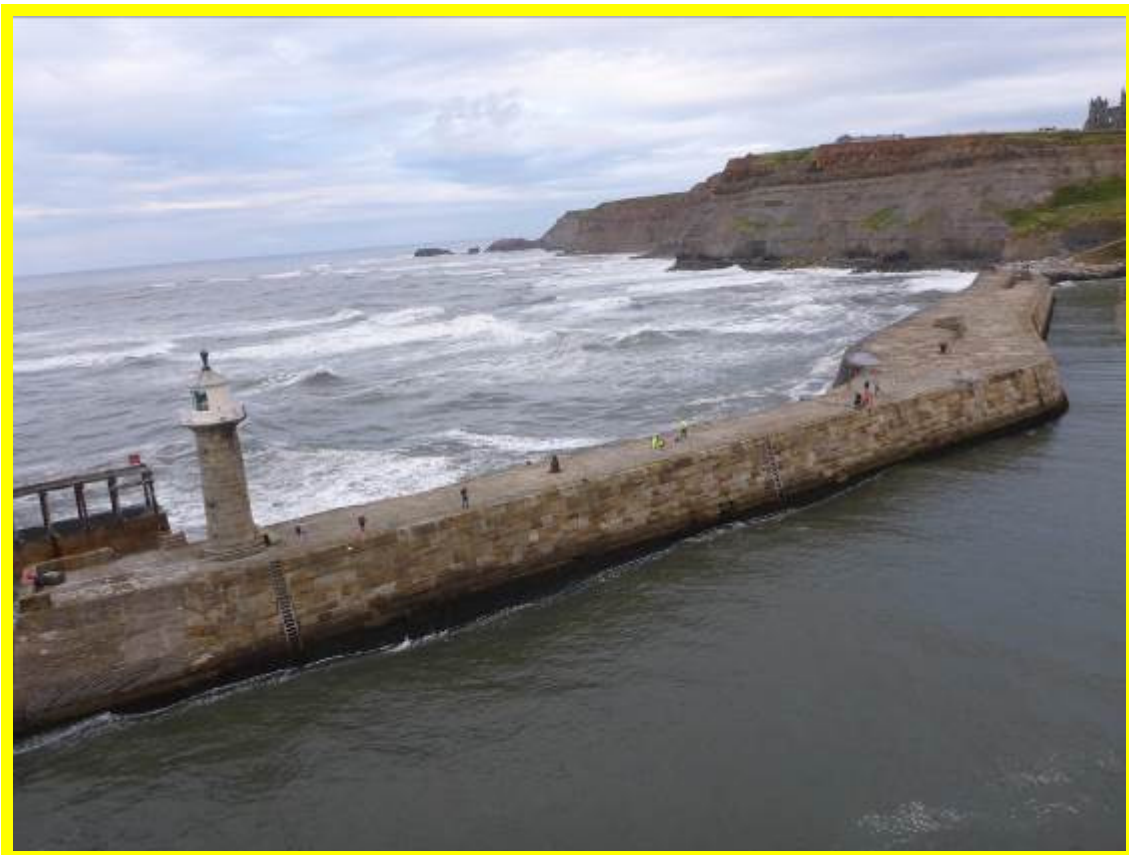
East Pier, generally in fair condition but locally very poor (803C03)

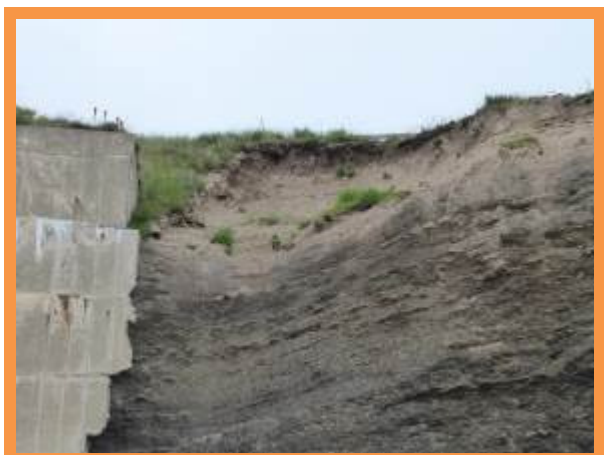
*Erosion of cliffs immediately adjacent to large northern end of large sea wall (/1003C03)*

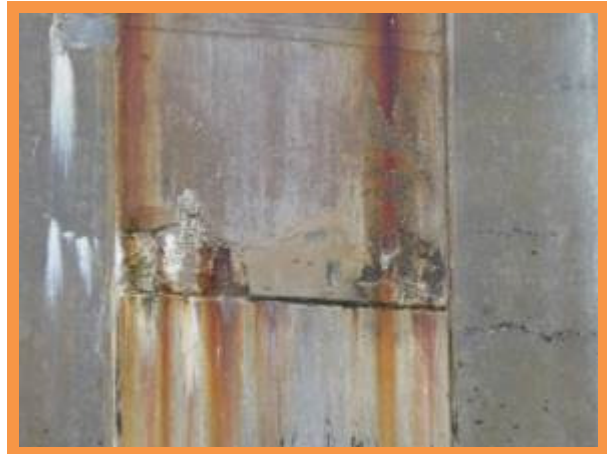
*Typical defects on large sea wall (/1003C02)*

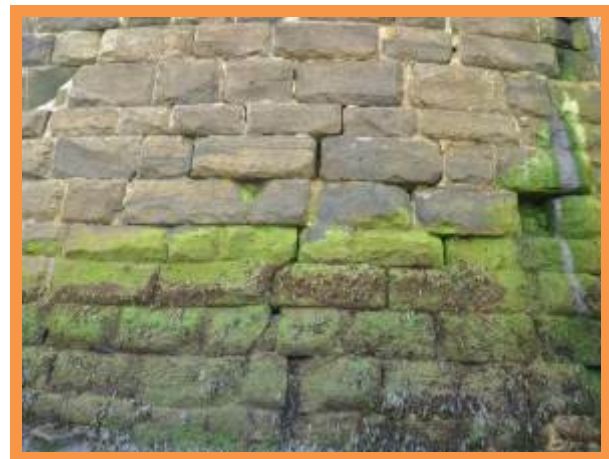
*Typical defects on blockwork wall (/1003C04)*

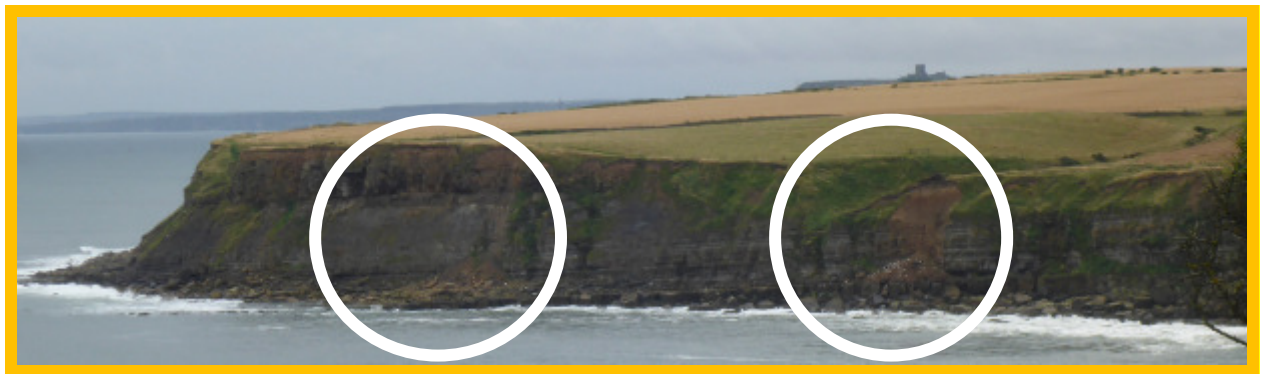
**MU19/6** Rockfalls on southern side of Cloughton Wyke (Partly Active)

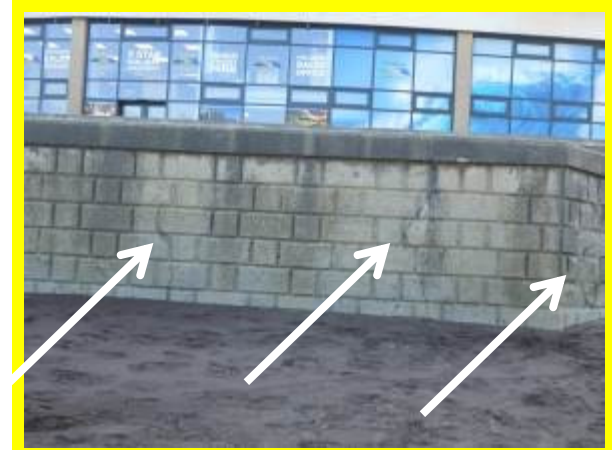
*Vertical cracks in wall protecting recent development (/1201C06)*

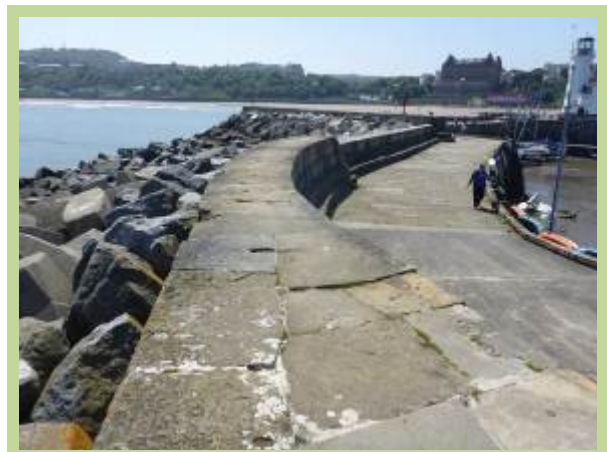
*Abrasion towards seaward end of East harbour outer wall (/1301C01)*

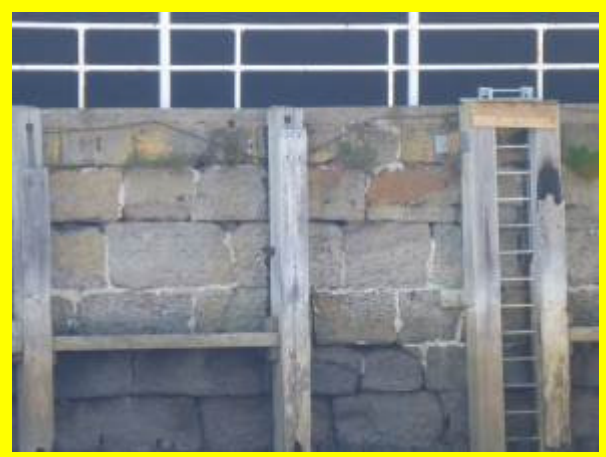
*Some open and some sealed joints in pier wall near lighthouse (/1301C03)*

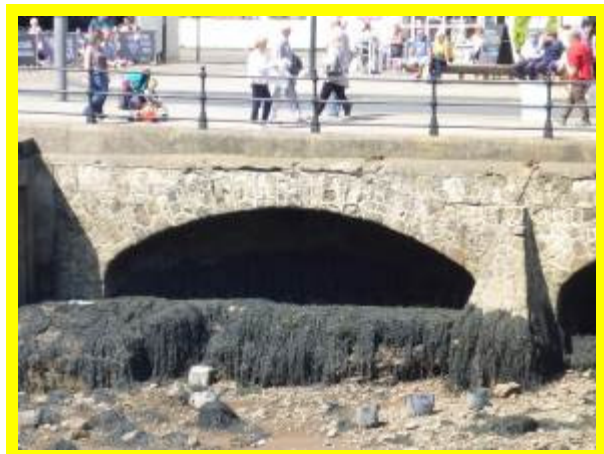
*Some open and some sealed joints in pier wall near lighthouse (/1301C05)*

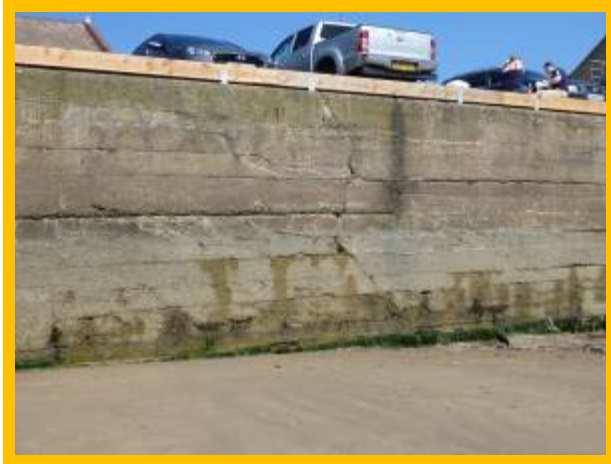
*Longitudinal cold joints in south face of West Pier wall (/1301C07)*

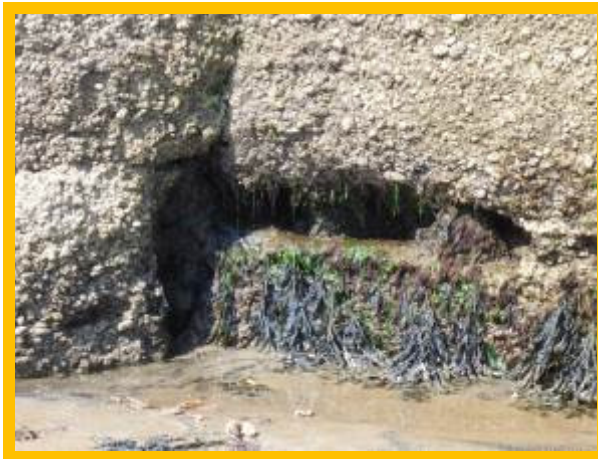
*Void at toe in south face of West Pier wall (/1301C07)*

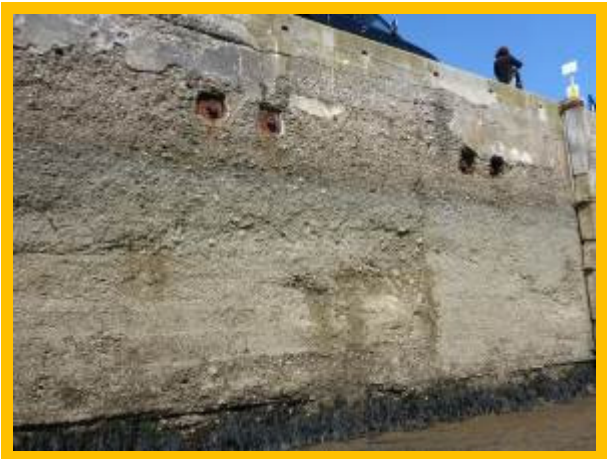
*Spalling and loss of render in south face of West Pier wall (/1301C07)*

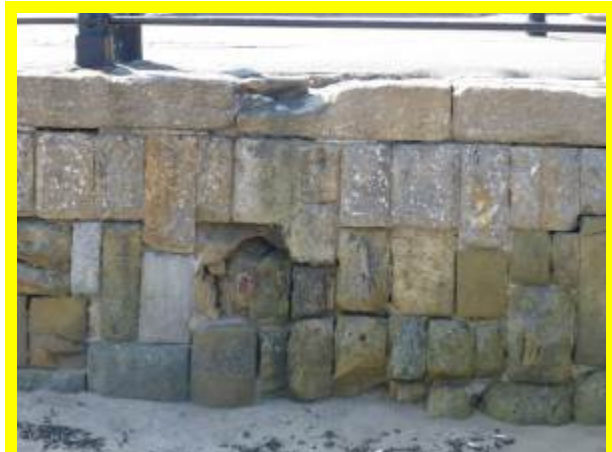
*One of the worst areas of abrasion and open joints (/1301C25)*

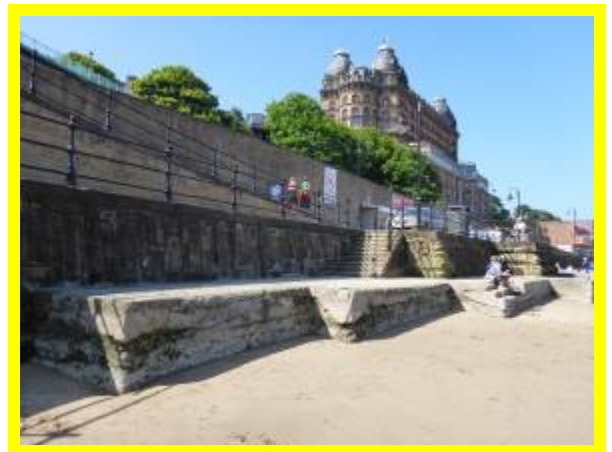
*Abrasion of toe apron south of previous repairs (/1301C09)*

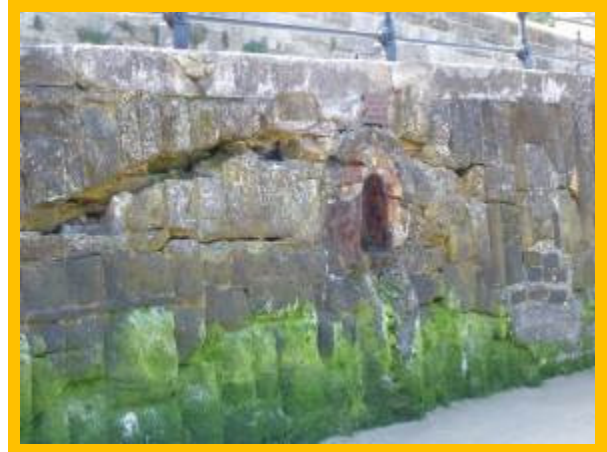
*Vertical crack in wall above access ramp (/1301C10)*

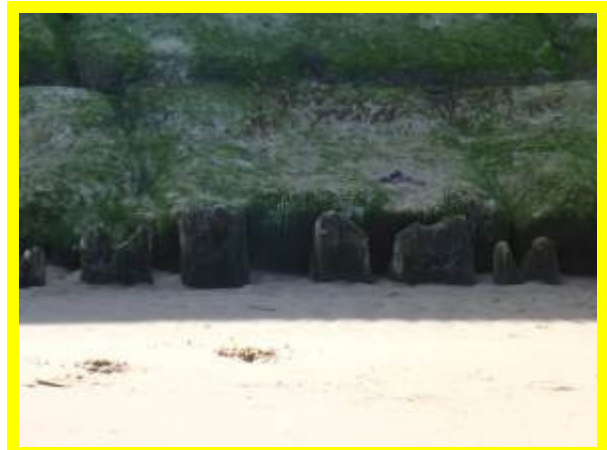
*Exposed timber toe piles (/1301C26)*

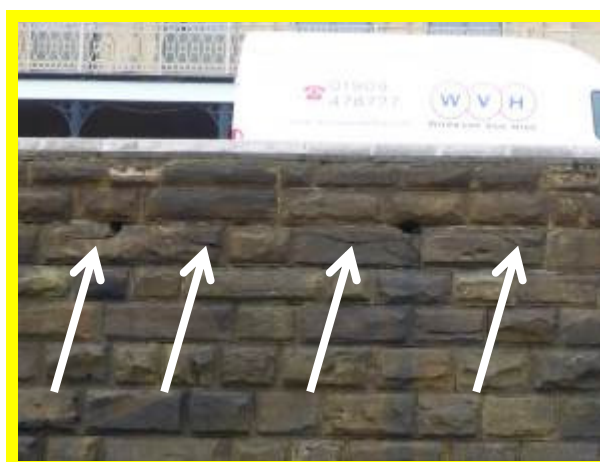
*Longitudinal cracks across blocks in sea wall (/1301C27)*

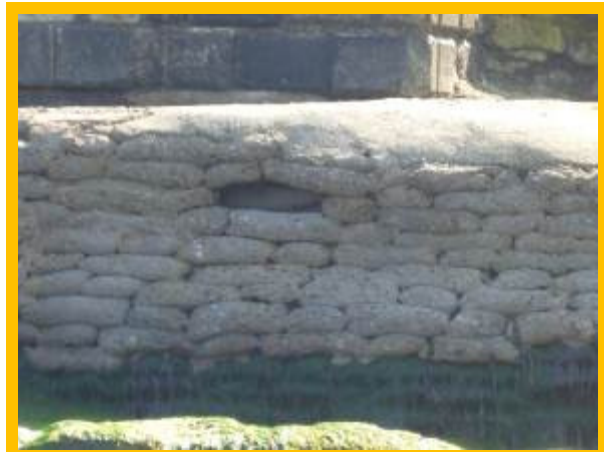
*Gaps in need of filling (/1302C02)*

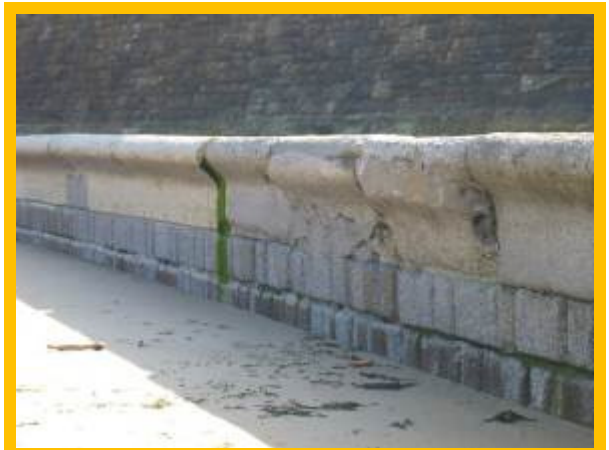
*Seawall in overall fair condition although with heavy abrasion damage locally (/1304C02)*

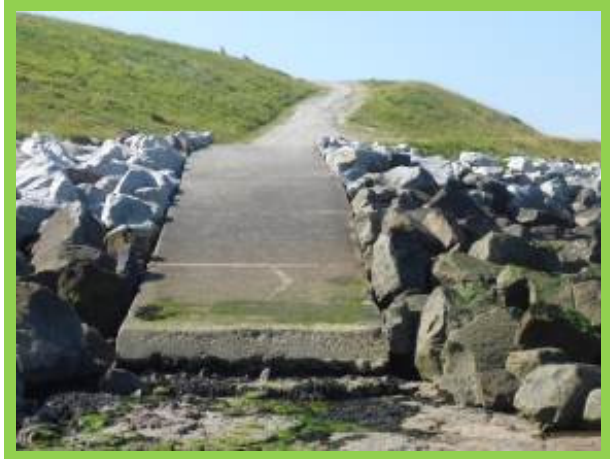
*Vertical drop and crack in concrete at end of access ramp at south end of revetment (/1304C01)*

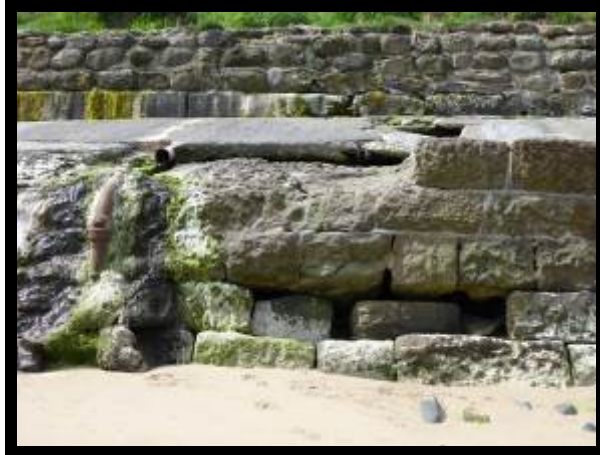
*Missing blockwork in May 2015 (/1402C04)*

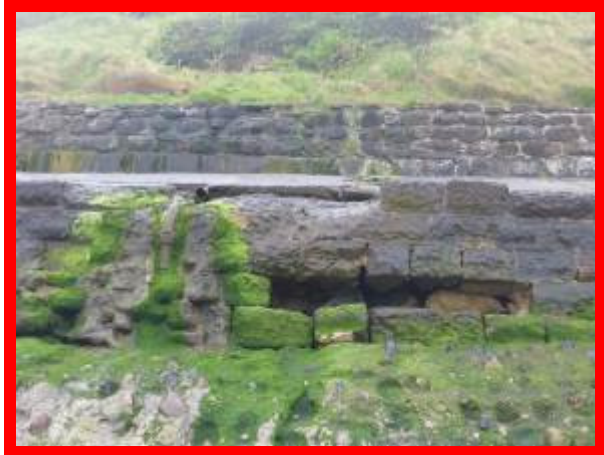
*Further missing blockwork in June 2016 (/1402C04)*

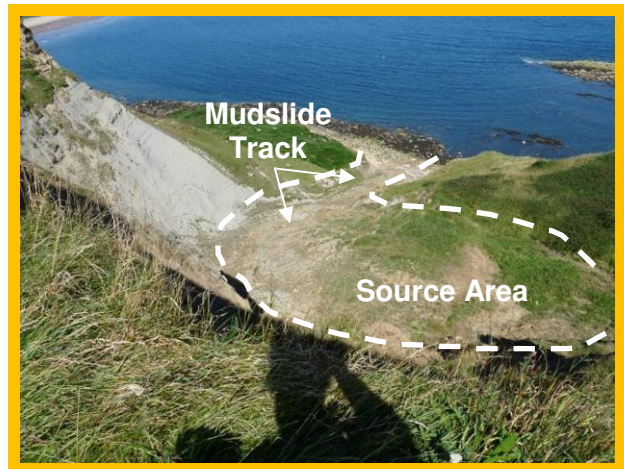
**MU24/V** - view from directly above the mudslide (Partly Active). [Reproduced from August 2014].
