Asset Inspection Document

Walk-over Visual Inspections of Assets

Scarborough Borough Council

NOVEMBER 2020

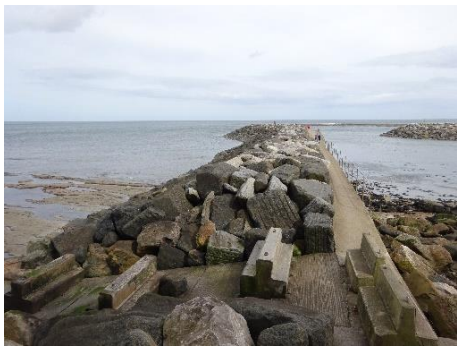
Asset Location:	NZ78271901, NZ78441906. North breakwater.	
	Asset Length:	370.8	
	Condition Assessment		
	Condition	Priority	Risk
	C	2	
	Brief Description		
	<p>Rock armour tightly packed to consistent profile. No evidence of significant displacement/movement. Possible local displacement of rock armour from crest at head of structure on inside east face. Two of stacked/pinned crest blocks missing adjacent to walkway (possible remains on foreshore). Heavily corroded steel sheet piling, particularly in uppermost 2m. Cracking to deck and crest wall. Crack to full width of deck and crest wall approx. 20m from seaward extent. Previous repair (grout/concrete infill) evident,</p> <p>Cracking and abrasion to crest, particularly coping on inside face. Rust staining of crest wall. Stainless steel guardrail in good condition although gap beneath bottom rail is large in areas with abrasion of crest.</p> <p>Possible evidence of undercutting of outer concrete face exposed by low beach levels close to landward end. Access ramp and concrete "baffles" at landward end in good condition. Approx. 0.5t armour rock sitting on concrete access ramp.</p>

Recommendations		
	<p>Grout voids in structure. Monitor rock armour at head (inside toe) and undercutting of inside concrete face (likely requiring boat survey). Repair crest locally or adjust guard railing to reduce risk of pedestrians falling.</p>

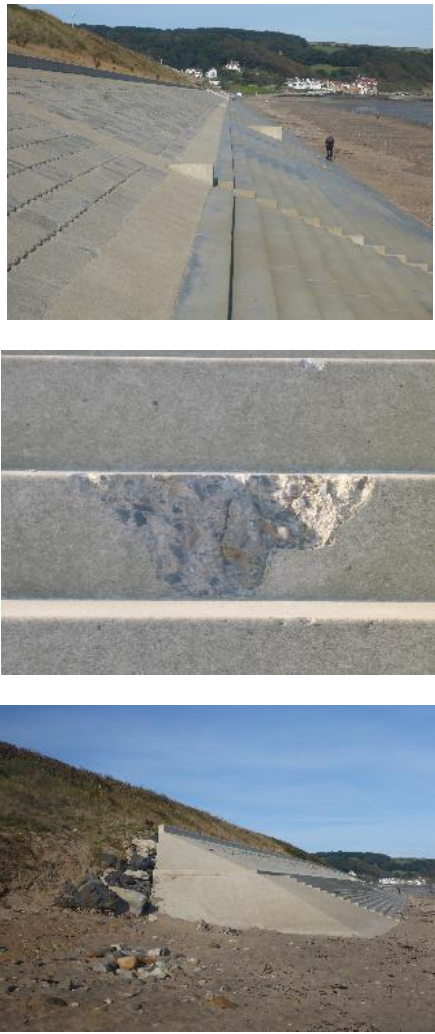
Asset Location:		
	Asset Length:	774.5	
	Condition Assessment		
	Condition	Priority	Risk
	A	4	>5
	Brief Description		
	<p>Coastal defences constructed between early 2015 and summer 2016. The new defences comprise a lower section with a stepped revetment built from pre-cast concrete units and a buried concrete toe beam that was cast <i>in situ</i>, with an upper section of interlocking pre-cast Dycel units.</p> <p>Natural coastal slope extends above the upper units to the plateau upon which the highway and footpaths sit, with re-graded and stabilised high coastal slopes to landward of the road.</p> <p>Sloping concrete tie-in revetments exist at either end of the structure.</p> <ul style="list-style-type: none"> • Outfall drains freely running • Toe beam and lower steps of revetment covered with beach sand • Some chipping damage to edge of steps (confined to lower steps on western end but becoming more frequent and higher up the structure to its central and southern sections). • Outflanking at eastern end has not worsened since being addressed by large beach boulders

Recommendations		
	Continue to monitor.

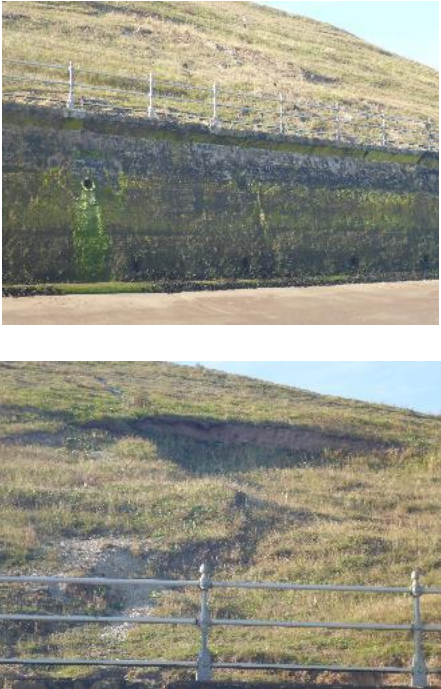
Asset Location:	NZ88541185, NZ88671180	
	Asset Length:	136.6	
	Condition Assessment		
	Condition	Priority	Risk
	C	3	
	Brief Description		
	Concrete wall has extensive minor cracking. Heavy abrasion over whole lower part of wall. Toe heavily abraded. Local damage to capping has been repaired in the past. Promenade has no major defects. Handrails have been replaced in relatively recent years.		
	Note – Cliffs behind this section in poor condition with past slippages evident.		
	Recommendations		
	Consider placing rock armourstone at toe of wall to create one continuous revetment, rather than leaving this small gap.

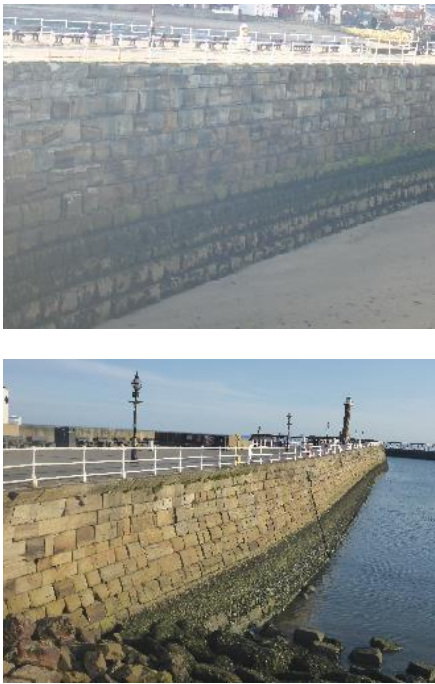
Asset Location:	NZ89861145, NZ89931173 West pier.	
	Asset Length:	639.7	
	Condition Assessment		
	Condition	Priority	Risk
	A	4	
	Brief Description		
	No visible defects following capital works.		
Recommendations			
Major refurbishment undertaken in 2018/19.

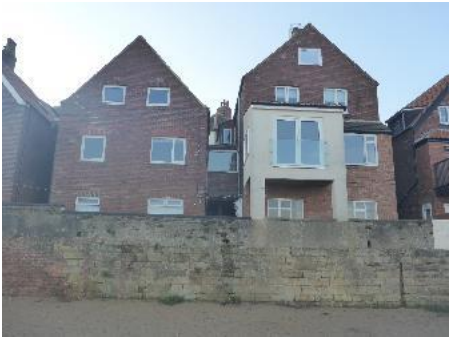
Asset Location:	South of Collier Hope and Mussel Beds	
	Asset Length:	154.9	
	Condition Assessment		
	Condition	Priority	Risk
	C	3	
	Brief Description		
	Riparian walls of (variably) brickwork, sandstone, and boulder construction in various conditions, some quite poor. Protected by sand and cobble beach. Spalling to the render and exposure of the aggregate. Slipway and steps weathered with missing joints.		
	Recommendations		
	Continue to monitor, repoint where needed. Replace missing blocks.

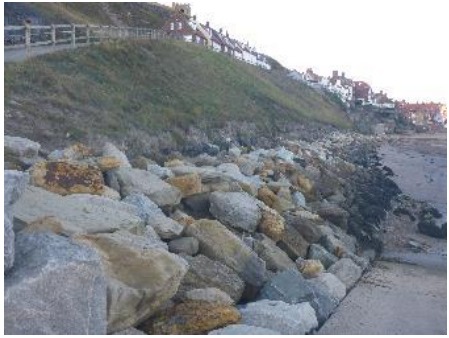
Asset Location:	NZ90171146, NZ90421143. East side of pier.	
	Asset Length:	420.7	
	Condition Assessment		
	Condition	Priority	Risk
	B	3	
	Brief Description		
	Rock armour previously described as very poor but appears generally fair on both 2018 and present inspection, although tends to taper out and could be improved in length and height. There is bare vegetation in the near-vertical section of cliff above the revetment and some exposed erosion-control matting.		
	Recommendations		
	Continue to monitor.

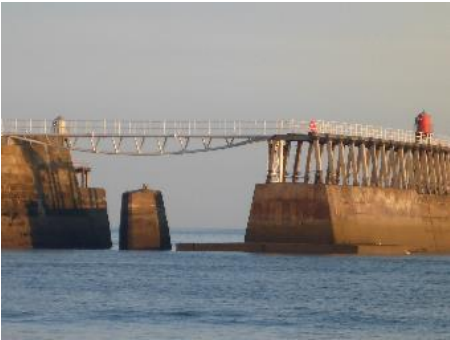
Asset Location:	NZ90041172, NZ89971186. East breakwater.	
	Asset Length:	330.9	
	Condition Assessment		
	Condition	Priority	Risk
	B	3	
	Brief Description		
	Access now possible due to replacement bridge erected in 2019.		
	Overall fair condition but limited inspection as toe is covered in water even at low tide.		
	Recommendations		
	Continue to monitor and replace planks in promenade deck as necessary. Detailed low water inspection from vessel recommended every 10 years.

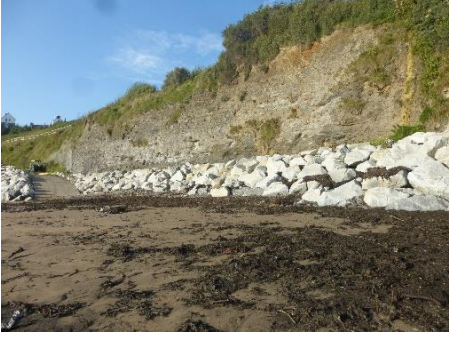
Asset Location:	Robin Hood's Bay.	
	Asset Length:	59.4	
	Condition Assessment		
	Condition	Priority	Risk
	B	4	>5
	Brief Description		
	Rock armour remains tightly packed and in good condition. Installed in 2001. Some activity on cliffs to rear.		
	Recommendations		
	Continue to monitor condition of revetment and impact of any localised rockfall.

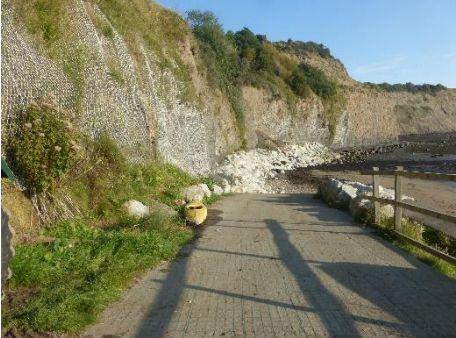
Asset Location:	Robin Hood's Bay.	
	Asset Length:	~70	
	Condition Assessment		
	Condition	Priority	Risk
	B	3	
	Brief Description		
	Slipway of mixed construction, fair condition in 2020. Periodic minor rockfall activity on slope above slipway. Missing section of fence between slipway and sea wall repaired.		
	Recommendations		
	Consider extending rock netting on slope above slipway. Continue to monitor.

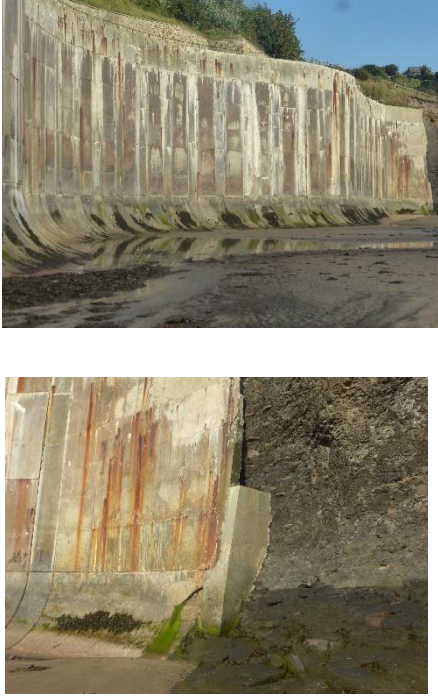
Asset Location:	NZ95330488, NZ95310502	
	Asset Length:	150.5	
	Condition Assessment		
	Condition	Priority	Risk
	C	2	
	Brief Description		
	<p>Toe not visible high beach levels. Concrete wall in poor condition. Wall displays surface cracking, spalling, rust staining and mineral encrustation. Defects appear significantly worse at northern transition. Transition is an area of longstanding outflanking concern; a recent mass concrete repair appears to have improved the condition in the lower reaches of the wall. Headscarp recession of the adjoining cliff has increased outflanking risk at the wall crest.</p> <p>Wall crest shows further cracking and spalling. Signs of recent and ongoing repairs and repainting on crest wall. Prom fair.</p>		
	Recommendations		
	Continue to monitor. Undertake capital repairs.

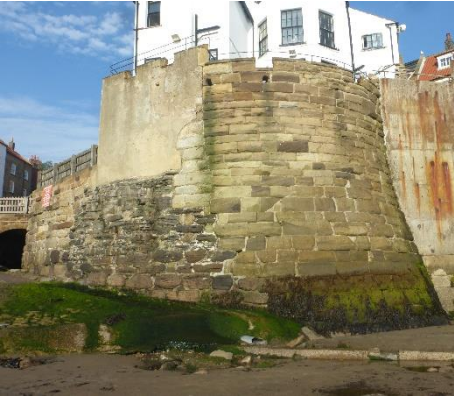
Asset Location:	NZ95320486, NZ95330488	
	Asset Length:	29.3	
	Condition Assessment		
	Condition	Priority	Risk
	C	2	
	Brief Description		
	<p>Repairs to open joints and voids noted and appear to be working effectively. Some areas of surface erosion and joint washout still exist. Voids and open joints in masonry near tie in to concrete wall have been grouted. Beach levels cover toe and obscure view of previously reported void.</p>		
	Recommendations		
	Continue to monitor remaining voids and joints. Monitor repairs. Perform detailed inspection of wall toe when beach levels drop.

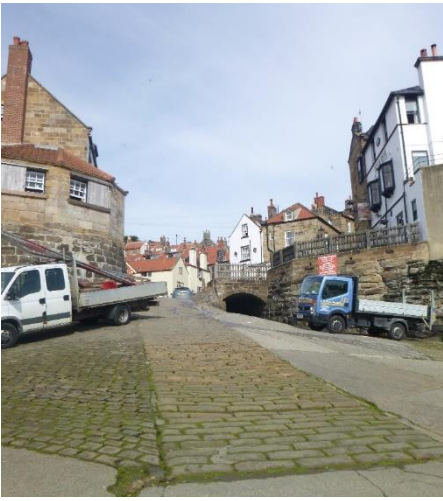
Asset Location:	NZ95310485, NZ95320486	
	Asset Length:	15.6	
	Condition Assessment		
	Condition	Priority	Risk
	B	3	
	Brief Description		
	Slipway generally in fair condition. Some cracking but appears stable at present. Previous repairs are generally effective and in good condition. A number of cracks and small voids remain, particularly on the concrete apron, which is undercut and generally in poor condition.		
	Recommendations		
Continue to monitor, reactive maintenance, repoint as necessary. Monitor beach levels and extent of undercutting to concrete apron.

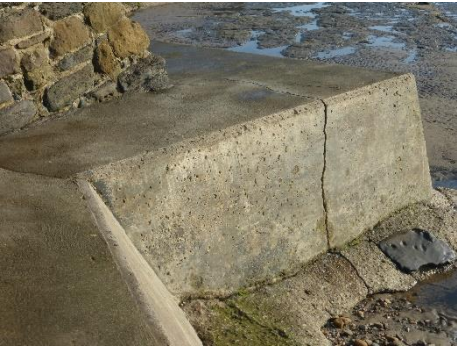
Asset Location:	NZ95310481, NZ95310485	
	Asset Length:	51.9	
	Condition Assessment		
	Condition	Priority	Risk
	B	2	
	Brief Description		
	Patchwork of repairs/repointing throughout. Void / undercutting to south end of concrete toe. Large crack through concrete toe and blinding layer at dogleg.		
	Recommendations		
Continue to monitor and repoint/repair. Repair crack at dogleg to prevent further damage to structure.

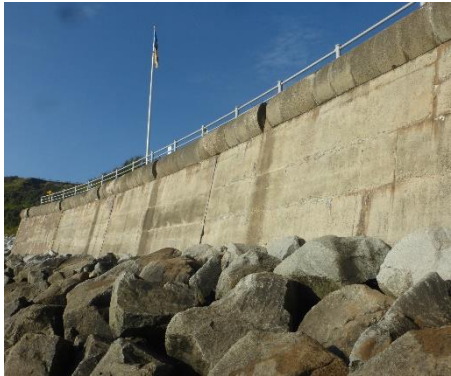
Asset Location:	NZ95320468, NZ95310481	
	Asset Length:	29.2	
	Condition Assessment		
	Condition	Priority	Risk
	B	3	
	Brief Description		
	Cracks and spalling to capping beam. Damage to previous repairs to South end of wall. Rock armour at toe in good condition, good interlock and profile.		
	Recommendations		
Continue to monitor. Repair spalling and joints where necessary.

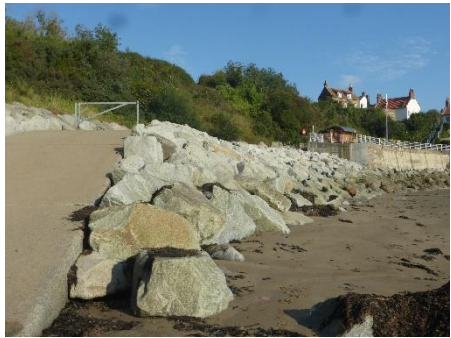
Asset Location:	NZ95320468, NZ95310481	
	Asset Length:	62	
	Condition Assessment		
	Condition	Priority	Risk
	B	4	>5
	Brief Description		
	Rock armour is generally tightly packed and good cover. Some smaller rocks show signs of movement. Promenade in good condition. Overall good.		
	Recommendations		
Monitor armour for need to re-profile in future.

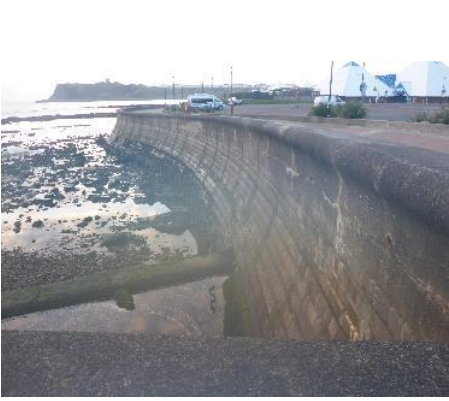
Asset Location:	TA03549057, TA03569082. Wall and promenade next to Sea Life Centre. Extends to Southern steps (40-20a-01)	
	Asset Length:	327.2	
	Condition Assessment		
	Condition	Priority	Risk
	B	3	
	Brief Description		
	Cracks to splash wall but looks sound. Prom good condition. Wall in fair condition. Stepped toe showing signs of abrasion. 1No. outlet failed but performance not affected.		
	Recommendations		
	Continue to monitor, refill joints and repair cracks.

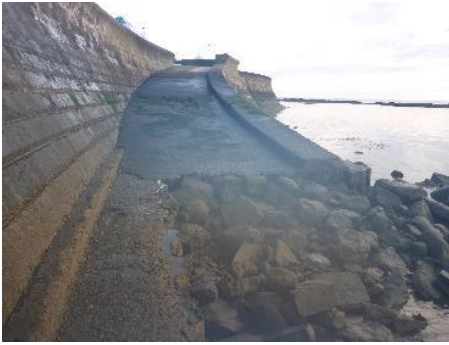
Asset Location:	TA03549057, TA03569082. Wall and promenade next to Sea Life Centre.	
	Asset Length:	~15	
	Condition Assessment		
	Condition	Priority	Risk
	C	3	
	Brief Description		
	Slipway not usable due to toe erosion. Deck slabs are in poor condition with joints heavy abraded. Recently repaired deck slab section is showing signs of damage.		
	Recommendations		
	Repair deck slab

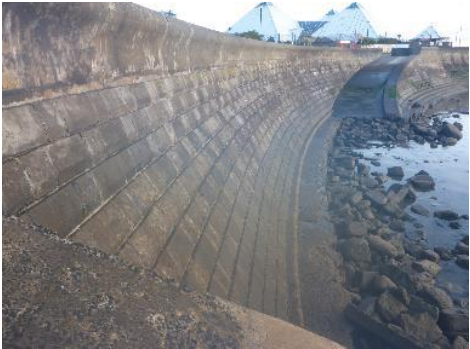
Asset Location:	Between slipway and steps	
	Asset Length:	Part of overall wall length (327.2)	
	Condition Assessment		
	Condition	Priority	Risk
	B	3	
	Brief Description		
	Blockwork in fair condition. Surface corrosion on sheet piles, with concrete toe beam heavily abraded in places. Prom good condition.		
	Recommendations		
	Continue to monitor

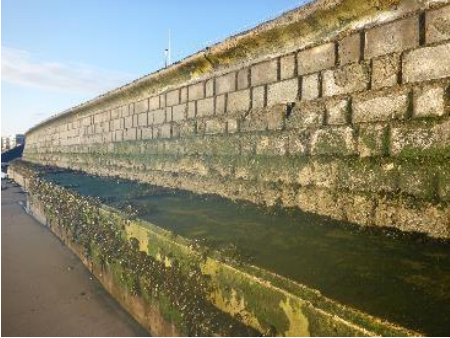
Asset Location:	TA03589031, TA03549057	
	Asset Length:	65	
	Condition Assessment		
	Condition	Priority	Risk
	C	3	
	Brief Description		
	Exposed aggregate and abrasion / spalling to capping beam and facing blockwork. Cracks throughout promenade. Repairs evident in rear revetment. Recent repairs to toe beam to the south remain in good condition.		
	Recommendations		
Continue to monitor. Repair damaged capping beam and cracks in promenade.

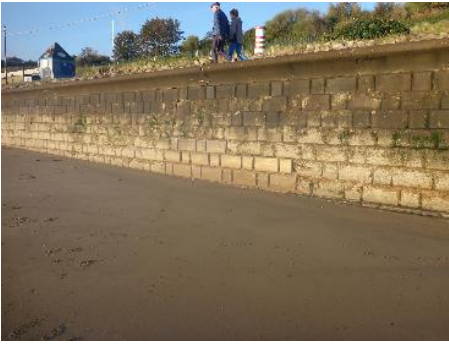
Asset Location:	TA0357690349 North of slipway and beach huts.	
	Asset Length:	73.8	
	Condition Assessment		
	Condition	Priority	Risk
	C	3	
	Brief Description		
	Face loss with exposed aggregates – Repairs to section of blockwork in centre remains in good condition. Cracking to parts of promenade. Revetment to rear of prom appears in good condition, recently repaired.		
	Recommendations		
Continue to monitor and repair cracks.

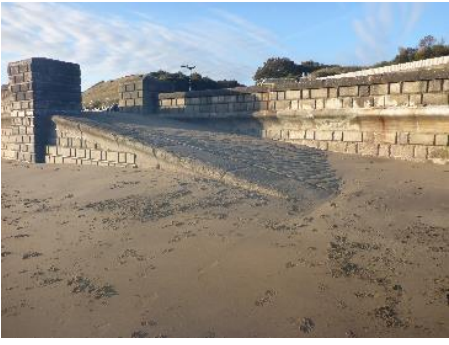
Asset Location:		
	Asset Length:	~6	
	Condition Assessment		
	Condition	Priority	Risk
	B	3	
	Brief Description		
	Slipway - Spalling coping on side wall and recurve blockwork. Missing joints on revetment. Sediment concealed toe of slipway.		
	Recommendations		
Replace missing joints.

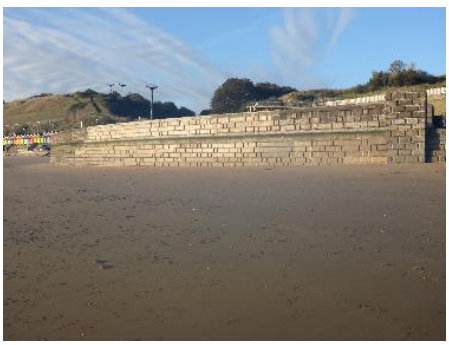
Asset Location:	TA03599020, TA03589031 At North end of beach huts.	
	Asset Length:	99.1	
	Condition Assessment		
	Condition	Priority	Risk
	B	3	
	Brief Description		
	No significant change observed in 2020. As reported previously repairs appear to be holding. Spalling coping next to southern ramp. Promenade in good condition. Heavily abrasion to unrepaired lower sections. Missing blockwork to low wall to grassed area at back of promenade. Outlet in good condition.		
	Recommendations		
Continue to monitor repair cracks and coping. Repair wall at back of promenade.

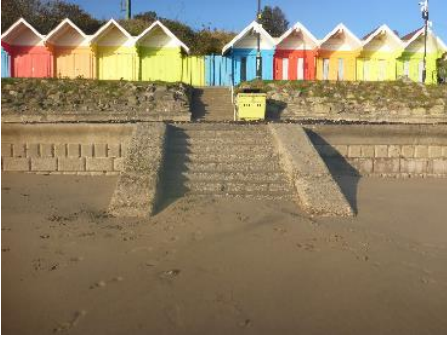
Asset Location:		
	Asset Length:		
	Condition Assessment		
	Condition	Priority	Risk
	B	3	
	Brief Description		
	Sediment approx. 500mm higher in 2020 concealing lower steps. Abutments remains heavily abraded. Steps chipped and rounded but fair condition overall.		
	Recommendations		
Repair cracks. Continue to monitor

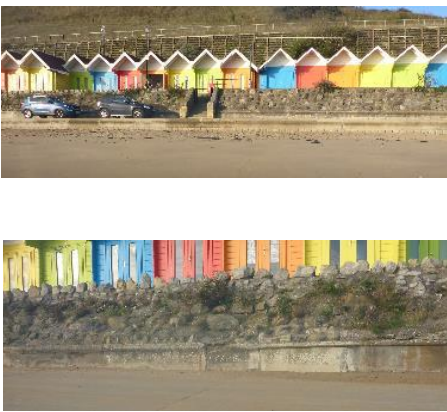
Asset Location:	TA03758981, TA03599020	
	Asset Length:	58.4	
	Condition Assessment		
	Condition	Priority	Risk
	B	4	5
	Brief Description		
	Sediment buried almost entirety of the seawall bar the cope stones. Repaired sections of cope are in good condition. Promenade in good condition but some spalling adjacent to coping. Rear revetment in fair condition, although mature vegetation growth was noted, some spalling to splash wall beneath revetment.		
	Recommendations		
Continue to monitor. Remove mature vegetation.

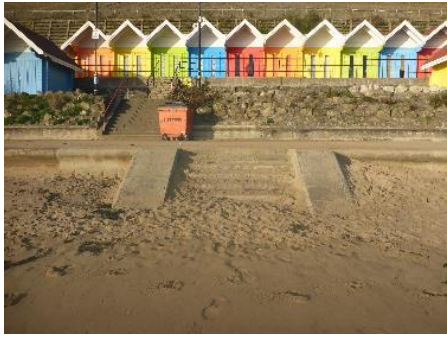
Asset Location:	TA03758981, TA03599020	
	Asset Length:	~3	
	Condition Assessment		
	Condition	Priority	Risk
	B	4	5
	Brief Description		
	Beach levels very high during the inspections, coming to the crest of the wall. Abutments (rebuilt in 2015) remain in good condition. Steps show minor signs of rounding.		
	Recommendations		
Continue to monitor.

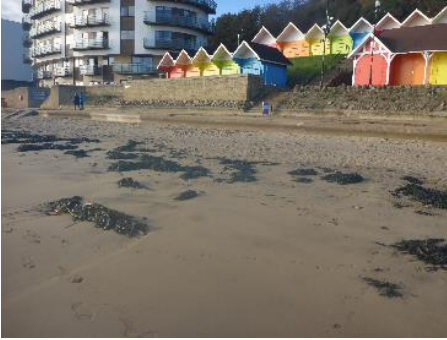
Asset Location:	TA03758981, TA03599020	
	Asset Length:	55.6	
	Condition Assessment		
	Condition	Priority	Risk
	B	4	5
	Brief Description		
	Beach levels very high during the inspections, coming to the crest of the wall. Sections of cope have been replaced since 2018 and are in good condition.		
	Recommendations		
Monitor and repair coping.

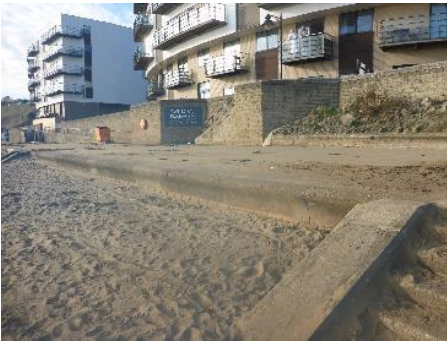
Asset Location:	In front on new apartments.	
	Asset Length:	22.8	
	Condition Assessment		
	Condition	Priority	Risk
	B	4	5
	Brief Description		
	Unchanged in 2018. Only capping and top row visible. Abrasion/cracks to coping/prom edge. Prom in good condition.		
	Recommendations		
Repair defects to coping/prom edge and rear revetment.

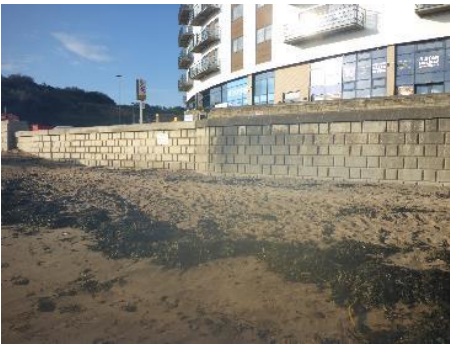
Asset Location:	TA03818971, TA03758981	
	Asset Length:	34.2	
	Condition Assessment		
	Condition	Priority	Risk
	B	3	
	Brief Description		
	Wall has been repaired since 2012 and is in good condition. South section rebuilt / overlaid. One full height crack evident in middle section although not worsened since 2018.		
	Recommendations		
Monitor and repair cracks.

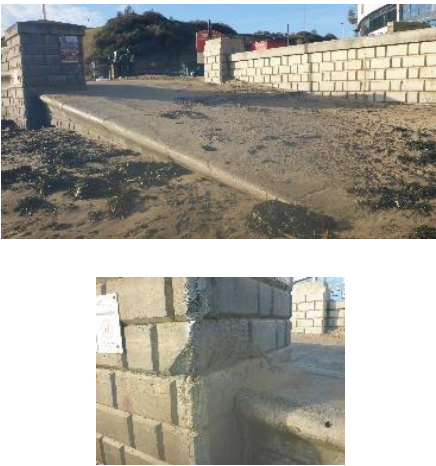
Asset Location:		
	Asset Length:		
	Condition Assessment		
	Condition	Priority	Risk
	B	3	
	Brief Description		
	Slipway in good condition. It was reported in 2018 that the slipway was fenced off to prevent access – This had been removed in 2020. Cracking and abrasion to seaward abutment.		
	Recommendations		
Repair seaward abutment. Monitor

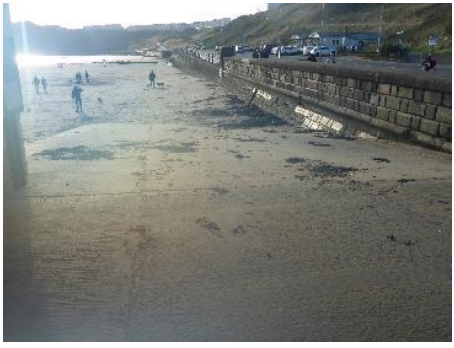
Asset Location:	South of new development.	
	Asset Length:	40.8	
	Condition Assessment		
	Condition	Priority	Risk
	B	3	
	Brief Description		
	Slipway. Deck slab appeared in fair condition. Blockwork wall damaged along upper slipway. Section of coping previously repaired.		
	Recommendations		
	Seal joints and repair cracks in coping and slabs. Continue to monitor.

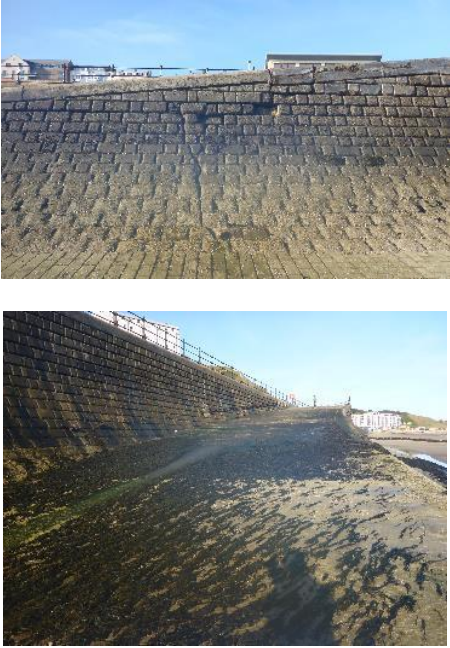
Asset Location:	Part of 45-20B-02	
	Asset Length:	25	
	Condition Assessment		
	Condition	Priority	Risk
	D	2	
	Brief Description		
	Slipway fenced off to prevent access due to previous settlement – Observed numerous members of the public still using in 2020. Large vertical crack on wingwall face with block missing, surrounding blocks at risk of being displaced. Crack and blockwork defects correlate to a depression in the deck suggesting settlement issues. Recently repaired (pre 2018) concrete slabs at top of slipway where tarmac had previously settled in good condition. New concrete slabs behind slipway on promenade.		
	Recommendations		
	Carry out repairs to make slipway safe or fence off at bottom as well as top

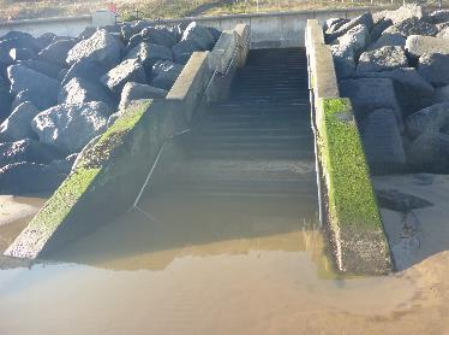
Asset Location:		
	Asset Length:	~5	
	Condition Assessment		
	Condition	Priority	Risk
	B	3	
	Brief Description		
	Steps: fair condition overall. Lower steps abraded exposing aggregate. Lower steps also have steel edge in place which is corroded. Scour pool at toe of steps makes use difficult. Upper Steps (north) in good condition		
	Recommendations		
Remove corroded steel edge to lower steps and recast. Continue to monitor.

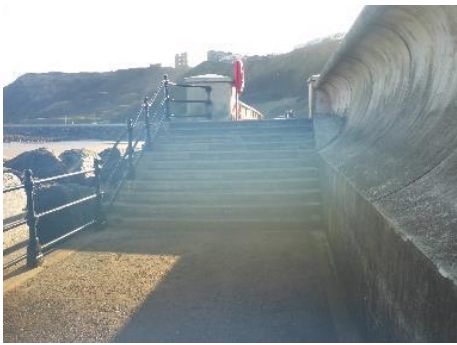
Asset Location:	Part of 46-20b-04	
	Asset Length:	~3	
	Condition Assessment		
	Condition	Priority	Risk
	B	4	>5
	Brief Description		
	2015: Good condition throughout. Steps combine with SBC Ref: 46-20B-02 with single flight to beach level 2018: Upper flight in good condition. No significant change in 2020.		
	Recommendations		
Continue to monitor

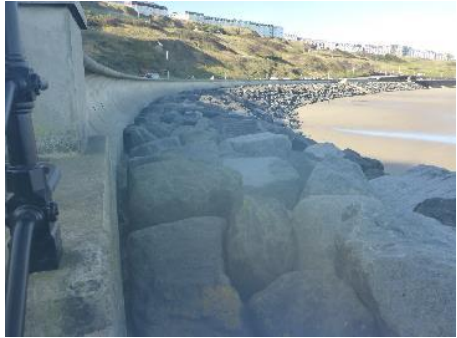
Asset Location:		
	Asset Length:	429.2	
	Condition Assessment		
	Condition	Priority	Risk
	B	4	>5
	Brief Description		
	Constructed 2003ish. The Holms. Prom & Splash wall in good condition. Armour well packed and good cover. Original wall not visible.		
	Recommendations		
Continue to monitor.

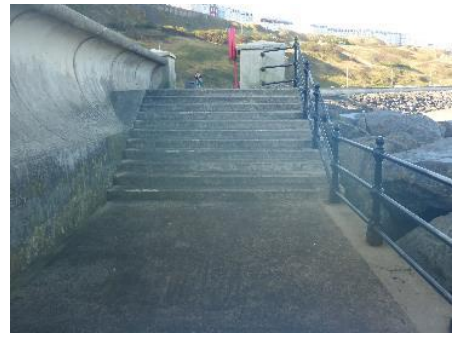
Asset Location:	Part of 46-20B-04	
	Asset Length:	~4	
	Condition Assessment		
	Condition	Priority	Risk
	A	4	>5
	Brief Description		
	Upper flight in good condition.		
	Recommendations		
Continue to monitor.

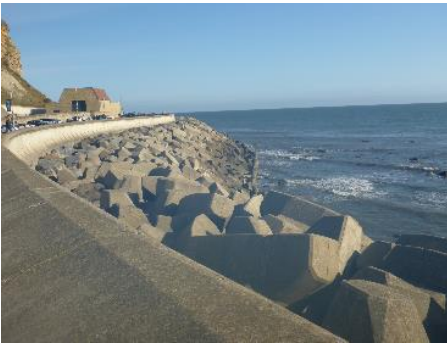
Asset Location:	TA05178883, TA04988952. East of Scarborough Castle.	
	Asset Length:	886.7	
	Condition Assessment		
	Condition	Priority	Risk
	B	4	>5
	Brief Description		
	Accropodes slightly abraded and chipped throughout. No concern at present.		
	Recommendations		
Continue to monitor.

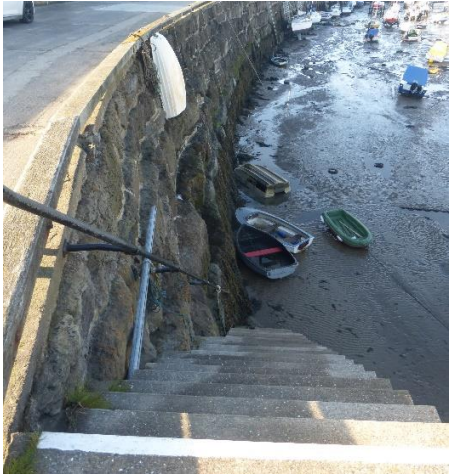
Asset Location:	Scarborough Harbour. North breakwater inner wall.	
	Asset Length:	362.1	
	Condition Assessment		
	Condition	Priority	Risk
	B	3	
	Brief Description		
	Vegetation at bottom half of wall. Wall was repaired 2004/5. Generally, repairs holding, but some voids at toe. Some cracks to promenade. Evidence of lateral voids at seaward end of breakwater. Visible during inspection from the beach to the south.		
	Recommendations		
Continue to monitor. Repair toe voids. Inspection of seaward end of structure required from boat.

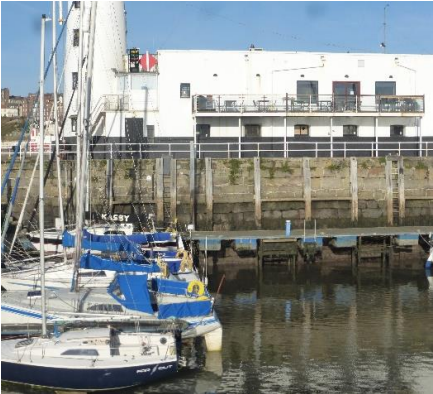
Asset Location:	TA04948860, TA05088877. Old Pier	
	Asset Length:	463.1	
	Condition Assessment		
	Condition	Priority	Risk
	B	3	
	Brief Description		
	Appears fair. Missing fill between blocks throughout wall, fenders, vegetation and boats obscuring the lower parts of wall on old harbour side. Promenade in good condition.		
Recommendations			
Continue to monitor and repoint cracks and missing joints.

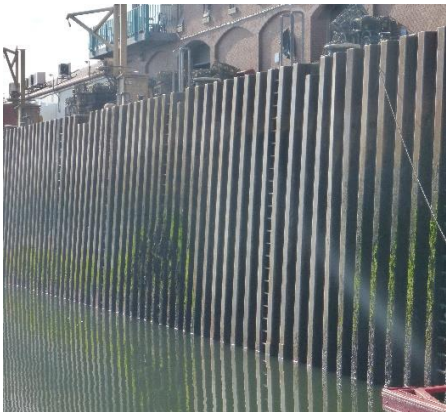
Asset Location:	TA04758875, TA04908862. West pier wall.	
	Asset Length:	140.2	
	Condition Assessment		
	Condition	Priority	Risk
	B	3	
	Brief Description		
	Sheet piles appear fair where visible, but only inspected from distance at low water. Promenade in good condition.		
	Recommendations		
Consider future inspection of quay from boat.

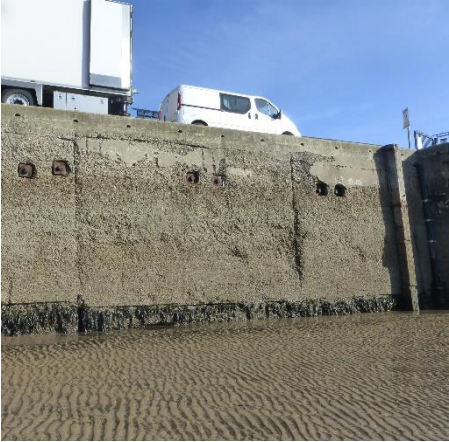
Asset Location:	TA04738870, TA04908862. Beach end of West Pier, between stairs.	
	Asset Length:	58.7	
	Condition Assessment		
	Condition	Priority	Risk
	C	2	
	Brief Description		
	Scour apron not visible due to beach level. Horizontal and vertical cracking at bend of wall, has had repairs carried out. Exposed aggregate throughout wall. Numerous cracks throughout wall. Exposed timber toe piles rotten with scoured concrete wall behind.		
	Recommendations		
	Continue to monitor and repair cracks, voids and damaged apron. Improve toe protection.

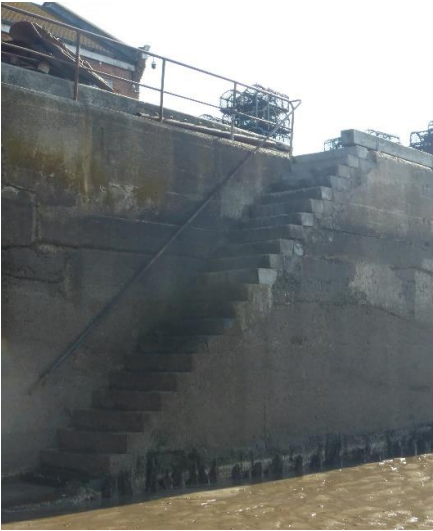
Asset Location:	TA04738870, TA04908862. Beach end of West Pier, between stairs.	
	Asset Length:	~5	
	Condition Assessment		
	Condition	Priority	Risk
	B	3	
	Brief Description		
	Precast steps have been repointed on exposed seaward side at upper part. No edge / toe protection seaward. Numerous cracks in side walls to steps.		
	Recommendations		
	Repairs cracks in walls. Continue to monitor.

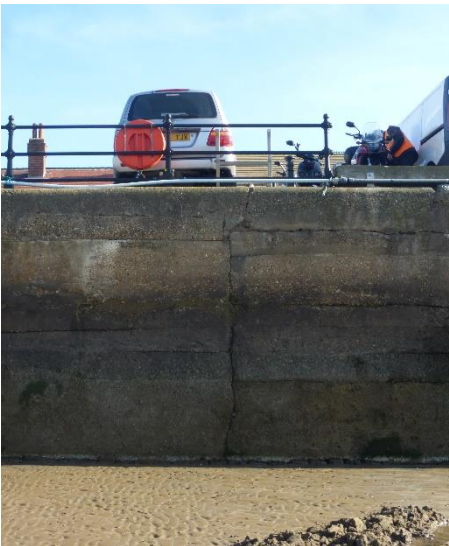
Asset Location:	TA04738870, TA04908862. Shore end of West Pier.	
	Asset Length:	110.4	
	Condition Assessment		
	Condition	Priority	Risk
	C	2	
	Brief Description		
	Vertical crack from top to bottom of wall at middle section of length, appears same as last inspection. Horizontal and vertical cracks and exposed aggregate throughout wall. Rotten timber toe piles exposed at deeper end. Scour hole developing behind the timber piles. Few minor cracks to promenade.		
Recommendations			
Continue to monitor and repair cracks and improve toe protection.

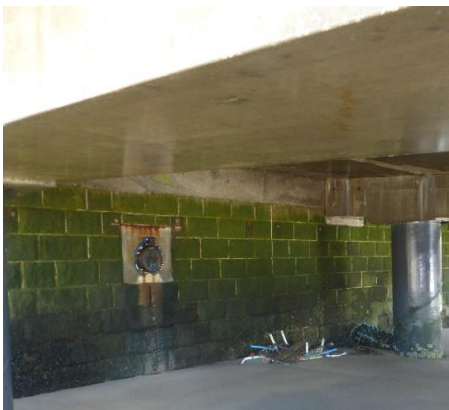
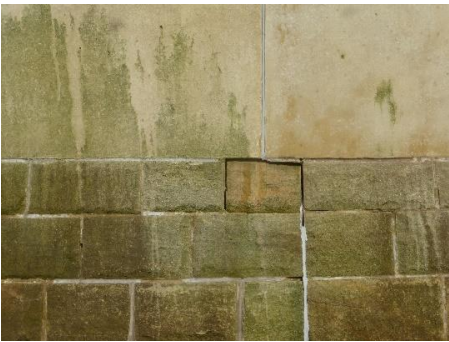
Asset Location:	TA04708872, TA04738870	
	Asset Length:	69.2	
	Condition Assessment		
	Condition	Priority	Risk
	B	4	
	Brief Description		
	Wall now replaced as part of RNLI development. New wall generally in good condition. Vegetation growth around full perimeter of wall may obscure defects. Vegetation coverage most dense beneath the slipway. One displaced block was noted to the south of the slipway.		
Recommendations			
Repair damaged blockwork. Clean vegetation, particularly beneath slipway.

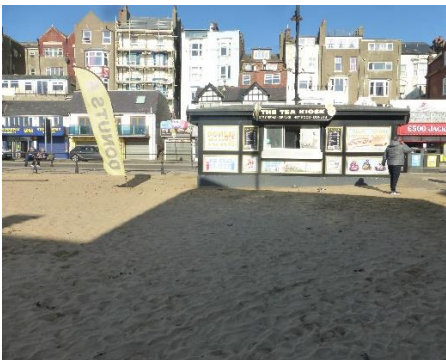
Asset Location:	Next to Life boat house.	
	Asset Length:	28.5	
	Condition Assessment		
	Condition	Priority	Risk
	B	3	
	Brief Description		
	Slipway appears in fair condition. Some cracked blocks and mortar required. High beach levels in 2020 obscured view of much of the slipway.		
	Recommendations		
Repoint and replace blocks as required

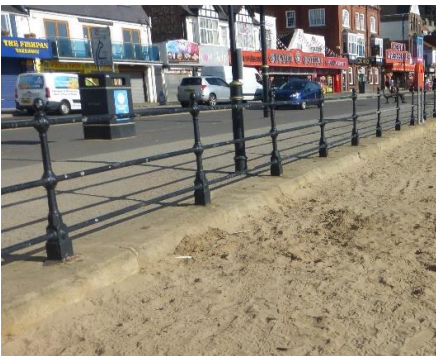
Asset Location:	TA04538856, TA04698873	
	Asset Length:	40.3	
	Condition Assessment		
	Condition	Priority	Risk
	B	3	
	Brief Description		
	Limited height of wall visible due to beach levels. Some missing mortar and corrosion to handrails		
	Recommendations		
Repair joints between blocks. Treat handrails

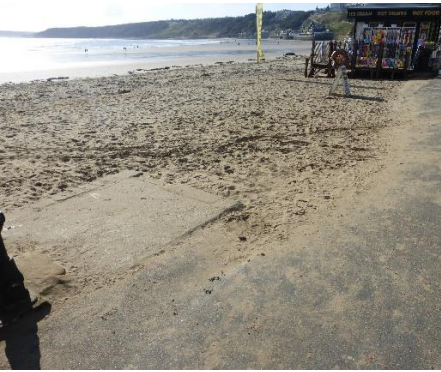
Asset Location:	TA04538856, TA04698873	
	Asset Length:	~10	
	Condition Assessment		
	Condition	Priority	Risk
	B	3	
	Brief Description		
	Small access ramp partly covered by the beach. Exposed surface looks in fair condition.		
	Recommendations		
Continue to monitor.

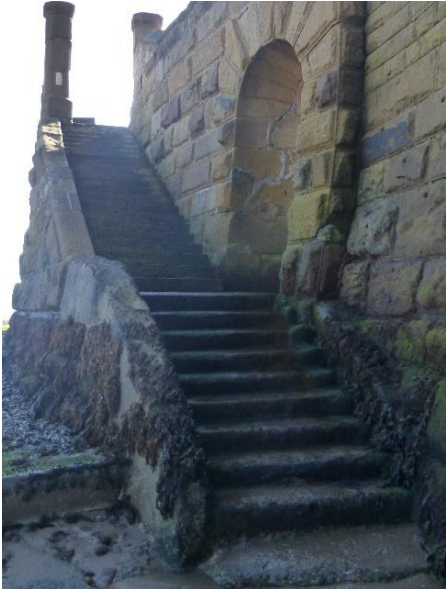
Asset Location:	Part of 53-22b-02	
	Asset Length:	~5	
	Condition Assessment		
	Condition	Priority	Risk
	B	3	
	Brief Description		
	Fair overall condition with bottom steps damaged in places. New concrete toe constructed to seaward side wall in fair condition although partially covered with vegetation growth.		
	Recommendations		
Continue to monitor.

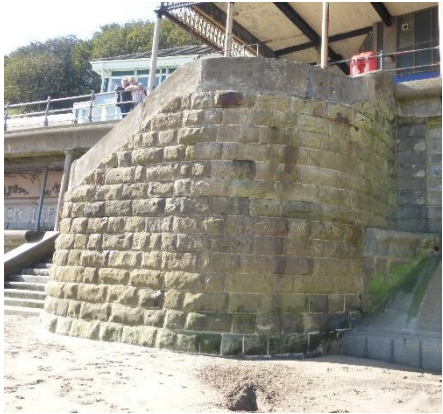
Asset Location:		
	Asset Length:	~4	
	Condition Assessment		
	Condition	Priority	Risk
	B	3	
	Brief Description		
	Repairs to side wall capping undertaken. Steps in fair condition.		
	Recommendations		
	Continue to monitor.
