Scarborough Borough Council
Strategic Coastal Monitoring Programme
2001 – 2006

Condition Analysis of Coast Protection Assets,
Cliffs and Beaches from Staithes to Speeton

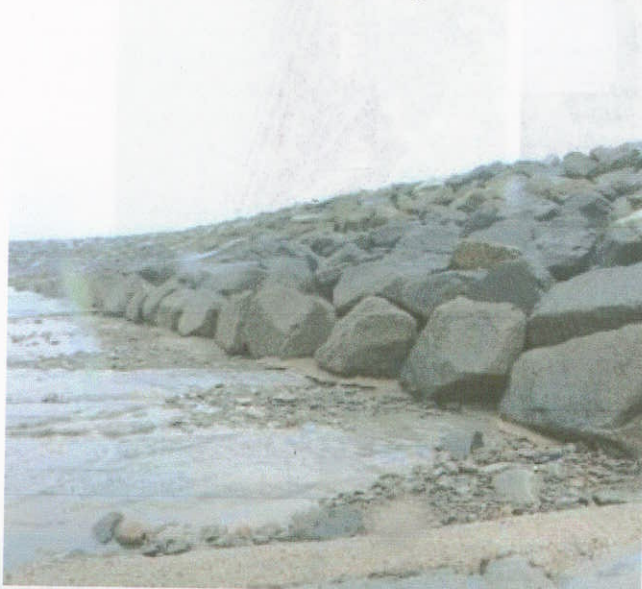
Photograph 3.1 Staithe Northern Breakwater.
View at root of seaward revetment

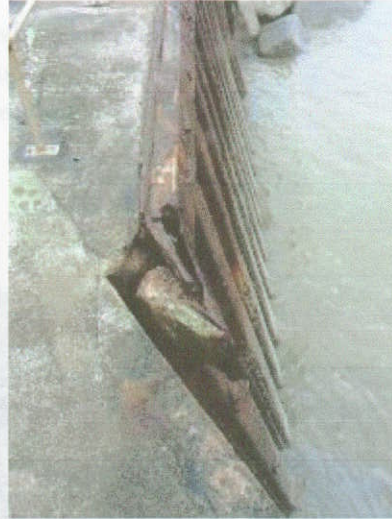
Photograph 3.4 Staithes Northern Breakwater. Corroded steel sheet piles

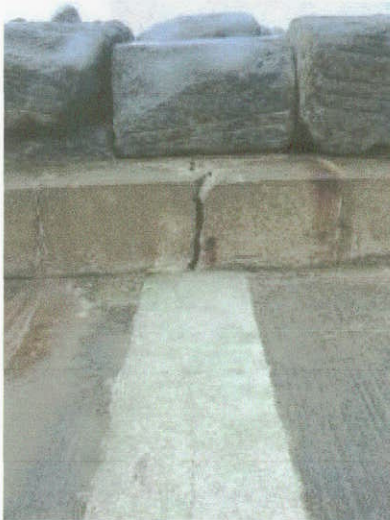
Photograph 3.5 Staithes Northern Breakwater. Abraded and damaged concrete coping

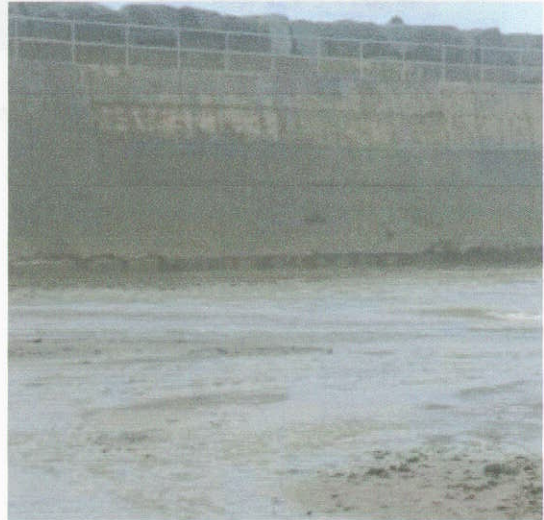
Photograph 3.6 Staithes Northern Breakwater. Abraded vertical surfaces and toe scour

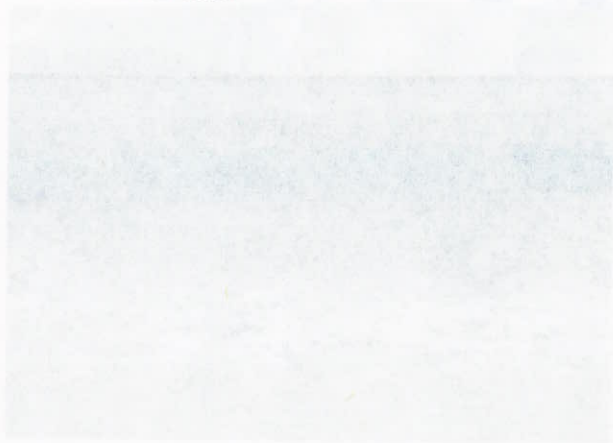
Moving eastwards, there are the remnants of a concrete promenade or apron. The coping and hand rails remain and are severely undermined. The function of these assets is not known for sure, but they are possibly there to keep people away from the cliff. However, their condition is such that they themselves could potentially present a Health and Safety Hazard. These will continue to deteriorate and should be removed.

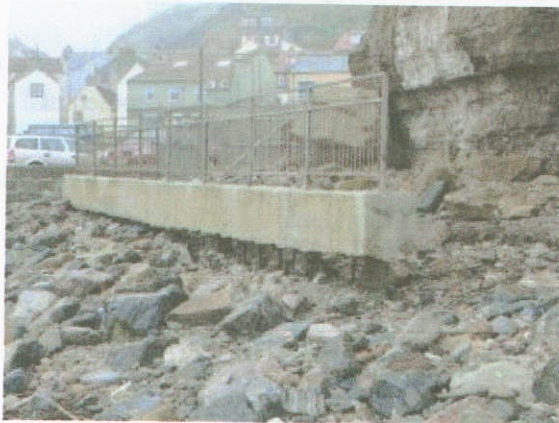
Photograph 3.8 Staithes between Northern Breakwater.

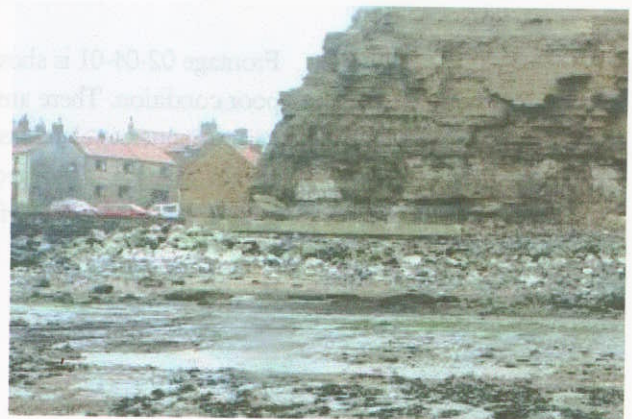
Photograph 3.9 Staithes between Northern Breakwater.

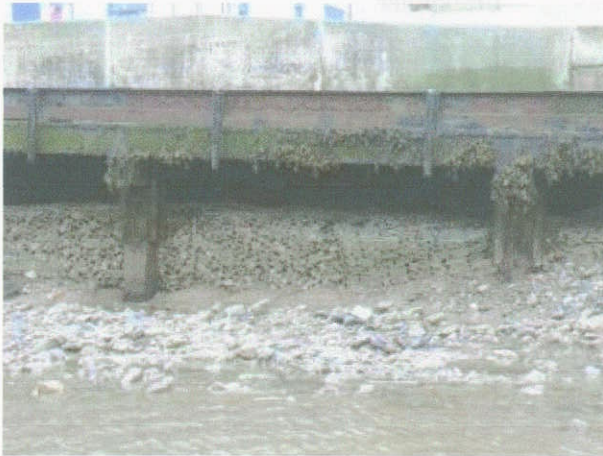
Photograph 3.10 Staithes RNLI Slipway.
Gabion Baskets beneath slipway

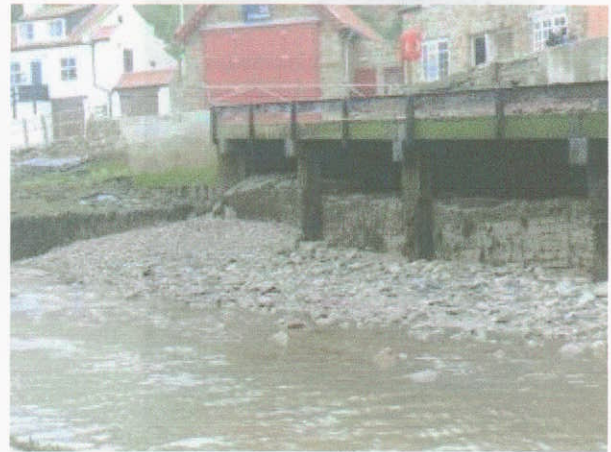
Photograph 3.11 Staithes RNLI Slipway.
Gabion Baskets beneath slipway

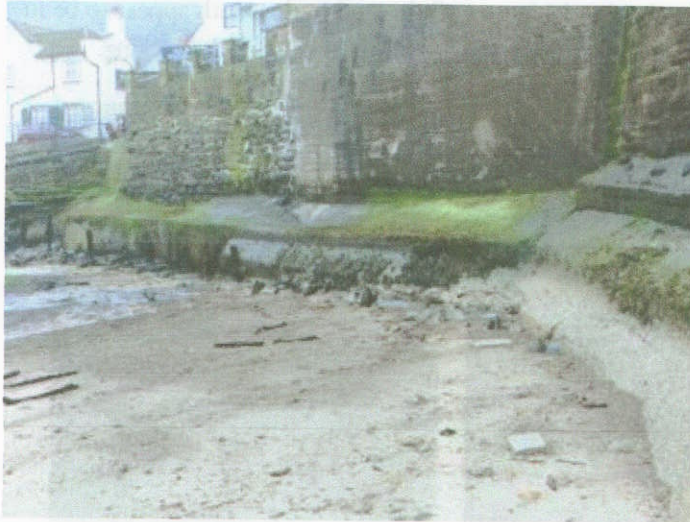
Photograph 3.12 Staithes 02-04-01.
Poor condition wall, missing blocks etc

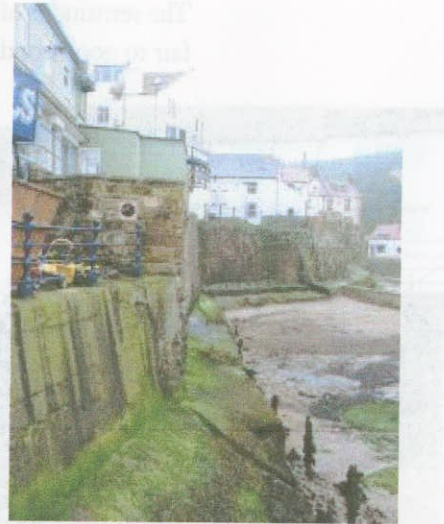
Photograph 3.13 Staithes 02-04-01.
Leaning wall with toe scour.

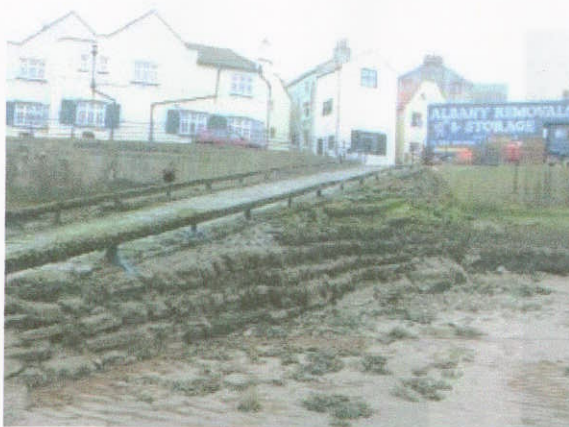
Photograph 3.14 Staithes 03-04-01.
Cod & Lobster Slipway

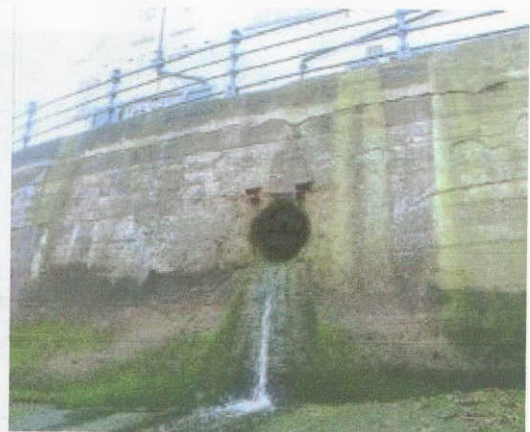
Photograph 3.15 03-04-01 Staithes.
Damaged flap valves and cracked seawall.

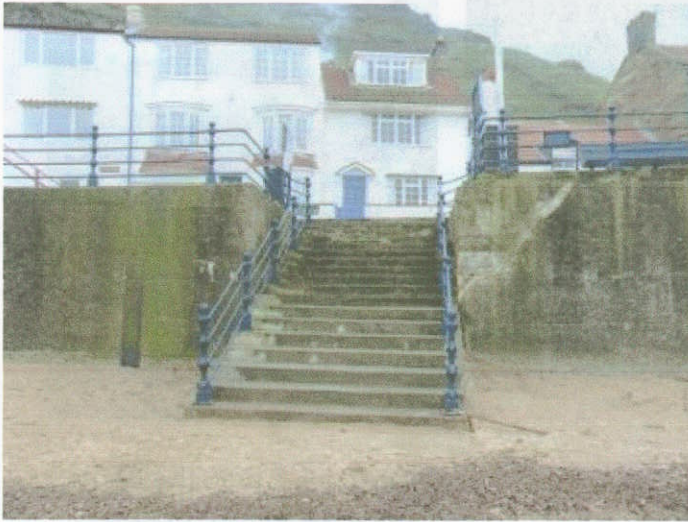
Photograph 3.16 Staithes 04-04-01.
Steps and hand railing

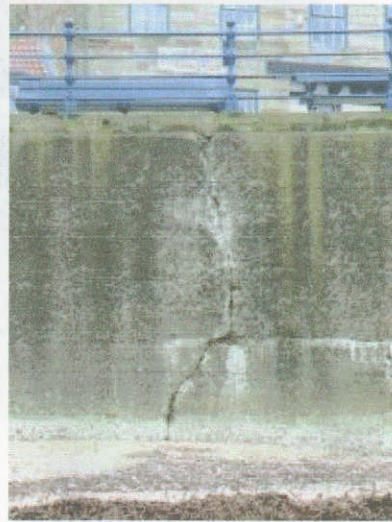
Photograph 3.17 Staithes 04-04-01
Cracked harbour walls.

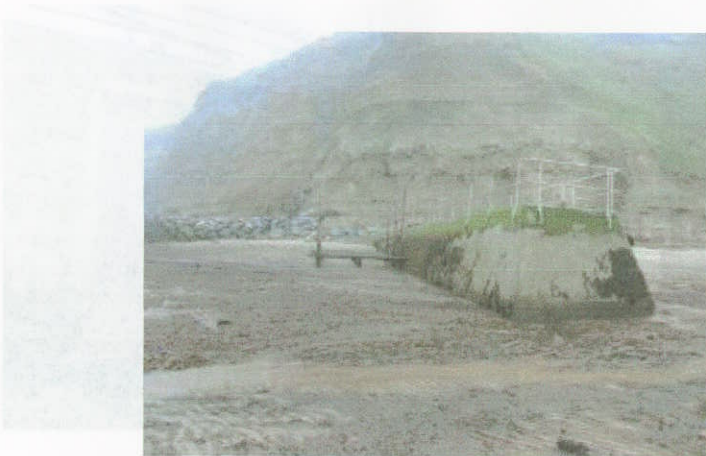
Photograph 3.18 Staithes.
Concrete Pier / groyne at south-eastern corner of harbour.

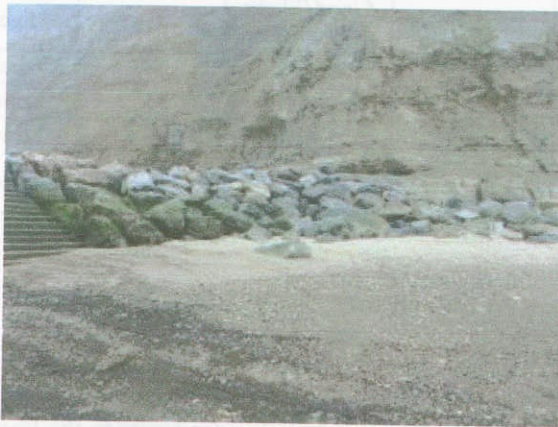
Photograph 3.20 Staithes Eastern Breakwater
Root of rock armour breakwater

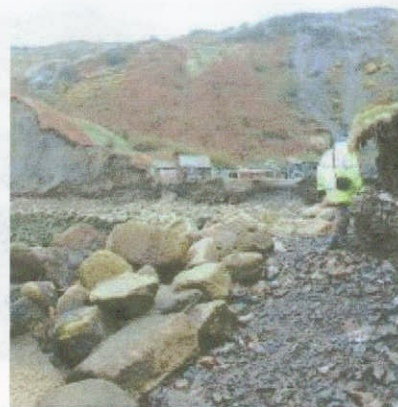
Photograph 3.25 Port Mulgrave.
Sheds, housing fishing equipment

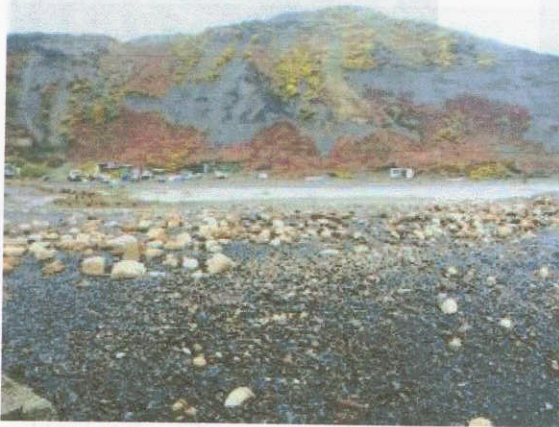
Photograph 3.26 Port Mulgrave.
Harbour basin with boats

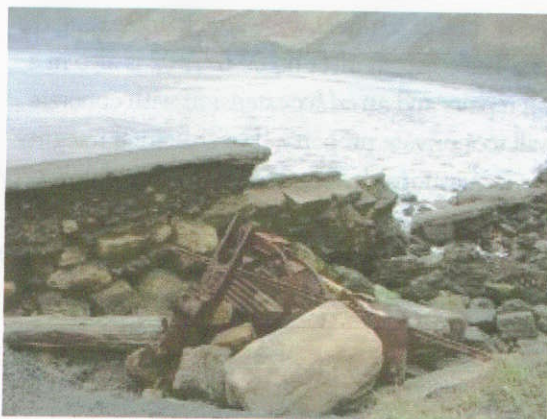
Only remnants indicate the former existences of a north breakwater and rock armour. Broken sections of this structure remain along the frontage.

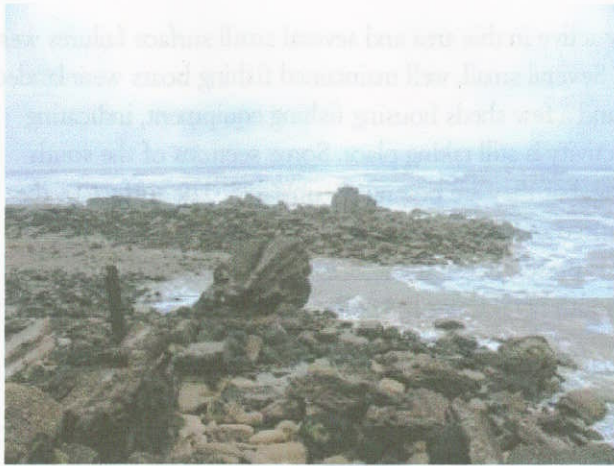
Photograph 3.29 Port Mulgrave.
End of south breakwater and view onto remains of north breakwater

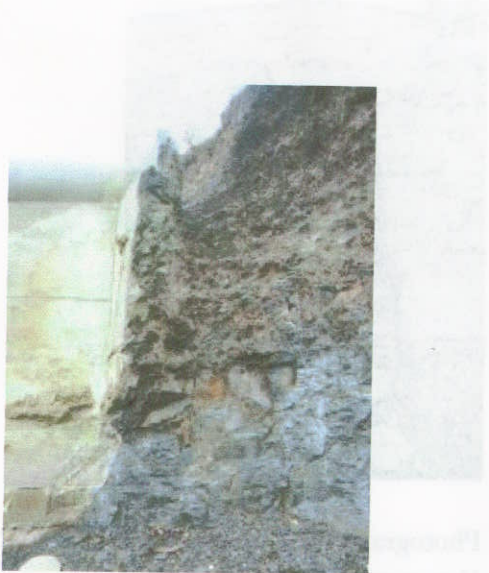
Photograph 3.31 Runswick Bay 07-07A-01
Failed seawall section

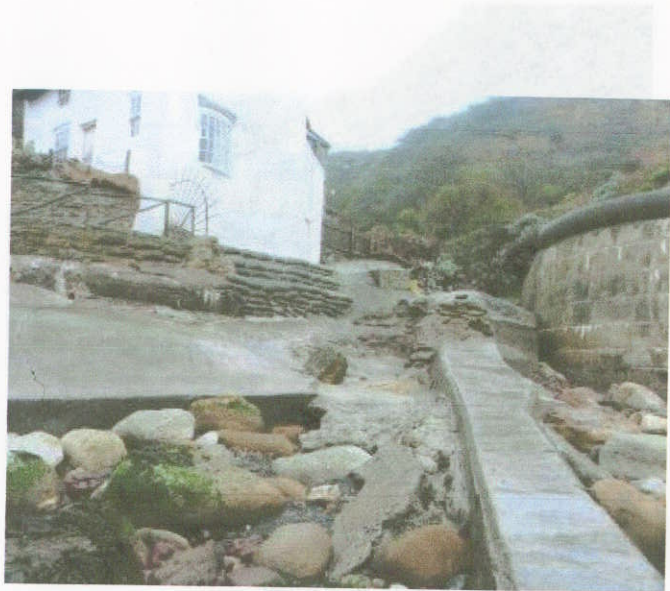
Photograph 3.32 Runswick Bay 07-07A-02
Patch repairs with ad-hoc extension of wall and access to beach

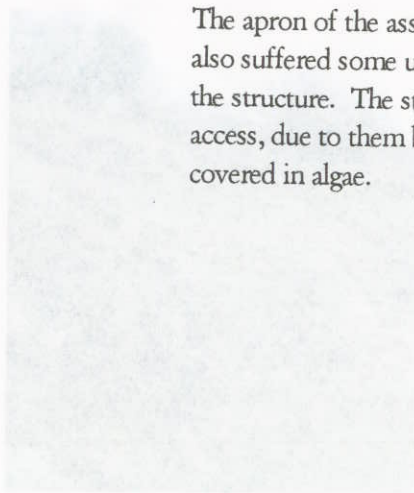
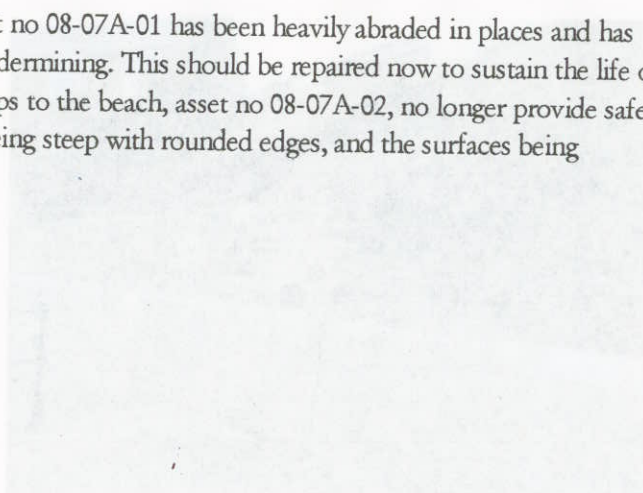
The apron of the asset no 08-07A-01 has been heavily abraded in places and has also suffered some undermining. This should be repaired now to sustain the life of the structure. The steps to the beach, asset no 08-07A-02, no longer provide safe access, due to them being steep with rounded edges, and the surfaces being covered in algae.

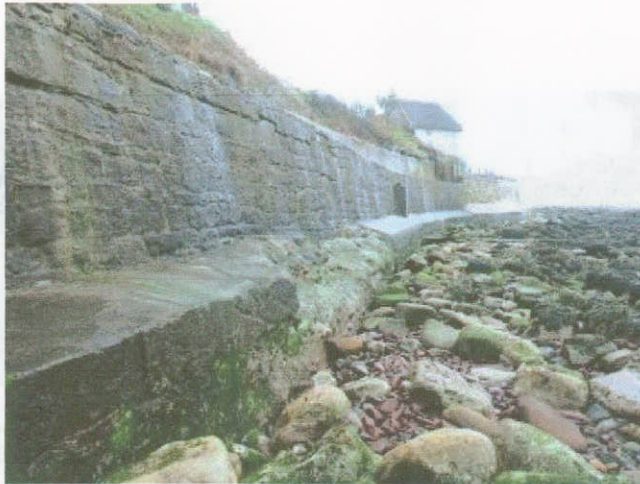
Photograph 3.33 Runswick Bay 08-07A-01.
Damaged apron in front of seawall

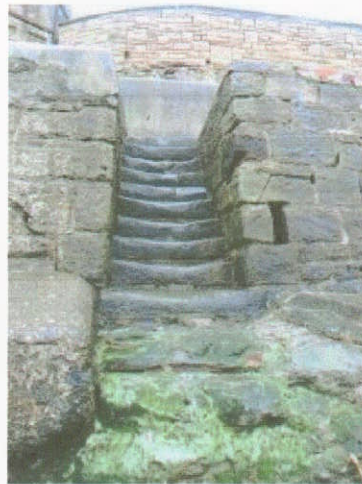
Photograph 3.34 Runswick Bay 08-07A-02.
Very rounded, slippery steps

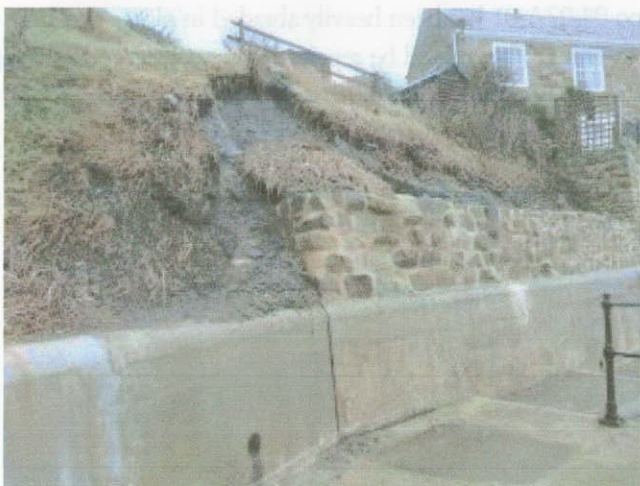
Photograph 3.35 Runswick Bay 08-07A-03.
Small slip onto the upper wall at promenade level.

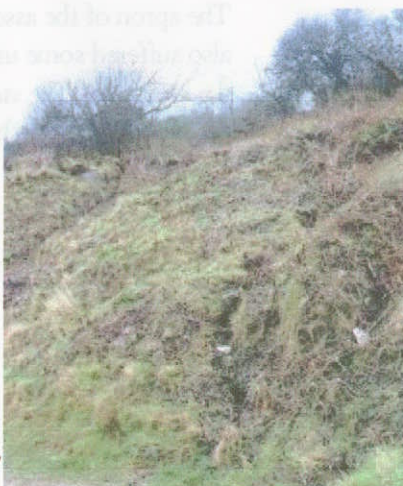
Photograph 3.36 Runswick Bay 10-07B-02.
Shallow localised slope failure above the rock revetment.

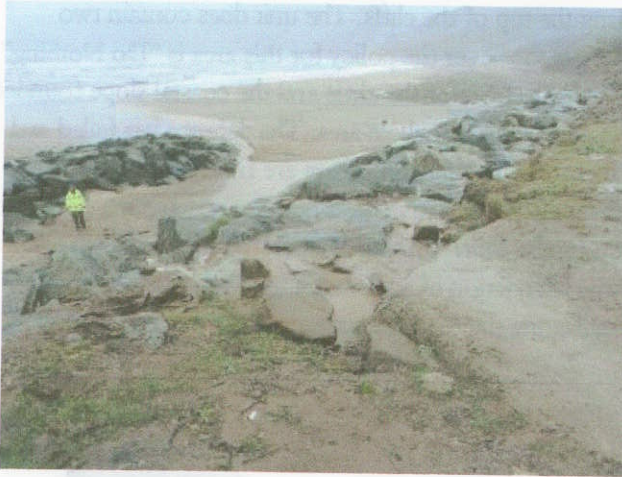
Photograph 3.37 Runswick Bay 10-07B-01
Water running through rock armour onto beach

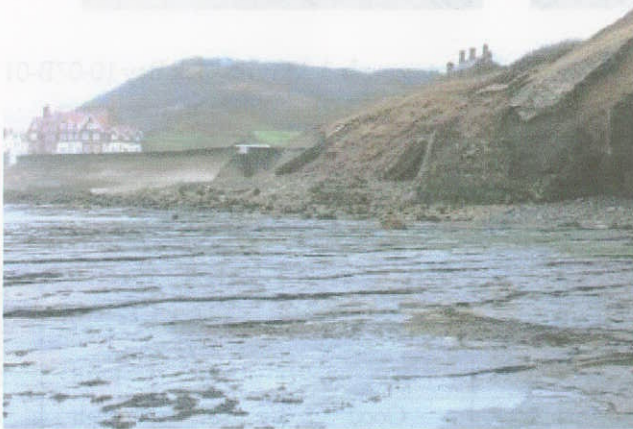
Photograph 3.39 Gouldsborough 12-08B-01.
Concrete base and masonry wall foundations.

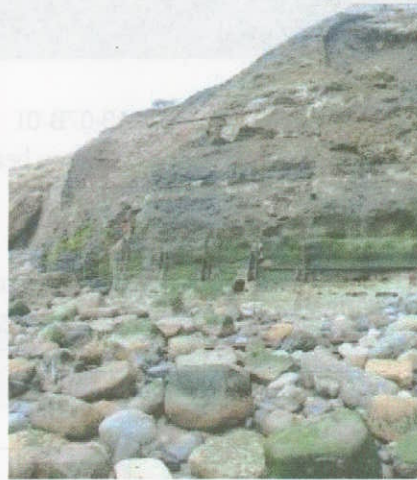
Photograph 3.40 Gouldsborough 12-08B-01.
Steel and concrete remnants of a wall

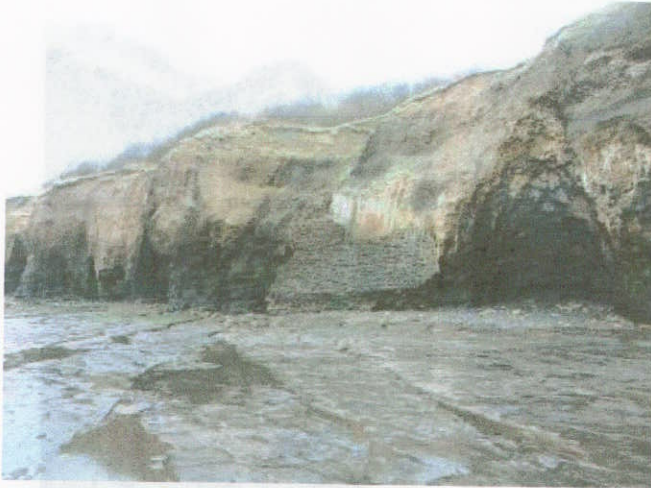
Photograph 3.41 Gouldsbrough 12-08B-01
Third remaining section of seawall

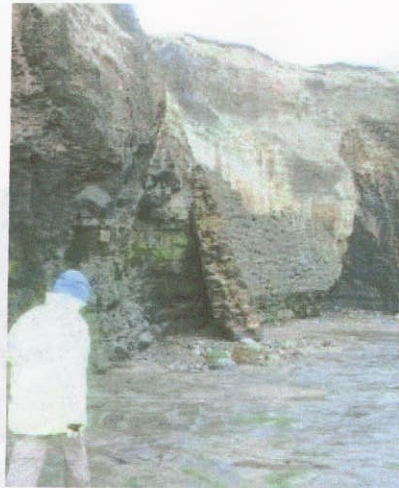
Photograph 3.42 Gouldsbrough 12-08B-01.
Wash-out behind remnant seawall

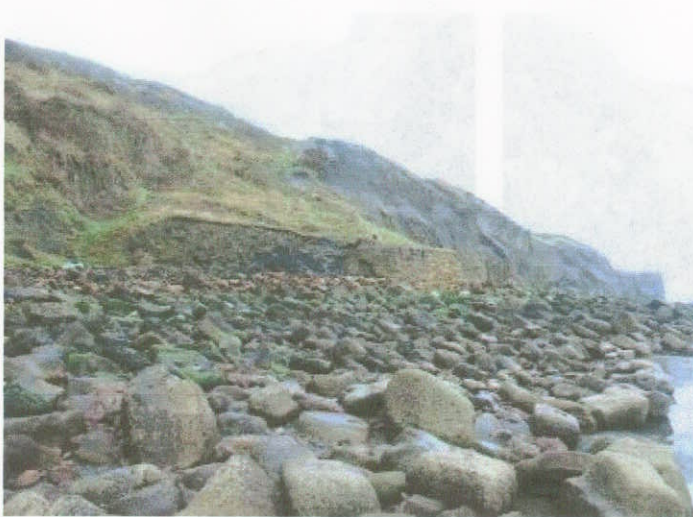
Photograph 3.43 Gouldsbrough 12-08B-01.
Failed seawall with rock armour

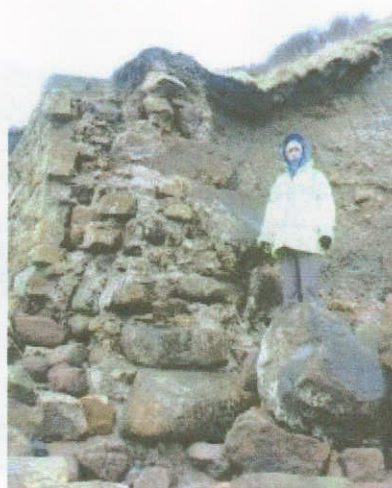
Photograph 3.44 Gouldsbrough 12-08B-01. Failed defence

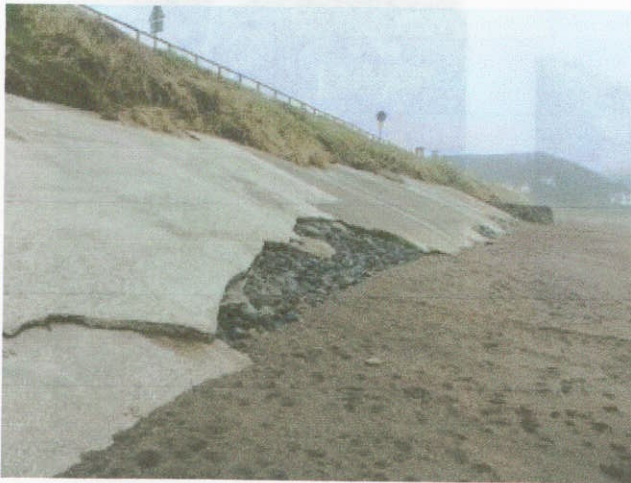
Photograph 3.45 Sandsend 17-09C-01.
Surface removed showing base material, small landslips

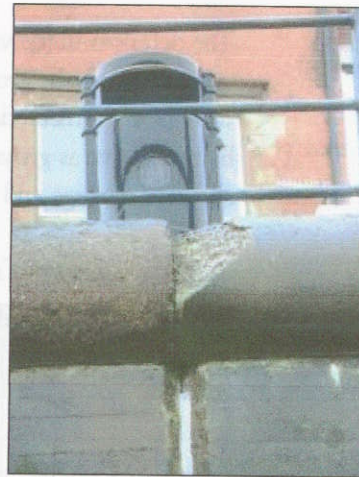
Photograph 3.48 Sandsend 14-09B-01.
Minor damage to wave return feature of wall

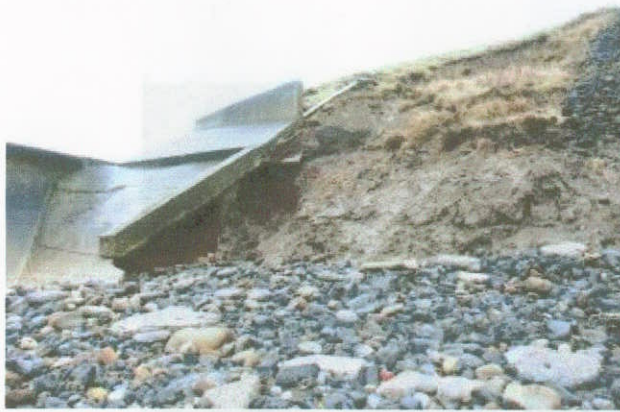
Photograph 3.49 Sandsend 13-09A-01
Undermining and erosion of defences

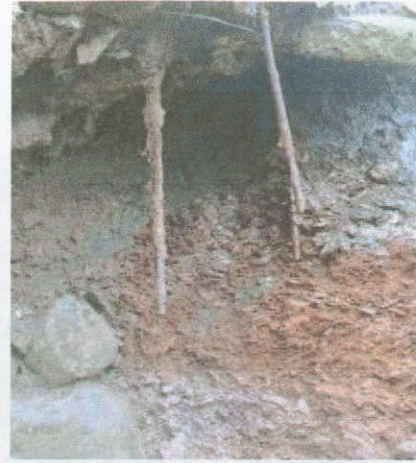
Photograph 3.50 Sandsend 13-09A-01
Weak, washed-out foundation

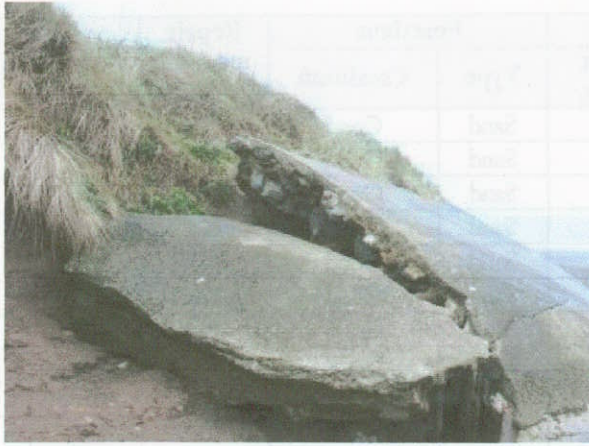
Photograph 3.51 Sandsend Wyke 17-10-01
Undermined and partially failed Defence

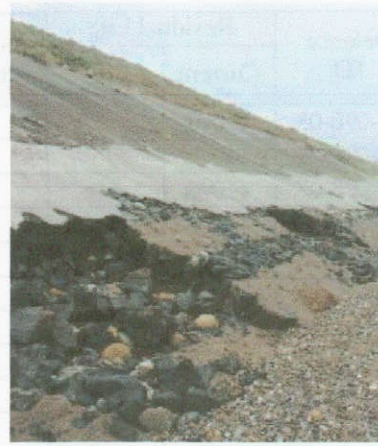
Photograph 3.52 Sandsend Wyke 17-10-01
Abrasion and scour at toe of defence

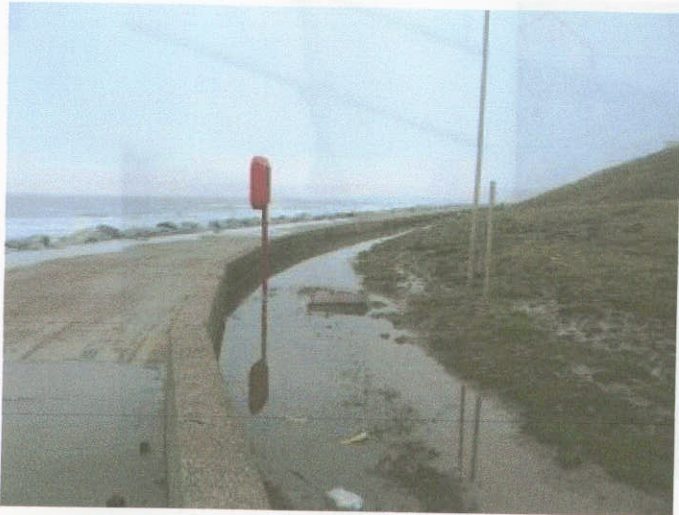
Photograph 3.53 Whitby West Cliff 18-11A-02.
Water standing behind the defence after a mild rain

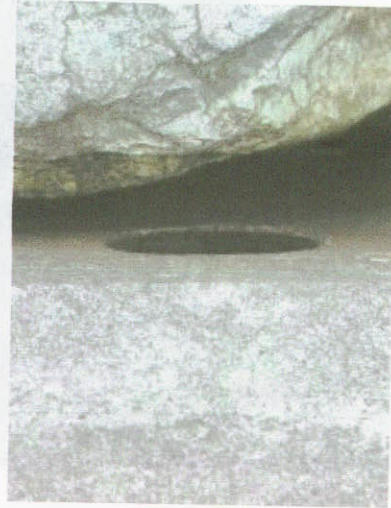
Photograph 3.54 Whitby West Cliff 18-11A-02
Drainage pipe

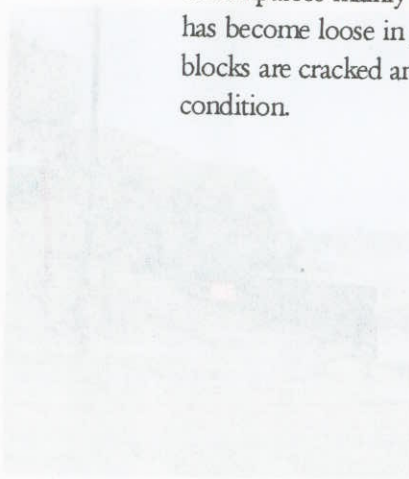
Photograph 3.55 Whitby West Cliff
18-11A-02. Severely cracked coping block

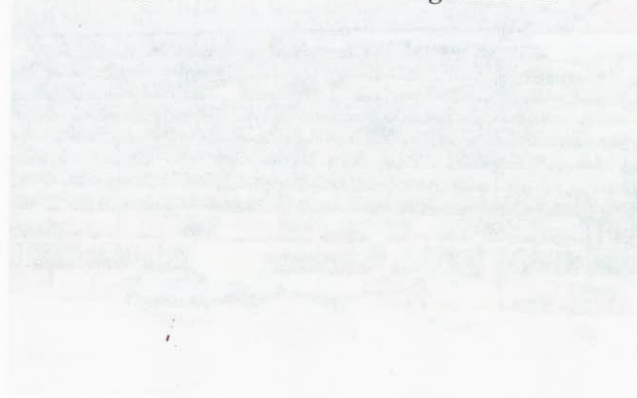
Photograph 3.56 Whitby West Cliff 18-11A-02.
Minor damage to coping block

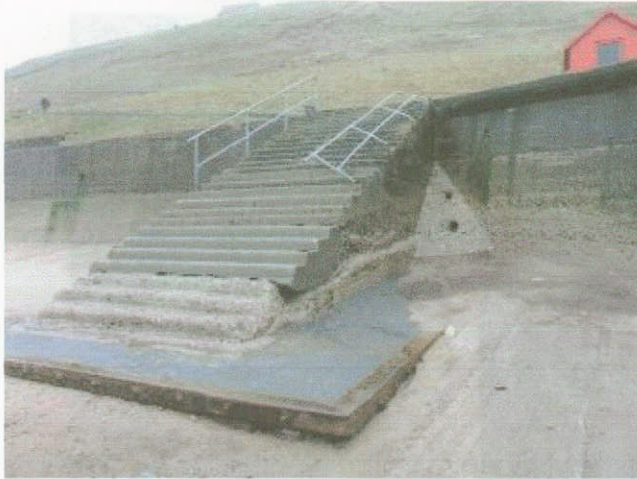
Photograph 3.55 Whitby West Cliff 20-11A-01.
Loose hand railing and scour

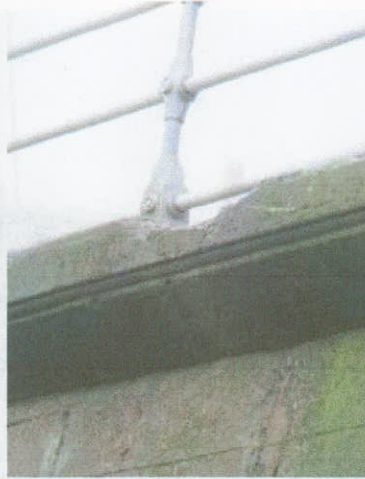
Photograph 3.56 Whitby West Cliff 19-11A-01. Damaged coping

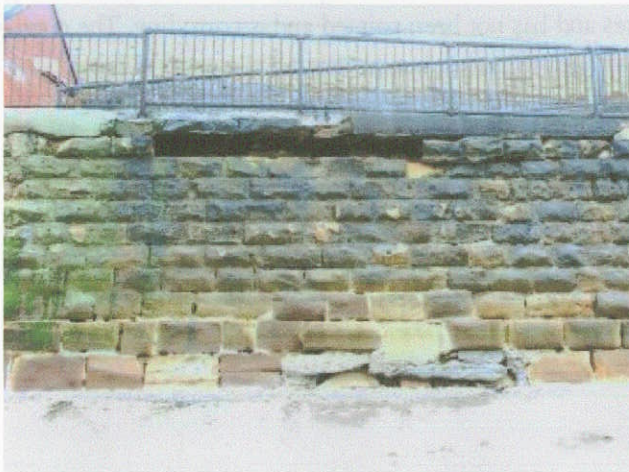
Photograph 3.57 Whitby West Cliff 20-11A-02.
Masonry blocks are missing just below the promenade

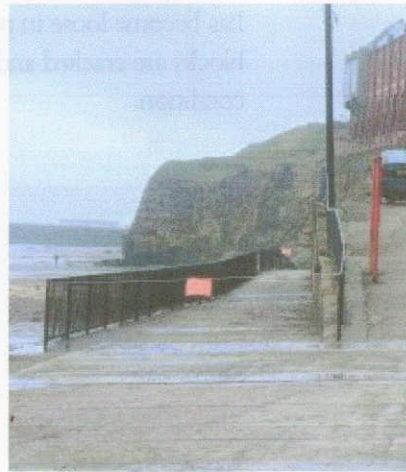
Photograph 3.58 Whitby West Cliff 20-11A-02. Informally blocked promenade

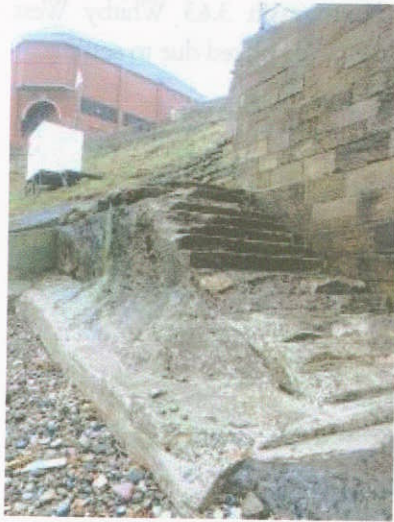
Photograph 3.59 Whitby West Pier 22-11A-02
Abraded steps

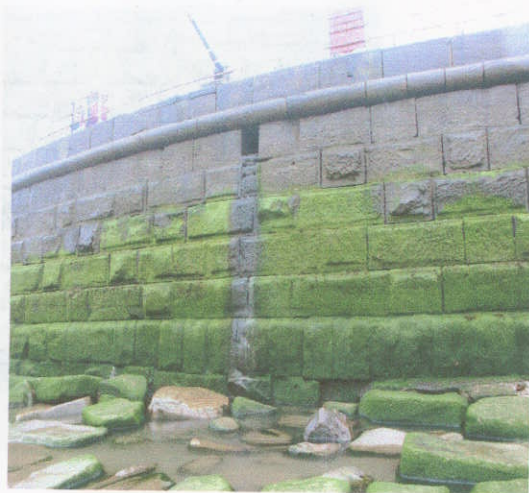
Photograph 3.60 Whitby West Pier 26-11B-01.
Masonry blocks missing and surface settlement has occurred.

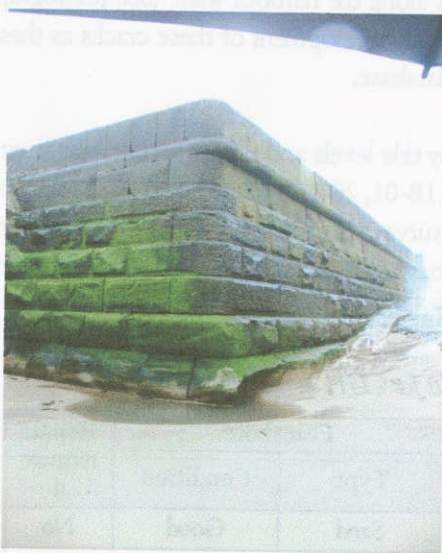
Photograph 3.61 Whitby West Pier 26-11B-02.
Scour at the base of harbour wall

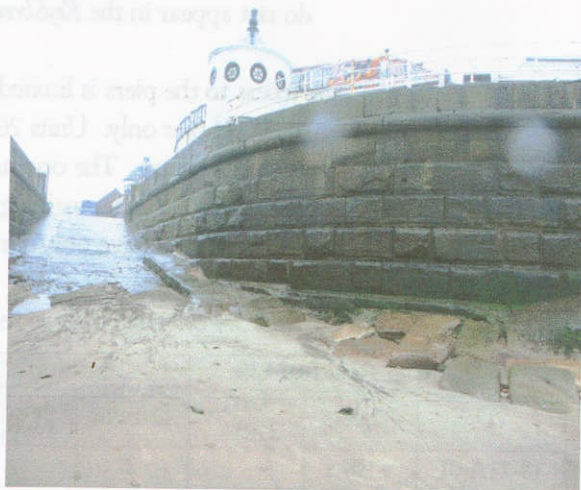
Photograph 3.62 Whitby West Pier 26-11B-02.
Uneven surface at access to walkway

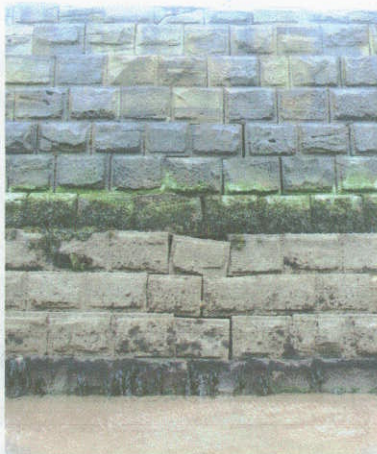
There are vertical cracks evident in the north face of the west pier (unit 27-11B-01). In addition, displacement of masonry blocks has occurred. Cracks and voids can be seen in several locations along the harbour wall. (See photograph 3.63). It is not possible to comment on the development of these cracks as these frontages do not appear in the *KeyShore* database.

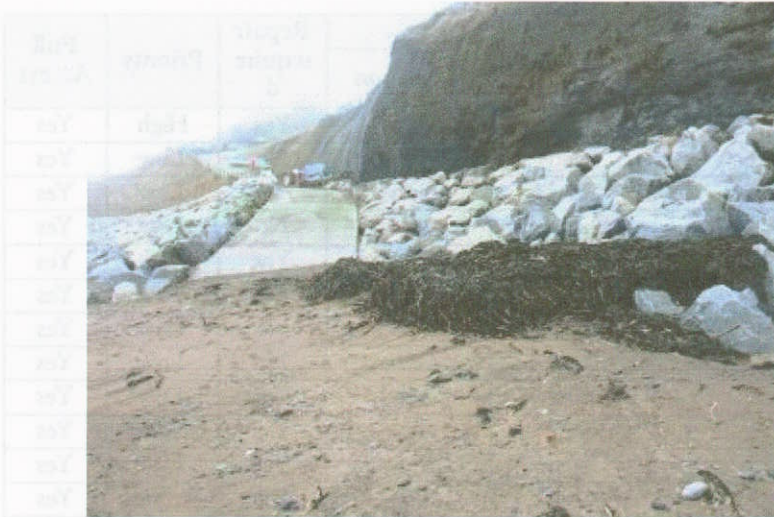
Photograph 3.64 Robin Hood's Bay (RHB) 32-16A-02.
Slipway with rocks partially covering access

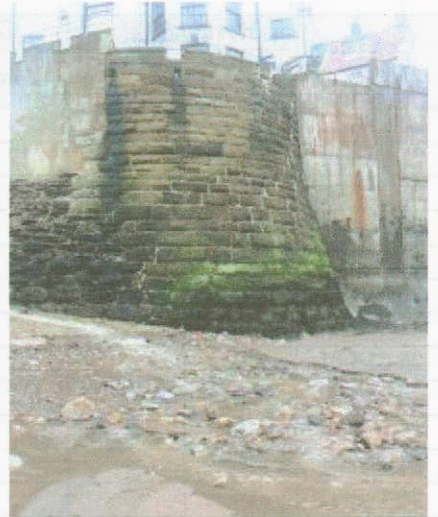
Photograph 3.65 RHB 34-16A-01.
Diagonal full height cracks

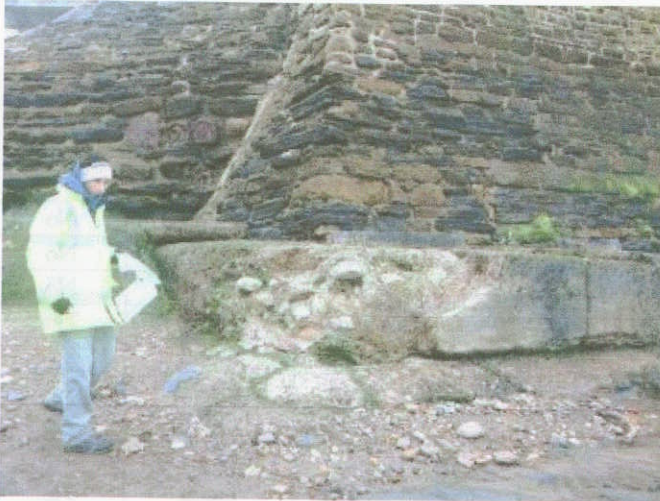
Photograph 3.66 RHB 36-16A-01.
Heavily abraded concrete apron

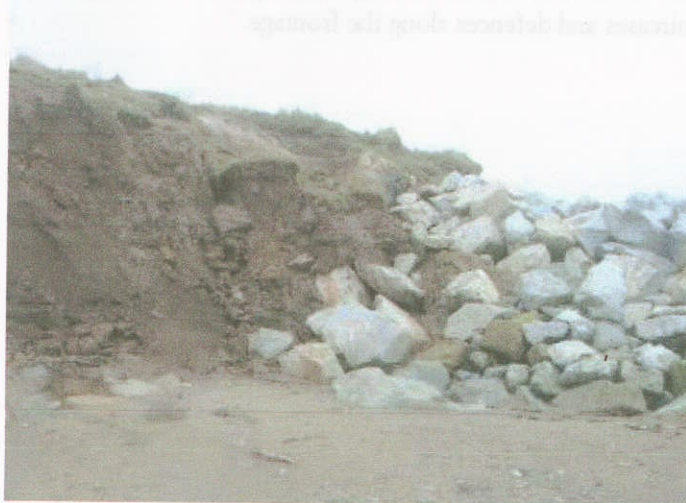
Photograph 3.67 RHB 37-16C-03.
Landslip partially covering defence asset

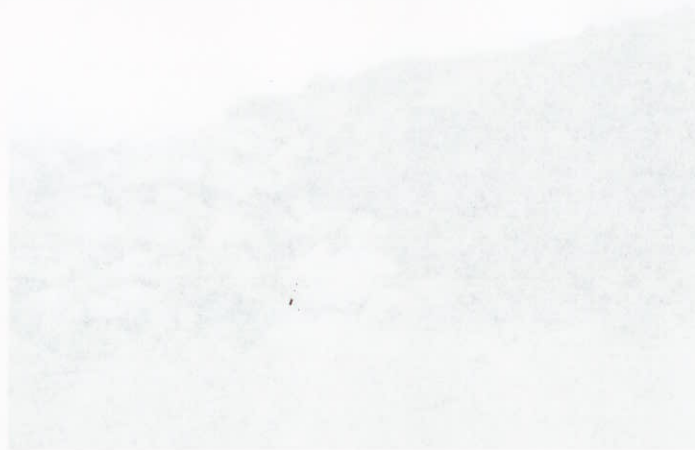
The coastal unit 20 covers Scarborough North Bay. The sea defences in this area comprise mainly of a seawall promenade with several access staircases to the beach. Normally the beach levels are relatively high and cover most of the staircases along the North Bay promenade, however a heavy storm on the 8th of April 2005 has lowered the beach levels significantly and has damaged several of the access staircases and defences along the frontage.

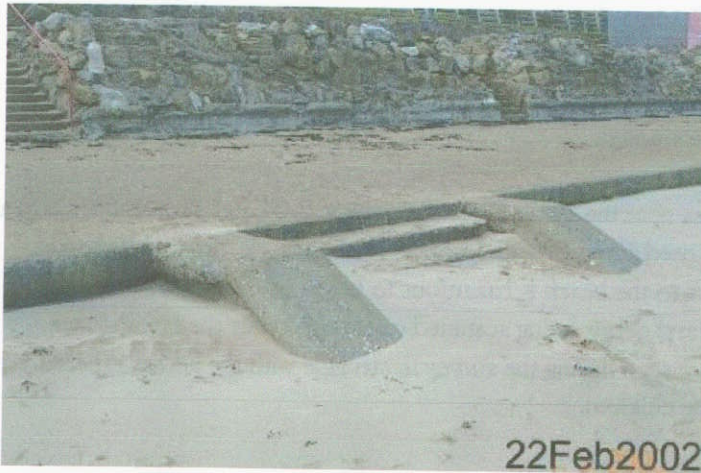
Photograph 3.68 – Scarborough North Bay (SNB) 42-20A-09. High beach levels with sand covering most of the staircase, 22 February 2002. Note elevation of sand relative to red staircase handrails in this image.

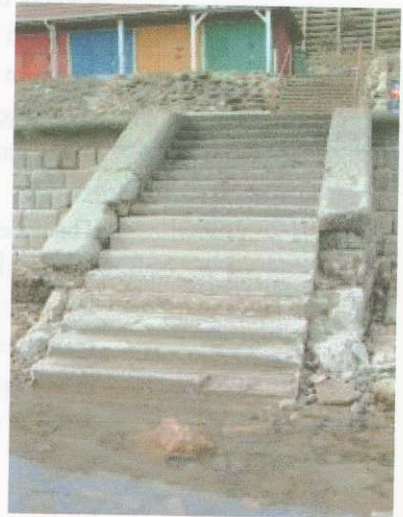
Photograph 3.69 SNB 42-20A-09. Damaged staircase with low beach levels and scouring 12 April 2005

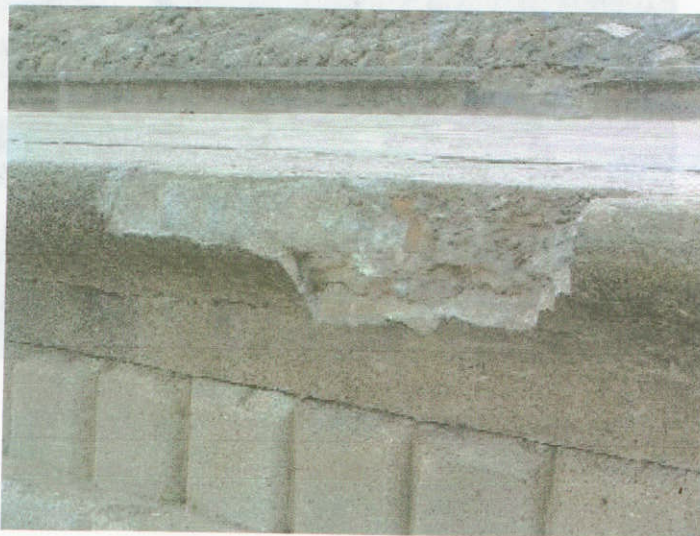
Photograph 3.70 SNB 42-20A-09. Damaged wave return wall

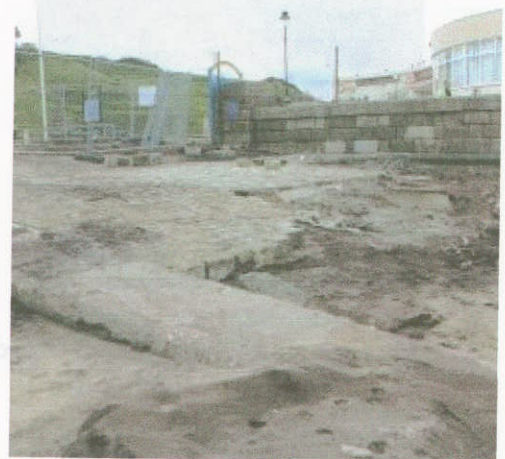
Photograph 3.71 SNB 43-20B-02. Works in progress

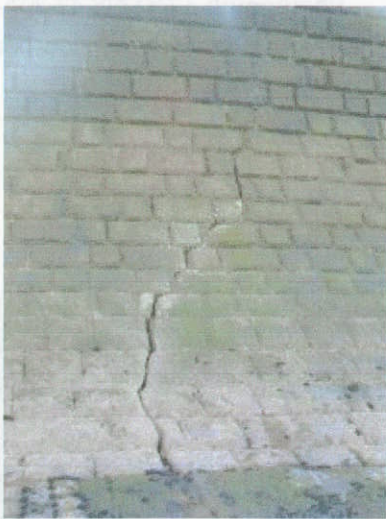
Photograph 3.60 SNB 44-20B-04 and 44-20B-03. Rocks and debris near staircase landing area

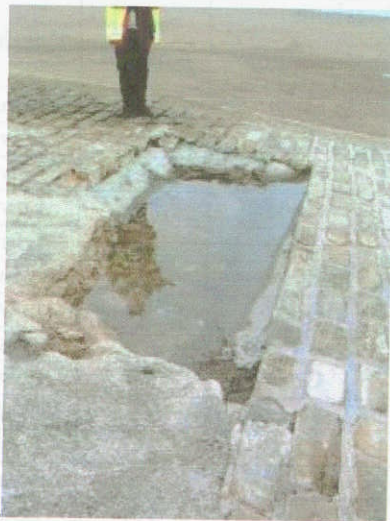
Photograph 3.74 SNB defences south of asset 44-20B-05 show some sign of wear and have suffered some damage. They require some remedial repairs

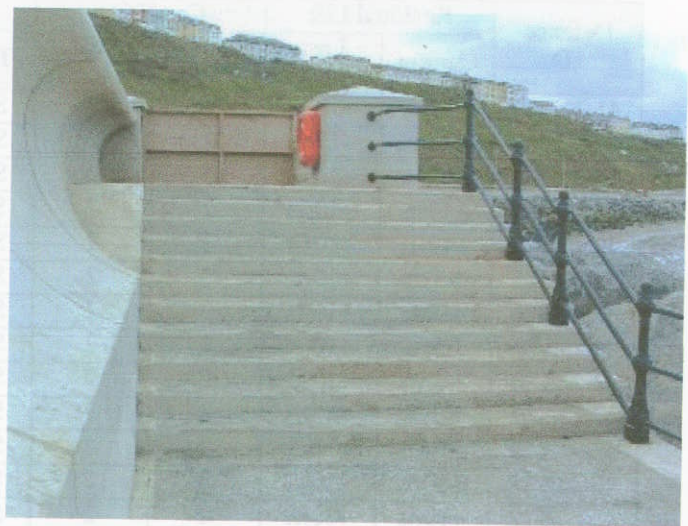
Photograph 3.75 SNB 46-20B-05. New defences have been constructed

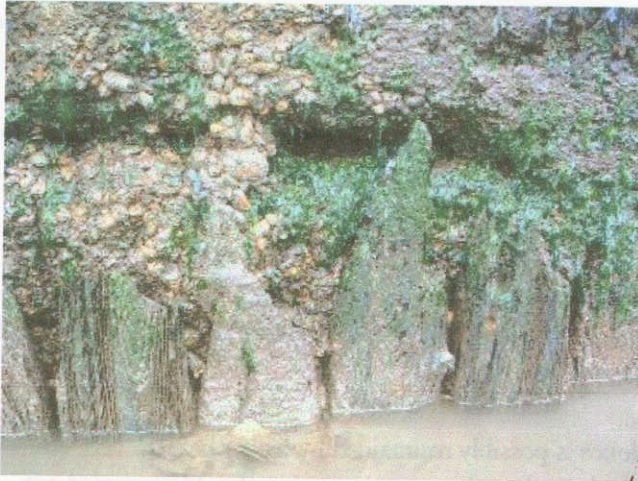
Photograph 3.76 Scarborough West Pier (SWP)
Timber toe piles and localised undermining

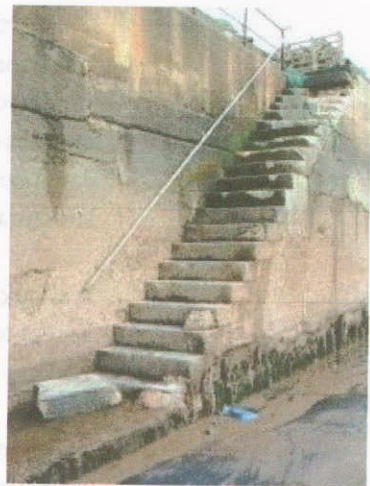
Photograph 3.77 SWP 49-21B-03
Damaged staircase

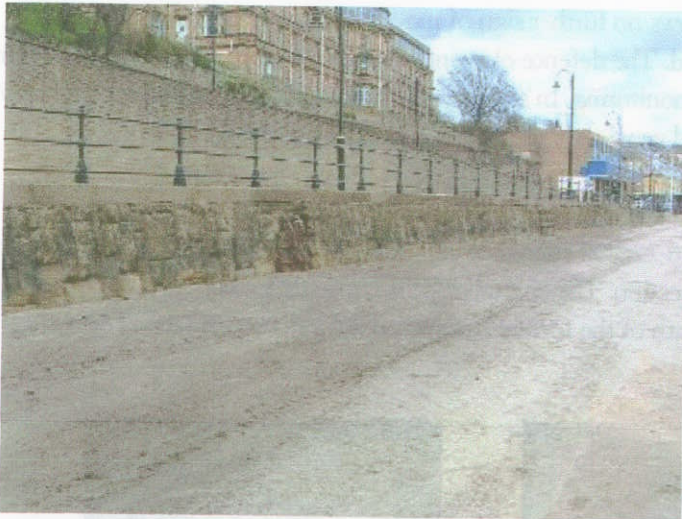
Photograph 3.78 Scarborough South Bay (SSB) 51-22A-12.
Seawall with promenade.

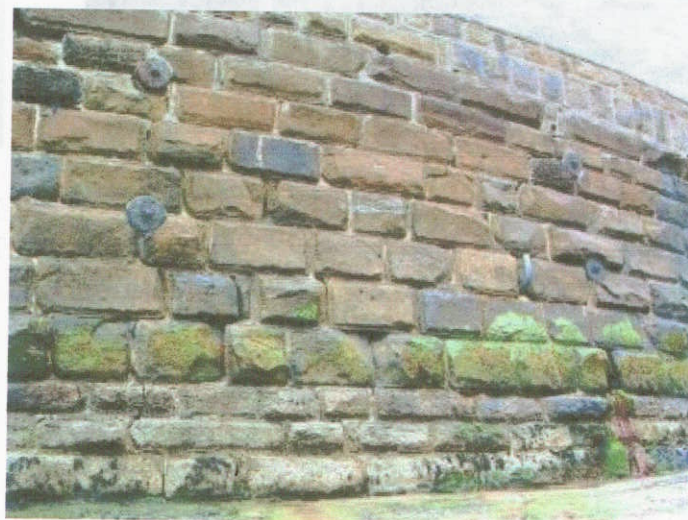
Photograph 3.81 SSB 53-22B-05.
Historical cracks and anchors

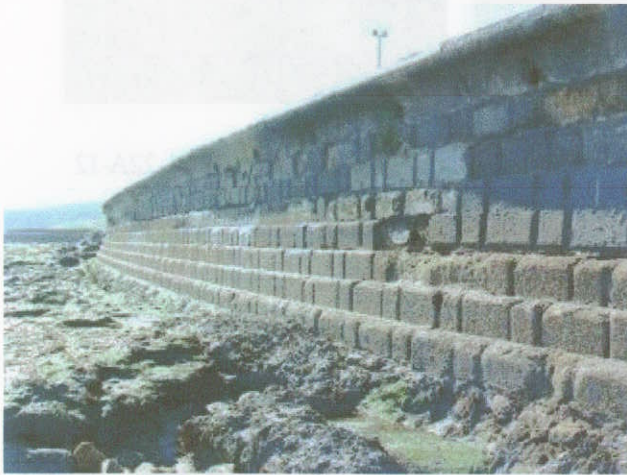
Photograph 3.82 SSB 55-22B-01.
Abraded masonry blocks

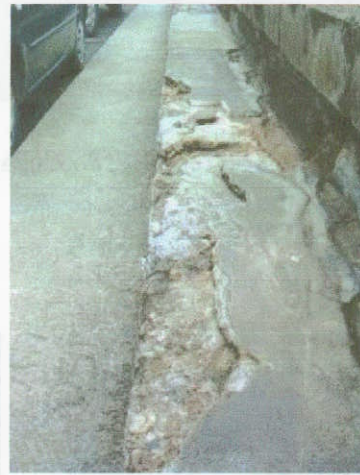
Photograph 3.83 SSB 53-22B-05.
Damaged promenade kerb

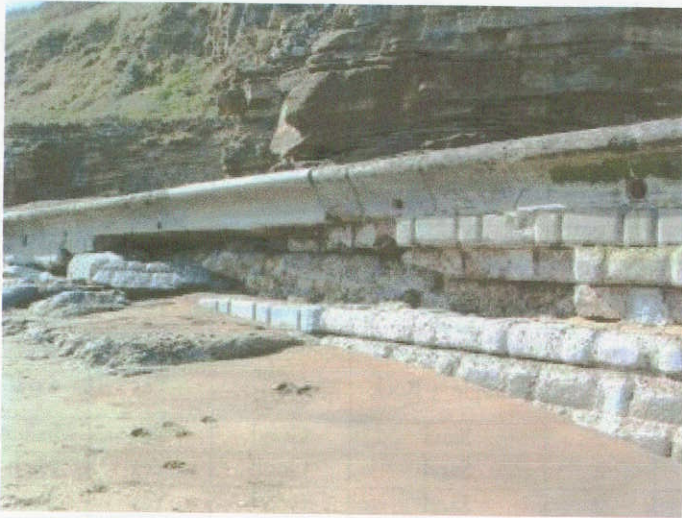
Photograph 3.84 SSB56-22B-02.
Damaged and failed defences.

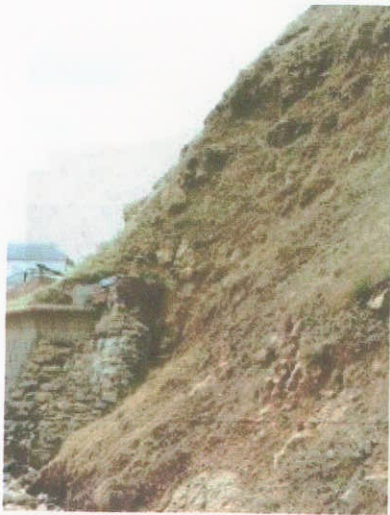
Photograph 3.85 Cayton Bay 58-24B-01. Steep coastal slope outflanking defence.

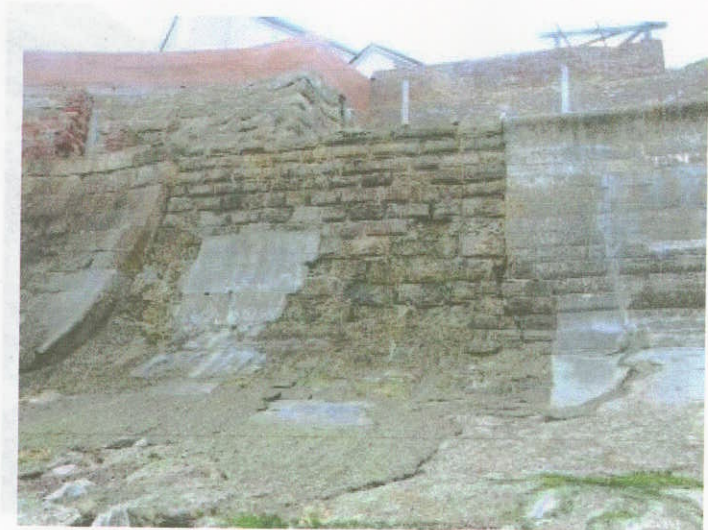
Photograph 3.86 Cayton Bay 59-24B-01. Patch repairs and interface between different wall elements

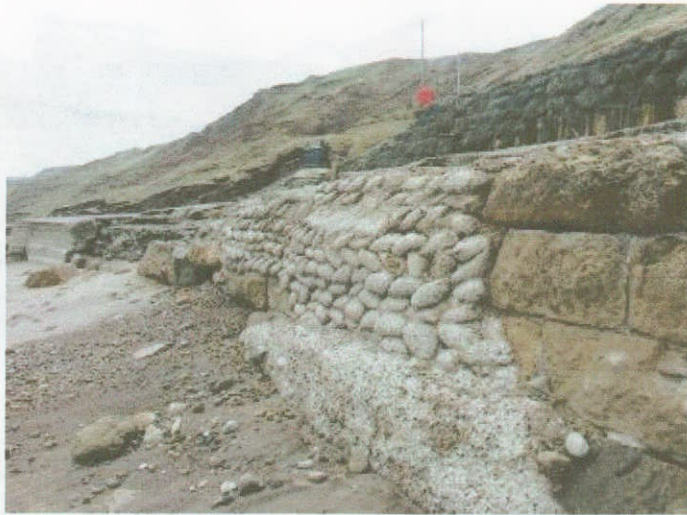
Photograph 3.87 Cayton Bay 60-24B-01.
Concrete bag-work and failed defence section.

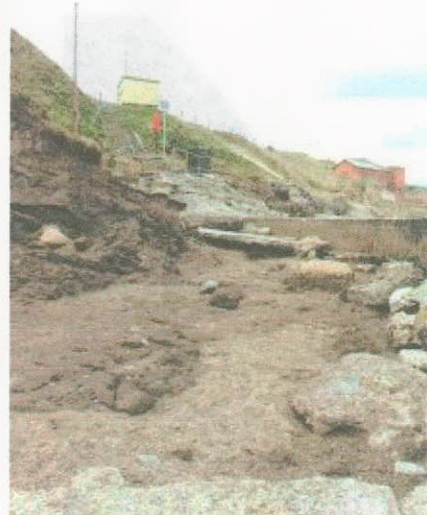
Photograph 3.88 Cayton Bay
60-24B-01. Landslip and erosion below
steps

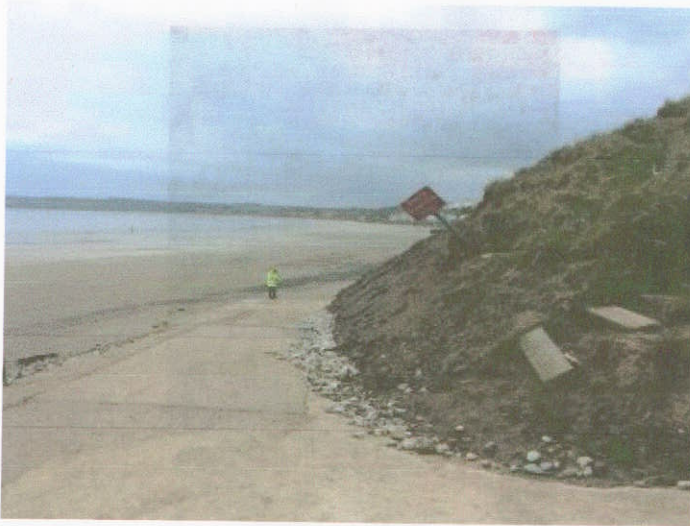
Photograph 3.89 Filey Bay 64-28A-01.
Landslide run-out lobe partially blocking the slipway
