Scarborough Borough Council
Strategic Coastal Monitoring Programme
2001 – 2006

Condition Analysis of Coast Protection Assets,
Cliffs and Beaches from Staithes to Speeton

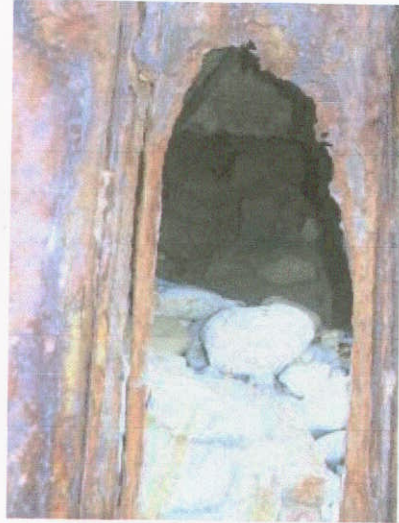
Photograph 3.90 Filey Bay 64-28A-02
Corroded sheet pile and scouring

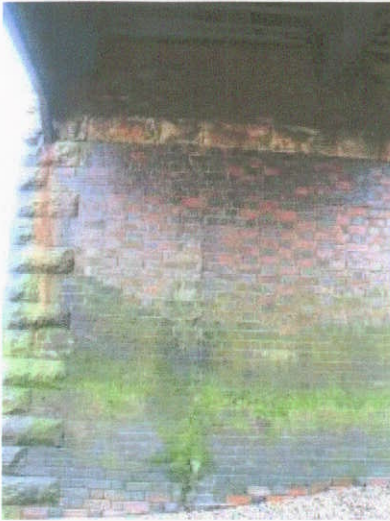
Photograph 3.91 Filey Bay 67-28B-04.
Full height vertical crack

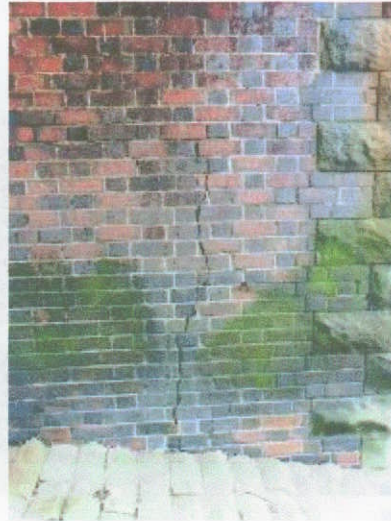
Photograph 3.92 Filey Bay 67-28B-04.
Vertical crack approx. 2m high

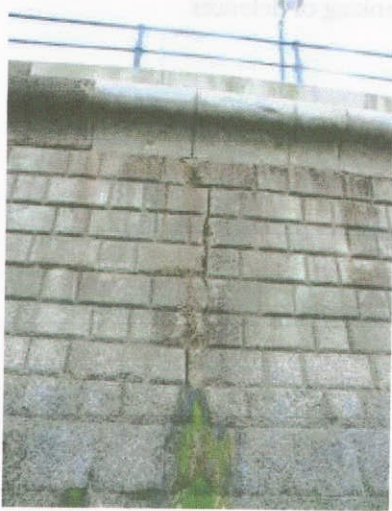
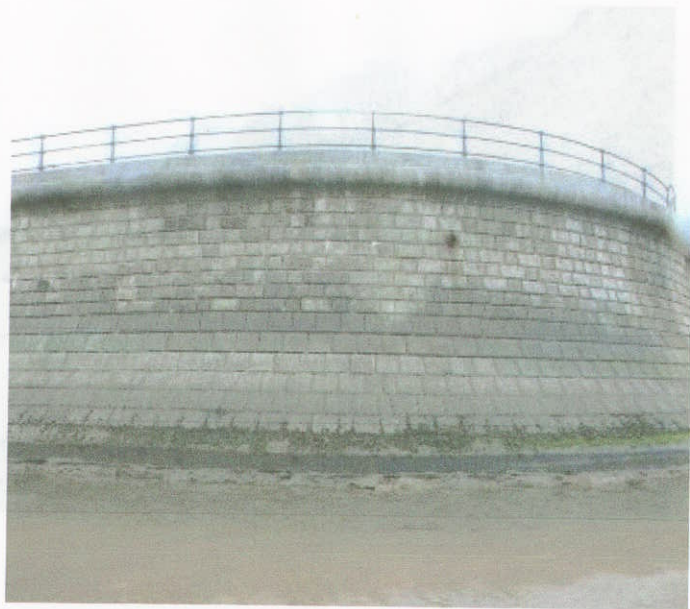
Photograph 3.93 Filey Bay 67-28B-05
Vertical full height crack

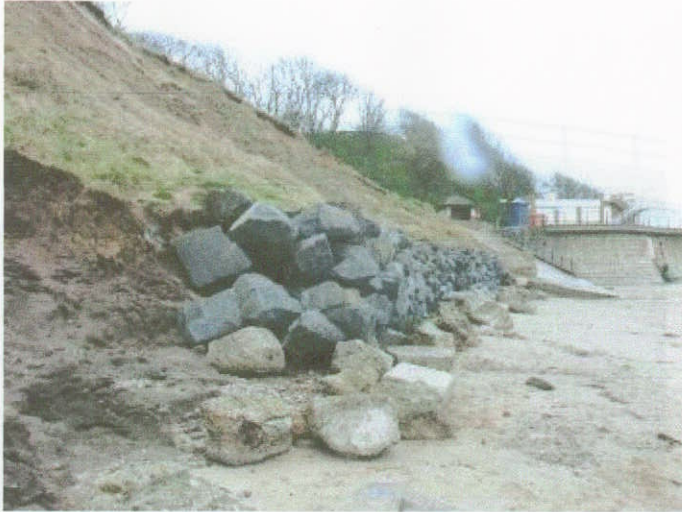
Photograph 3.95 Filey Bay 67-28B-13.
On-going coastal erosion and
outflanking of defences

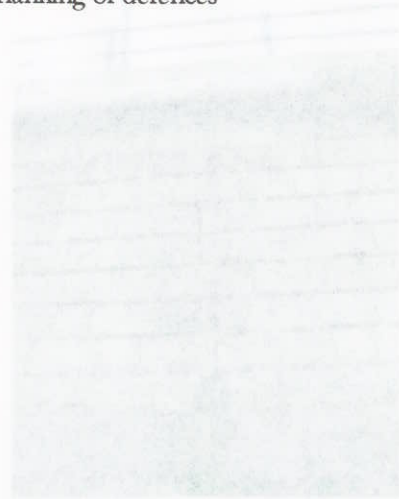
Table 3.10 Summary of survey results for CU28 Filey Bay

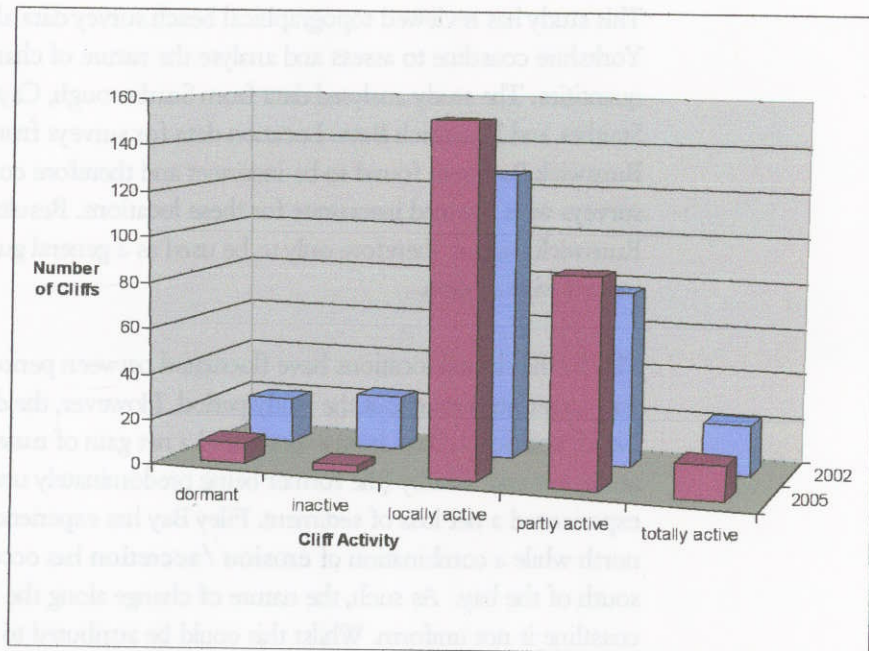
Figure 5.2. Distribution of cliff activity classification in 2002 and 2005.
