**Walk-over Visual Inspections of Assets  
including Coastal Slopes**

**Scarborough Borough Council  
Final Report**

**October - November 2012**

## Coast Protection Assets and Coastal Slope Condition Analysis

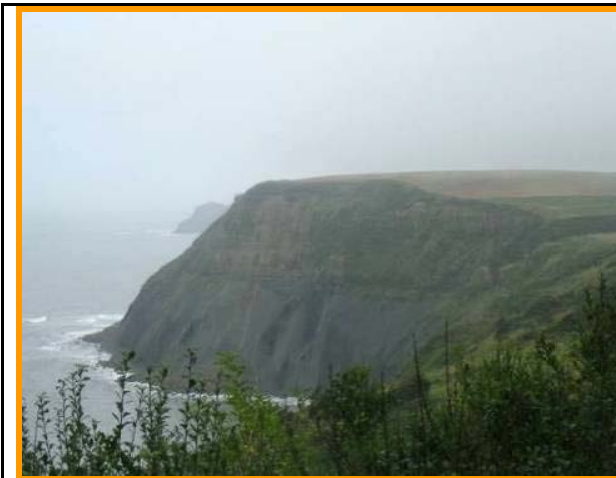
**MU6/6** – The cliffs show signs of vegetation on the upper slopes while the lower slopes are exposed. There were a number of small failures in the face (Partly Active).

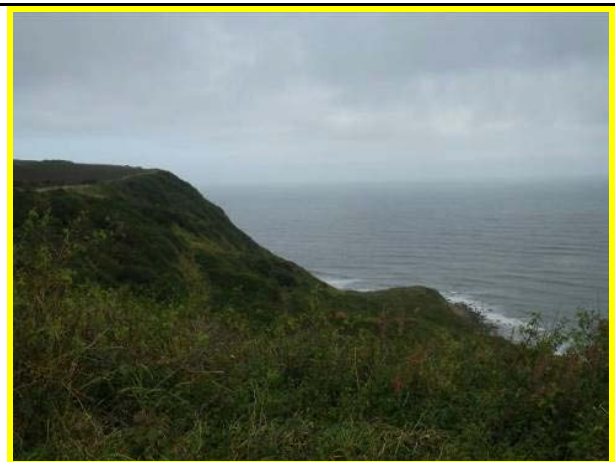
**MU6/7** – The cliffs are densely vegetated on the upper slopes while the sea cliff is prone to wave attack (Locally Active).

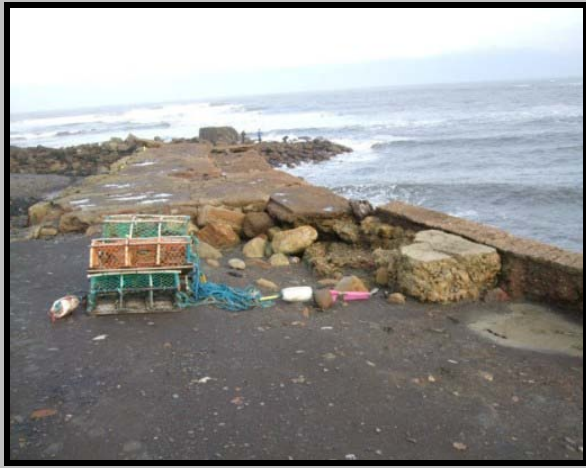
Looking at the end of the breakwater with evidence of erosion and failure in 2009 (Asset Ref. 1221D901D0502C01)

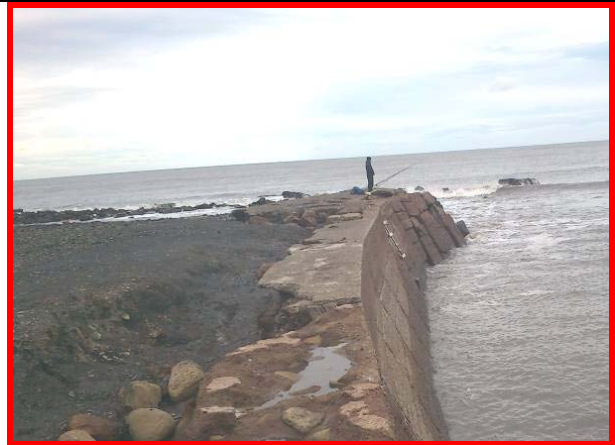
View of breakwater 30/10/2012 (Asset Ref. 1221D901D0502C01)

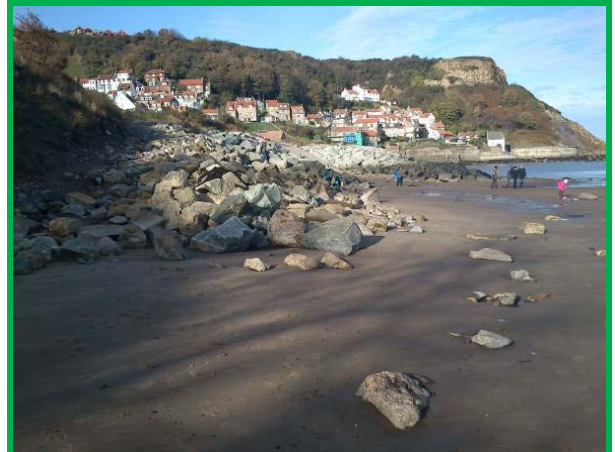
Southern end of Runswick bay rock armour defences (Asset Ref. 1221D901D0602C01)

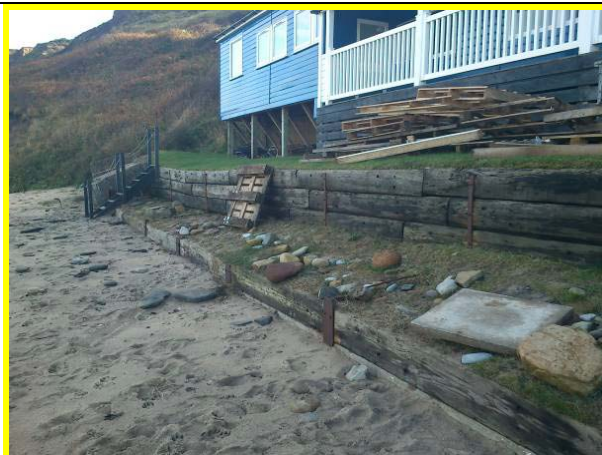
The Sailing Club, located in the bay some 600m south of the village, where the beach is wider has been constructed on timber struts and features a mix of coastal defences (Asset Ref. 1221D901D0602C05), below left and right. The informally placed relic tank trap blocks at the south end show extensive cracking. The timber defences across the front of the main building are showing signs of rot and will need replacement in future.

Runswick Bay sailing club timber defences at south end. (Asset Ref. 1221D901D0602C05)

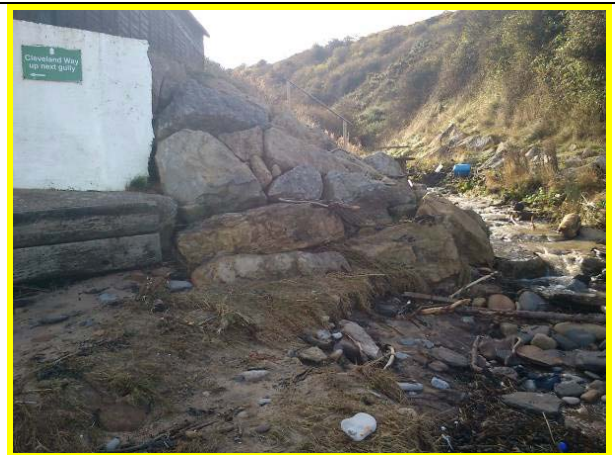
Northern end of defences at Runswick Bay sailing club (Asset Ref. 1221D901D0602C05)

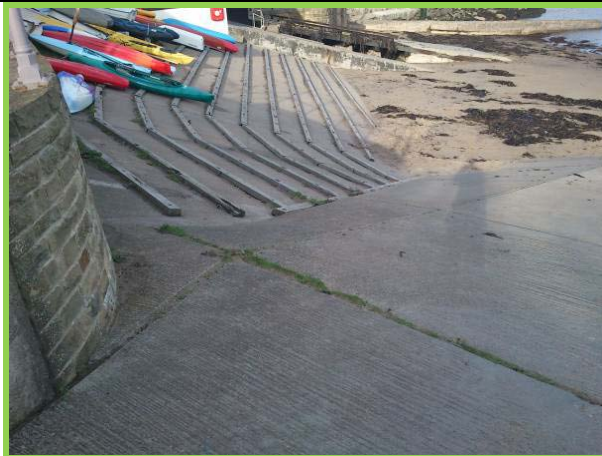
At the northern end of the rock armour, the slipway adjacent to the RNLI building remains in good overall condition, although the timber strips to support the small boats are rotting in many places and will need replacing and joints between slabs need resealing, below left. The seawall around the pumping station to the north of the RNLI building is in very good condition, below right, although the standards for all of the handrails are showing corrosion and need cleaning and repainting.

Northern slipway adjacent to the RNLI  
(Asset Ref. 1221D901D0601C04)

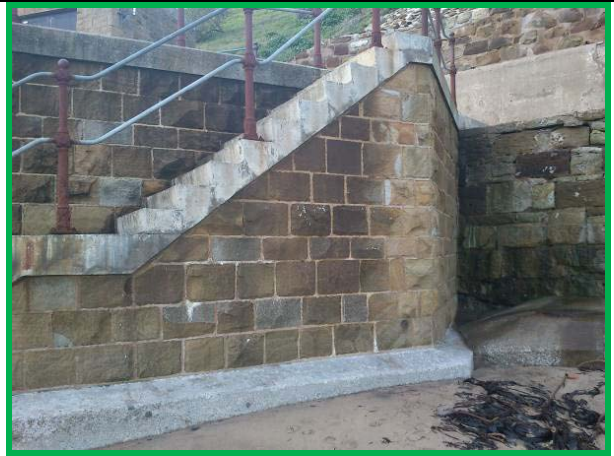
Seawall around the pumping station (Asset Ref. 1221D901D0601C07)

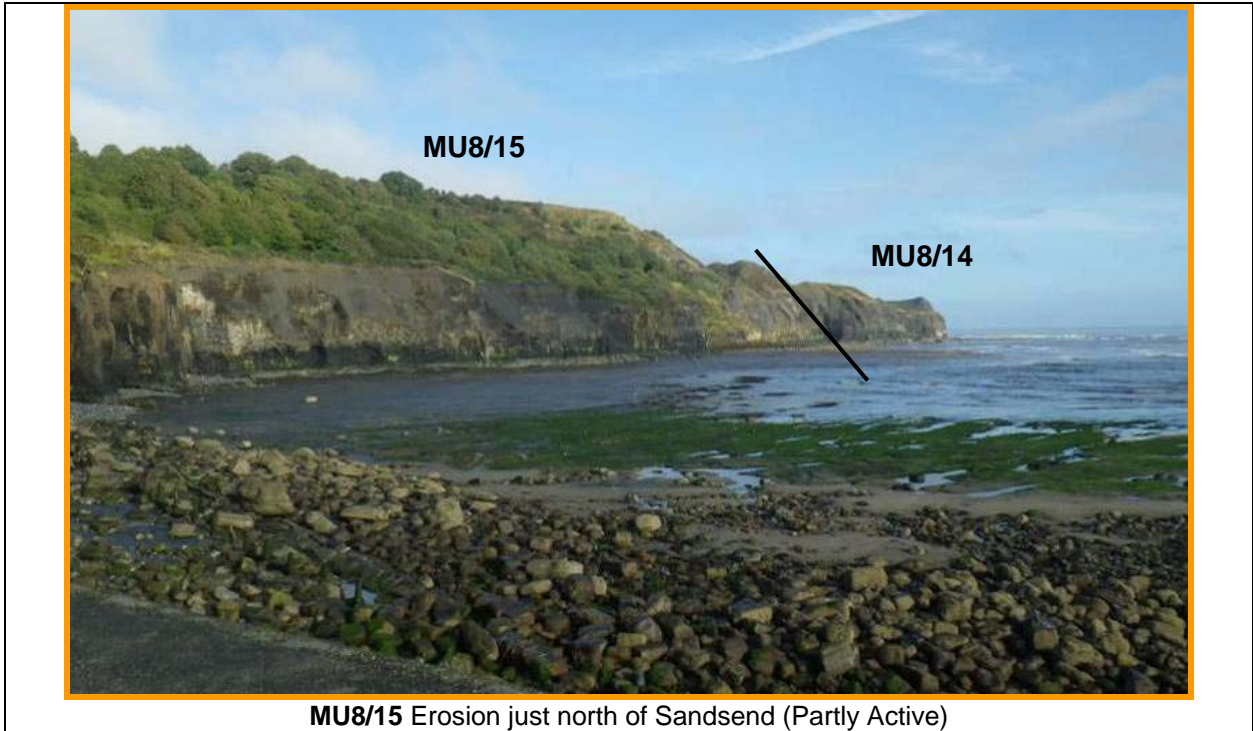
**MU8/15** Erosion just north of Sandsend (Partly Active)

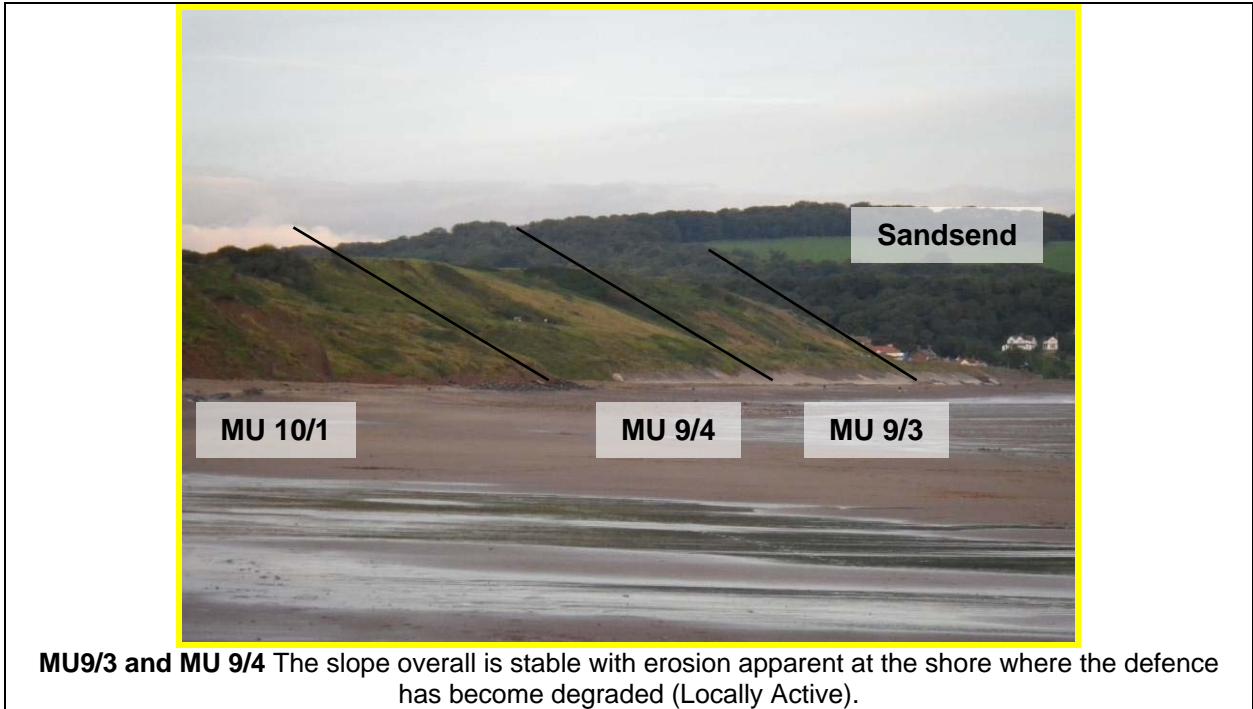
**MU9/3 and MU 9/4** The slope overall is stable with erosion apparent at the shore where the defence has become degraded (Locally Active).

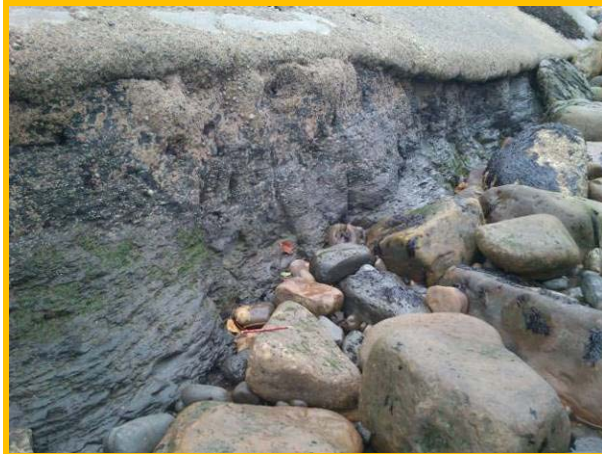
The most northerly defence at Sandsend car park area, is a sloping concrete revetment with recurve crest wall and rock armour toe protection (Asset Ref No.1221D901D0701C02). The concrete wall is in fair condition with minimal damage to the surface. There is some minor cracking and surface erosion which is typical of concrete defences such as this. The north end of the revetment has lost thickness of concrete at the base through abrasion, with exposure of reinforcement bars, although the worst area noted in the 2009 inspection was not visible as it was covered with cobbles and may have been repaired. Encasement of this reinforcement is advised from a structural perspective, as well as preventing any H&S accidents occurring due to sharp edges of the exposed bars. The toe of the revetment is exposed and undercut in many places, with abrasion of the soft rock on which the wall is founded ongoing, see below left. The toe armour is displaced and not fully protecting the toe; this could be ameliorated by re-profiling and topping up the rock armour protection. There is a large void under the south side of slipway adjacent to Sandsend Beck, see below right. There is also missing filler in the slipway joints and in the crest wall joints.

Displaced toe armour, undercutting to concrete revetment and abrasion damage to revetment (Asset Ref No.1221D901D0701C02)

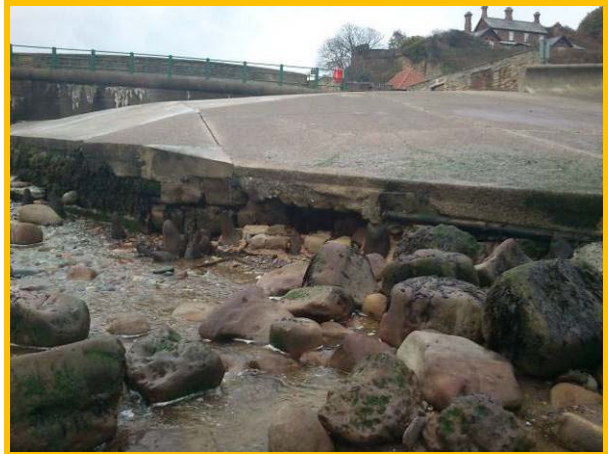
Void under slipway at the north of Sandsend (Asset Ref No.1221D901D0701C02)

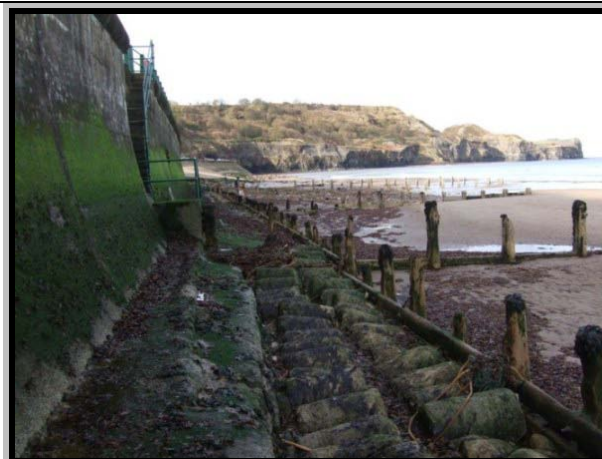
Similarly to the 2009 inspection, the beach was low in front of the main concrete seawall in front of Sandsend village (Asset Ref. 1221D901D0702C01). The groyne field is derelict and the remains have no significant impact on sand movement. The toe of the seawall was showing evidence of significant damage and movement in 2009 and the defence appears to have worsened over the last three years, with the timber breastwork deteriorating and allowing the ad hoc toe protection units to move. There are cracks in the wall and significant abrasion at the steps.

Timber toe of sea wall in a poor state - photo from 2009 (Asset Ref. 1221D901D0702C01)

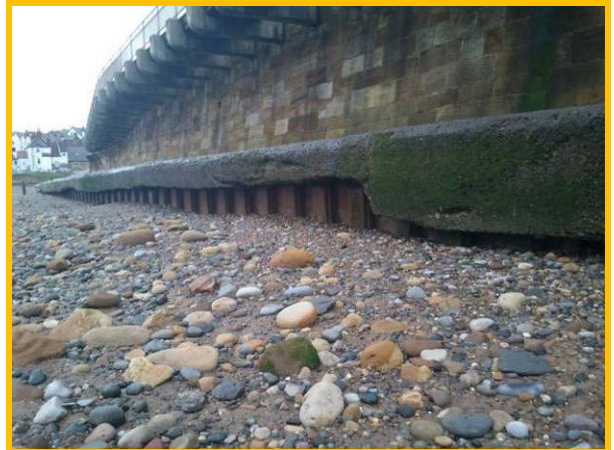
Exposure of toe piling below masonry wall. (Asset Ref. 1221D901D0702C04)

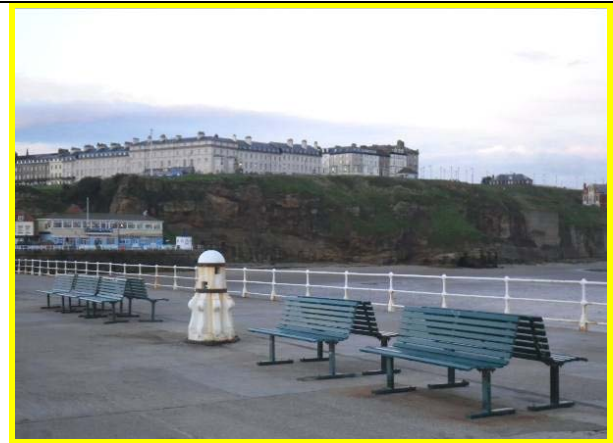
**MU11/4** Localised erosion above Whitby Sands (Locally Active)

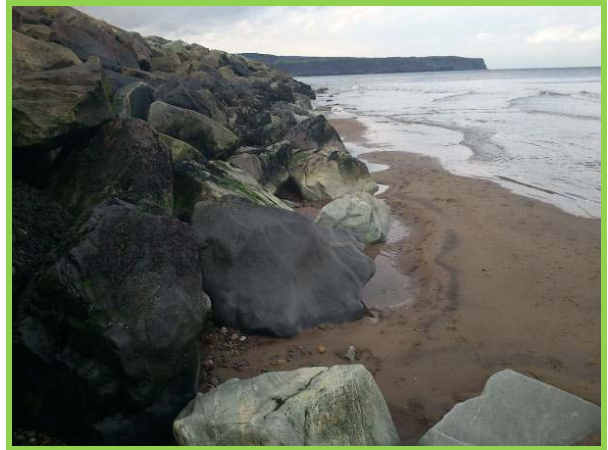
Rock armour in good condition (Asset Ref. 1221D901D0801C01)

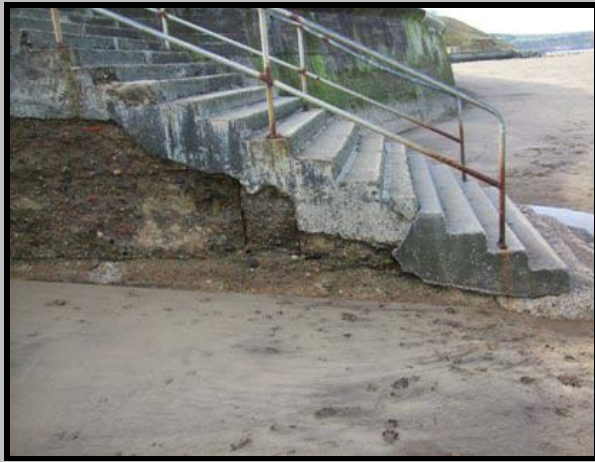
East of the north beach café the steps and ramps show signs of repairs, but are generally in poor overall condition with defects such as undercutting, erosion, cracking, exposure of aggregate and rounding of step edges. Repair work is needed to some structures to prevent future failure. Undercutting and erosion is occurring to the side walls of the stairs along the West Cliff and are in need of repair (Asset Ref. 1221D901D0802C04001).

Erosion and cracking to stair side wall - image from 2009 (Asset Ref. 1221D901D0802C04001)

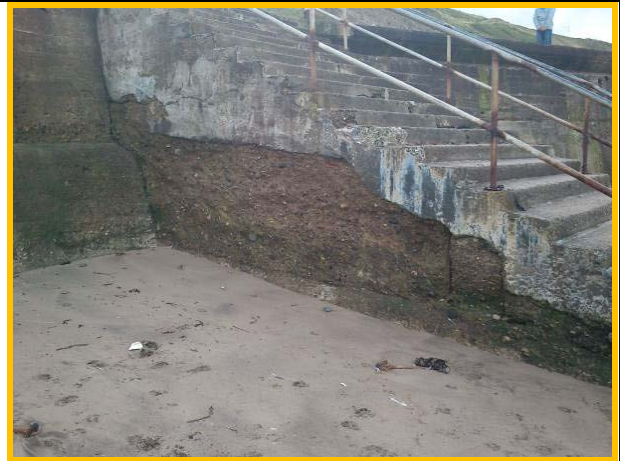
No change from 2009 - image from 31/10/2012 inspection (Asset Ref. 1221D901D0802C04001)

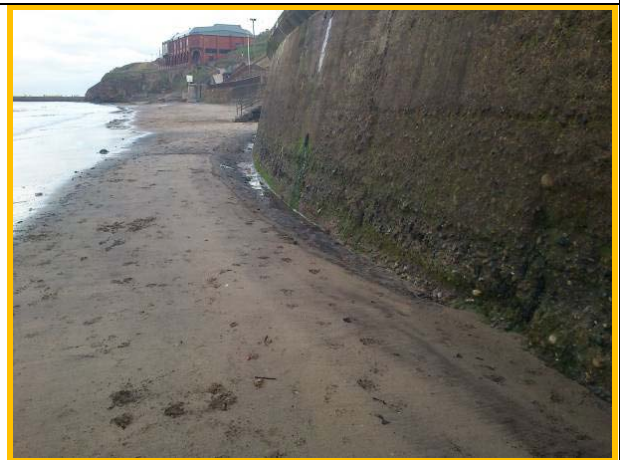
Abrasion damage to wall (Asset ref. 1221D901D0802C14)

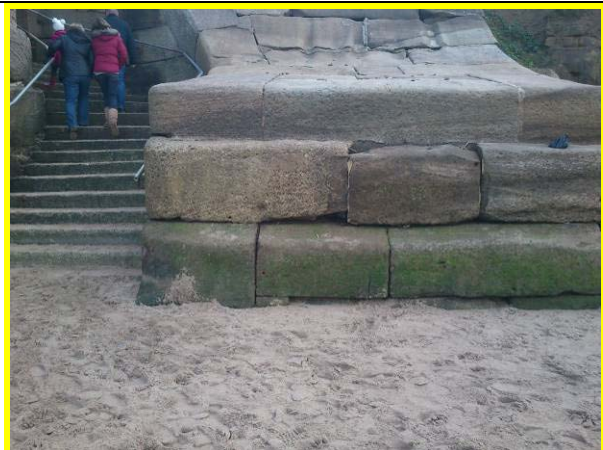
Evidence of recent movement of central block (Asset Ref. 1221D901D0802C12)

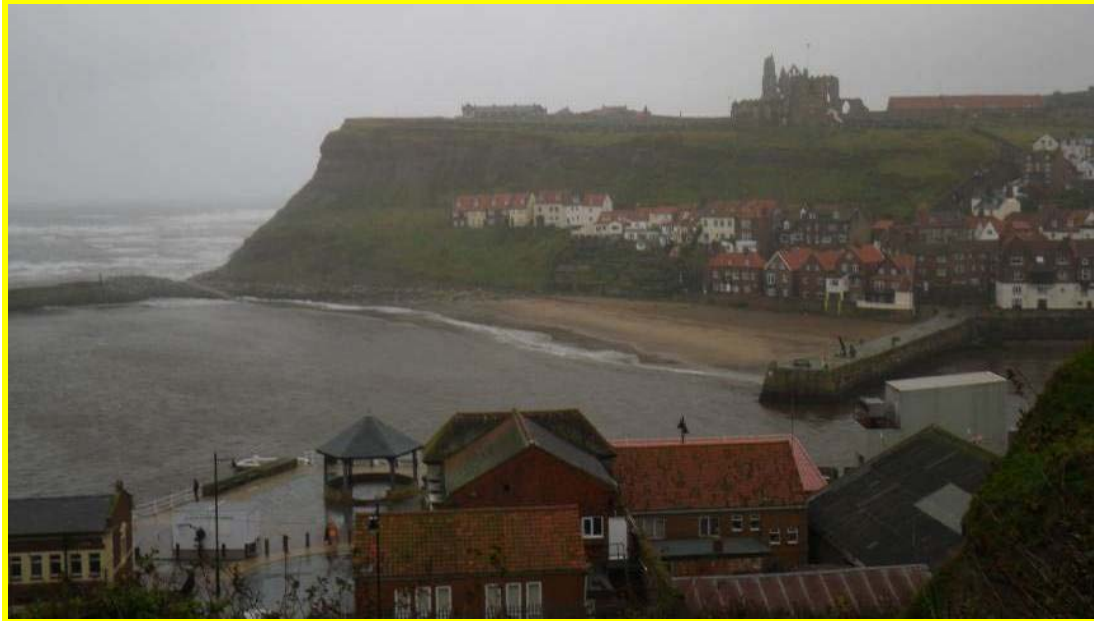
Following the inspection, a significant but localised failure of the headscarp occurred on 29 November 2012, which led to loss of part of the graveyard of St Mary's church and deposition of debris on properties along Henrietta Street. It is thought that the failure was associated with damaged drainage pipes and the very wet conditions of 2012.

**MU12/1** Below Whitby Abbey the slopes are vegetated, but with localised signs of erosion (Locally Active). Cliffs behind Henrietta St (row of white cottages extending along cliff face below St Mary's church) are subject to periodic failure.

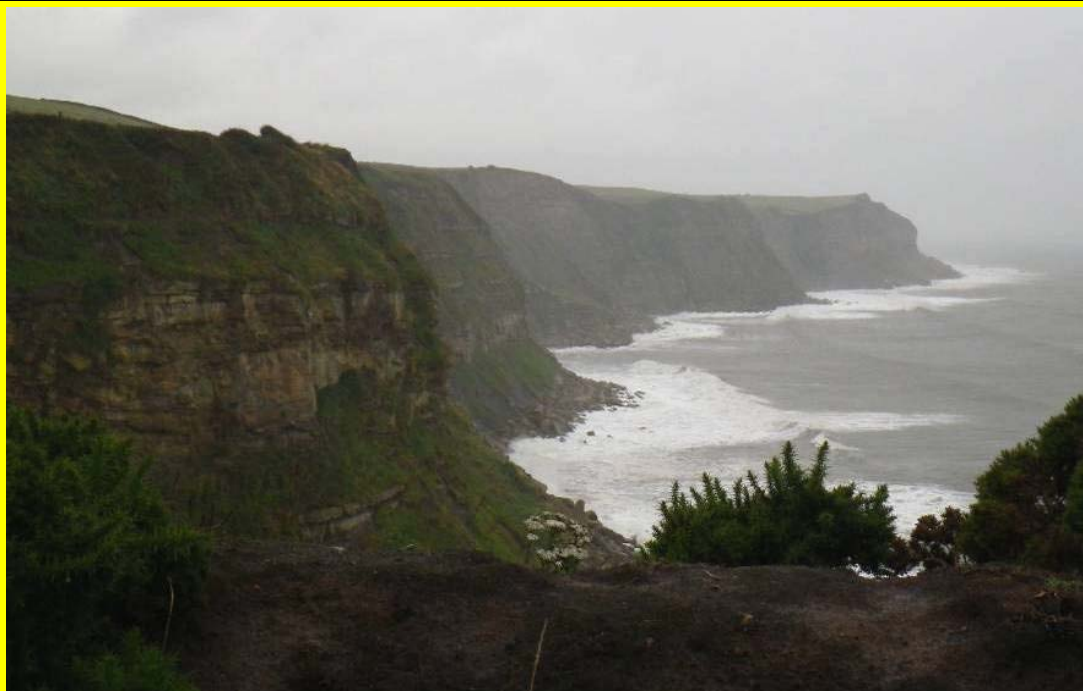
**MU14/1** stable cliffs with largely-vegetated debris aprons and boulder lobes (Locally Active)

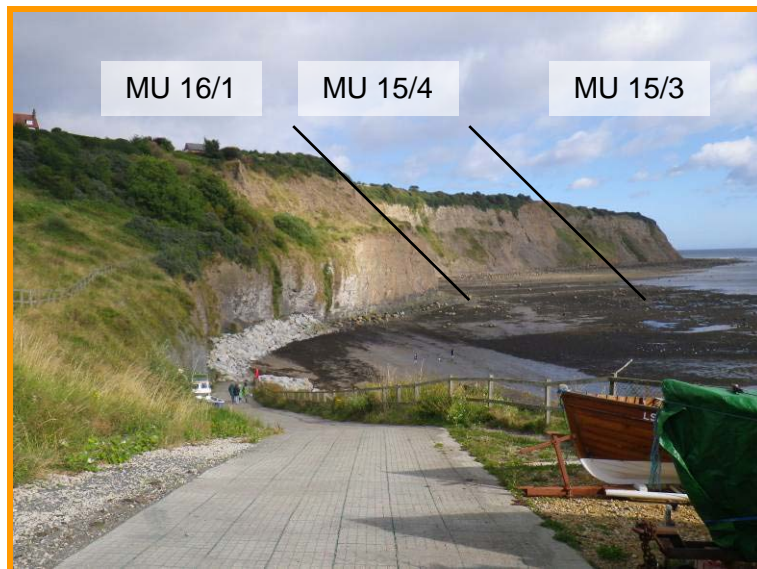
**MU15/4** Exposed cliffs with boulders at the toe (Partly Active)

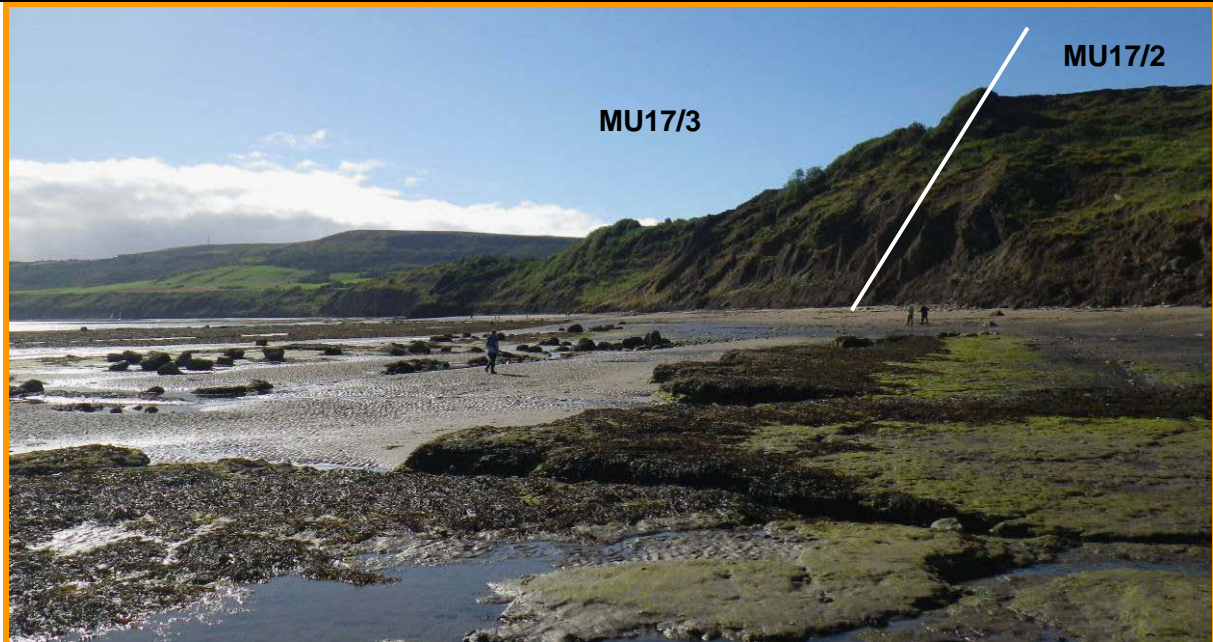
**MU17/3** Looking south across Robin Hood's Bay (Partly Active) (approx. unit extents shown)

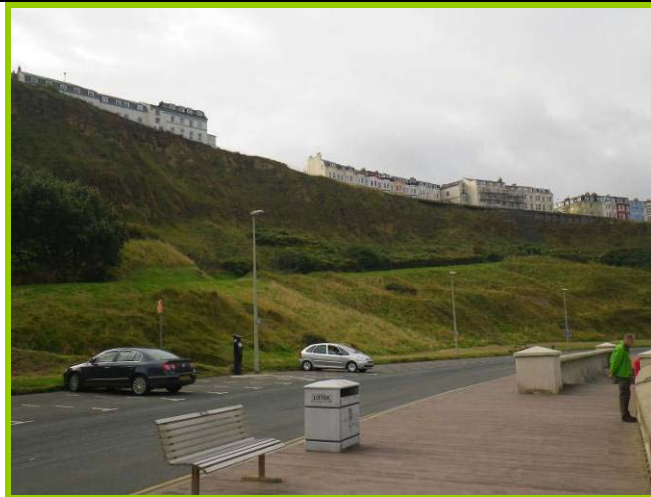
**MU20/4b** Exposed rock headscarp (Inactive)

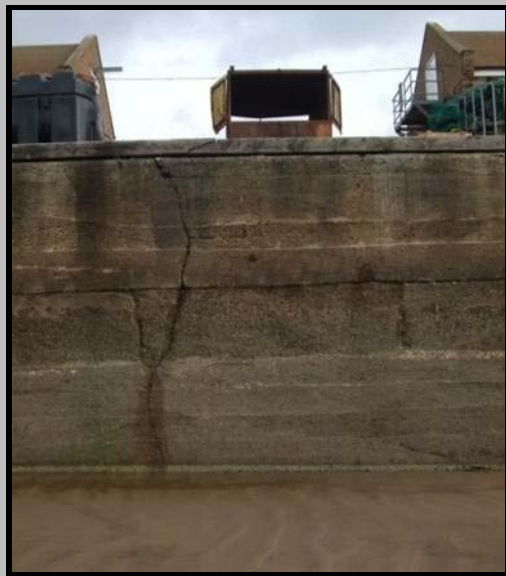
Large vertical crack extending through the wall photo from 2009 (Asset Ref. 1221D901D1301C19)

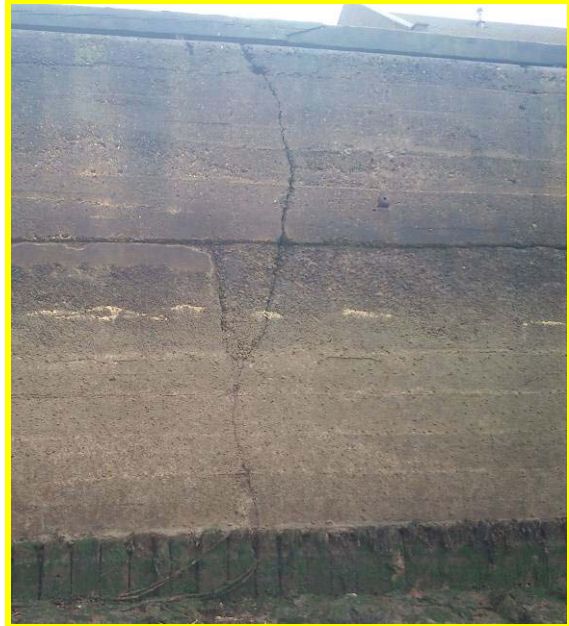
No change to vertical crack extending through the wall photo from 16/10/12, but lower beach exposing timber toe piles. (Asset Ref. 1221D901D1301C19)

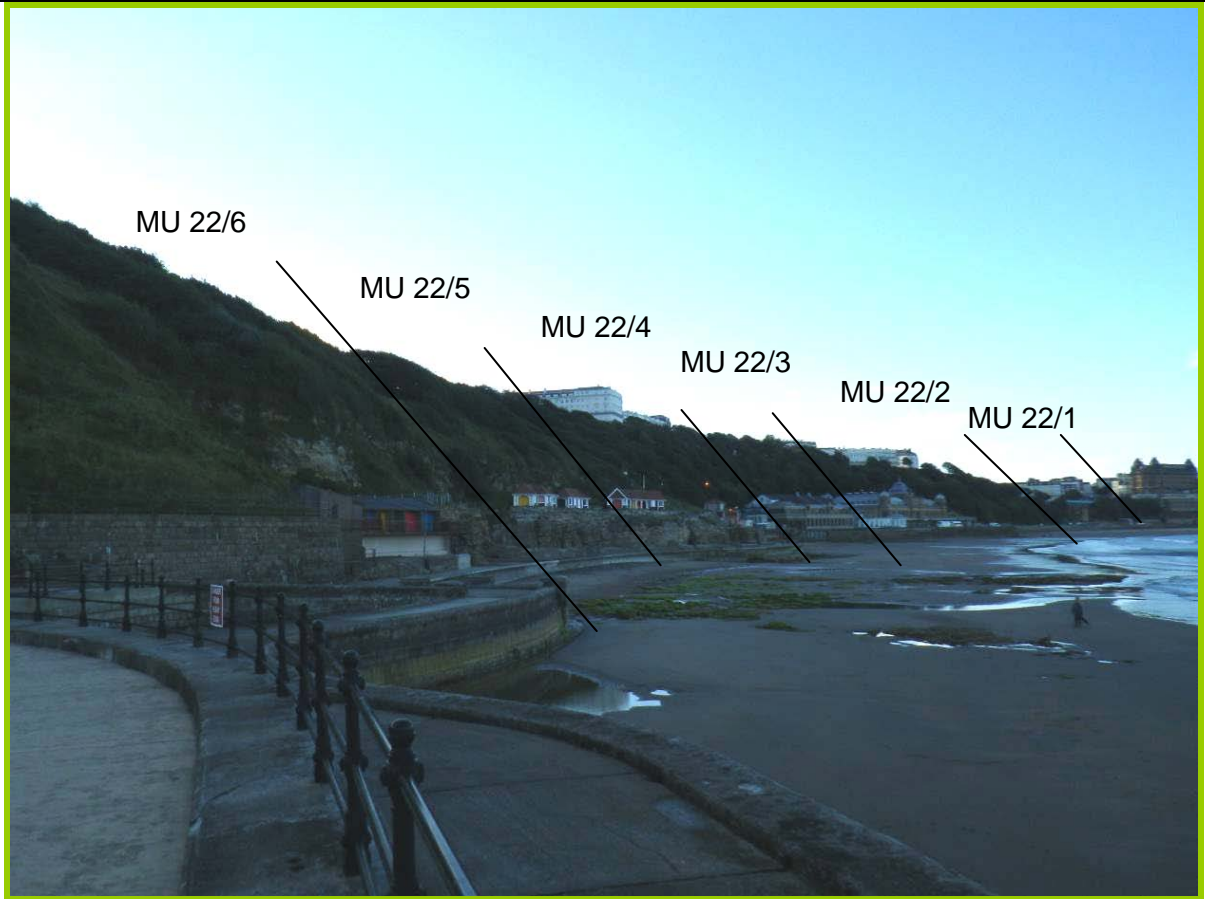
**MU22/1 to MU 22/6** Well vegetated slopes with large coastal defences at the toe (Inactive)

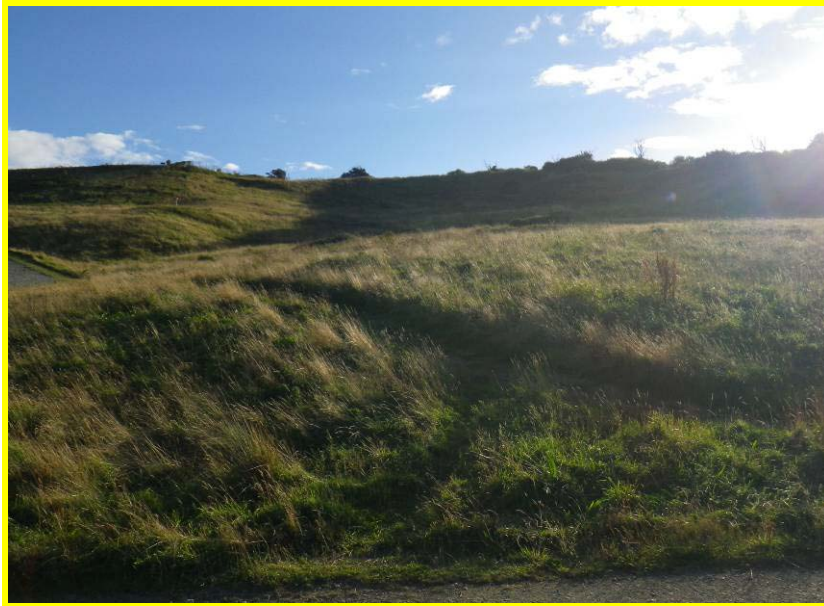
**MU22/8** Localised activity at the headscarp of the Holbeck Hall landslide run-out (Locally Active)

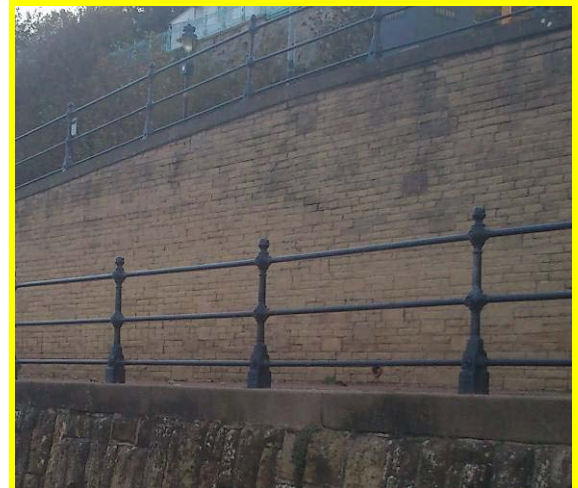
Second stage wall, with crack, 16/10/12 (Asset Ref. 1221D901D1301C09)

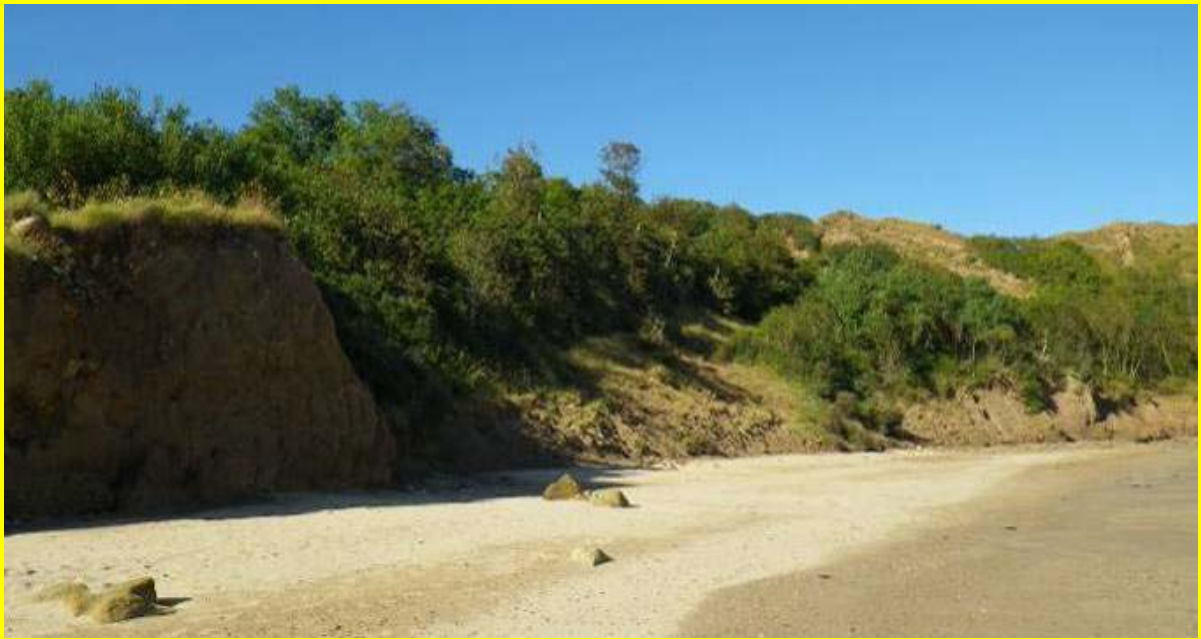
**MU24/A** The toe of Cayton Cliff is Partly Active

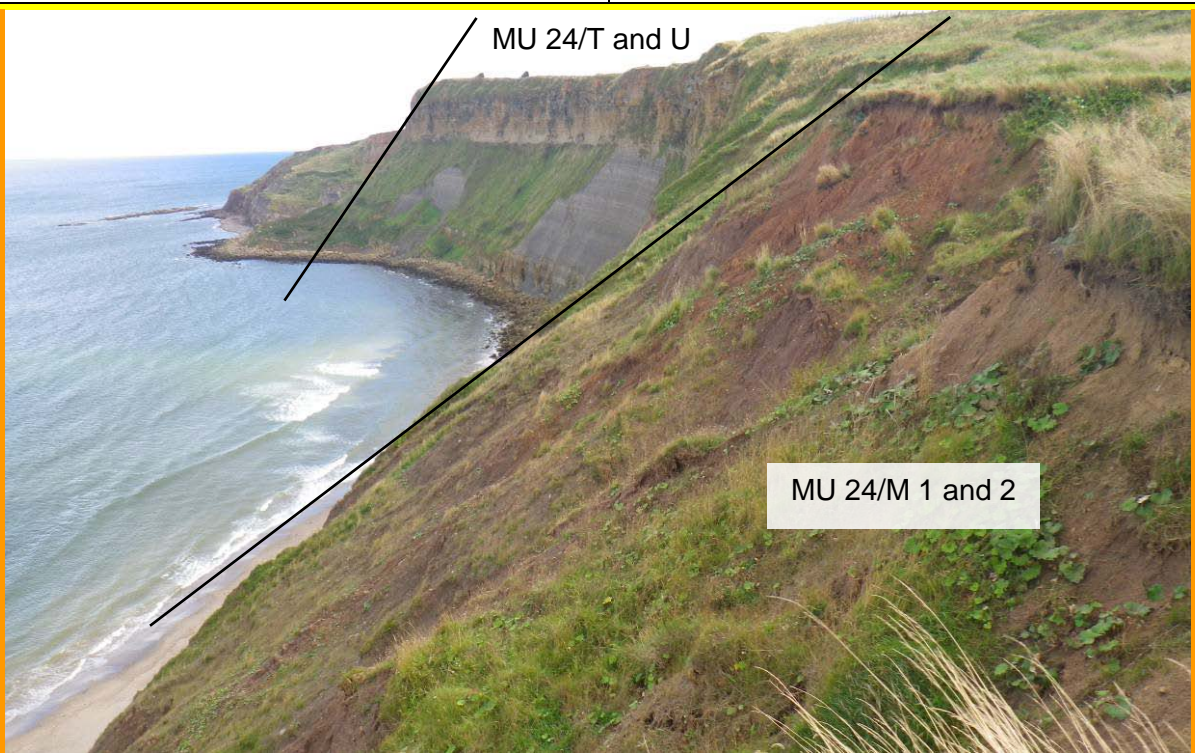
**MU24/M1 and 2 to MU U** The slope has patchy vegetation with localised areas of erosion and bare rock. The majority of the units are Partly Active with the exception of MU U, which is Locally Active.

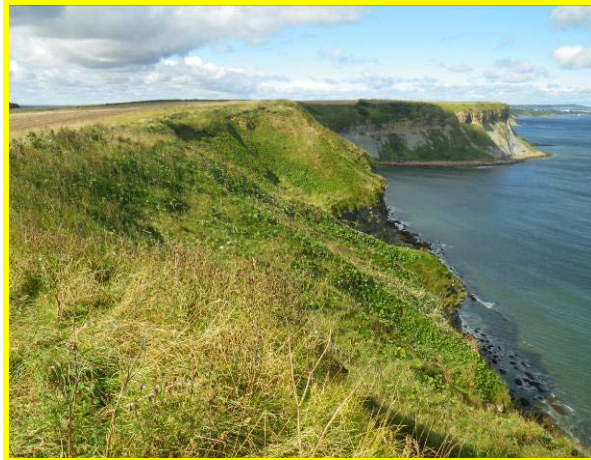
**MU26/AM to MU26/AN** Locally Active.

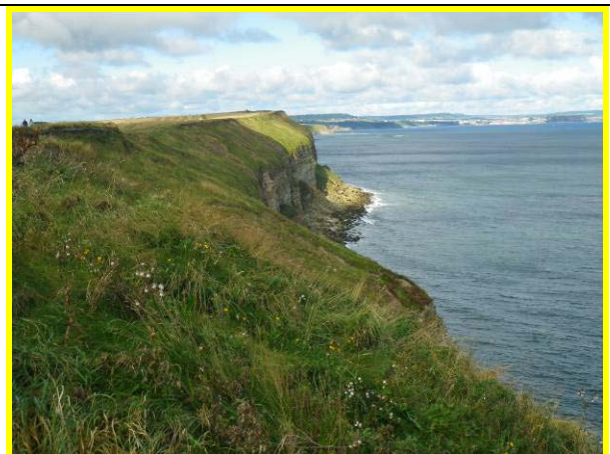
**MU26/AX** Localised erosion of upper soft till layer (Locally Active)

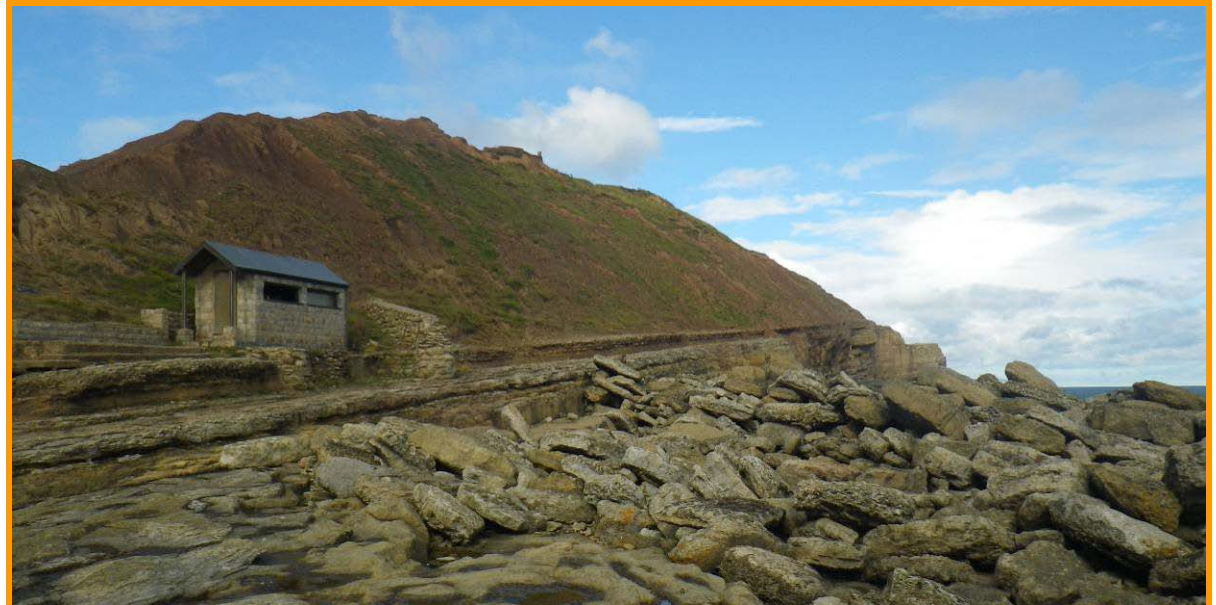
**MU27/B** The toe is protected to some extent but the cliff slope continues to erode (Partly Active)

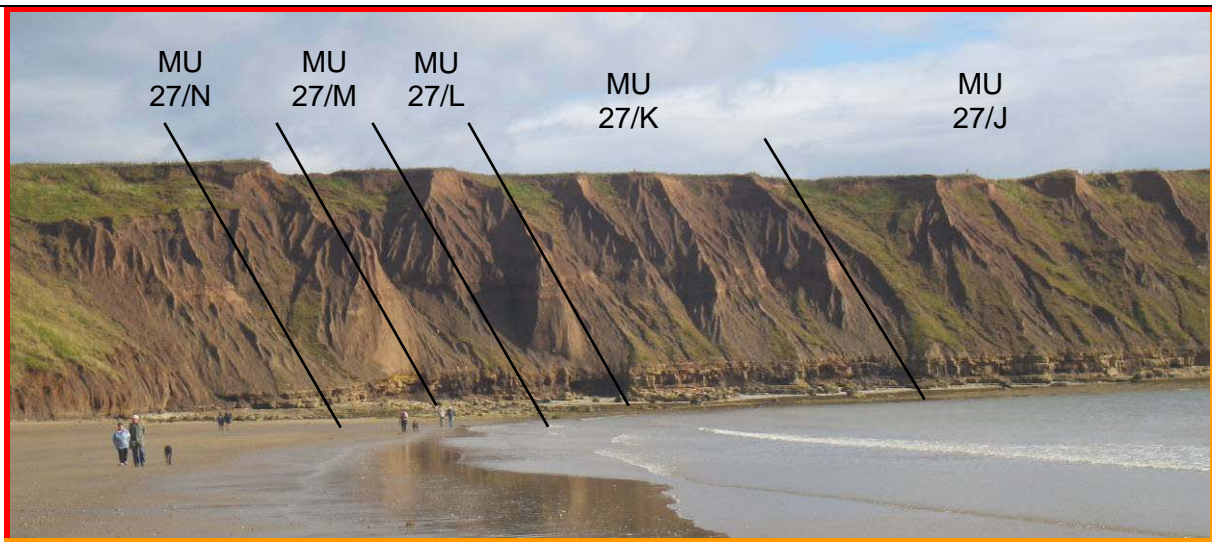
**MU27/J to MU27/N** Continuing denudation of Filey Brigg, with gullies and mudslides evident in the thick glacial sediments (Partly Active and Totally Active)

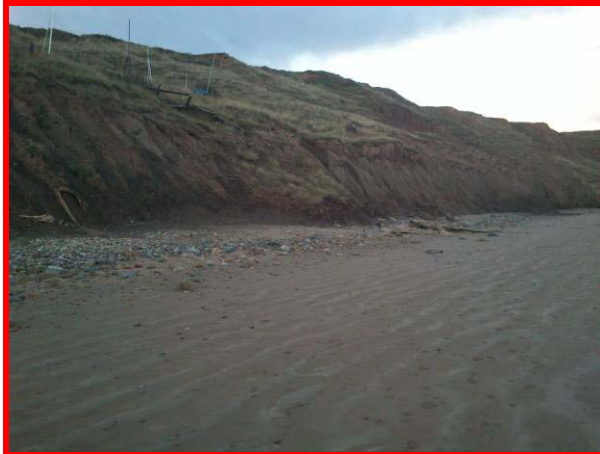
Debris from former slope stabilisation works being eroded at Filey sailing club boat park  
(Asset Ref. 1221D901D1601C01)

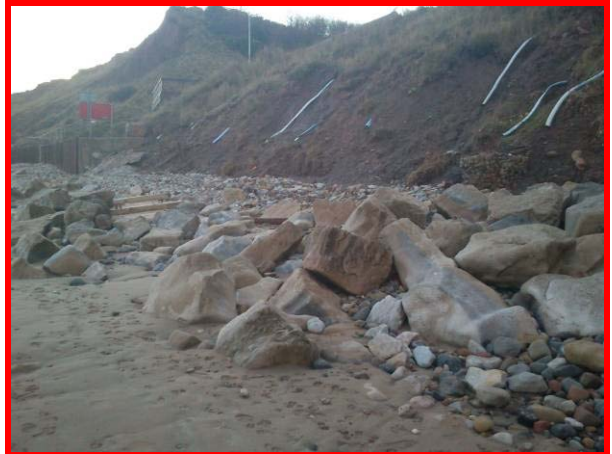
Debris from failed defence and former slope stabilisation at Sailing Club.  
(Asset Ref. 1221D901D1601C02)

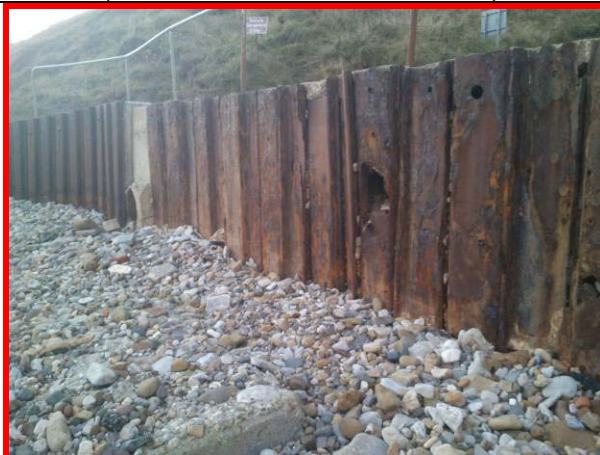
Centre section of sheet piling below Sailing Club house in failed condition.  
(Asset Ref. 1221D901D1601C03)

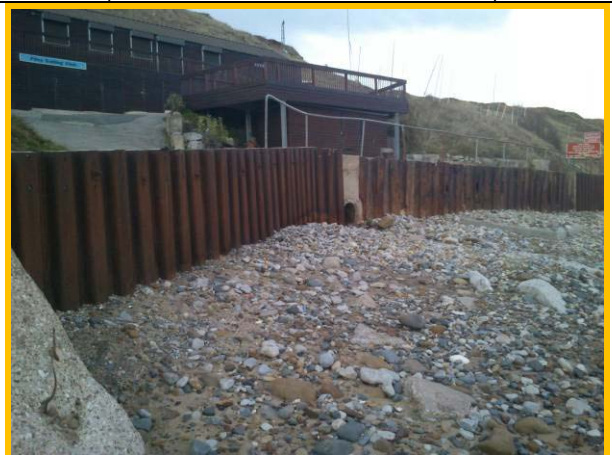
Newer section of sheet piling at Sailing Club ramp on left of photo.  
(Asset Ref. 1221D901D1601C03)

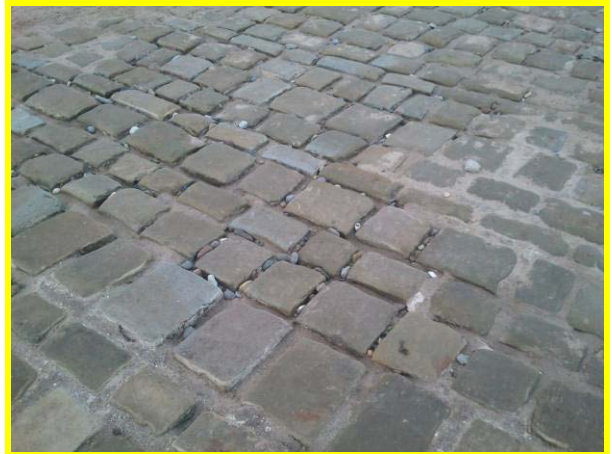
Missing grout in sections of cobbles in slipway (Asset Ref. 1221D901D1602C01)

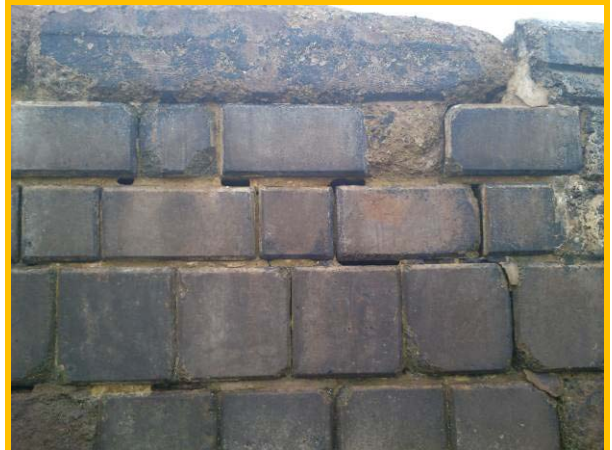
Cracks in wall and loose blocks adjacent to slipway 08/11/12. (Asset Ref. 1221D901D1602C01)

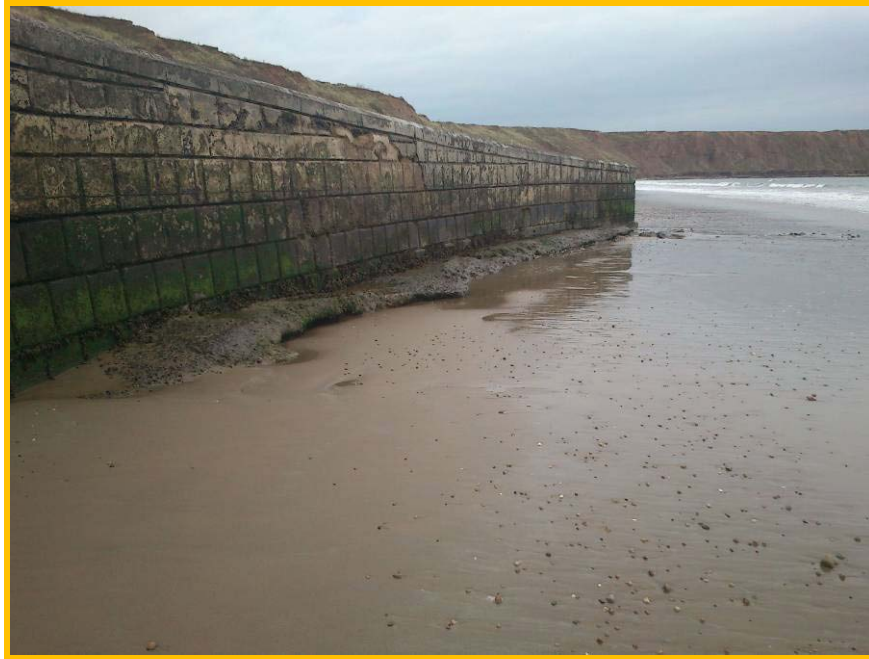
Exposed and undercut toe apron at Cobble Landing  
(Asset Ref. 1221D901D1602C09)

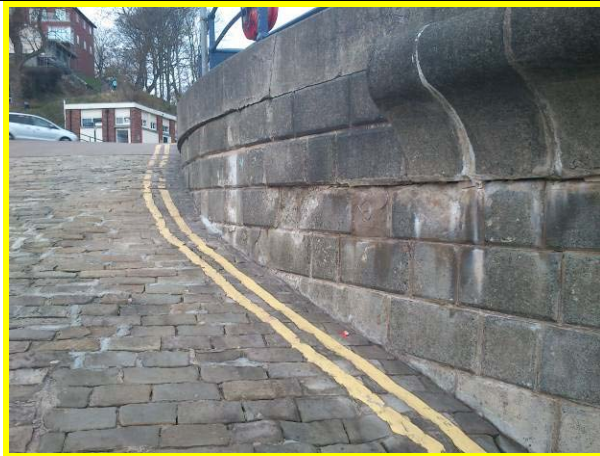
Damaged blocks at ramp with evidence of previous repairs. (Asset ref. 1221D901D1602C06)

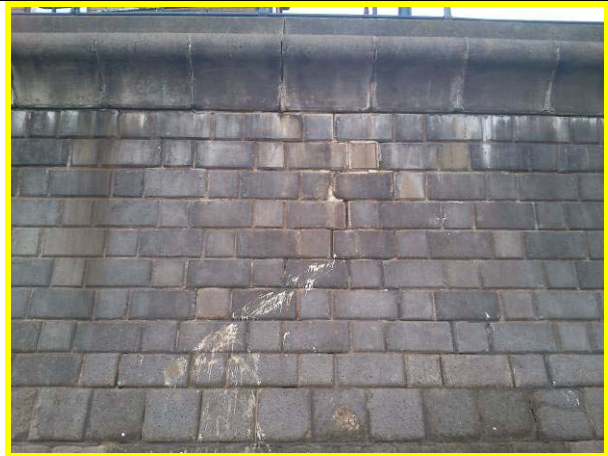
Small vertical crack in wall that has been repaired previously. (Asset ref. 1221D901D1602C06)

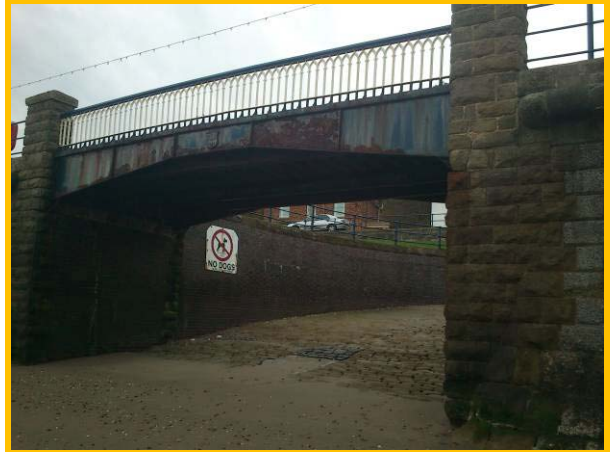
Pedestrian bridge at access slipway from Cargate Hill. Corrosion to bridge and open joints in slipway blocks need attention. (Asset Ref. 1221D901D1602C08)

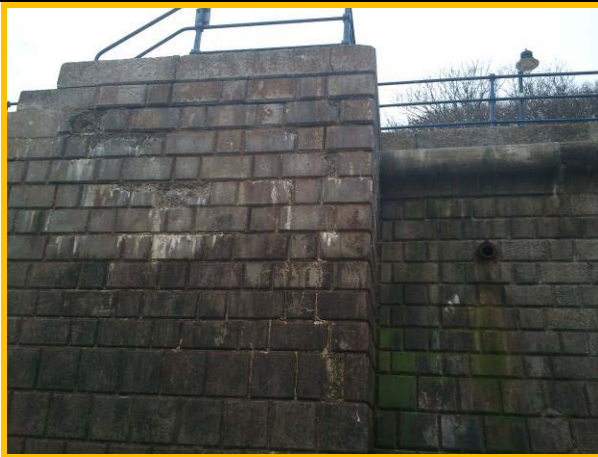
Sea wall with minor, localised defects (Asset Ref. 1221D901D1602C07)

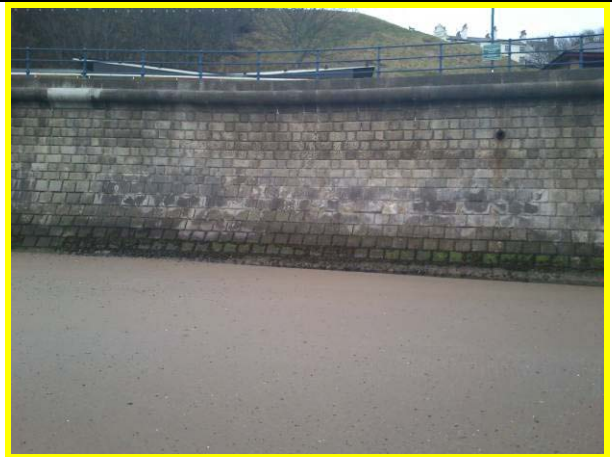
General view of wall showing area of damaged blocks and previous repairs to coping / splash beam. (Asset ref. 1221D901D1602C07)

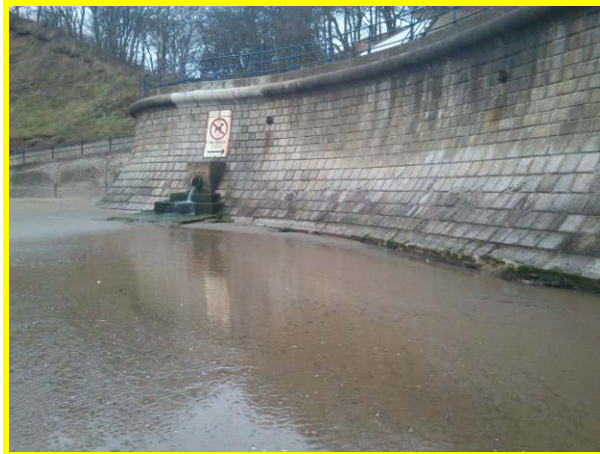
View of south end of wall and discharge from outfall. Damaged toe blocks to wall on right. (Asset Ref. 1221D901D1602C05)

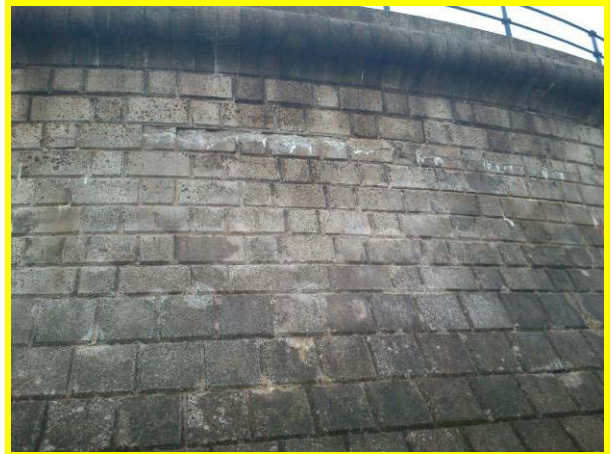
Horizontal crack in upper wall on southern promontory. (Asset Ref. 1221D901D1602C05)

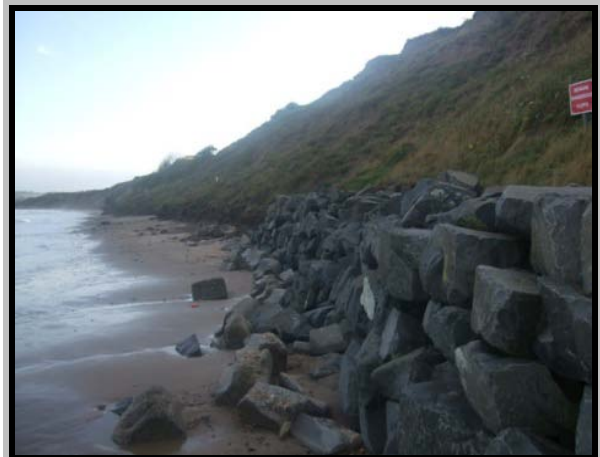
Rock revetment with gabion baskets beneath. Photo from 2009 inspections. (Asset Ref. 1221D901D1602C02)
