**Walk-over Visual Inspections of Assets  
including Coastal Slopes**

**Scarborough Borough Council  
Final Report**

**October - November 2012**

## Coast Protection Assets and Coastal Slope Condition Analysis

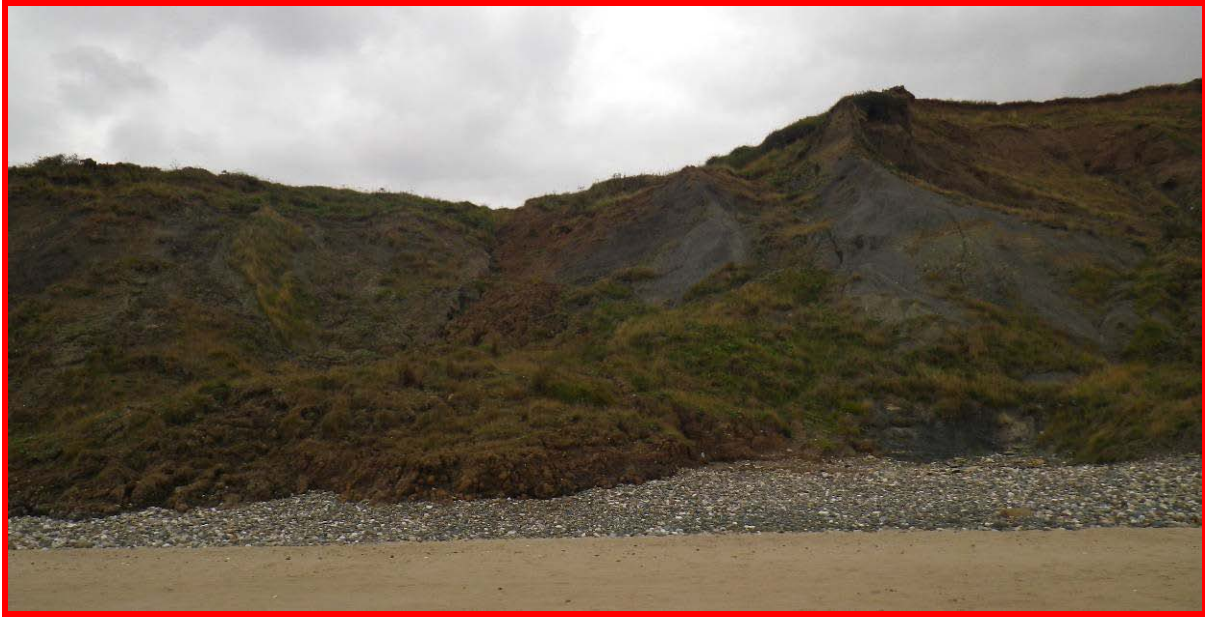
**MU29/CCa** The mudslide system continues to slump onto the beach (Totally Active)

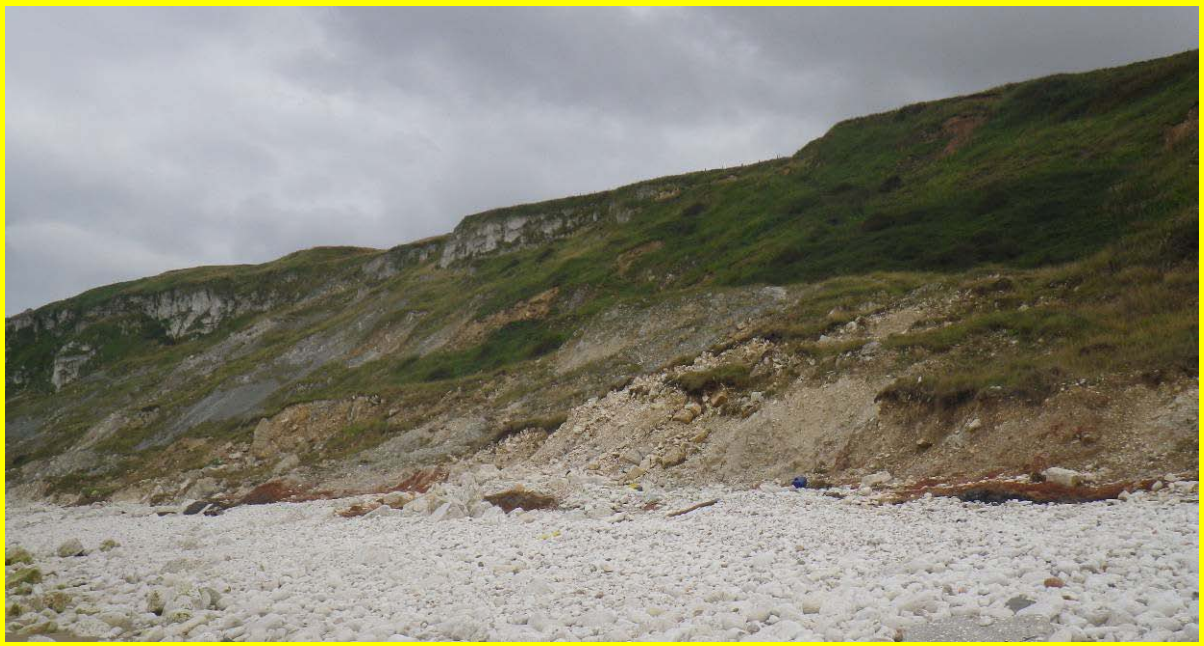
**MU29/CJ** Active toe erosion and localised mudsliding (Locally Active)
