Analysis and Interpretation of Coastal Monitoring Data

Geotechnical Interpretative Report

Document Ref No 721228/001/GR/01/FINAL
February 2009

Scarborough Borough Council
Town Hall
St. Nicholas Street
Scarborough
N. Yorkshire
YO11 2HG

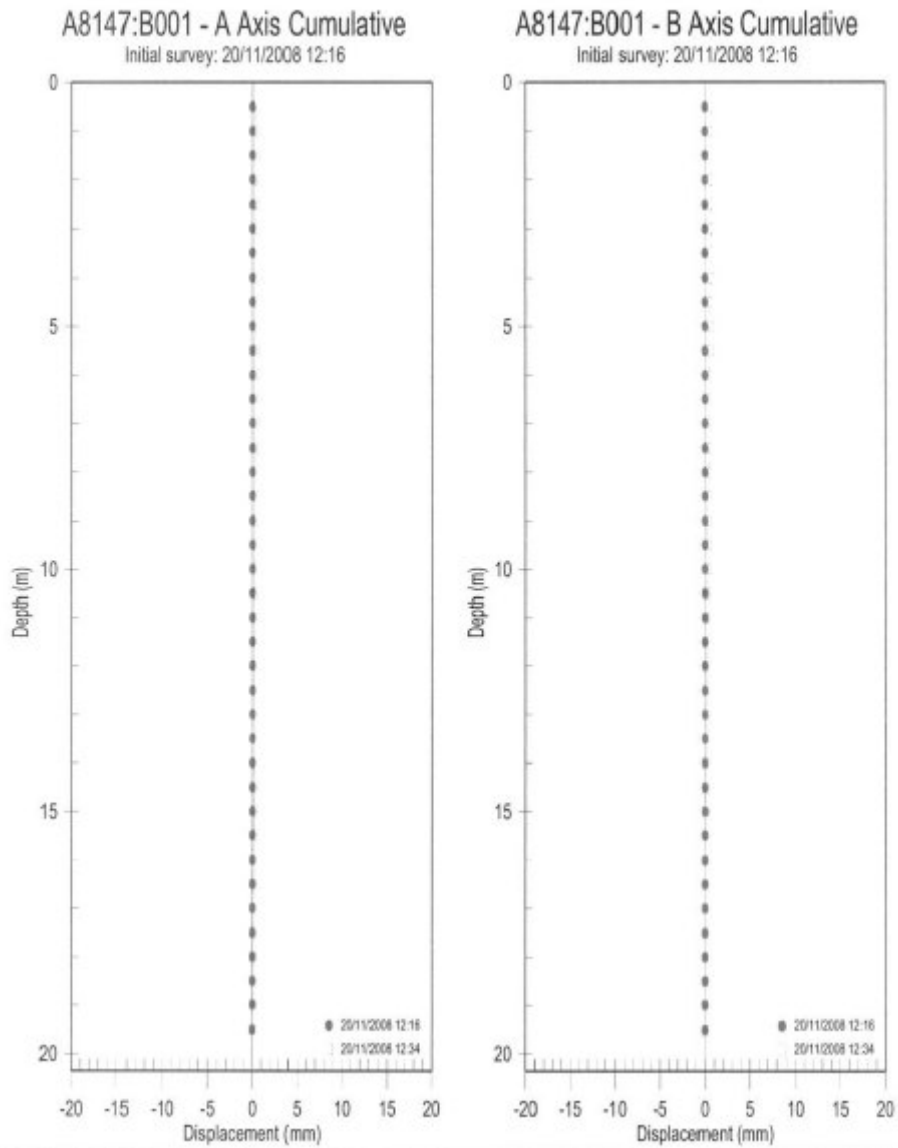
Figure 14: Inclinometer Data

The latest set of readings (Fig. 14) are 'baseline' values and therefore do not indicate ground movements. No further comment is offered.

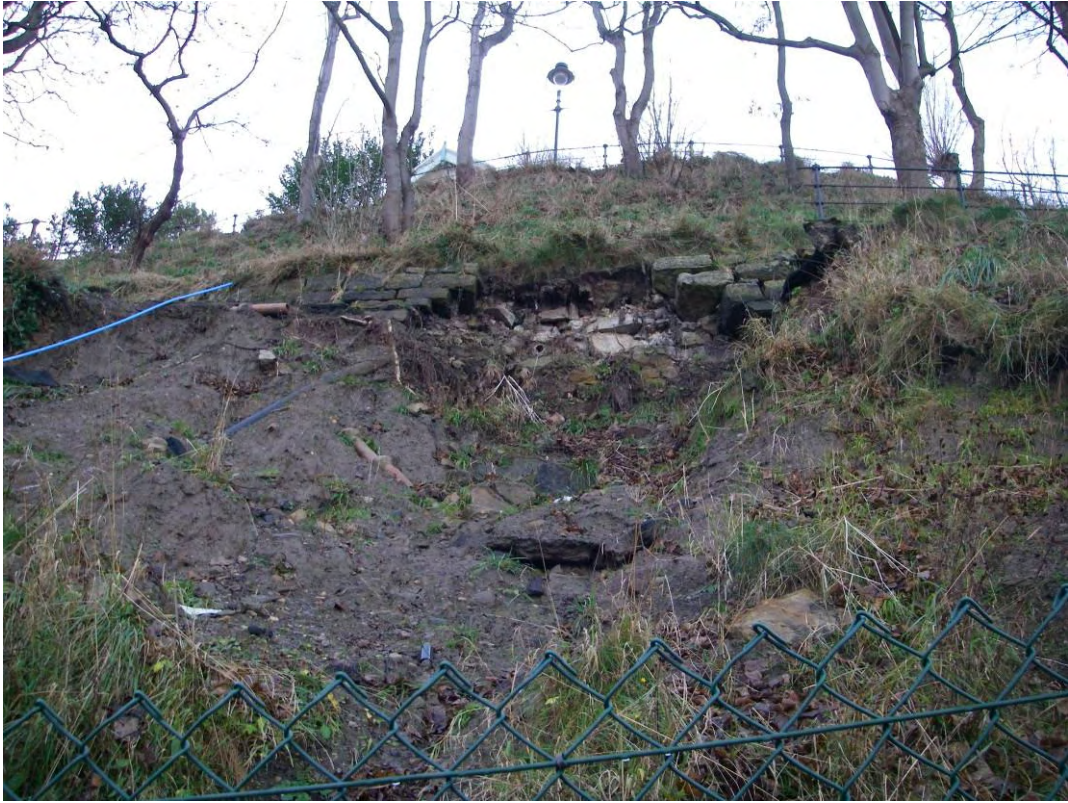
Plate 27. Site view of retaining wall and slope failure behind The Spa on Spa Cliff.

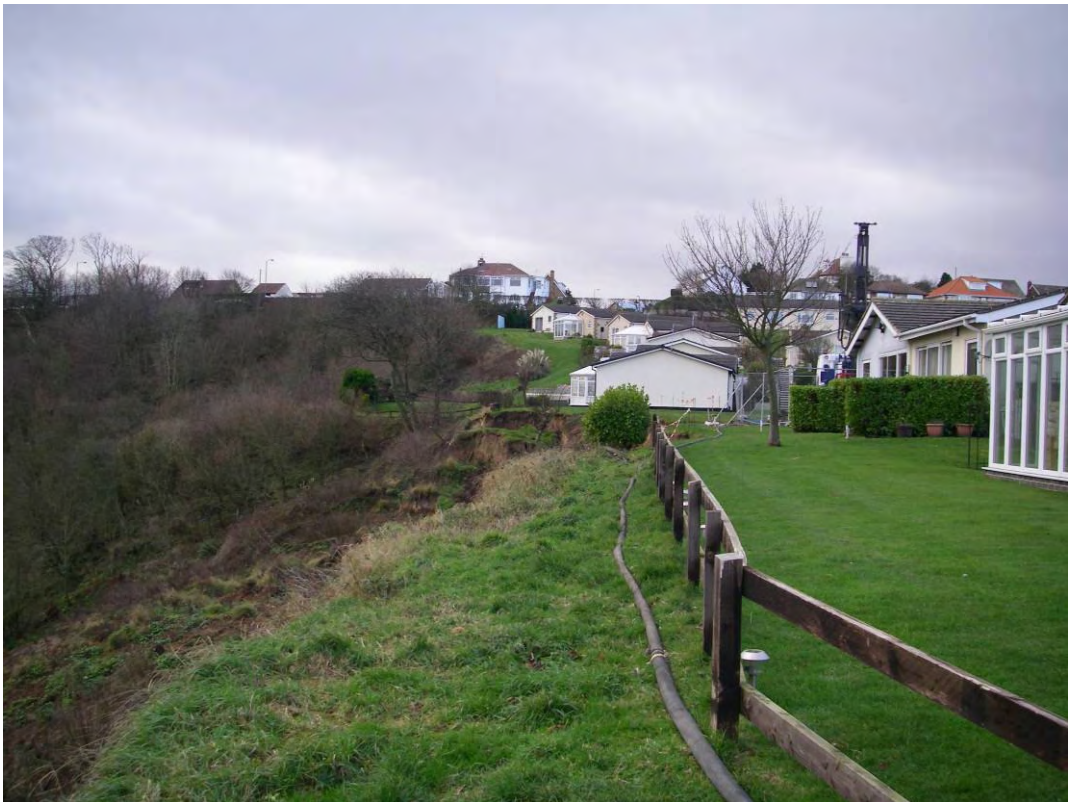
Plate 32. Site view looking south west along regressing crest showing recent failure.

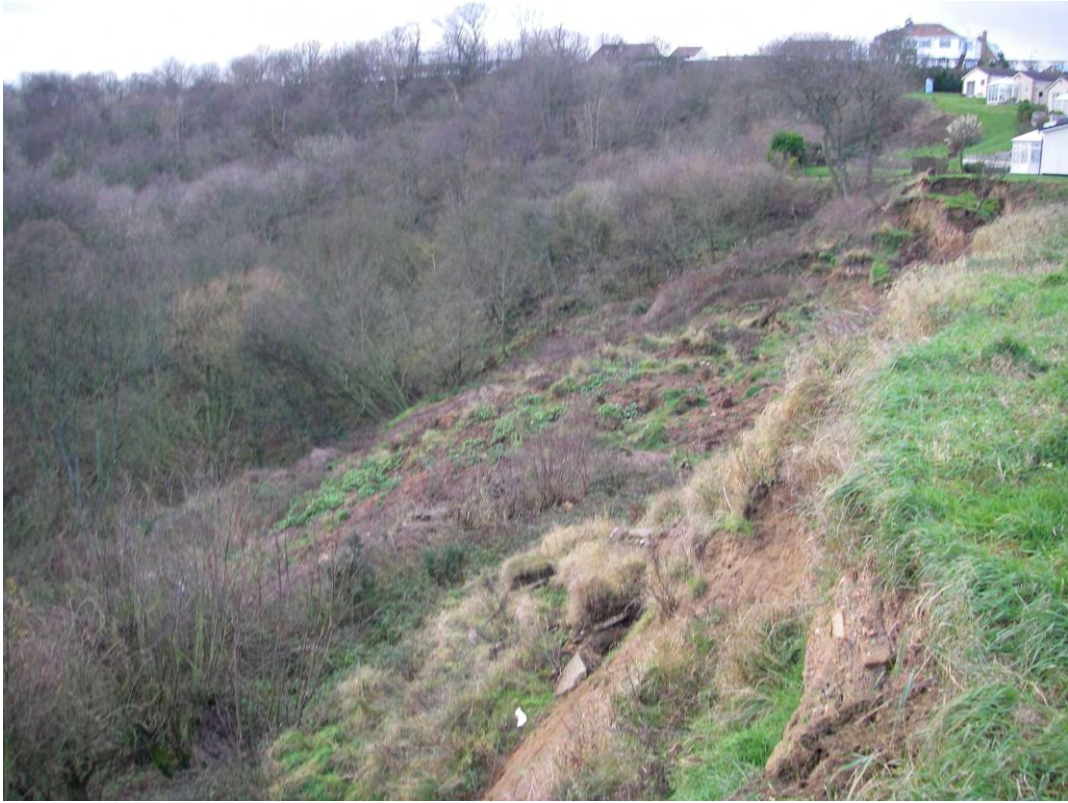
Plate 33. Site view looking south west at slope debris flow.

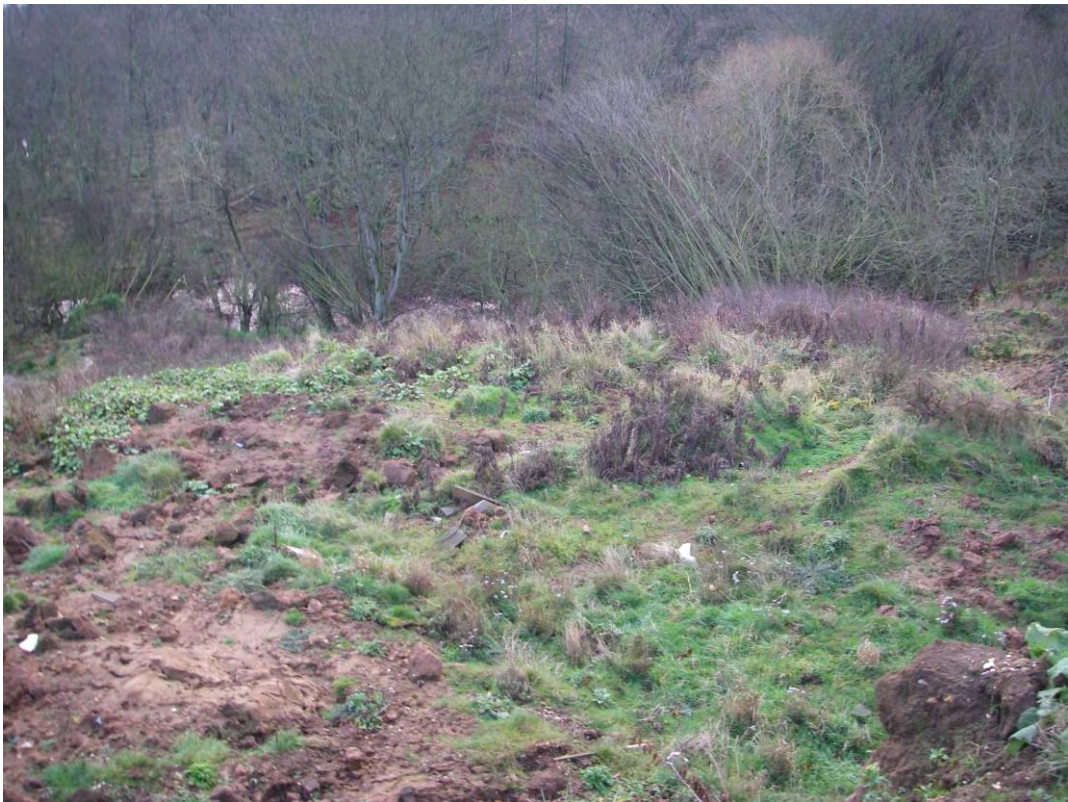
Plate 34. Site view looking south east at slope debris and ponding water near base.

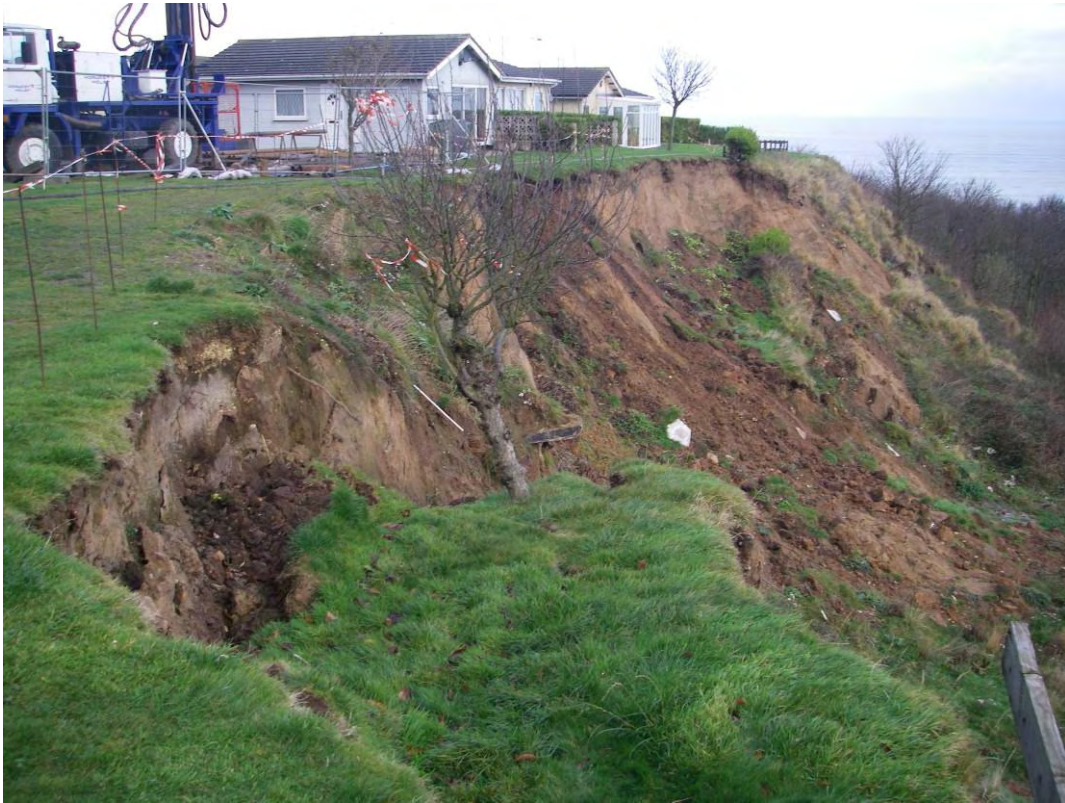
Plate 35. Site view looking north east along regressing crest showing recent failure.

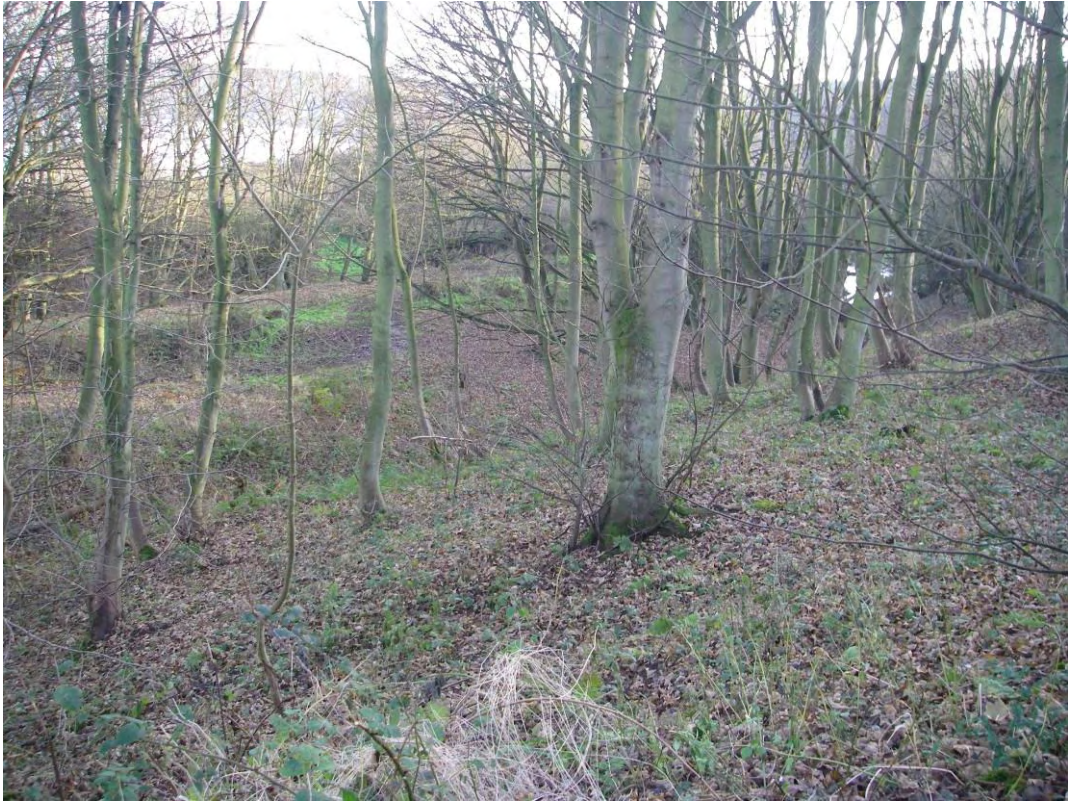
Plate 37. Site view of mid-slope 'benching' from retrogressive rotational slides.

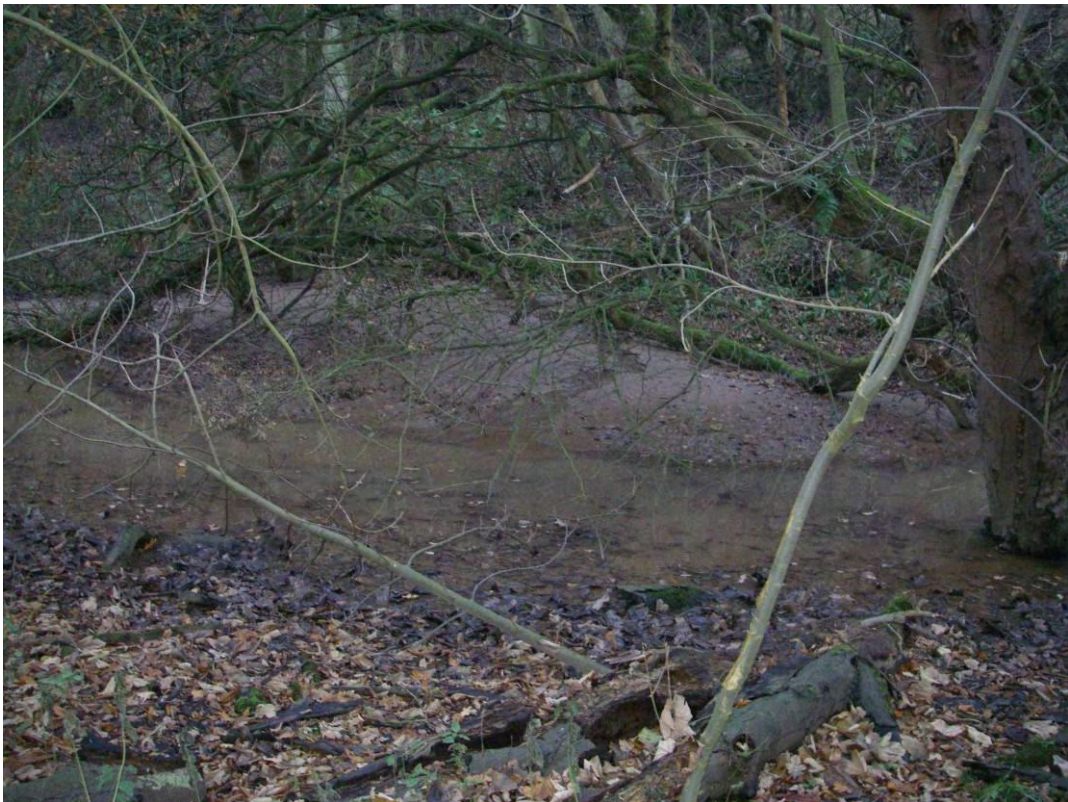
Plate 38. Site view of ponding water and mudslide on mid-slope location.

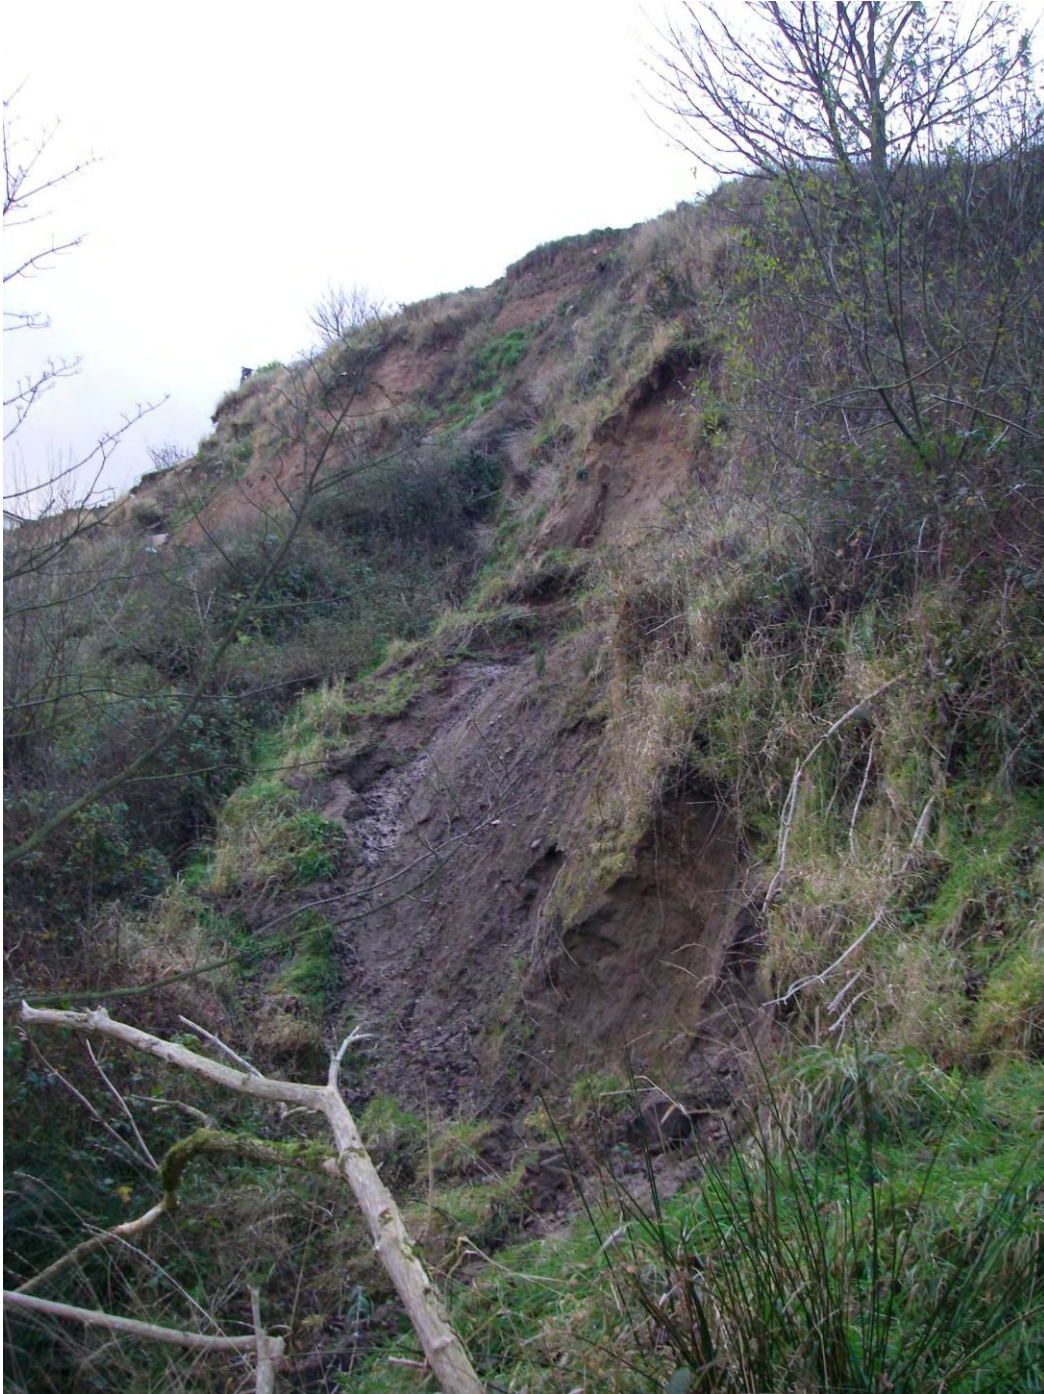
Plate 39. Site view (taken below Plate 33) of backscarp showing groundwater issues.

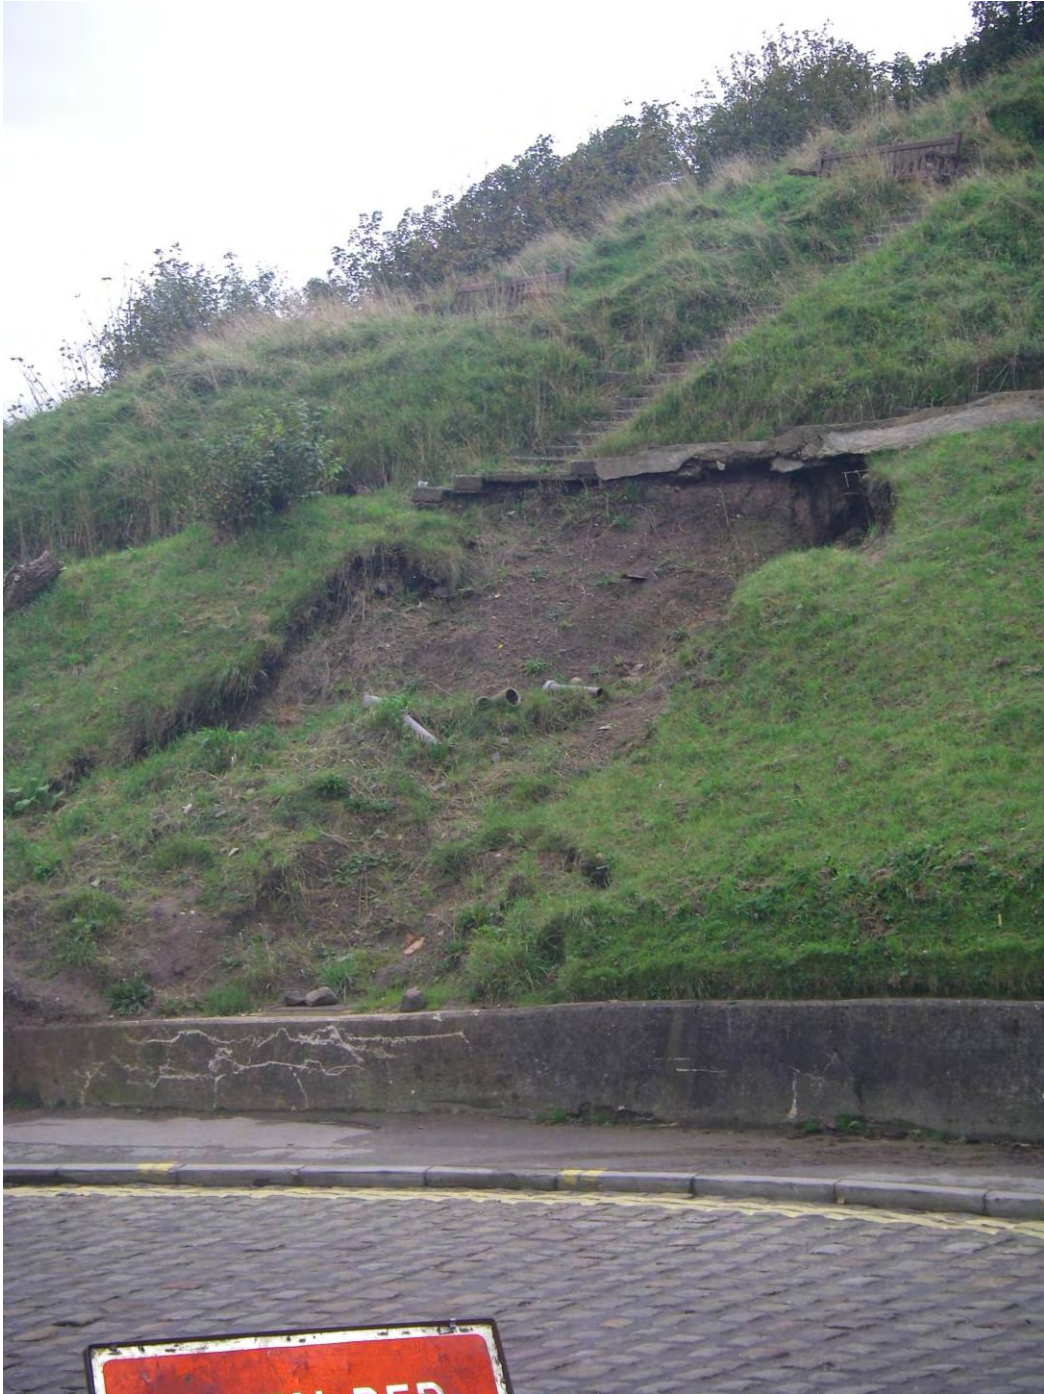
Plate 42. Site view of Crescent Hill showing lower slope failure.

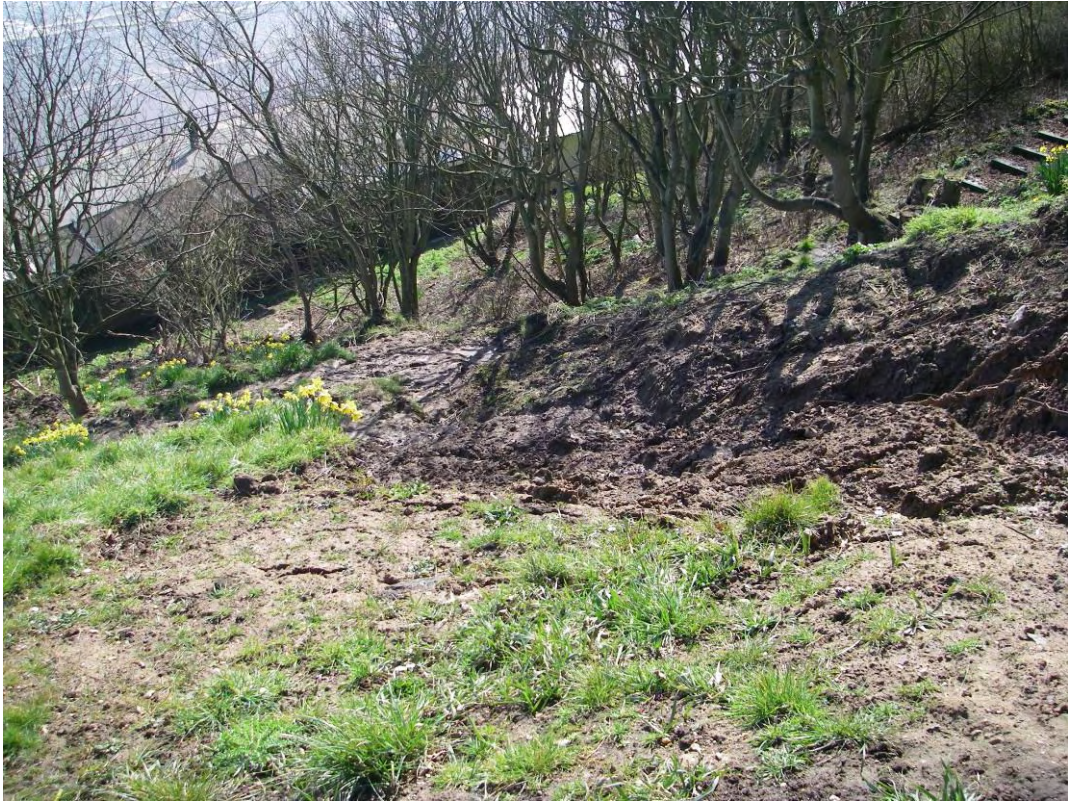
Plate 43. Site view from Glen Gardens looking down slope failure to Royal Parade.

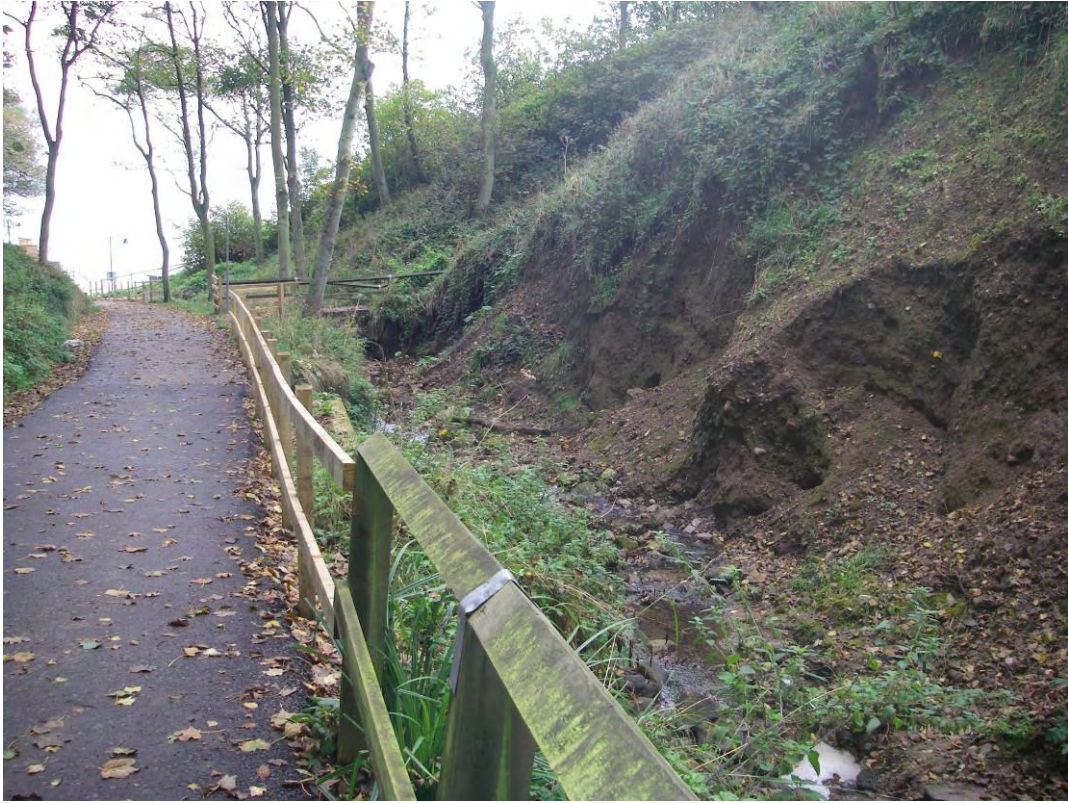
Plate 47. Site view of slope failures towards the base of Martin's Ravine.

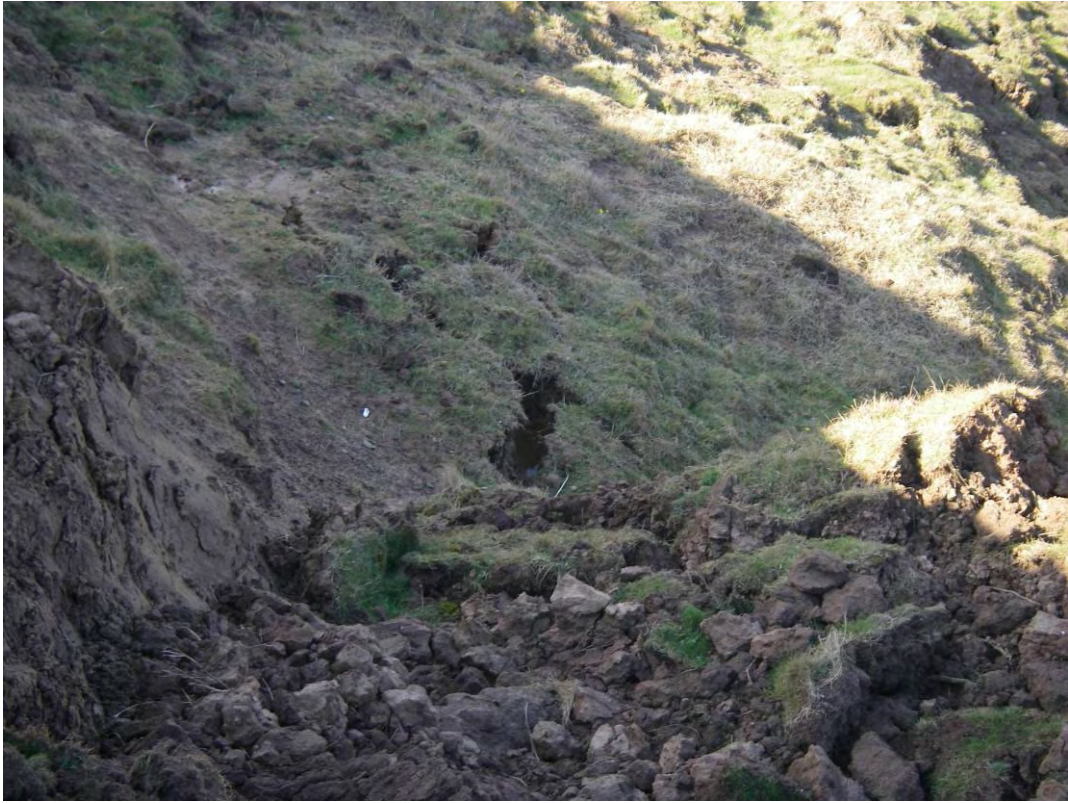
Plate 51. Site view of tension cracks in slumped glacial tills at Filey Brigg.

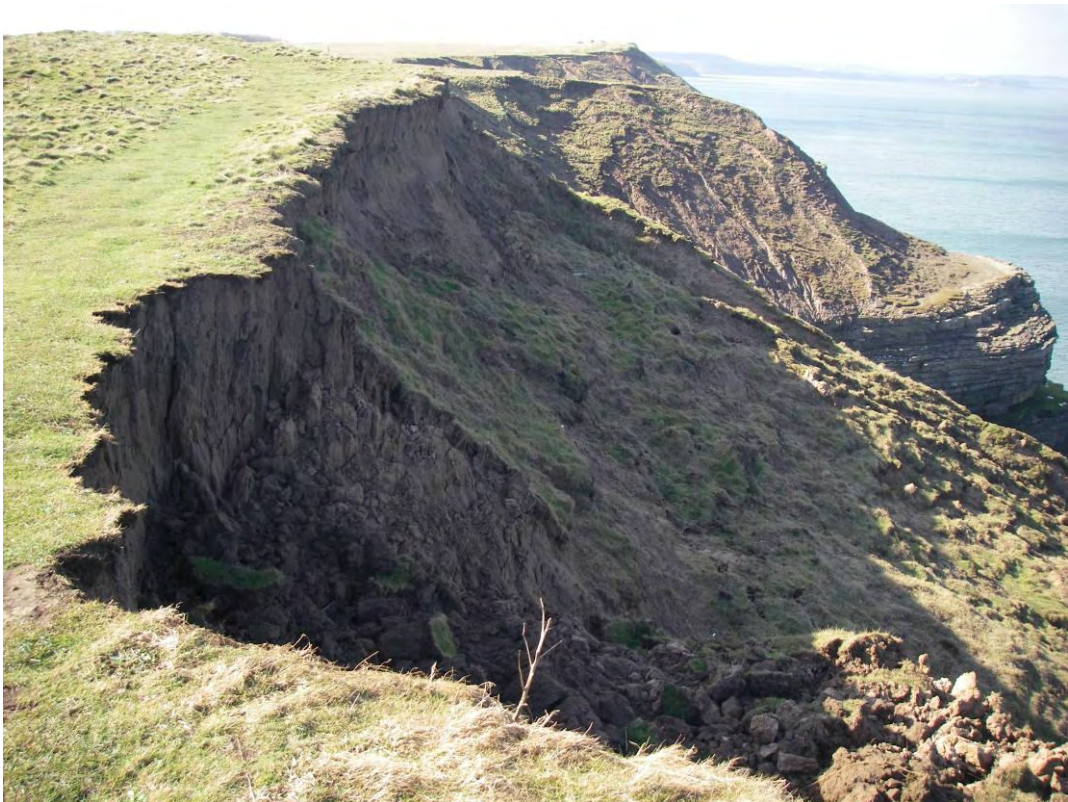
Plate 52. Site view looking east at slumped glacial tills at Filey Brigg.

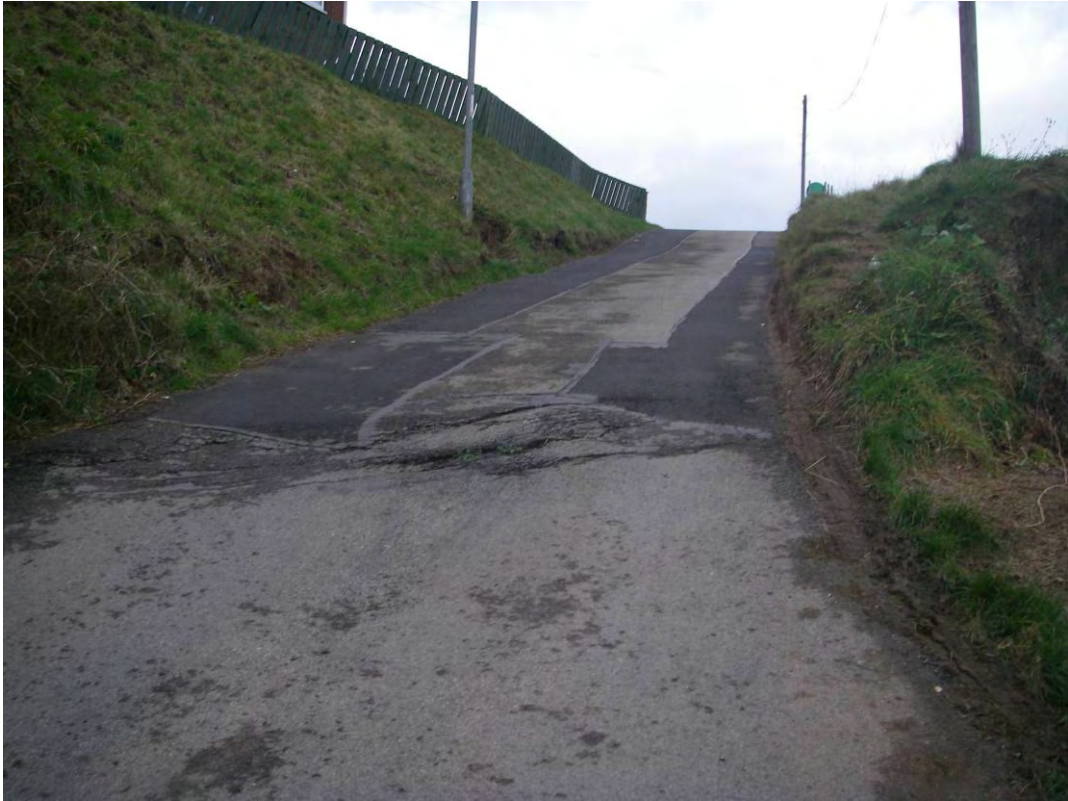
Plate 55. Site view of tension cracks in access road into Flat Cliffs.

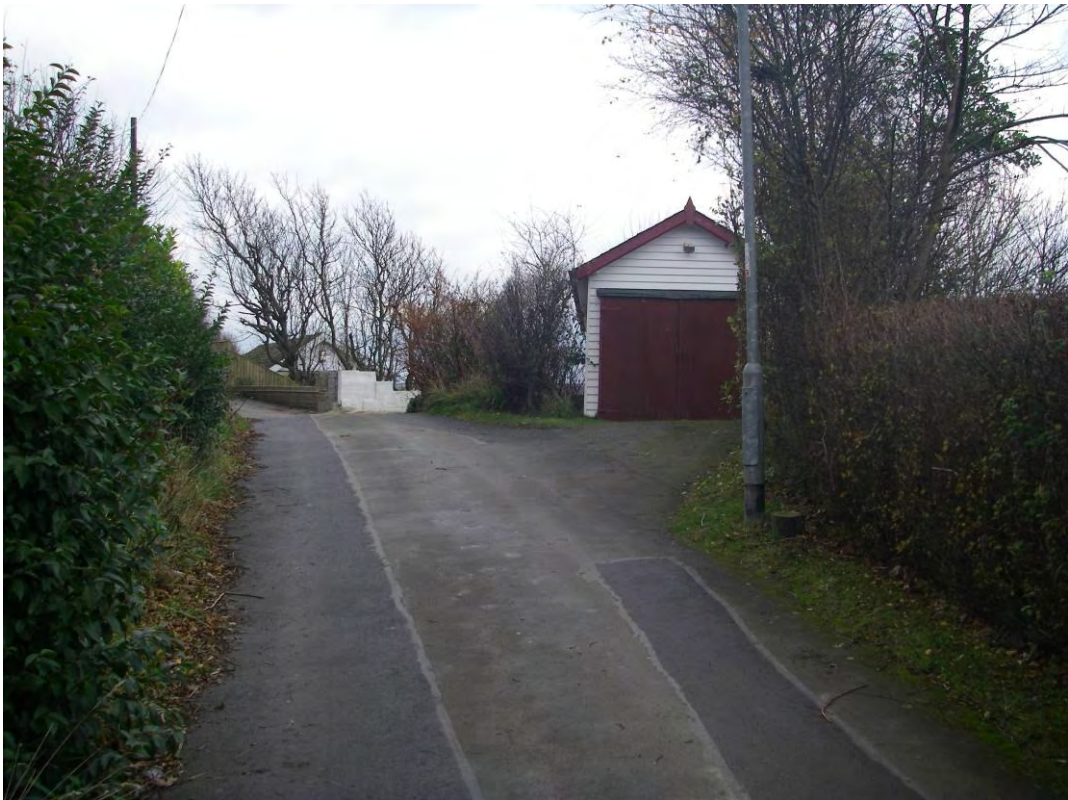
Plate 56. Site view of leaning timber garage at No. 5 Flat Cliffs, seaward of coastal slopes.
