Ongoing Analysis and Interpretation of Coastal Monitoring Data

Initial Review of Full Suite Monitoring

Geotechnical Interpretative Report

Document Ref. No. 721229/002/GIR/002/Final

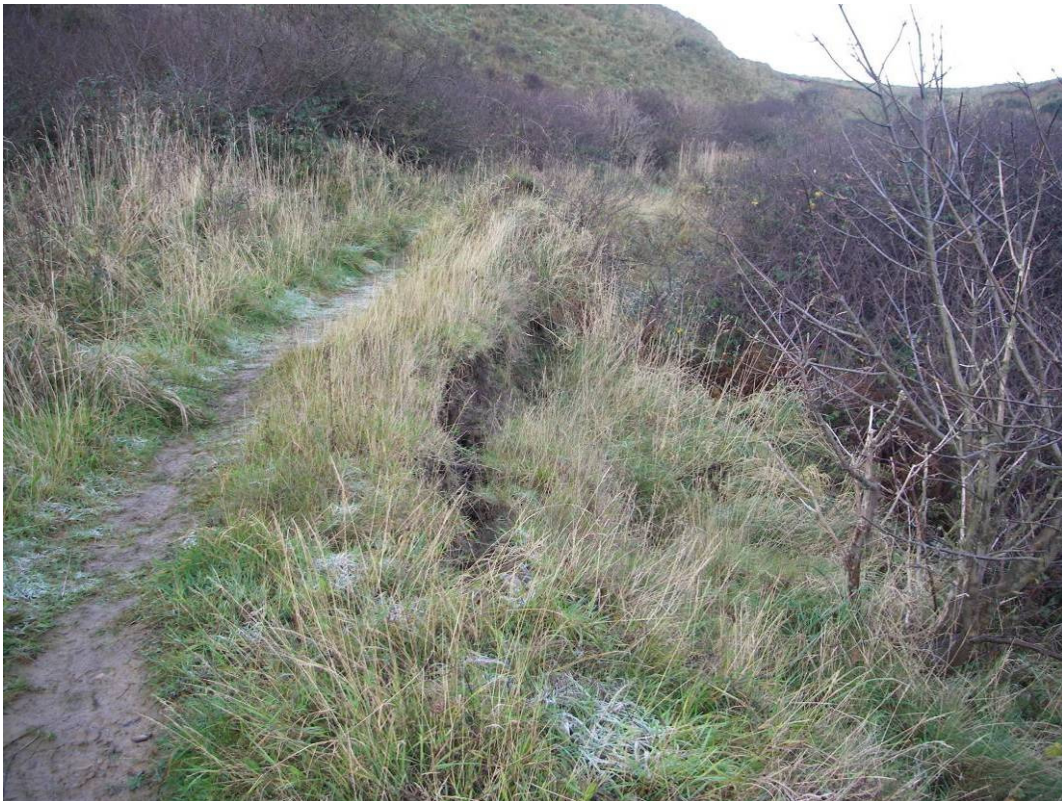
Plate 14 Site view of slopes showing mid-slope back rotated block and surface tension cracking.

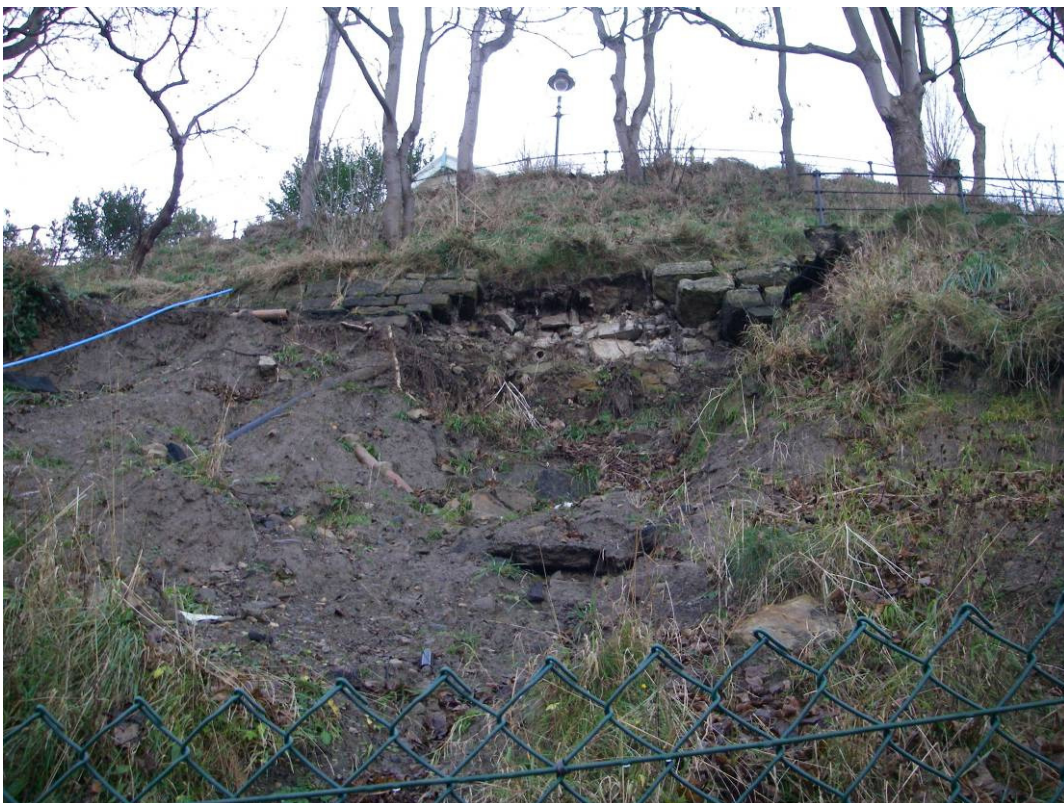
Plate 30 Site view of retaining wall and slope failure behind The Spa on Spa Cliff.

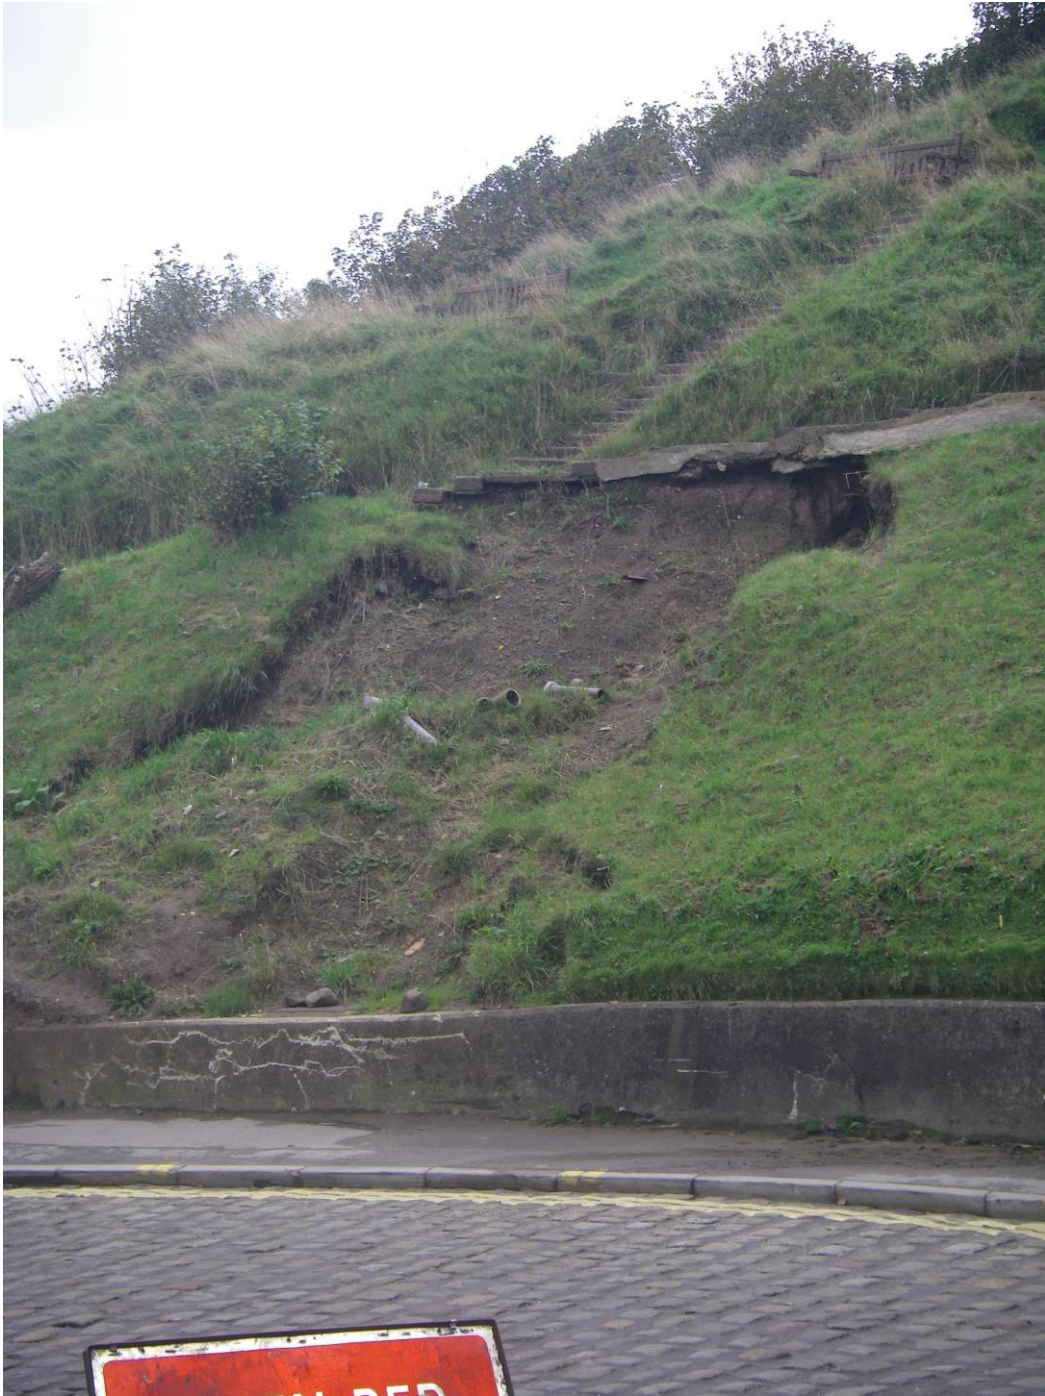
Plate 42. Site view of Crescent Hill showing lower slope failure.

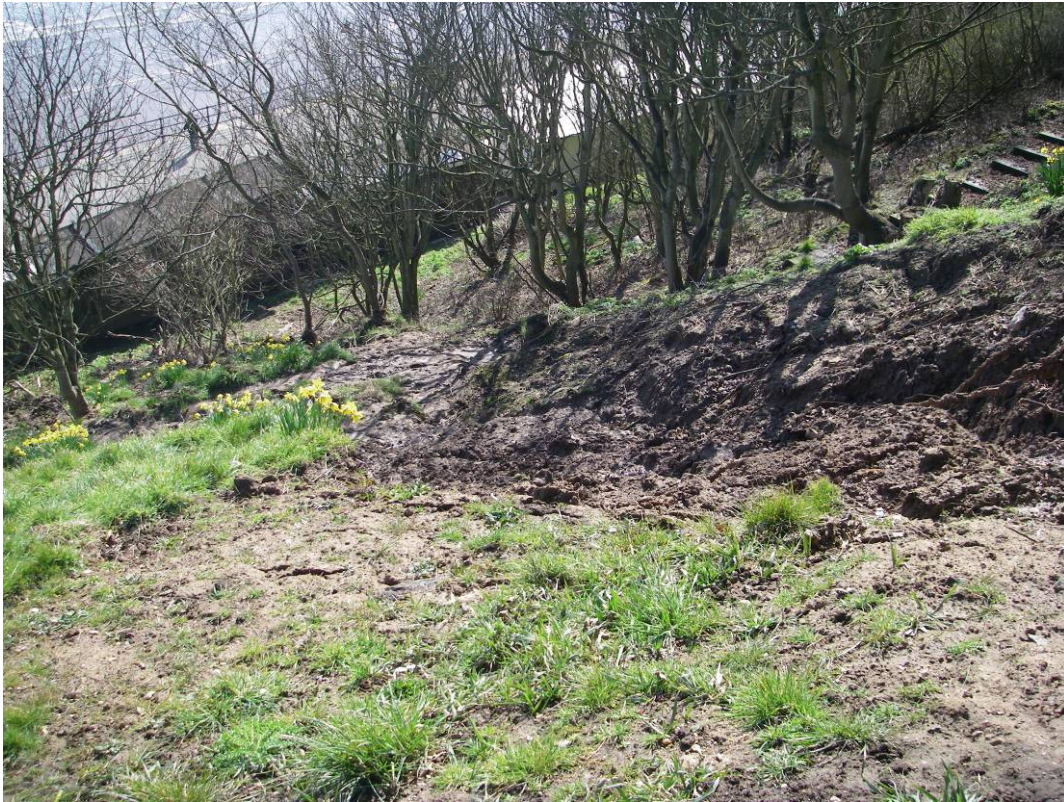
Plate 43. Site view from Glen Gardens looking down slope failure to Royal Parade.

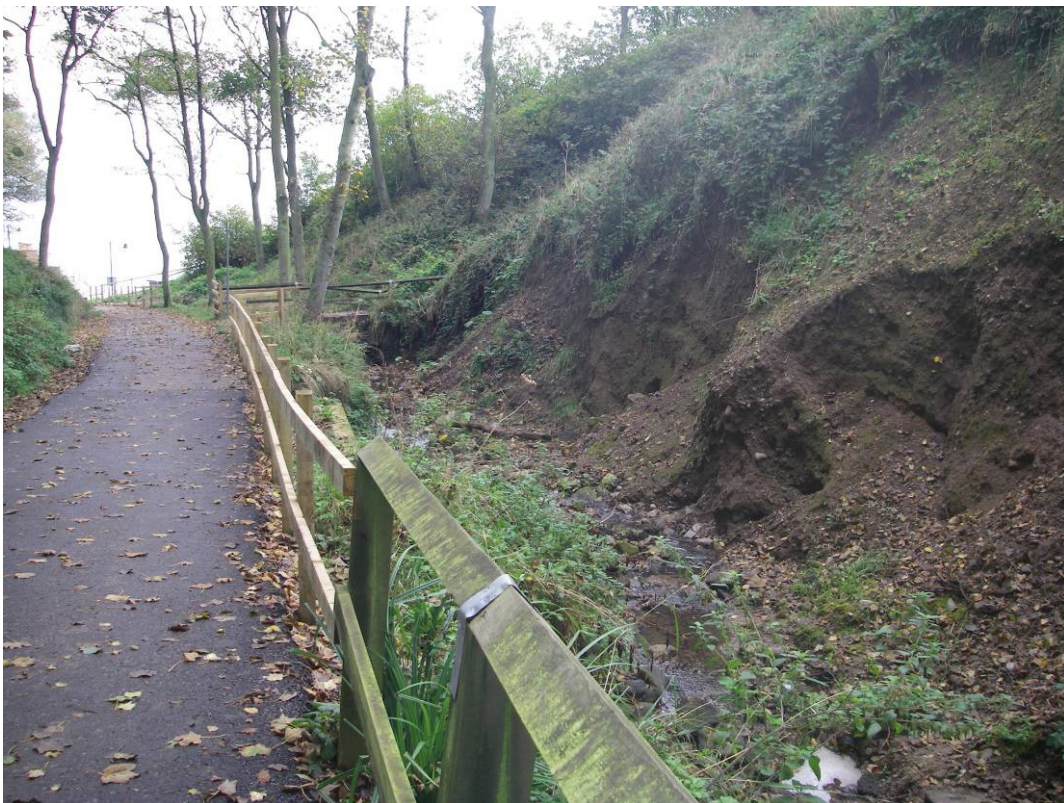
Plate 46 Site view of slope failures towards the base of Martin's Ravine.

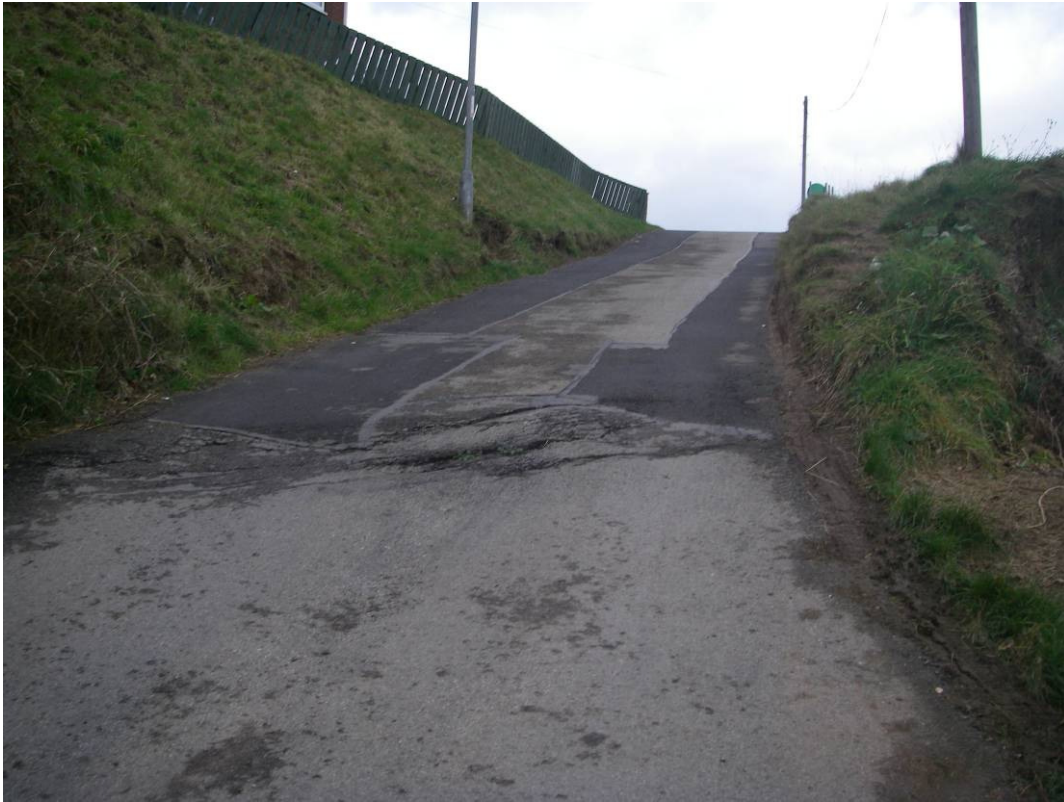
Plate 55 Site view of tension cracks in access road into Flat Cliffs.

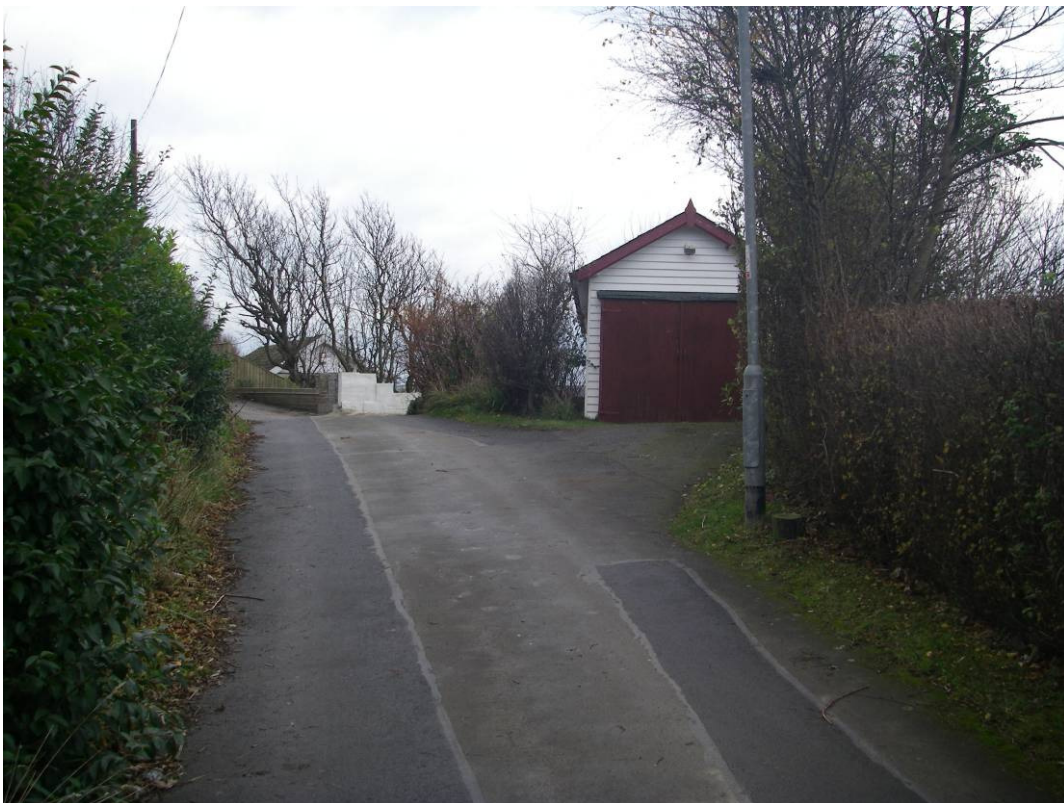
Plate 56 Site view of leaning timber garage at No. 5 Flat Cliffs, seaward of coastal slopes.
