# Ongoing Analysis and Interpretation of Coastal Monitoring Data

Third Review of Restricted Suite Monitoring

## Geotechnical Interpretative Report

Document Ref. No. 721229/002/GIR/005/Final

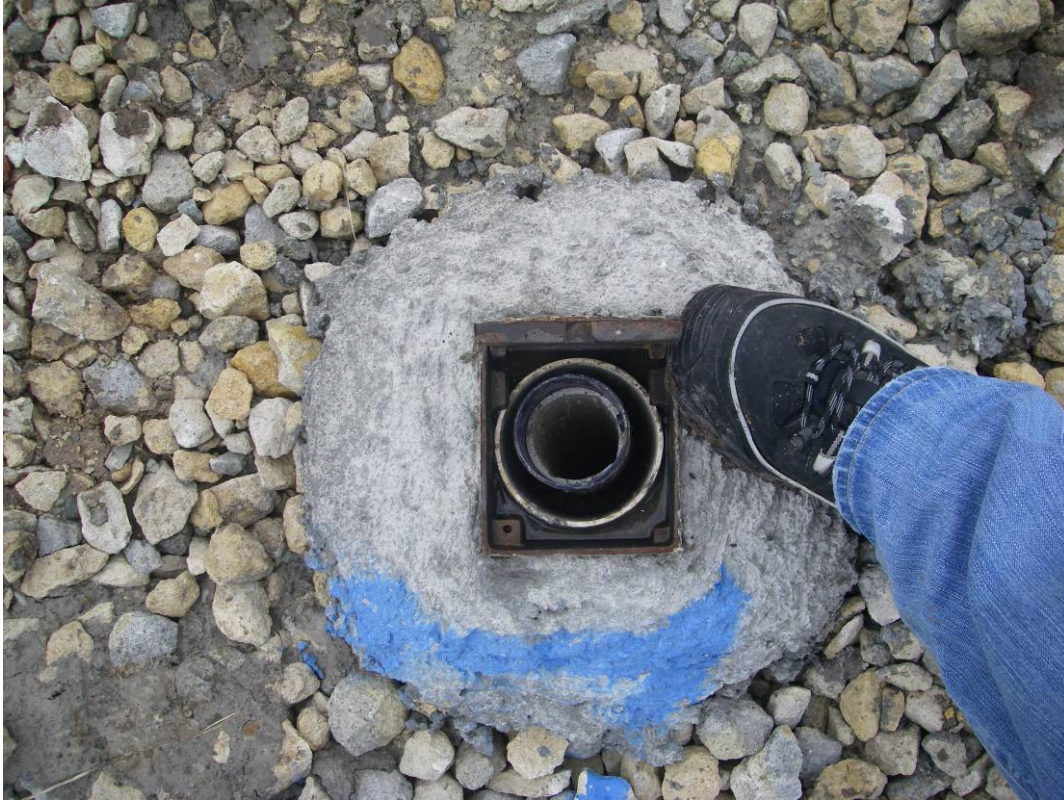
Plate 12 Scarborough North Bay (Oasis Café) BH1I

Inclinometer data from the Oasis Café inclinometers (BH1 and 4) appear to indicate ground movements of between 3mm and 5mm although this 'apparent' movement is due to inaccuracies arising from the use of two different probes (different calibration values) for the monitoring events. Data from BH3 does not show this apparent movement as a single probe has been used to record data. The results of inclinometer monitoring indicate that slopes above the Oasis Café are presently in a stable condition in the vicinity of the inclinometers.
