Ongoing Analysis and Interpretation of Coastal Monitoring Data

Sixth Review of Restricted Suite Monitoring

Geotechnical Interpretative Report

Document Ref. No. 721229/002/GIR/009/Final

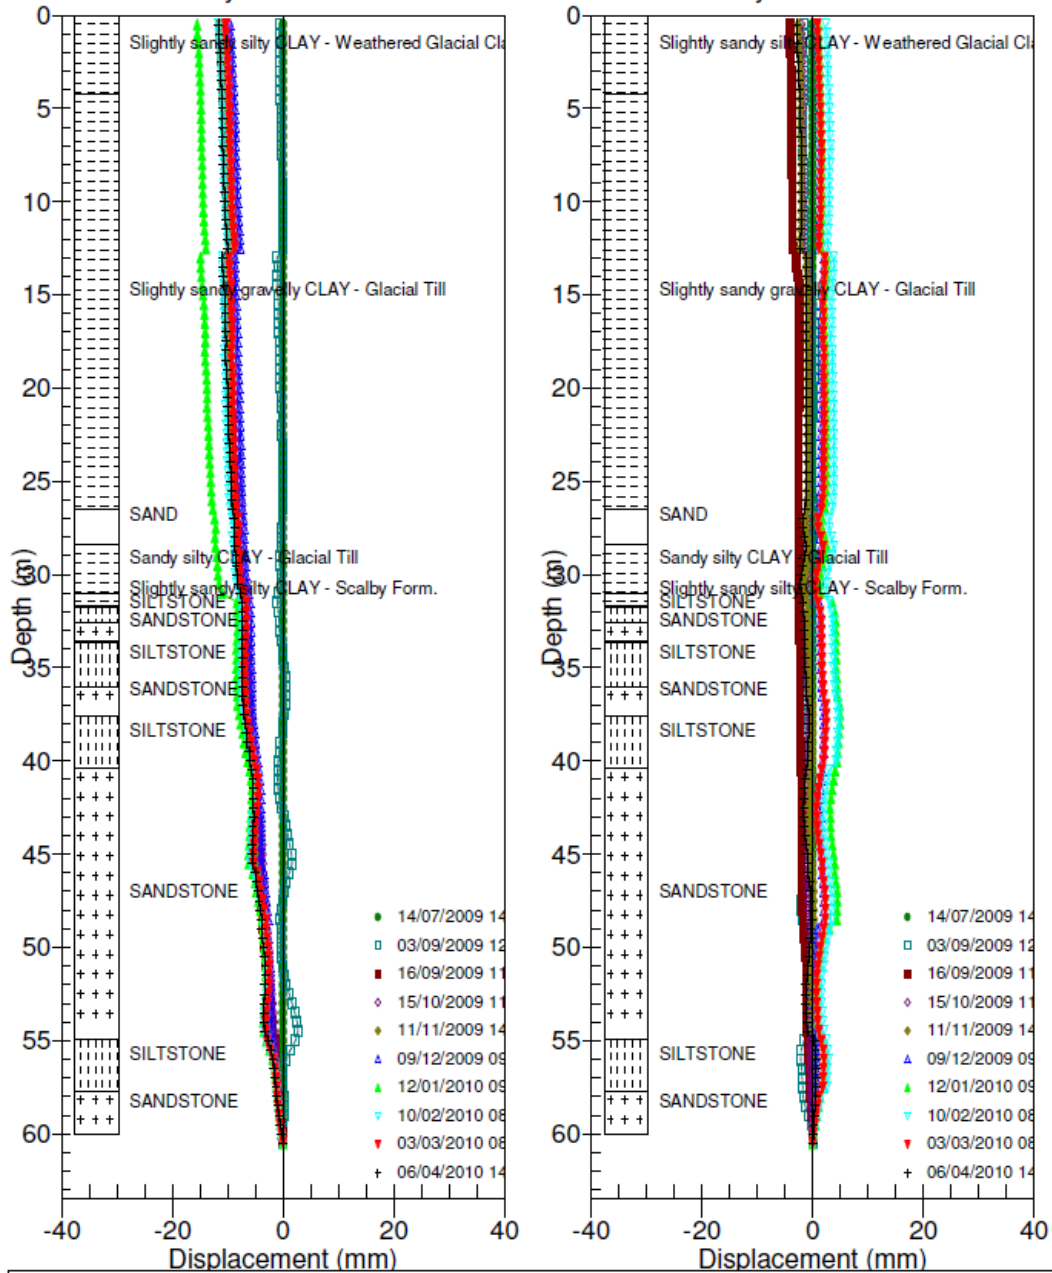
PROJECT: 721229 Ongoing Analysis of Coastal Monitoring Data
 SITE: Scarborough South Cliff
 INSTALLATION: AA07 (BH2)
 COMPANY: Mouchel Ltd
 CLIENT: Scarborough Borough Council
 NOTE: A0 direction: North East

North Bay	No coverage of The Holms area	No coverage of The Holms area
South Cliff	Survey points not monitored since December. AA04 shows no further movement AA07 shows <3mm movement from 60.0 to 26.5 metres AA08 shows <2mm movement from 6.5 to 6.0 metres AA10 shows further movement in top 3.50m of ground AA11 shows <2mm movement from 19.5 to 14.0 metres depth Continued development of cracks in pavements	AA04 shows 2mm movement in top 7.0m of ground AA07 <3mm movement from 60.0 to 26.5 metres AA08 shows <2mm movement from 6.5 to 6.0 metres AA10 shows 4mm movement in top 3.50m of ground AA11 shows <3mm movement in top 3.0m of ground
Knipe Point	Slower recession rates of Cornelian, Knipe Point and limited at A165 headscarps.*	New instruction for March 2010
Filey Flat Cliffs	BB02 shows 3mm movement from 12.5 to 10.5 metres and 2-3mm movement at 19.80 metres. Continued development of cracks in road surfaces	BB02 shows 3mm movement from 12.5 to 10.5 metres and 2-3mm movement at 19.80 metres. Continued development of cracks in road surfaces

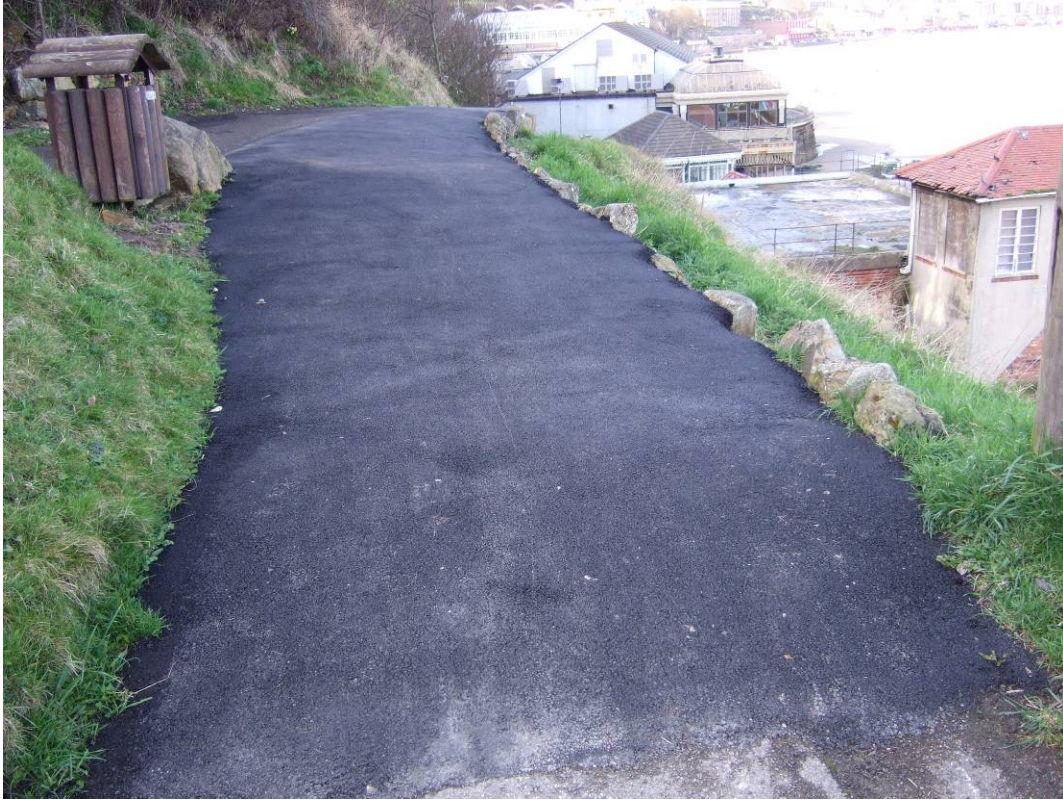
Plate 54 Scarborough South Cliff. Pavement cracks above the Clock Café (March. 2010)

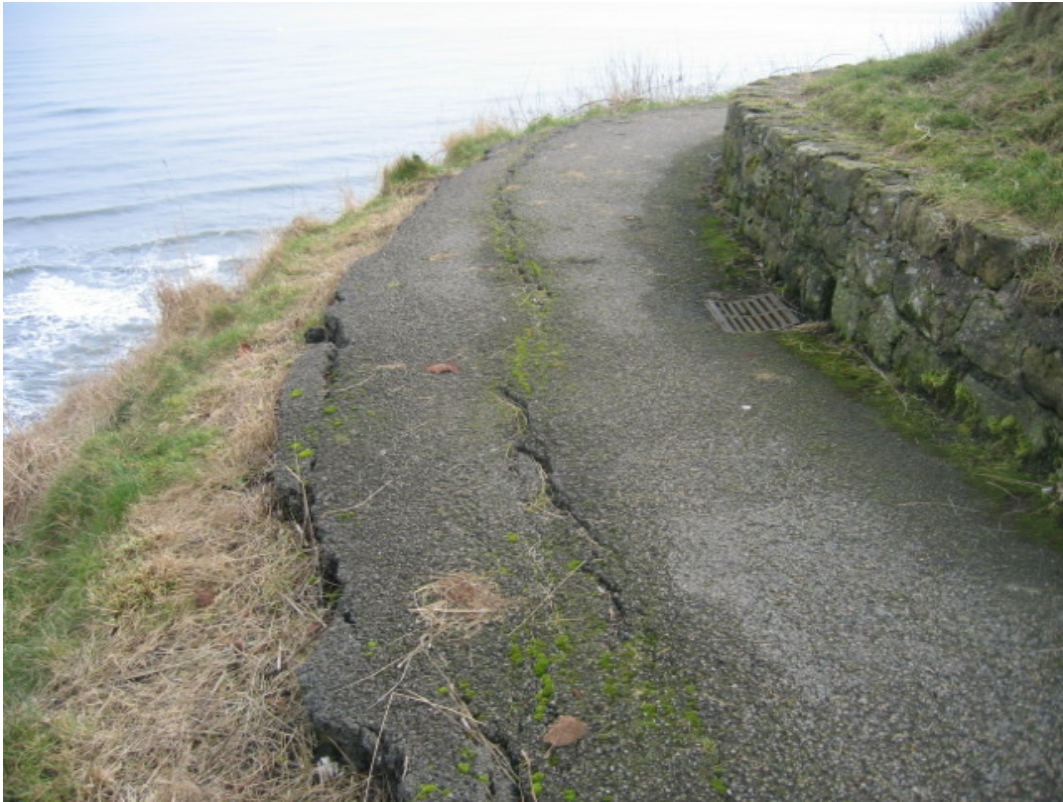
Plate 56 Scarborough South Cliff Slope bulging adjacent the Clock Café (Jan 2010).

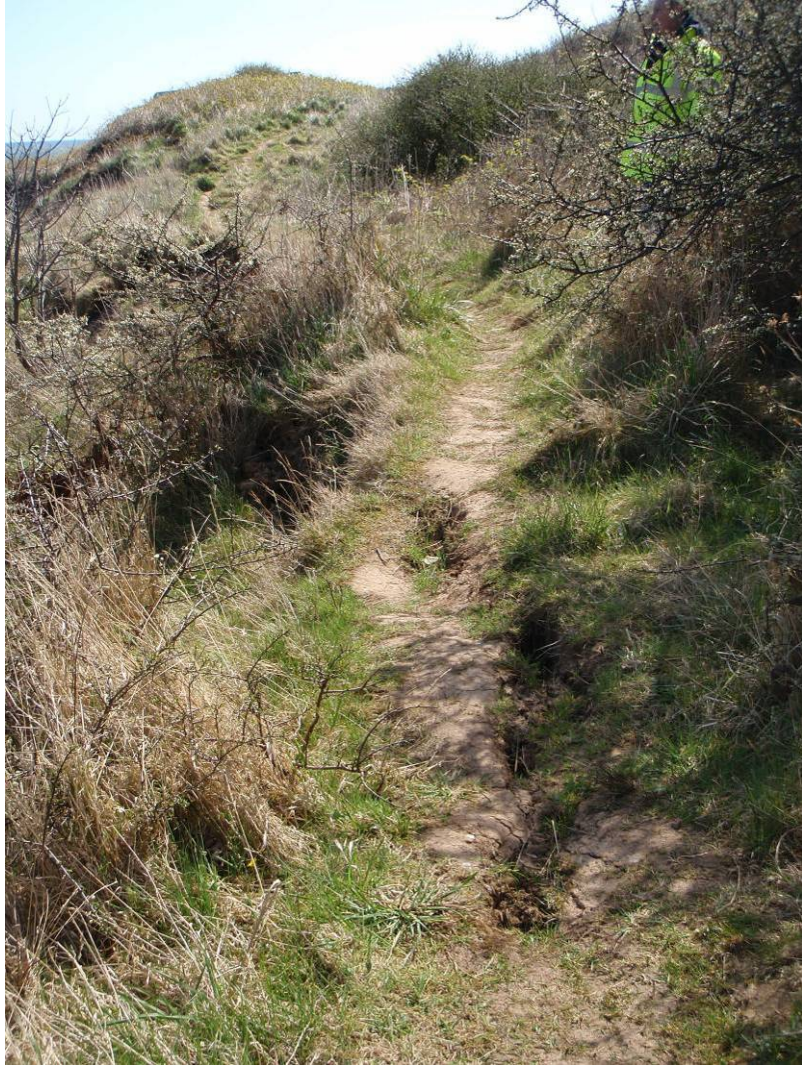
A walkover of the slopes of Behavioural Unit II and III revealed further development and widening of tension cracks over the mid-slope areas (Appendix G, Plate 1) of the former unit. Pondered water levels in this area were noted to have fallen noticeably and issues from this were observed on the slopes lower down. Immediately below the southern plateau of the latter unit (Behavioural Unit III) a relict slope failure is evident where the cliff headscarp has receded and dropped some 500-600mm. This feature has recently been exposed by the clearance of trees in this vicinity (Appendix G, Plates 7 and 8) although this feature is not a recent occurrence. The de-vegetation of slopes such as these can lead to an increase in slope instability and reduced factors of safety. Further loss of vegetation cover, whether accidental or deliberate, should be discouraged.

Plate 1 Mid-slope tension crack development on Behavioural Unit II slopes.
(14th April 2010)

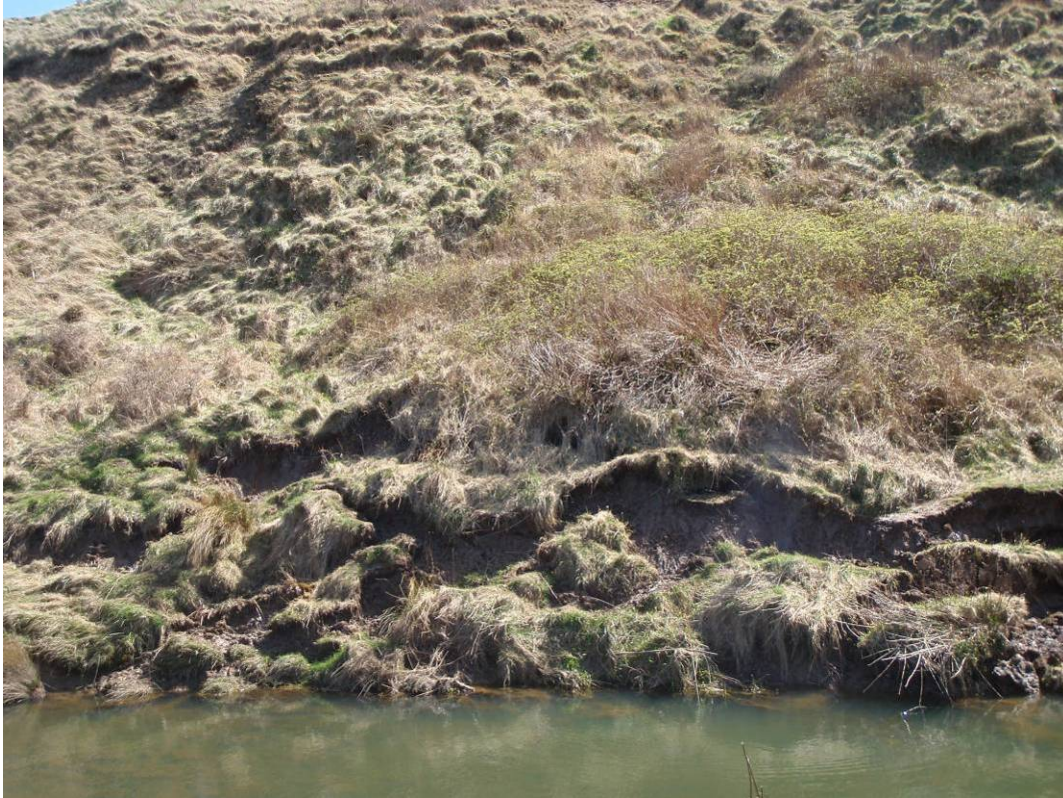
A site visit to Scalby Ness was conducted on 21st April 2010, during this visit a slope failure was noted as having occurred near the base of the North West facing slopes of Behavioural Unit I. This failure had developed between two scheduled monitoring visits of 2nd March and 21st April 2010.

- The failure consists of a shallow type slip (2 metres depth) up to 10 metres in height from current water level of river and at the base this extends some 7-8 metres from edge to edge.

Plate 2 Slope failures along river's edge of Behavioural Unit I. (14th April 2010)

Following the discovery of slope failures and associated features on the North West side of Scalby Ness, Mouchel recommended to SBC that a series of walkover surveys should be carried out immediately on a weekly basis for four weeks in order to observe and collect data on this slip in order to formulate a long term strategy. Each event was to pick up all salient slope features such as tension cracks in the slopes and the plateau above, ground water issues, etc and published as a letter style report. SBC have chosen not to undertake this course of work but to include this area into the Cell 1 Project with the installation of virtual recession points and analysis in line with other Cell 1 cliff top monitoring at some time in the future. In addition, SBC are to carry out observations of this site outside of the scheduled monitoring events currently made by Mouchel.

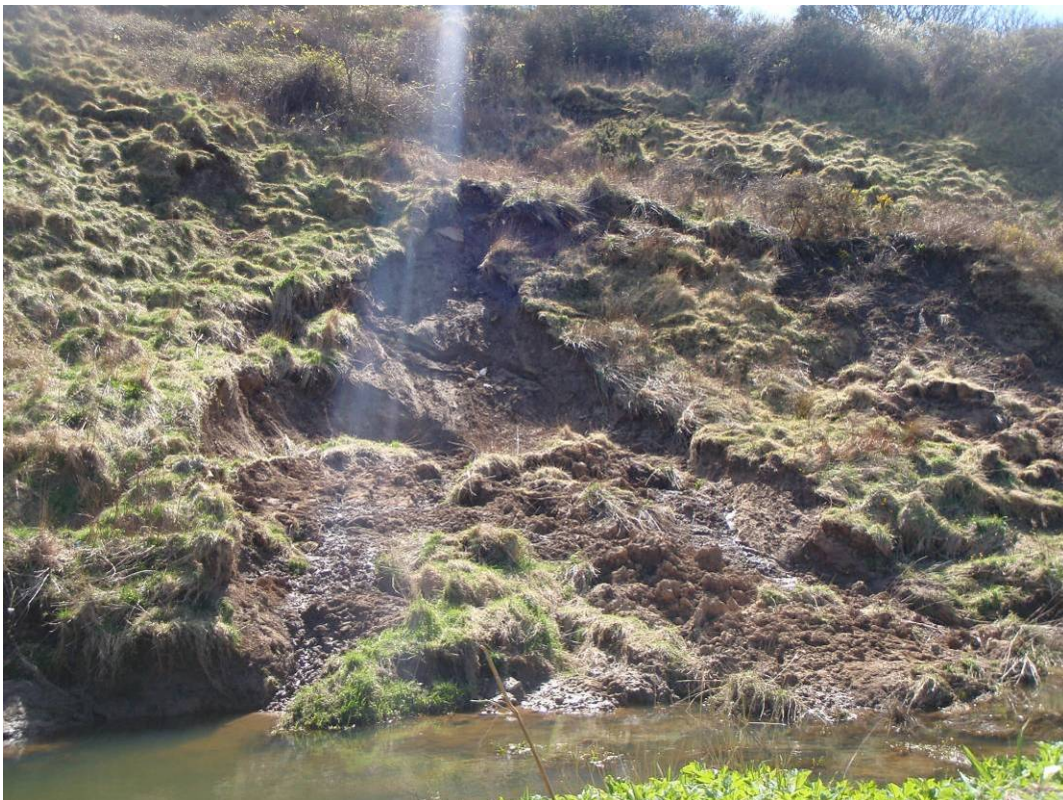
- To the right of the failure (Plate 3, Appendix G) there is some undisturbed ground beyond which there is another slip failure of lesser extent. The ground between the two slips is evidently unstable and likely to fail imminently (Plate 5, Appendix G) leading to a larger scaled failure which will probably propagate up slope.

Plate 3 Slope failure along river's edge of Behavioural Unit I. (14th April 2010)

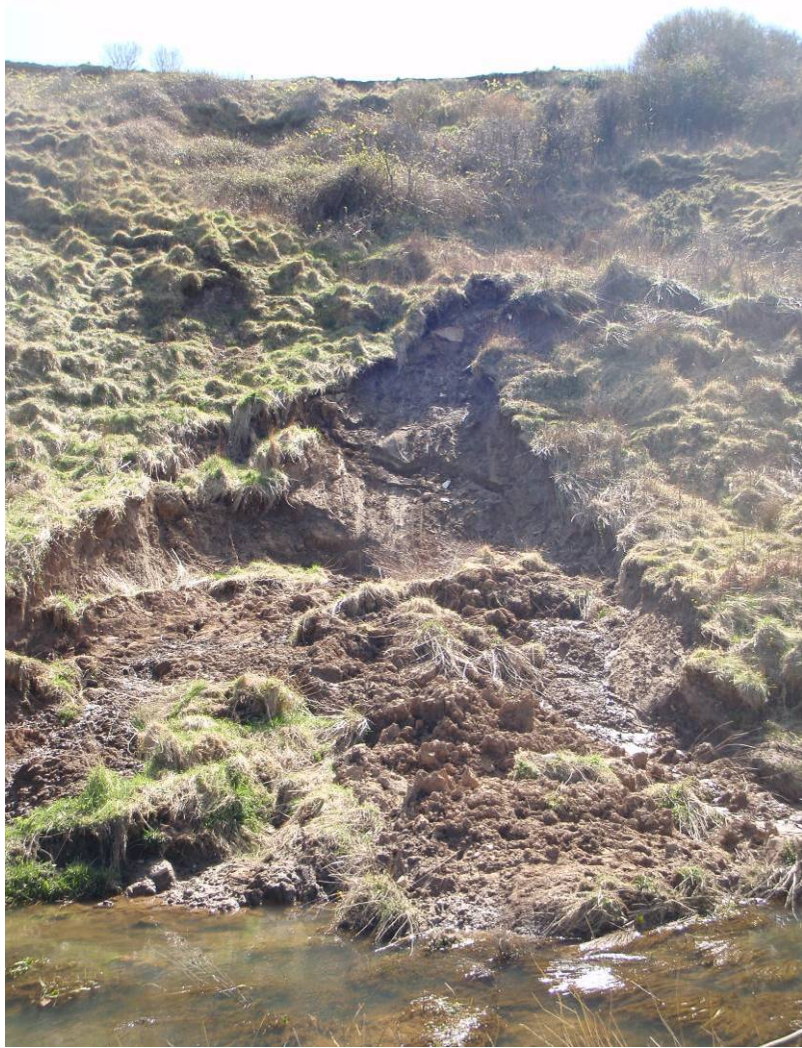
Plate 4 Slope failure along river's edge of Behavioural Unit I. (14th April 2010)

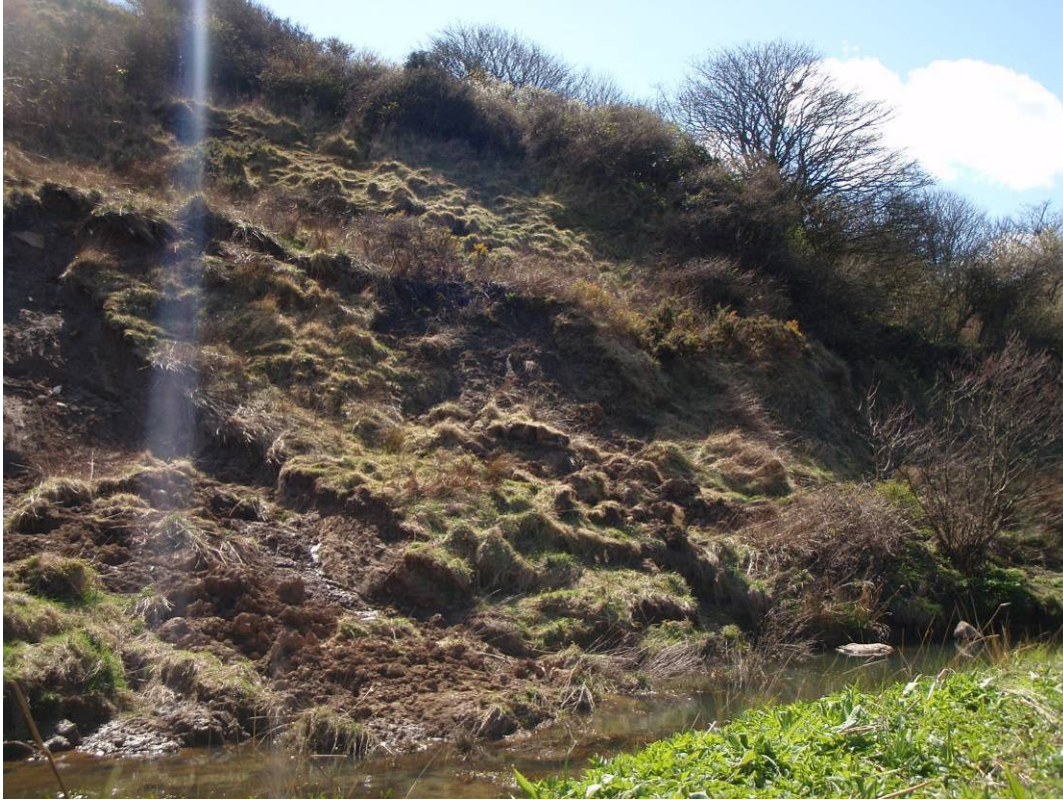
Plate 5 Slope failure along river's edge of Behavioural Unit I. (14th April 2010)

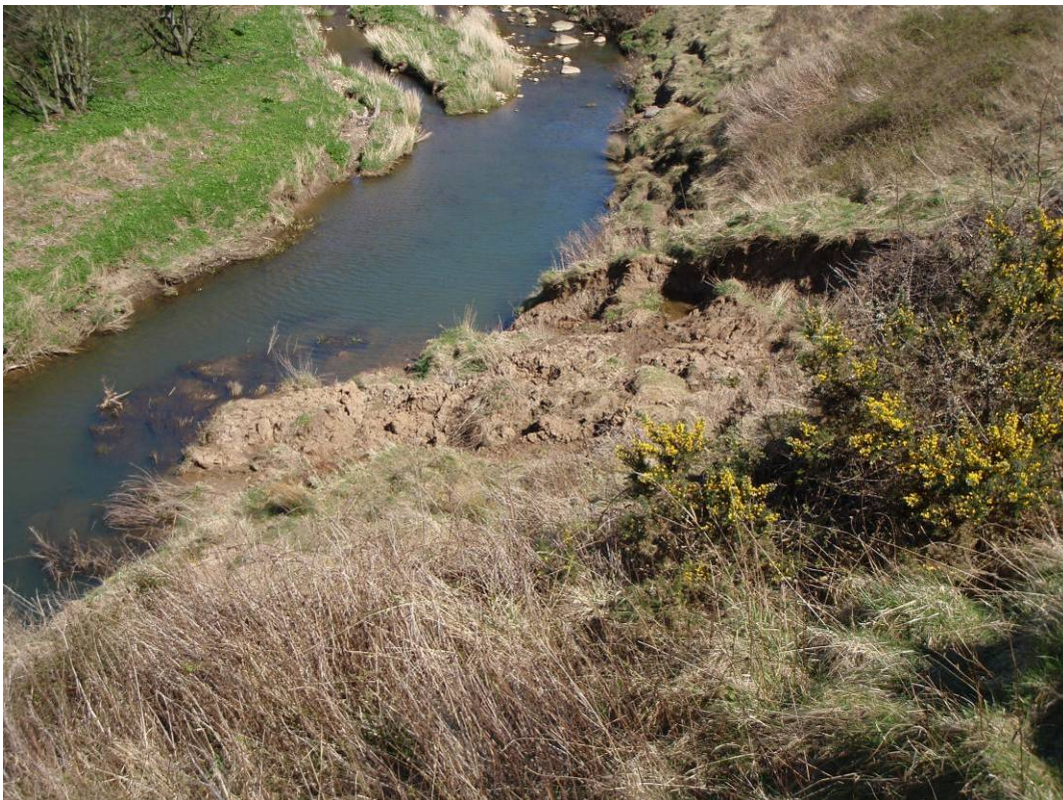
Plate 6 Slope failure along river's edge of Behavioural Unit I. (14th April 2010)

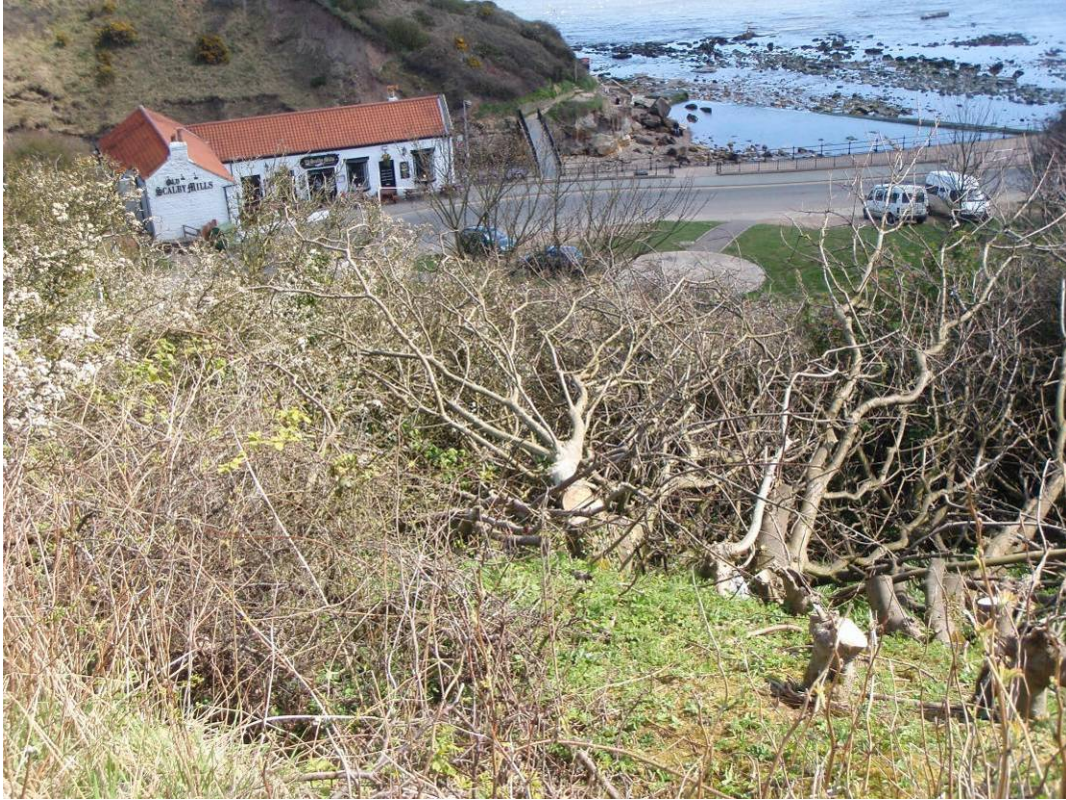
Plate 7 Tree clearance along relict slope failure at crest of Behavioural Unit III

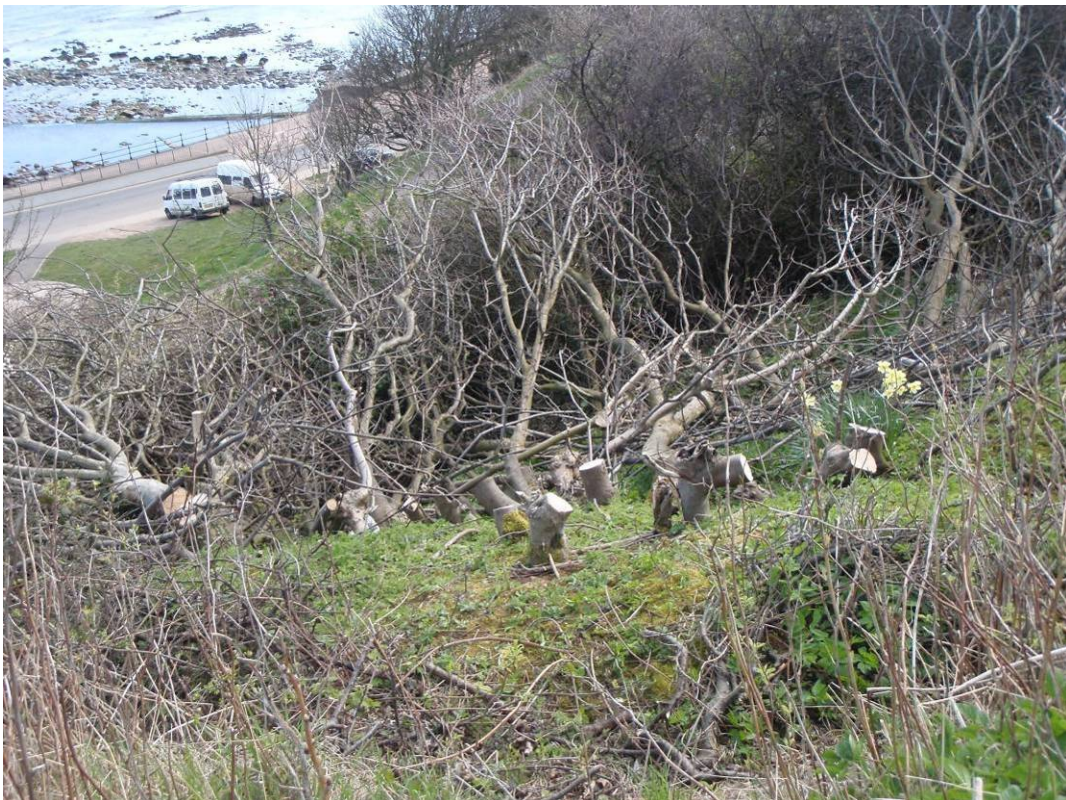
Plate 8 Tree clearance along relict slope failure at crest of Behavioural Unit III

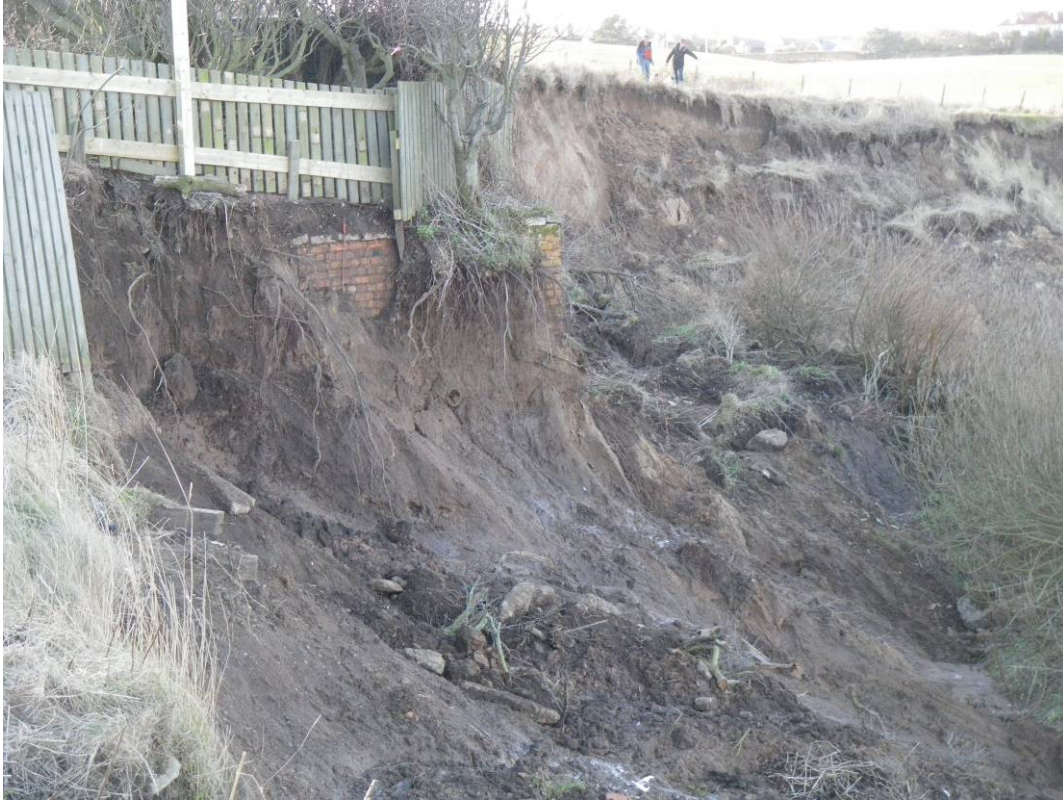
Plate 1 Slope failures on Cornelian Bay side of Knipe Point looking northwest

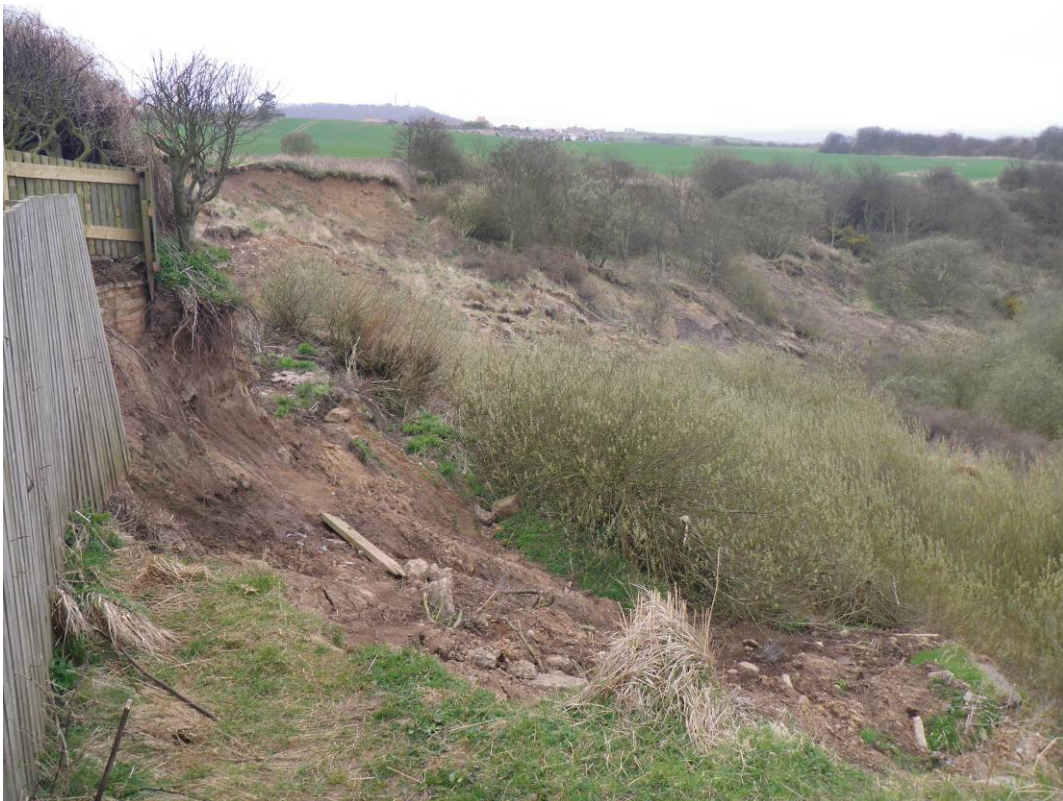
Plate 2 Slope failures on Cornelian Bay side of Knipe Point looking northwest

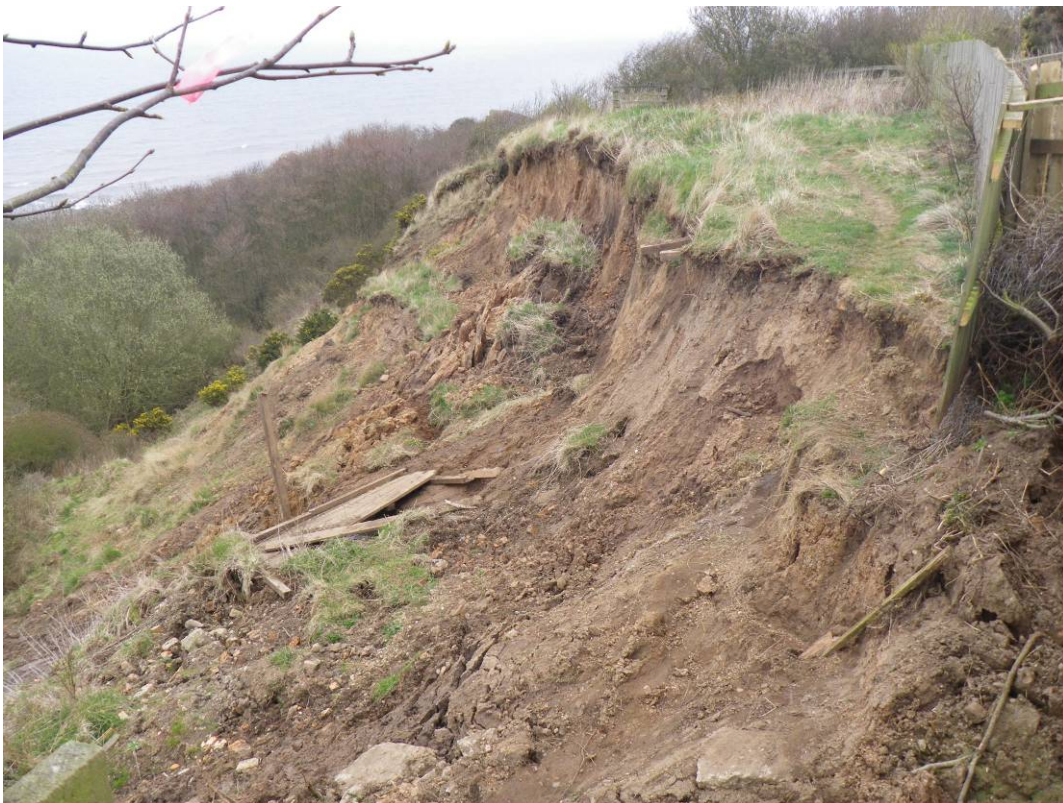
Plate 4 Slope failures on Cornelian Bay side looking east (14th April 2010)

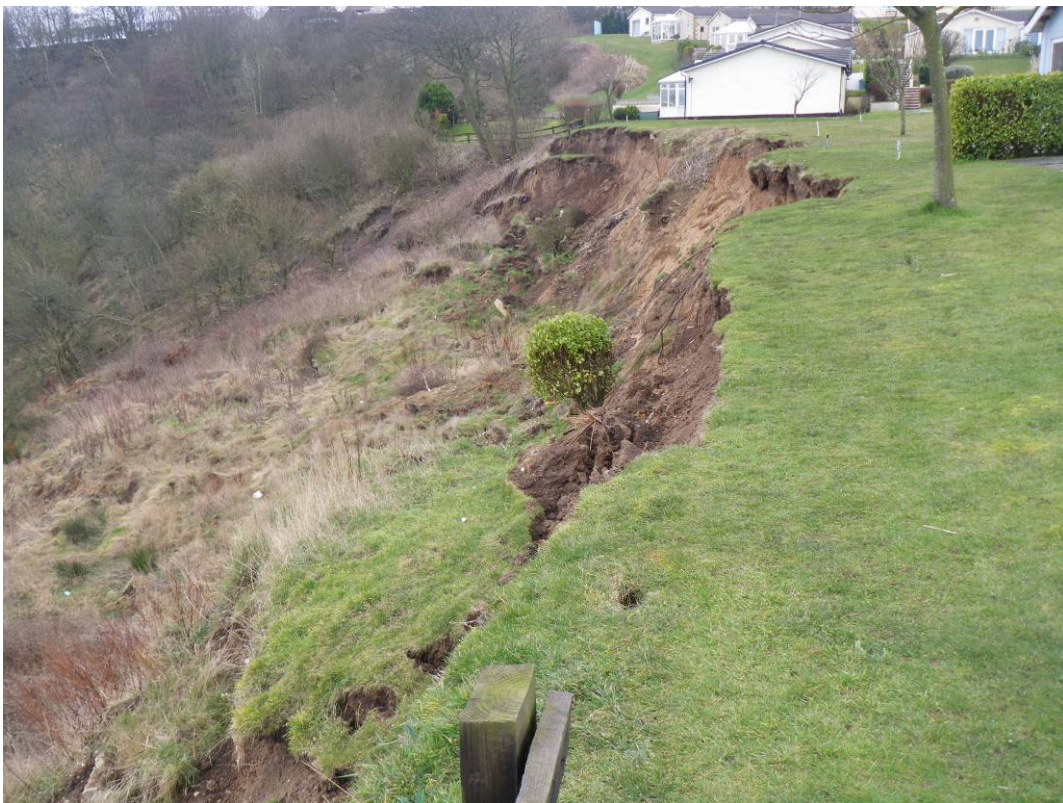
Plate 8 Cliff recession at Knipe Point Headscarp (8th March 2010)

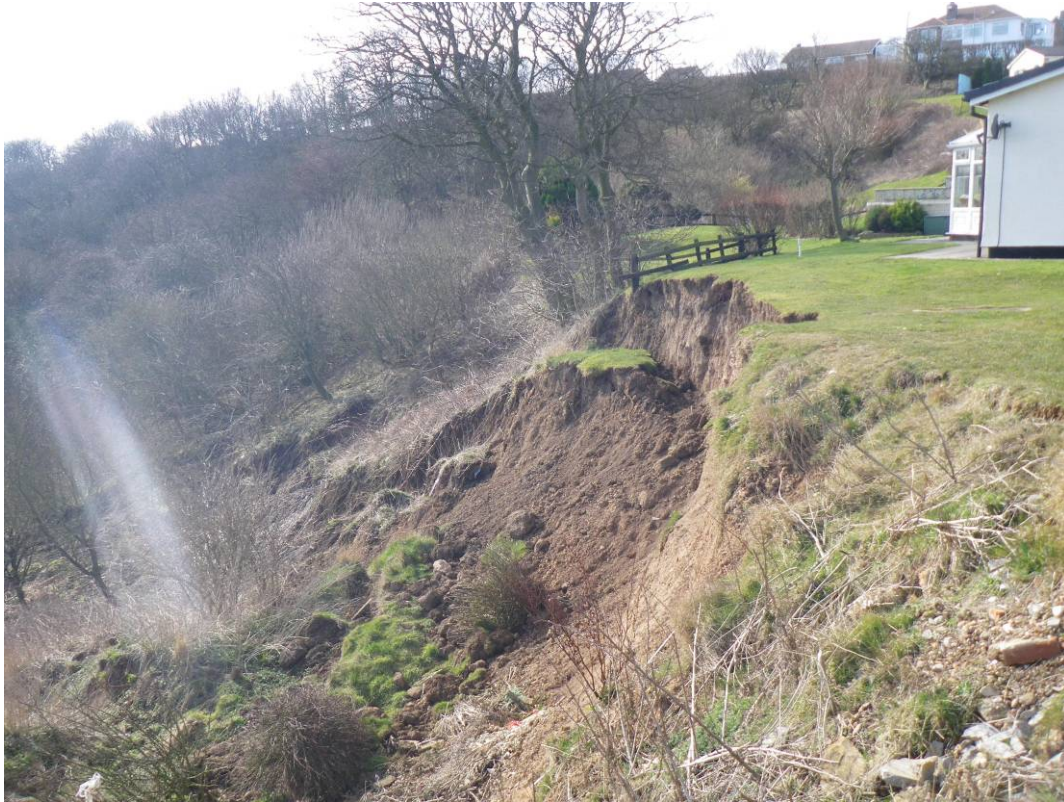
Plate 9 Cliff recession at Knipe Point Headscarp (16th March 2010)

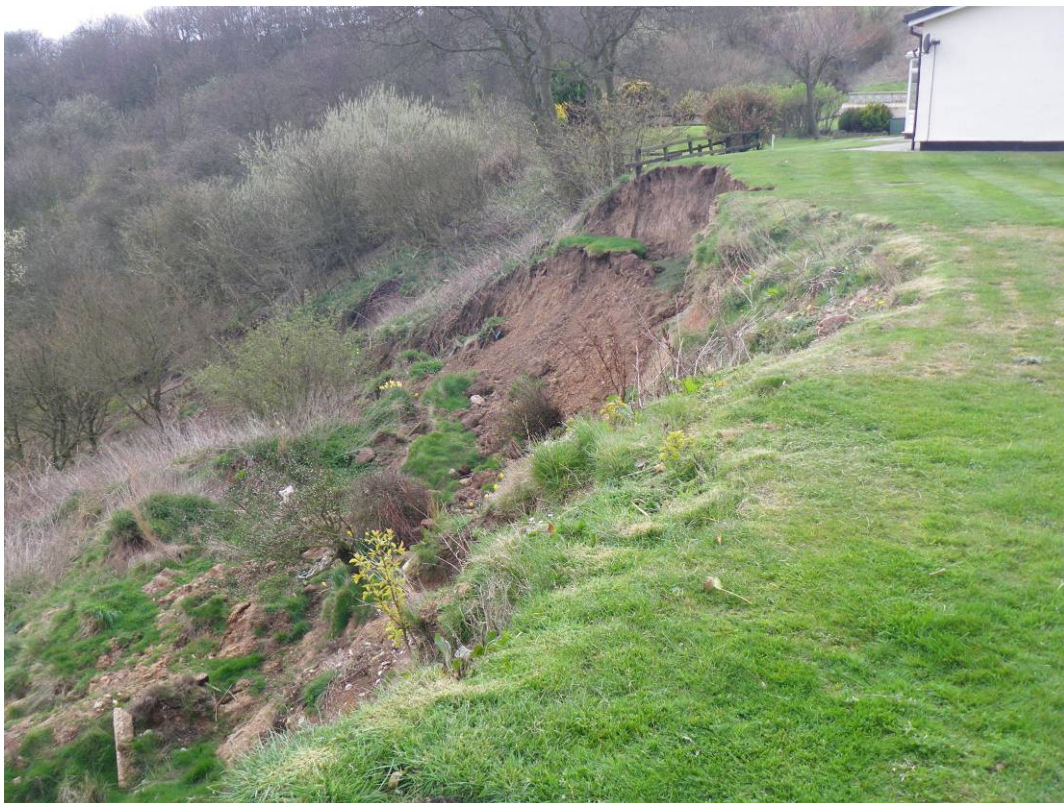
Plate 10 Cliff recession at Knipe Point Headscarp (14th April 2010)

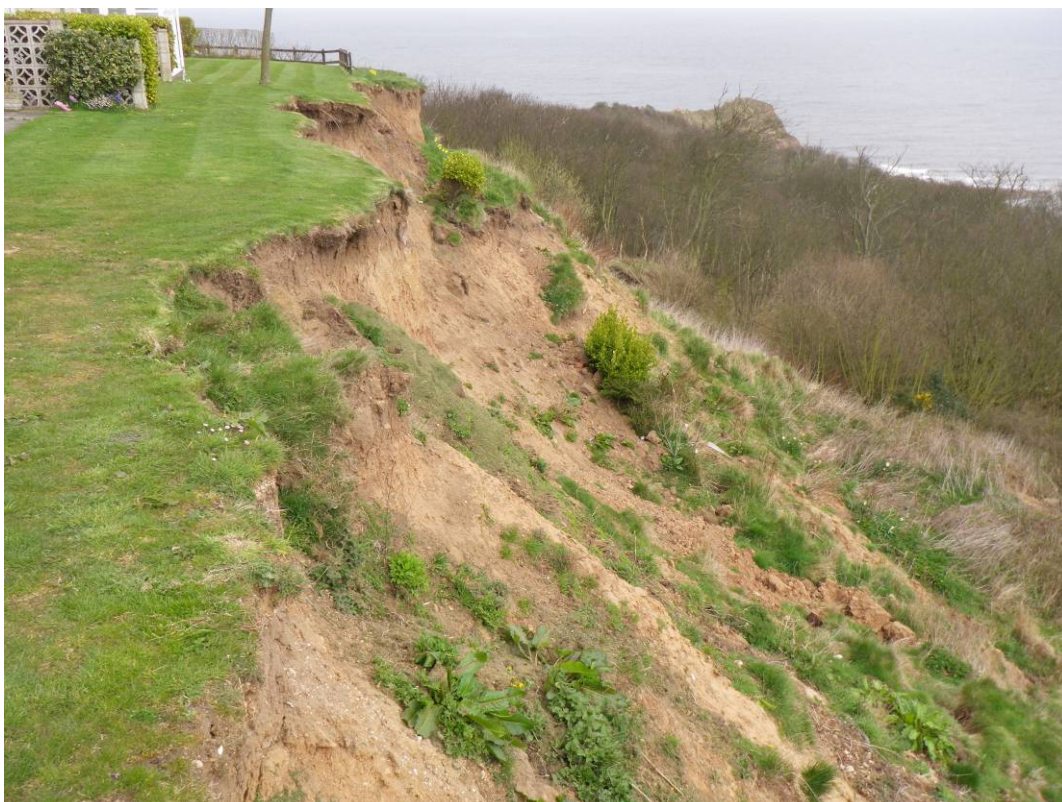
Plate 12 Cliff recession at Knipe Point Headscarp (14th April 2010) looking east
