Ongoing Analysis and Interpretation of Coastal Monitoring Data

Review of Runswick Bay / Knipe Point Monitoring

Geotechnical Interpretative Report

Document Ref. No. 721229/023-024/GIR/001/Final

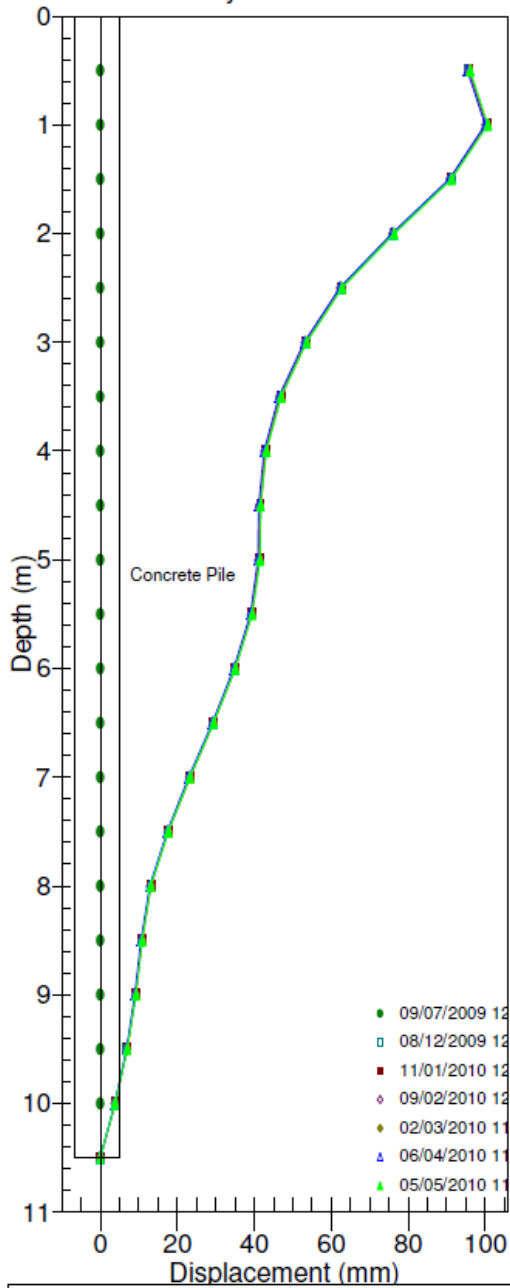
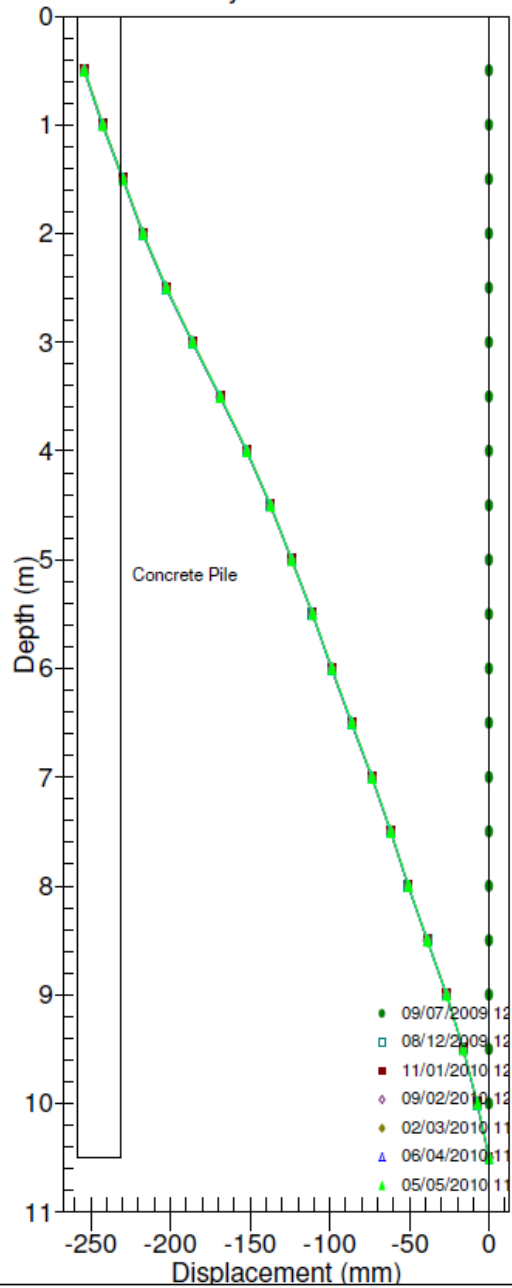
RB:A004 - A Axis Cumulative RB:A004 - B Axis Cumulative

At Runswick Bay, ground movements were observed in installations A001 and A004 of up to 15mm in May 2010.

SITE	Observations made since last Monitoring Event (May 2010)*	Total observed movement since first Monitoring Event (July 2009)
Runswick Bay	A001 shows 2-3mm movement from 22.0 to 20.0 metres depth. A004 shows 5mm movement from 10.0m depth, reaching a maximum of 15mm at 2.0m depth. Groundwater relatively static	5mm movement indicated in A001 between 22.0 and 20.0 metres depth. 5mm movement indicated in A004 from 10.0m depth increasing to 15mm at 2.0m depth. Groundwater relatively static
Knipe Point	Reduction in cliff recession rates along headscarps 'New' mid-slope mudslide observed in April 2010 below Knipe Point Headscarp at monitoring point H06I still active	Since February 2010 - Continued recession of Cornelian and Knipe Point headscarps. Limited (14mm) recession noted along A165*

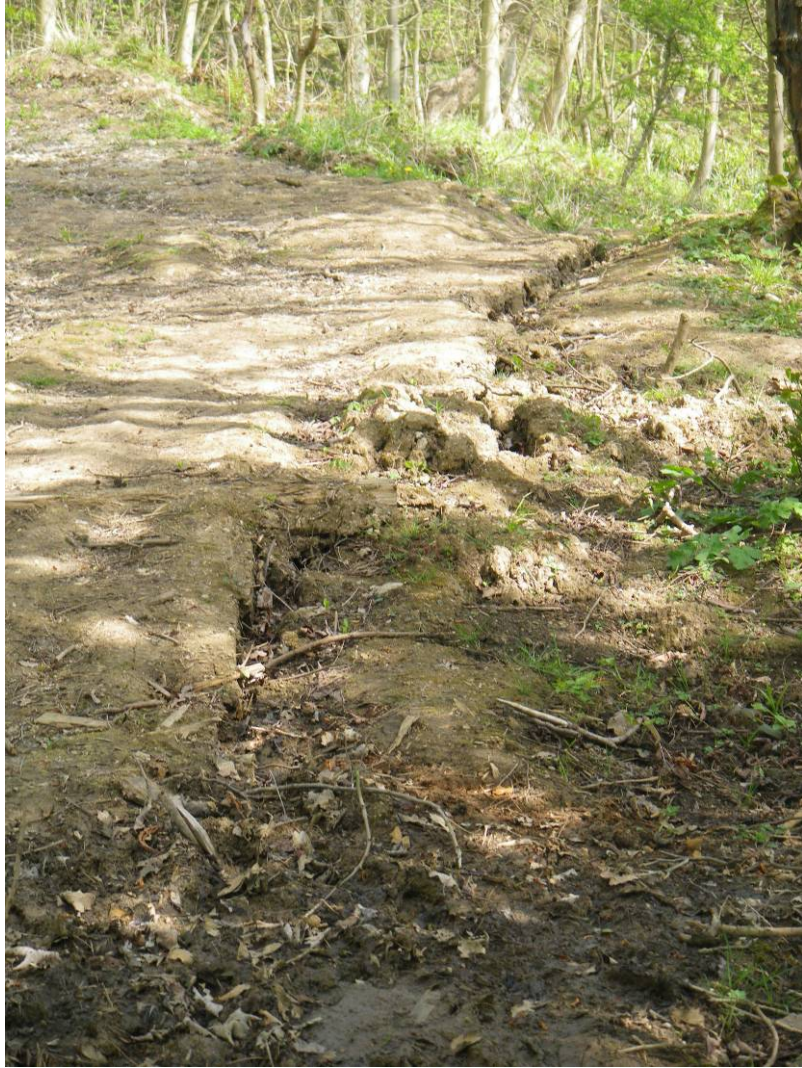
Plate 1 Tension cracks trending northeast / southwest landward of BH05

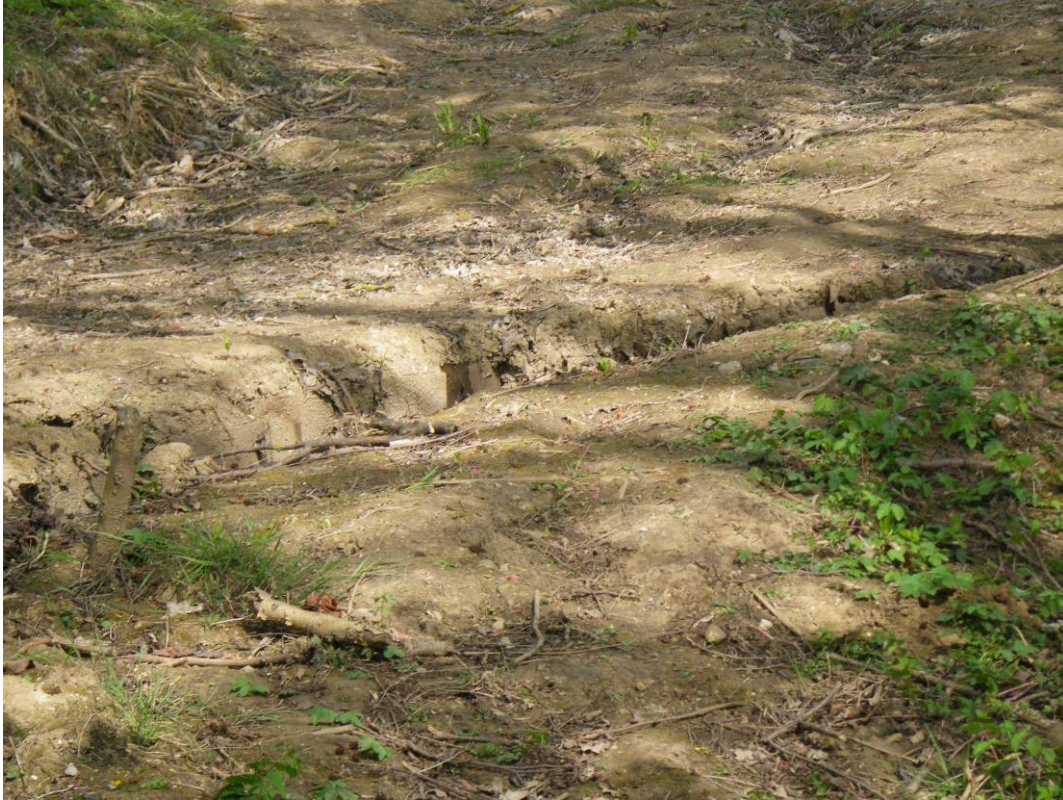
Plate 2 Tension cracks trending northeast / southwest landward of BH05

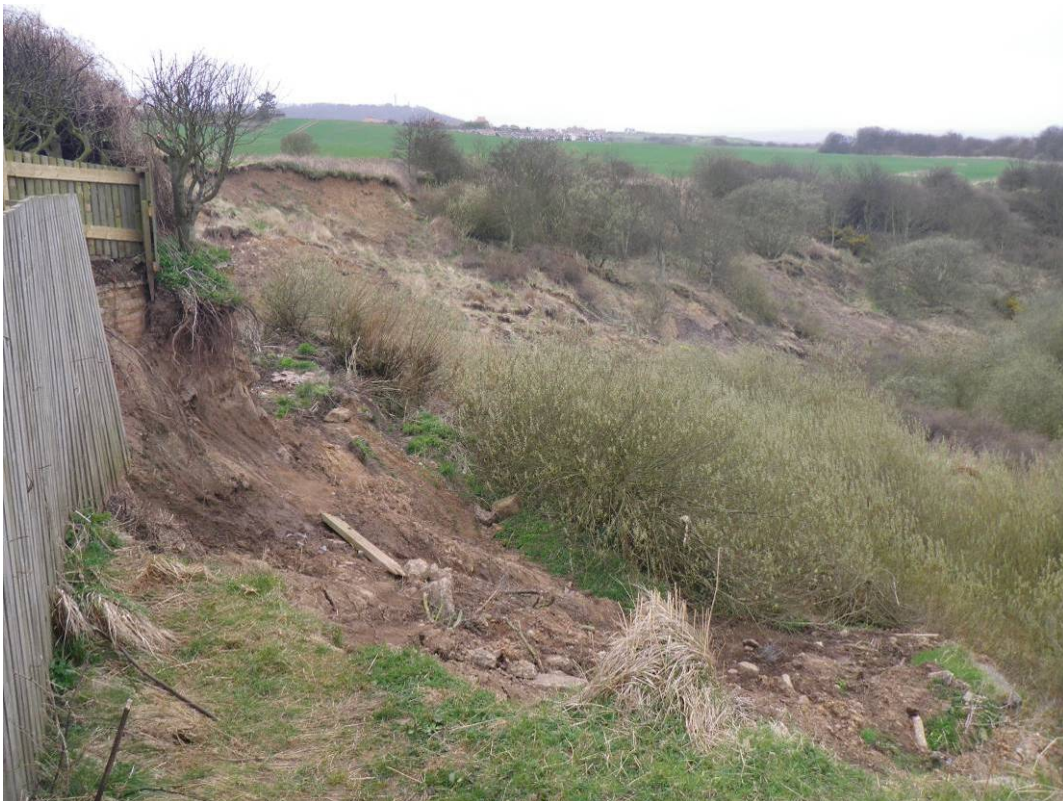
Plate 3 Slope failures on Cornelian Bay side of Knipe Point looking northwest

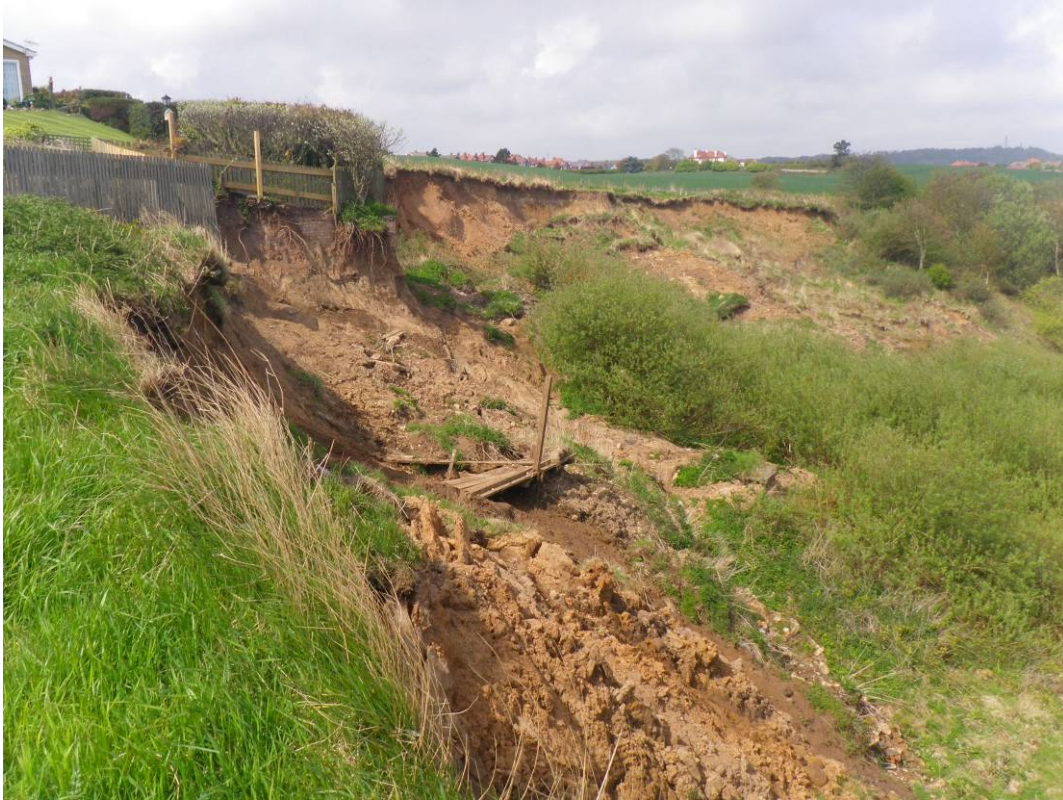
Plate 4 Slope failures on Cornelian Bay side of Knipe Point looking northwest
(5th May 2010)

Note groundwater seepage from slope above horizontal timbers

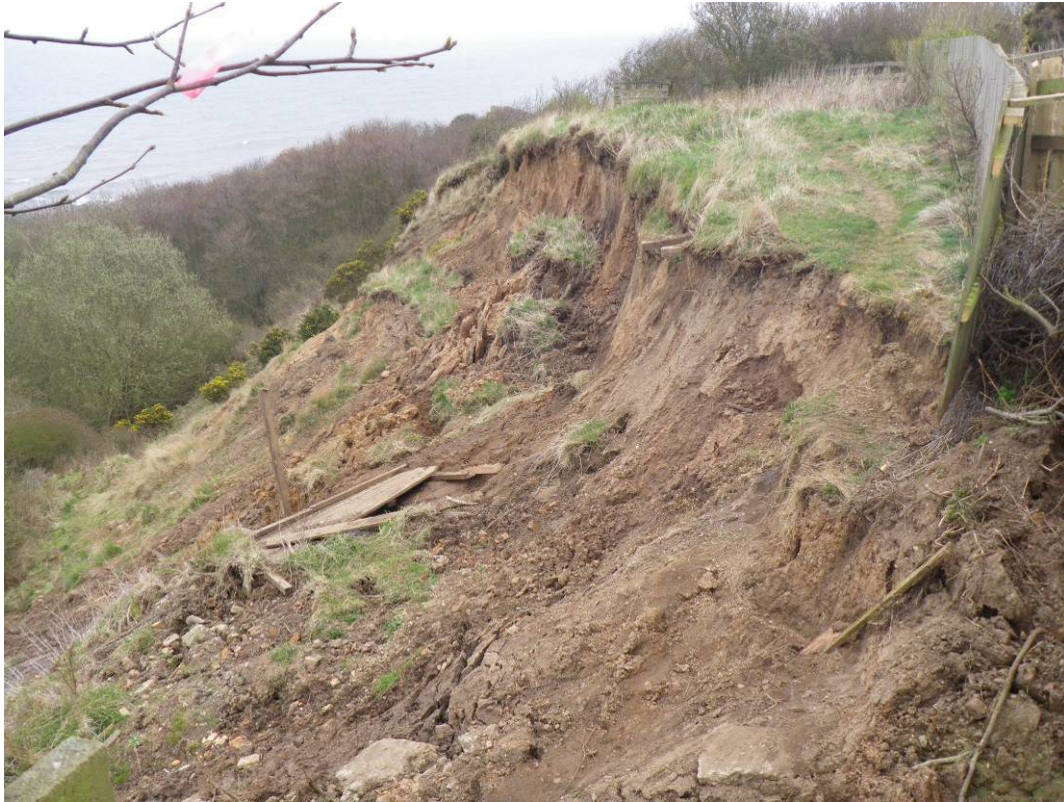
Plate 5 Slope failures on Cornelian Bay side looking east (14th April 2010)

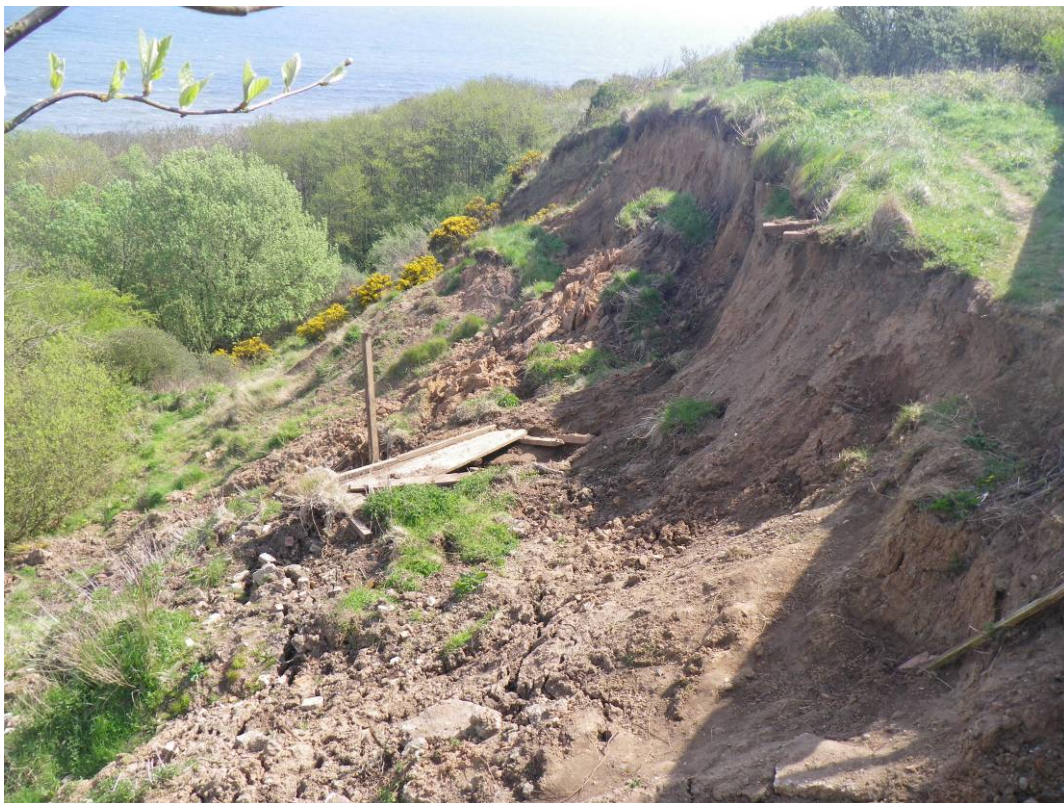
Plate 6 Slope failures on Cornelian Bay side looking east (5th May 2010)

Note groundwater seepage from slope immediately above timbers and below headscarp

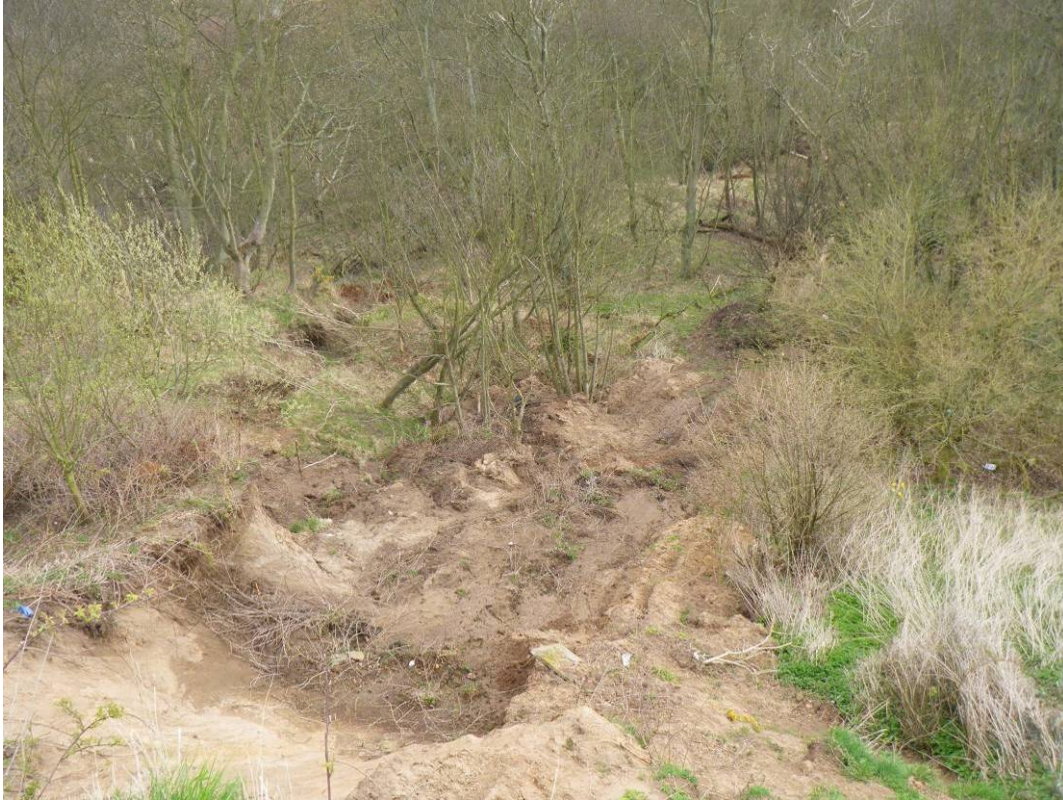
During the survey of April 2010 a 'fresh' mudslide was observed on the slopes of Knipe Point immediately below monitoring point H06I. During the site monitoring of May this mudslide was observed to have developed further and was approximately 10 metres below ground level, extending further down the slopes (Appendix G, Plates 7 & 8). Ground water seepages were observed to be active from this point in the slope and continue to be coincident with the mudslide.

Plate 7 View of 'fresh' mudslide on Knipe Point Headscarp, below Property No. 18 (14th April 2010) Note groundwater issues from slope

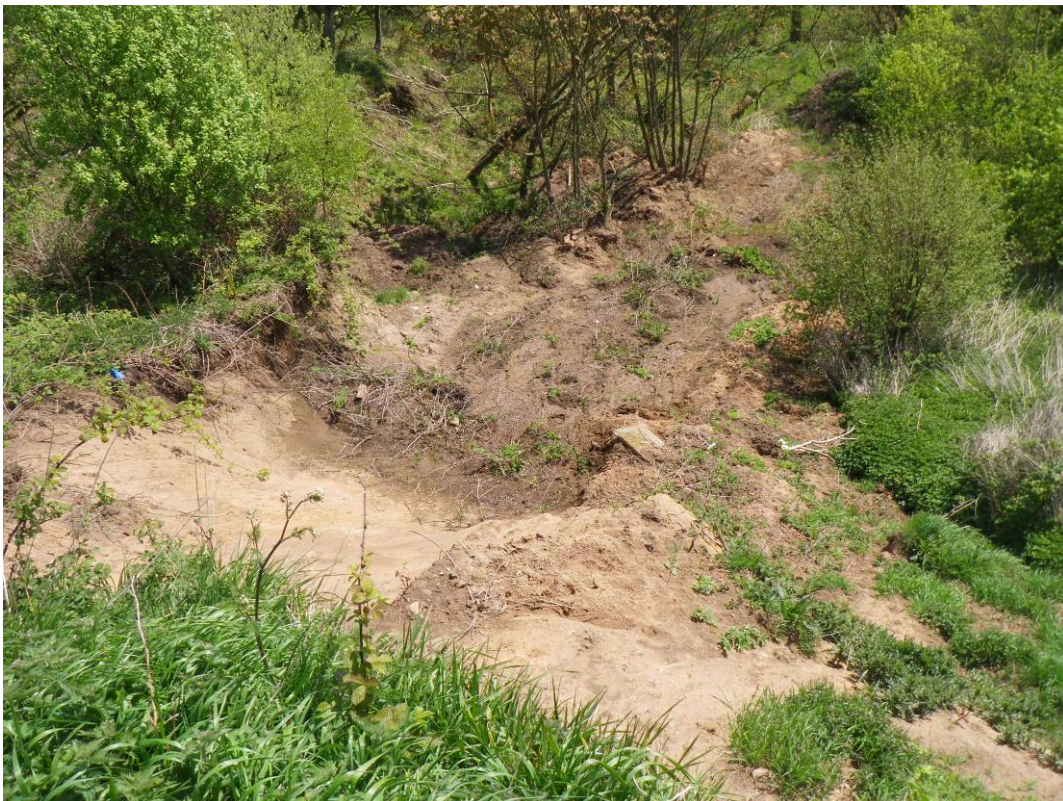
Plate 8 View of mudslide on Knipe Point Headscarp, below Property No. 18 (5th May 2010) Note continued groundwater issues from slope

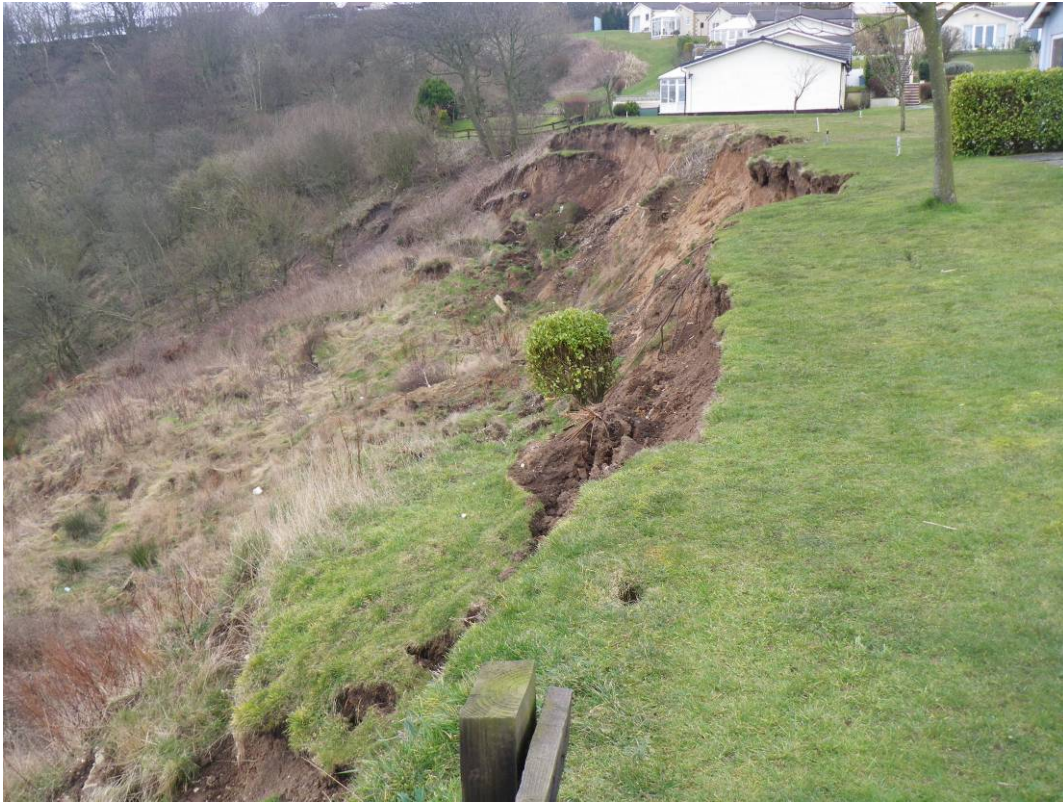
Plate 9 Cliff recession at Knipe Point Headscarp (8th March 2010)

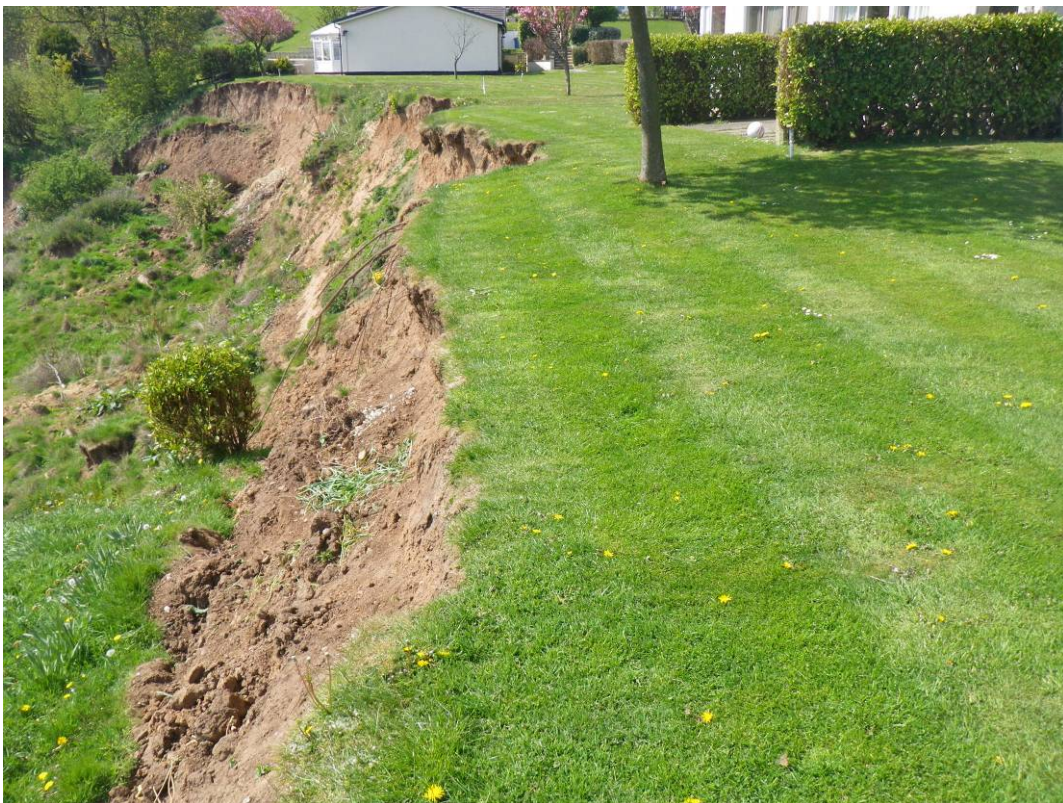
Plate 10 Cliff recession at Knipe Point Headscarp (5th May 2010)

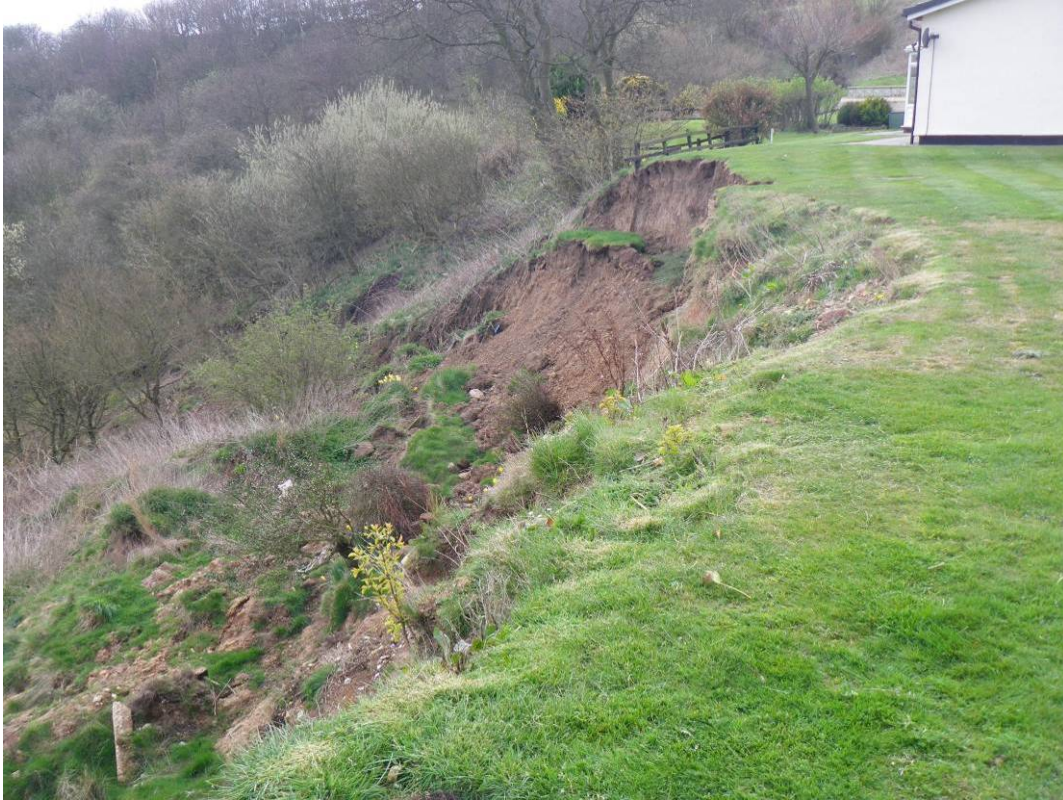
Plate 11 Cliff recession at Knipe Point Headscarp (14th April 2010)

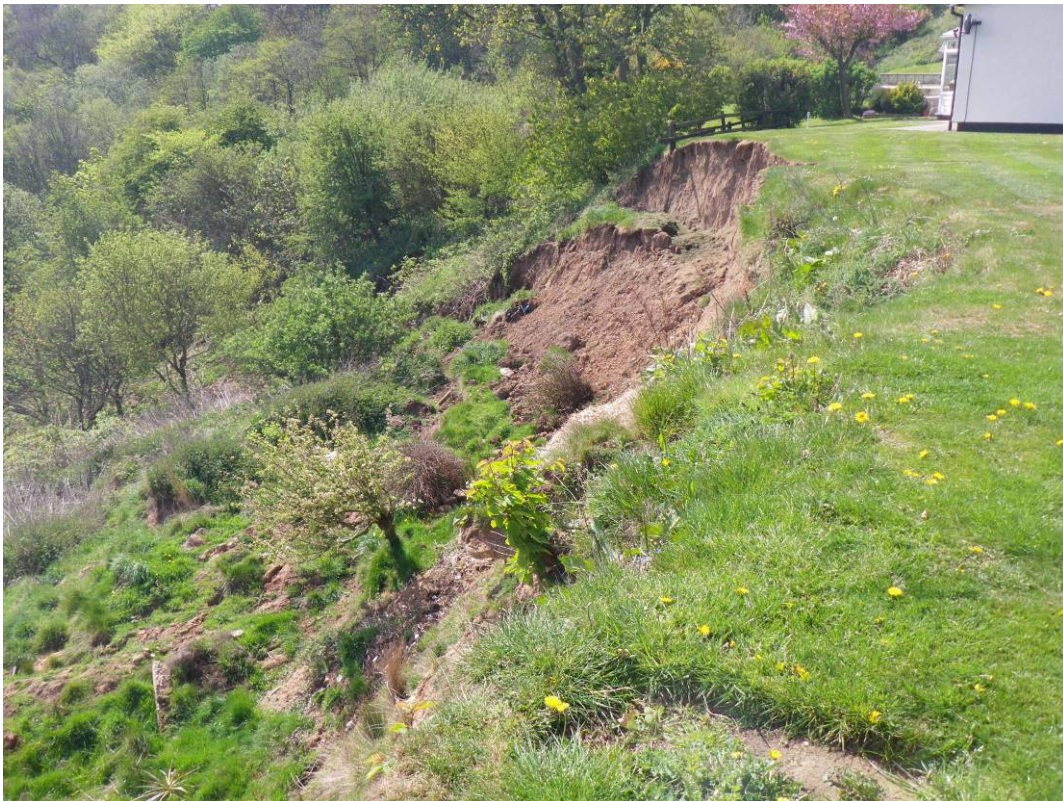
Plate 12 Cliff recession at Knipe Point Headscarp (5th May 2010)

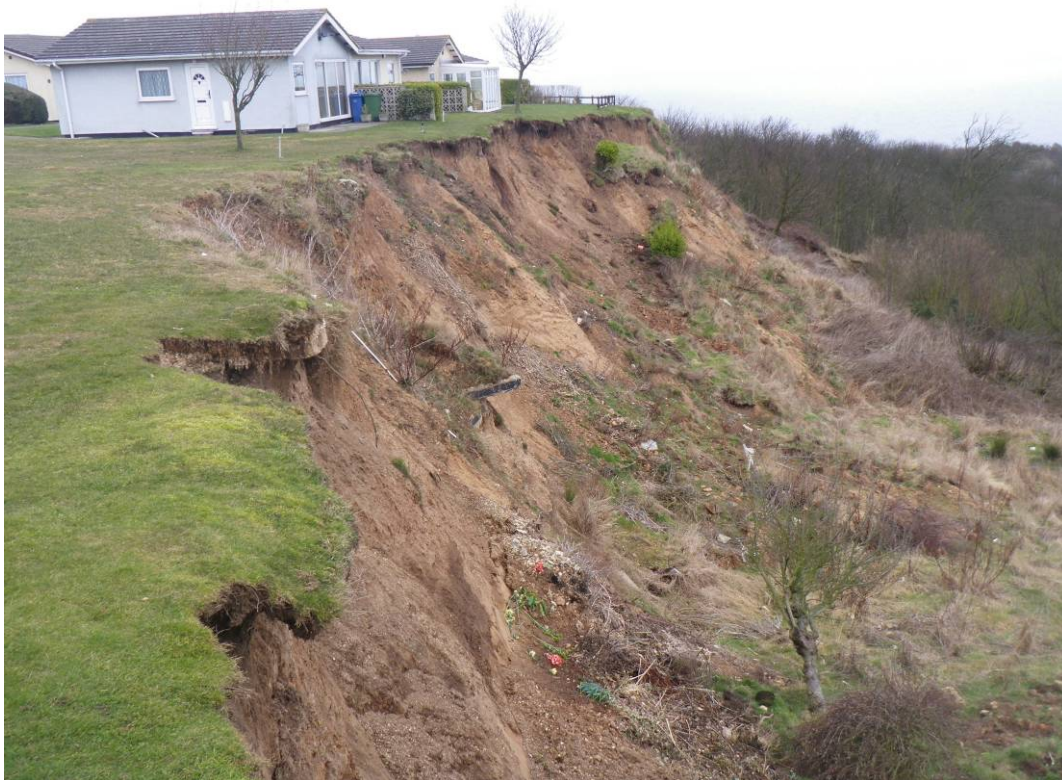
Plate 13 Cliff recession at Knipe Point Headscarp looking east (8th March 2010)

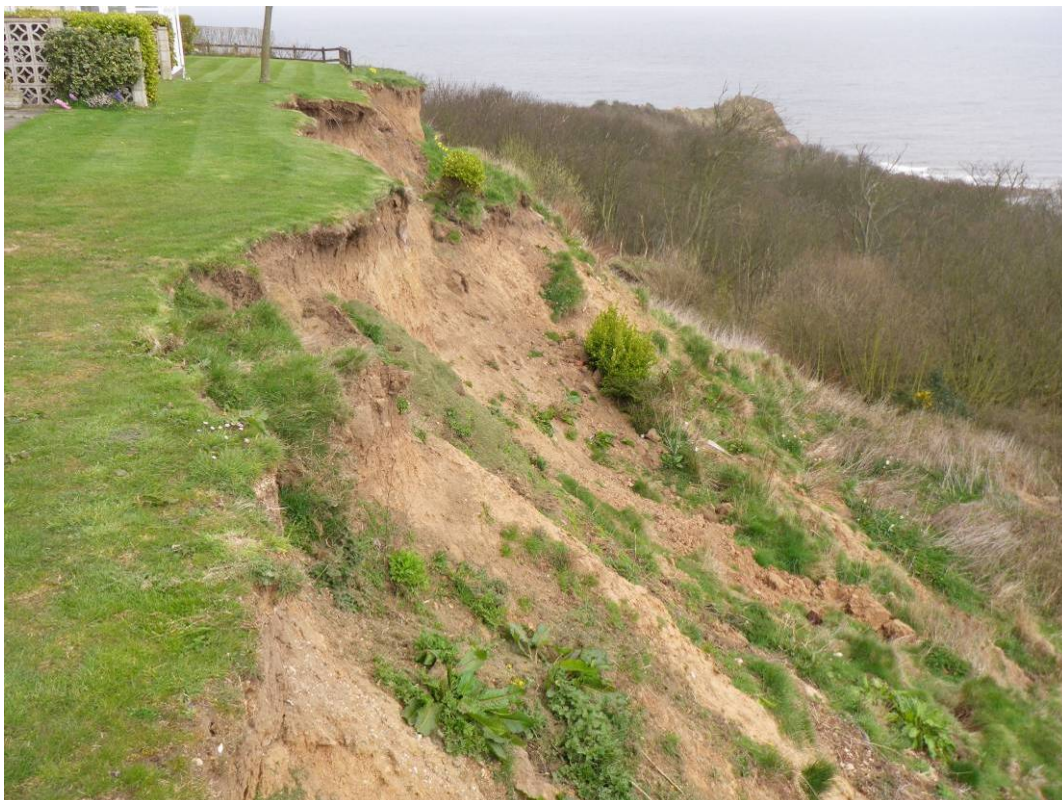
Plate 14 Cliff recession at Knipe Point Headscarp looking east (14th April 2010)

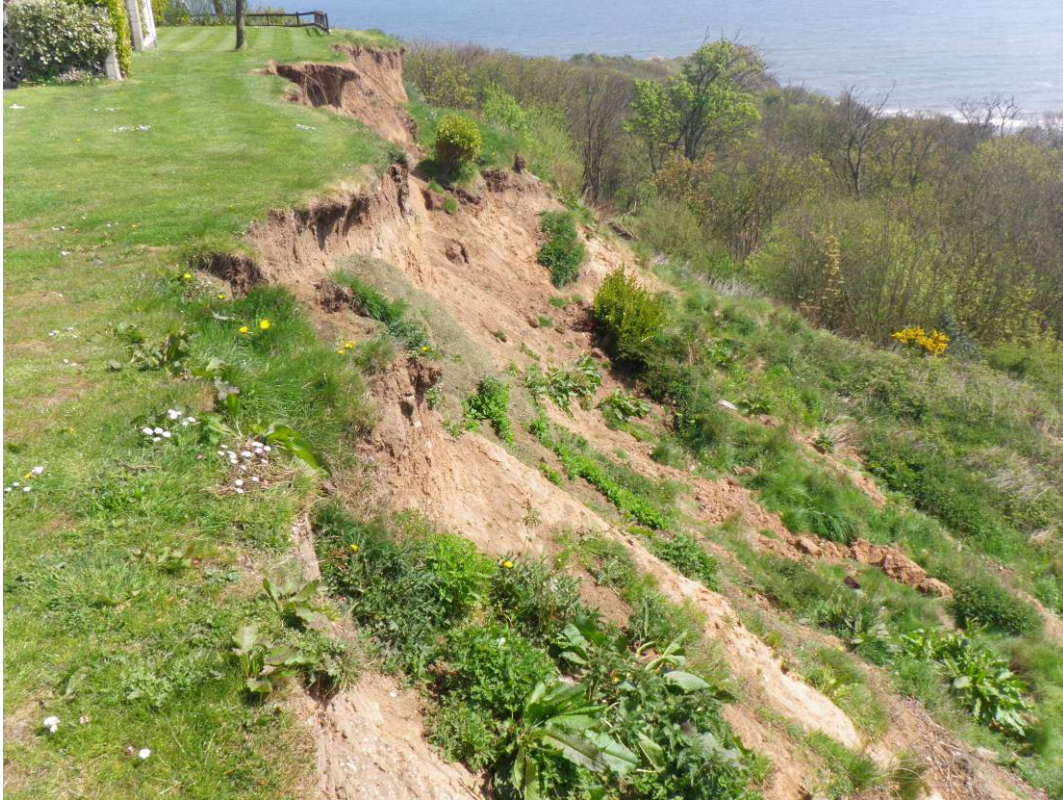
Plate 15 Cliff recession at Knipe Point Headscarp looking east (5th May 2010)

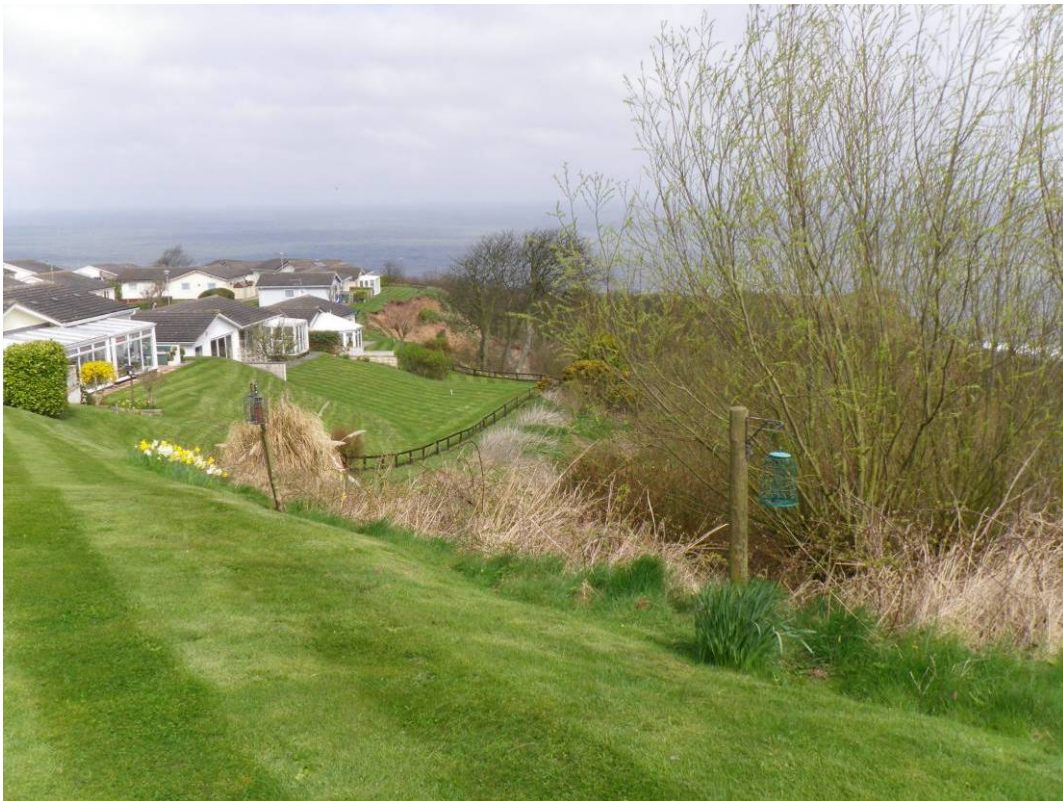
Plate 16 Cliff recession at Knipe Point Headscarp looking east (14th April 2010)

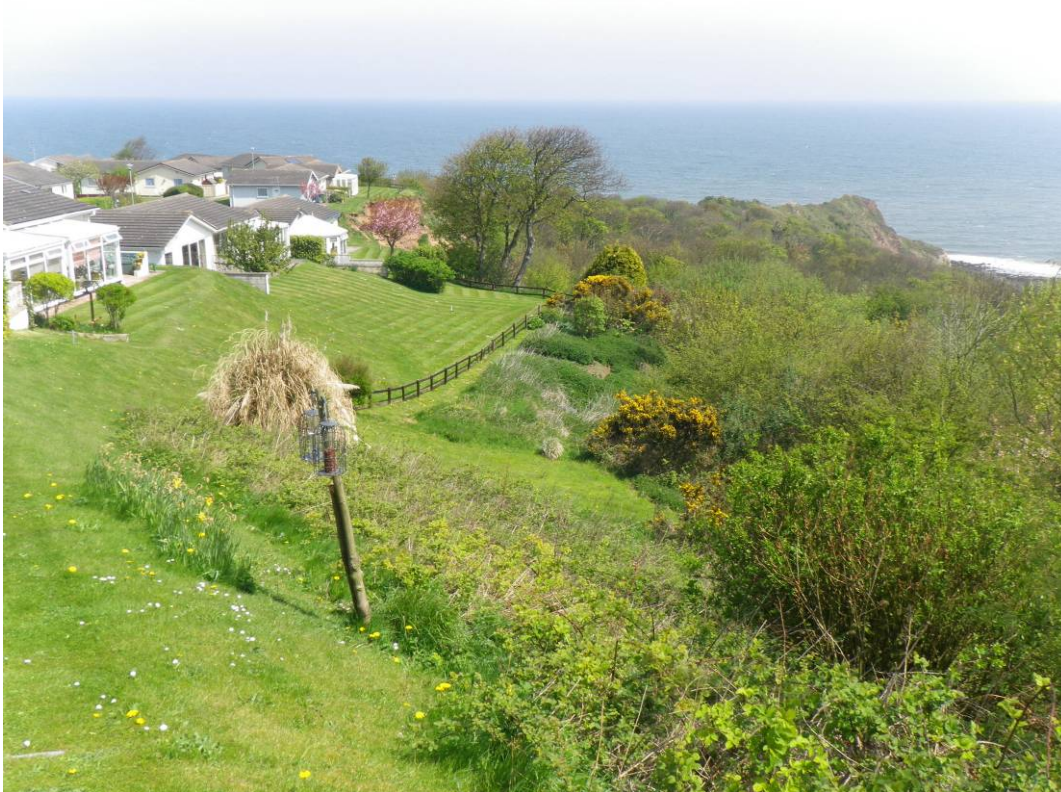
Plate 16 Cliff recession at Knipe Point Headscarp looking east (5th May 2010)
