Interpretation Report 10: December 2017 to May 2018

Prepared for
Scarborough
Borough Council

August 2018

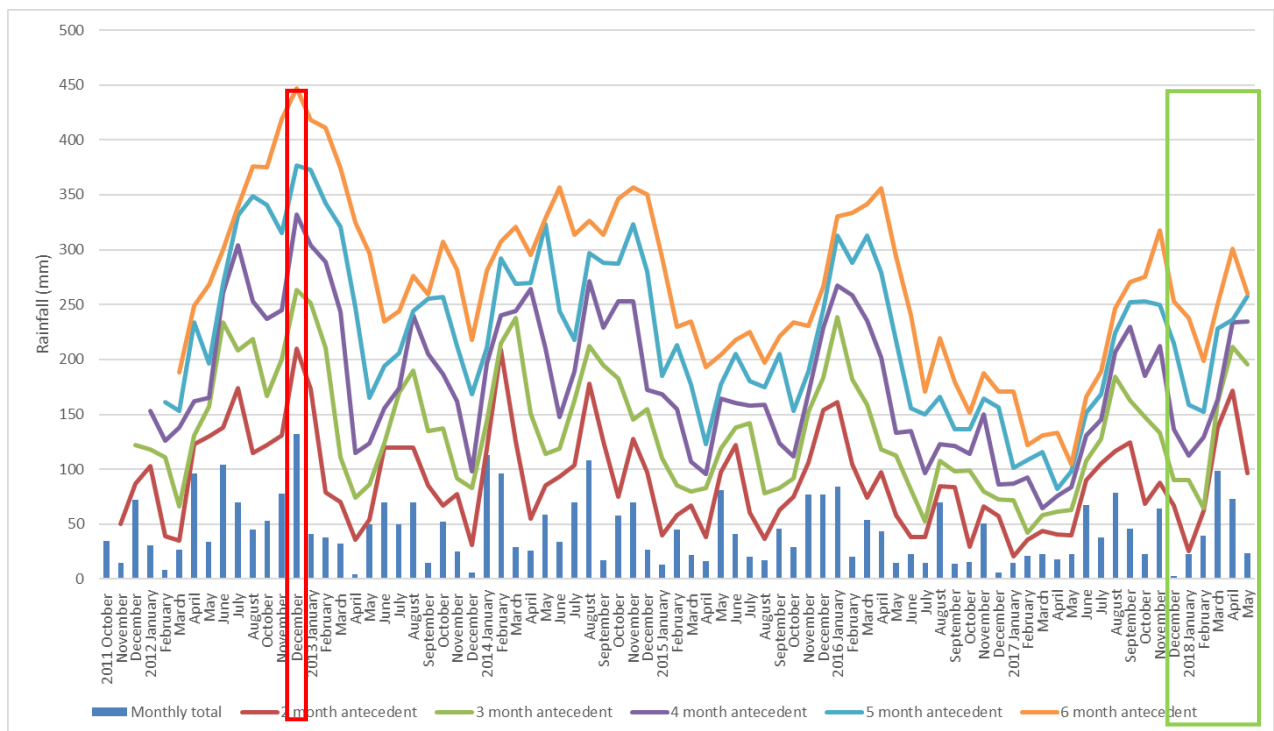
Antecedent rainfall over the current December-May monitoring period show peaks that are lower than that seen in December 2012, however a rapidly increasing trend in antecedent rainfall over the monitoring period is evident, unlike the pattern to the previous December to May monitoring period which shows antecedent rainfall rises after May. Antecedent rainfall totals do not reach those seen in December 2012 and it is therefore concluded there is a low likelihood of rainfall-induced landslides occurring in the monitoring period. However, the antecedent rainfall levels at the end of this monitoring period are relatively high, which means if the summer of 2018 is wet, there may be an increased likelihood of ground movement in the next monitoring period.

Figure 2.6. Monthly rainfall and two to six month antecedent totals (2011 to 2018). Ground movements were recorded at Scalby Mills during December 2012 (red box). Current monitoring period shown by green box.

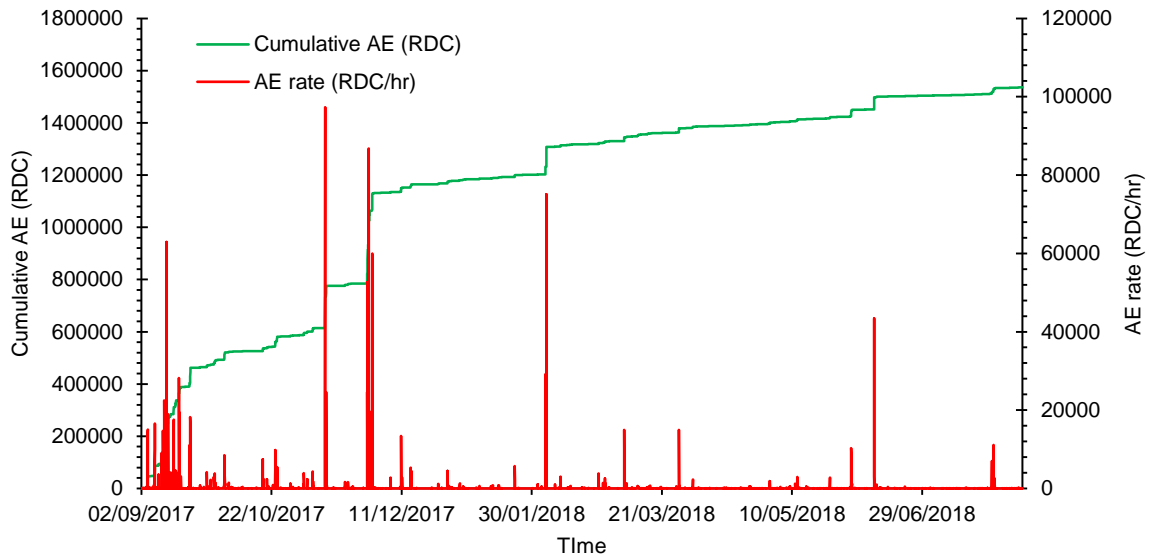
Figure 9.2. Cumulative AE (RDC) and AE rate (RDC/hr) time series at Scarborough Spa for the period September 2017 to August 2018.

- Acoustic emissions (AE) detected are negligible and do not suggest slope movement. Fluctuations in the data represent the specific hydrogeological conditions at this site (i.e. time dependent seepage conditions following rainfall events). This is supported by the inclinometer measurements at BH105, which show negligible movement. (Figure 9.2 and 9.3). It is also possible that extraneous noise generated at Scarborough could be due to ongoing construction activities to stabilise the slope.

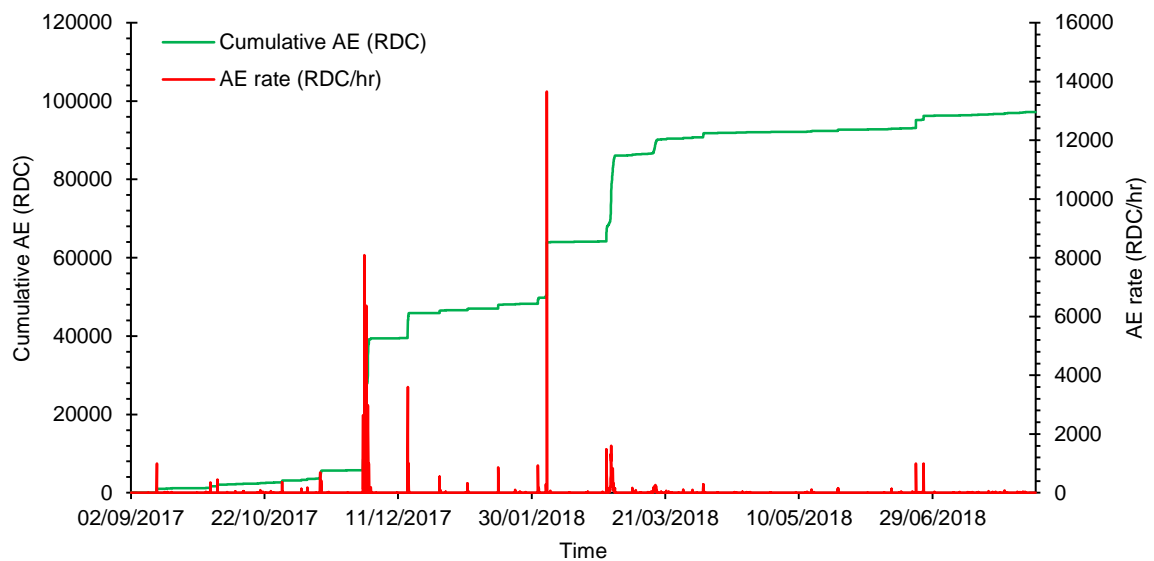
Figure 11.2 Cumulative AE (RDC) and AE rate (RDC/hr) time series at Flat Cliffs, Filey for the September 2017 to August 2018.

- No evidence for ground movements is shown by inclinometers.
- AE measurements between December 2016 and September 2017 do not show significant slope movements. The periods of elevated AE activity, which are shown by periods of increased gradient of the cumulative RDC record, could be indicative of deformations but of a very slow rate and small magnitude. However, it is more likely that this increased AE activity was caused by extraneous noise (e.g. interference with the surface cover).
- Groundwater data show levels have risen in borehole B1, however remain within the historical range.
- No data collected at piezometer in borehole C4a, A3 and D1, requires readings to be retaken.
