Interpretation Report 12: December 2018 to May 2019

Prepared for
Scarborough
Borough Council

September 2019

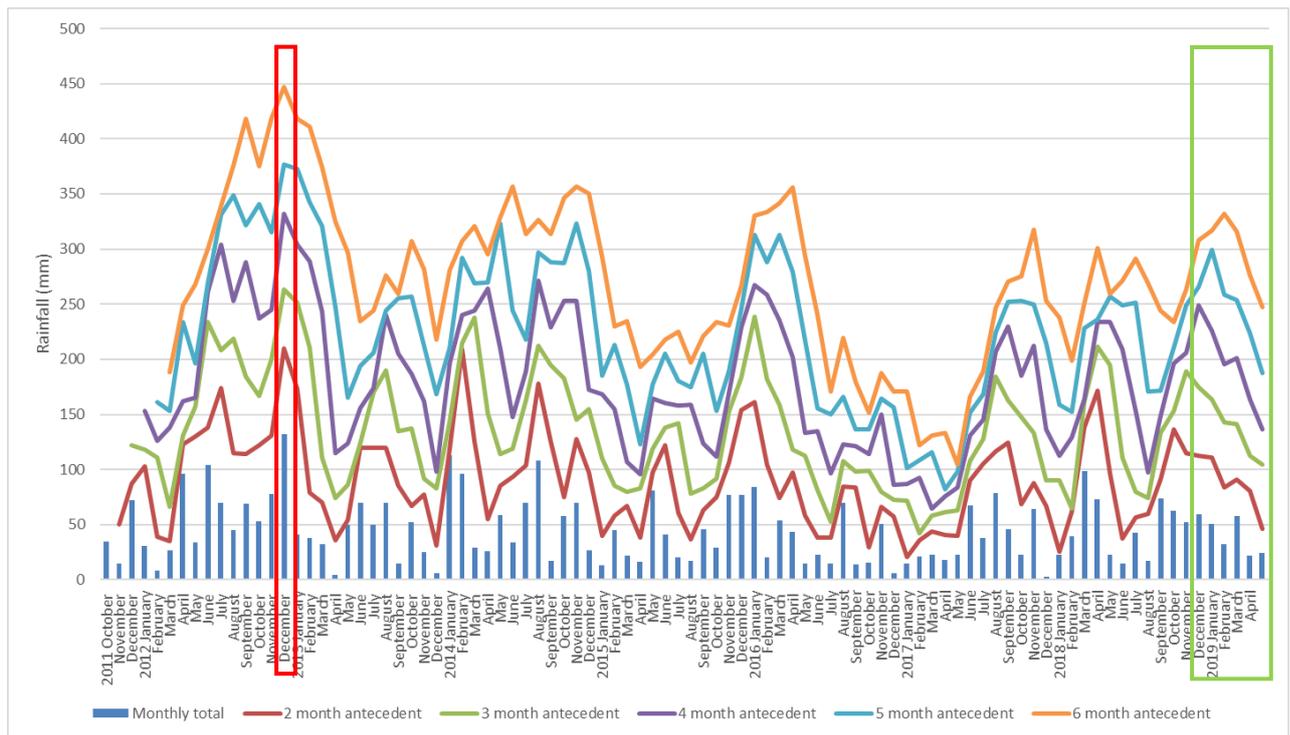
Figure 2.6. Monthly rainfall and two to six month antecedent totals (2011 to 2019). Ground movements were recorded at Scalby Mills during December 2012 (red box). Current monitoring period shown by green box.

Antecedent rainfall over the current December-May monitoring period show peaks that are lower than that seen in December 2012. Antecedent rainfall conditions during this monitoring period are already elevated and declining gradually, unlike the pattern to the previous December-May monitoring period which shows antecedent rainfall rises after January. Instead, antecedent rainfall rapidly increases earlier in September 2018. Antecedent rainfall totals do not reach those seen in December 2012 and it is therefore concluded there is a low likelihood of rainfall-induced landslides occurring in the monitoring period. However, the antecedent rainfall levels at the end of this monitoring period are elevated, which means if the summer of 2019 is wet, there may be an increased likelihood of ground movement in the next monitoring period.

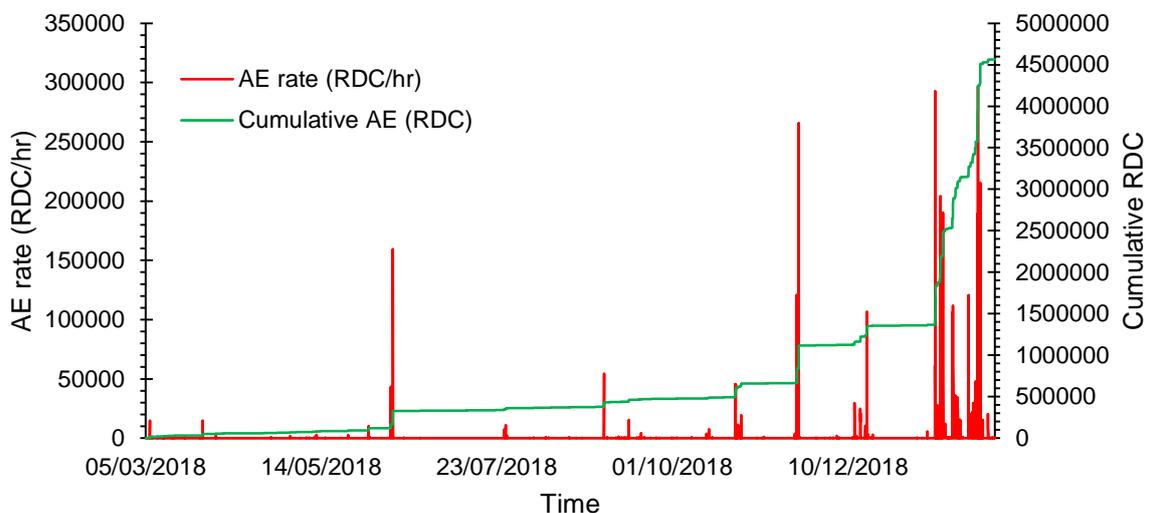
Figure 9.2. Cumulative AE (RDC) and AE rate (RDC/hr) time series at Scarborough Spa for the period March 2018 to January 2019.

- Acoustic emissions (AE) data could not be collected during this monitoring period due to on-going construction works in the vicinity of the borehole. Figures 9.2 and 9.3 show results from the previous monitoring period.

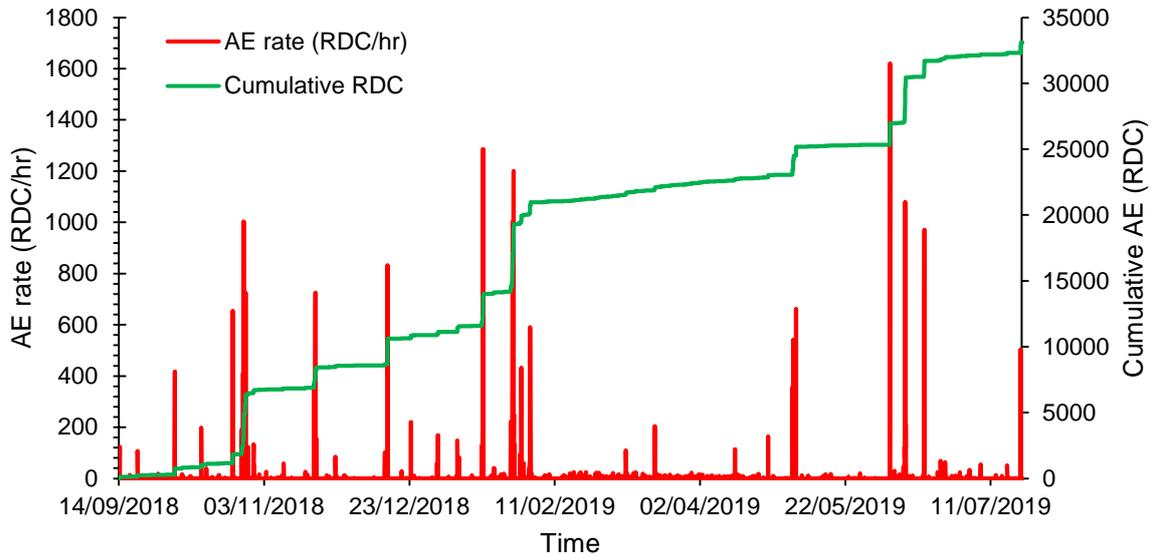
Figure 11.2 Cumulative AE (RDC) and AE rate (RDC/hr) time series at Flat Cliffs, Filey for the September 2018 to July 2019.

- AE measurements between December 2018 and May 2019 do not show significant slope movements. The periods of elevated AE activity, which are shown by periods of increased gradient of the cumulative RDC record, could be indicative of deformations but of a very slow rate and small magnitude. However, it is more likely that this increased AE activity was caused by extraneous noise (e.g. interference with the surface cover).
- Groundwater data show levels have fallen in borehole B1.
- No data collected at piezometer in borehole C4a, A3 and D1, requires readings to be retaken.
