**Local Coastal Slope Monitoring Analysis**  
**Interpretation Report 16: December 2020 to June 2021**

7 December 2021

**Scarborough Borough Council**

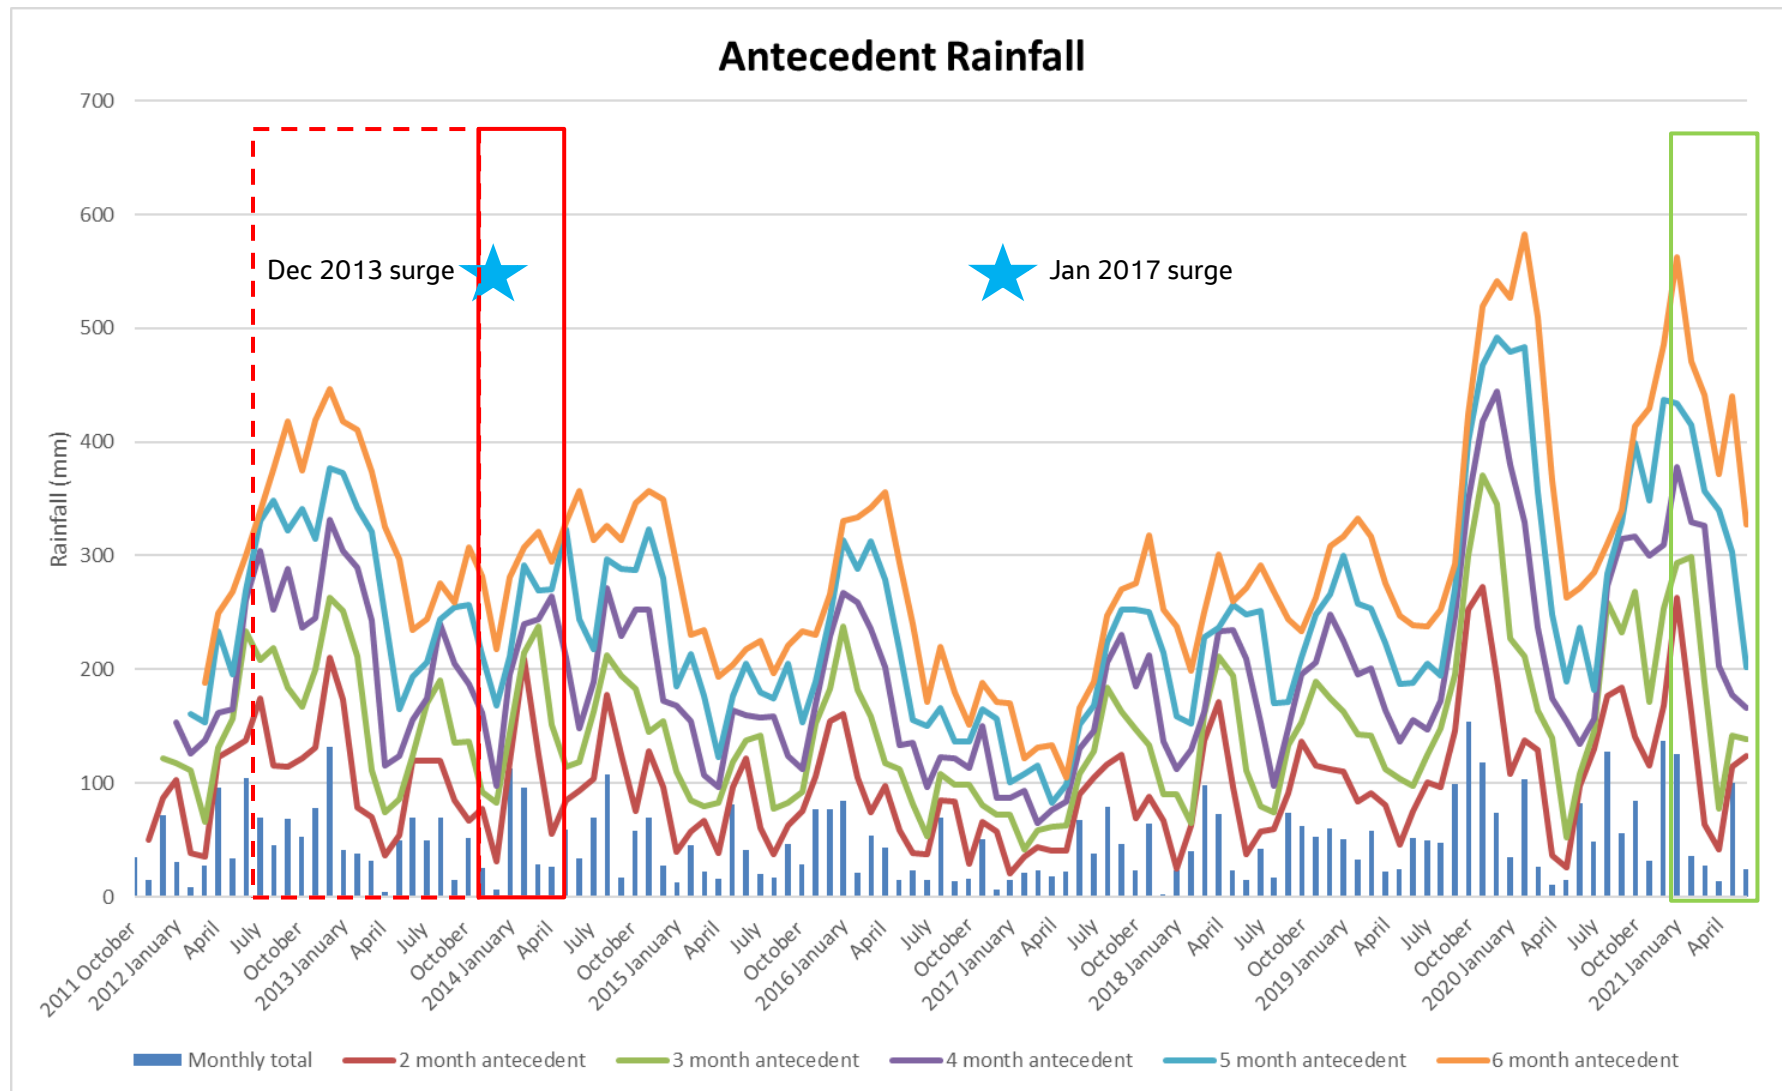
Figure 2.6 Monthly rainfall, two to six-month antecedent totals (2011 to 2021) and notable storm surges. Ground movements were recorded at Scalby Mills during June-Dec 2010 and Feb-June 2011 at times of high groundwater levels. Slight movement was recorded during June 2012-Nov 2013 (red dashed box) with significant movements between November 2013 and May 2014 (solid red box). Current monitoring period shown by green box.

Antecedent conditions prior to the current monitoring over the winter of 2020/21 show peaks higher than those seen in 2012, meaning ground movements could be expected. However, no ground movements were recorded by in situ monitoring. After a fall in rainfall over the summer of 2020, levels began to rise in the autumn and exceeded the peak recorded in 2012. The winter of 2020/21 almost reached the peak of 2019/20, and the likelihood of ground movement was therefore high.

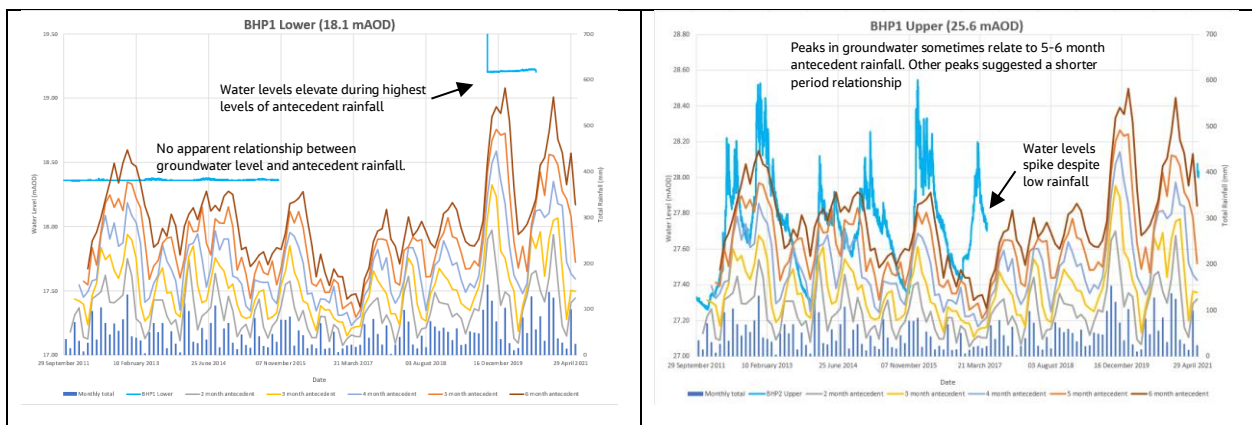
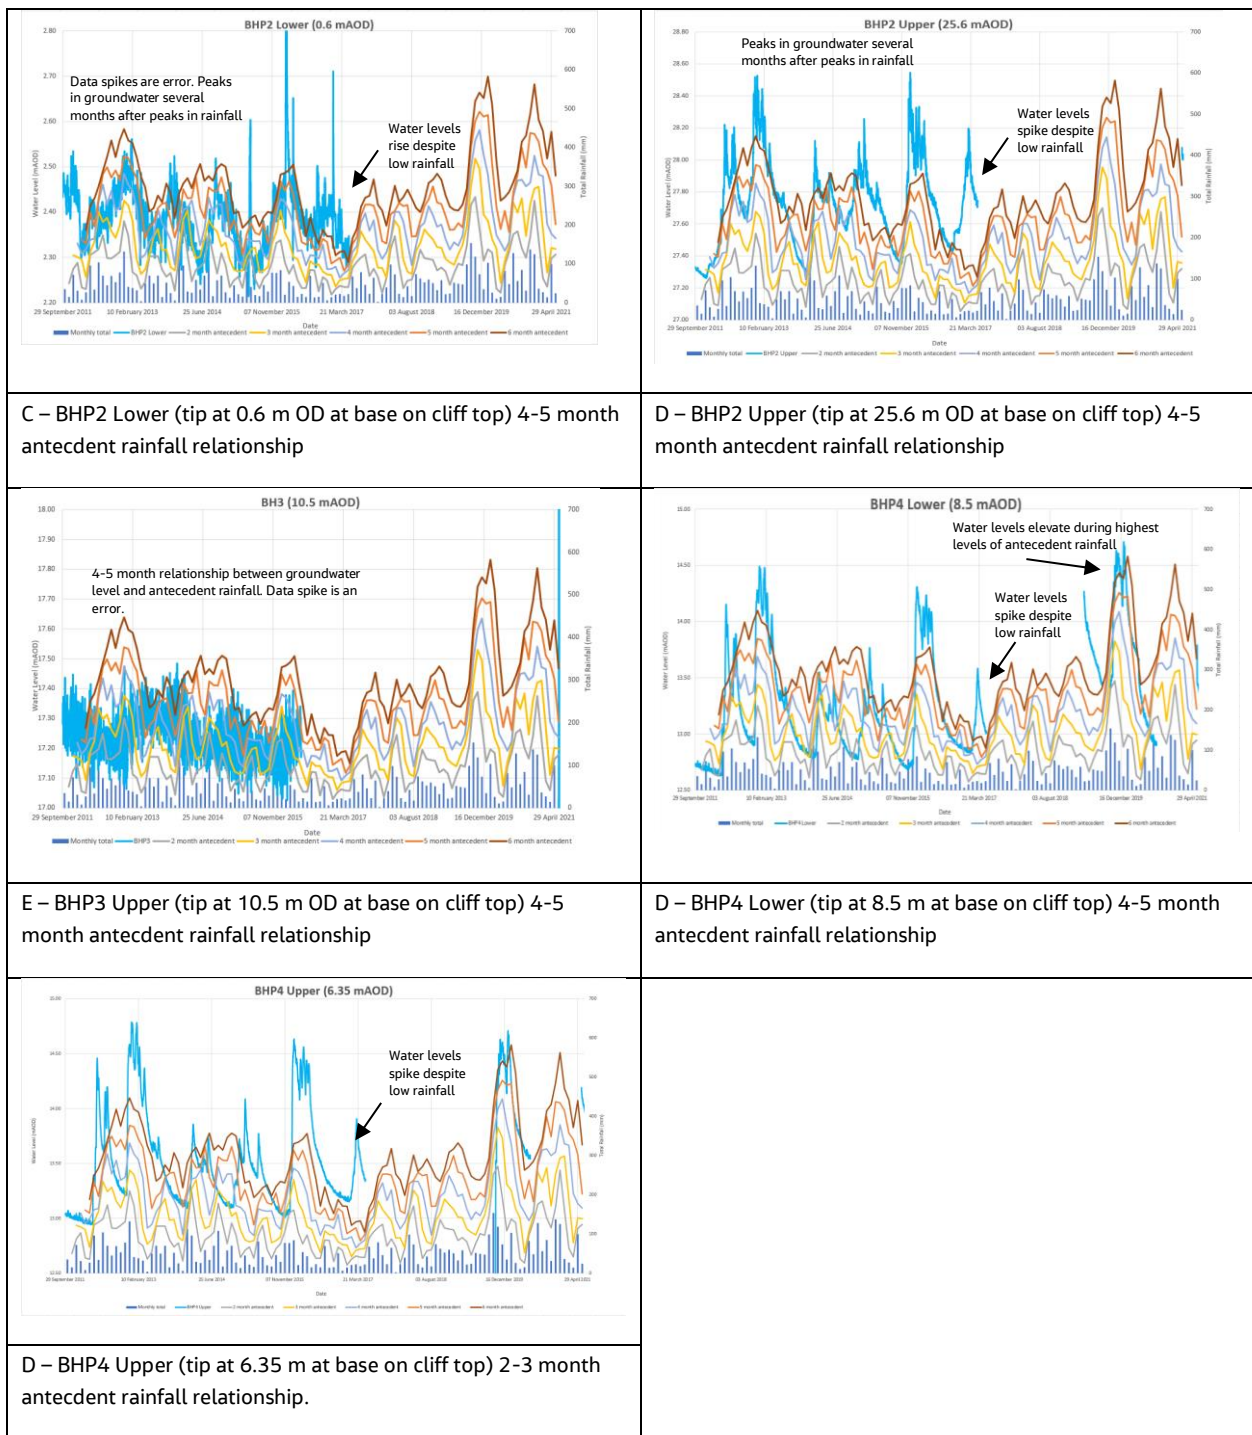
Figure 6.2: Relationship between groundwater levels and antecedent rainfall.

These data confirm that deeper piezometers take longer to respond to rainfall than shallower piezometers and suggests a 4 to 5 month antecedent rainfall relationship at depth, and a 2-3 month relationship for shallower piezometers. These long response times reflect the impermeable nature of the glacial sediments.

<p>A – BHP1 Lower (tip at 18.1m OD at base on cliff top). No apparent antecedent rainfall relationship.</p>	<p>B – BHP1 Upper (tip at 25.6m OD at base on cliff top). The data show a complex 5 to 6 month antecedent relationship.</p>
---	---

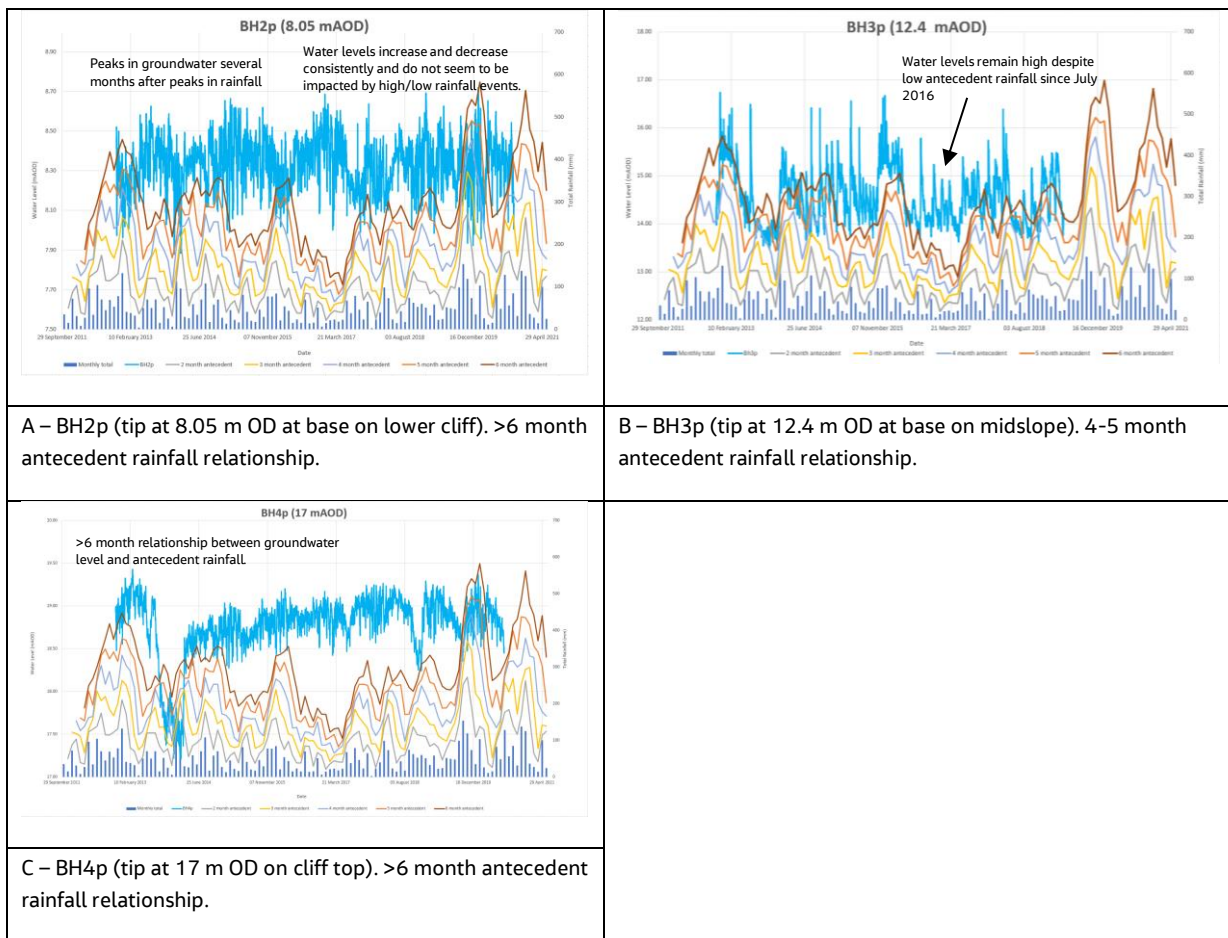
Figure 7.2: Relationship between groundwater levels and antecedent rainfall at Oasis Café.

BH3p, located mid-way down the cliff, has a 4-5 month antecedent rainfall relationships. In contrast BH2p and BH4p, at the base and top of the cliff respectively, appear to have antecedent rainfall relationship greater than 6 months. These complex spatial relationships probably reflect variation in the glacial sediments that are typically low permeability clays, but locally high permeability sands.

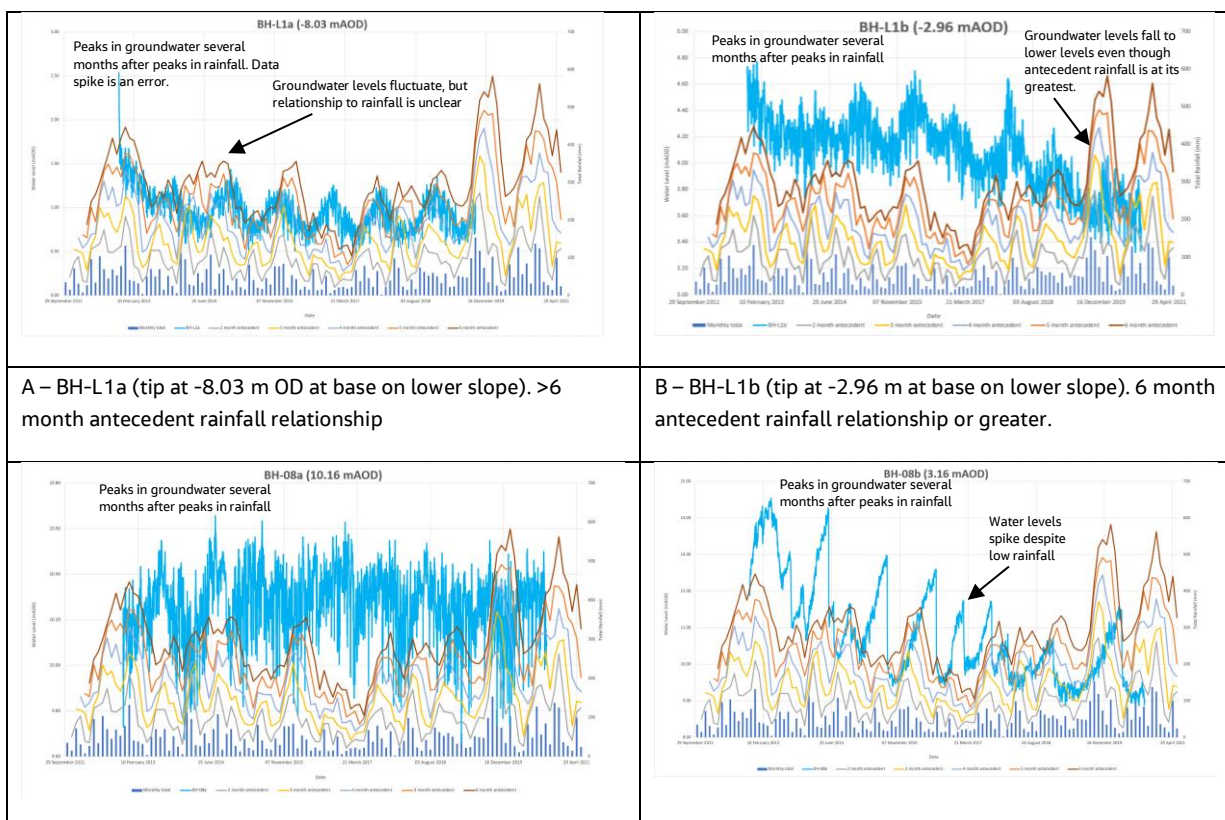
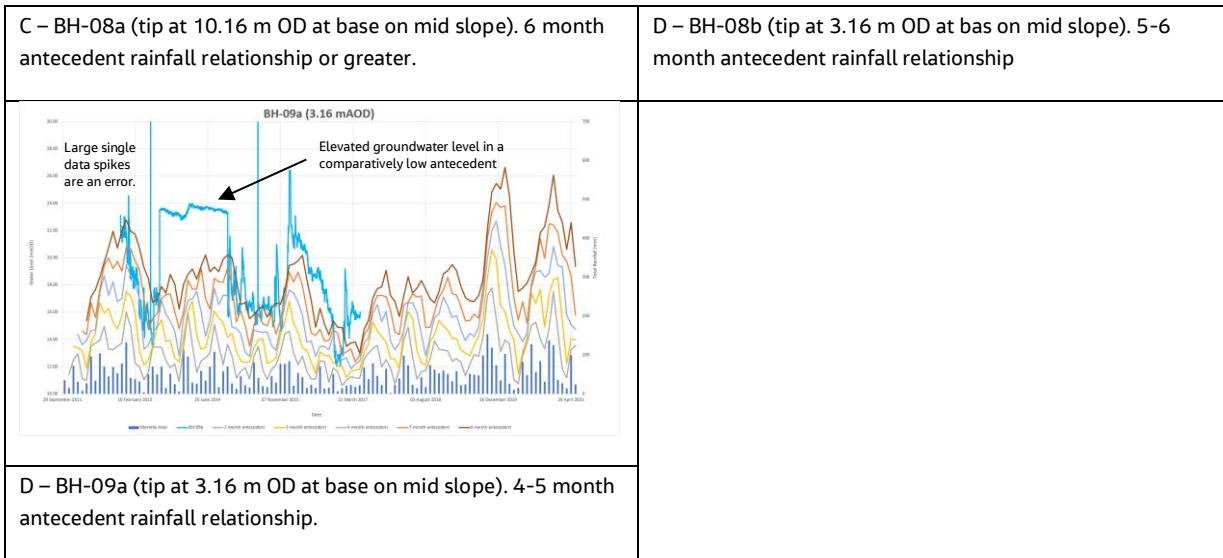
Figure 8.2: Relationship between groundwater levels and antecedent rainfall at the Holmes

The piezometers at The Holms show a lagged response to above average rainfall conditions, with only BH8a showing a rapid response. Groundwater levels in BH8a responded rapidly to higher than average rainfall in May 2015, March and November 2016. Levels fell during winter 2016/2017 following months of dry conditions then stabilised following a wet summer in 2017. Levels increased again over the drier than average winter 2017/18 and have stabilised at average levels following this. Other boreholes show a continuation of past fluctuating or steady levels of groundwater, suggesting they respond to several months' antecedent rainfall. Over the whole record, BH8b shows a different pattern of gradual highs followed by sharp falls, however movements are not shown in the inclinometer upslope at BH10A. There is no clear response in any of the boreholes to the extreme rainfall events experienced on 23 August 2017, 20 September 2018 or during autumn. During this monitoring period, the response to the wetter than average conditions in summer are not clear at the functioning piezometers. The steady and falling groundwater levels recorded may be representative of 3-month antecedent rainfall conditions.

Figure 8.2 presents the groundwater levels at the Holmes recorded by each piezometer (with a data logger) with enough continuous data and highlights the best relationship to antecedent rainfall, which has been assessed visually by plotting various antecedent rainfall totals against the piezometer records. BH-L 1a, BH-L 1b and BH-08a all have an observed antecedent rainfall relationship of greater than 6-months, whereas BH-08b and BH-09a have 5-6 month and 4-5 month antecedent rainfall relationships respectively. A groundwater level spike at BH-08b in late 2016 does not coincide with antecedent rainfall levels, which probably reflects a very localised rainfall event at The Holmes.

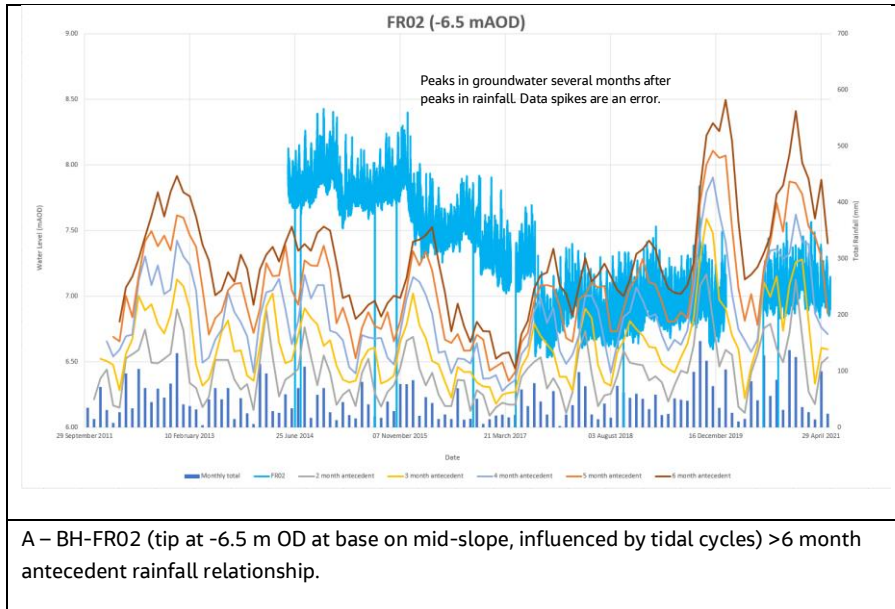
Figure 9.2: Relationship between groundwater levels and antecedent rainfall at St Nicholas Cliff.

At St Nicholas cliff (Figure 9.2) BH-FR02 shows an antecedent rainfall relationship that appears greater than 6 months. At Spa Chalet (Figure 9.3), antecedent rainfall relationships are unclear, with responses often appearing

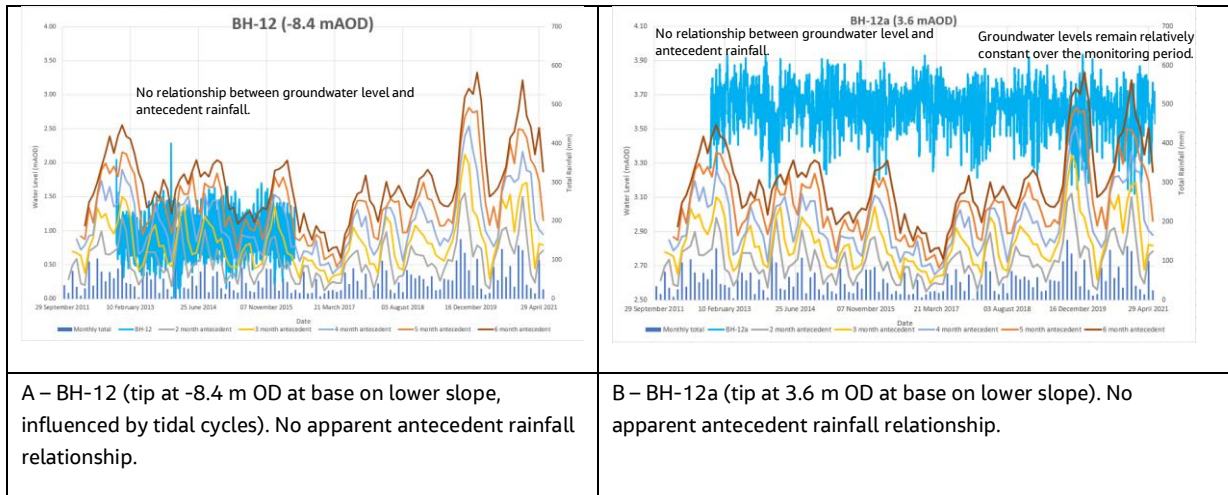
Figure 9.3: Relationship between groundwater levels and antecedent rainfall at Spa Chalet.

significantly greater than 6 months. The picture is similar at The Spa (Figure 9.4), where BH-01a Spa and BH-01 Prom also show responses of greater than 6 months. In contrast BH-H5, which is at the base of the slope behind the Spa building, suggests an antecedent rainfall relationship of 4 months. All other automated piezometers at the Spa do not have an apparent antecedent rainfall relationship. At South Cliff Gardens (Figure 9.5), the antecedent rainfall relationship is greater than 6 months at BH-D2a, BH-E2a and BH-E2b. Relationships at other automated piezometers at the South Cliff Gardens remain complex.

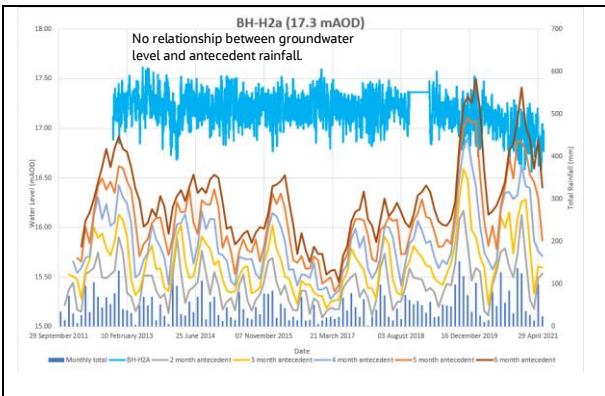
A – BH-H2a (tip at 17.3 m OD at base on upper slope near the headscarp of the Spa landslide). No apparent antecedent rainfall relationship.

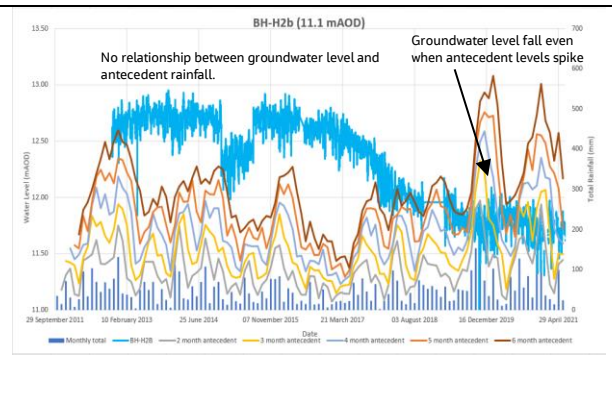
B – BH-H2b (tip at 11.1 m OD at base on upper slope near the headscarp of the Spa landslide). No apparent antecedent rainfall relationship.

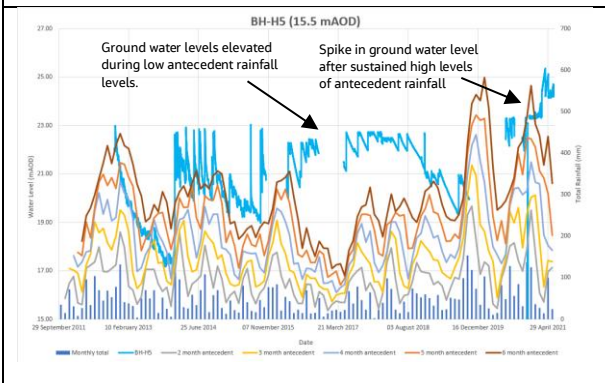
C – BH-H5 (tip at 15.5 m OD at base on lower slope near the base of the cliff behind the Spa building). Antecedent rainfall relationship is unclear due to spikes in day, but could be 4 months

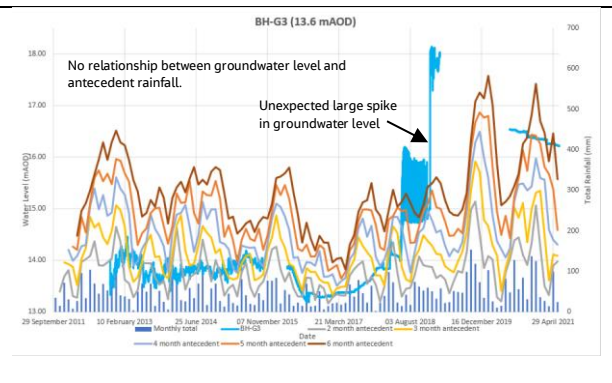
D – BH-G3 (tip at 13.6 m OD at base on lower slope near the base of the cliff). No apparent antecedent rainfall relationship.

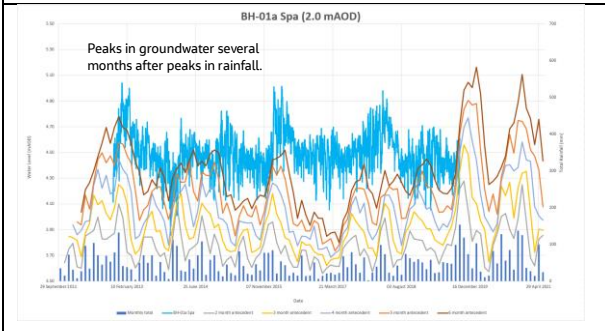
E – BH-01a Spa (tip at 2 m OD at base on lower slope at the toe of the Spa landslide). >6 month antecedent rainfall relationship.

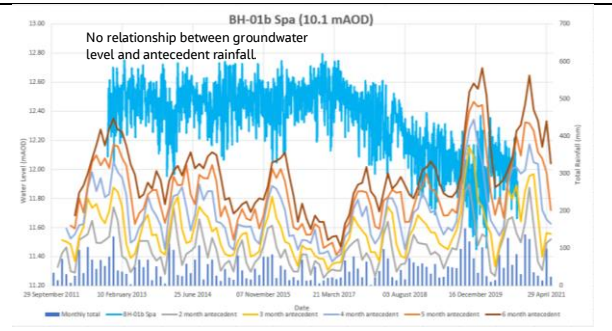
F – BH-01b Spa (tip at 10.1 m OD at base on lower slope at the toe of the Spa landslide) >6 month antecedent rainfall relationship.

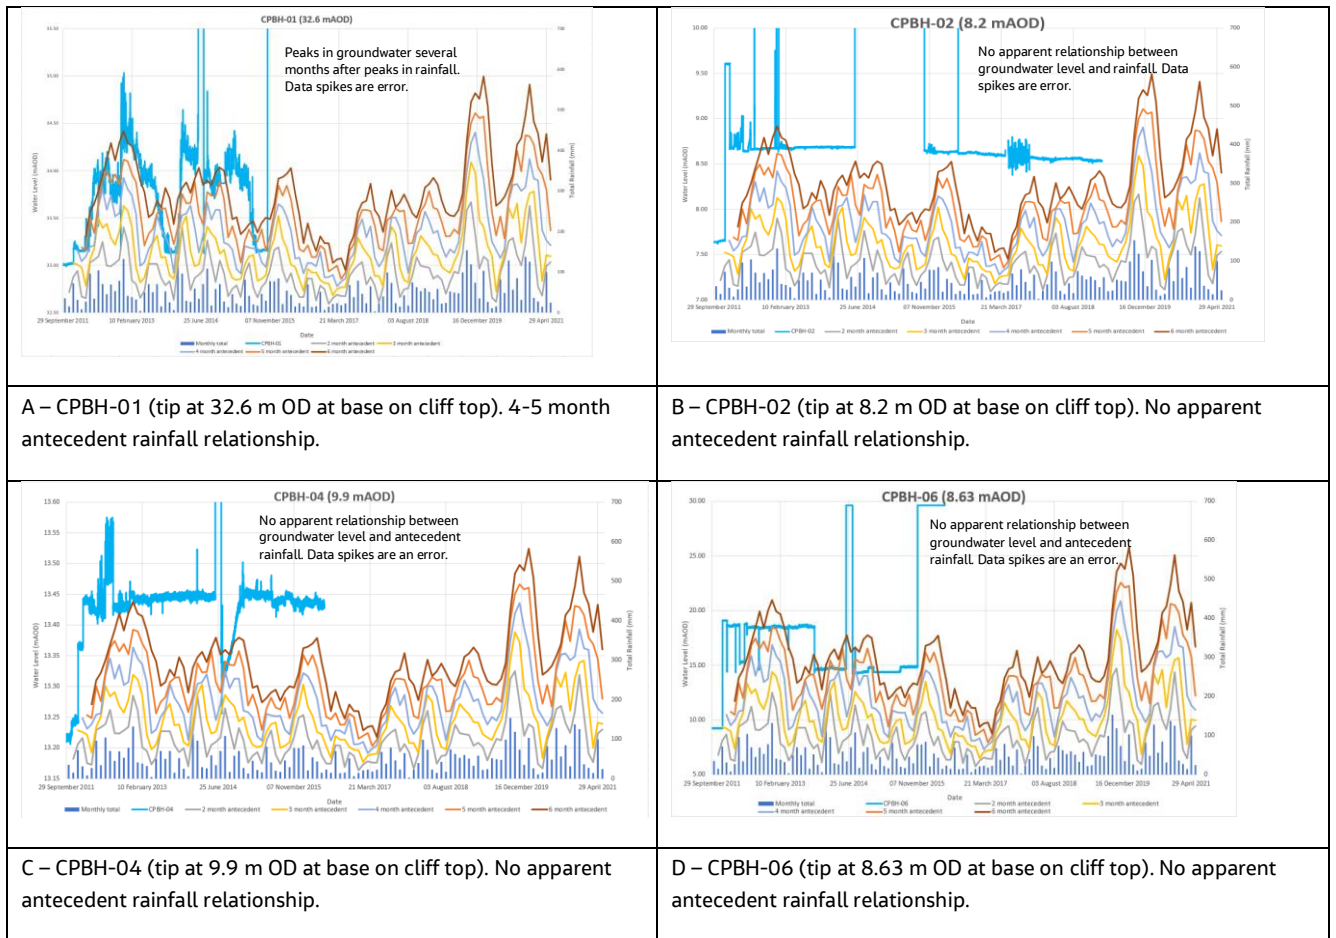
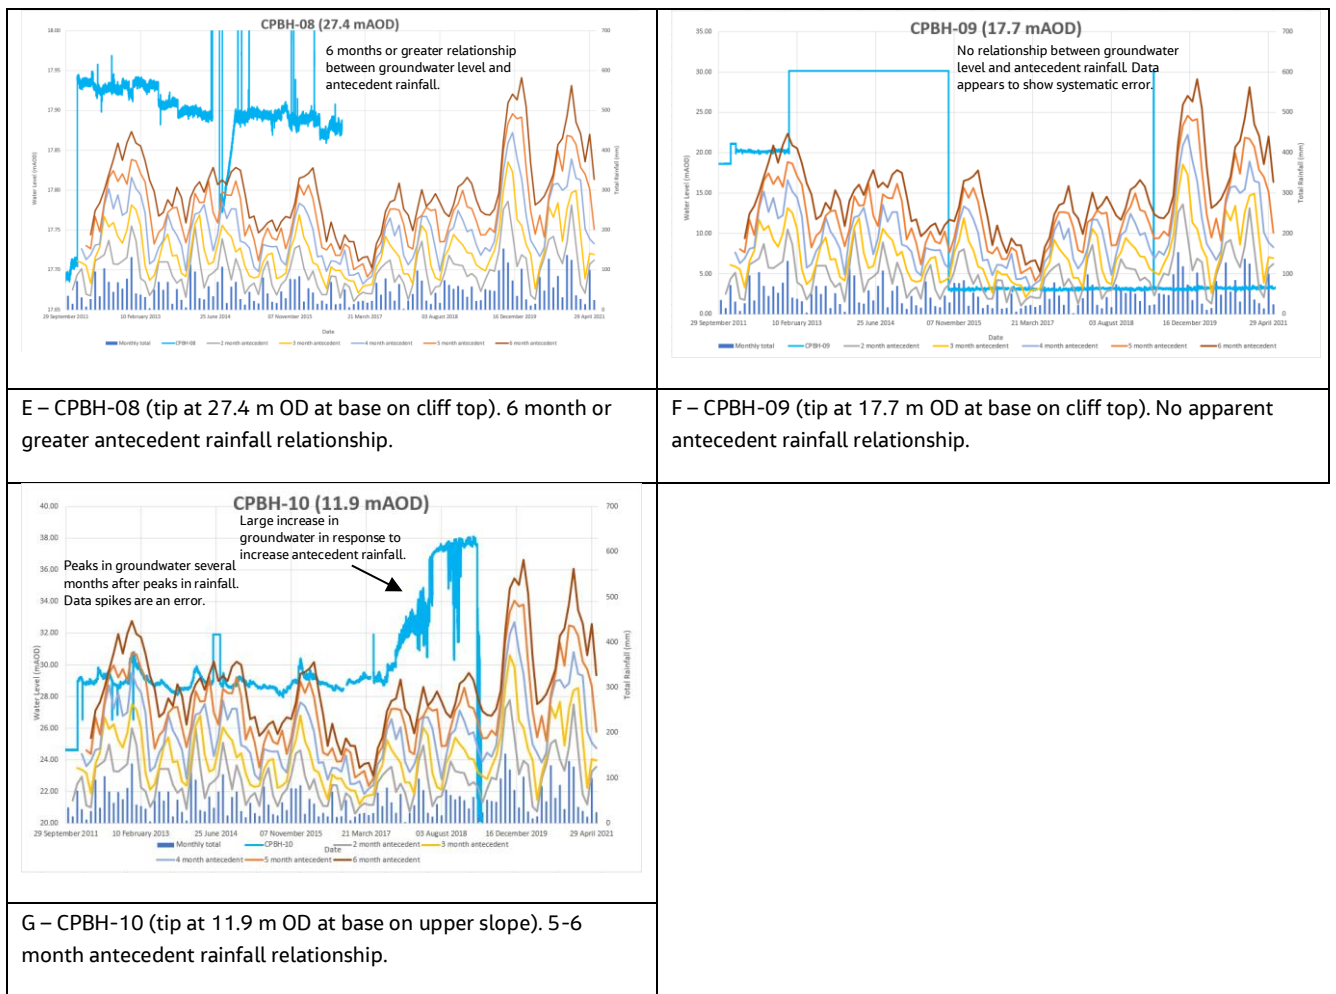
Figure 10.2: Relationship between groundwater levels and antecedent rainfall at Filey Town.

Figure 10.2 presents the groundwater levels at Filey town recorded by each piezometer (with a data logger) to highlight the relationships to antecedent rainfall. CPBH-01 and CPBH-10 have antecedent rainfall relationships of 4-5 months and 5-6 months respectively. Other automated piezometers at Filey Town have an unclear antecedent rainfall relationship.

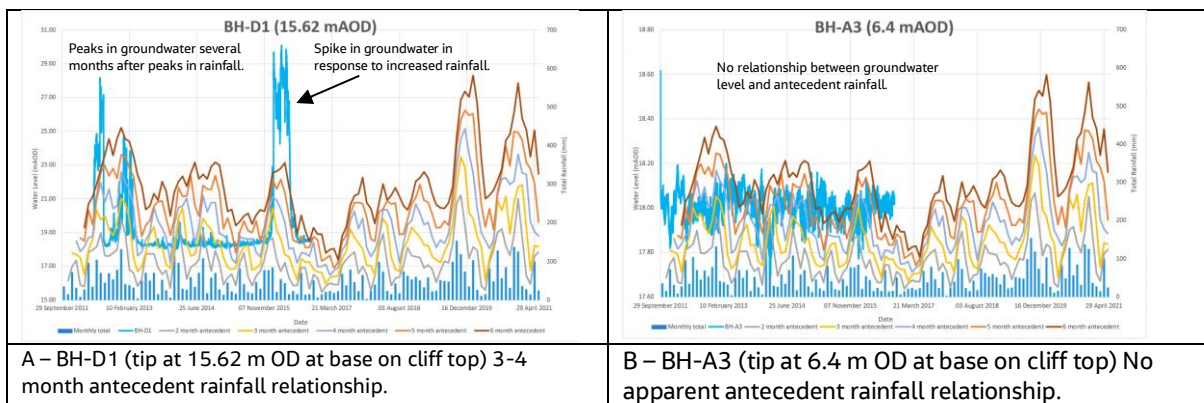
Figure 11.2: Relationship between groundwater levels and antecedent rainfall at Filey Flat Cliffs.

Figure 11.2 presents the groundwater levels at Filey Flat Cliffs recorded by each piezometer (with a data logger) to highlight the relationships to antecedent rainfall. BH-D1 has an antecedent rainfall relationship of 3-4 months. BH-A3 has an unclear antecedent rainfall relationship.
