Local Coastal Slope Monitoring Analysis: Interpretation Report 1

Prepared for
Scarborough Borough Council

February 2014

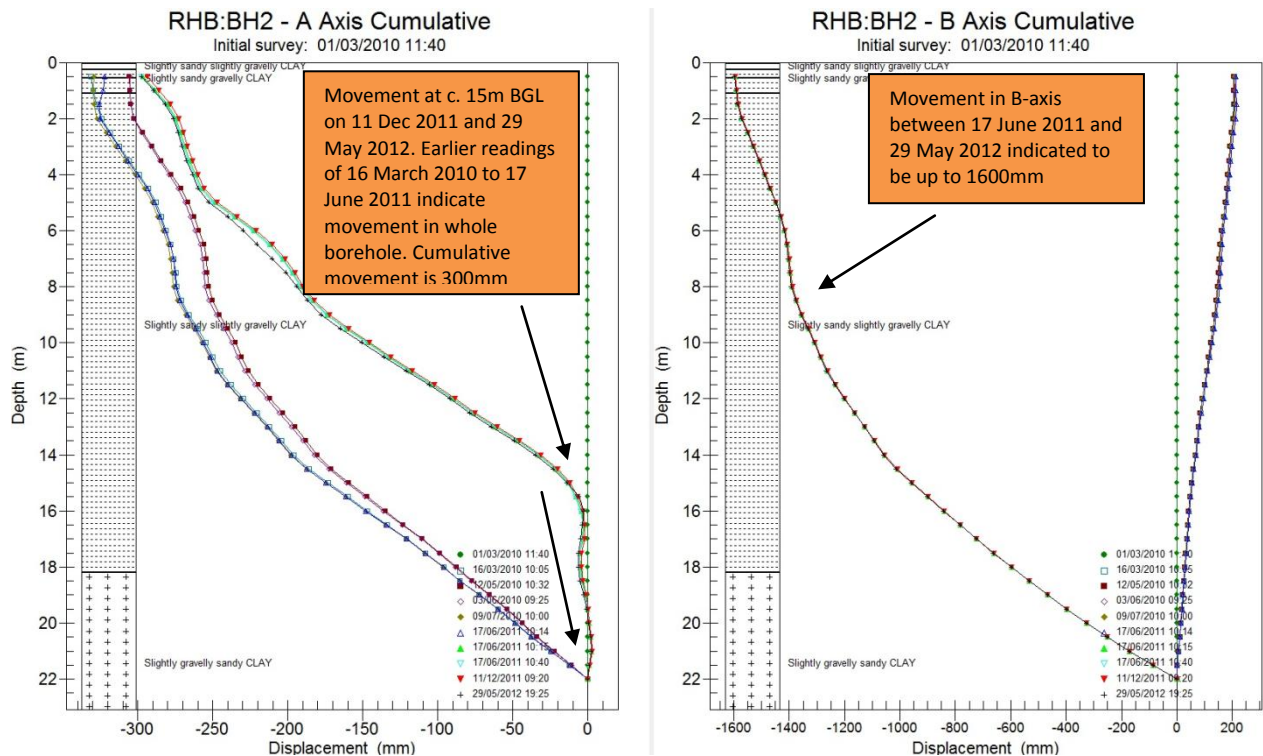
The groundwater data indicates a continuation of past patterns at Robin Hood's Bay. BH3a shows a marked rise in groundwater, but this is thought to represent ingress of surface water and or surcharge of groundwater from domestic sources. Previous work by Mouchel has noted that piezometer tubes have progressively become shallower, suggesting ingress of sediment. It is therefore recommended that the four piezometer tubes be flushed out. Results from inclinometers are hard to interpret and appear to be erroneous, meaning there is uncertainty over the nature of any recent ground movement. These data should be carefully reviewed in future monitoring reports and erroneous data removed from record.

Figure 5.2 Probable erroneous inclinometer data from Robin Hood's Bay BH2

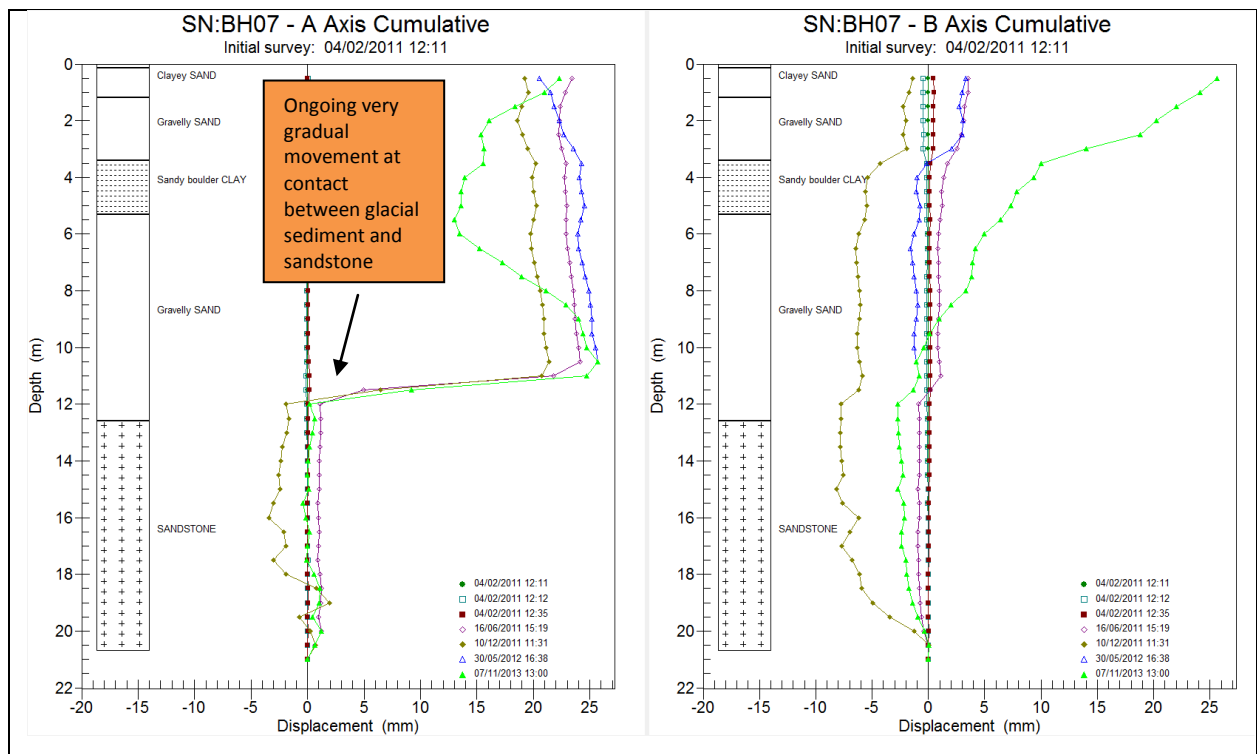
- A small amount of on-going movement was recorded in BH 7 (Figure 6.2)
- Exceptionally high ground water levels were achieved December 2012, before the current phase of monitoring. Since then water levels have fallen or remained stable in all boreholes except WS5, where levels reached their highest point in October 2013.
- Water levels recorded in boreholes P4a and P4b are curious and calibration of the piezometers should be checked.

Figure 6.2. Inclinometer data at Scalby Ness BH07

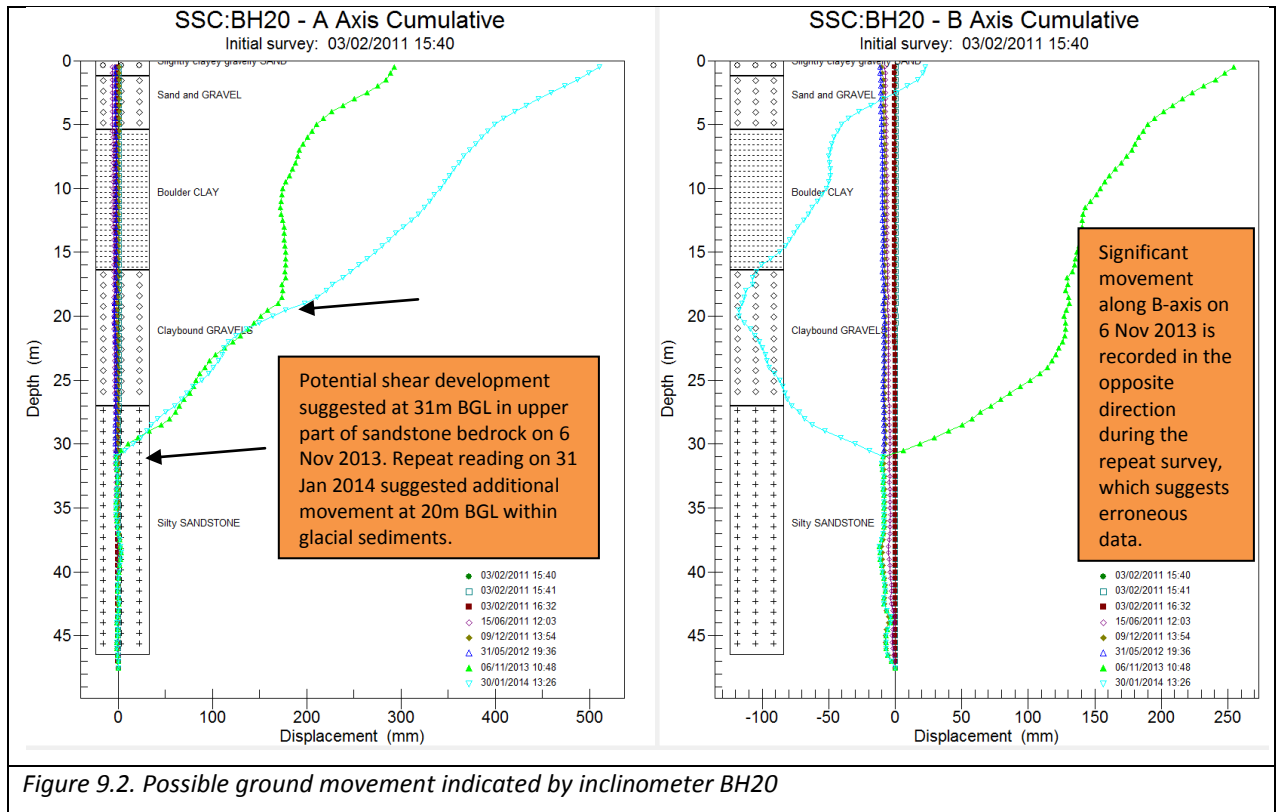
Figure 9.2. Possible ground movement indicated by inclinometer BH20

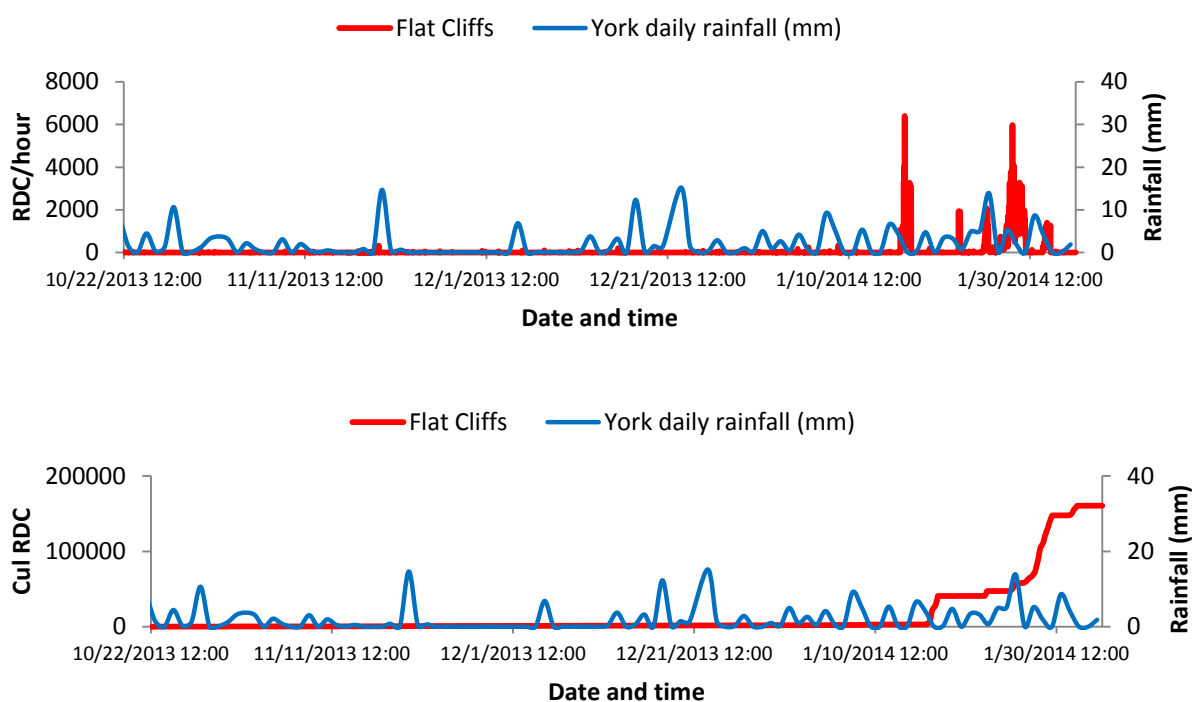
- No firm evidence for ground movements is shown by inclinometers. Indicated movements are erroneous, and linked to the probe coming free from the inclinometer tube keyway.
- Acoustic inclinometer data suggests some strain in the borehole occurred in late January 2014 (Figure 11.2). This is beyond the period where other monitoring data are available and therefore inclinometer data will be reviewed in the next report.
- Groundwater data show stable or falling groundwater levels except at borehole B1, where infrequent manual readings suggest an increase.

Figure 11.2 Acoustic emission (AE) rate (RDC/hour) and cumulative RDC compared to rainfall at Flat Cliffs, October 2013 to January 2014.
