Local Coastal Slope Monitoring Analysis

Interpretation Report 2 December 2013 to May 2014

Prepared for
Scarborough Borough Council

November 2014

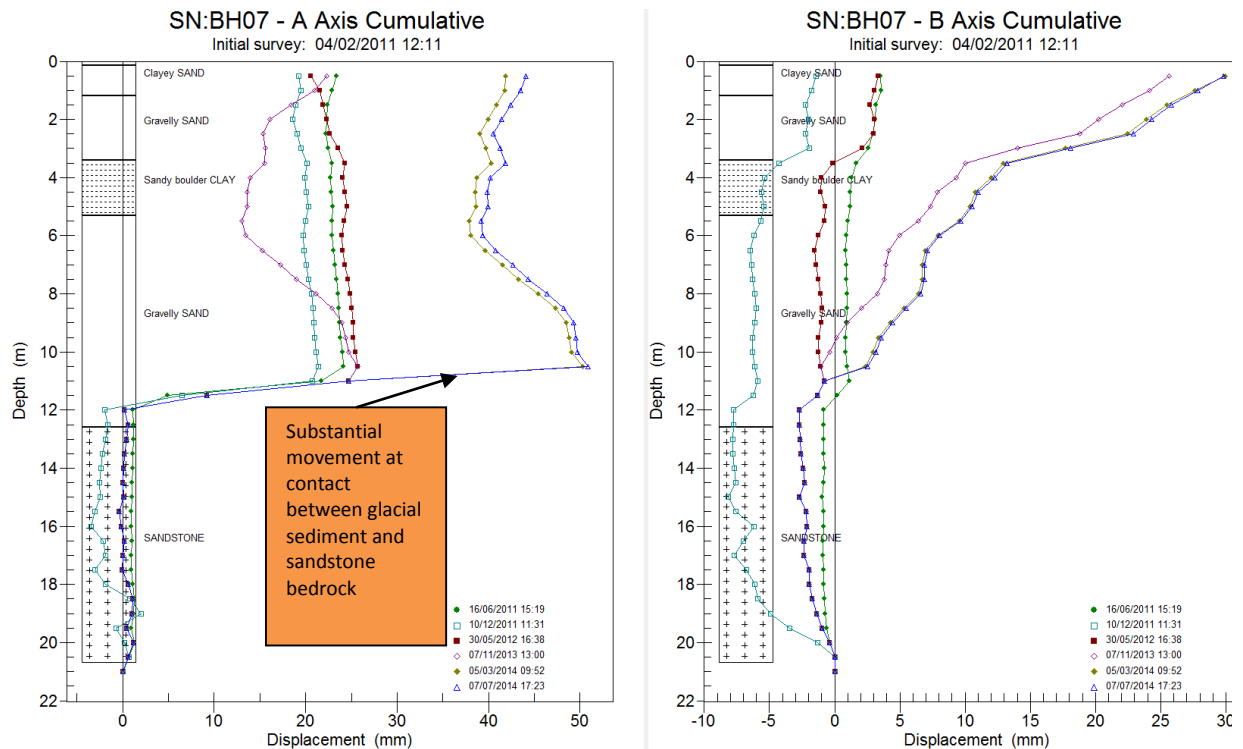
The inclinometers in BH7 and L2 show significant sub-surface movement. BH7 is the most pronounced and indicates movement on an existing shear plane just above the sandstone bedrock in glacial sediments. This movement occurred between November 2013 and March 2014, and is likely to be associated with the period of high groundwater levels (nearby piezometers P4a and P4b show elevated groundwater peaking in mid-February 2014). This suggests a threshold groundwater level for movement occurred.

Figure 6.2. Inclinometer data at Scalby Ness BH07

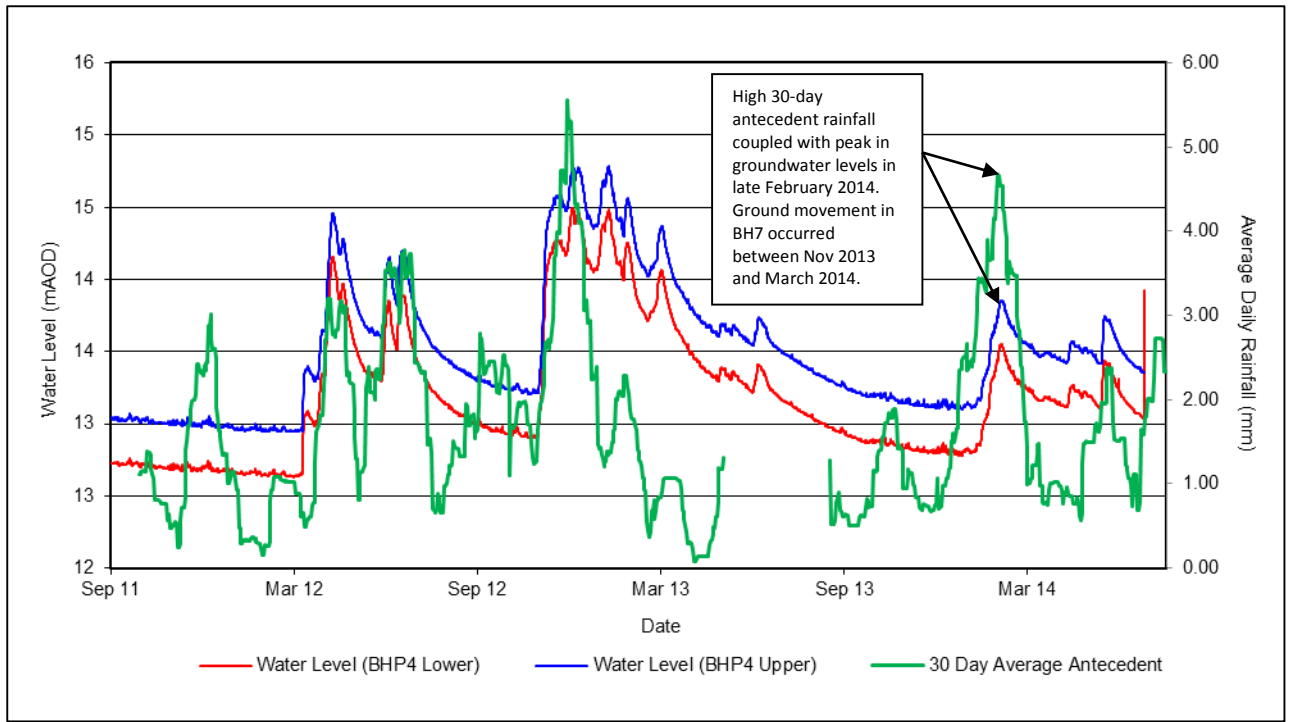
Figure 6.3: 30-Day antecedent rainfall and groundwater levels in piezometers BHP4a and BHP4b. 30-day antecedent average daily rainfall is, on any given day, the average rainfall from that day and the preceding 29 days.

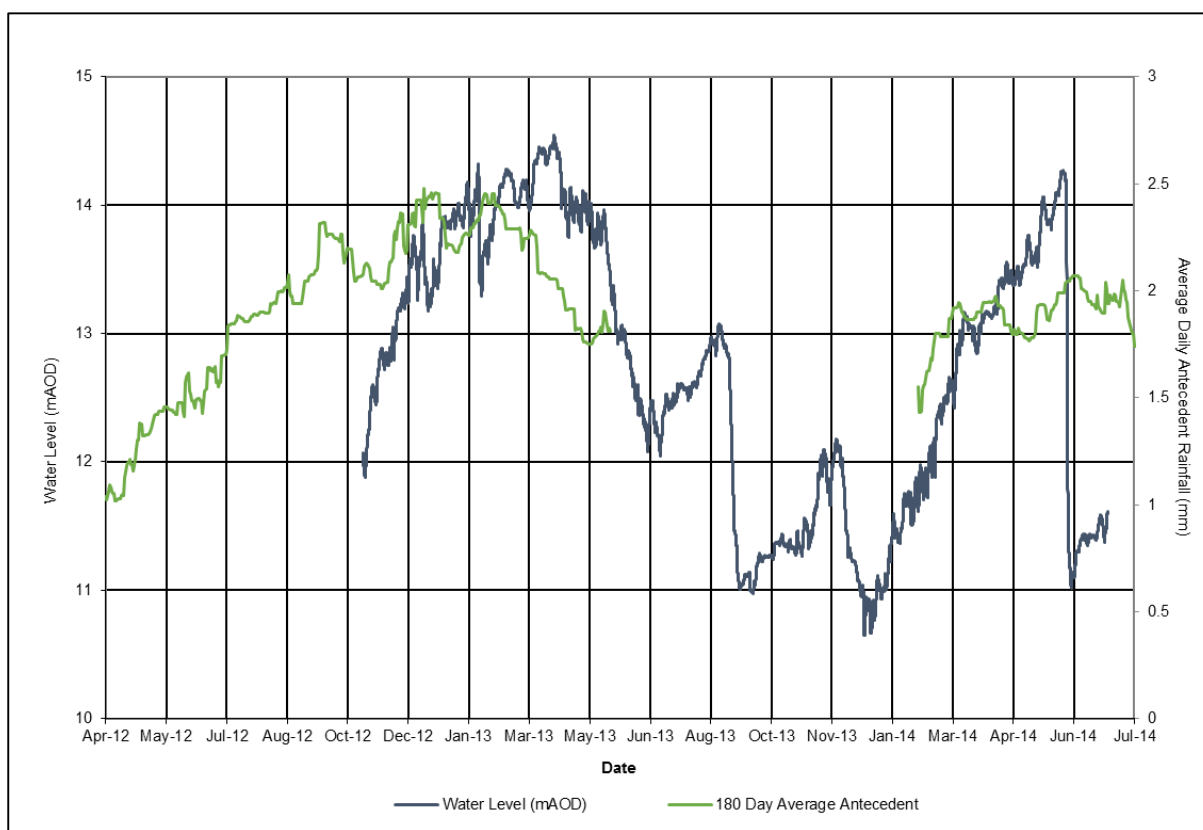
The relationship between 180-day (c. 6-month) antecedent rainfall pattern and groundwater level at BH8b is presented in Figure 8.2. A gap in the rainfall data between late May and early August 2013 means that the extent of the relationship through that period and the following 180 days (i.e. from late May 2013 until late January 2014) cannot be accurately determined.

Figure 8.2: Relationship between 180-day antecedent rainfall and groundwater level at BH8b.

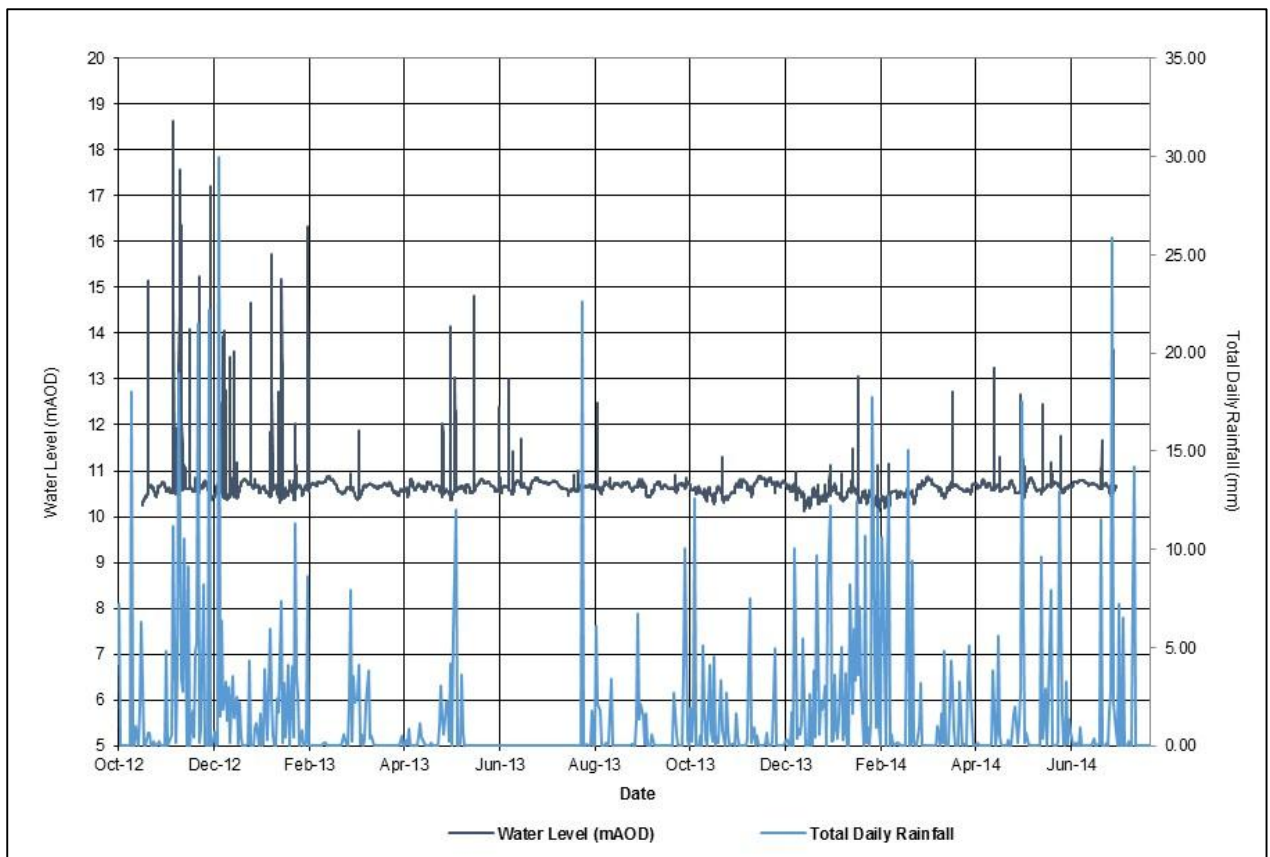
- BH19a, D2b and Bh3a have not been read due to problems with the data loggers.
- Bh3b and BH18a show a pattern of spikes which are unlikely to be due to actual changes in groundwater level and appear to be associated with ingress of surface water during wet periods (See Figures 9.2 and 9.3).

Figure 9.2: Spikes in groundwater in BH3b compared to total daily rainfall from Flat Cliffs. Note a limited correlation between days with higher rainfall and spikes in groundwater level.

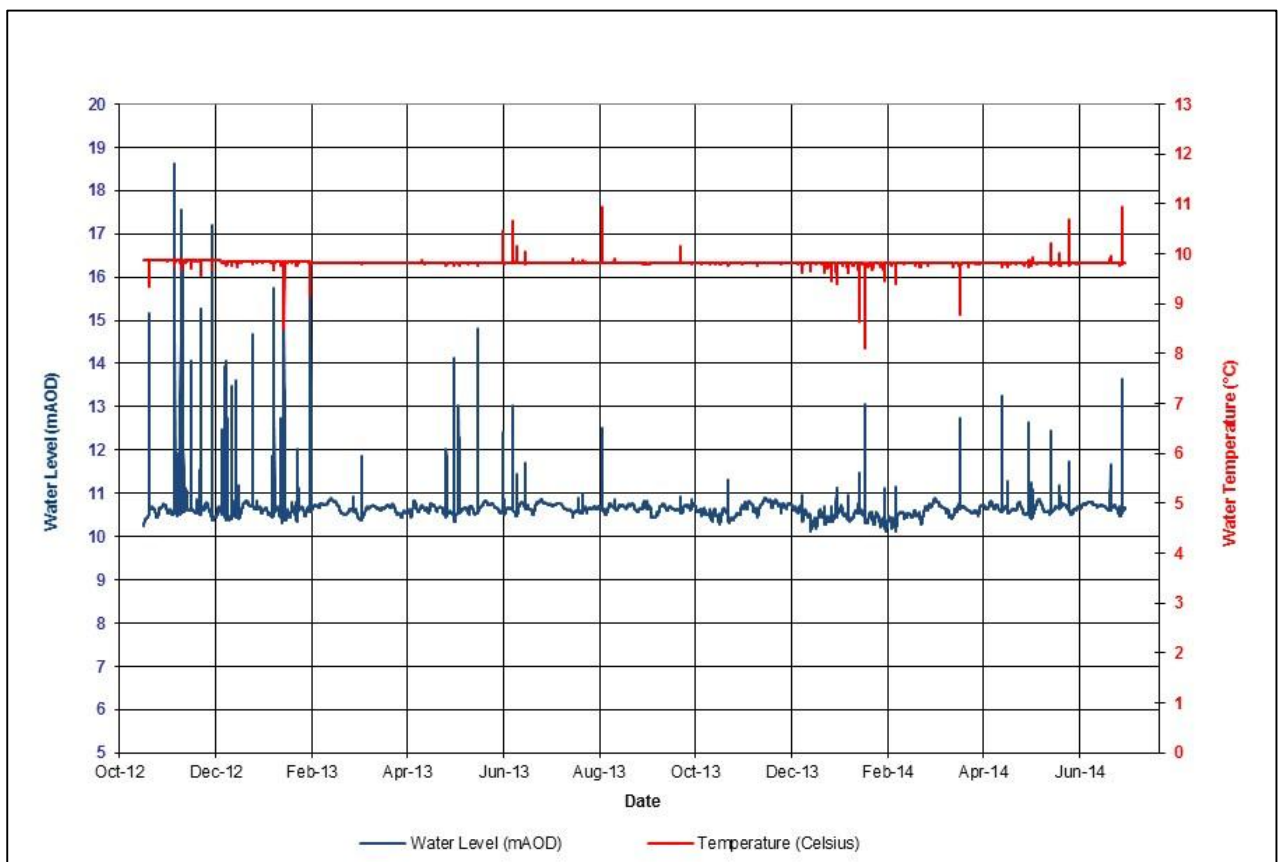
Figure 9.3: Correlation between peak groundwater levels and changes in temperature. During summer groundwater temperature rises at the time of water-level peaks, while during winter groundwater temperature drops. The relationship during spring and autumn is more muted and the direction of change is less consistent, but the timing of the changes still correlate with the apparent peaks in groundwater level.

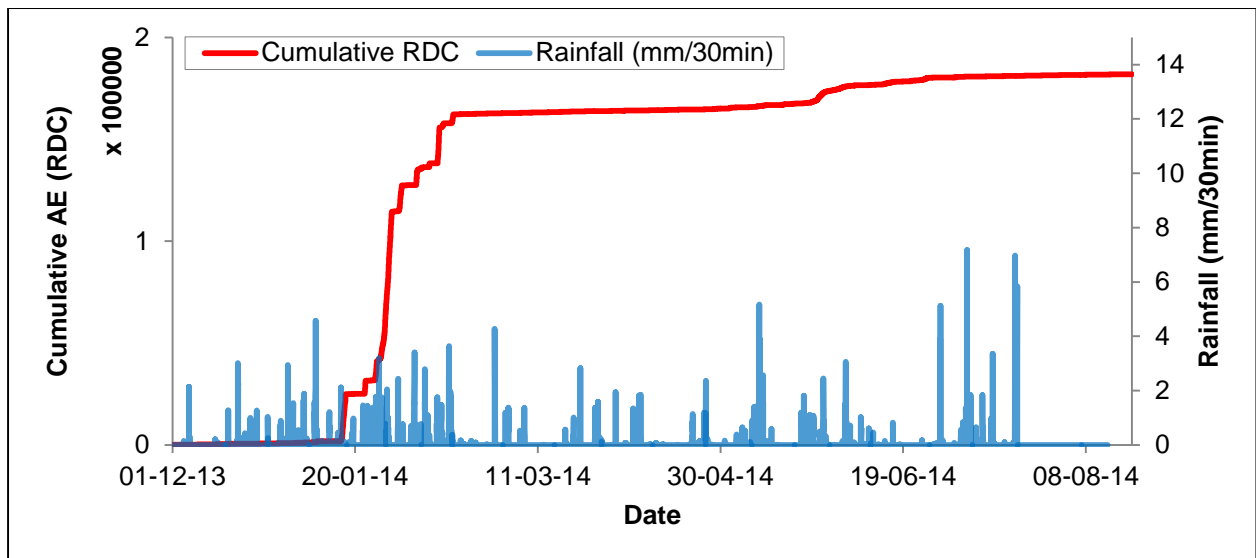
- Acoustic inclinometer data suggests some strain in the borehole occurred between January and February 2014 (Figure 11.2), but ground movements were not indicated in adjacent inclinometer borehole C1. The results may indicate strain within the slope material, but do not indicate development of a shear surface.

Figure 11.2 Acoustic emission (AE) rate (RDC/hour), cumulative RDC and rainfall at Flat Cliffs

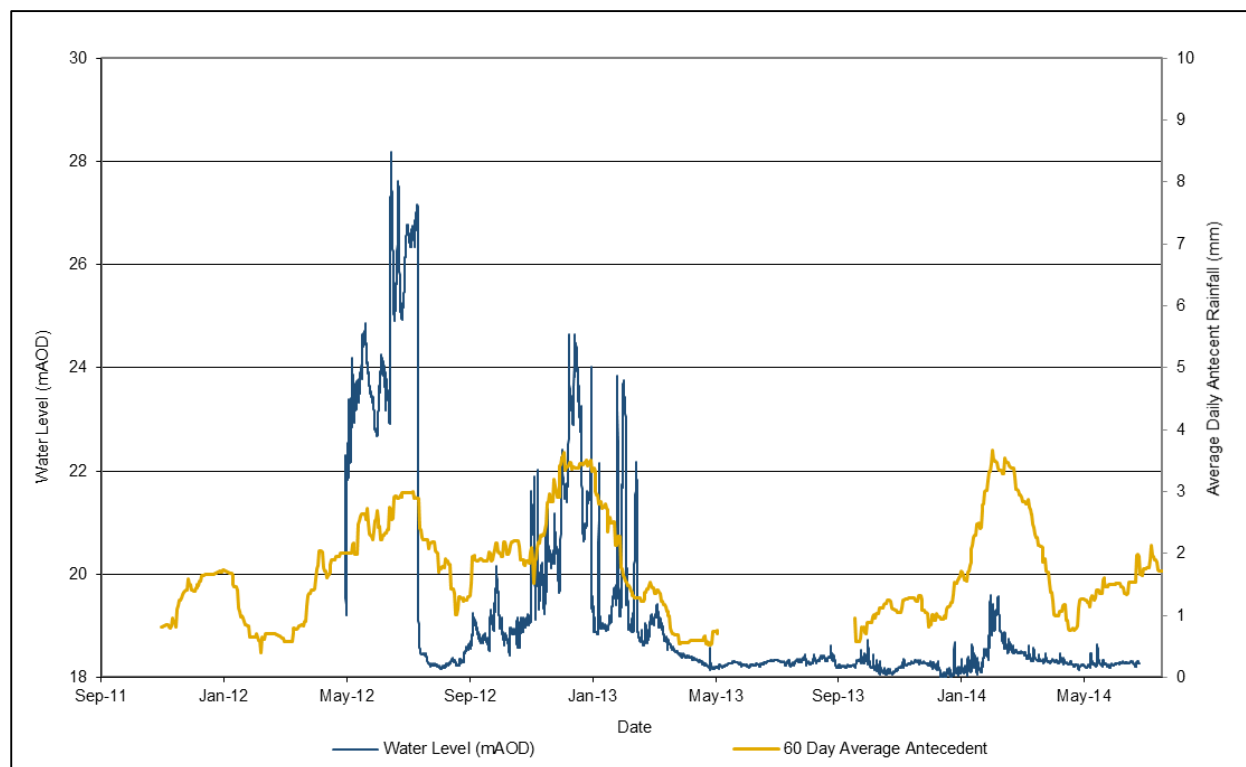
No relationship is identifiable between ground movements and rainfall as no substantial ground movements have occurred. However, borehole D1 appears to show a response to above average rainfall in January and February 2014 and borehole C4a clearly shows the effect of the 5 December 2013 storm surge on groundwater levels as the highest peak in the record (Figure 11.3).

Figure 11.3: Relationship between 60-day antecedent rainfall and groundwater levels in borehole D1.
