*Local Coastal Slope Monitoring Analysis*

# Interpretation Report 3 June 2014 to November 2014

Prepared for  
**Scarborough Borough Council**

March 2015

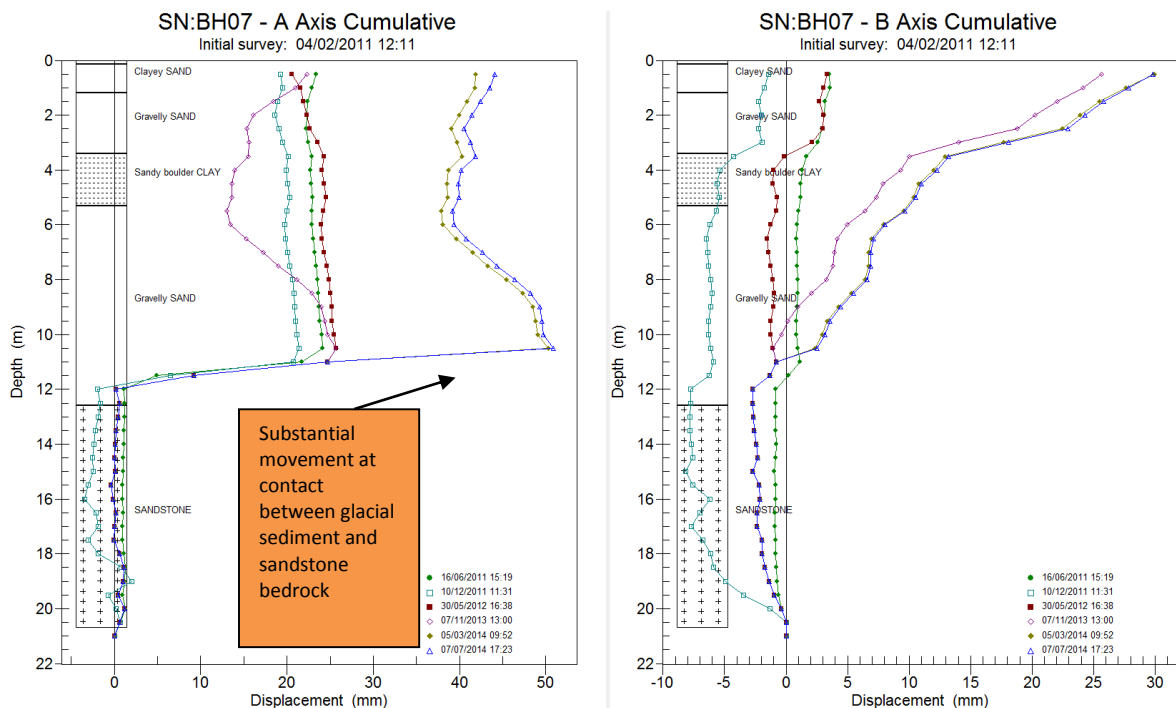
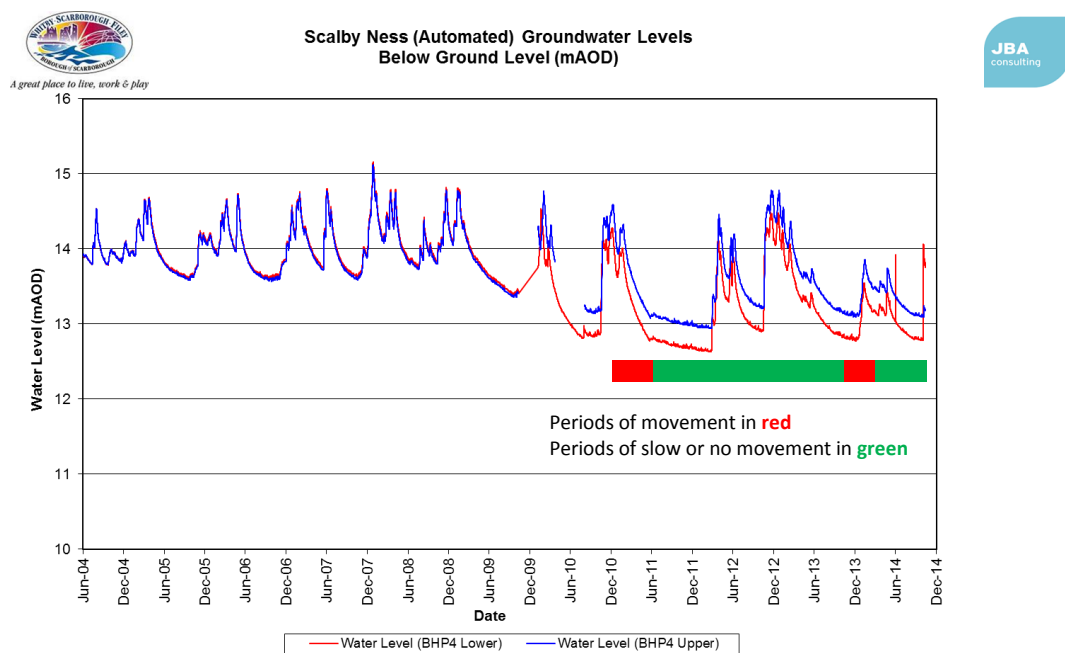
Figure 6.2. Correspondence of ground movement at inclinometer Scalby Ness BH07 and piezometer P4.

The inclinometers in BH7 and L2 show significant sub-surface movement. BH7 is the most pronounced and indicates movement on an existing shear surface in glacial sediments above sandstone bedrock. Movement occurred between November 2013 and March 2014, associated with a period of high groundwater levels (nearby piezometers P4a and P4b show elevated groundwater peaking in mid-February 2014 at 13.5 and 13.8m respectively) (Figure 6.2). Neither inclinometer recorded movement between June and November 2014, associated with low groundwater levels. As Figure 6.2 indicates, the relationship between groundwater level and ground movement is unclear. While movement in the winters of 2010/11 and 2013/14 can be associated with elevated groundwater, similarly high groundwater levels in the winter of 2012/13 are not associated with ground movement, possibly due to slow borehole equilibration with the surrounding ground.

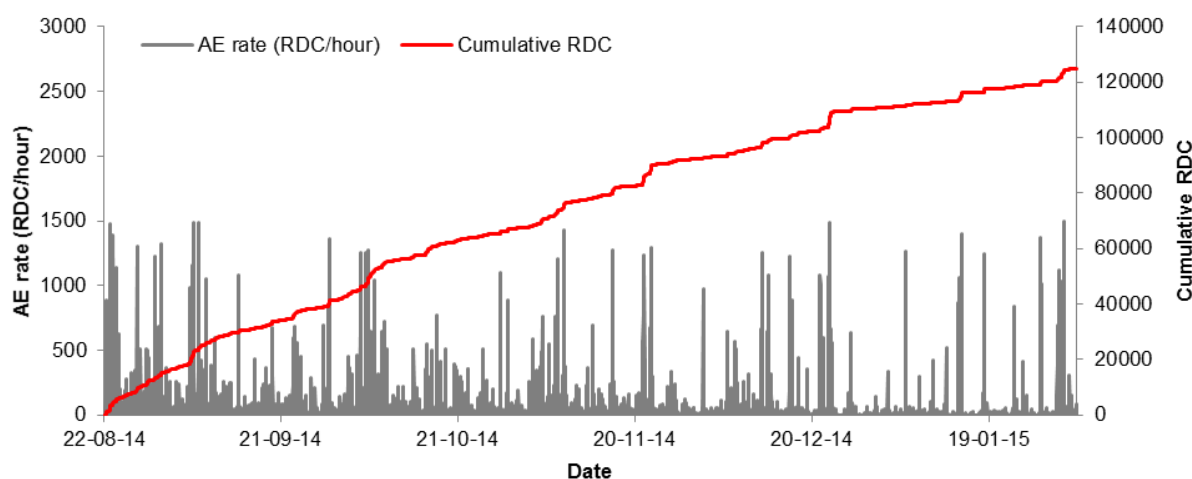
Figure 9.2. AE rate- and cumulative AE-time series measurements at Scarborough Spa for the period August 2014 to February 2014.

- Borehole BH109 shows possible minor ground movements. The accuracy of readings is unclear and the record should be reviewed once the borehole has been cleaned.
- Piezometers H5, 5 Spa, G1a and BH108a should be checked because they are dry or show rapid peaks in water level that reach ground level. These readings suggest the boreholes are being flooded.
- Acoustic emissions (AE) detected are most likely a response to rainfall events and groundwater seepage and not slope movements (Figure 9.2)

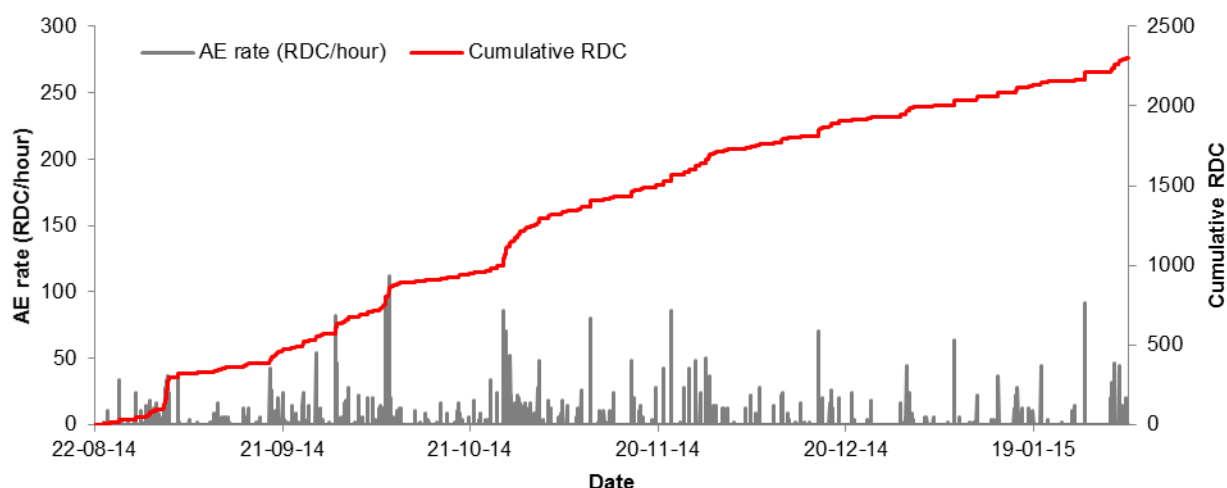
Figure 11.2 Acoustic emission (AE) rate- and cumulative AE time series measurements at Flat Cliffs for the period August 2014 to February 2015

- No evidence for ground movements is shown by inclinometers.
- Acoustic inclinometer data for the period August 2014 to February 2015 do not show any significant slope movement (Figure 11.2). Fluctuations in the data represent rainfall-induced groundwater flows interacting with the wave guide.
- Groundwater data show no significant change, except for a 1.6m fall in water level at piezometer B1 , reflecting the below average rainfall experienced in the region.
