Interpretation Report 5: June to November 2015

Prepared for
Scarborough
Borough Council

February 2016

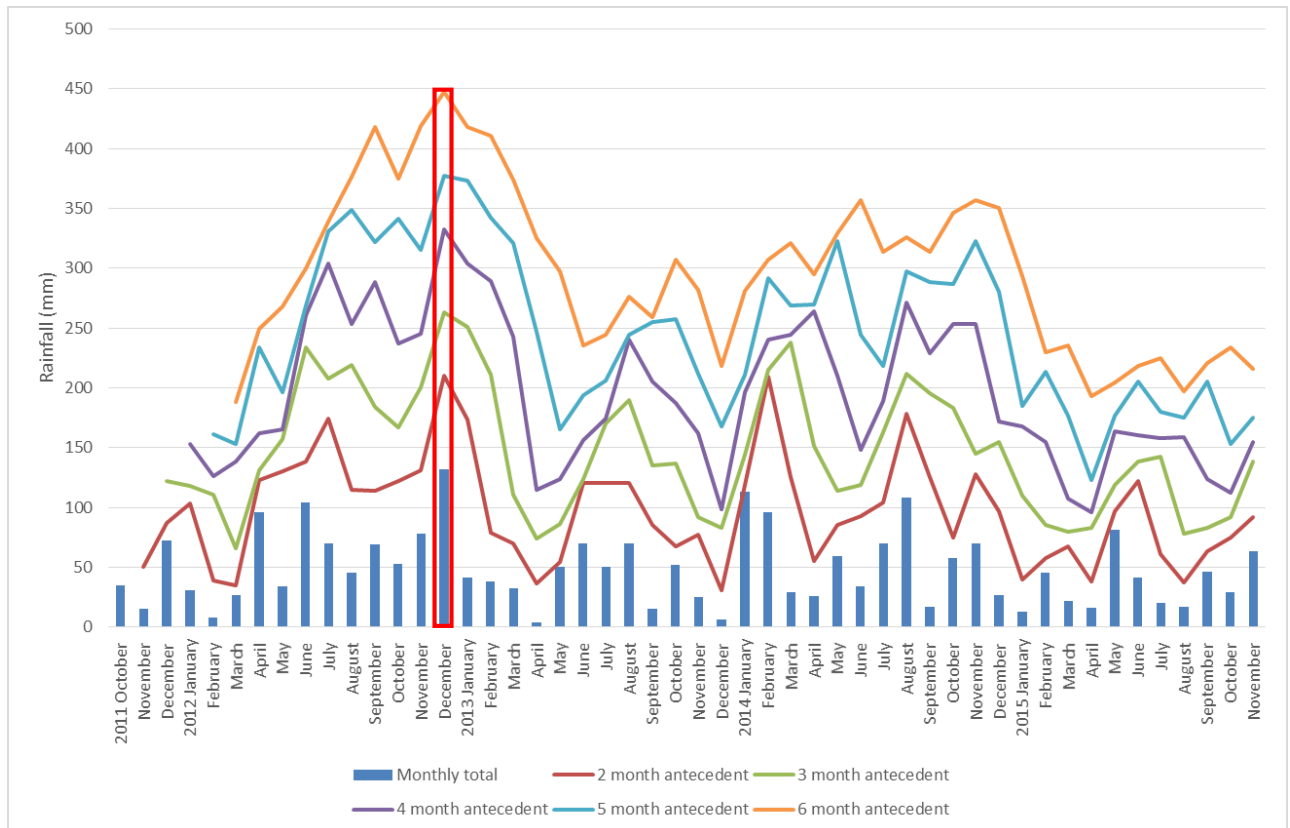
Figure 2.7. Monthly rainfall and antecedent totals (2011 to 2015). Ground movements were recorded at Scalby Mills during December 2012 (red box).

The weather records for the SBC frontage spans a relatively short time period, but does include the particularly wet year of 2012. The only 'significant' ground movements at this time were recorded in BH7 at Scalby Ness, which occurred during December 2012. Monthly rainfall totals are provided in Table 2.1 and antecedent totals are presented in Figure 2.8. Assuming that rainfall was the sole trigger of this ground movement, it suggests a three month antecedent rainfall threshold of 263mm is required to trigger movement. The absence of movements elsewhere on the coast at this time suggests that the antecedent rainfall threshold levels are above this at other locations.

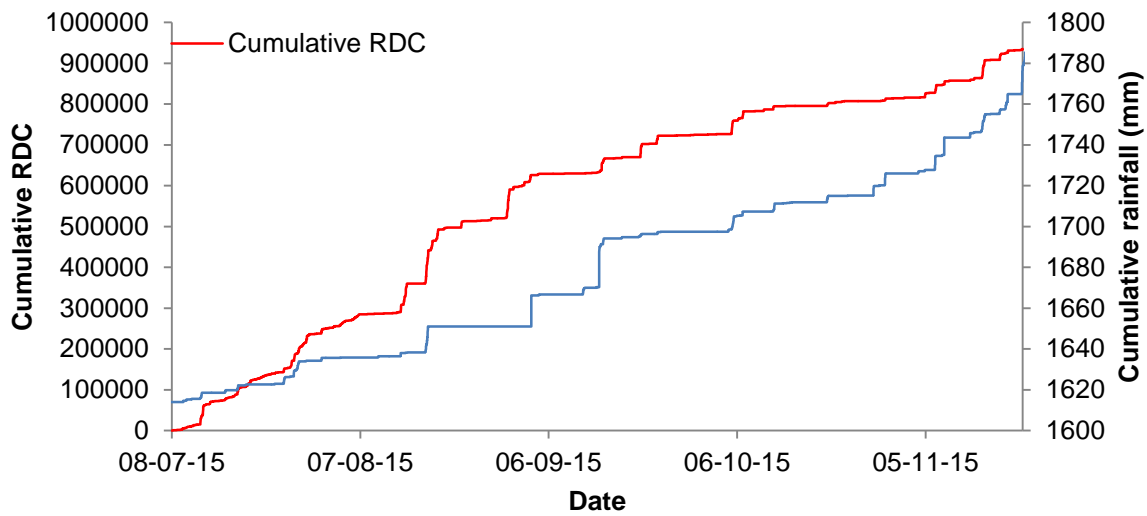
Figure 9.2. AE rate- and cumulative AE-time series measurements at Scarborough Spa for the period July 2015 to November 2015.

- Acoustic emissions (AE) detected are negligible and do not suggest slope movement. Fluctuations in the data represent rainfall-induced groundwater flows interacting with the wave guide. (Figure 9.2)

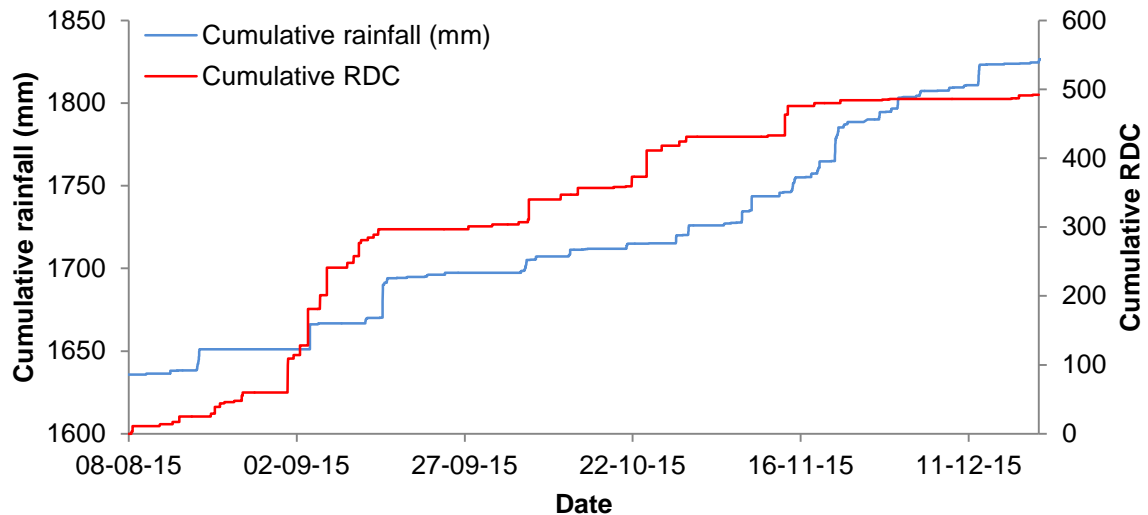
Figure 11.2 Acoustic emission (AE) rate- and cumulative AE time series measurements at Flat Cliffs for the period August 2014 to September 2015

- No evidence for ground movements is shown by inclinometers.
- Acoustic inclinometer data for the period August to December 2015 do not show any significant slope movement (Figure 11.2). Fluctuations in the data represent rainfall-induced groundwater flows interacting with the wave guide. Periods of elevated AE activity during September is indicative of deformations of a very slow rate and small magnitude.
- Groundwater data show no significant change, with the exception of B1 where levels reach a historical high.
