## **Cell 1 Regional Coastal Monitoring Programme Analytical Report 14: 'Full Measures' Survey 2021**

(\*) The present report is **Analytical Report 14** and provides an analysis of the 2021 Full Measures survey for Northumberland County Council's frontage.

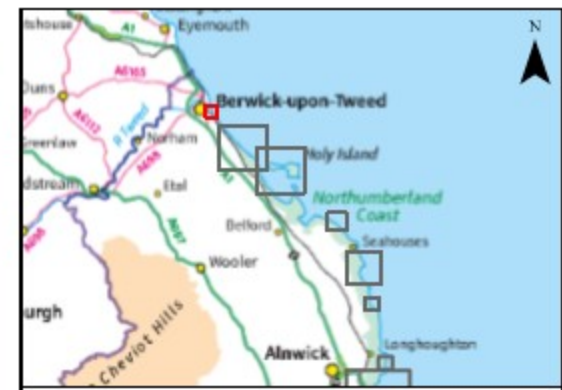
**SURVEY LOCATIONS**

The location of these surveys is shown in **Figure 2**. The Full Measures survey was undertaken on various dates along this frontage between 24<sup>th</sup> August and 8<sup>th</sup> October 2021. During this time, weather conditions varied considerably; refer to the survey reports for details of the weather conditions over this survey period.

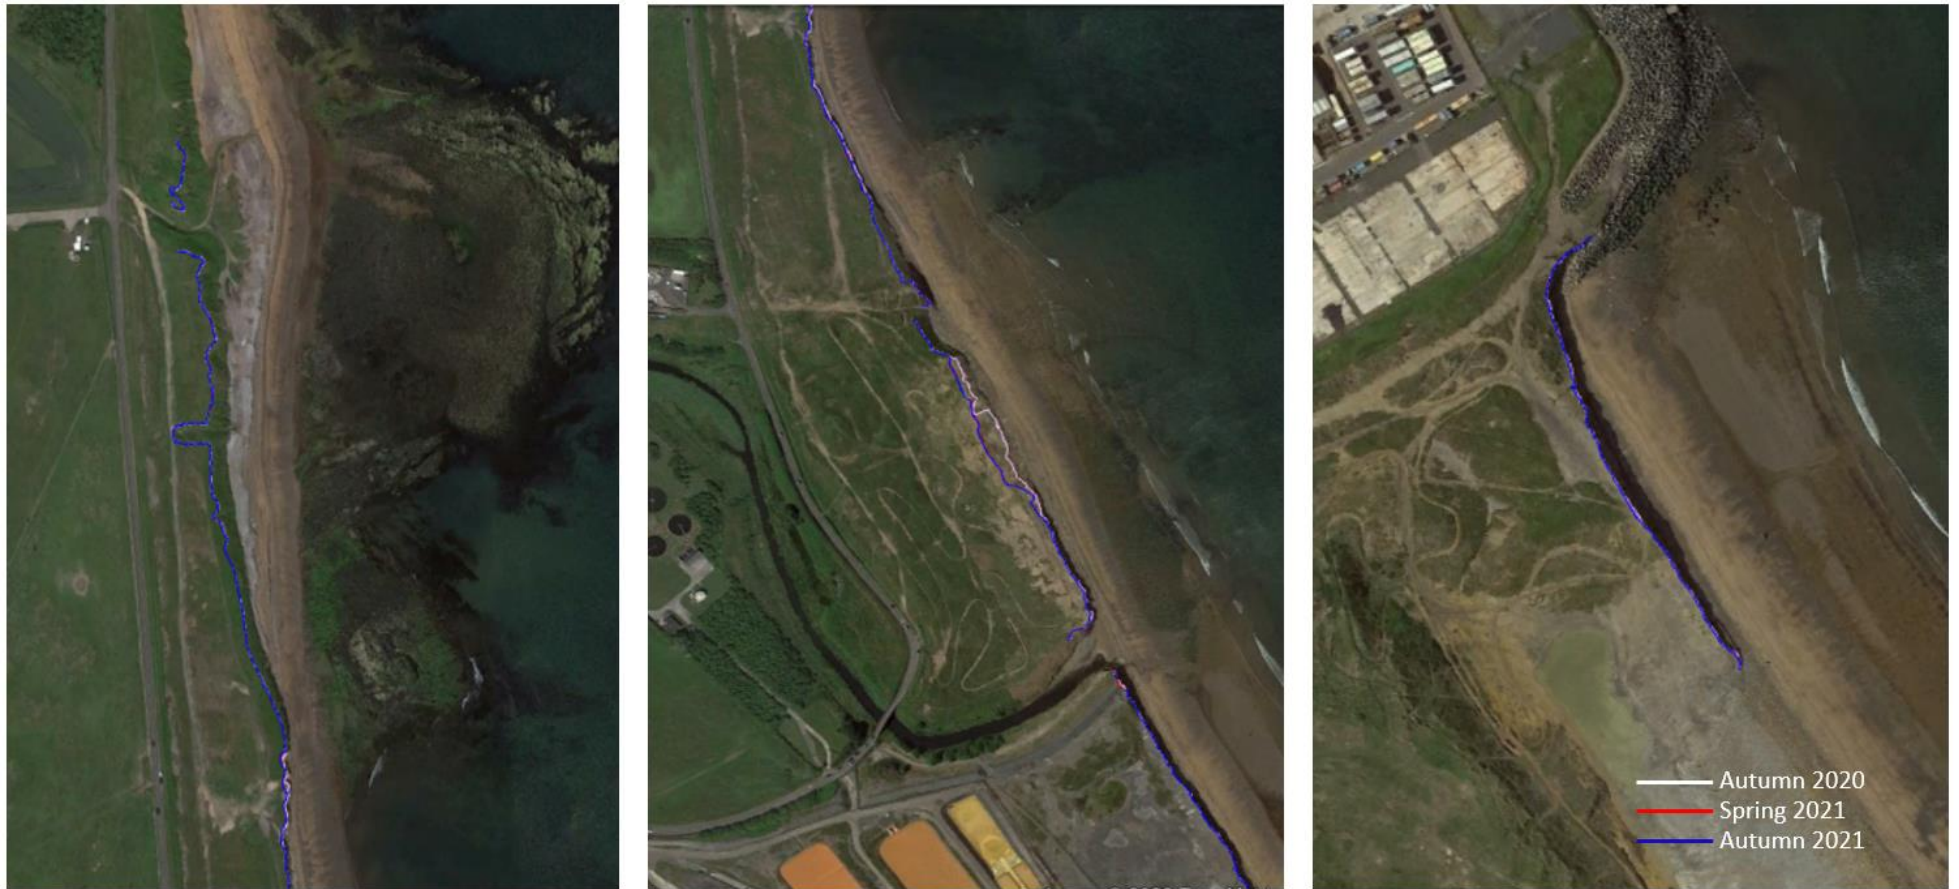
Figure 3 Lynemouth cliff top survey – autumn 2021 (north: left, centre: middle, and south: right)

September 2021	<p><b>Colliery Spoil Edge Survey:</b></p> <p>Colliery spoil edge survey data was collected for a baseline survey in December 2020. Subsequent surveys have been taken in spring 2021 and autumn 2021 (Figure 3).</p> <p>In the very north of the bay, the colliery spoil forms a beach and the survey of the low cliffed edge of this spoil beach shows a progradation of sediment in the lee of the Headagee rock outcrops. The edge of the colliery spoil beach then merges back into the colliery spoil cliff toe just to the south of the rock outcrops. It has been observed empirically that the spoil beach is eroding landwards and the point where it merges into the cliff is moving northwards, causing the cliffs to become exposed and start eroding. Further north, the remaining spoil beach protects natural cliffs/ coastal slopes. The cliff</p>	<p>Where a spoil beach is present on the foreshore, the backing spoil cliffs or natural cliffs/dune are stable because they are not currently affected by marine processes.</p> <p>Where the spoil beach is absent, the backing colliery spoil cliffs are actively eroding, causing measurable landward recession.</p> <p><b>Longer term trends:</b> Since cliff top surveys began in December 2020, cliff movement has been greatest in</p>

Survey Date	Description of Changes Since Last Survey	Interpretation
	<p>edge has remained stable in this part of the bay since the previous survey, with very little change recorded.</p> <p>In the centre of the bay (immediately north of the power station north towards Headagee the colliery spoil cliff is no longer protected by a distinct fronting colliery spoil beach (although the natural beach is very much intermixed with spoil, it does not form a distinct spoil beach like that present in the north of the bay). Colliery spoil between the Power Station and the River Lyne has remained relatively stable, with only small areas of recession by up to 0.5m. The greatest change is recorded opposite Lynemouth, where a 14m section eroded by up to 2.0m since the previous survey. This extent of change is beyond the landward of extent of the enabling works and must be deemed at least part erosion.</p> <p>In the south of the bay south of the power station) the colliery spoil extends some distance seaward of the backing (and underlying) natural dunes, forming a 'berm' (rather than a distinct cliff edge) at the seaward edge. This berm has been eroding landwards, but at a lesser rate than in the centre of the bay. There has been little movement in the colliery spoil edge since the previous survey.</p>	<p>the centre of the bay (north of the River Lyne) with up to 19.0m of cliff top retreat, whilst the northern and southern parts of the survey area have shown less movement with small sections of retreat up to 3.0m.</p> <p>Future repeat cliff top surveys are expected to help quantify rates of erosion (landward recession) of the historically tipped colliery spoil on a wider basis than is possible from the beach profile surveys alone.</p>

- At Lynemouth Bay, the recorded profiles show a retreat of the toe of the colliery spoil bank north of the power station by 0.5-1.0m and is now at its most landward position recorded. The cliff top survey shows that where the spoil beach is absent, the backing cliffs are eroding, often at a measurable rate. To monitor this trend, repeat cliff top/colliery spoil edge surveys were recommended to help quantify rates of erosion of the historically tipped colliery spoil on a wider basis than is possible from the beach profile surveys alone. Between spring 2021 and autumn 2021 the spoil cliff has remained stable in the north and very south of the bay. In the centre of the bay it has generally remained stable, except for one 14m section which has eroded by 2.0m since the previous survey.

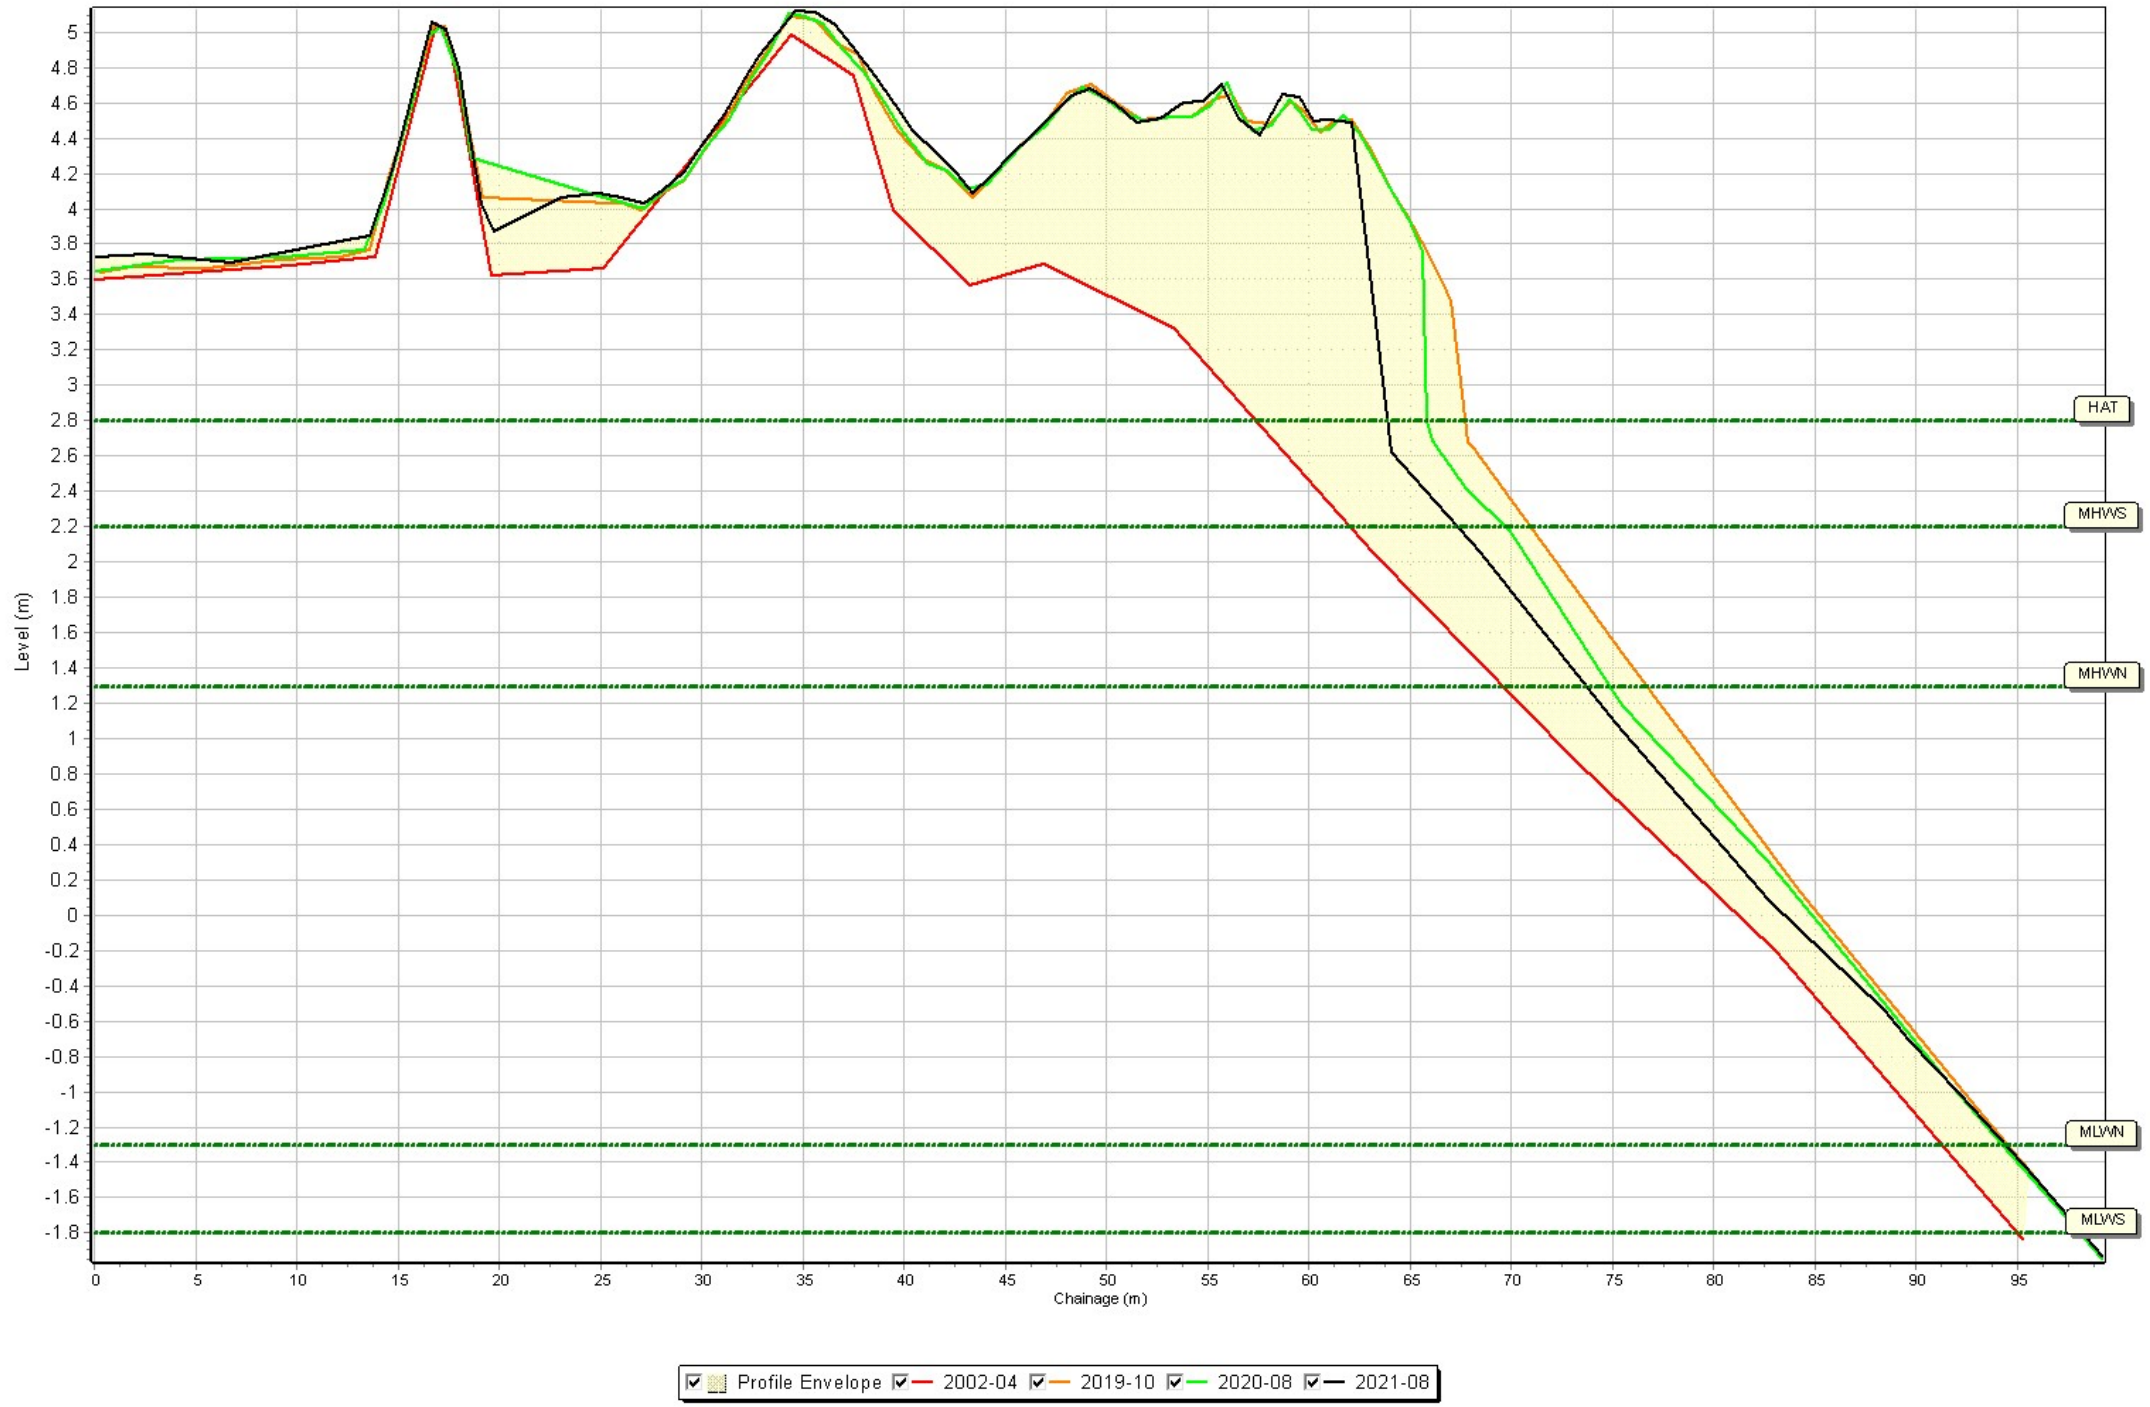
Profiles: 1aBTBC03

- At Sandstell Point (Spittal A), the recorded profiles and topographic survey present no causes for concern. However, the seaward face of the dune at profile **1aBTBC03** has shown a continued landward recession since November 2018.

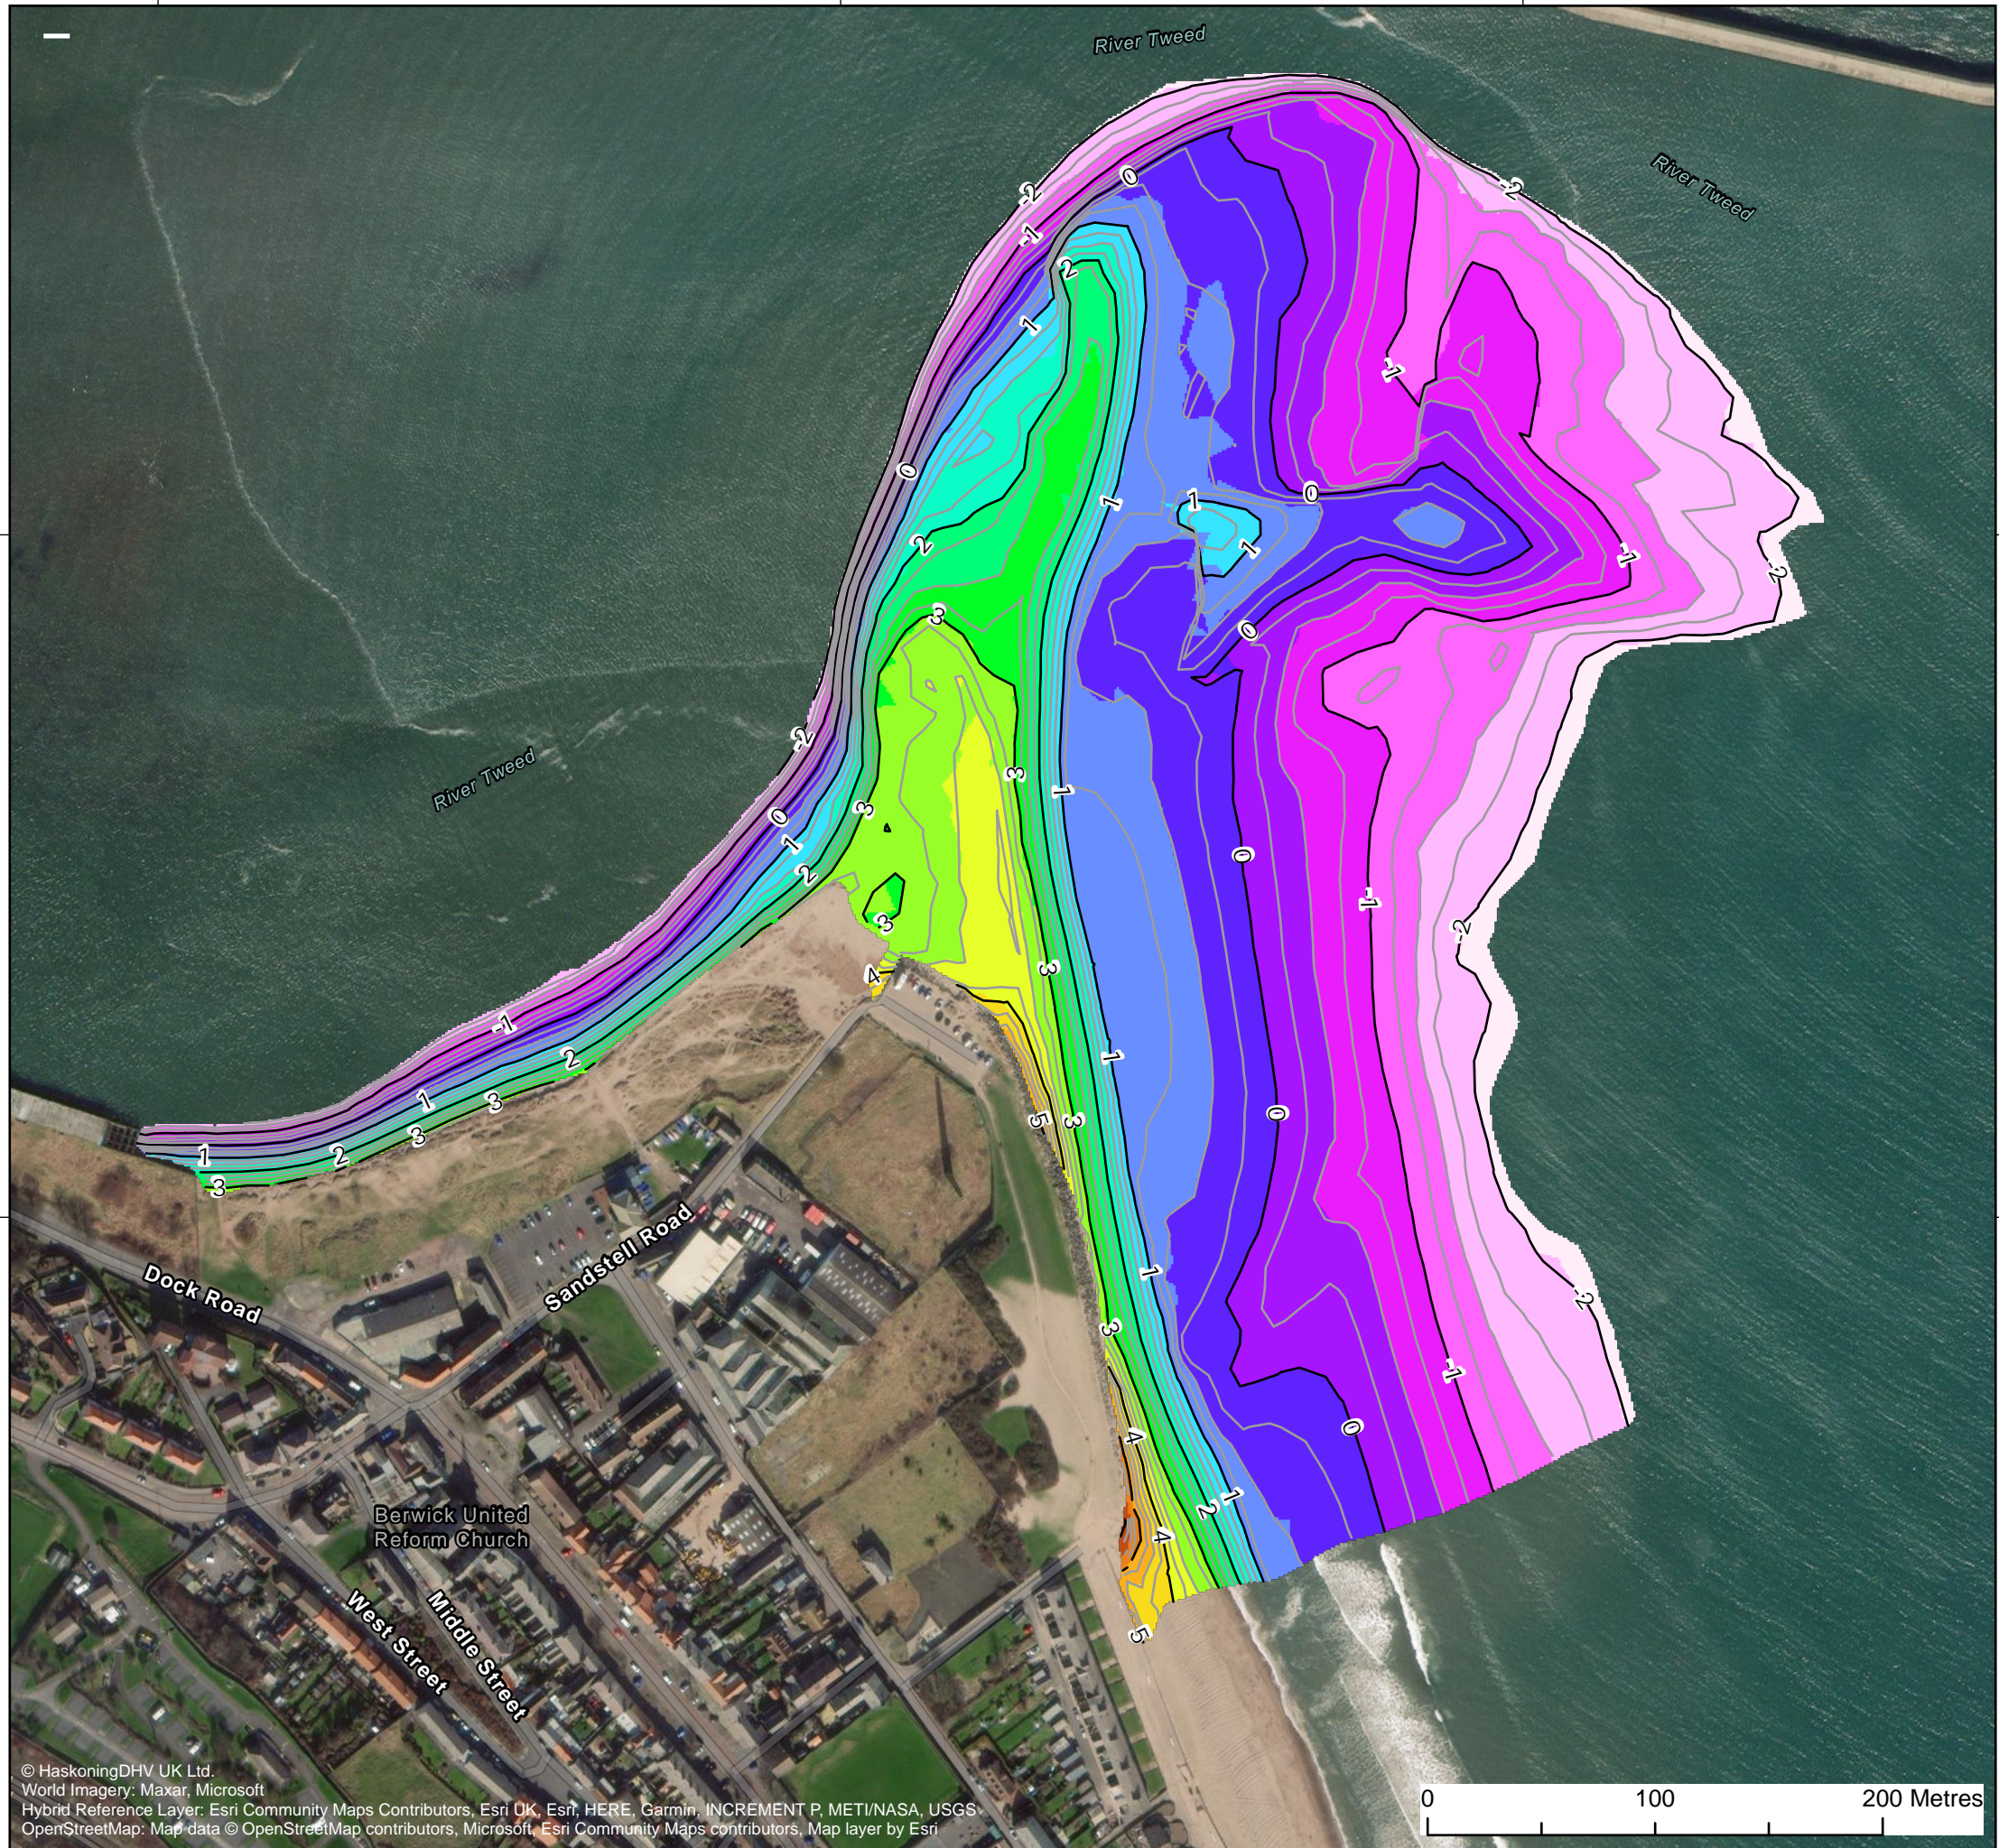
**TOPOGRAPHIC SURVEY (August 2021)**

<p><b>Mar – Aug 2021</b></p>	<p><b>Topographic Survey:</b></p> <p>Due to the significant changes that have been observed from the beach profiles along the spit at Sandstell Point, and the three-dimensional nature of these changes, a topographic survey was introduced to the monitoring programme in November 2011. The previous survey was undertaken for the Partial Measures survey in spring 2021.</p> <p>Data from the most recent topographic survey (Full Measures, autumn 2021) have been used to create a digital ground model (DGM) (Appendix B – Map 1) using a Geographical Information System (GIS). A difference plot has also been produced using the DGM (Appendix B – Map 5) produced from the last topographic survey and the present survey.</p> <p>The difference plot for this survey generally shows; (i) little change in the dunes on the south bank of the River Tweed; (ii) a wide band of accretion on the riverward edge of the spit (up to 2.0m) and some lower magnitude patches of accretion on the lower spit facing the open sea; and (iii) large patches of erosion on the crest of the spit and on the upper and lower foreshore of the open beach.</p>	<p>Findings are relatively similar to those seen between autumn 2020 and spring 2021, except on the riverward edge of the spit which previously eroded by up to 1.75m.</p>
