**Cell 1 Regional Coastal Monitoring Programme  
Update Report 1: 'Partial Measures' Survey 2009**

**Project:** Cell 1 Regional Coastal Monitoring Programme

Update Report 1  
'Partial Measures' Survey 2009

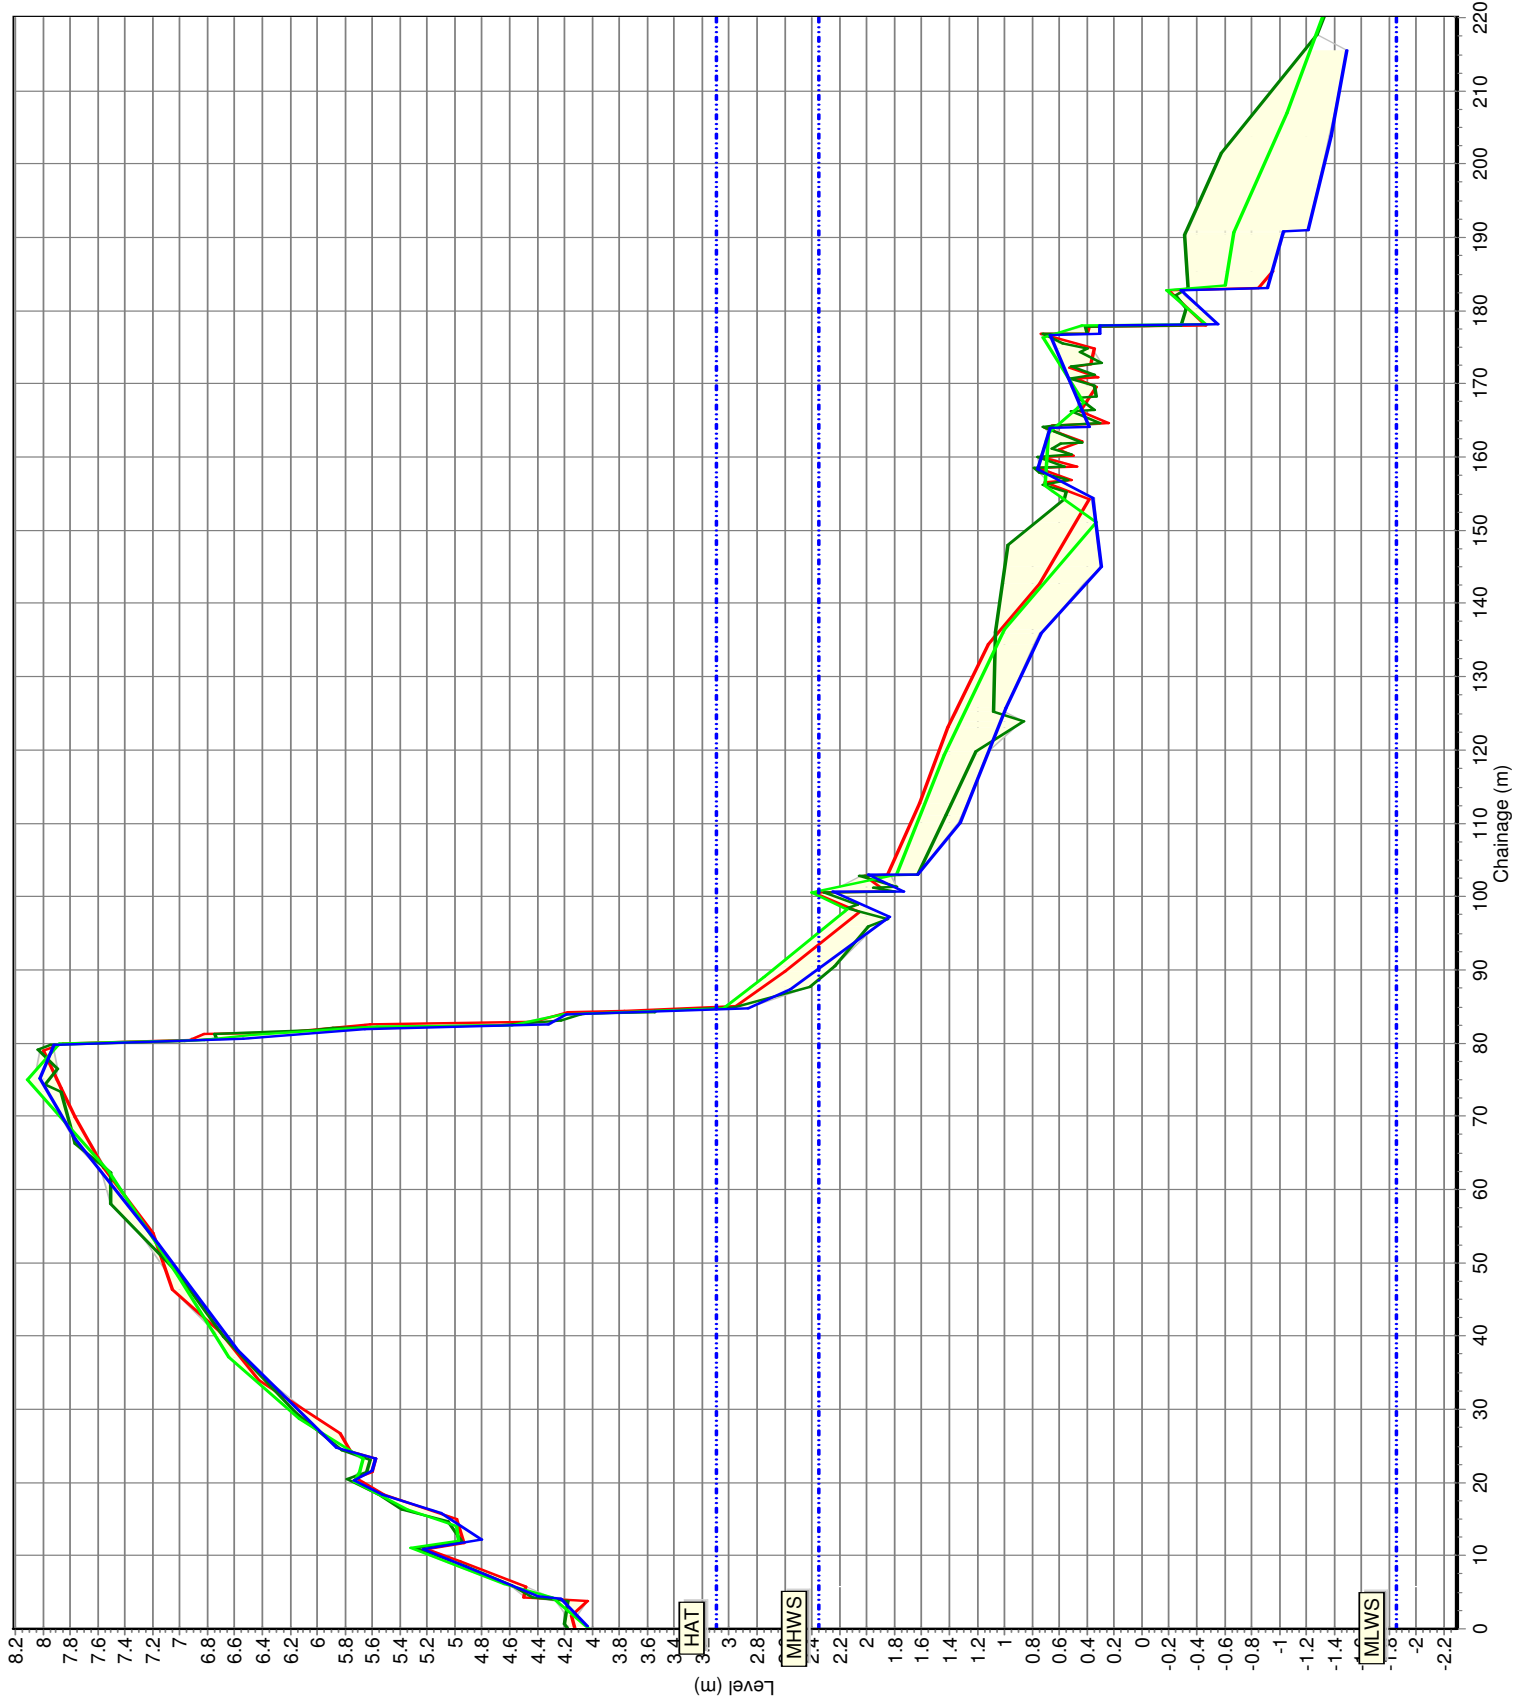
# Beach Profiles: 1aADC16B

Survey Date	Description of Changes Since Last Survey	Interpretation
	<p>ADC16B experienced lowering, especially between the rock outcrops on the upper and lower beach. Levels dropped by as much as 0.5m in places.</p> <p>ADC17 exhibited no change in the position of the main dune crest or upper beach profile, but lowering of around 0.15m in level occurred between chainages of around 60m and 190m. This remained within the bounds of previously observed behaviour.</p> <p>Upper beach levels were relatively stable along ADC17A, and further down the profile only modest redistribution of sediment occurred, with a berm being flattened. Changes were within previously observed envelopes.</p> <p>The berm previously identified at the very seaward end of the survey along profile CMBC01 had been pushed up-profile and was located at around a chainage of 300m. A smaller berm had also formed around MHWS, resulting in beach level increases at the dune toe.</p> <p>Similarly, the berm previously identified along CMBC02 at a chainage of around 300m remained intact, but was pushed up-profile by around 40m.</p>	<p>In the southern section of Druridge Bay, seasonal behaviour continues to dominate, with regular berm formation, migration and flattening continue to occur in response to changing forcing conditions.</p>

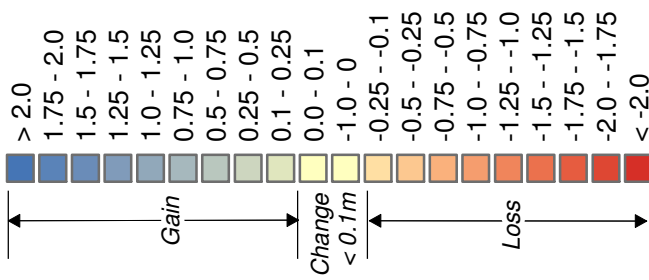
**TOPOGRAPHIC SURVEY**  
 Elevation (m OD)

Change in Elevation (m OD)
