**Cell 1 Regional Coastal Monitoring Programme  
Update Report 5: 'Partial Measures' Survey 2013**

(\*) The present report is **Update Report 5** and provides an analysis of the 2013 Partial Measures survey for Northumberland County Council's frontage.

Update Report 5  
 Partial Measures Survey  
 Spring 2013

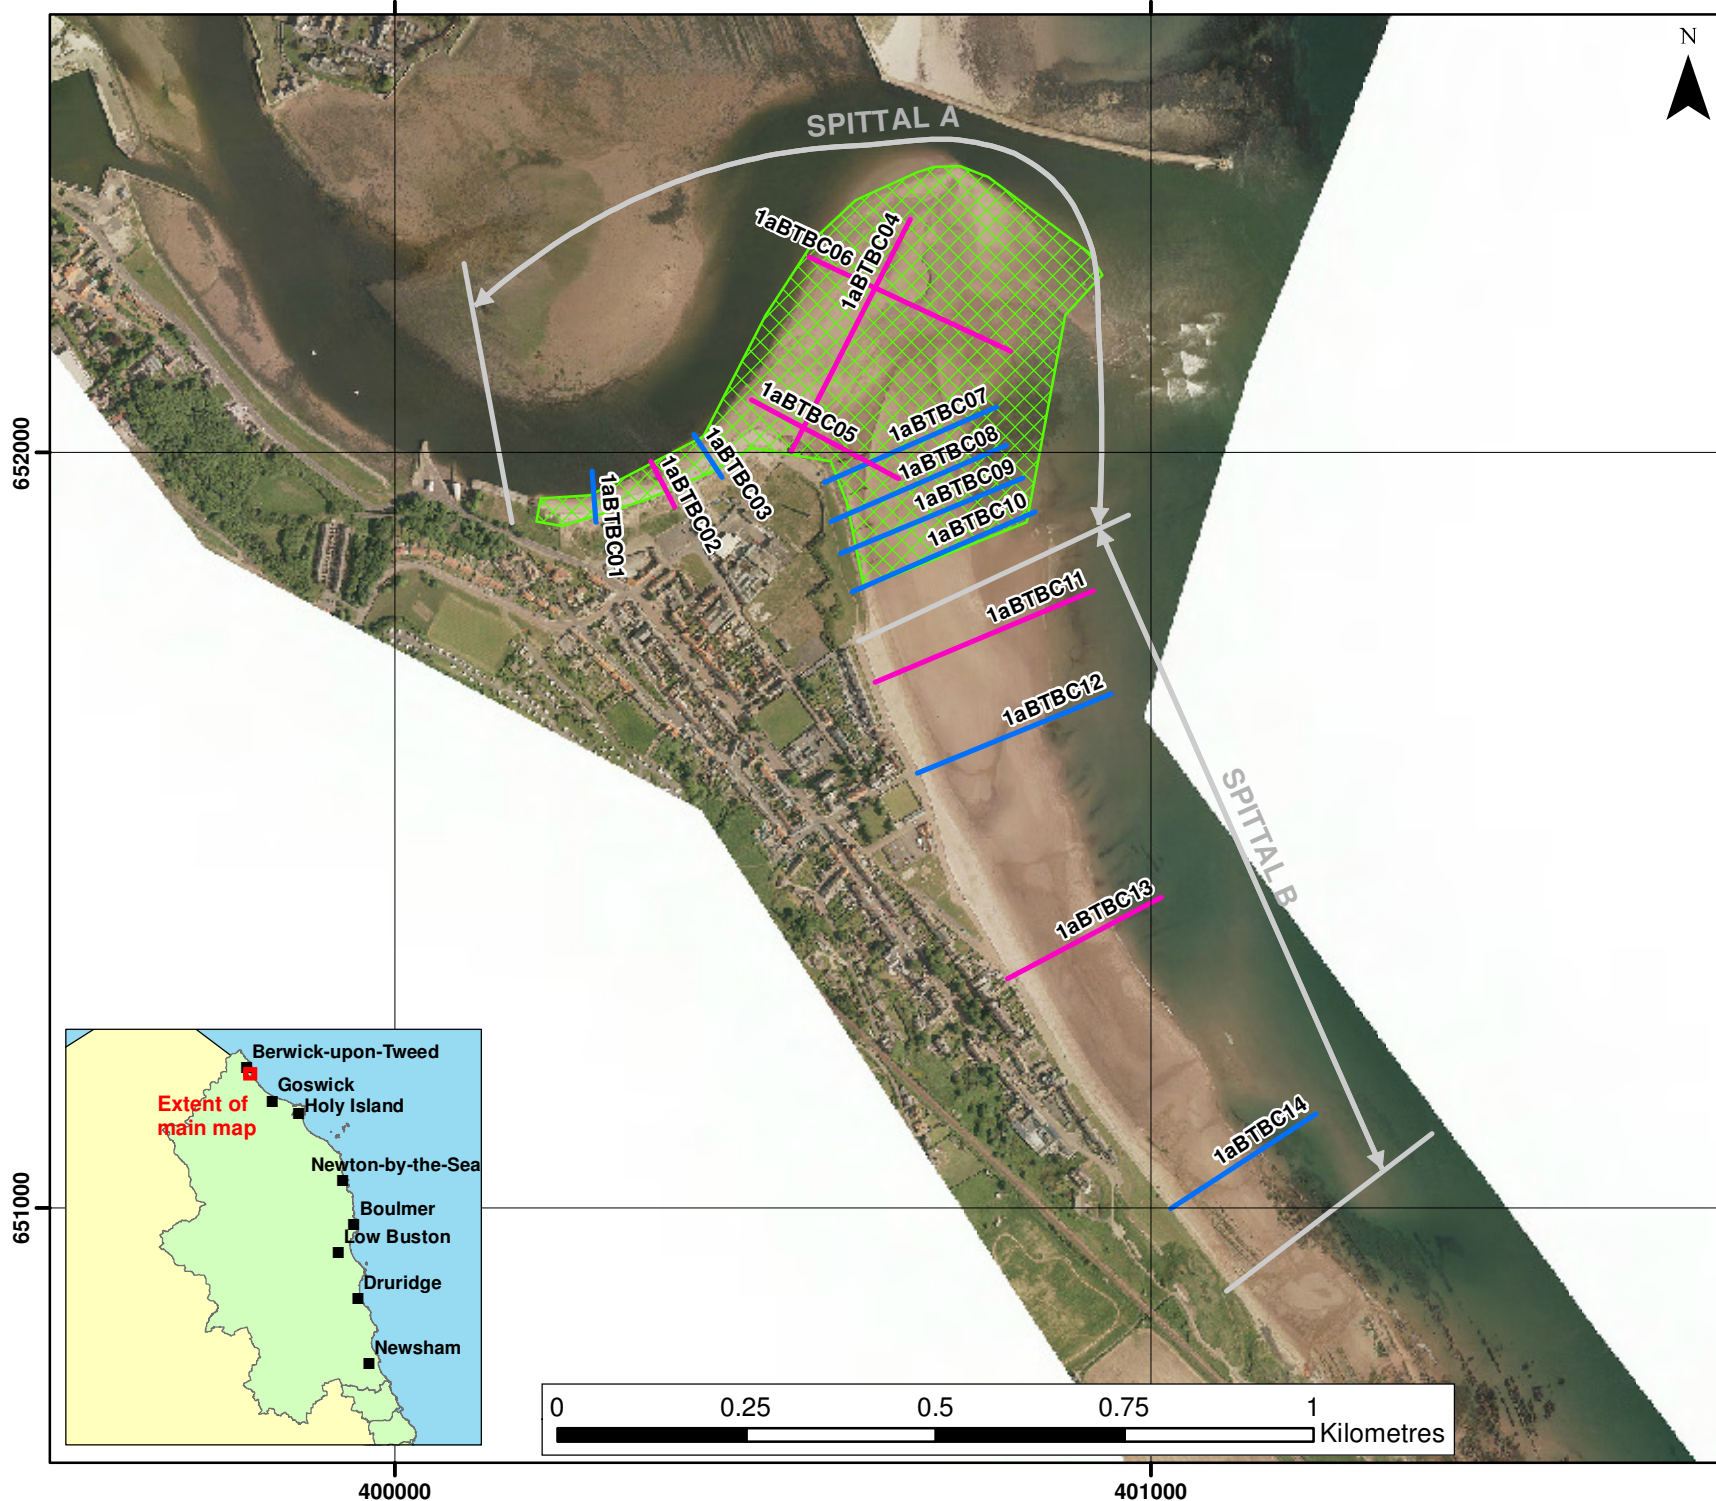
**Figure 2 - Map 1**  
**Survey Locations**  
**Sandstell Point (Spittal A)**  
**Northumberland**  
**County Council**

The location of these surveys is shown in Figure 2. The Partial Measures survey was undertaken along this frontage between 5<sup>th</sup> and 6<sup>th</sup> March 2013, 11<sup>th</sup> and 15<sup>th</sup> March 2013, 25<sup>th</sup> and 28<sup>th</sup> March 2013, 7<sup>th</sup> April 2013, 25<sup>th</sup> and 25<sup>th</sup> April, 28<sup>th</sup> April and 30<sup>th</sup> April. During this time weather conditions varied considerably; refer to the survey reports for details of the weather conditions over this survey period.

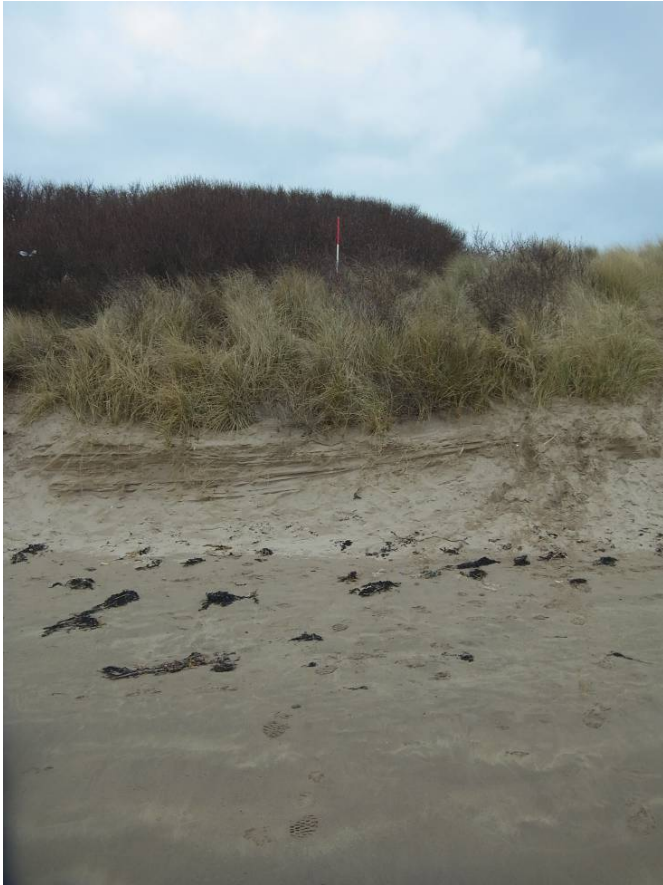
Plate 1 – Survey photograph 1aBTBC33\_20130328\_Up2.JPG

Survey Date	Description of Changes Since Last Survey	Interpretation
Mar 2013	<p><b>Beach Profiles:</b></p> <p>Beadnell Bay is covered by five beach profile lines for the Partial Measures survey (Appendix A). The previous survey was undertaken for the Full Measures survey in autumn 2012.</p> <p>Profiles <b>1aBTBC33</b> and <b>1aBTBC34</b> are located to the north of Beadnell Bay, in Beadnell Harbour. Profile <b>1aBTBC37</b> is located further south towards the outfall of Brunton Burn/Long Nanny.</p> <p>At <b>1aBTBC33</b>, the toe of the dunes has receded by up to 3m. The survey photographs in Plates 1 and 2 show the dune toe at the time of the present and previous surveys. The photographs show how the dune toe has cut-back to the vegetation line, with the occurrence of cliffing to form a vertical dune face at the toe. These changes indicate the occurrence of wave action at the dune toe, likely to have occurred under storm conditions over the winter months.</p> <p>At profile <b>1aBTBC34</b>, the dunes have remained stable since the last survey. Beach levels have fallen across the majority of the profile by approximately 0.5m, exposing the underlying rocky foreshore more than the previous survey (as shown by the survey photographs in Plates 3 and 4). Across a small section of profile seaward of chainage 160m, beach levels have increased by approximately 0.2m. This is likely to indicate material being drawn-down from the beach by cross-shore transport under winter storm conditions.</p> <p>At <b>1aBTBC37</b>, the dunes have remained stable since the last survey. There has been a slight change to the slope of the dune face, with the development of a steeper slope of continuous gradient to the toe and no slumping (shown by the survey photographs in Plates 5 and 6). Beach levels have fallen across the profile, by up to 0.5m.</p> <p>Profiles <b>1aADC01</b> and <b>1aADC02</b> are located along the frontage to the south of the outfall of Brunton Burn/Long Nanny. The dunes at 1aADC01 and 1aADC02 have not changed from or position. Beach levels at both locations have fallen across the profile, by up to 0.2m to 0.3m and 0.5m respectively.</p>	<p>Along the length of Beadnell Bay, the dunes have remained stable, retaining the same form and position since the last survey. The dune toe has been subject to some erosion. With the exception of the most northern section of the bay (at profile 1aBTBC33), beach levels have fallen across the profile.</p> <p><b>Longer term trends:</b> Along the length of Beadnell Bay, the dunes are of a similar form to those observed in the past. The changes in beach profile form and position observed since the last survey are also within the bounds of previous surveys.</p>

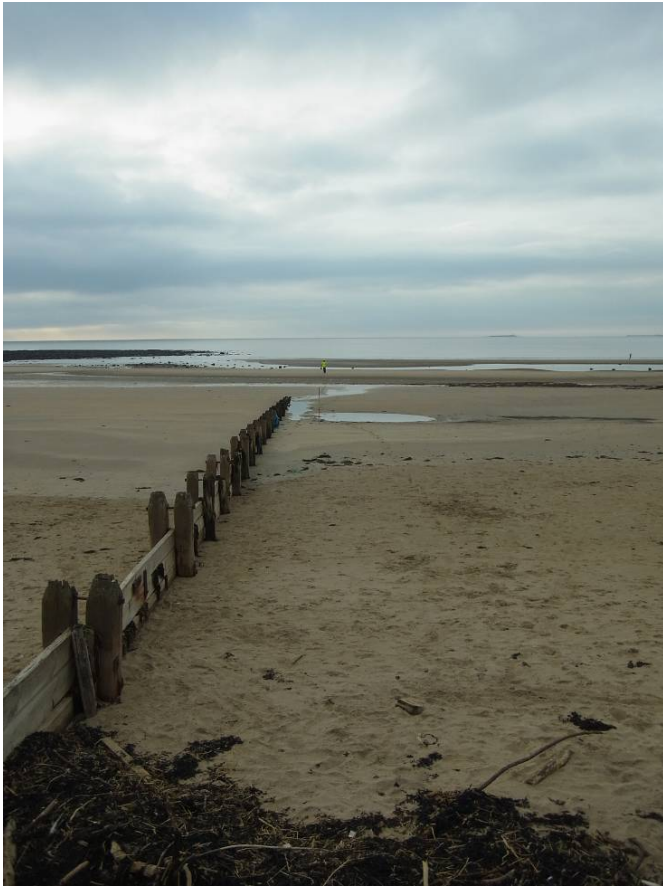
Plate7 – Survey photograph 1aADC07\_20130407\_Dwn2.JPG

<p><b>Apr 2013</b></p>	<p><b>Topographic Survey:</b></p> <p>The northern part of Alnmouth Bay (to the north of the River Aln estuary) is covered by bi-annual topographic survey, which commenced in April 2005. Data from the most recent topographic survey (Partial Measures, spring 2013) have been used to create a DGM (Appendix B – Map 2a) using a Geographical Information System (GIS). A difference plot has also been produced using the DGM (Appendix B – Map 2b) produced from the last produced topographic survey (Full Measures, autumn</p>	<p>The findings of the topographic survey show patchy areas of increased elevation interspersed with patchy areas of decreased elevation. This complies with the findings of the beach profile surveys, which show the beach to be very dynamics.</p> <p>The topographic survey report notes that a '<i>new line of formed dunes from the south end of car park to river</i></p>

Survey Date	Description of Changes Since Last Survey	Interpretation
	<p>2012) and the present survey.</p> <p>The difference plot shows (i) patchy areas of increased elevation interspersed with patchy areas of decreased elevation; (ii) accretion along the backshore to the river (it is noted in the topographic survey report for Alnmouth that 'a <i>new line of formed dunes from the south end of car park to river seems to be holding well and becoming more established</i>'); and (iii) accretion around the east bank of the river.</p>	<p><i>seems to be holding well and becoming more established</i>. This is supported by the findings of the topographic survey, which shows an increase in elevation along the backshore at this location.</p> <p><b>Longer term trends:</b> The longer term trends are covered by the long term topographic trends autumn 2011 to autumn 2013 (see next report, Full Measures 2013).</p>

- Elsewhere along Beadnell Bay, the recorded profiles present no causes for concern.
- At Boulmer, the recorded profiles present no causes for concern.
- At Alnmouth Bay, the concrete blocks have become exposed, but the changes are within the bounds of previous changes, so it is likely that in time, they will again be covered. A result of ongoing seasonal changes.

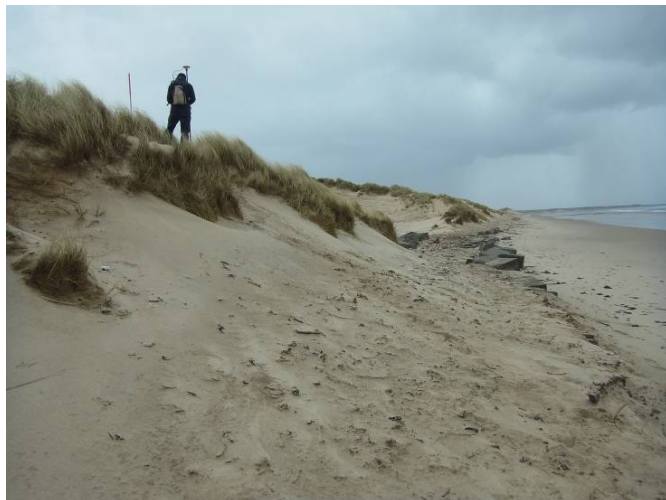
Plate 10 – Survey photograph 1aCMBC01\_20130326\_N11.JPG

Survey Date	Description of Changes Since Last Survey	Interpretation
Mar 2012	<p><b>Beach Profiles:</b></p> <p>High Hauxley to Druridge Bay is covered by eight beach profile lines during the Partial Measures survey (Appendix A). Four of these (with 'A' or 'B' suffixes) were added to the programme in October 2007. The previous survey was undertaken for the Full Measures survey in autumn 2012.</p> <p><b>1aADC15A, 1aADC16 and 1aADC16A</b> are located around Hauxley Haven. At profile <b>1aADC15A</b>, the dunes have remained stable since the last survey. With the exception of the dune toe, beach levels have increased across the profile by approximately 0.2m. This increase is greater on the lower shore, where the rocky outcrop, which was observed to be exposed in the previous survey, is once again buried. At profile <b>1aADC16</b>, the dunes have remained stable. Beach levels between the dune toe and a chainage of 175m have fallen by approximately 0.2m. Between a chainage of 175m and 250m, beach levels have increased to form a wider flatter beach. At profile <b>1aADC16A</b>, the dunes have remained stable. Between MHWs and a level of 0m (chainage 165m), beach levels have reduced by 0.5m, seaward of which they have increased by 0.5m. This suggests that material has been moved across the beach, likely to have taken place during winter storms.</p> <p><b>1aADC16B, 1aADC17 and 1aADC17A</b> are located to the north of Druridge Bay, between Bondi Carrs and Hadston Carrs and extend seawards from Togston Links. At <b>all locations</b>, the dunes have remained stable since the last survey. At profile <b>1aADC16B</b>, beach levels have virtually remained the same since the last survey. At profile <b>1aADC17</b>, beach levels have fallen across the majority of the profile, from the dune toe to a chainage of 165m. At profile <b>1aADC17A</b>, beach levels between the toe of the dunes and a chainage of 40m have increased marginally. Seaward of this point they have reduced by 0.4m across the profile.</p> <p><b>1aCMBC01 and 1aCMBC02</b> are located in the southern section of Druridge Bay. At both locations, the dunes have remained stable since the last survey. At profile <b>1aCMBC01</b>, beach levels have fallen considerably (by up to 1m), to form a more concave profile. This is a trend that has continued from the last survey. The concrete dune toe protection has become exposed (as shown by the survey photographs in Plates 10 and 11). At profile <b>1aCMBC02</b>, beach levels have fallen considerably (by up to 1m), to form a more concave profile. This is a trend that has continued from the last survey.</p>	<p>At Hauxley Haven, the dunes have remained stable, retaining the same form and position since the last survey. The beach to the north has accreted, while the beach to the centre and south of Hauxley Haven has been more dynamic with the cross-shore transport of material from the upper to the lower beach, likely to have taken place via draw-down during winter storms.</p> <p>North of Druridge Bay, the dunes have remained stable, retaining the same form and position since the last survey. To the north, in the lee of the rocky outcrop of Bondi Carrs / Elm Bush, the beach has remained stable. To the south, the beach levels have reduced, to form a slightly more concave profile.</p> <p>South of Druridge Bay, the dunes have remained stable, however, beach levels have fallen considerably across the profile.</p> <p><b>Longer term trends:</b> At Hauxley Haven, the dunes have demonstrated a long-term trend of stability. The changes in beach profile form and position observed since the last survey are generally within the bounds of previous surveys. The exception is at the centre and south of Hauxley Bay, where beach levels around a level of -0.4m, are highest observed to date (April 2002, when monitoring began).</p> <p>North of Druridge Bay, the dunes have demonstrated a long-term trend of stability. The changes in beach</p>

Survey Date	Description of Changes Since Last Survey	Interpretation
		<p>profile form and position observed since the last survey are within the bounds of previous surveys.</p> <p>South of Druridge Bay, the dunes have demonstrated a long-term trend of stability. The changes in beach profile form and position observed since the last survey are within the bounds of previous surveys.</p>

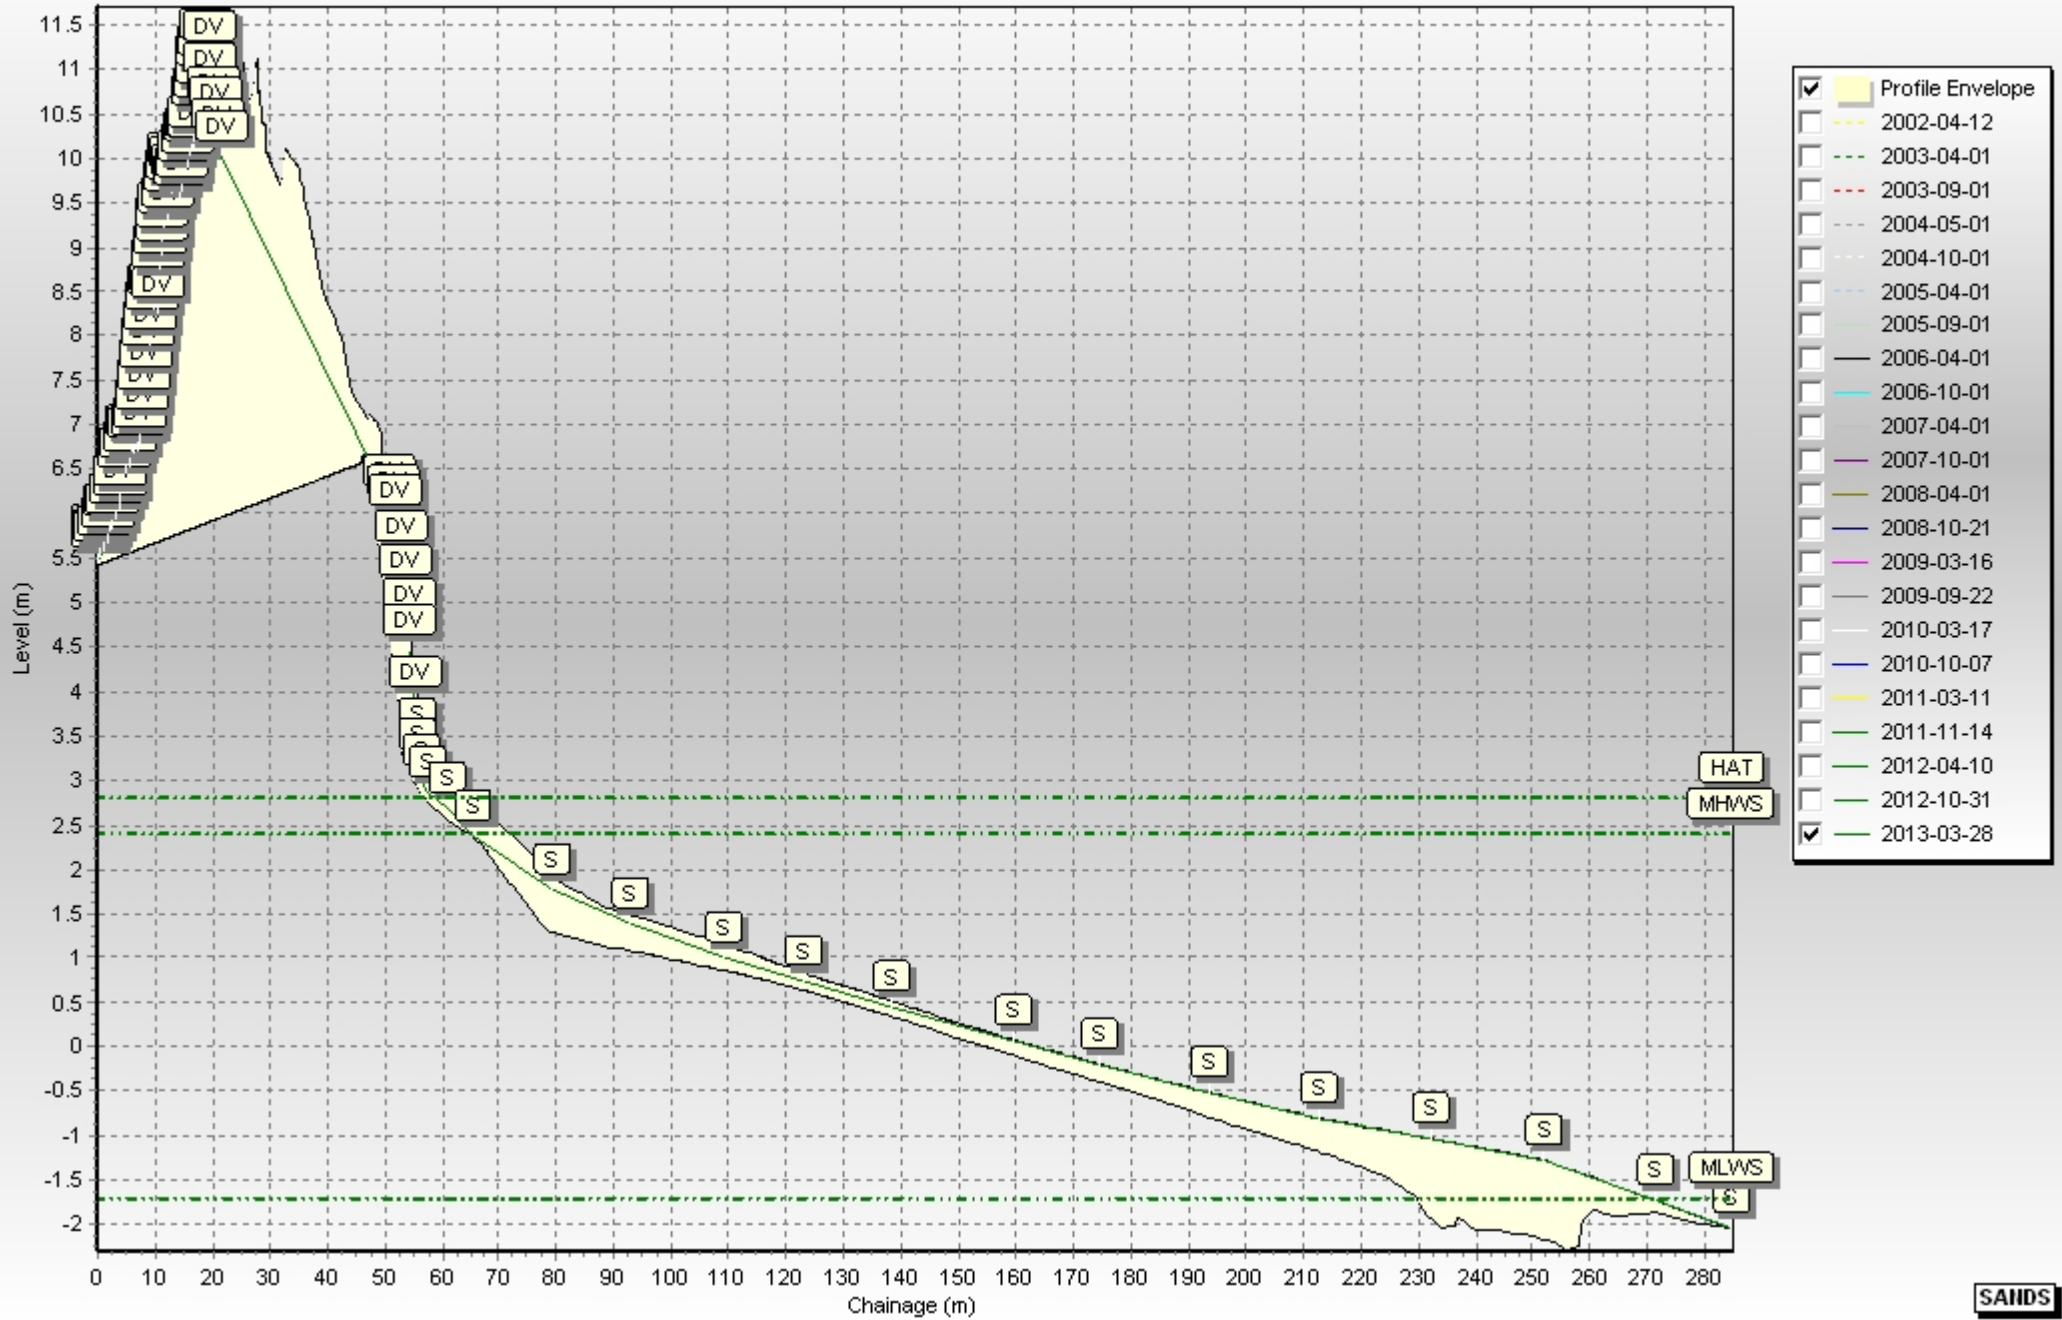
Profiles: 1aBTBC33

At profile 1aBTBC33 there is a gap in the data due to dense vegetation (previously called bushes on top of dunes, as first noted in Full Measures, autumn 2011). Care is needed interpolating the data as this would incorrectly imply erosion.

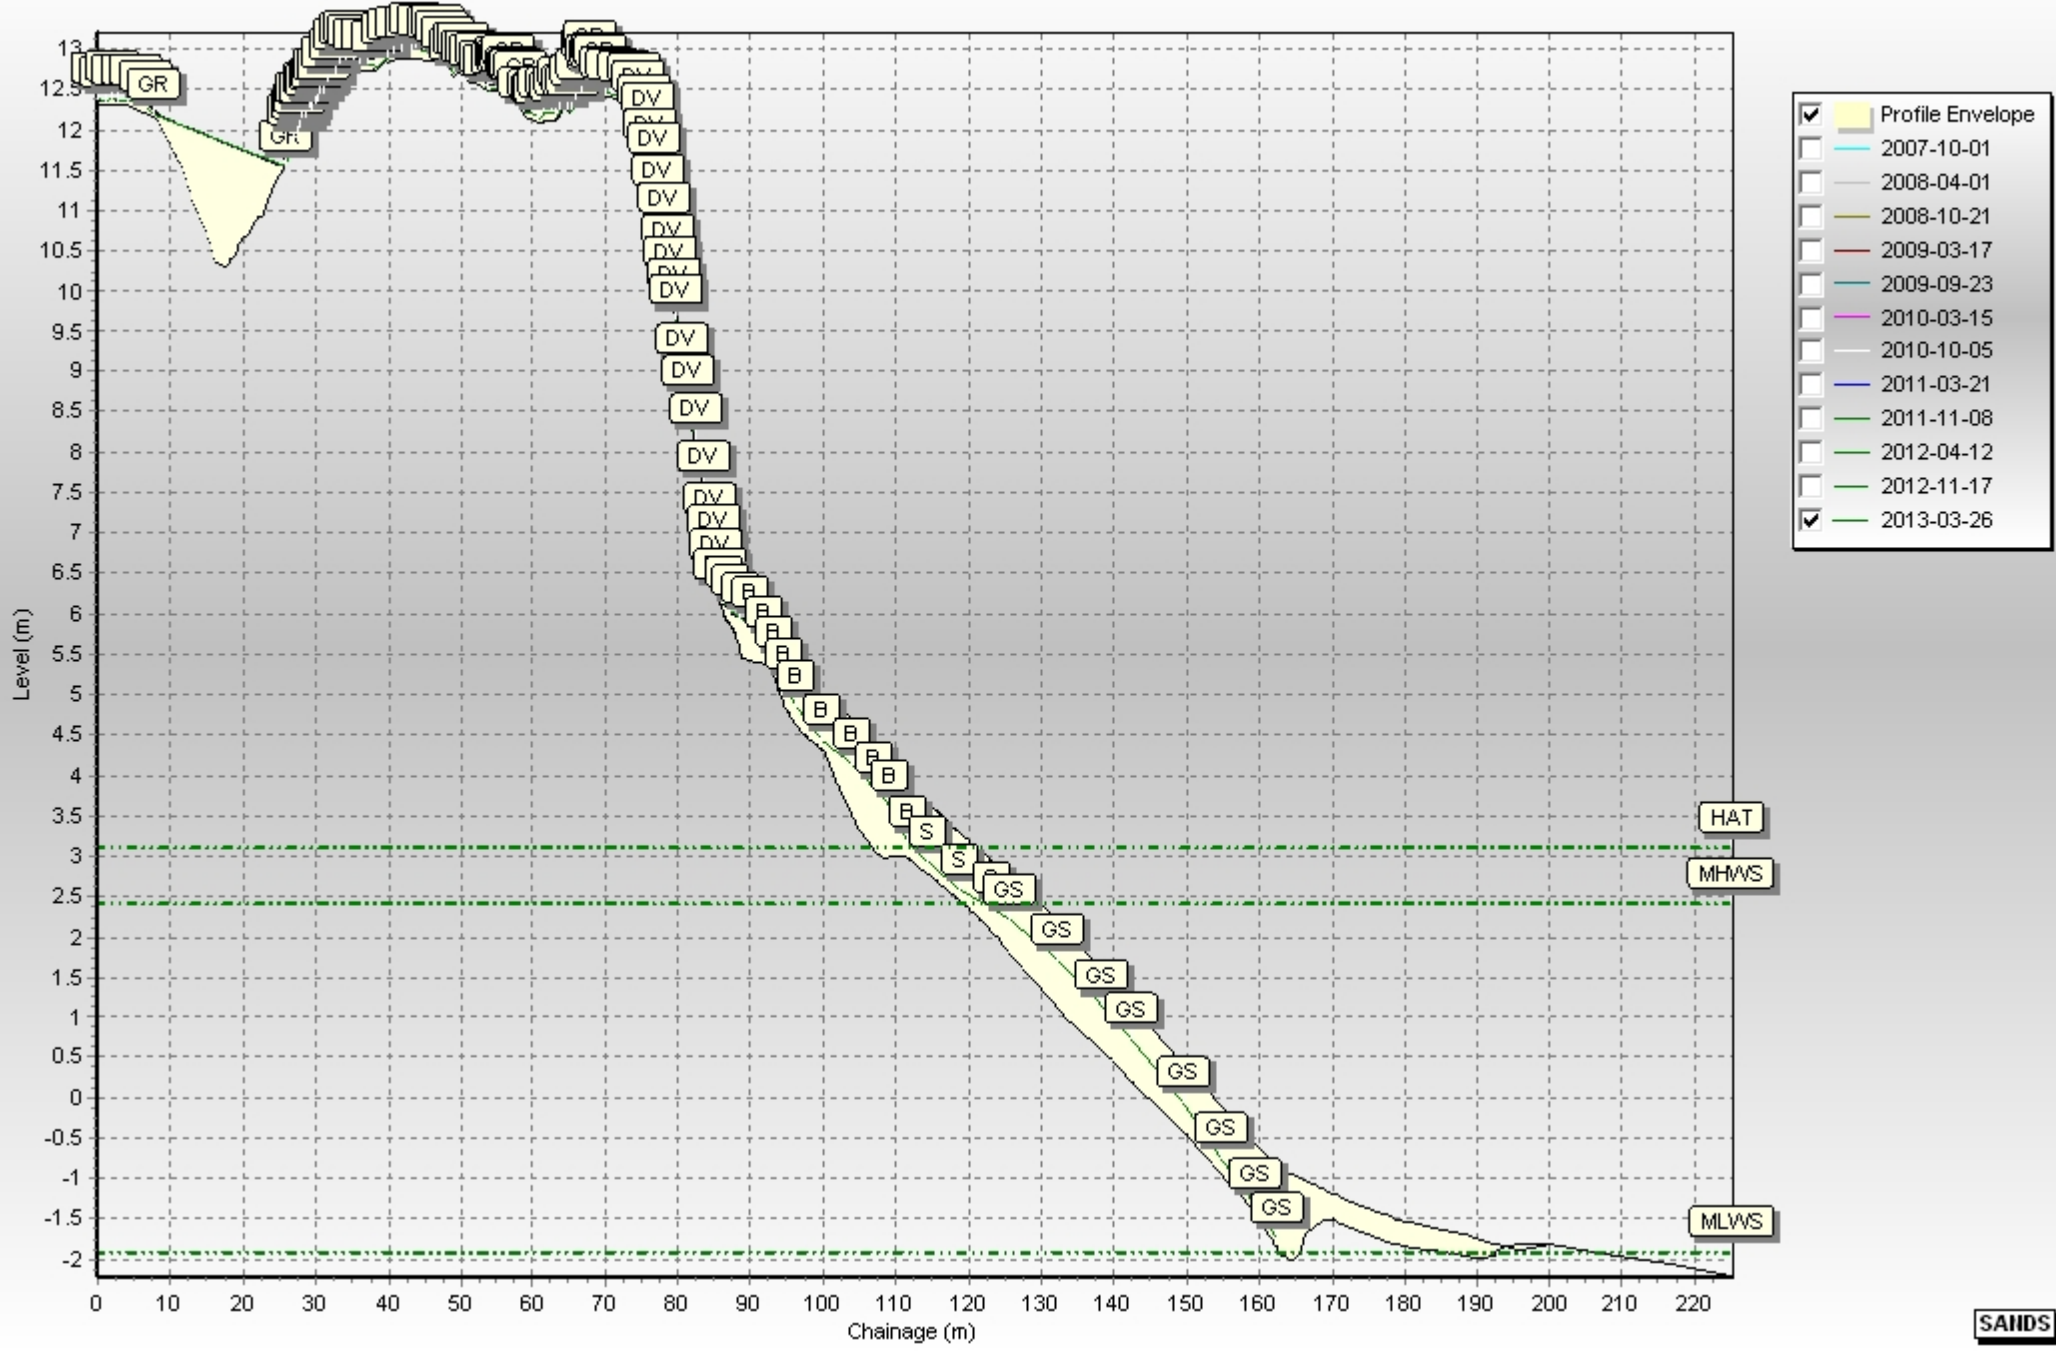
### Profiles: 1aCMBC03B

- At Lynemouth Bay, opposite the Power Station (profile 1aCMBC03B), the slag bank and beach have been eroded significantly. It is possible that further mechanical re-grading of the slag tip profile has occurred between the present and previous Full Measures survey and could explain the observed erosion.

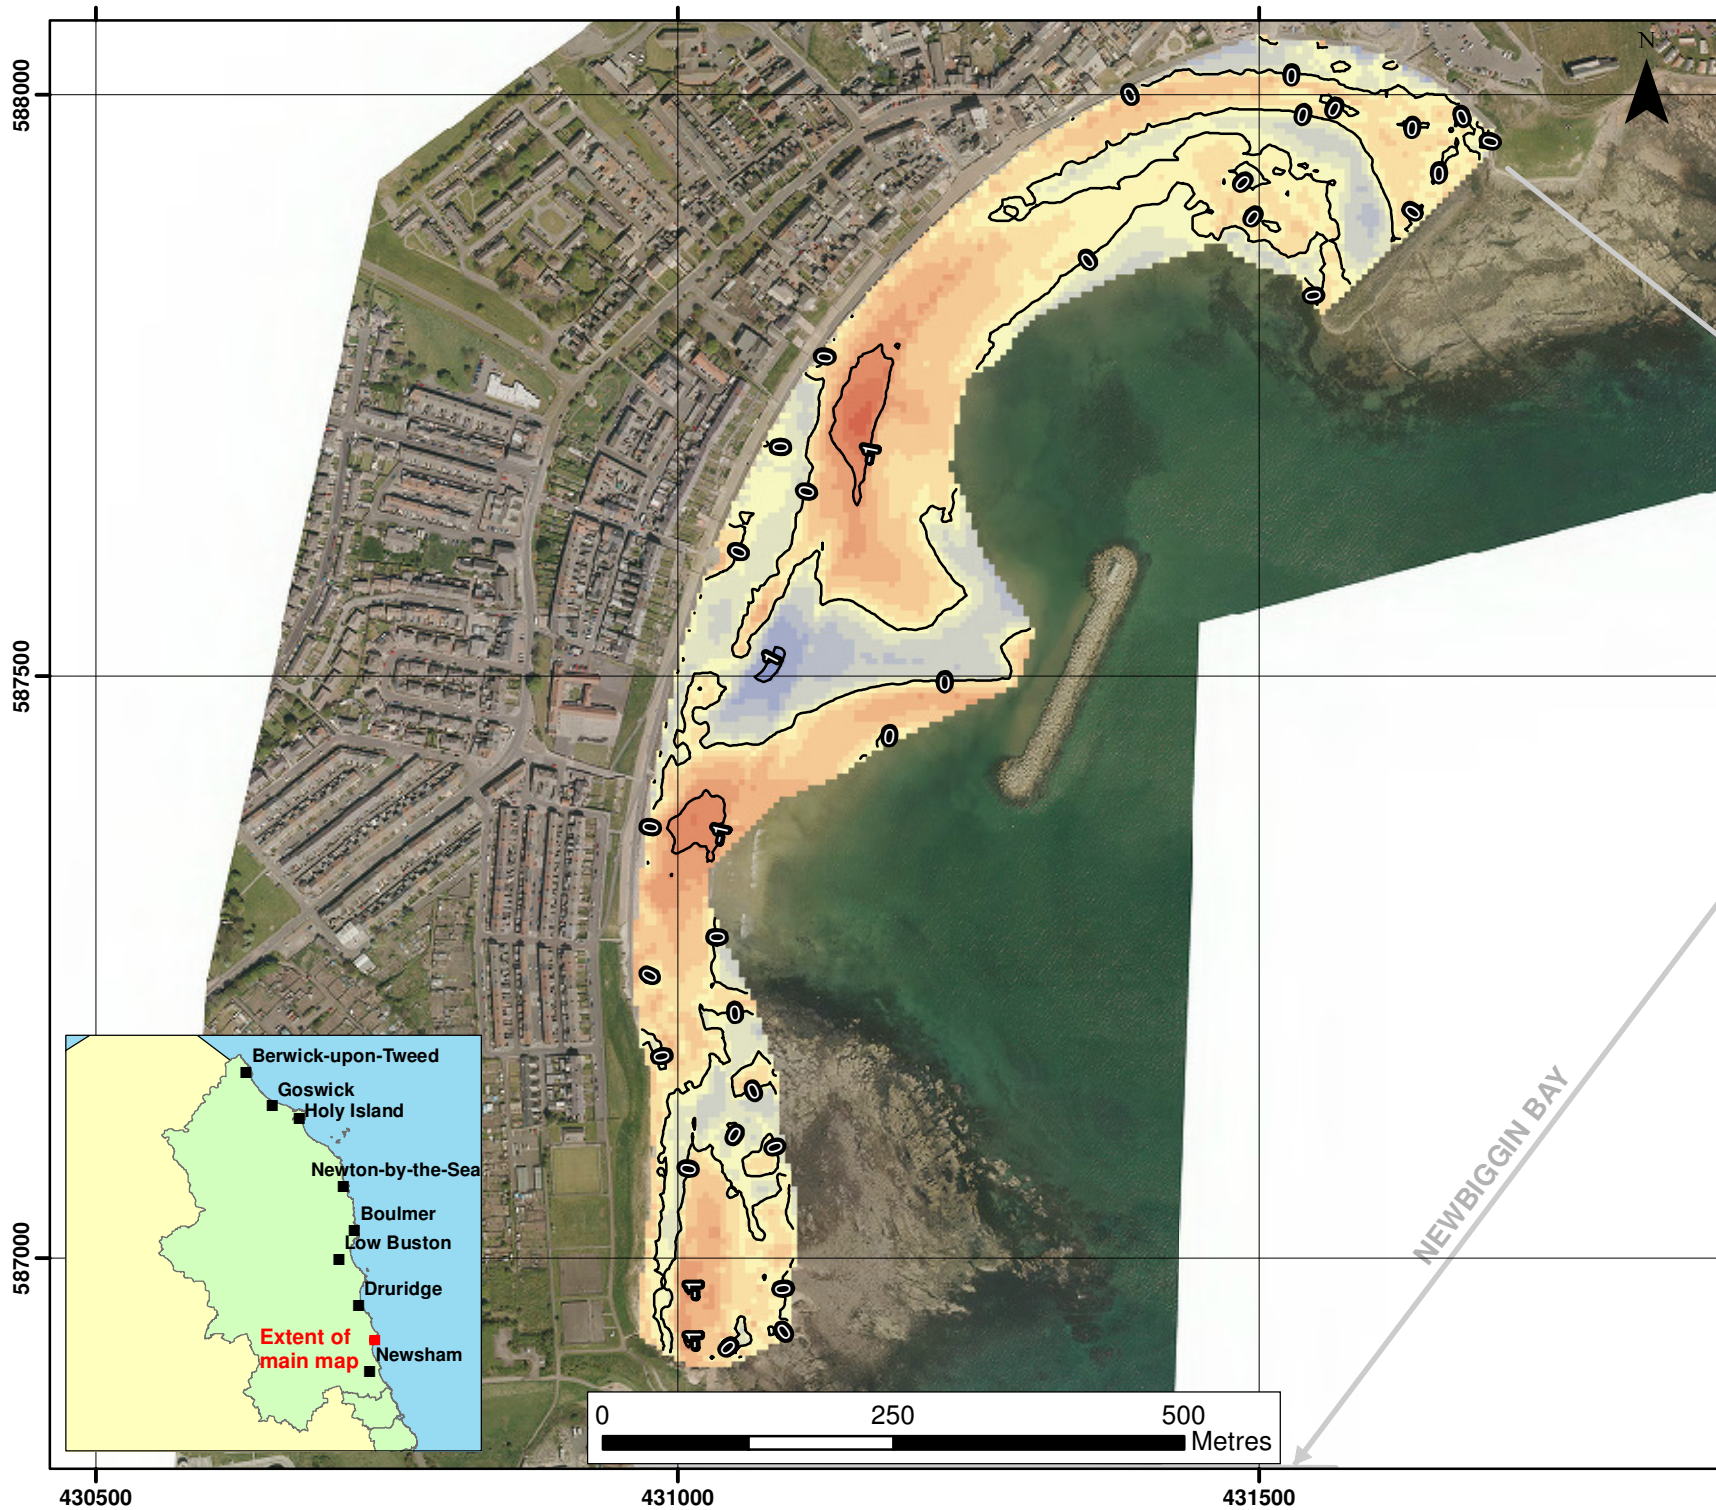
**Appendix B Map 3b**  
**Short-term**  
**Elevation Change**  
**Newbiggin**  
**Northumberland**  
**County Council**

- Elsewhere along Lynemouth Bay, the recorded profiles and cliff top survey present no causes for concern.
- At Newbiggin-by-the-Sea, the beach has fluctuated quite considerably, with the accretion of the upper beach and erosion of the lower beach. This is an opposite trend to beach behaviour observed for the beaches in Northumberland and probably reflects beach management through re-profiling undertaken in autumns of 2011 and 2012. As in the previous Partial Measures report (spring 2011) and Full Measures report (autumn, 2012), it is anticipated that ongoing maintenance associated with the capital recharge scheme will again be required.
