Cell 1 Regional Coastal Monitoring Programme Update Report 6: 'Partial Measures' Survey 2014

**Northumberland County
Council
Final Report**

July 2014

(*) The present report is **Update Report 6** and provides an analysis of the 2014 Partial Measures survey for Northumberland County Council's frontage.

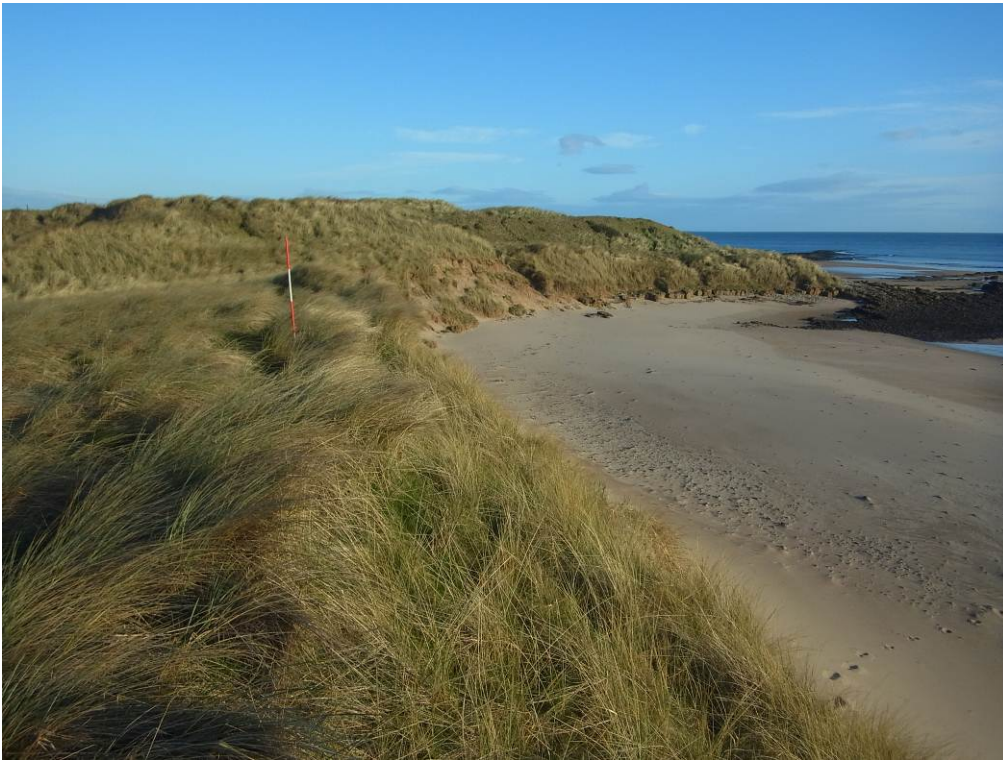
Figure 1 Sediment Cells in England and Wales

The Cell 1 Regional Coastal Monitoring Programme covers approximately 300km of the north east coastline, from the Scottish Border (just south of St. Abb's Head) to Flamborough Head in East Yorkshire. This coastline is often referred to as 'Coastal Sediment Cell 1' in England and Wales (Figure 1).

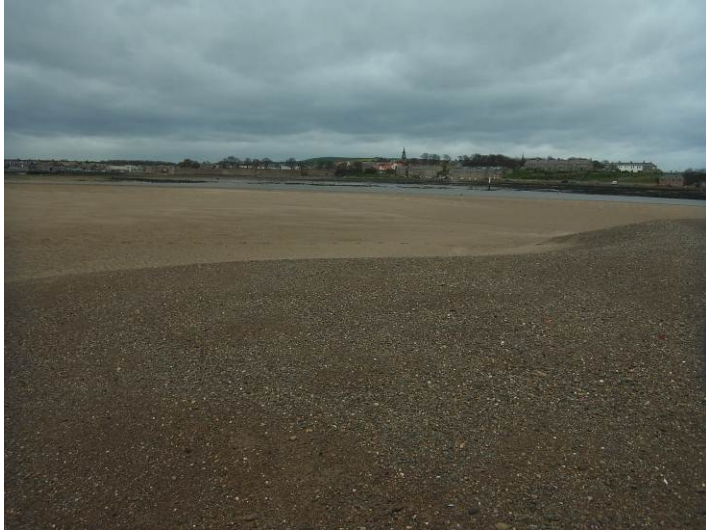
Plate 1 – Survey photograph 1aBTBC04_20140417_W13.JPG

Survey Date	Description of Changes Since Last Survey	Interpretation
Mar 2014	<p>Topographic Survey:</p> <p>Due to the significant changes that have been observed from the beach profiles along the spit at Sandstell Point, and the three dimensional nature of these changes, a topographic survey was introduced to the monitoring programme in 2011. The previous survey was undertaken for the Full Measures survey in autumn 2013.</p> <p>Data from the most recent topographic survey (Partial Measures, spring 2014) have been used to create a digital ground model (DGM) (Appendix B – Map 1a) using a Geographical Information System (GIS). A difference plot has also been produced using the DGM (Appendix B – Map 1b) produced from the last produced topographic survey and the present survey.</p> <p>In particular, the difference plot shows: (i) an area of erosion of up to 3m on the western side of the spit where it abuts the headland (on the outside of the bend of the river) (ii) a linear area of accretion (up to 2m), running in a north south direction from the northwest of the spit to the south of the spit where it joins the land and (iii) an area of accretion at the north eastern tip of the spit of up to 1m.</p>	<p>The findings of the topographic survey show similar trends to the profile survey. Notably, this is the movement of material in a riverwards direction across the middle of the spit, but with an area of erosion on the western side near to the headland and an area of accretion on the north eastern tip of the spit.</p> <p>Longer term trends: The longer term trends are covered by the long term topographic trends autumn 2011 to autumn 2014 (see next report, Full Measures 2014).</p>

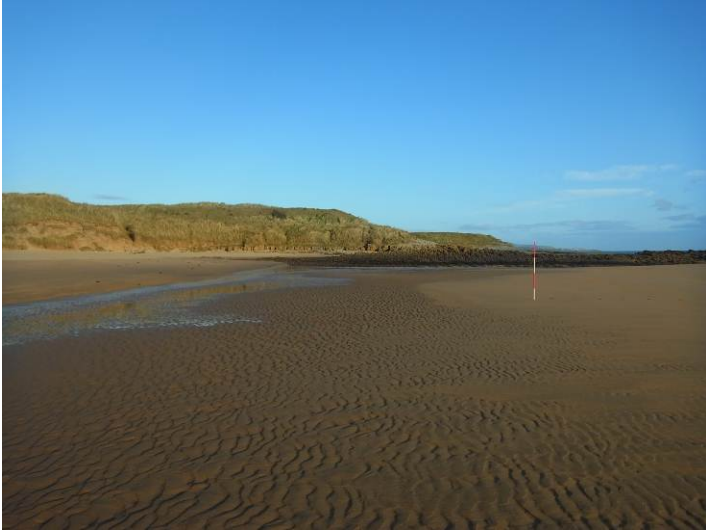
Plate 3 – Survey photograph 1aBTBC16_20140413_N12.JPG

Survey Date	Description of Changes Since Last Survey	Interpretation
Apr 2014	<p>Beach Profiles:</p> <p>Goswick Sands are covered by two beach profile lines for the Partial Measures survey (Appendix A). The previous survey was undertaken for the Full Measures survey in autumn 2013.</p> <p>Profile 1aBTBC16 is located to the north of Goswick Sands, between Far Skerr and Cheswick Black Rocks. The dune has remained stable since the last survey. Beach levels across the beach have increased by varying amounts between 0.1m and 0.9m. The beach has become more undulating (see Plate 3 and Plate 4) with a number of ridges and runnels forming in the sand.</p> <p>Profile 1aBTBC19 is located to the south of Goswick Sands. The dunes have remained stable since the last survey. Beach levels have increased across the profile but only by 0.1m or less. The survey report notes a '<i>step on the dune face</i>'.</p>	<p>Beach levels have generally increased at Goswick Sands since the last survey. The northern profile (1aBTBC16) Shows a greater increase in beach level than the southern profile (1aBTBC19).</p> <p>Longer term trends: At Profile 1aBTBC16 the beach levels on the upper and middle beach are the highest recorded to date. At Profile 1aBTBC19 the changes observed since the last survey are generally within the bounds of the previous surveys.</p>

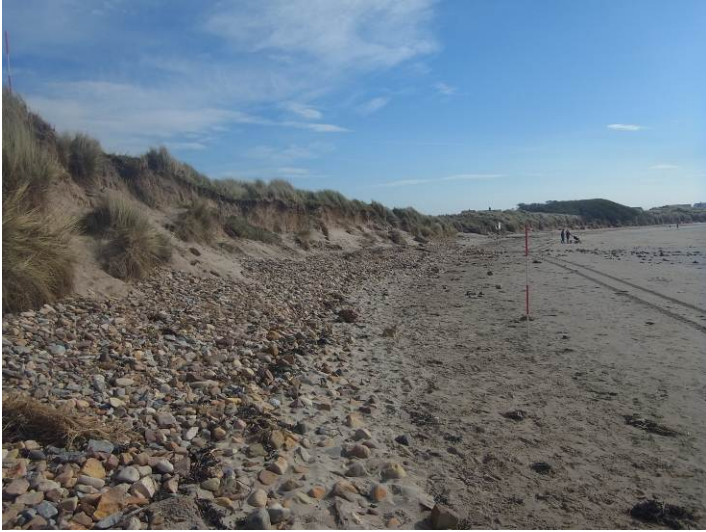
Plate 5 – Survey photograph 1aBTBC34_20140416_E3.JPG

Survey Date	Description of Changes Since Last Survey	Interpretation
	<p>1aADC01 the beach has steepened with an increase in beach level of up to 0.6m on the upper beach (chainage 300m to 425m) and a decrease in beach level of up to 0.7 on the lower beach (chainage 425m to the seaward end of the profile at 550m) .</p> <p>At profile 1aADC02 the dune face has cut back by up to 0.2m towards the dune toe. Below this, towards the middle of the beach profile between a chainage of 70m and 165m, beach levels have increased by up to 0.5m. Towards the toe of the beach (chainage 180m and seawards) the beach levels have dropped by up to 0.3m. These changes in beach level have resulted in a smoother but slightly steeper beach profile.</p>

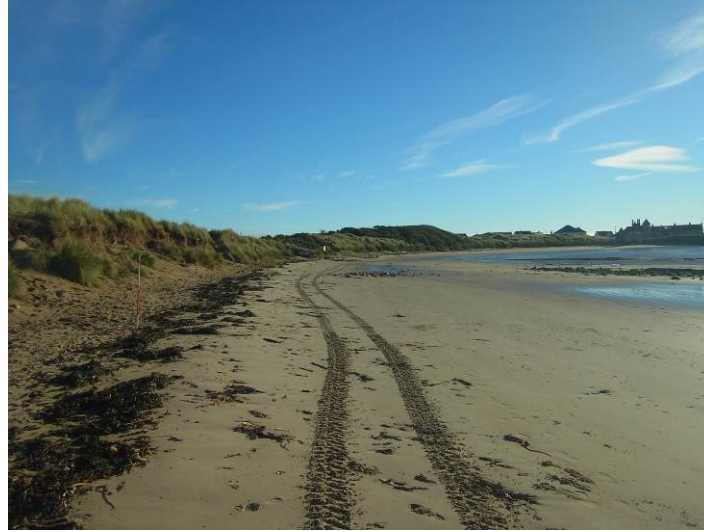
Plate 6 – Survey photograph 1aBTBC34_20131005_E4.JPG

Survey Date	Description of Changes Since Last Survey	Interpretation
Apr 2014	<p>Beach Profiles:</p> <p>Beadnell Bay is covered by five beach profile lines for the Partial Measures survey (Appendix A). The previous survey was undertaken for the Full Measures survey in autumn 2013.</p> <p>Profiles 1aBTBC33 and 1aBTBC34 are located to the north of Beadnell Bay, in Beadnell Harbour. Profile 1aBTBC37 is located further south towards the outfall of Brunton Burn/Long Nanny.</p> <p>At 1aBTBC33, the toe of the dunes has receded by up to 6m and steepened. This indicates wave action at the dune toe, likely to have occurred under storm conditions over the winter months. The dunes have remained stable and it is noted in the survey report '<i>middle of dunes missing due to dense vegetation</i>', which further indicates a stable dune system. The beach profile has become steeper with some slight accretion (around 0.1m) between a chainage of 80m and 130m and erosion of up to 0.8m has occurred at the beach toe.</p> <p>At profile 1aBTBC34, the front face of the dunes has cut back by over 1m since the last survey and a step has formed in the profile (noted in the survey report and observed in the measured profile). The dune toe has steepened (see Plate 5 and Plate 6) and photographs indicate a change in material type with shingle now being present at the dune toe. This change in the dune profile is likely to be the result of storm waves reaching the due toe. Beach levels have fluctuated across the profile by between 0.1m and 0.65m. The upper beach has tended to reduce in level whilst the middle of the beach has accreted and the toe of the beach has eroded. The underlying rocky foreshore which was exposed in the previous spring 2013 survey but covered with sand in the autumn 2013 survey remains covered. The fluctuation in level across the profile is likely to indicate material being drawn-down the beach by cross-shore transport under winter storm conditions.</p> <p>At 1aBTBC37, the dunes have remained stable since the last survey but the dune face has steepened and cut back by around 1m. Accretion has occurred between the berms which were present in the autumn 2013 profile, filling in the troughs and resulting in a smoother profile. A berm is observed on the lower beach at around 130m chainage.</p> <p>Profiles 1aADC01 and 1aADC02 are located along the frontage to the south of the outfall of Brunton Burn/Long Nanny. The dunes at 1aADC01 and 1aADC02 have not changed form or position. At</p>	<p>Along the length of Beadnell Bay, the toe of the dunes has been cut back following the winter storm waves. The beach levels across the bay have fluctuated with no clear trend of erosion or accretion, although most profiles have steepened slightly in response to the winter wave conditions.</p> <p>Longer term trends: Along the length of Beadnell Bay, the dunes are of a similar form to those observed in the past. The changes in beach profile form and position observed since the last survey are generally within the bounds of previous surveys.</p> <p>The exceptions to this are; (i) Profile 1aBTBC37 shows the highest level recorded to date at the profile toe; (ii) Profile 1aBTBC34 shows the lowest recorded level at the profile toe and the dune face is at its most landward position since surveys began;(iii) Profile 1aBTBC33 shows the lowest level recorded to date at the dune toe; (iv) Profile 1aADC01 shows the highest beach level recorded to date on the upper beach (at the dune toe) and the lowest level recorded to date at the beach toe, and (v) Profile 1aADC02 shows the most landward position of the due face at the toe of the dunes and the lowest level recorded to date at the beach toe.</p>

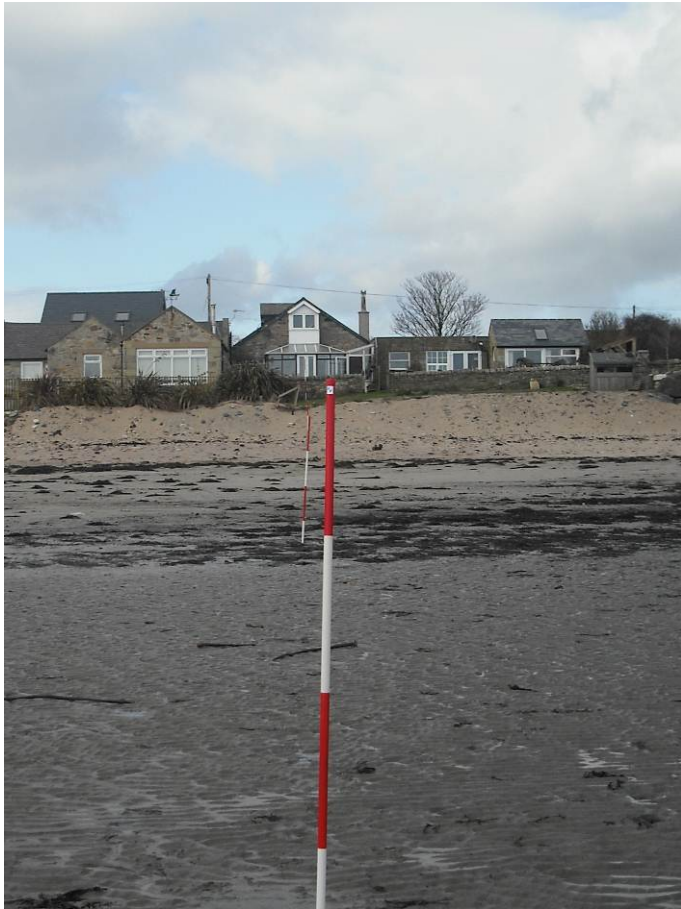
Plate 7 – Survey photograph 1aADC04A_20140324_Up.JPG

Survey Date	Description of Changes Since Last Survey	Interpretation
Mar2014	<p>Beach Profiles:</p> <p>Boulmer is covered by two beach profile lines for the Partial Measures survey (Appendix A). These were added to the programme in October 2007. The previous survey was undertaken for the Full Measures survey in autumn 2013.</p> <p>At profile 1aADC04A the dune cliff backshore has retreated slightly since the last survey (by up to 1.1m) and at the toe of the dune cliff beach levels have accreted slightly. This may indicate a movement of material from the top of the dune cliff to the toe. The beach level has increased by about 0.25m between chainage 28m and 75m. The rocky beach toe has remained stable. It is noted in the survey report that a ramp previously located adjacent to this profile is no longer present (see Plate 7 and Plate 8).</p> <p>At profile 1aADC04B it is noted in the survey report that new rock armour has been constructed at the top of the profile since the previous survey. This can be seen in Plate 9 and Plate 10 and has resulted in the backshore advancing seawards slightly. Along the beach profile the upper beach levels (chainage 15m to 55m) have increased by up to 0.2m while the lower beach levels (chainage 55m and seawards) have increased by up to 0.4m, with the increase in level decreasing seawards along the profile. It is likely that storm waves have moved material seawards from the upper beach over the winter period. This has resulted in a shallower beach profile.</p>	<p>The dune cliff backshore at Boulmer has retreated slightly at the northern profile, but has advanced slightly on the southernmost profile where new rock armouring has been constructed.</p> <p>The beach level on the northernmost profile has generally increased with the upper beach gaining material from the eroded dune cliff backshore. At the southernmost profile the upper beach has eroded while the lower beach has accreted, indicating cross shore movement of material by storm waves.</p> <p>Longer term trends: Generally, the changes in beach profile form and position observed since the last survey are within the bounds of previous surveys. The exceptions are; at profile 1aADC04A, between chainages 20m to 40m and 50m to 70m, where the beach levels are the highest recorded to date, and at profile 1aADC04B, between chainages 70m and 90m, where the beach levels are the highest recorded to date.</p>

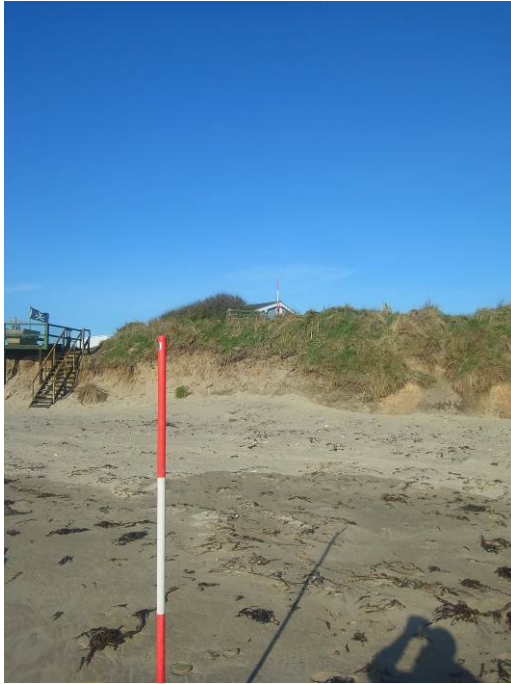
Plate 11 – Survey photograph 1aADC15A_20140415_Up1.JPG

- Elsewhere along Alnmouth Bay, the recorded profiles and topographic survey show no cause for concern.
- At Hauxley Haven, at profile 1aADC16A the dunes have been cut back and the dune toe is at it's the lowest recorded level. At Profile 1aADC15A the dune face has retreated to its most landward location measured to date.

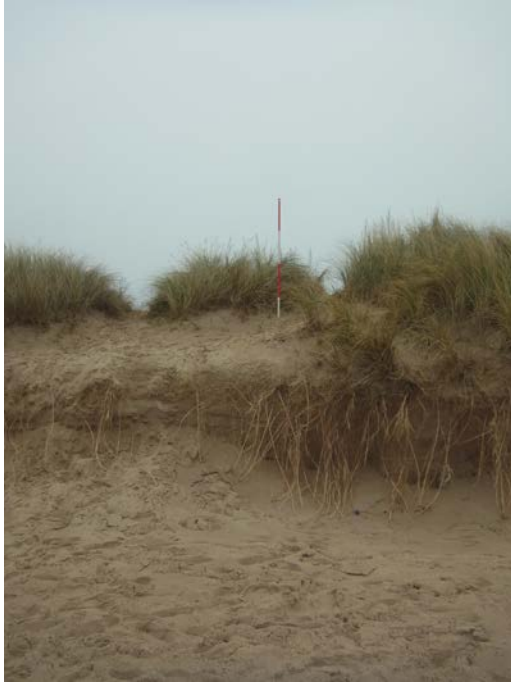
Plate 18 – Survey photograph 1aBVBC03_20140331_Up3.JPG

Survey Date	Description of Changes Since Last Survey	Interpretation
Mar 2014	<p>Beach Profiles:</p> <p>Blyth South Beach is covered by six beach profile lines for the Partial Measures survey (Appendix A). The previous survey was the Full Measures assessment undertaken in autumn 2013.</p> <p>1aBVBC01 is located towards the north of South Beach, in front of the land owned by the Port of Blyth. There have been no significant changes to the position and form of the dune crest since the last survey. The front dune face, however, has cut-back by up to 2.5m and the beach levels have decreased by up to 0.5m between the dune toe at 32m chainage and 49m chainage. Across the middle of the profile beach, levels have increased by approximately 0.2m and at the toe a berm has developed with beach levels increasing by as much as 0.9m. This suggests that storm waves have eroded the dune face and drawn material down the beach, eroding the upper beach and building up the lower beach, forming in a shallower beach profile.</p> <p>At profile 1aBVBC02, a similar trend can be observed as at 1aBVBC01. Beach levels have decreased across the upper beach, with the berm previously observed at around HAT no longer being present, and increased across the across the lower beach (from chainage 55m seawards) by up to 1m.</p> <p>At profile 1aBVBC03, there have been no significant changes to the position and form of the dune crests since the last survey, but the front face of the dune has steepened and cut back (see Plate 18 and Plate 19). Beach levels have reduced by up to 1m in front of the dune toe around HAT/MHWS but generally increased across the remainder of the profile. There is now one berm present at around MHWS (2.4mAOD), whereas the previous survey (autumn 2013) recorded one landward of the current berm near the dune toe and another seaward of the current berm.</p> <p>At profile 1aBVBC04, there have been no significant changes to the position or form of the dunes since the last survey. Beach levels have increased at the toe of the dune, where the berm previously at HAT (3.1mAOD) has moved landwards to around 4mAOD. The upper and middle beach has steepened, with a reduction in beach level of 1m to 0.1m from a chainage of 53m to 100m. Seaward of this there is a berm at the toe of the beach, just above MLWS. This lower section was not measured in the previous survey (autumn 2013) so it cannot be compared, but it is likely that it was not measured as beach levels</p>	<p>Since the last survey, the dune crests at Blyth South Beach have remained stable, retaining the same form and position. The beach has been subject to erosion, with a considerable drop in beach levels (in the order of 1m) on the upper beach, but the subsequent deposition of this eroded material, on the lower shore, forming a berm on the more northern profiles. This indicates that storm waves have eroded the upper beach during the winter period and drawn material down the beach.</p> <p>The exception is profile 1aBVBC05, towards the southern end of the bay near Mile Hill, where the berm at HAT has moved landwards resulting in slight accretion of the upper beach and slight erosion of the middle beach while the lower beach has remained fairly stable.</p> <p>Longer term trends: At Blyth South Beach, the dunes have generally demonstrated a long-term trend of stability. Data from when monitoring began (in May 2002), shows that prior to April 2007 (inclusive), the seaward face of the dune and dune crest were positioned further seaward and 1.5m higher. Thereafter the dune was narrower and the crest height lower, however, this position and form has been retained since then.</p> <p>The changes in beach profile form and position observed since the last survey are within the bounds</p>
