**Cell 1 Regional Coastal Monitoring Programme  
Update Report 7: 'Partial Measures' Survey 2015**

(\*) The present report is **Update Report 7** and provides an analysis of the 2015 Partial Measures survey for Northumberland County Council's frontage.

Update Report 7  
 Partial Measures Survey  
 Spring 2015

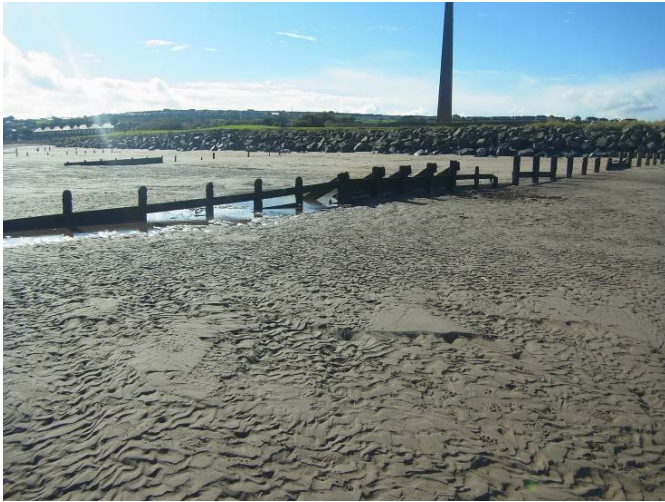
Plate 1 – Survey photograph 1aBTBC05\_20141010\_S9.JPG

Survey Date	Description of Changes Since Last Survey	Interpretation
April 2015	<p><b>Topographic Survey:</b></p> <p>Due to the significant changes that have been observed from the beach profiles along the spit at Sandstell Point and the three dimensional nature of these changes, a topographic survey was introduced to the monitoring programme in 2011. The previous survey was undertaken for the Full Measures survey in autumn 2014.</p> <p>Data from the most recent topographic survey (Partial Measures, spring 2015) have been used to create a digital ground model (DGM) (Appendix B – Map 1a) using a Geographical Information System (GIS). A difference plot has also been produced using the DGM (Appendix B – Map 1b) produced from the last produced topographic survey and the present survey.</p> <p>In particular, the difference plot shows: (i) a band of beach elevation increase that extends from north to south along the longest length of the spit; (ii) adjacent to that a band of beach elevation decrease, with particular change at the centre of the spit; and (iii) on the seaward side of the spit, beach elevation reduction to the north and beach elevation increase to the south. The topographic survey report notes <i>'very few groynes visible, suggesting increased sand levels'</i>.</p>	<p>The findings of the topographic survey show similar trends to the profile survey. Notably, this is the movement of material towards the river mouth, to form a higher and narrower spit. The build-up of material at the neck of the spit has resulted in burial of the groynes, which is evident from the survey photographs and supported by the surveyor's notes.</p>

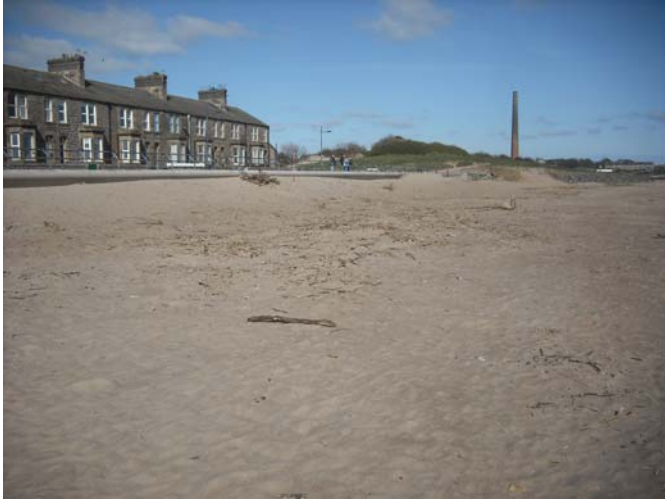
Plate 3 – Survey photograph 1aBTBC11\_20150407\_N1.JPG

Survey Date	Description of Changes Since Last Survey	Interpretation
April 2015	<p><b>Beach Profiles:</b></p> <p>Spittal B is covered by two beach profile lines for the Partial Measures survey (Appendix A). The previous survey was undertaken for the Full Measures survey in autumn 2014.</p> <p>Profile <b>1aBTBC11</b> is located to the north of Spittal Beach. Beach levels have increased across the profile by approximately 0.4m from the toe of the seawall to a chainage of 50m (see Plate 3) and 0.8, between a chainage of 100m and 200m, to form a flatter lower beach.</p> <p>Profile <b>1aBTBC13</b> is located towards the centre of Spittal Beach. Beach levels here have decreased on the upper/middle beach (from the seawall to a chainage of 80m) by 0.3m and increased seaward of there by 0.3m, suggesting a cross-shore movement of material with draw-down across the beach face.</p>	<p>Since the last survey, beach levels along Spittal have generally increased to the north, but to the south there has been dynamic movement with the draw-down of material from the upper to lower beach.</p> <p><b>Longer term trends:</b> At both profile locations along Spittal Beach, the changes observed from the present survey are generally within the bounds of previous surveys.</p>

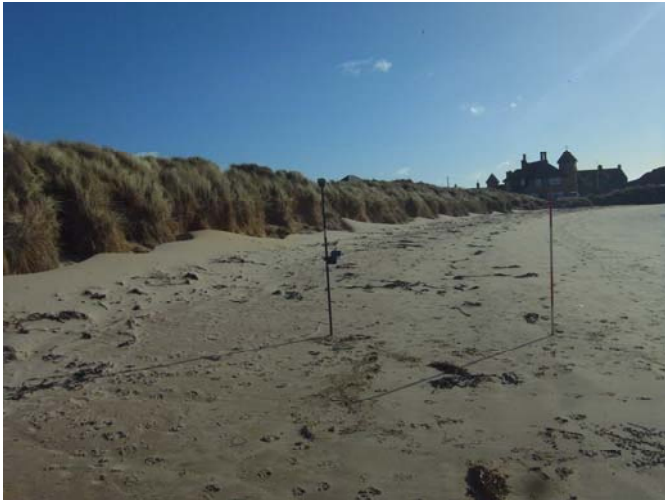
Plate 4 – Survey photograph 1aBTBC33\_20150310\_E4.JPG

Survey Date	Description of Changes Since Last Survey	Interpretation
<p><b>March 2015</b></p>	<p><b>Beach Profiles:</b></p> <p>Beadnell Bay is covered by five beach profile lines for the Partial Measures survey (Appendix A). The previous survey was undertaken for the Full Measures survey in autumn 2014.</p> <p>Profiles <b>1aBTBC33</b> and <b>1aBTBC34</b> are located to the north of Beadnell Bay, in Beadnell Harbour. Profile <b>1aBTBC37</b> is located further south towards the outfall of Brunton Burn/Long Nanny.</p> <p>At <b>1aBTBC33</b>, the beach profile shows the dune to have accreted, however, this is explained in the topographic survey report, which notes '<i>middle of dunes missing due to dense vegetation [which blocked access]</i>'. Beach levels at the toe of the dune have increased, which appears to be wind-blown material (refer to Plates 4 and 5). Seaward of a chainage of 60m, beach levels have fallen across the profile in the region of 0.2m to 0.3m.</p> <p>At profile <b>1aBTBC34</b>, beach levels have increased at the toe of the dune in the region of 0.4m, so that the dune face slopes more gently to the beach. Otherwise, the beach has fluctuated across the profile by various amounts, ranging from just over 0m to 0.2m.</p> <p>At <b>1aBTBC37</b>, the dunes have remained stable since the last survey but the dune face has advanced (see Plate 7). Immediately seaward of the dune toe to a chainage of 100m, beach levels have fallen by approximately 0.2m, but seaward of there they have increased by approximately 0.2m. This suggests a cross-shore movement of sand across the profile, particularly from the upper beach to the dune face.</p> <p>Profiles <b>1aADC01</b> and <b>1aADC02</b> are located along the frontage to the south of the outfall of Brunton Burn/Long Nanny. The dunes at 1aADC01 and 1aADC02 have not changed form or position. At <b>1aADC01</b> beach levels at the dune toe and on the upper beach have increased by approximately 0.4m, and seaward of a chainage of 376m, beach levels have fallen by 0.4m. This suggests that material has been transferred from the lower to upper beach.</p> <p>At profile <b>1aADC02</b> beach levels at the dune toe and on the upper beach have increased by approximately 0.2m, and seaward of a chainage of 70m, beach levels have fallen by 0.2m. This suggests that material has been transferred from the lower to upper/middle beach.</p>	<p>Along the length of Beadnell Bay, the dunes have remained stable since the last survey.</p> <p>The lower dune face/dune toe and upper beach has accreted to form a more gently sloping dune face. Survey photographs indicate this material was deposited by wind-blown processes. Beach levels have changed along the length of the bay with a pattern of consistent steepening caused by increased levels at the upper/middle beach and a drop in levels at the lower beach. This suggests cross-shore transfer of material during the autumn/spring months.</p> <p><b>Longer term trends:</b> Along the length of Beadnell Bay, the dunes are of a similar form to those observed in the past. The changes in beach profile form and position observed since the last survey are generally within the bounds of previous surveys.</p>

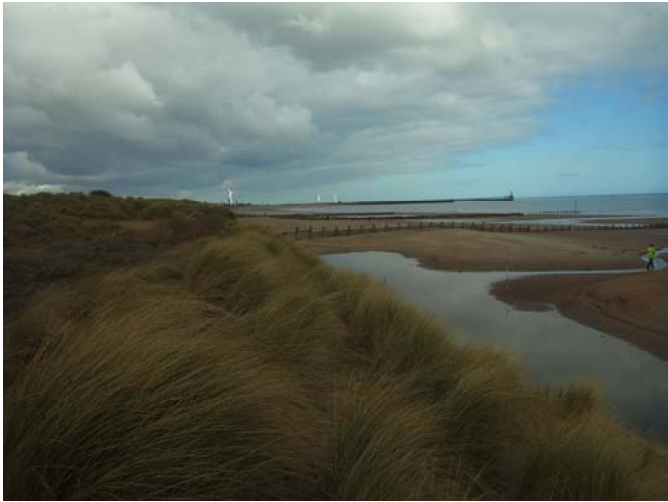
Plate 8 – Survey photograph 1aBVBC03\_20150324\_N6.JPG

<b>Survey Date</b>	<b>Description of Changes Since Last Survey</b>	<b>Interpretation</b>
	130m and 170m, where a former runnel has been infilled.	this is reflected with the presence of a large body of ponded water at the top of the beach (as shown in Plate 8).
